**Municipal Facilities Assessment-2011  
Capital Improvement Committee  
Hanover, Massachusetts  
September 2011**

# Building Study

# **Town of Hanover - MUNICIPAL FACILITIES ASSESSMENT - 2011**

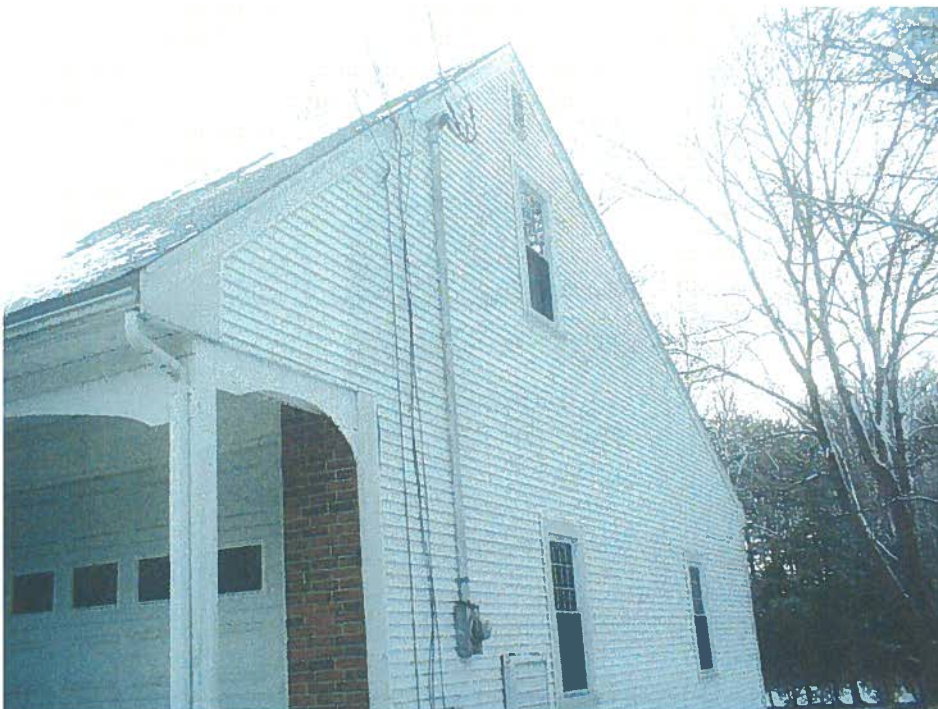
Exterior, east corner of building; vinyl siding; fair condition. Electrical meter.

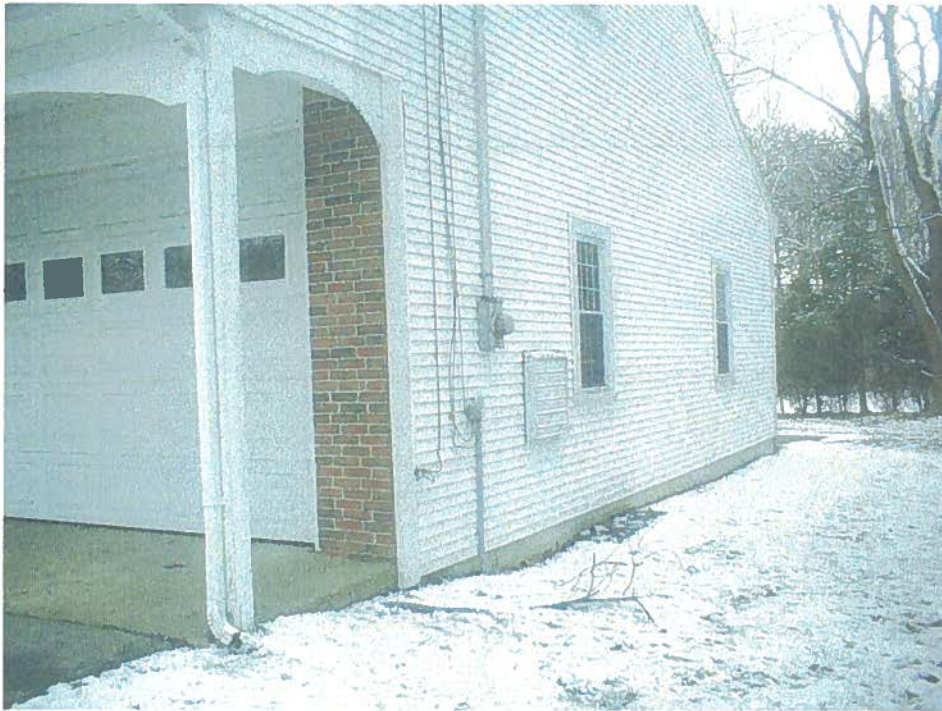
Exterior, detail of downspout drainage. Loose data/phone wiring.

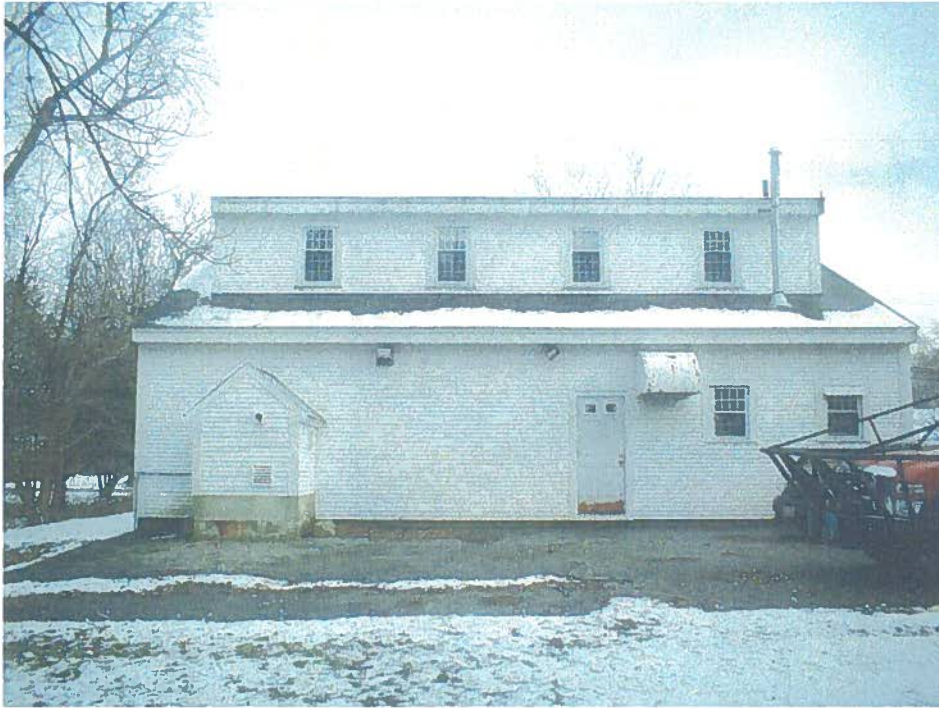
Exterior, back northwest facing facade; paved parking area. Rusty Door.

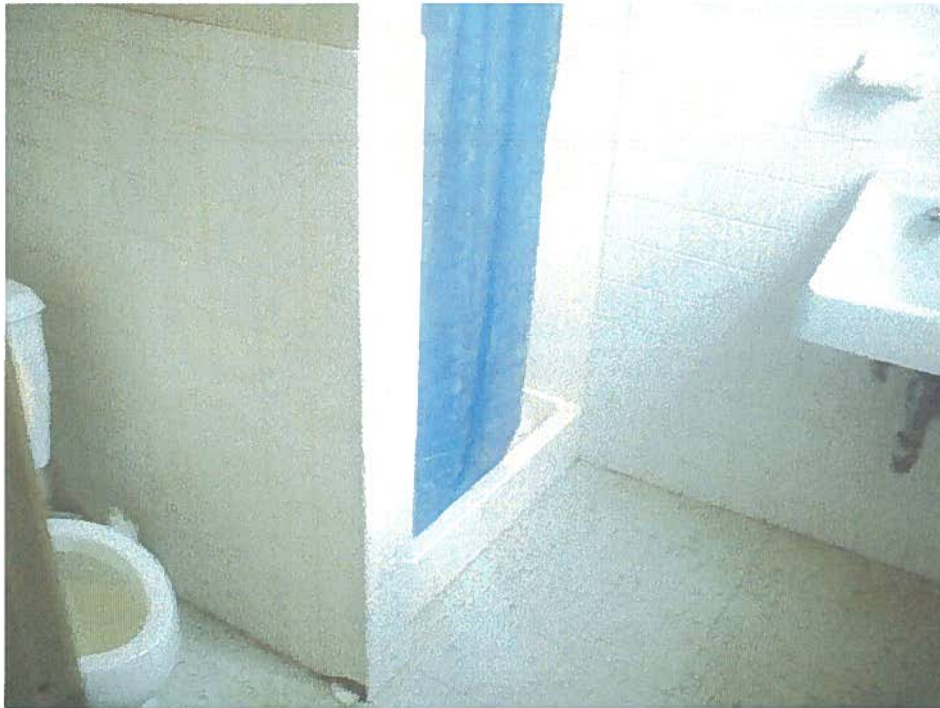
Interior, bathroom on first floor; non-accessible.

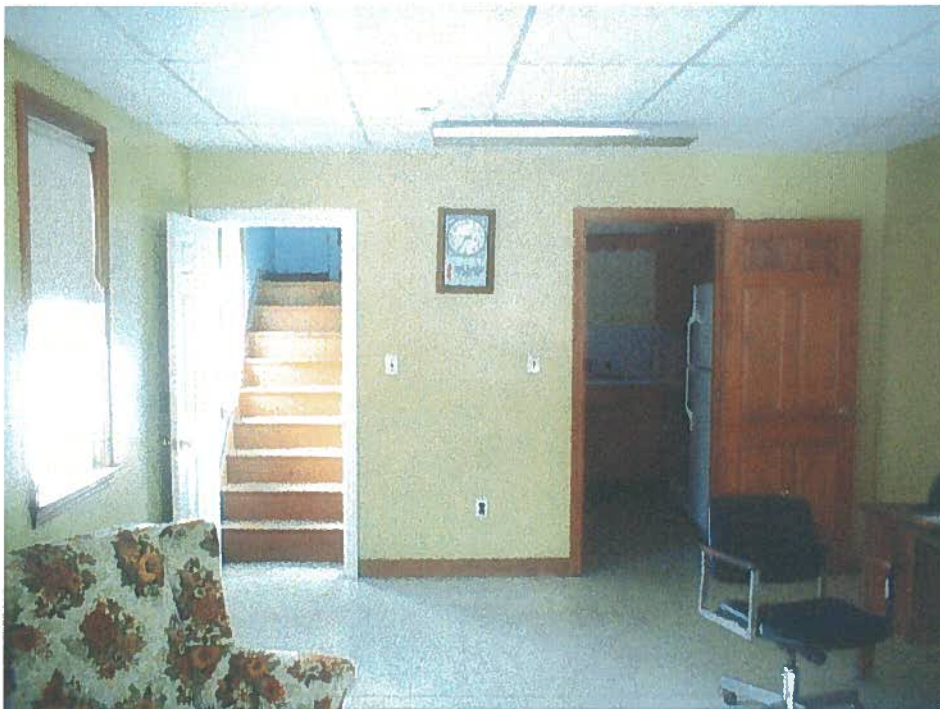
Interior, common room in first floor. Kitchen is on the right, non-accessible.

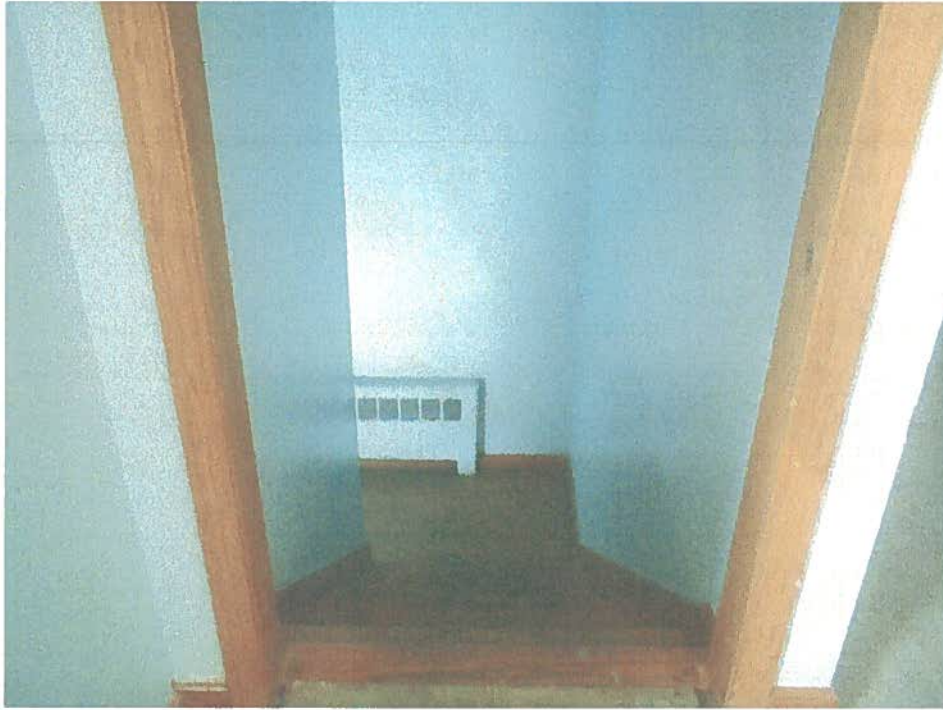
Interior, looking down stairway from second floor; no handrails.

- Remove asbestos-containing floor tile and replace with new resilient tile.
- Remove deteriorated perimeter fence around property.
- Install handrails at stairs.
- Install security system with protection at ground floor doors and windows.
- Install emergency lighting.
- Install improved exhaust air system at vehicle bays.

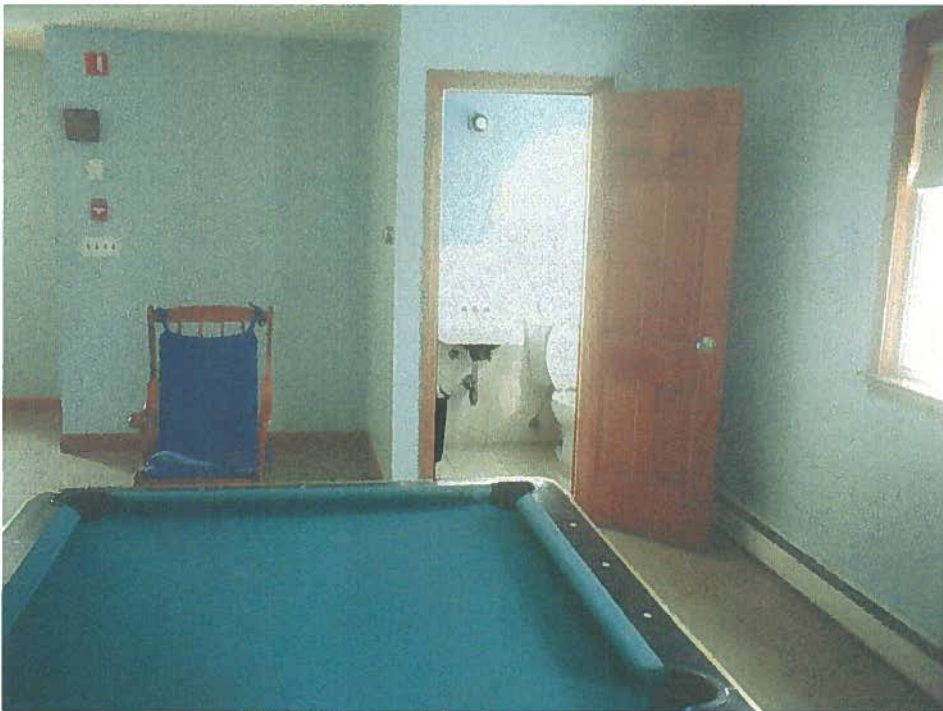
Interior, recreation room on second floor; non-accessible half-toilet.

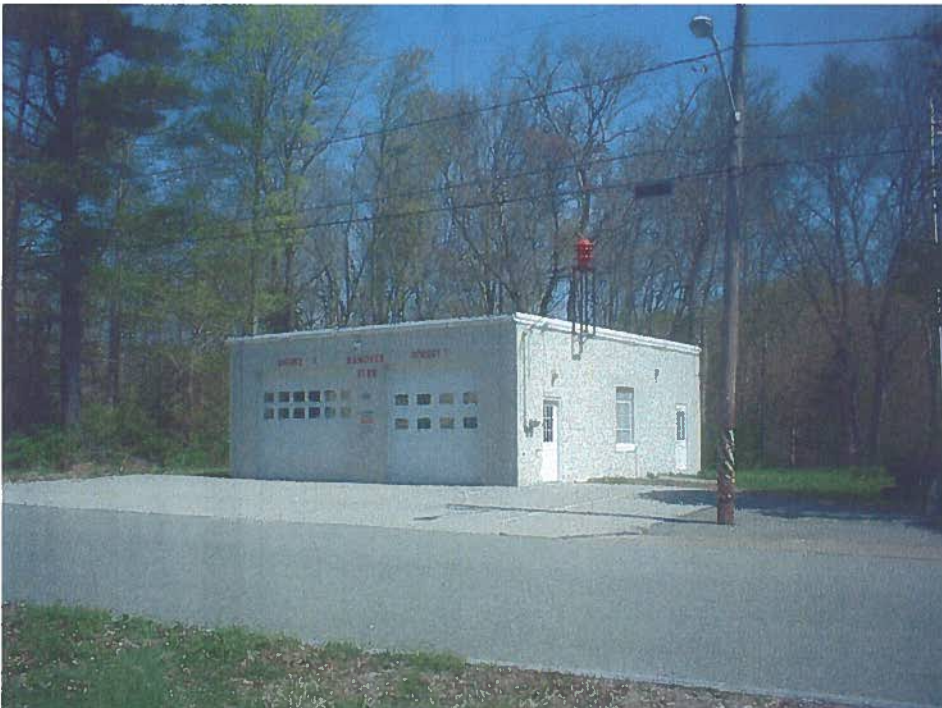
Exterior view of south corner - utility pole position causes problems.

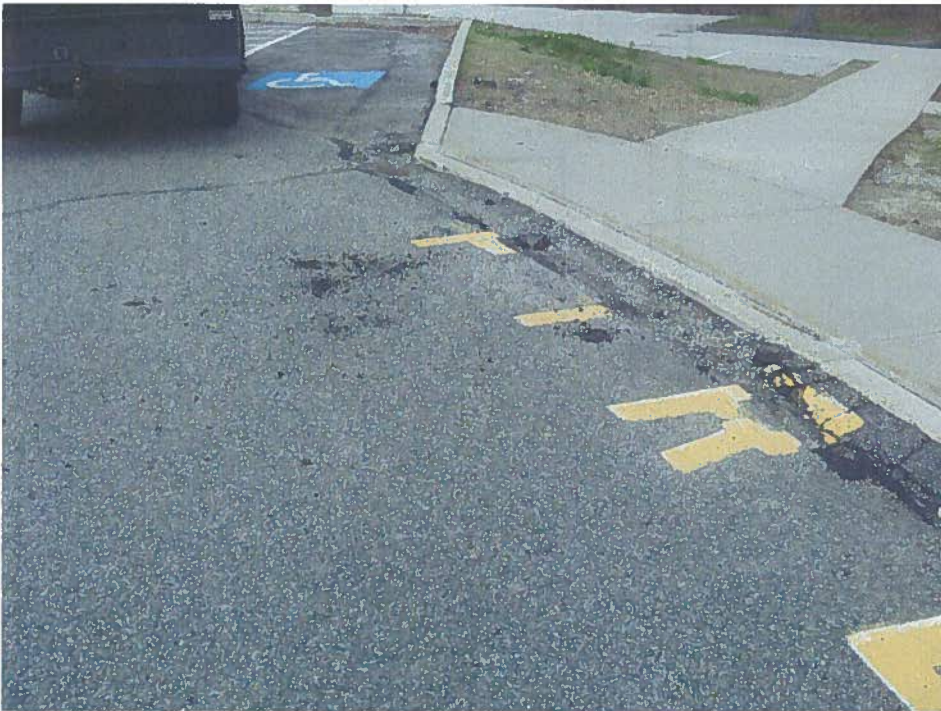
Pavement deterioration at fire lane.

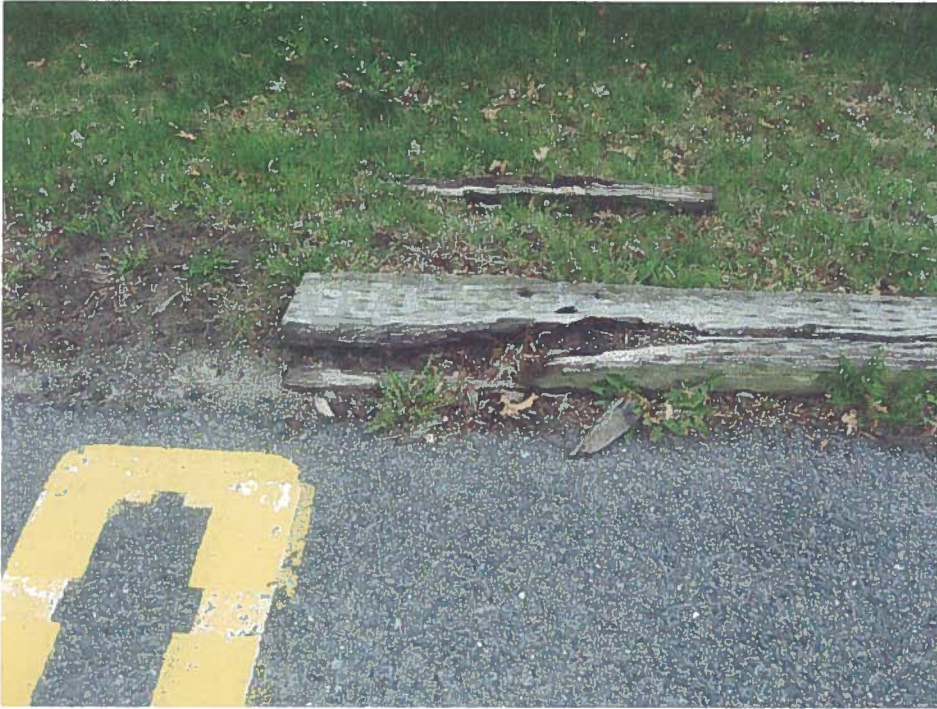
Deteriorated wood, landscape timber

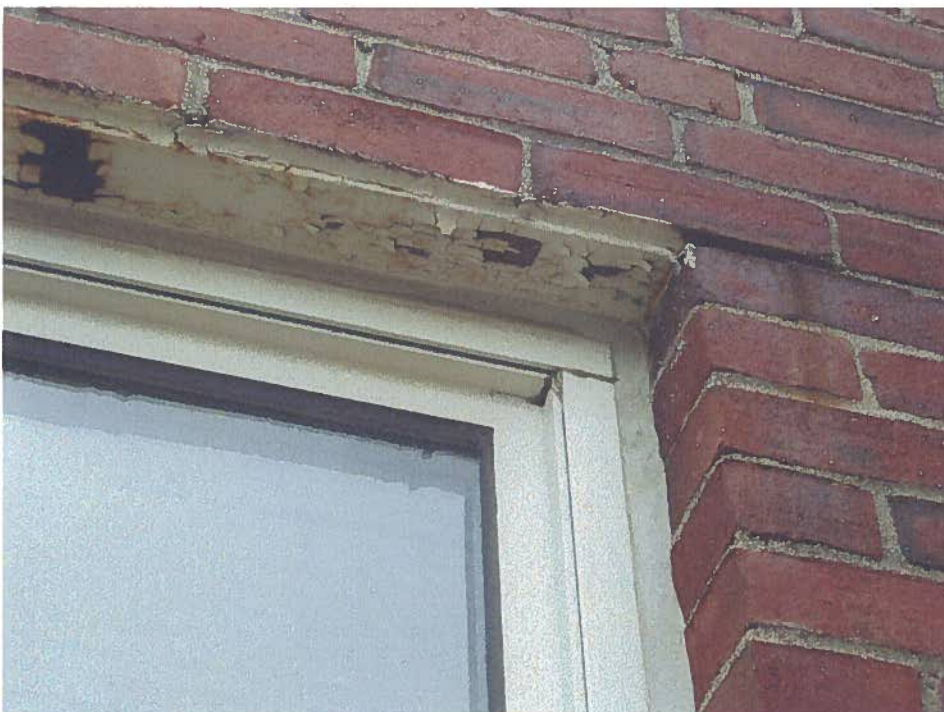
Deterioration at window lintel.

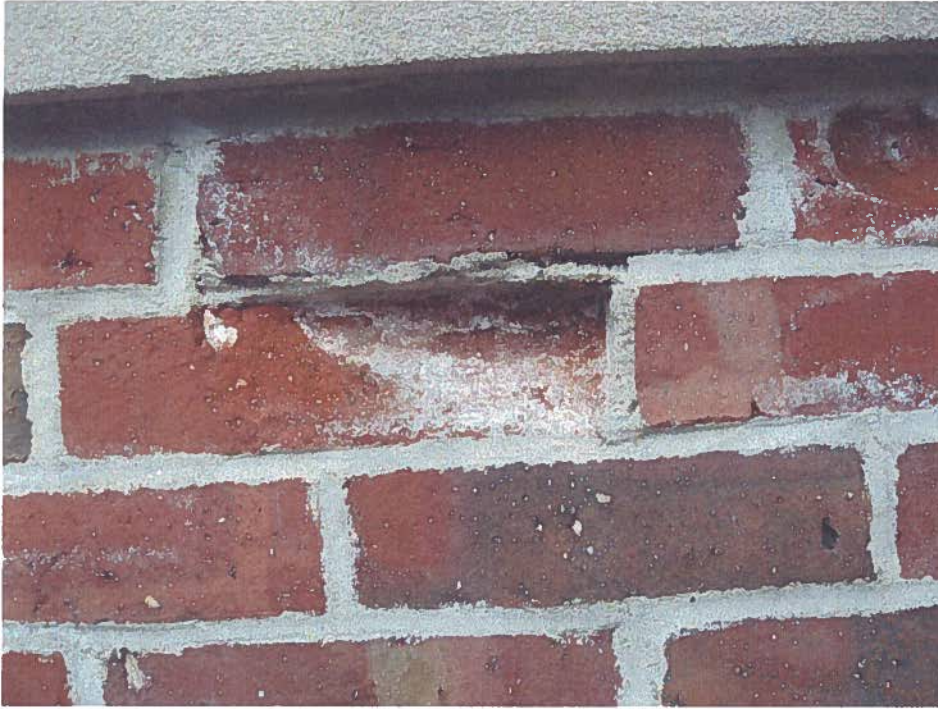
Damaged brickwork.

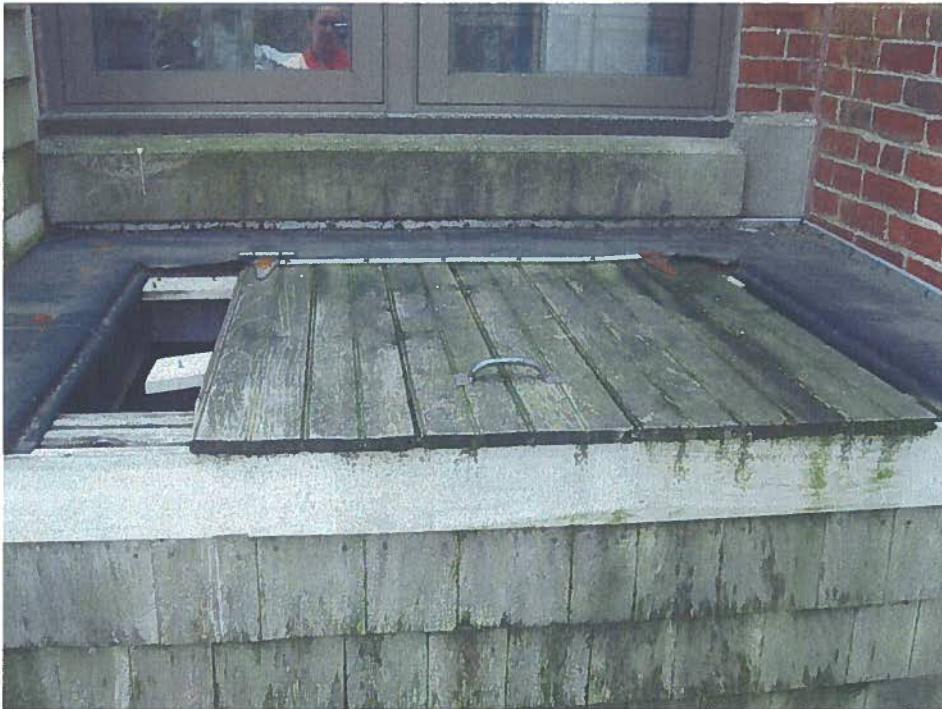
Broken cover.

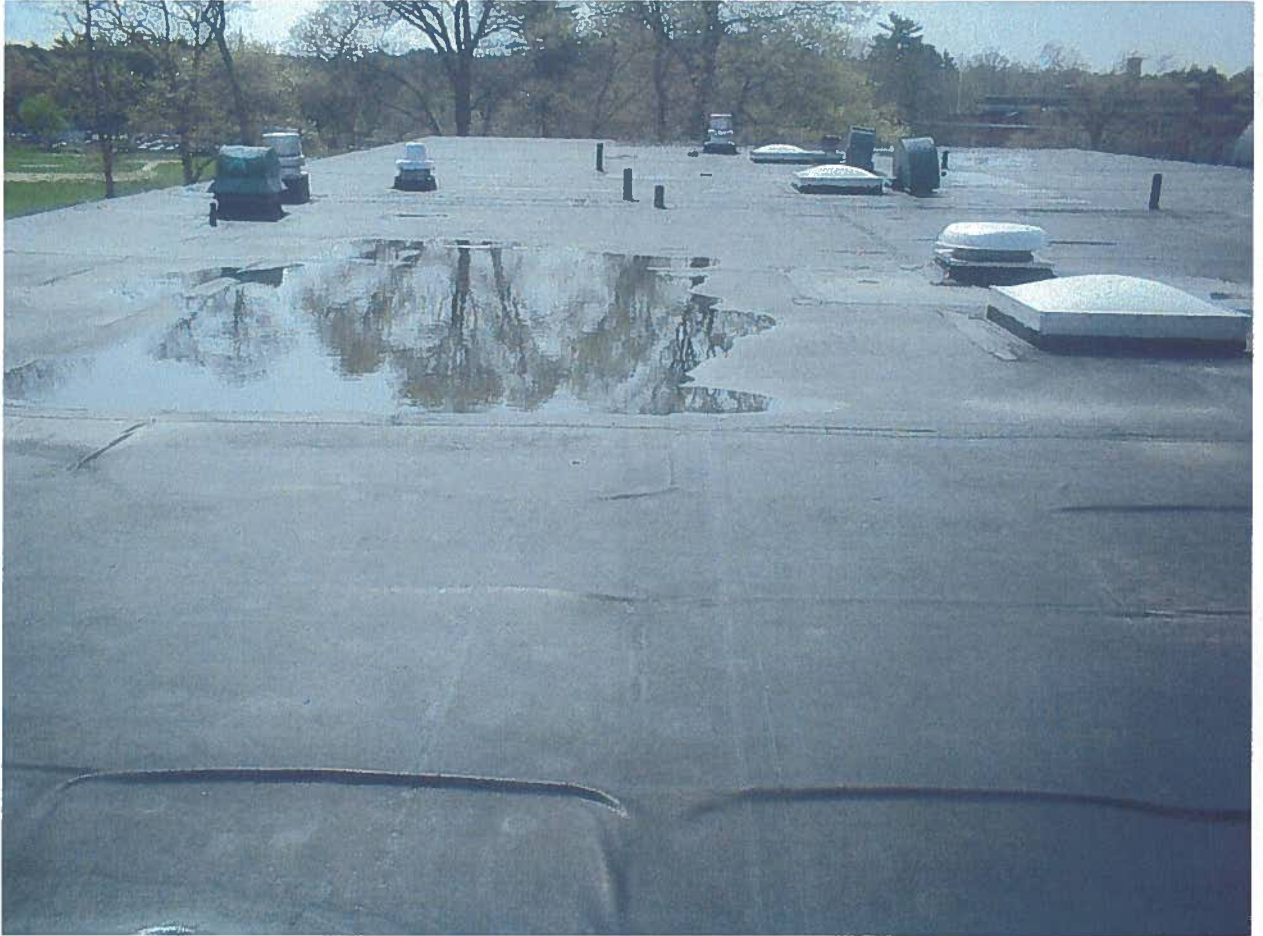
Ponding water on roof.

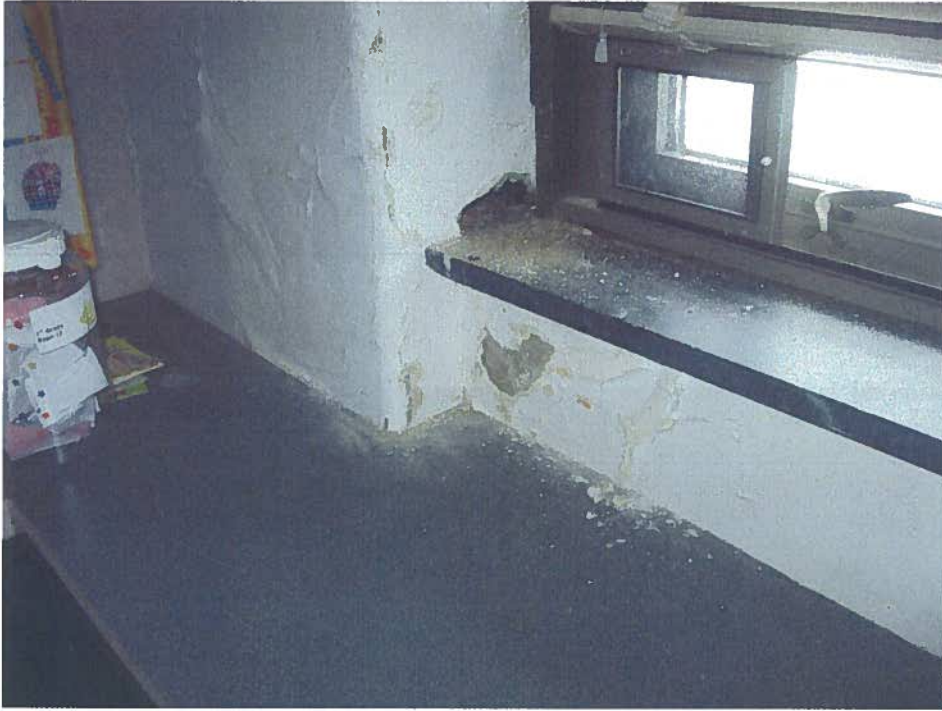
Deterioration near window, water damage

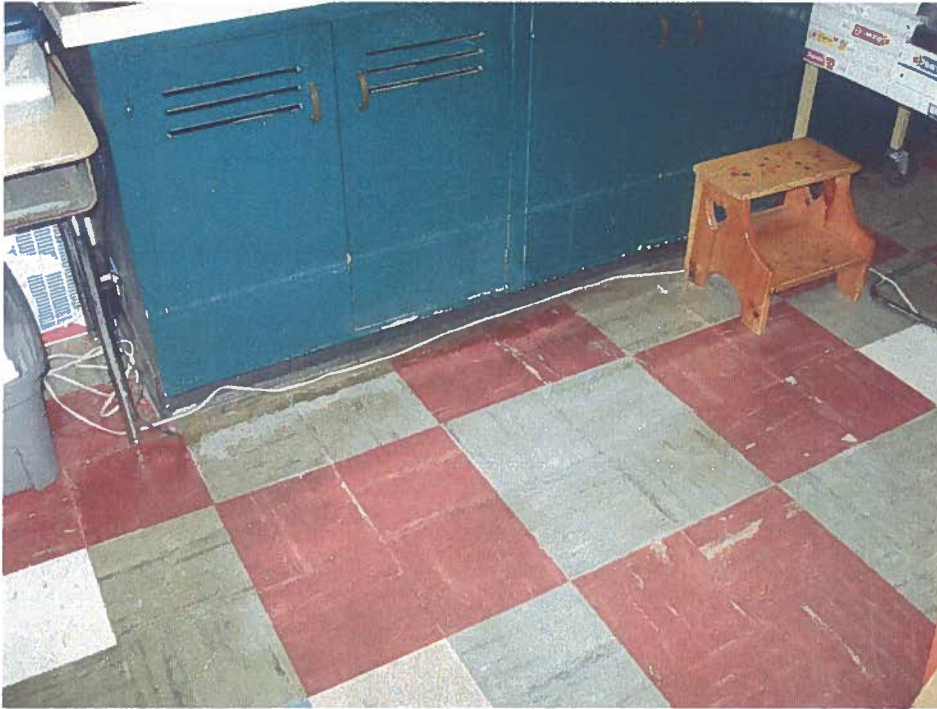
Damaged cabinets.

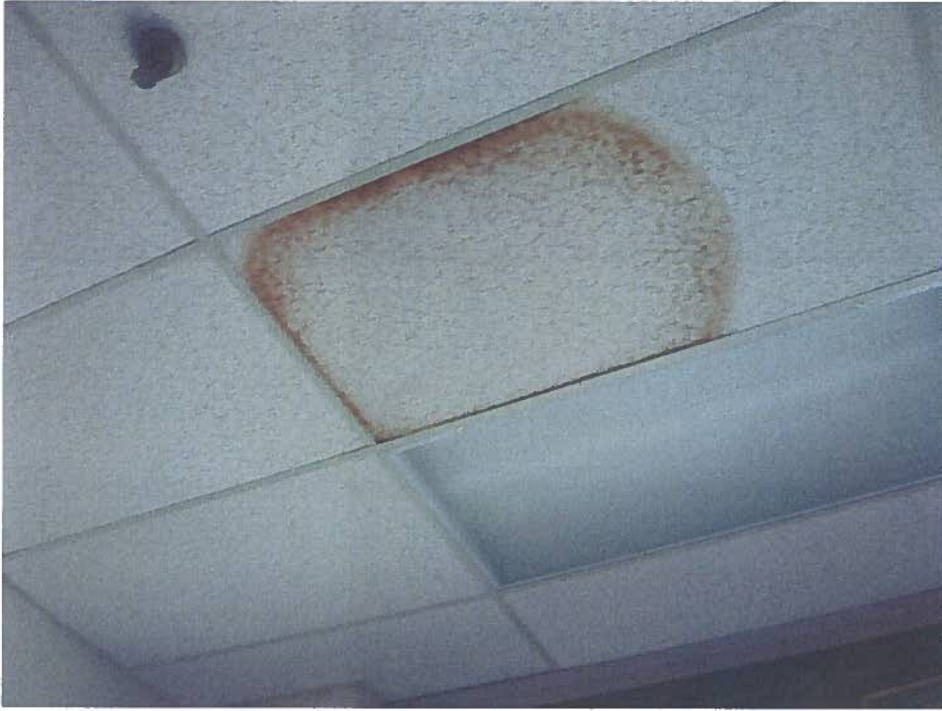
Ceiling showing signs of water damage.

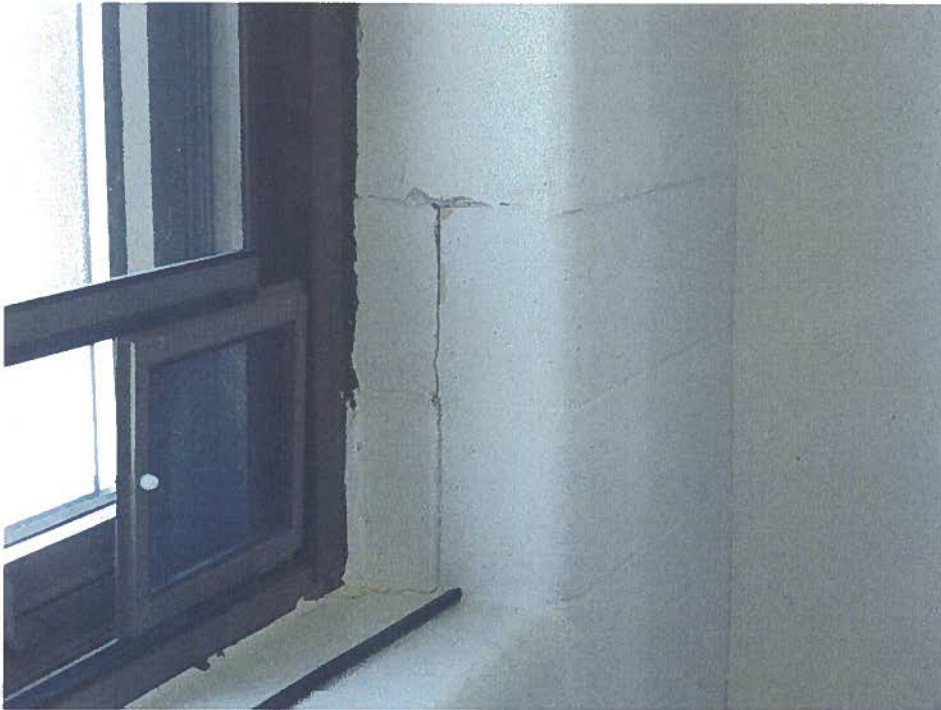
Window detail, cracked plaster.

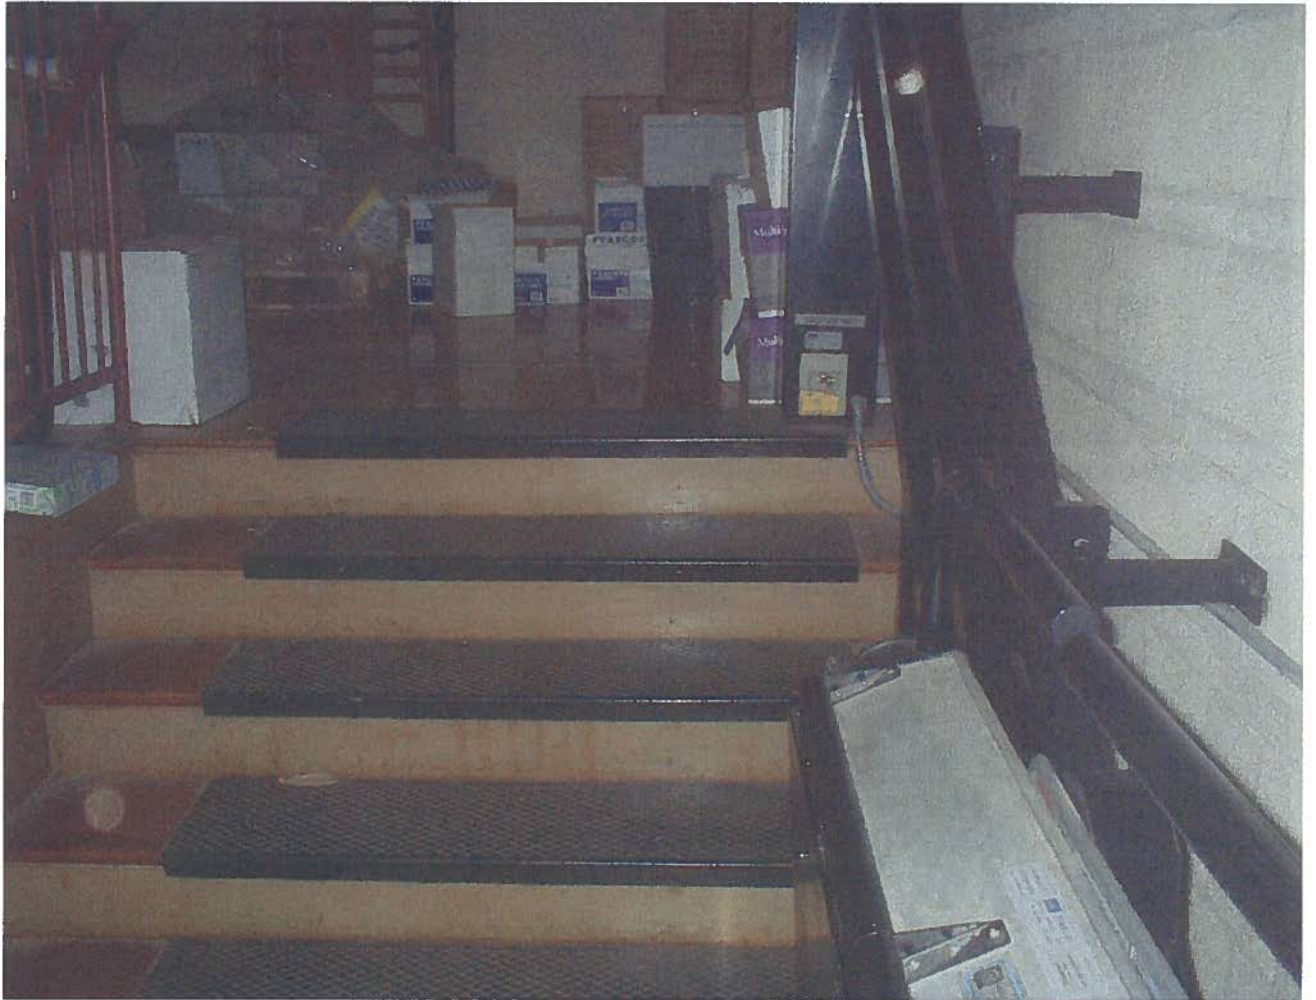
Stair lift to auditorium stage, not accessibility compliant; must go outside auditorium to use lift.

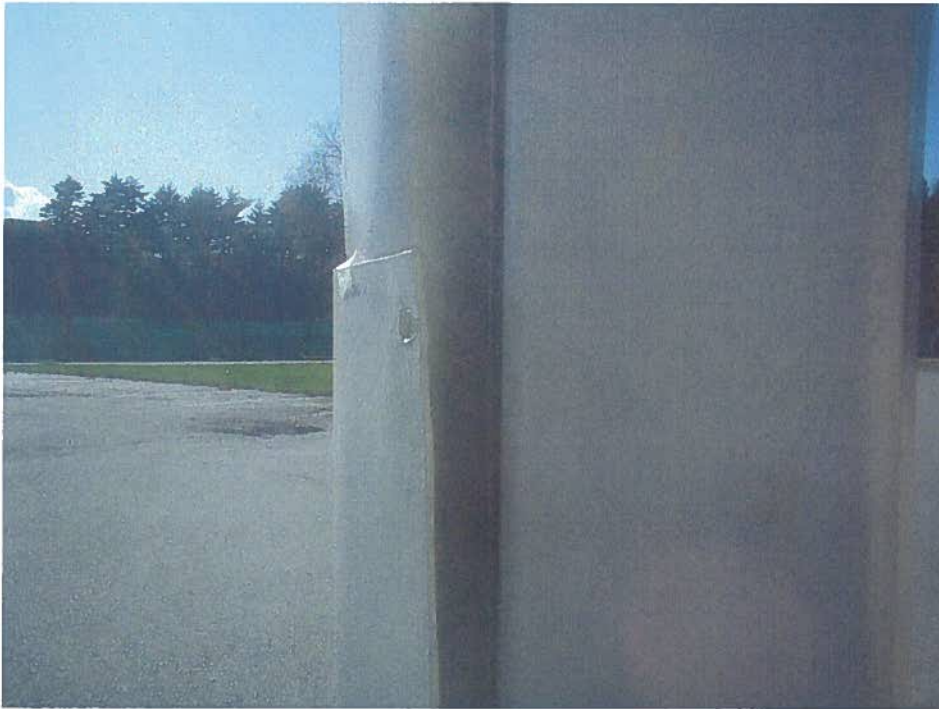
Detail at exterior column- loose guard at downspout.

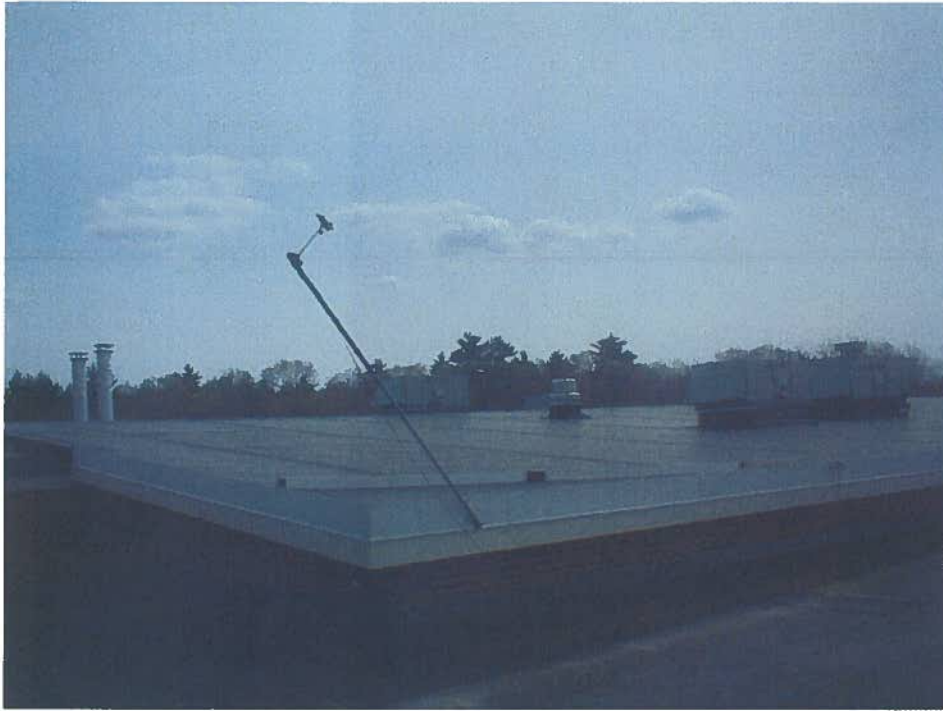
General roofscape - detached support pole.

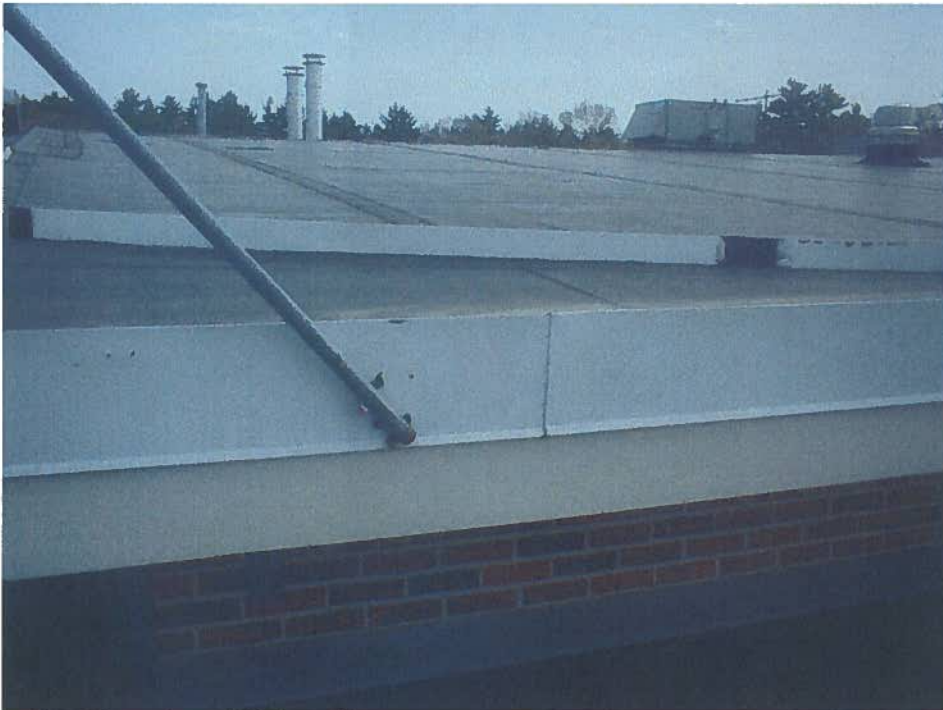
Detail of roofscape - pole mounting has failed.

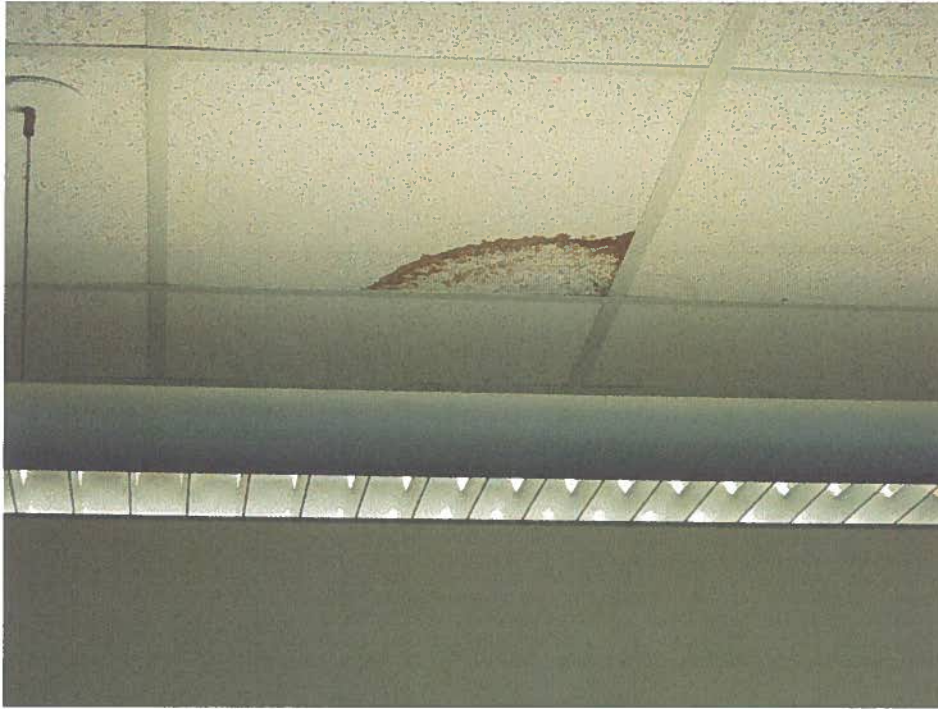
Ceiling tile shows deterioration-water damage.

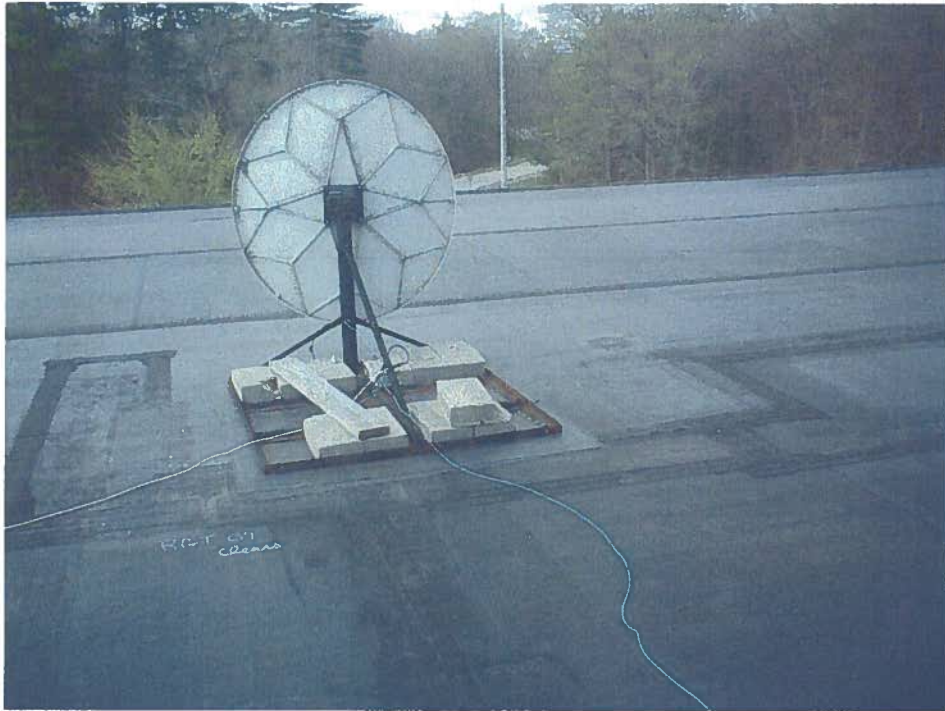
Loose wiring at satellite dish.

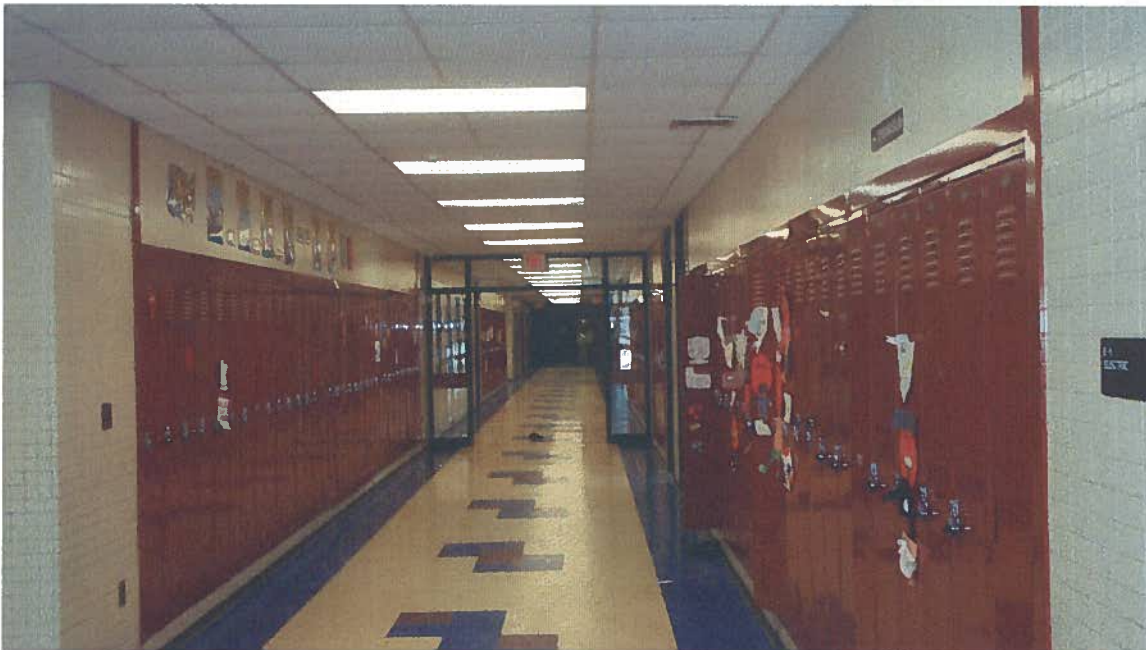
Smoke doors have been removed. Should be reinstalled.

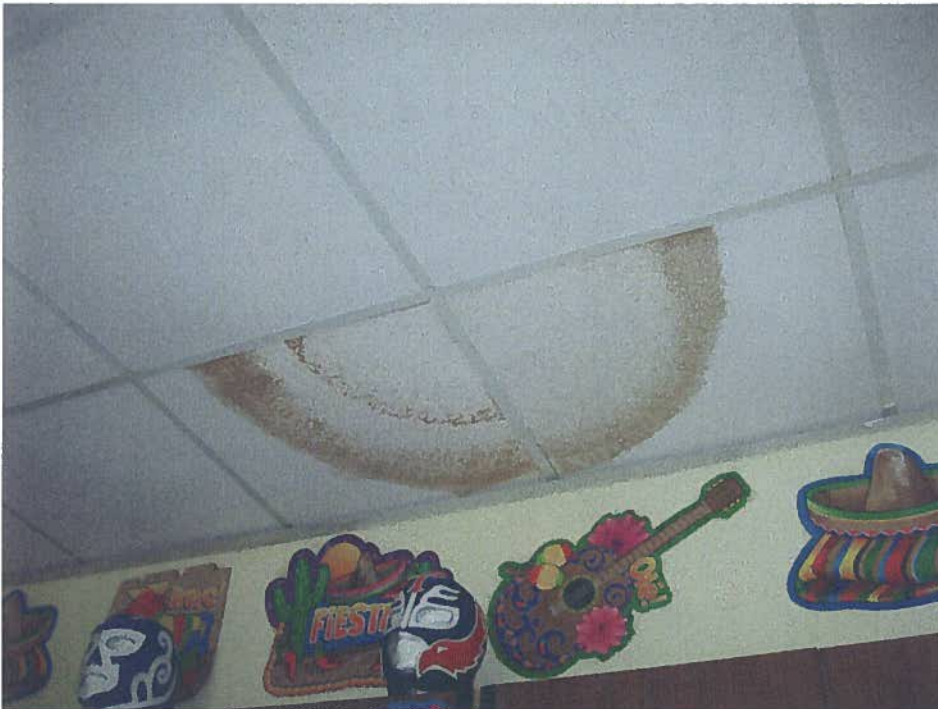
Damage from leaking in ceiling.

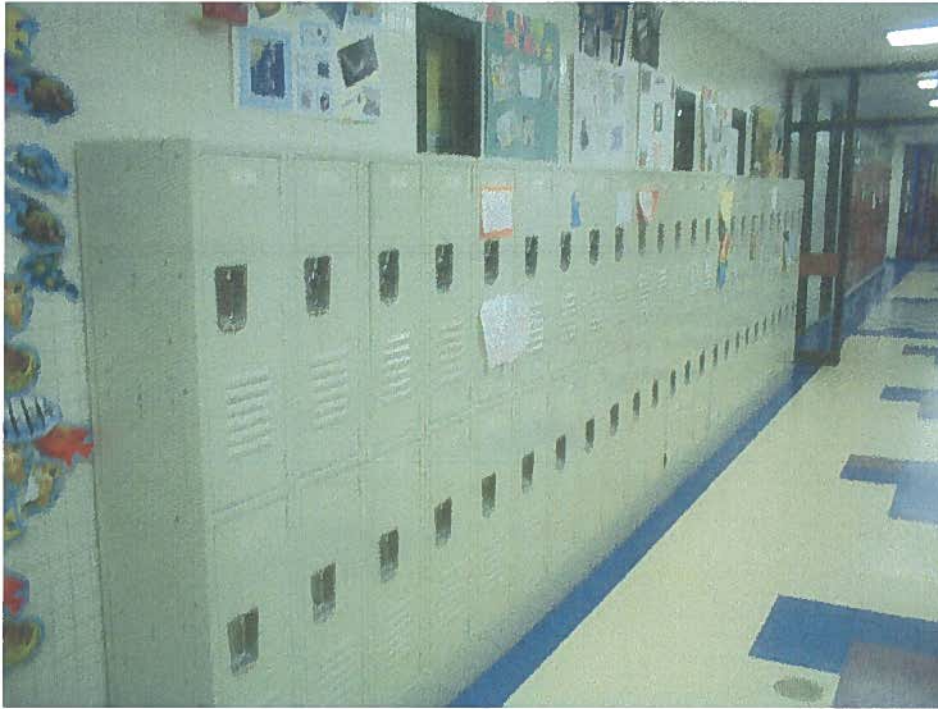
View of lockers blocking doorways (unused doors).

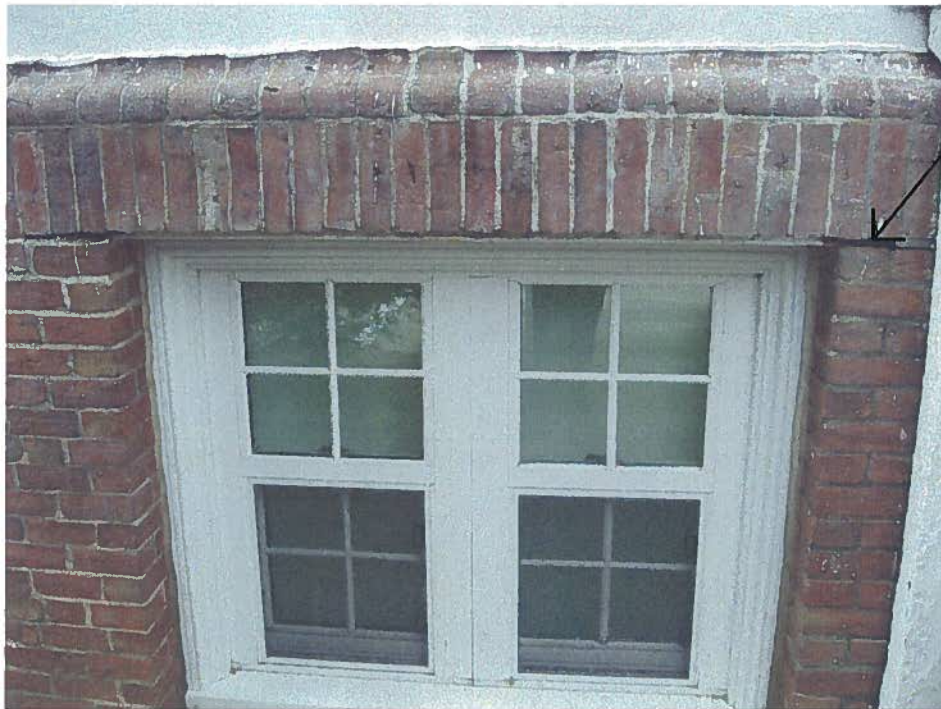
Cracked brick at steel  
lintels, typical

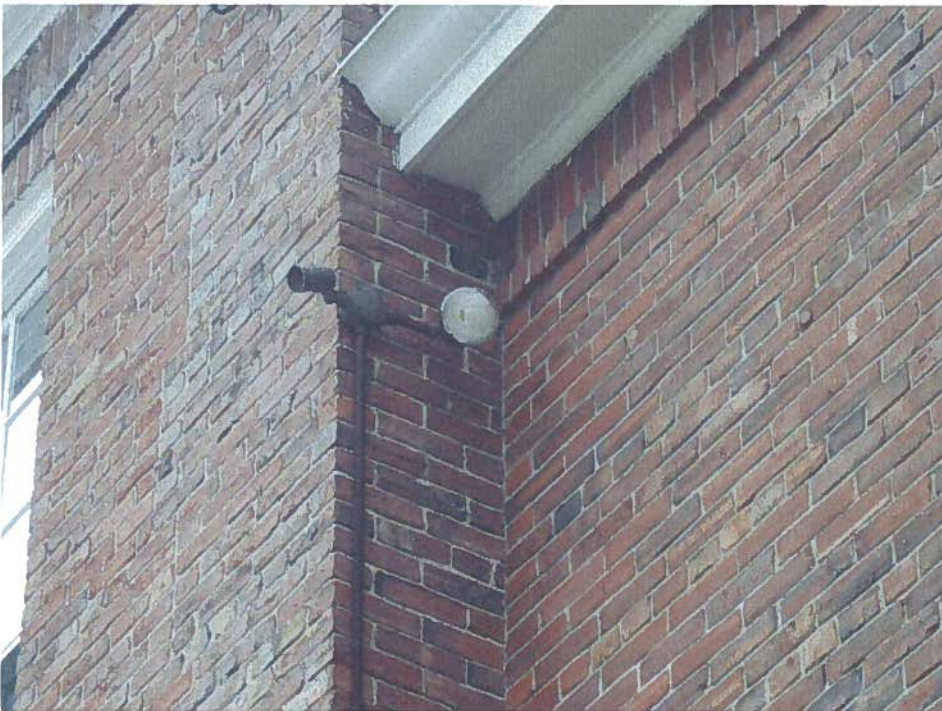
Old exterior light ?, broken fitting

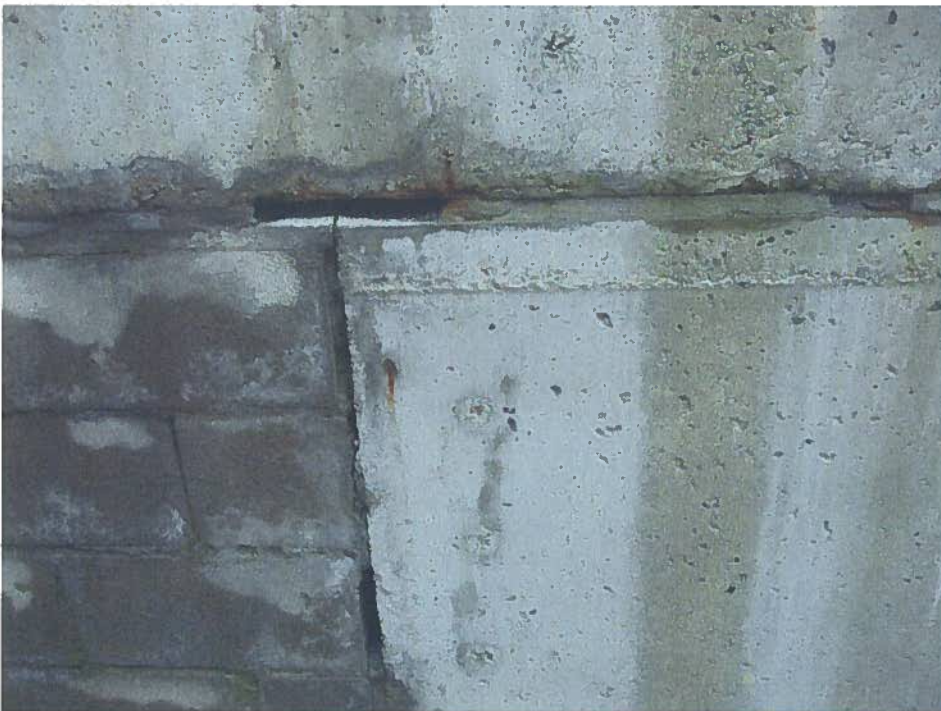
Cracks between block and concrete at steps. This condition was repaired during the summer of 2010 with parging.

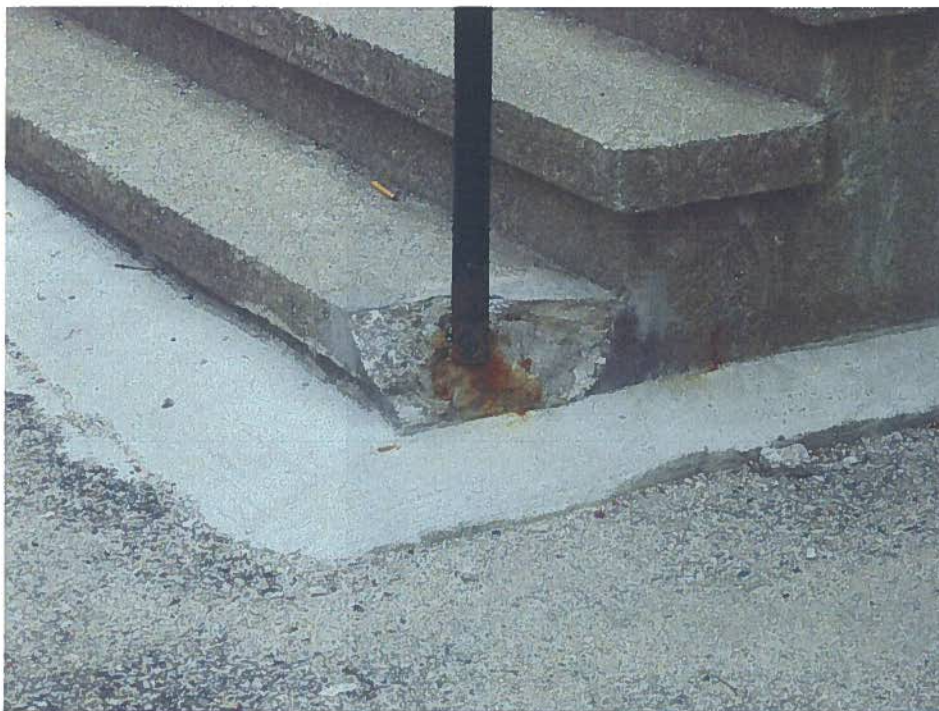
Deteriorating concrete stairs (repaired summer 2010).

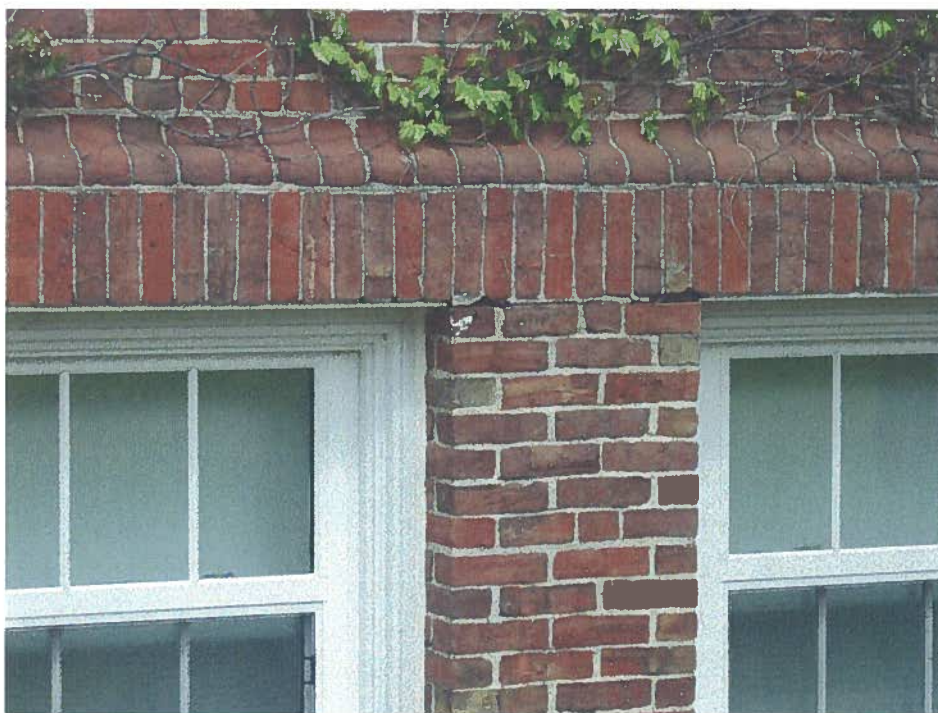
Cracks in brick near windows (lintels).
