**Municipal Facilities Assessment-2011  
Capital Improvement Committee  
Hanover, Massachusetts  
September 2011**

# Building Study

# **Town of Hanover - MUNICIPAL FACILITIES ASSESSMENT - 2011**

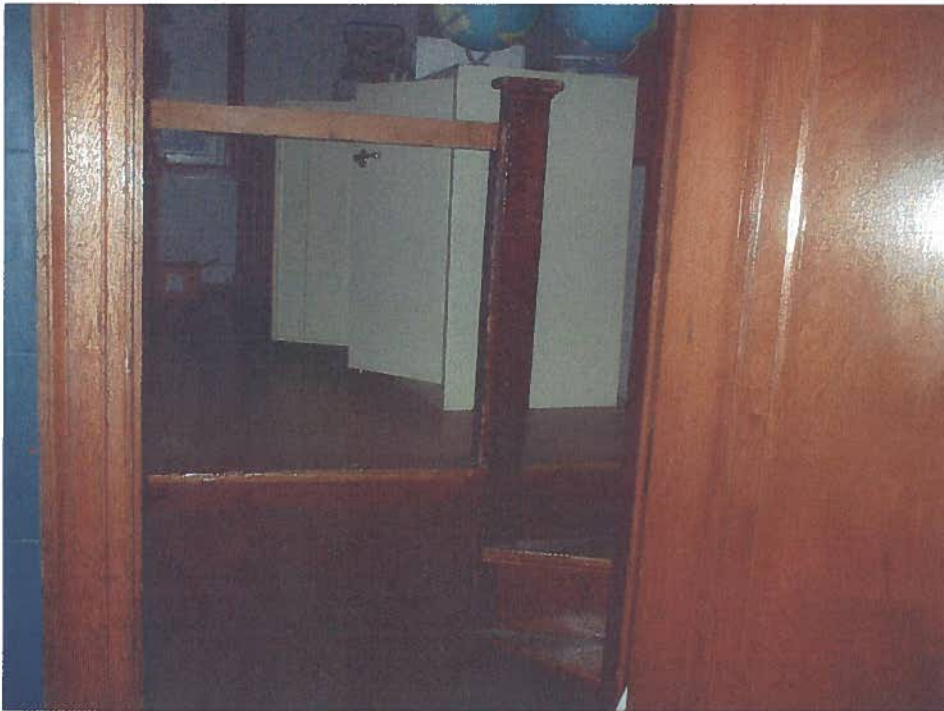
Steps to stage not code compliant. No lift. Missing guard rail balusters.

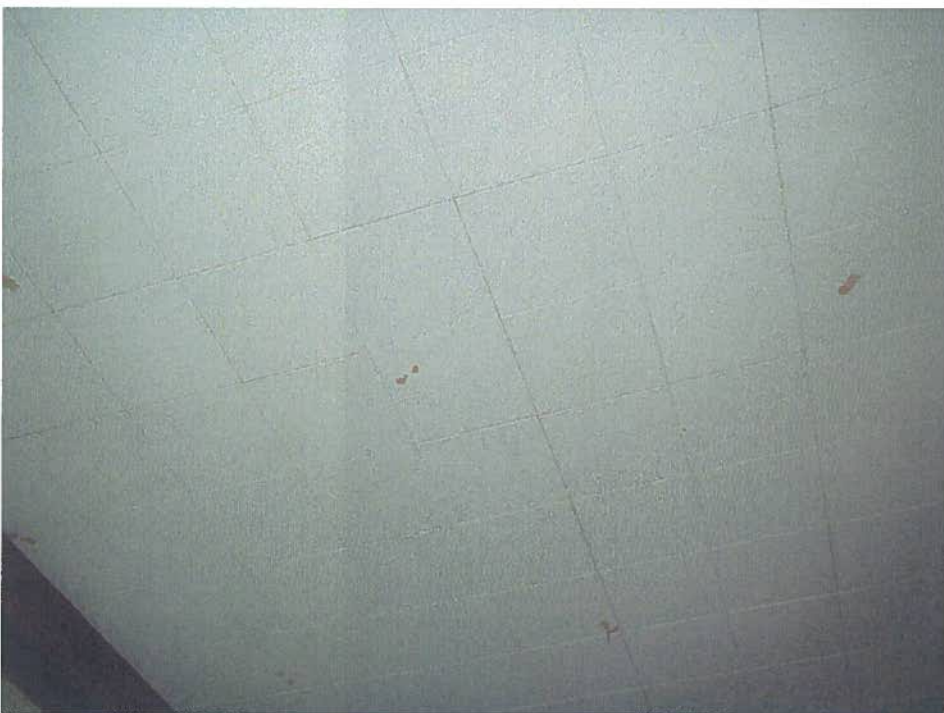
12x12 ceiling tiles reported to have black mastic possibly containing asbestos.

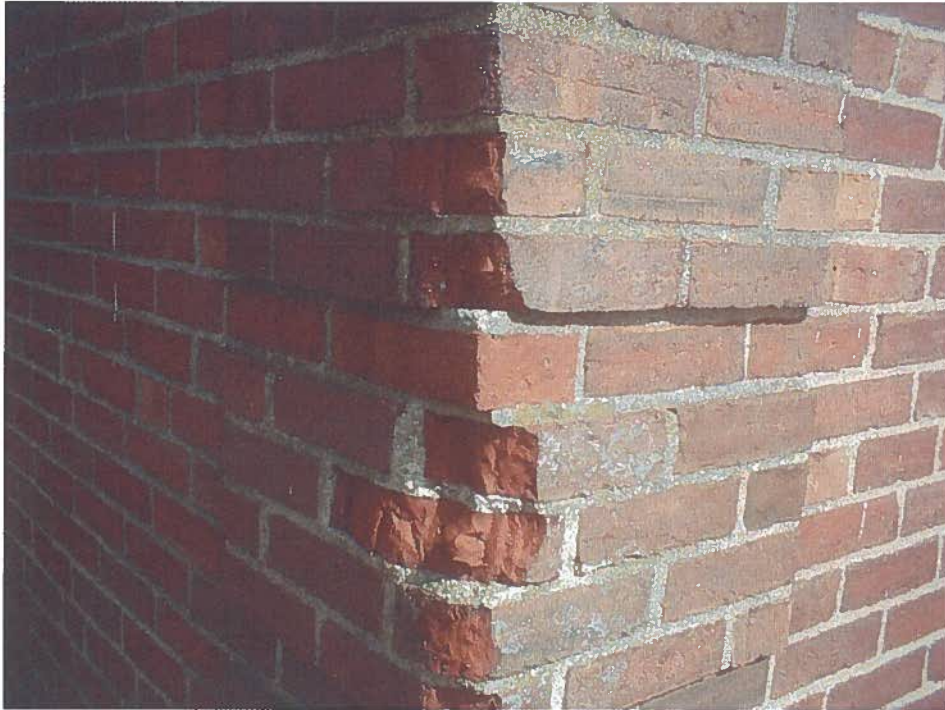
Brick deterioration/damage

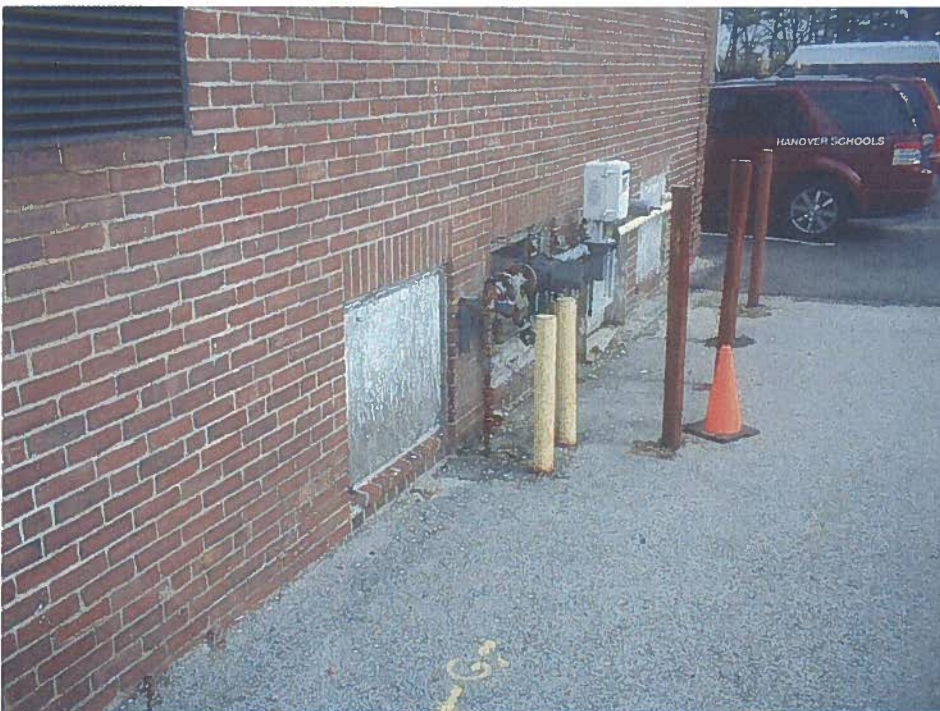
View of the gas entrance piping; minimal protection with widely-spaced bollards.

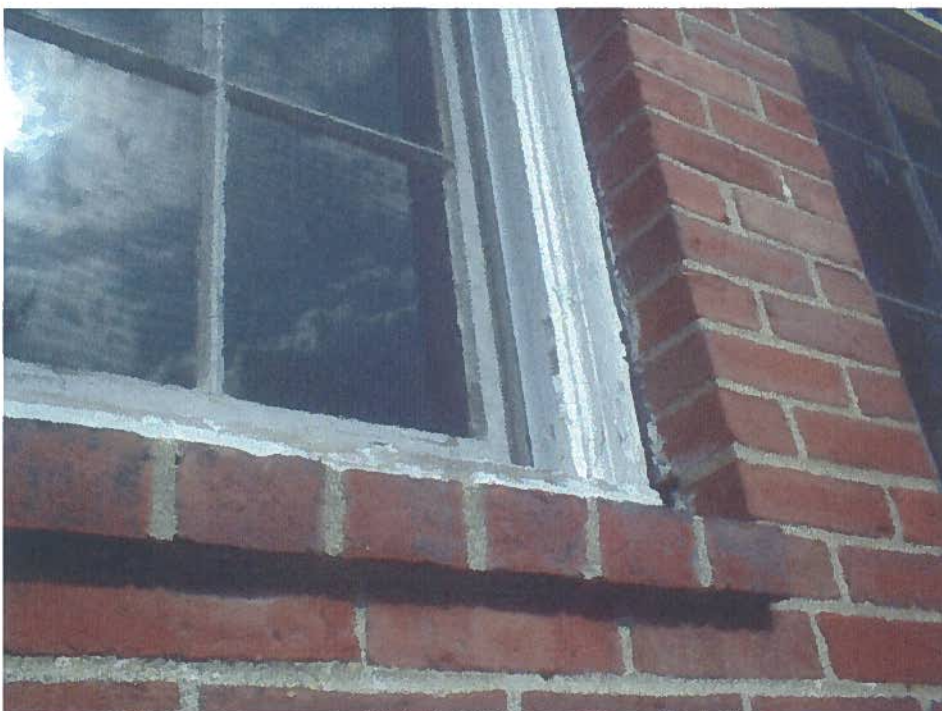
Detail of window condition-deteriorated frames and sash. Loose glazing putty.

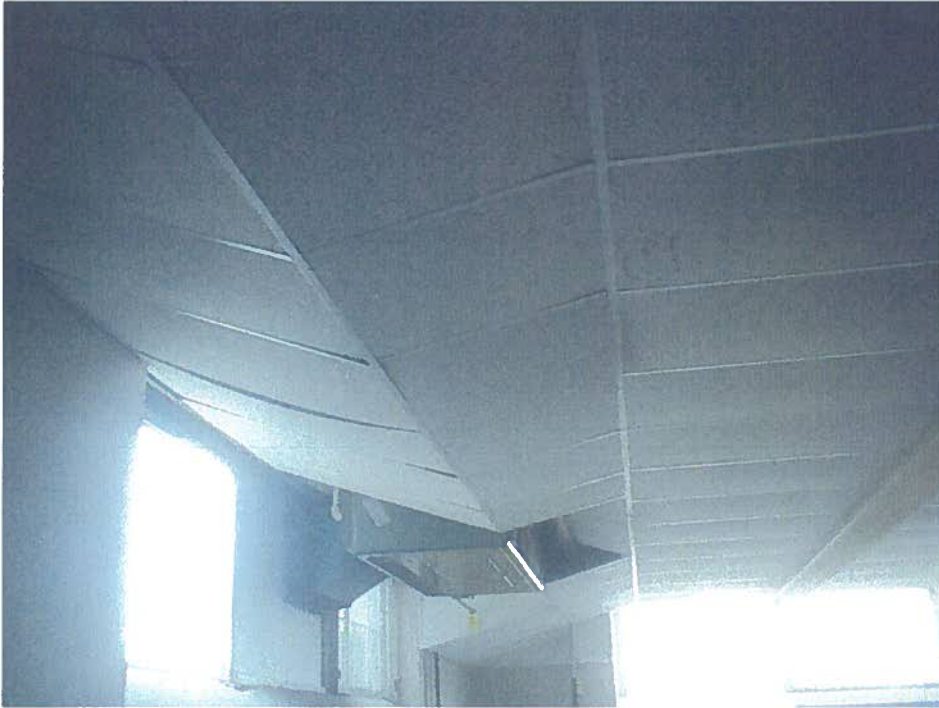
Ceiling detail at windows-poor condition.

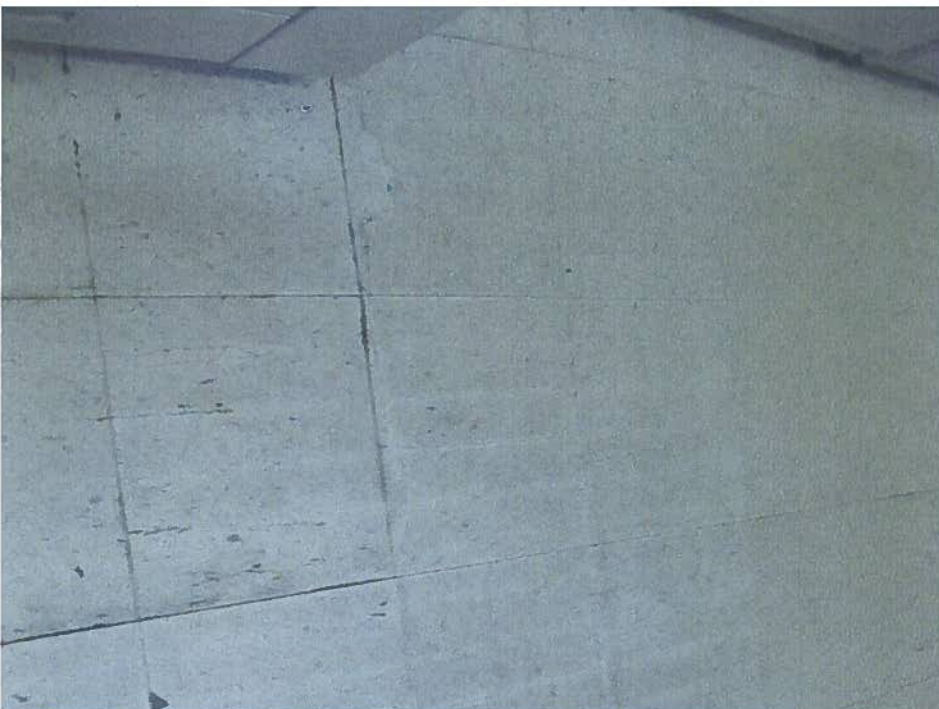
Damaged floor tile.

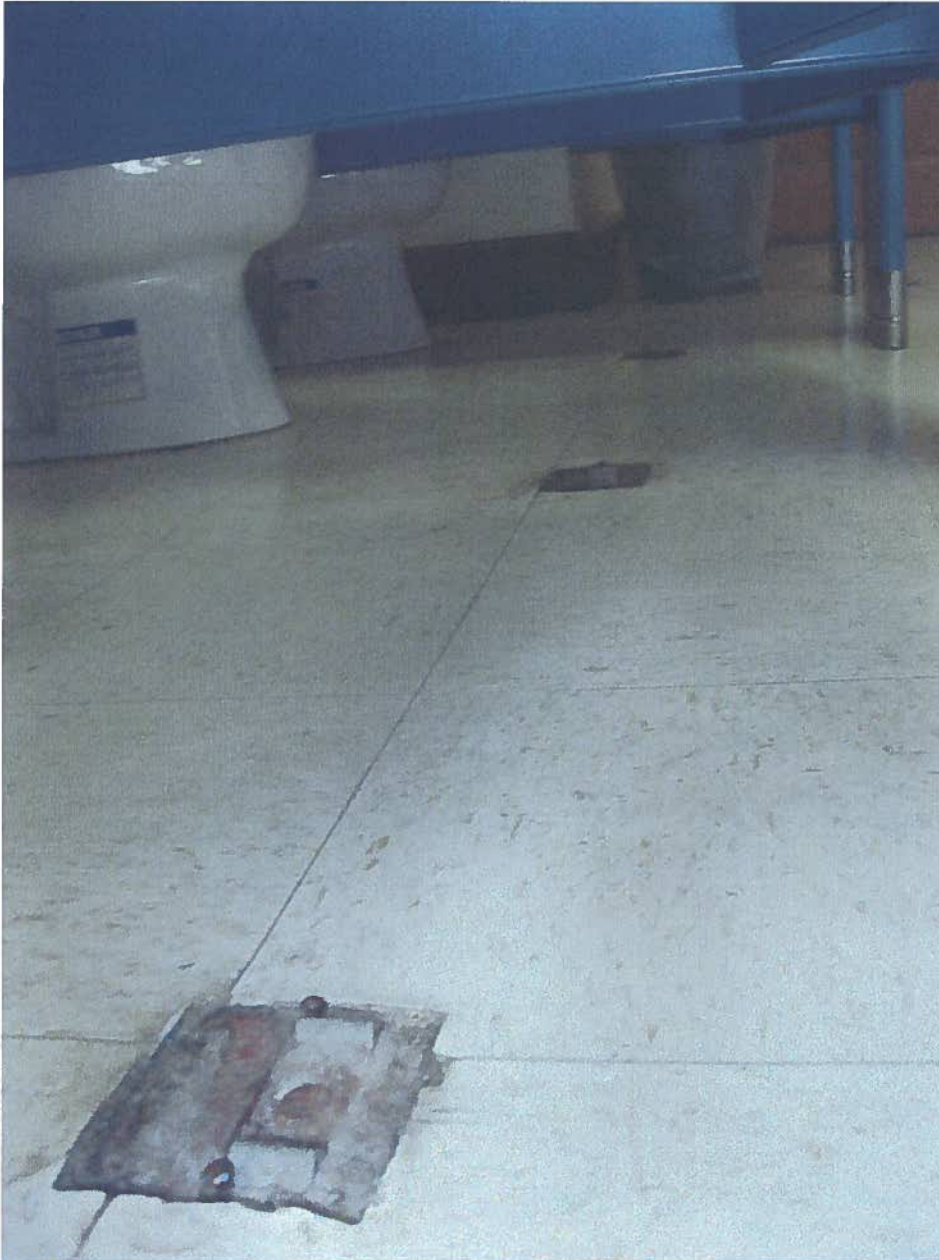
Toilet room floor damaged areas.

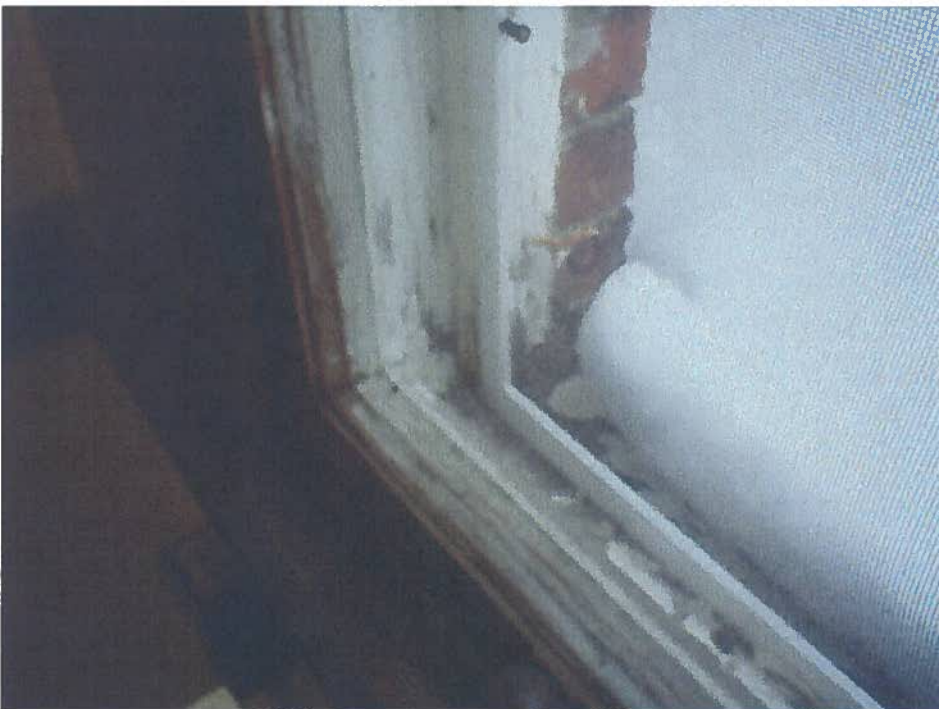
Window closeup shows deterioration.

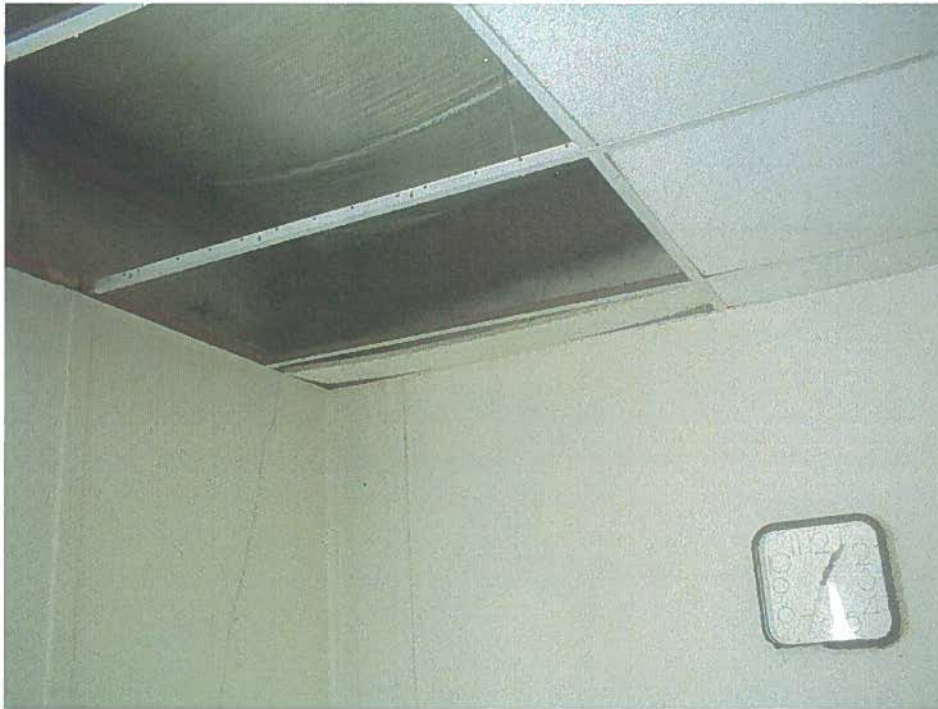
Leak in roof near main entrance; damaged ceiling tiles

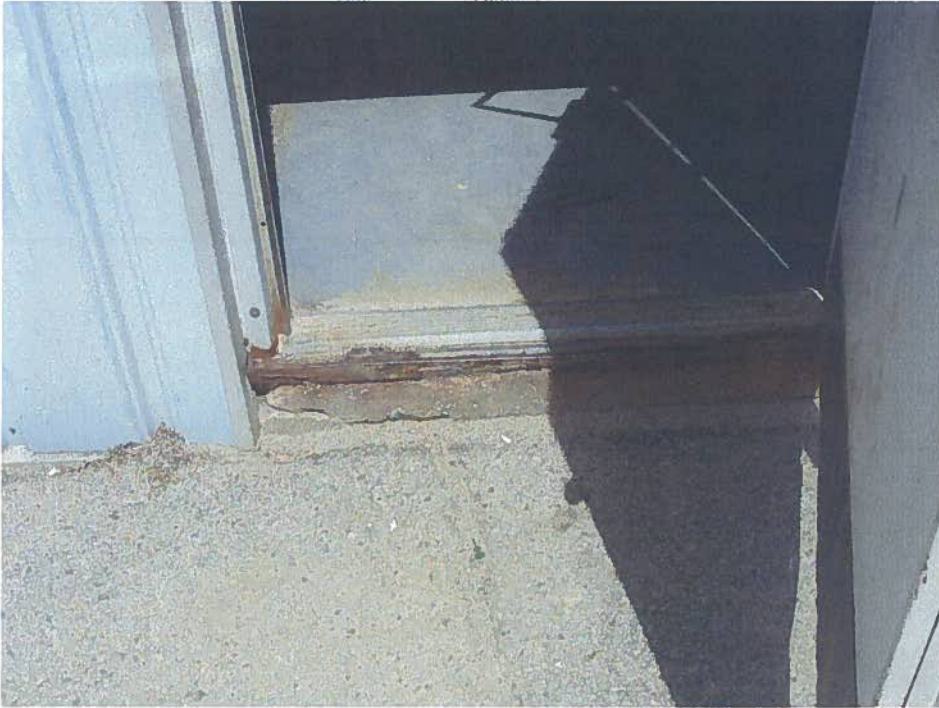
Damage near door.

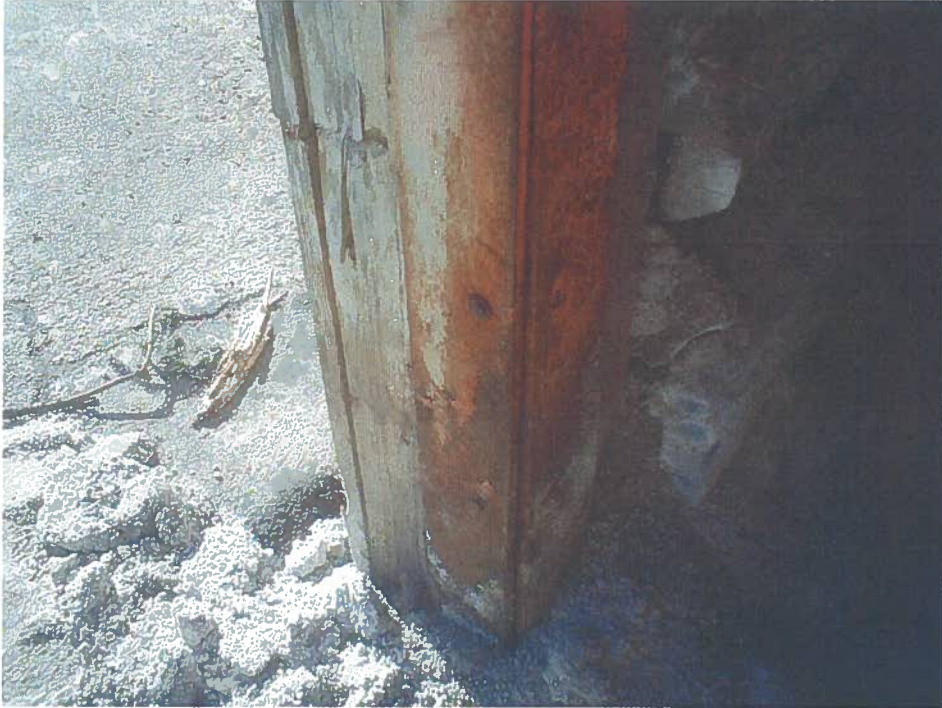
Rust at overhead door-salt shed.

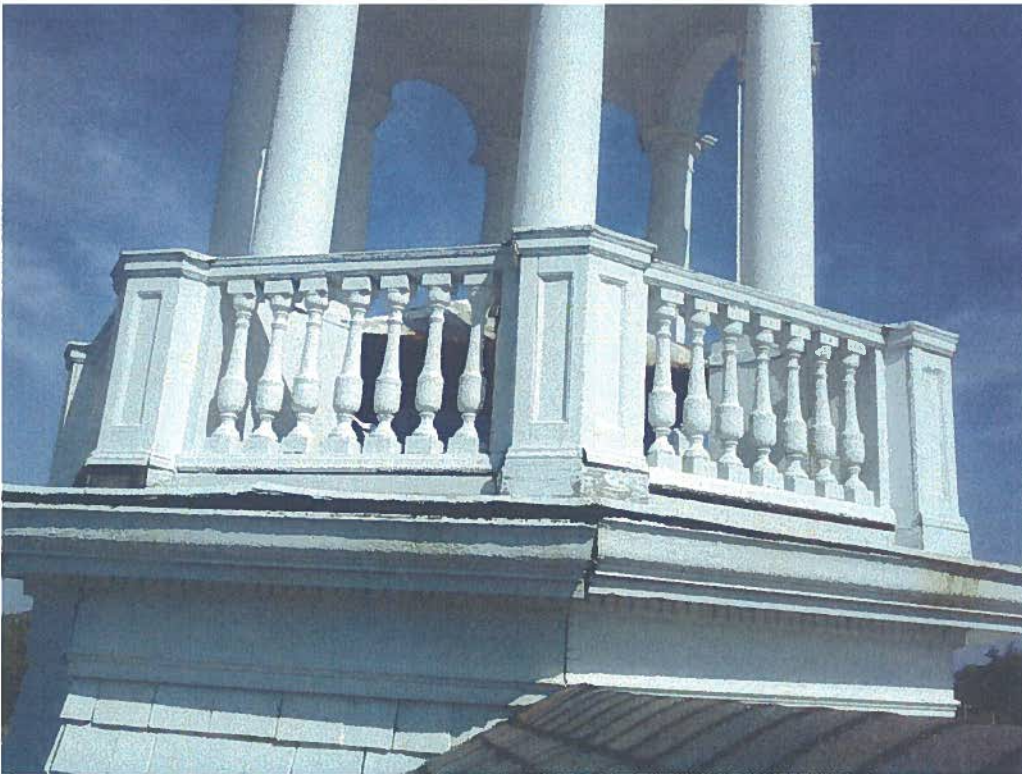
Cuppola conditions.

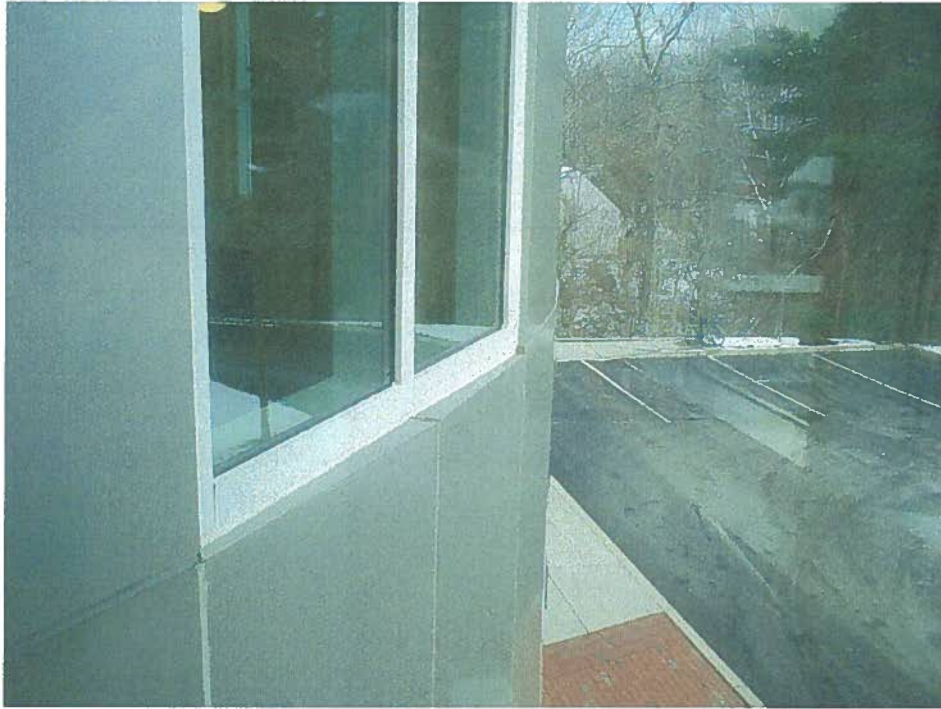
Detailed view of metal panels; leaks at windows in this area.

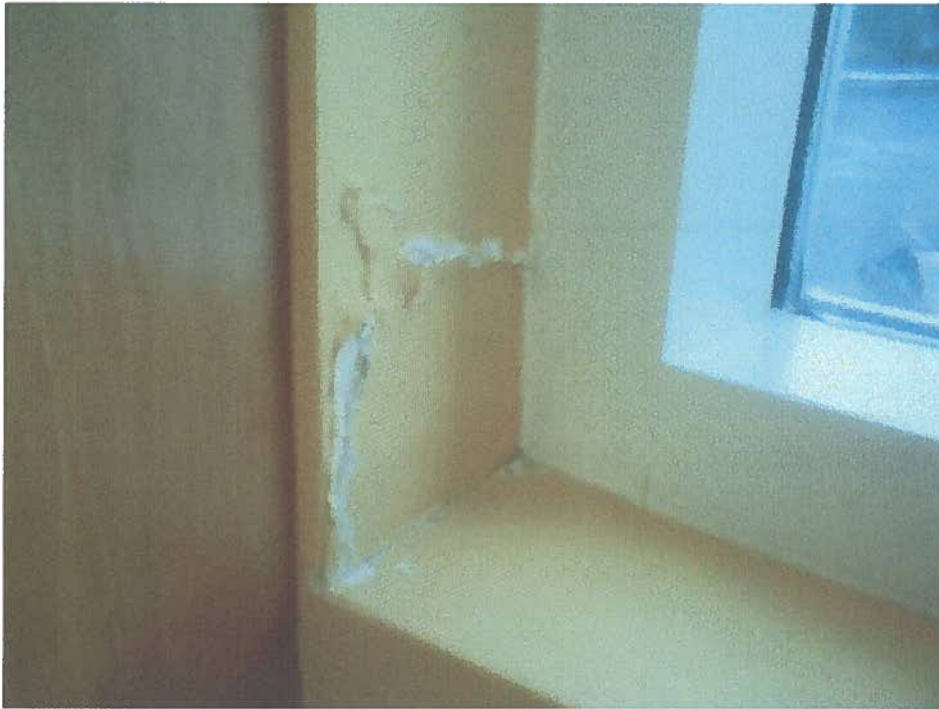
Detail at window damage.

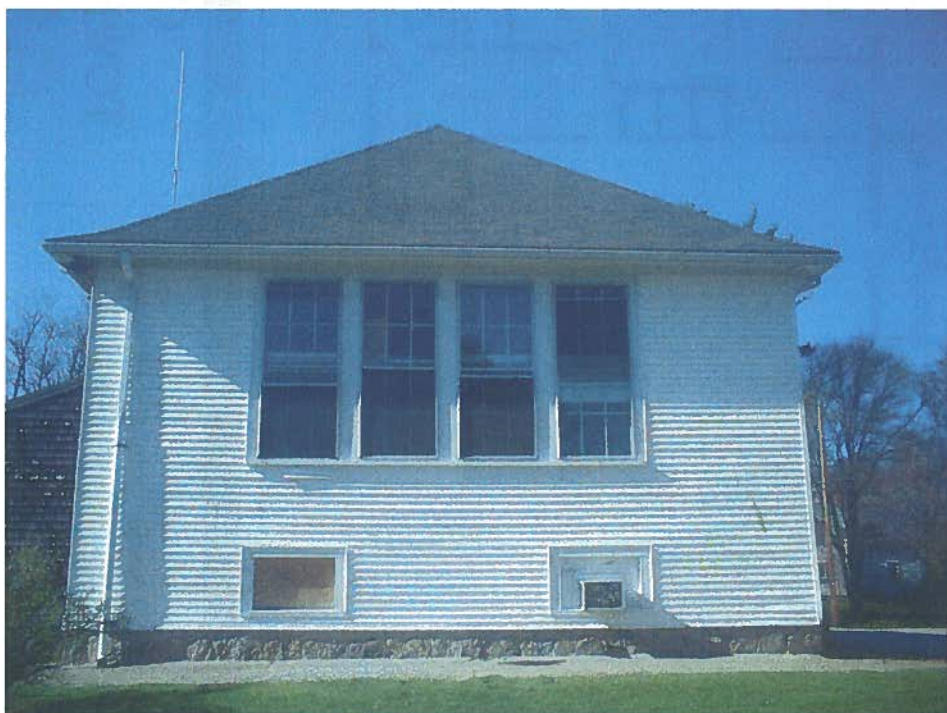
Exterior view of south facade, broken glass on ground.

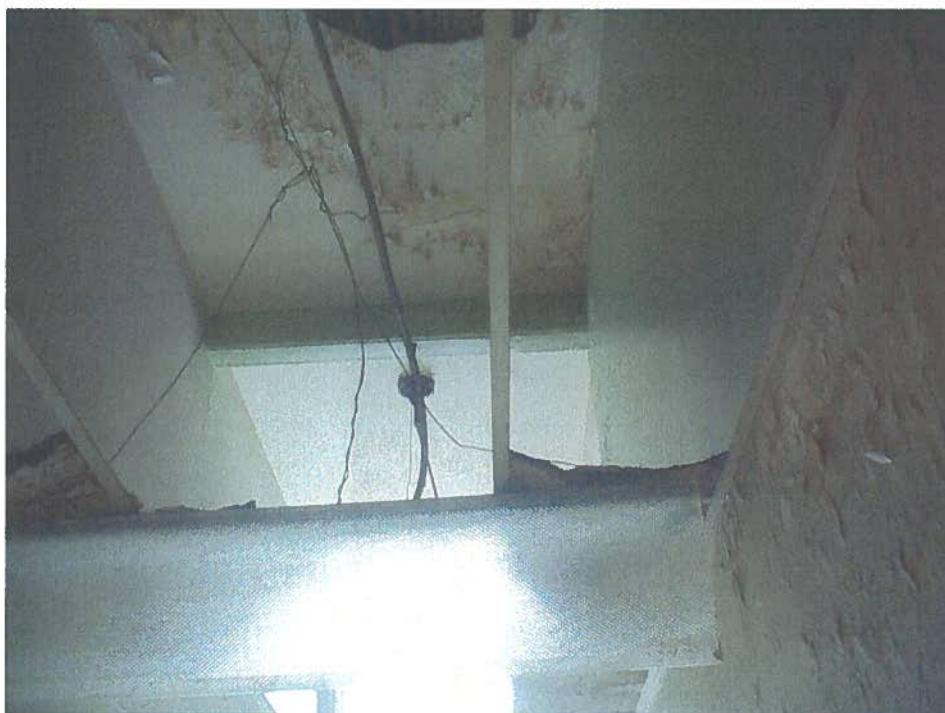
Interior, view of conditions of wall and ceiling in stairs.
