**Sylvester School  
495 Hanover Street  
Hanover, MA**

## **MEP Facilities Assessment**

**October 23, 2019**

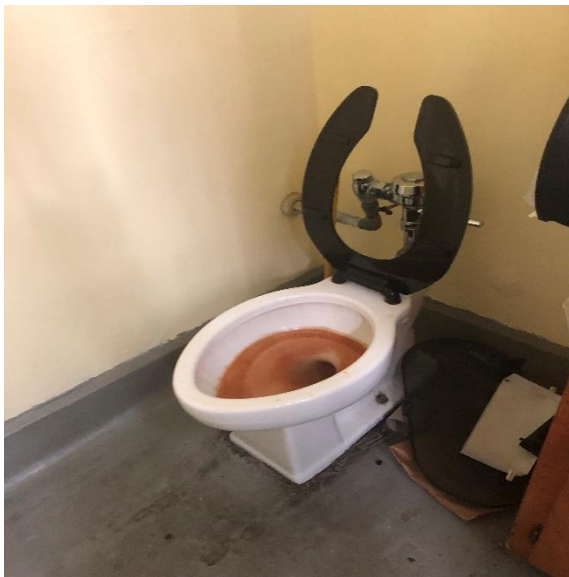
Cold water is provided to the plumbing fixtures throughout the building. The existing plumbing fixtures appear to be a mixture of old non-conservation type and newer low-flow type. The toilet fixtures that were observed are floor mounted with flush valves with some of toilets being stamped as water conservation type and some without any identifying markings. Urinals are wall mounted with flush valves. Bathroom lavatories are counter mounted with double handle faucet, the faucets are not water conservation type and do not have metering/mixing features. Kitchen sinks are stainless steel with traditional fixed spout faucets and do not appear to be water conservation type. Classroom sinks are stainless steel with single fixed spout faucet and drinking fountain spout. The water coolers are single basin type and are surface wall mounted. Almost all of the plumbing fixtures are showing signs of deterioration, some from lack of use and some from age. None of the plumbing fixtures observed appear to be ADA compliant.

***Typical Toilet***

The existing plumbing fixtures should be removed in their entirety and should be replaced with new fixtures, flush valves, faucets and trim. ADA compliant fixtures should be provided as required. All new plumbing fixtures will be water conservation type. Toilets will be 1.28 gpf flush valve type and will be wall or floor mounted as dictated by the architectural features of the building renovation. Urinals will be wall mounted with 0.5 gpf flush valves. Bathroom lavatories will be wall or counter mounted as desired and will be provided with 0.5 gpm faucets. Each lavatory faucet shall be provided with a mixing valve to limit the hot water temperature to the faucet to a maximum of 110 degrees F. Kitchen sinks will be stainless steel with 1.5 gpm faucets. Classroom sinks, if used, will be provided with a hand washing faucet and a drinking fountain fitting. All classroom sink faucets will be provided with a mixing valve to limit the hot water temperature to the faucet to a maximum of 110 degrees F. If art room sinks are provided then solids interceptors will be provided on the drain piping from the sinks. Water coolers will be wall mounted and will be ADA compliant with Hi-Low basin design with the low basin on the right-hand side. A bottle filler station may be provided if desired. Shower fixtures, if provided, will be 1.5 gpm rated. Janitors closet mop sinks will be provided with wall mounted faucets with vacuum breaker, pail hook, wall support and integral check valves to prevent hot or cold water cross-over.

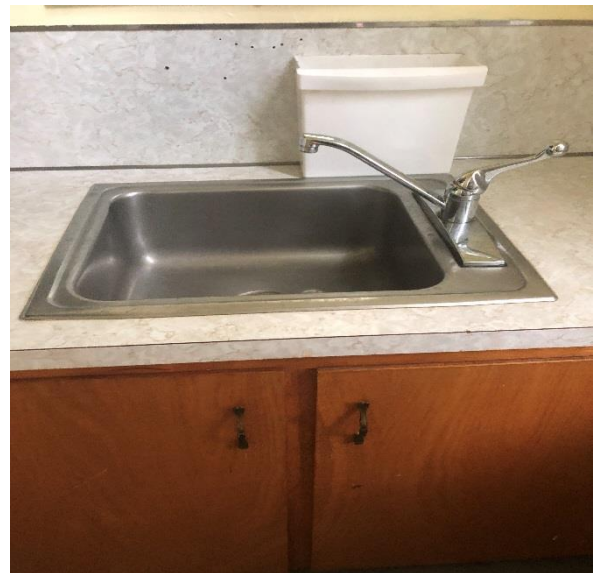
***Typical sink***

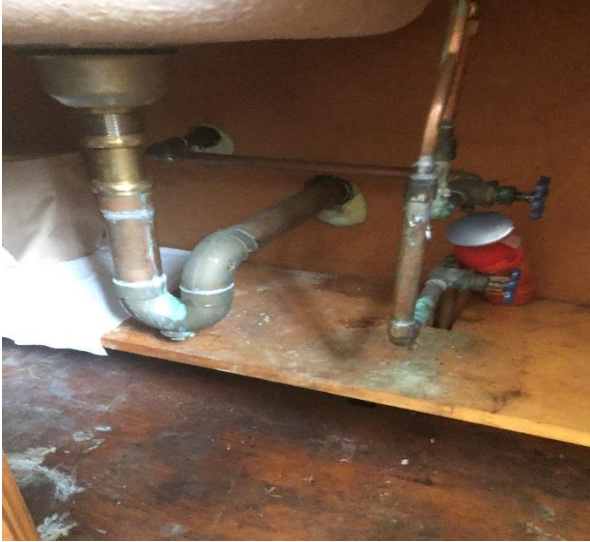
The existing building is currently fed via an existing domestic water service that appears to be a 4" diameter pipe that enters into a cabinet within one of the bathrooms. This 4" diameter water service is reduced to 2" diameter to supply the building. An existing water meter has been installed on the 2" pipe within the cabinet. The existing water piping appears to be a mixture of older copper tubing with solder fittings and newer copper tubing with the solder fittings. In general, the existing piping systems appear to be in fair to good condition, however, these piping systems are showing signs of deterioration especially at valves and fittings. The valves that were observed are a mixture of older gate valves and ball valves. The cold water distribution piping is run through the building to the various plumbing fixtures and appears to have been provided with pipe insulation for most of the observable piping systems. The pipe insulation is old and is showing signs of deterioration.

***Typical old and corroded fixture piping***

The existing building is reported to have been built in 1927 and is approximately 92 years old. Some of the existing piping systems appear to be original to the building while some appear to have been updated as part of renovation work. It is not possible to trace the existing plumbing systems to determine what portions of these systems may be salvageable if at all. It is recommended that all of the existing plumbing systems be removed in their entirety as part of a building renovation project.

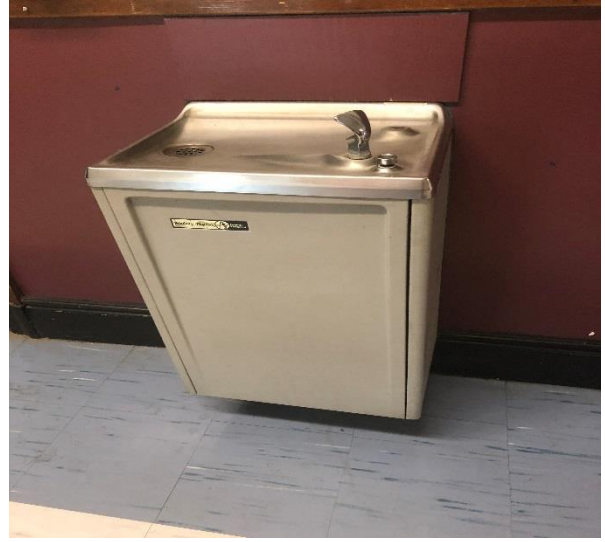
**Typical Water Cooler**

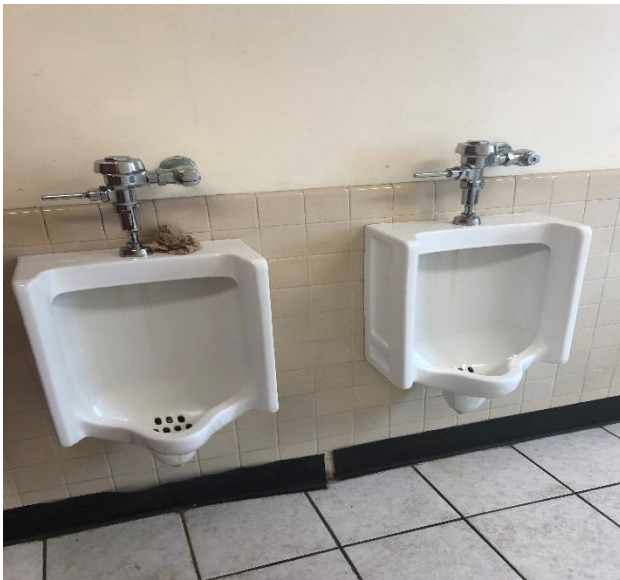
***Typical Urinals***

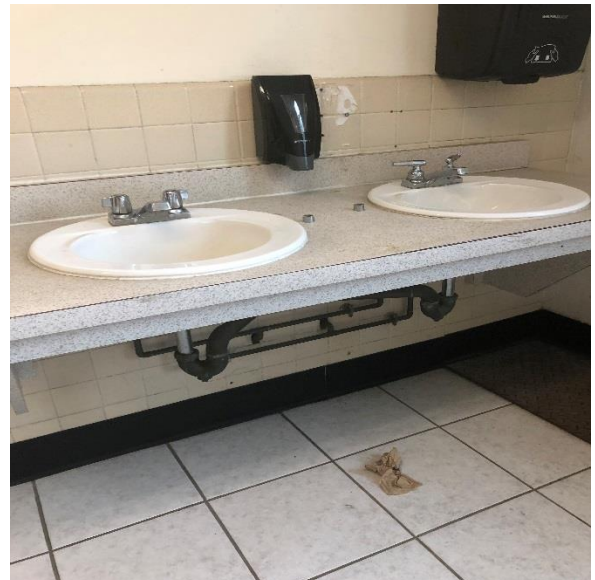
***Typical Lavatories***

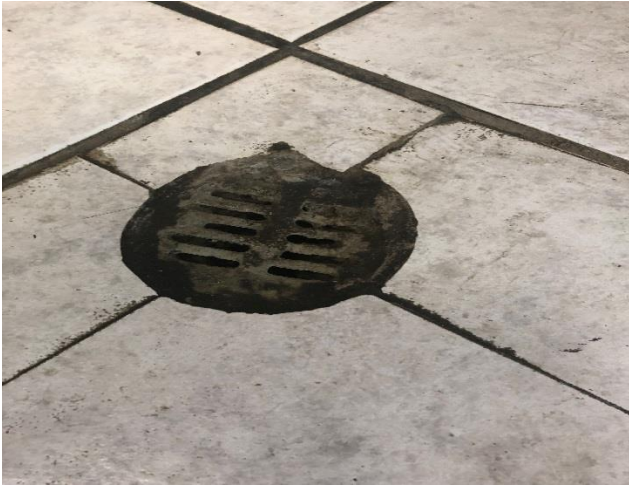
*Typical corroded floor drain*

All new sanitary and vent piping systems will be provided for the building. The new sanitary piping systems will connect all of the new plumbing fixtures and drains. New floor drains will be provided as required. All floor drains will be provided with trap primer systems. The new vent piping systems will be taken up through the roof of the building. All fixtures and drains will be properly vented. It is being assumed that the underground piping systems are all original to the building. Given the fact that the building is approximately 92 years old it should be assumed that the existing underground piping systems are not usable for a building renovation project and should be replaced in their entirety with new underground piping systems. The new sanitary piping systems will be taken to below the floor slab and to outside the building where the new building sewer will be connected to the site sewer system by the civil engineer. The plumbing contractors work will terminate at a point 10 feet outside of the building. A civil engineer will need to determine if the new building sewer will be connected to a septic system or to the municipal sewer system. The new sanitary and vent piping systems will be cast iron with hubless fittings and copper DWV piping with solder fittings.

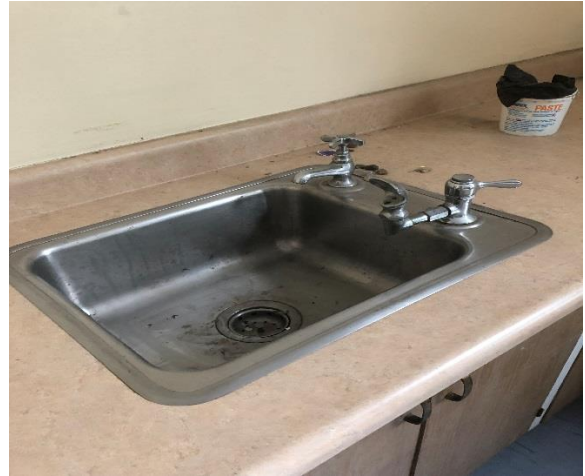
*Typical classroom sink*

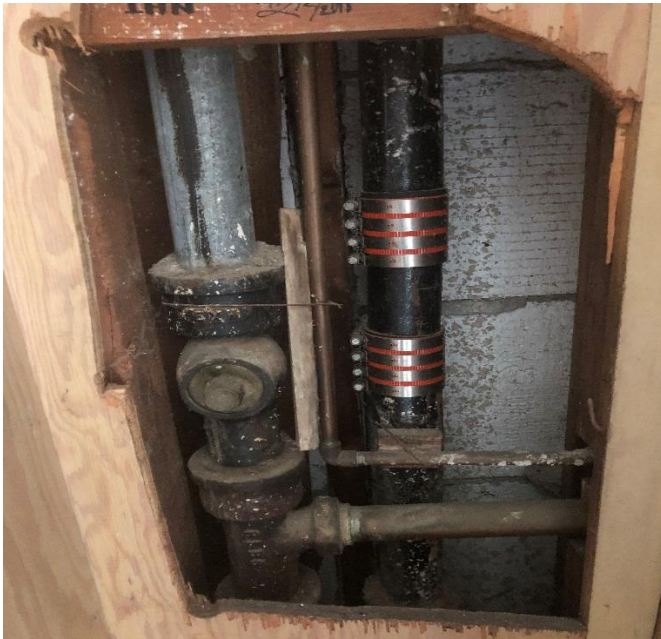
**Typical example of original and replacement piping**

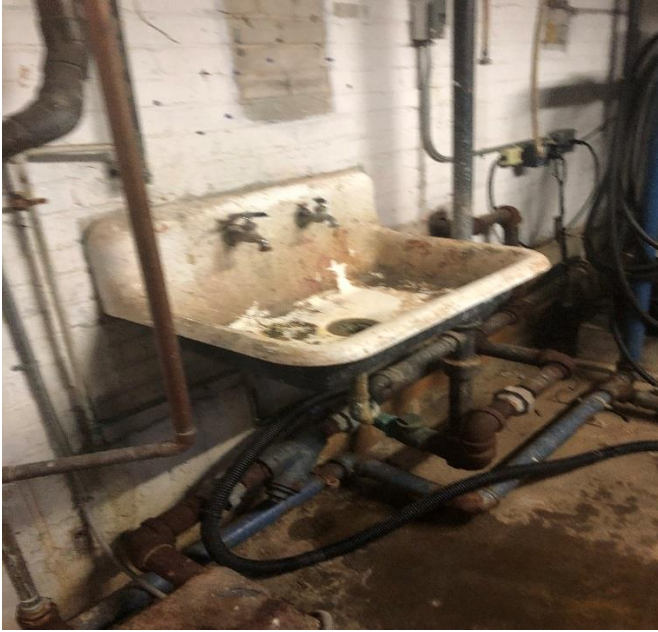
**Typical original fixture and piping**

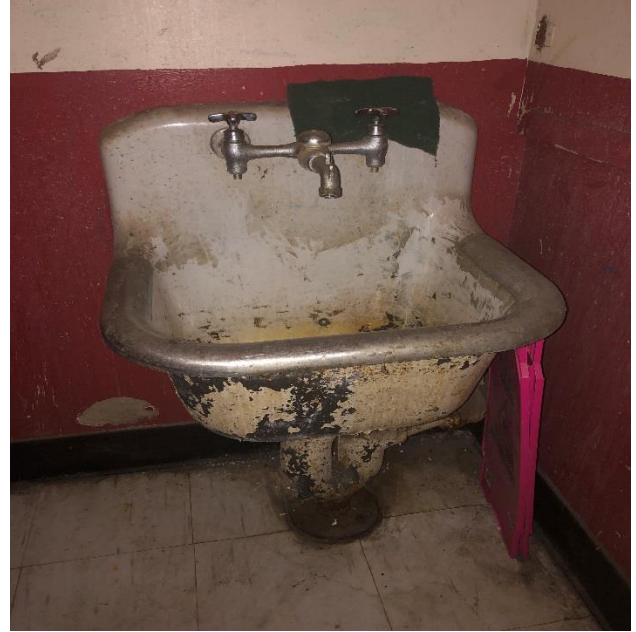
**Existing janitors sink**

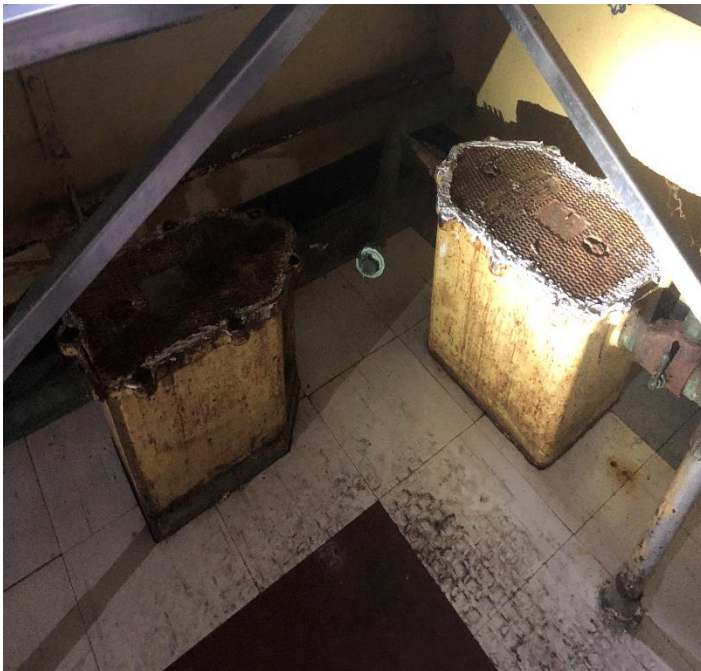
A Commercial Kitchen has been provided in the school building. This kitchen contains various food preparation equipment and fixtures, hand washing sink fixtures, and a dishwashing room with pot washing sink and a commercial dish machine. All of the existing fixtures and equipment are showing signs of age and deterioration as are the floor drains that have been located in the kitchen areas. There are three interior grease interceptors that have been provided as point-of-use installations at the grease waste producing fixtures. One interceptor is on the floor at the dish machine, one is on the floor at a pot washing station and one is on the floor at a pre-rinse station. All of these interior interceptors are old and are in poor condition. It was relayed to BLW that an exterior grease interceptor has not been installed for the commercial kitchen and that the interior interceptors are the only grease waste treatment currently provided.

**Existing grease interceptors**

grease interceptor discharge pipe will be determined by the civil engineer. Small point of use grease interceptors will be provided on the interior of the building and will be located at individual grease waste producing fixtures in order to take as much grease out of the underground piping system prior to its connection to the large exterior grease interceptor. The commercial kitchen will be provided with hot water and cold water piping systems that will supply the fixtures and equipment throughout the kitchen space. Hot water to the kitchen will be 140 degrees and will be provided with a circulation loop back to the central water heater that will be located in the mechanical room. All equipment and fixtures in the kitchen will be provided with cold water and 140 degree hot water. Hand washing sinks will be provided with mixing valves that will temper the hot water to a maximum of 120 degrees to prevent scalding. Natural gas will be provided to the kitchen cooking equipment. The natural gas supply will be provided with a safety shut off system that will be connected to a carbon monoxide detection system located in the cookline room where the exhaust hood will be.

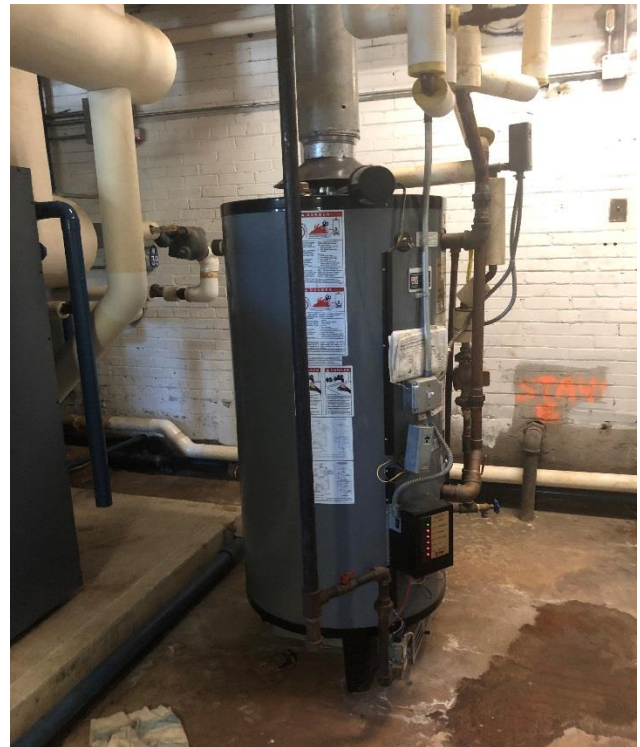
Hot water is provided to the plumbing fixtures throughout the building via an existing gas fired atmospheric type water heater. The unit appears to be an 80 gallon storage tank type and is in fair to good condition, however, the unit is nearing the end of its life expectancy. The existing water piping appears to be a mixture of older copper tubing with solder fittings and newer copper tubing with the solder fittings. In general, the existing piping systems appear to be in fair to good condition, however, these piping systems are showing signs of deterioration especially at valves and fittings. The valves that were observed are a mixture of older gate valves and ball valves. The hot water distribution piping is run through the building to the various plumbing fixtures and appears to have been provided with pipe insulation for most of the observable piping systems. The pipe insulation is old and is showing signs of deterioration. There appears to be a small circulation pump located adjacent to the water heater indicating that the hot water distribution system has been provided with a circulation system with pump and controls. An existing mixing valve has been provided to temper the hot water to the building and to prevent over heating of the hot water in the distribution piping system. The mixing valve and the immediate associated piping appear to be a fairly recent replacement and are in good condition.

**Existing gas fired water heater**

The existing water heater will be removed in its entirety. Hot water will be provided to the building via a new gas fired water heater. The new water heater will be storage type and will be high efficiency with CPVC exhaust flue and CPVC fresh air intake flue. These flue pipes will be run independently up through the building and out through the roof. Hot water will be provided as a two-temperature system. A 140 degree hot water piping system will be used to supply the commercial kitchen. A 120 degree hot water piping system will be used to supply the plumbing fixture throughout the building. A master mixing valve will be provided at the water heater to temper the 140 degree hot water down to 120 degrees for the building use. Each hot water piping system will be provided with its own dedicated circulation loop with

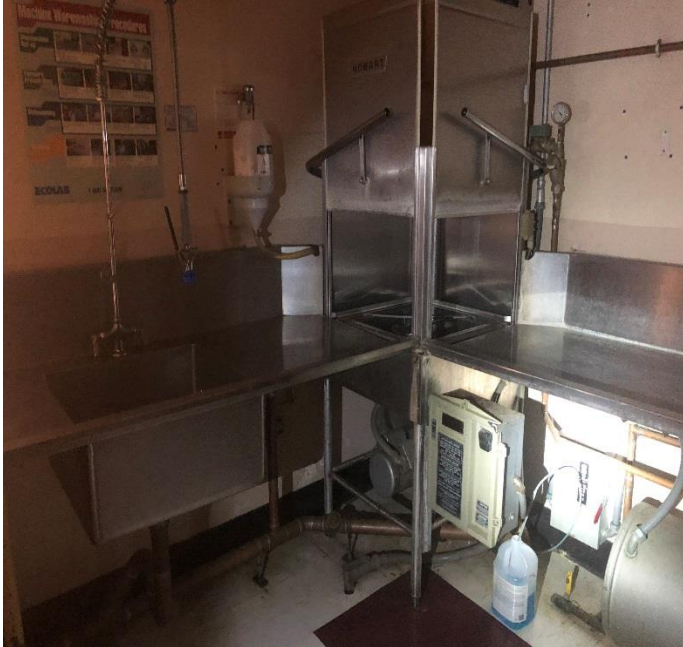
**Existing kitchen equipment and fixtures**

At this time it is unknown if a new commercial kitchen will be provided as part of the building renovation. If a new commercial kitchen is proposed then all of the existing kitchen equipment will be removed and new equipment will be provided. The existing kitchen has not been provided with a large central exterior grease interceptor. A new kitchen, or any renovation to the existing kitchen will most like trigger the need for the installation of a large exterior grease interceptor. All kitchen waste will need to be entirely new and will need to be taken underground and out to the exterior grease interceptor. The new kitchen fixtures will be provided with a dedicated kitchen waste piping system that will collect all of the new kitchen fixtures, equipment drains and floor drains. This dedicated kitchen waste system will be connected to the new exterior grease interceptor. The discharge of the exterior grease interceptor will be taken by the civil engineer to a septic system or to a municipal sewer system, whichever is available. The destination of the

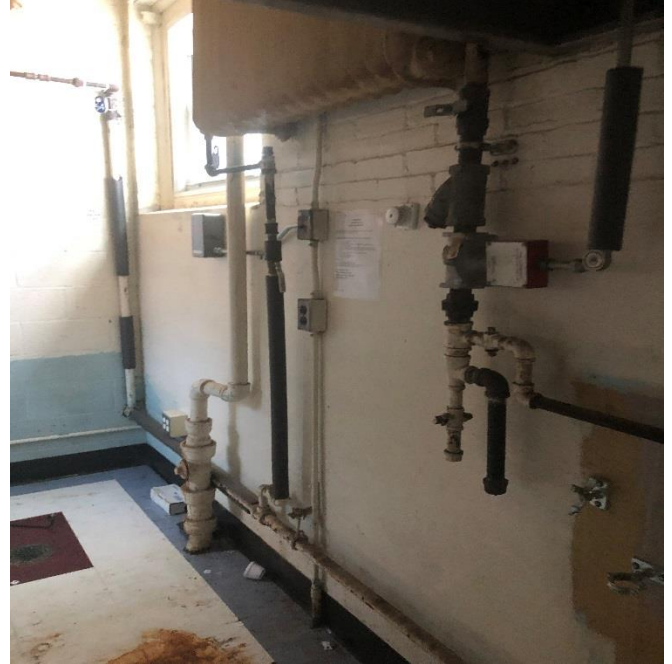
**Existing piping at kitchen hood**

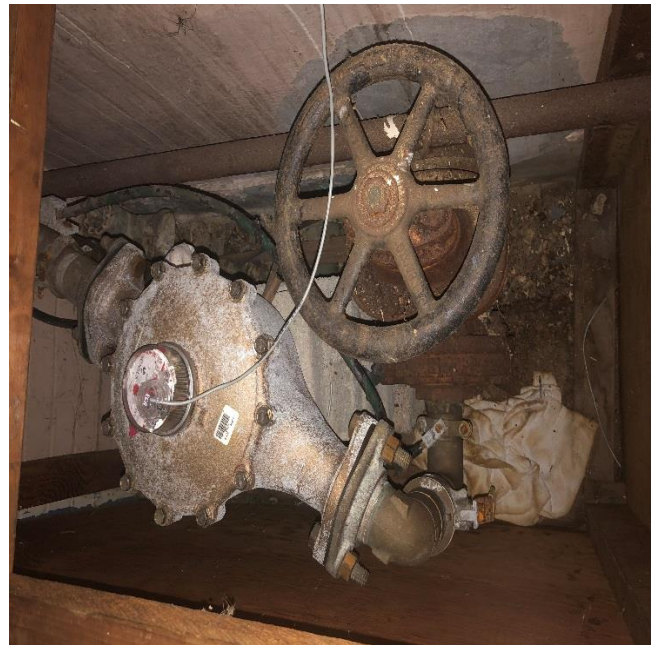
**Existing water service and meter**

Cold Water will be provided to the building via the existing 4" domestic water service if this service can be verified to be in good condition and usable. Coordination with the local water department will need to be performed in order to identify the age and condition of the existing domestic water service. If it is determined that the existing water service is usable then the existing water service may remain in place, however, a new water room will need to be provided for the water service and meter. If it is determined that the existing water service is too old to be usable then a new domestic water service will need to be installed and should be brought into the mechanical room of the building. A new water shut off valve and meter will be provided at the water service point of entry into the building. Cold water piping systems will be provided to supply the plumbing fixtures and kitchen fixtures throughout the building. All water piping systems will be copper with solder fittings. All water pipe, fittings and valves will be provided with insulation. All water pipe will be labeled to indicate service type.

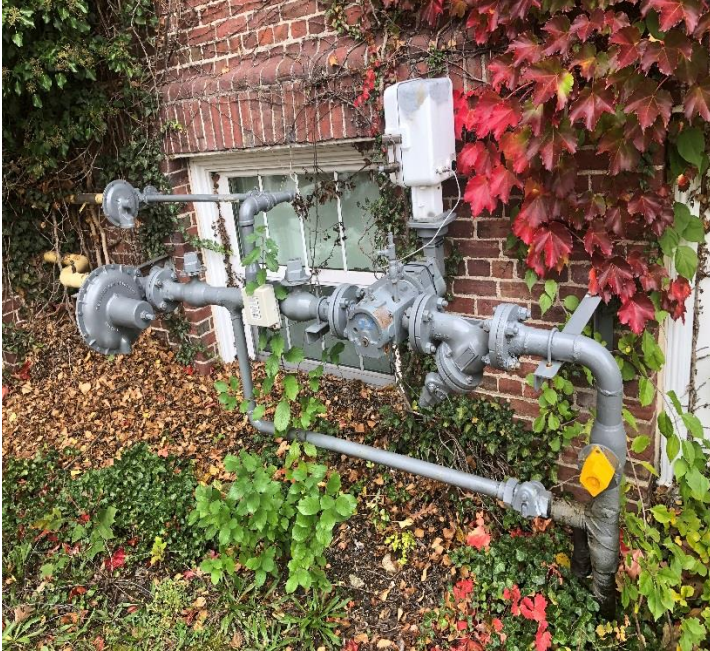
**Existing Gas Meter**

The natural gas piping systems for the building shall be entirely new. All new piping distribution systems will be provided to supply the new gas fired equipment and appliances as required. Gas will be provided to the HVAC boilers and the new domestic water heater. Gas will be provided to the new commercial kitchen cooking appliances. The gas supply to the cooking appliances located under a mechanical exhaust hood will be provided with a safety shut off system that will be connected to a carbon dioxide detection system that will be dedicated for the commercial kitchen spaces. The new gas piping systems within the building will be changed to low pressure not to exceed 14" w.c. Once the new gas loads are known, coordination with the gas company will be performed to insure that the existing gas service and meter have enough capacity to supply the renovation project.

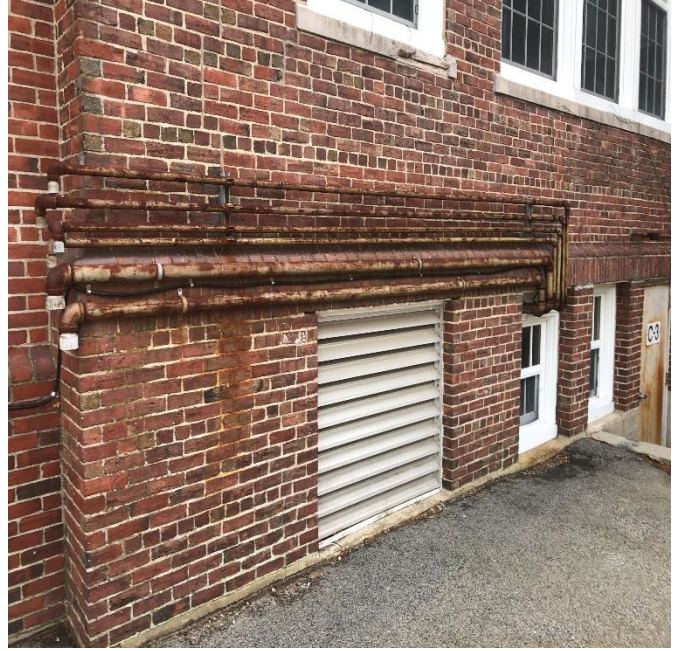
**Exterior Gas Vent Piping**

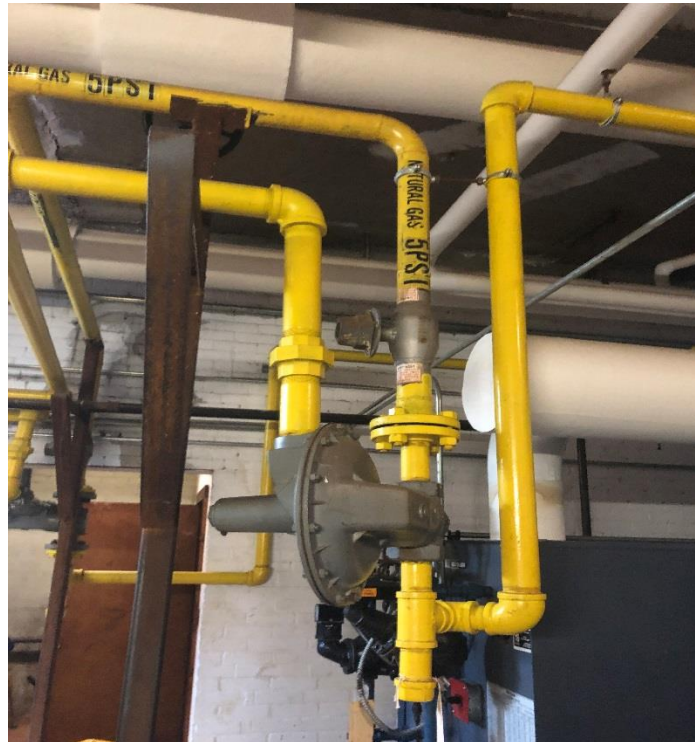
Natural Gas has been provided to the building via an existing underground gas service with an existing gas meter located on the outside of the building. The gas piping is painted yellow and is labeled "5 PSI" which is indicative of a high

**Existing high pressure gas pipe**

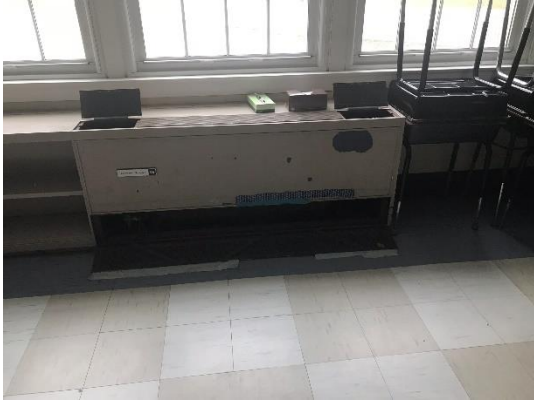
Space heating is through steam radiators and unit ventilators. The radiators appear to be original to the building and the unit ventilators appear to be more than 20 years old.

Typical Unit Ventilator

The existing HVAC systems, including steam boilers, condensate receiver, piping, ventilation system, and exhaust systems are at the end or past their useful life expectancy. BLW would recommend the systems be removed and replaced with new.

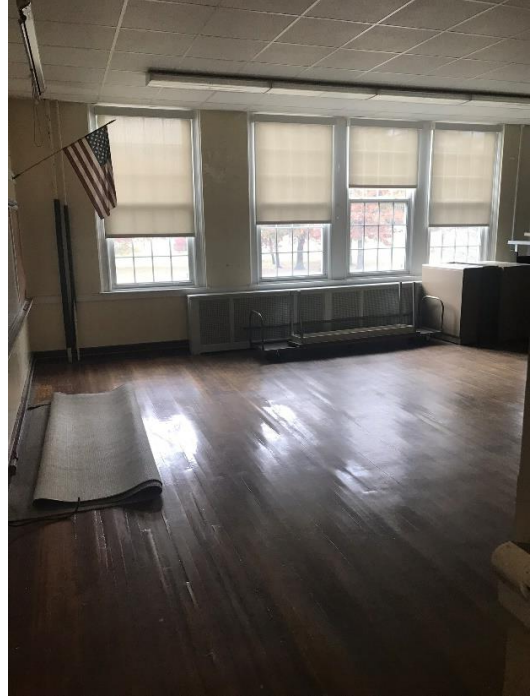
Typical Radiator with Cover

Heating shall be provided through finned tube radiation.

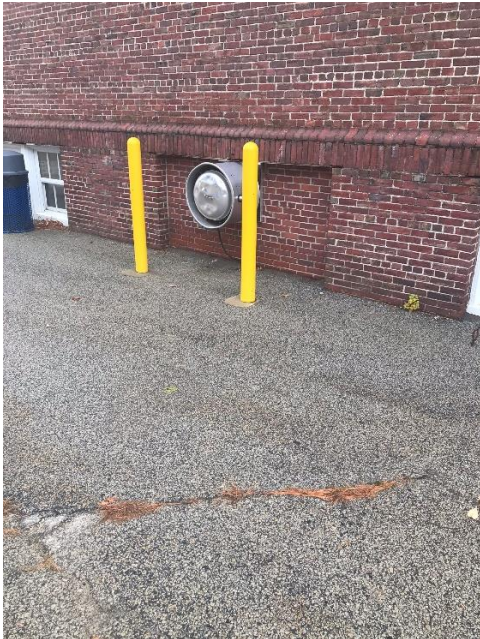
Kitchen hood exhaust is through a side wall fan. The fan appears to be 10-15 years old. The space has not been provided make-up air.

Kitchen Exhaust Fan

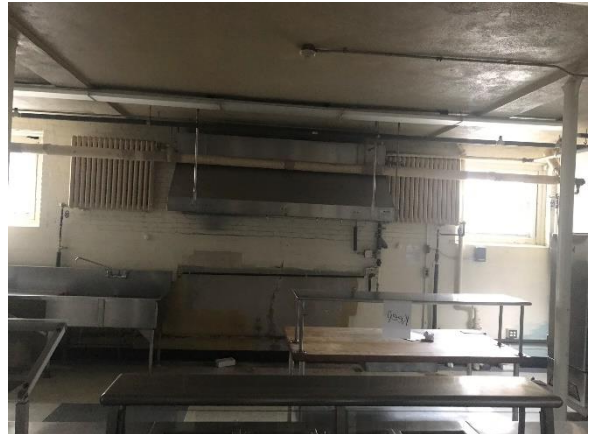
Kitchen Exhaust Hood

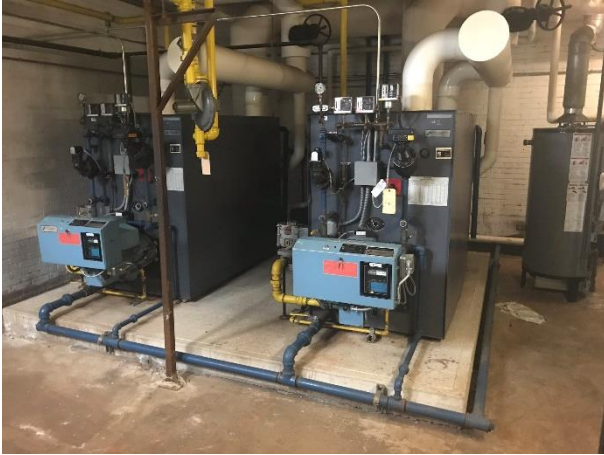
The building is heated with (2) Weil-McLain natural gas fired boilers that generate steam. The boilers have been reported to have been installed in 2003 and are 16 years old. Steam is distributed throughout the building with steam pipe distribution system. Condensate is collected through a condensate piping system and is drained back the condensate receiver located within the boiler room. The condensate receiver appears to be 16 years old. The steam and condensate piping system are insulated. This insulation is noted to potentially have asbestos.

Steam Boilers

BLW would recommend heating be provided through high efficiency hot water boilers, hot water piping distribution systems, pump and water specialties.

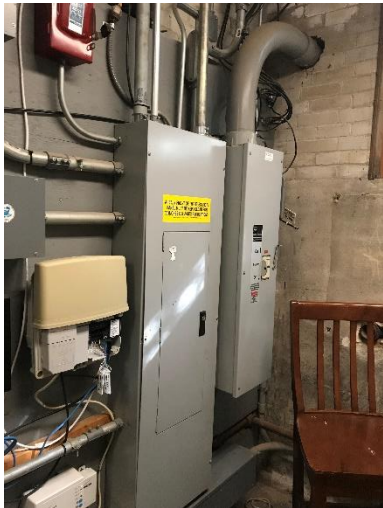
*Condition:* The general condition of the main disconnect and panelboard were observed to be in fair condition.

*Capacity:* The existing 400A service at 240V equates to 96kVA which allows for approximately 3 W/sqft based on the approximated overall school size of 31,000sqft. Given the building size and occupancy 3W/sqft is undersized.

**Main Service Disconnect and Main panelboard**

The capacity of the existing electrical service is undersized and single phase. For this building to be able to power up a new 3 stop elevator the service will need to be upgraded to provide three phase power. There is three phase power available on Hanover street. Any extension of the street's three phase overhead lines would have to be provide by the Utility Co to the existing pole adjacent to the main driveway.

Given the recommendation to the upgrade the service per the above, new distribution equipment will have to be provided to accommodate a larger service size. A new 800A distribution panelboards with service entrance rated main breaker is recommended.

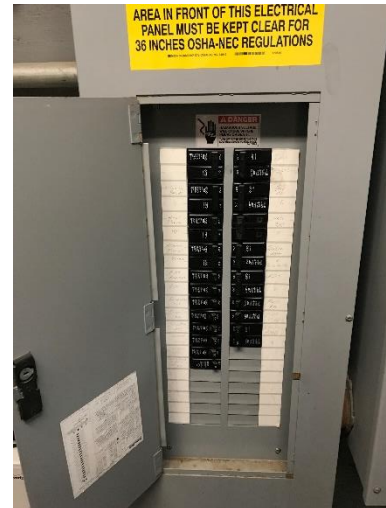
**Main Panelboard**

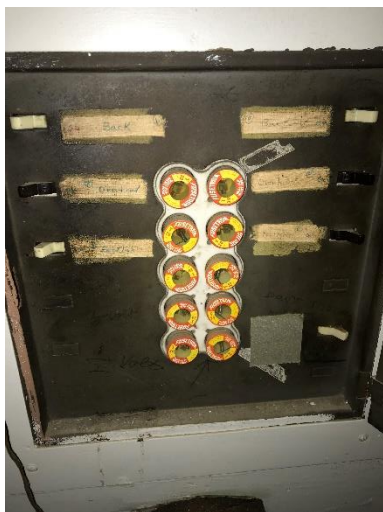
In general, the newer electrical distribution equipment in the building is predominantly mixed. Older fused panels are still in use while newer panels have replaced older panels in approximately 75% of the building. Older panels in the building appear to be from the original construction and are well past the end of their useful life expectancy. An auditorium lighting panel was observed to be using fuse technology and a rheostat for dimming.

**Older Auditorium Lighting Panel**

While some of the existing panels could be proposed for reuse, it is recommended that at least 4-5 of the building's panels be replaced with new. Each approximately 100A

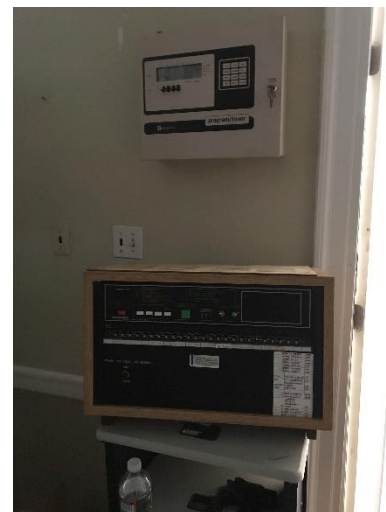
The existing systems is manufactured by Bogen and does have connectivity with all rooms in the building. The system is an older system, but was spot tested and does operate properly.

**PA Intercom System Head End**

While the existing PA/Intercom system is functional new technologies can offer additional benefits with regard to privacy and emergency situations.

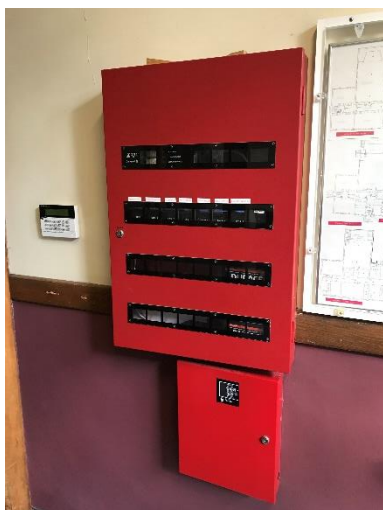
The main fire alarm control panel is located in the main vestibule. The control panel is a Gamewell Zans 400 which is a conventional panel, with general evacuation. The fire alarm system is approximately 25-30 years old. All detection, initiation and notification devices appear to meet current code requirements. While the system appears to be operational, it is an older system and does not meet current code requirements for a voice evacuation system.

**Fire alarm Control Panel**

Although functional, depending on the amount of renovations to the building, to meet current codes for an education use group, a voice evacuation system is required. It is recommended that the existing panel be replaced with a new

addressable voice evacuation panel. Modification to the existing NAC circuit wiring will need to be made to accommodate new speaker/strobe notification devices.

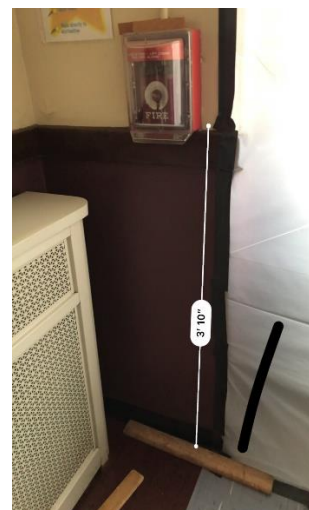
**Fire alarm Pull Station Height**

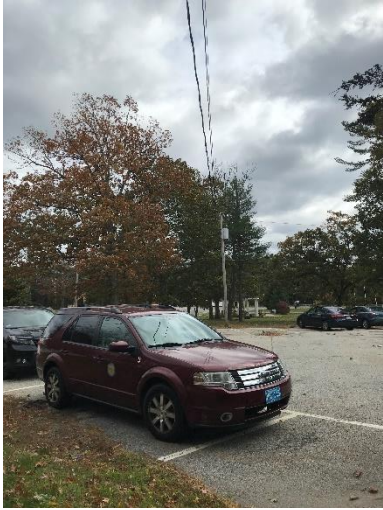
Primary power provided by NGrid originates from an overhead pole mounted transformer located on a pole adjacent to the main driveway. The main circuit breaker and main panelboard, located in the main electric room, are manufactured by Cutler Hammer/Thomas & Betts, rated 400A, 120/240V, 1-phase, 3-wire. Circuit breakers distribute the remainder of loads to secondary distribution panelboards and miscellaneous loads located throughout the building.

***Incoming Overhead Service Wires (Pole mount Trans)***

Because of the anticipated new service size (estimated 800A) there will need to be room on site for an approximate 8'x8' pad mount transformer (it does appear there is space directly outside of the electric room.)

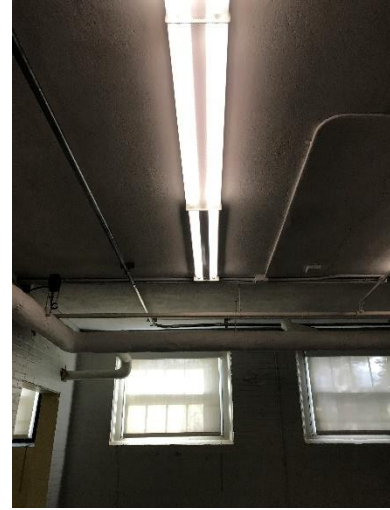
The lighting system installed throughout the building consists predominantly of lensed wraparound fluorescent lamped fixtures. There is also a variety of utility strip, direct/indirect, pendant, and down light fixtures in the building. Many fixture lenses were observed to be dirty, cracked and or missing. In most cases, lighting fixtures are controlled via wall toggle switches.

***Typical Hallway Lighting***

Although functional, all existing lighting should be considered for replacement with a more energy efficient LED style fixture.

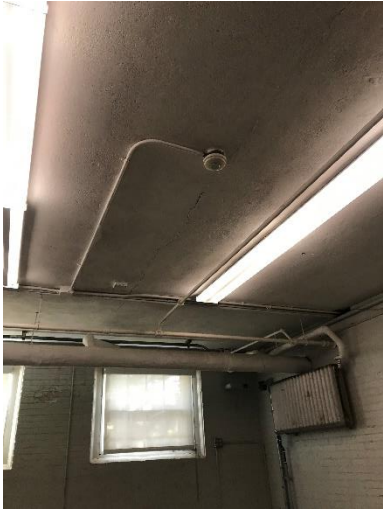
***Typical Smoke Detector***

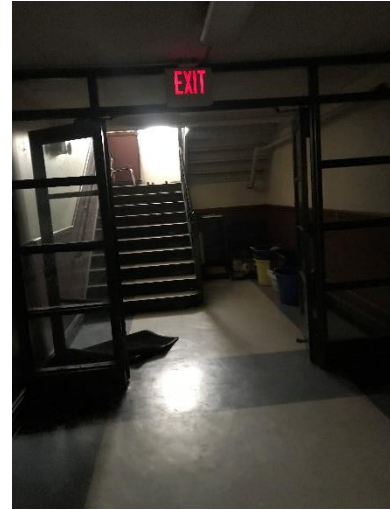
Emergency lighting is achieved using battery units with dual heads in common corridors and auditorium space. Lit Exit signage also appears to be fed from integral batteries.

***Typical Lit Exit Sign***

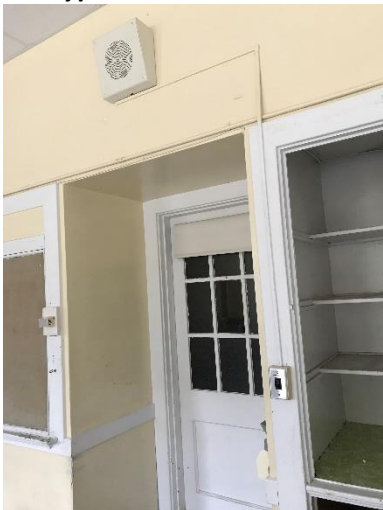
***Classroom PA/Intercom***

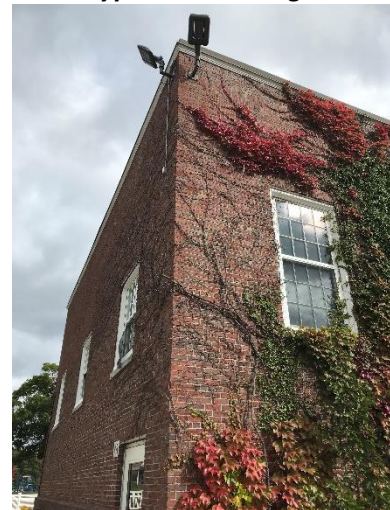
Newer exterior lighting fixtures surface mounted to walls are visible source type LED flood lights. While these are efficient they offer poor visual quality. Not all exterior doorways have lighting fixtures directly at the door, but those that do have older fixtures (jelly jar and decorative style). It does not appear that any of the egress doors have emergency lighting capabilities.

***Typical Exterior Flood Lighting***

Exterior emergency lighting should be added to all egress doors from the building.

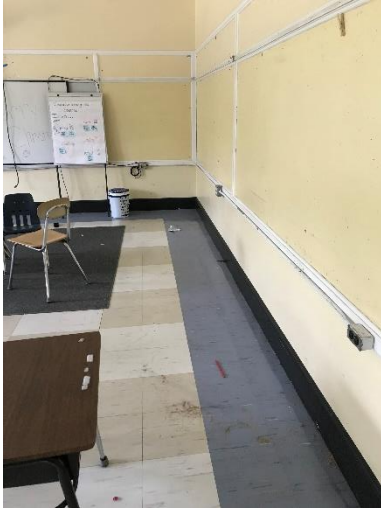
***Typical Classroom Receptacles***

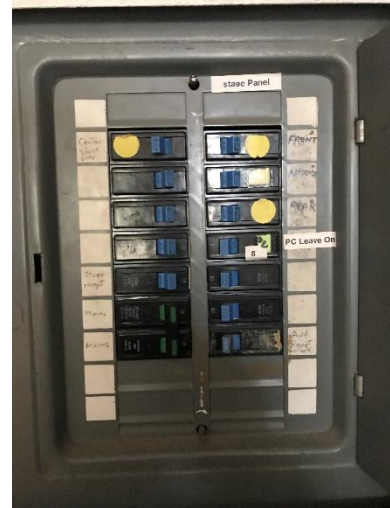
***Typical Older Style Panel***
