Section 08 - SYLVESTER ELEMENTARY SCHOOL

Building Summary

Town of Hanover - MUNICIPAL FACILITIES ASSESSMENT - 2010

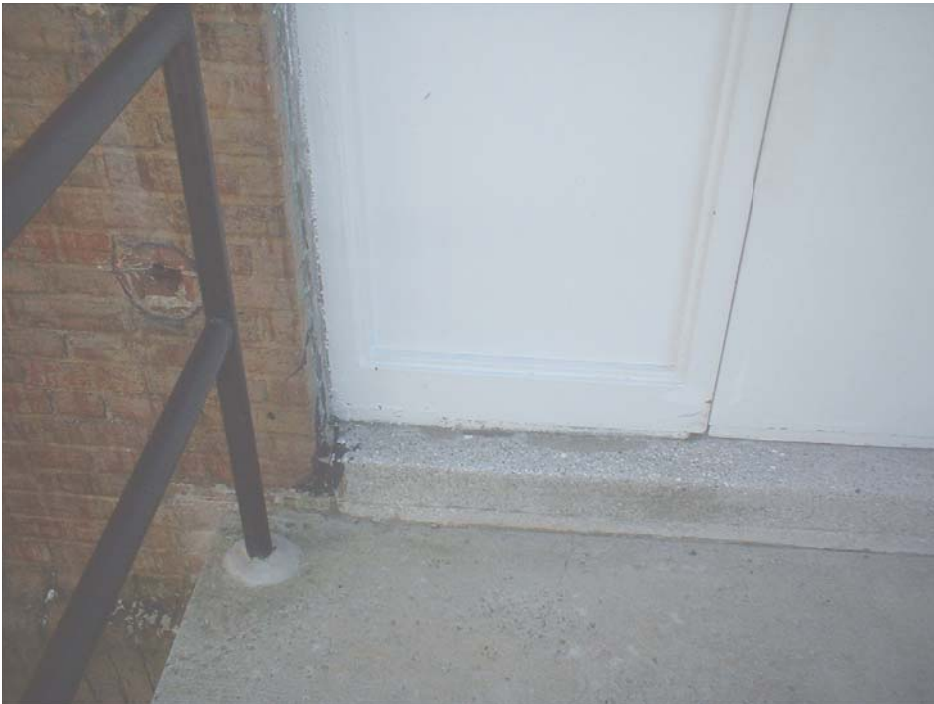
Non-accessible step into entrance.

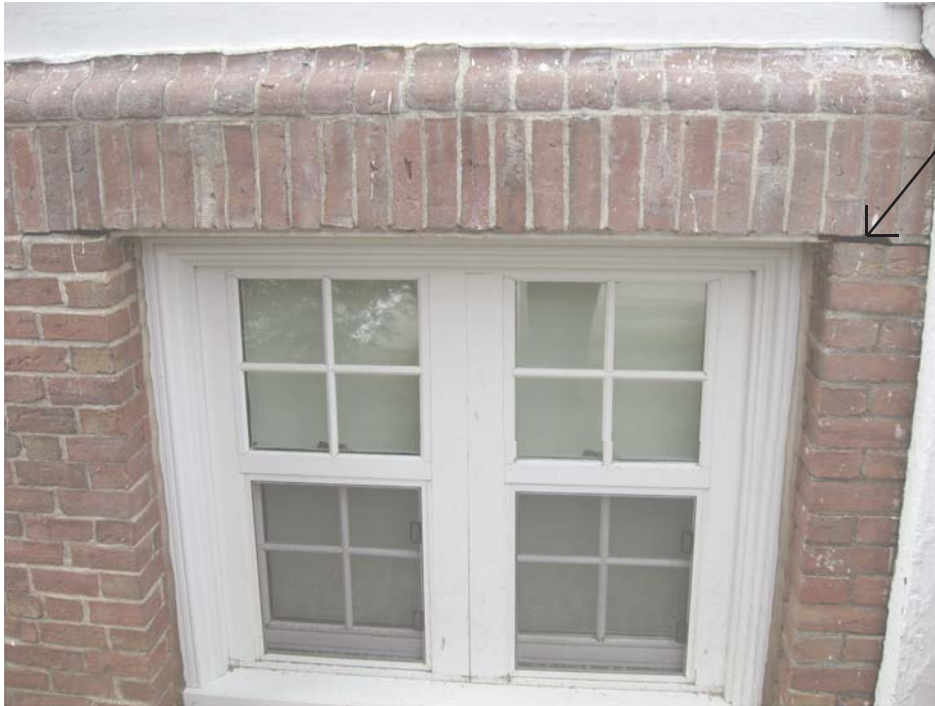
- Brick masonry, is in generally fair condition. There are isolated areas of brick deterioration and step-cracking, and repointing is needed. In particular, brick is cracked and displaced at steel, lintels over window openings, perhaps as a result of rusting of the lintels.
- Wood work is in general fair condition, with some carpentry repairs & painting needed.
- Hole in cement stair on south side
- Steel headers could be power washed and new mortar over top
- Ivy on north west side of building

Cracked brick at steel
lintels, typical

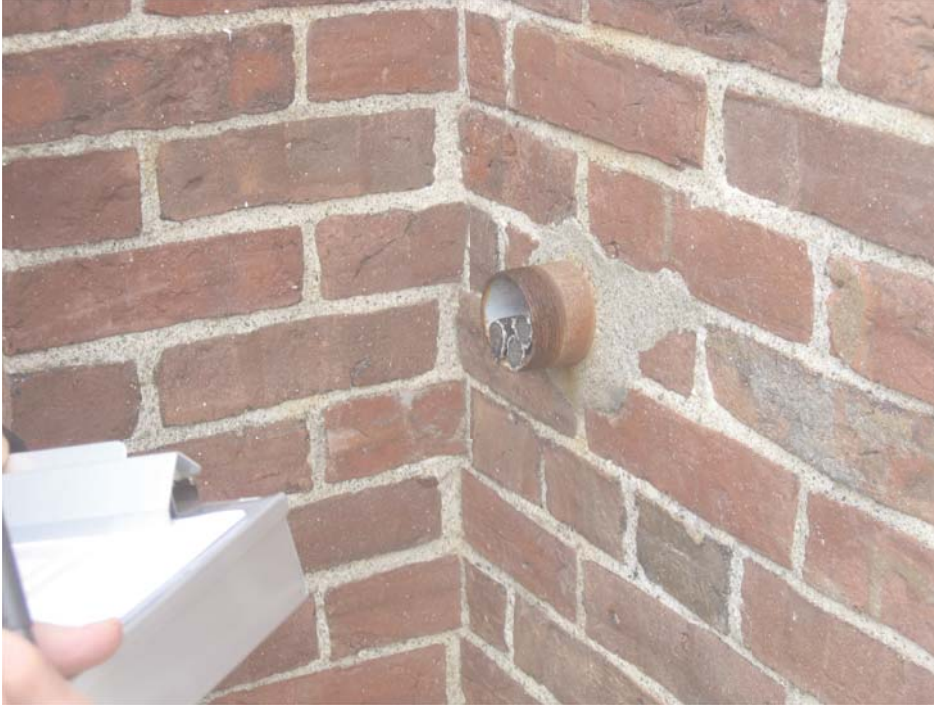
Electrical conduit; large feeder cables inside cut off.

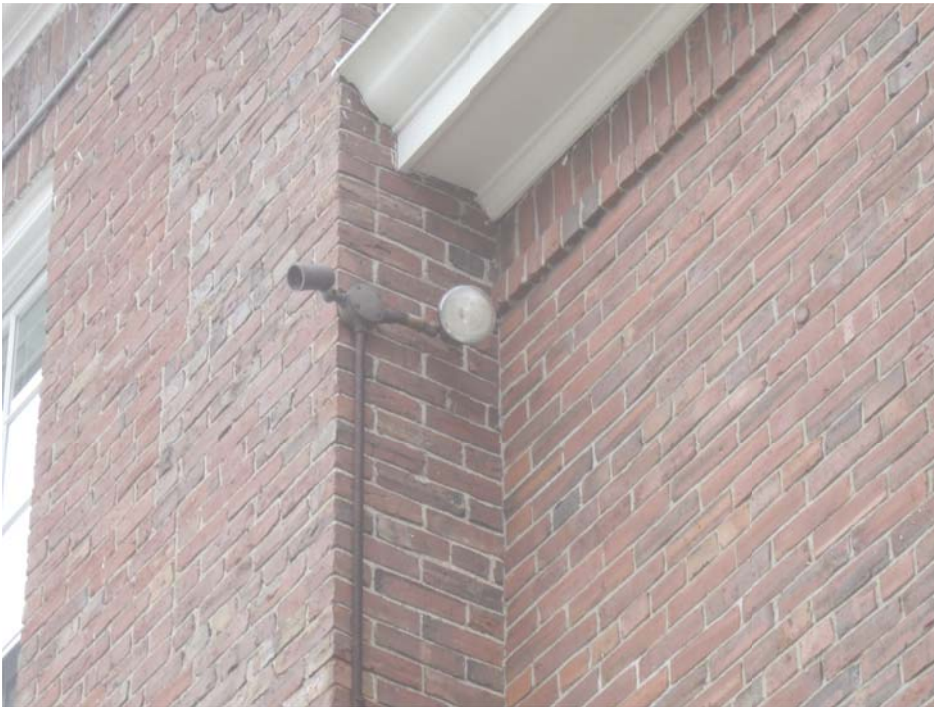
Old exterior light ?, broken fitting

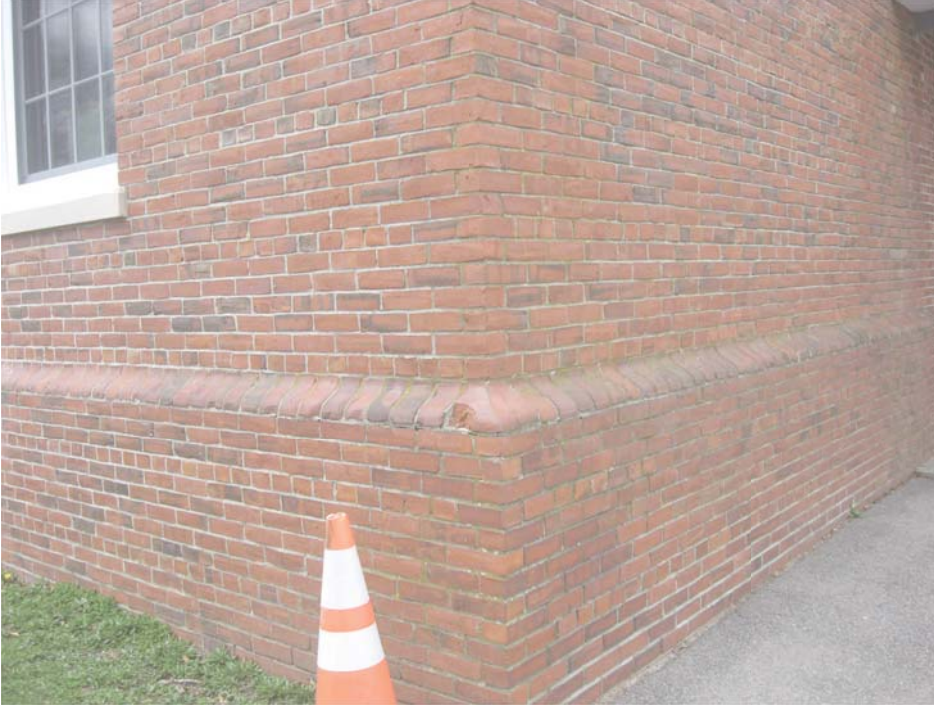
View of brick corner detail. Damage at corner.

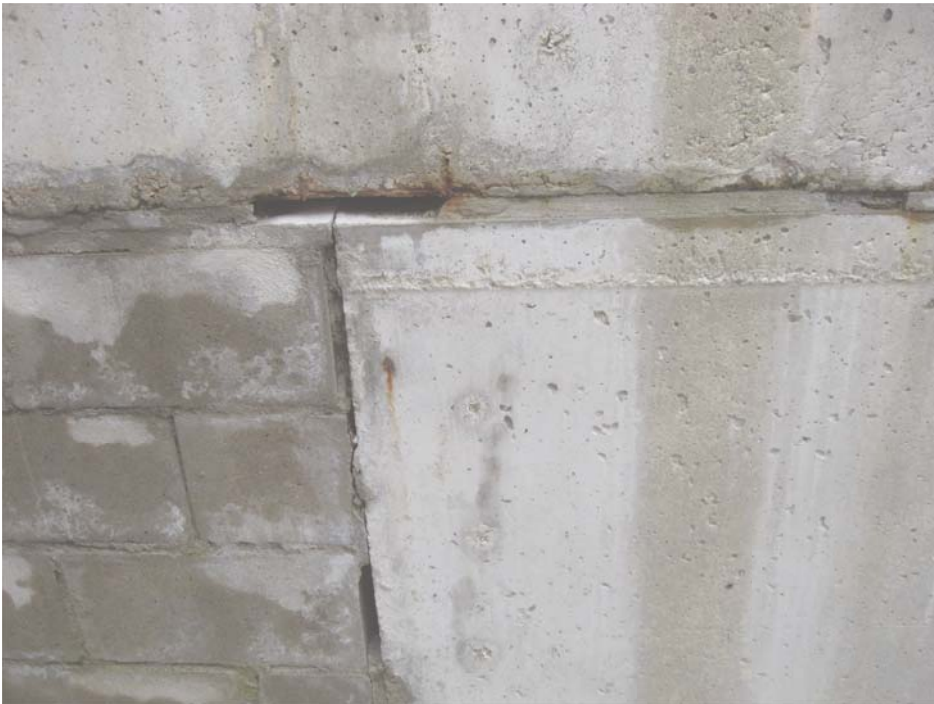
Cracks between block and concrete at steps. This condition was repaired during the summer of 2010 with parging.

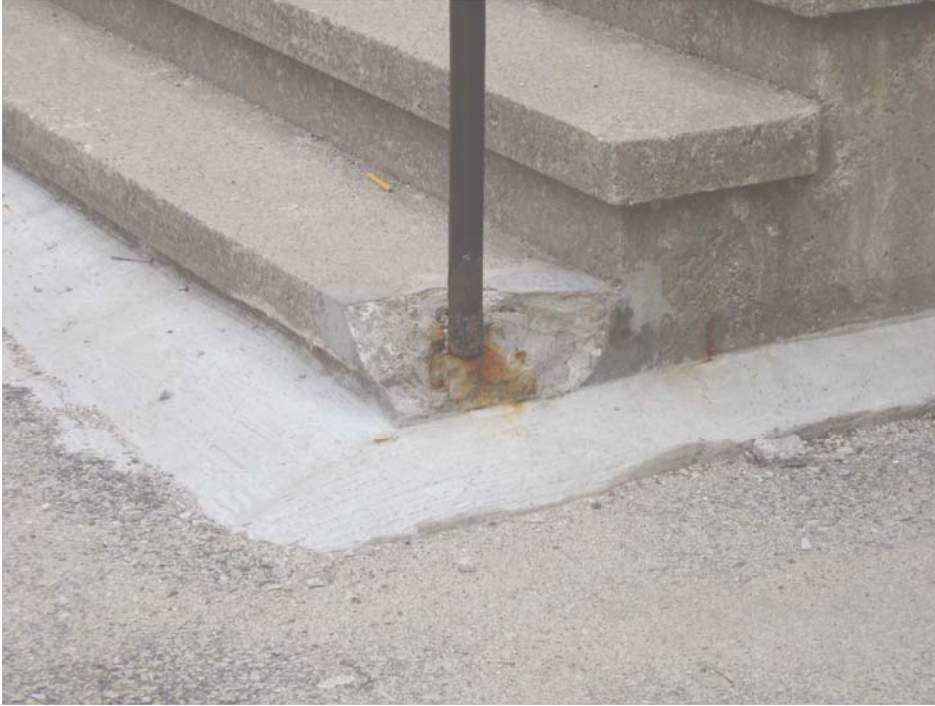
Deteriorating concrete stairs (repaired summer 2010).

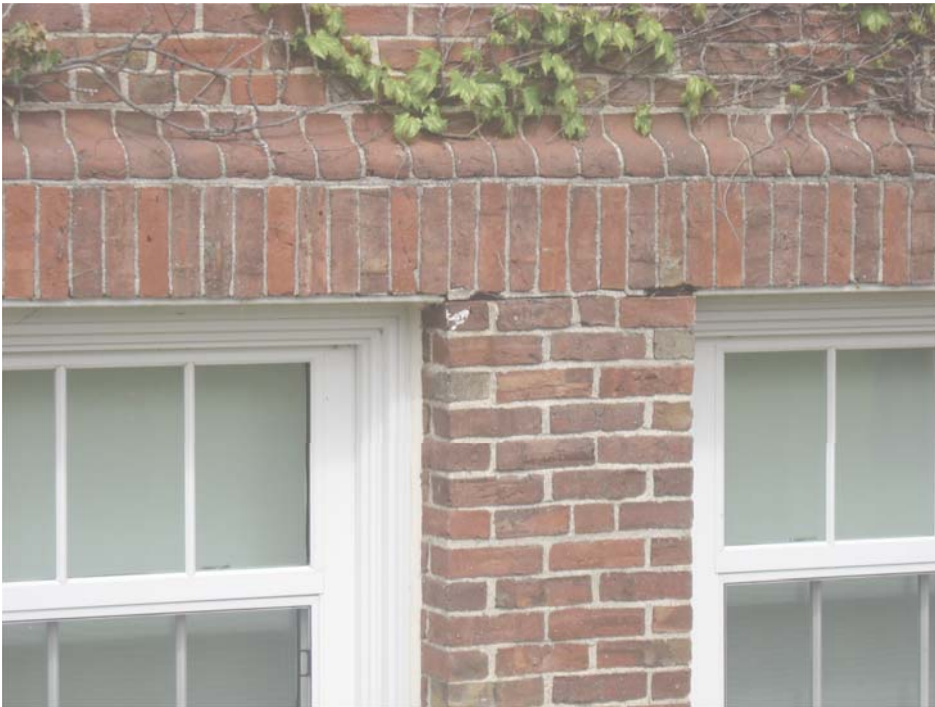
Cracks in brick near windows (lintels).

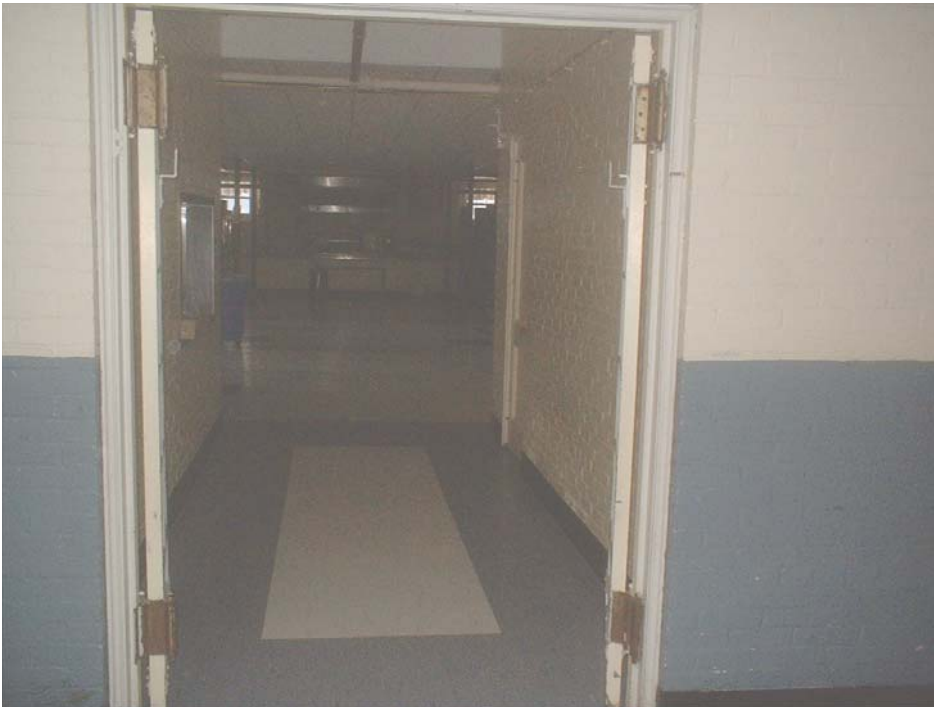
Entrance doors to cafeteria; wood. Narrow doors do not meet access codes.

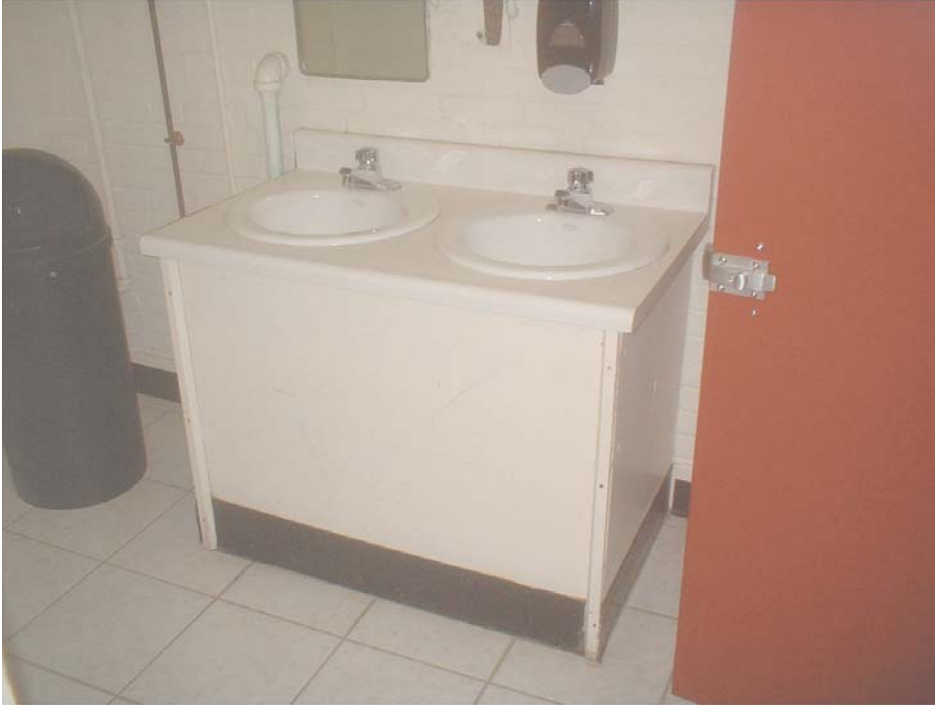
Non-accessible sinks in basement boys' toilets.

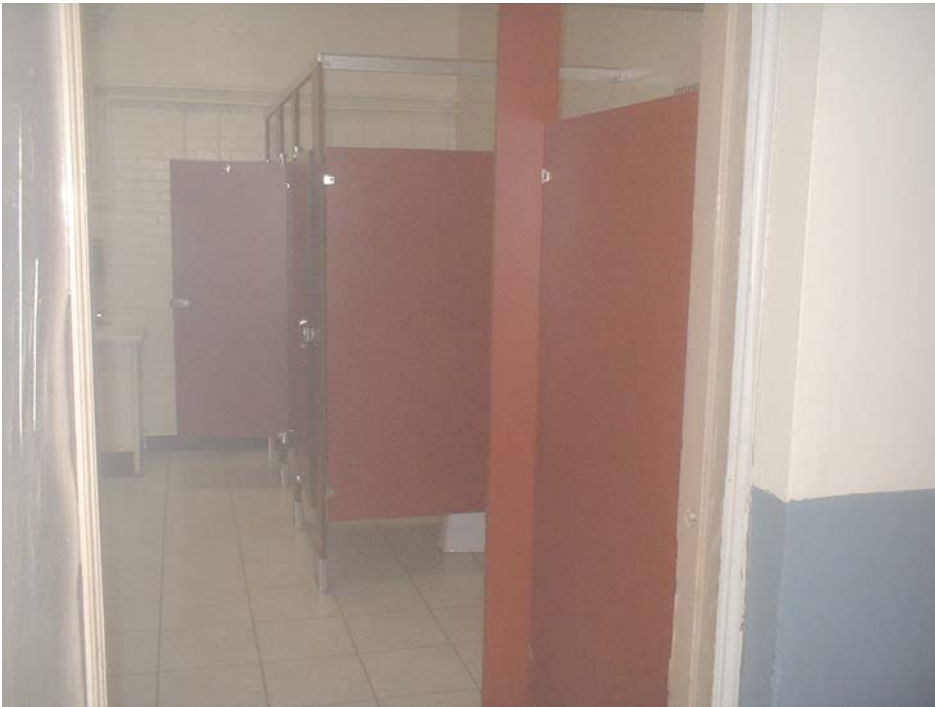
Basement boys' toilets, privacy issues from hallway.

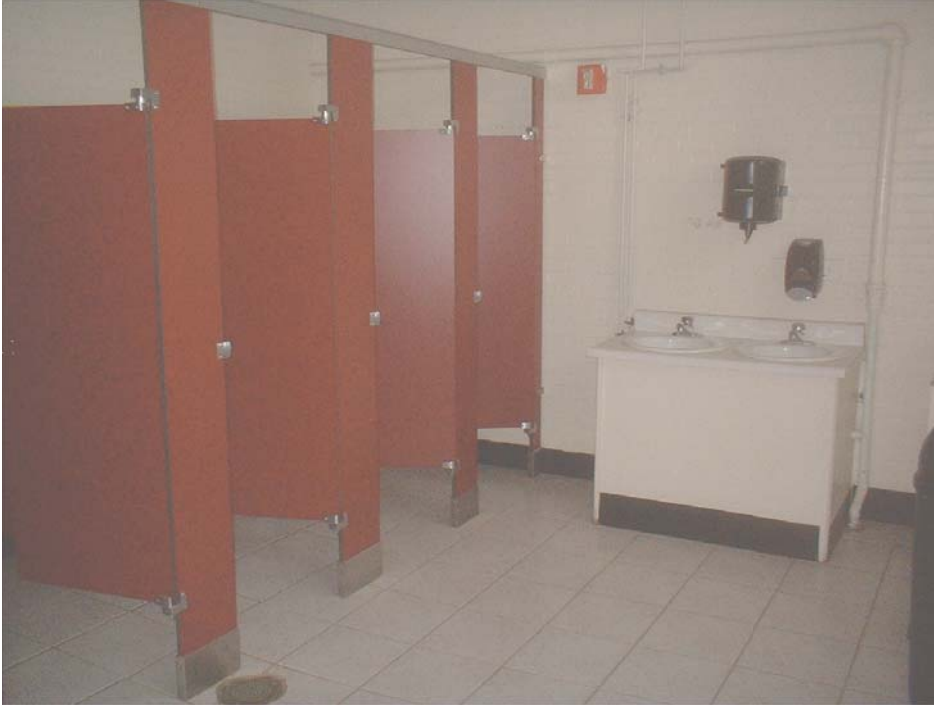
Girls' room lower level, non-accessible.

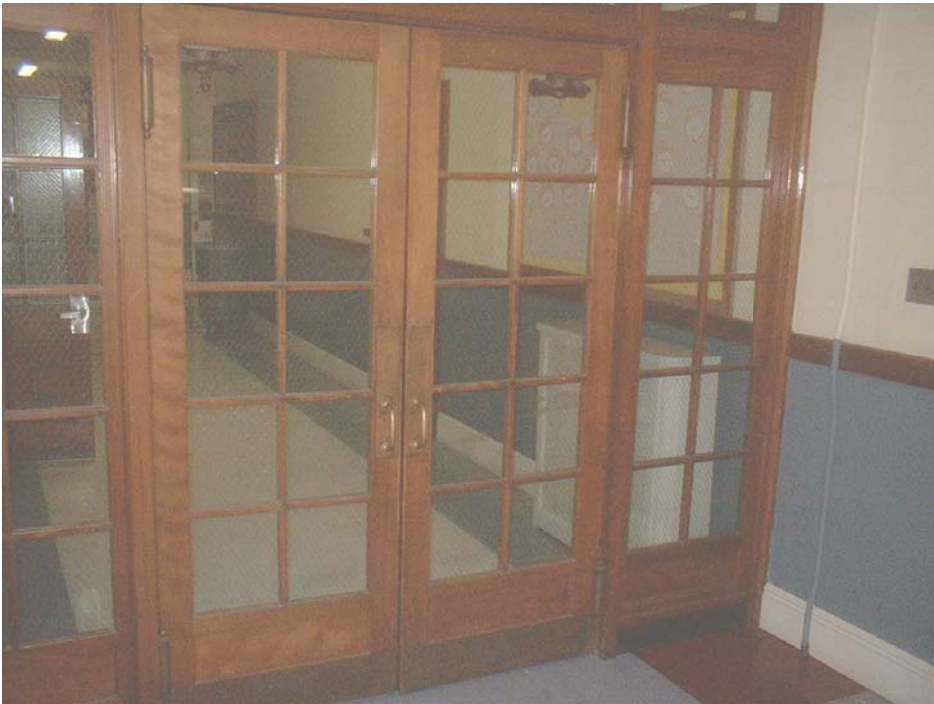
Double 2'-6" doors at stairs; double-acting hinges modified.

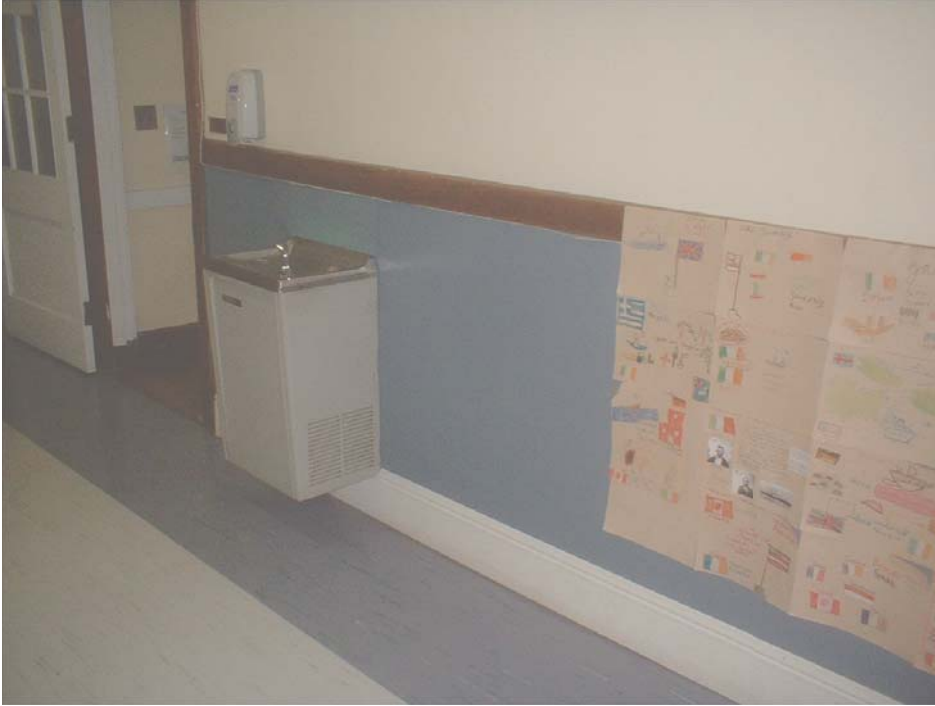
Non-accessible drinking fountain at main lobby.

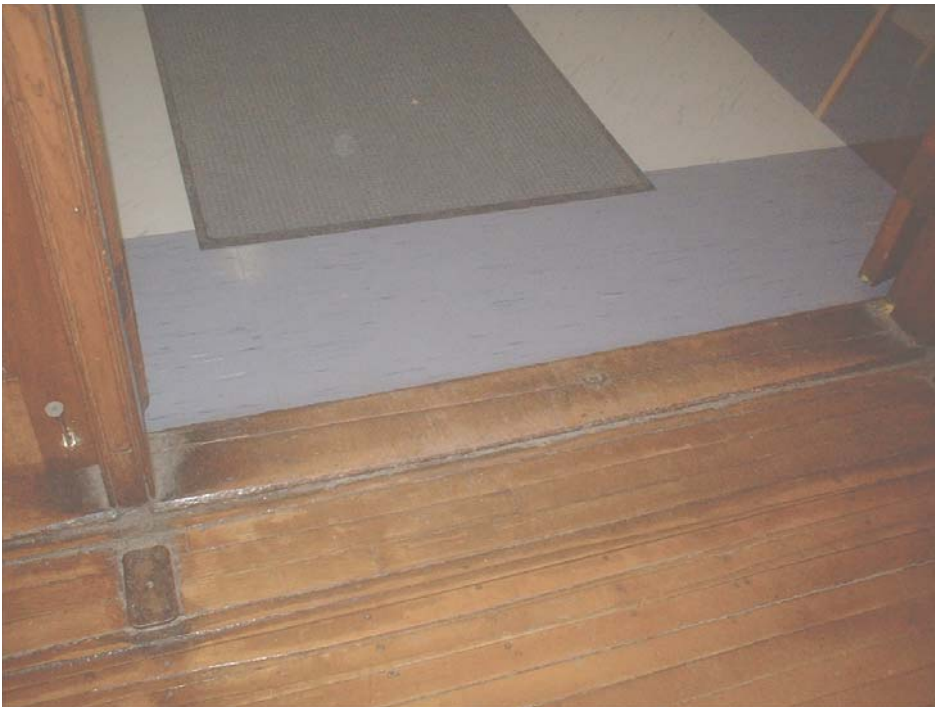
Threshold too high at gym entrance doors.

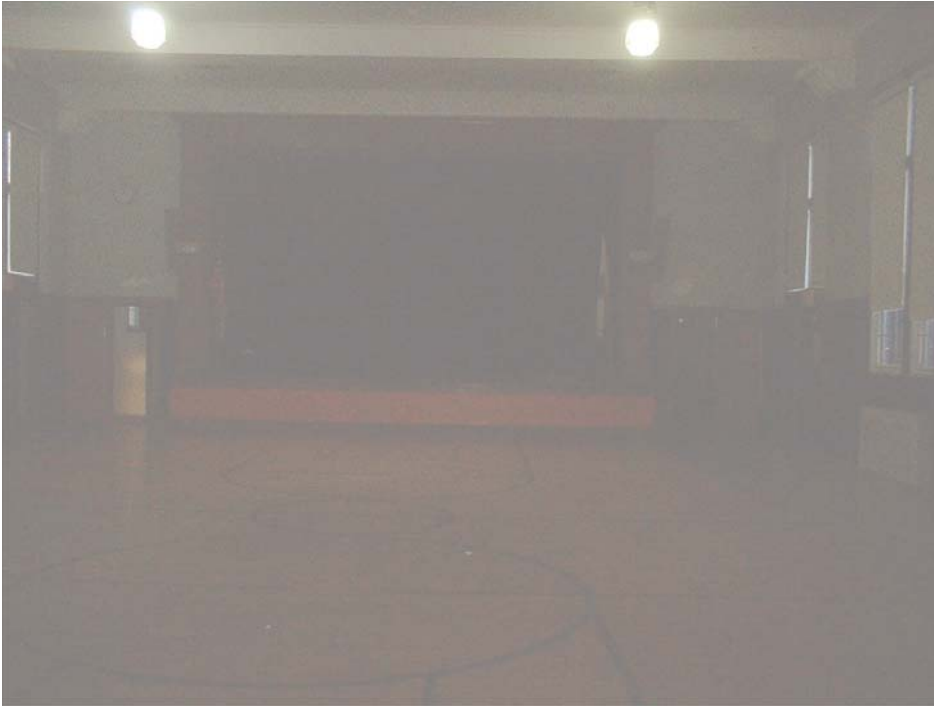
Stage in gym.
No lift; steps missing handrail baulasters.

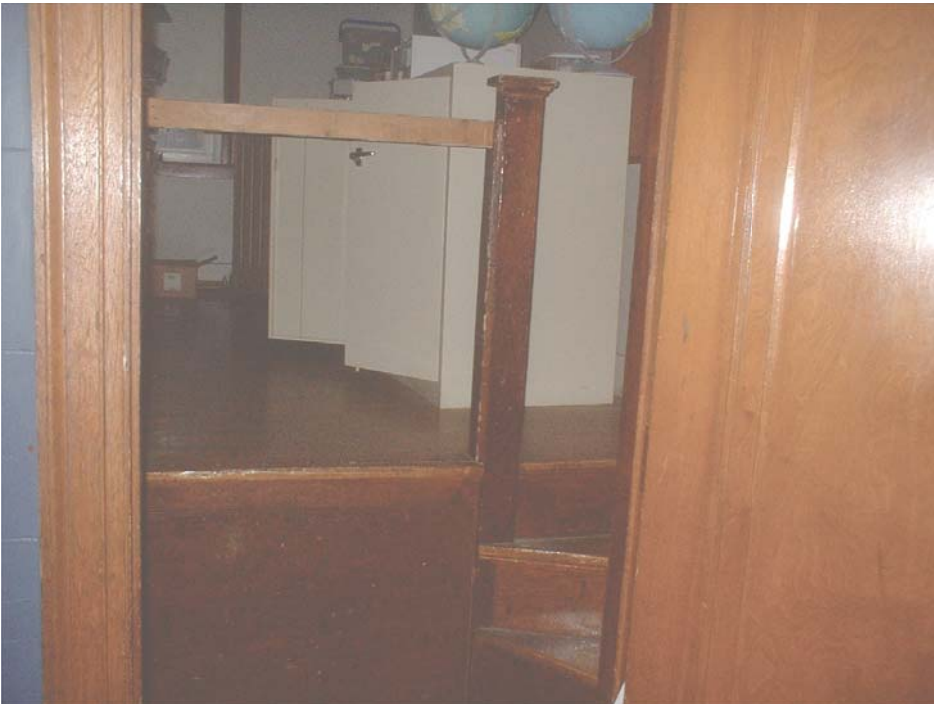
Steps to stage not code compliant.

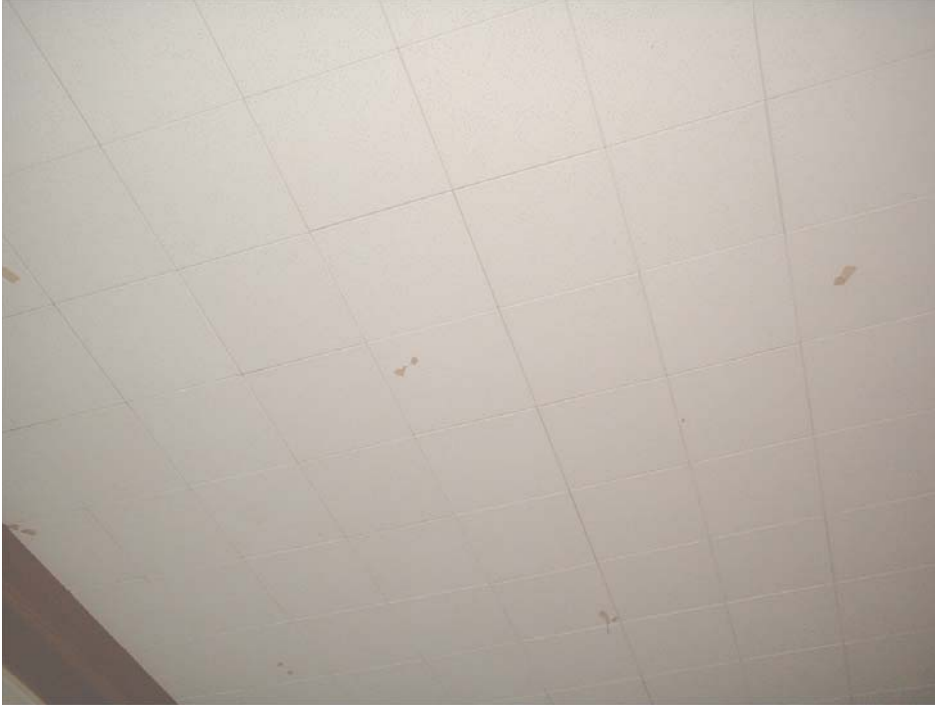
12x12 ceiling tiles reported to have black mastic or black mastic-containing asbestos.

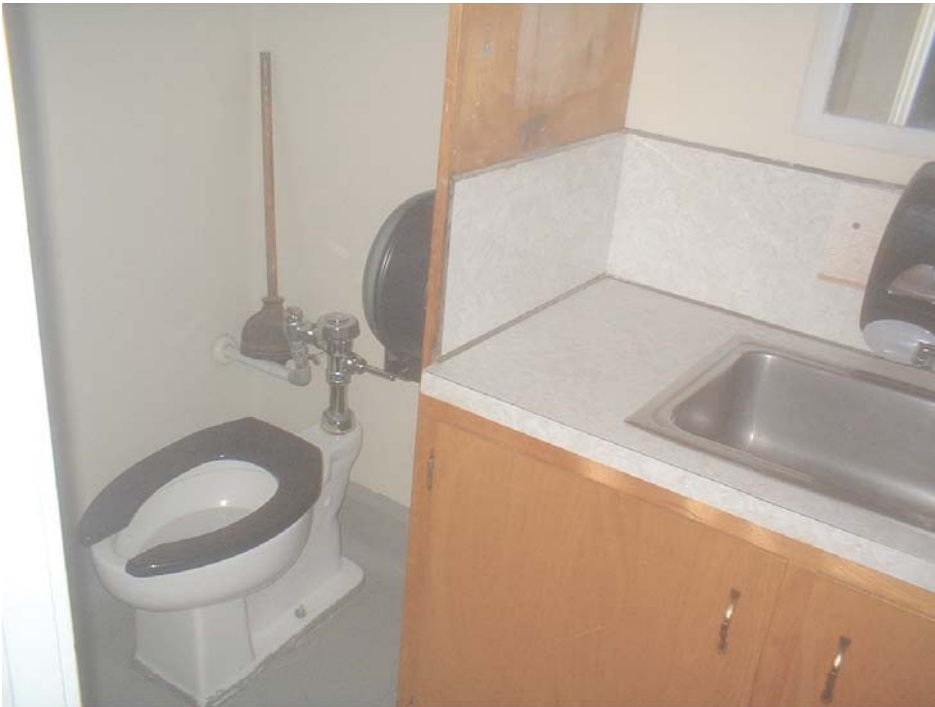
Non-accessible toilet in nurse's room.

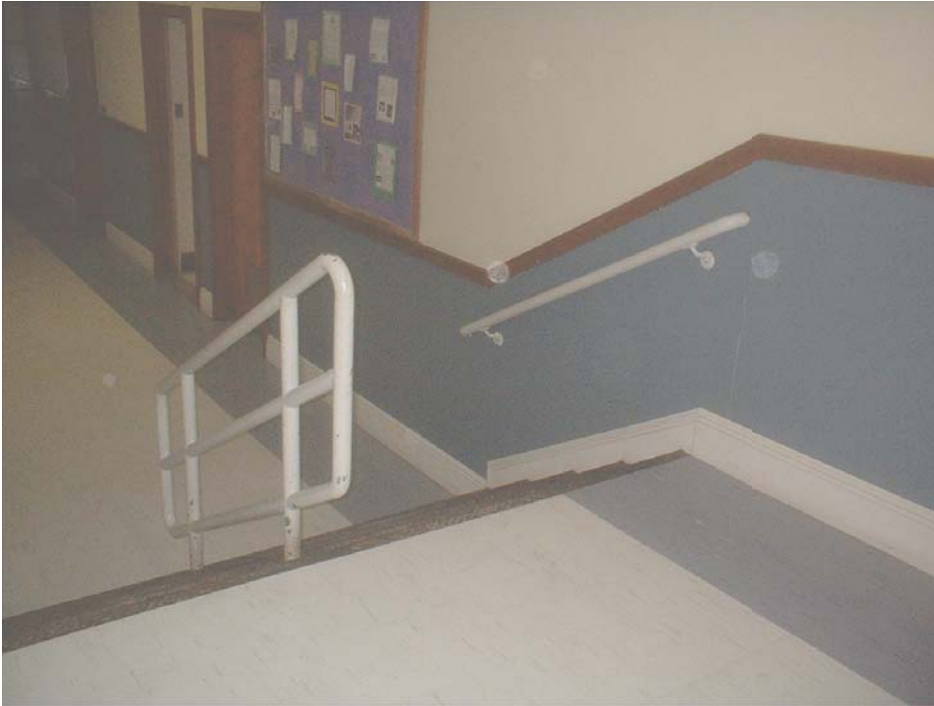
Steps in hallway with no lift.

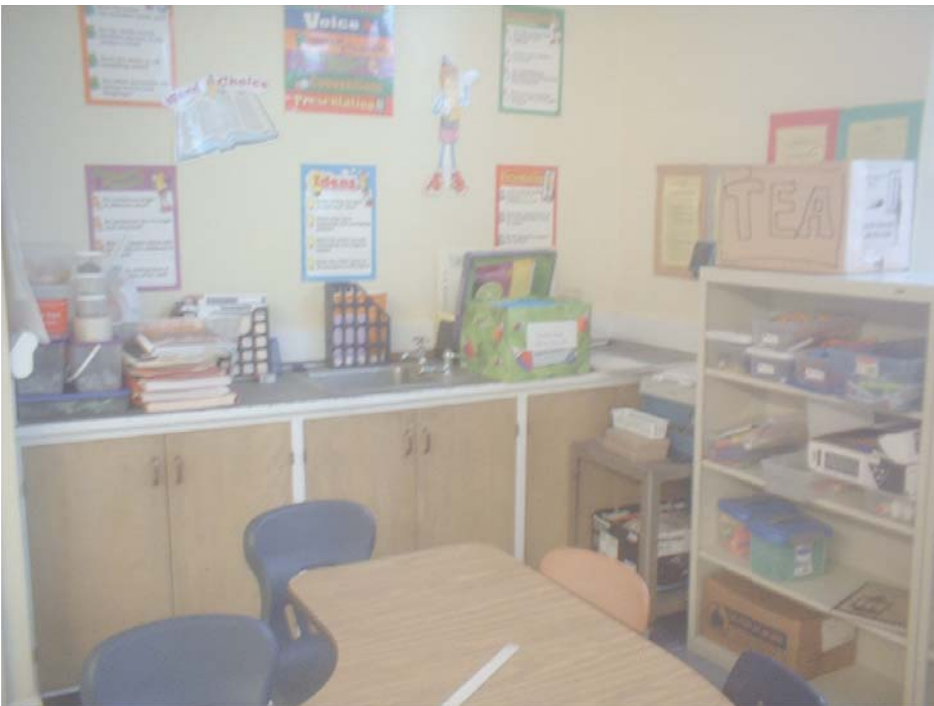
Non-accessible sink in classroom on 3rd floor.
