DOCUMENTATION OF STONE CONSERVATION TREATMENTS TO ASSINIPPI CEMETERY, HANOVER, MA June 2015

**MONUMENT CONSERVATION COLLABORATIVE LLC, NORFOLK, CT**

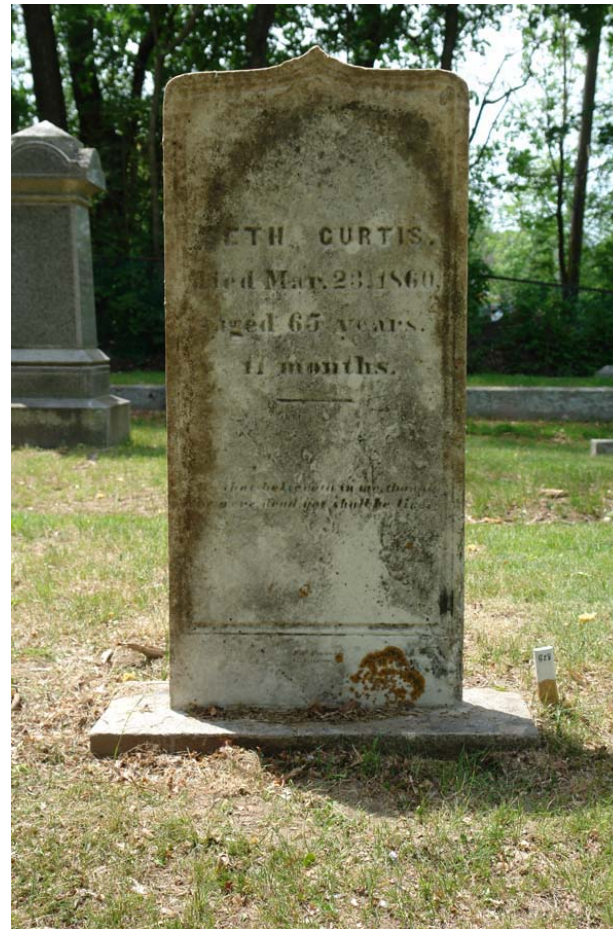
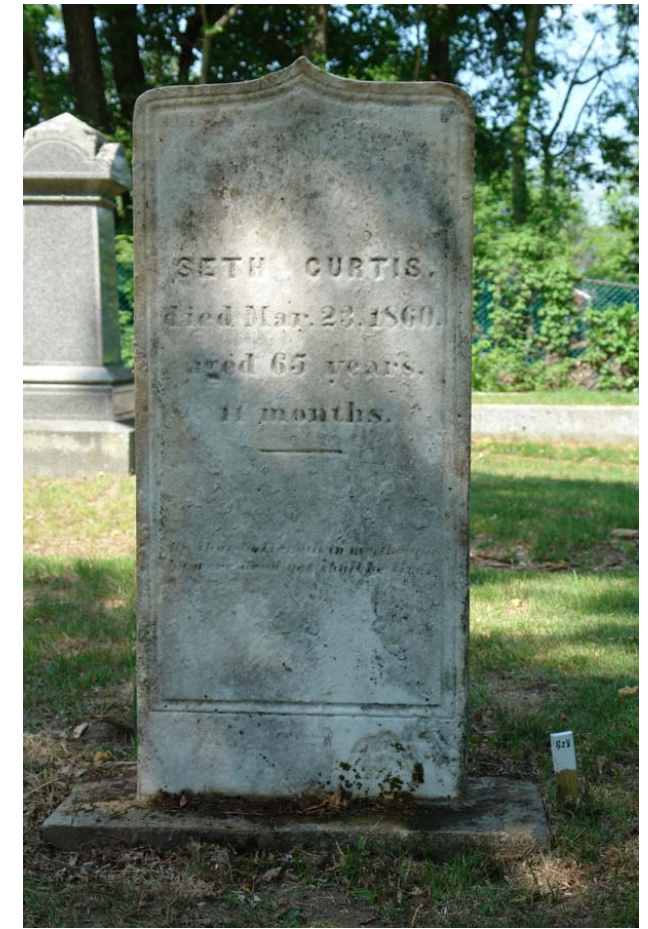
B28 Seth Curtis, before and after treatment with D/2

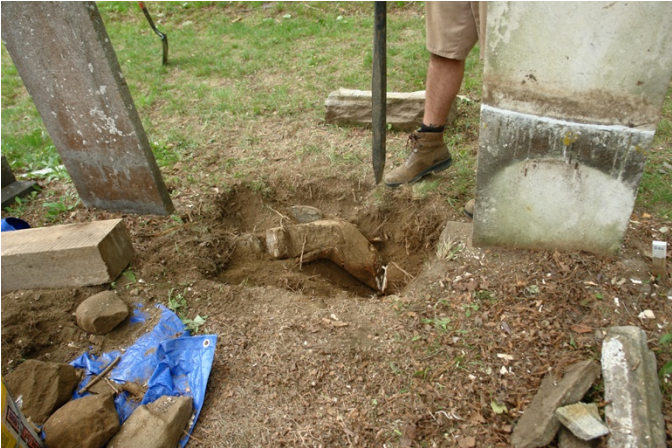
A common cause of tilted markers are roots from nearby trees

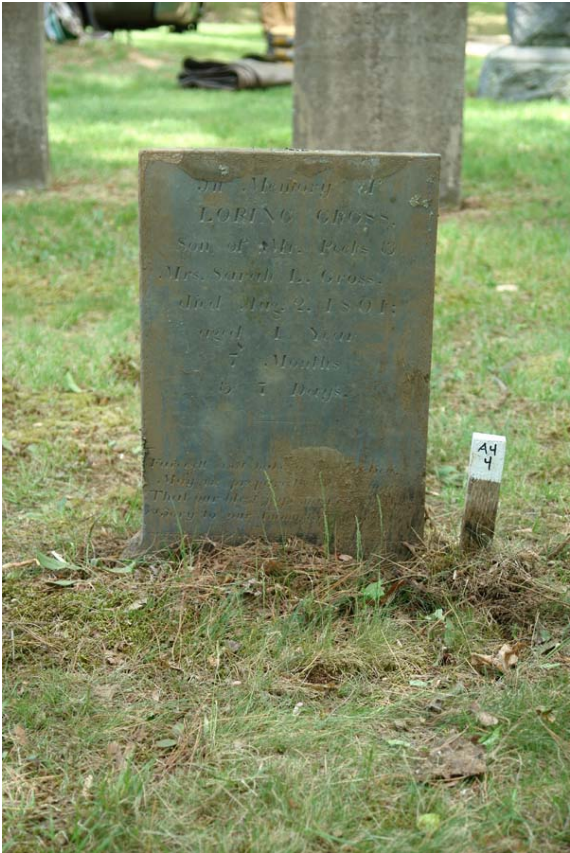
A4.4 Luring Cross Before and after– severely tilted

Union Assinippi Cemetery, Hanover, MA	
NAME ON MARKER	Loring Cross
Death Date: 8/2/1801	Marker Type: Headstone
Cond. of Inscription: Legible	Material: Marble
EXISTING CONDITIONS	CONSERVATION STRATEGY
Tilted	Reset plumb
TREATMENT	
Treatment Dates 5/20/2015	
1. Marker carefully excavated. The soil around tilted markers was removed to an appropriate depth. When required, the marker was removed from the ground. Marker appears to be sound.	
2. Soling removed by light brushing with nylon brushes and water.	
3. Setting area excavated to sufficient depth and stone re-set plumb at appropriate height and level onto gravel bed, aligned with adjacent markers	
4. Area backfilled around marker with tamped sand and gravel	
5. Disturbed areas re-graded with existing topsoil and sod.

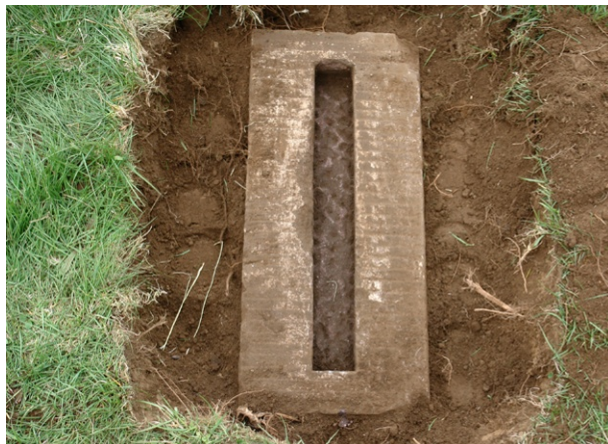
Old base aligned with adjacent markers and reset level.

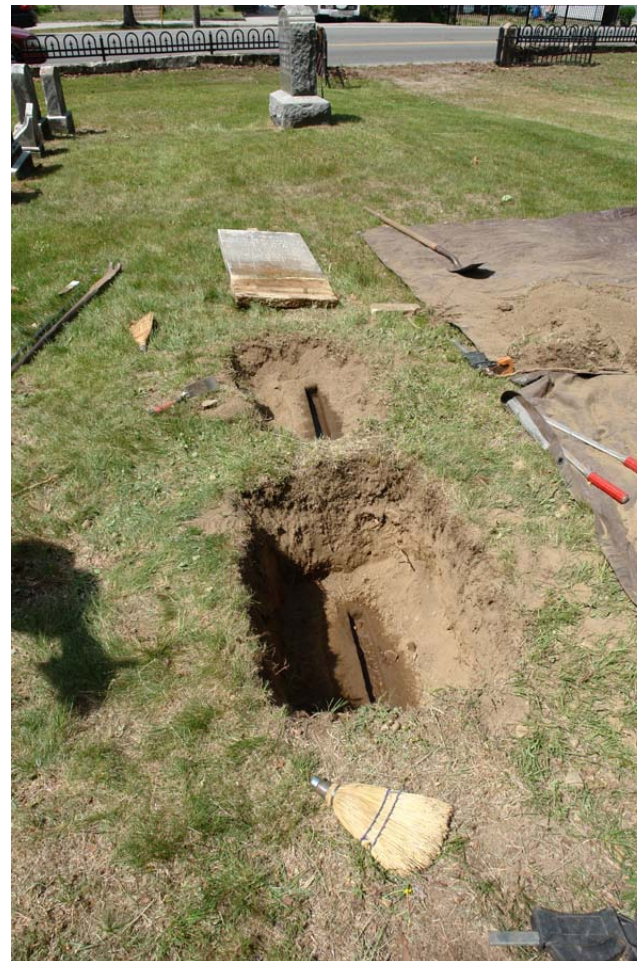
These original bases were raised to an appropriate level and reset plumb

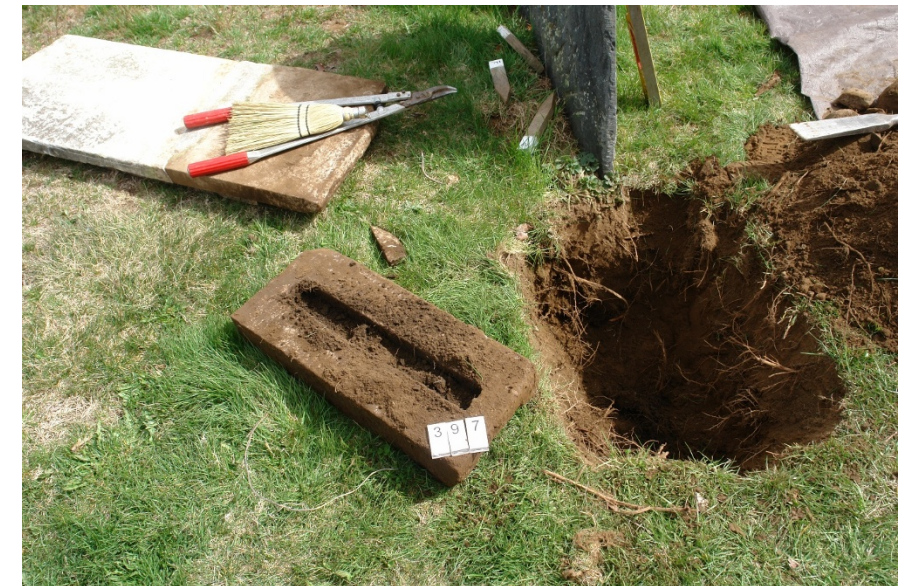
When excavating for resetting often original, or old bases are discovered

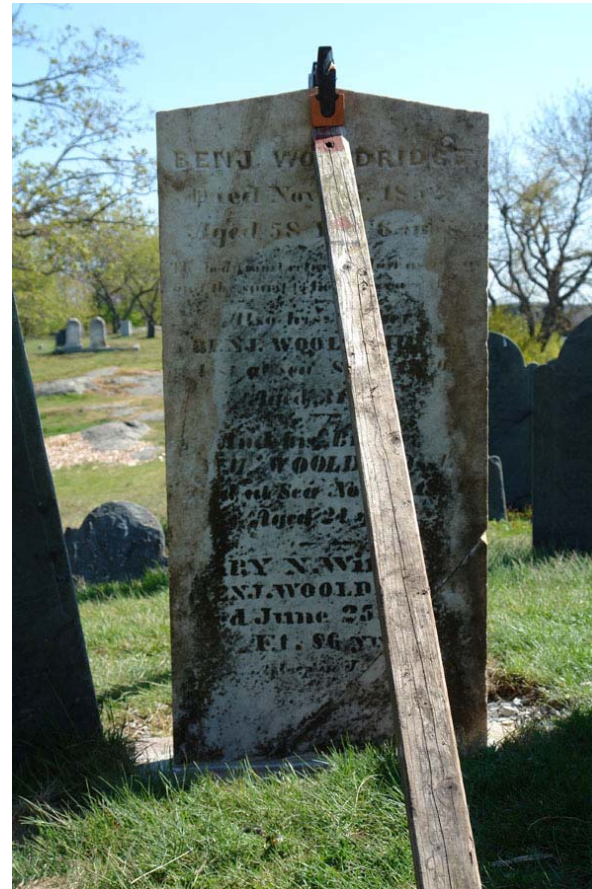
Example of marker reset into slot and braced

Gravestones that required insertion into existing bases were set with a relatively weak cement/lime-based grout (3:2:9:1) with fine aggregates (000), made fluid with a high-range water reducer which ensures a complete fill. This was poured or injected into the base slot. Stones were braced for a minimum of three days to limit movement during curing of the grout.

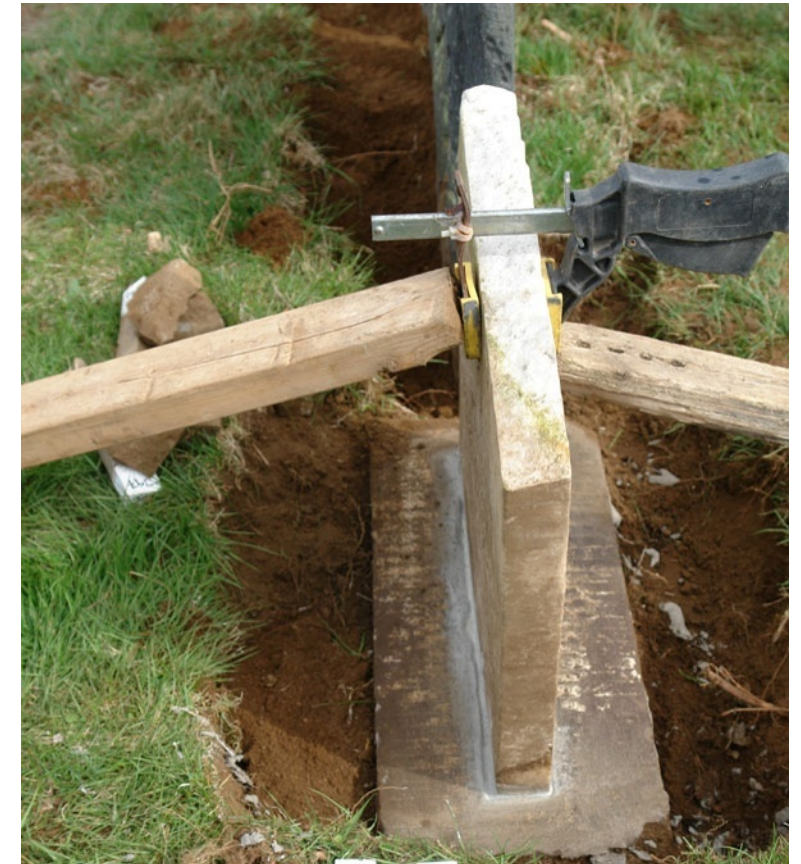
Lower fragment reset into slot and braced. Top fragment will be attached with structural adhesive after grout has sufficiently cured.

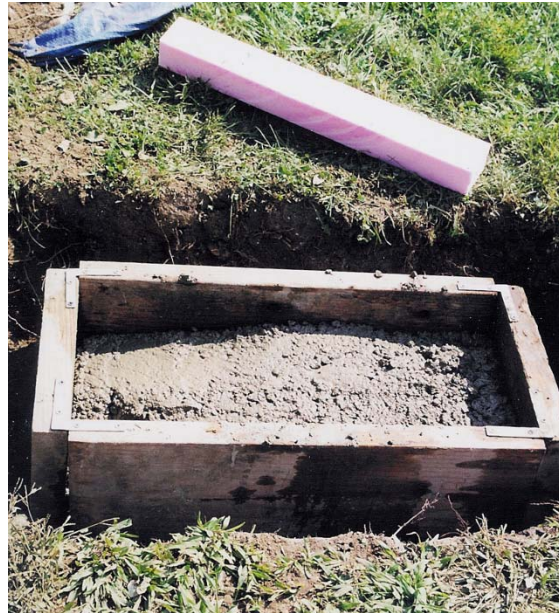
Form for new below grade concrete base

Bases were made on site by casting in place with concrete. The casting is generally 9 to 12 inches deep, and 6 inches greater in both thickness and width than the stone itself. The finished top surface of the base should be entirely below grade. A form for a 2 inch deep setting slot, $\frac{1}{2}$ inch wider and $\frac{1}{2}$ thicker than the stone, was positioned in the concrete. After the base cured, the gravestone was reset into the slot with a cement/lime-based grout as previously described. The top of the new base was covered with topsoil.

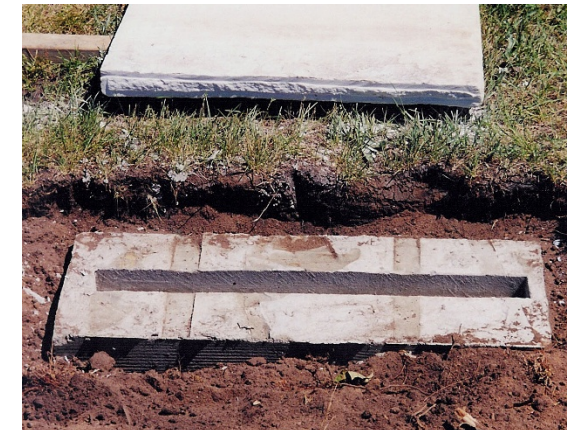
Form removed, ready for resetting marker

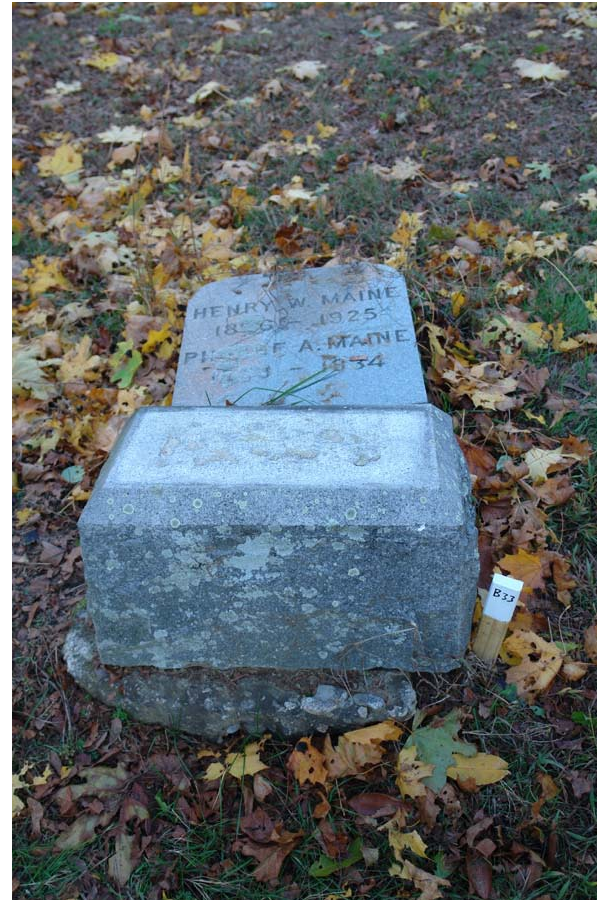
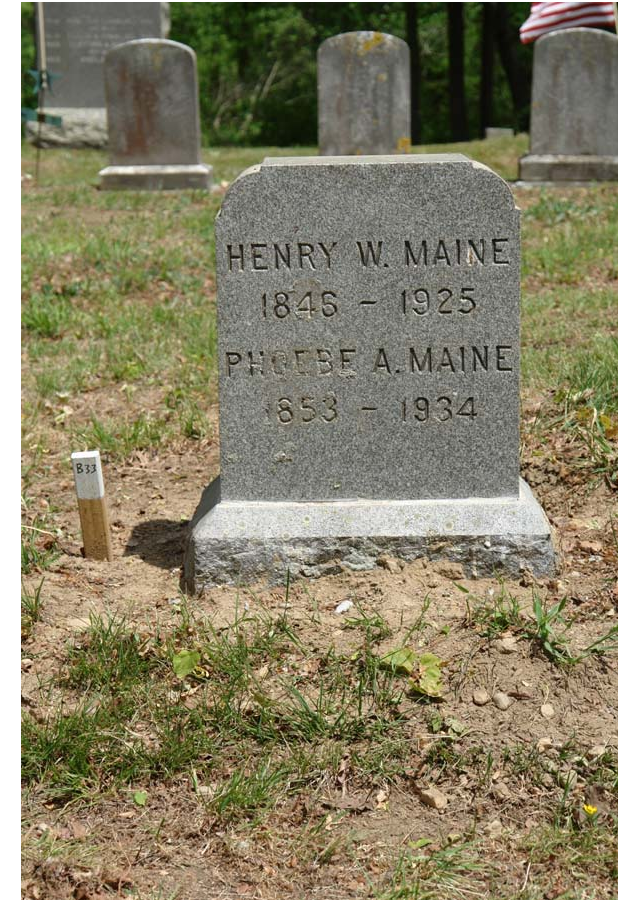
B33 Henry and Phoebe Maine reset onto existing base.

For resetting onto existing bases or ledgers, setting surfaces were first primed with Acryl 60 diluted with water 1:3, and markers were reset with a cement/lime-based grout (3:2:9:1) with fine aggregates (000).

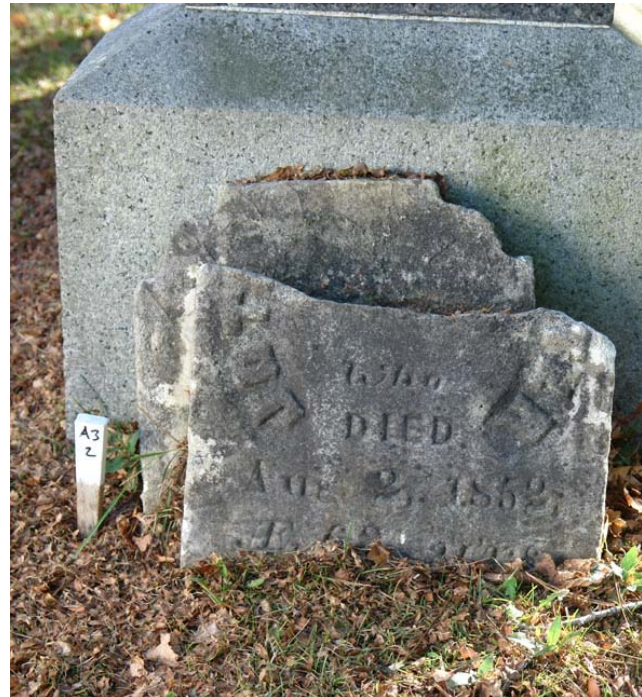
#A3.2 Jotham Sylvester. An example of a marker requiring structural adhesion

Union Assinippi Cemetery, Hanover, MA	
NAME ON MARKER	Jotham Sylvester
Death Date: 8/2/1852	Marker Type: Headstone
Cond. of Inscription: Legible	Material: Marble
EXISTING CONDITIONS	CONSERVATION STRATEGY
Fractured Out of ground	Evaluate Reset if possible
<div> <div>TREATMENT</div> <div>Treatment Dates 5/17-6/12/2015</div> <div> <div>1. Existing base located below grade and found to be sound.</div> <div>2. Area excavated to an appropriate depth and base was aligned with adjacent markers and re-set level and backfilled with tamped gravel.</div> <div>3. Setting slot cleaned of debris or failed mortar</div> <div>4. Lower fragment reset plumb and level into slot using a cement/lime grout (3/2/9) with 000 sand. Braced for min 3 days</div> <div>5. All mating edges of fragments cleaned with water and any failed adhesives removed with hand tools</div> <div>6. Fragments attached with structural adhesive (Abatron 55-22), clamped and braced until cured. Excess epoxy removed with hand chisels within 24 hours.</div> <div>7. Cracks and losses filled with RepliCal Marble products .</div> <div>8. Filled areas misted with water and covered for 3 days minimum</div> <div>9. Filled surface areas treated with light acid wash rinsed thoroughly</div> <div>10. When required, all surfaces treated with D/2 Biological Solution, scrubbed with nylon brushes and water. Rinsed fully with water</div> </div> </div>

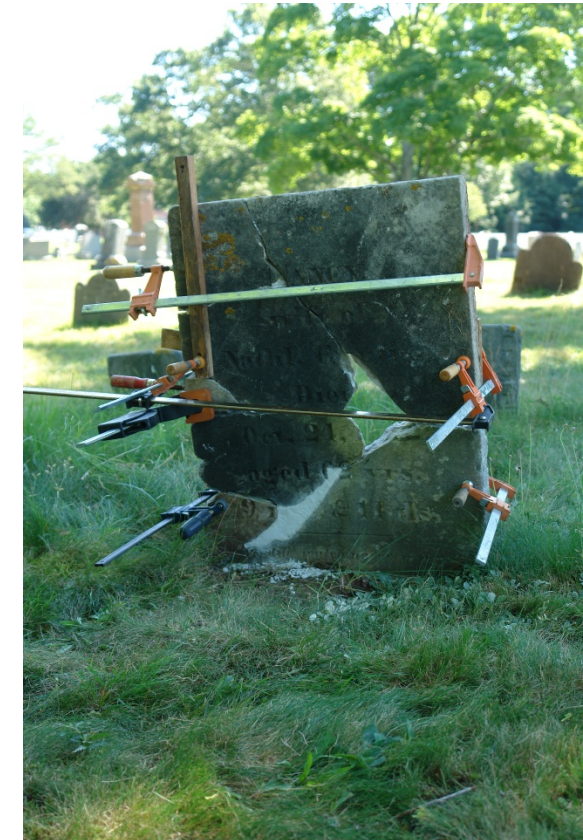
Clamping and bracing in a vertical position allows gravity to help position fragments. Often marble becomes "bowed" or curved with time.

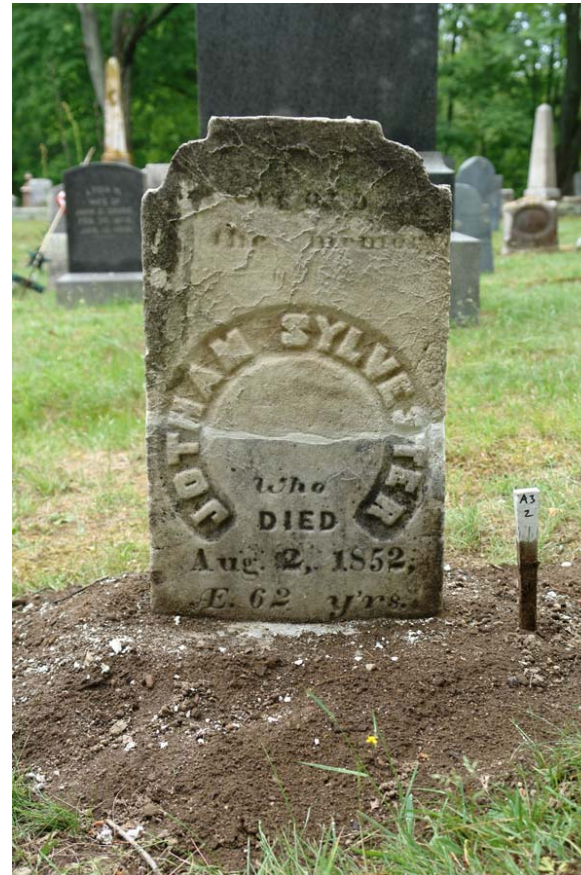
#A3.2 Jotham Sylvester. Open joints filled with Replical crack filler.

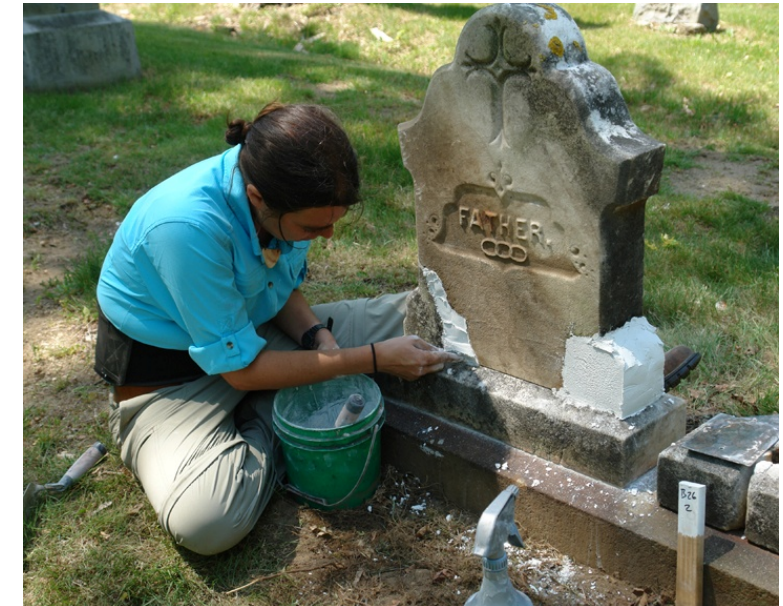
B26.2, William Jacobs. Losses were filled with Jahn M-70 pigmented restoration mortar.

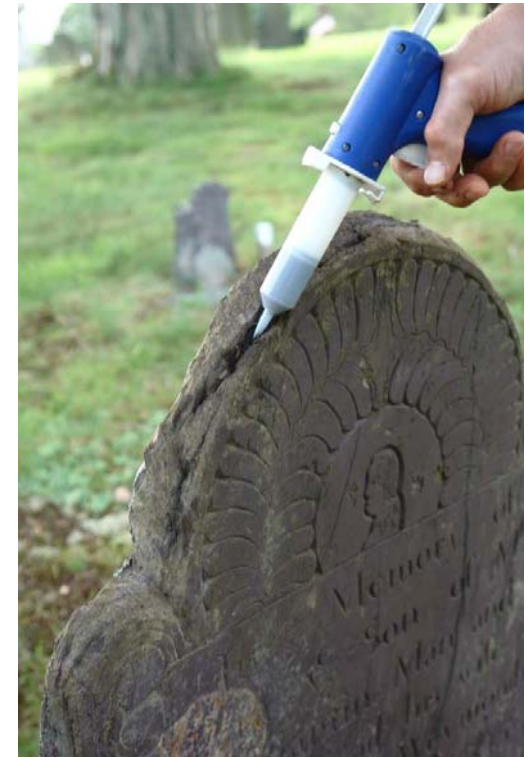
Filling top cavities with a pigmented crack filler by Sto. Material can be applied by trowel or injection. Excess material will be immediately wiped off with damp sponging

Open joints along the top were filled with a pigmented flexible industrial “crack filler” by Sto.

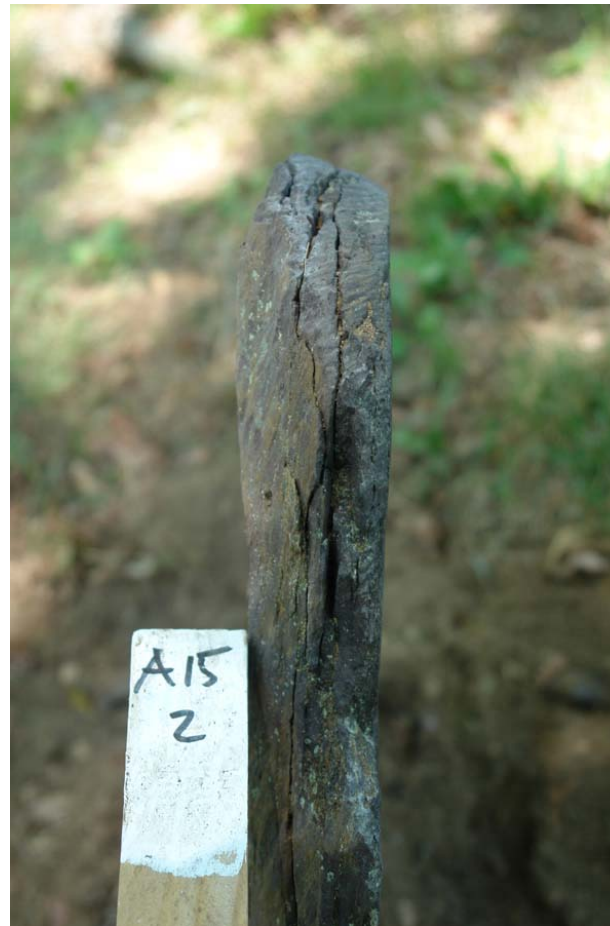
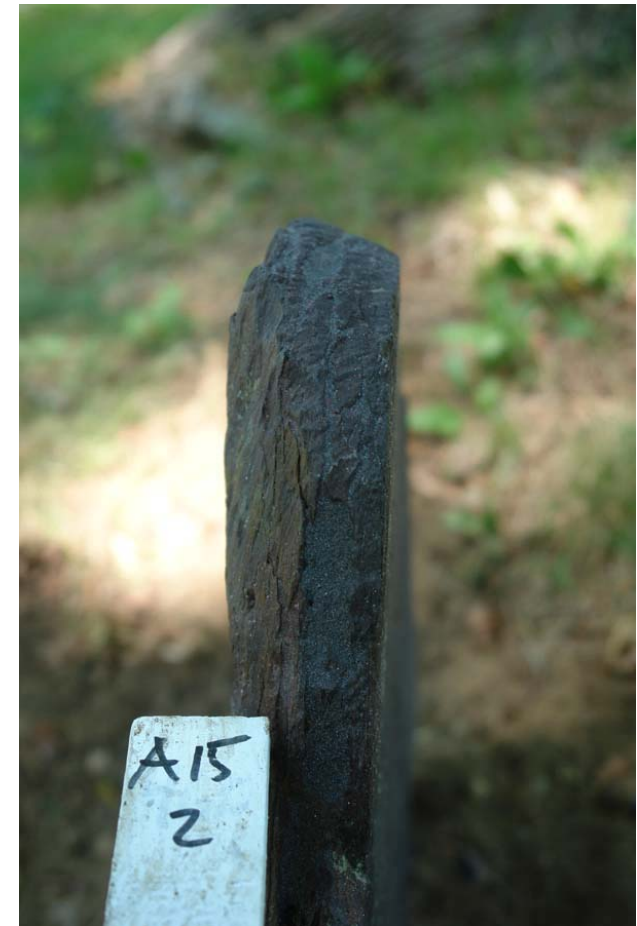
#A15.2, Jemima Farrow. Before and After. Delaminations filled with Sto Crack Filler

Small open joints along the top were filled with a pigmented flexible industrial “crack filler” by Sto. Excess grout is immediately removed with damp sponging.

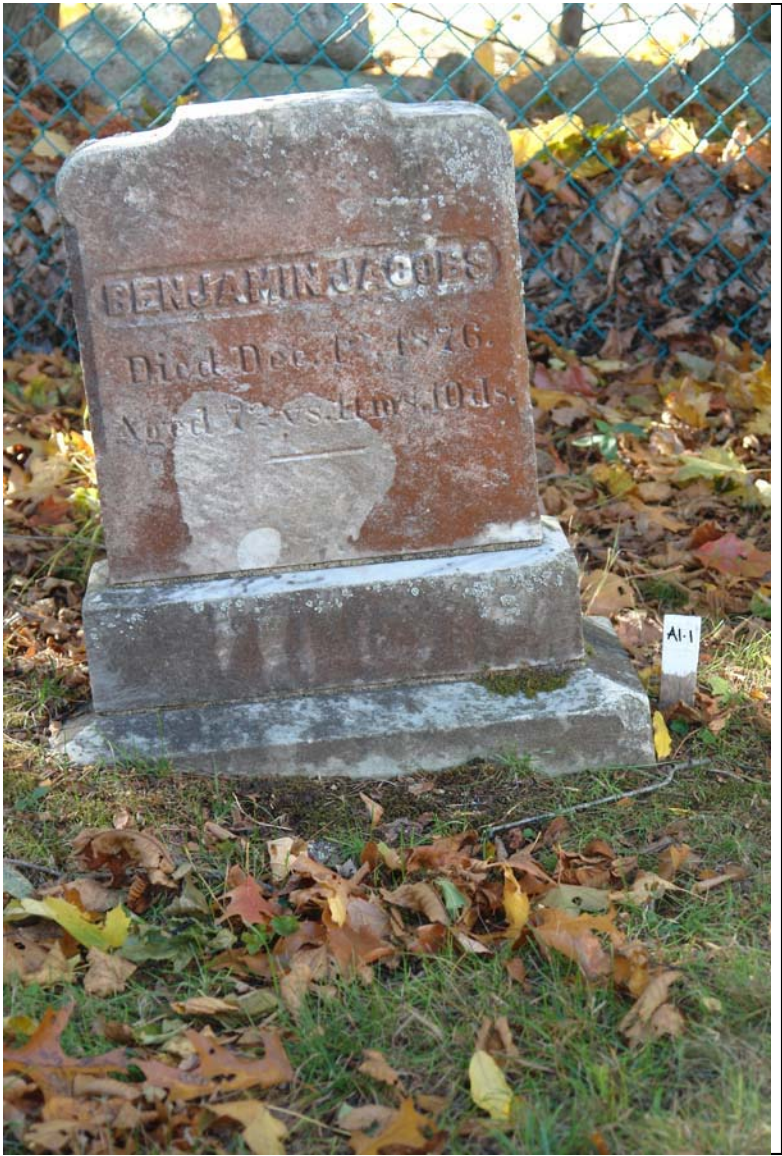
Union Assinippi Cemetery, Hanover, MA	
NAME ON MARKER	Benjamin Jacobs
Death Date: 12/12/1876	Marker Type: Headstone/base
Cond. of Inscription: Decipherable	Material: Marble
EXISTING CONDITIONS	CONSERVATION STRATEGY
Loose in base Tilted	Level base Reset elements
<div> <div>TREATMENT</div> <div>Treatment Dates 5/10/2015</div> <div> <ol style="list-style-type: none"> 1. Soundness of setting joint of marker to base inspected, if found to be unstable, marker removed from base. 2. Area excavated to an appropriate depth removing any roots or large stones. 3. Base is aligned with adjacent markers and re-set level. 4. Area around base was backfilled with tamped gravel and re-graded with existing topsoil 5. Failed mortar removed from setting area and bottom of marker 6. When required, any existing pins were inspected, and if necessary, replaced with stainless steel threaded pins 7. Setting surfaces primed with Acryl 60 diluted 1:3 with water. 8. Marker reset plumb onto base with cement/lime mortar (3/2/8) with 000 sand. 9. Excess grout removed and joint area cleaned. </div> </div>

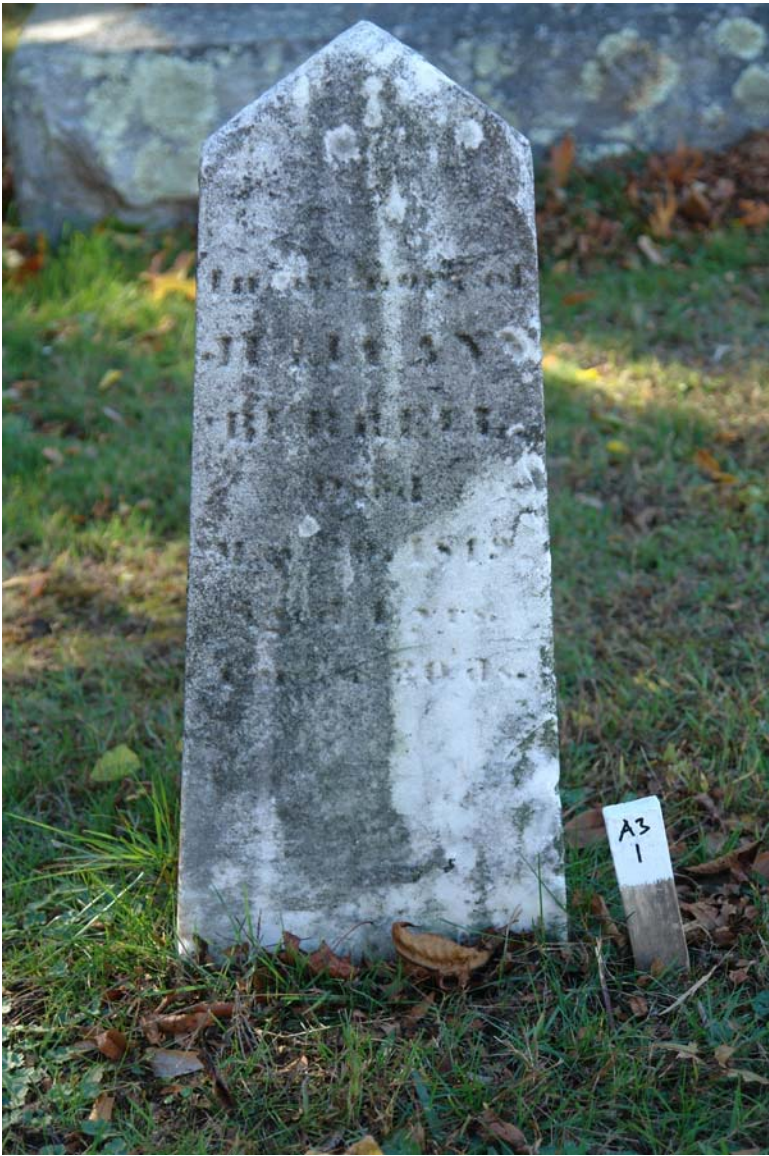
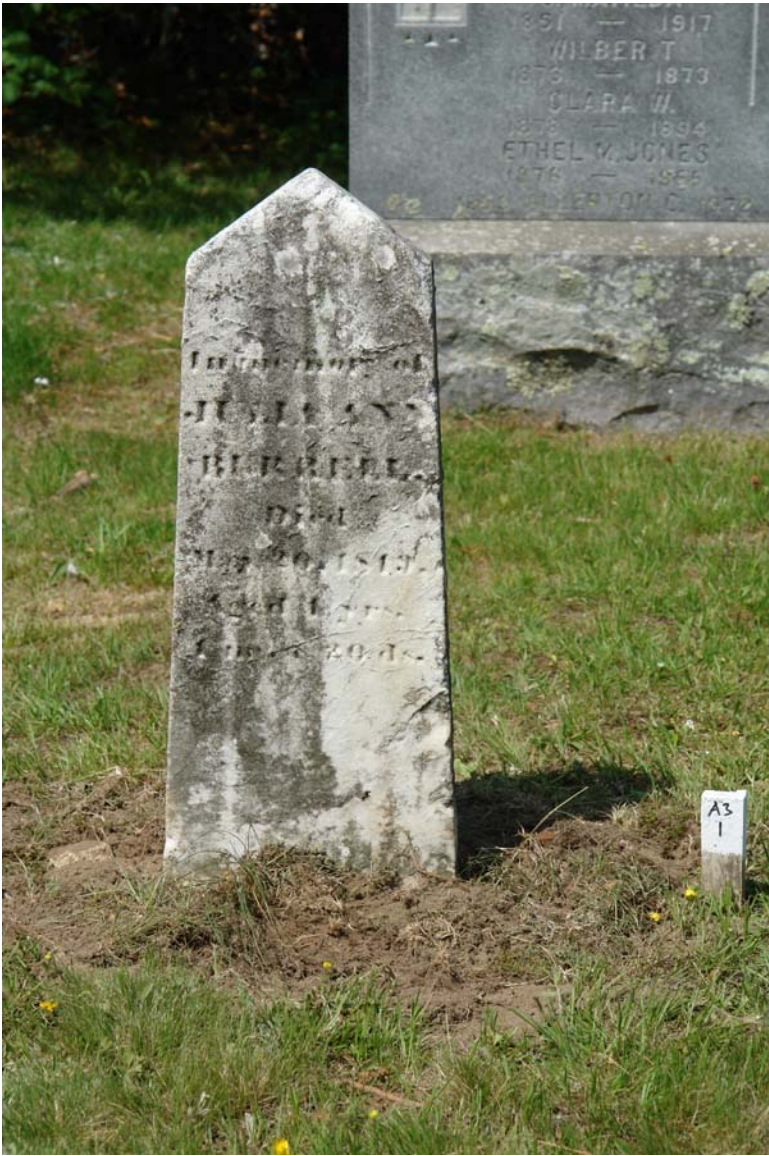
EXISTING CONDITIONS	CONSERVATION STRATEGY
Tilted	Reset plumb Possible new below grade base

2. Base inspected and found to be sound and re-useable

6. Failed mortar removed from setting area and bottom of marker

7. When required, any existing pins were inspected, and if necessary, replaced with stainless steel threaded pins

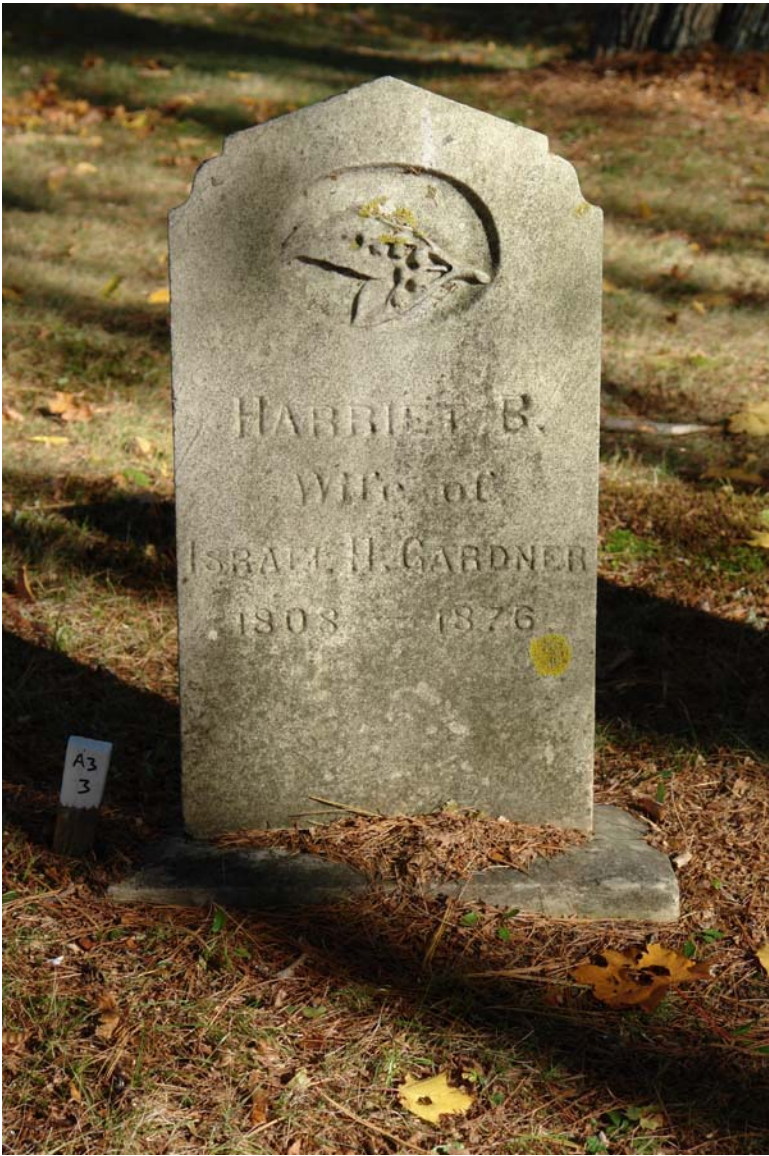
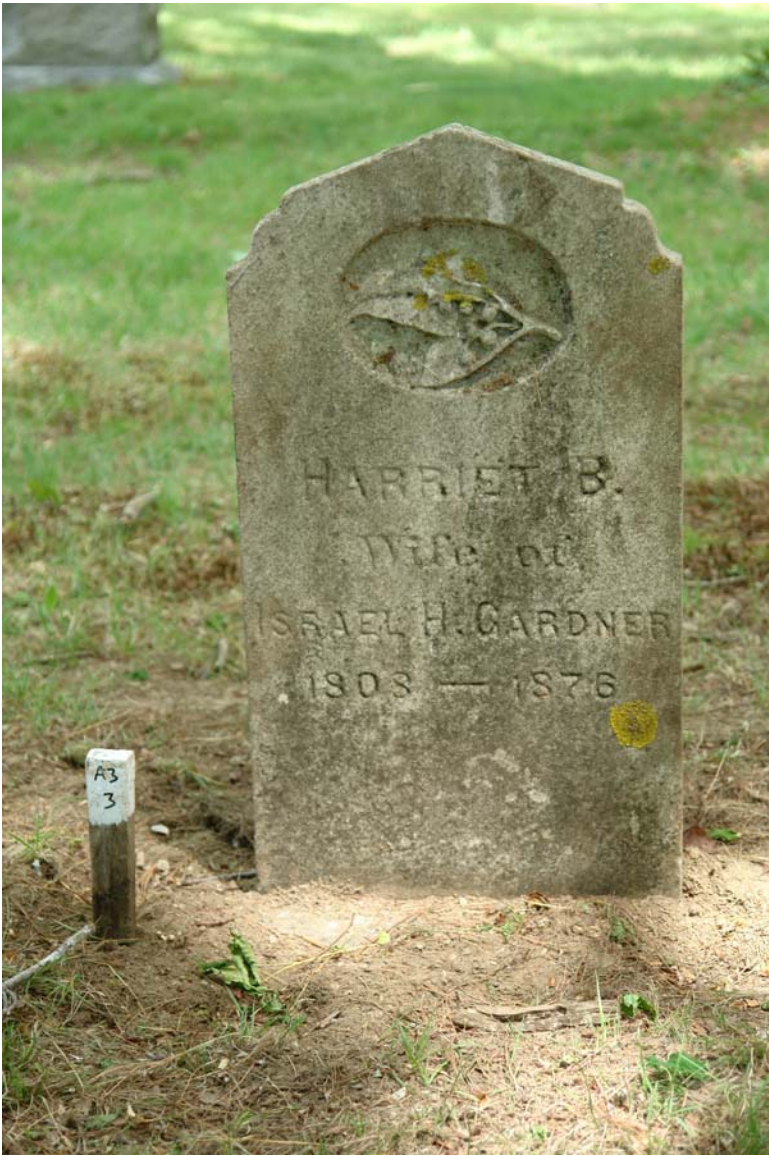
EXISTING CONDITIONS	CONSERVATION STRATEGY
Tilted base	Reset base with marker plumb

- Existing base located below grade while excavating for resetting. Area excavated to an appropriate depth removing any roots or large stones.
- Base inspected and found to be sound and re-useable
- Base is aligned with adjacent markers and re-set level.
- Area around base was backfilled with tamped gravel and re-graded with existing topsoil
- Debris removed from setting slot. When required, power grinders were used to facilitate removal of stone fragments.
- When required, the lower setting edge was re-squared by power grinder with minimal loss.
- Marker reset plumb and level into setting slot with cement/lime grout (3/2/9) with 000 sand made fluid with a super plasticizer.
- Excess grout removed and joint area cleaned.
- Marker braced for a minimum 3 days

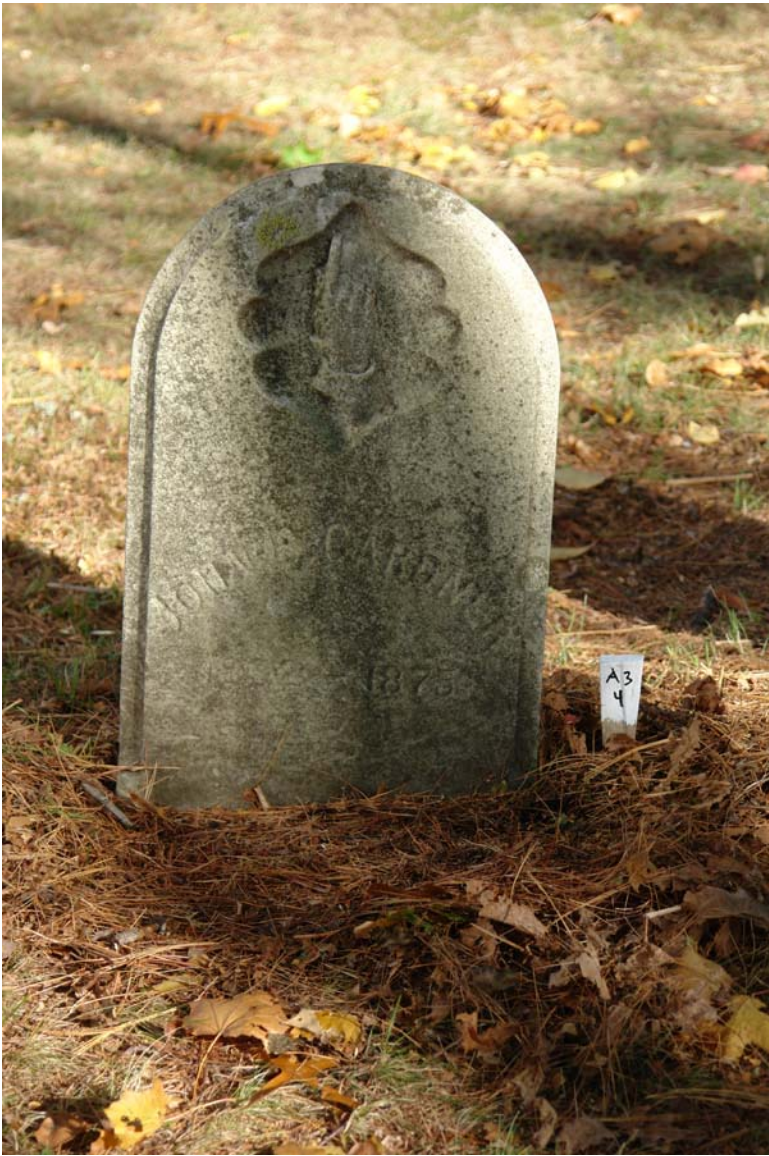
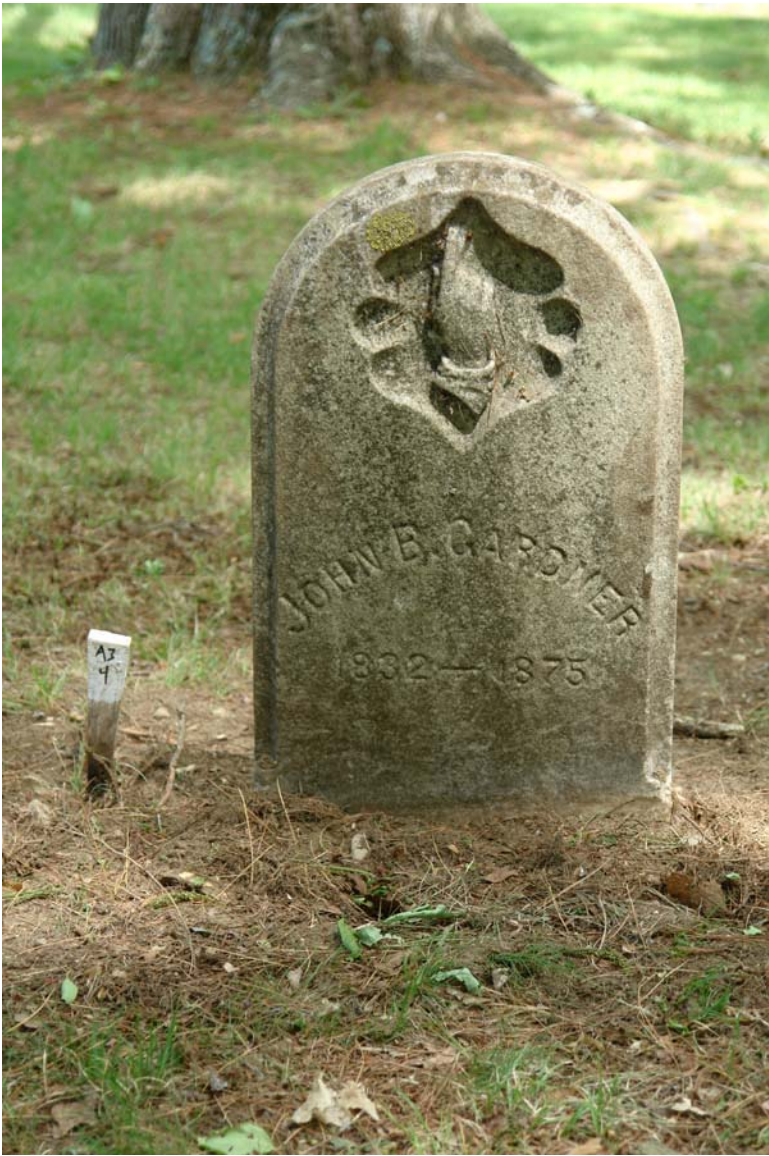
Union Assinippi Cemetery, Hanover, MA	
NAME ON MARKER	John Gardner
Death Date: 1875	Marker Type: Headstone/base
Cond. of Inscription: Decipherable	Material: Marble
EXISTING CONDITIONS	CONSERVATION STRATEGY
Tilted	Reset Possible new base
TREATMENT Treatment Dates 5/19/2015	
<div>1. Existing base located below grade while excavating for resetting. Area excavated to an appropriate depth removing any roots or large stones.</div> <div>2. Base inspected and found to be sound and re-useable</div> <div>3. Base is aligned with adjacent markers and re-set level.</div> <div>4. Area around base was backfilled with tamped gravel and re-graded with existing topsoil</div> <div>5. Debris removed from setting slot. When required, power grinders were used to facilitate removal of stone fragments.</div> <div>6. When required, the lower setting edge was re-squared by power grinder with minimal loss.</div> <div>7. Marker reset plumb and level into setting slot with cement/lime grout (3/2/9) with 000 sand made fluid with a super plasticizer.</div> <div>8. Excess grout removed and joint area cleaned.</div> <div>9. Marker braced for a minimum 3 days</div>

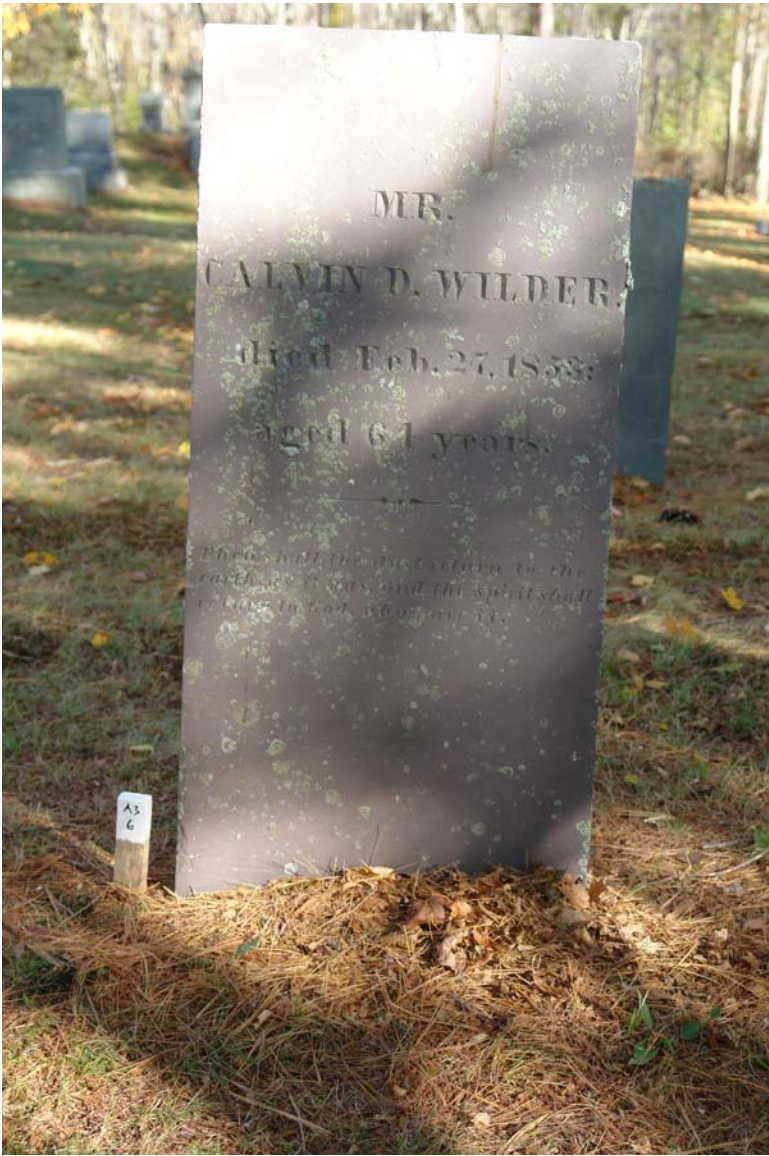
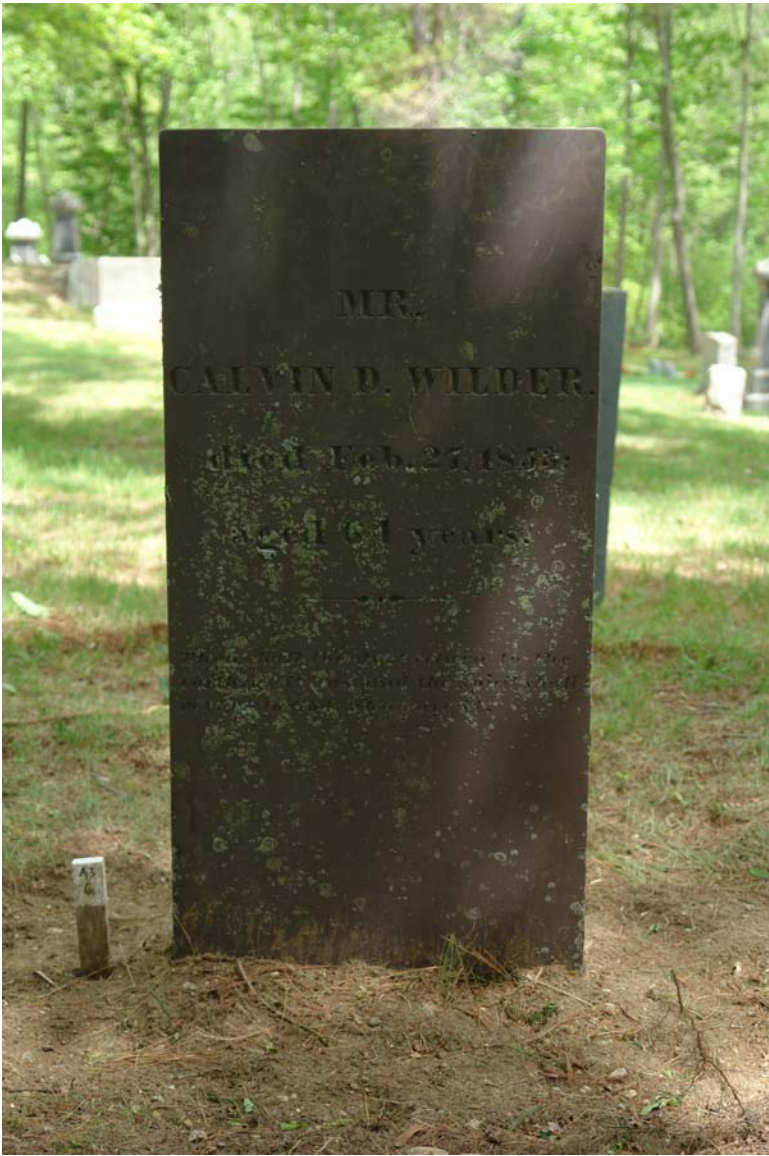
Height 19 Width 12 Thickness 2.5 Marker# **A.3.5**

Union Assinippi Cemetery, Hanover, MA	
NAME ON MARKER	Calvin Wilder
Death Date: 2/27/1853	Marker Type: Headstone
Cond. of Inscription: Legible	Material: Slate
EXISTING CONDITIONS	CONSERVATION STRATEGY
Tilted	Reset plumb
<div>TREATMENT</div> <div>Treatment Dates 5/19/2015</div> <div> 1. Marker carefully excavated. The soil around tilted markers was removed to an appropriate depth. When required, the marker was removed from the ground. Marker appears to be sound. 2. Soling removed by light brushing with nylon brushes and water. 3. Setting area excavated to sufficient depth and stone re-set plumb at appropriate height and level onto gravel bed, aligned with adjacent markers 4. Area backfilled around marker with tamped sand and gravel 5. Disturbed areas re-graded with existing topsoil and sod. </div>

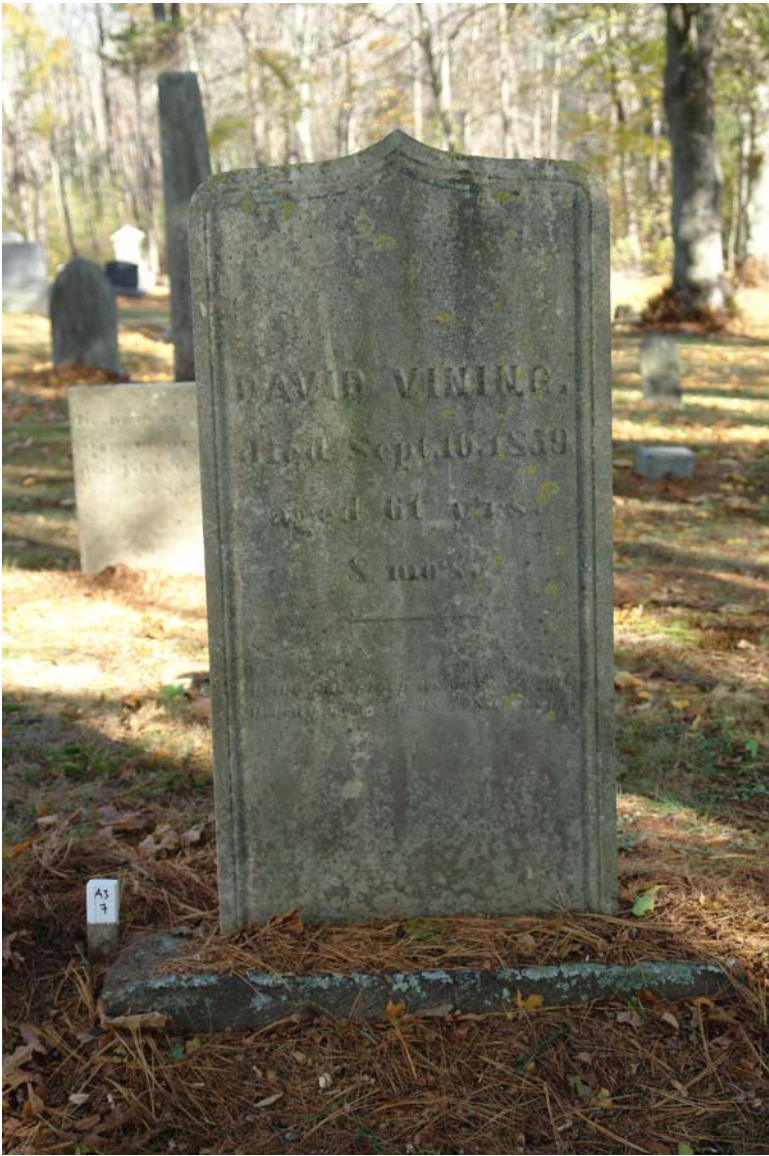
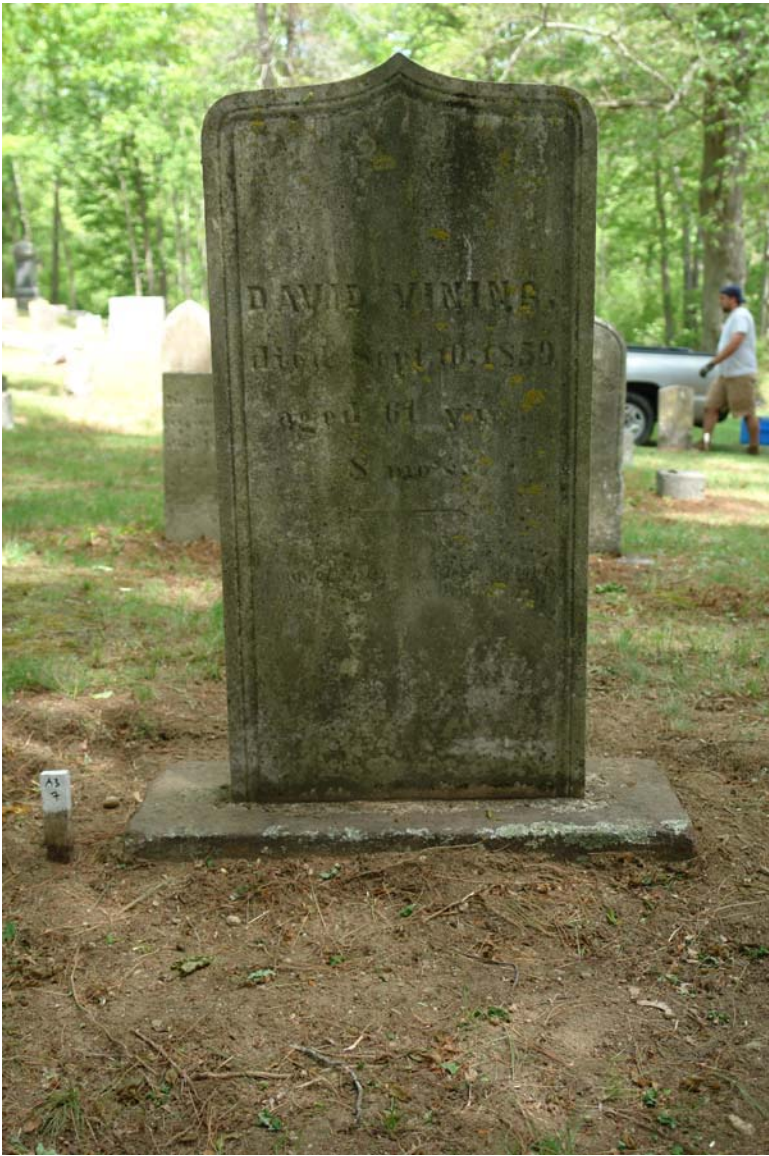
Union Assinippi Cemetery, Hanover, MA	
NAME ON MARKER	David Vining
Death Date: 9/10/1859	Marker Type: Headstone/base
Cond. of Inscription: Legible	Material: Marble
EXISTING CONDITIONS	CONSERVATION STRATEGY
Tilted base	Reset base with marker plumb
<div> <div>TREATMENT</div> <div>Treatment Dates 5/19/2015</div> <div> <ol style="list-style-type: none"> Existing base located below grade while excavating for resetting. Area excavated to an appropriate depth removing any roots or large stones. Base inspected and found to be sound and re-useable Base is aligned with adjacent markers and re-set level. Area around base was backfilled with tamped gravel and re-graded with existing topsoil Debris removed from setting slot. When required, power grinders were used to facilitate removal of stone fragments. When required, the lower setting edge was re-squared by power grinder with minimal loss. Marker reset plumb and level into setting slot with cement/lime grout (3/2/9) with 000 sand made fluid with a super plasticizer. Excess grout removed and joint area cleaned. Marker braced for a minimum 3 days </div> </div>
