DOCUMENTATION OF STONE CONSERVATION TREATMENTS TO ASSINIPPI CEMETERY, HANOVER, MA June 2015

**MONUMENT CONSERVATION COLLABORATIVE LLC, NORFOLK, CT**

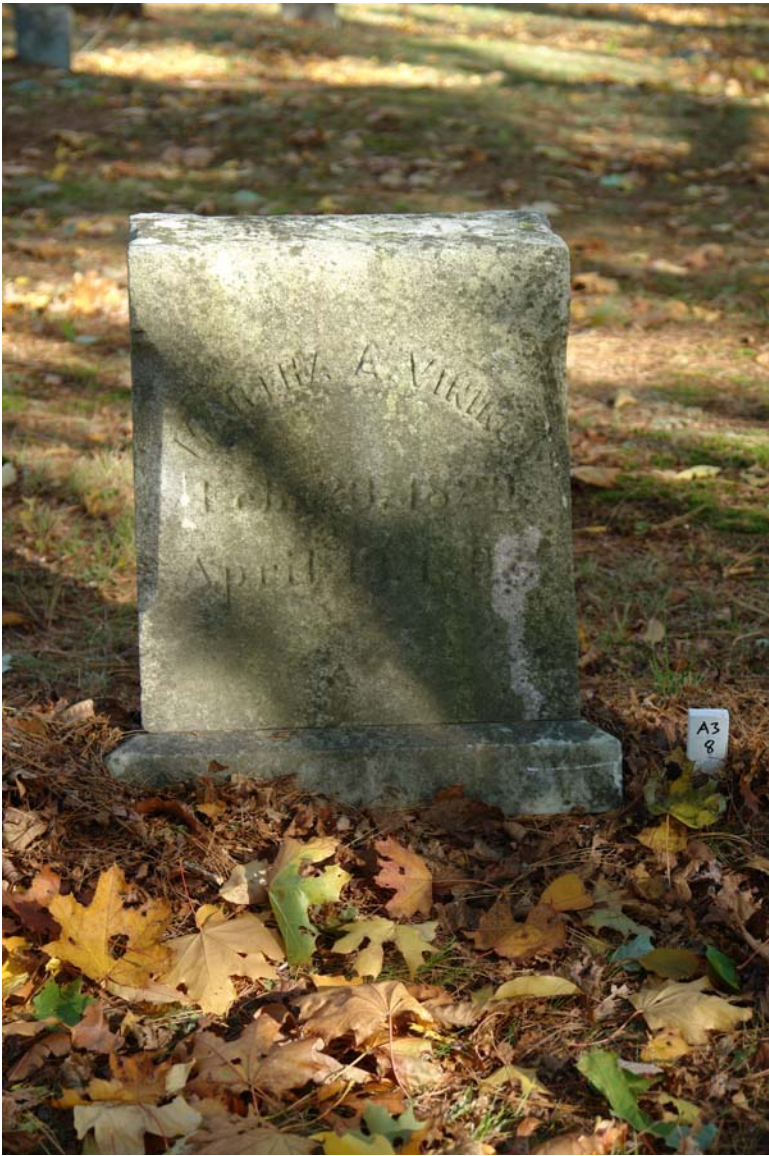
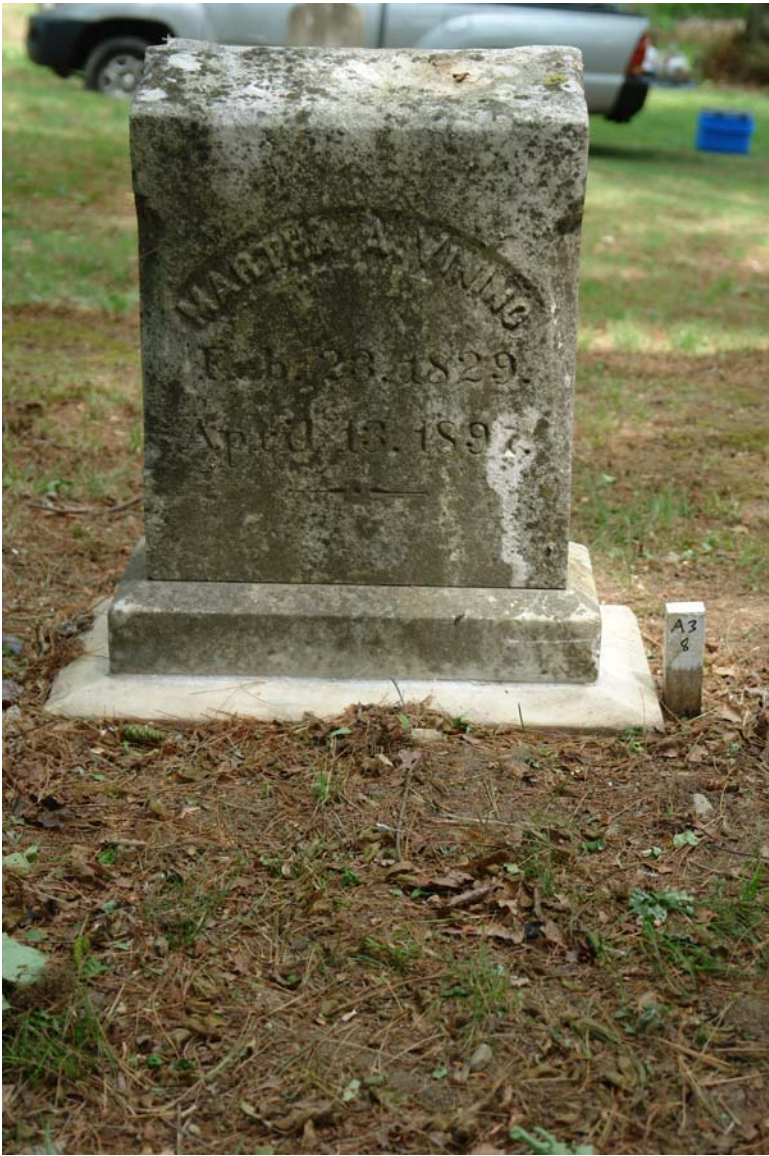
Height 37 Width 19 Thickness 3 Marker# **A.3.7**

EXISTING CONDITIONS	CONSERVATION STRATEGY
Tilted, sunken	Reset base higher Reset marker to base

TREATMENT	Treatment Dates 5/12/2015
<div>1. Soundness of setting joint of marker to base inspected, if found to be unstable, marker removed from base.</div> <div>2. Area excavated to an appropriate depth removing any roots or large stones.</div> <div>3. Base is aligned with adjacent markers and re-set level.</div> <div>4. Area around base was backfilled with tamped gravel and re-graded with existing topsoil</div> <div>5. Failed mortar removed from setting area and bottom of marker</div> <div>6. When required, any existing pins were inspected, and if necessary, replaced with stainless steel threaded pins</div> <div>7. Setting surfaces primed with Acryl 60 diluted 1:3 with water.</div> <div>8. Marker reset plumb onto base with cement/lime mortar (3/2/9) with 000 sand.</div> <div>9. Excess grout removed and joint area cleaned.</div>

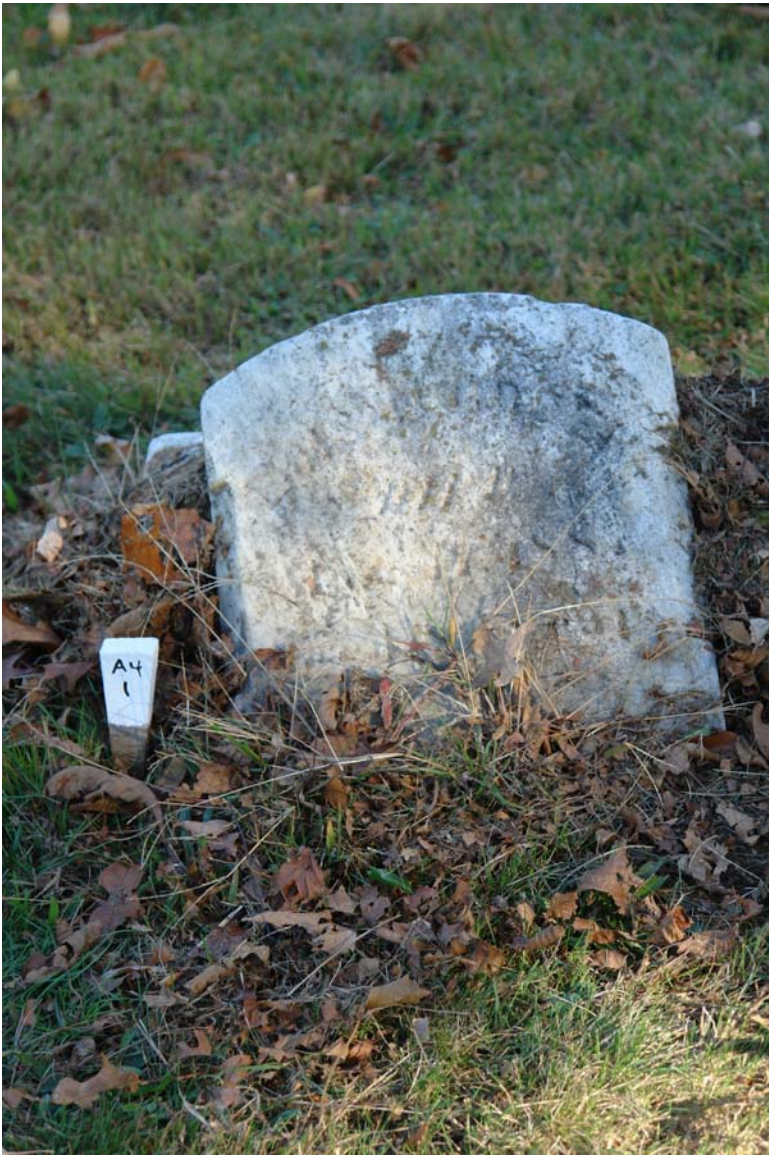
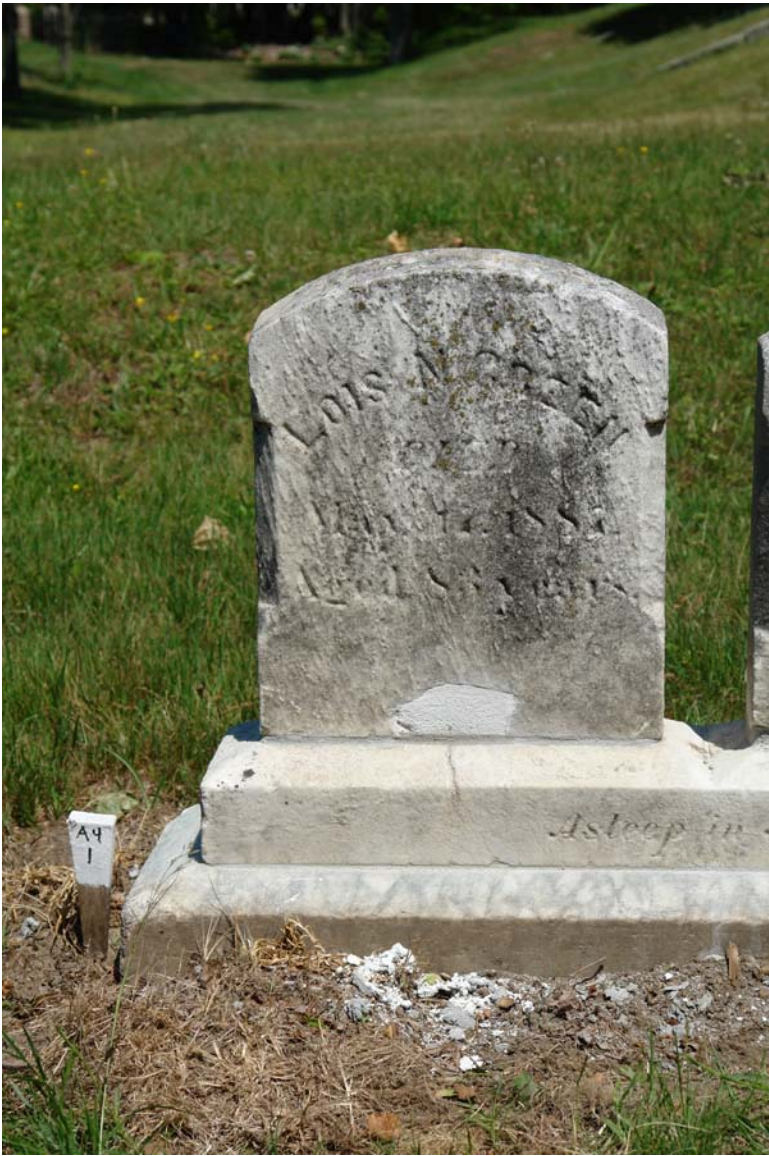
Height 12 Width 14 Thickness 5 Marker# **A.3.8**

EXISTING CONDITIONS	CONSERVATION STRATEGY
Off base Tilted base Losses	Level base Reset marker Fill loses

TREATMENT	Treatment Dates 5/26-26/2015
<div>1. Marker and base found to be in sound condition.</div> <div>2. Area excavated to an appropriate depth removing any roots or large stones.</div> <div>3. Base is aligned with adjacent markers and re-set level.</div> <div>4. Area around base was backfilled with tamped gravel and re-graded with existing topsoil</div> <div>5. Failed mortar removed from setting area and bottom of marker</div> <div>6. When required, any existing pins were inspected, and if necessary, replaced with stainless steel threaded pins</div> <div>7. Setting surfaces primed with Acryl 60 diluted 1:3 with water.</div> <div>8. Marker reset plumb onto base with cement/lime mortar (3/2/9) with 000 sand.</div> <div>9. Excess grout removed and joint area cleaned.</div>

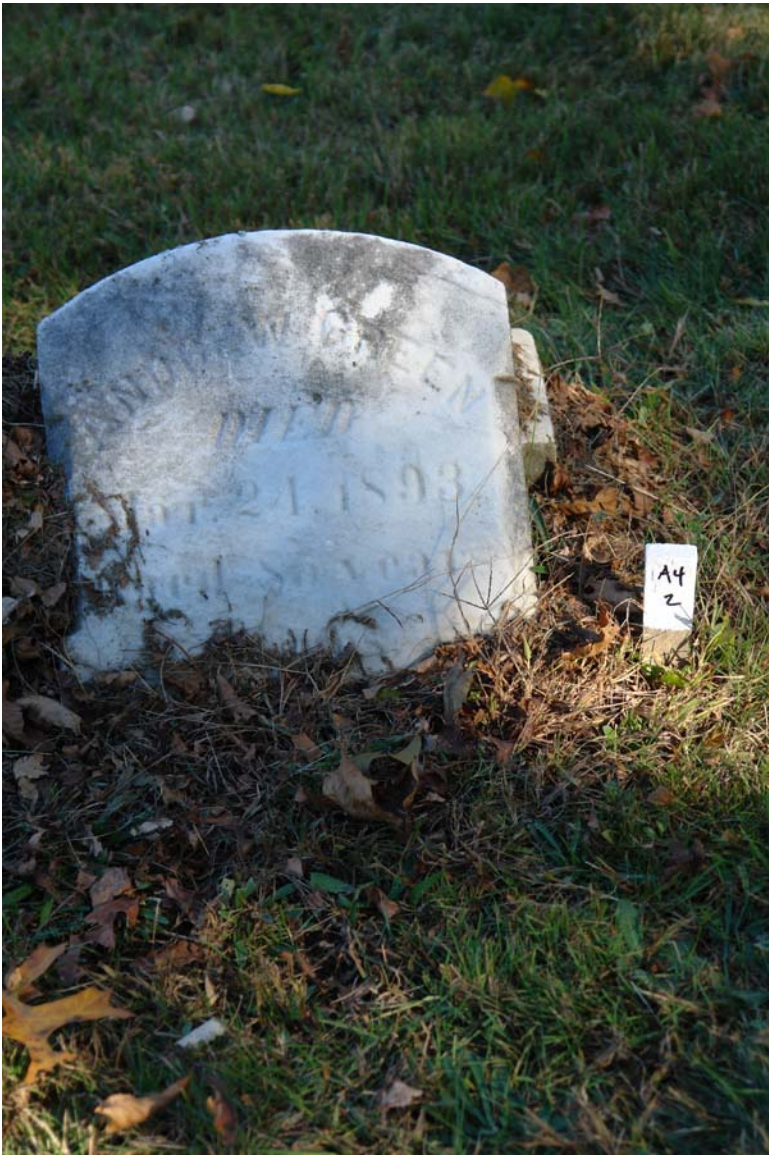
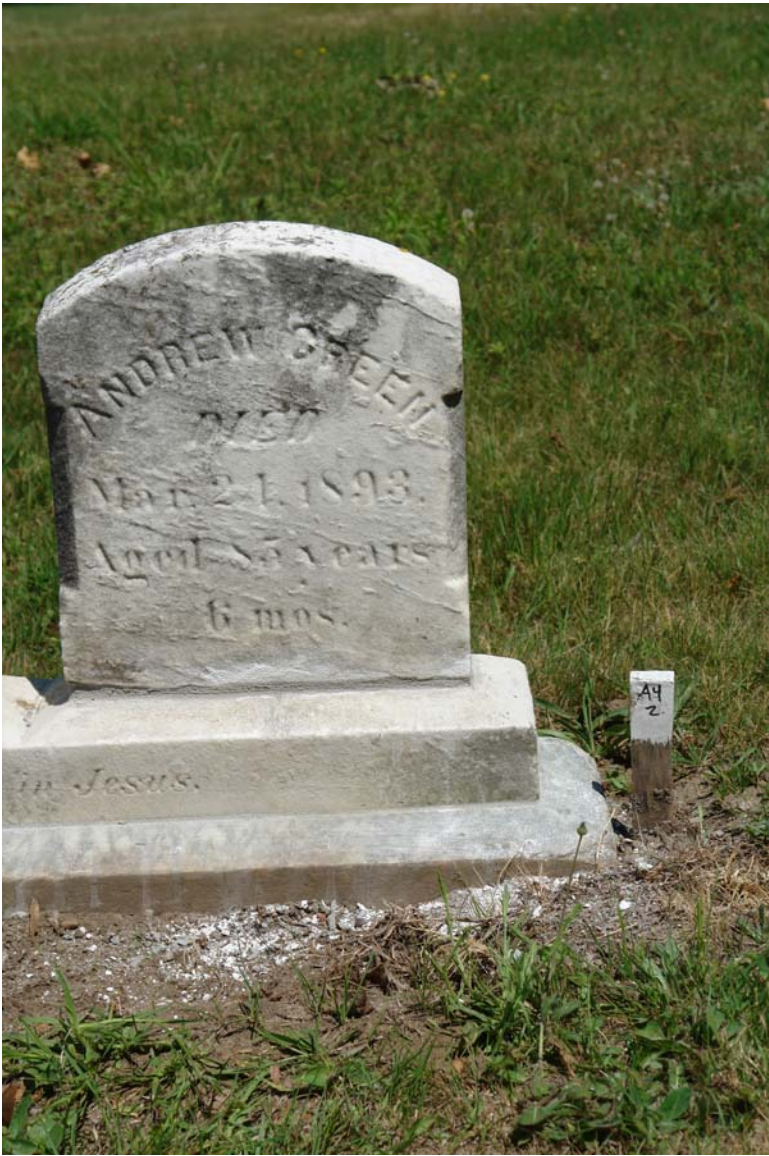
EXISTING CONDITIONS	CONSERVATION STRATEGY
Off base Tilted base Losses	Level base Reset marker Fill loses

TREATMENT	Treatment Dates 5/26-27/2015
<div>1. Marker and base found to be in sound condition.</div> <div>2. Area excavated to an appropriate depth removing any roots or large stones.</div> <div>3. Base is aligned with adjacent markers and re-set level.</div> <div>4. Area around base was backfilled with tamped gravel and re-graded with existing topsoil</div> <div>5. Failed mortar removed from setting area and bottom of marker</div> <div>6. When required, any existing pins were inspected, and if necessary, replaced with stainless steel threaded pins</div> <div>7. Setting surfaces primed with Acryl 60 diluted 1:3 with water.</div> <div>8. Marker reset plumb onto base with cement/lime mortar (3/2/9) with 000 sand.</div> <div>9. Excess grout removed and joint area cleaned.</div>

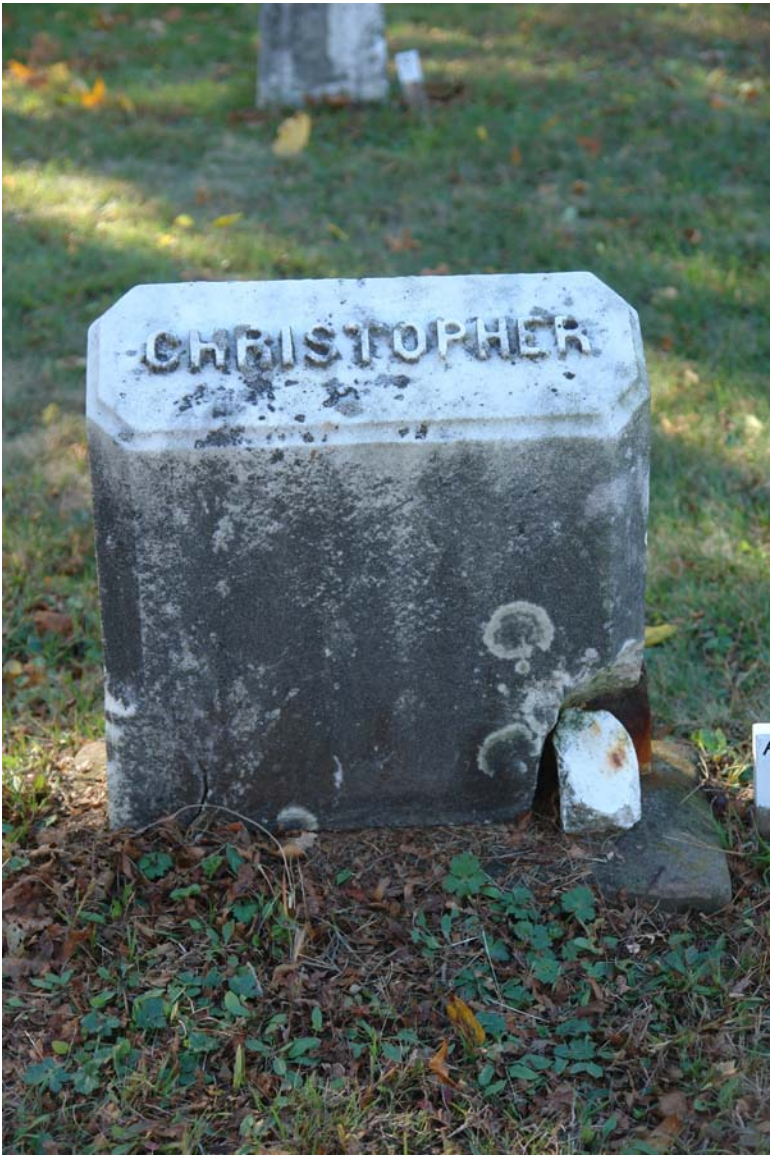
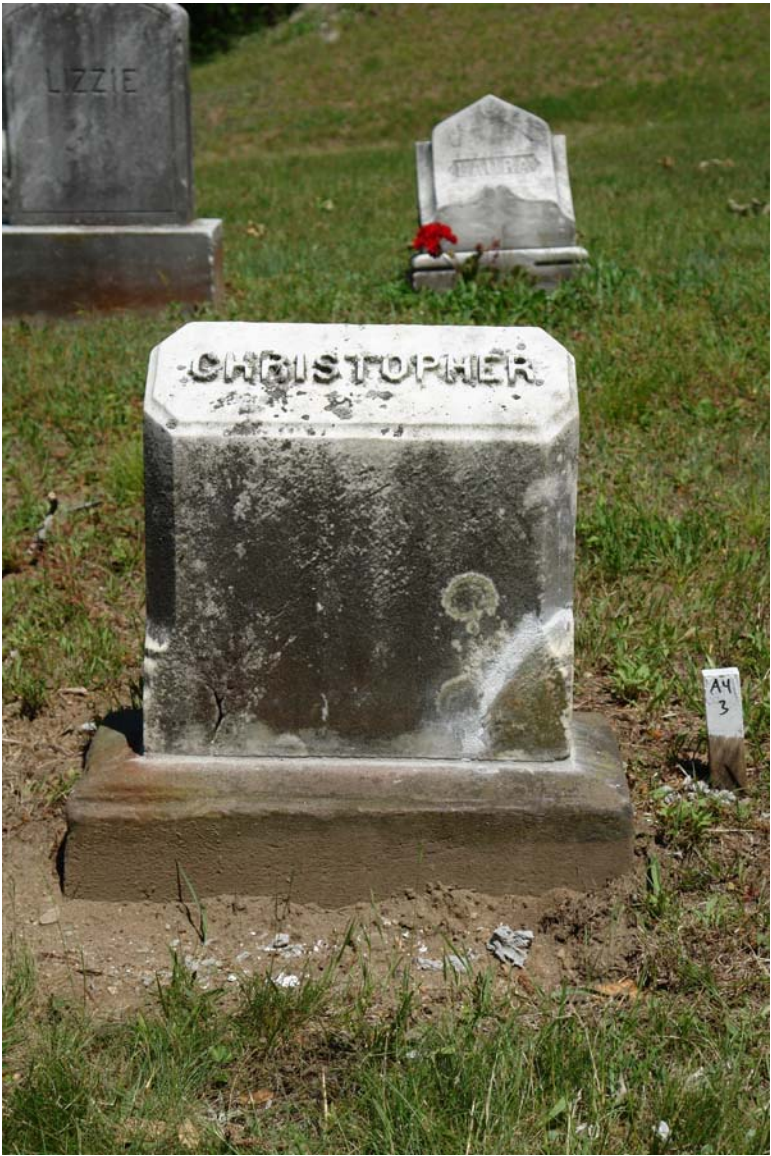
Union Assinippi Cemetery, Hanover, MA	
NAME ON MARKER	Christopher
Death Date: n.a.	Marker Type: Small marker
Cond. of Inscription: Legible	Material: Marble
EXISTING CONDITIONS	CONSERVATION STRATEGY
Loose from base Tilted base Fragmented	Reset base plumb Attach fragments Reset marker
TREATMENT Treatment Dates 5/26-6/10/2015

1. Area excavated to an appropriate depth removing any roots or large stones aligning base with adjacent markers and re-set level. 2. Setting surfaces cleaned with water and any failed adhesives or mortar removed with hand tools from setting area and bottom of marker 3. Fragments attached with structural adhesive, clamped and braced until cured. Epoxy removed with hand chisels within 24 hours. 4. When required, any existing pins were inspected, and if necessary, replaced with stainless steel threaded pins 5. Setting surfaces primed with Acryl 60 diluted 1:3 with water. 6. Marker reset plumb and level onto base with cement/lime grout (3/2/9) with 000 sand. Braced for min 3 days. Excess grout removed. 7. Cracks and losses filled with RepliCal Marble products or Jahn restoration mortar. 8. Filled areas misted with water and covered for 3 days minimum 9. Filled surface areas treated with light acid wash and rinsed thoroughly

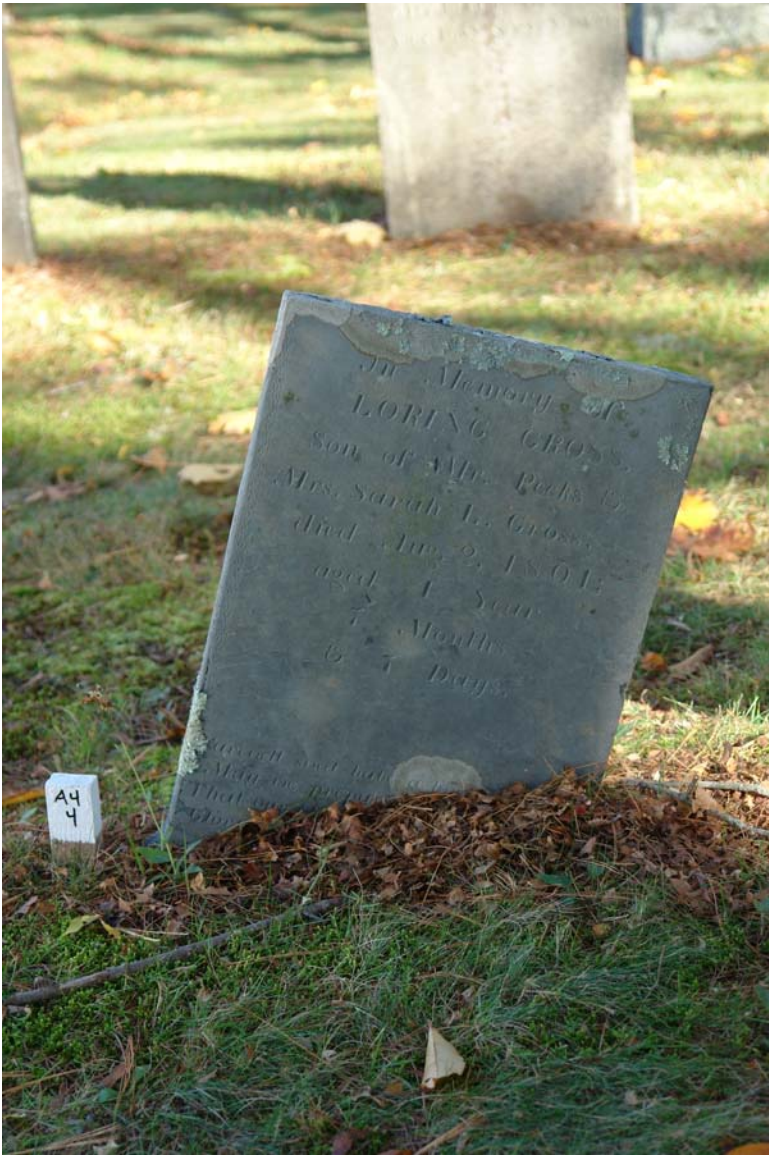
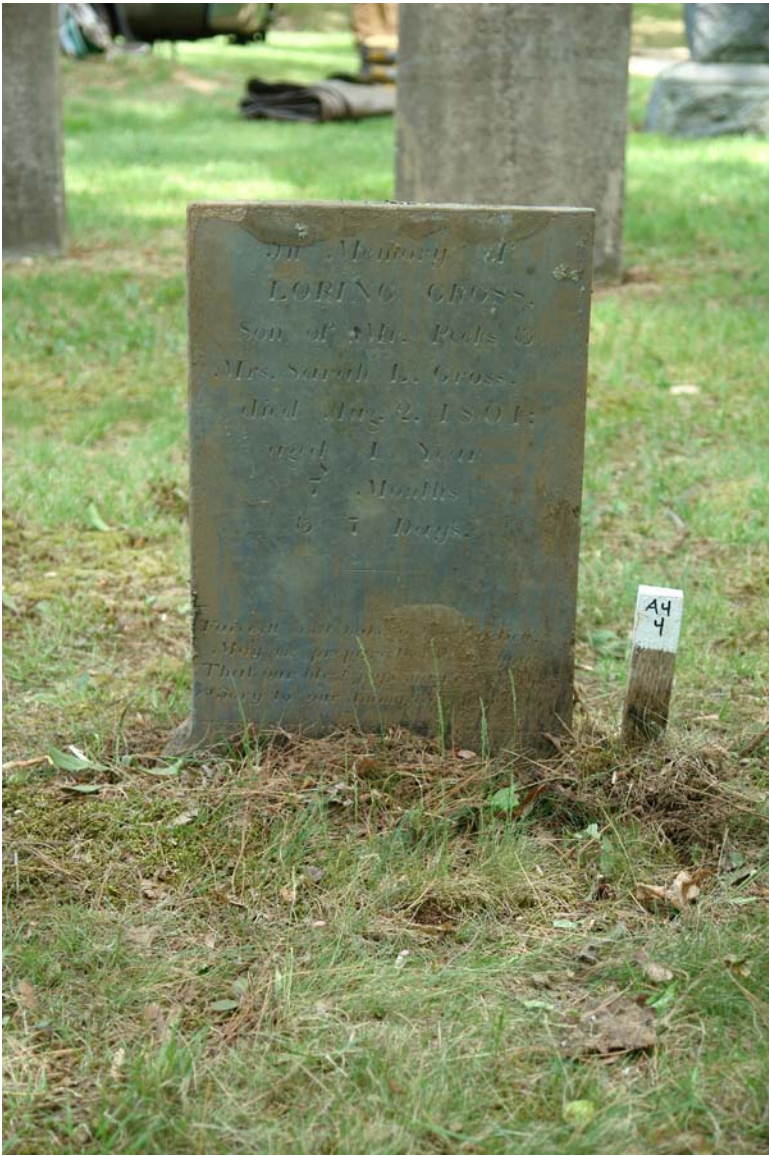
Height 15 Width 15 Thickness 5 Marker# **A.4.3**

Union Assinippi Cemetery, Hanover, MA	
NAME ON MARKER	Loring Cross
Death Date: 8/2/1801	Marker Type: Headstone
Cond. of Inscription: Legible	Material: Marble
EXISTING CONDITIONS	CONSERVATION STRATEGY
Tilted	Reset plumb
TREATMENT	
Treatment Dates 5/20/2015	
1. Marker carefully excavated. The soil around tilted markers was removed to an appropriate depth. When required, the marker was removed from the ground. Marker appears to be sound.	
2. Soling removed by light brushing with nylon brushes and water.	
3. Setting area excavated to sufficient depth and stone re-set plumb at appropriate height and level onto gravel bed, aligned with adjacent markers	
4. Area backfilled around marker with tamped sand and gravel	
5. Disturbed areas re-graded with existing topsoil and sod.

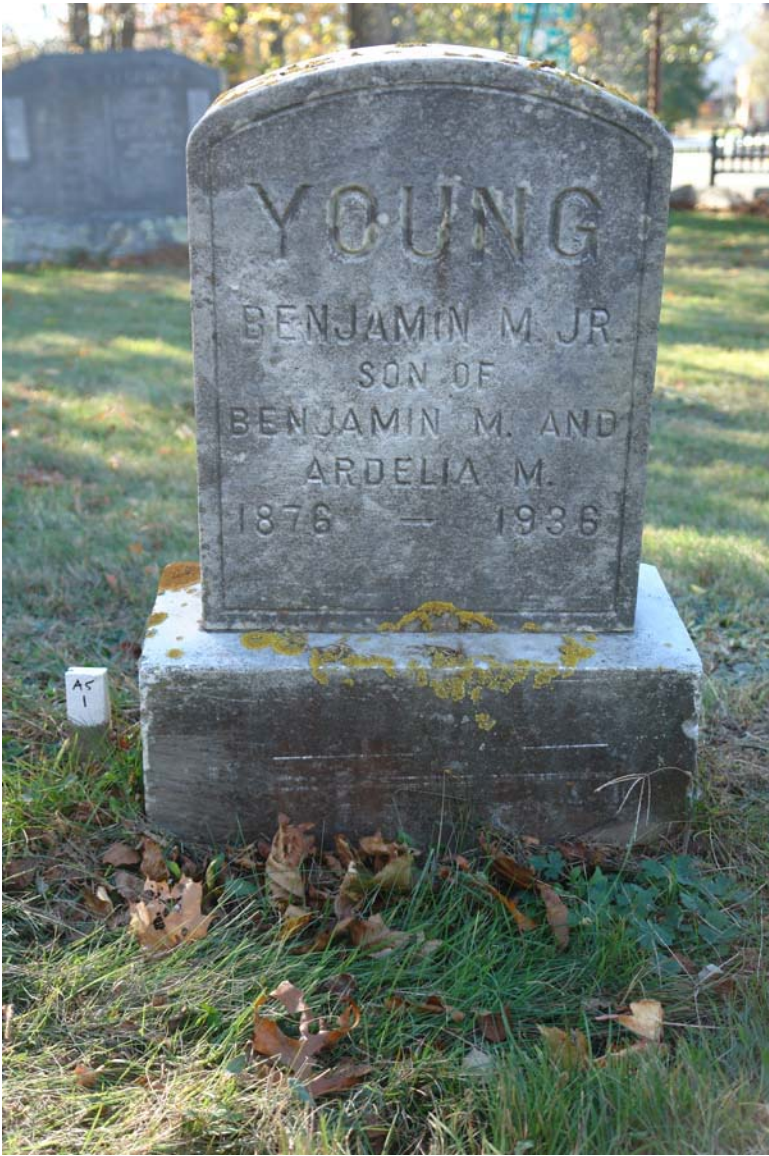
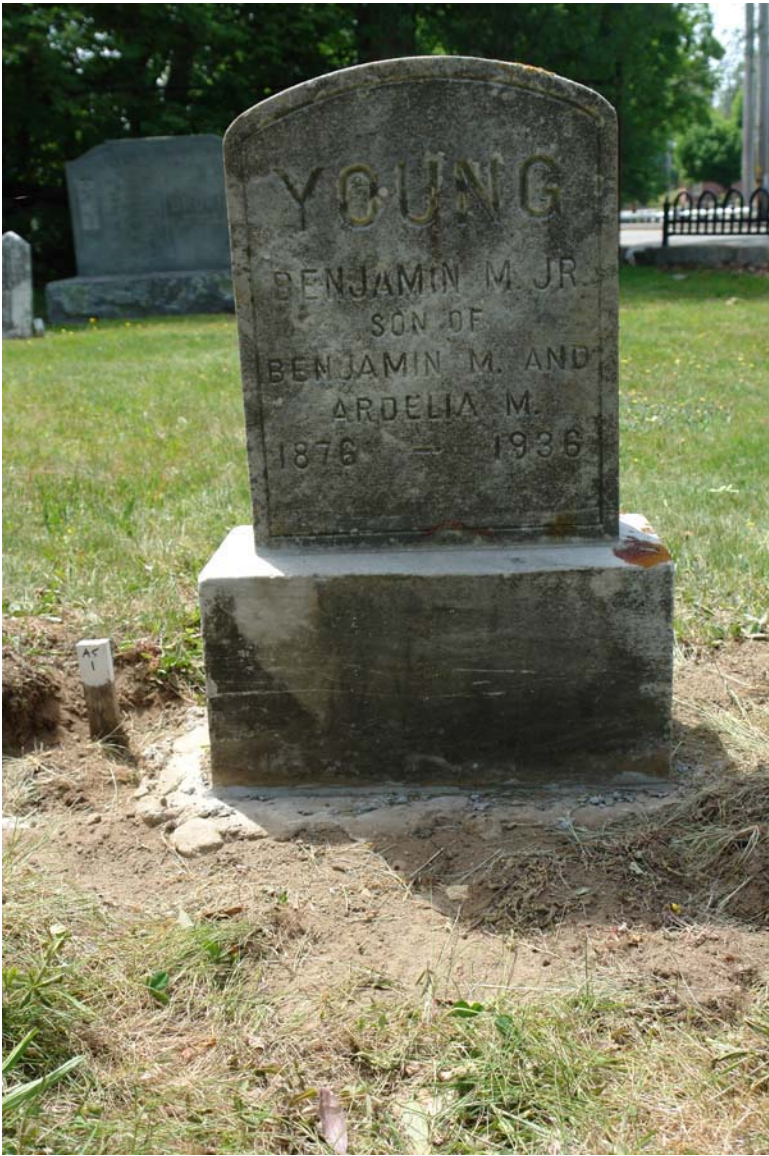
EXISTING CONDITIONS	CONSERVATION STRATEGY
Loose in base Tilted	Level base Reset elements

1. Soundness of setting joint of marker to base inspected, if found to be unstable, marker removed from base.
 2. Area excavated to an appropriate depth removing any roots or large stones.
 3. Base is aligned with adjacent markers and re-set level.
 4. Area around base was backfilled with tamped gravel and re-graded with existing topsoil
 5. Failed mortar removed from setting area and bottom of marker
 6. When required, any existing pins were inspected, and if necessary, replaced with stainless steel threaded pins
 7. Setting surfaces primed with Acryl 60 diluted 1:3 with water.
 8. Marker reset plumb onto base with cement/lime mortar (3/2/9) with 000 sand.
 9. Excess grout removed and joint area cleaned.

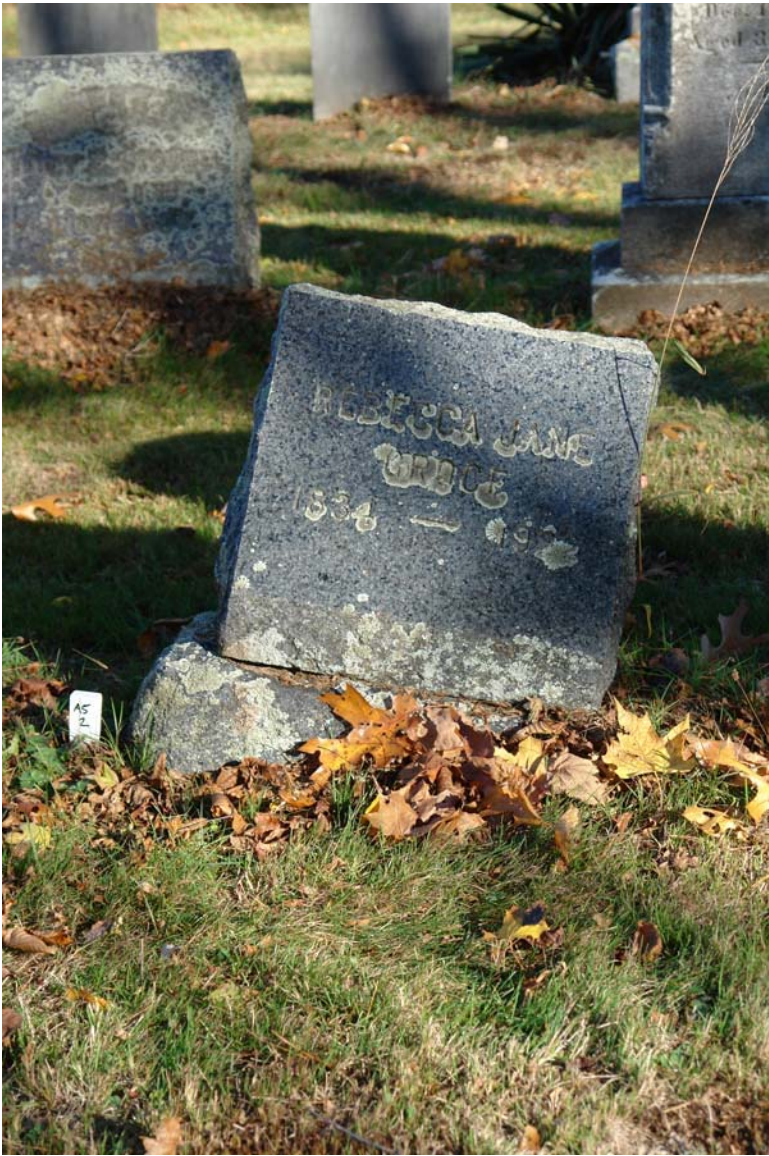
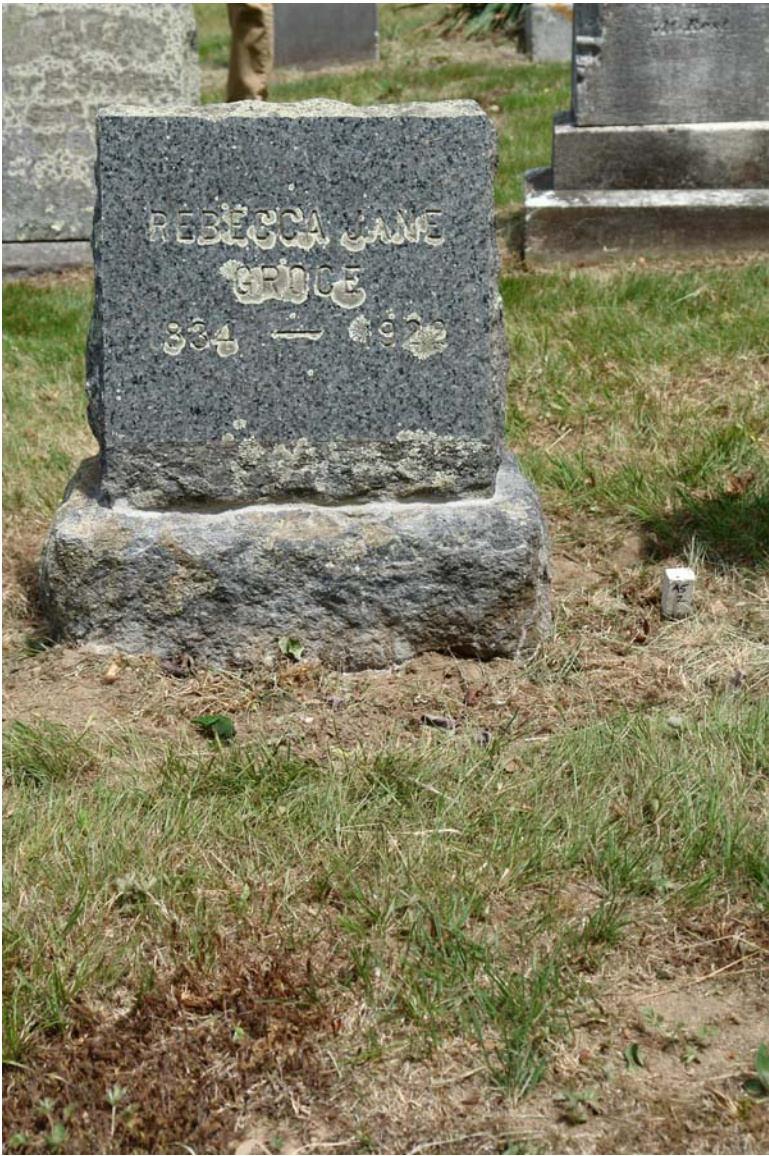
Union Assinippi Cemetery, Hanover, MA	
NAME ON MARKER	Rebecca Groce
Death Date: 1922	Marker Type: Monument
Cond. of Inscription: Legible	Material: Granite
EXISTING CONDITIONS	CONSERVATION STRATEGY
Tilted, sunken	Reset base higher Reset marker to base
<div> <div>TREATMENT</div> <div>Treatment Dates 5/30/2015</div> <div> <ol style="list-style-type: none"> 1. Soundness of setting joint of marker to base inspected, if found to be unstable, marker removed from base. 2. Area excavated to an appropriate depth removing any roots or large stones. 3. Base is aligned with adjacent markers and re-set level. 4. Area around base was backfilled with tamped gravel and re-graded with existing topsoil 5. Failed mortar removed from setting area and bottom of marker 6. When required, any existing pins were inspected, and if necessary, replaced with stainless steel threaded pins 7. Setting surfaces primed with Acryl 60 diluted 1:3 with water. 8. Marker reset plumb onto base with cement/lime mortar (3/2/9) with 000 sand. 9. Excess grout removed and joint area cleaned. </div> </div>

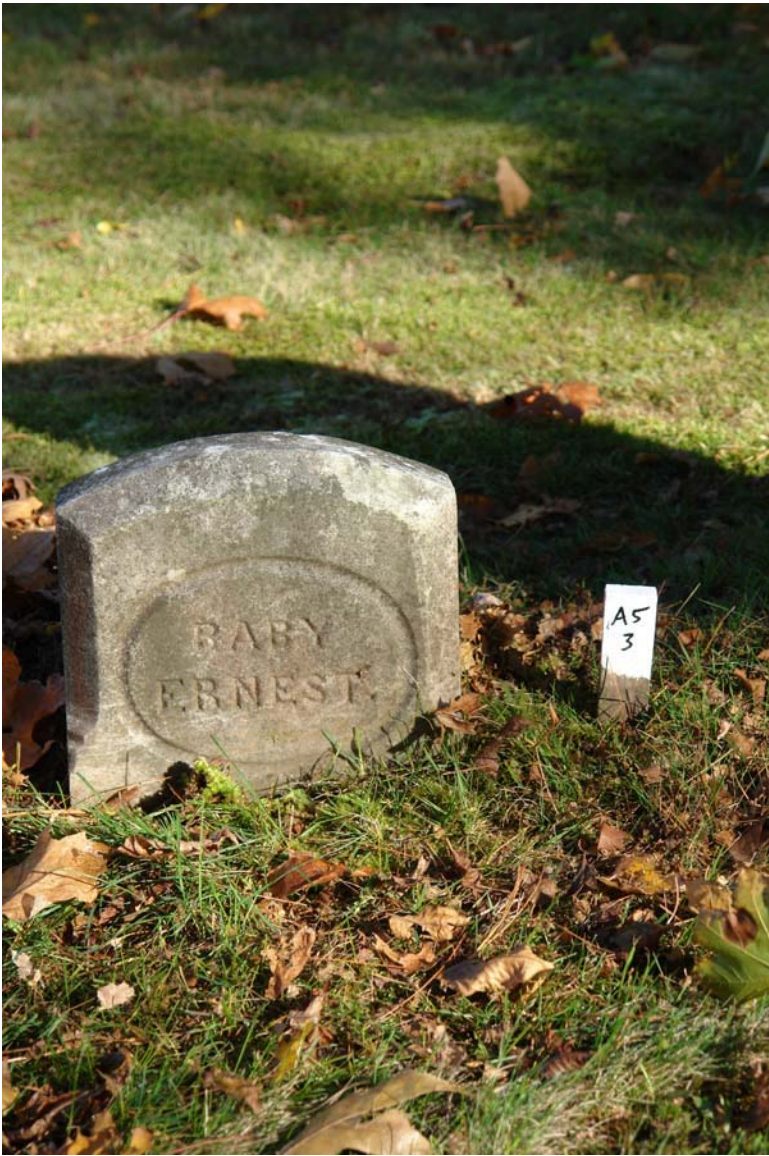
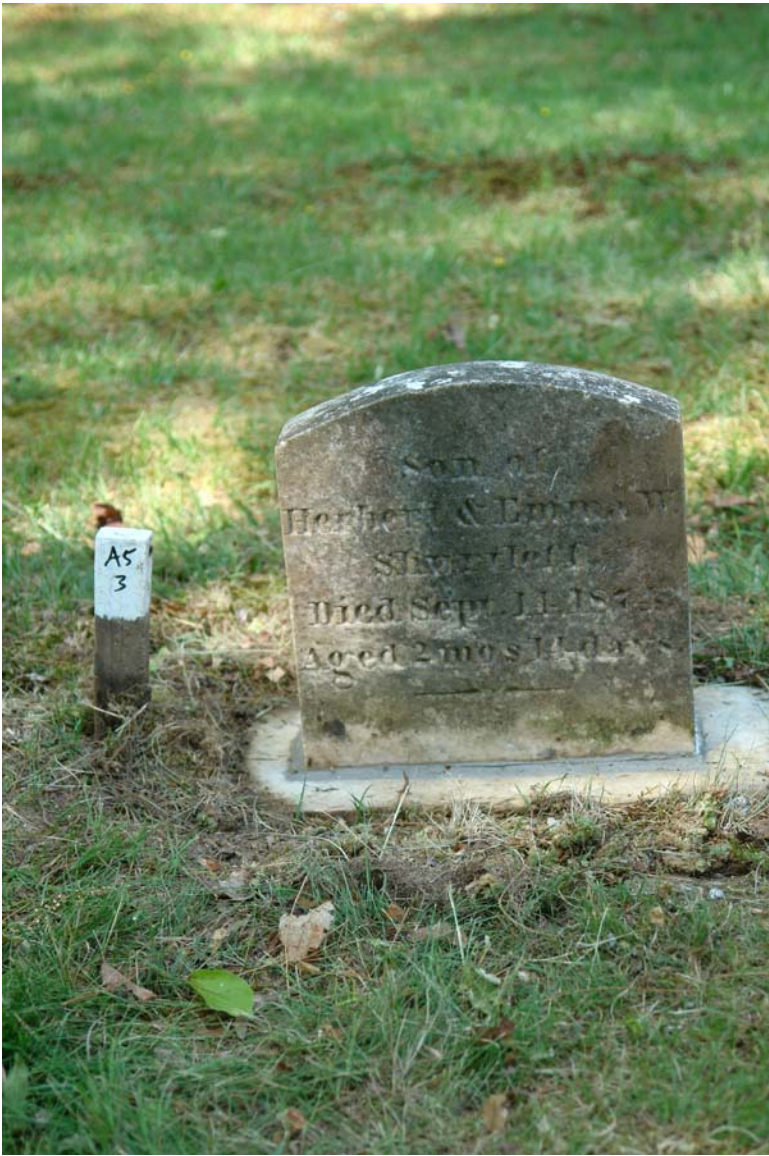
Union Assinippi Cemetery, Hanover, MA
 NAME ON MARKER **Baby Ernest (Ernest Shurtleff)**
 Death Date: 1936 Marker Type: Small marker
 Cond. of Inscription: Legible Material: Marble

EXISTING CONDITIONS	CONSERVATION STRATEGY
Loose in base Marker set too low	Level base and reset higher Reset elements

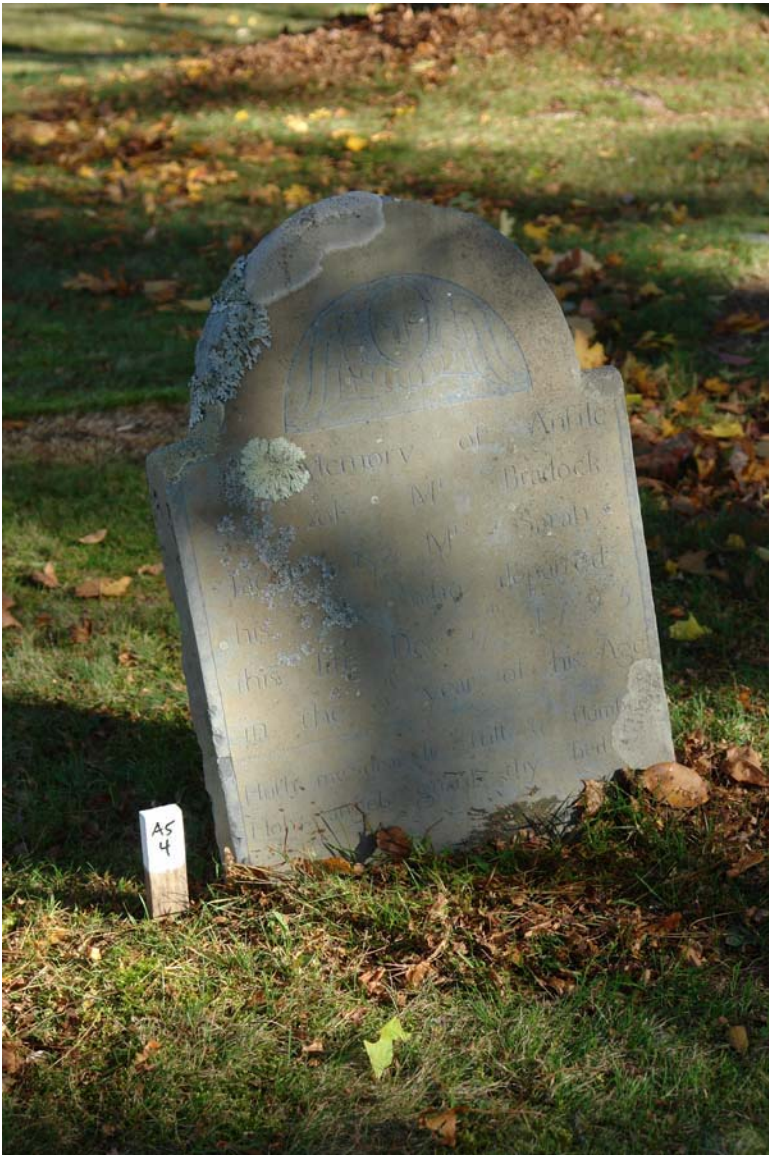
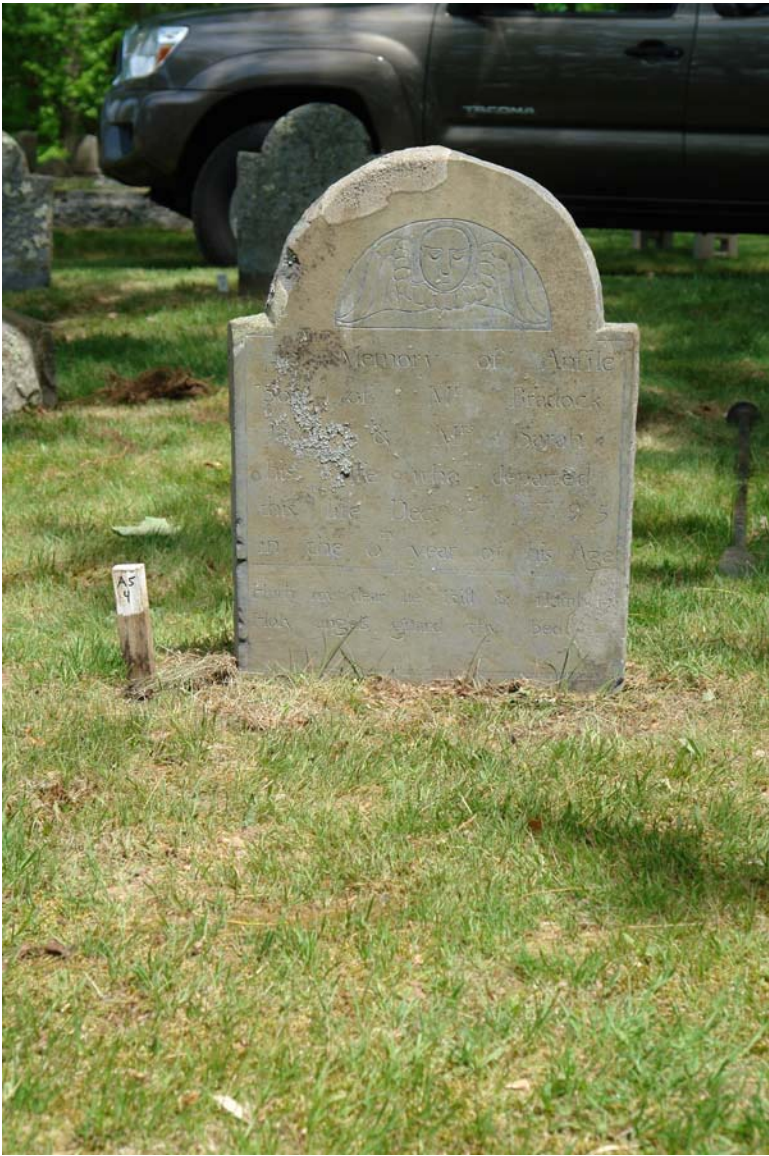
Union Assinippi Cemetery, Hanover, MA	
NAME ON MARKER	Ansile Jacob
Death Date: 12/17/1795	Marker Type: Headstone
Cond. of Inscription: Legible	Material: Slate
EXISTING CONDITIONS	CONSERVATION STRATEGY
Tilted	Reset plumb
TREATMENT	
Treatment Dates 5/20/2015	
1. Marker carefully excavated. The soil around tilted markers was removed to an appropriate depth. When required, the marker was removed from the ground. Marker appears to be sound. 2. Soling removed by light brushing with nylon brushes and water. 3. Setting area excavated to sufficient depth and stone re-set plumb at appropriate height and level onto gravel bed, aligned with adjacent markers 4. Area backfilled around marker with tamped sand and gravel 5. Disturbed areas re-graded with existing topsoil and sod.

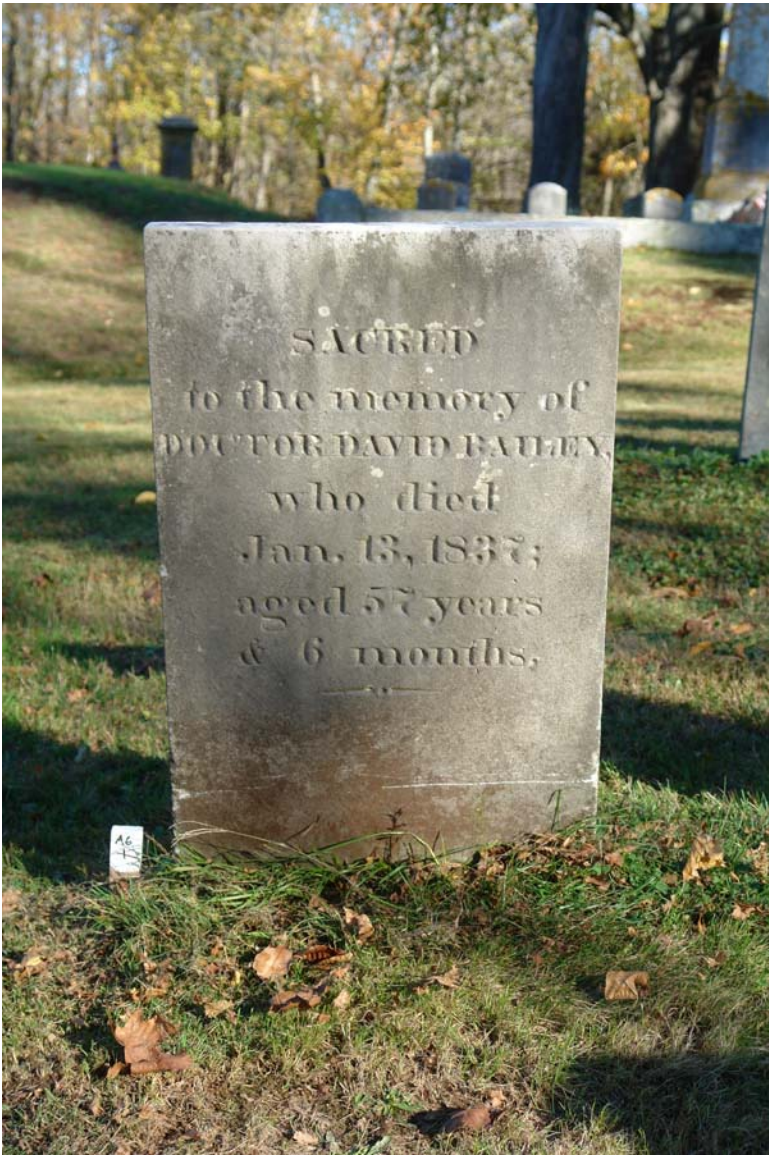
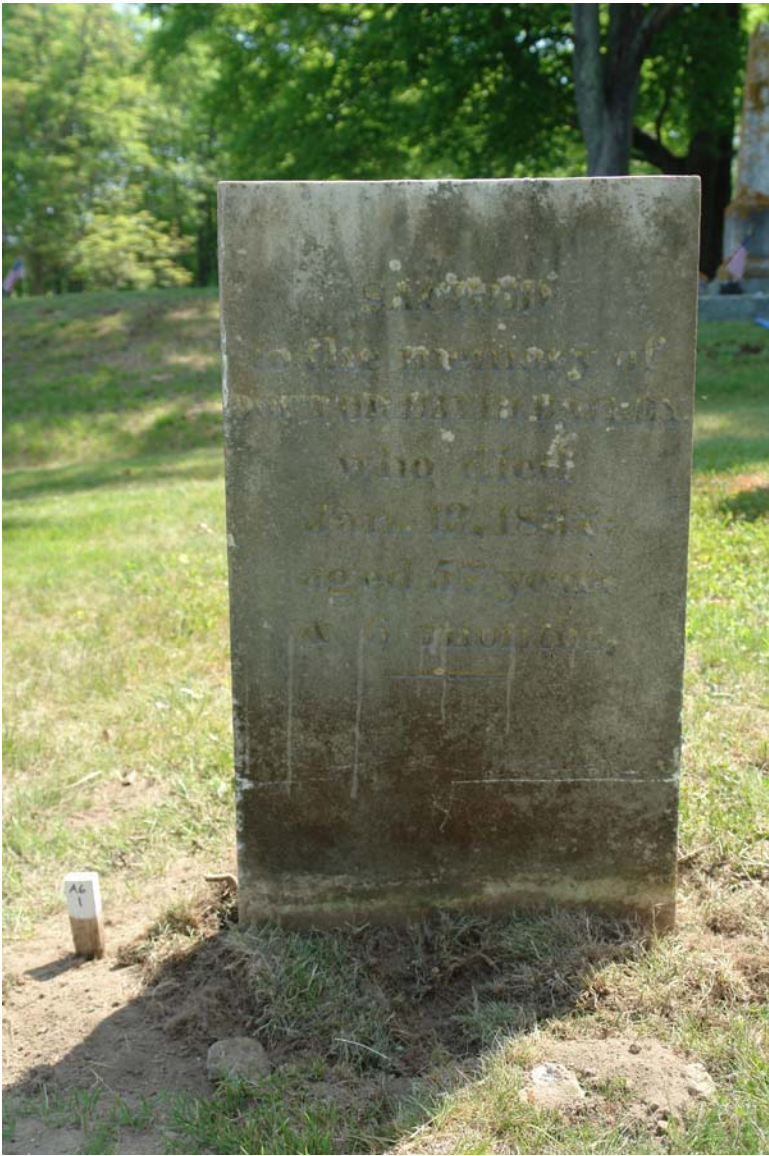
Union Assinippi Cemetery, Hanover, MA	
NAME ON MARKER	Doctor David Bailey
Death Date: 1/13/1837	Marker Type: Headstone
Cond. of Inscription: Legible	Material: Marble
EXISTING CONDITIONS	CONSERVATION STRATEGY
Loose in base Tilted	Level base Reset elements
<div>TREATMENT</div> <div>Treatment Dates 5/26/2015</div> <div> <ol style="list-style-type: none"> Existing base located below grade while excavating for resetting. Area excavated to an appropriate depth removing any roots or large stones. Base inspected and found to be sound and re-useable Base is aligned with adjacent markers and re-set level. Area around base was backfilled with tamped gravel and re-graded with existing topsoil Debris removed from setting slot. When required, power grinders were used to facilitate removal of stone fragments. When required, the lower setting edge was re-squared by power grinder with minimal loss. Marker reset plumb and level into setting slot with cement/lime grout (3/2/9) with 000 sand made fluid with a super plasticizer. Excess grout removed and joint area cleaned. Marker braced for a minimum 3 days </div>

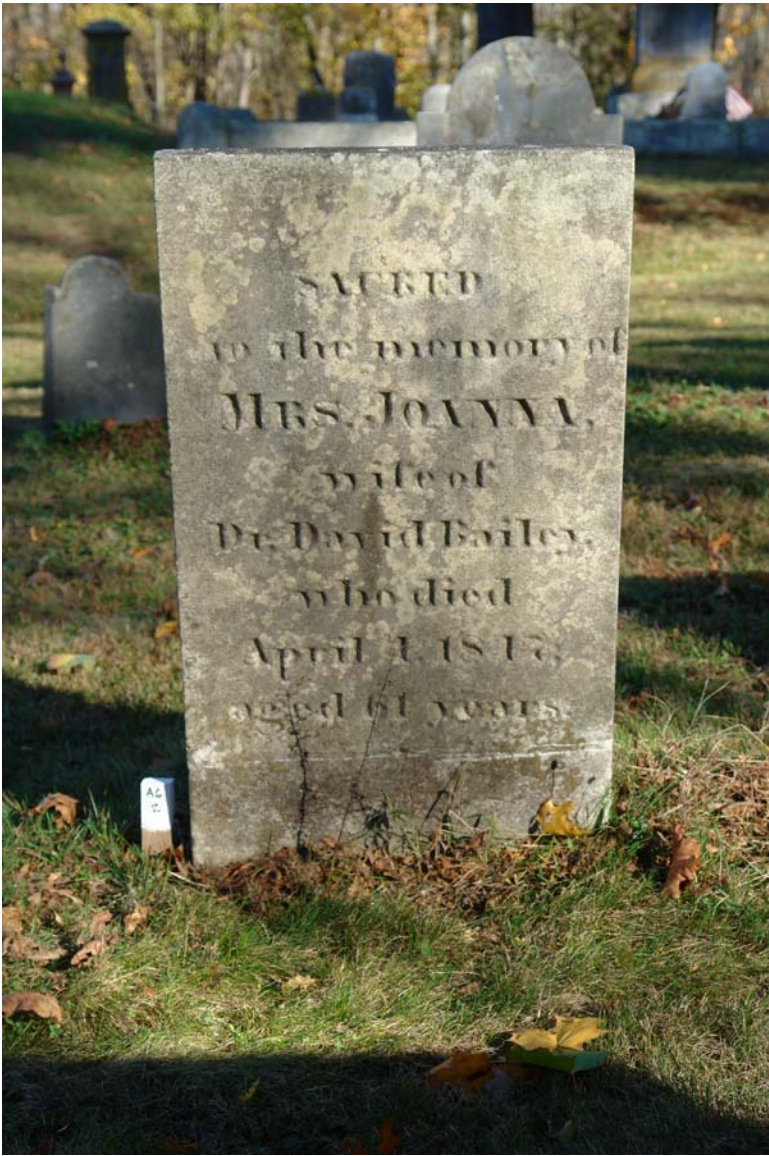
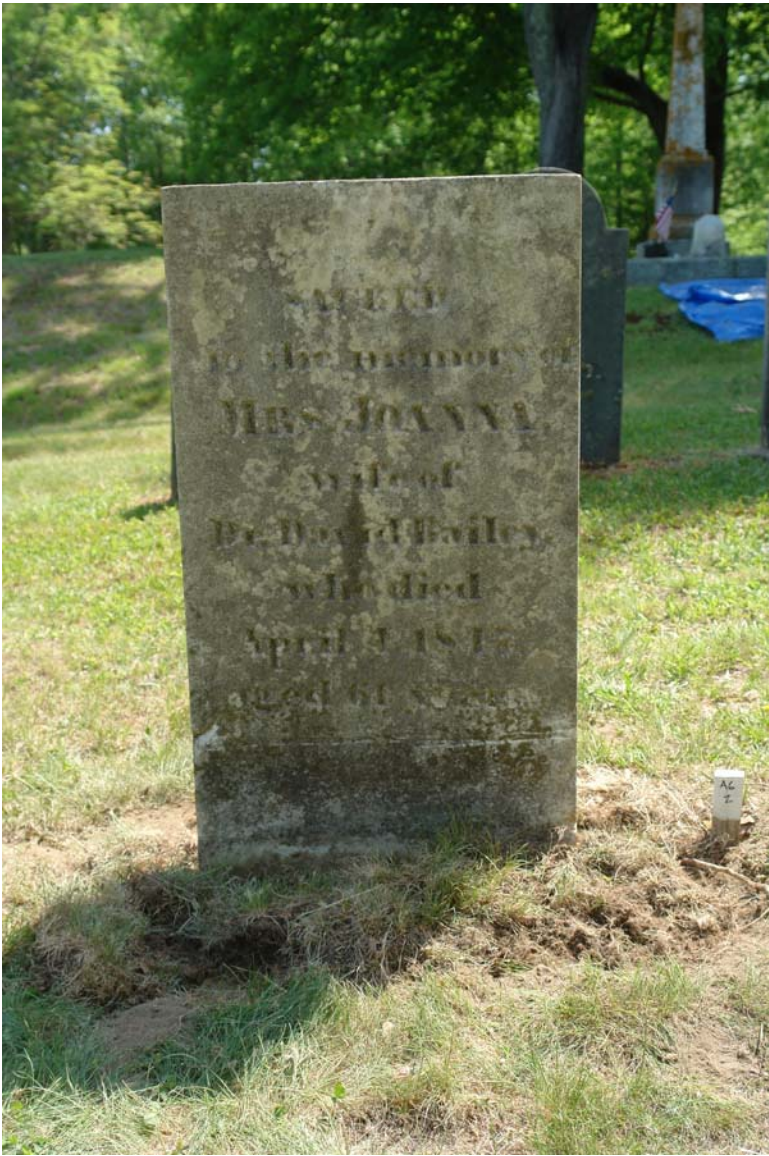
EXISTING CONDITIONS	CONSERVATION STRATEGY
Tilted	Reset plumb

2. Base inspected and found to be sound and re-useable
