DOCUMENTATION OF STONE CONSERVATION TREATMENTS TO ASSINIPPI CEMETERY, HANOVER, MA June 2015

**MONUMENT CONSERVATION COLLABORATIVE LLC, NORFOLK, CT**

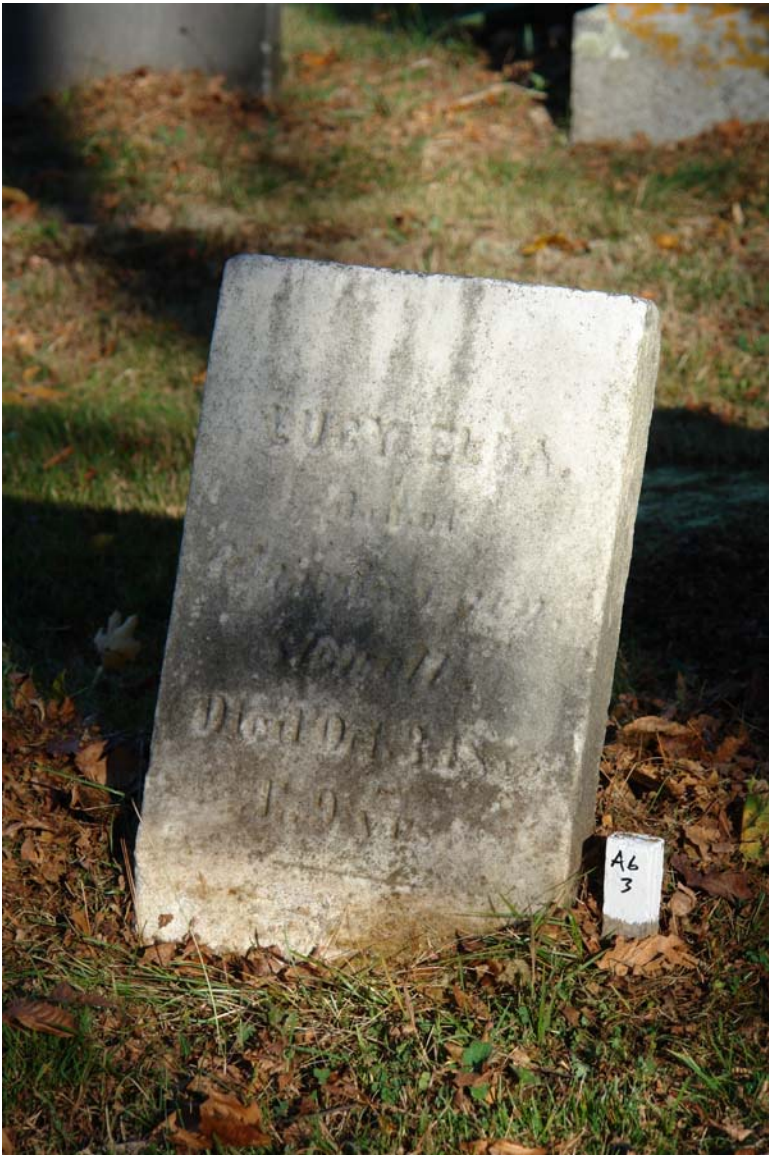
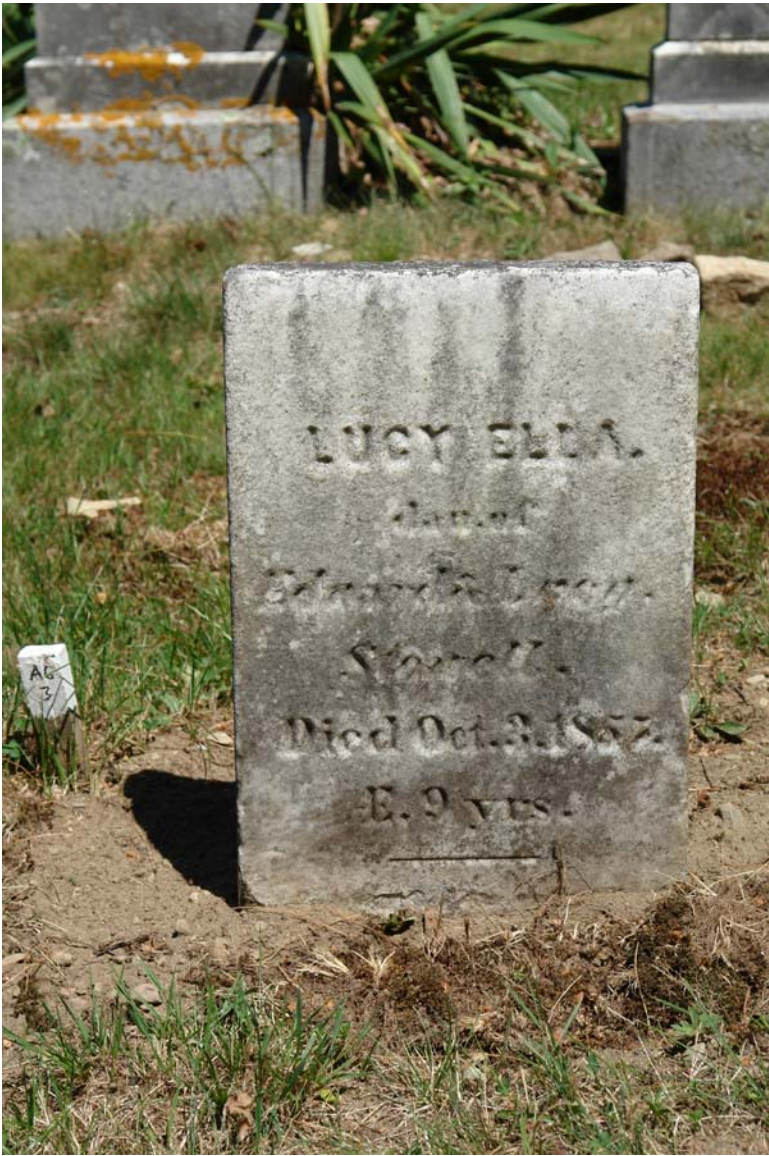
Union Assinippi Cemetery, Hanover, MA	
NAME ON MARKER	Lucy Stowell
Death Date: 10/3/1857	Marker Type: Headstone
Cond. of Inscription: Decipherable	Material: Marble
EXISTING CONDITIONS	CONSERVATION STRATEGY
Tilted base	Reset base reset marker plumb
TREATMENT Treatment Dates 5/26/2015	
<div>1. Existing base located below grade while excavating for resetting. Area excavated to an appropriate depth removing any roots or large stones.</div> <div>2. Base inspected and found to be sound and re-useable</div> <div>3. Base is aligned with adjacent markers and re-set level.</div> <div>4. Area around base was backfilled with tamped gravel and re-graded with existing topsoil</div> <div>5. Debris removed from setting slot. When required, power grinders were used to facilitate removal of stone fragments.</div> <div>6. When required, the lower setting edge was re-squared by power grinder with minimal loss.</div> <div>7. Marker reset plumb and level into setting slot with cement/lime grout (3/2/9) with 000 sand made fluid with a super plasticizer.</div> <div>8. Excess grout removed and joint area cleaned.</div> <div>9. Marker braced for a minimum 3 days</div>

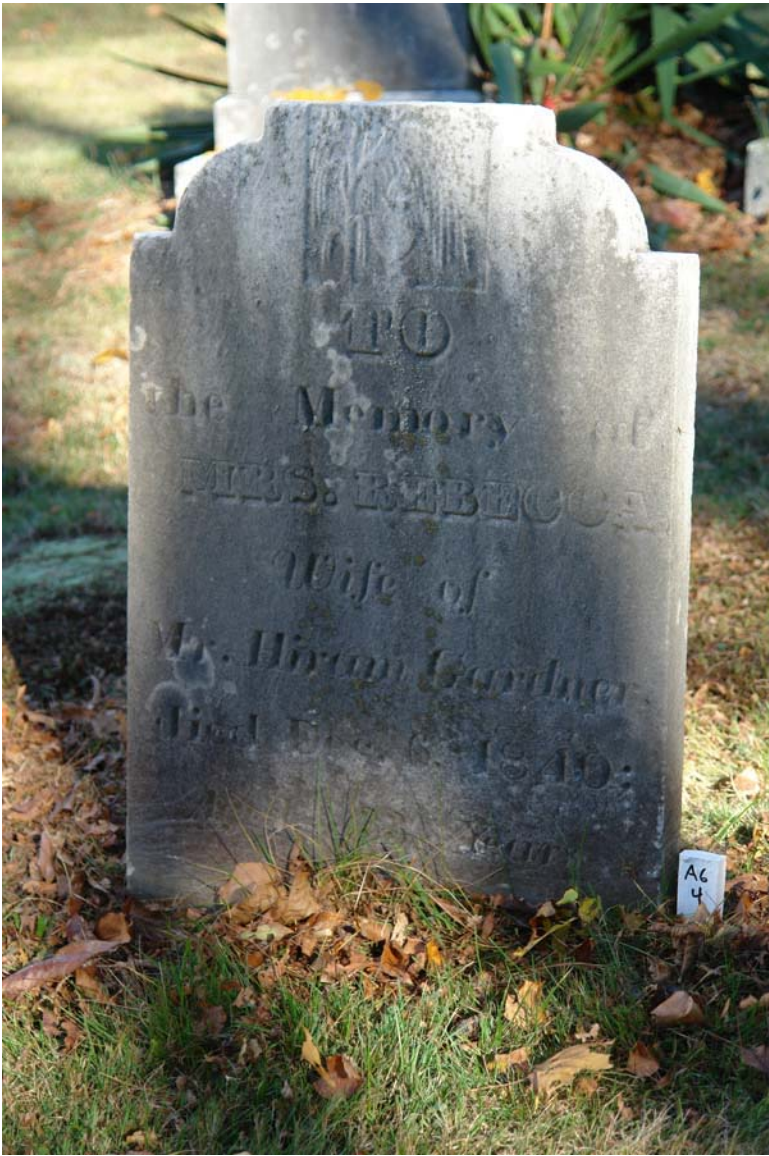
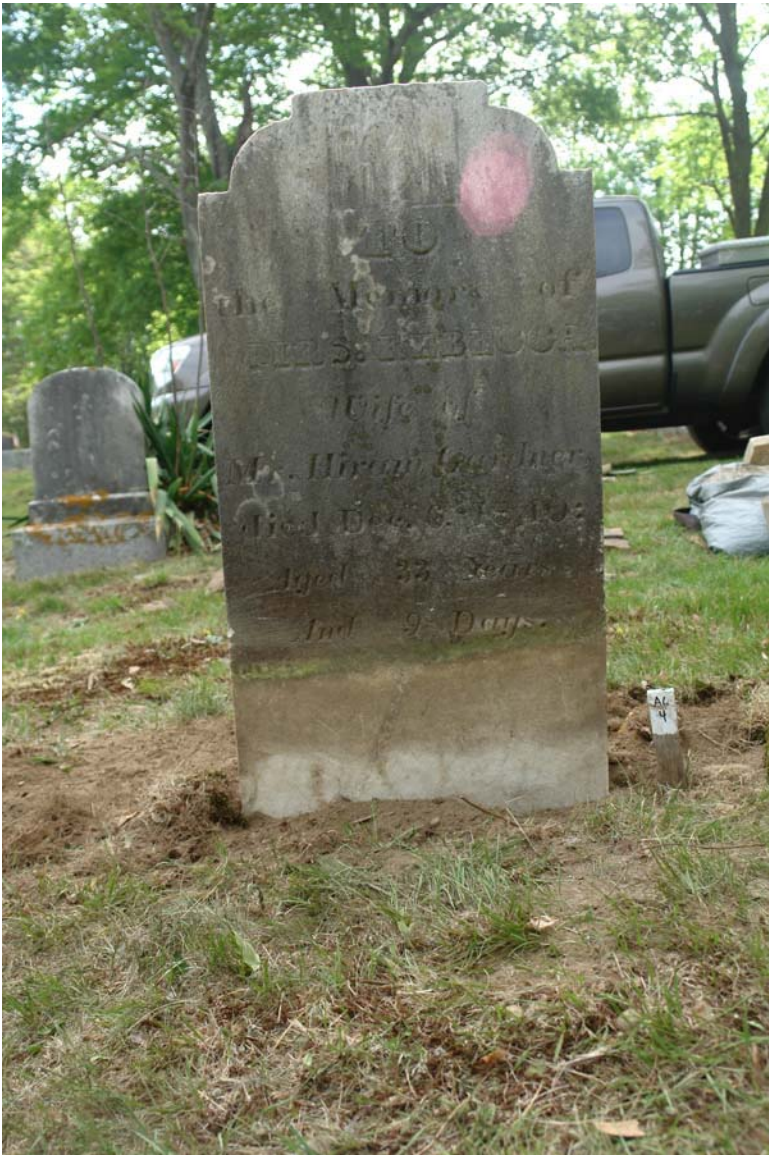
Union Assinippi Cemetery, Hanover, MA	
NAME ON MARKER	Rebecca Gardner
Death Date: 12/6/1840	Marker Type: Headstone
Cond. of Inscription: Legible	Material: Marble
EXISTING CONDITIONS	CONSERVATION STRATEGY
Tilted Sunken	Reset higher
TREATMENT	
Treatment Dates 5/26-27/2015

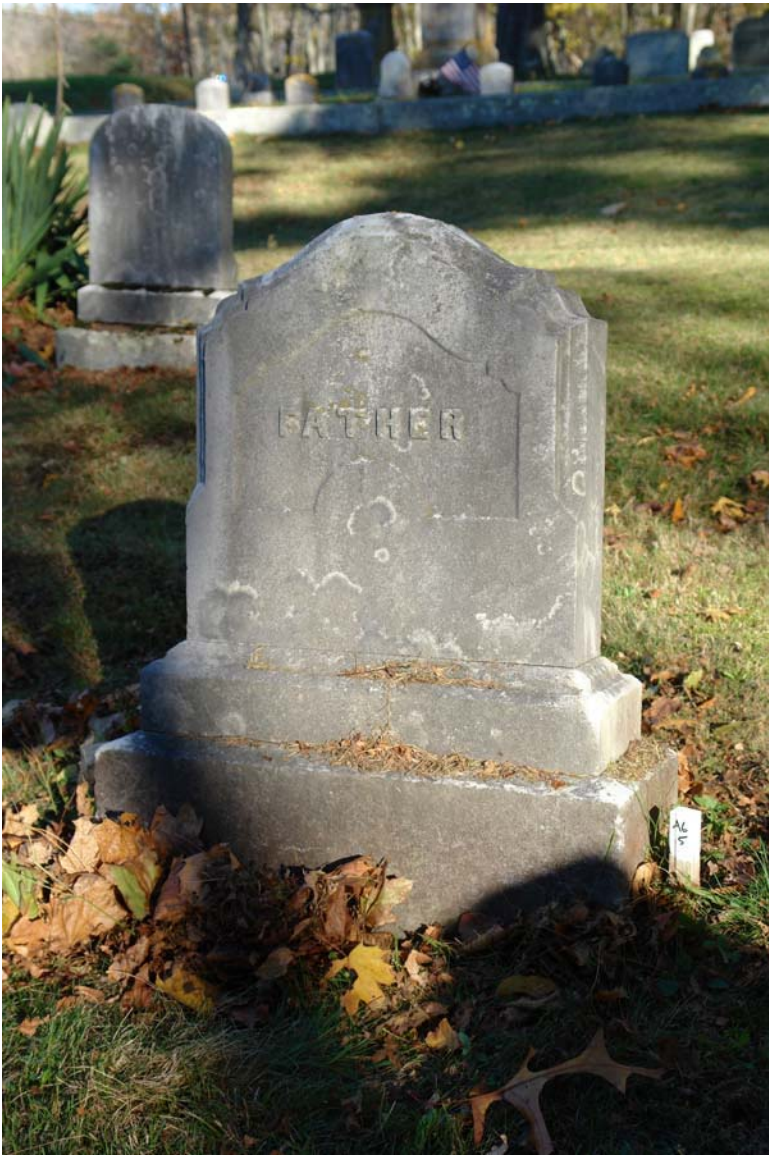
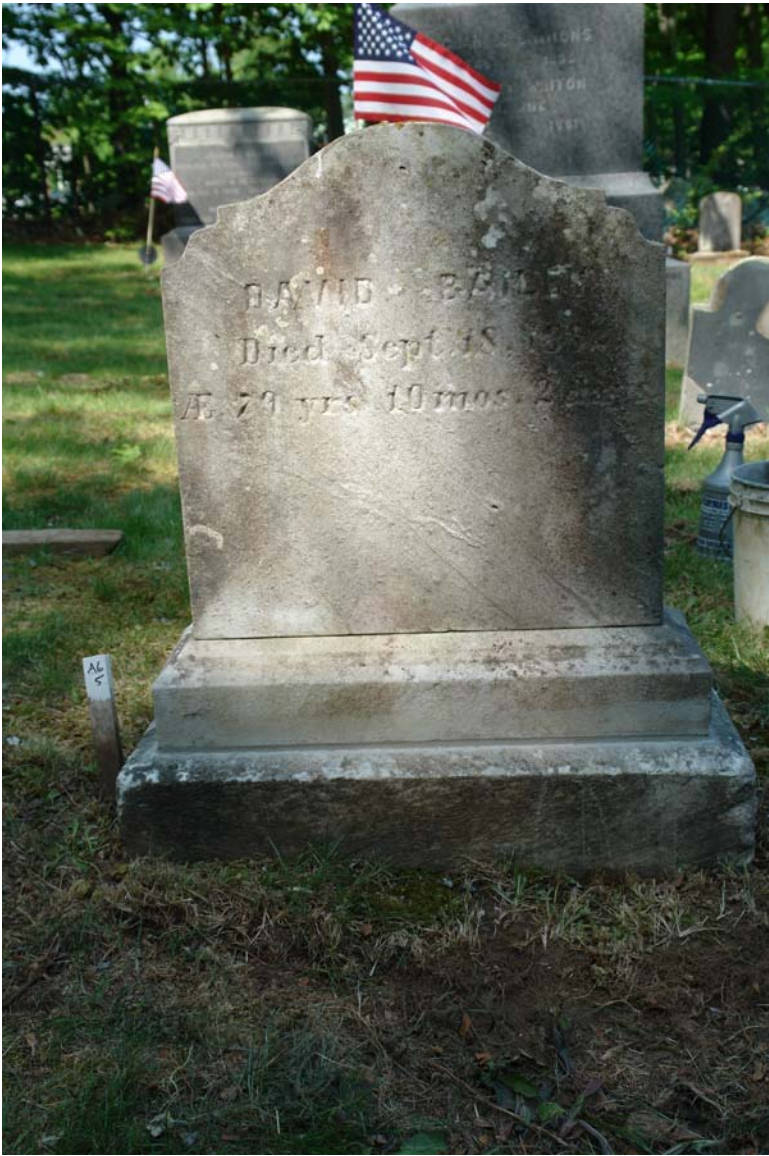
Union Assinippi Cemetery, Hanover, MA	
NAME ON MARKER	David Bailey
Death Date: 9/18/1882	Marker Type: Small monument
Cond. of Inscription: Legible	Material: Marble
EXISTING CONDITIONS	CONSERVATION STRATEGY
Tilted base	Reset base with marker plumb
TREATMENT Treatment Dates 5/26-27/2015	
<div>1. Marker and base found to be in sound condition.</div> <div>2. Area excavated to an appropriate depth removing any roots or large stones.</div> <div>3. Base is aligned with adjacent markers and re-set level.</div> <div>4. Area around base was backfilled with tamped gravel and re-graded with existing topsoil</div> <div>5. Failed mortar removed from setting area and bottom of marker</div> <div>6. When required, any existing pins were inspected, and if necessary, replaced with stainless steel threaded pins</div> <div>7. Setting surfaces primed with Acryl 60 diluted 1:3 with water.</div> <div>8. Marker reset plumb onto base with cement/lime mortar (3/2/9) with 000 sand.</div> <div>9. Excess grout removed and joint area cleaned.</div>

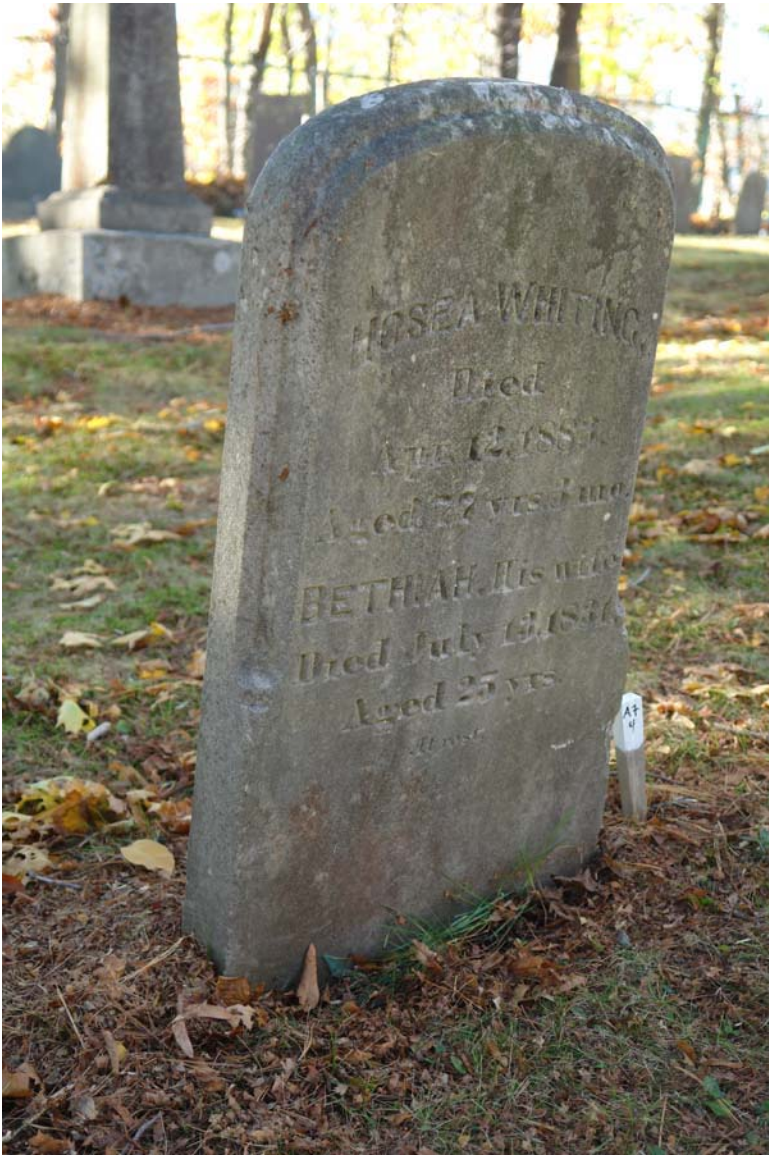
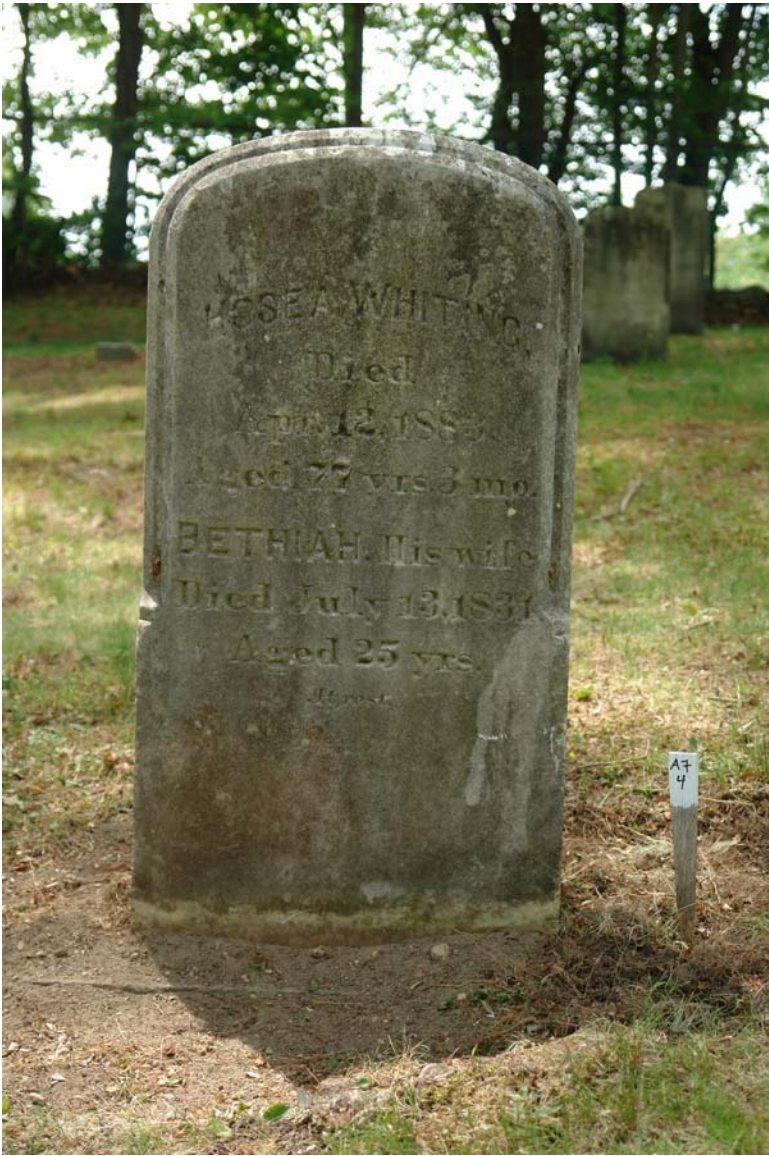
Height 34 Width 18 Thickness 3 Marker# A.7.4

Union Assinippi Cemetery, Hanover, MA	
NAME ON MARKER	Lydia Doten
Death Date: 6/15/1837	Marker Type: Headstone
Cond. of Inscription: Decipherable	Material: Marble
EXISTING CONDITIONS	CONSERVATION STRATEGY
Tilted	Reset Possible new base
TREATMENT Treatment Dates 5/18/2015	
<div>1. Existing base located below grade while excavating for resetting. Area excavated to an appropriate depth removing any roots or large stones.</div> <div>2. Base inspected and found to be sound and re-useable</div> <div>3. Base is aligned with adjacent markers and re-set level.</div> <div>4. Area around base was backfilled with tamped gravel and re-graded with existing topsoil</div> <div>5. Debris removed from setting slot. When required, power grinders were used to facilitate removal of stone fragments.</div> <div>6. When required, the lower setting edge was re-squared by power grinder with minimal loss.</div> <div>7. Marker reset plumb and level into setting slot with cement/lime grout (3/2/9) with 000 sand made fluid with a super plasticizer.</div> <div>8. Excess grout removed and joint area cleaned.</div> <div>9. Marker braced for a minimum 3 days</div>

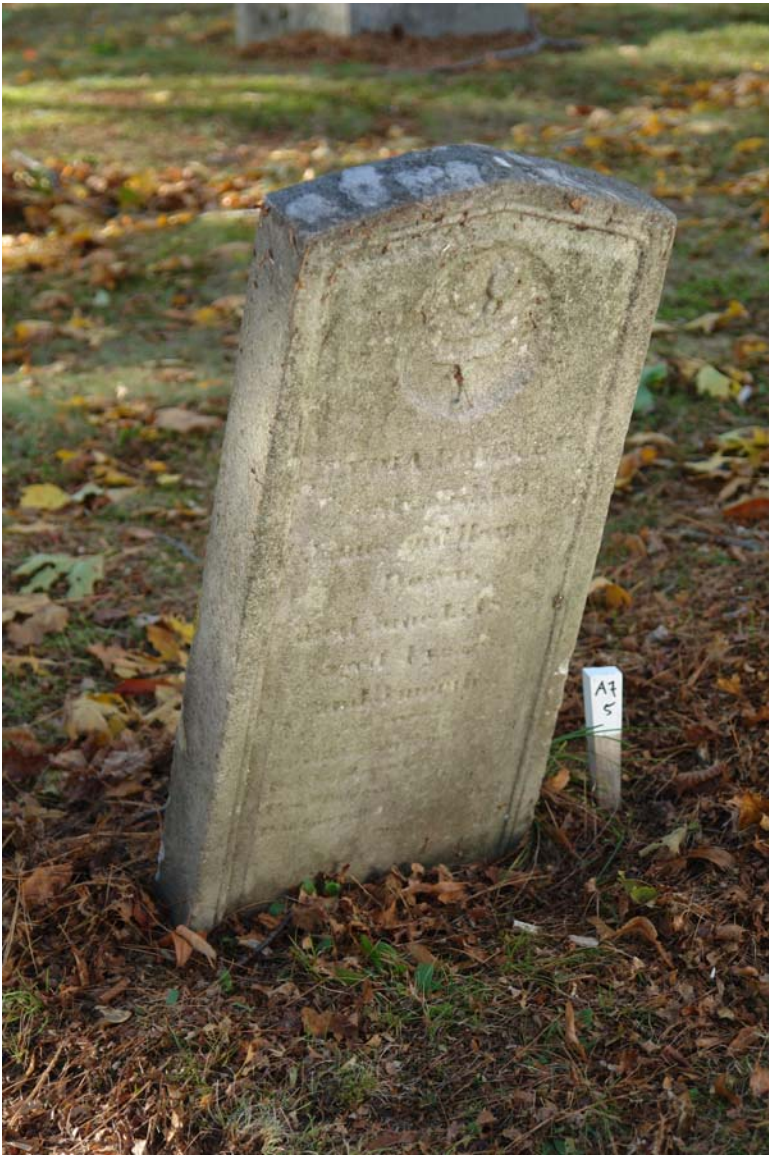
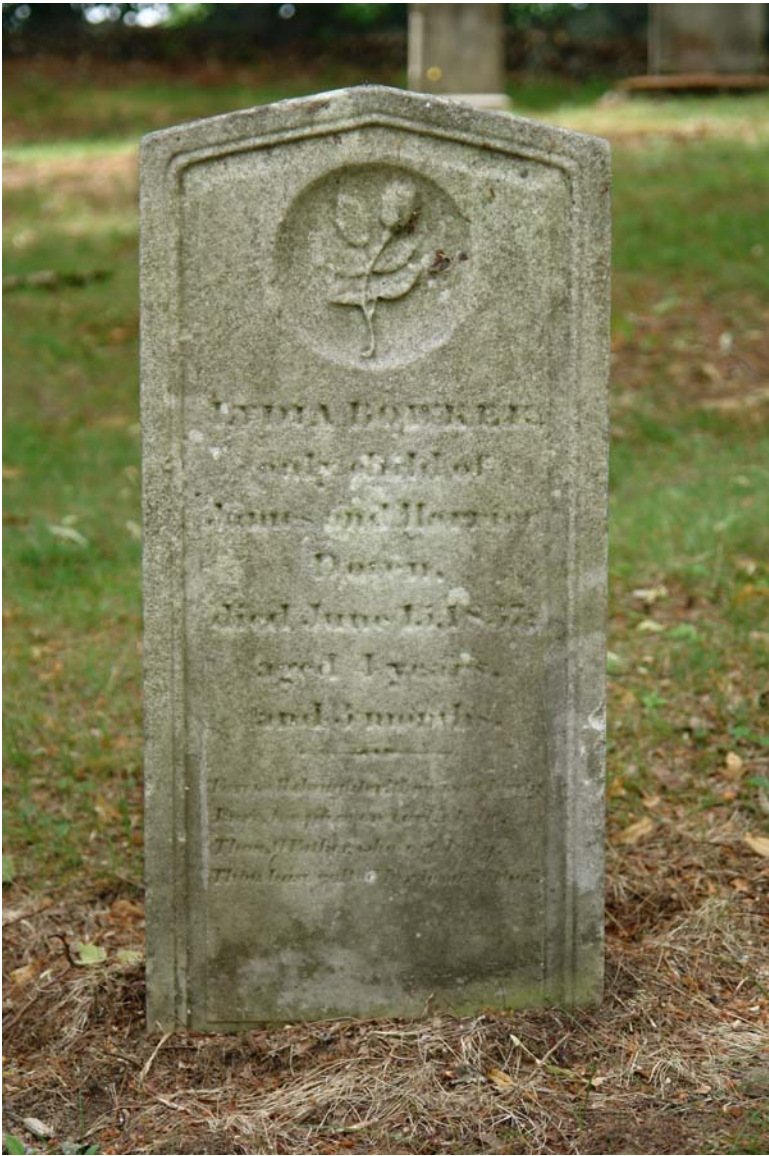
Height 23 Width 11.5 Thickness 2.5 Marker# **A.7.5**

Union Assinippi Cemetery, Hanover, MA	
NAME ON MARKER	Charles Totman
Death Date: 7/21/1825	Marker Type: Small marker
Cond. of Inscription: Decipherable	Material: Marble
EXISTING CONDITIONS	CONSERVATION STRATEGY
Marker off base	Check base for level Reset marker
TREATMENT Treatment Dates 5/27-28/2015	
1. Marker excavated and found to be sound. Light soiling removed by brushing with nylon brushes and water. 2. No existing bases were found. Setting area excavated for new below grade cast concrete base using a 8” sonotube as a form about 18” deep. . 3. Marker was reset onto new base with a cement/lime mortar (3/2/9) with 000 sand

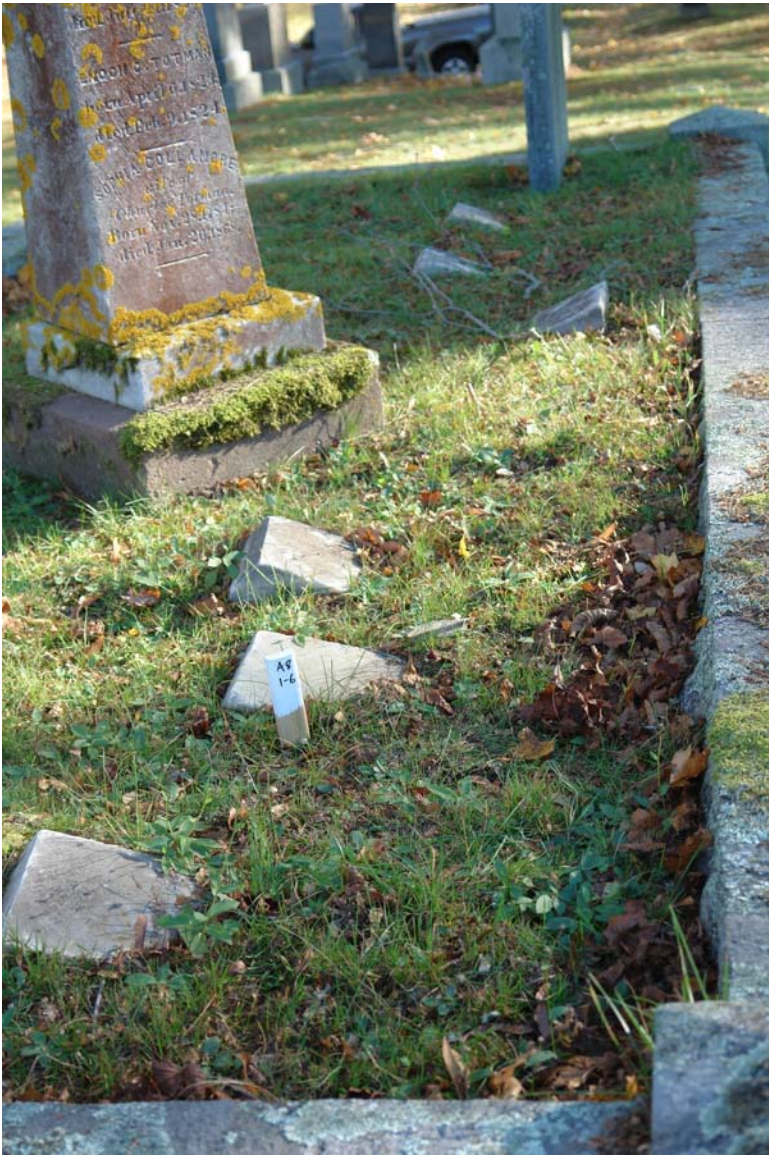
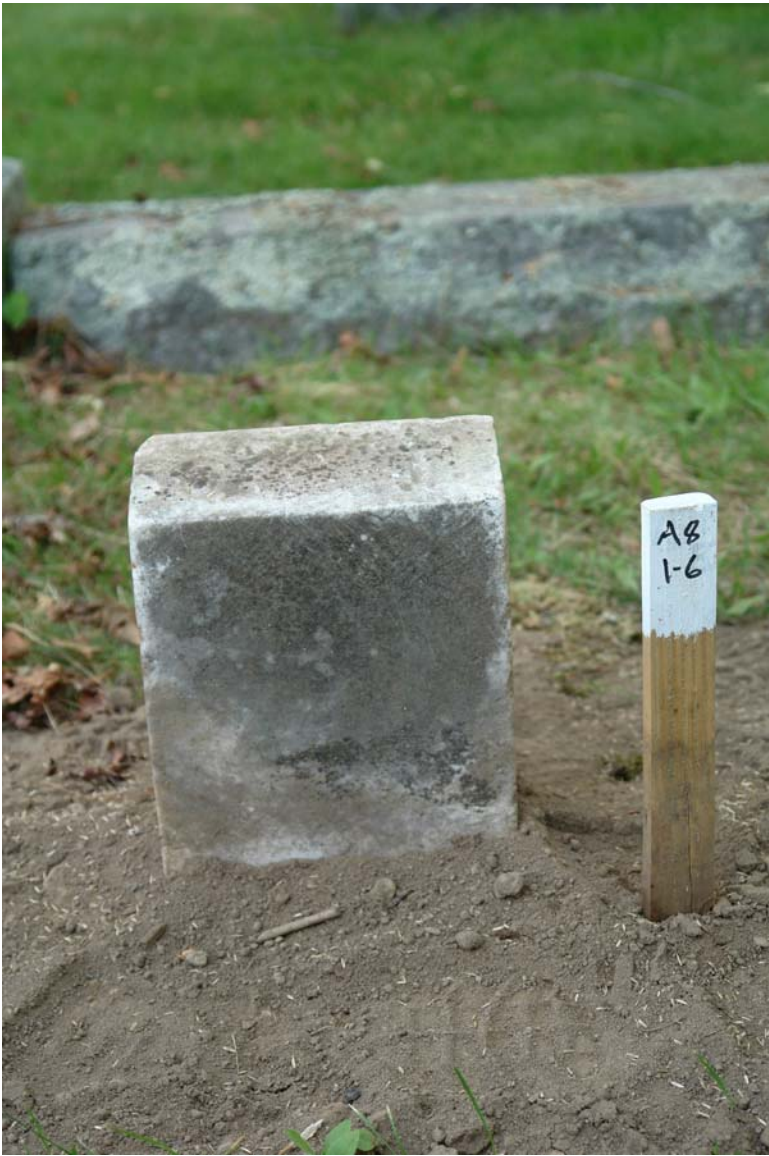
Union Assinippi Cemetery, Hanover, MA	
NAME ON MARKER	Sophia Totman
Death Date: 1/20/1868	Marker Type: Small marker
Cond. of Inscription: Decipherable	Material: Marble
EXISTING CONDITIONS	CONSERVATION STRATEGY
Marker off base	Check base for level Reset marker
<div> <div>TREATMENT</div> <div> <div>Treatment Dates 5/27-28/2015</div> <div> 1. Marker excavated and found to be sound. Light soiling removed by brushing with nylon brushes and water. 2. No existing bases were found. Setting area excavated for new below grade cast concrete base using a 8" sonotube as a form about 18" deep. . 3. Marker was reset onto new base with a cement/lime mortar (3/2/9) with 000 sand </div> </div> </div>

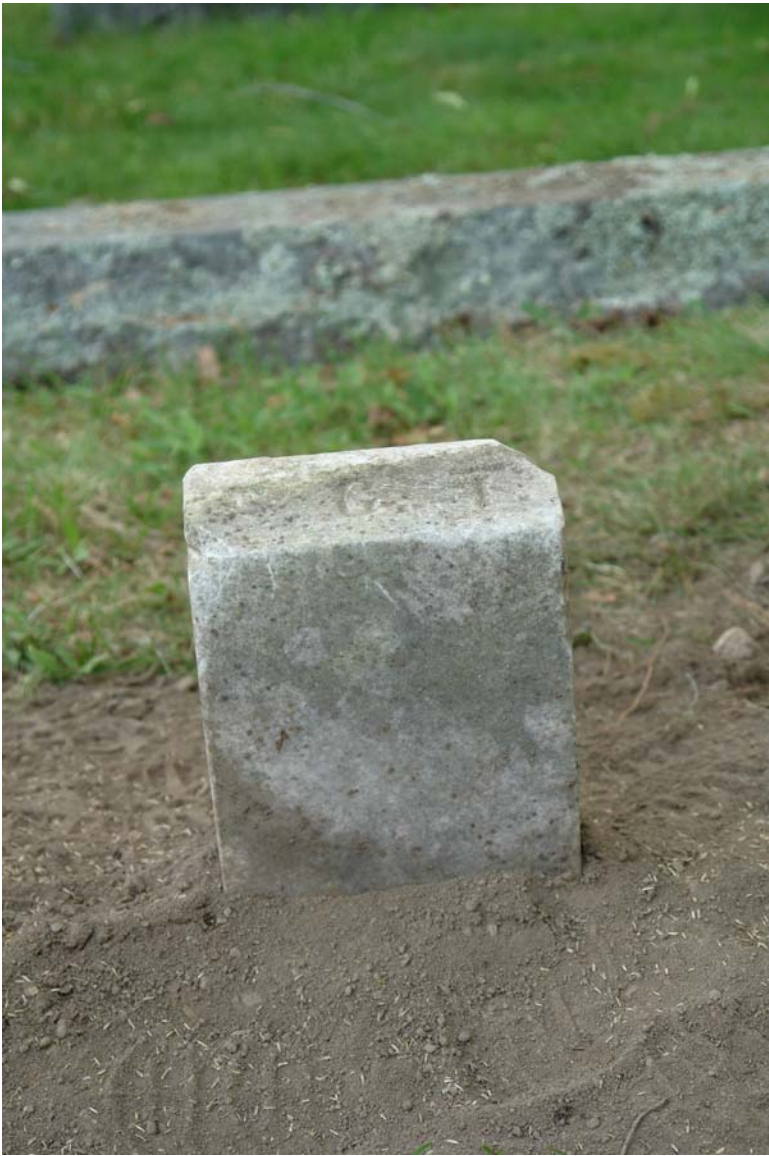
Union Assinippi Cemetery, Hanover, MA	
NAME ON MARKER	Enoch Totman
Death Date: 4/6/1824	Marker Type: Small marker
Cond. of Inscription: Decipherable	Material: Marble
EXISTING CONDITIONS	CONSERVATION STRATEGY
Marker off base	Check base for level Reset marker
TREATMENT Treatment Dates 5/27-28/2015	
1. Marker excavated and found to be sound. Light soiling removed by brushing with nylon brushes and water. 2. No existing bases were found. Setting area excavated for new below grade cast concrete base using a 8” sonotube as a form about 18” deep. . 3. Marker was reset onto new base with a cement/lime mortar (3/2/9) with 000 sand

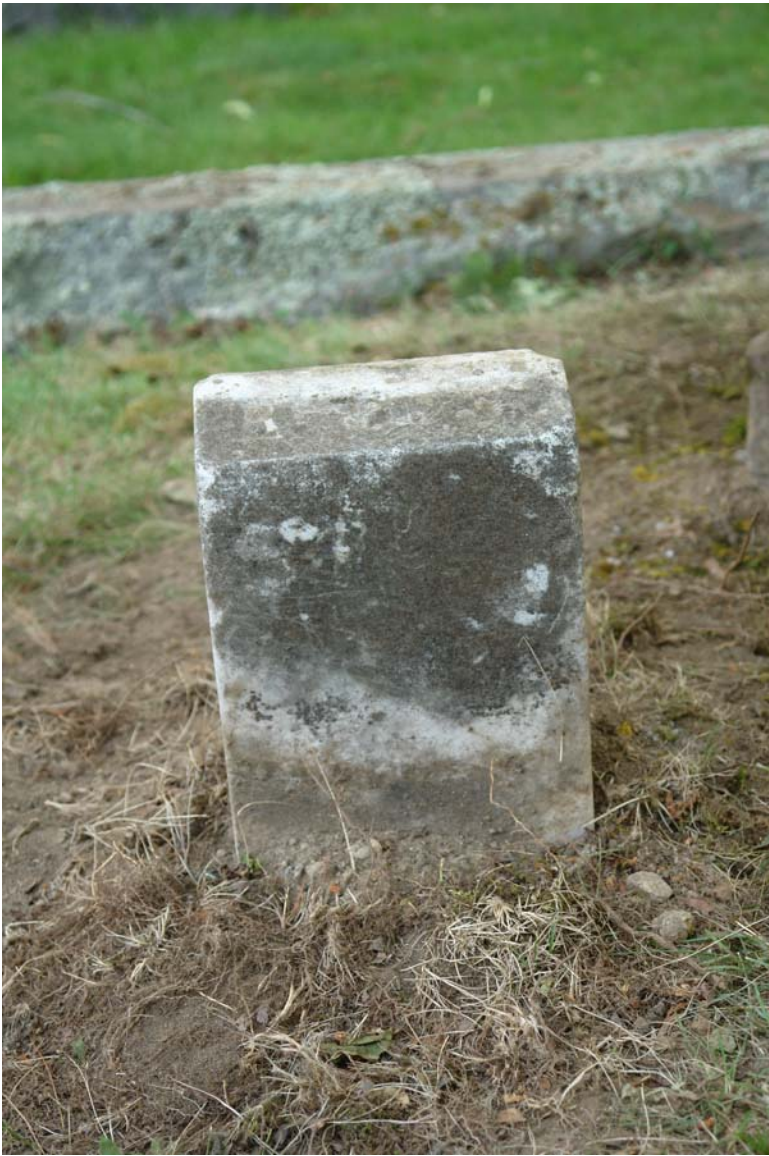
Height 7.5 Width 9 Thickness 3 Marker# **A.8.3**

Union Assinippi Cemetery, Hanover, MA	
NAME ON MARKER	Charles Totman
Death Date: 11/20/1888	Marker Type: Small marker
Cond. of Inscription: Decipherable	Material: Marble
EXISTING CONDITIONS	CONSERVATION STRATEGY
Marker off base	Check base for level Reset marker
<div> <div>TREATMENT</div> <div> <div>Treatment Dates 5/27-28/2015</div> <div> 1. Marker excavated and found to be sound. Light soiling removed by brushing with nylon brushes and water. 2. No existing bases were found. Setting area excavated for new below grade cast concrete base using a 6" sonotube as a form about 18" deep. . 3. Marker was reset onto new base with a cement/lime mortar (3/2/9) with 000 sand </div> </div> </div>

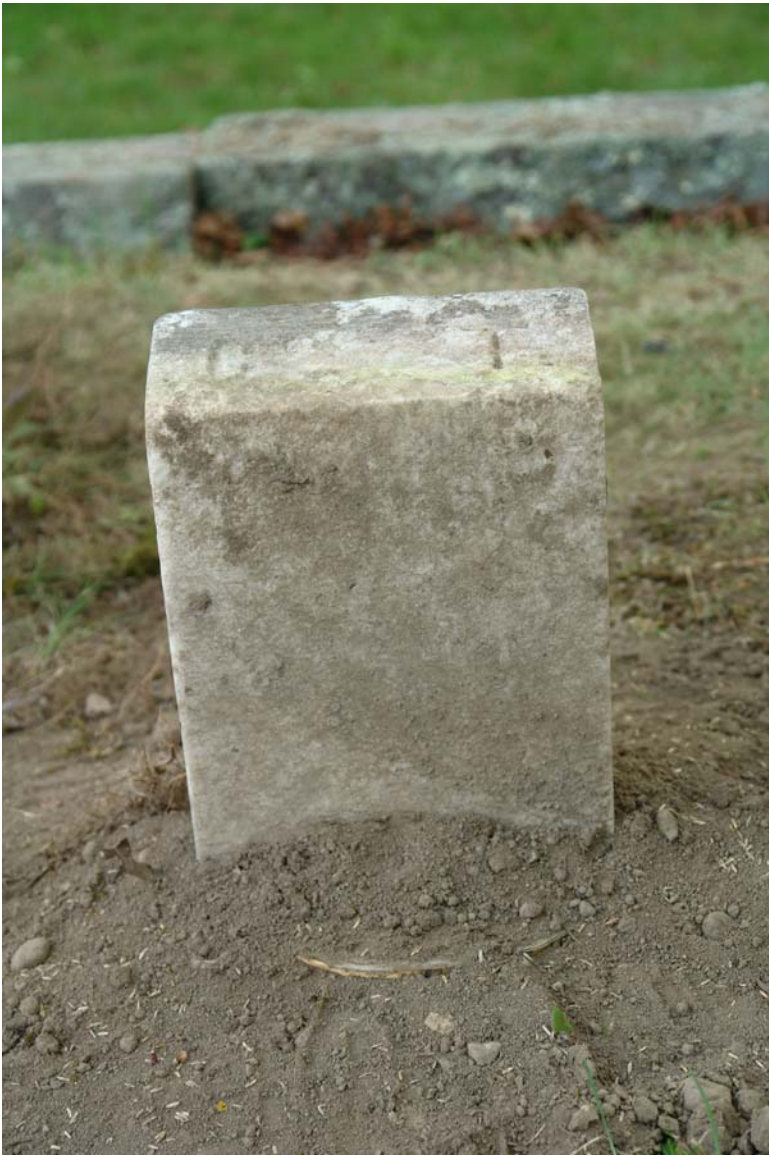
Height 7.5 Width 9 Thickness 3 Marker# **A.8.4**

Union Assinippi Cemetery, Hanover, MA	
NAME ON MARKER	Thais Totman
Death Date: 9/2/1868	Marker Type: Small marker
Cond. of Inscription: Decipherable	Material: Marble
EXISTING CONDITIONS	CONSERVATION STRATEGY
Marker off base	Check base for level Reset marker
TREATMENT Treatment Dates 5/27-28/2015	
1. Marker excavated and found to be sound. Light soiling removed by brushing with nylon brushes and water. 2. No existing bases were found. Setting area excavated for new below grade cast concrete base using a 6” sonotube as a form about 18” deep. . 3. Marker was reset onto new base with a cement/lime mortar (3/2/9) with 000 sand

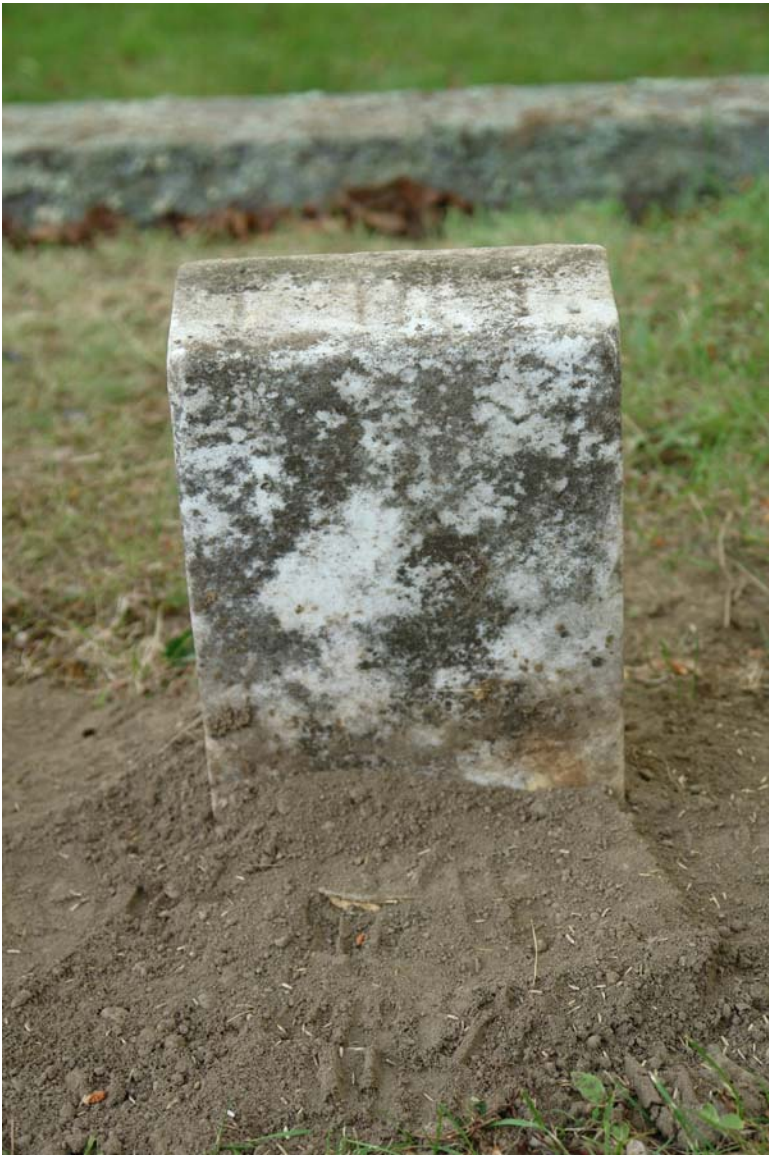
Height 7.5 Width 9 Thickness 3 Marker# **A.8.5**

Union Assinippi Cemetery, Hanover, MA	
NAME ON MARKER	Anthony Totman
Death Date: 8/21/1856	Marker Type: Small marker
Cond. of Inscription: Decipherable	Material: Marble
EXISTING CONDITIONS	CONSERVATION STRATEGY
Marker off base	Check base for level Reset marker
TREATMENT Treatment Dates 5/27-28/2015	
1. Marker excavated and found to be sound. Light soiling removed by brushing with nylon brushes and water.	
2. No existing bases were found. Setting area excavated for new below grade cast concrete base using a 6" sonotube as a form about 18" deep. .	
3. Marker was reset onto new base with a cement/lime mortar (3/2/9) with 000 sand

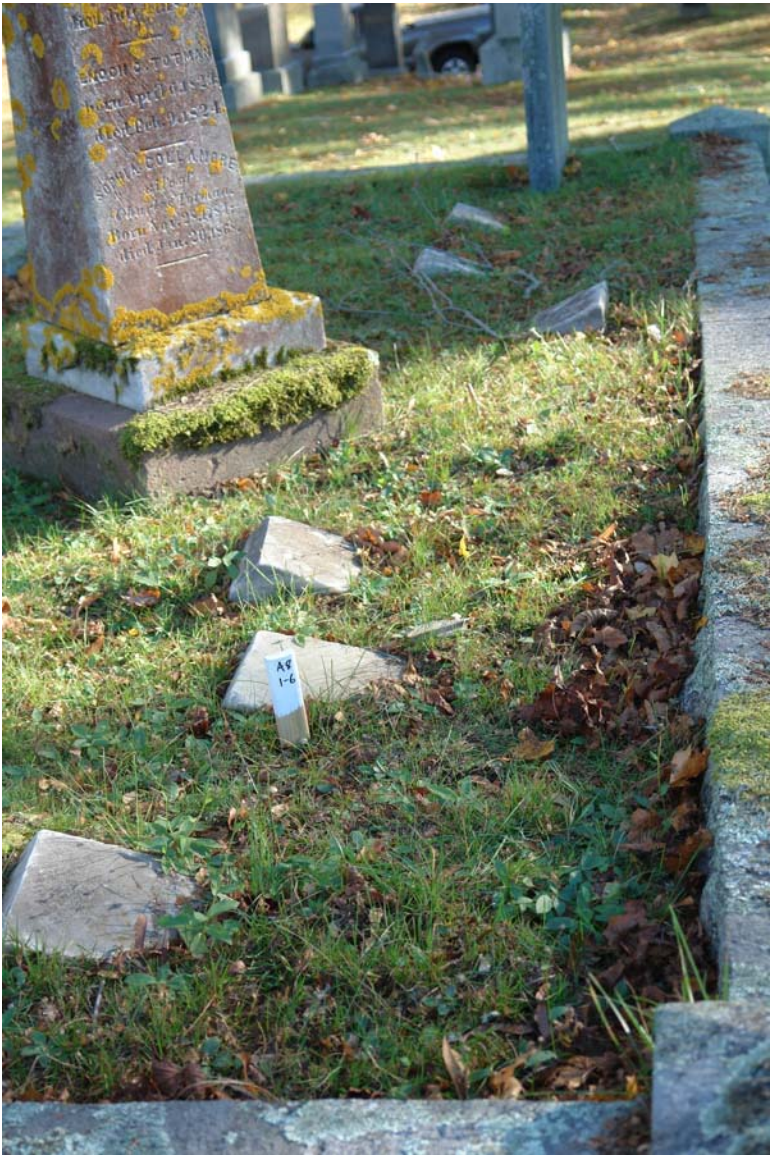
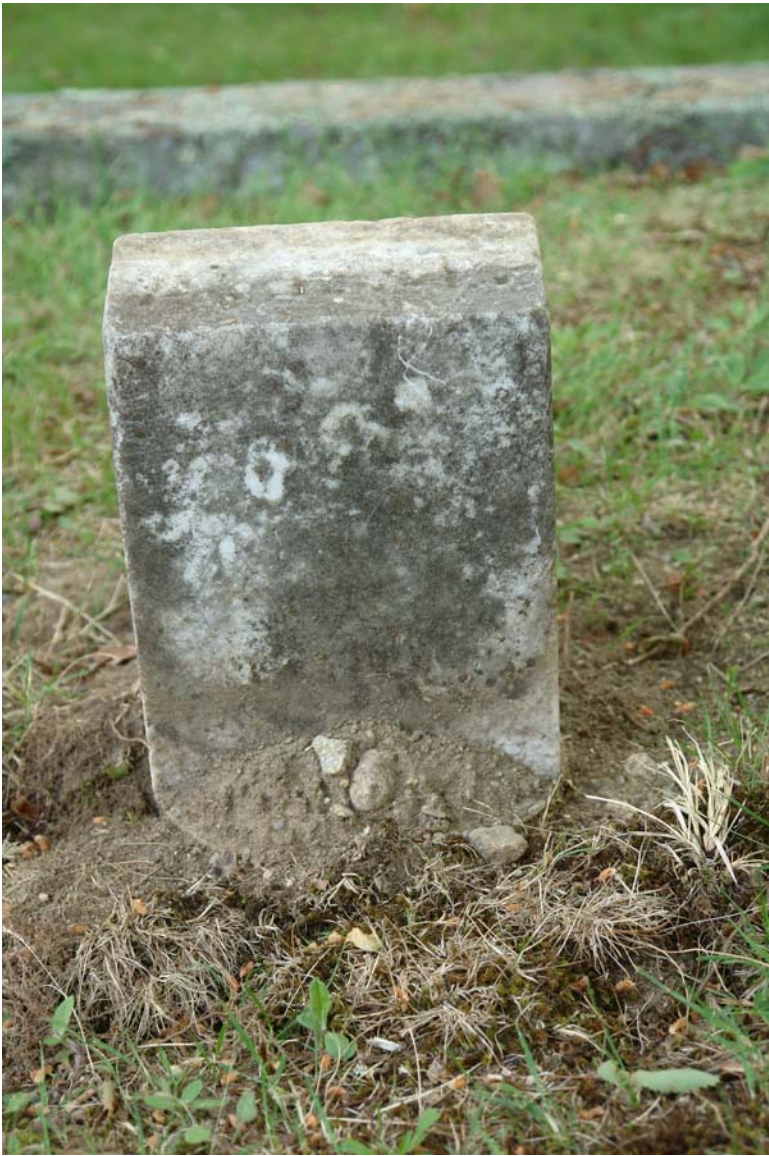
Height 7.5 Width 9 Thickness 3 Marker# **A.8.6**

Union Assinippi Cemetery, Hanover, MA	
NAME ON MARKER	Totman Monument
Death Date: 1824-1888	Marker Type: Obelisk
Cond. of Inscription: Decipherable	Material: Marble
EXISTING CONDITIONS	CONSERVATION STRATEGY
Tilted Reset elements	Stabilize base Reset elements
<div> <div>TREATMENT</div> <div>Treatment Dates 6/10/2015</div> <div> <div>1. Monument removed from base area with mechanical assistance, inspected for soundness,</div> <div>2. Setting base excavated and aligned with adjacent markers and re-set level, backfill w/ gravel.</div> <div>3. Setting areas cleared of debris and any failed setting mortar removed. Setting surfaces treated with D/2 antimicrobial, scrubbed with nylon brushes and fully rinsed with water.</div> <div>4. Setting bed primed with Acryl 60 diluted 1:3 with water.</div> <div>5. Monumnet reset with a cement/lime mortar (3/2/9) with 000 sand. If necessary lead shims facilitated leveling. Excess mortar removed and joint area cleaned</div> <div>6. Excess mortar removed and joint area cleaned</div> <div>7. All surfaces treated with D/2 Biological Solution, rinsed fully with water.</div> </div> </div>

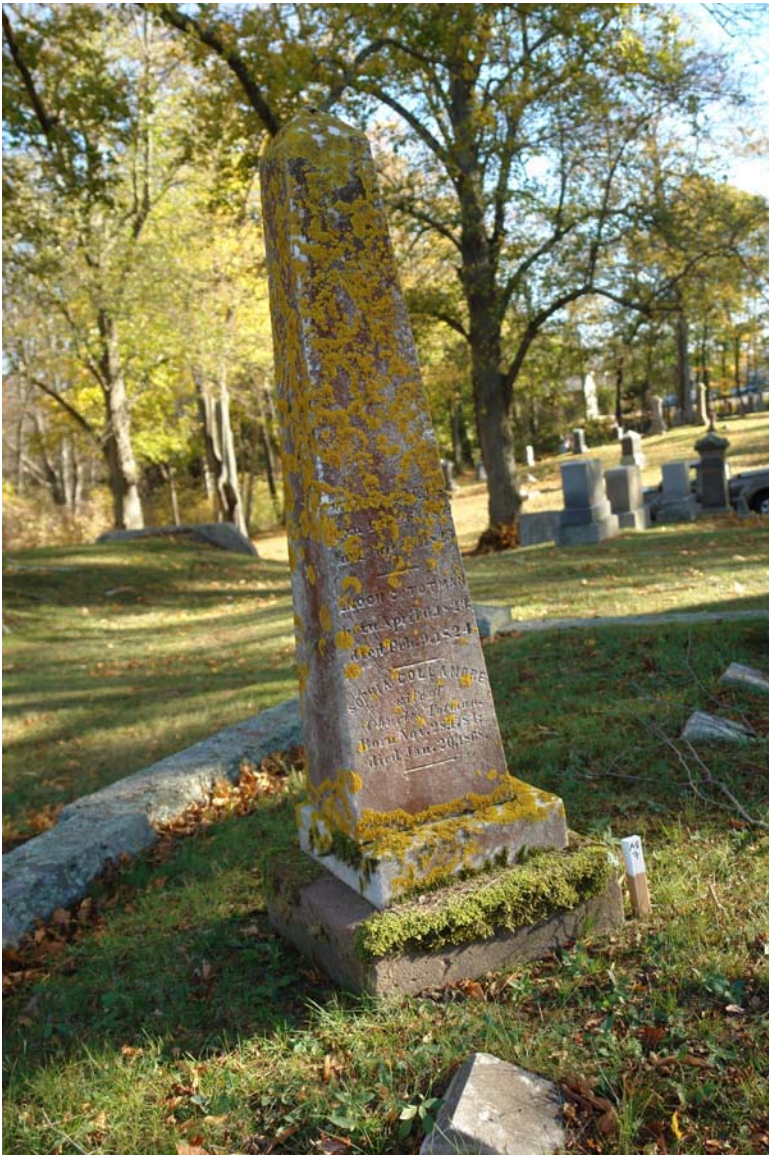
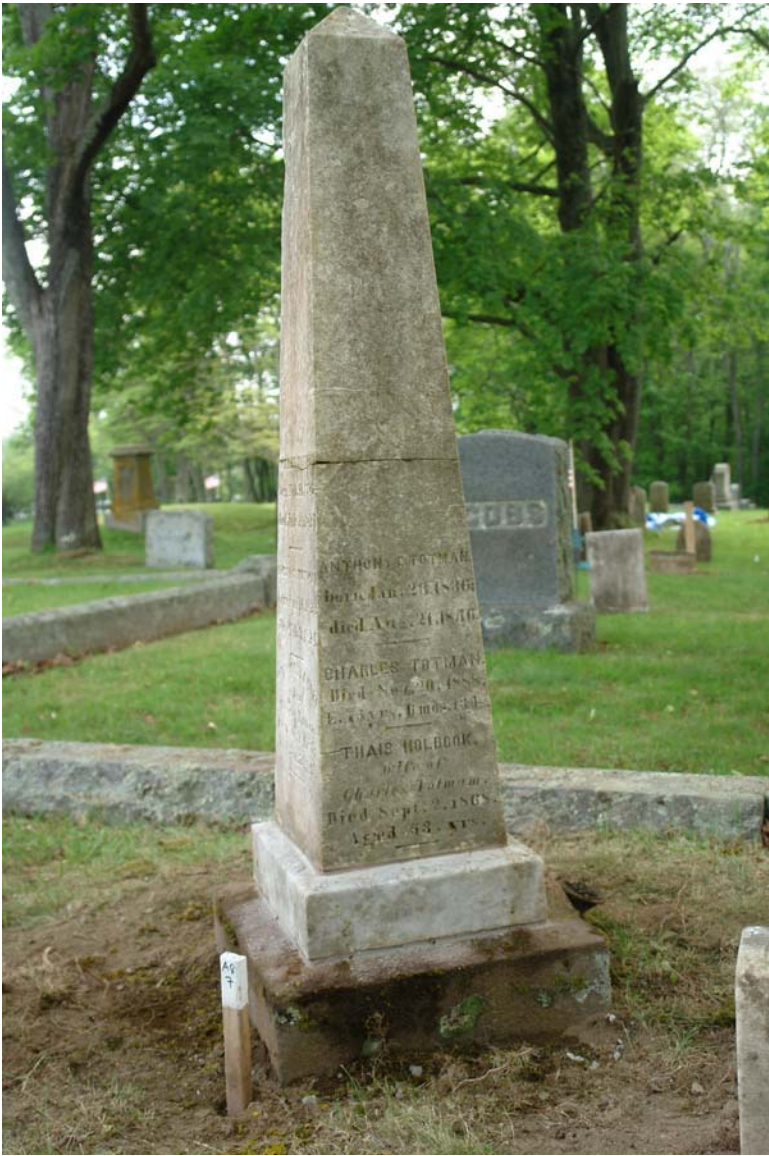
Height 53 Width 12 Thickness 12 Marker# A.8.7

Union Assinippi Cemetery, Hanover, MA	
NAME ON MARKER	Hannah Whiting
Death Date: 9/25/1824	Marker Type: Headstone/base
Cond. of Inscription: Decipherable	Material: Marble
EXISTING CONDITIONS	CONSERVATION STRATEGY
Base tilted Fractured Loose on base	Reset base plumb Attach fragments Reset marker
<div> <div>TREATMENT</div> <div>Treatment Dates 5/27-6/10/2015</div> <div> <div>1. Area excavated to an appropriate depth removing any roots or large stones aligning base with adjacent markers and re-set level.</div> <div>2. Setting surfaces cleaned with water and any failed adhesives or mortar removed with hand tools from setting area and bottom of marker</div> <div>3. Fragments attached with structural adhesive, clamped and braced until cured. Epoxy removed with hand chisels within 24 hours.</div> <div>4. When required, any existing pins were inspected, and if necessary, replaced with stainless steel threaded pins</div> <div>5. Setting surfaces primed with Acryl 60 diluted 1:3 with water.</div> <div>6. Marker reset plumb and level onto base with cement/lime grout (3/2/9) with 000 sand. Braced for min 3 days. Excess grout removed.</div> <div>7. Cracks and losses filled with RepliCal Marble products or Jahn restoration mortar.</div> <div>8. Filled areas misted with water and covered for 3 days minimum</div> <div>9. Filled surface areas treated with light acid wash and rinsed thoroughly</div> </div> </div>

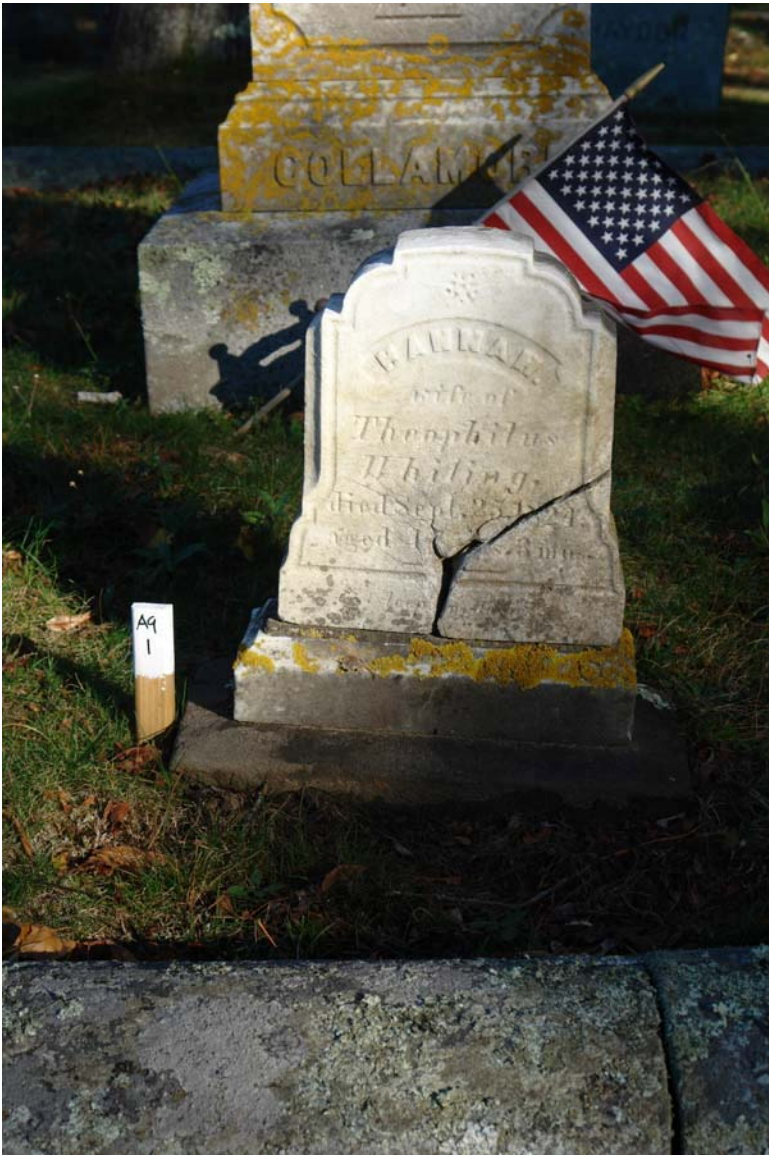
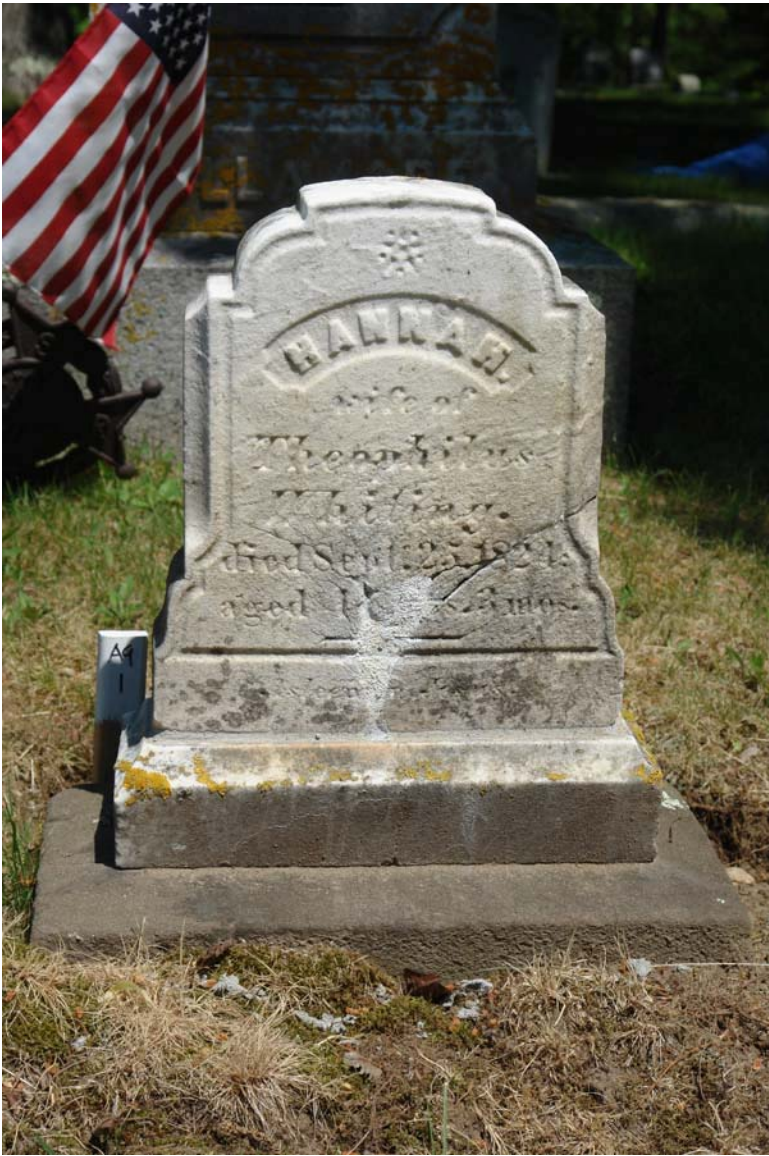
Union Assinippi Cemetery, Hanover, MA
 NAME ON MARKER **Enoch Collamore**
 Death Date: 3/17/1839 Marker Type: Small headstone/base
 Cond. of Inscription: Decipherable Material: Marble

EXISTING CONDITIONS	CONSERVATION STRATEGY
Loose in base Tilted	Level base Reset elements

TREATMENT	Treatment Dates 5/27/2015
1. Existing base located below grade while excavating for resetting. Area excavated to an appropriate depth removing any roots or large stones. 2. Base inspected and found to be sound and re-useable 3. Base is aligned with adjacent markers and re-set level. 4. Area around base was backfilled with tamped gravel and re-graded with existing topsoil 5. Debris removed from setting slot. When required, power grinders were used to facilitate removal of stone fragments. 6. When required, the lower setting edge was re-squared by power grinder with minimal loss. 7. Marker reset plumb and level into setting slot with cement/lime grout (3/2/9) with 000 sand made fluid with a super plasticizer. 8. Excess grout removed and joint area cleaned. 9. Marker braced for a minimum 3 days
