DOCUMENTATION OF STONE CONSERVATION TREATMENTS TO ASSINIPPI CEMETERY, HANOVER, MA June 2015

**MONUMENT CONSERVATION COLLABORATIVE LLC, NORFOLK, CT**

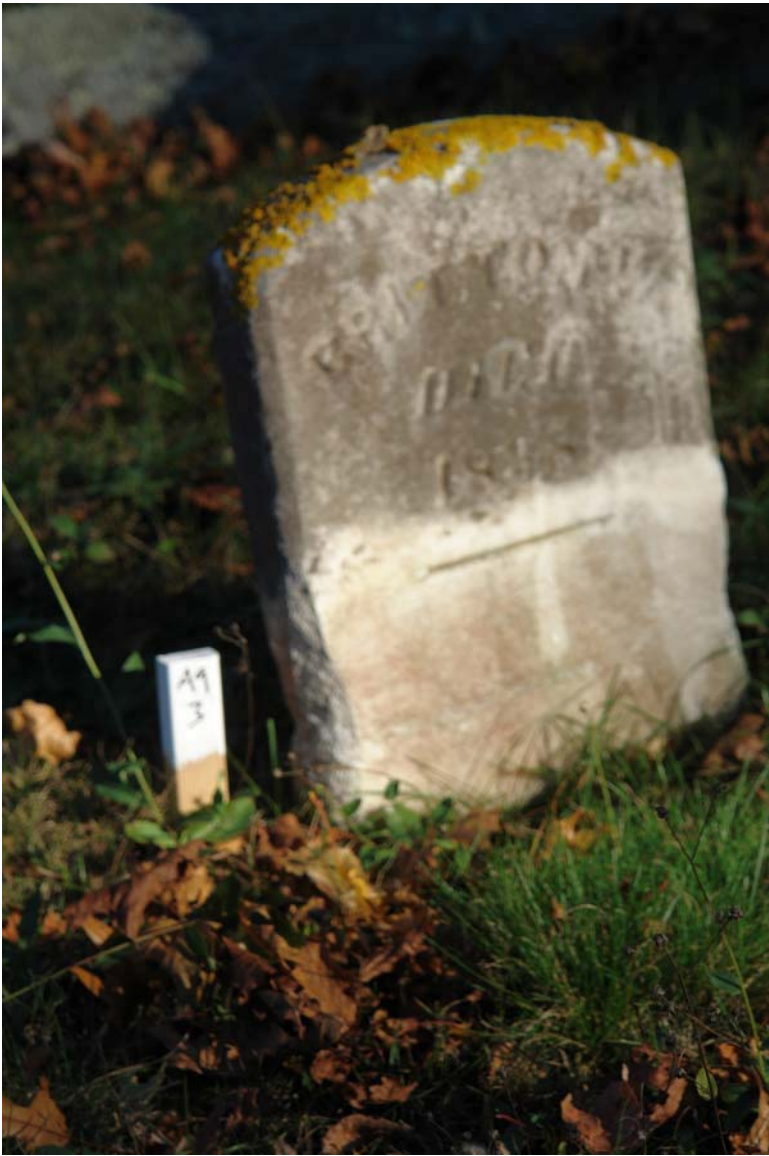
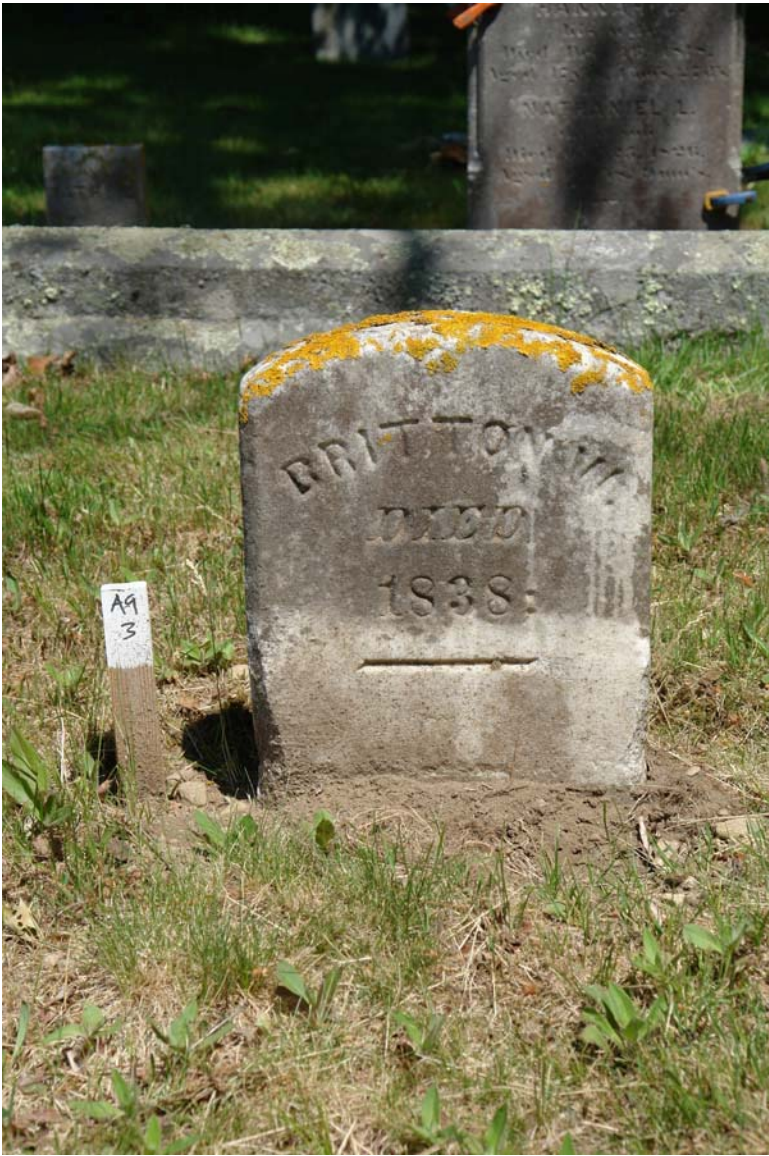
Union Assinippi Cemetery, Hanover, MA	
NAME ON MARKER	Michael Lapham
Death Date: 2/24/1809	Marker Type: Headstone
Cond. of Inscription:n.a.	Material: Marble
EXISTING CONDITIONS	CONSERVATION STRATEGY
Overgrown fractured	Attach fragments with structural adhesive Reset to base
<div> <div>TREATMENT</div> <div>Treatment Dates 5/27-6/11/2015</div> <div> <div>1. Area excavated to an appropriate depth. Base is aligned with adj. markers and reset level at appropriate height.</div> <div>2. Setting slot cleaned of debris or failed mortar and bottom frag- ment reset plumb and level into setting slot with a cement/lime grout (3/2/9) with 000 sand made fluid with a super plasticizer. Excess grout removed and joint area cleaned.</div> <div>3. Marker braced for a minimum 3 days</div> <div>4. All mating edges of fragments cleaned with water and any failed adhesives removed with hand tools</div> <div>5. Fragments attached with structural adhesive (Abatron 55-22), clamped and braced until cured. Excess epoxy removed with hand chisels within 24 hours.</div> <div>6. Cracks and losses filled with RepliCal Marble products, filled ar- eas misted with water and covered for 3 days minimum</div> <div>7. Filled areas treated with light acid wash and rinsed thoroughly.</div> <div>8. All Surfaces treated with D/2 Biological Solution, scrubbed with nylon brushes and water. Rinsed fully with water</div> </div> </div>

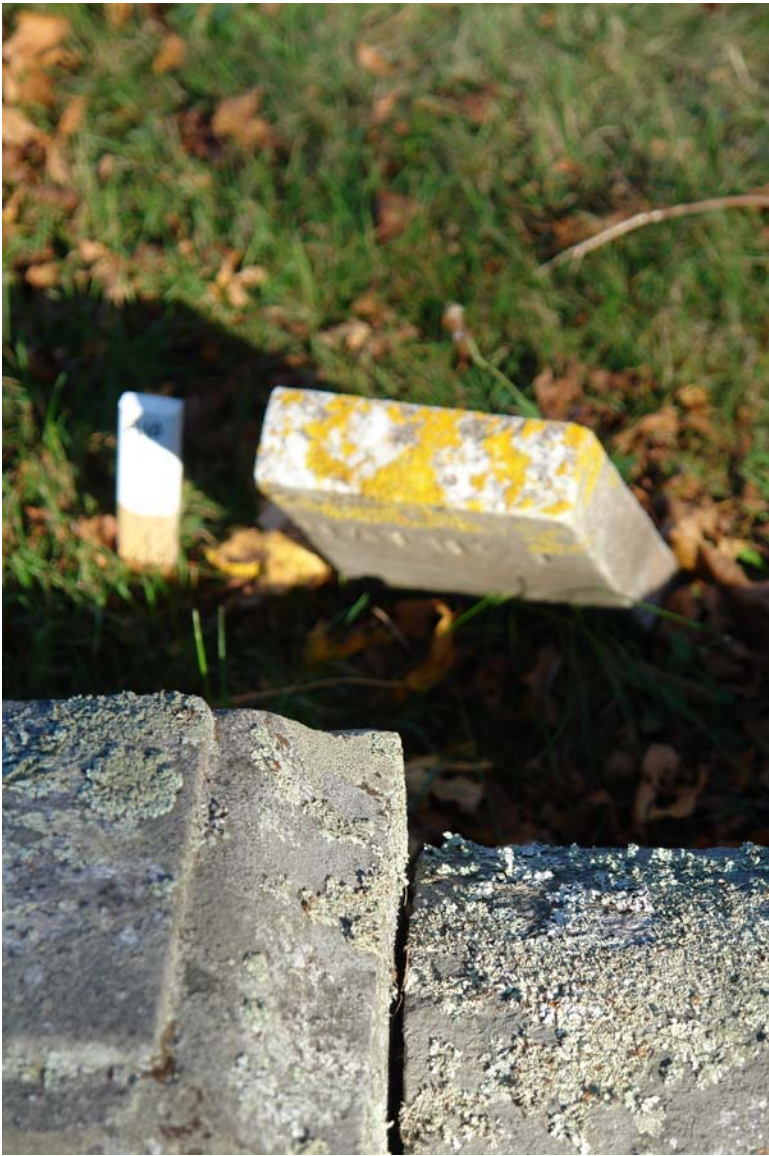
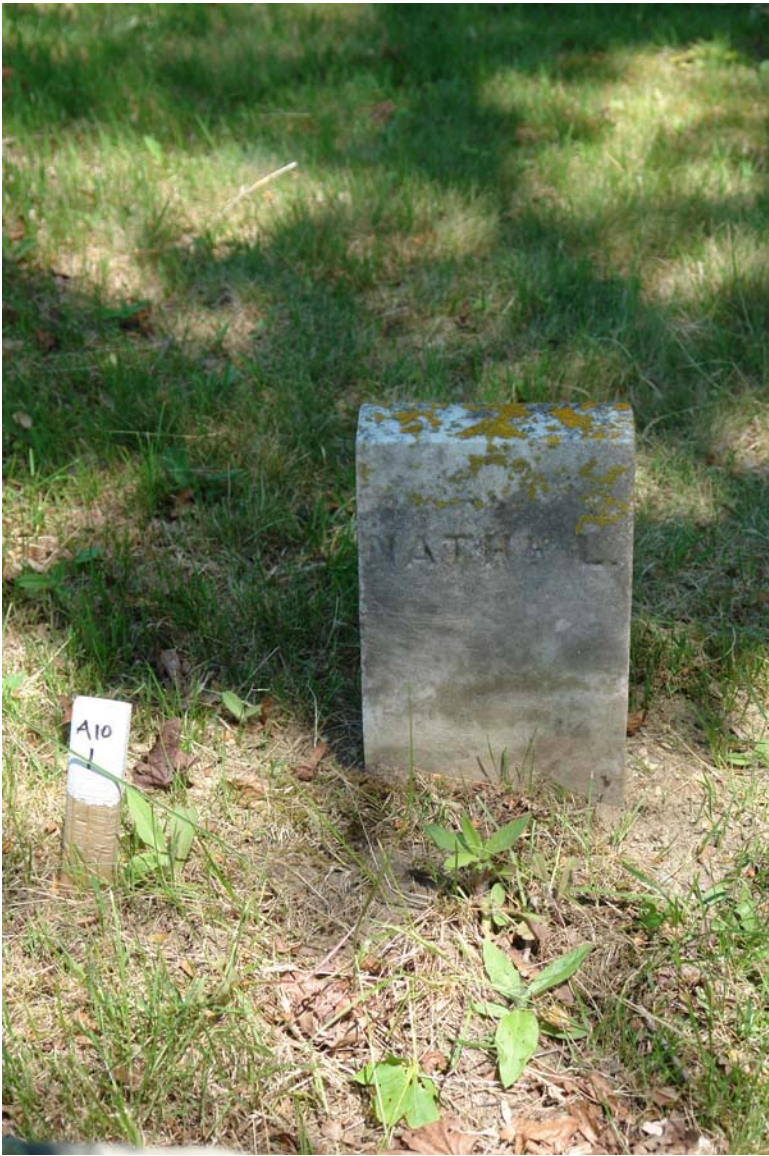
Height 12 Width 7 Thickness 2 Marker# **A.10.1**

Union Assinippi Cemetery, Hanover, MA	
NAME ON MARKER	William Prouty
Death Date: 5/23/1842	Marker Type: Headstone/base
Cond. of Inscription: Decipherable	Material: Marble
EXISTING CONDITIONS	CONSERVATION STRATEGY
Fractures	Attach fragments with structural adhesive
<div>TREATMENT</div> <div>Treatment Dates 5/28-6/11/2015</div> <div> <ol style="list-style-type: none"> Area excavated to an appropriate depth. Base is aligned with adj. markers and reset level at appropriate height. Setting slot cleaned of debris or failed mortar and bottom fragment reset plumb and level into setting slot with a cement/lime grout (3/2/9) with 000 sand made fluid with a super plasticizer. Excess grout removed and joint area cleaned. Marker braced for a minimum 3 days All mating edges of fragments cleaned with water and any failed adhesives removed with hand tools Fragments attached with structural adhesive (Abatron 55-22), clamped and braced until cured. Excess epoxy removed with hand chisels within 24 hours. Cracks and losses filled with RepliCal Marble products, filled areas misted with water and covered for 3 days minimum Filled areas treated with light acid wash and rinsed thoroughly. All Surfaces treated with D/2 Biological Solution, scrubbed with nylon brushes and water. Rinsed fully with water </div>

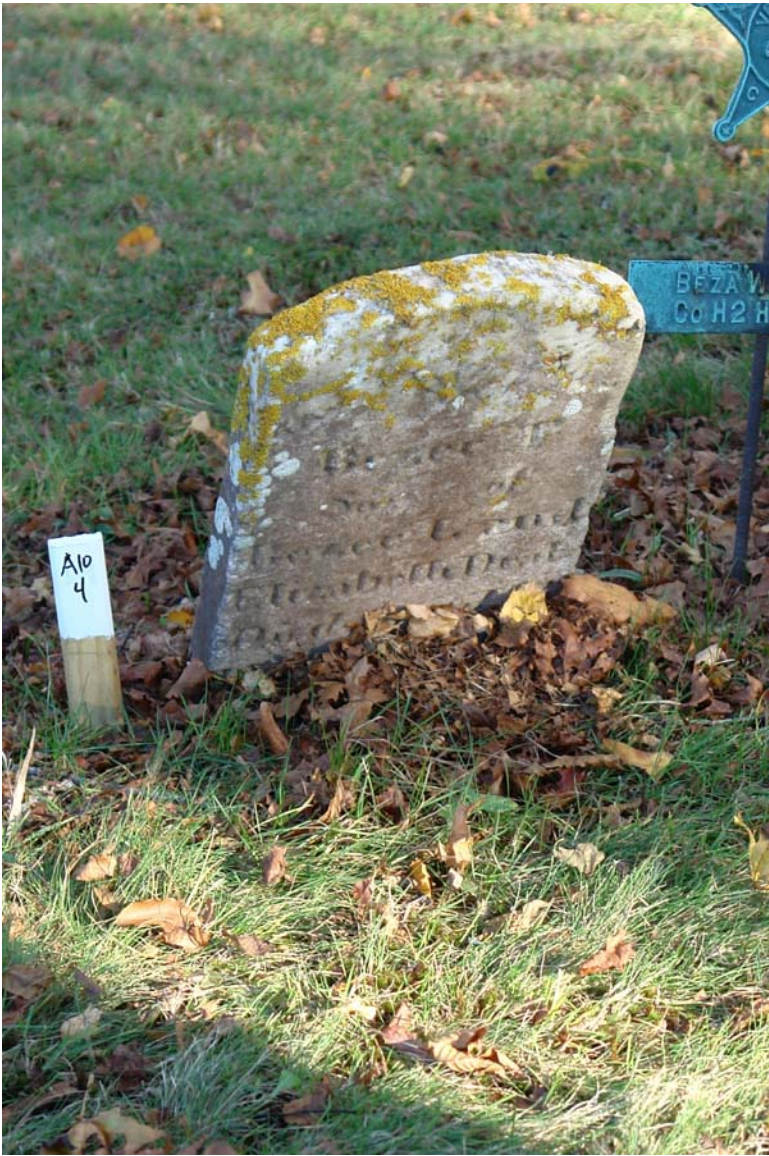
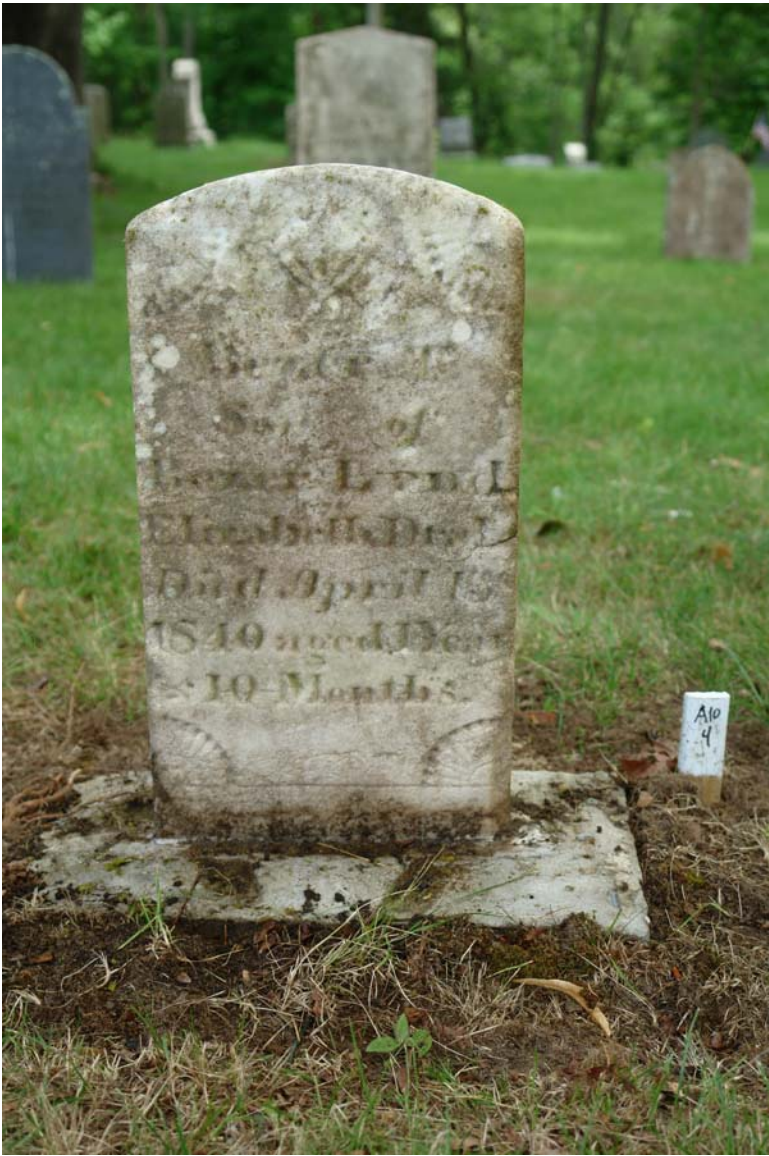
Height 16 Width 10 Thickness 2 Marker# A.10.4

Union Assinippi Cemetery, Hanover, MA	
NAME ON MARKER	Galen Prouty
Death Date: 10/25/1804	Marker Type: Headstone
Cond. of Inscription: Currently illegible	Material: Slate
EXISTING CONDITIONS	CONSERVATION STRATEGY
Tilted	Reset plumb
<div> <div>TREATMENT</div> <div> <div>Treatment Dates 5/27/2015</div> <div> 1. Marker carefully excavated. The soil around tilted markers was removed to an appropriate depth. When required, the marker was removed from the ground. Marker appears to be sound. 2. Soling removed by light brushing with nylon brushes and water. 3. Setting area excavated to sufficient depth and stone re-set plumb at appropriate height and level onto gravel bed, aligned with adjacent markers 4. Area backfilled around marker with tamped sand and gravel 5. Disturbed areas re-graded with existing topsoil and sod. </div> </div> </div>

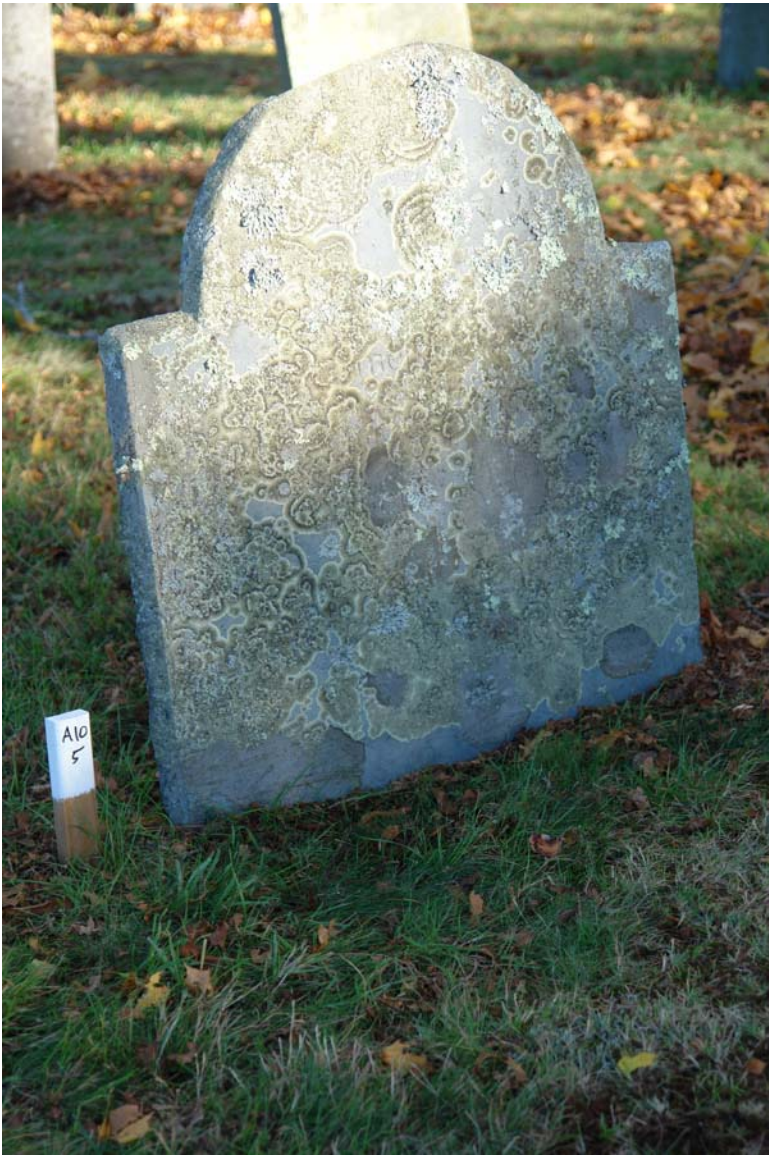
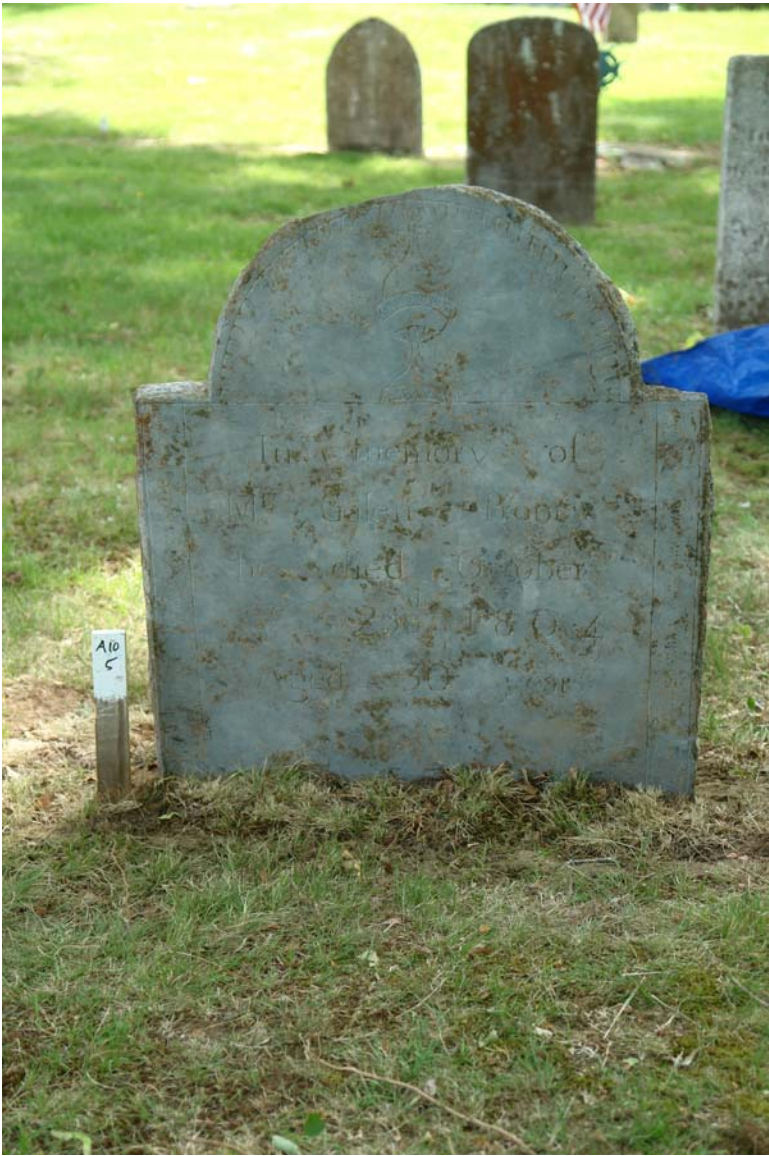
Height 24 Width 22 Thickness 1.5 Marker# **A.10.5**

Union Assinippi Cemetery, Hanover, MA	
NAME ON MARKER	Elizabeth Prouty
Death Date: 5/21/1800	Marker Type: Headstone
Cond. of Inscription: Currently illegible	Material: Slate
EXISTING CONDITIONS	CONSERVATION STRATEGY
Tilted Fragmented	Reset lower fragment plumb Attach fragments with structural adhesive
TREATMENT Treatment Dates 5/27-28/2015	
<div>1. Setting area excavated for new below grade cast concrete base</div> <div>2. A new concrete base sized min. 12" deep, 12" greater in thickness and 6" wider than the stone is cast. The finished top to be below grade. A form for a setting slot is placed in the concrete.</div> <div>3. Setting forms are removed after partial curing of the concrete and the base backfilled with tamped sand or gravel</div> <div>4. When required, the lower edge of marker is re-squared with minimal loss using a power grinder</div> <div>5. Lower fragment was reset plumb and level into slot using a cement/ lime grout (3/2/9) with 000 sand. Braced for min 3 days</div> <div>6. All mating edges of fragments cleaned with water and any failed adhesives removed with hand tools</div> <div>7. Fragments attached with structural adhesive (Abatron 55-22), clamped and braced until cured. Excess epoxy removed with hand chisels within 24 hours.</div> <div>8. All surfaces treated with D/2 Biological Solution, scrubbed with nylon brushes and water. Rinsed fully with water</div>

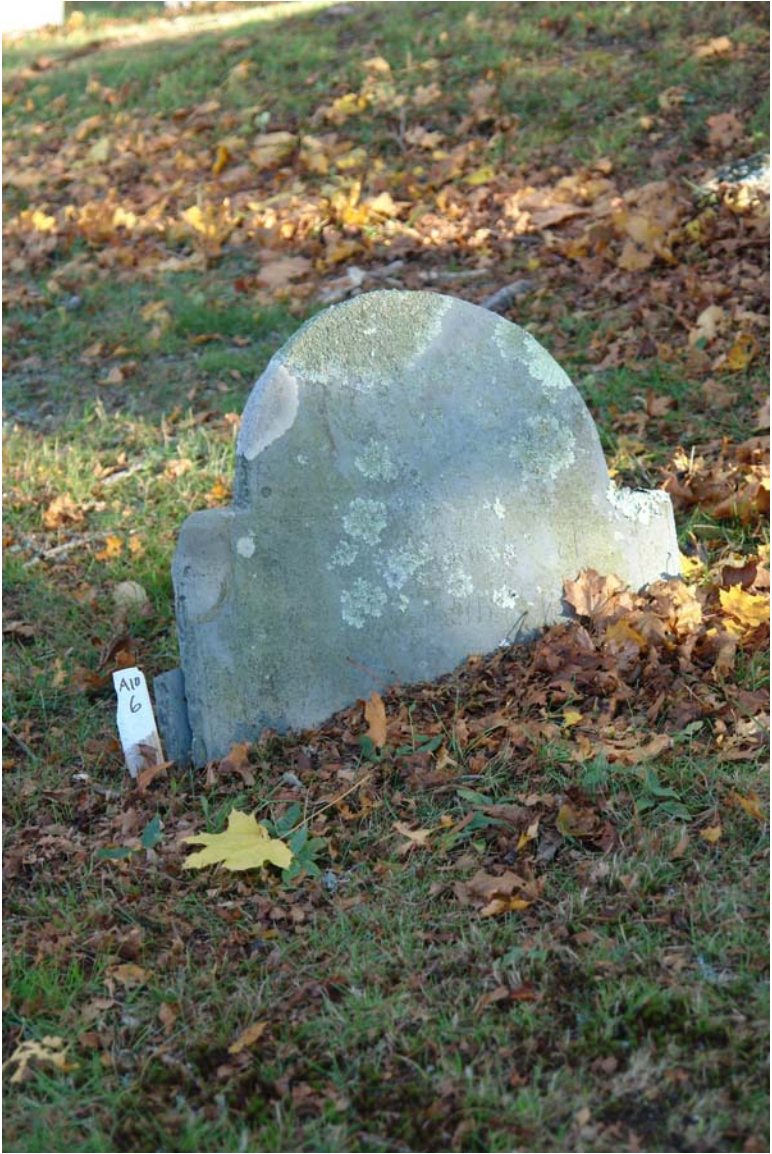
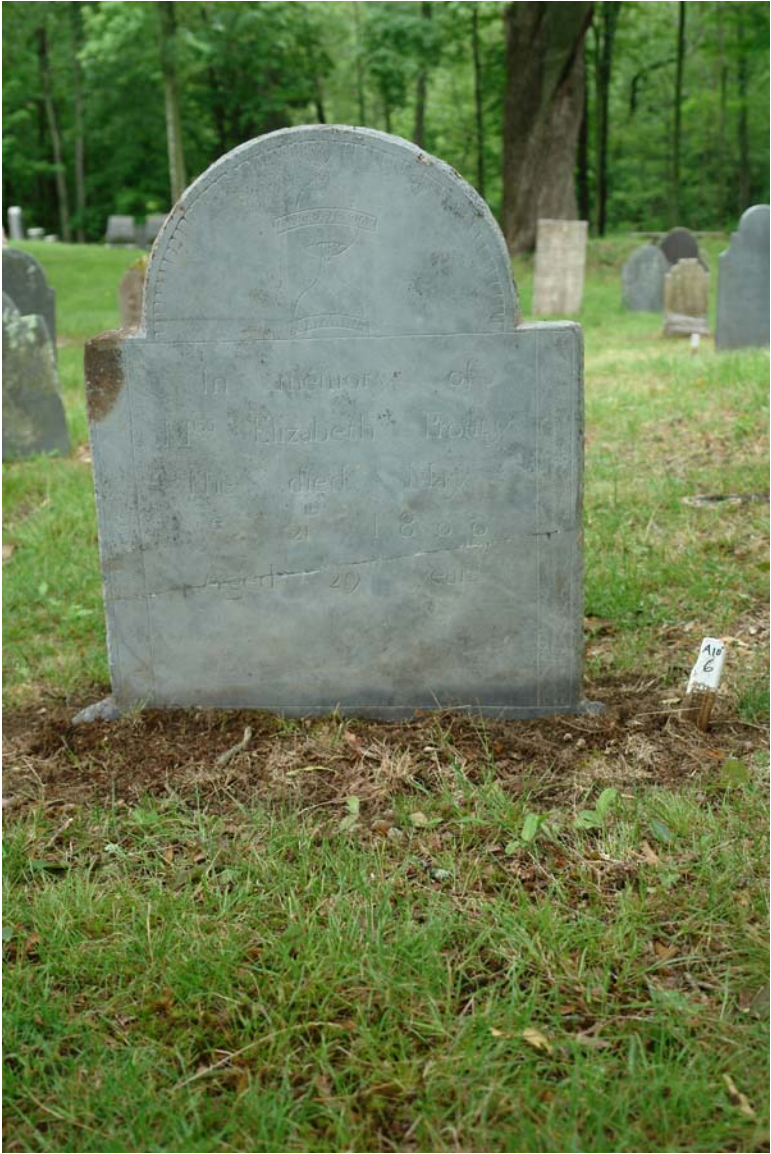
Height - Width - Thickness - Marker# **A.10.6**

Union Assinippi Cemetery, Hanover, MA	
NAME ON MARKER	Lucy Whiting
Death Date: 1/3/1837	Marker Type: Headstone
Cond. of Inscription: Decipherable	Material: Marble
EXISTING CONDITIONS	CONSERVATION STRATEGY
Fallen fractured	Attach fragments with structural adhesive Reset to base
TREATMENT Treatment Dates 6/10-12/2015	
<div>1. Area excavated to an appropriate depth. Base is aligned with adj. markers and reset level at appropriate height.</div> <div>2. Setting slot cleaned of debris or failed mortar and bottom fragment reset plumb and level into setting slot with a cement/lime grout (3/2/9) with 000 sand made fluid with a super plasticizer. Excess grout removed and joint area cleaned.</div> <div>3. Marker braced for a minimum 3 days</div> <div>4. All mating edges of fragments cleaned with water and any failed adhesives removed with hand tools</div> <div>5. Fragments attached with structural adhesive (Abatron 55-22), clamped and braced until cured. Excess epoxy removed with hand chisels within 24 hours.</div> <div>6. Cracks and losses filled with RepliCal Marble products, filled areas misted with water and covered for 3 days minimum</div> <div>7. Filled areas treated with light acid wash and rinsed thoroughly.</div> <div>8. All Surfaces treated with D/2 Biological Solution, scrubbed with nylon brushes and water. Rinsed fully with water</div>

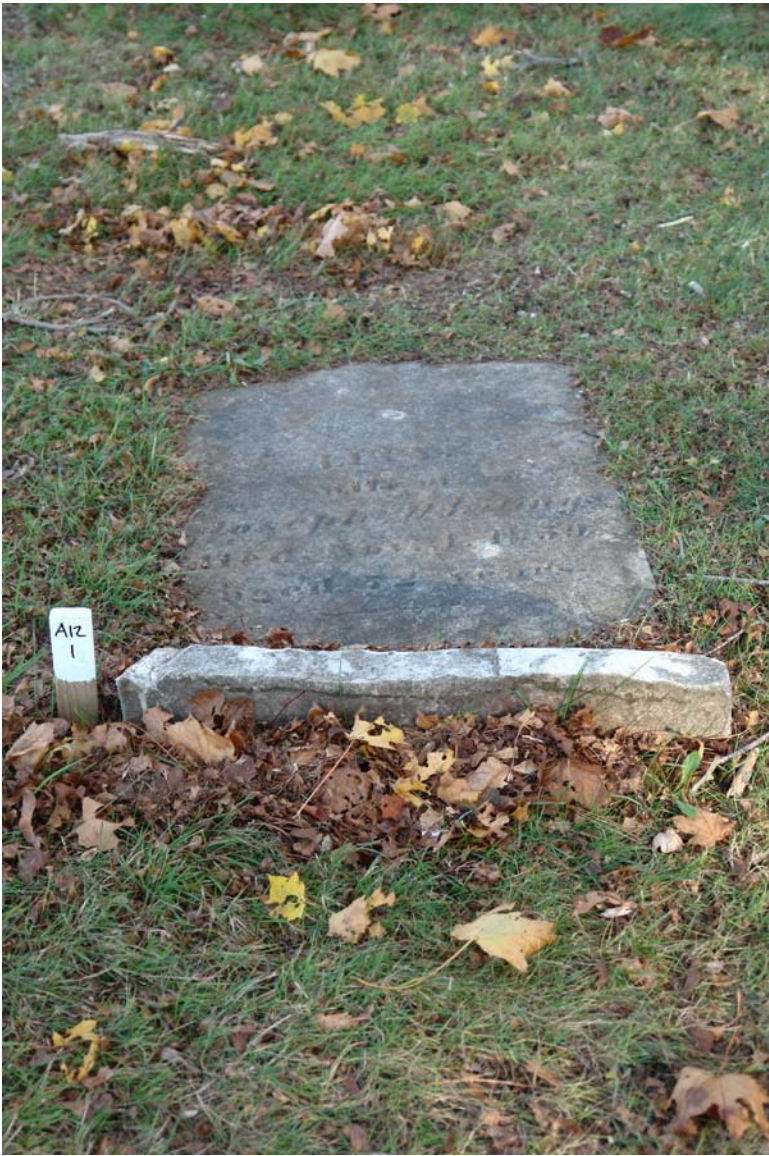
Union Assinippi Cemetery, Hanover, MA	
NAME ON MARKER	James Barrell
Death Date: 4/16/1827	Marker Type: Headstone
Cond. of Inscription: Decipherable	Material: Slate
EXISTING CONDITIONS	CONSERVATION STRATEGY
Tilted	Reset plumb
TREATMENT Treatment Dates 5/27/2015	
<div>1. Marker carefully excavated. The soil around tilted markers was removed to an appropriate depth. When required, the marker was removed from the ground. Marker appears to be sound.</div> <div>2. Soling removed by light brushing with nylon brushes and water.</div> <div>3. Setting area excavated to sufficient depth and stone re-set plumb at appropriate height and level onto gravel bed, aligned with adjacent markers</div> <div>4. Area backfilled around marker with tamped sand and gravel</div> <div>5. Disturbed areas re-graded with existing topsoil and sod.</div>

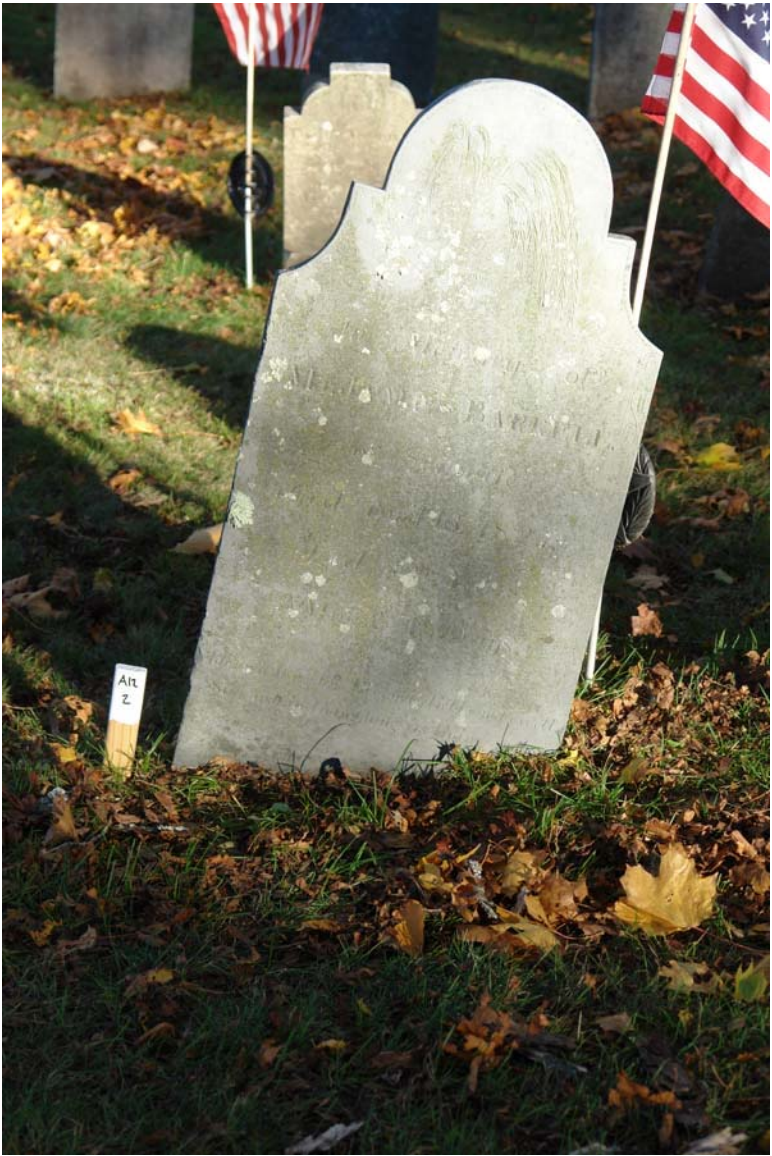
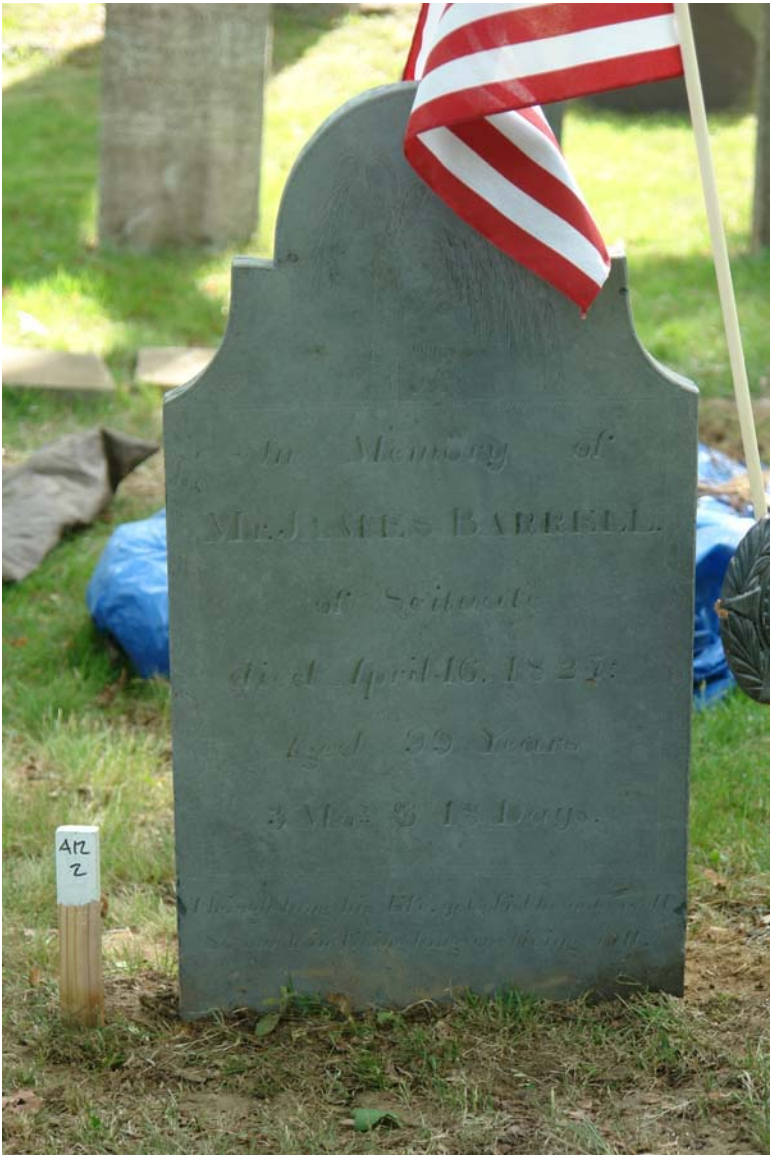
Height 30 Width 16 Thickness 1.5 Marker# **A.12.2**

Union Assinippi Cemetery, Hanover, MA	
NAME ON MARKER	Deborah Barrell
Death Date: 3/10/1813	Marker Type: Headstone
Cond. of Inscription: Legible	Material: Slate
EXISTING CONDITIONS	CONSERVATION STRATEGY
Tilted	Reset plumb
<div>TREATMENT</div> <div>Treatment Dates 5/27-6/10/2015</div> <div> <div>1. Marker excavated and found to be sound. A new, below base concrete base will be required for resetting.</div> <div>2. Setting area excavated for new below grade cast concrete base sized minimum of 12 inches deep, 12 inches greater in thickness and 6 inches wider than the stone.</div> <div>3. Wooden forms and setting slot form stabilized and aligned with adjacent markers before concrete is poured</div> <div>4. When required, the lower edge of marker is re-squared with minimal loss using a power grinder</div> <div>5. Setting forms are removed after partial curing of the concrete and the base backfilled with tamped sand or gravel</div> <div>6. Marker reset into setting slot with a cement/lime grout (3/2/9) with 000 sand made fluid with a super plasticizer.</div> <div>7. Marker set plumb and level, and braced for minimum of 5 days.</div> <div>8. Disturbed areas backfilled with existing topsoil.</div> </div>

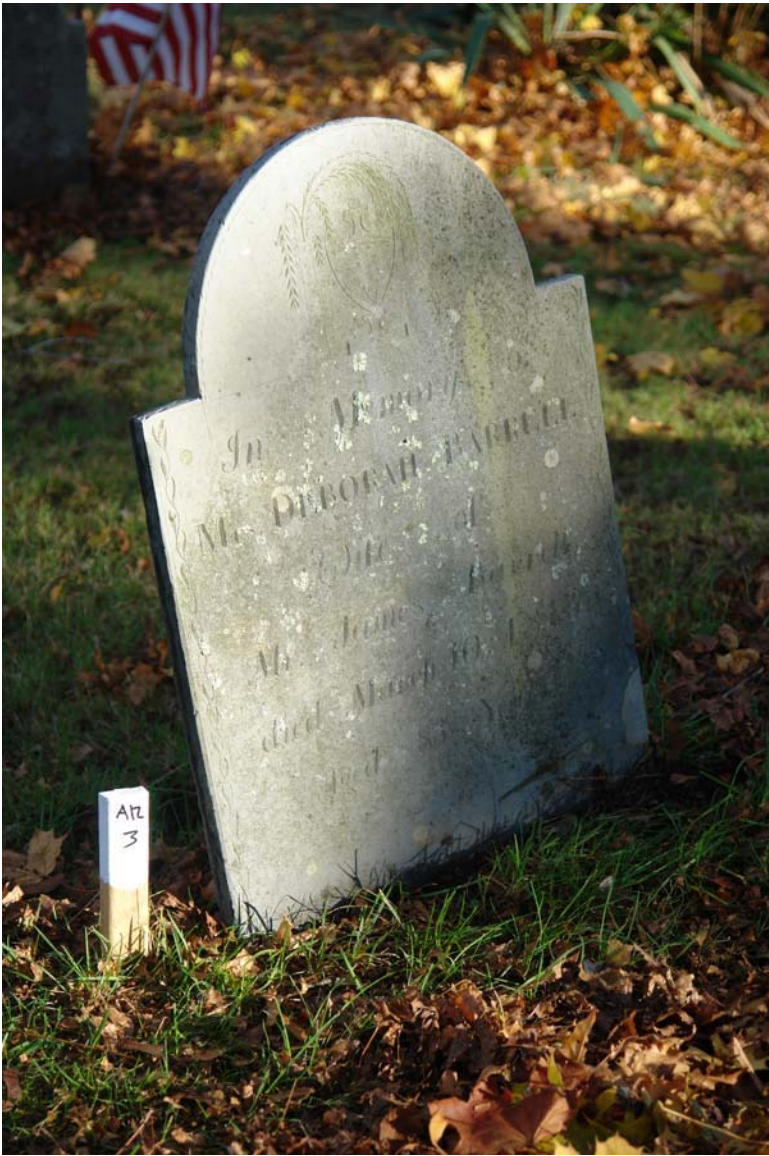
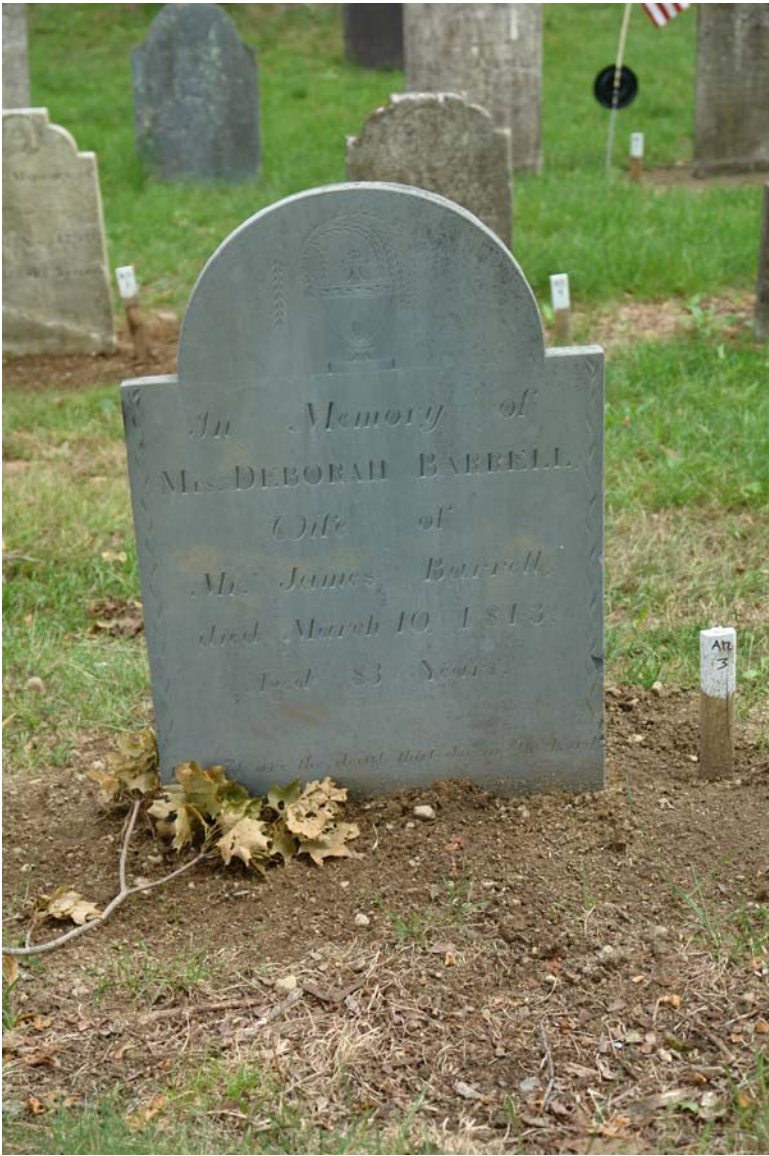
Height 23 Width 17 Thickness 1 Marker# A.12.3.

Union Assinippi Cemetery, Hanover, MA	
NAME ON MARKER	Barrell
Death Date: n.a.	Marker Type: Headstone
Cond. of Inscription: Partially legible	Material: Marble
EXISTING CONDITIONS	CONSERVATION STRATEGY
Fallen, overgrown	Evaluate Reset if possible
TREATMENT	Treatment Dates
Area probed unsuccessfully for additional fragments. Remaining fragment found to be sugary and not restorable

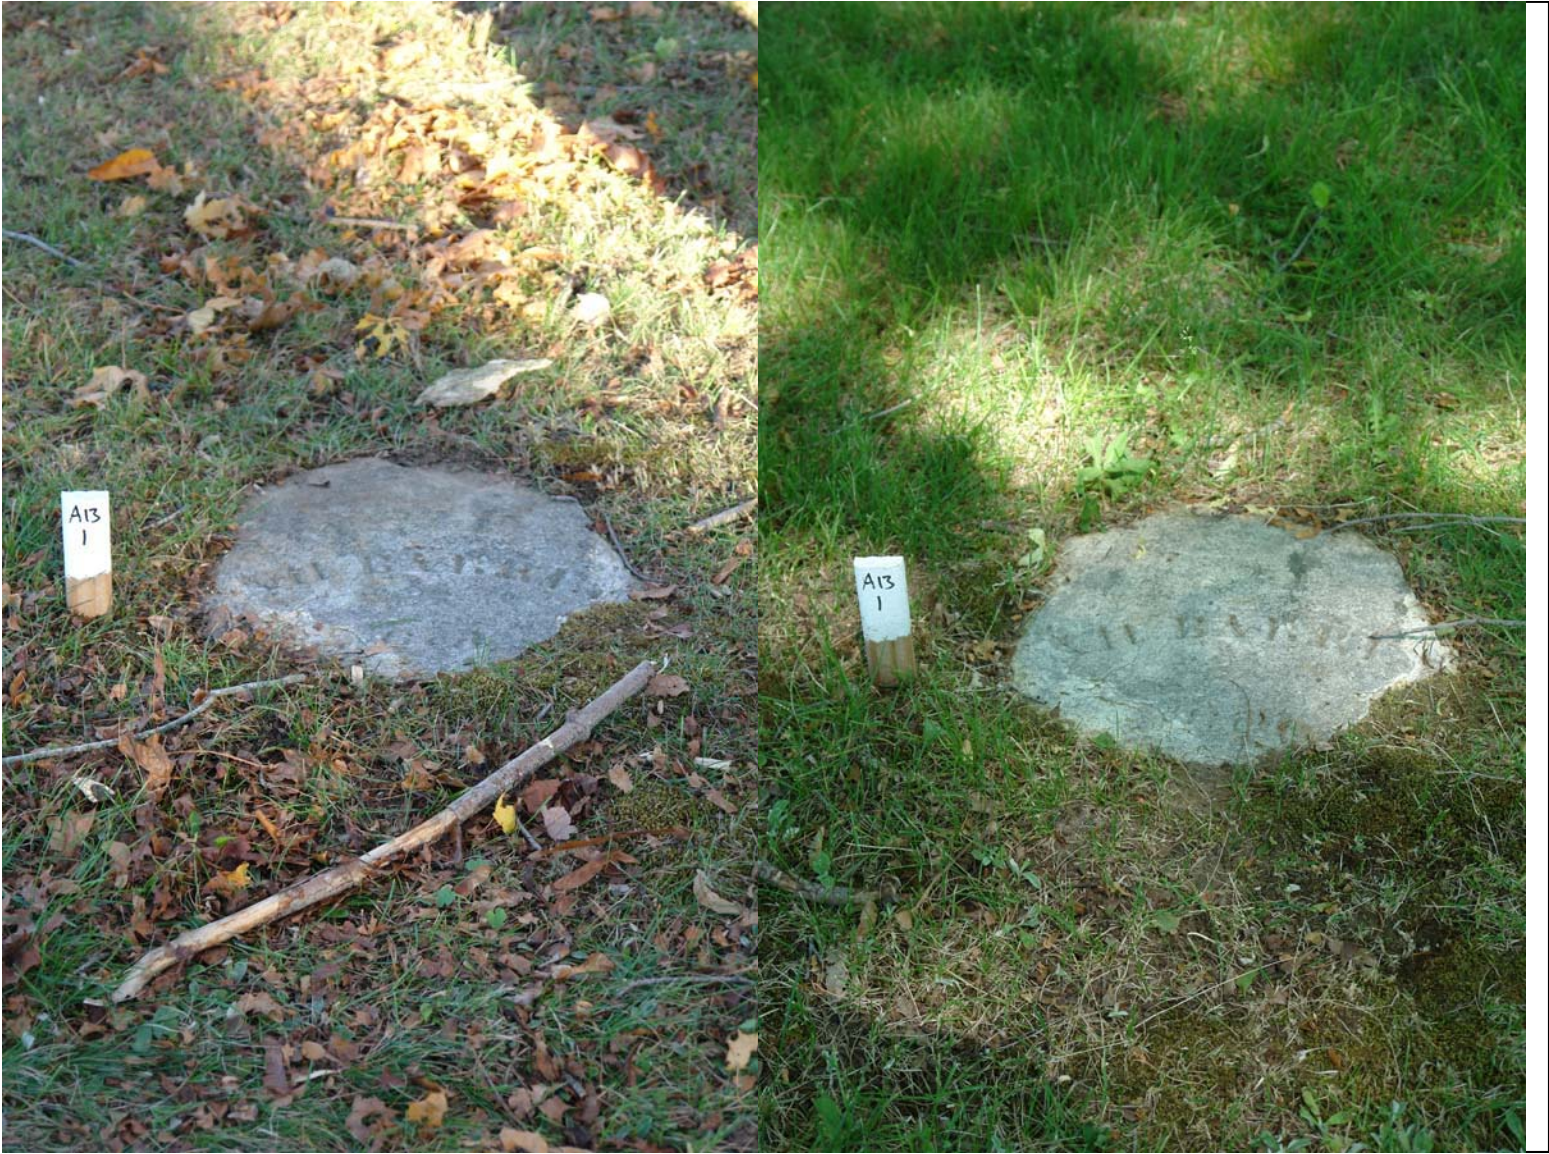
Union Assinippi Cemetery, Hanover, MA	
NAME ON MARKER	Noah Barrell
Death Date: 5/27/1839	Marker Type: Headstone
Cond. of Inscription: Partial/missing	Material: Marble
EXISTING CONDITIONS	CONSERVATION STRATEGY
Fallen, fractured	Evaluate Reset if possible
TREATMENT Treatment Dates	
Area probed unsuccessfully for additional fragments. Remaining fragment found to be sugary and not restorable

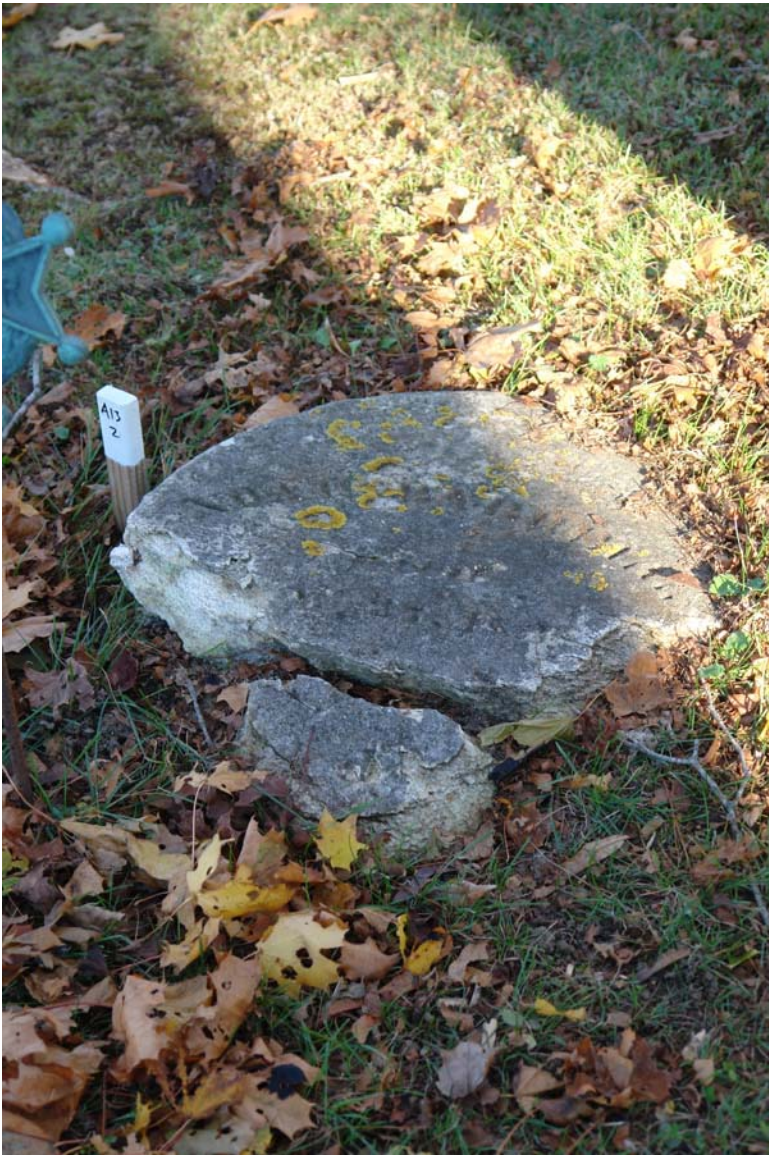
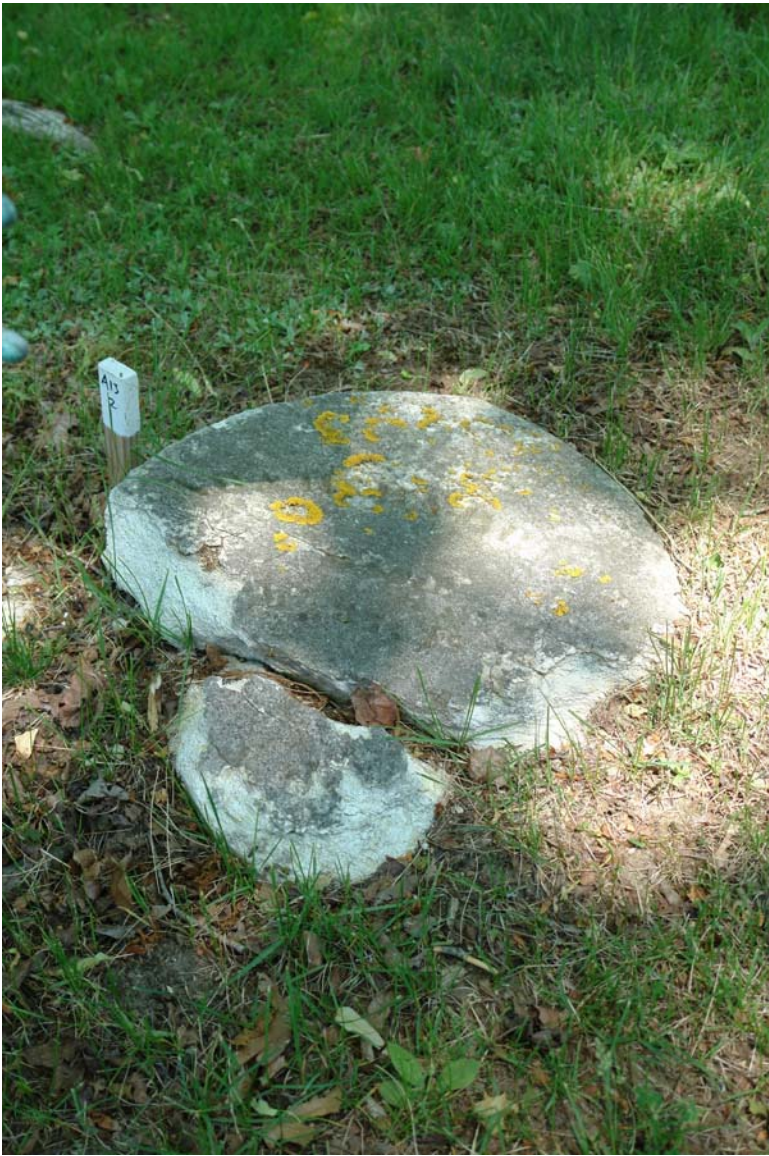
Height - Width - Thickness - Marker# **A.13.2**

Union Assinippi Cemetery, Hanover, MA	
NAME ON MARKER	James Barrell
Death Date: 11/1790	Marker Type: Headstone
Cond. of Inscription: Decipherable	Material: Marble
EXISTING CONDITIONS	CONSERVATION STRATEGY
Tilted	Reset Possible new base
TREATMENT Treatment Dates 5/28/2015	
<div>1. Area excavated to an appropriate depth. Base is aligned with adj. markers and reset level at appropriate height.</div> <div>2. Setting slot cleaned of debris or failed mortar and bottom fragment reset plumb and level into setting slot with a cement/lime grout (3/2/9) with 000 sand made fluid with a super plasticizer. Excess grout removed and joint area cleaned.</div> <div>3. Marker braced for a minimum 3 days</div> <div>4. All mating edges of fragments cleaned with water and any failed adhesives removed with hand tools</div> <div>5. Fragments attached with structural adhesive (Abatron 55-22), clamped and braced until cured. Excess epoxy removed with hand chisels within 24 hours.</div> <div>6. Cracks and losses filled with RepliCal Marble products, filled areas misted with water and covered for 3 days minimum</div> <div>7. Filled areas treated with light acid wash and rinsed thoroughly.</div> <div>8. All Surfaces treated with D/2 Biological Solution, scrubbed with nylon brushes and water. Rinsed fully with water</div>

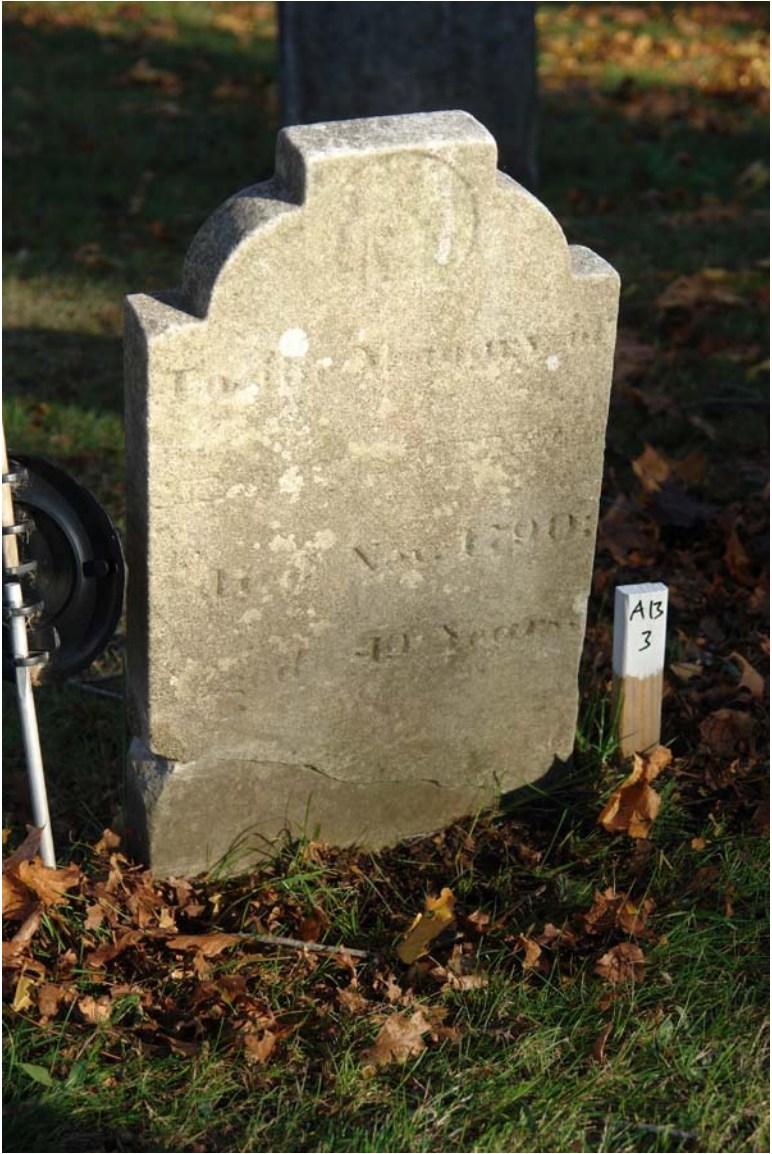
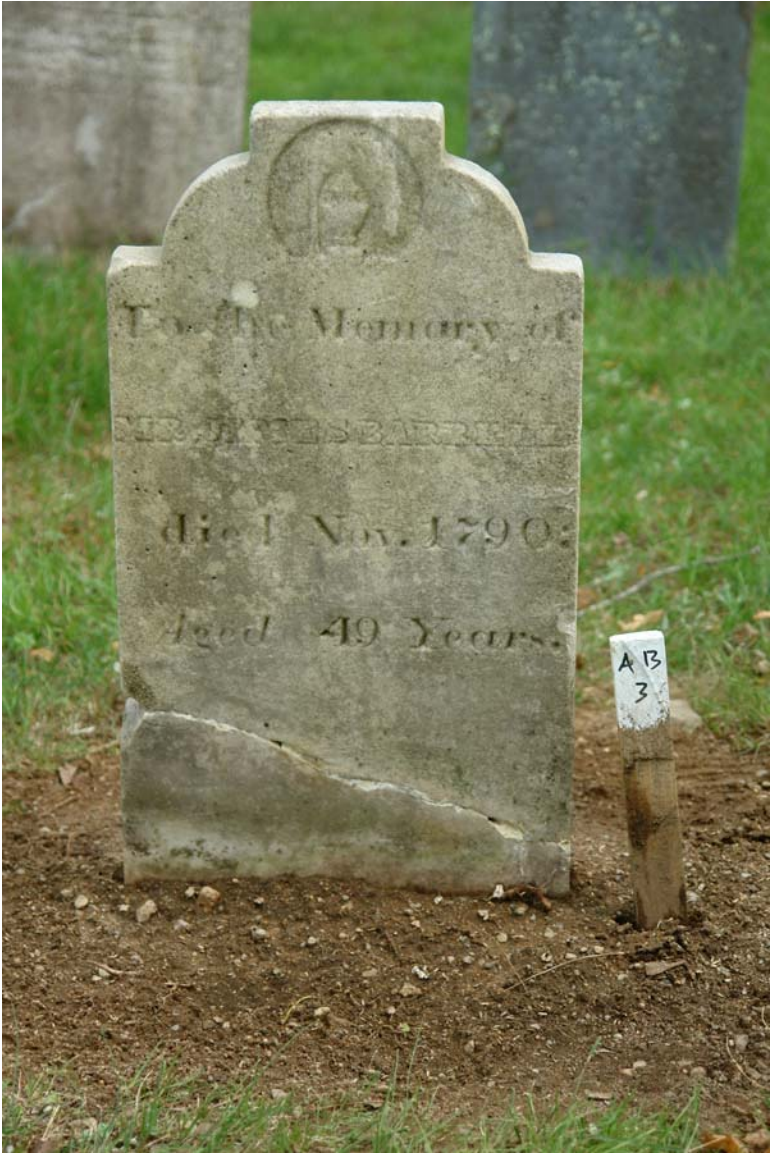
Height 20 Width 12 Thickness 2 Marker# **A.13.3**

EXISTING CONDITIONS	CONSERVATION STRATEGY
Tilted	Reset Possible new base

Treatment Dates 5/27/2015
 1. Existing base located below grade while excavating for resetting. Area excavated to an appropriate depth removing any roots or large stones.
 2. Base inspected and found to be sound and re-useable
 3. Base is aligned with adjacent markers and re-set level.
 4. Area around base was backfilled with tamped gravel and re-graded with existing topsoil
 5. Debris removed from setting slot. When required, power grinders were used to facilitate removal of stone fragments.
 6. When required, the lower setting edge was re-squared by power grinder with minimal loss.
 7. Marker reset plumb and level into setting slot with cement/lime grout (3/2/9) with 000 sand made fluid with a super plasticizer.
 8. Excess grout removed and joint area cleaned.
 9. Marker braced for a minimum 3 days
