DOCUMENTATION OF STONE CONSERVATION TREATMENTS TO ASSINIPPI CEMETERY, HANOVER, MA June 2015

**MONUMENT CONSERVATION COLLABORATIVE LLC, NORFOLK, CT**

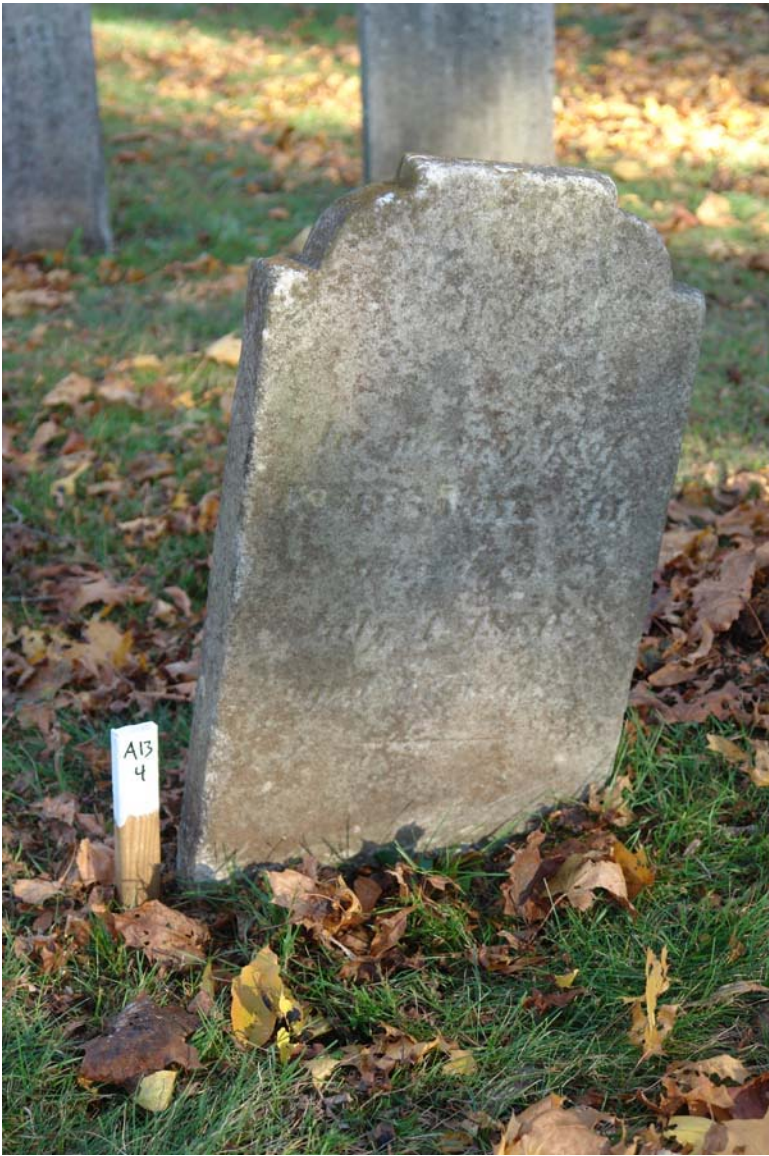
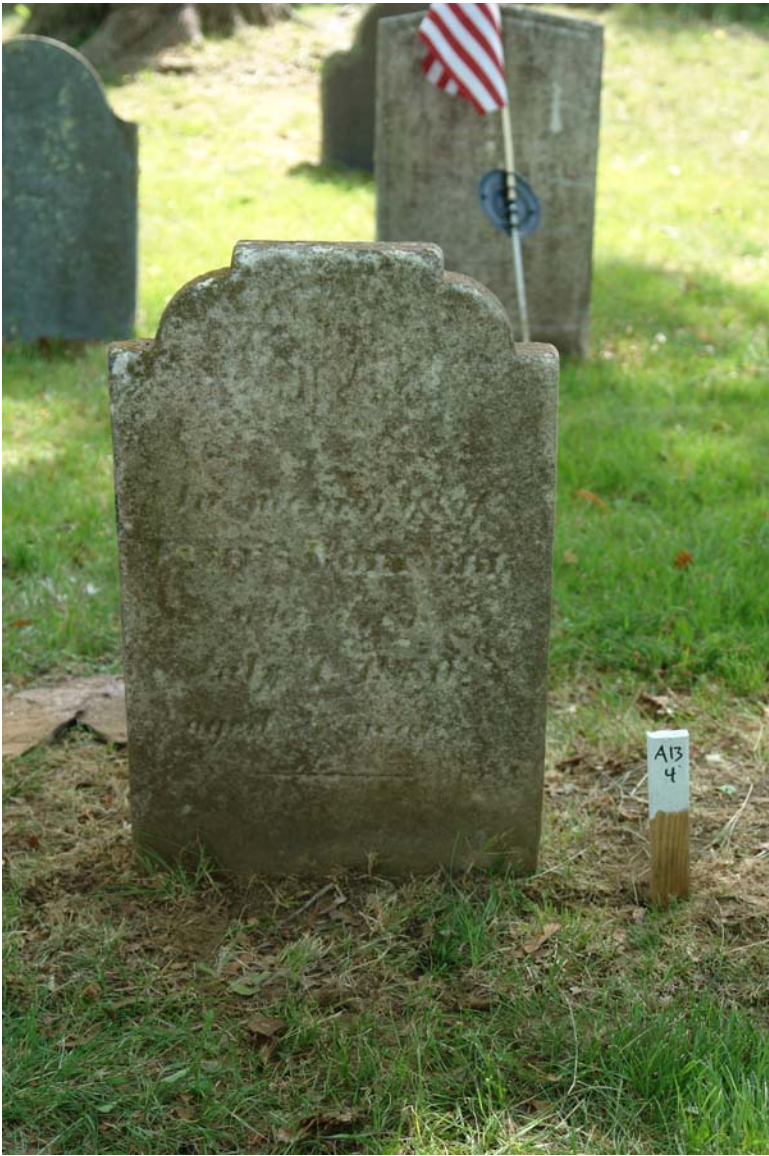
EXISTING CONDITIONS	CONSERVATION STRATEGY
Tilted base	Reset base with marker plumb

2. Base inspected and found to be sound and re-useable

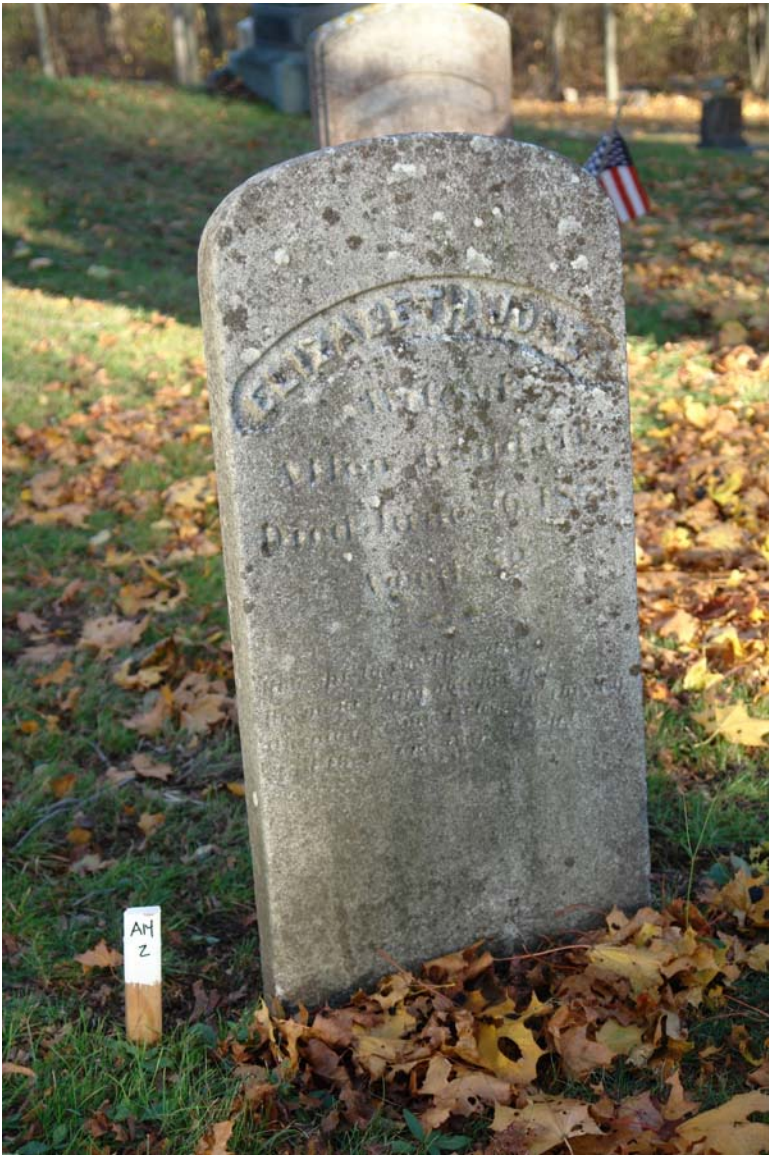
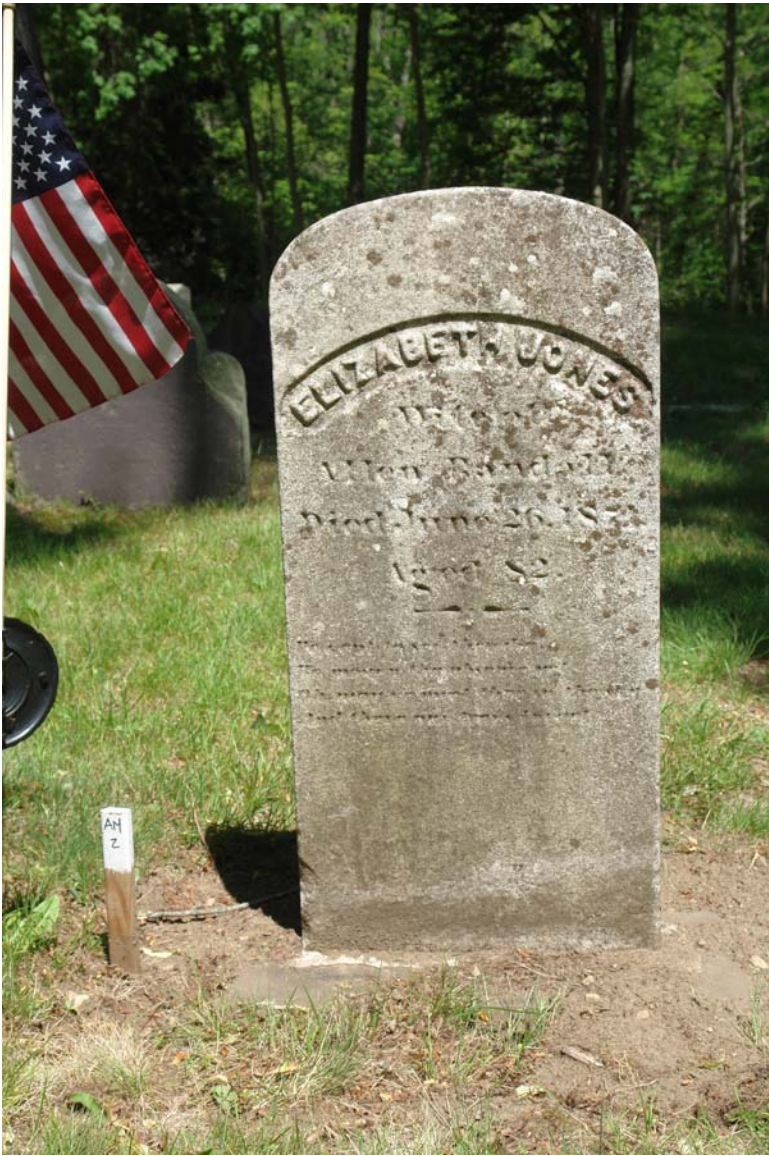
Union Assinippi Cemetery, Hanover, MA	
NAME ON MARKER	Infant Prouty
Death Date: 4/4/1799	Marker Type: Headstone
Cond. of Inscription: Decipherable	Material: Slate
EXISTING CONDITIONS	CONSERVATION STRATEGY
Tilted Delaminating	Reset plumb Cap delaminations
<div> <div>TREATMENT</div> <div>Treatment Dates 6/10/2015</div> <div> <div>1. Marker carefully excavated. The soil around tilted markers was removed to an appropriate depth. When required, the marker was removed from the ground. Marker appears to be sound. No filling to delaminated areas necessary.</div> <div>2. Soling removed by light brushing with nylon brushes and water.</div> <div>3. Setting area excavated to sufficient depth and stone re-set plumb at appropriate height and level onto gravel bed, aligned with adjacent markers</div> <div>4. Area backfilled around marker with tamped sand and gravel</div> <div>5. Disturbed areas re-graded with existing topsoil and sod.</div> </div> </div>

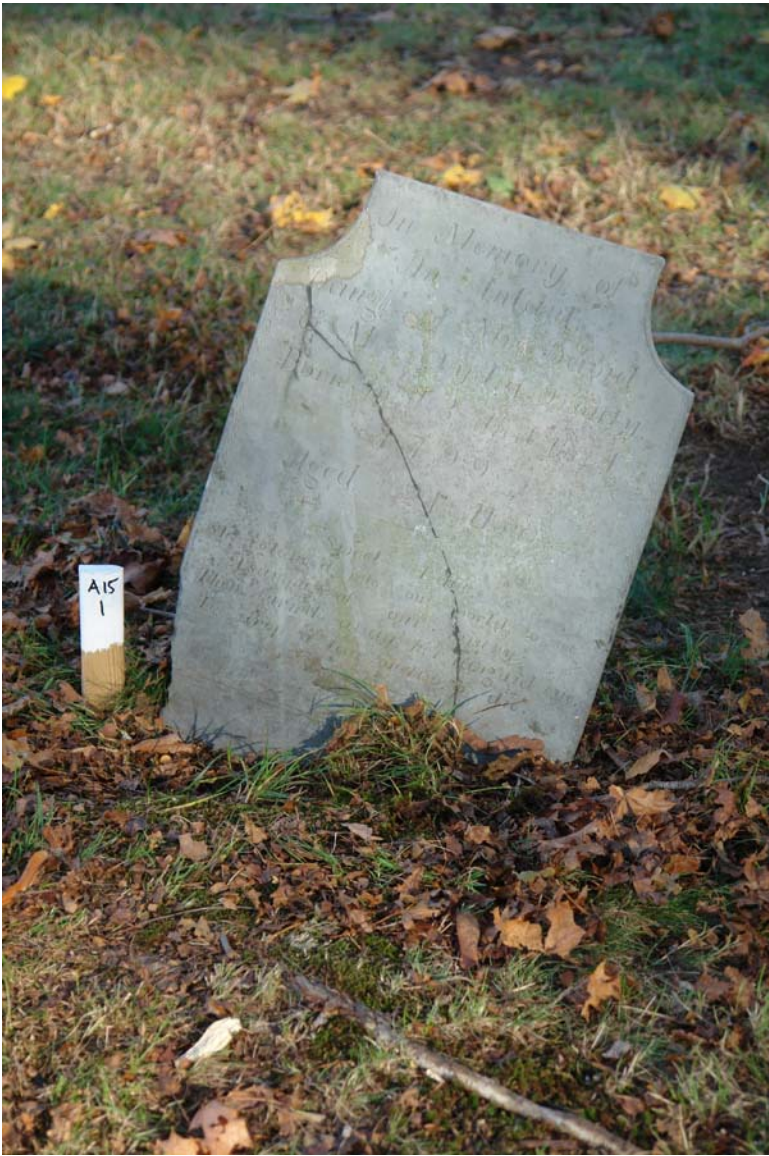
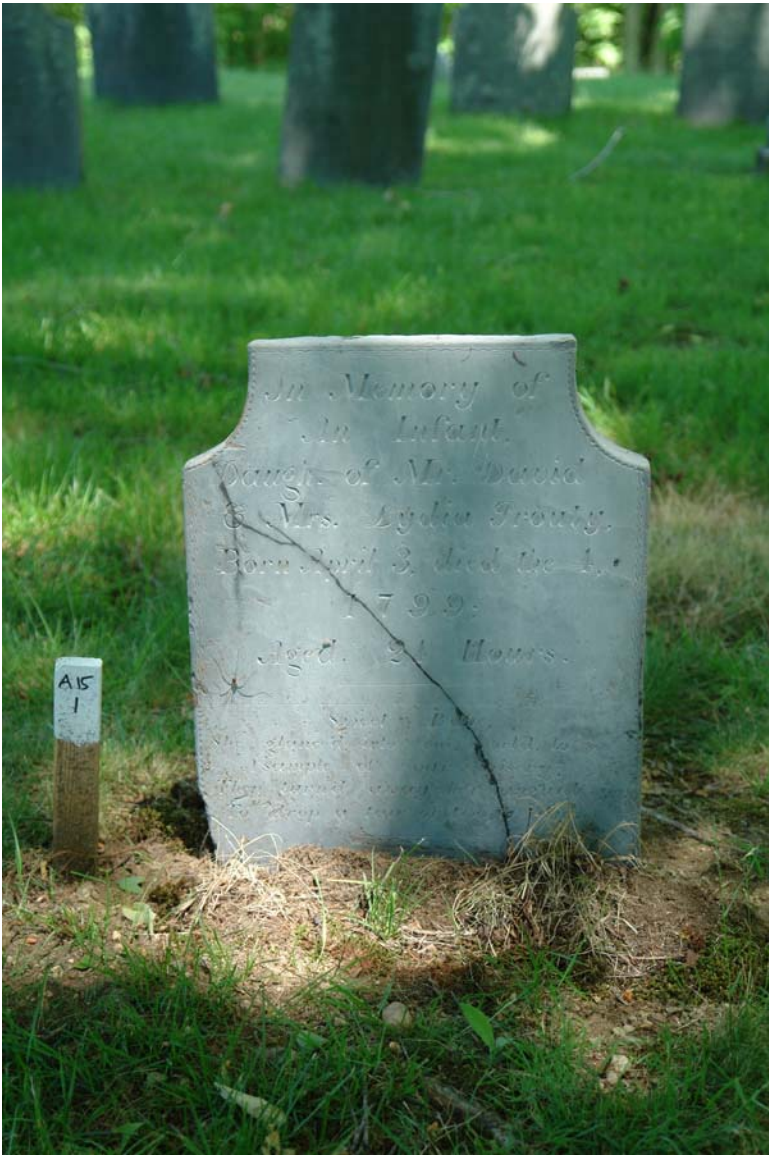
Height 18 Width 13 Thickness 1.5 Marker# A.15.1

EXISTING CONDITIONS	CONSERVATION STRATEGY
Tilted Delaminating	Reset plumb Cap delaminations

6. After full drying, all voids caused by splitting or delaminations at top edge of marker filled with a pigmented Sto Crack Filler using injection syringes and/or trowels. Voids along sides of monument typically left open to allow escape of any water which may enter.

7. Excess crack filler immediately removed with repeated damp sponging.

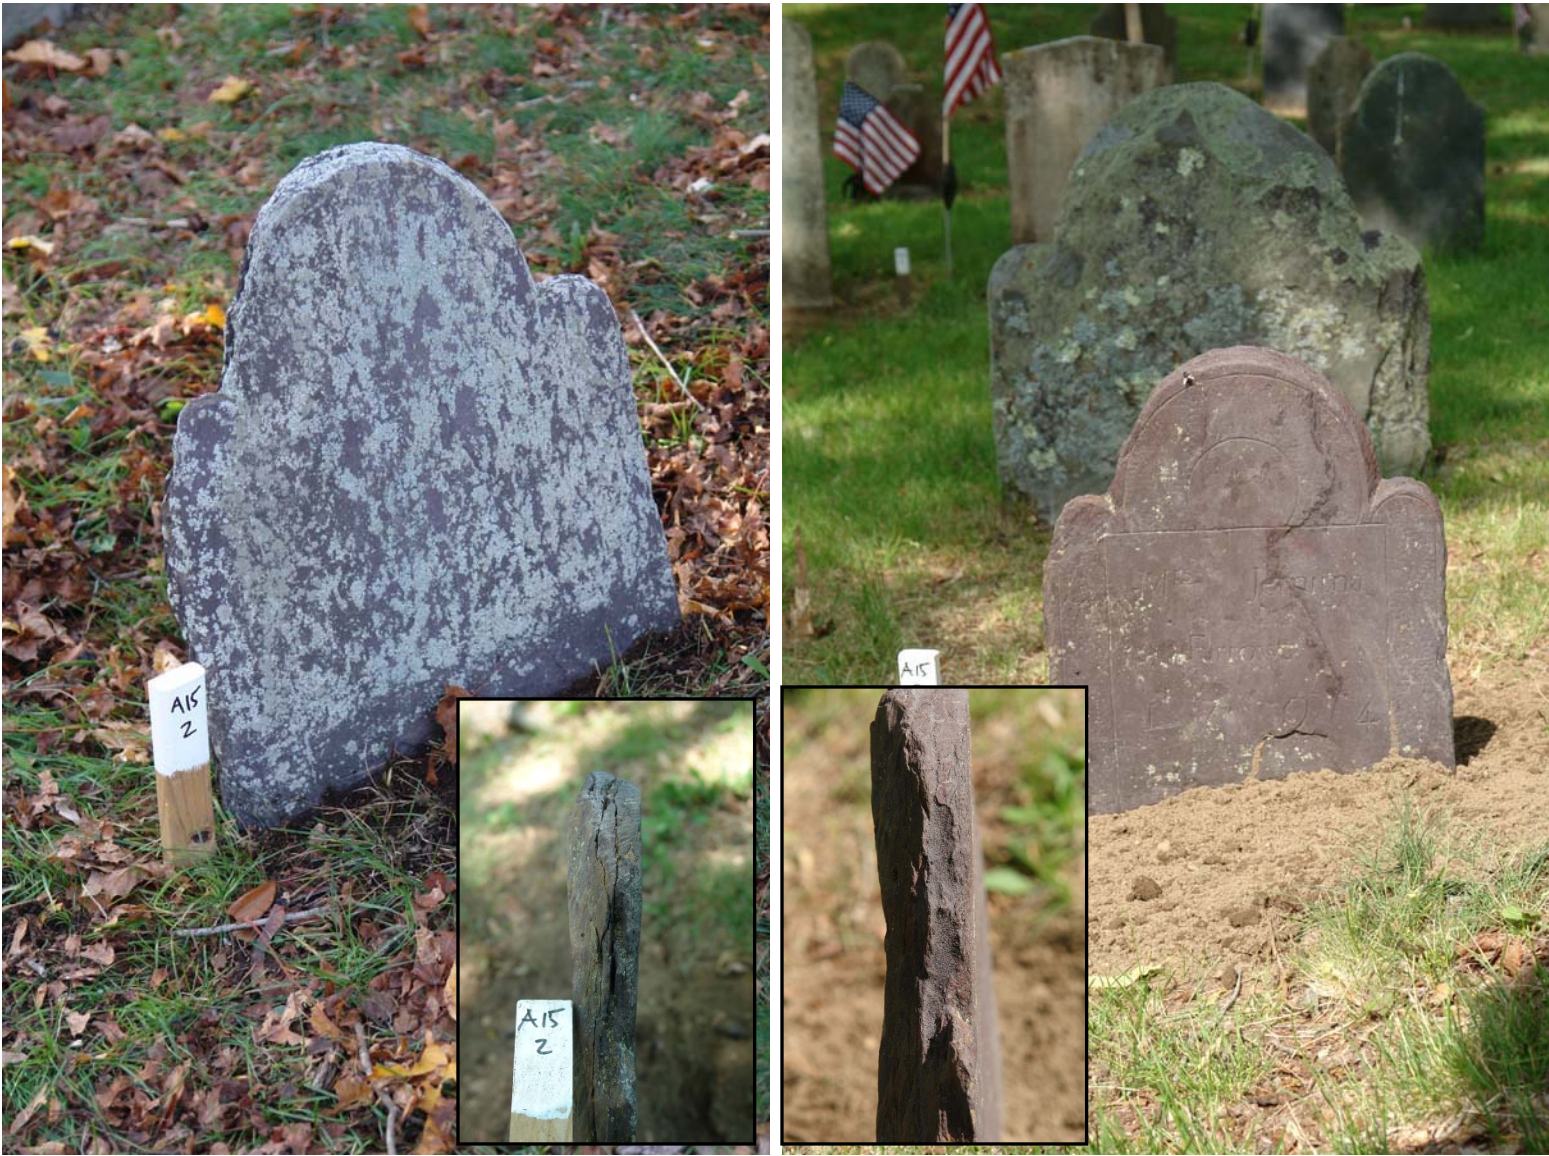
Union Assinippi Cemetery, Hanover, MA	
NAME ON MARKER	Judith Damon
Death Date: 6/24/1867	Marker Type: Headstone/base
Cond. of Inscription: Decipherable	Material: Marble
EXISTING CONDITIONS	CONSERVATION STRATEGY
Tilted base Tree roots	Reset base with marker plumb
<div>TREATMENT</div> <div>Treatment Dates 6/10/2015</div> <div> <ol style="list-style-type: none"> Existing base located below grade when excavating. Base inspected and found to be sound and re-useable Area excavated to an appropriate depth removing any roots or large stones and base aligned with adjacent markers re-set level. Area around base was backfilled with tamped gravel and re-graded with existing topsoil Debris removed from setting slot. When required, power grinders were used to facilitate removal of stone fragments. When required, the lower setting edge was re-squared by power grinder with minimal loss. Marker reset plumb and level into setting slot with cement/lime grout (3/2/9) with 000 sand made fluid with a super plasticizer. Excess grout removed and joint area cleaned. Marker braced for a minimum 3 days </div>

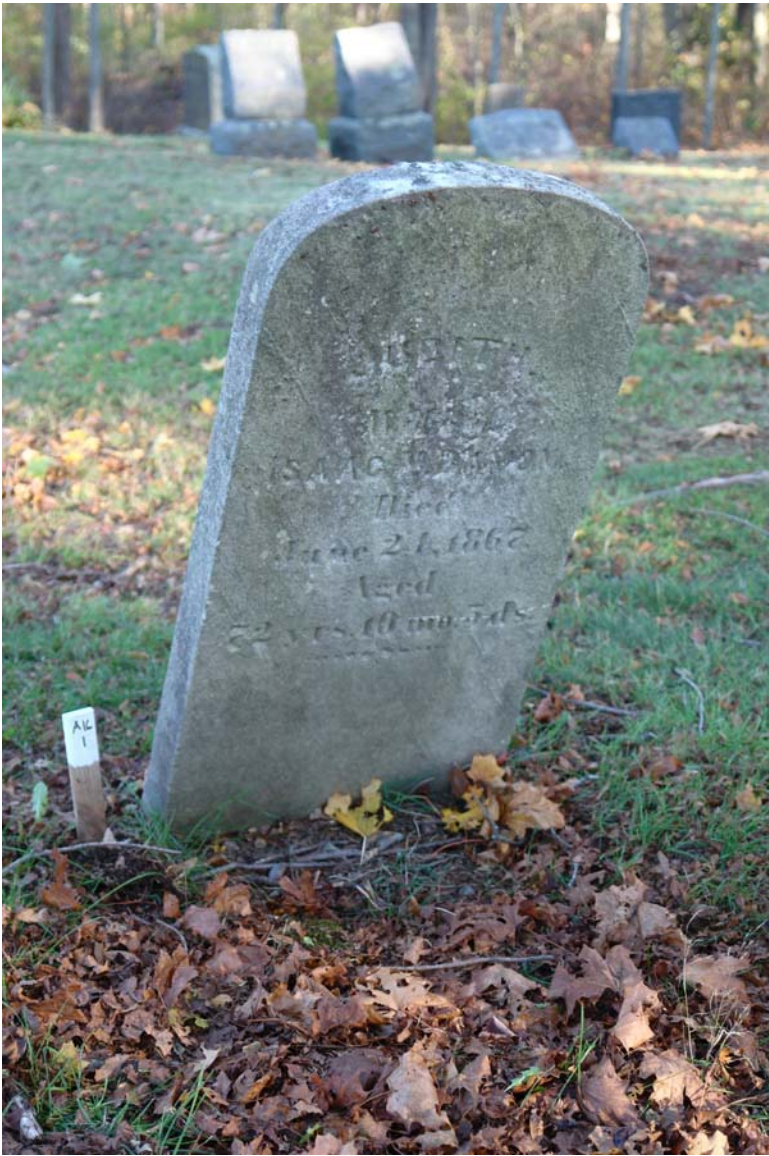
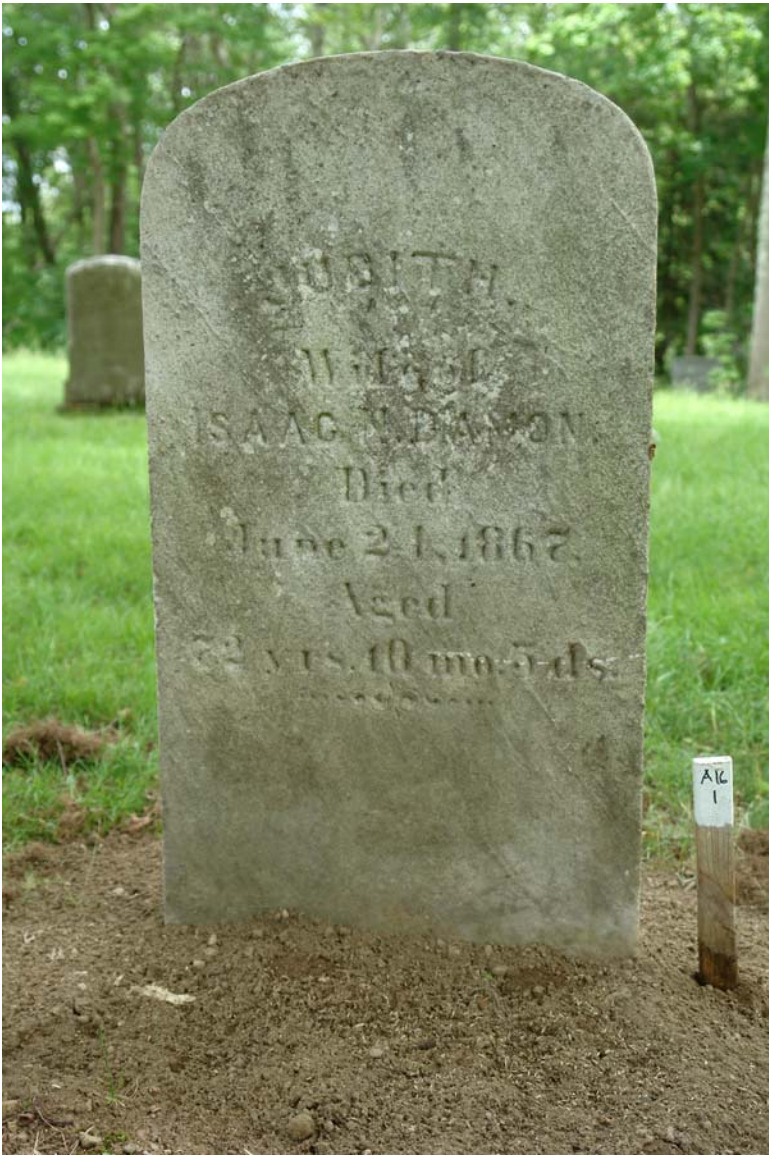
Height 32 Width 18 Thickness 2.5 Marker# A.16.1

Union Assinippi Cemetery, Hanover, MA					
NAME ON MARKER	Heman Stoddard				
Death Date: 3/29/1864	Marker Type: Headstone				
Cond. of Inscription: Legible	Material: Marble				
EXISTING CONDITIONS	CONSERVATION STRATEGY				
Fractured at grade Losses	Reset into new below grade base Patch losses				
<table><tr><td>TREATMENT</td><td>Treatment Dates</td></tr><tr><td colspan="2"><div>1. Existing base located below grade when excavating.</div><div>2. Base inspected and found to be sound and re-useable</div><div>3. Area excavated to an appropriate depth removing any roots or large stones and base aligned with adjacent markers re-set level.</div><div>4. Area around base was backfilled with tamped gravel and re-graded with existing topsoil</div><div>5. Debris removed from setting slot. When required, power grinders were used to facilitate removal of stone fragments.</div><div>6. When required, the lower setting edge was re-squared by power grinder with minimal loss.</div><div>7. Marker reset plumb and level into setting slot with cement/lime grout (3/2/9) with 000 sand made fluid with a super plasticizer.</div><div>8. Excess grout removed and joint area cleaned.</div><div>9. Marker braced for a minimum 3 days</div></td></tr></table>		TREATMENT	Treatment Dates	<div>1. Existing base located below grade when excavating.</div> <div>2. Base inspected and found to be sound and re-useable</div> <div>3. Area excavated to an appropriate depth removing any roots or large stones and base aligned with adjacent markers re-set level.</div> <div>4. Area around base was backfilled with tamped gravel and re-graded with existing topsoil</div> <div>5. Debris removed from setting slot. When required, power grinders were used to facilitate removal of stone fragments.</div> <div>6. When required, the lower setting edge was re-squared by power grinder with minimal loss.</div> <div>7. Marker reset plumb and level into setting slot with cement/lime grout (3/2/9) with 000 sand made fluid with a super plasticizer.</div> <div>8. Excess grout removed and joint area cleaned.</div> <div>9. Marker braced for a minimum 3 days</div>	
TREATMENT	Treatment Dates				
<div>1. Existing base located below grade when excavating.</div> <div>2. Base inspected and found to be sound and re-useable</div> <div>3. Area excavated to an appropriate depth removing any roots or large stones and base aligned with adjacent markers re-set level.</div> <div>4. Area around base was backfilled with tamped gravel and re-graded with existing topsoil</div> <div>5. Debris removed from setting slot. When required, power grinders were used to facilitate removal of stone fragments.</div> <div>6. When required, the lower setting edge was re-squared by power grinder with minimal loss.</div> <div>7. Marker reset plumb and level into setting slot with cement/lime grout (3/2/9) with 000 sand made fluid with a super plasticizer.</div> <div>8. Excess grout removed and joint area cleaned.</div> <div>9. Marker braced for a minimum 3 days</div>

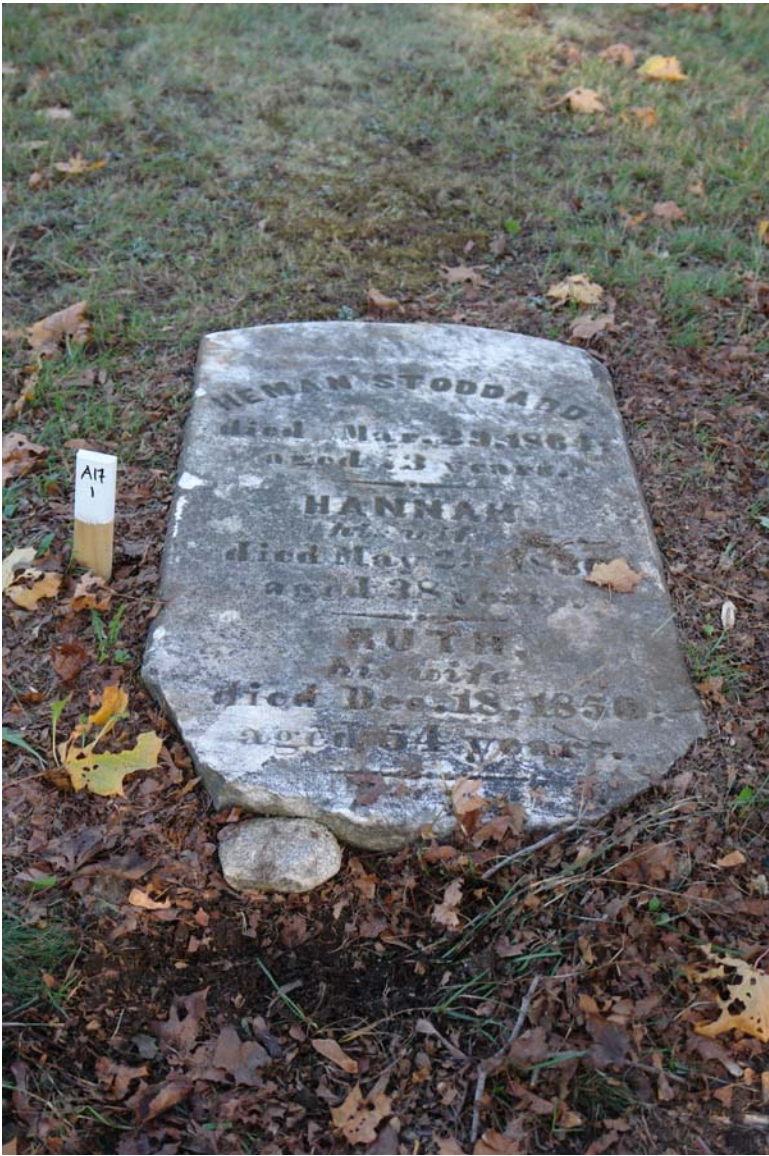
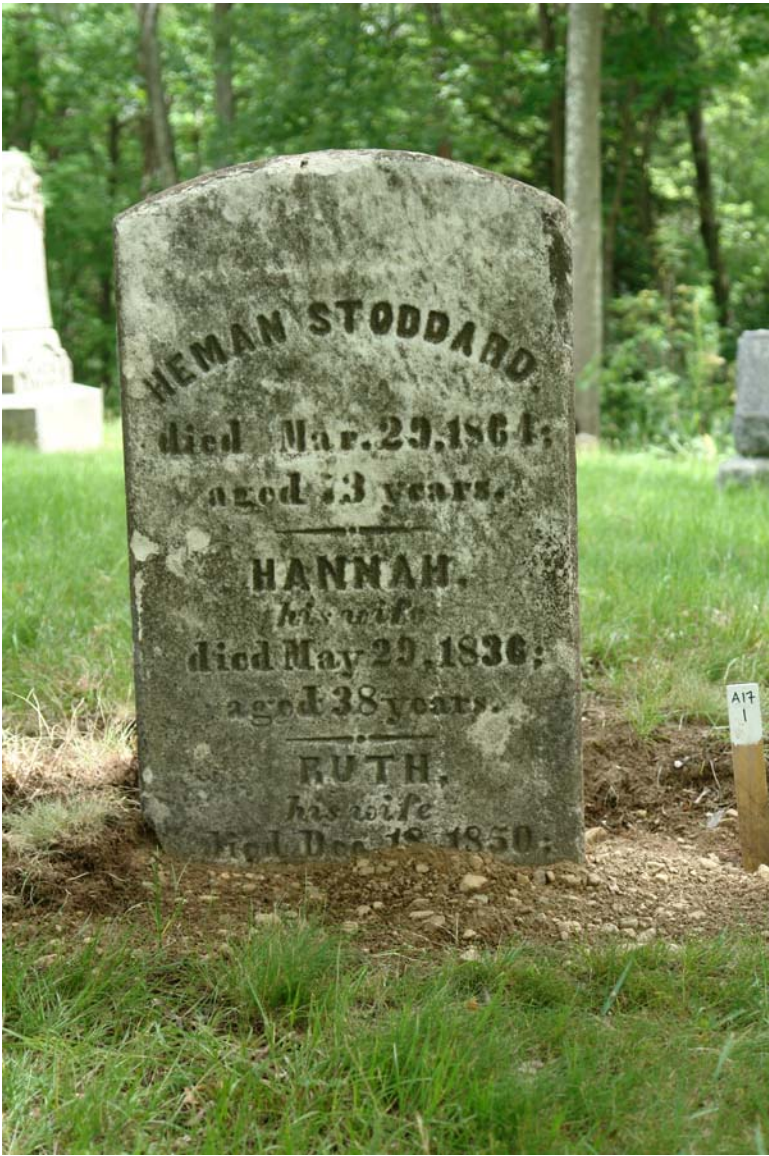
Union Assinippi Cemetery, Hanover, MA	
NAME ON MARKER	Harriet Wilder
Death Date: 3/27	Marker Type: Headstone
Cond. of Inscription: Decipherable	Material: Marble
EXISTING CONDITIONS	CONSERVATION STRATEGY
Tilted	Reset plumb
TREATMENT Treatment Dates 5/28/2015	
1. Marker carefully excavated. The soil around tilted markers was removed to an appropriate depth. When required, the marker was removed from the ground. Marker appears to be sound.	
2. Soling removed by light brushing with nylon brushes and water.	
3. Setting area excavated to sufficient depth and stone re-set plumb at appropriate height and level onto gravel bed, aligned with adjacent markers	
4. Area backfilled around marker with tamped sand and gravel	
5. Disturbed areas re-graded with existing topsoil and sod.

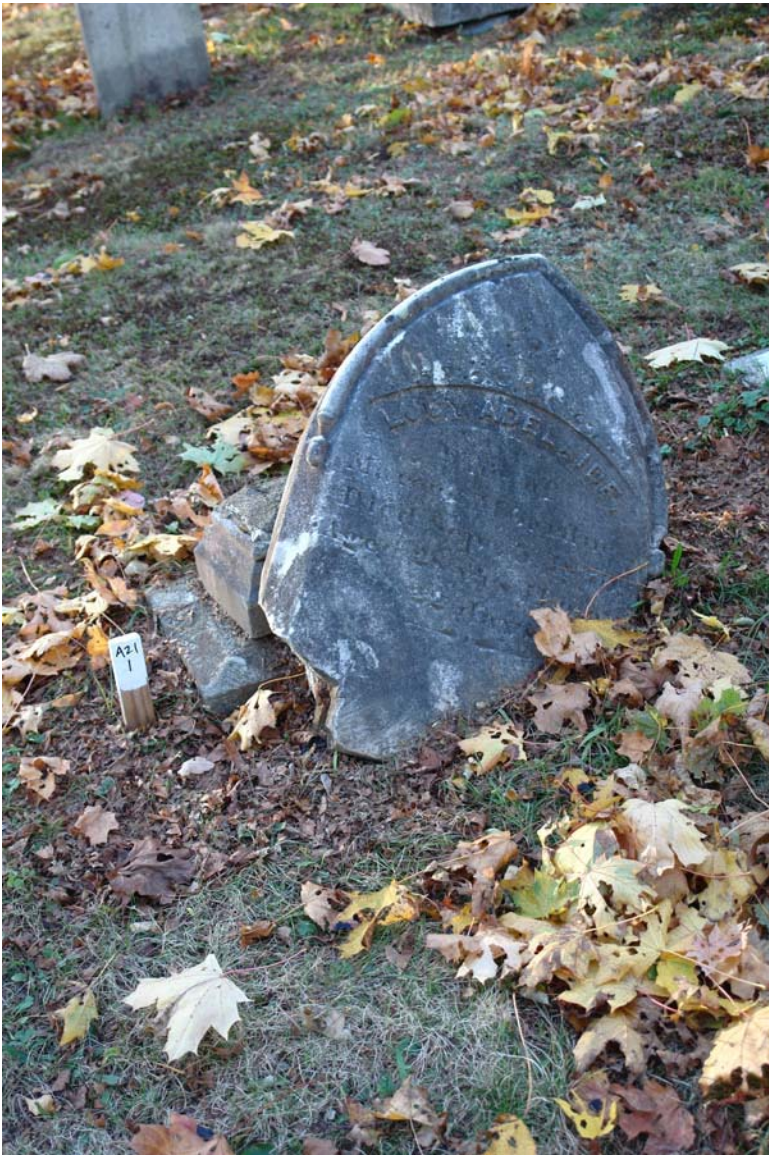
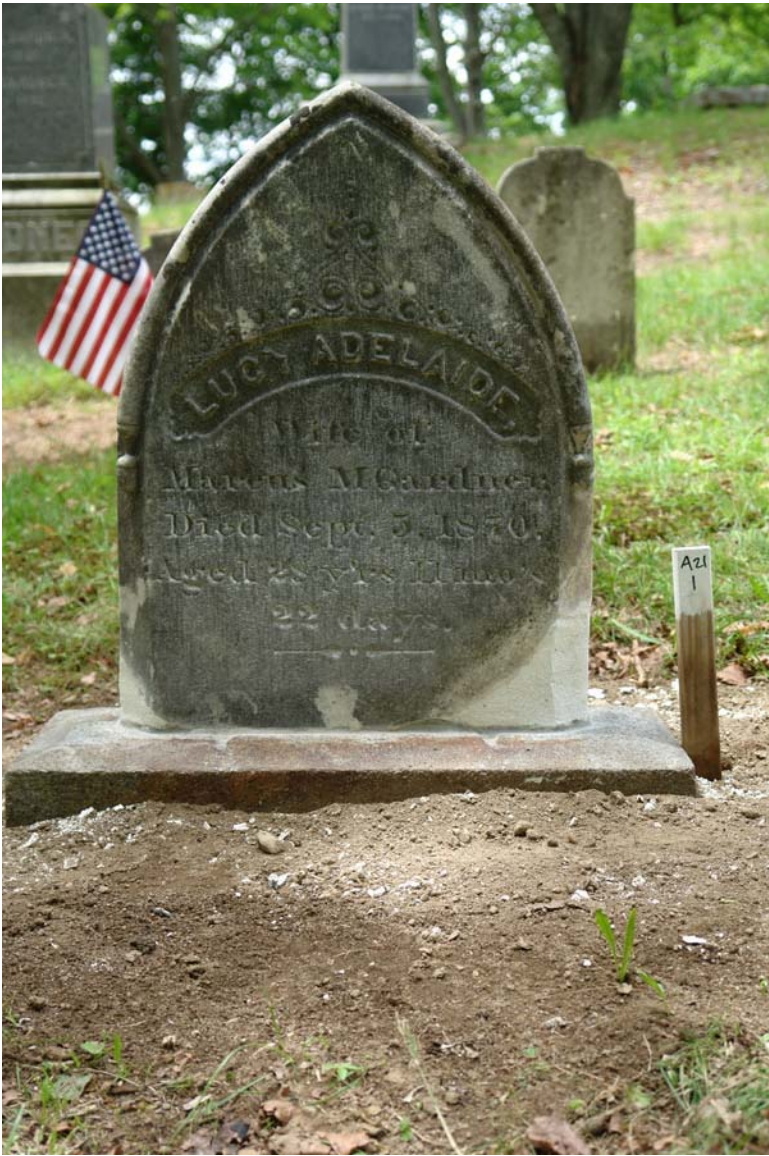
Height 27 Width 18 Thickness 4 Marker# A.21.1

EXISTING CONDITIONS	CONSERVATION STRATEGY
Overgrown with vegetation	Remove vegetation

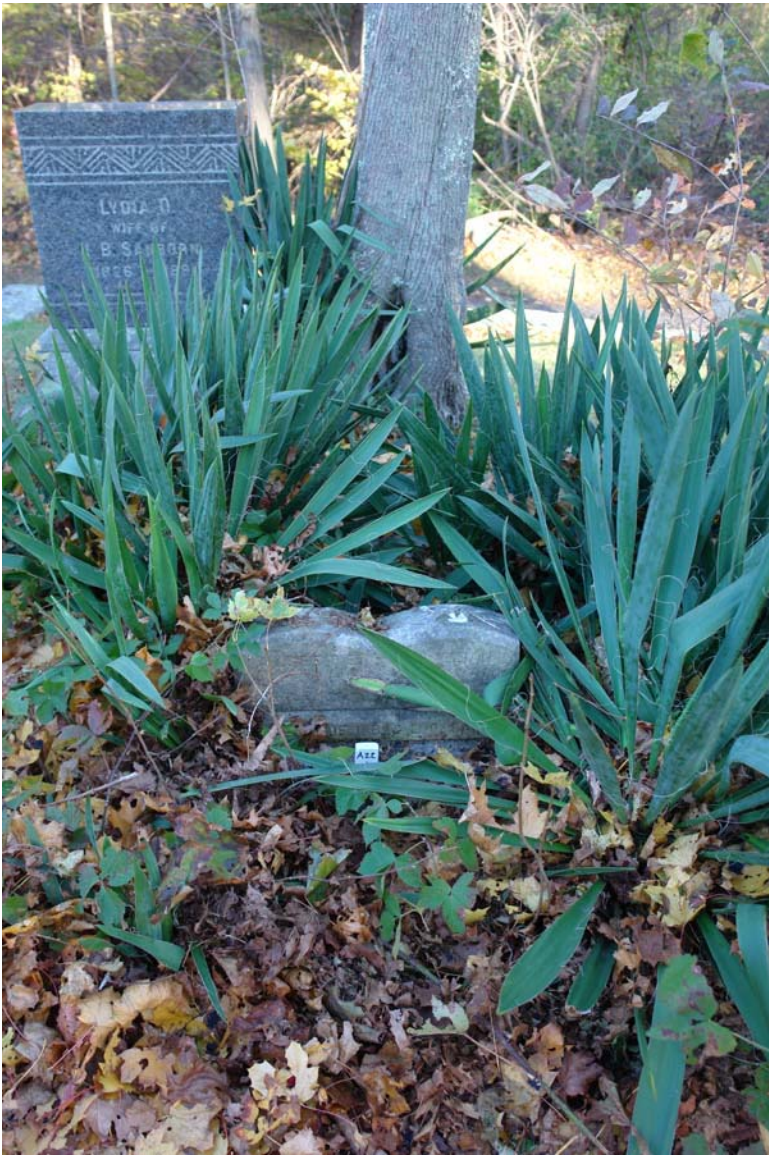
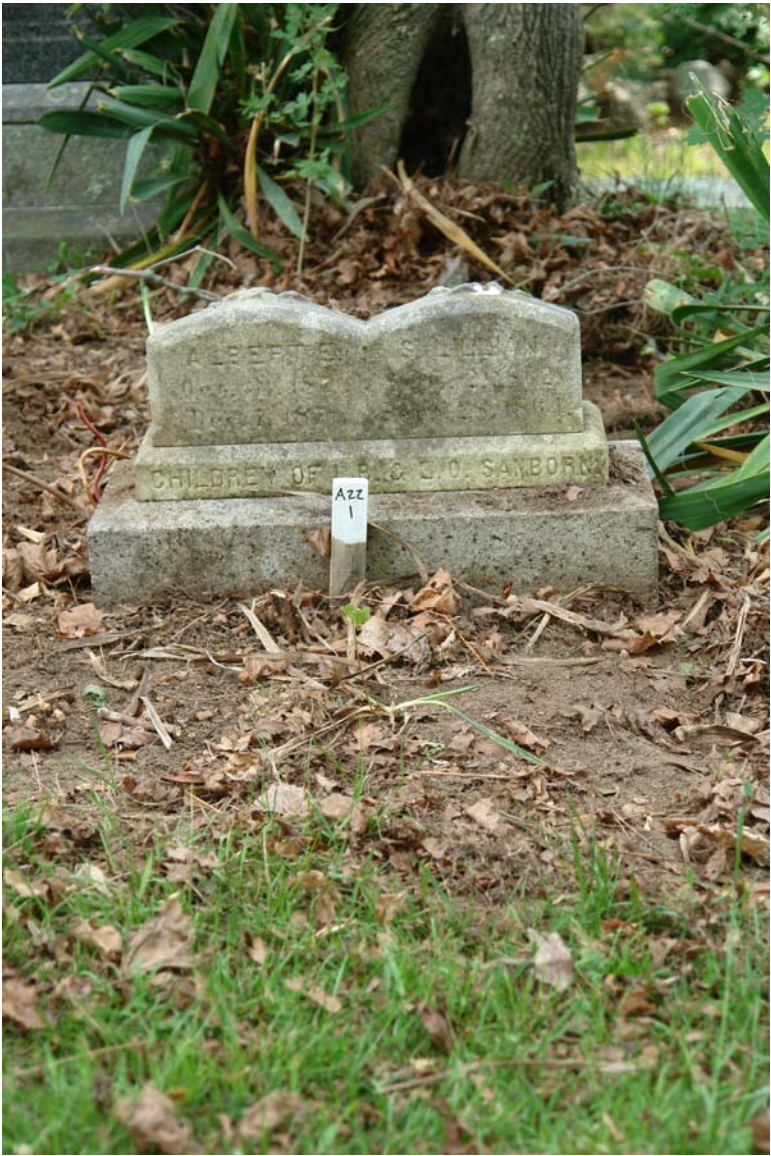
Height - Width - Thickness - Marker# **A22.1**

Union Assinippi Cemetery, Hanover, MA NAME ON MARKER Paul Curtis Death Date: 7/21/1867 Marker Type: Marker on base Cond. of Inscription: n.a. Material: Marble	
EXISTING CONDITIONS Marker off base	CONSERVATION STRATEGY Check base for level Reset marker
TREATMENT Treatment Dates 5/19-20/2015 1. Area excavated to an appropriate depth removing any roots or large stones. 2. Setting post inspected and found to be sound and re-useable 3. Posts were aligned and re-set level. 4. Area around post was backfilled with tamped gravel and re-graded with existing topsoil 5. Failed mortar removed from setting area and bottom of marker using hand tools. 6. Setting surfaces primed with Acryl 60 diluted 1:3 with water. 7. Marker reset plumb onto post with cement/lime mortar (3/2/9) with 000 sand. 8. Excess grout removed and joint area cleaned.

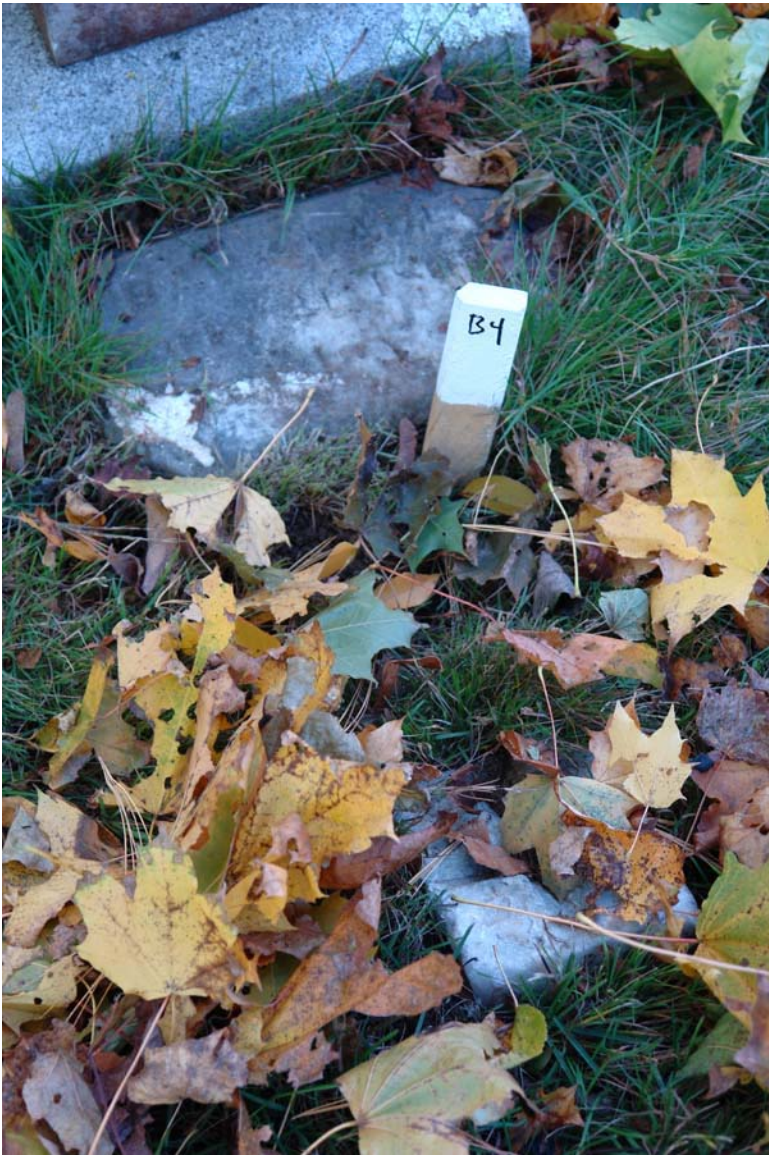
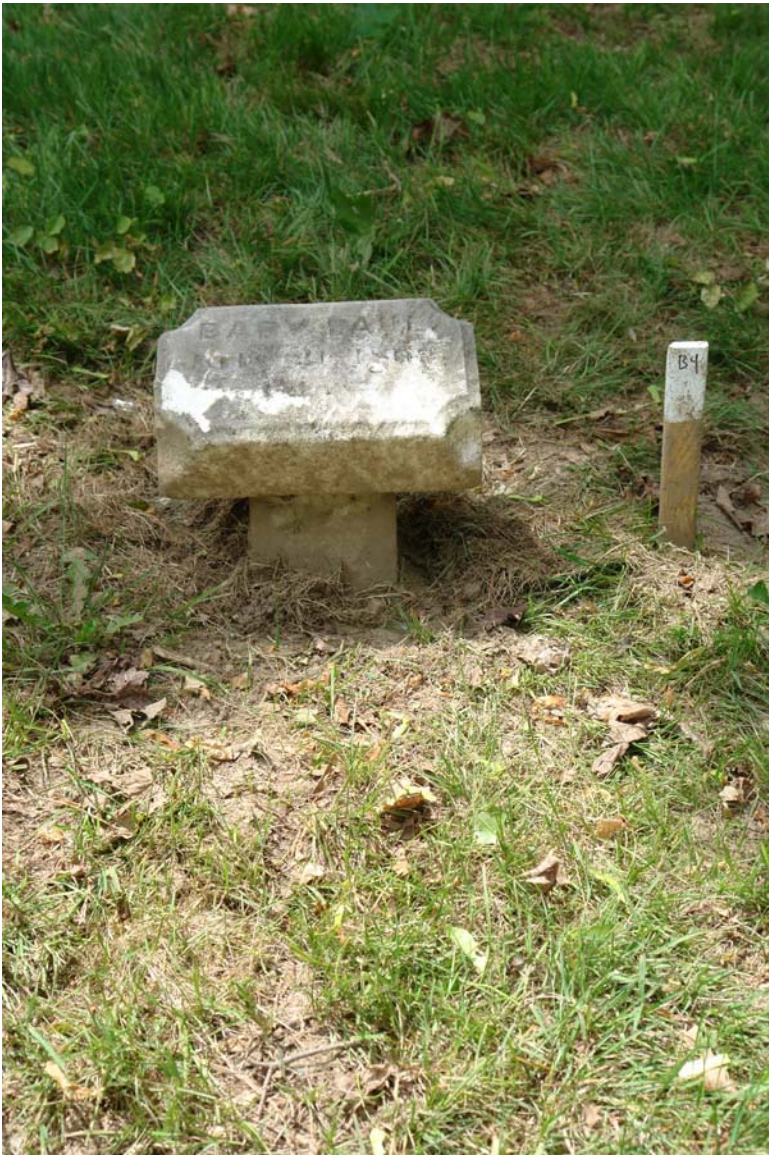
Height - Width - Thickness - Marker# **B.4.1**

Union Assinippi Cemetery, Hanover, MA	
NAME ON MARKER	Lydia Morse
Death Date: 4/22/1880	Marker Type: Small marker
Cond. of Inscription: Decipherable	Material: Marble
EXISTING CONDITIONS	CONSERVATION STRATEGY
Loose on post	Inspect base unit Reset marker to post
<div> <div>TREATMENT</div> <div>Treatment Dates 5/19-26/2015</div> <div> <div>1. Area excavated to an appropriate depth removing any roots or large stones.</div> <div>2. Setting post inspected and found to be sound and re-useable</div> <div>3. Posts were aligned and re-set level.</div> <div>4. Area around post was backfilled with tamped gravel and re-graded with existing topsoil</div> <div>5. Failed mortar removed from setting area and bottom of marker using hand tools.</div> <div>6. Setting surfaces primed with Acryl 60 diluted 1:3 with water.</div> <div>7. Marker reset plumb onto post with cement/lime mortar (3/2/9) with 000 sand.</div> <div>8. Excess grout removed and joint area cleaned.</div> </div> </div>

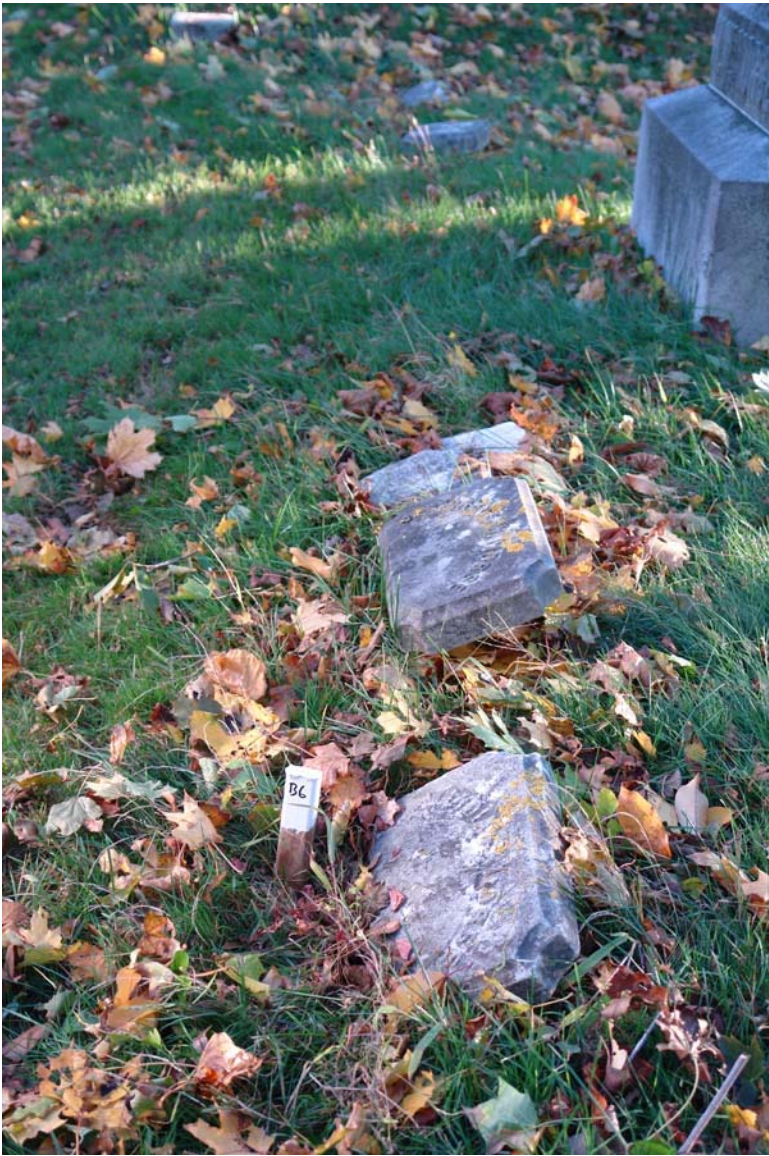
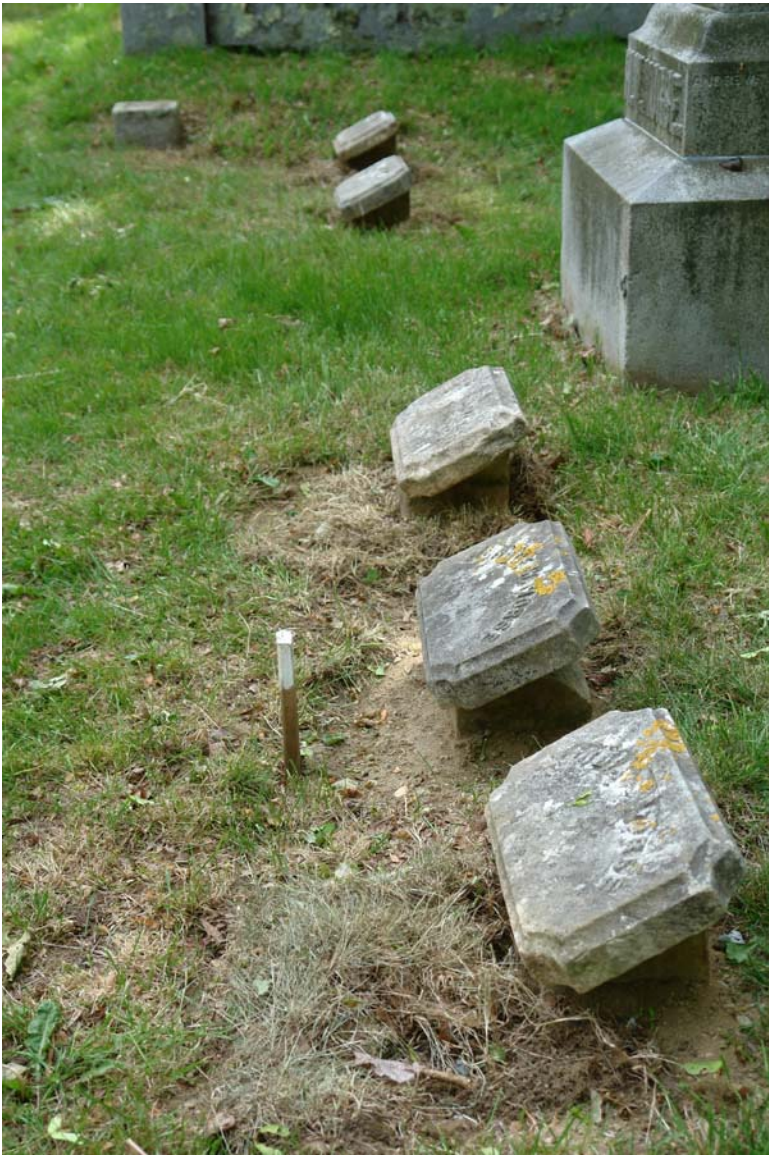
Height - Width - Thickness - Marker# B.6.1

Union Assinippi Cemetery, Hanover, MA	
NAME ON MARKER	Horace Morse
Death Date: 3/1/1903	Marker Type: Small marker
Cond. of Inscription: Legible	Material: Marble
EXISTING CONDITIONS	CONSERVATION STRATEGY
Loose on post	Inspect base unit Reset marker to post
TREATMENT Treatment Dates 5/19-26/2015	
<div>1. Area excavated to an appropriate depth removing any roots or large stones.</div> <div>2. Setting post inspected and found to be sound and re-useable</div> <div>3. Posts were aligned and re-set level.</div> <div>4. Area around post was backfilled with tamped gravel and re-graded with existing topsoil</div> <div>5. Failed mortar removed from setting area and bottom of marker using hand tools.</div> <div>6. Setting surfaces primed with Acryl 60 diluted 1:3 with water.</div> <div>7. Marker reset plumb onto post with cement/lime mortar (3/2/9) with 000 sand.</div> <div>8. Excess grout removed and joint area cleaned.</div>

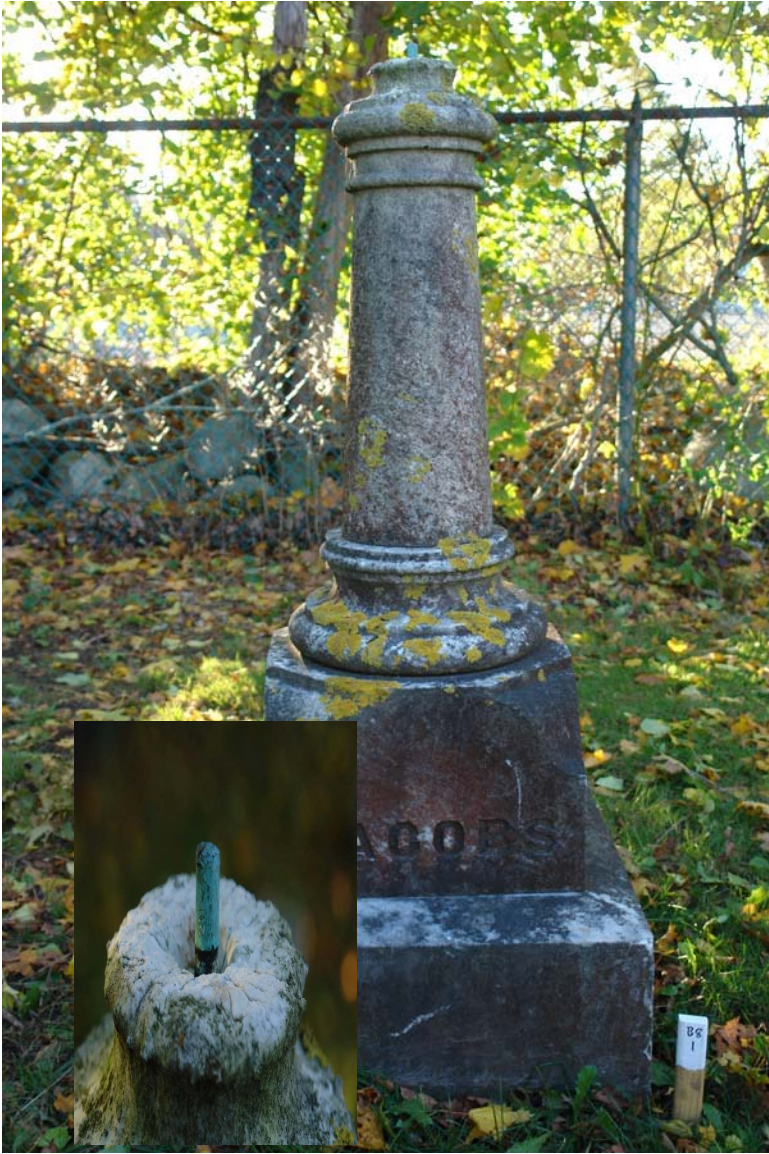
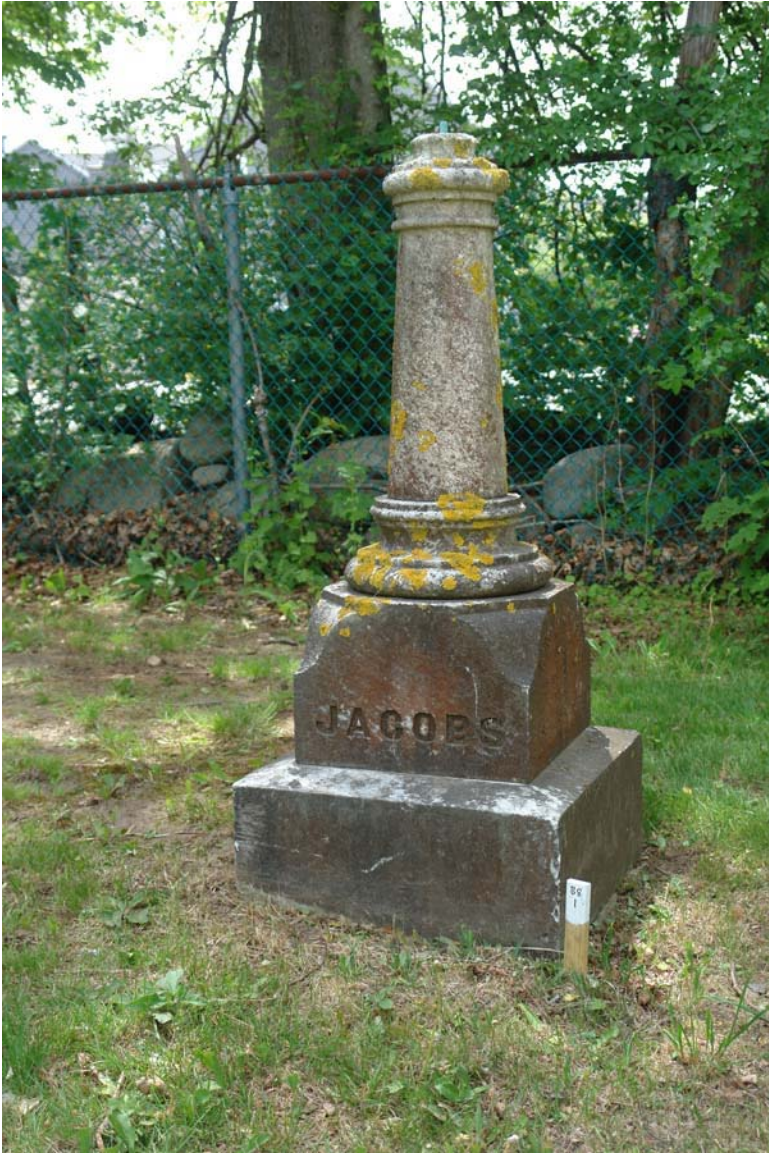
Height 41 Width 16 Thickness 16 Marker# **B.8.1**

Union Assinippi Cemetery, Hanover, MA
NAME ON MARKER **Husband (Loring Jacobs)**
Death Date: 9/15/1879 Marker Type: Small marker
Cond. of Inscription: Legible Material: Marble

EXISTING CONDITIONS	CONSERVATION STRATEGY
Loose on post	Inspect base unit Reset marker to post
