DOCUMENTATION OF STONE CONSERVATION TREATMENTS TO ASSINIPPI CEMETERY, HANOVER, MA June 2015

**MONUMENT CONSERVATION COLLABORATIVE LLC, NORFOLK, CT**

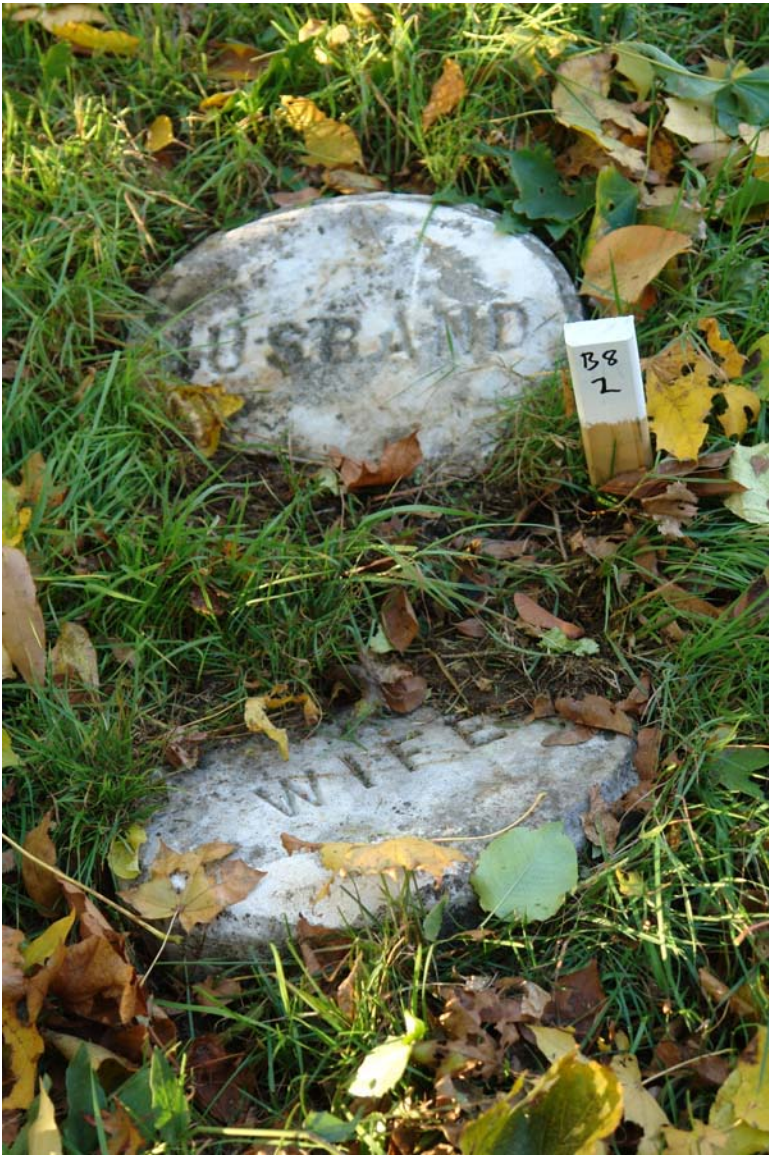
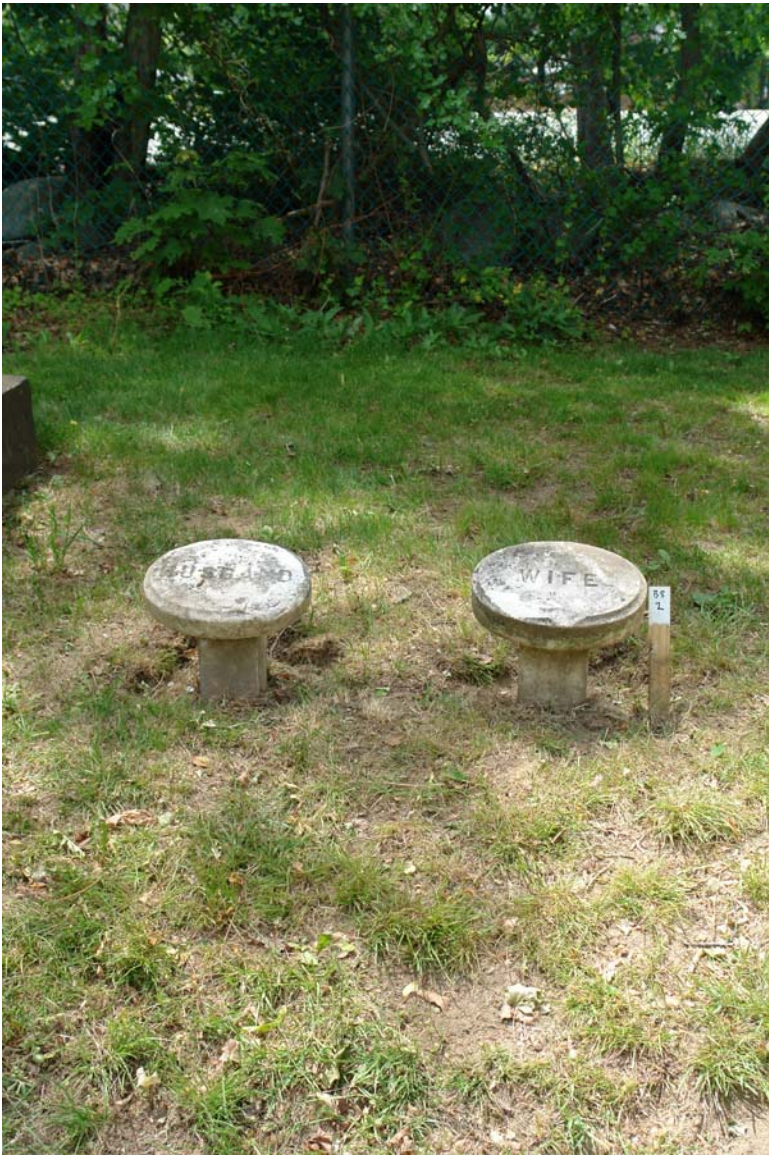
EXISTING CONDITIONS	CONSERVATION STRATEGY
Loose on post	Inspect base unit Reset marker to post

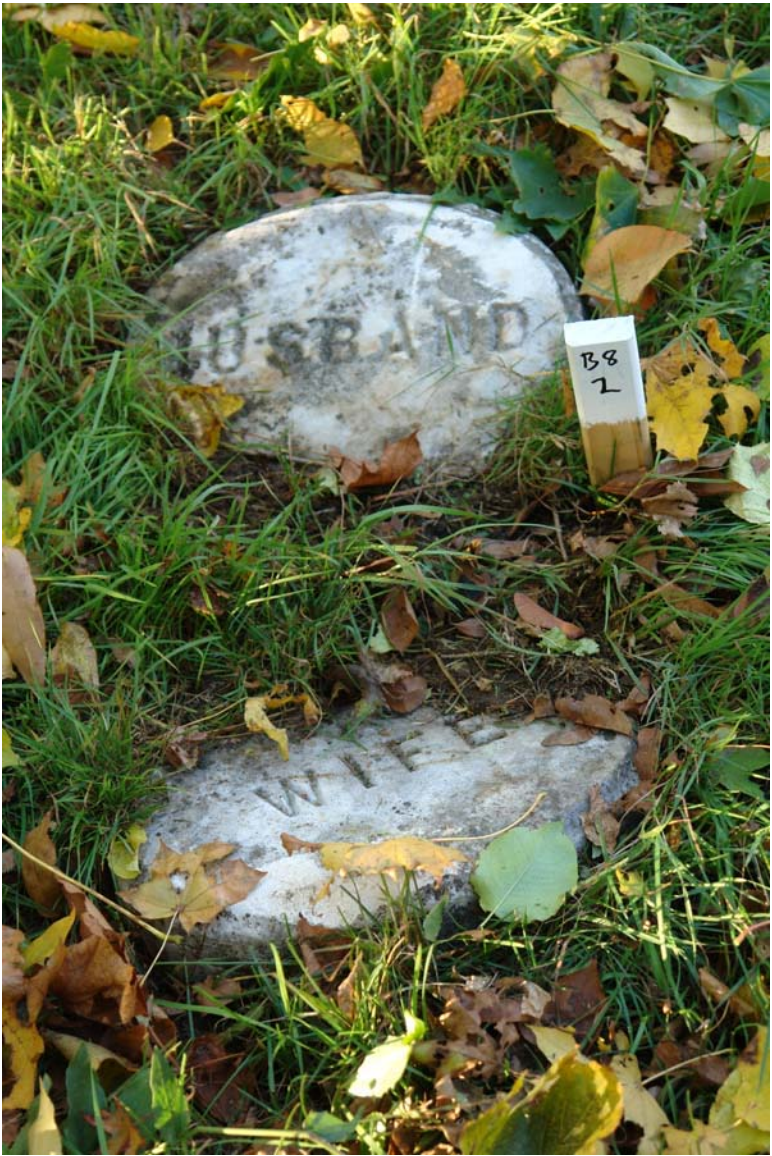
Union Assinippi Cemetery, Hanover, MA	
NAME ON MARKER	Wife (Mary Jacobs)
Death Date: 2/1/1903	Marker Type: Small marker
Cond. of Inscription: Legible	Material: Marble
EXISTING CONDITIONS	CONSERVATION STRATEGY
Loose on post	Inspect base unit Reset marker to post
TREATMENT Treatment Dates 5/20/2015	
1. Setting posts excavated and aligned and reset plumb 2. Small markers were attached with structural adhesive 3. Losses filled with Jahn restoration mortar

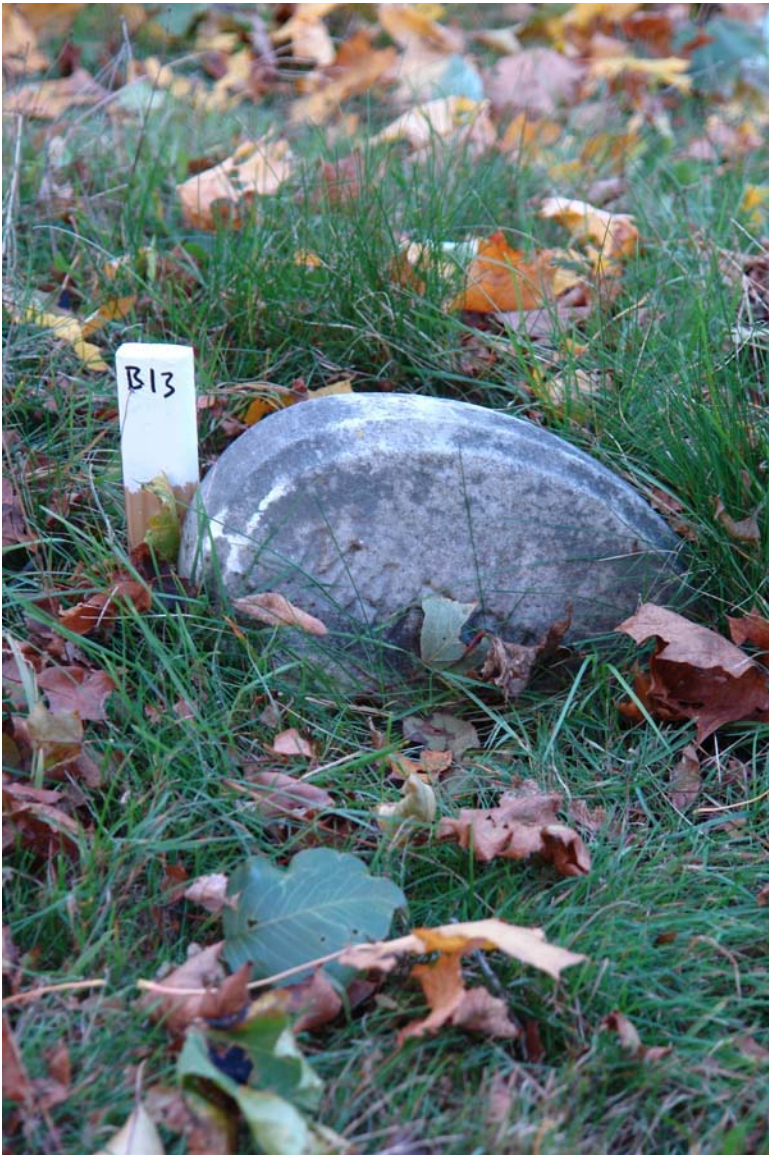
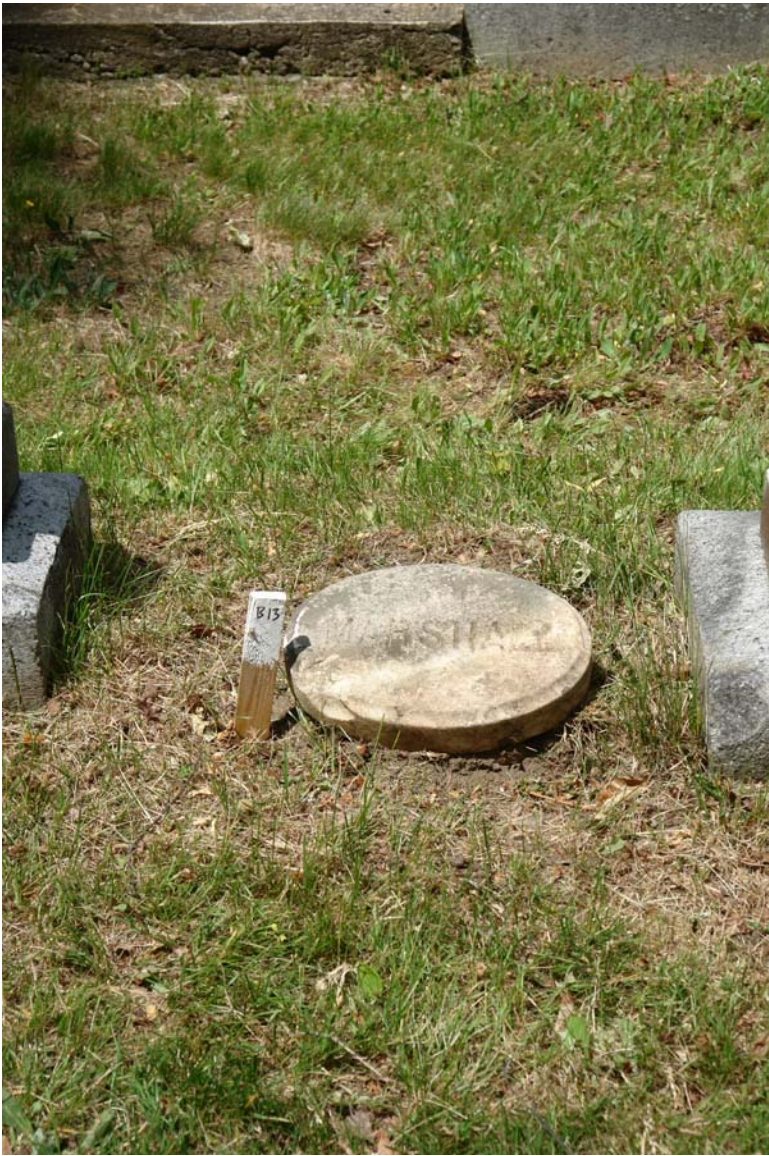
EXISTING CONDITIONS	CONSERVATION STRATEGY
Detached from base	Reset to base

1. Original base excavated and found to be sound, reset level at appropriate height and alignment.
2. Marker reset onto base with 000 grout

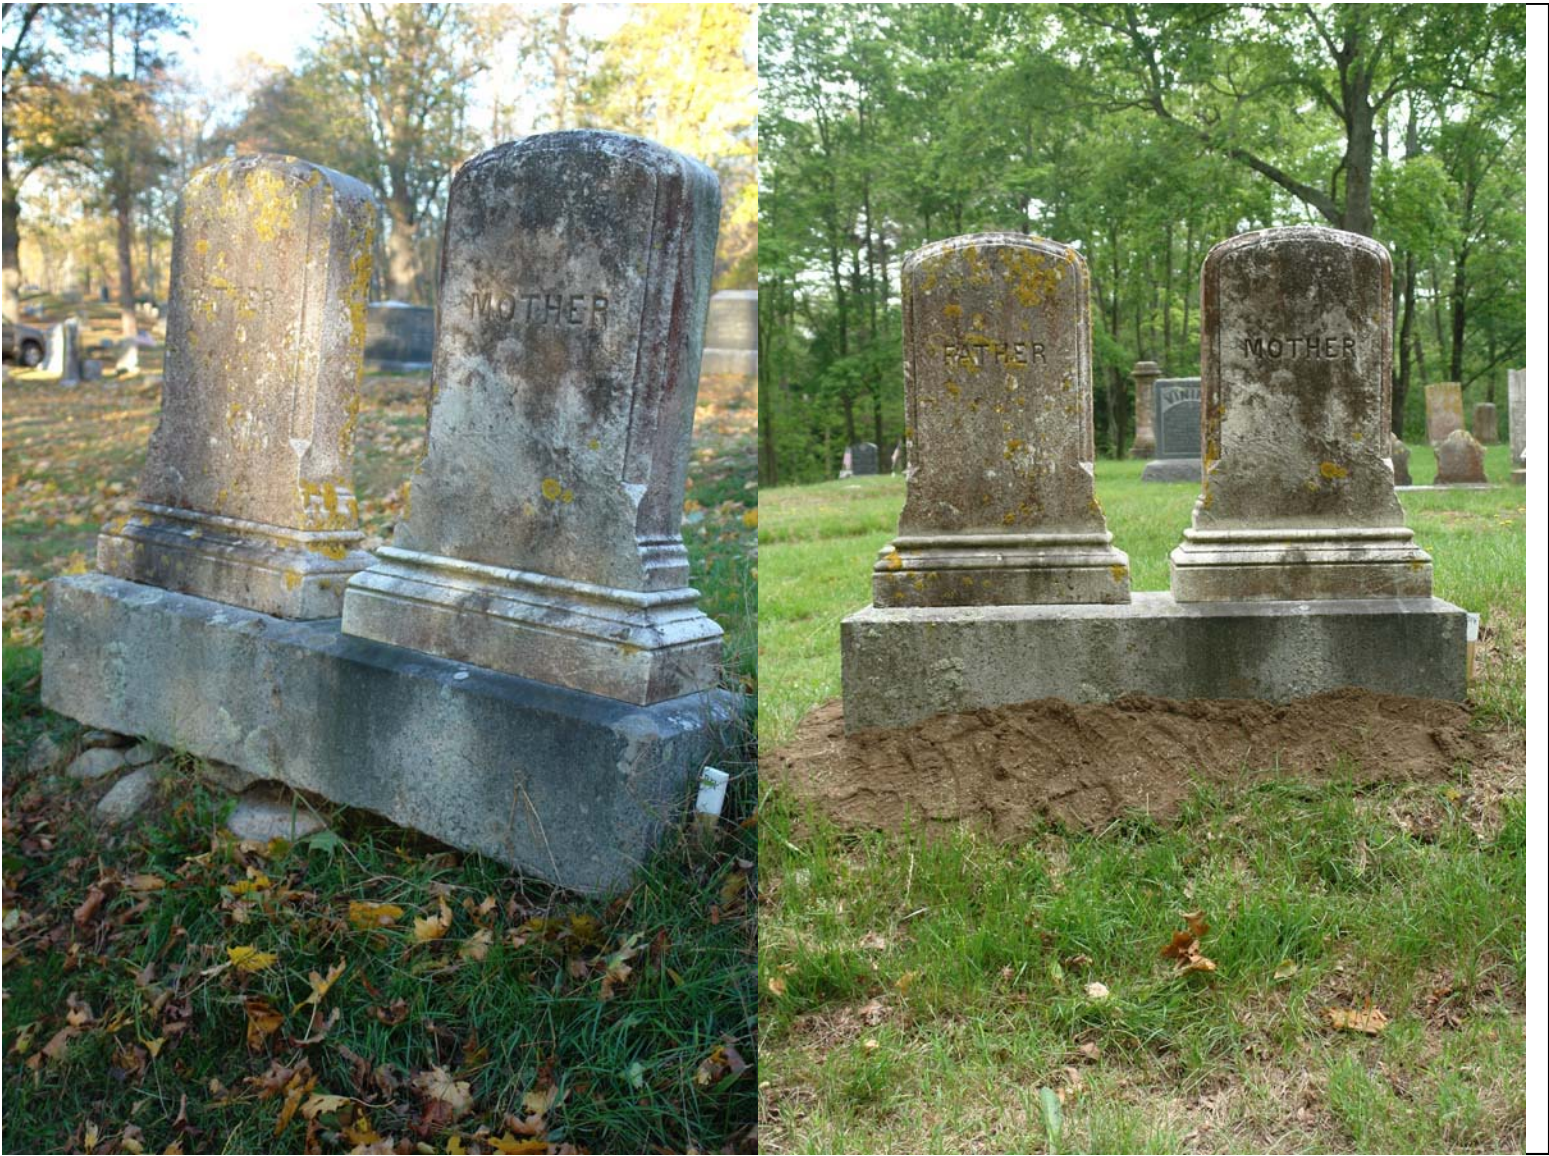
Union Assinippi Cemetery, Hanover, MA	
NAME ON MARKER	Lapham “Mother”
Death Date: n.a.	Marker Type: Marker/base
Cond. of Inscription: Legible	Material: Marble
EXISTING CONDITIONS	CONSERVATION STRATEGY
Tilted base	Level and stabilize large base
TREATMENT Treatment Dates 5/26/2015	
Markers appear to be securely set to the base.	
1. Base jacked up and area beneath setting base excavated and base reset level onto stone foundation.	
2. Area re-graded with fill and seeded.

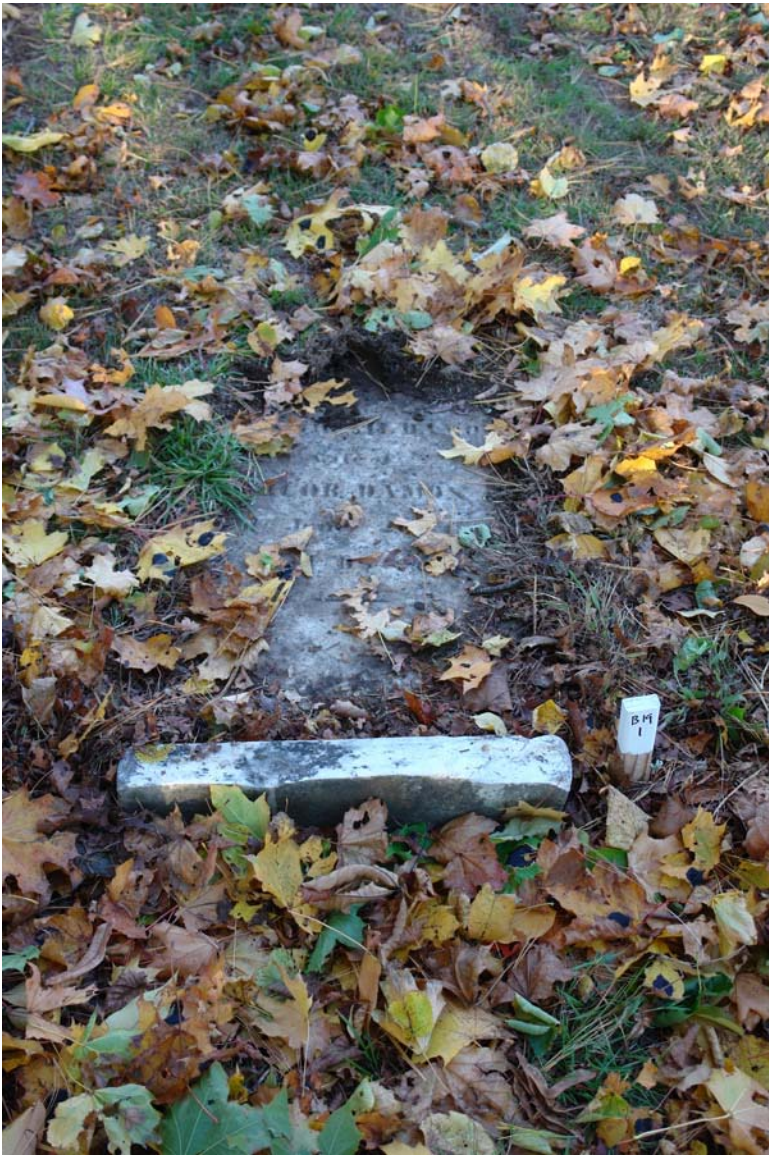
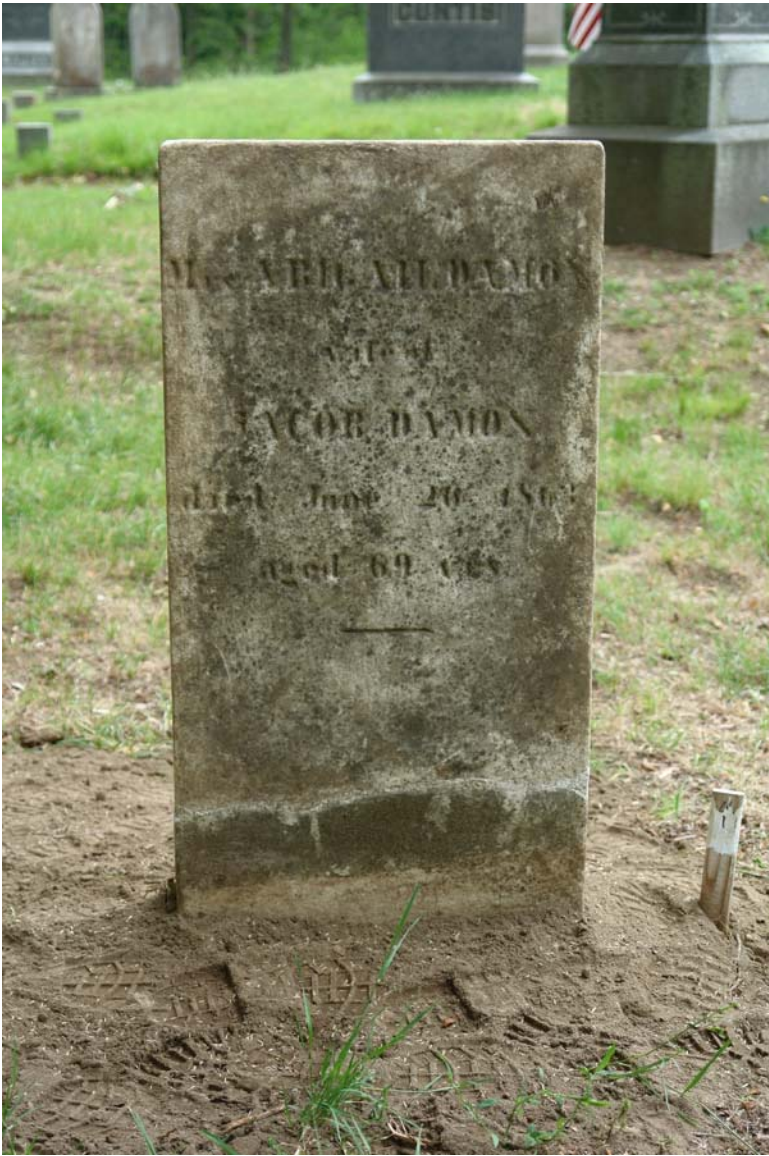
Union Assinippi Cemetery, Hanover, MA	
NAME ON MARKER	Abigail Damon
Death Date: 6/26/1863	Marker Type: Headstone
Cond. of Inscription: Decipherable	Material: Marble
EXISTING CONDITIONS	CONSERVATION STRATEGY
Fractured at grade	Remove in-ground fragment and reset into new below grade base
TREATMENT Treatment Dates 5/12-20/2015	
<div>1. Original base discovered and aligned with adj. markers and re-set level at appropriate height.</div> <div>2. Setting slot cleaned of debris or failed mortar and bottom fragment reset plumb and level into setting slot with a cement/lime grout (3/2/9) with 000 sand made fluid with a super plasticizer. Excess grout removed and joint area cleaned.</div> <div>3. Marker braced for a minimum 3 days</div> <div>4. All mating edges of fragments cleaned with water and any failed adhesives removed with hand tools</div> <div>5. Fragments attached with structural adhesive (Abatron 55-22), clamped and braced until cured. Excess epoxy removed with hand chisels within 24 hours.</div> <div>6. Cracks and losses filled with RepliCal Marble products, filled areas misted with water and covered for 3 days minimum</div> <div>7. Filled areas treated with light acid wash and rinsed thoroughly.</div> <div>8. All Surfaces treated with D/2 Biological Solution, scrubbed with nylon brushes and water. Rinsed fully with water</div>

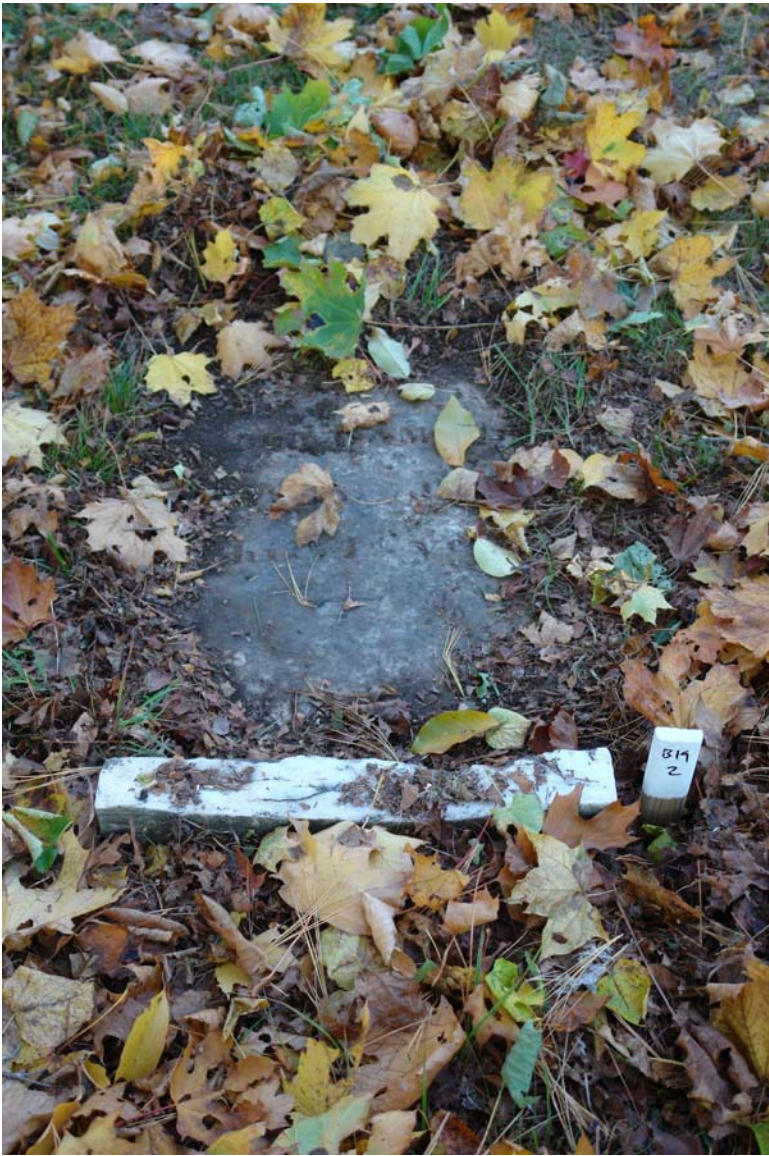
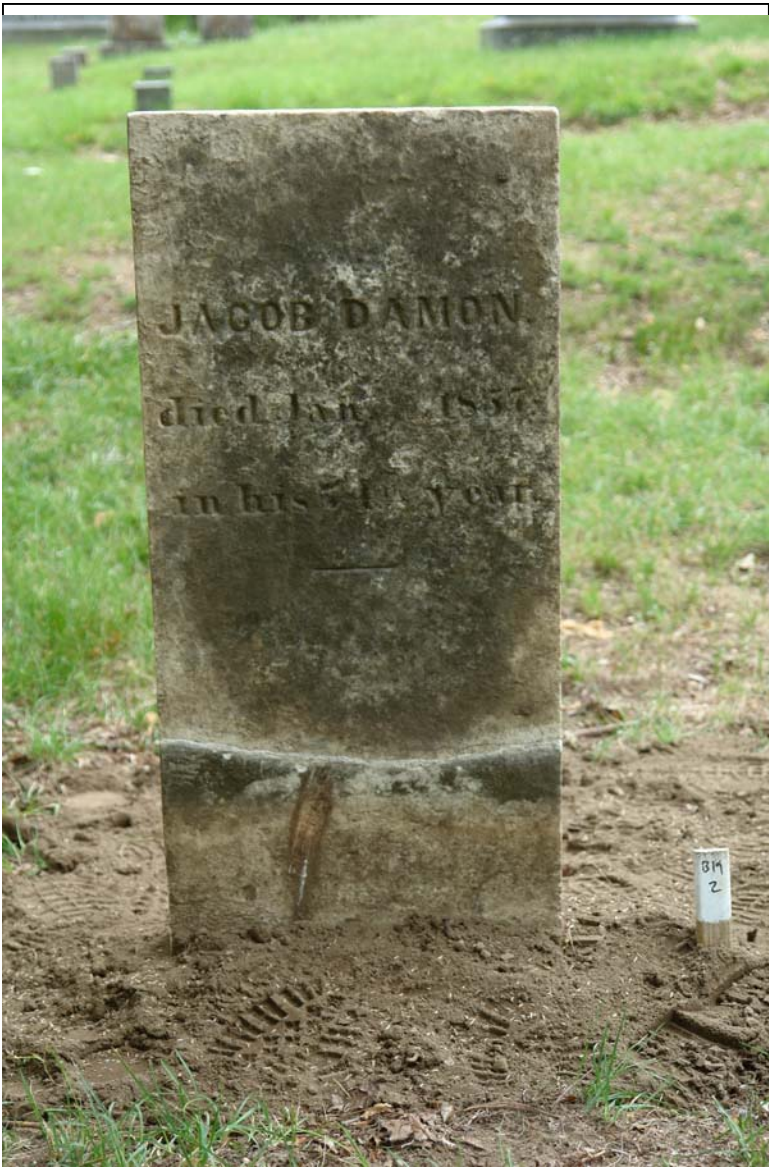
Union Assinippi Cemetery, Hanover, MA	
NAME ON MARKER	Jacob Damon
Death Date: 1/1857	Marker Type: Headstone
Cond. of Inscription: Decipherable	Material: Marble
EXISTING CONDITIONS	CONSERVATION STRATEGY
Fractured at grade	Remove in-ground fragment and reset into new below grade base
<div>TREATMENT</div> <div>Treatment Dates 5/12-20/2015</div> <div> 1. Original base discovered and aligned with adj. markers and re-set level at appropriate height. 2. Setting slot cleaned of debris or failed mortar and bottom fragment reset plumb and level into setting slot with a cement/lime grout (3/2/9) with 000 sand made fluid with a super plasticizer. Excess grout removed and joint area cleaned. 3. Marker braced for a minimum 3 days 4. All mating edges of fragments cleaned with water and any failed adhesives removed with hand tools 5. Fragments attached with structural adhesive (Abatron 55-22), clamped and braced until cured. Excess epoxy removed with hand chisels within 24 hours. 6. Cracks and losses filled with RepliCal Marble products, filled areas misted with water and covered for 3 days minimum 7. Filled areas treated with light acid wash and rinsed thoroughly. 8. All Surfaces treated with D/2 Biological Solution, scrubbed with nylon brushes and water. Rinsed fully with water </div>

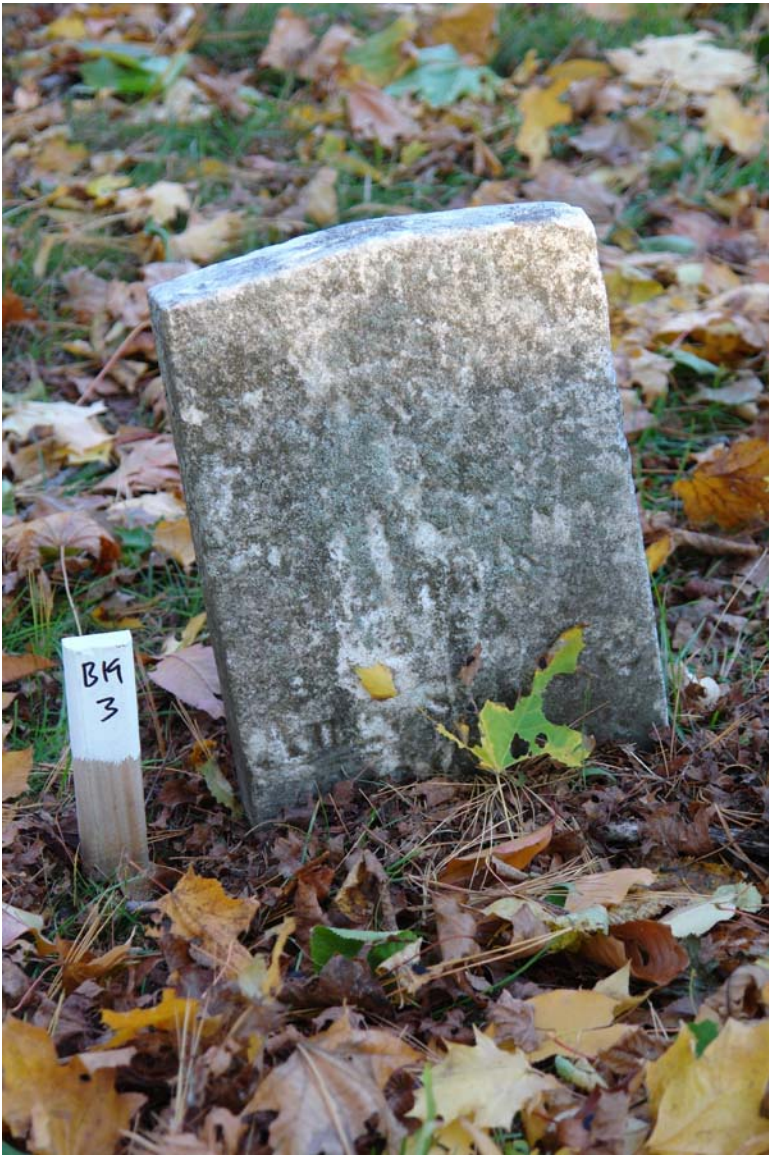
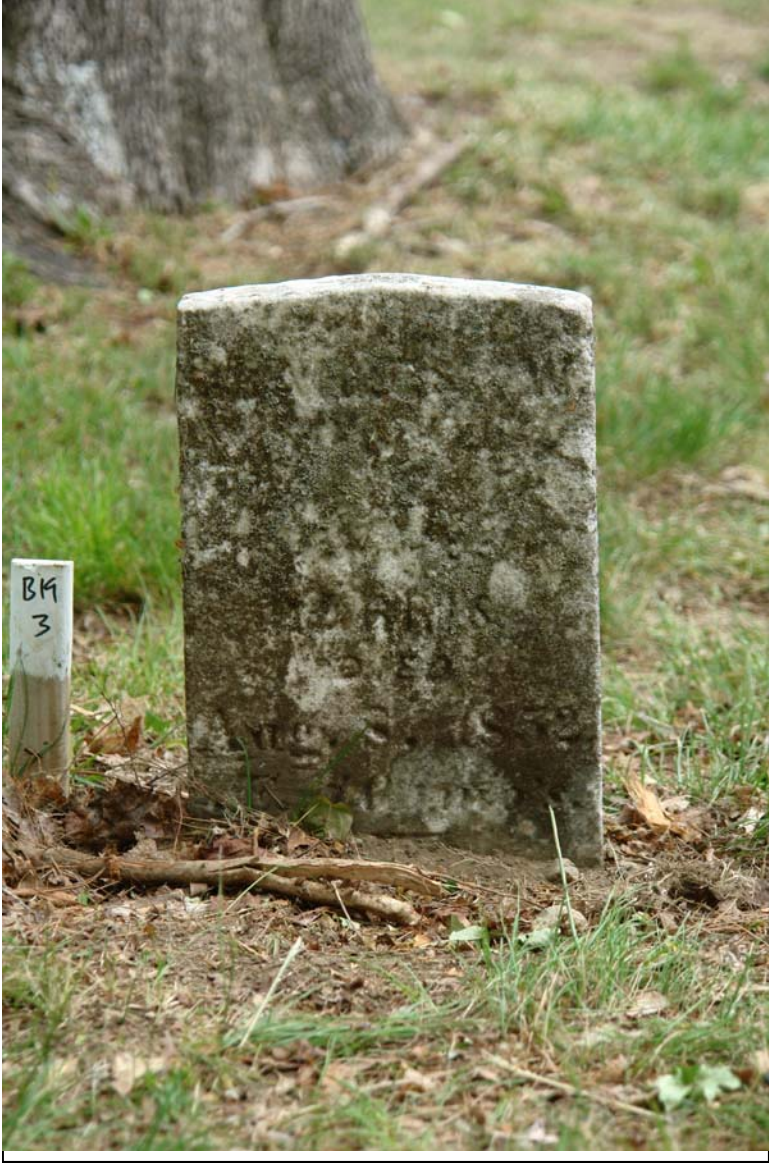
Union Assinippi Cemetery, Hanover, MA	
NAME ON MARKER	Charles Harris
Death Date: 8/8/1852	Marker Type: Small headstone
Cond. of Inscription: Illegible	Material: Marble
EXISTING CONDITIONS	CONSERVATION STRATEGY
Tilted	Reset plumb
TREATMENT Treatment Dates 5/12/2015	
1. Marker carefully excavated. The soil around tilted markers was removed to an appropriate depth. When required, the marker was removed from the ground. Marker appears to be sound. 2. Soling removed by light brushing with nylon brushes and water. 3. Setting area excavated to sufficient depth and stone re-set plumb at appropriate height and level onto gravel bed, aligned with adjacent markers 4. Area backfilled around marker with tamped sand and gravel 5. Disturbed areas re-graded with existing topsoil and sod.

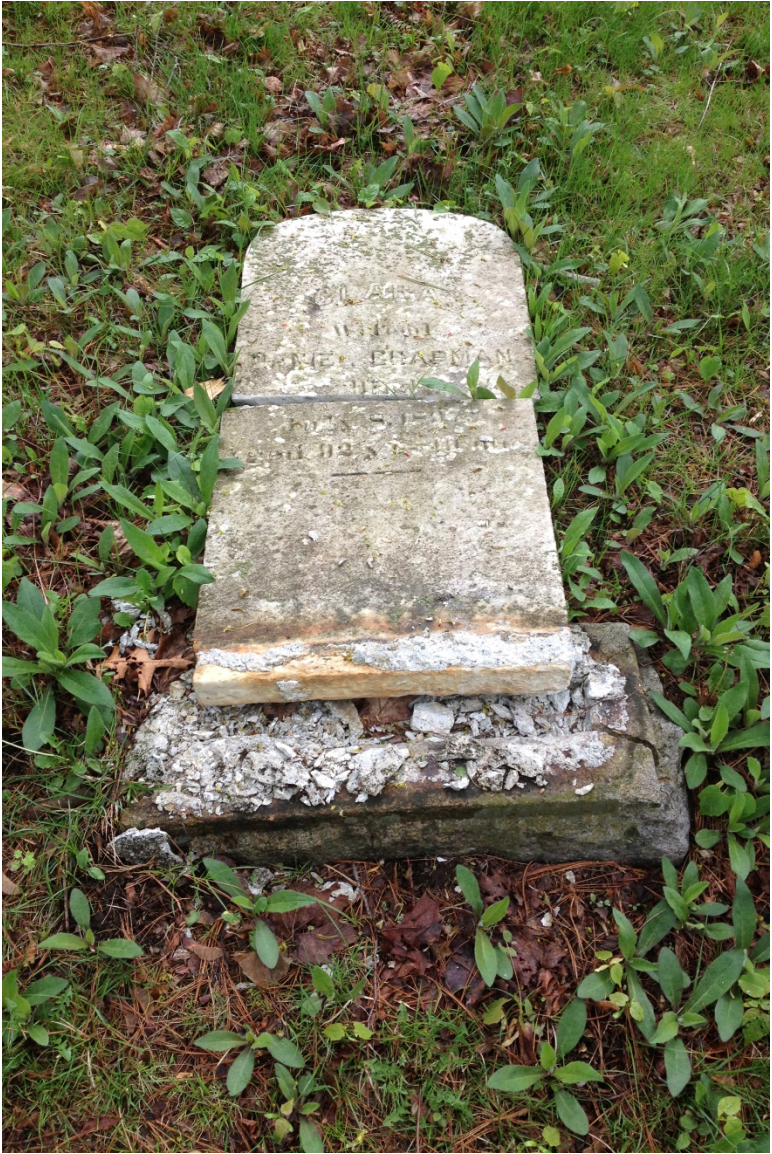
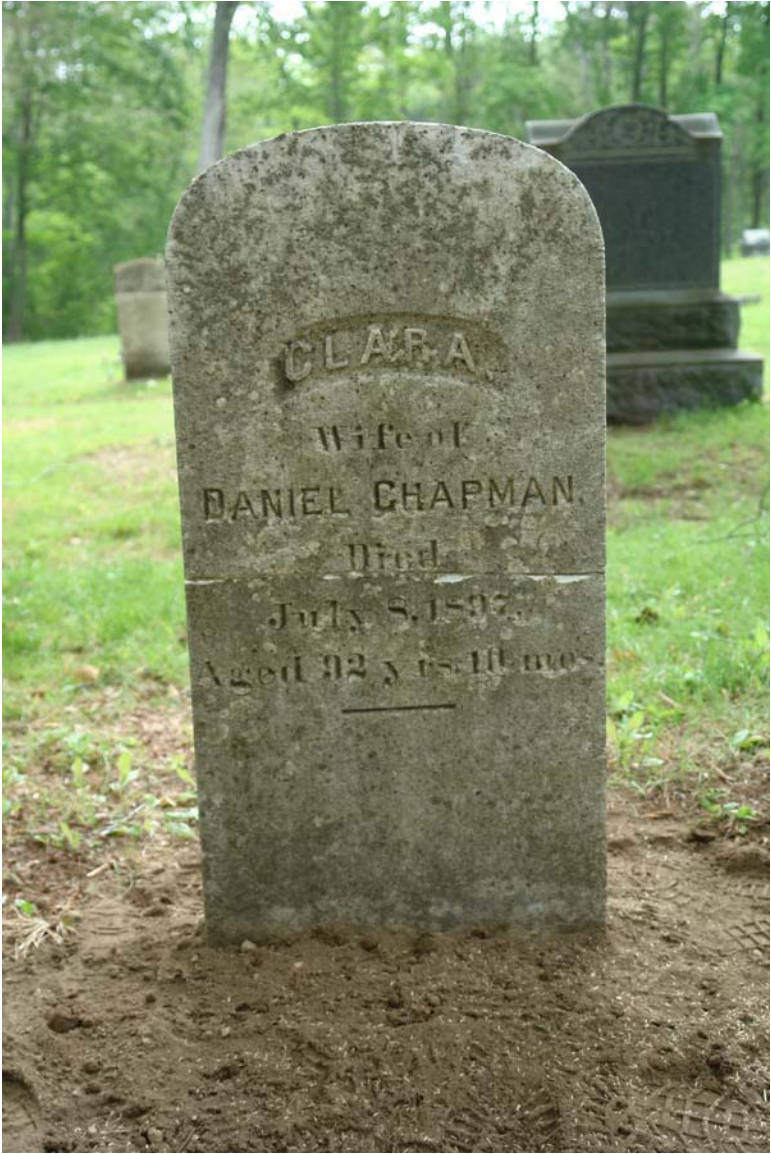
Union Assinippi Cemetery, Hanover, MA	
NAME ON MARKER	Clara Chapman
Death Date:	Marker Type: Headstone in base
Cond. of Inscription:	Material: Marble
EXISTING CONDITIONS	CONSERVATION STRATEGY
Recently fallen and fractured	Construct new below grade base Attach fragments with structural adhesive
TREATMENT Treatment Dates 5/28-6/11/2015

1. Setting area excavated for new below grade cast concrete base	
2. A new concrete base sized min. 12” deep, 12” greater in thickness and 6” wider than the stone is cast. The finished top to be below grade. A form for a setting slot 1” wider than the marker is placed in the concrete.

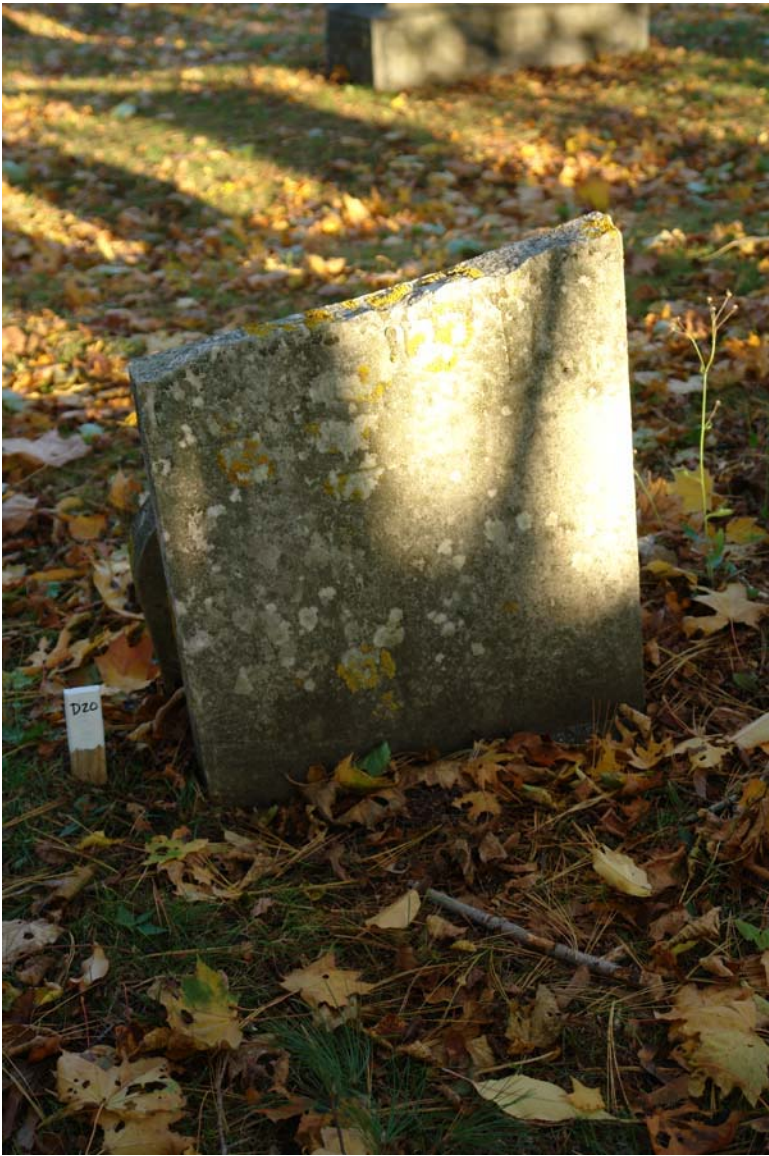
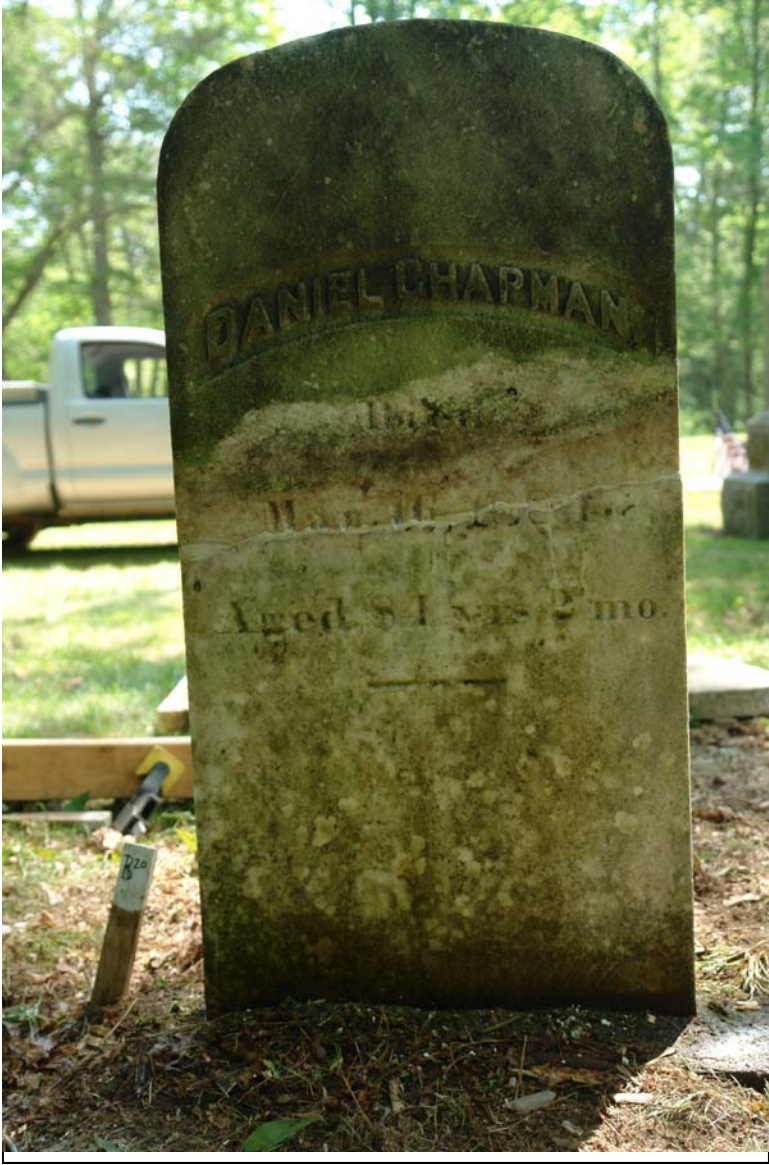
Union Assinippi Cemetery, Hanover, MA	
NAME ON MARKER	Daniel Chapman
Death Date: 3/18/1881	Marker Type: Headstone
Cond. of Inscription: illegible	Material: Marble
EXISTING CONDITIONS	CONSERVATION STRATEGY
Fractured	Attach fragments with structural adhesive
TREATMENT Treatment Dates 5/12-20/2015	
<div>1. Original base discovered and aligned with adj. markers and re-set level at appropriate height.</div> <div>2. Setting slot cleaned of debris or failed mortar and bottom fragment reset plumb and level into setting slot with a cement/lime grout (3/2/9) with 000 sand made fluid with a super plasticizer. Excess grout removed and joint area cleaned.</div> <div>3. Marker braced for a minimum 3 days</div> <div>4. All mating edges of fragments cleaned with water and any failed adhesives removed with hand tools</div> <div>5. Fragments attached with structural adhesive (Abatron 55-22), clamped and braced until cured. Excess epoxy removed with hand chisels within 24 hours.</div> <div>6. Cracks and losses filled with RepliCal Marble products, filled areas misted with water and covered for 3 days minimum</div> <div>7. Filled areas treated with light acid wash and rinsed thoroughly.</div>

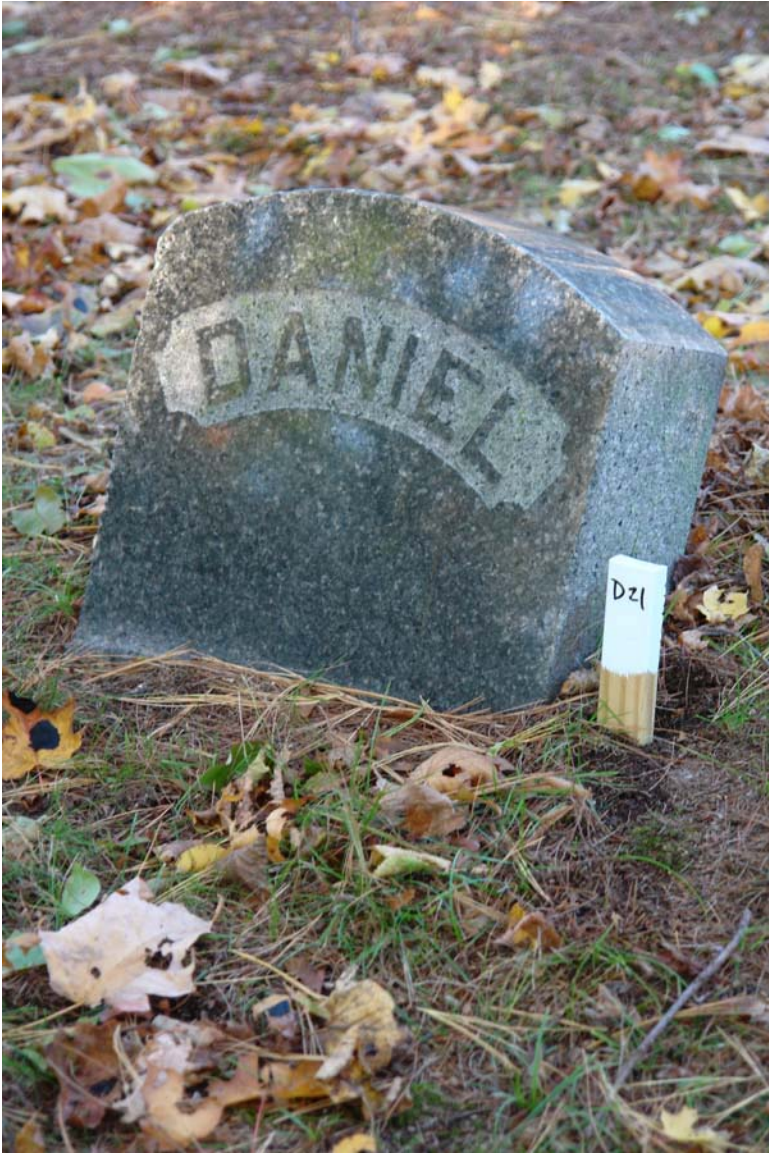
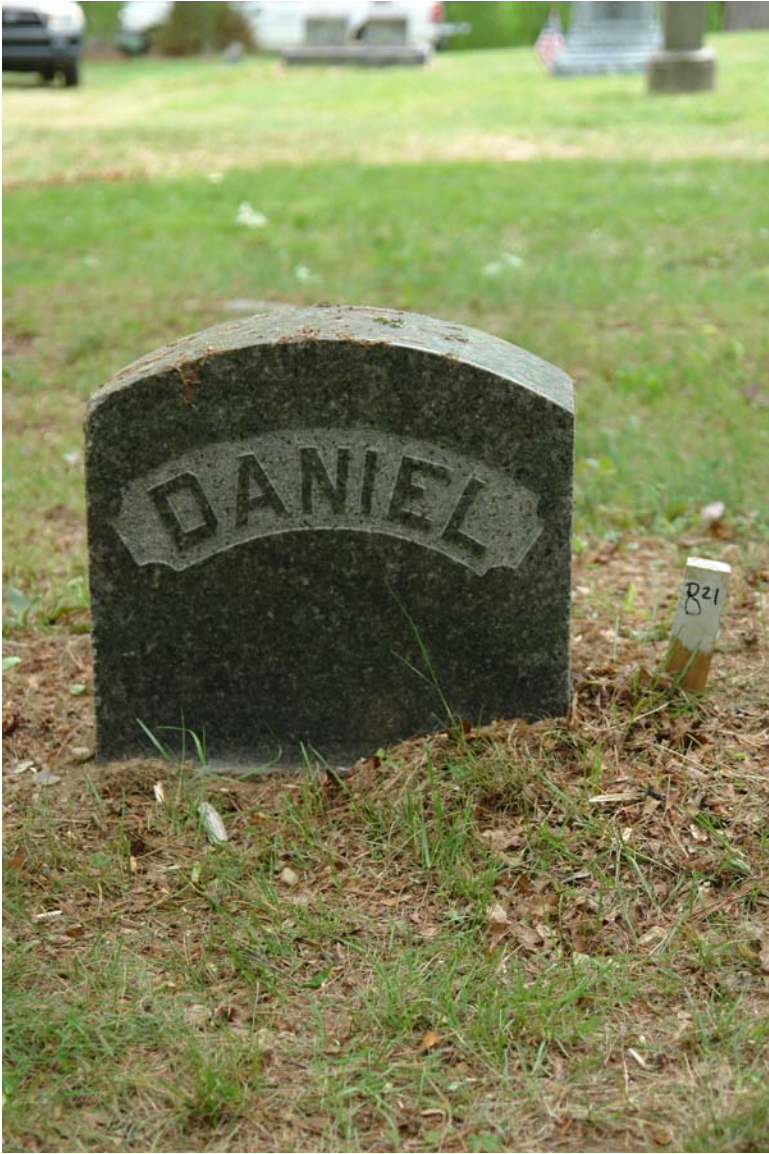
Union Assinippi Cemetery, Hanover, MA	
NAME ON MARKER	Daniel Daman
Death Date: 3/3/1896	Marker Type: Small marker
Cond. of Inscription: Legible	Material: Granite
EXISTING CONDITIONS	CONSERVATION STRATEGY
Tilted	Reset plumb
<div> <div>TREATMENT</div> <div>Treatment Dates 5/12/2015</div> <div> <div>1. Marker carefully excavated. The soil and large roots around tilted markers were removed to an appropriate depth. When required, the marker was removed from the ground. Marker appears to be sound.</div> <div>2. Soling removed by light brushing with nylon brushes and water.</div> <div>3. Setting area excavated to sufficient depth and stone re-set plumb at appropriate height and level onto gravel bed, aligned with adjacent markers</div> <div>4. Area backfilled around marker with tamped sand and gravel</div> <div>5. Disturbed areas re-graded with existing topsoil and sod.</div> </div> </div>	
Comments:

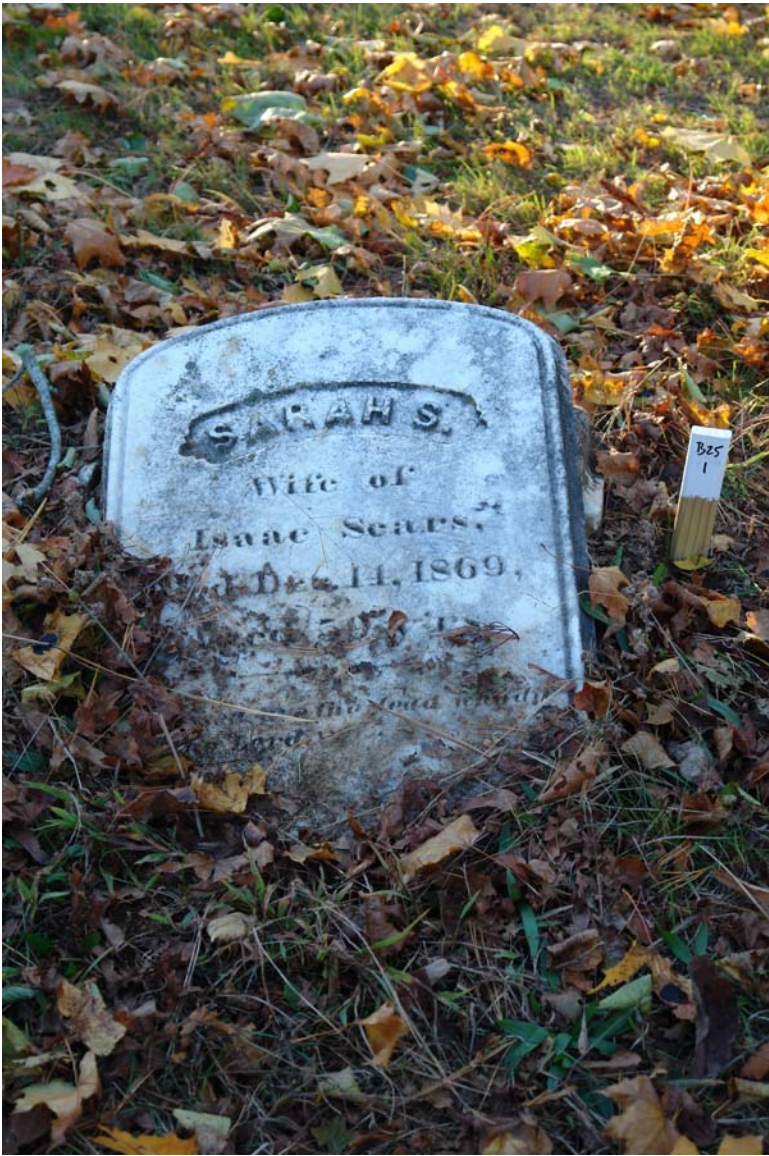
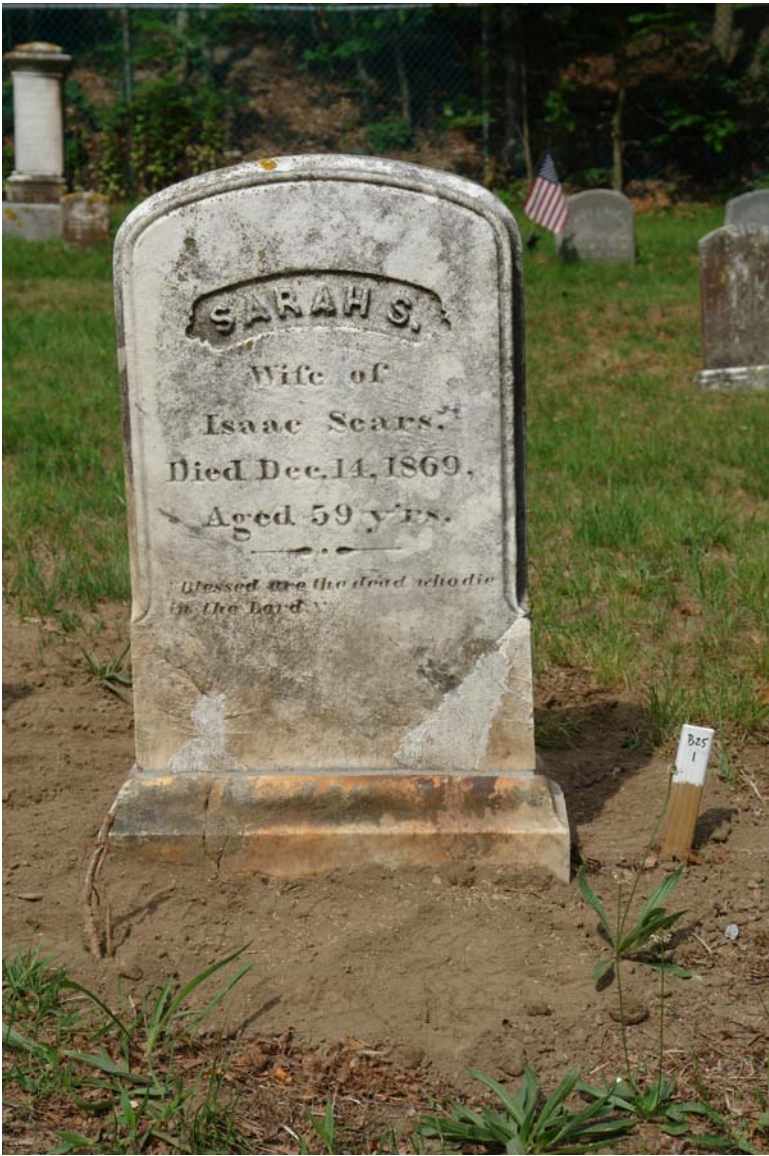
Union Assinippi Cemetery, Hanover, MA	
NAME ON MARKER	Sarah Sears
Death Date: 12/14/1869	Marker Type: Headstone
Cond. of Inscription: Legible	Material: Marble
EXISTING CONDITIONS	CONSERVATION STRATEGY
Off base Tilted base Losses	Level base Reset marker Fill loses
<div> <div>TREATMENT</div> <div>Treatment Dates 5/12-19/2015</div> <div> <div>1. Area excavated to an appropriate depth removing any roots or large stones aligning existing base with adjacent markers and re-set level.</div> <div>2. Setting surfaces cleaned with water and any failed adhesives or mortar removed with hand tools from setting area and bottom of marker</div> <div>3. When required, any existing pins were inspected, and if necessary, replaced with stainless steel threaded pins</div> <div>4. Marker reset plumb and level onto base with structural adhesive, leveled as necessary with lead shims. Braced for min 3 days.</div> <div>5. Cracks and losses filled with Jahn restoration mortar.</div> <div>6. Filled areas misted with water and covered for 3 days minimum</div> <div>7. Filled surface areas treated with light acid wash and rinsed thoroughly</div> <div>8. All surfaces treated with D/2 Biological Solution, scrubbed with nylon brushes and water. Rinsed fully with water</div> </div> </div>
