DOCUMENTATION OF STONE CONSERVATION TREATMENTS TO ASSINIPPI CEMETERY, HANOVER, MA June 2015

**MONUMENT CONSERVATION COLLABORATIVE LLC, NORFOLK, CT**

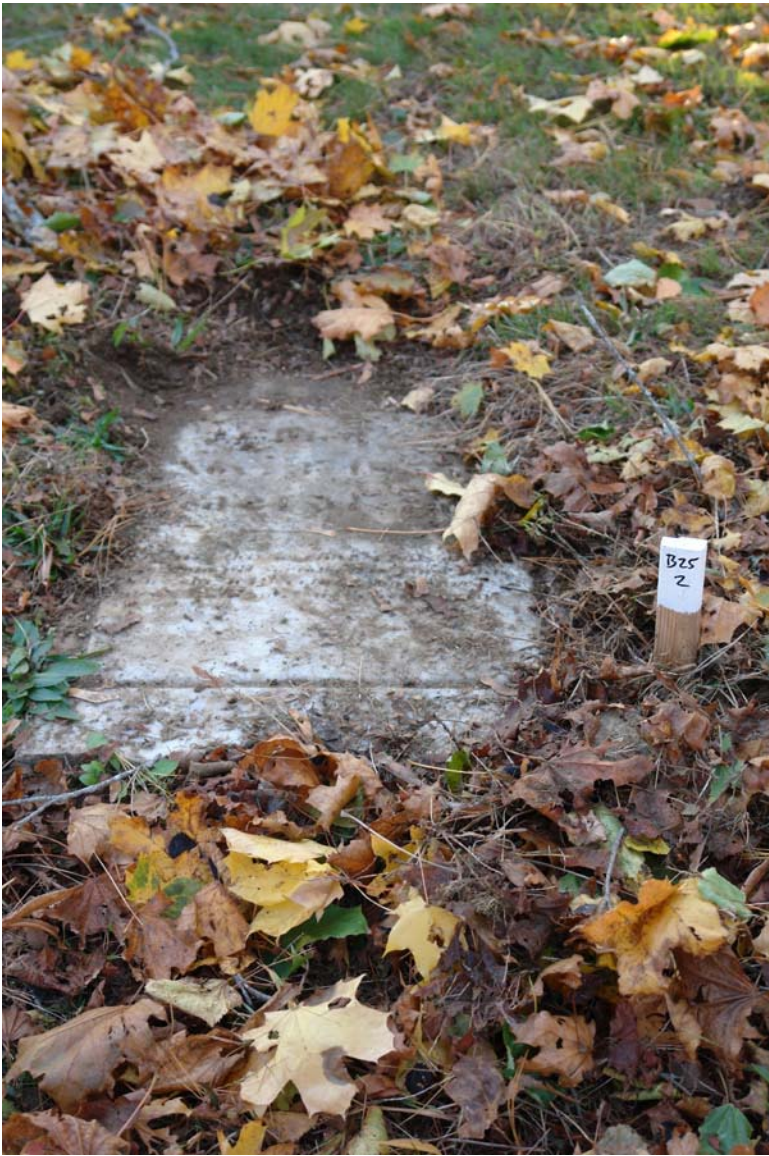
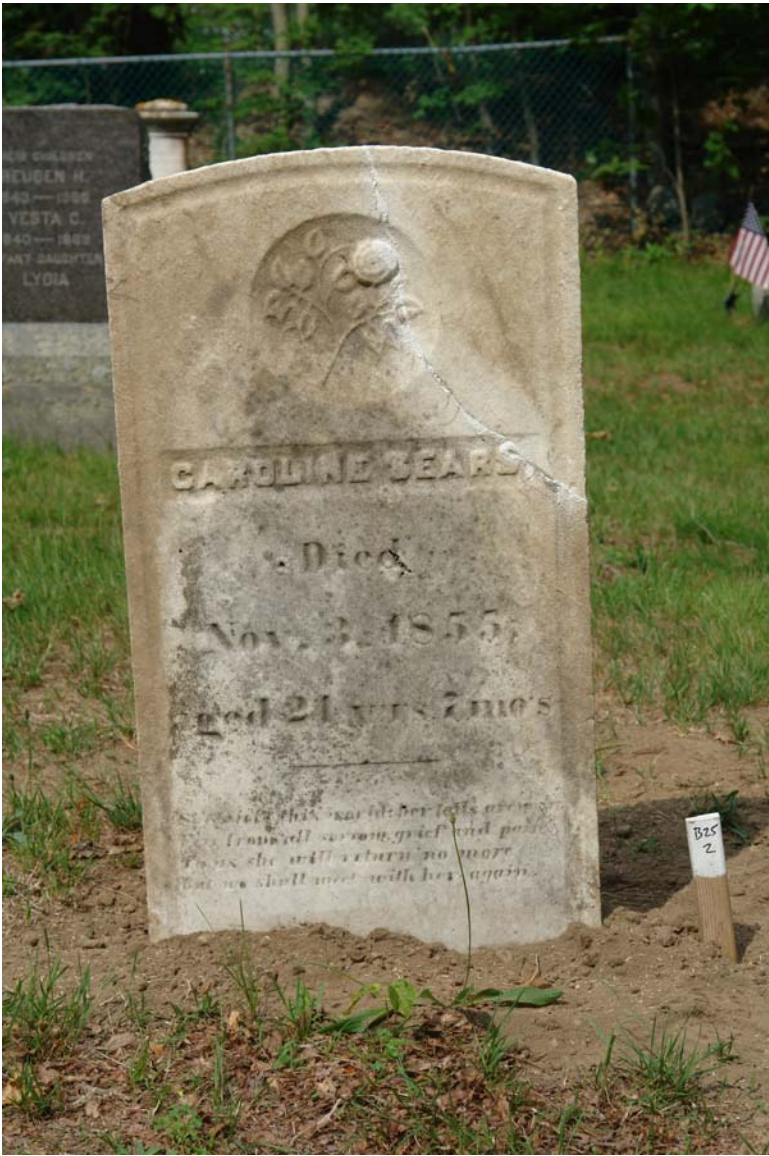
Union Assinippi Cemetery, Hanover, MA	
NAME ON MARKER	Caroline Sears
Death Date: 11/3/1855	Marker Type: Headstone
Cond. of Inscription: Decipherable	Material: Marble
EXISTING CONDITIONS	CONSERVATION STRATEGY
Fractured at grade	Reset into new below grade base
<div>TREATMENT</div> <div>Treatment Dates 5/12-20/2015</div> <div> 1. Original base discovered while excavating. Base is aligned with adj. markers and reset level at appropriate height. 2. Setting slot cleaned of debris or failed mortar and bottom fragment reset plumb and level into setting slot with a cement/lime grout (3/2/9) with 000 sand made fluid with a super plasticizer. 3. Marker braced for a minimum 3 days 4. All mating edges of fragments cleaned with water and any failed adhesives removed with hand tools 5. Fragments attached with structural adhesive (Abatron 55-22), clamped and braced until cured. Excess epoxy removed with hand chisels within 24 hours. 6. Cracks and losses filled with RepliCal Marble products, filled areas misted with water and covered for 3 days minimum 7. Filled areas treated with light acid wash and rinsed thoroughly. 8. All Surfaces treated with D/2 Biological Solution, scrubbed with nylon brushes and water. Rinsed fully with water </div>

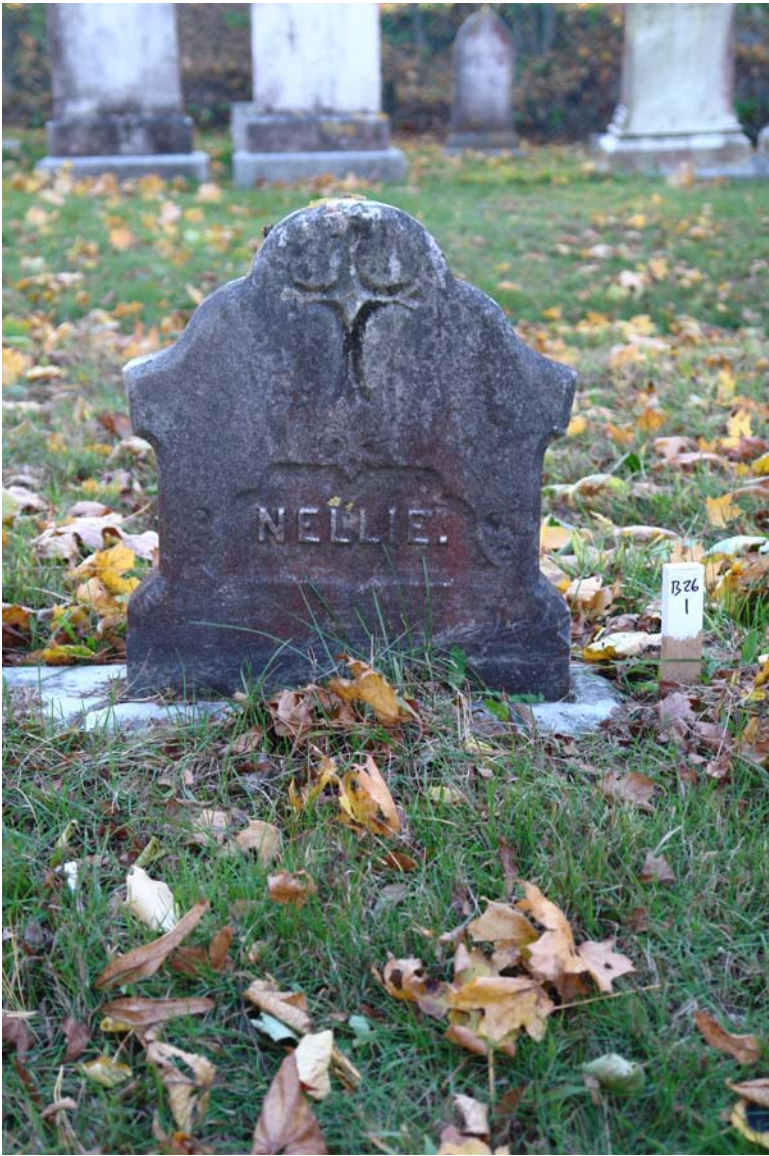
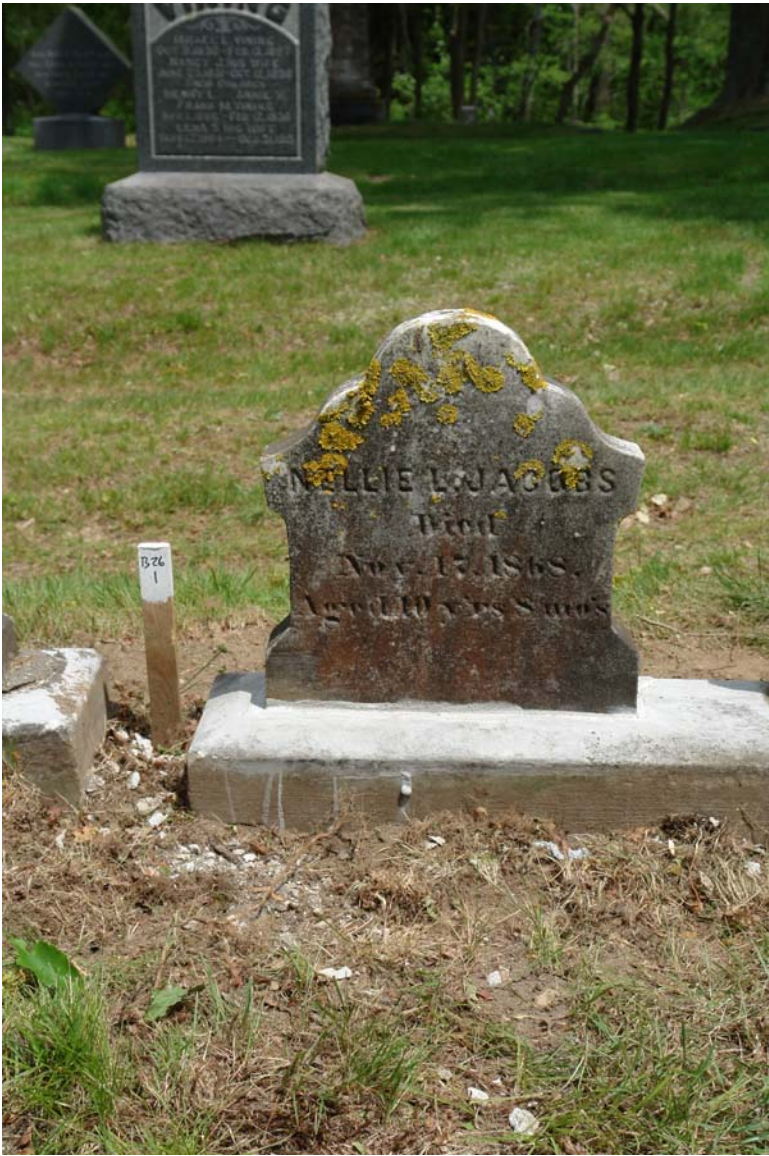
Height - Width - Thickness - Marker# B.25.2

EXISTING CONDITIONS	CONSERVATION STRATEGY
Loose in base	Reset

- Soundness of setting joint of marker to base inspected, if found to be unstable, marker removed from base.
- Area excavated to an appropriate depth removing any roots or large stones.
- Base is aligned with adjacent markers and re-set level.
- Area around base was backfilled with tamped gravel and re-graded with existing topsoil
- Failed mortar removed from setting area and bottom of marker
- When required, any existing pins were inspected, and if necessary, replaced with stainless steel threaded pins
- Setting surfaces primed with Acryl 60 diluted 1:3 with water.
- Marker reset plumb onto base with cement/lime mortar (3/2/8) with 000 sand.
- Excess grout removed and joint area cleaned.

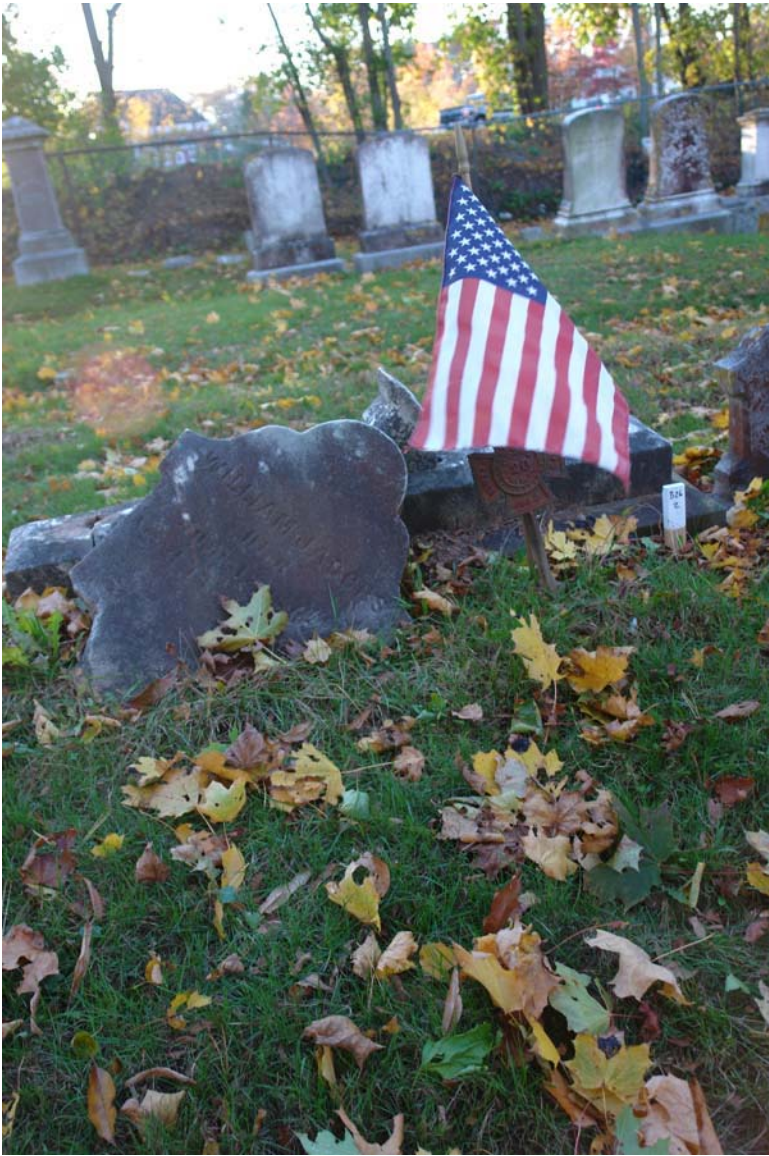
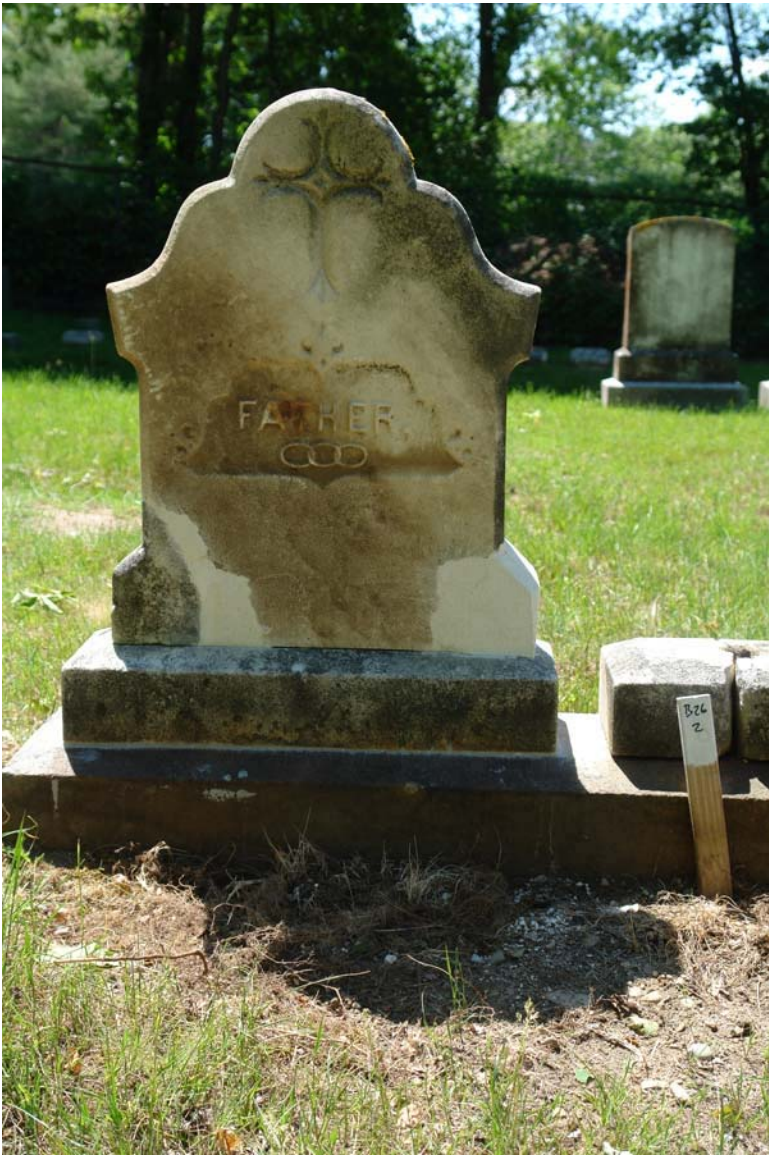
EXISTING CONDITIONS	CONSERVATION STRATEGY
Marker off base Fractured	Reset base Attach fragments with structural adhesive

TREATMENT	Treatment Dates 5/26-27/2015
<div>1. Area excavated to an appropriate depth removing any roots or large stones aligning base with adjacent markers and re-set level.</div> <div>2. Setting surfaces cleaned with water and any failed adhesives or mortar removed with hand tools from setting area and bottom of marker</div> <div>3. When required, any existing pins were inspected, and if necessary, replaced with stainless steel threaded pins</div> <div>4. Marker reset plumb and level onto base with structural adhesive and plumbed with lead shims. Braced for min 3 days.</div> <div>5. Fragment attached with structural adhesive.</div> <div>6. Cracks and losses filled with Jahn restoration mortar.</div> <div>7. Filled areas misted with water and covered for 3 days minimum</div>

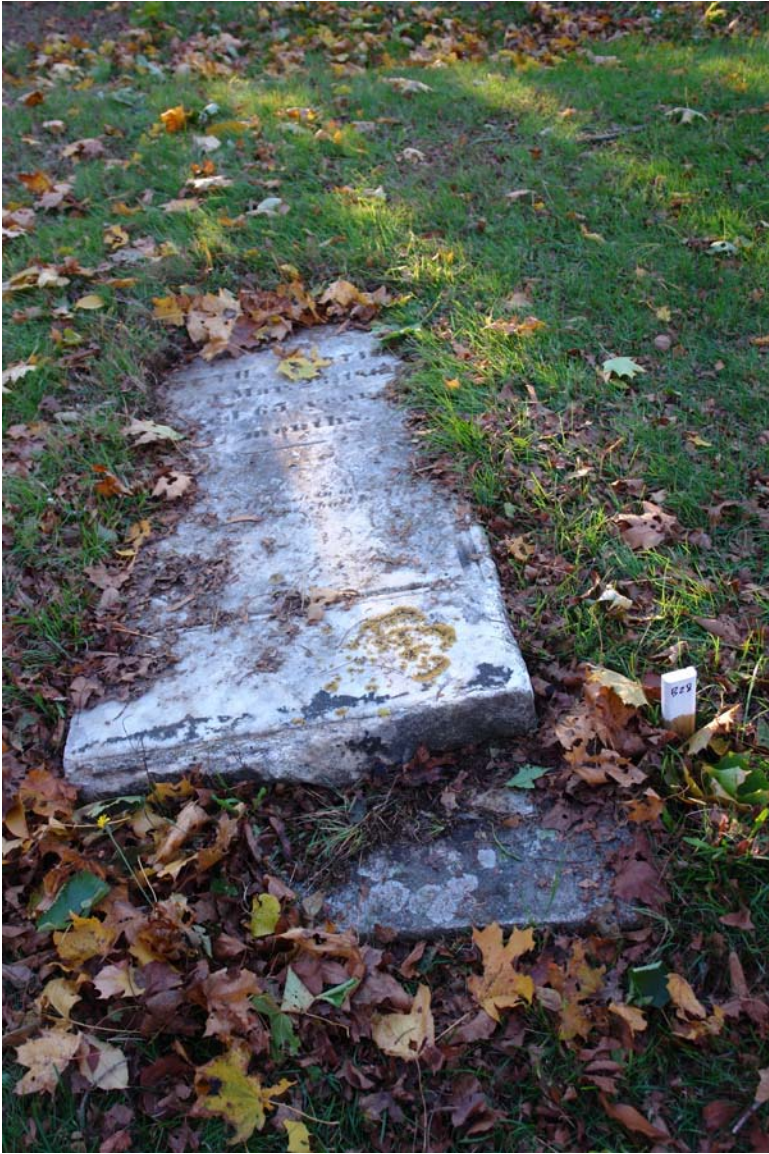
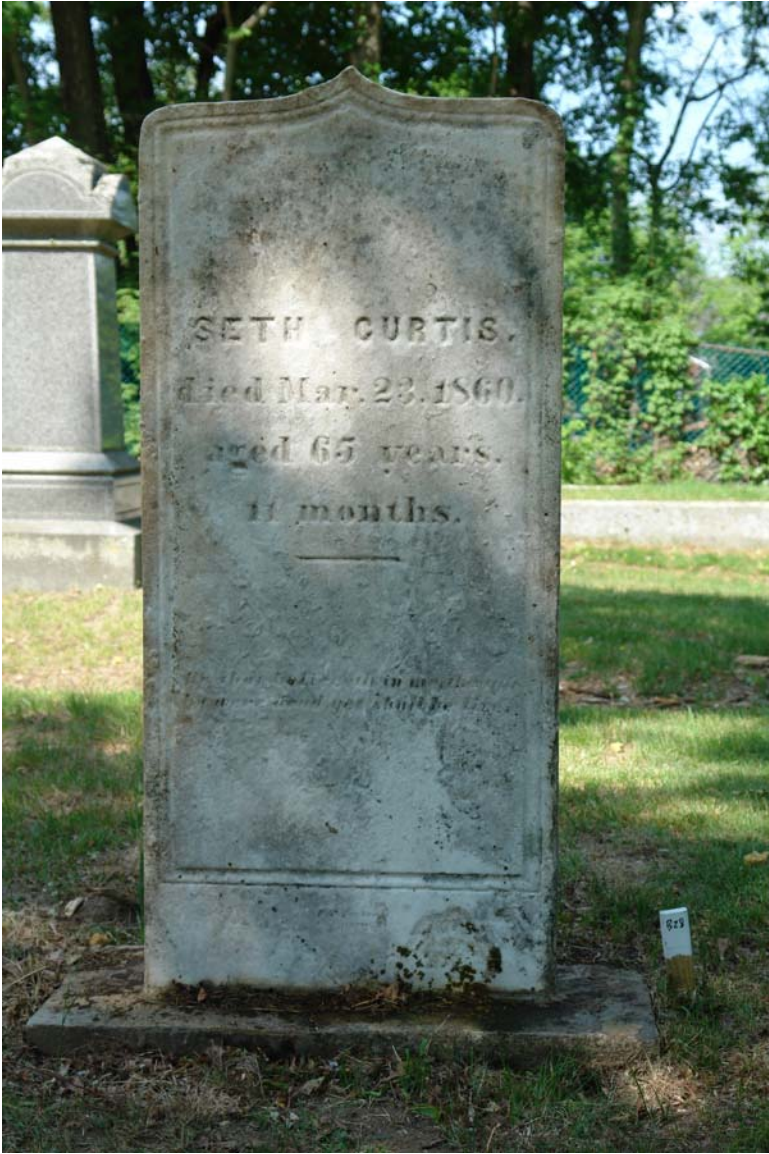
Union Assinippi Cemetery, Hanover, MA	
NAME ON MARKER	Seth Curtis
Death Date: 3/23/1860	Marker Type: Headstone/base
Cond. of Inscription: Legible	Material: Marble
EXISTING CONDITIONS	CONSERVATION STRATEGY
Off base Tilted base	Level base Reset marker
TREATMENT Treatment Dates 5/12-13/2015	
<div>1. Area excavated to an appropriate depth removing any roots or large stones.</div> <div>2. Base inspected and found to be sound and re-useable</div> <div>3. Base is aligned with adjacent markers and re-set level.</div> <div>4. Area around base was backfilled with tamped gravel and re-graded with existing topsoil</div> <div>5. Debris removed from setting slot. When required, power grinders were used to facilitate removal of stone fragments.</div> <div>6. When required, the lower setting edge was re-squared by power grinder with minimal loss.</div> <div>7. Marker reset plumb and level into setting slot with cement/lime grout (3/2/9) with 000 sand made fluid with a super plasticizer.</div> <div>8. Excess grout removed and joint area cleaned.</div> <div>9. Marker braced for a minimum 3 days</div> <div>10. All Surfaces treated with D/2 Biological Solution, scrubbed with nylon brushes and water. Rinsed fully with water</div>

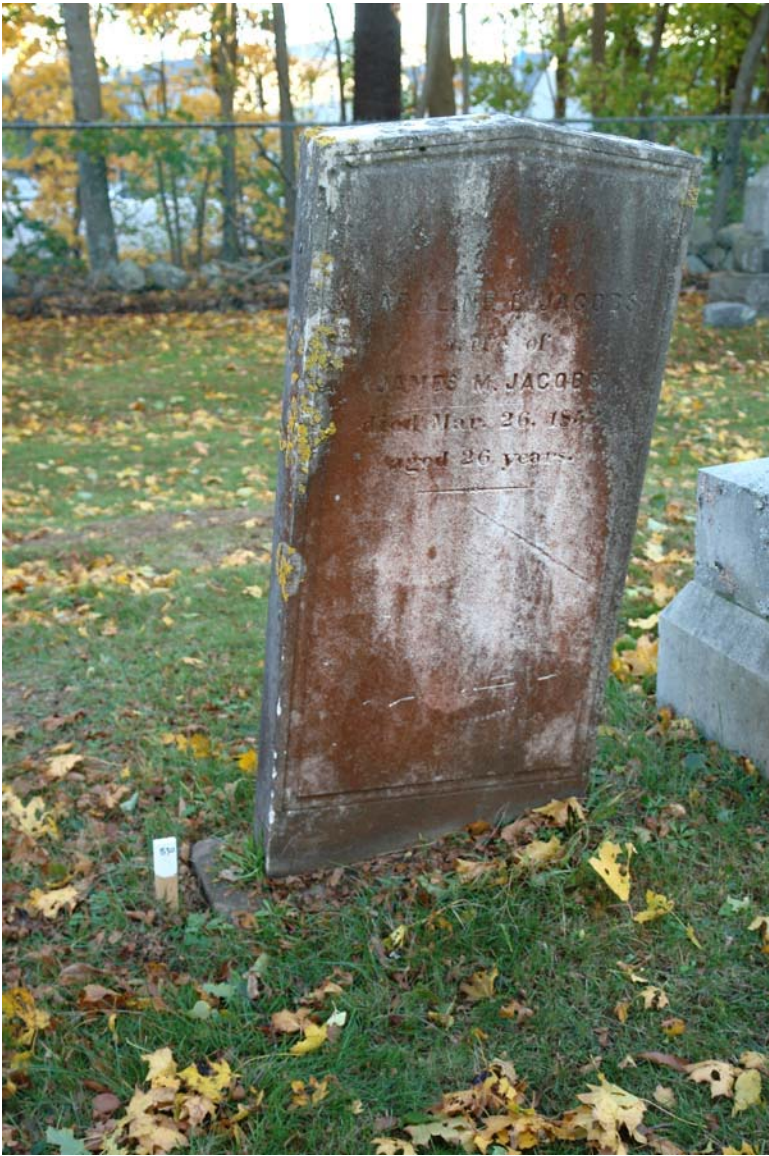
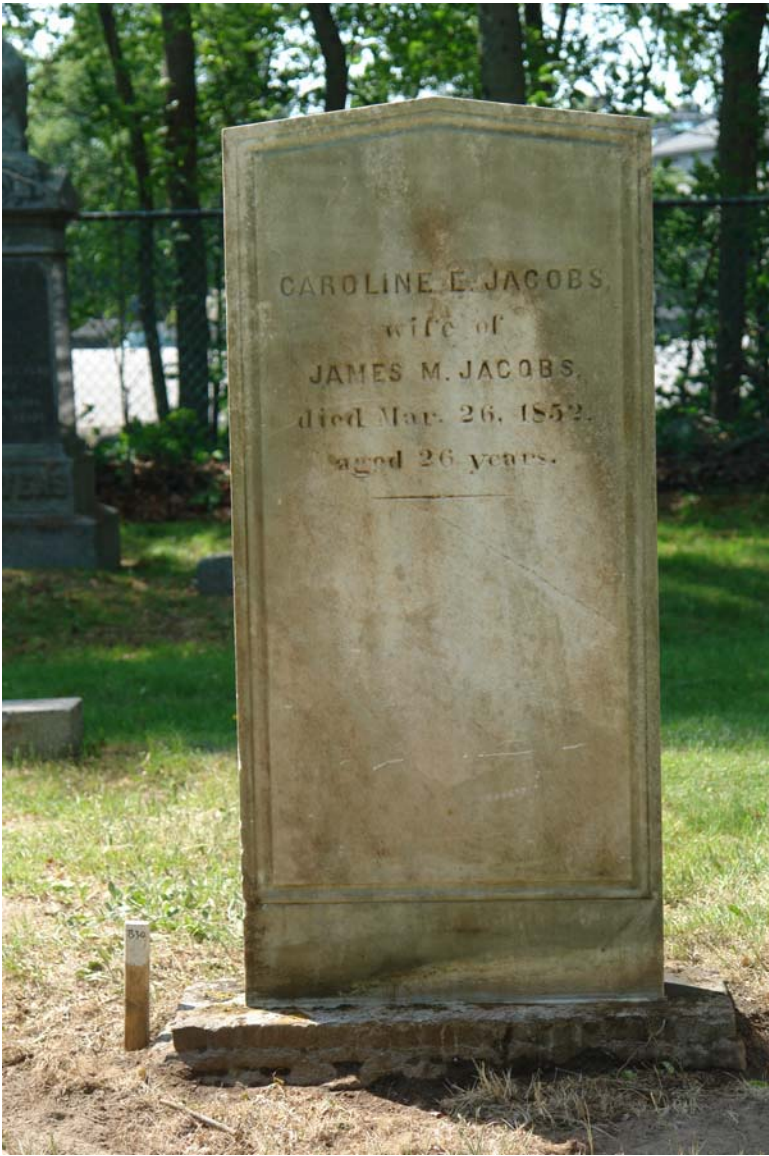
Height 43 Width 20 Thickness 3 Marker# **B.28.1**

Union Assinippi Cemetery, Hanover, MA					
NAME ON MARKER	Caroline Jacobs				
Death Date: 3/26/1852	Marker Type: Headstone/base				
Cond. of Inscription: Legible	Material: Marble				
EXISTING CONDITIONS	CONSERVATION STRATEGY				
Loose in base Tilted	Level base Reset elements				
<table><tr><td>TREATMENT</td><td>Treatment Dates 5/18-20/2015</td></tr><tr><td colspan="2"><div>1. Area excavated to an appropriate depth removing any roots or large stones.</div><div>2. Base inspected and found to be sound and re-useable</div><div>3. Base is aligned with adjacent markers and re-set level.</div><div>4. Area around base was backfilled with tamped gravel and re-graded with existing topsoil</div><div>5. Debris removed from setting slot. When required, power grinders were used to facilitate removal of stone fragments.</div><div>6. When required, the lower setting edge was re-squared by power grinder with minimal loss.</div><div>7. Marker reset plumb and level into setting slot with cement/lime grout (3/2/9) with 000 sand made fluid with a super plasticizer.</div><div>8. Excess grout removed and joint area cleaned.</div><div>9. Marker braced for a minimum 3 days</div><div>10. All Surfaces treated with D/2 Biological Solution, scrubbed with nylon brushes and water. Rinsed fully with water</div></td></tr></table>		TREATMENT	Treatment Dates 5/18-20/2015	<div>1. Area excavated to an appropriate depth removing any roots or large stones.</div> <div>2. Base inspected and found to be sound and re-useable</div> <div>3. Base is aligned with adjacent markers and re-set level.</div> <div>4. Area around base was backfilled with tamped gravel and re-graded with existing topsoil</div> <div>5. Debris removed from setting slot. When required, power grinders were used to facilitate removal of stone fragments.</div> <div>6. When required, the lower setting edge was re-squared by power grinder with minimal loss.</div> <div>7. Marker reset plumb and level into setting slot with cement/lime grout (3/2/9) with 000 sand made fluid with a super plasticizer.</div> <div>8. Excess grout removed and joint area cleaned.</div> <div>9. Marker braced for a minimum 3 days</div> <div>10. All Surfaces treated with D/2 Biological Solution, scrubbed with nylon brushes and water. Rinsed fully with water</div>	
TREATMENT	Treatment Dates 5/18-20/2015				
<div>1. Area excavated to an appropriate depth removing any roots or large stones.</div> <div>2. Base inspected and found to be sound and re-useable</div> <div>3. Base is aligned with adjacent markers and re-set level.</div> <div>4. Area around base was backfilled with tamped gravel and re-graded with existing topsoil</div> <div>5. Debris removed from setting slot. When required, power grinders were used to facilitate removal of stone fragments.</div> <div>6. When required, the lower setting edge was re-squared by power grinder with minimal loss.</div> <div>7. Marker reset plumb and level into setting slot with cement/lime grout (3/2/9) with 000 sand made fluid with a super plasticizer.</div> <div>8. Excess grout removed and joint area cleaned.</div> <div>9. Marker braced for a minimum 3 days</div> <div>10. All Surfaces treated with D/2 Biological Solution, scrubbed with nylon brushes and water. Rinsed fully with water</div>

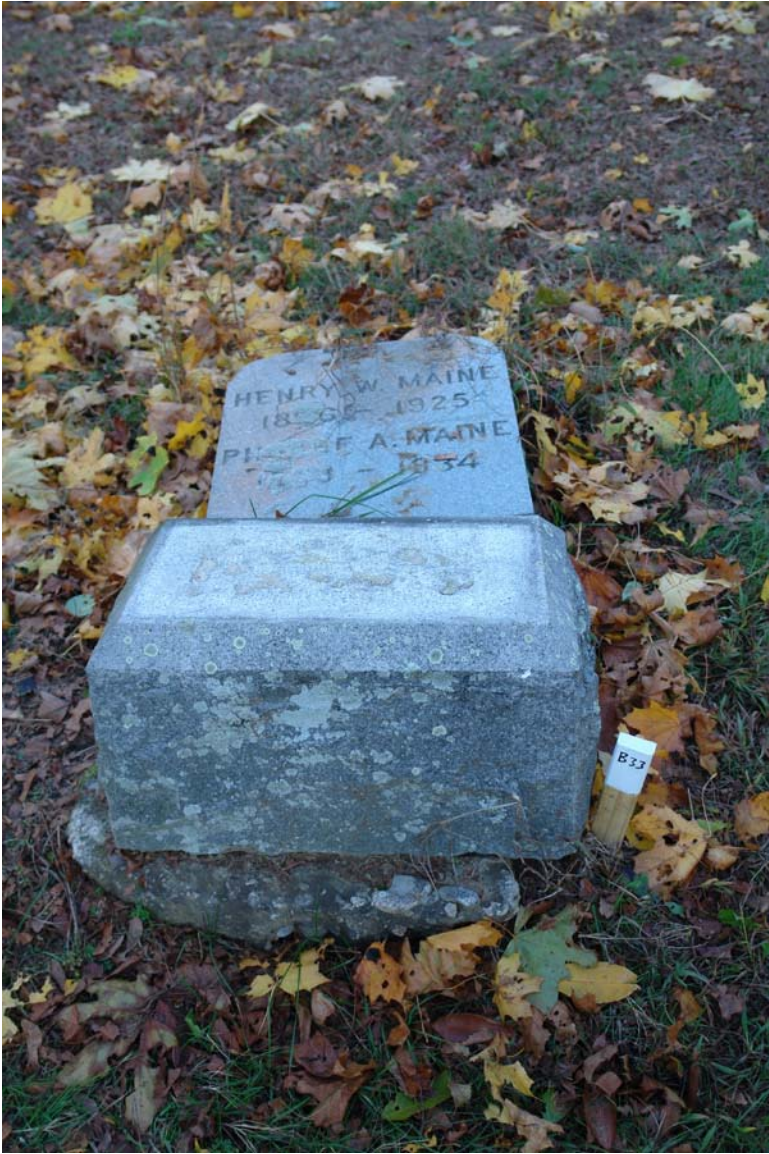
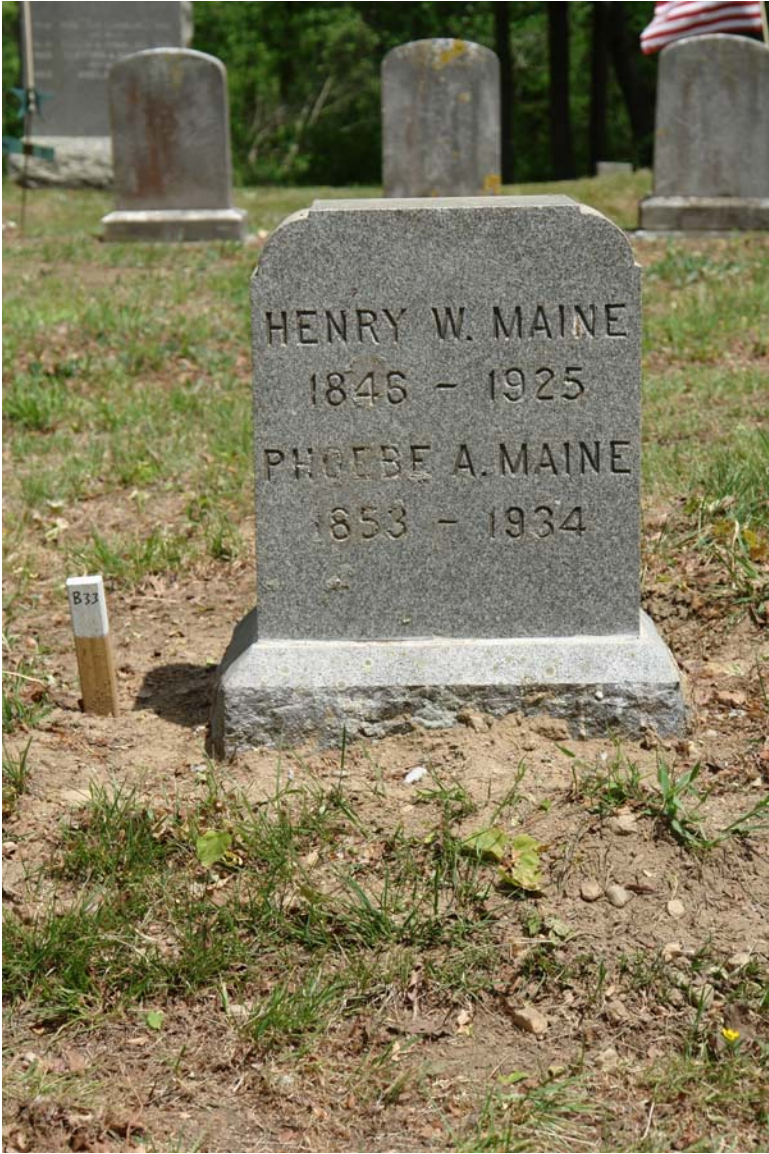
Height 47 Width 22 Thickness 4 Marker# **B.30.1**

EXISTING CONDITIONS	CONSERVATION STRATEGY
Tilted base Reset to base	Reset base plumb Reset marker to base

5. Failed setting mortars removed from setting bed with hand chisels as necessary

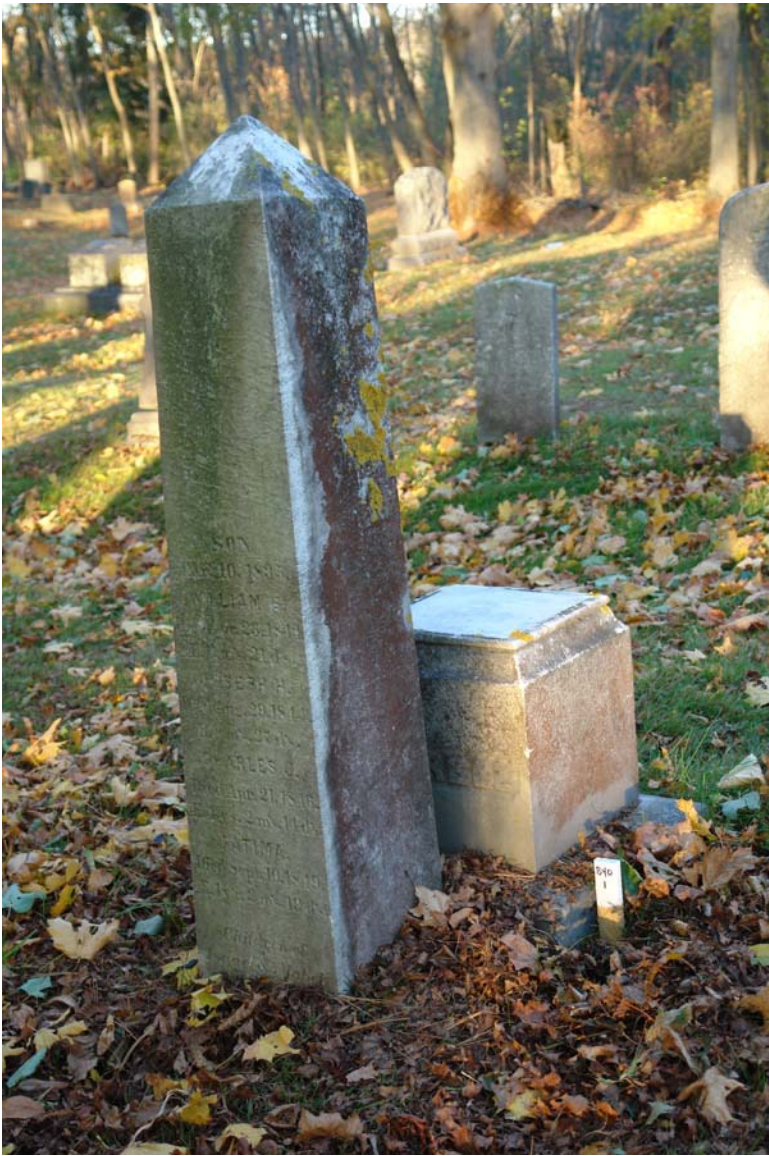
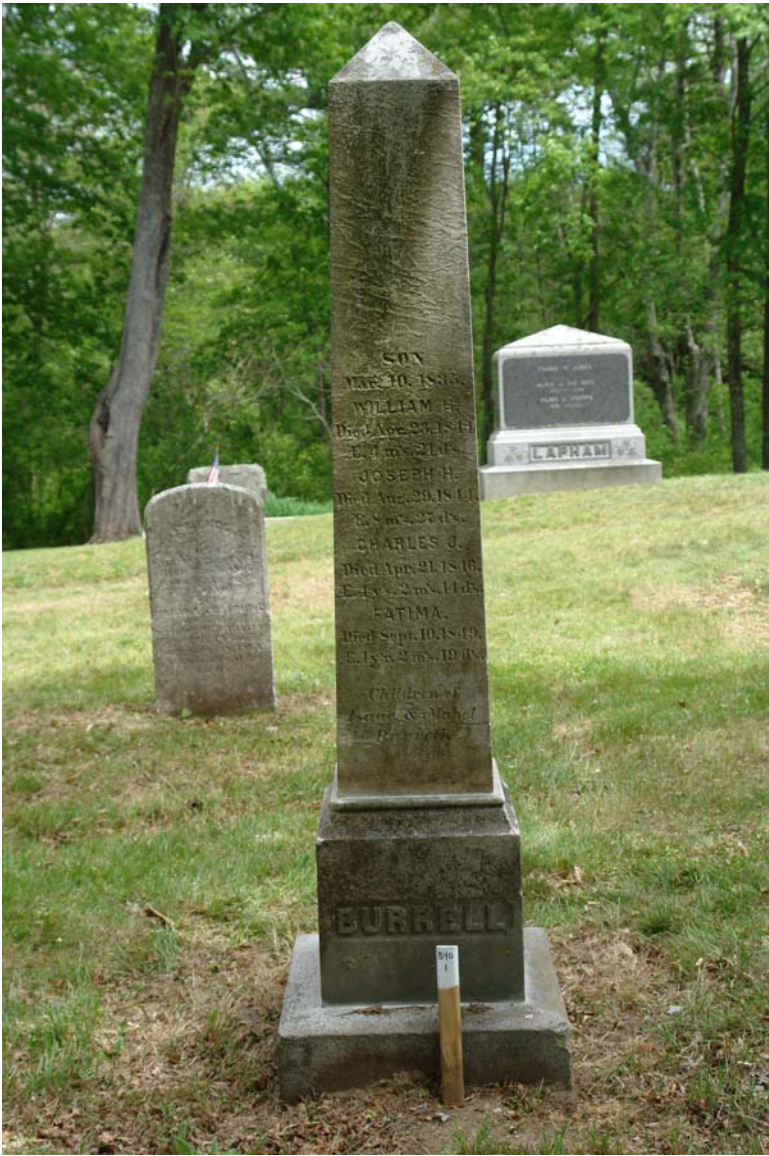
Union Assinippi Cemetery, Hanover, MA	
NAME ON MARKER	Isaac Burrell
Death Date: 5/23/1878	Marker Type: Small obelisk
Cond. of Inscription: Decipherable	Material: Marble
EXISTING CONDITIONS	CONSERVATION STRATEGY
Monument off base	Reset to base
<div>TREATMENT</div> <div>Treatment Dates 5/12/2015</div> <div> <div>1. Elements removed from in-ground base unit and base reset plumb at appropriate height and level, aligned with adjacent markers</div> <div>2. Area around base backfilled with tamped sand and gravel</div> <div>3. Disturbed areas re-graded with existing topsoil.</div> <div>4. Failed setting mortars removed from setting bed as necessary with hand chisels</div> <div>5. Setting bed area primed with Acryl 60 diluted 1:3 with water, intermediate base reset with cement/lime grout (3/2/9) with 000 sand.</div> <div>6. Obelisk reset as above and plumbed as necessary with lead shims.</div> <div>7. Excess grout removed and joint areas cleaned.</div> </div>

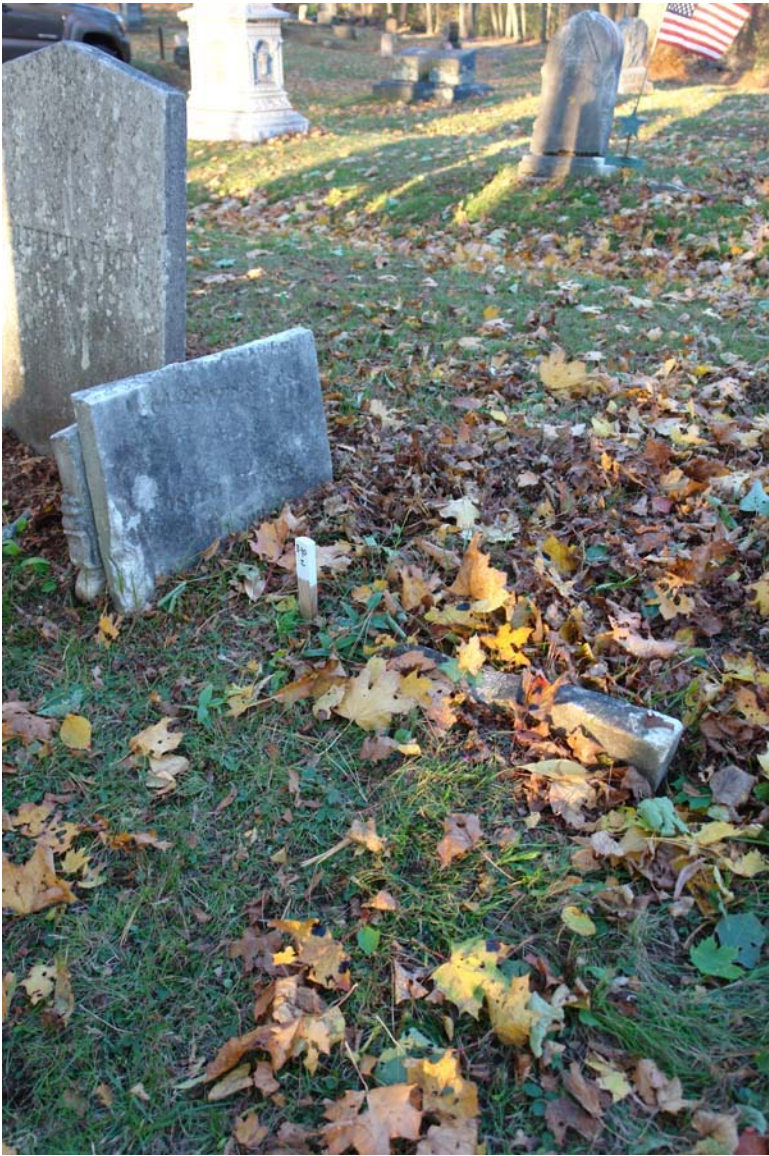
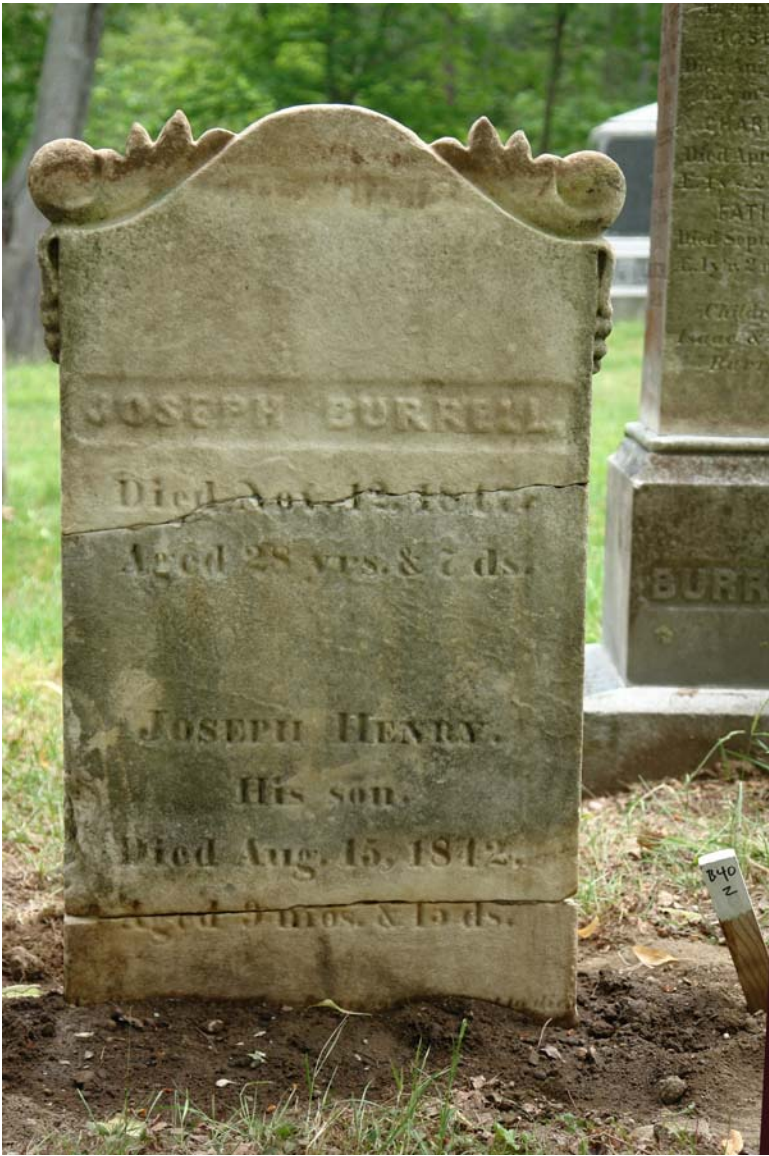
Union Assinippi Cemetery, Hanover, MA	
NAME ON MARKER	Joseph Burrell
Death Date: 11/12/1847	Marker Type: Headstone/base
Cond. of Inscription: Decipherable	Material: Marble
EXISTING CONDITIONS	CONSERVATION STRATEGY
Fractured	Possible new base Structural adhesion
TREATMENT Treatment Dates 6/11-12/2015	
<div>1. Original base discovered while excavating. Base is aligned with adj. markers and reset level at appropriate height.</div> <div>2. Setting slot cleaned of debris or failed mortar and bottom fragment reset plumb and level into setting slot with a cement/lime grout (3/2/9) with 000 sand made fluid with a super plasticizer.</div> <div>3. Marker braced for a minimum 3 days</div> <div>4. All mating edges of fragments cleaned with water and any failed adhesives removed with hand tools</div> <div>5. Fragments attached with structural adhesive (Abatron 55-22), clamped and braced until cured. Excess epoxy removed with hand chisels within 24 hours.</div> <div>6. Cracks and losses filled with RepliCal Marble products, filled areas misted with water and covered for 3 days minimum</div> <div>7. Filled areas treated with light acid wash and rinsed thoroughly.</div> <div>8. All Surfaces treated with D/2 Biological Solution, scrubbed with nylon brushes and water. Rinsed fully with water</div>

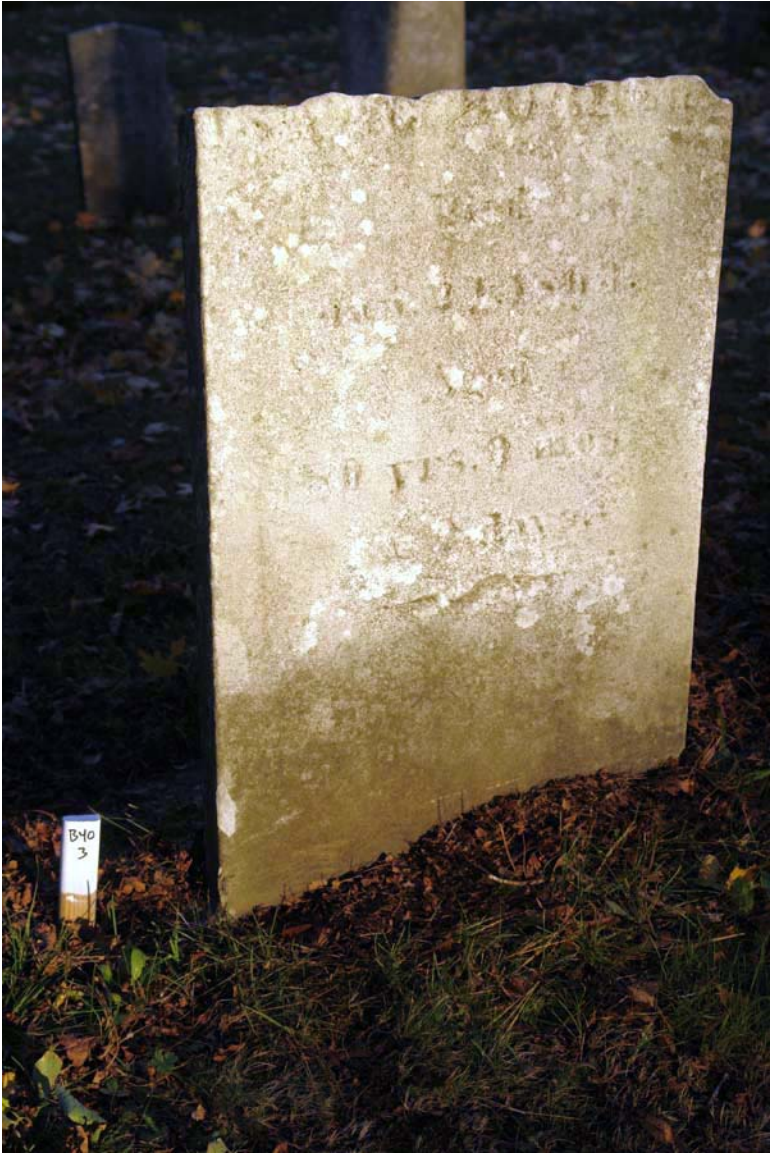
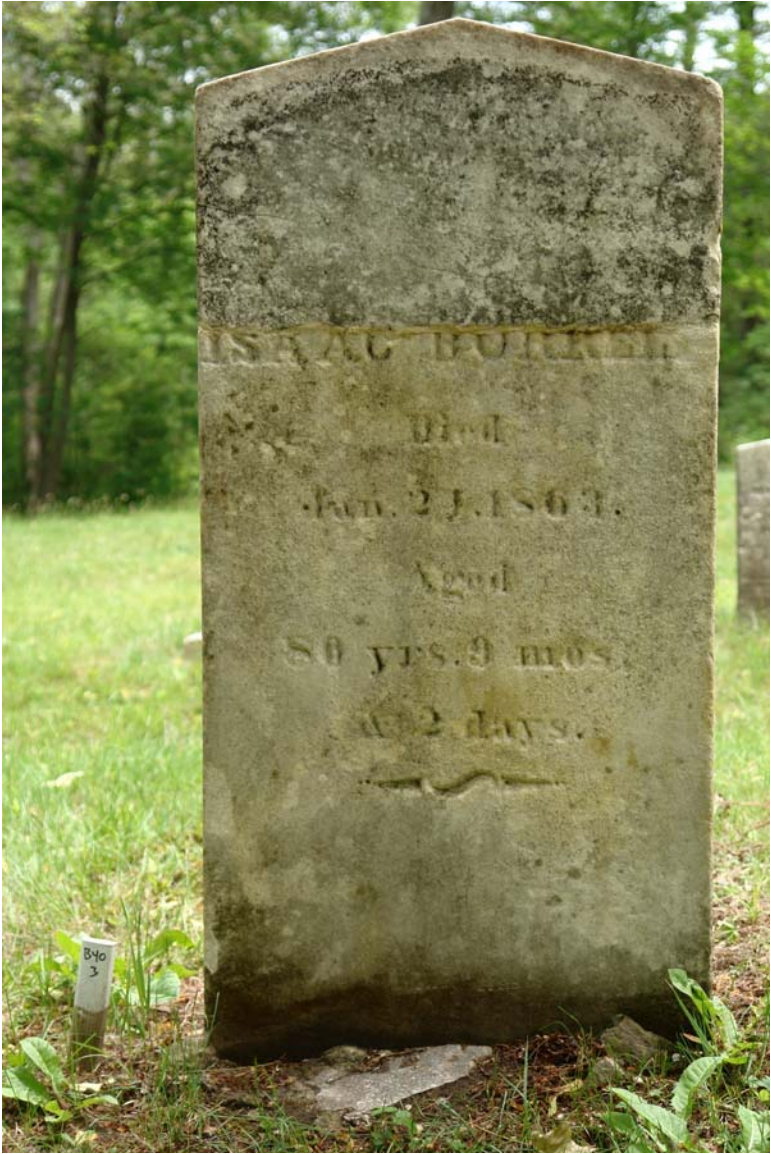
Union Assinippi Cemetery, Hanover, MA	
NAME ON MARKER	Isaac Burrell
Death Date: 1/24/1863	Marker Type: Headstone
Cond. of Inscription: Decipherable	Material: Marble
EXISTING CONDITIONS	CONSERVATION STRATEGY
Fractured	Attach fragments with structural adhesive
TREATMENT Treatment Dates 5/13-20/2015

1. Mating surfaces cleaned and any failed adhesives or mortar removed 2. Where required, mating edges were treated with D/2 Biological Solution, scrubbed with nylon brushes and water. Rinsed fully with water 3. Fractured elements were dry fitted to ascertain final soundness and to check for large losses at mating areas. 4. Dry fragments attached with structural adhesive (Abatron 55-22), clamped and braced until cured. Excess epoxy removed by hand chisels 5. Cracks and voids filled with RepliCal products. Any large losses filled with Jahn cementitious mortar. 6. Filled areas misted with water and covered for 3 days minimum 7. Filled surface areas treated with light acid wash and rinsed thoroughly 8. All surfaces treated with D/2 Biological Solution, scrubbed with nylon brushes and water. Rinsed fully with water

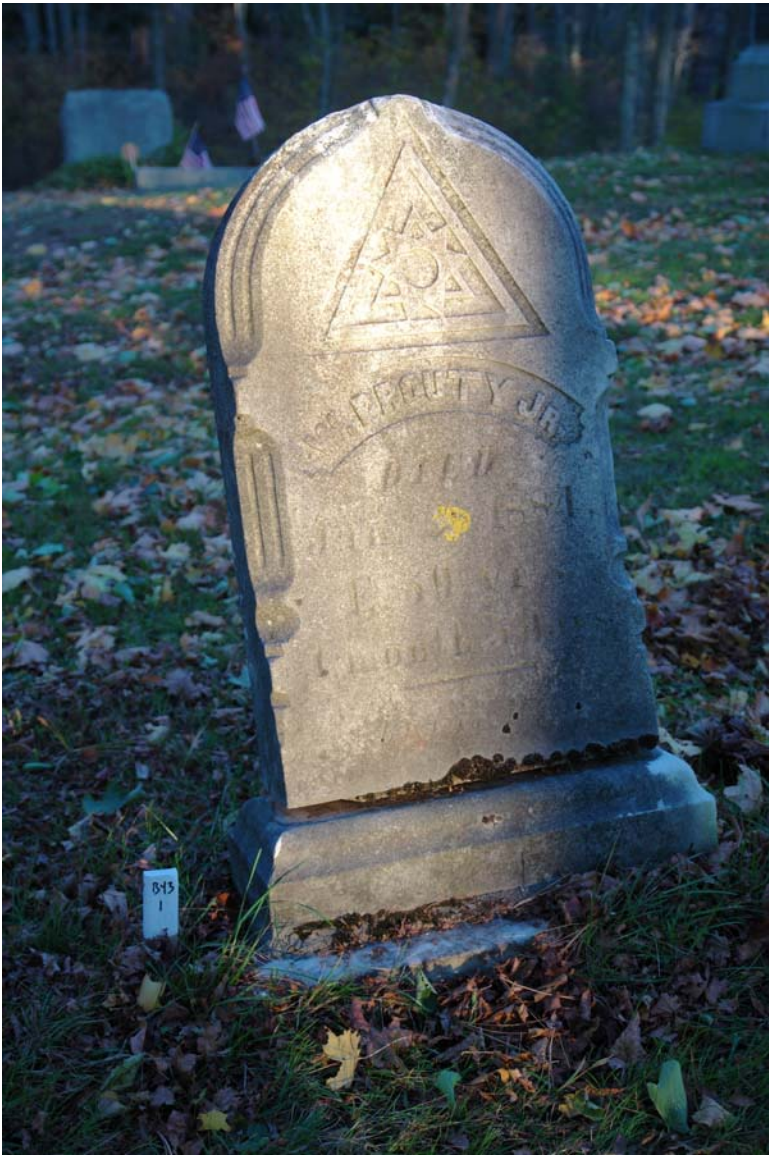
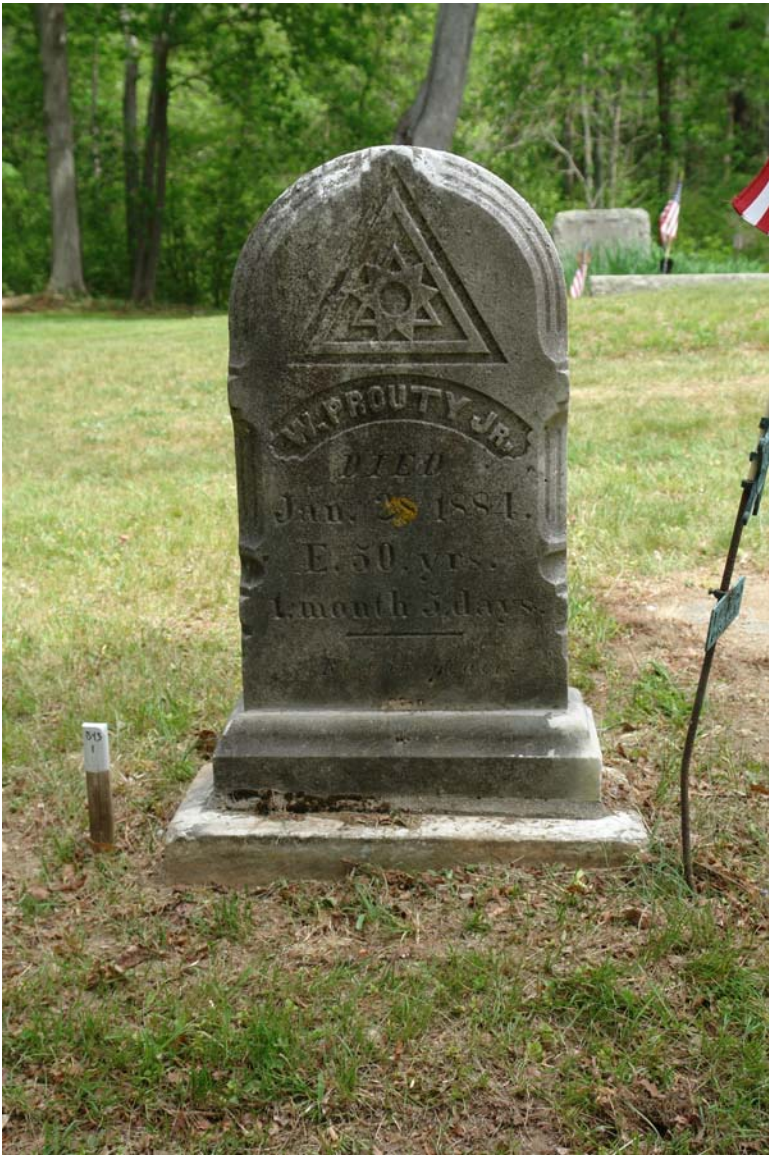
Union Assinippi Cemetery, Hanover, MA	
NAME ON MARKER	Martha Prouty
Death Date: n.a.	Marker Type: Headstone
Cond. of Inscription: n.a.	Material: Marble
EXISTING CONDITIONS	CONSERVATION STRATEGY
Fallen, fractured	Evaluate Reset if possible
TREATMENT	Treatment Dates
Area probed unsuccessfully for additional fragments. Remaining fragments found to be sugary and not restorable

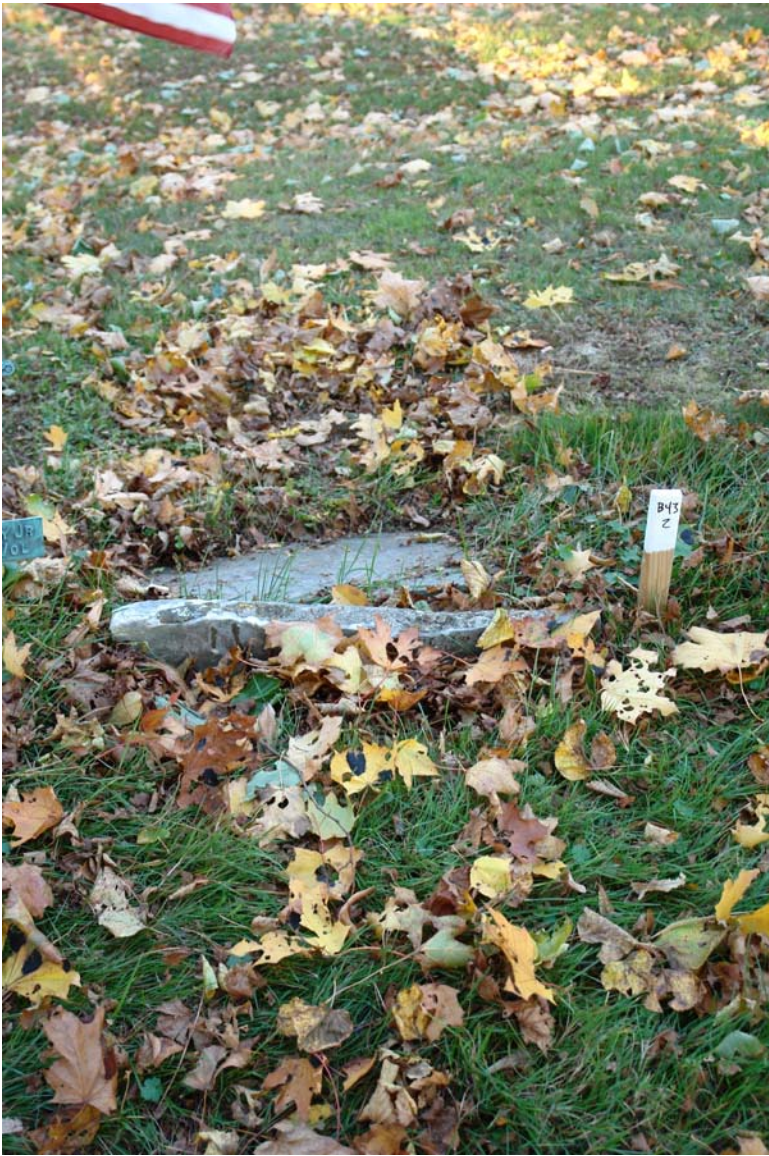
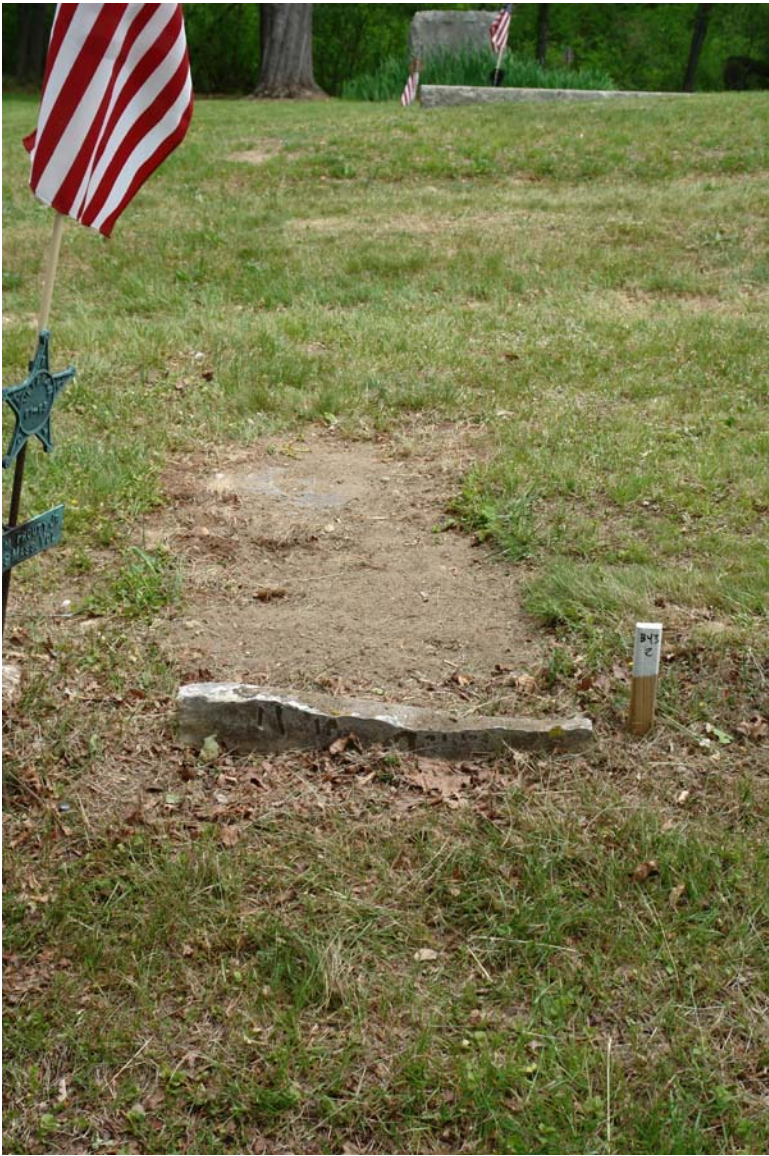
Height - Width - Thickness - Marker# **B.43.2**

Union Assinippi Cemetery, Hanover, MA	
NAME ON MARKER	Eliza Curtis
Death Date: 5/18/1905	Marker Type: Headstone/base
Cond. of Inscription: Decipherable	Material: Marble
EXISTING CONDITIONS	CONSERVATION STRATEGY
Tilted base	Reset base with marker plumb
TREATMENT Treatment Dates 5/18/2015	
<div>1. Soil removed around base unit.</div> <div>2. Base re-set plumb at appropriate height and level, aligned with adjacent markers</div> <div>3. Area around base backfilled with tamped sand and gravel</div> <div>4. Disturbed areas re-graded with existing topsoil.</div> <div>5. Failed setting mortars removed from setting bed with hand chisels as necessary</div> <div>6. Setting bed area primed with Acryl 60 diluted 1:3 with water, marker reset with cement/lime grout (3/2/9) with 000 sand.</div> <div>7. Marker plumbed as necessary with lead shims.</div> <div>8. Excess grout removed and joint area cleaned.</div>
