DOCUMENTATION OF STONE CONSERVATION TREATMENTS TO ASSINIPPI CEMETERY, HANOVER, MA June 2015

**MONUMENT CONSERVATION COLLABORATIVE LLC, NORFOLK, CT**

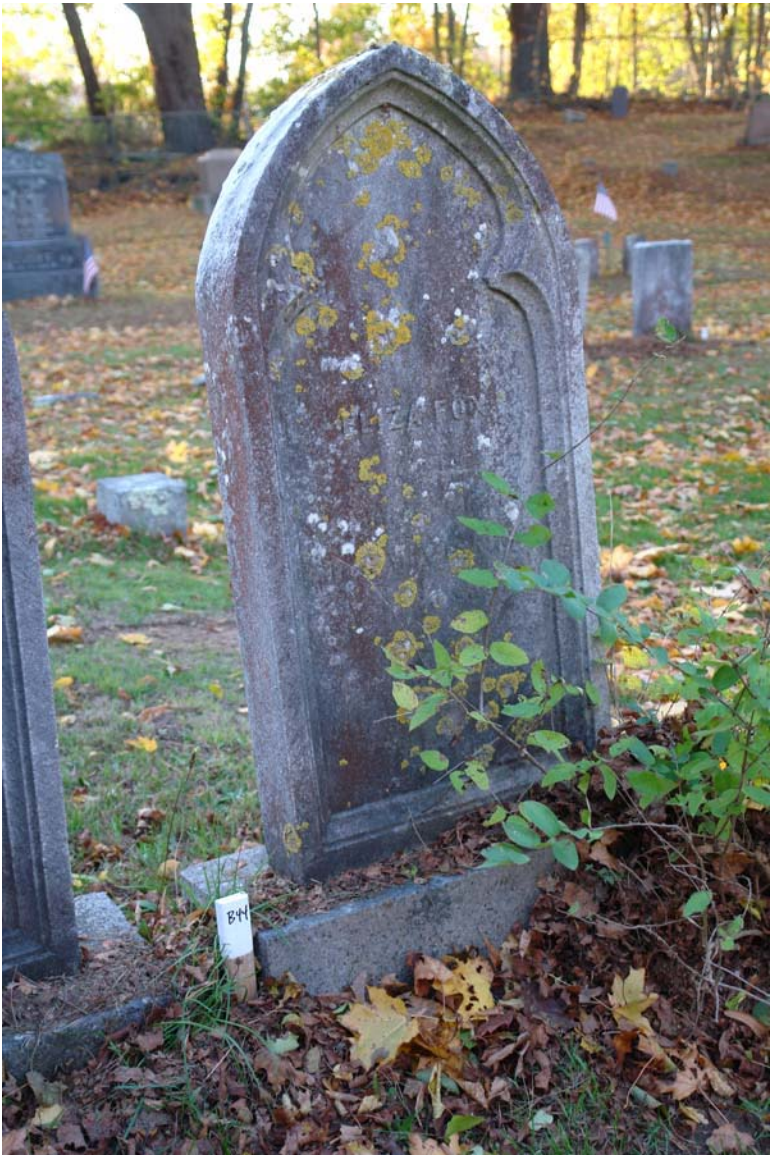
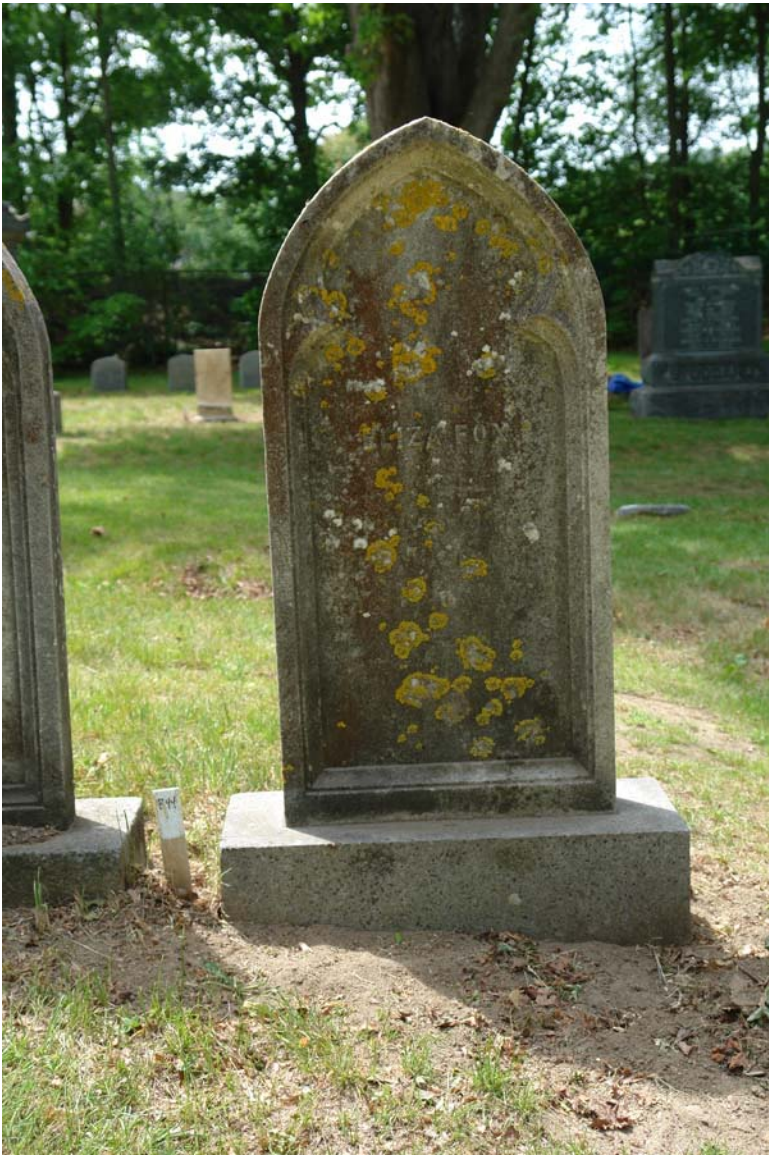
Height 37 Width 18 Thickness 4 Marker# **B.44.1**

EXISTING CONDITIONS	CONSERVATION STRATEGY
Fallen, fractured	Evaluate Reset if possible

Area probed unsuccessfully for additional fragments.
Remaining fragment found to be sugary and not restorable

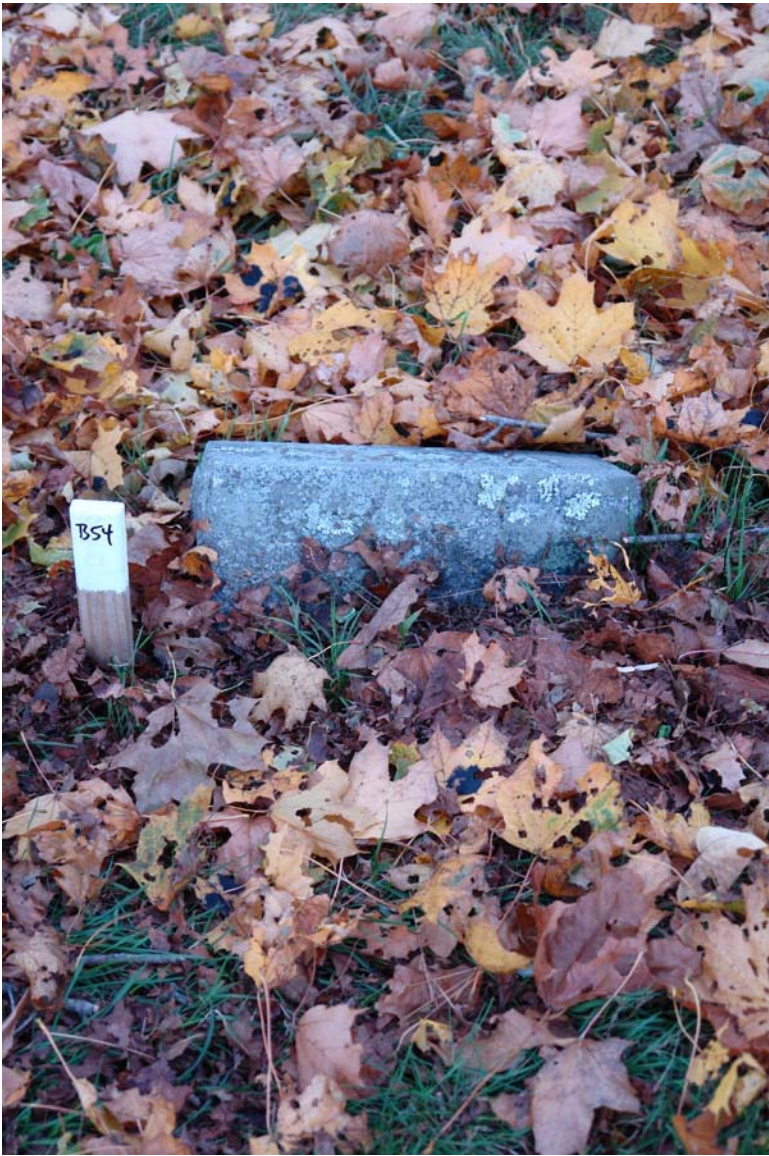
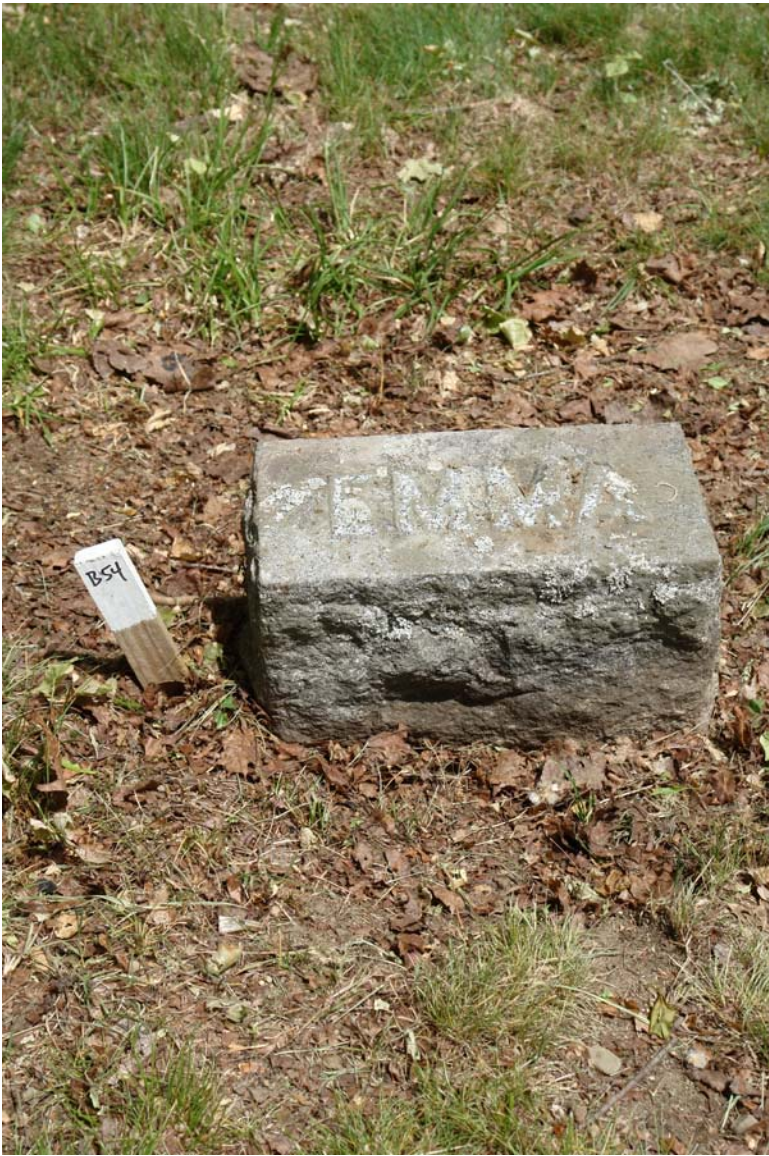
EXISTING CONDITIONS	CONSERVATION STRATEGY
Marker off base	Check base for level Reset marker

1. Marker excavated and found to be sound. Light soiling removed by brushing with nylon brushes and water.
 2. No existing bases were found. Setting area excavated for new below grade cast concrete base using a 8" sonotube as a form about 18" deep. .
 3. Marker was reset onto new base with a cement/lime mortar (3/2/9) with 000 sand

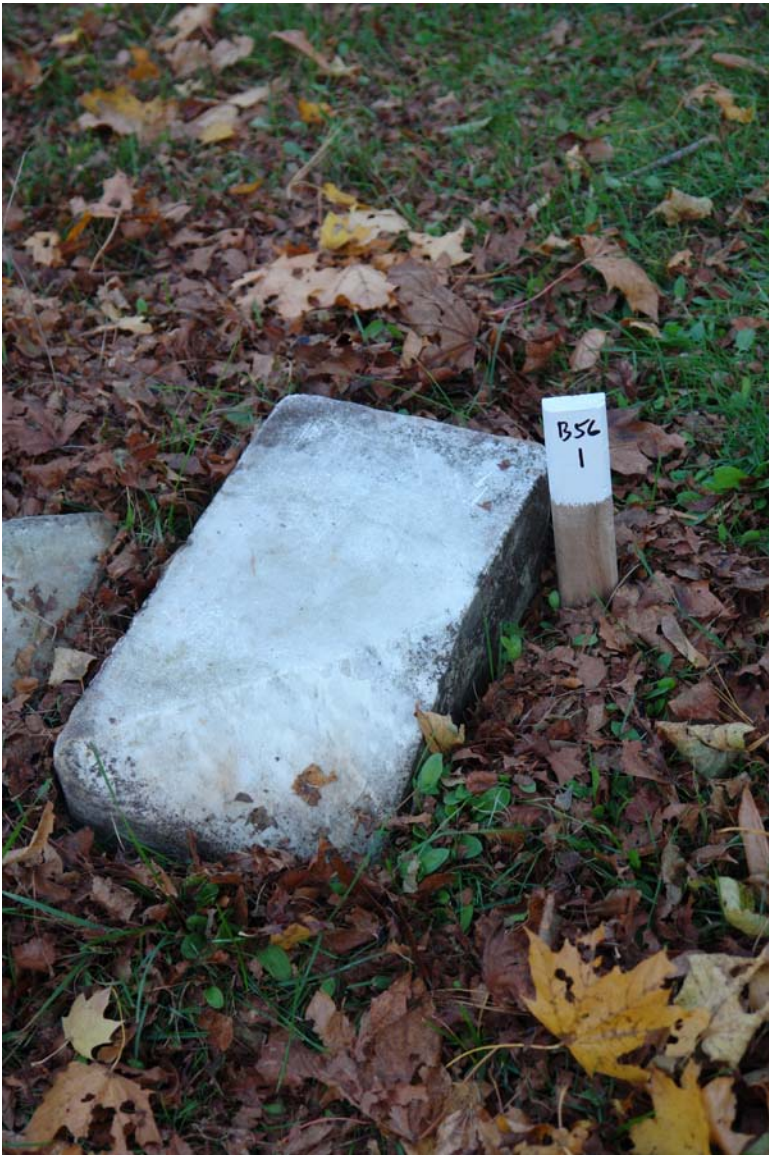
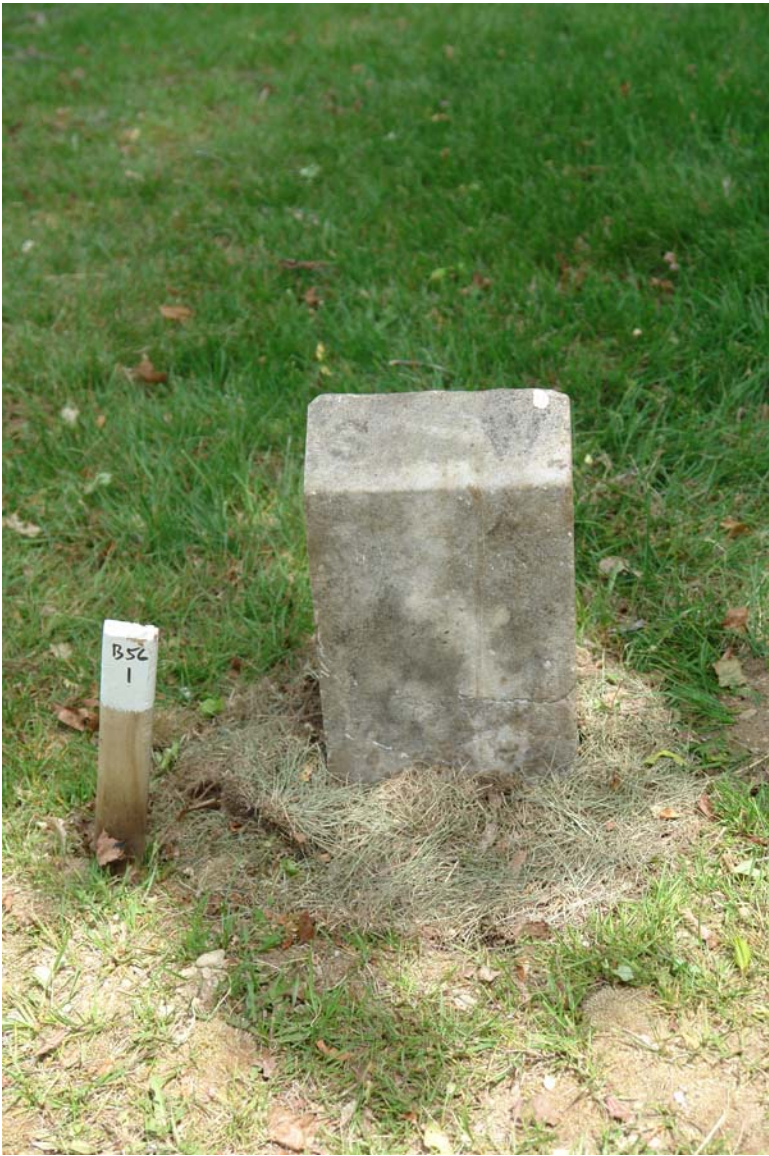
Union Assinippi Cemetery, Hanover, MA	
NAME ON MARKER	D.R.W (Deborah Wade)
Death Date: 3/11/1888	Marker Type: Small marker/base
Cond. of Inscription: Legible	Material: Marble

EXISTING CONDITIONS	CONSERVATION STRATEGY
Marker off base	Check base for level Reset marker

TREATMENT	Treatment Dates 5/18-19/2015
1. Marker excavated and found to be sound. Light soiling removed by brushing with nylon brushes and water.	
2. No existing bases were found. Setting area excavated for new below grade cast concrete base using a 8” sonotube as a form about 18” deep. .	
3. Marker was reset onto new base with a cement/lime mortar (3/2/9) with 000 sand

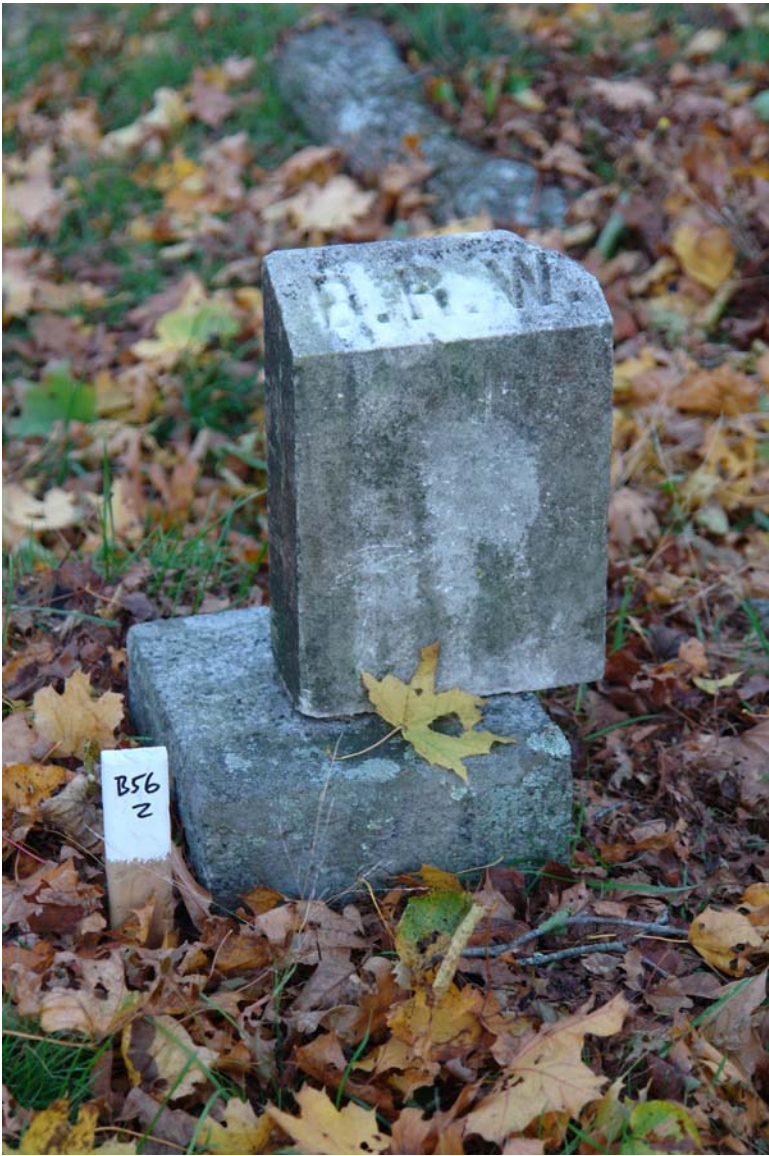
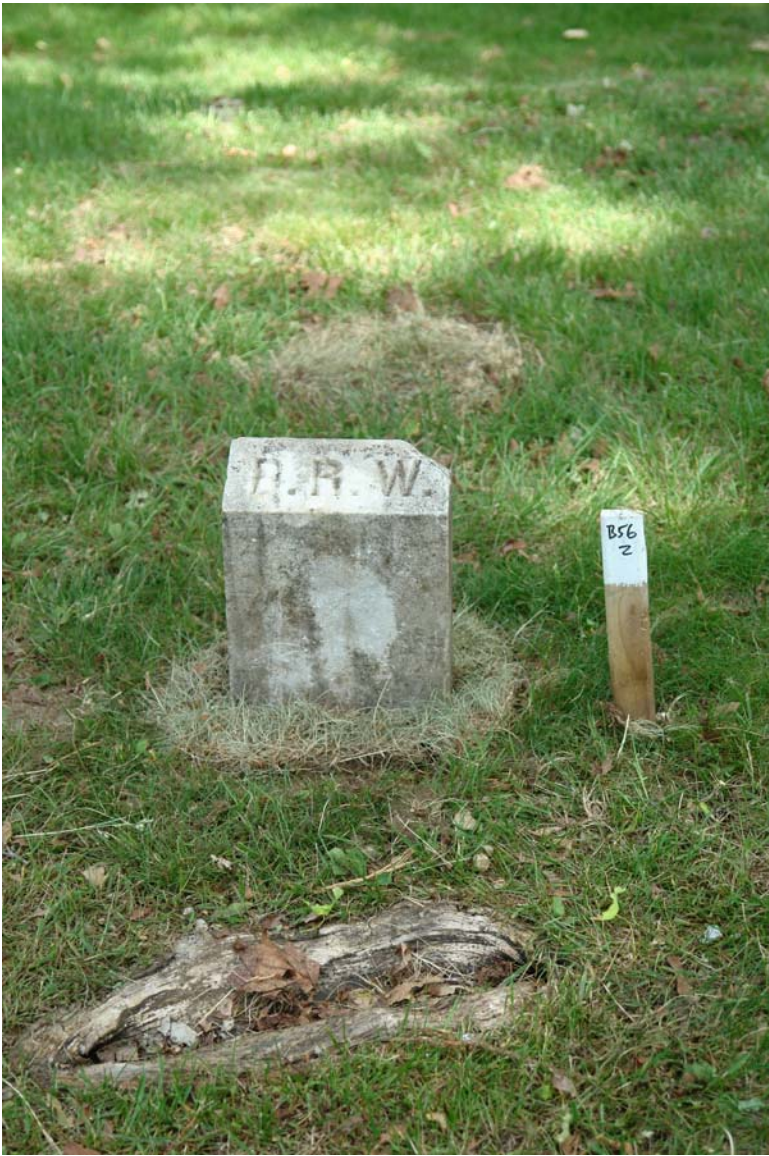
Height - Width - Thickness - Marker# **B.56.2**

Union Assinippi Cemetery, Hanover, MA					
NAME ON MARKER	Sarah Lapham				
Death Date: 8/11/1886	Marker Type: Headstone/base				
Cond. of Inscription: Legible	Material: Marble				
EXISTING CONDITIONS	CONSERVATION STRATEGY				
Tilted base	Reset base with marker plumb				
<table><tr><td>TREATMENT</td><td>Treatment Dates 5/13/2015</td></tr><tr><td colspan="2"><div>1. Soil removed around base unit. 2. Base re-set plumb at appropriate height and level, aligned with adjacent markers 3. Area around base backfilled with tamped sand and gravel 4. Disturbed areas re-graded with existing topsoil. 5. Failed setting mortars removed from setting bed with hand chisels as necessary 6. Setting bed area primed with Acryl 60 diluted 1:3 with water, marker reset with cement/lime grout (3/2/9) with 000 sand. 7. Marker plumbed as necessary with lead shims. 8. Excess grout removed and joint area cleaned.</div></td></tr></table>		TREATMENT	Treatment Dates 5/13/2015	<div>1. Soil removed around base unit. 2. Base re-set plumb at appropriate height and level, aligned with adjacent markers 3. Area around base backfilled with tamped sand and gravel 4. Disturbed areas re-graded with existing topsoil. 5. Failed setting mortars removed from setting bed with hand chisels as necessary 6. Setting bed area primed with Acryl 60 diluted 1:3 with water, marker reset with cement/lime grout (3/2/9) with 000 sand. 7. Marker plumbed as necessary with lead shims. 8. Excess grout removed and joint area cleaned.</div>	
TREATMENT	Treatment Dates 5/13/2015				
<div>1. Soil removed around base unit. 2. Base re-set plumb at appropriate height and level, aligned with adjacent markers 3. Area around base backfilled with tamped sand and gravel 4. Disturbed areas re-graded with existing topsoil. 5. Failed setting mortars removed from setting bed with hand chisels as necessary 6. Setting bed area primed with Acryl 60 diluted 1:3 with water, marker reset with cement/lime grout (3/2/9) with 000 sand. 7. Marker plumbed as necessary with lead shims. 8. Excess grout removed and joint area cleaned.</div>
