# ROAD SAFETY AUDIT

Route 139 (Hanover Street) at  
Main Street, Center Street, and Silver Street  
Town of Hanover  
December 8, 2023

Prepared For:  
MassDOT

Prepared By:  
Tighe & Bond, Inc.

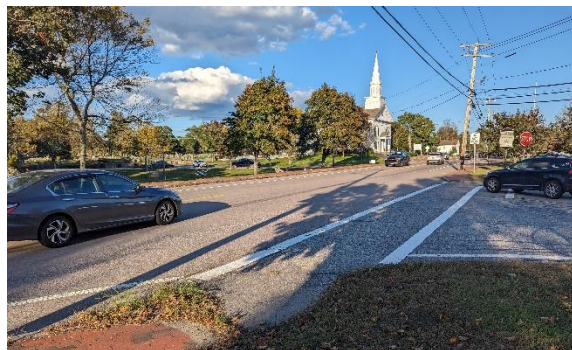
Brick sidewalks are present along both sides of Route 139 through the Town Center. No sidewalks are provided on Center Street. A crosswalk is provided across the Center Street approach to Route 139.

**Image 1: Route 139 at Center Street (looking east)**

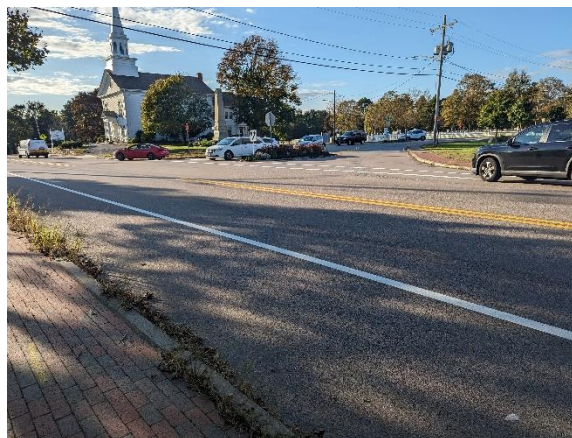
Route 139 and Main Street form a 3-legged, T-type intersection with Main Street under STOP sign control. Main Street is median divided at its intersection with Route 139, with wide approach and departure lanes. The approach lane on Main Street is wide enough for left and right turning vehicles to stack side by side; faded arrow markings are provided conveying separate left and right turn lanes, although lane striping is not provided. Route 139 provides a single lane of travel in each direction at its intersection with Main Street with wide shoulders, which are at times used by eastbound through drivers when vehicles are queued to make a left turn to Main Street.

**Image 2: Route 139 at Main Street (looking west)**

- Evaluate turning paths and existing median island on Main Street at Route 139. In addition to the recommendation above to evaluate the corner radius to reduce turning speeds, the median island should be reviewed to determine whether it impedes larger vehicle movements, as suggested by tire tracks observed in the median on the day of the audit.

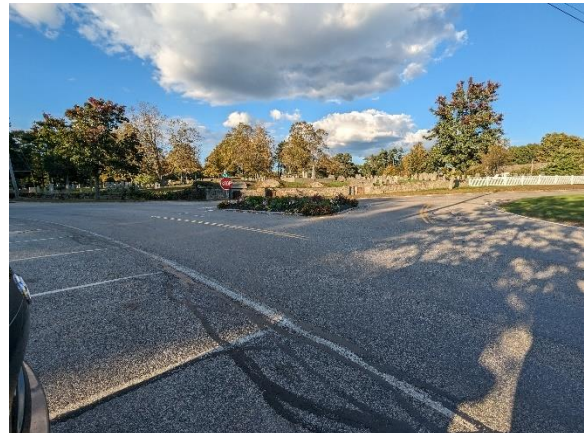
No pedestrian accommodations are provided at the intersection. Head-in perpendicular parking along Briggs field continues along the western side of Center Street through this intersection, with the northern limit of parking abutting Main Street.

**Image 3: Center Street at Main Street  
(looking north)**

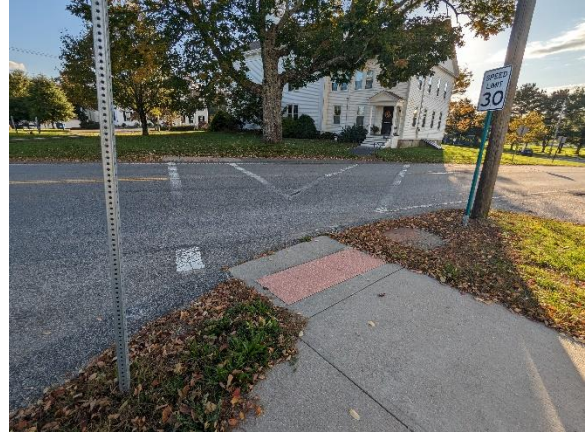
Finally, the V-shaped crosswalks across Main Street at Silver Street were discussed as a potential safety issue. While both crosswalks may be utilized by pedestrians, the presence of dual crosswalks presents potential confusion for drivers as to where conflicts with pedestrians may be encountered.

- Consider pedestrian desire lines in the proposed design. In addition to specific recommendations for consolidation of crosswalks, the overall design should consider the addition or relocation of existing crosswalks as appropriate to meet pedestrian desire lines within the Town Center.

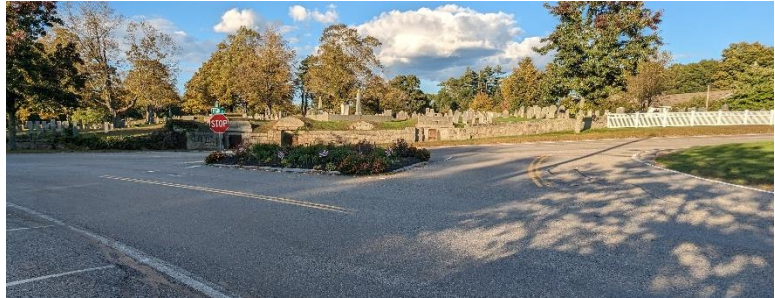
Audit participants also noted that there is only one STOP sign provided where the east leg of Center Street intersects Main Street, although two distinct two-way links are provided which are both assumed to be under stop control. A missing street name sign was also identified on the west leg of Center Street at Main Street. DPW personnel noted that this sign is frequently knocked down.

**Image 5: Missing stop sign for Center Street at Main Street (looking north)**

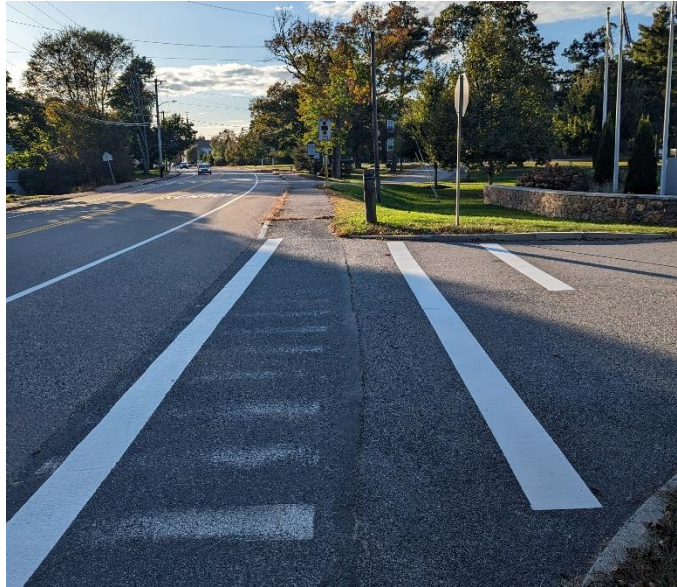
The presence of both current and former schools within and adjacent to the Town Center were noted by audit participants. School zone speed limit signage is presently provided on Route 139 in both directions east of Main Street; however, audit participants noted that the sign placement is likely to support the former Sylvester School and not the current Center Elementary School. This is most apparent westbound, where the flashing school speed limit sign is located beyond the Center School driveway and immediately in advance of the former Sylvester School driveway.

**Image 6: Westbound school zone sign seen looking west from Center Elementary School driveway**

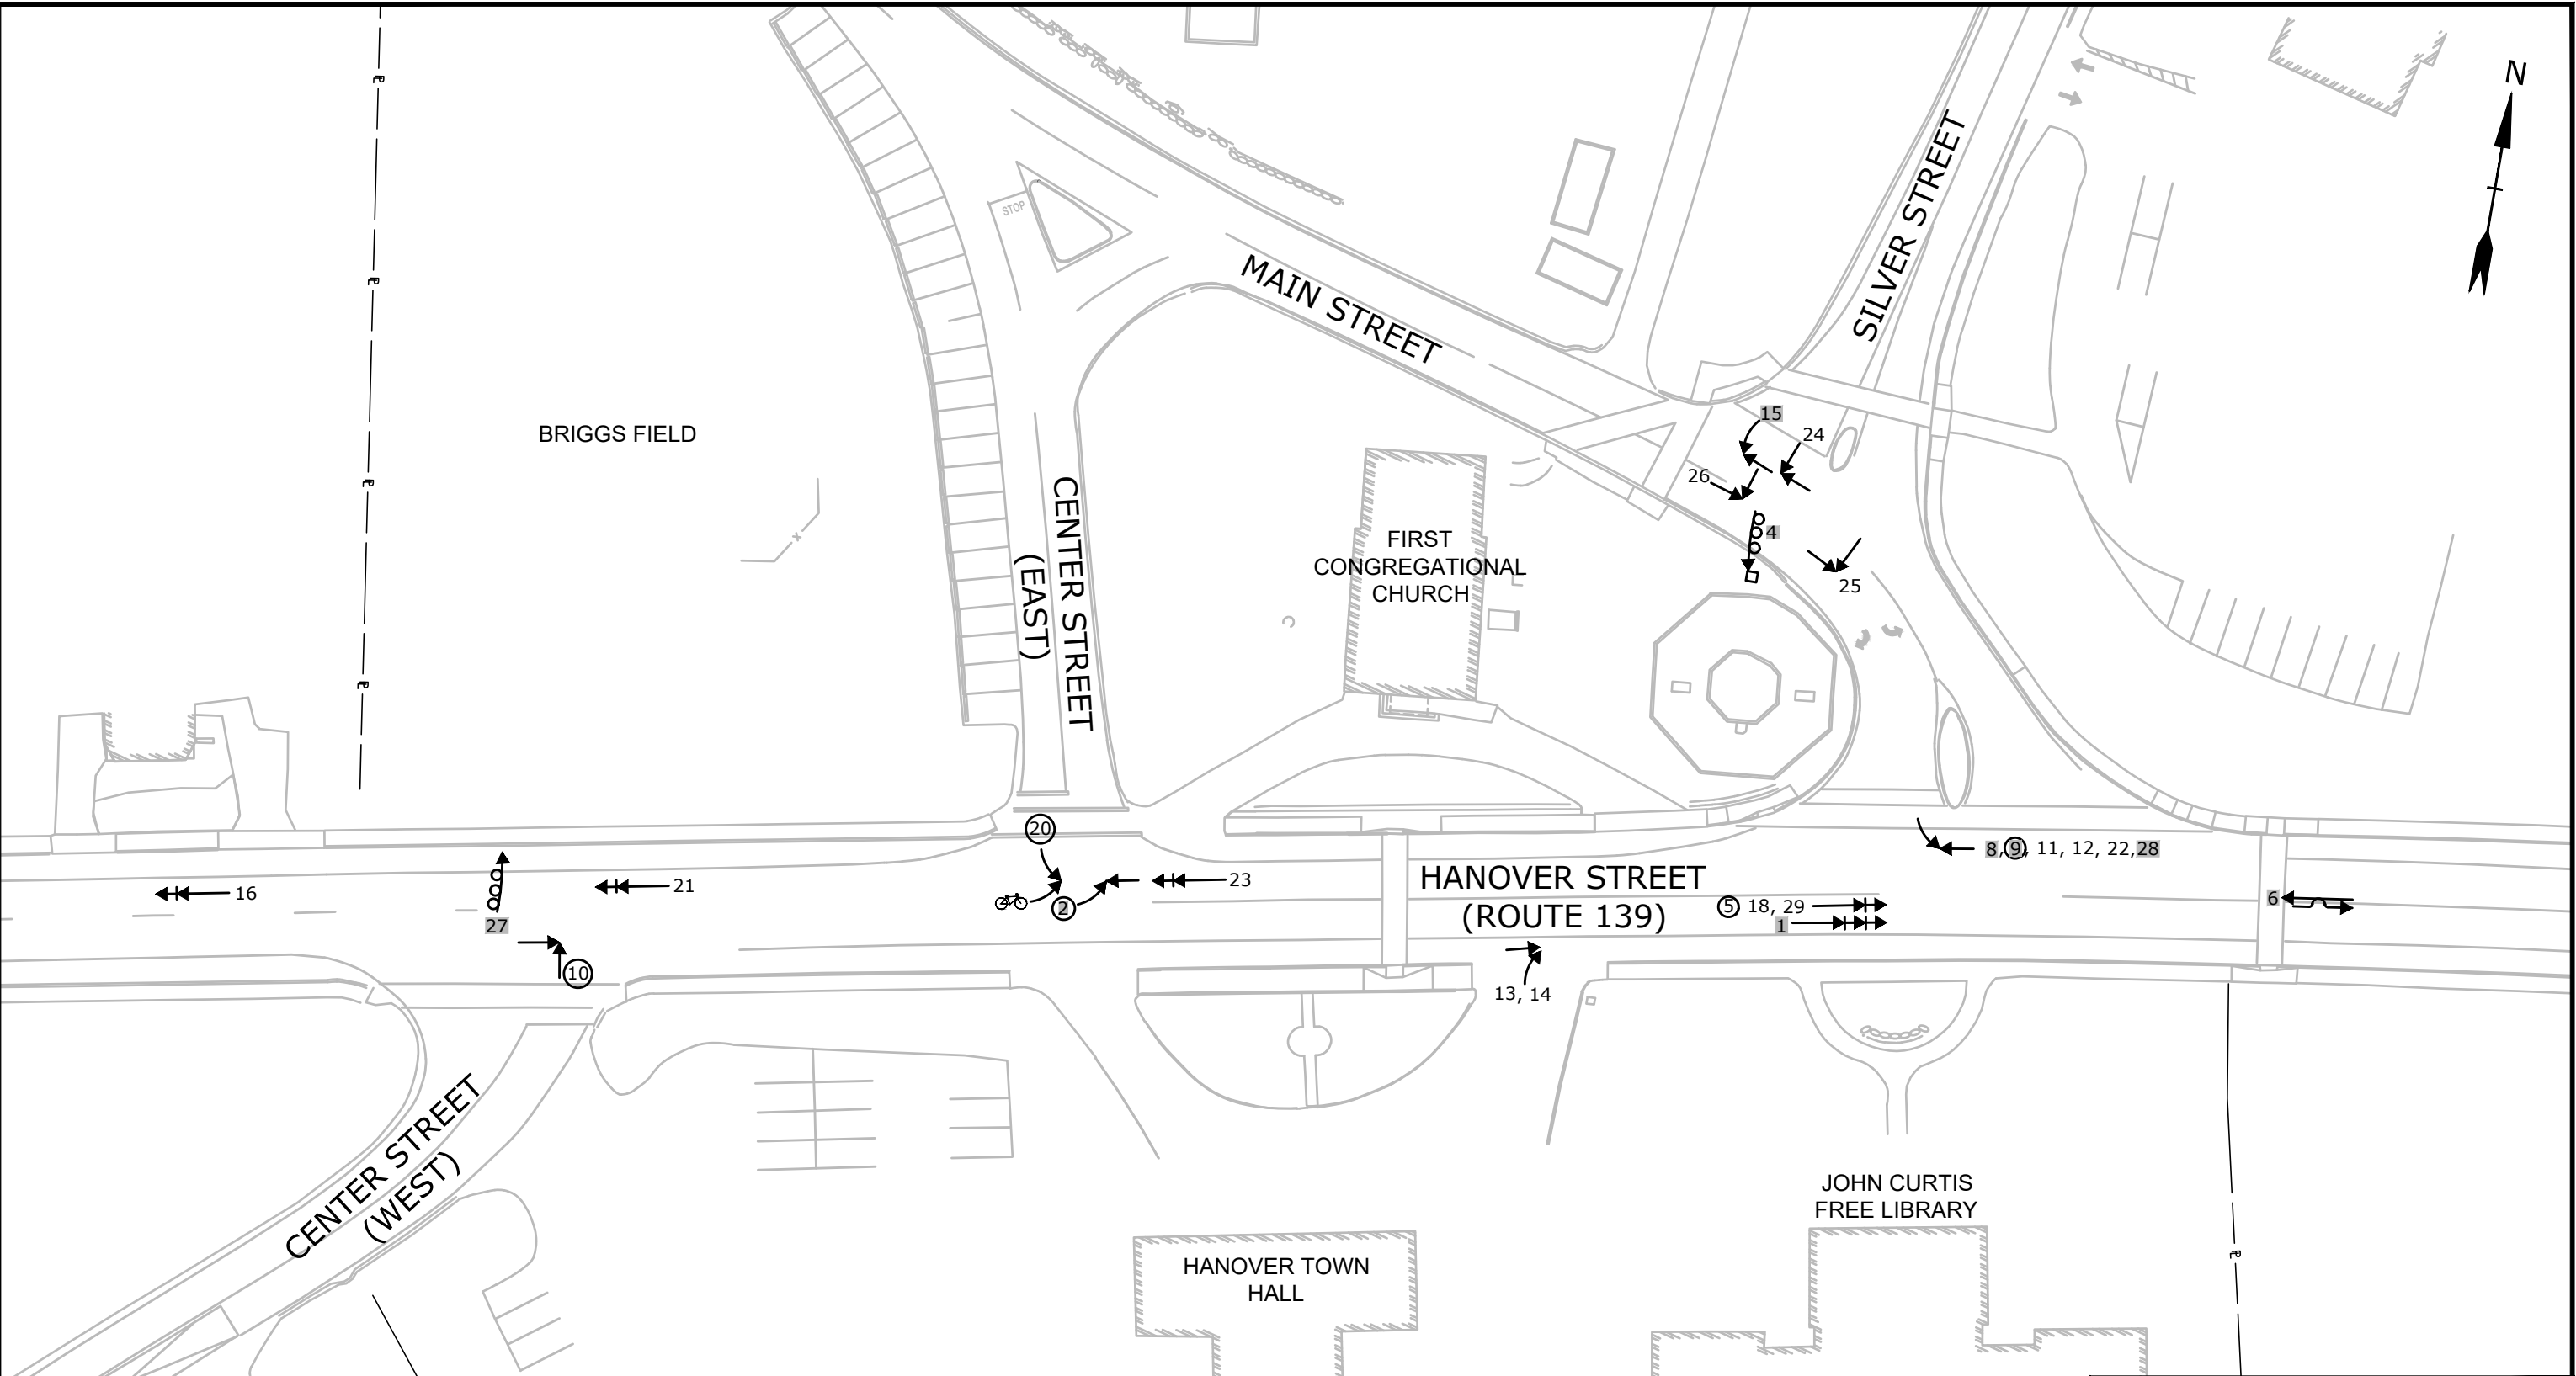
HANOVER TOWN CENTER HANOVER, MA	
COLLISION DIAGRAM	
DATE: 06/15/2023	
SCALE: 1" = 50'	
FIGURE: 1

- NOTES:**
- 1. CRASH 19 WAS NOT ABLE TO BE MAPPED.
  - 2. INTERSECTIONS INCLUDED IN FIGURE 1:
    - HANOVER STREET (ROUTE 139) AT CENTER STREET (WEST)
    - HANOVER STREET (ROUTE 139) AT CENTER STREET (EAST)
    - HANOVER STREET (ROUTE 139) AT MAIN STREET
    - MAIN STREET AT CENTER STREET
    - MAIN STREET AT SILVER STREET
  - 3. DATE RANGE: JANUARY 1, 2018 TO DECEMBER 31, 2022

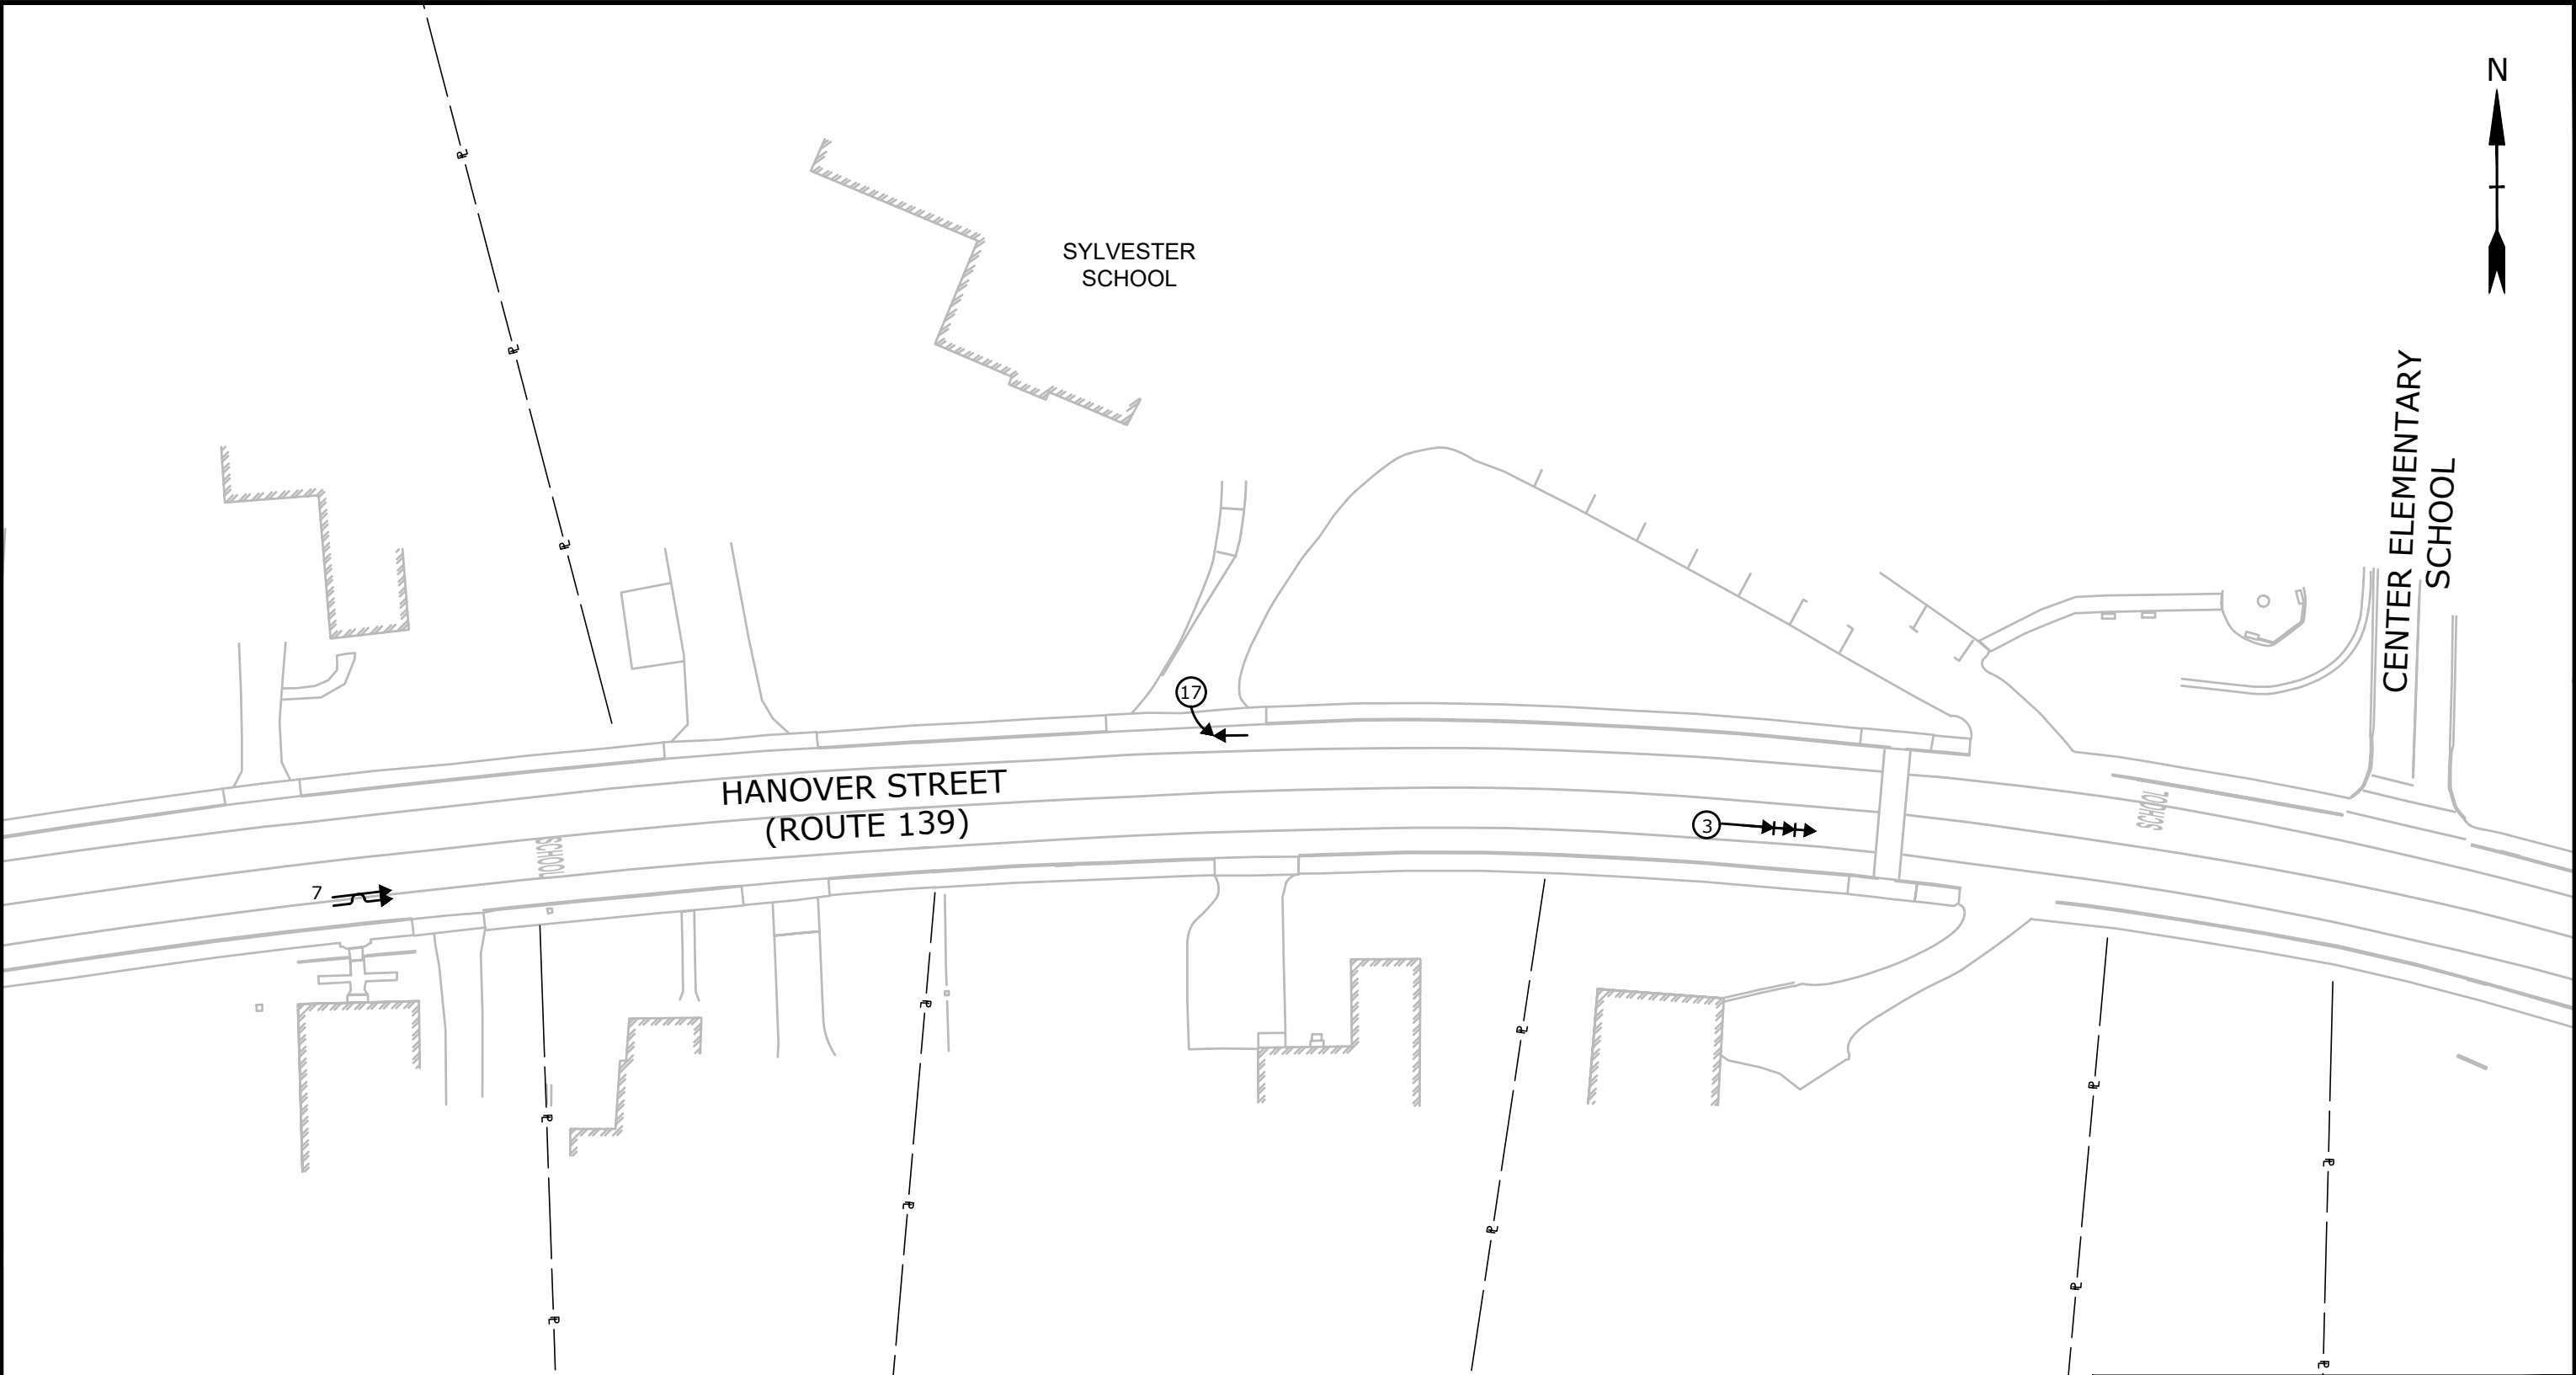
- NOTES:**
- 1. CRASH 19 WAS NOT ABLE TO BE MAPPED.
  - 2. INTERSECTIONS INCLUDED IN FIGURE 2:
    - HANOVER STREET (ROUTE 139) AT CENTER ELEMENTARY SCHOOL
  - 3. DATE RANGE: JANUARY 1, 2018 TO DECEMBER 31, 2022
