Hanover Cemeteries Preservation Plan

*Hanover Center Cemetery – Union Assinippi Cemetery – West Hanover Cemetery
Hanover, Massachusetts*

*Martha Lyon Landscape Architecture, LLC
Fannin-Lehner Preservation Consultants
CME Associates, Inc.*

October 2010

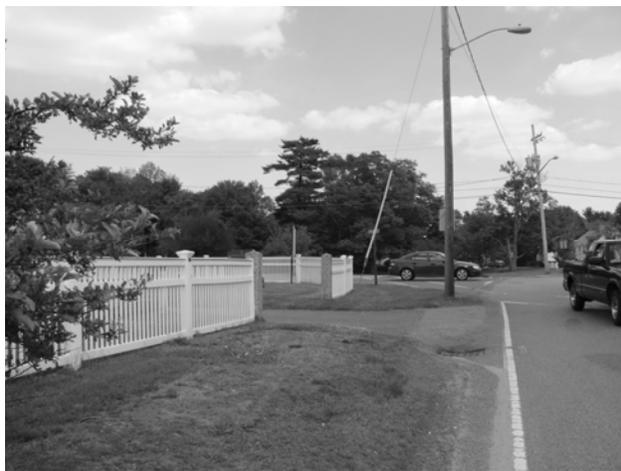
One of four entrances to the old section lies at the southeast corner, at the intersection of Main and Silver Streets. Granite posts mark the entry drive.

- Replace the PVC perimeter fencing with wood picket-style fencing. Secure the fencing with granite posts to match those located at the southeast cemetery entrance.

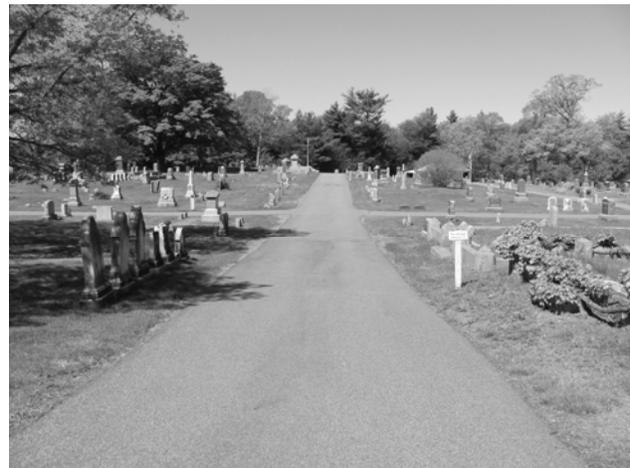
The entrances off Silver Street lead to roadways with wide expanses of pavement. These cast a harshness onto the cemetery landscape.

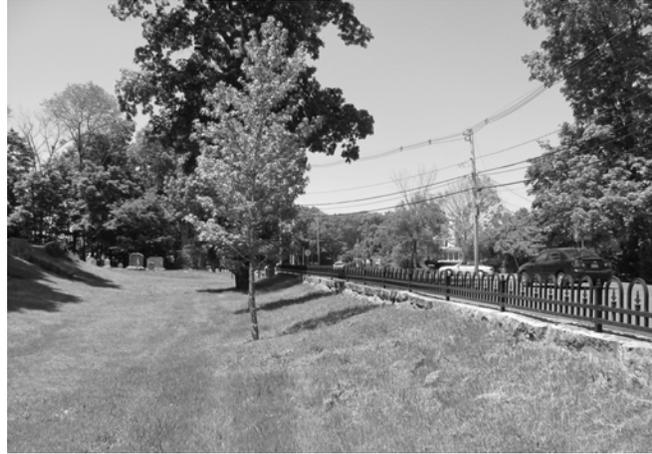
The northern edge of Union Cemetery features a cut granite retaining wall topped by a historic reproduction metal fence. The center of Assinippi lies in the background.

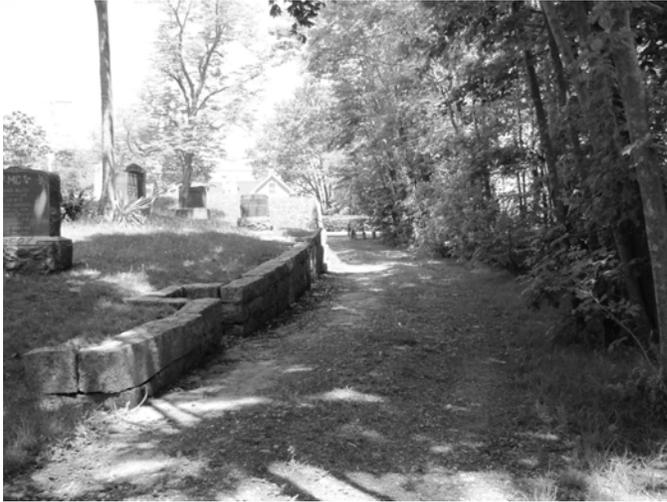
The cemetery's grassy paths are one of its most appealing historic features, leading visitors on a series of loops throughout the landscape.

- Create a defined point of entry into (at the eastern gate) and exit out (at the western gate) of the cemetery.
- Retain the grassy pathway system and under no circumstances add an impervious surface to the roads. In places where the turf has worn, patch with reinforced turf, using a special shade mix.

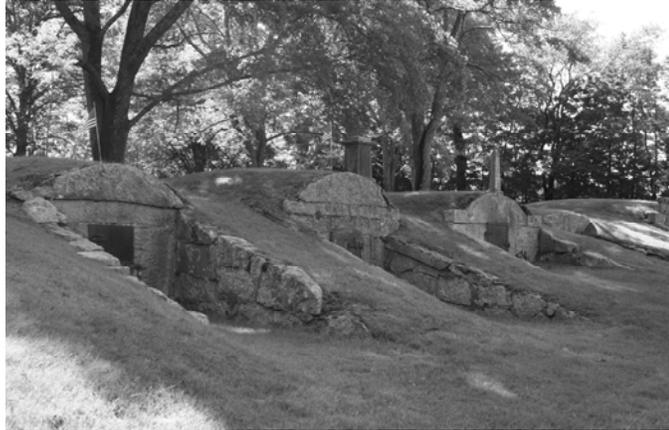
The six private tombs extending across the northern end mimic front doors, creating a series of cemetery portals.

- Clean and stabilize the cemetery's masonry structures including the private tombs (rehabilitating the facades and wing-walls), and retaining walls.
- Replace any worn turf on the cemetery roadways with reinforced turf.

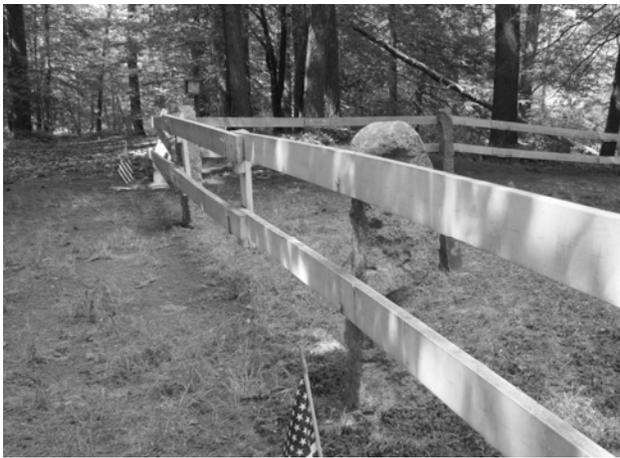
While historic granite posts, spaced evenly around the perimeter, add to the cemetery's historic character, the modern, 1" x 6" board railings introduce a contemporary, conflicting element.

- Remove the existing 1" x 6" wood board fence with a clear-stained (or naturally weathered) picket-style white cedar fence, including a new, operable gate assembly.

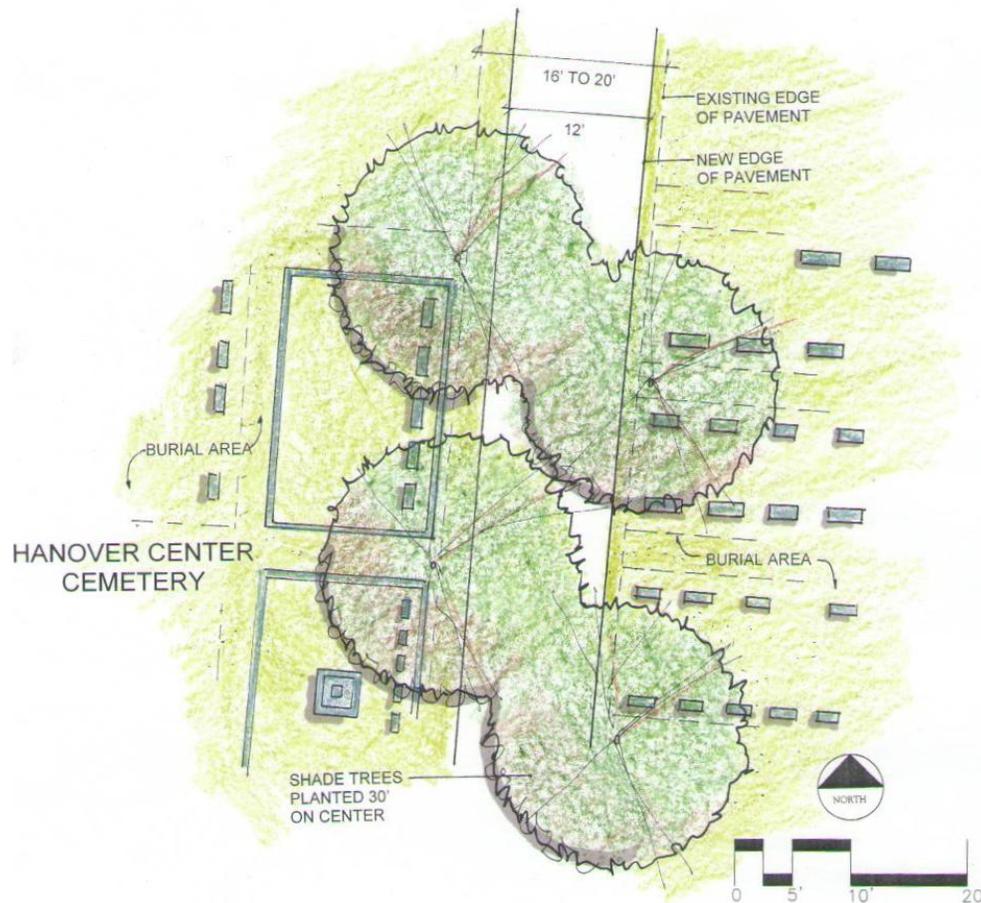
A lower priority project involves the narrowing of the Center Cemetery roadways to 12', and planting new shade trees along the edges. This will allow the Town to introduce a variety of tree species, and provide more shade to the cemetery's dry, open areas.

- Upgrade the cemetery's interior roadways by (1) narrowing the widths to 12 feet; (2) reinforcing the turf shoulders with reinforced turf; (3) surfacing the roadways with oil and stone (gravel rolled into an asphalt emulsion) and (4) planting new shade trees on the shoulders.

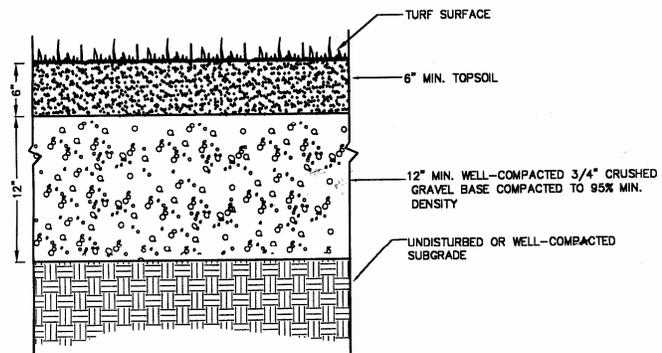
Reinforced paving detail, to be applied to the road shoulders (Center) and for patching of turf paths and roads.

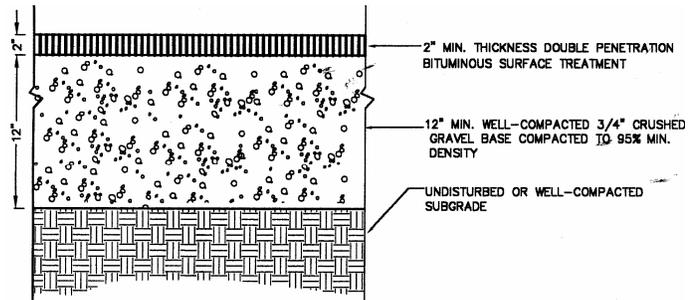
Oil and stone (also referred to as chip seal) paving detail. 3/8" gravel is rolled into the top of existing bituminous asphalt roads with asphalt emulsion.

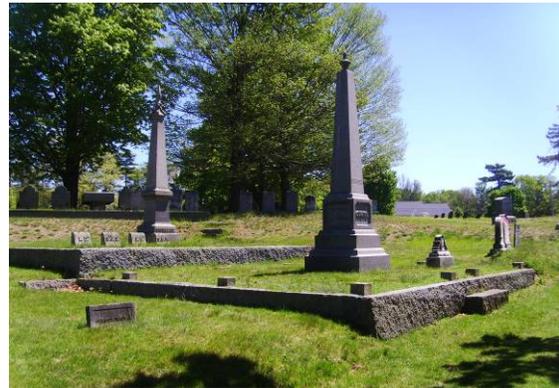
Most of the curbs are in very good condition; however some have shifted and settled. The limited depth of the stones combined with the soil pressure and the growth of occasional tree roots behind the curbs has led to this movement. Many of the curbs catch surface water runoff behind them, which exacerbates this problem.

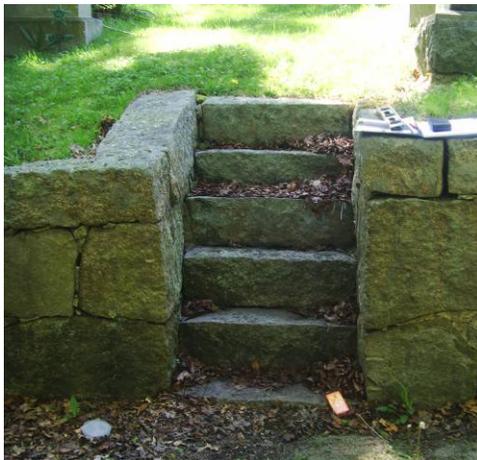
There are several stone steps that were located during the inspections. In general, these steps consist of granite blocks that are set into the hillside. The majority of these steps have shifted and settled over the years. In addition, several of the steps are far steeper than what modern codes allow. None of the steps have handrails.

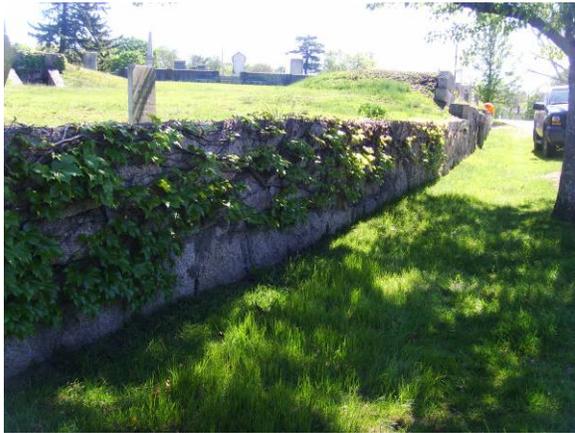
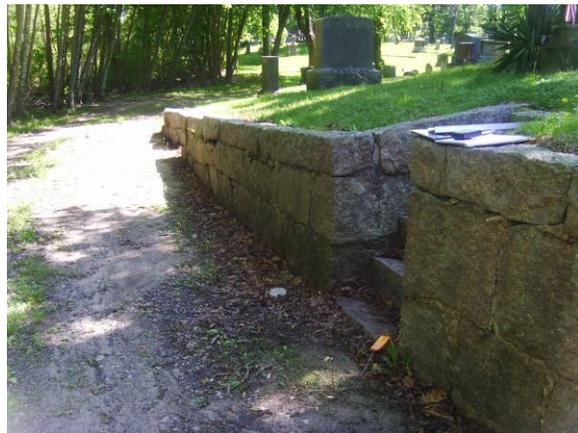
There are several stone retaining walls in two cemeteries studied. The front facades of the tombs are also soil retaining structures; therefore they are reported here. The purpose of retaining walls is to provide relatively level ground where slopes exist. This is typically done in cemeteries to provide additional space for burials on uneven ground. The Hanover Cemeteries have several small retaining walls that are supporting embankments and gravesites. The walls have been inspected, cataloged, and are reported in the appendix of this section. Most of the walls are sound and in good condition. Several are leaning and partially collapsed. Two tomb facades were access from inside. Both of these facades are pushing outward. This has led to gaps in the joints, sinkholes in the soil above, and missing brick and mortar. This problem is common in buried tombs. It is reasonable to assume that most of the tombs are experiencing this problem.

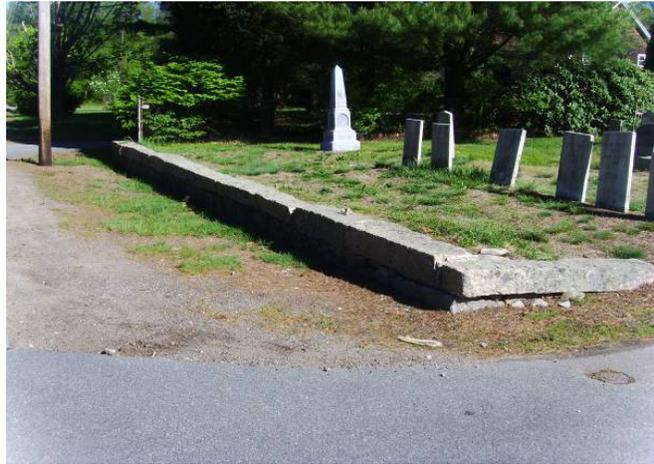
Overall elevation looking west

Inspection Items	Comments
Movement	No significant lean
Joints	Repointed. Most has fallen out
Staining	Minor
Plant Growth	Some lichen
Overall Condition	<p>Very good. The repointing is missing in many areas, however this is only a aesthetic issue. The wall is true and plumb.</p> <p>The condition of the pointing is poor and needs to be replaced at some time in the future. The condition of the pointing does not affect the structural integrity of the wall.</p> <p>The only significant issue is the damage from the vehicle impact.</p>
Short Term Repairs	Reset corner stone
Long Term Repairs	Re-pointing and cleaning

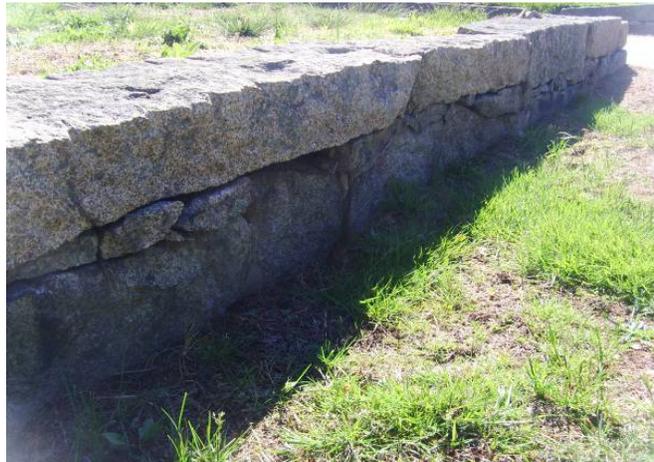
Typical condition of joints

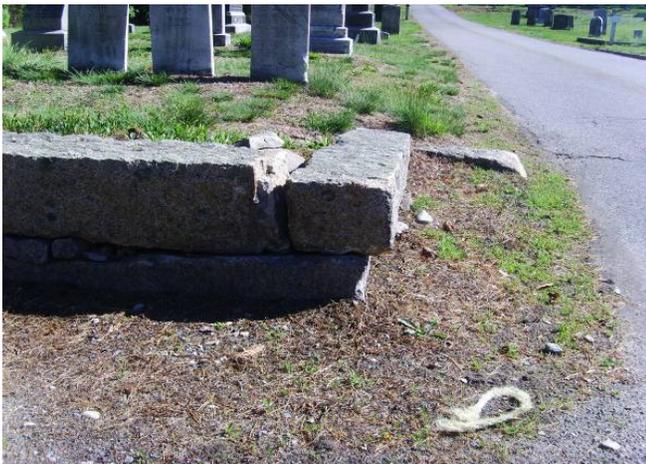
- *Border Walls.* These structures line Main Street and form the cemetery's southern edge. The bulk of this wall is structurally sound, however mortar is missing in several locations, and re-pointing is required. The western portion of the wall shows signs of vehicular damage and is in need of repair.

Vehicle Impact Damage

- Clean and re-point the Main Street border wall; clean and re-point the tombs, and rehabilitate the façade of the Town receiving tomb.
- Commission a detailed evaluation of the historic trees and implement recommendations to save the best trees.

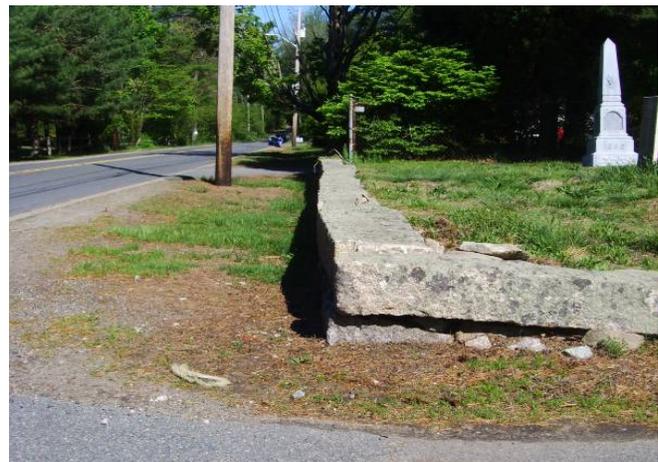
Wall alignment

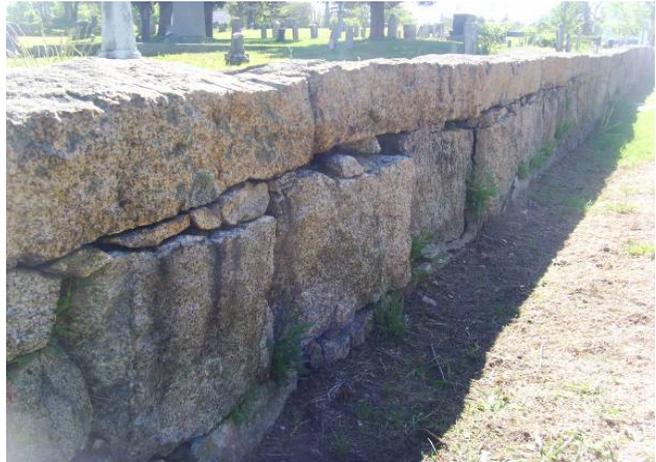
Elevation looking east

Inspection Items	Comments
Movement	No significant lean. There are aras with minor leans and and bulges.
Joints	Repointed. Most has fallen out
Staining	Minor
Plant Growth	Some lichen
Overall Condition	Very good. The repointing is missing in many areas, however this is only a aesthetic issue. For the most part, the wall is true and plumb. The backfill is sloping away from the wall and there is signs of rubble backfill material, wich is a good thing. The rubble improves the structural integrity. The condition of the pointing is poor and needs to be replaced at some time in the future. The condition of the pointing does not affect the structural integrity of the wall.
Short Term Repairs	None
Long Term Repairs	Repointing and cleaning

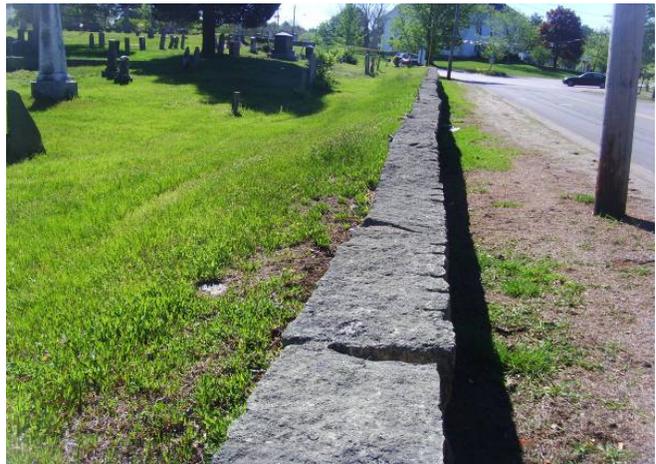
Typical backfill (note rubble backfill)

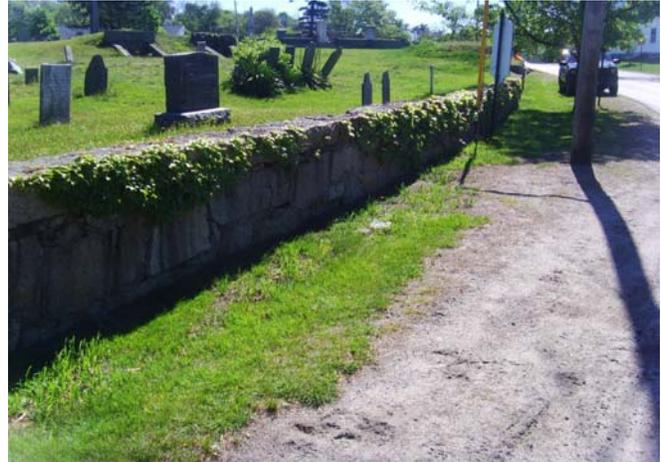
Elevation looking east

Inspection Items	Comments
Movement	Minor leaning in several areas.
Joints	Repointed. Some has fallen out
Staining	Minor
Plant Growth	Vines and some lichen
Overall Condition	<p>Very good. The repointing is missing in many areas, however this is only a aesthetic issue. The wall is true and plumb.</p> <p>The vines can lead to deterioration of the pointing over time, but will have no effect on the stone.</p> <p>The condition of the pointing is poor and needs to be replaced at some time in the future. The condition of the pointing does not affect the structural integrity of the wall.</p>
Short Term Repairs	Remove vines if there is a concern for aesthetics.
Long Term Repairs	Repointing and cleaning

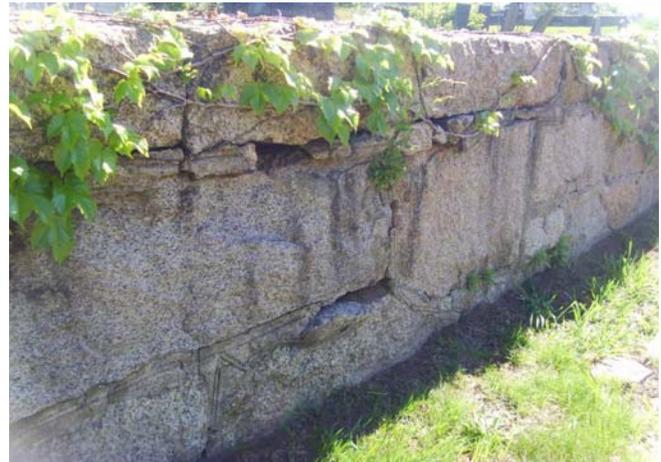
Typical condition of joints

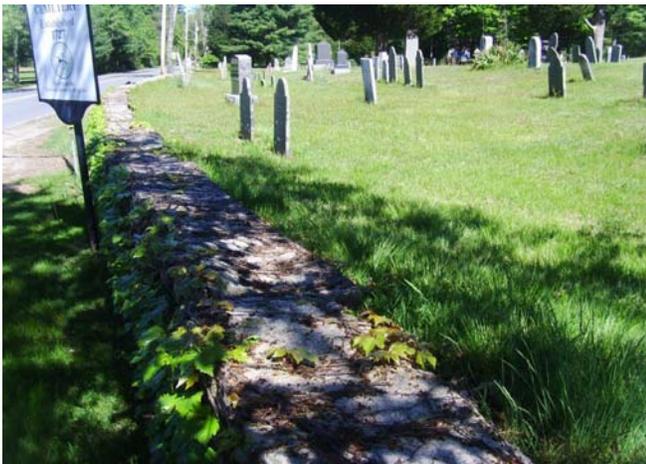
Backfill and wall alignment

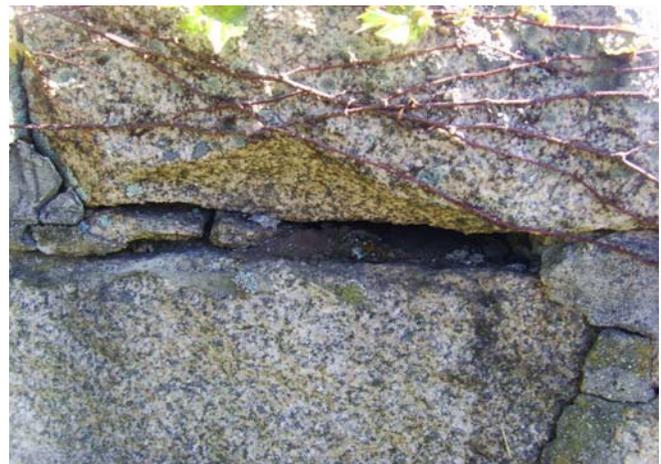
Close-up of joint

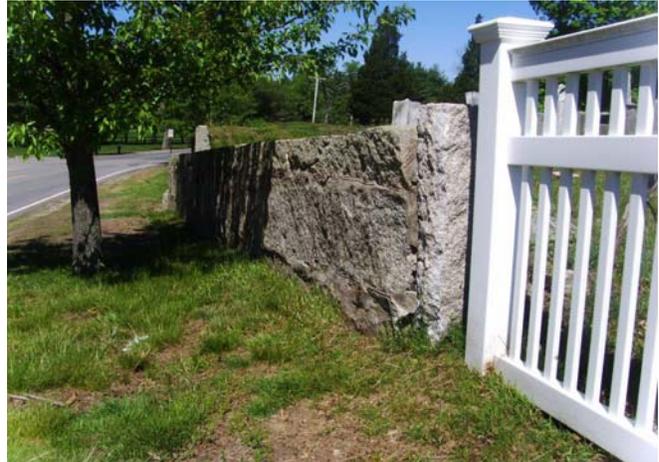
Elevation looking west

Inspection Items	Comments
Movement	No significant lean
Joints	Repointed. Some has fallen out
Staining	Minor
Plant Growth	Some weeds in joints and some lichen
Overall Condition	Very good. The repointing is loose in many areas, however this is only a aesthetic issue. The wall is true and plumb. The condition of the pointing is poor and needs to be replaced at some time in the future. The condition of the pointing does not affect the structural integrity of the wall.
Short Term Repairs	None
Long Term Repairs	Repointing and cleaning

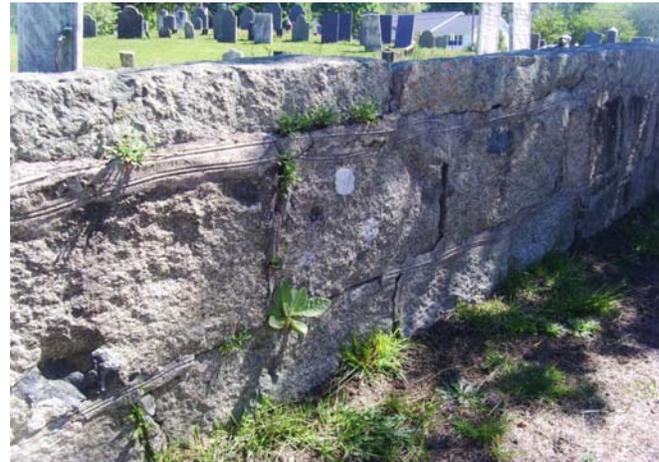
Typical condition of joints

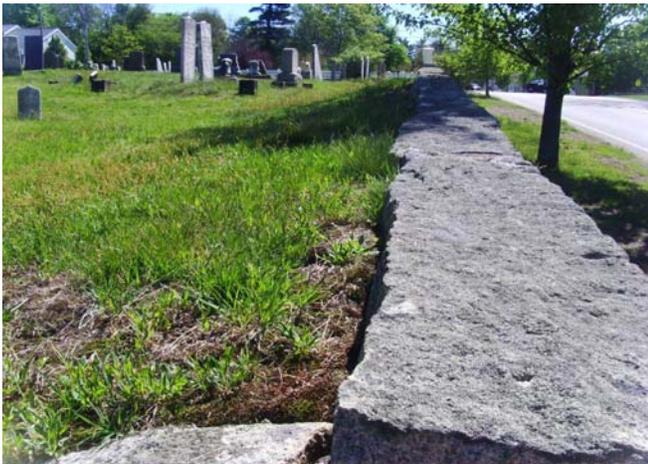
Backfill and wall alignment

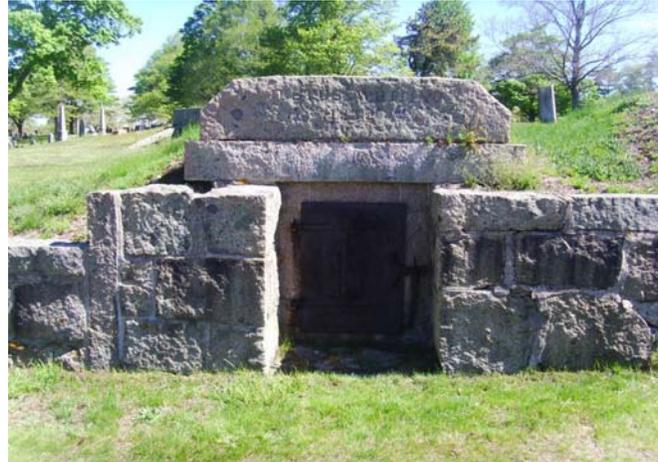
Front elevation

Inspection Items	Comments
Movement	None noted
Joints	Repointed. Some has fallen out
Staining	Minor staining on stone and around door.
Plant Growth	Some weeds in joints
Door	Heavy rust, but in sound condition. Hinges have seized.
Overall Condition	Excellent condition. The left wingwall has been repaired. The repointing needs repair in some areas. The walls are true and plumb. There are hinges on the wingwalls where a gate once stood.
Short Term Repairs	Remove plant growth
Long Term Repairs	Repointing and cleaning Paint door.

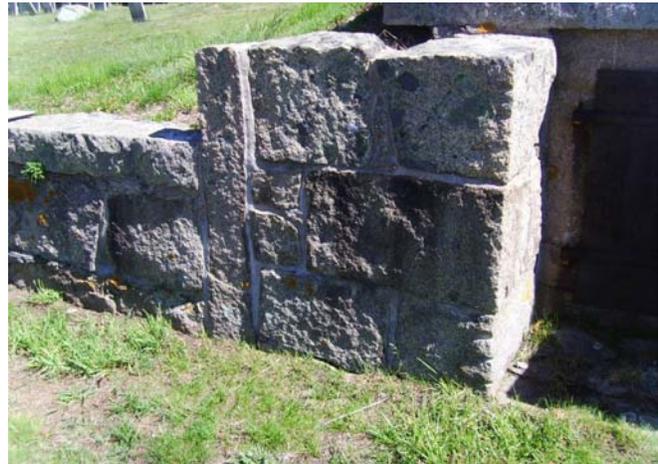
Vehicle damage repair

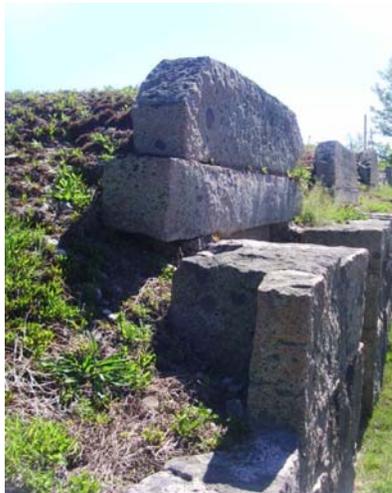
Lintel and Headwall

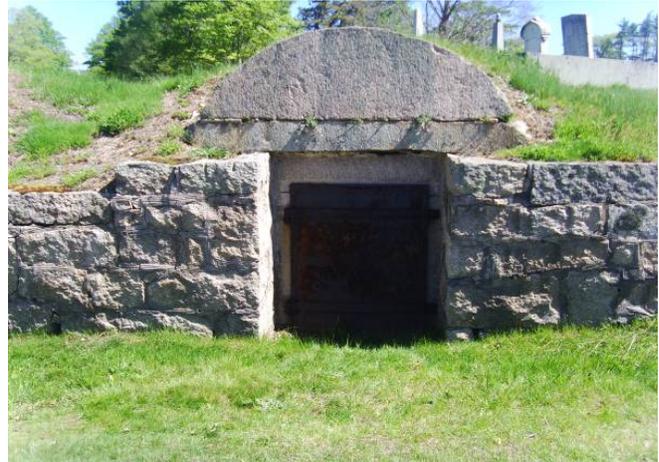
Front elevation

Inspection Items	Comments
Movement	Bulging of the wingwalls noted
Joints	Repointed. Some has fallen out. There is some original lead pointing at the header.
Staining	Minor staining on stone and around door.
Plant Growth	Some weeds in joints
Door	Heavy rust, but in sound condition. Hinges have seized.
Overall Condition	Good. The repointing is loose in many areas, however this is only a aesthetic issue. The lean of the wingwalls is a concern. The movement will get worse over time.
Short Term Repairs	Remove plant growth
Long Term Repairs	Remove wingwalls, add drainage and reset Clean stone surfaces Paint door.

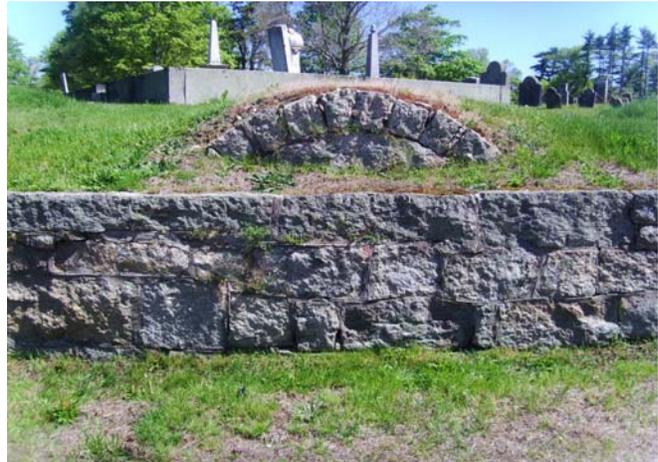
Front elevation

Inspection Items	Comments
Movement	None noted
Joints	Repointed. Some has fallen out
Staining	Minor
Plant Growth	Some weeds and lichen
Door	None
Overall Condition	Very good. The repointing is missing in many areas, however this is only a aesthetic issue. Most of this tomb is buried. The access door is most likely underground, either on the roof or at one end.
Short Term Repairs	Remove plant growth
Long Term Repairs	Repoint joints

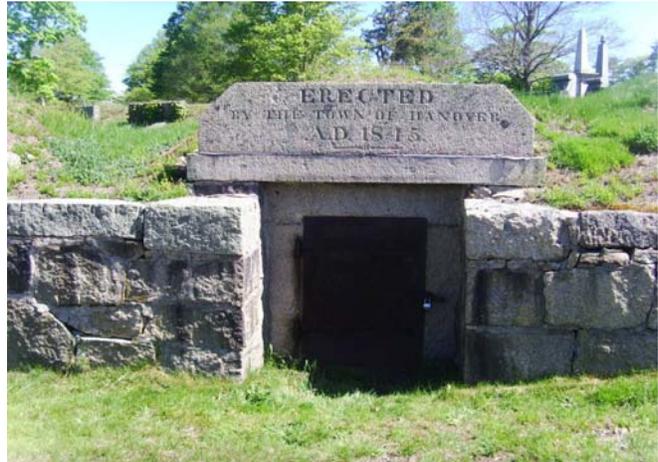
Front elevation

Inspection Items	Comments
Movement	Bulging of the wingwalls noted The front façade wall has moved forward.
Joints	Repointed. Most is loose. There is some original lead pointing at the header.
Staining	Minor staining on stone and around door.
Plant Growth	None
Door	Heavy rust, but in sound condition. Hinges have partially seized.
Overall Condition	Good. The repointing is missing in many areas, however this is only a aesthetic issue. The tomb interior was accessed. All walls and the roof are sound except the front wall. This wall has pushed resulting in an open joint. Soil is falling through this opening. This is due to frost action behind the header and lintel stones.
Short Term Repairs	None
Long Term Repairs	Remove wingwalls, header and lintel stones, add drainage and reset. Clean stone surfaces Paint door.

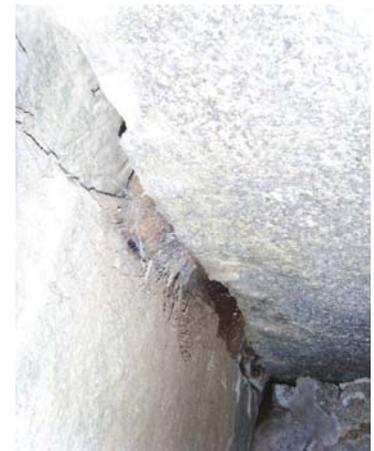
Gap in Front Wall at roof

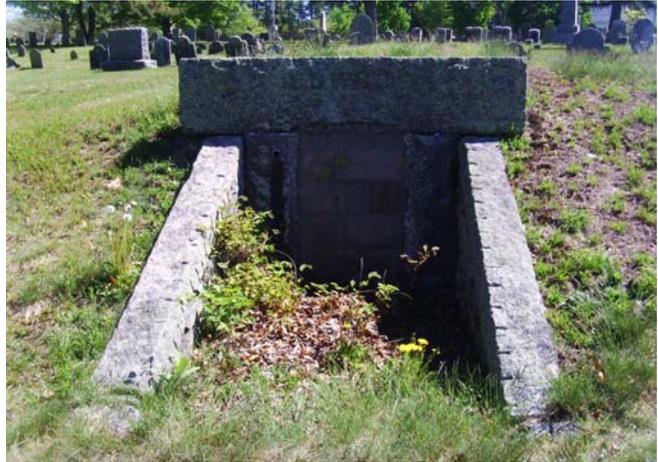
Front elevation

Inspection Items	Comments
Movement	None noted
Joints	Dry joints, no mortar
Staining	Minor
Plant Growth	Weeds growing in entrance
Door	Missing. Hinges in place
Overall Condition	Very good.
Short Term Repairs	Remove plant growth
Long Term Repairs	Install historically accurate door

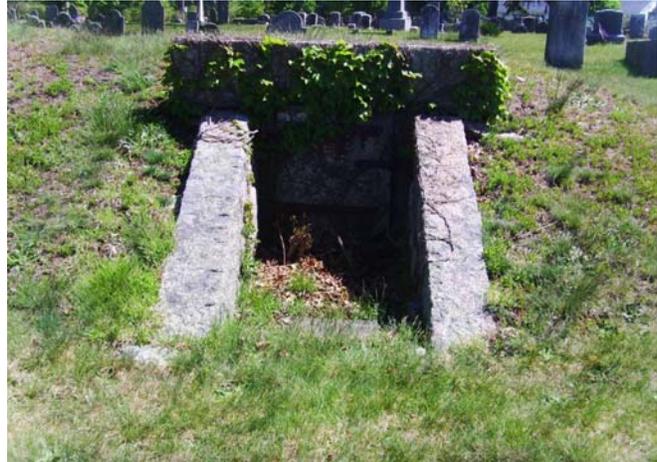
Front elevation

Inspection Items	Comments
Movement	None noted
Joints	Dry joints, no mortar
Staining	Lichen and rust stains on door
Plant Growth	Weeds in entrance. Vines on header
Door	Stone is heavily cracked and missing a corner
Overall Condition	Very good. The door is in poor condition. It is un-repairable. The hinges can be salvaged.
Short Term Repairs	Remove plant growth
Long Term Repairs	Replace door in kind.

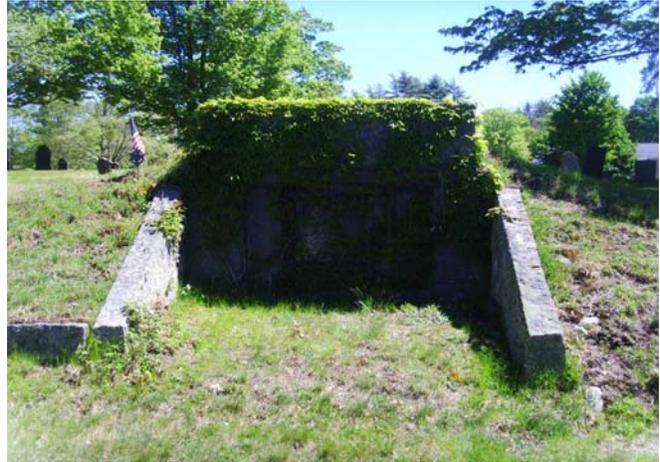
Front elevation

Inspection Items	Comments
Movement	Nothing significant
Joints	Original lead pointing in place and in good condition
Staining	
Plant Growth	Heavy vine growth
Door	Stone and in fair condition. Missing corners
Overall Condition	Very good. The door may need to be replaced at some time in the future.
Short Term Repairs	Remove plant growth
Long Term Repairs	Replace door in kind if condition worsens.

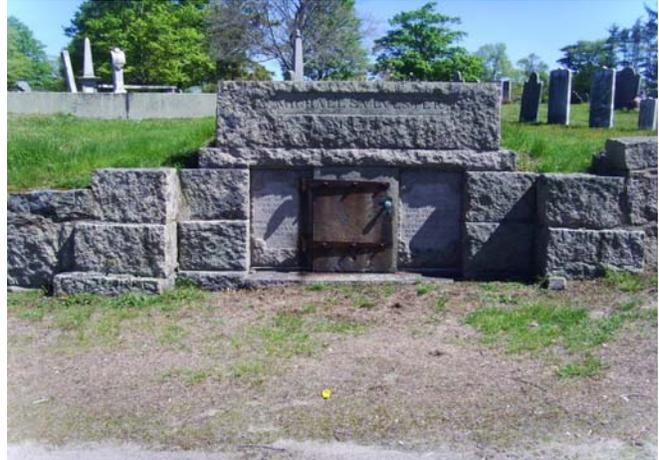
Front elevation

Inspection Items	Comments
Movement	None noted
Joints	Lead pointing in some joints. In good condition
Staining	Minor staining on stone and around door.
Plant Growth	Some lichen
Door	Heavy rust, on hinges, but in sound condition. Minor spalling of door face.
Overall Condition	Excellent condition. The walls are true and plumb.
Short Term Repairs	None
Long Term Repairs	Repointing and cleaning Paint door hinges.

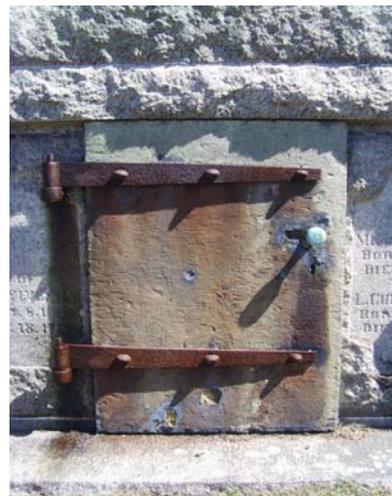
Door

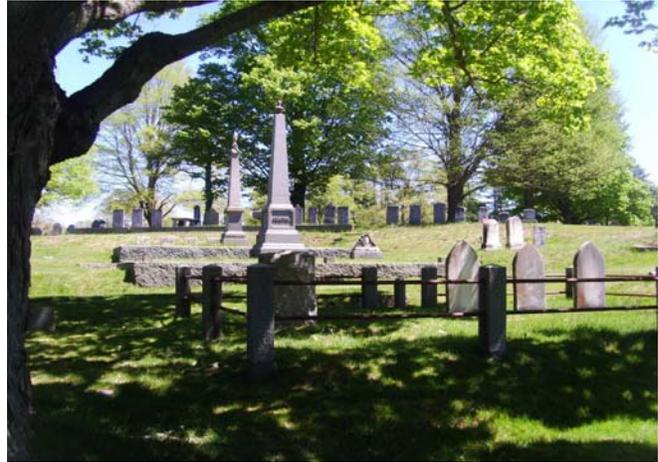
Inspection Items	Comments
Movement	Most are good. Some have minor movement
Joints	Some lead pointed. Others are dry.
Staining	Minor staining on most.
Plant Growth	Minor
Overall Condition	The border curbing on most plots is in good condition. Some are in excellent condition. The worst issues are the leaning of several of the plot borders, which is not significant.
Short Term Repairs	None
Long Term Repairs	Remove and reset leaning stones. Consider adding drainage if water is being trapped behind the stones.

Typical Plot Border

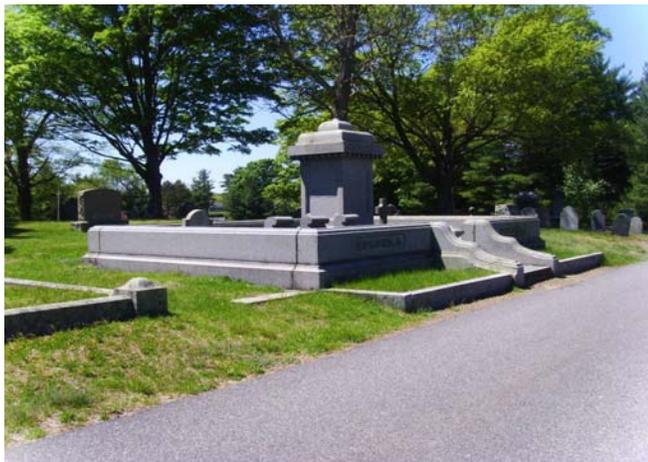
Ornate Border

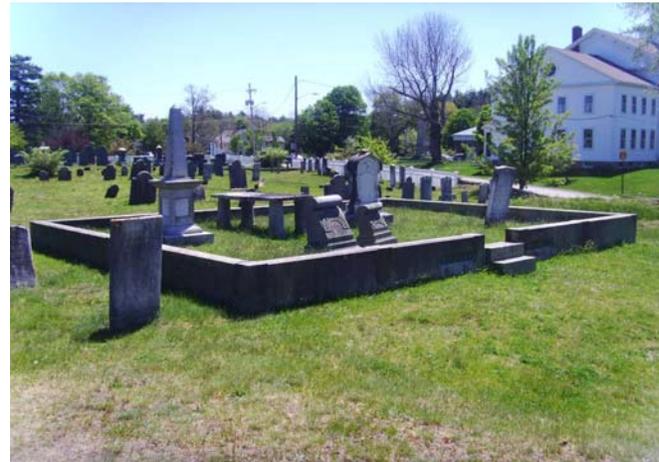
Typical Plot Border

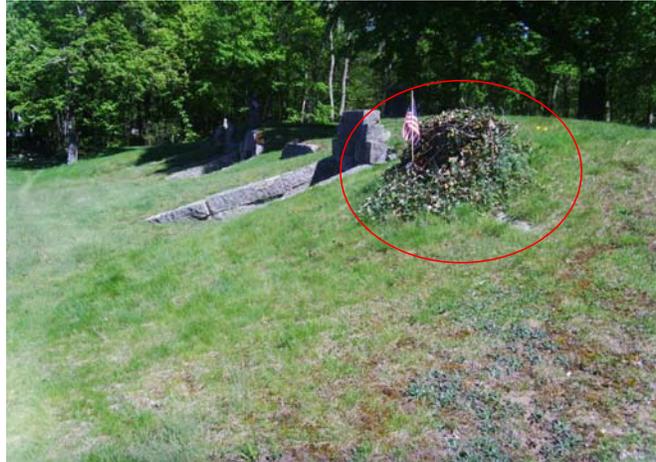
Inspection Items	Comments
Movement	Nothing noted
Joints	Hidden
Staining	Minor staining
Plant Growth	Heavy plant growth
Door	Not visible
Overall Condition	The condition could not be determined.
Short Term Repairs	Remove plant growth
Long Term Repairs	Repoint exposed joints Clean stone surfaces

Entrance area

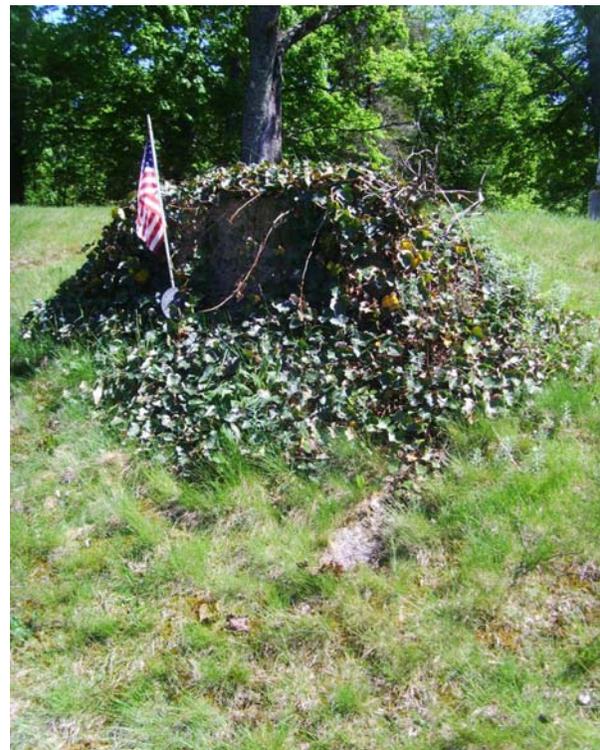
Entrance

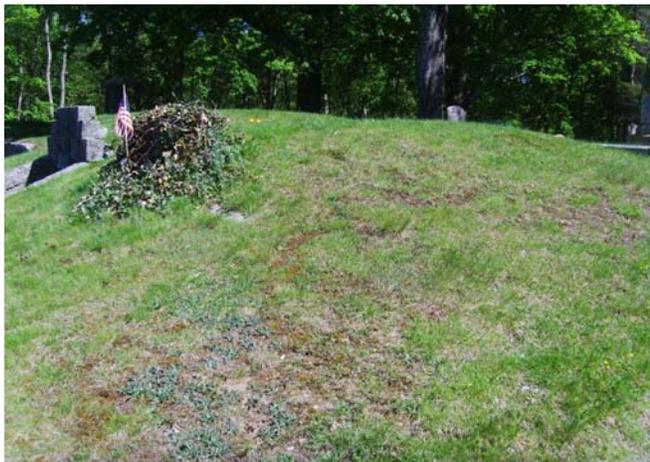
Overall side view

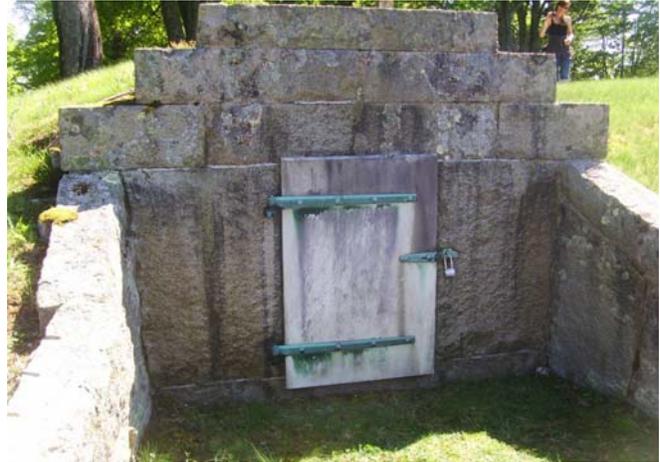
Inspection Items	Comments
Movement	The wingwalls are bulging significantly. The front façade wall has moved forward.
Joints	Lead pointing is in good condition Interior pointing is in fair condition
Staining	Staining on stone and around door.
Plant Growth	Lichen
Door	Excellent condition. Hinges working well.
Overall Condition	Good. The tomb interior was accessed. All walls and the roof are sound except the front wall. This wall has pushed resulting in an open joint. Bricks are falling out in this area. This is due to frost action behind the header and lintel stones. There is a crack running from front to back in the brick arch. The interior is damp which has led to deterioration of the mortar. The wingwall are failing. The caskets have been disturbed
Short Term Repairs	None
Long Term Repairs	Remove wingwalls, header and lintel stones, add drainage and reset. Clean stone surfaces and door

Front elevation

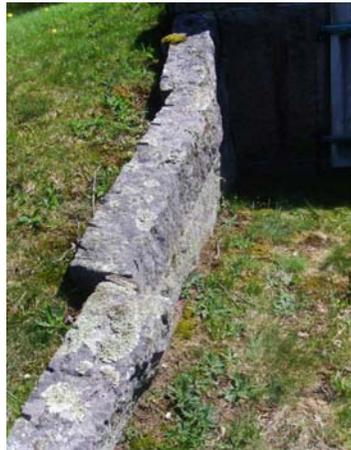
Bulging Wingwall

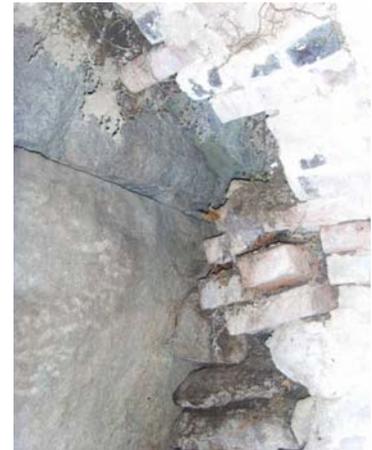
Gap in Front Wall at roof (note missing bricks)

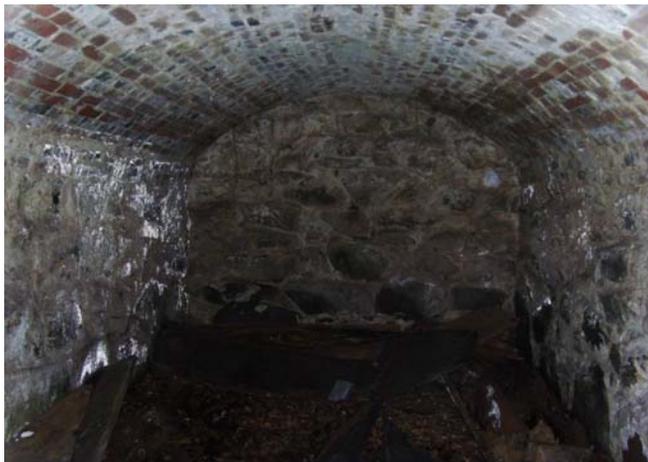
Interior walls and roof

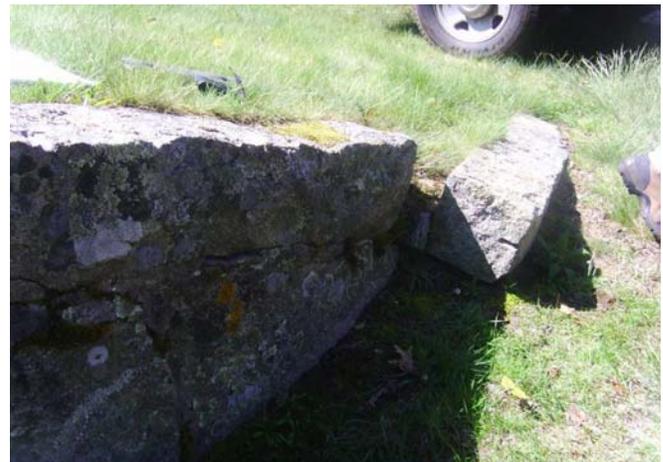
Damaged wingwall

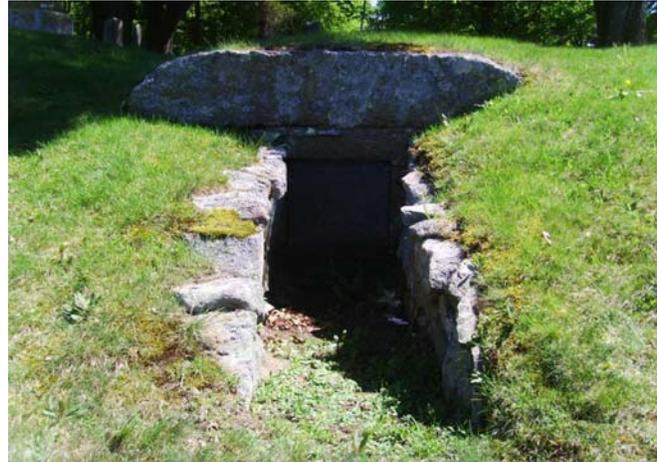
Inspection Items	Comments
Movement	The wingwalls are bulging significantly.
Joints	Repointed. Most is loose.
Staining	Staining on stone and around door.
Plant Growth	Lichen
Door	Good condition. Hinges rusting
Overall Condition	Fair The wingwall are failing. They will continue to move over time.
Short Term Repairs	None
Long Term Repairs	Remove wingwalls, header and lintel stones, add drainage and reset. Clean stone surfaces and door

Front elevation

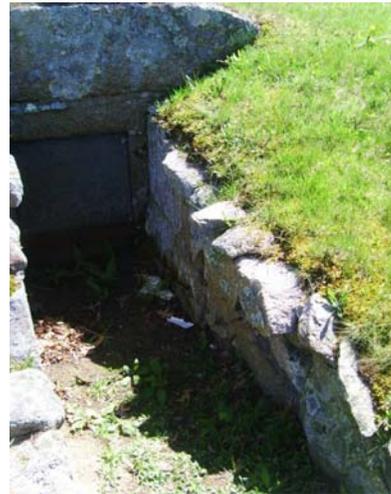
Right wingwall

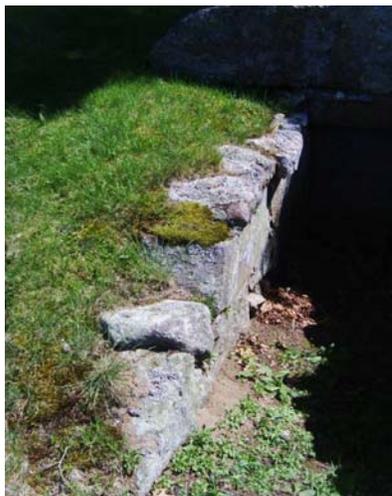
Left wingwall

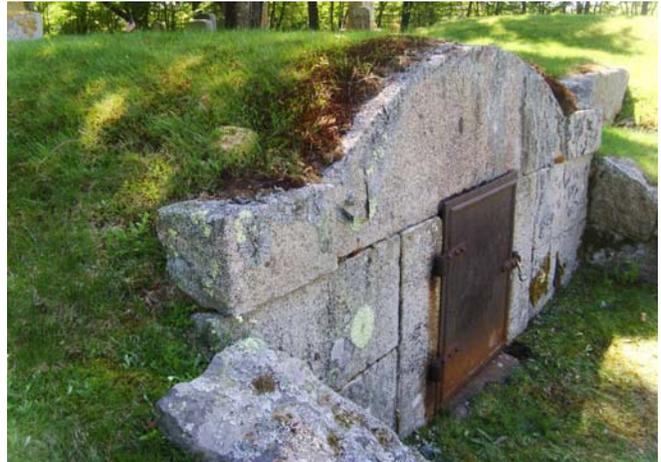
Inspection Items	Comments
Movement	The wingwalls and header are bulging.
Joints	Repointed. Most is loose.
Staining	Staining on stone and around door.
Plant Growth	Lichen and moss
Door	Good condition, but rusting The hinges are seized
Overall Condition	Fair The wingwalls are failing. They will continue to move over time. The headwall is also bulging.
Short Term Repairs	None
Long Term Repairs	Remove wingwalls, header and lintel stones, add drainage and reset. Clean stone surfaces Paint door

Header and door

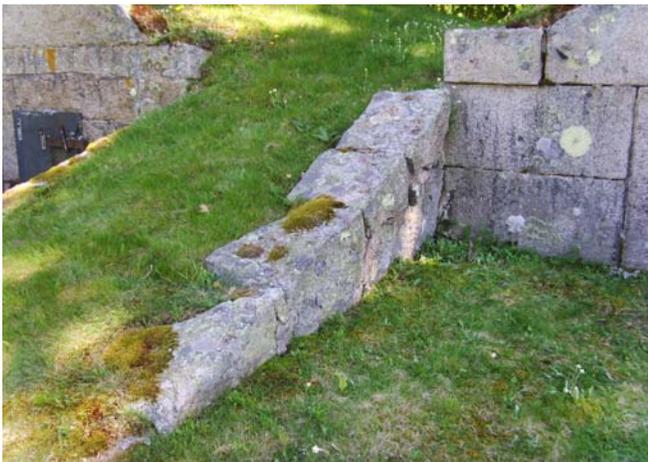
Left wingwall

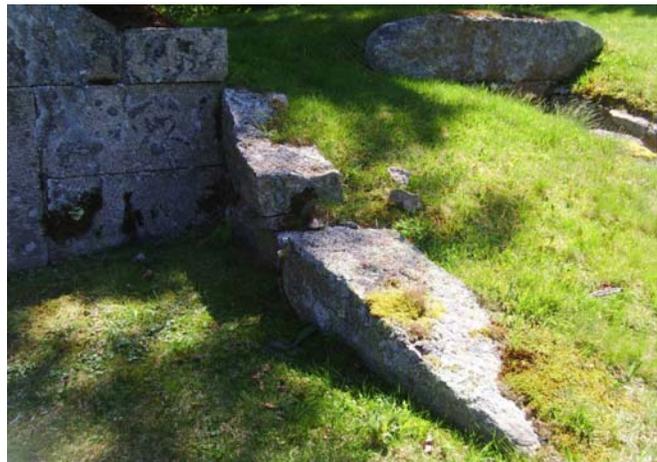
Right wingwall

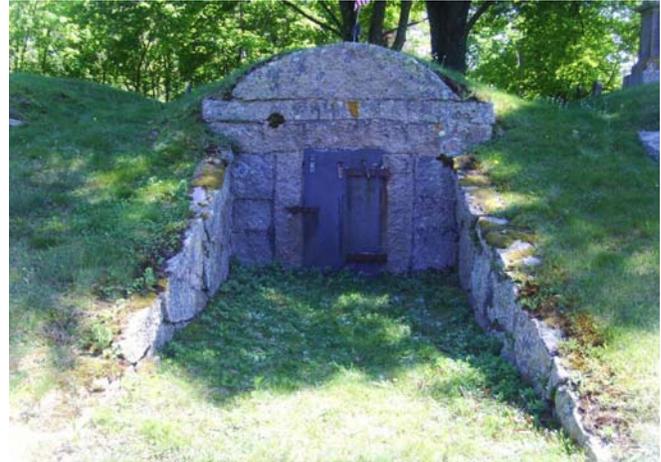
Inspection Items	Comments
Movement	The wingwalls and header are bulging.
Joints	Repointed. Some is loose.
Staining	Staining on stone and on door.
Plant Growth	Lichen and moss
Door	Poor condition. Cracked in several places
Overall Condition	Fair The wingwalls are failing. They will continue to move over time. The headwall is also bulging. The door is broken and has been poorly repaired at one crack.
Short Term Repairs	None
Long Term Repairs	Remove wingwalls, header and lintel stones, add drainage and reset. Clean stone surfaces Repair door if possible. If not, replace in kind.

Front elevation

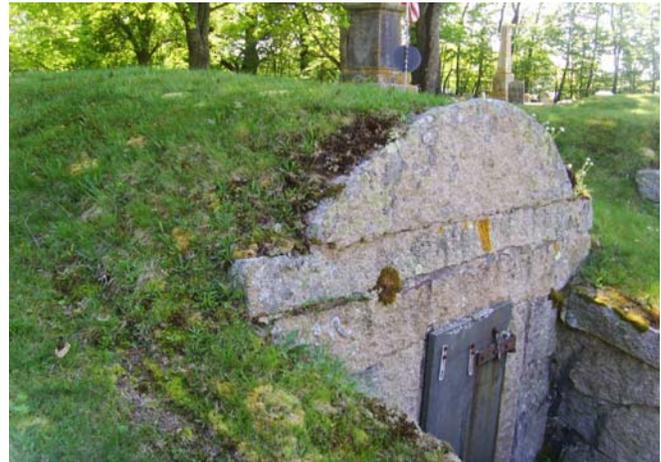
Header and door

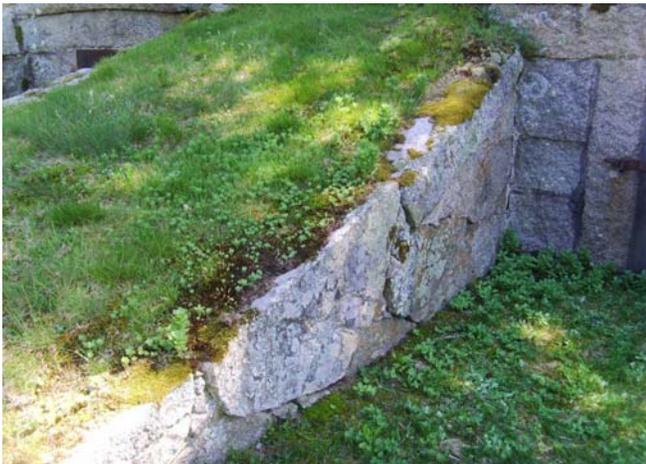
Left wingwall

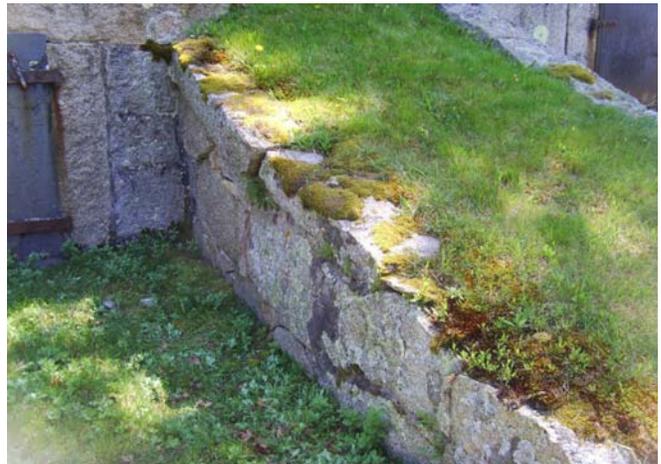
Right wingwall

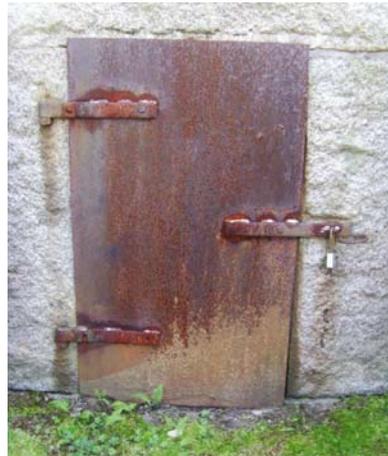
Inspection Items	Comments
Movement	The wingwalls and header are bulging.
Joints	Repointed. Some is loose.
Staining	Staining on stone and around door.
Plant Growth	Lichen and moss
Door	May not be original. Hinges appear to be original
Overall Condition	Fair The wingwalls and headwall are starting to fail. They will continue to move over time. The door does appear to be a replacement that was welded in place.
Short Term Repairs	None
Long Term Repairs	Remove wingwalls, header and lintel stones, add drainage and reset. Clean stone surfaces Replace door with historically accurate door. Salvage hinges. Paint the new door.

Door

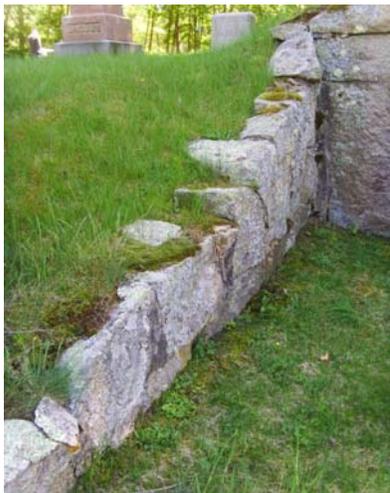
Left wingwall

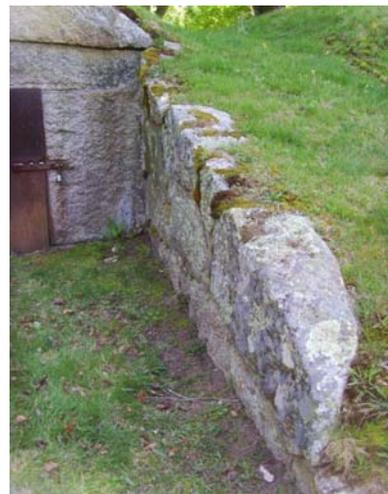
Right wingwall

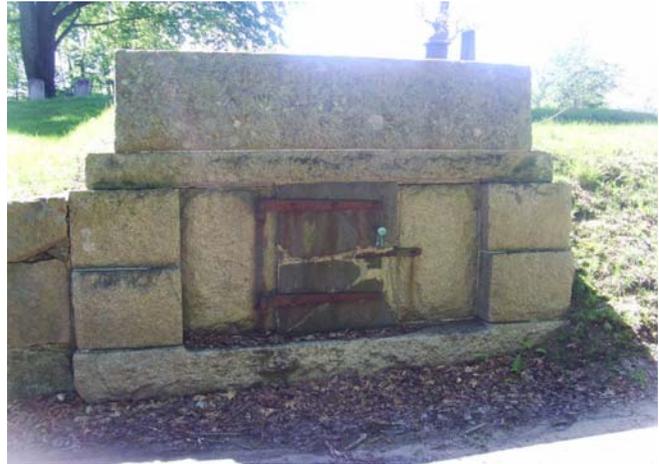
Inspection Items	Comments
Movement	No movement noted
Joints	Original lead pointing in place and in good condition
Staining	Staining on stone and around door.
Plant Growth	Lichen
Door	The door is in poor condition. It is broken in several places
Overall Condition	Very good The wingwalls and headwall are sound. over time. The only significant issue with this tomb is the door.
Short Term Repairs	None
Long Term Repairs	Clean stone surfaces Replace door with historically accurate door. Salvage hinges. Paint the hinges.

Front elevation
