Hanover Cemeteries Preservation Plan

*Hanover Center Cemetery – Union Assinippi Cemetery – West Hanover Cemetery
Hanover, Massachusetts*

*Martha Lyon Landscape Architecture, LLC
Fannin-Lehner Preservation Consultants
CME Associates, Inc.*

October 2010

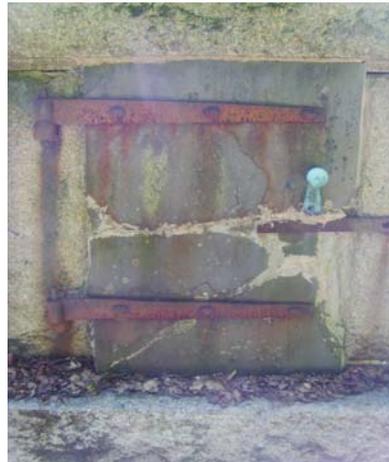
Inspection Items	Comments
Movement	No movement noted
Joints	Original lead pointing in place and in good condition
Staining	Staining on stone and around door.
Plant Growth	Lichen
Door	The door is in poor condition. It is broken in several places
Overall Condition	Very good The wingwalls and headwall are sound. over time. The only significant issue with this tomb is the door.
Short Term Repairs	None
Long Term Repairs	Clean stone surfaces Replace door with historically accurate door. Salvage hinges. Paint the hinges.

Door

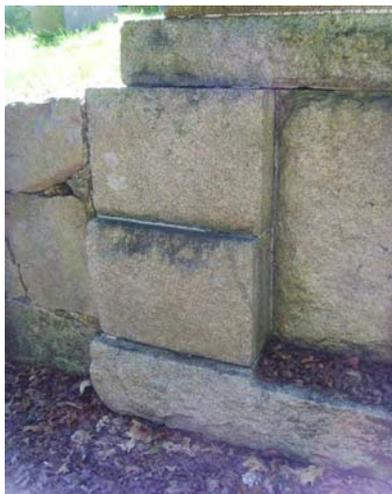
Left wingwall

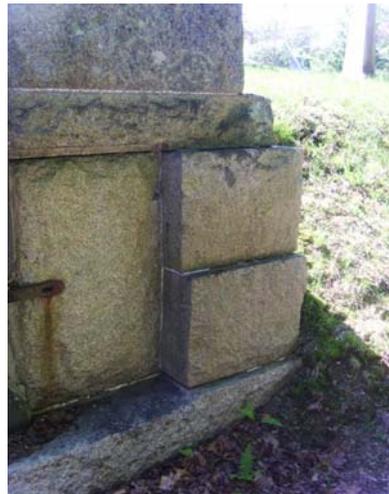
Right wingwall

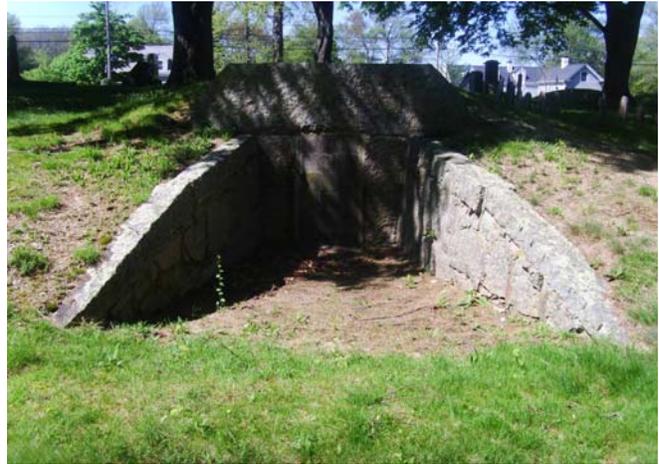
Inspection Items	Comments
Movement	The wingwalls and header are bulging.
Joints	Repointed. Most is loose.
Staining	Staining on stone
Plant Growth	Lichen
Door	Missing. Hinges are still in place.
Overall Condition	Fair The wingwalls are failing. They will continue to move over time. The headwall is also bulging. Mortar has been added to fill the gap between the headwall and tomb. The door is missing.
Short Term Repairs	None
Long Term Repairs	Remove wingwalls, header and lintel stones, add drainage and reset. Clean stone surfaces Replace door with historically accurate door.

Front elevation

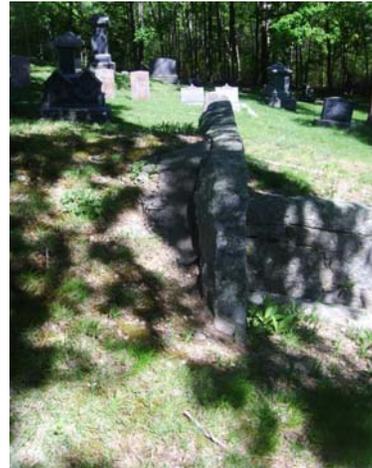
Signs of headwall movement

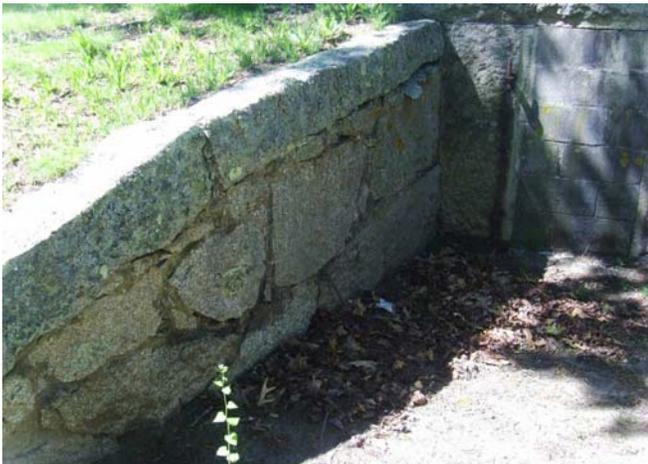
Left wingwall

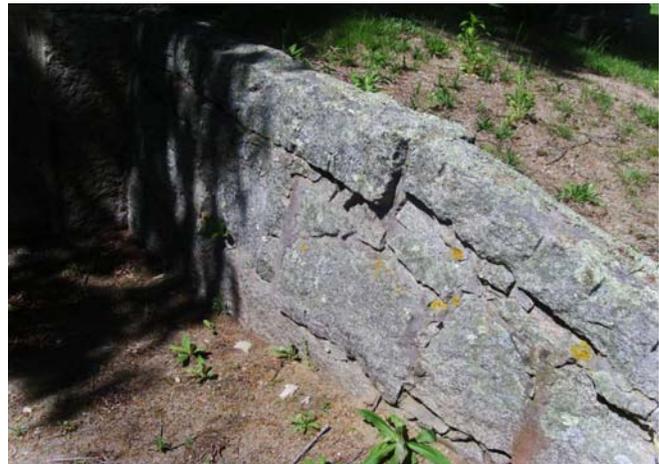
Right wingwall

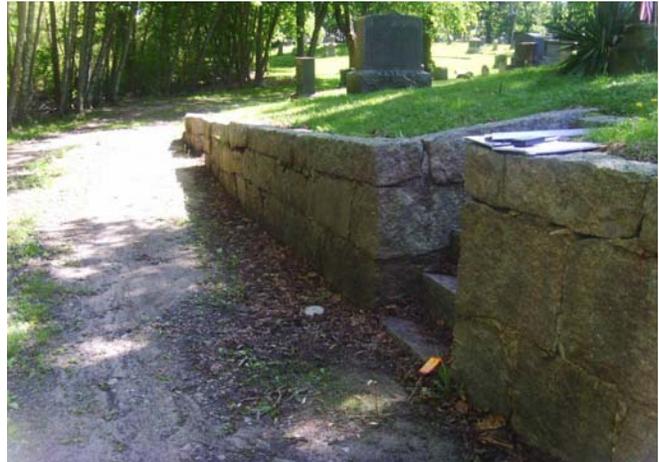
Inspection Items	Comments
Movement	Minor leaning in several areas.
Joints	Repointed. Some has fallen out
Staining	Minor
Plant Growth	Lichen
Overall Condition	<p>Good. The repointing is missing in many areas, however this is only a aesthetic issue. The wall is fairly true and plumb.</p> <p>The condition of the pointing is poor and needs to be replaced at some time in the future. The condition of the pointing does not affect the structural integrity of the wall.</p> <p>There are no handrails on the stairs, which poses a safety risk.</p>
Short Term Repairs	Close off access to stairs
Long Term Repairs	Repointing and cleaning Install handrails or restrict access to stairs

Overall wall

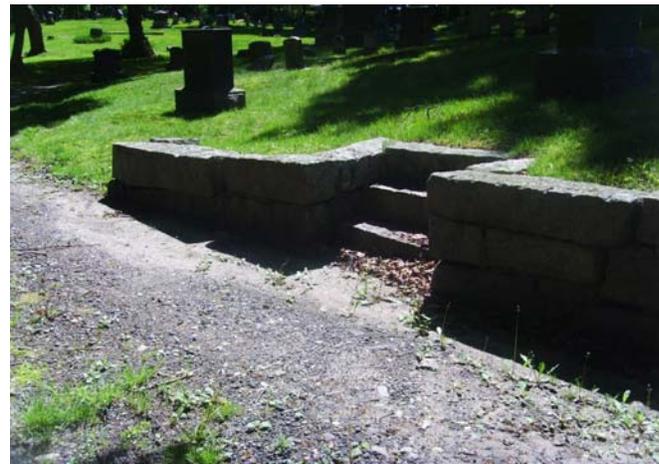
Left stairs

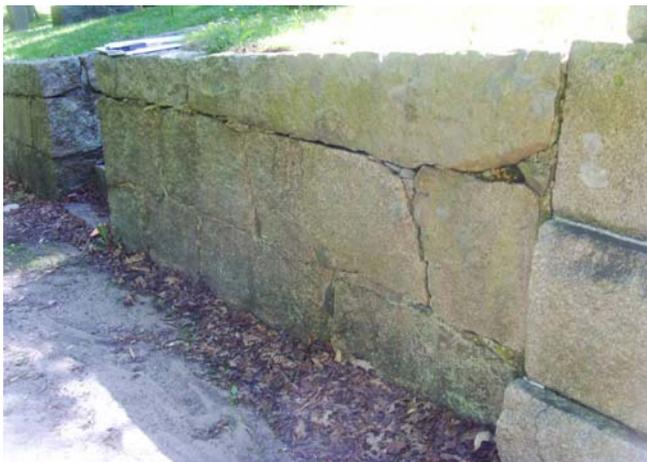
Typical condition of joints

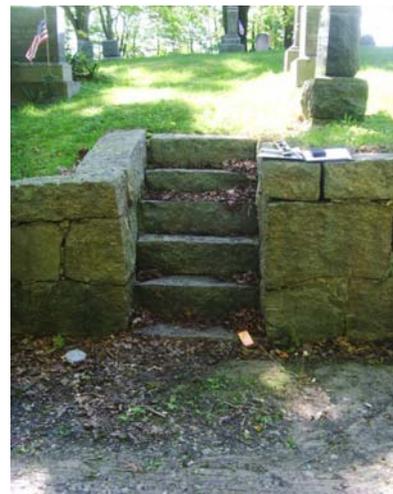
Right stairs

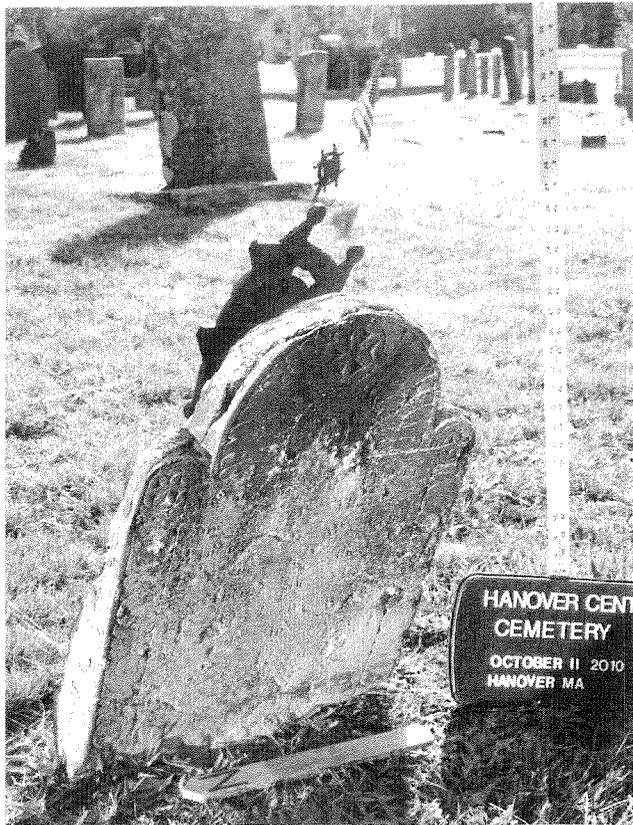
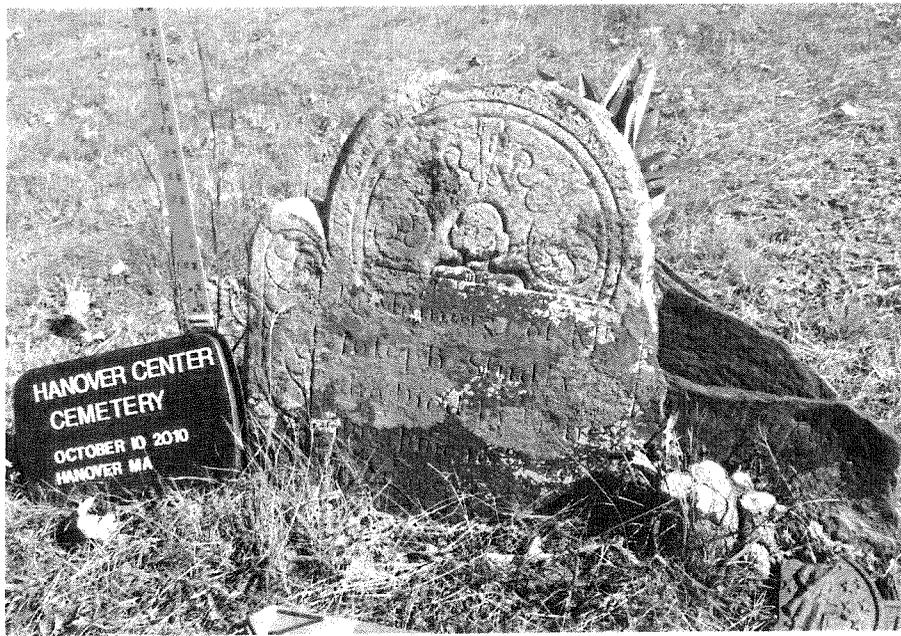
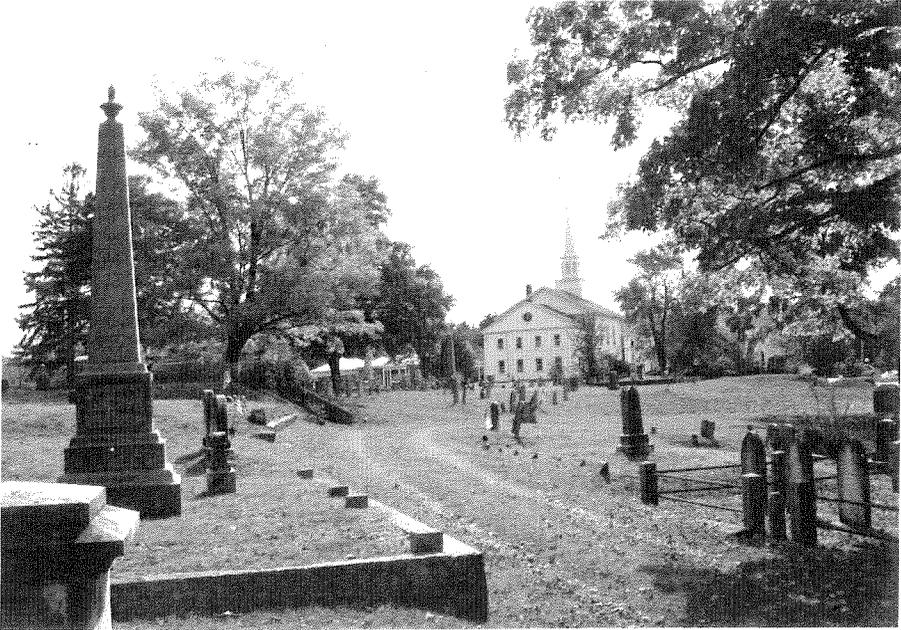
EXAMPLES OF SLATE GRAVESTONES REQUIRING CONSERVATION

Fannin•Lehner
271 Lexington Rd.
Concord MA 01742
Hanover Center Cemetery
Hanover MA - 10/10-11/2010
Set: 2 Photo: 161 - 6111 ex: broken

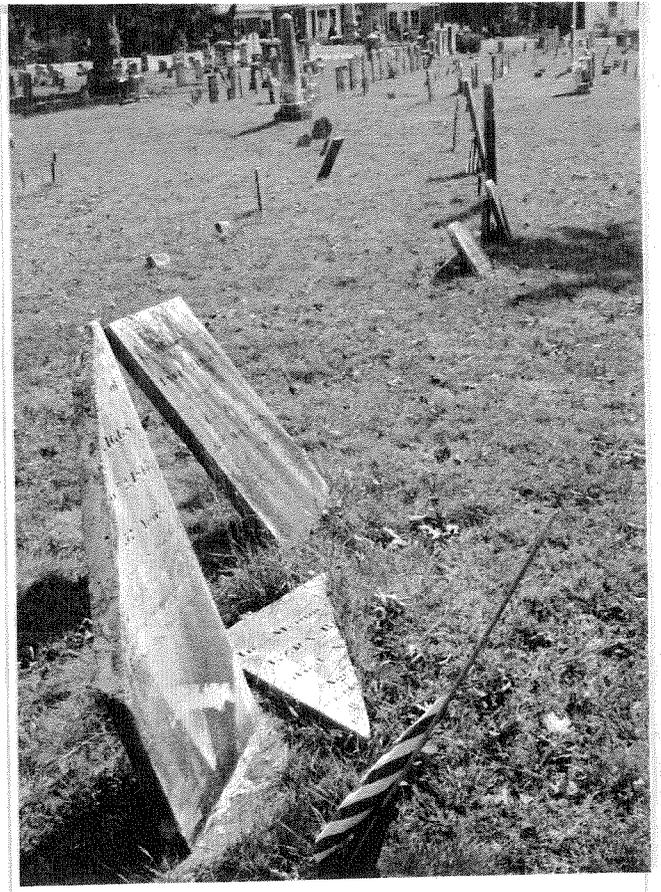
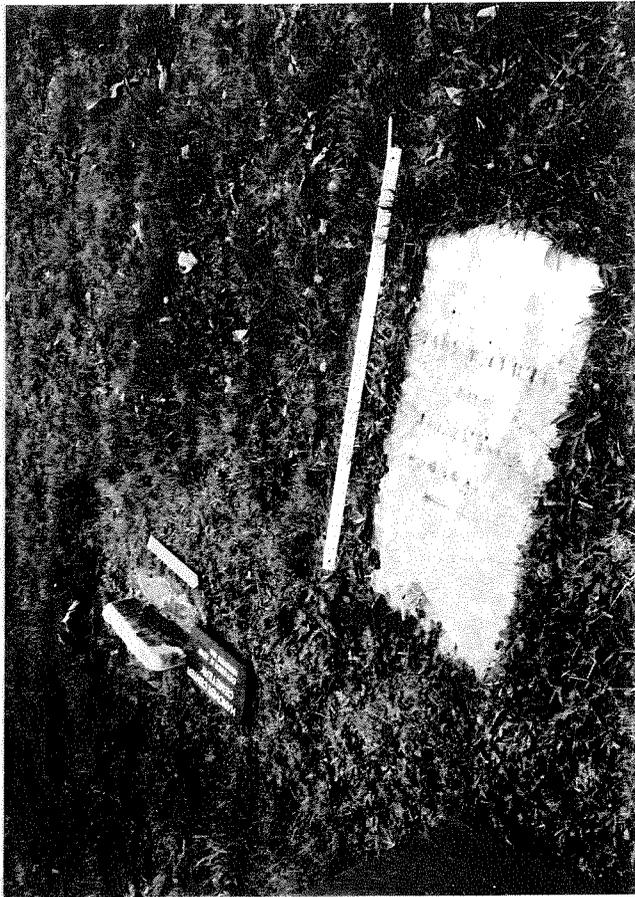
EXAMPLES OF MARBLE GRAVESTONES
AND MONUMENTS REQUIRING
CONSERVATION

Sally Tildin
d. 3/18/1980
old sec. 1
ex: Tilted

Gates + Briggs
Families
Old sec. 2
ex: broken/
filled

Seth H. Virali
d. 8/11/1902
old sec. 1
ex: Fallen

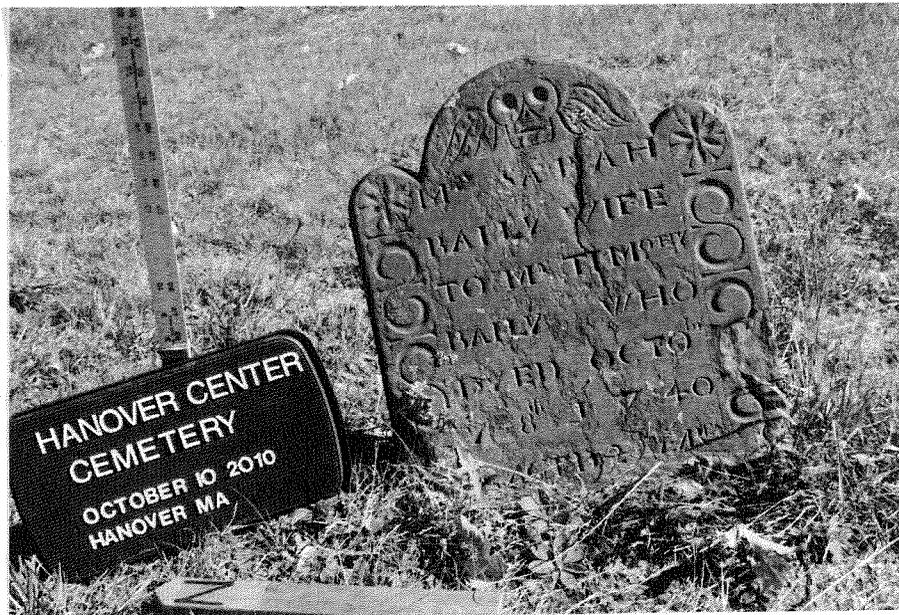
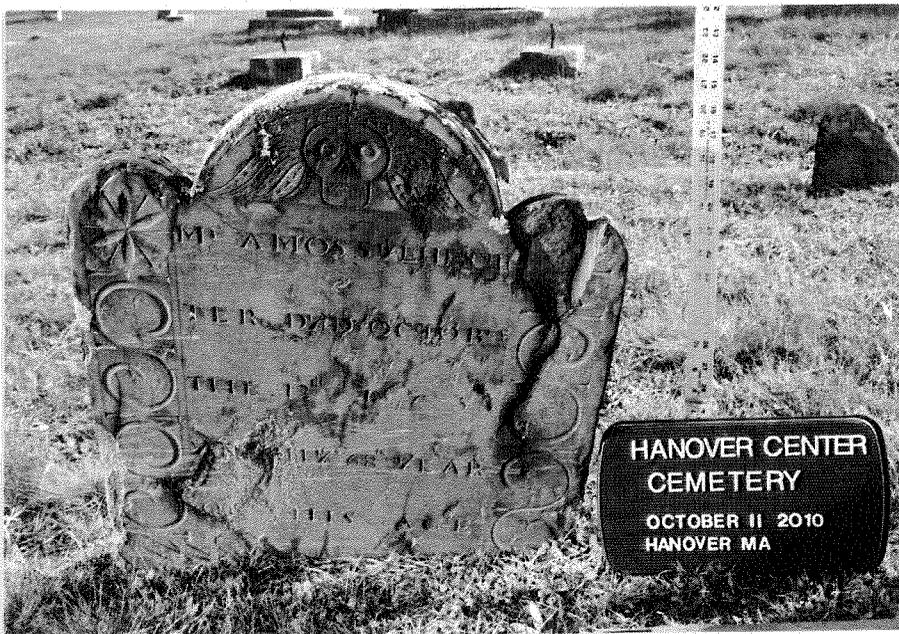
EXAMPLES OF GRAVESTONES BY IDENTIFIED CARVERS: "NORTH RIVER CARVER" AND JOHN NEW

Fannin•Lehner Mrs. Sarah Bailey,
271 Lexington Rd. d. Oct. 8, 1740
Concord MA 01742 old section 1
Hanover Center Cemetery carver:
Hanover MA - 10/10-11/2010 "North River"
Set: 2 Photo: 161 - 6110 Carver"

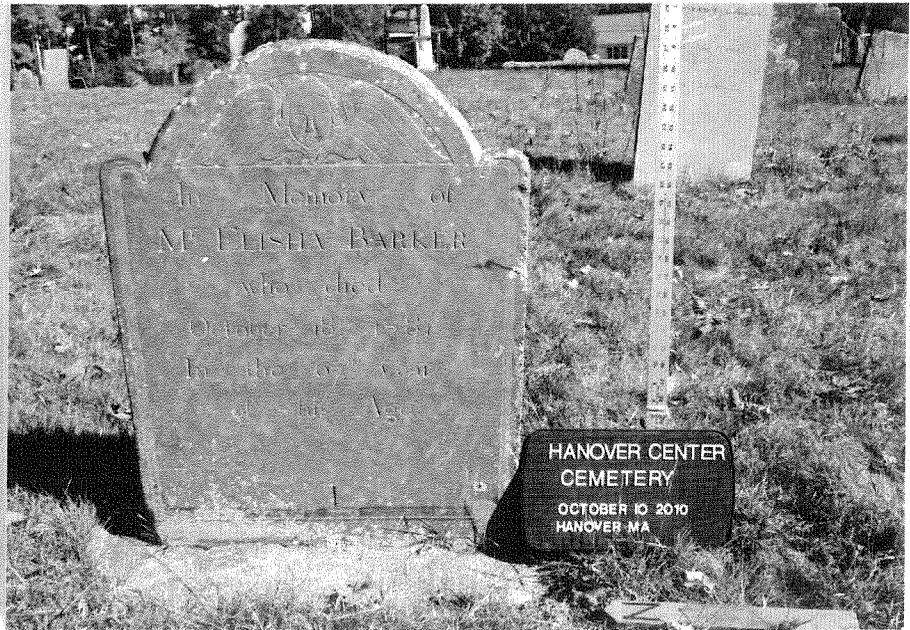
HANOVER CENTER
CEMETERY
OCTOBER 10 2010
HANOVER MA

EXAMPLES OF GRAVESTONES BY
IDENTIFIED CARVERS: BILDAD
WASHBURN

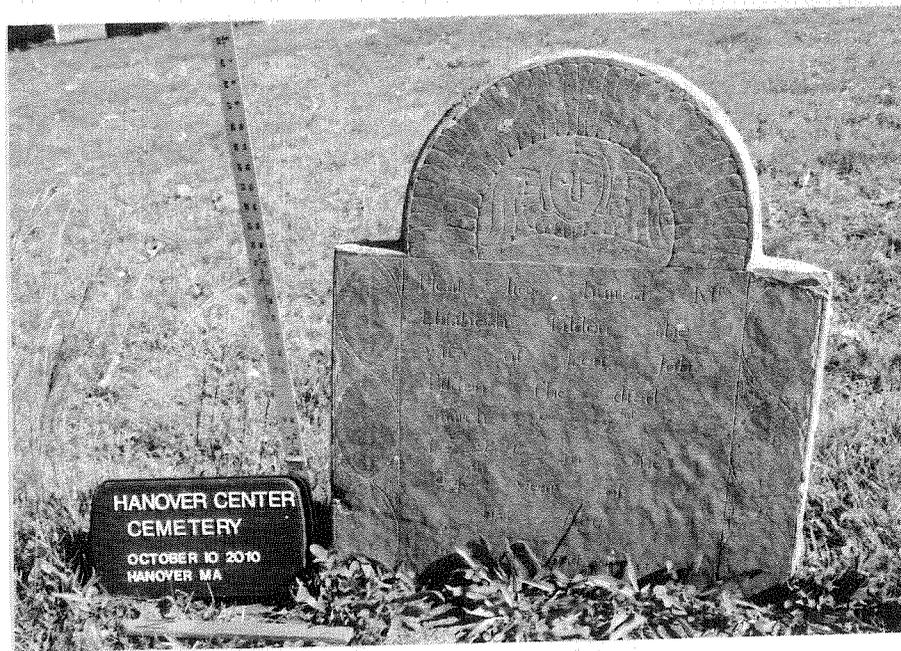
EXAMPLES OF GRAVESTONES BY IDENTIFIED CARVERS: PRATT FAMILY CARVERS

Fannin•Lehner Deacon Samuel Barston
271 Lexington Rd. d. Nov. 19, 1801
Concord MA 01742 old sect. 2
Hanover Center Cemetery caver: Seth
Hanover MA - 10/10-11/2010 Jones Pratt
Set: 2 Photo: 161 - 6133

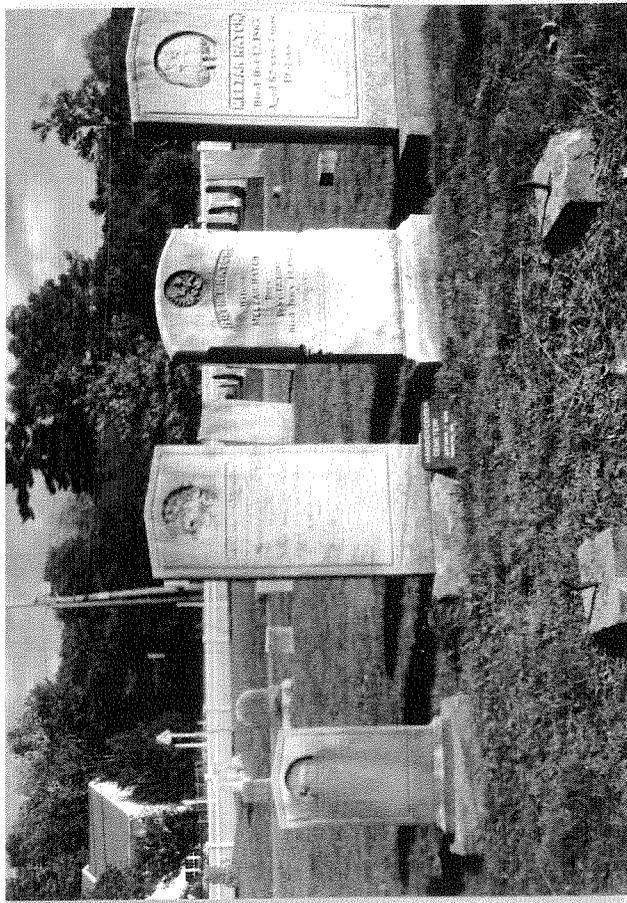
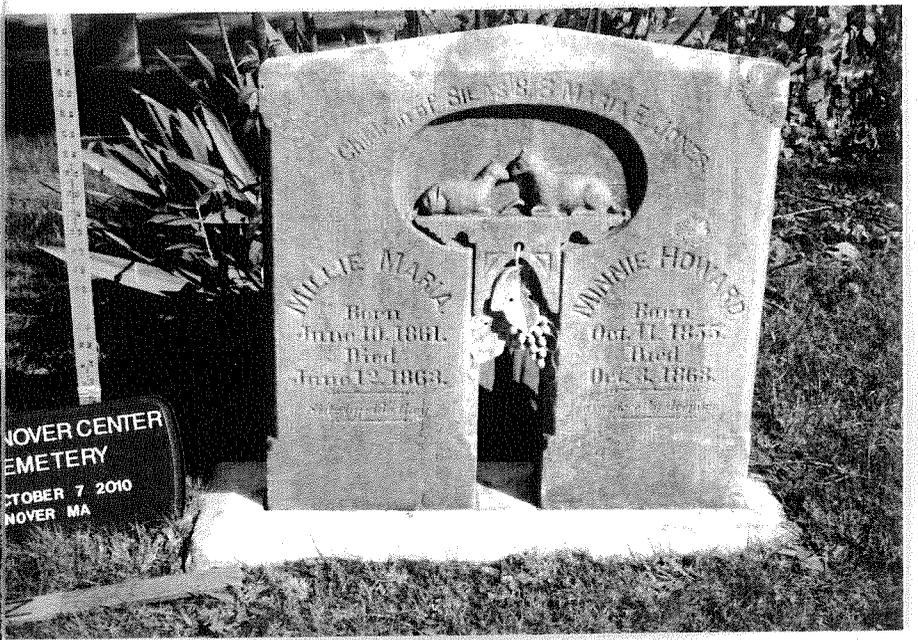
EXAMPLES OF MARBLE AND GRANITE GRAVESTONES AND MONUMENTS OF AESTHETIC SIGNIFICANCE

HANOVER CENTER CEMETERY
OCTOBER 7 2010
HANOVER MA

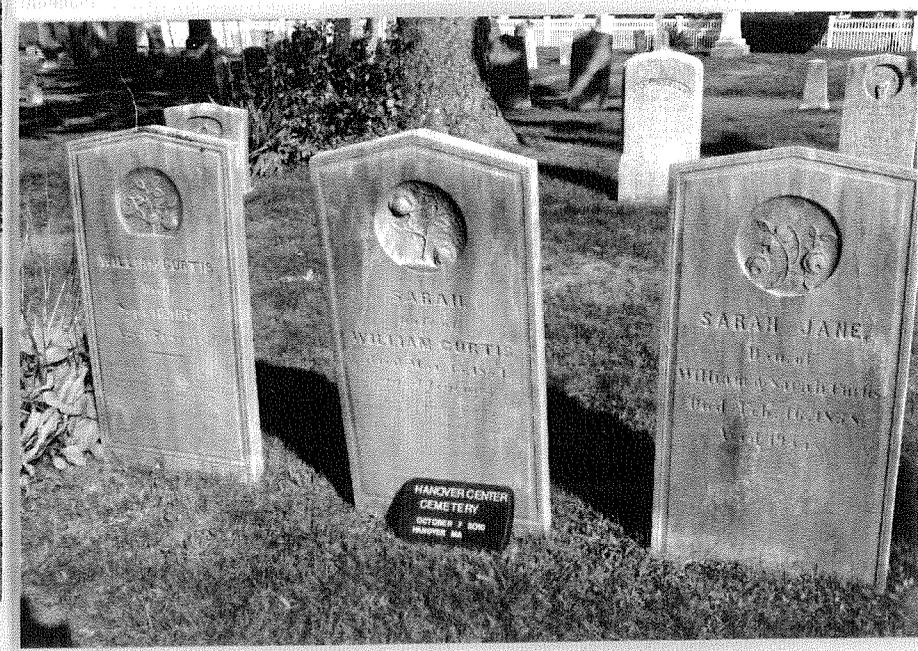
HANOVER CENTER CEMETERY
OCTOBER 7 2010
HANOVER MA

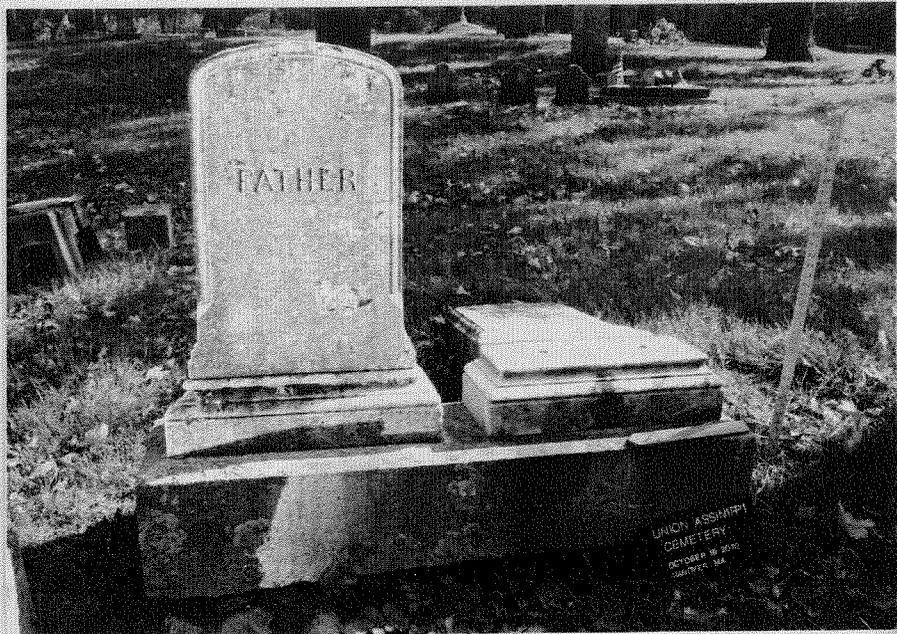
Fannin•Lehner
271 Lexington Rd.
Concord MA 01742
Union-Assinippi Cemetery
Hanover MA - 10/17/2010
Set: 1 Photo: 161 - 1163

Tanna Bailey
d. 7/11/1873
Section: A-6
ex: Fallen

EXAMPLES OF GRAVESTONES AND MONUMENTS REQUIRING CONSERVATION

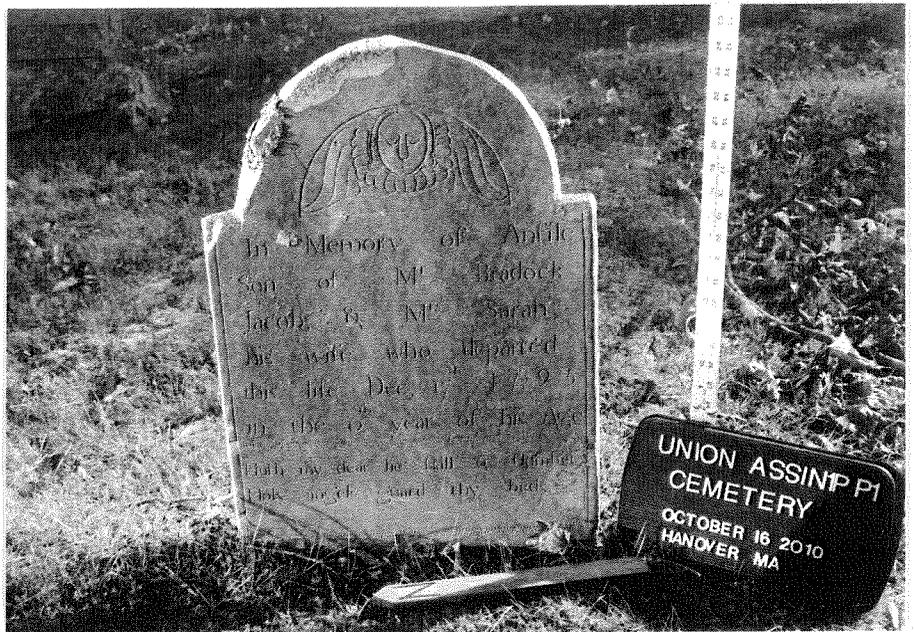
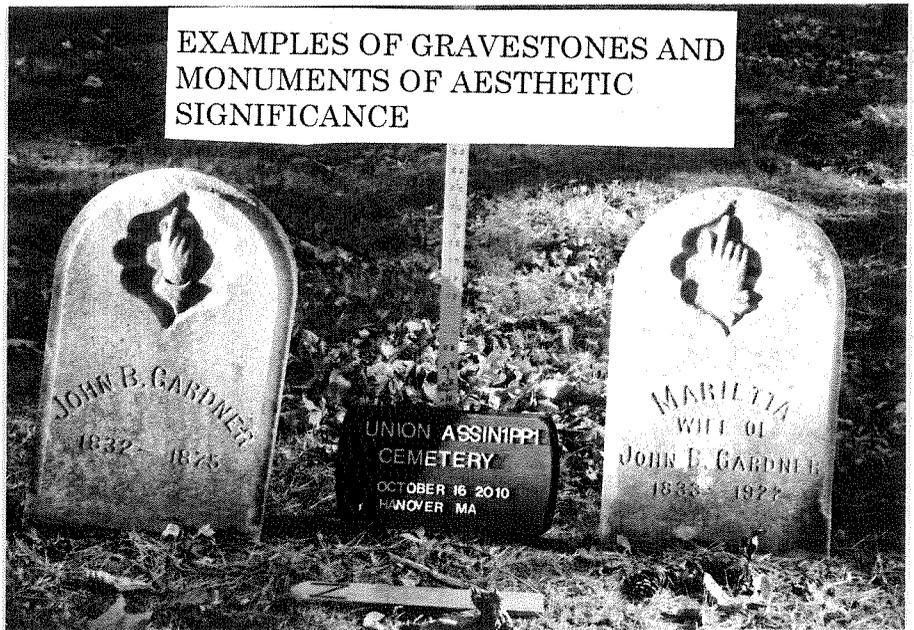
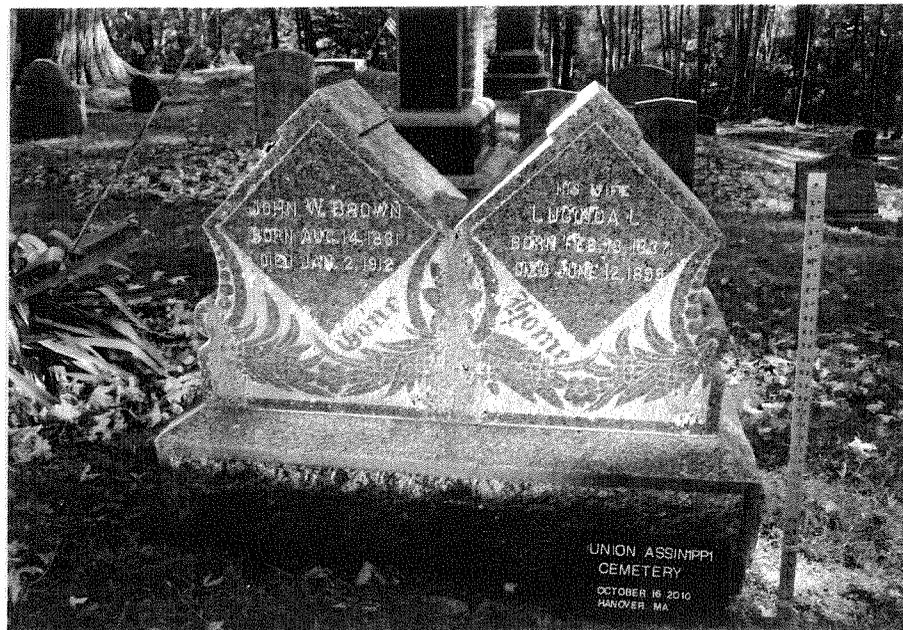
Fannin•Lehner
 271 Lexington Rd.
 Concord MA 01742
 Union-Assinippi Cemetery Section: A-7
 Hanover MA - 10/17/2010
 Set: 1 Photo: 161-163

Hosea Whiting
d. 4/12/1883
Lydia Dwyer Dyer
d. 1/13/1837
ex: Tilted

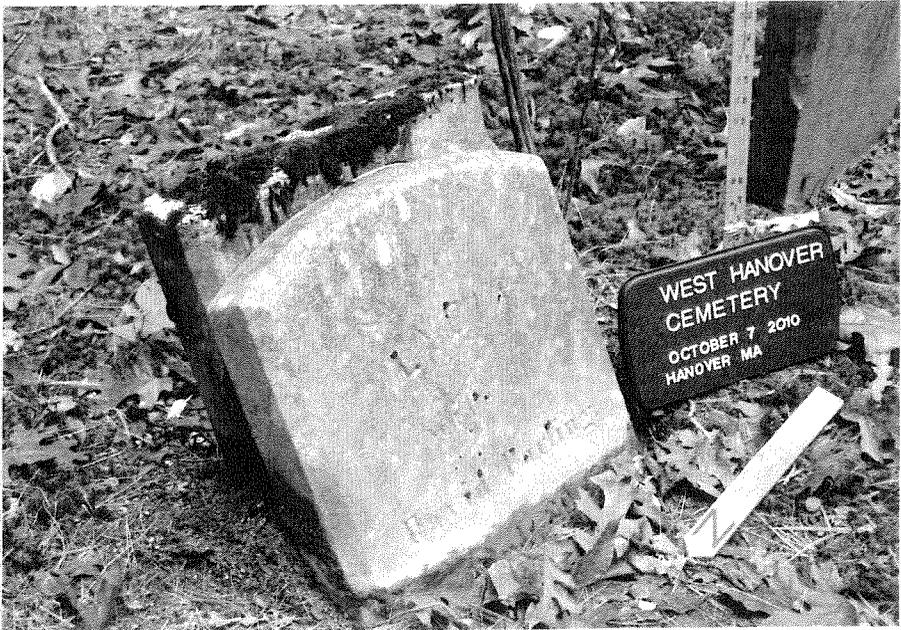
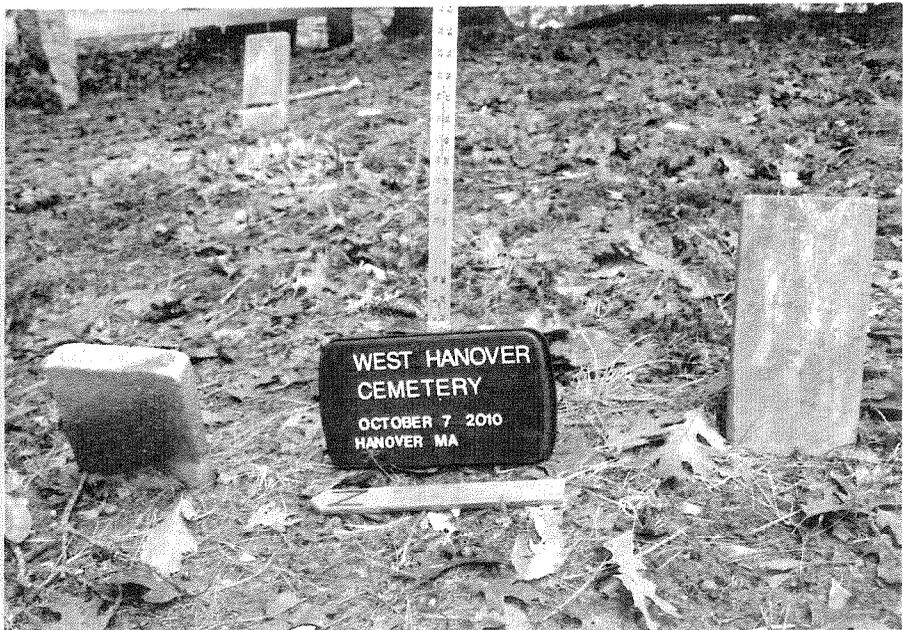
Fannin•Lehner
271 Lexington Road
Concord, MA01742
West Hanover Cemetery
Hanover, MA - 10/7/10

EXAMPLES OF GRAVESTONES AND MONUMENTS REQUIRING CONSERVATION
