HANOVER TOWN HALL. HANOVER, MASS. PAINTED WITH DUTCH BOY LIQUID LEAD.

PRESENTATION TO THE TOWN OF HANOVER COMMUNITY PRESERVATION COMMITTEE

Preliminary Findings

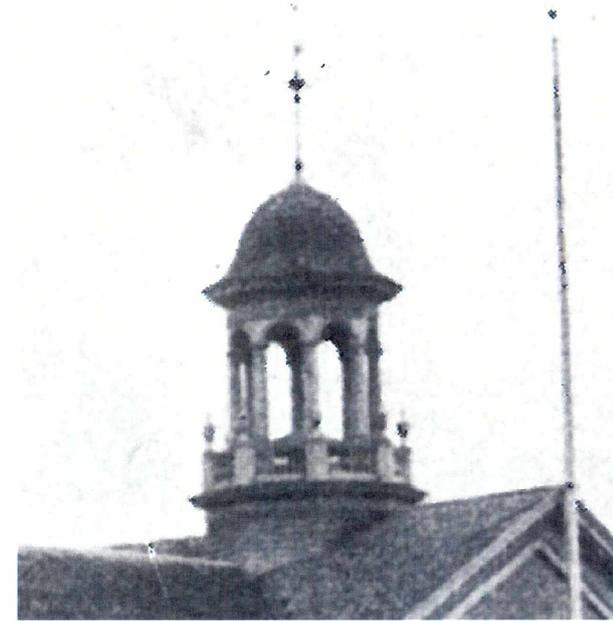
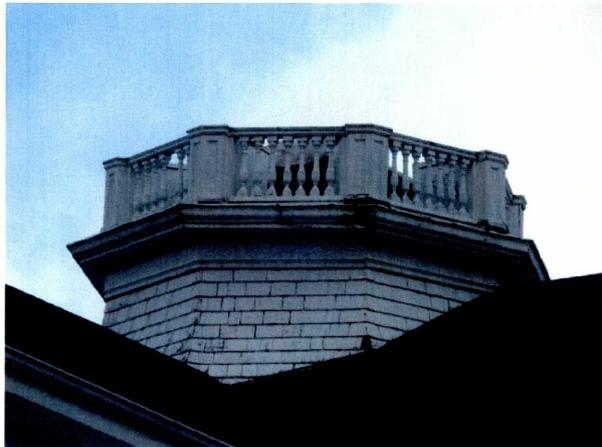
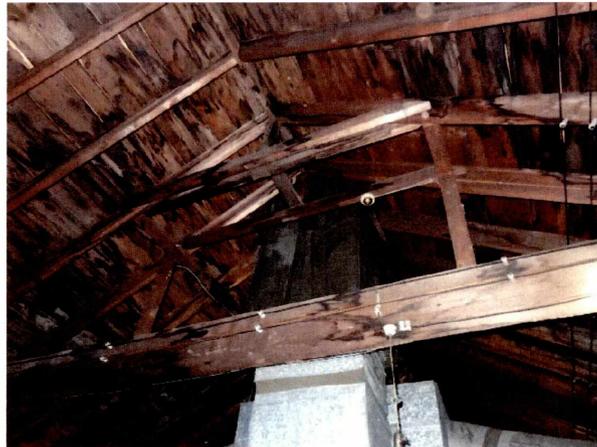
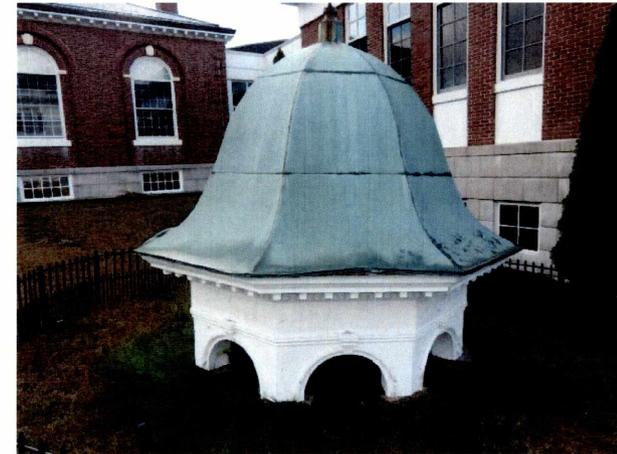
Restoration of the Cupola

Roof replacement

Cupola Structure

Deteriorated decorative woodwork

Paint build up

Loose flashing on cupola & aging asphalt shingle roof

- Provide new structure at cupola, anchorage to roof and interior framing to prevent future toppling, hoist cupola and secure to new framing

- Close open joints, mill new trim to match existing, replace missing urns, balusters and trim, make new legs

- Strip to bare wood, paint historic colors

- Replace deck roof, flashing and cupola roof
- Replace Town Hall roof

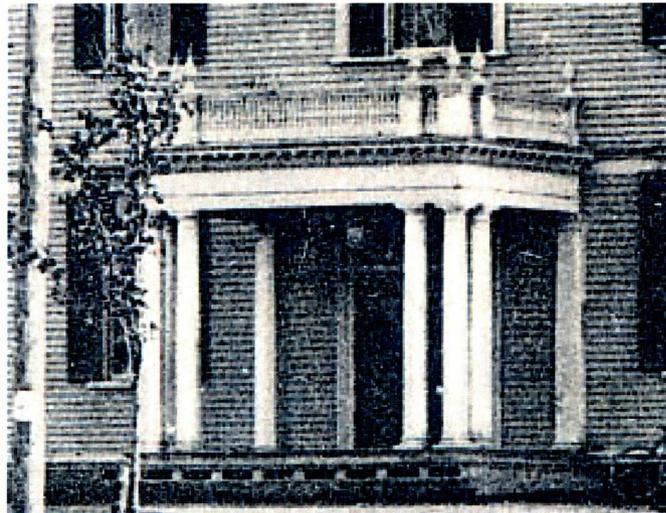
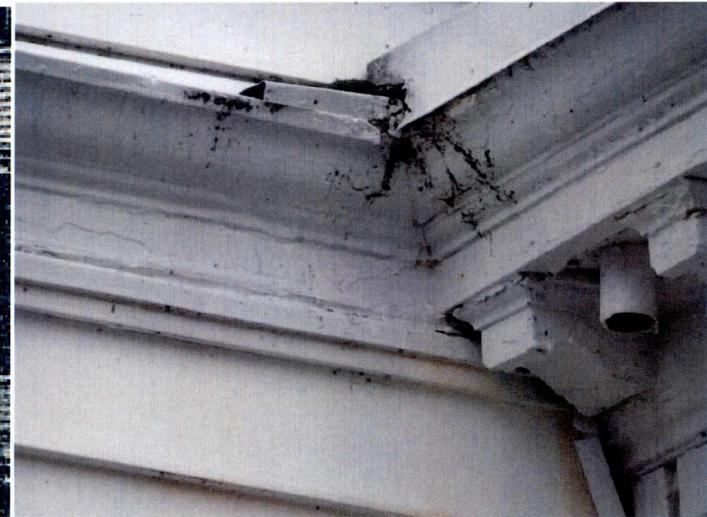
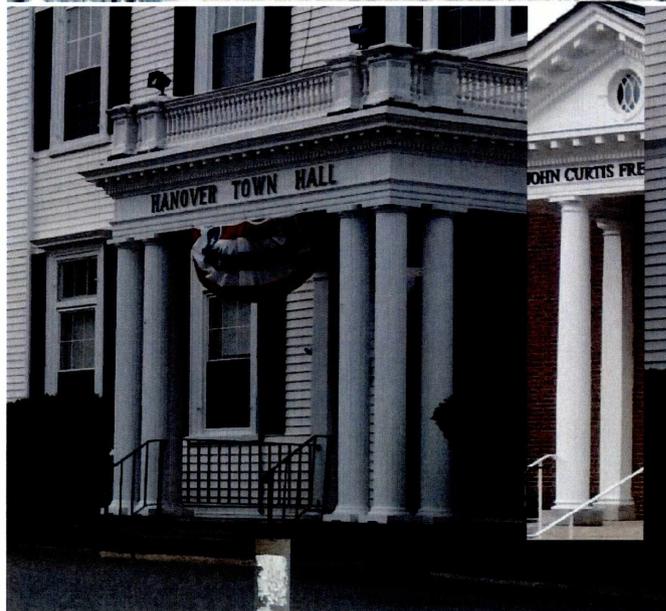
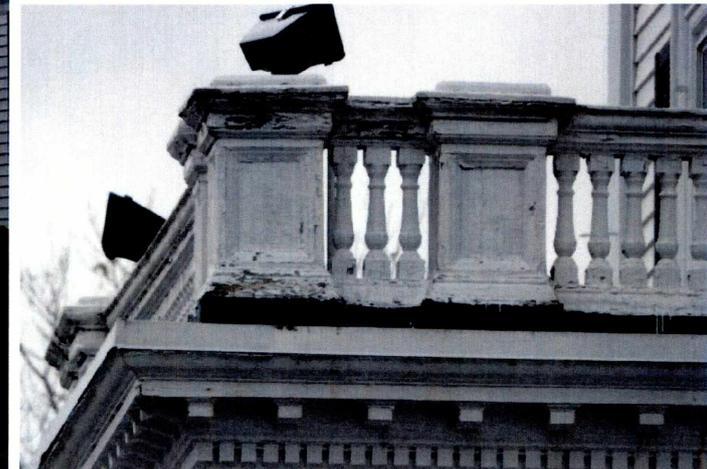
Restoration of the Portico

Paint build up

Deteriorated woodwork

Inappropriate aluminum columns

Flashing and drainage off flat roof

Deteriorated concrete landing

- Strip to bare wood, paint historic colors

- Close open joints, mill new trim to match existing, replace missing urns

- Replace with properly proportioned and tapered shaft

- Replace flat roof and gutter liner, copper where visible

- Reconstruct with new stone treads

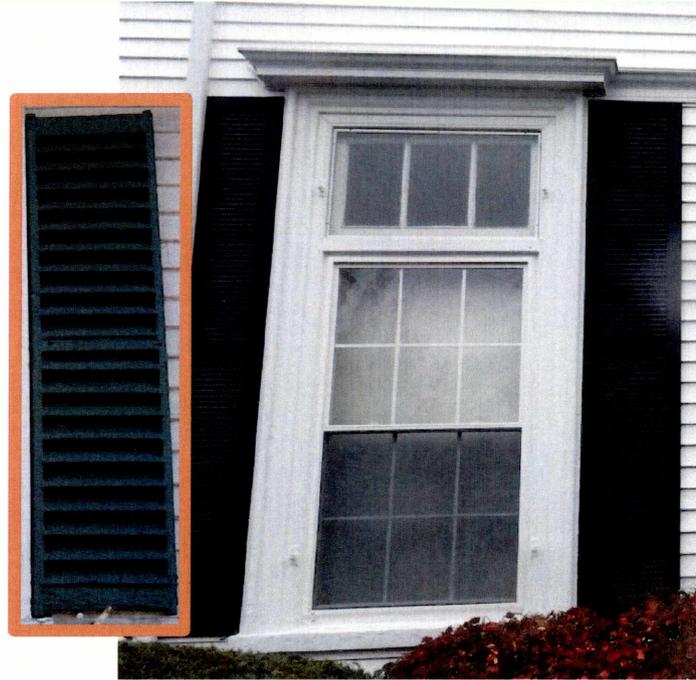
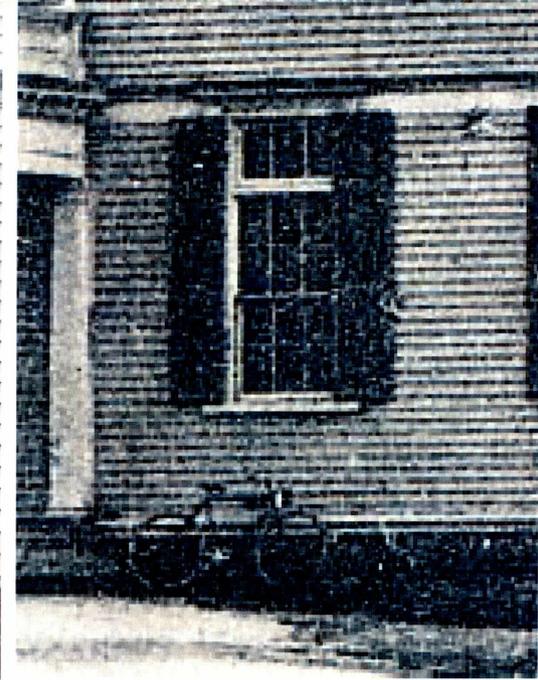
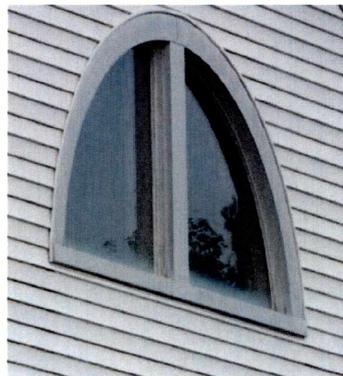
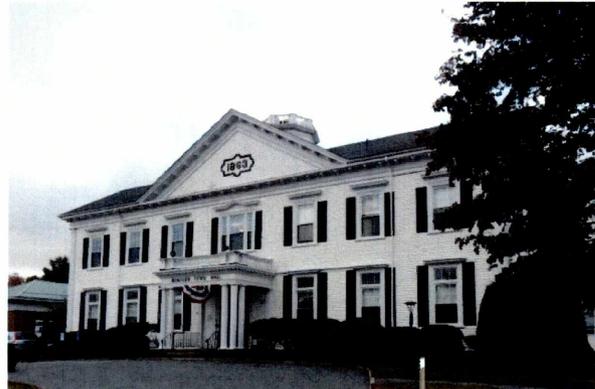
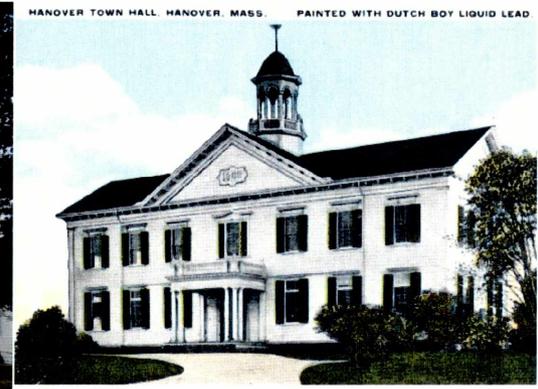
Replacement of Windows and Shutters

Flat muntins, poorly operating, energy inefficient windows

Fake shutters screwed to siding

Seals failing and wood deterioration

- Replace with SDL clad wood operating sash

- Replace with accurate replicas, wood or PVC, properly mount to frame of windows.

- Replace 40 year old insulated glass windows with new clad wood operating and fixed sash.

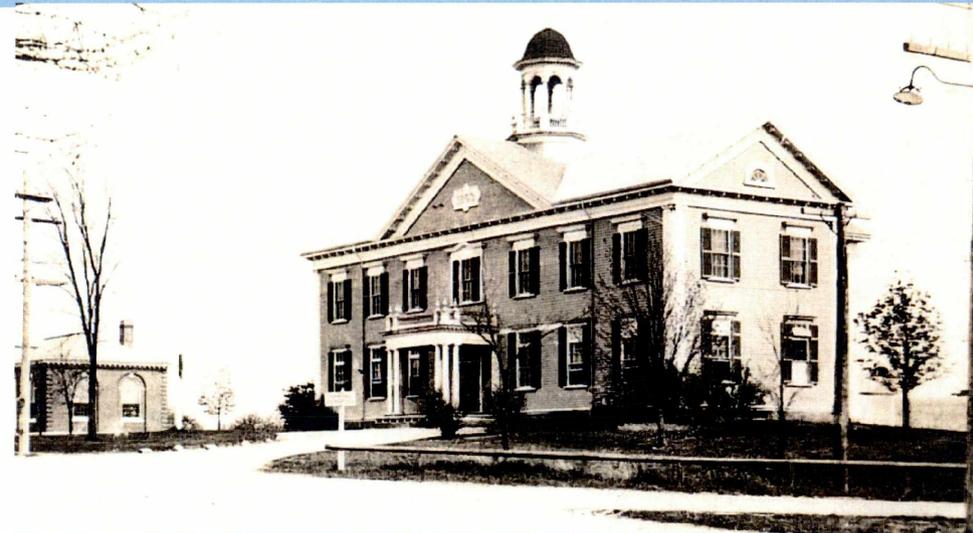
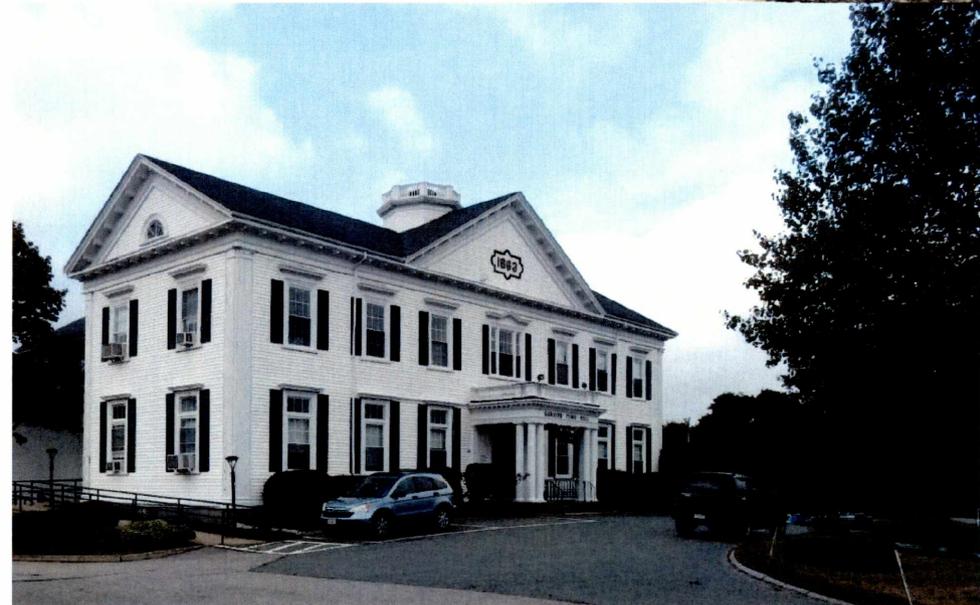
Replace siding, paint historic colors

Synthetic siding traps moisture, obscures historic detail prevents access to areas for structural repair and strengthening

White on white paint scheme

Wall insulation of 1977 addition could be improved

- Remove synthetic siding
- Remove wood siding beneath, document
- Remove sheathing
- Restore framing, repair sills
- Infill voids in blown in insulation
- New rigid insulation boards
- New structural sheathing

- Perform paint analysis on extant historic materials to confirm colors of contrasting paint scheme shown in historic black and white photos.
- Refer to contemporary accounts of the building for clues.

- Adding exterior insulation is an opportunity to replace aging siding and trim.
- Opportunity to rethink siding material

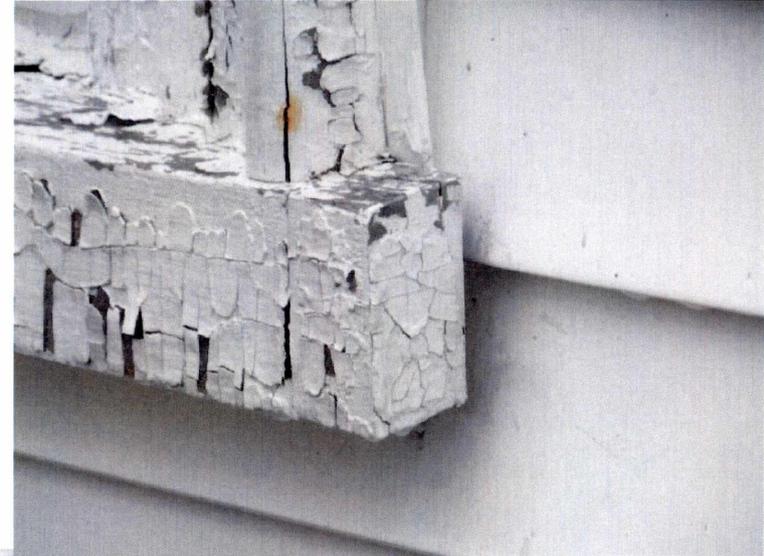
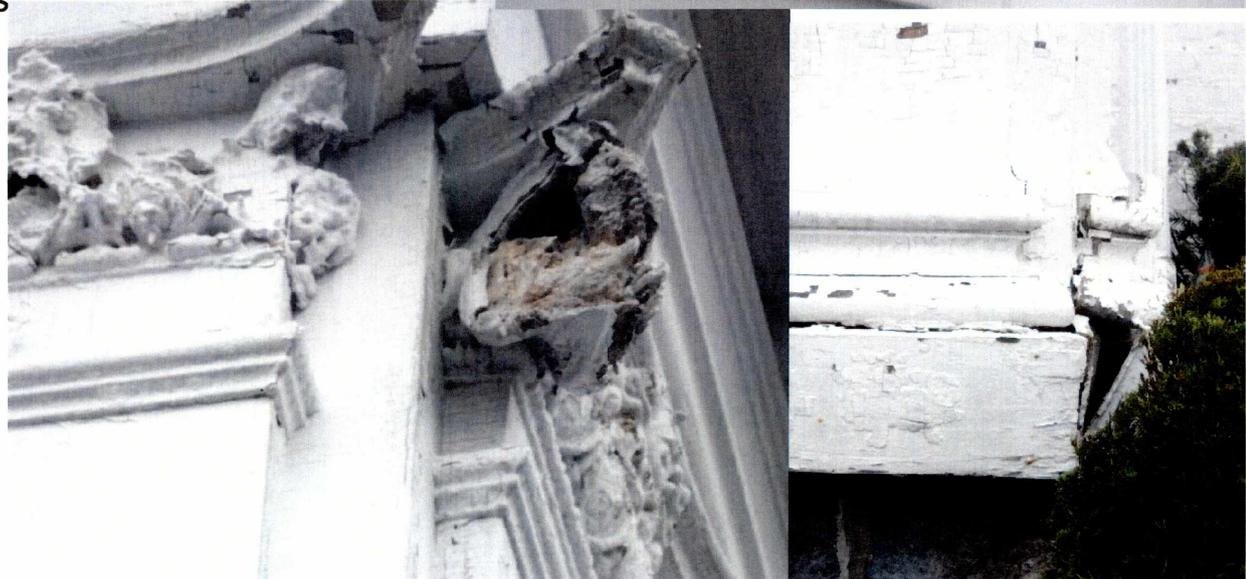
Remove heavily built-up paint & restore historic details

Heavy paint build up on wood

Historic wood work joinery opening

Missing or damaged historic ornament

- Strip paint to bare wood for better paint adhesion

- Close joints open to weather
- Use stainless steel screws

- Salvage extant remnants for creating models to cast into replacement ornament
- Further research photos for size and proportion of missing elements and turn or cast new replacement pieces

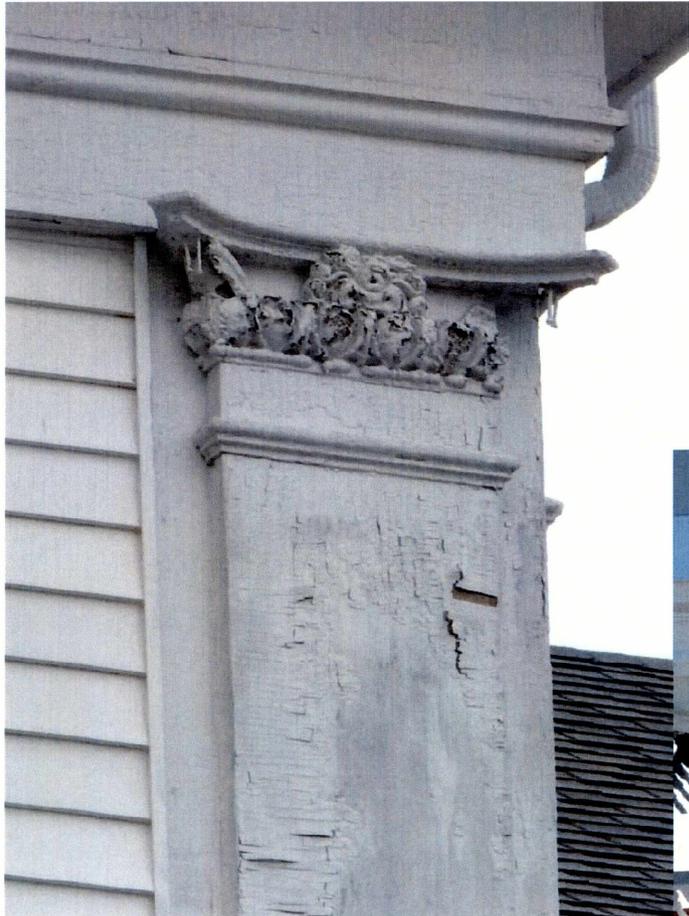
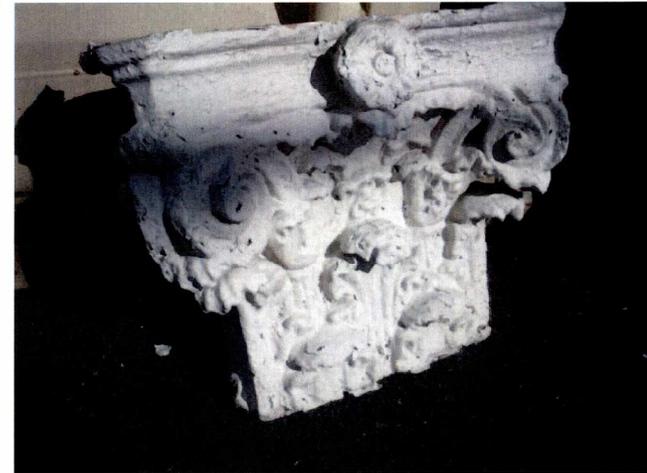
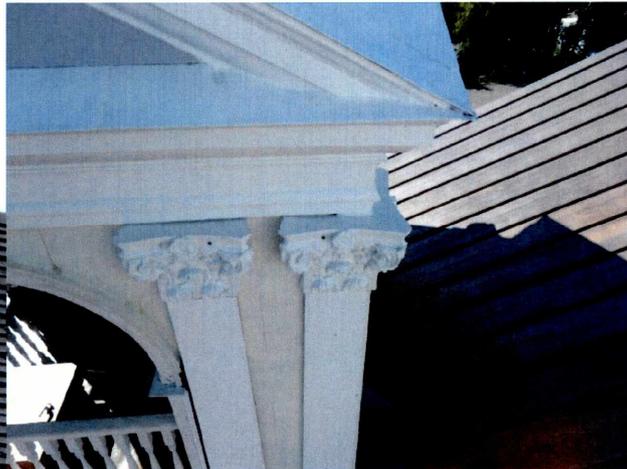
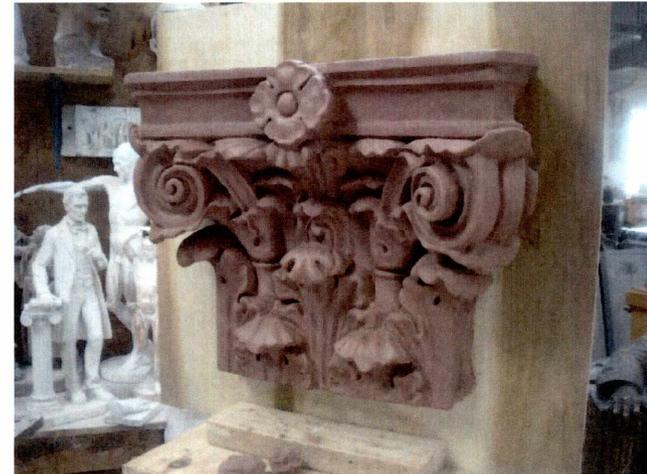
Remove heavily built-up paint & restore historic details

An example of replication of historic details

- A pilaster capital from the Hanover Town Hall shown at left.
- A similar restoration from original to model to install of the cast replacement.

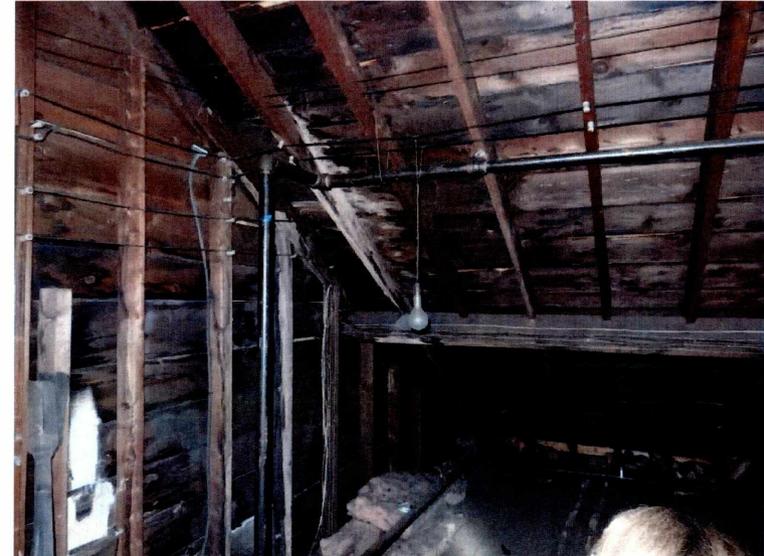
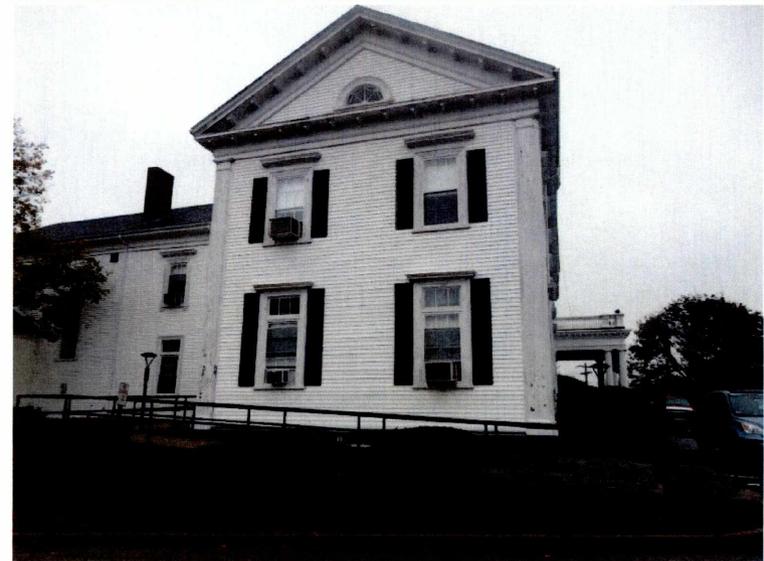
Systems Improvements

Knob and Tube Wiring is a fire and life safety hazard and power delivery is unreliable due to the age of the system.

Window mounted AC units are inefficient, allow air infiltration reduce views out and detract from historic appearance.

- Remove knob and tube
- Install code compliant wiring.

- Install a central air conditioning system.

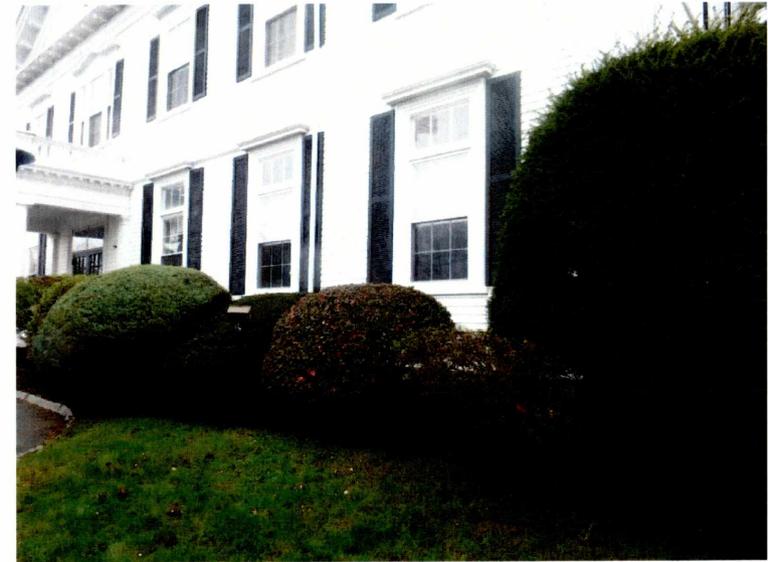
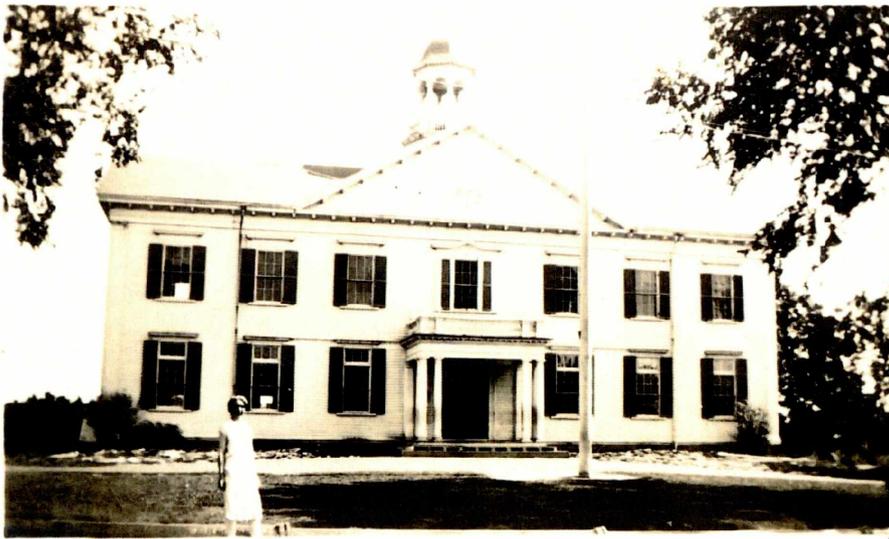
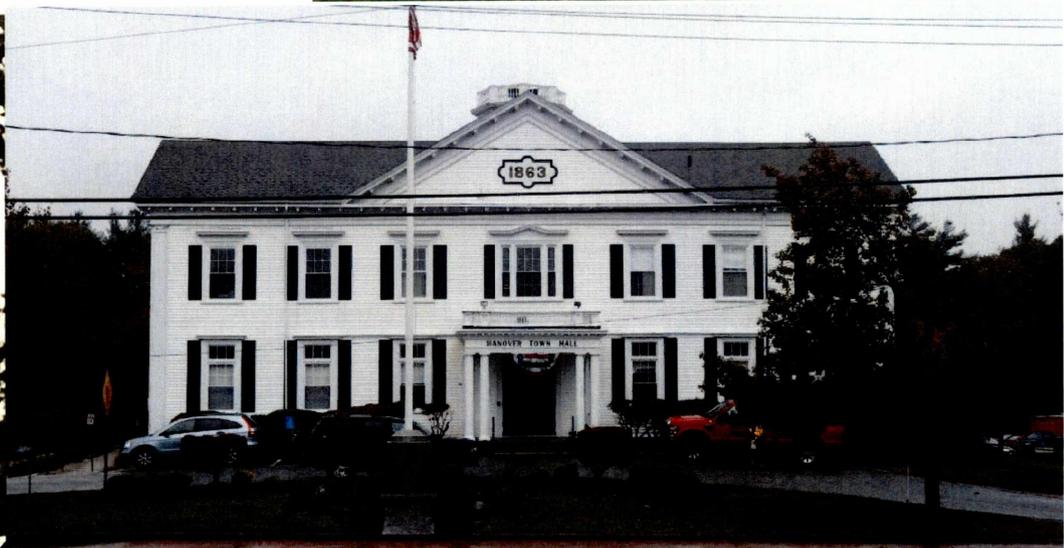
Landscape Improvements

Foundation plantings and mulching trap moisture against the foundations.

- Thin plantings to more historic appearance
- Regrade for improved drainage.
