# Hanover Rails To Trails Project Feasibility Study

**Prepared for: Hanover Rails to Trails Committee**

**Town of Hanover, Massachusetts**

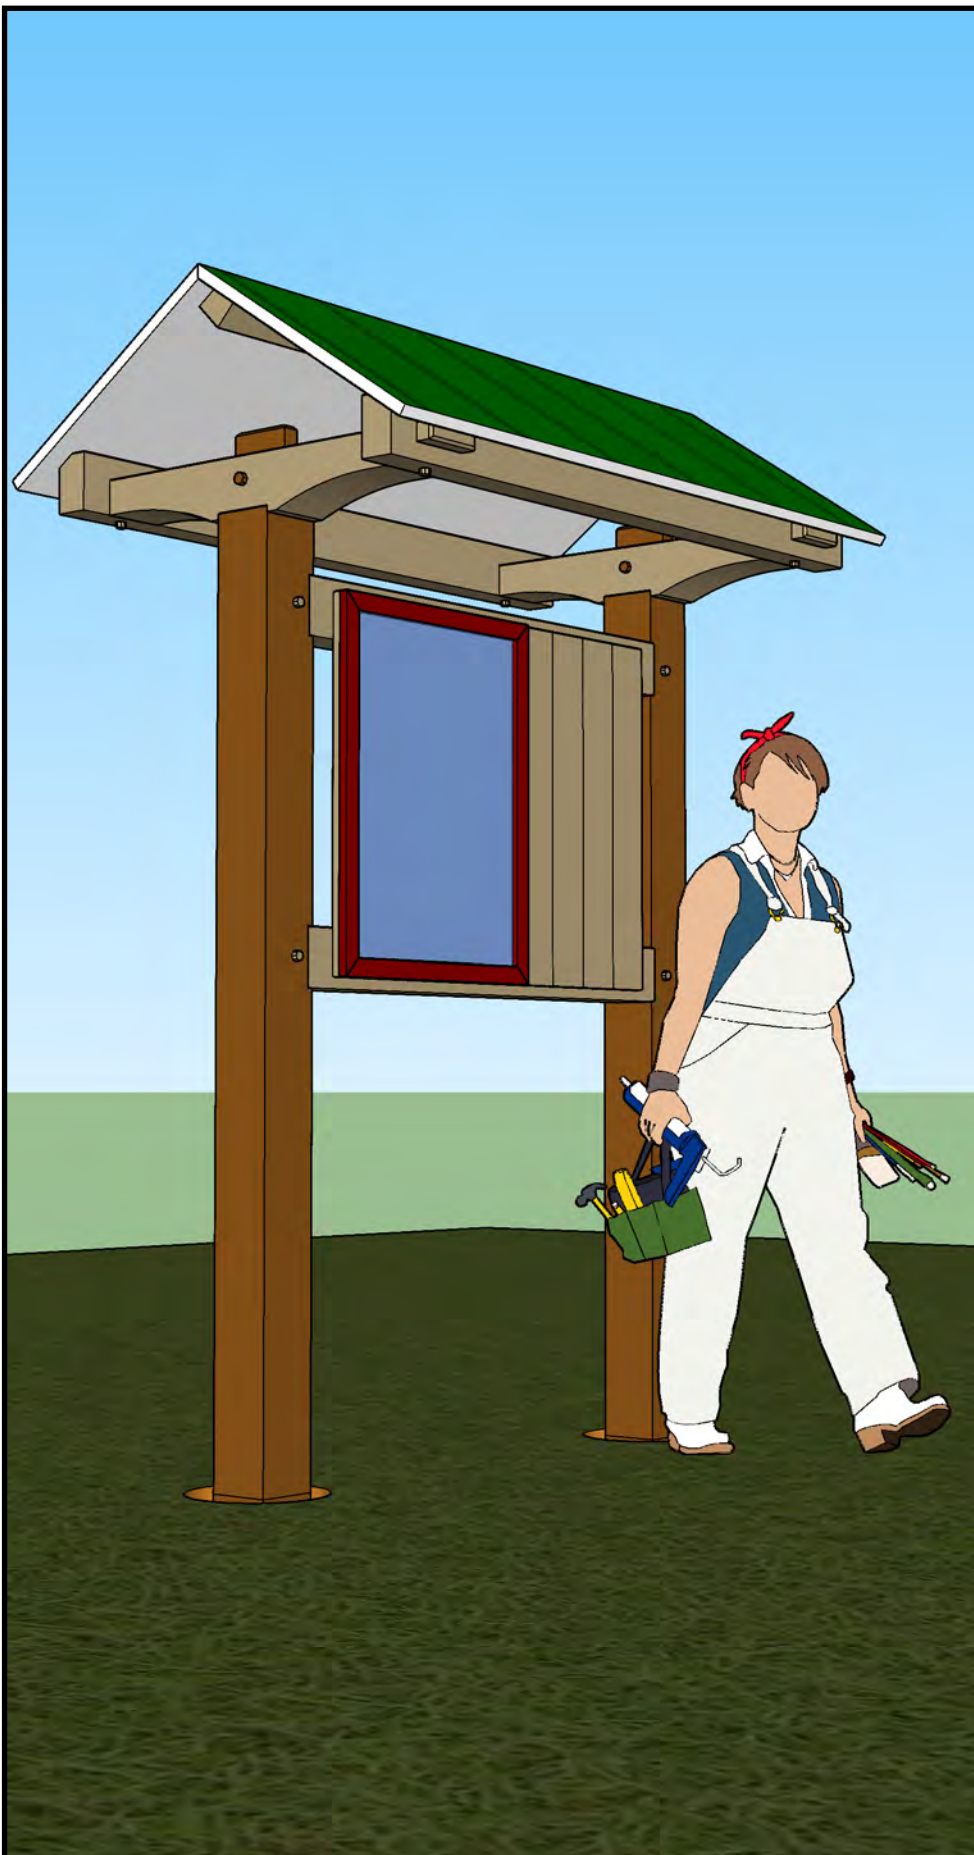
## Specifications:

- Posts are Black Locust, all other timbers are White Pine.
  - Principle timber joints secured with White Oak pegs.
- Posts are 5.5"x5.5"; Girts are 4"x5"; Ties are 5.5"x5"; Plates are beveled 3"x4"; Ridge is 3"x3".
  - Roof is rough sawn pine boards with channel drain roofing.
- Signboard 42"x32" of 3/4" tongue-in-groove eastern white cedar.

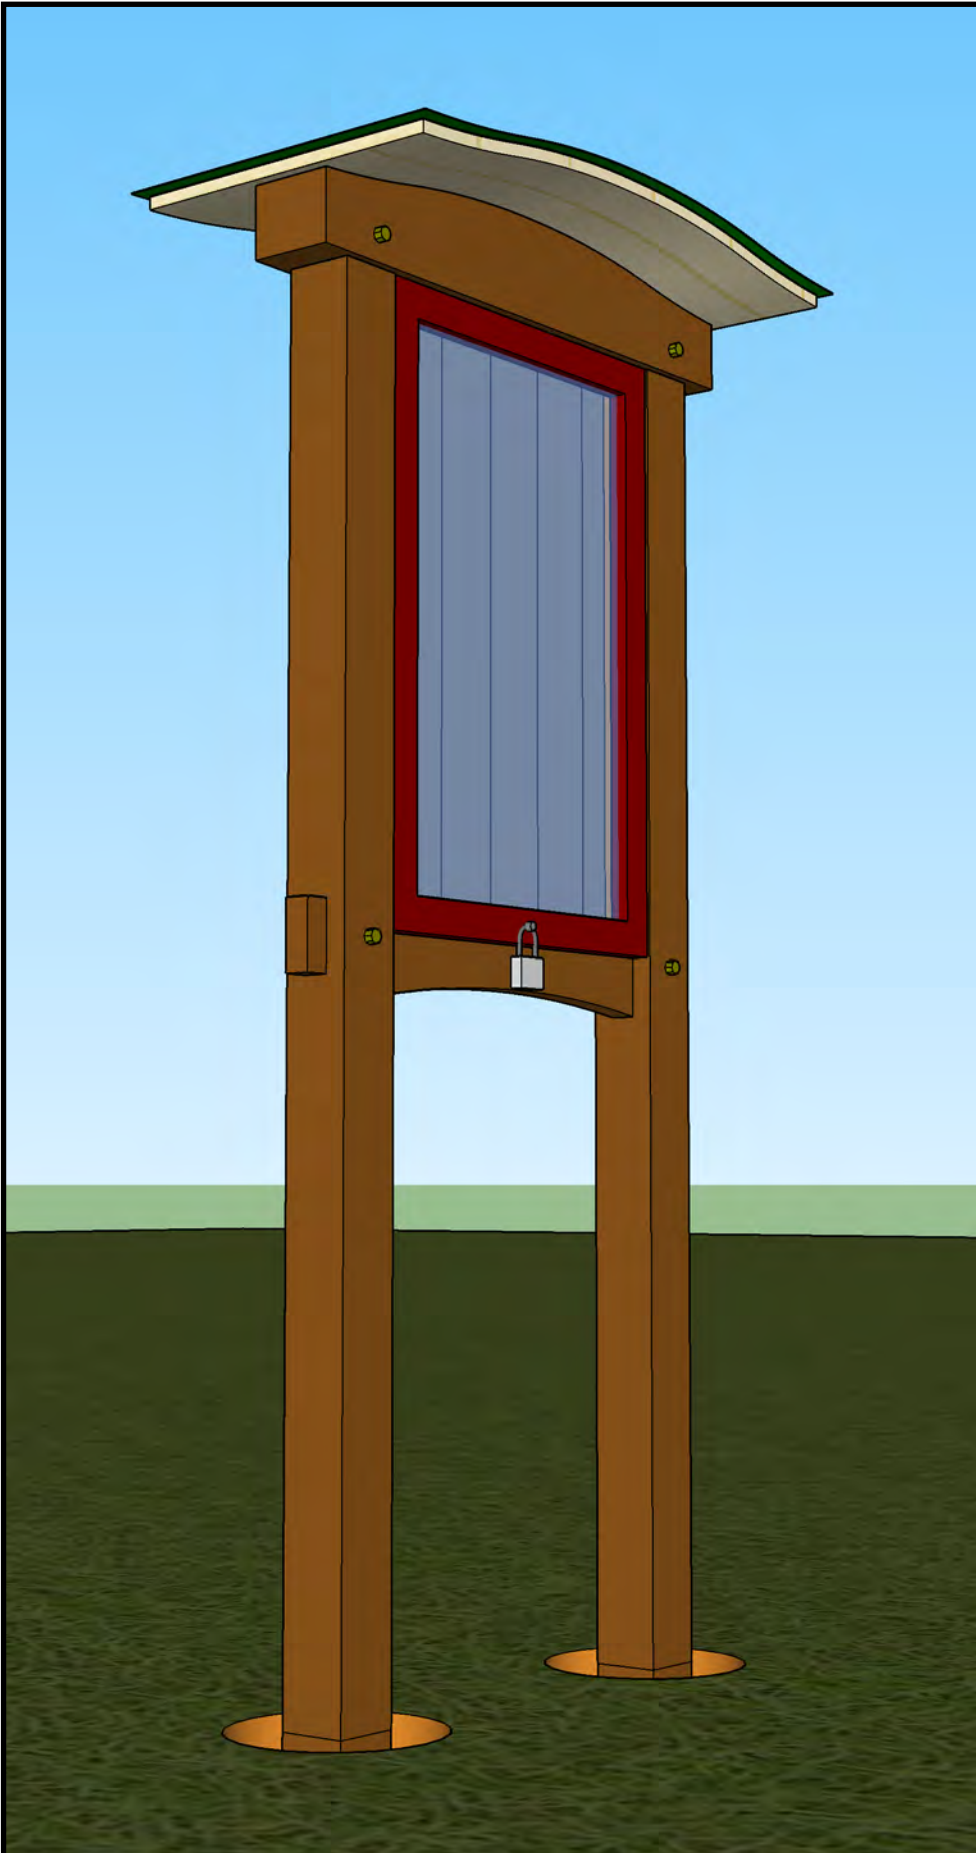
## Specifications:

- Posts are Black Locust, all other timbers are white pine with 1/4" chamfer throughout.
  - Principle timber joints secured with white oak pegs.
  - Posts are 4"x4"; Girts are 2"x6"; Headers are 5"x6"
  - Roof is rough sawn pine boards with metal roofing.
- Signboard 2'x3', made of 3/4" tongue-in-groove eastern white cedar. Front side has a hinged, top-swinging lockable Cherry/plexi signboard cover

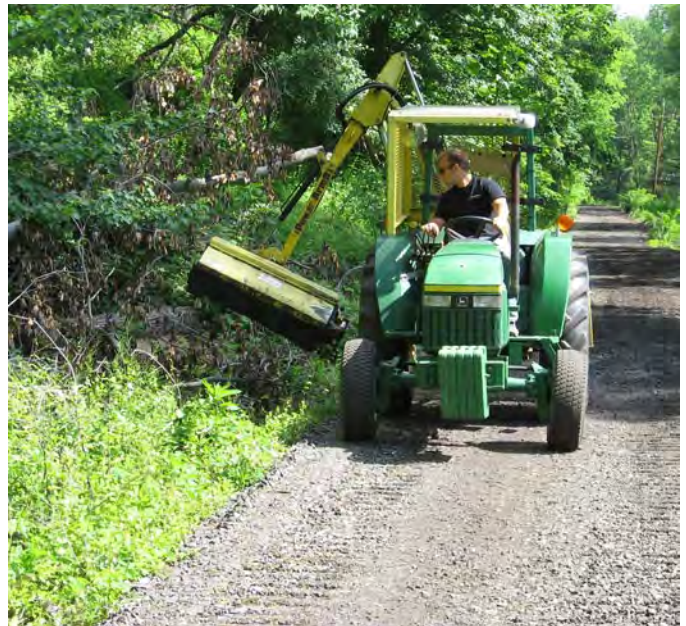
Trail side mowing along the Perkiomen Trail in PA.

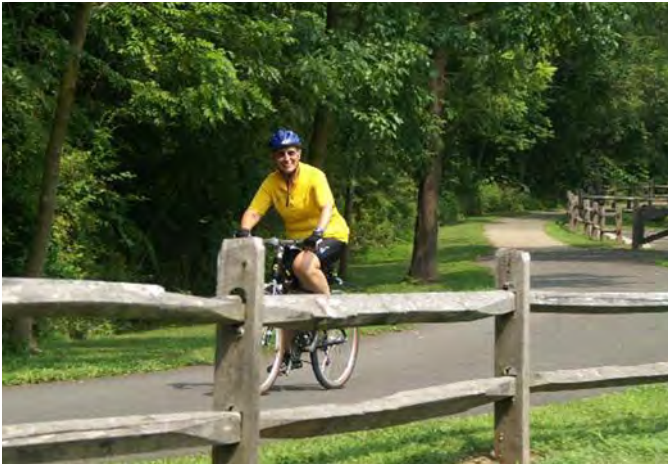
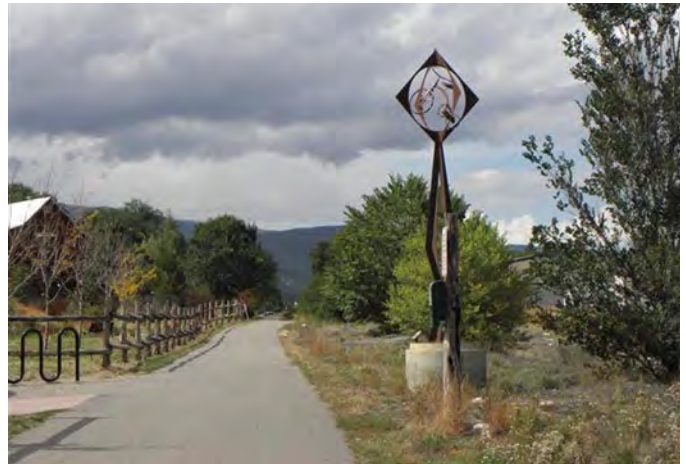
**Perkiomen Rail Trail, PA**  
**20 miles**  
**Annual mowing costs \$12,542**

**Rio Grande Rail Trail, CO**  
**20 miles**  
**Annual mowing costs \$2,112**

The Perkiomen Trail has a significant amount of grass along the shoulders of the trail and fencing that needs to be cut around manually. On the other hand, the Rio Grande Trail has more native vegetation or stone shoulders that do not require frequent mowing.

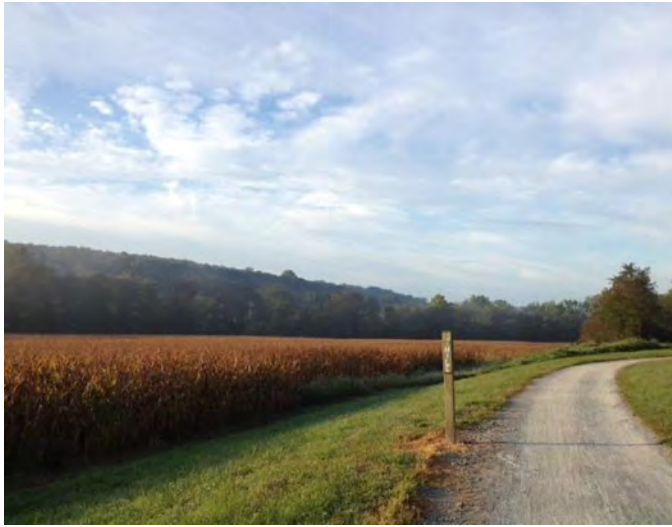
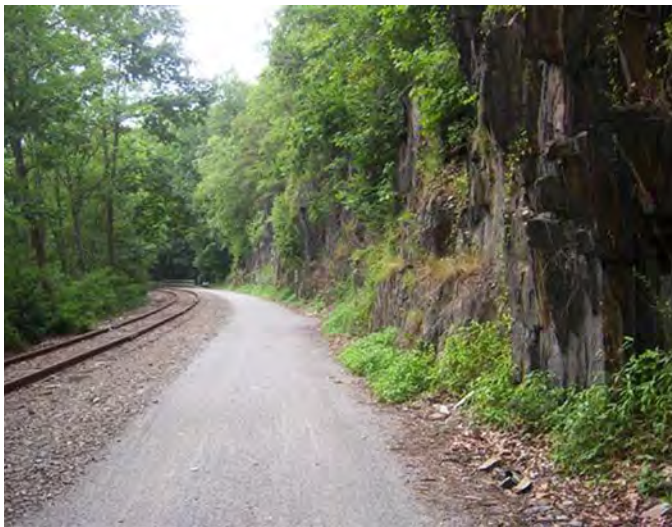
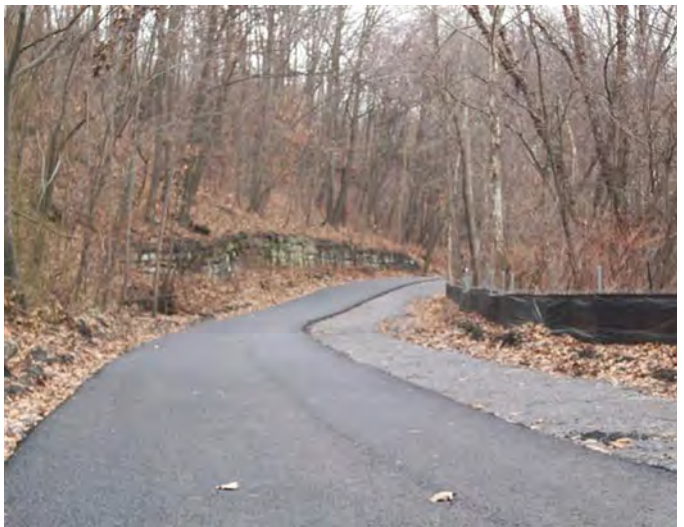
**Heritage Rail Trail County Park, PA**  
**21.1 miles**  
**Annual mowing costs \$6,000**

**Lackawanna River Heritage Trail, PA**  
**19.9 miles**  
**Annual mowing costs \$7,367**

The mowing cost for these two trails is fairly close on a per mile basis. The Heritage Rail Trail has a parallel rail bed along most of its length that requires herbicide treatment but no mowing. The Lackawanna Trail allows natural vegetation to grow along the shoulders or has placed stone shoulders.

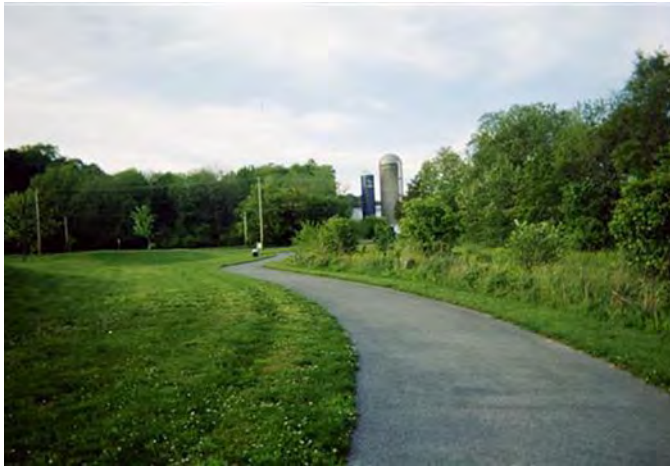
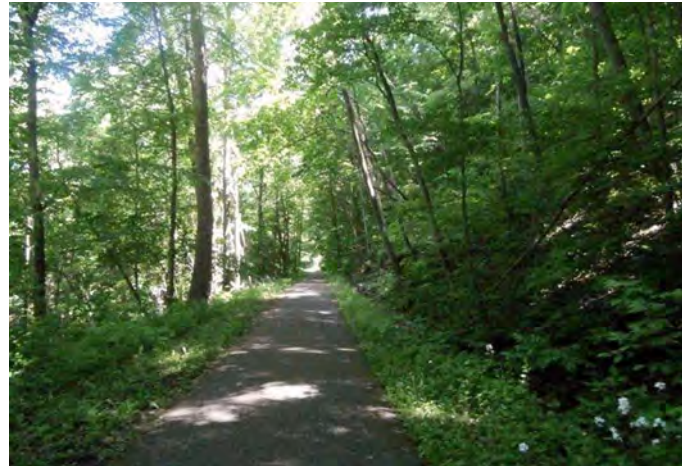
**Lititz-Warwick Trailway, PA**  
**3 miles**  
**Annual Hours mowing 240**  
**Annual mowing costs \$3,553**

**Oil Creek State Park Trail, PA**  
**9.7 miles**  
**Annual hours mowing 240**  
**Annual mowing costs \$3,739**

The Lititz-Warwick Trailway has significant amounts of grassy areas that require mowing along trail edges in a primarily suburban setting. Oil Creek State Park Trail is more rural and relies on natural vegetation along the trail edges that does not require much maintenance. Surprisingly, however, both reported 240 hours was required for mowing each year. This example appears to indicate that there is no correlation between labor hours and costs.

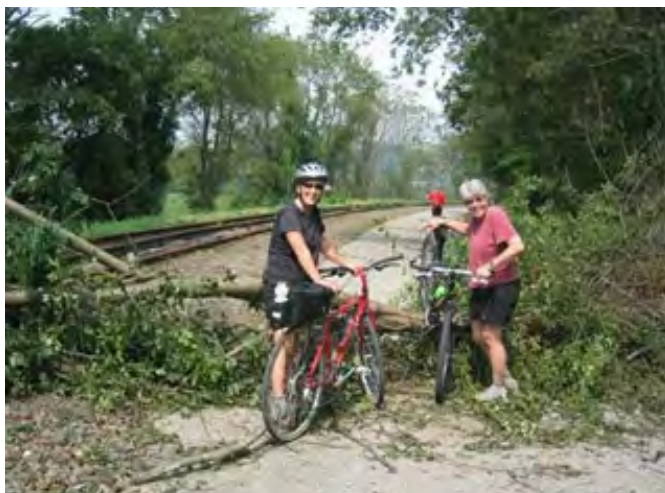
Tree down on Heritage Rail Trail County Park, PA.

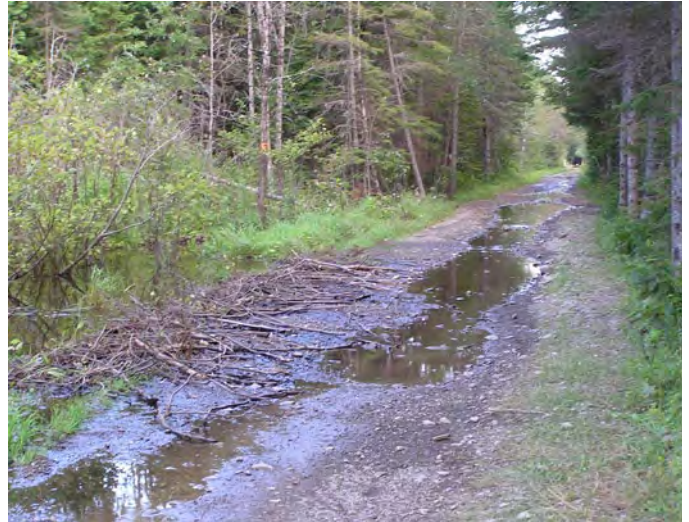
Beaver caused erosion damage, Ashuelot Rail-Trail, NH.

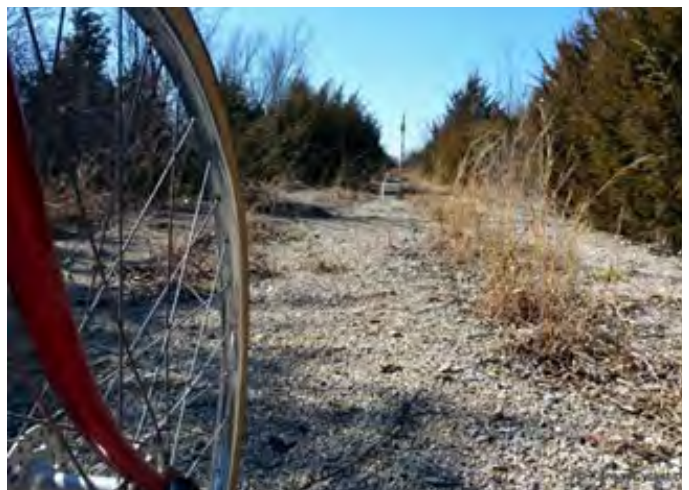
Uncontrolled weed growth through trail surface.

The second biggest cause for repairs is because of vegetation, as reported by 25 percent of survey respondents. This can be caused by grass growing through non-asphalt trail surface, vegetation encroaching on trail edges or proliferation of invasive species. Controlling damage caused by vegetation encroachment is manageable with a program of regular, scheduled inspection and preventative maintenance.

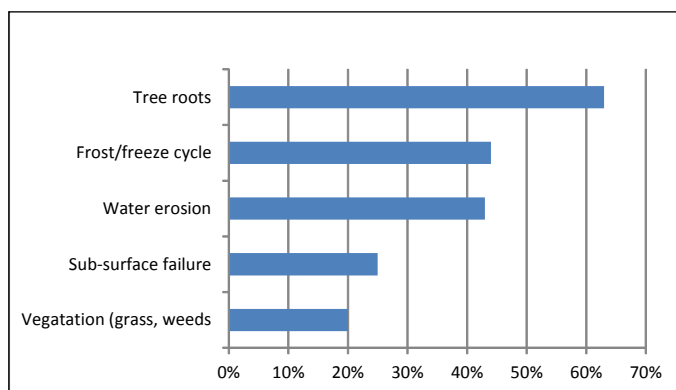
**Figure 7. Sources of Surface Damage (2014 Survey)**

Respondents to the detailed maintenance cost survey submitted significant costs for repair of asphalt-surfaced trails. Examples include \$9,600 for a 71-mile trail; \$7,350 for a three-mile trail; and \$7,200 for 39-mile trail. Only 30 percent of trail managers reported any asphalt repair. Only eight percent of managers of asphalt-surface trails reported that they seal-coated their trail. On a three-mile trail, the cost of the sealant material was \$4,000 and the labor to apply it took 24 hours, or three work days.

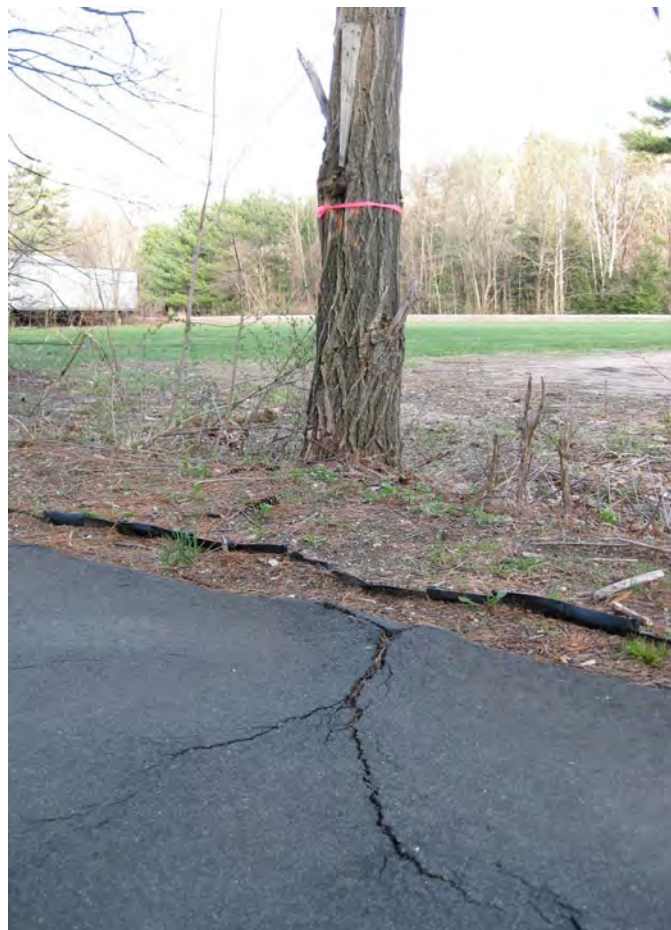
**Tree root damage Manhan Rail Trail, MA.**

Another task required for maintenance of asphalt trails is crack sealing. The Willard Munger State Trail in Minnesota reported spending 240 hours sealing cracks on the 71-mile trail. That's \$5,760 in labor costs and \$2,500 in material costs. Similarly, the Oil Creek State Park Trail in Pennsylvania had labor costs of \$935 and material costs of \$1,500 to seal cracks along the 9.7-mile asphalt trail. Lack of a crack-sealing program can lead to vegetation growing up through the cracks, and this will contribute to deterioration of the asphalt surface.

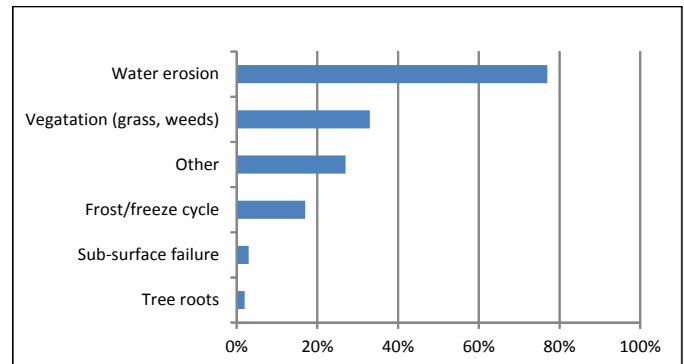
**Figure 8. Sources of Damage to Crushed Stone Surface (2014 Survey)**

Vegetation encroaching through the trail surface was the second most common cause of damage to a crushed stone trail, with one-third of respondents citing this cause. Less than 2 percent of respondents indicated tree roots as a cause of damage to a crushed stone surface trail.

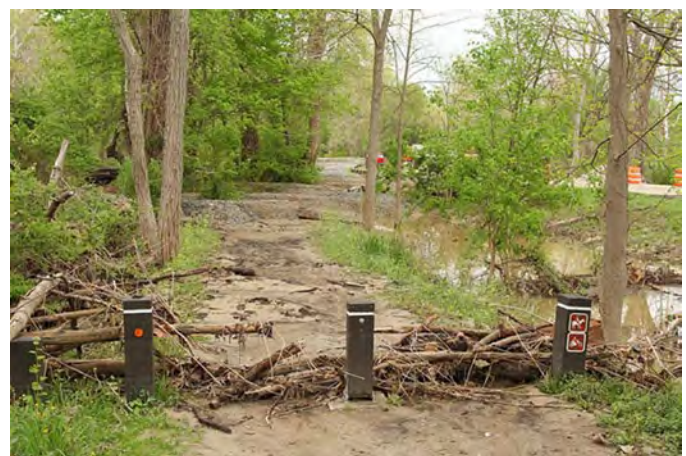
**Erosion damage to stone dust trail.**

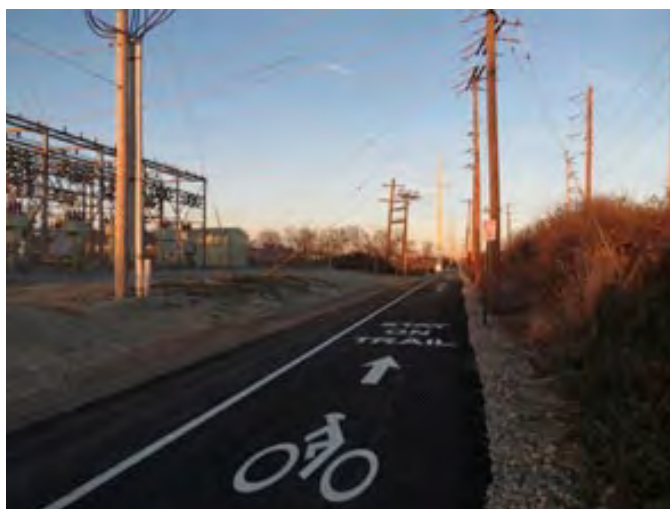
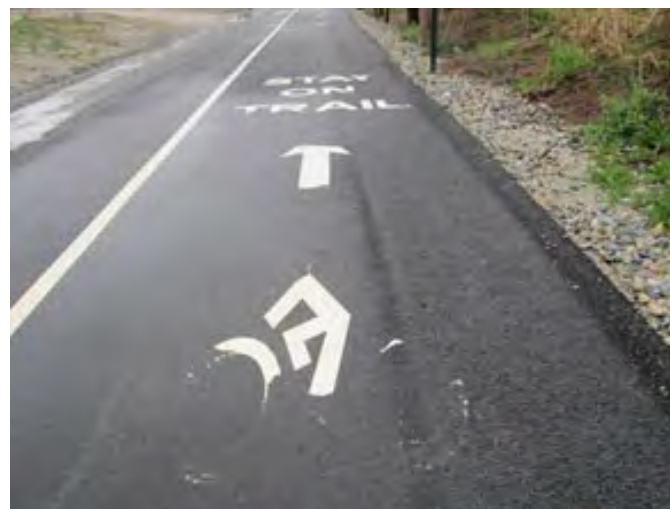
Pavement markings, Hanover Trolley Trail, PA.

Pavement markings are generally associated with asphalt-surfaced trails. This study found that a painted center line was the most common type of pavement marking. Other pavement markings are safety or instructional in nature. Some markings are painted on the trail surface, while others are applied thermally. The detailed cost analysis revealed that this activity, while not reported by many respondents, varied in cost from \$19 per mile to \$140 per mile.

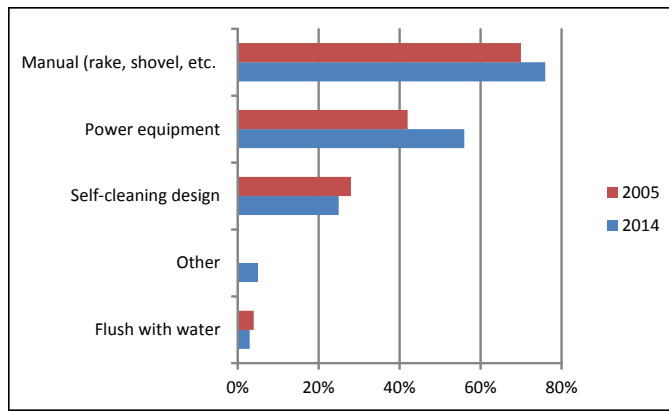
Figure 9. Drainage Activities (2014 Survey)

Maintenance of drainage areas is critical to helping minimize the damage to both asphalt and crushed stone surfaced trails caused by water erosion. As we found in the 2005 survey, this activity is primarily carried out manually with the use of rakes and shovels. In both surveys, this manual activity was reported by 70 percent or more of the respondents.

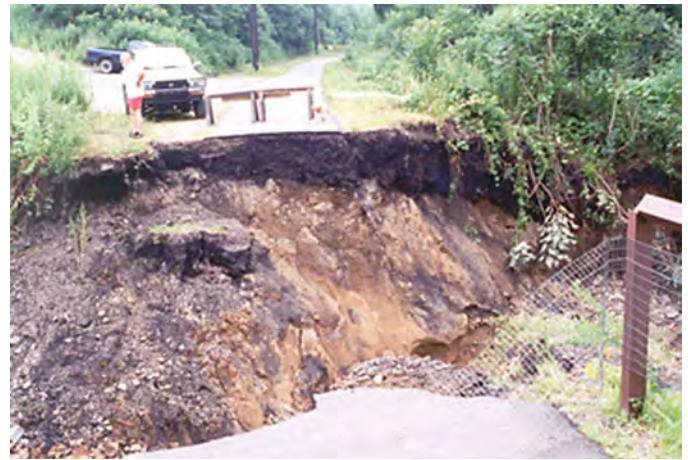
Culvert failure, Allegheny River Trail, PA.

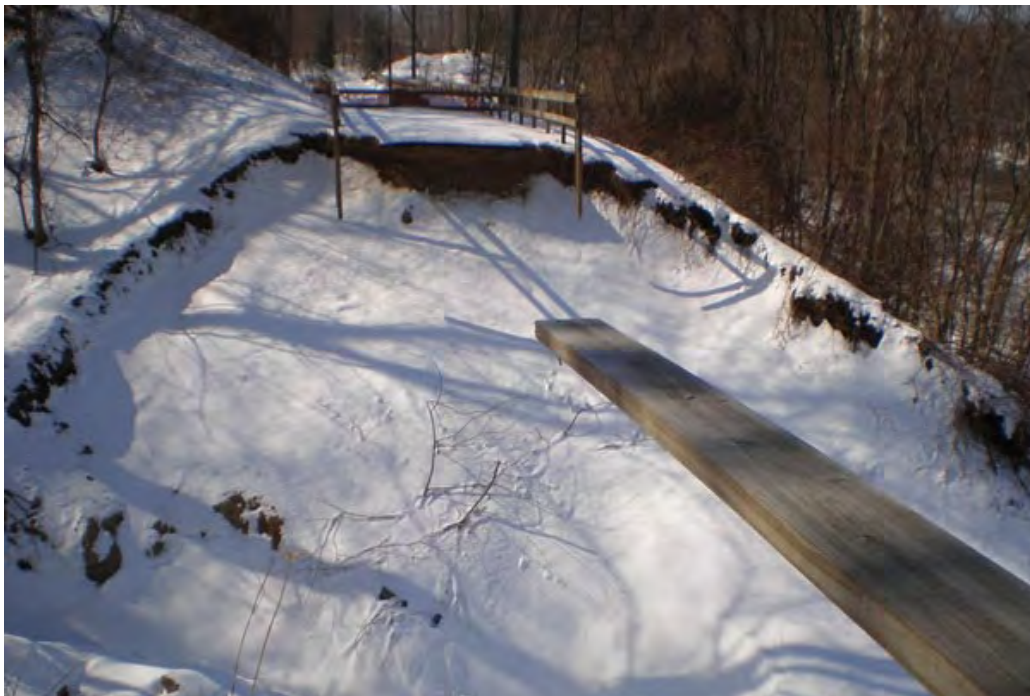
Culvert failure, Manhan Rail Trails, MA.

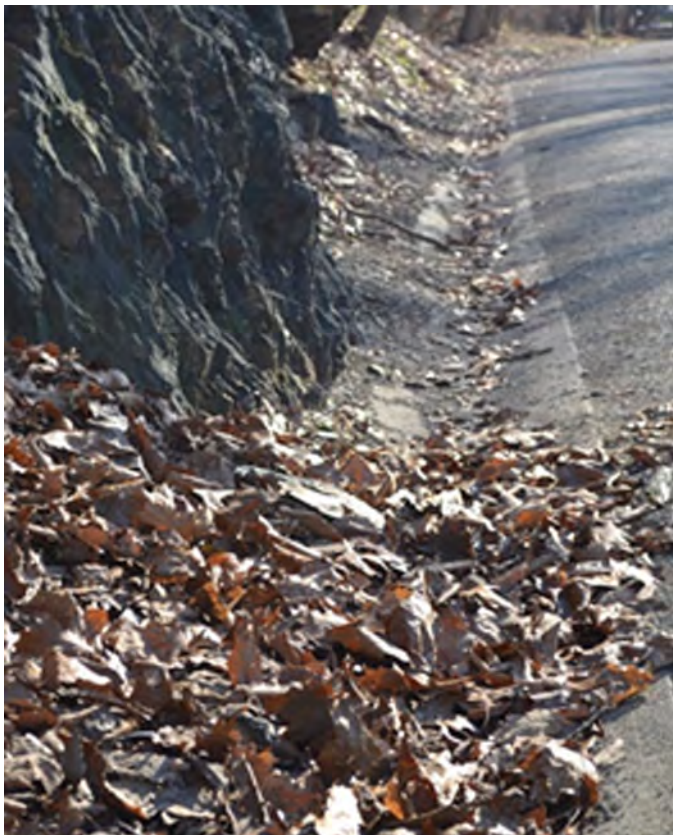
**Drainage swale in need of cleaning.**

The Montgomery County Pennsylvania Regional Trail maintenance schedule requires that drains, pipes, culverts and inlets are cleared out three times per year and must be checked after all heavy rainfalls. All leaf litter, branches and other debris are required to be removed at inlets and along drainage swales.

The West Penn trail maintenance plan calls for clearing drainage swales twice a year or as needed. Most of this work is done with rakes and shovels. Some larger ditches may require the use of a backhoe.

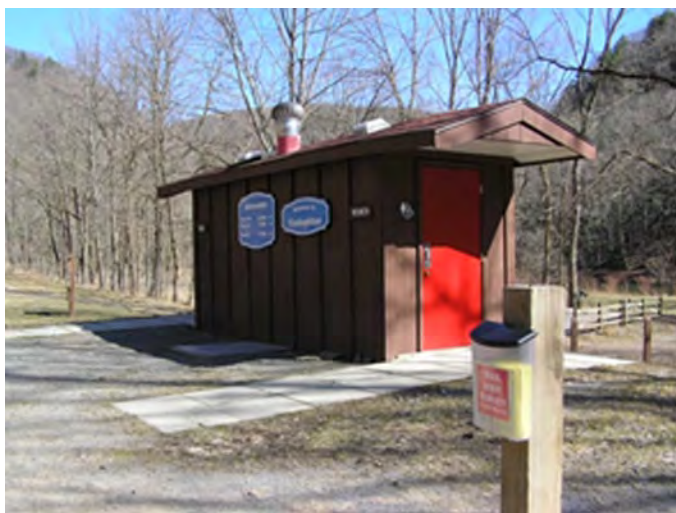
Permanent toilet facility along the Pine Creek Rail Trail, PA.

Maintenance of restroom facilities, whether at trailheads or along the trail, can be an ongoing annual expense. Respondents to the detailed cost analysis survey provided information about maintenance of both permanent facilities and portable toilets. Costs varied widely. The Heritage Rail Trail County Park in Pennsylvania has both permanent and portable toilets at trailheads along the 21- mile trail. Maintenance costs for these facilities were reported at more than \$14,000 a year.

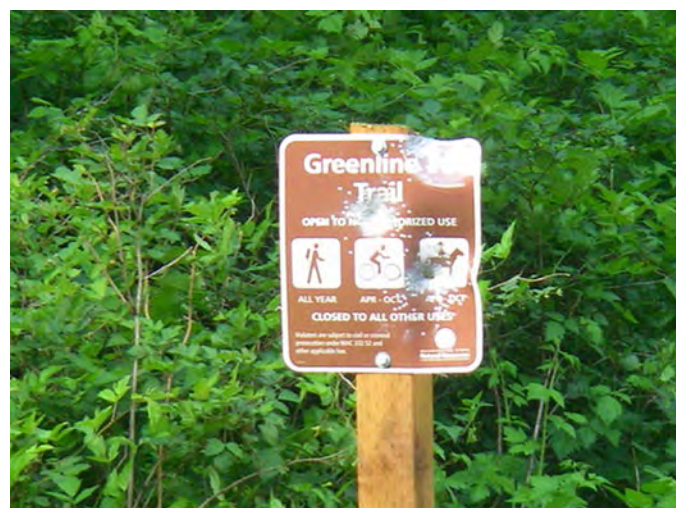
Greenline Trail sign used for target practice.

More than 75 percent of the respondents to the general maintenance survey reported that vandalism was the major cause of damage requiring signage repair and maintenance.

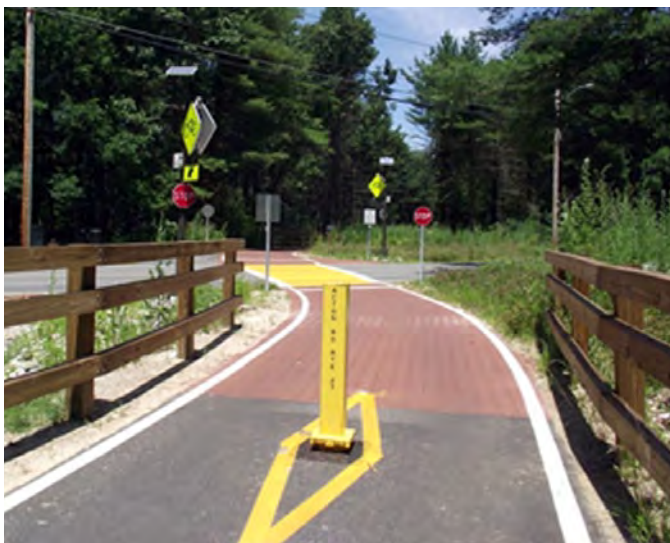
**Bollard at intersection, Bruce Freeman Rail Trail, MA.**

Gates and bollards are used to keep automobiles and other motorized vehicles off of trails that are intended only for non-motorized use. While maintenance costs associated with gates and bollards were reported by only 15 percent of detailed cost analysis respondents, most indicated costs of between \$2,300 and \$5,000.

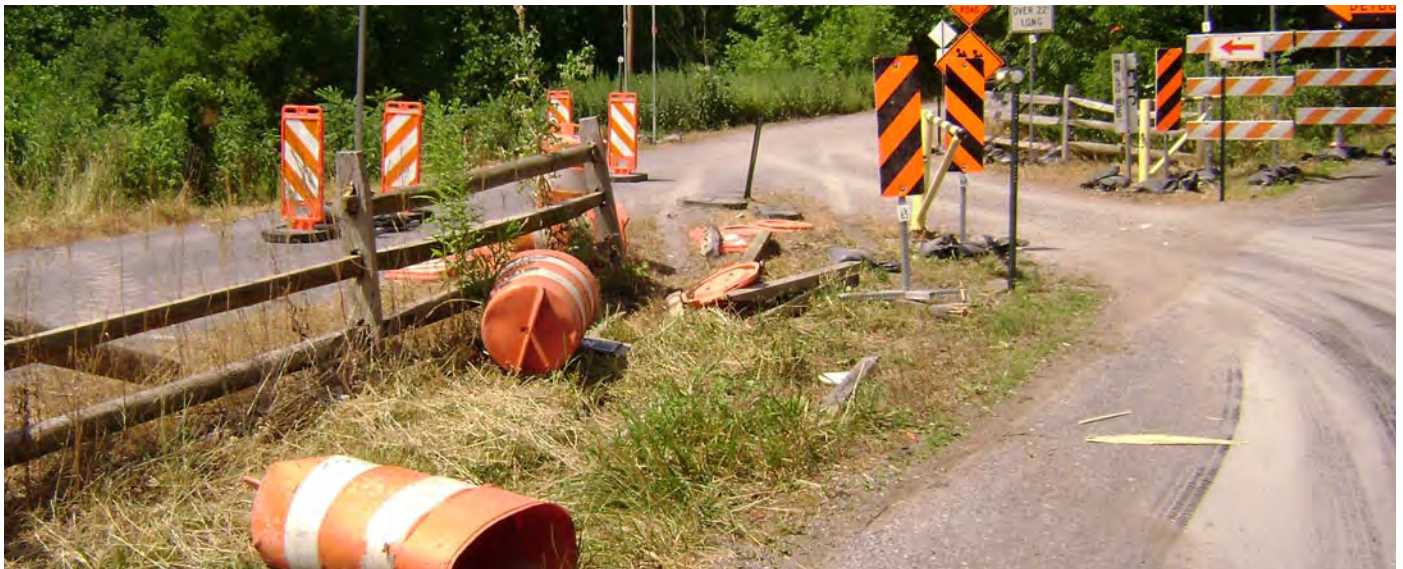
**Damaged split rail fence along the Pine Creek Rail Trail, PA.**

Of these three types, wooden fencing was reported to require the most maintenance. Thirty percent of the detailed cost survey respondents reported time repairing wooden fencing. This maintenance can take the form of replacing fencing that had rotted or fencing that had been damaged by accident or acts of vandalism. Only 8 percent of respondents reported repairs to chain link fence. No respondents reported repairs to vinyl fencing.

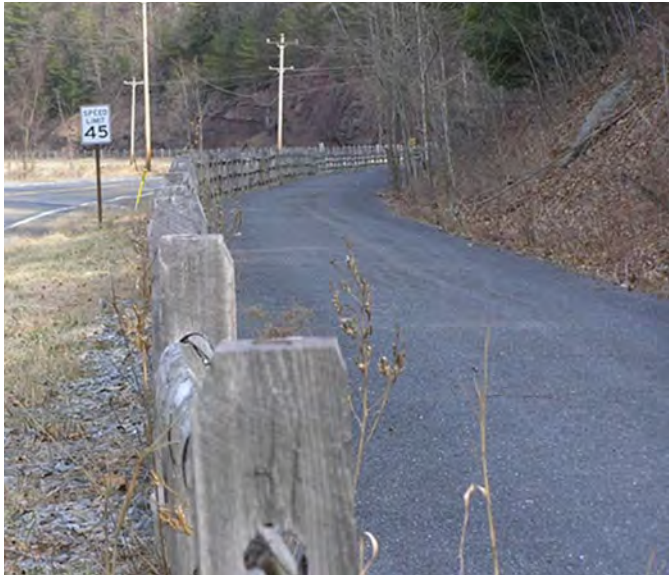
Split rail fencing, Pine Creek Rail Trail, PA.

A majority of the respondents to our survey, 51 percent, indicated that they had some type of fencing along their trail. Most common was split rail wooden fencing, which was mentioned by 45 percent of the respondents. Over time this becomes a maintenance issue, as posts and rails rot or become damaged in some way.

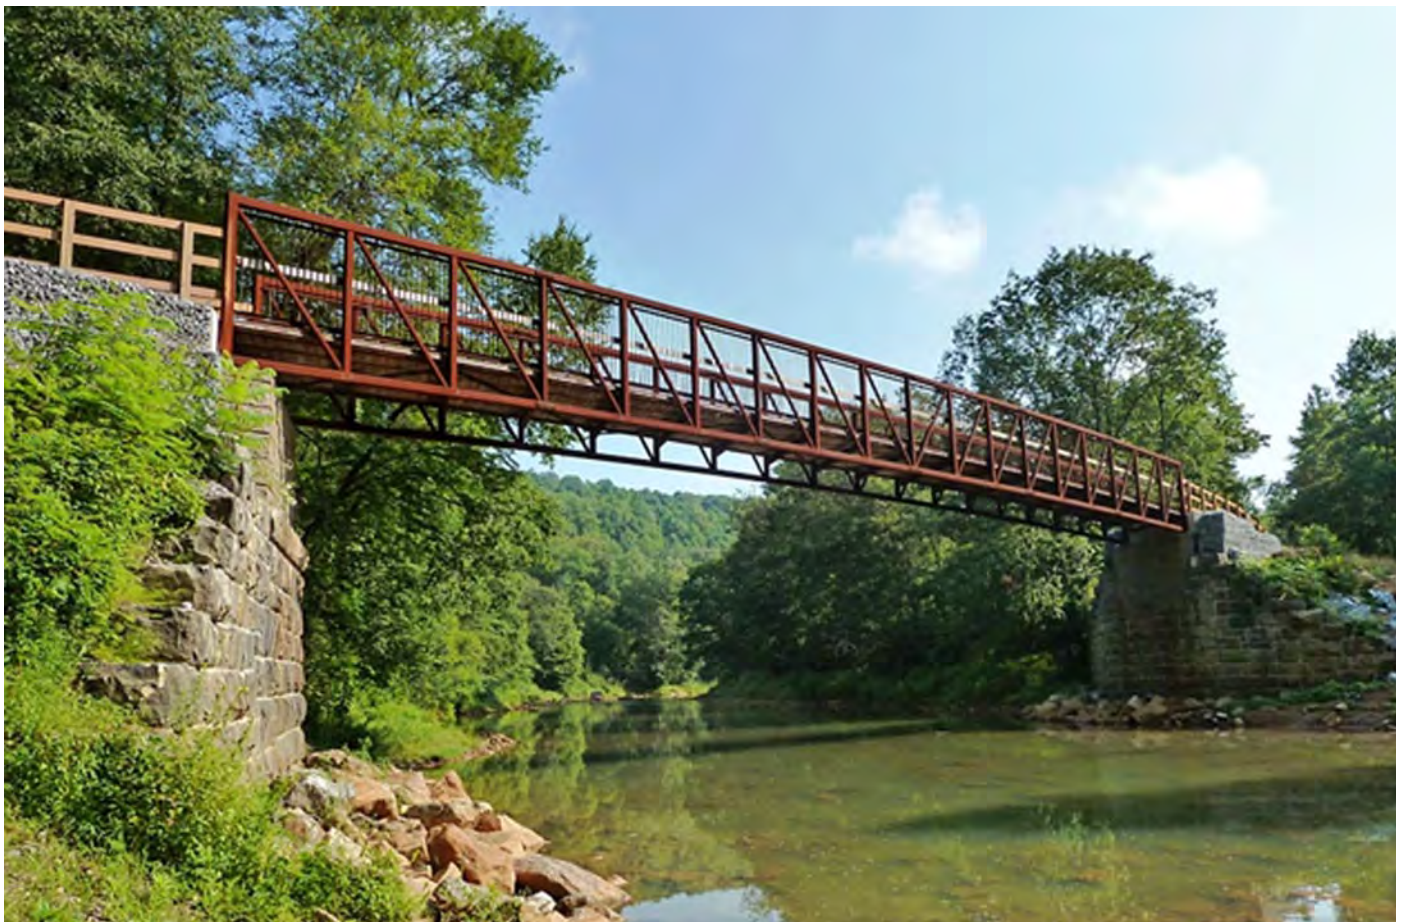
Scott Glen Bridge, Ghost Town Trail, PA.

A full 88 percent of the trail managers indicated that they have at least one bridge along their trail. The most common — 61 percent — are original railroad bridges. The second most common type of bridge is new bike/pedestrian bridges with vehicle capacity. Surprisingly, 43 percent of respondents indicated that their bridges are not inspected on a regular basis by a certified inspectors or professional engineers. Fortunately, the number of trail managers reporting that their bridges are inspected increased from 33 percent in 2005 to 57 percent in 2014. The most frequent interval for bridge inspections reported in 2014 was two to three years, which is a shorter interval than that reported in 2005.
