STONE CONSERVATION TREATMENTS

Hanover Center Cemetery, Hanover, MA

July, 2012

Documentation of Restorations to Center Cemetery

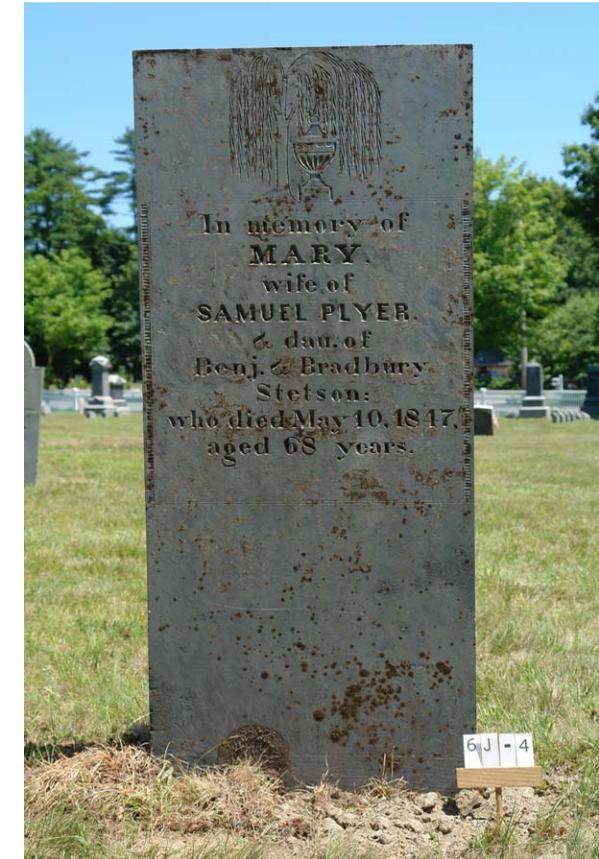
*6J.04 Mary Plyer, before and after treatment with D/2*

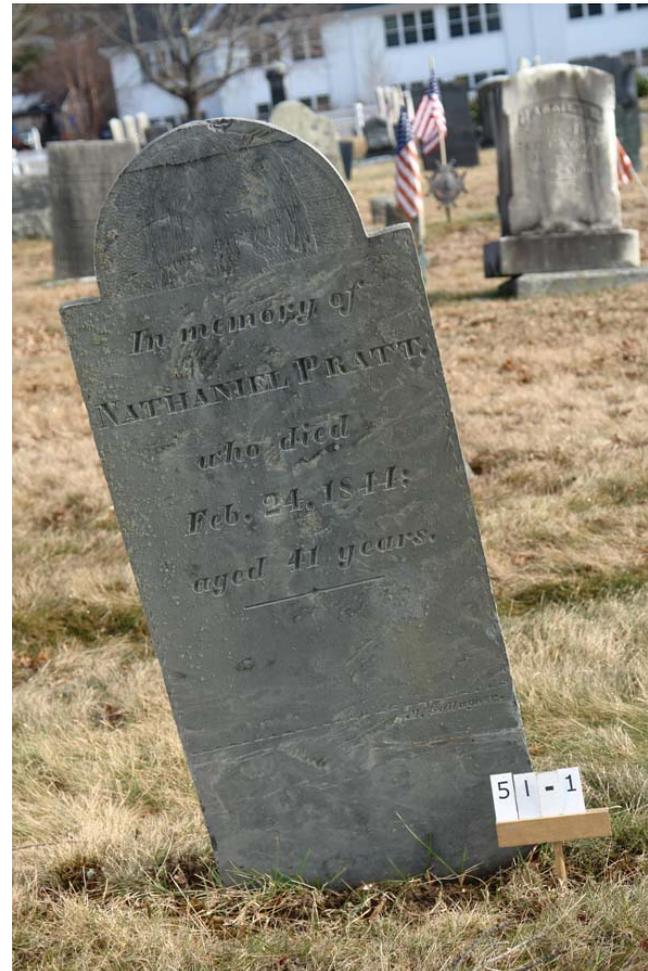
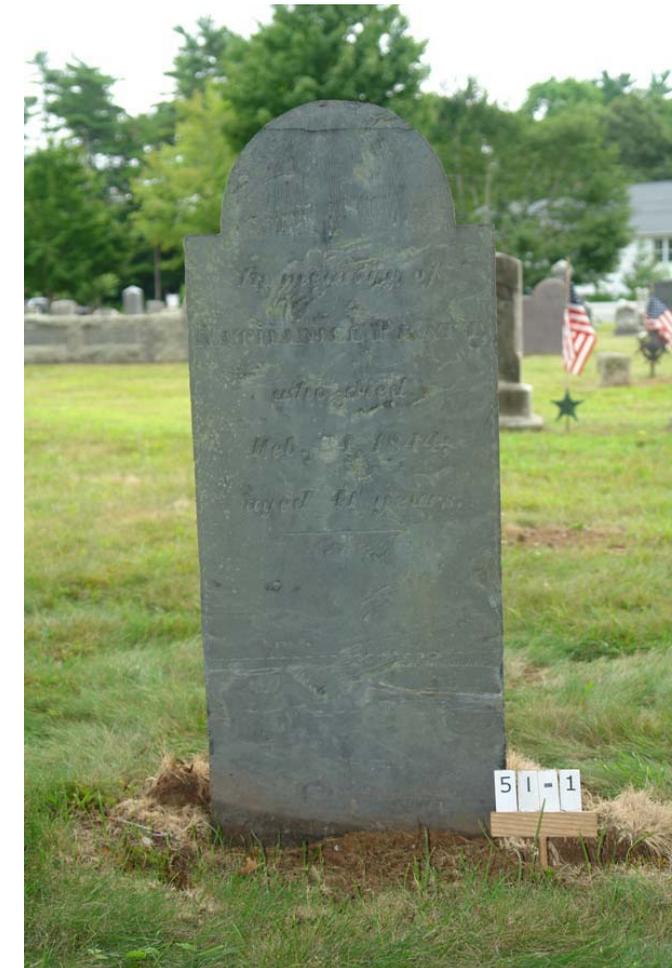
*Before and after— severely tilted 51.01 Nathaniel Pratt*

Earlier gravestones are typically long panels of stone that were set directly into the ground. After determination of the correct location and orientation of the stone, soil was removed to an appropriate depth. Gravel (or broken stone) was introduced to establish a stable base. The stone was made plumb and level, and set in plane with the adjacent markers. Backfilling was done with sand and gravel, wetted and compacted. Every effort was to replace disturbed areas with existing topsoil and turf, however additional topsoil was required at a number of sites.

A number of markers were found to have large concrete and rubble “foundations”, probably done about 50 years ago. In most cases these foundations were removed and replaced when necessary.

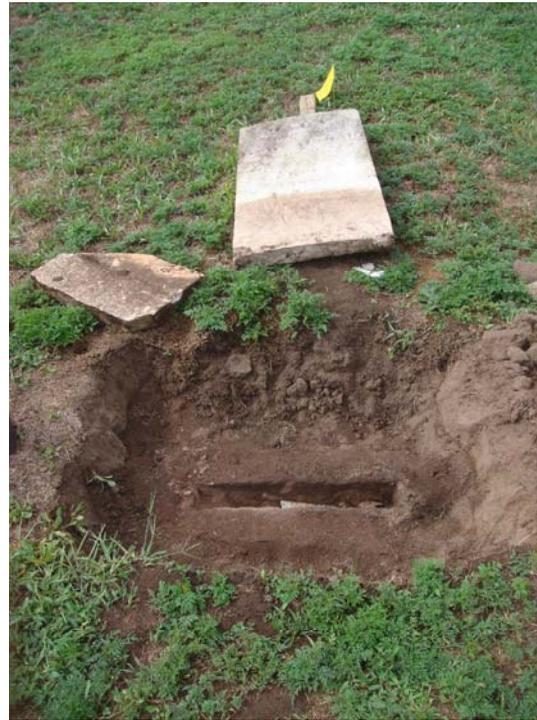
*When excavating for resetting often original, or old bases are discovered*

In many cases, fallen markers had been originally set into below grade sandstone bases. When discovered, these bases were often uncommonly deep, more than one foot. Bases were excavated, examined for soundness and reset level at a higher elevation and aligned with adjacent markers.

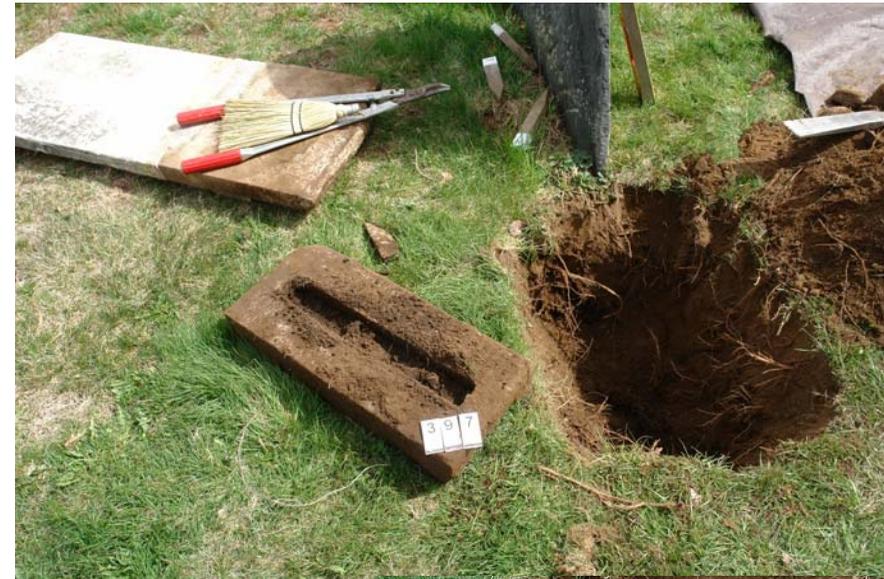
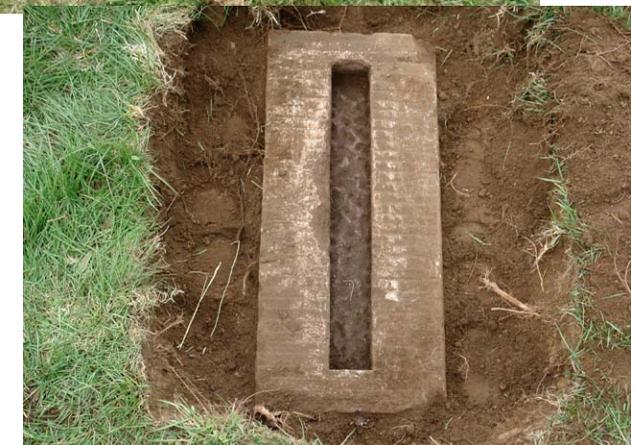
*Old base aligned with adjacent markers and reset level.*

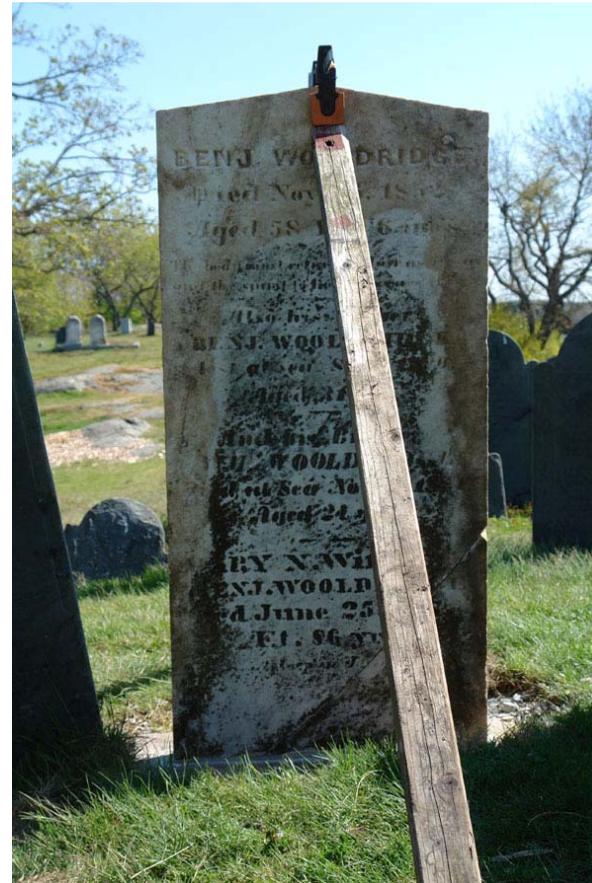
*Example of marker reset into slot and braced*

Gravestones that required insertion into existing bases were set with a relatively weak cement/lime-based grout (3:2:8:1) with fine aggregates (000), made fluid with a high-range water reducer which ensures a complete fill. This was poured or injected into the base slot. Stones were braced for a minimum of three days to limit movement during curing of the grout.

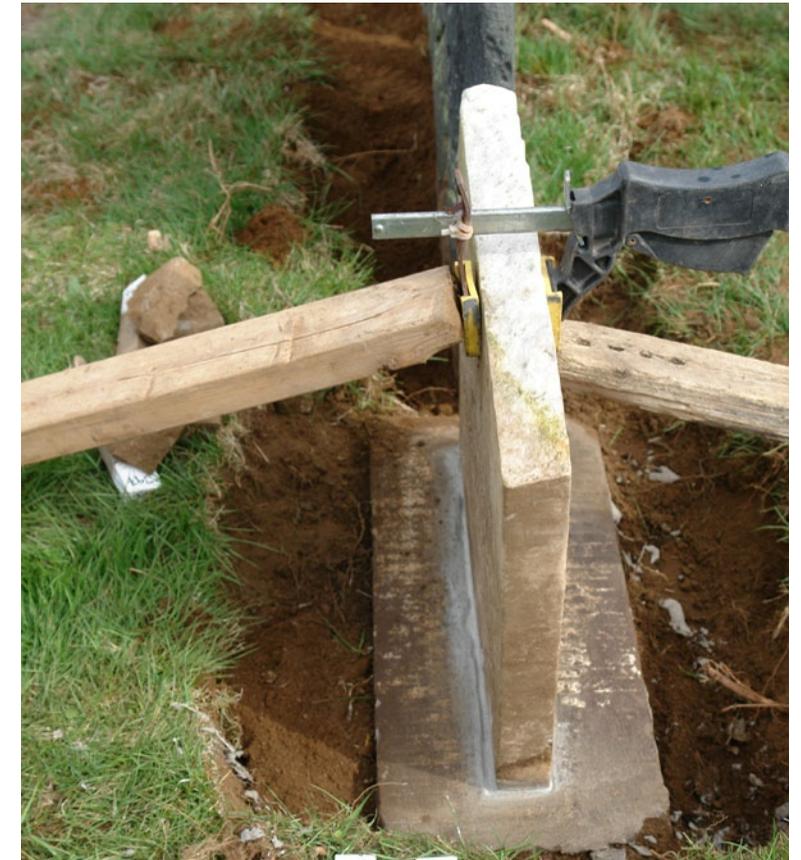
*Lower fragment reset into slot and braced. Top fragment will be attached with structural adhesive after grout has sufficiently cured.*

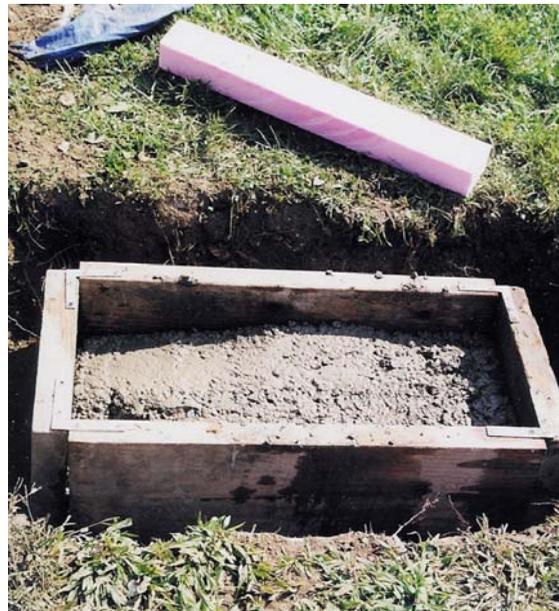
*Form for new below grade concrete base*

Bases were made on site by casting in place with concrete. The casting is generally 9 to 12 inches deep, and 6 inches greater in both thickness and width than the stone itself. The finished top surface of the base should be entirely below grade. A form for a 2 inch deep setting slot, ½ inch wider and ½ thicker than the stone, was positioned in the concrete. After the base cured, the gravestone was reset into the slot with a cement/lime-based grout as previously described. The top of the new base was covered with topsoil.

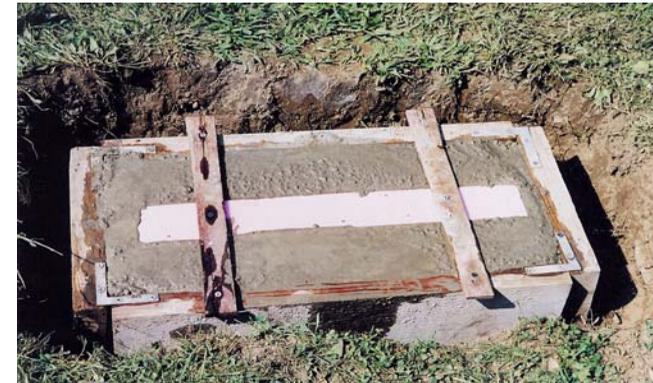
*Concrete poured, with form for setting slot in place*

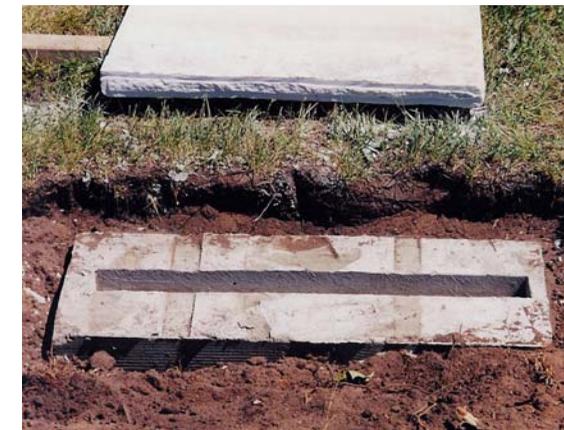
*Form removed, ready for resetting marker*

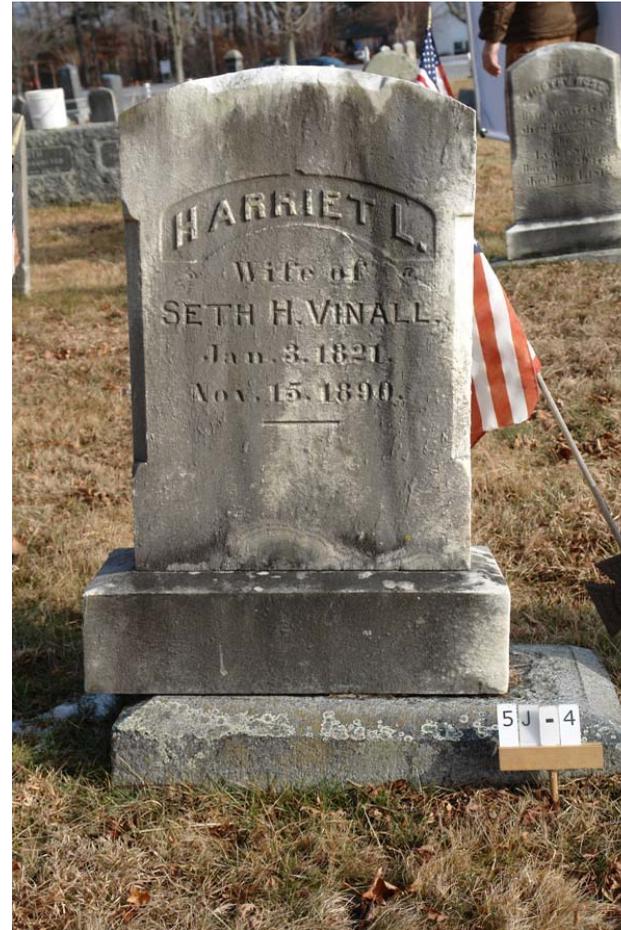
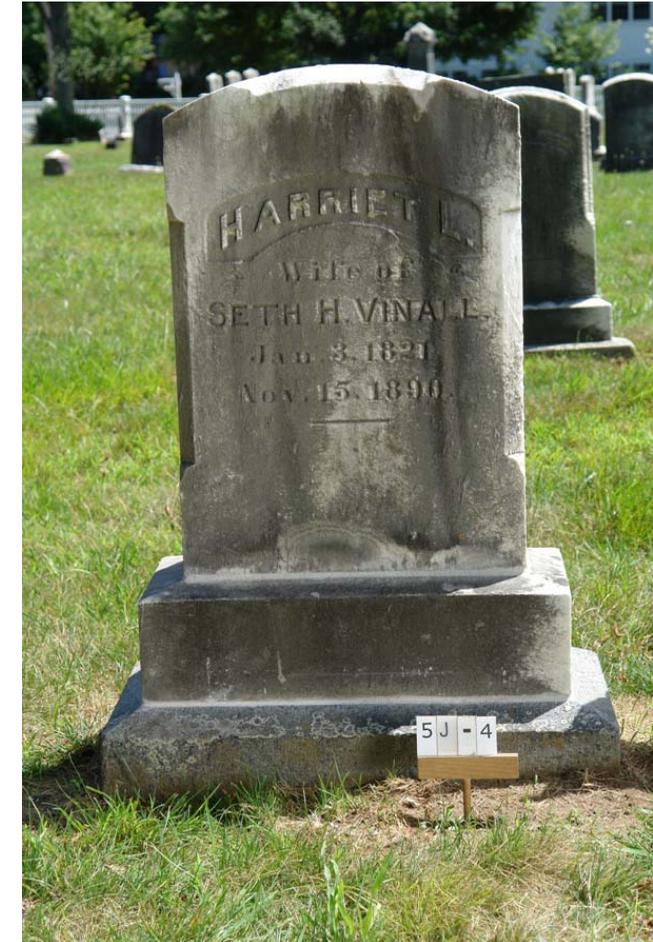
*5J.04 Harriet Vinall reset onto existing base.*

For resetting onto existing bases or ledgers, setting surfaces were first primed with Acryl 60 diluted with water 1:3, and markers were reset with a cement/lime-based grout (3:2:8:1) with fine aggregates (000).

When necessary, stones were braced for a minimum of three days to limit movement during curing of the grout.

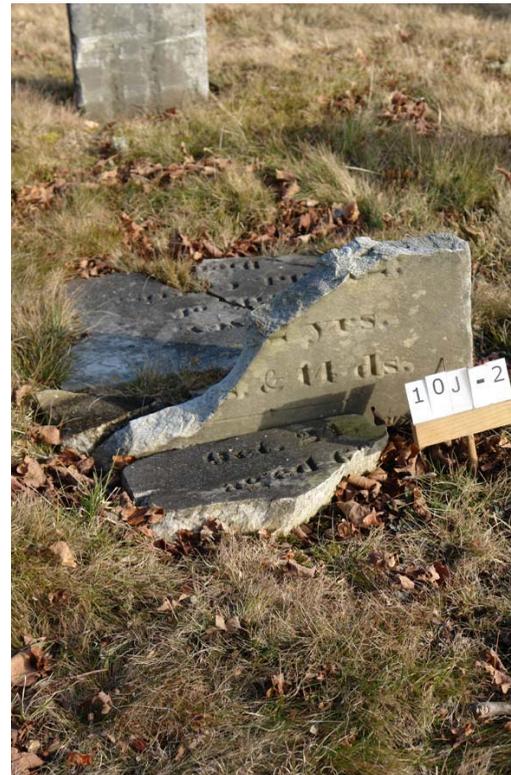
#10J.02 Nancy Curtis, as found

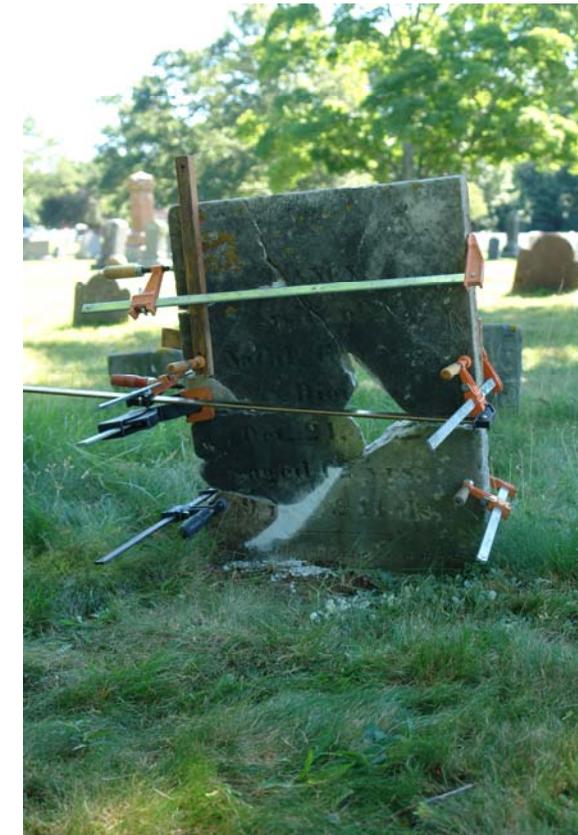
*Clamping and bracing in a vertical position allows gravity to help position fragments. Often marble becomes "bowed" or curved with time.*

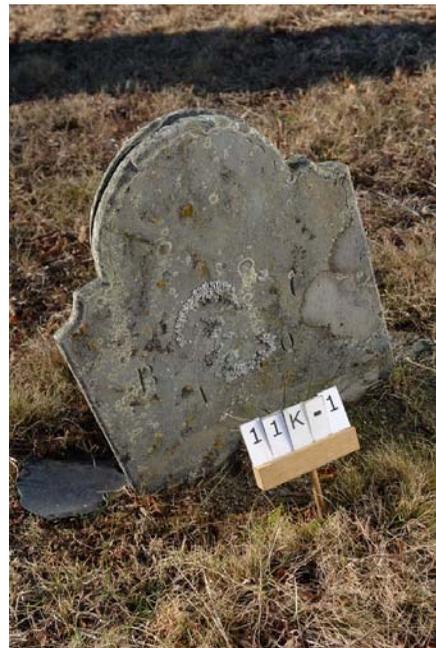
11K.01 Betsey Curtis— as found

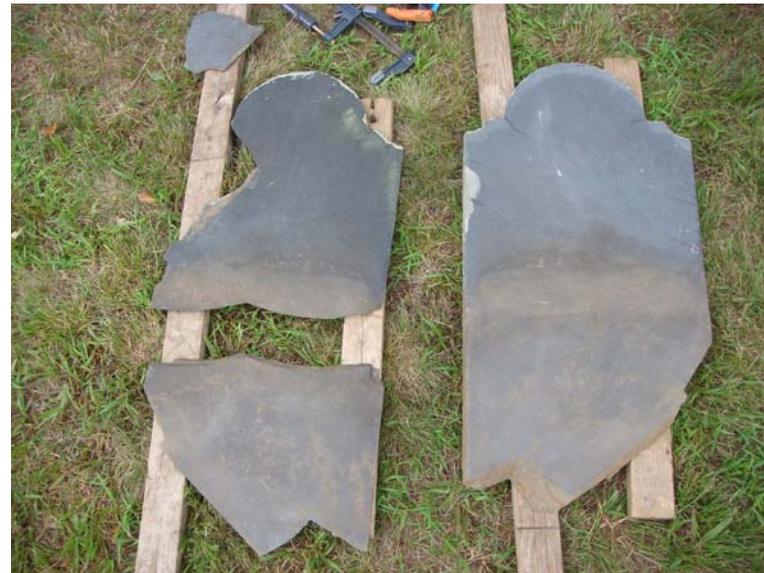
After careful excavating, four fragments were found

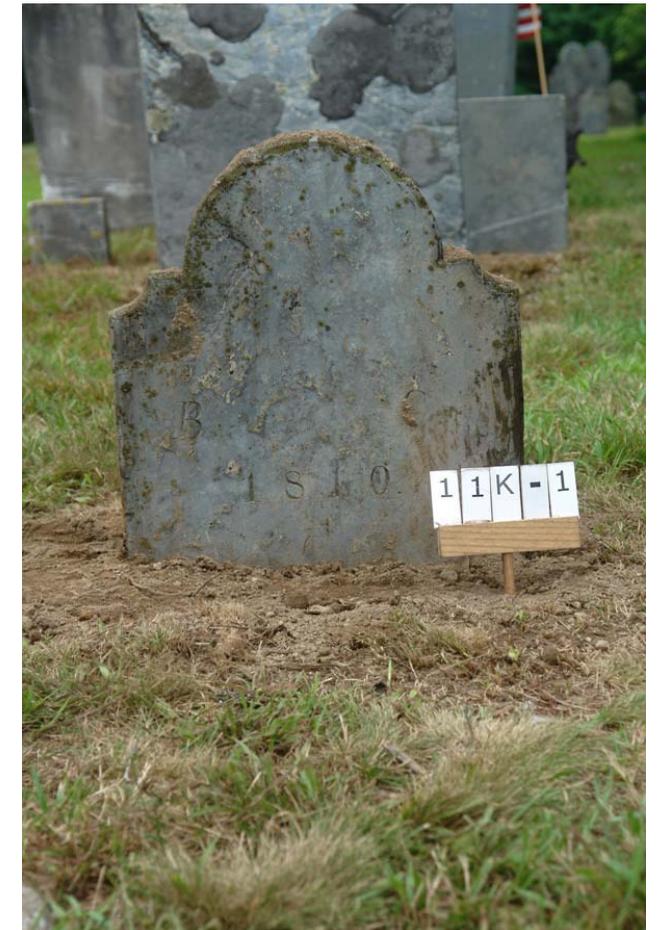
11K.01 Betsey Curtis— completed

Early slate markers appear smooth, however the surfaces may not be in the same plane, thus adhesions are usually done in place with gravity as a guide for a proper fit.

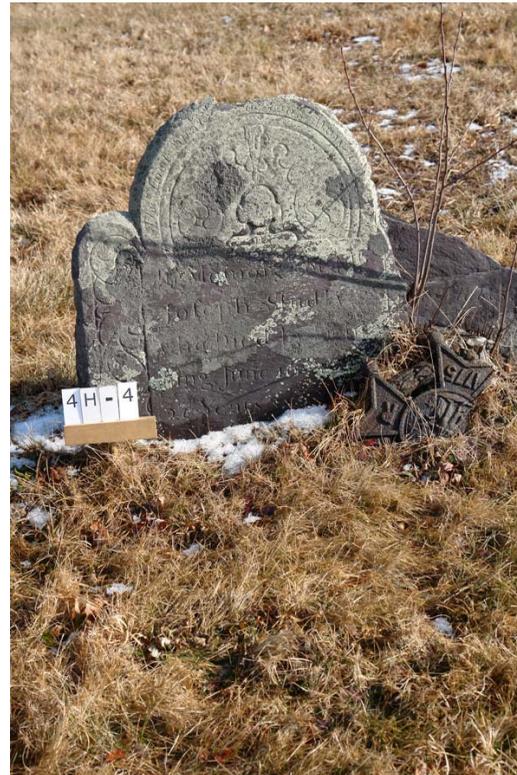
*4H.04 Joseph Study. As found. Additional fragments were not found after extensive probing.*

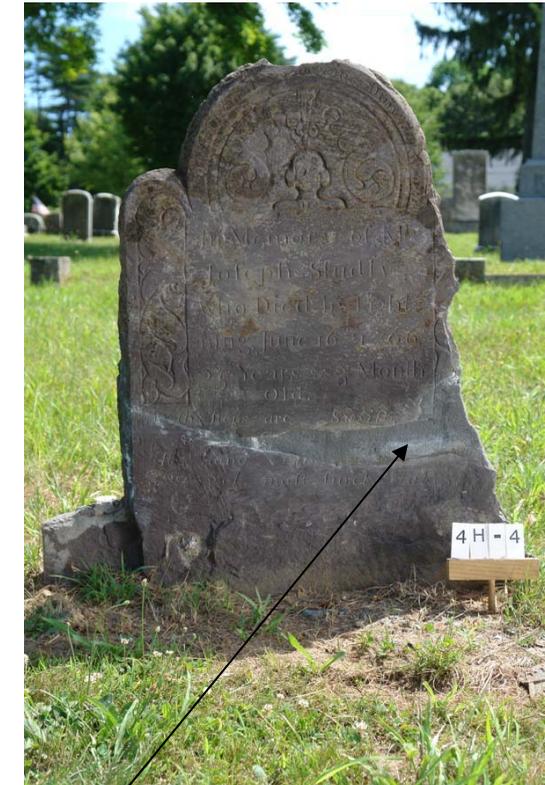
*After structural adhesion, losses were filled with Jahn M-70 pigmented mortar.*

The color and texture of all composites used to fill cracks and losses was matched to that of adjacent unsoiled stone. Fine cracks were filled with an integrally colored cement/lime-based formulation (RepliCal™ Crack Filler). Larger areas of loss were filled with either Jahn™ M-70 Restoration Mortar or with RepliCal™ a cementitious repair composite designed to match weathered surfaces. For marbles, RepliCal contains specially sized and graded marble aggregates.

In these areas the filled plane is kept slightly back from the stone surface to indicate that there is a loss. Areas where there are no inscriptions can be filled level with the original stone.

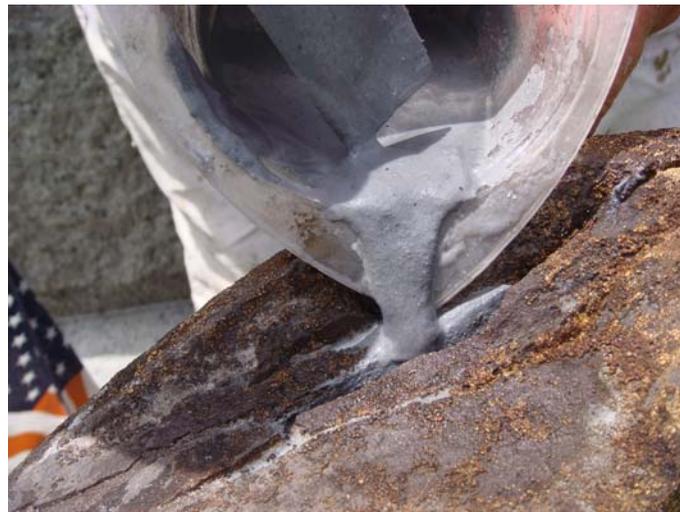
*Filling voids with a pigmented flowable grout (VoidSpan PHLc)*

A pigmented pozzolanic hydraulic lime manufactured by VoidSpan (PHLc) was used as a flowable grout to fill large cavities.

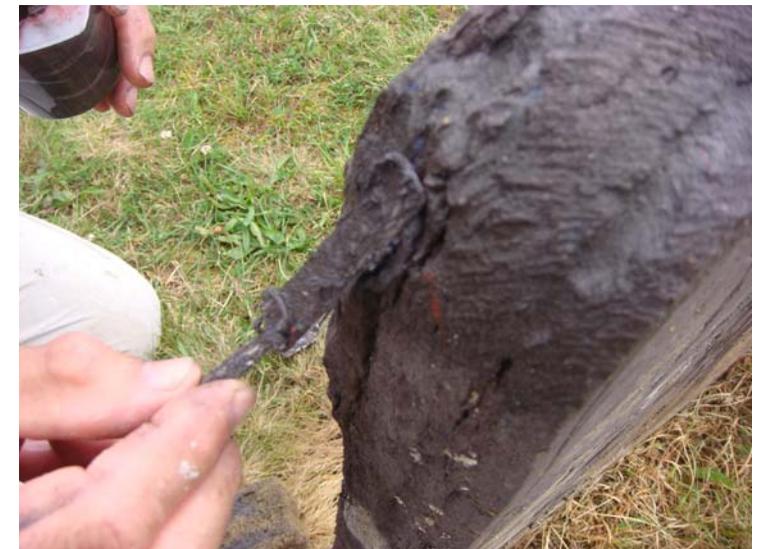
*Filling top cavities with a pigmented crack filler by Sto. Excess material will be immediately wiped off with damp sponging*

Open joints along the top were filled with a pigmented flexible industrial “crack filler” by Sto.

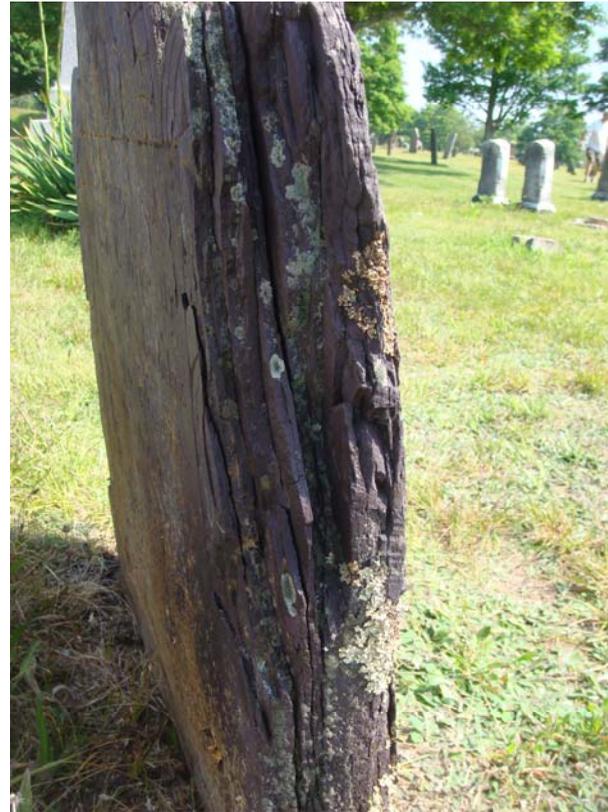
31.10 Sarah White, before and after filling of voids

After removal of loose material, the interior surfaces are saturated with a wetting solution, such as isopropanol/ water.

When necessary, a low strength cement/lime (3:2:8) grout, with fine aggregates and pigmented to match the stone was used to fill wider voids. Excess grout is immediately removed with damp sponging.

The filled areas and surrounding surfaces are lightly misted with water and kept covered for a minimum of 3 days. After a partial cure the covering is removed and the filled areas and adjoining surfaces of the stone are treated with a weak acetic acid wash applied with a soft brush to remove excess grout and fully rinsed with water.

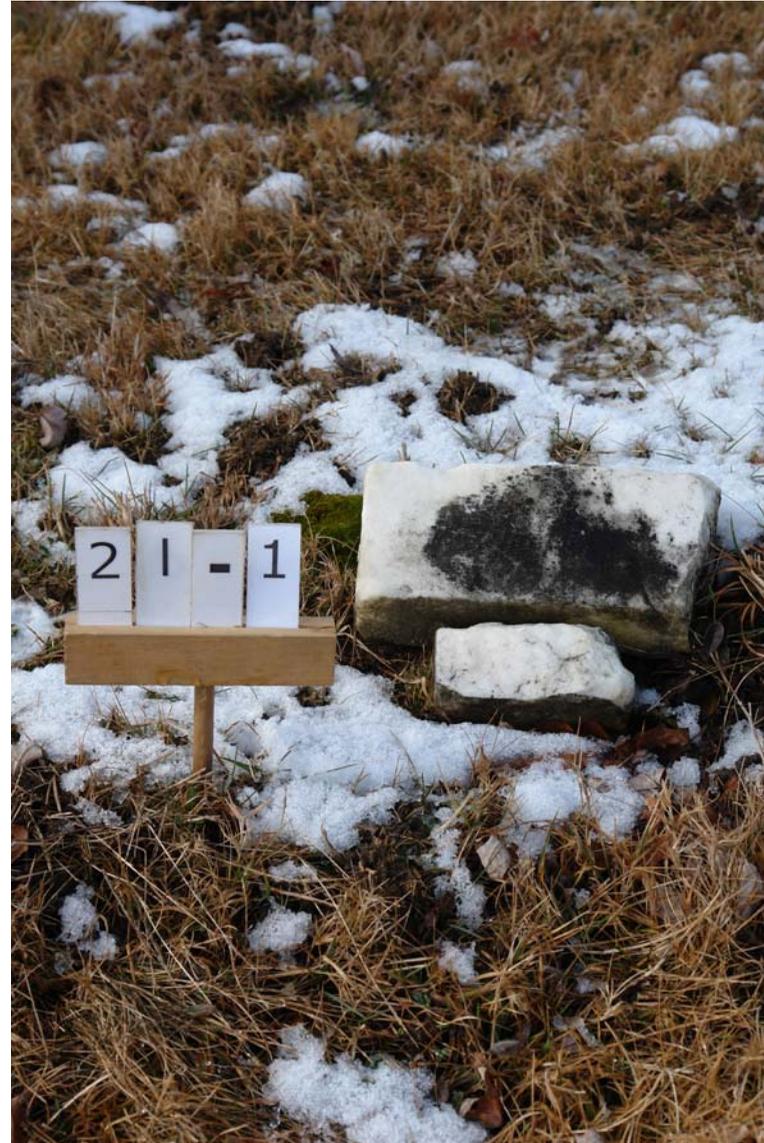
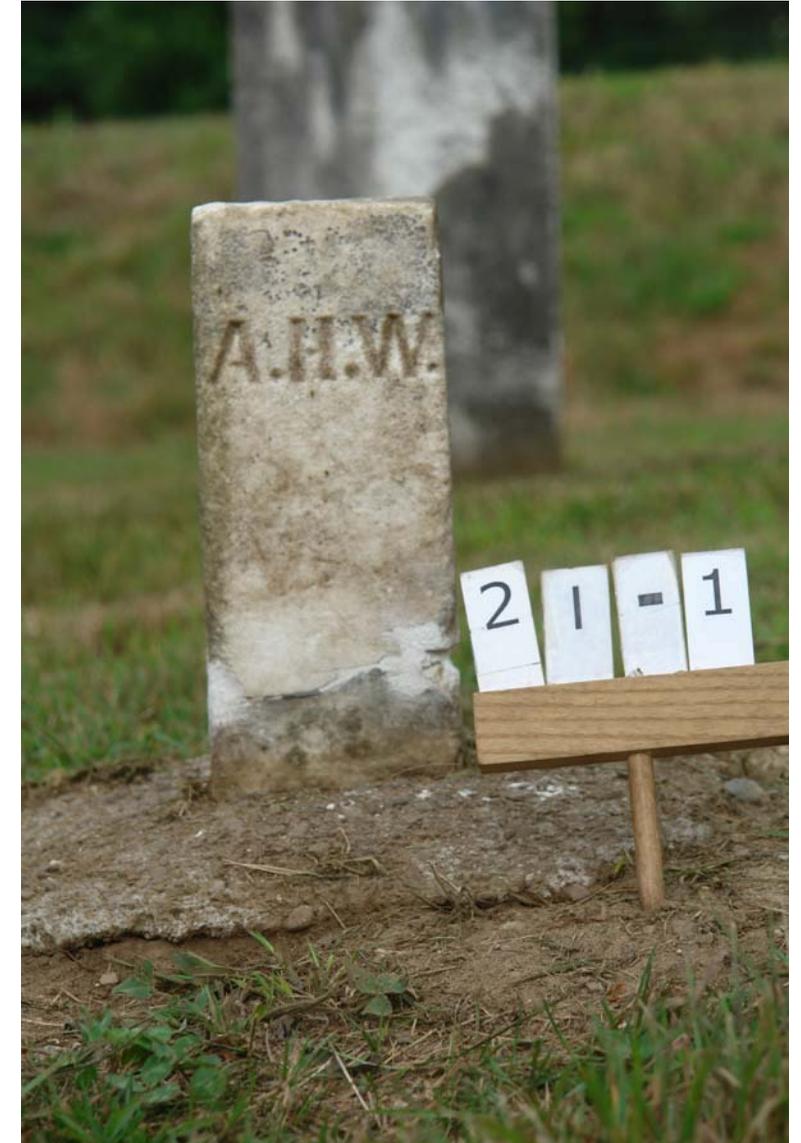
Fractured  
Tilted

1. Fragment(s) excavated and area probed for missing pieces.
2. Lower fragment reset plumb at appropriate height, aligned with adjacent markers.
3. Any failed adhesives or mortar removed.
4. Mating surfaces of fragment(s) treated with D/2 biological solution and scrubbed with nylon brushes, then rinsed with water.
5. Fragment(s) attached with structural adhesive, and braced until cured.
6. Cracks and losses filled with RepliCal and Jahn products, misted and wrapped min. 3 days.
7. After partial cure, any excess fill material on adjacent surfaces treated with acetic acid, brushed, and fully rinsed with water

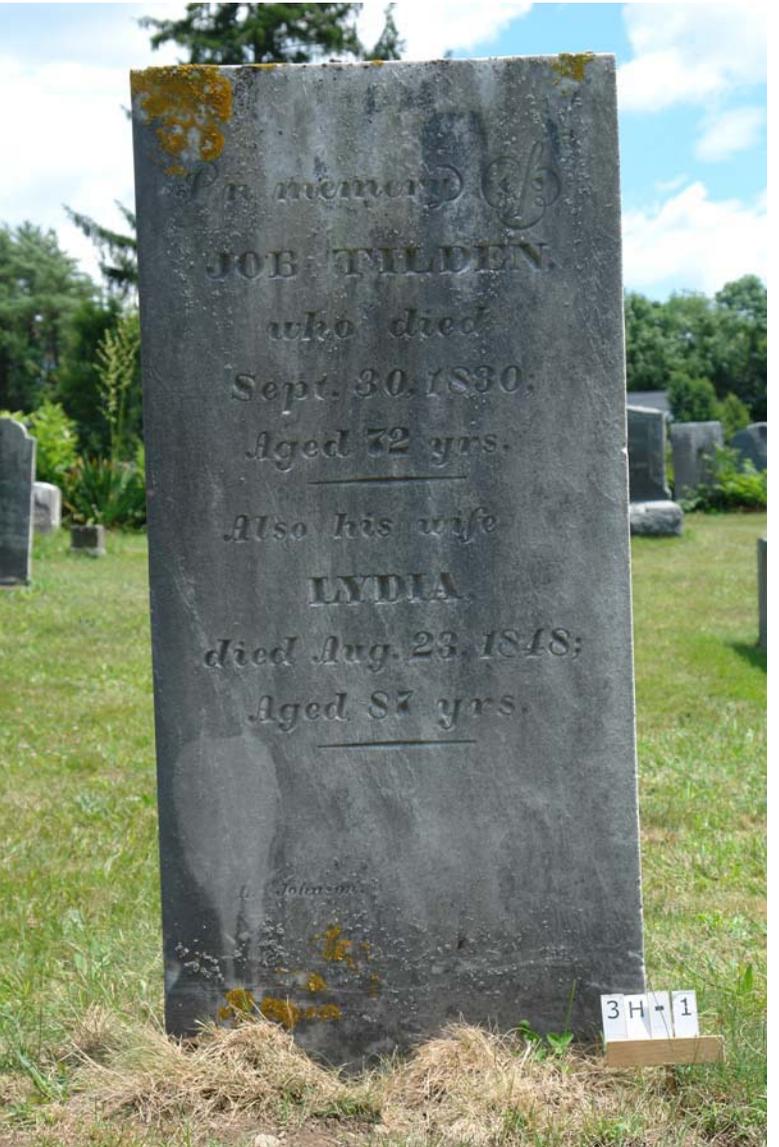
EXISTING CONDITIONS	CONSERVATION STRATEGY
Tilted	Excavate Clean Reset

1. Marker carefully excavated. Soil around tilted marker removed to an appropriate depth. Marker appears to be sound.
2. When required, marker is removed from the ground.
3. Surface soiling removed by light brushing with nylon brushes and water.
4. When setting area is excavated to sufficient depth stone is re-set plumb and level onto gravel bed, aligned with adjacent markers.
5. Area backfilled around marker with tamped sand and gravel.
6. Disturbed areas re-graded with existing topsoil and sod.

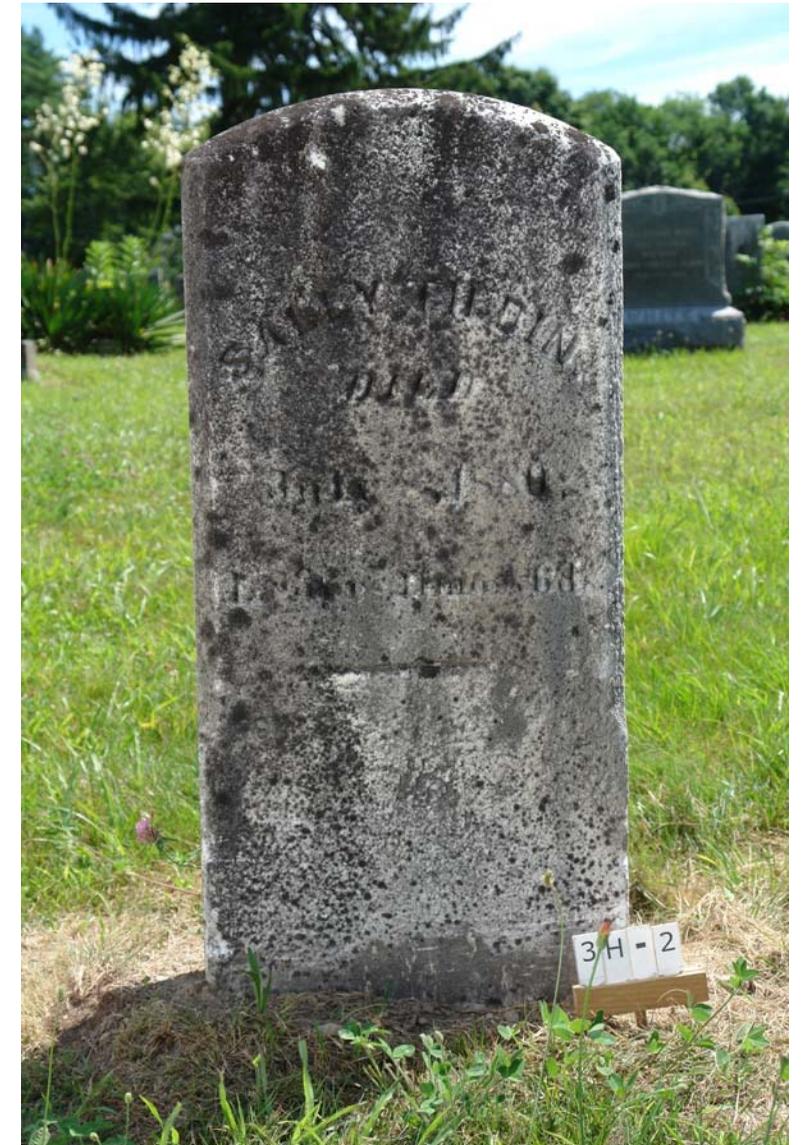
**EXISTING CONDITIONS**

1. Marker carefully excavated. Soil around tilted marker removed to an appropriate depth. Marker appears to be sound.
2. When required, marker is removed from the ground.
3. Surface soiling removed by light brushing with nylon brushes and water.
4. When setting area is excavated to sufficient depth stone is re-set plumb and level onto gravel bed, aligned with adjacent markers.
5. Area backfilled around marker with tamped sand and gravel.
6. Disturbed areas re-graded with existing topsoil and sod.

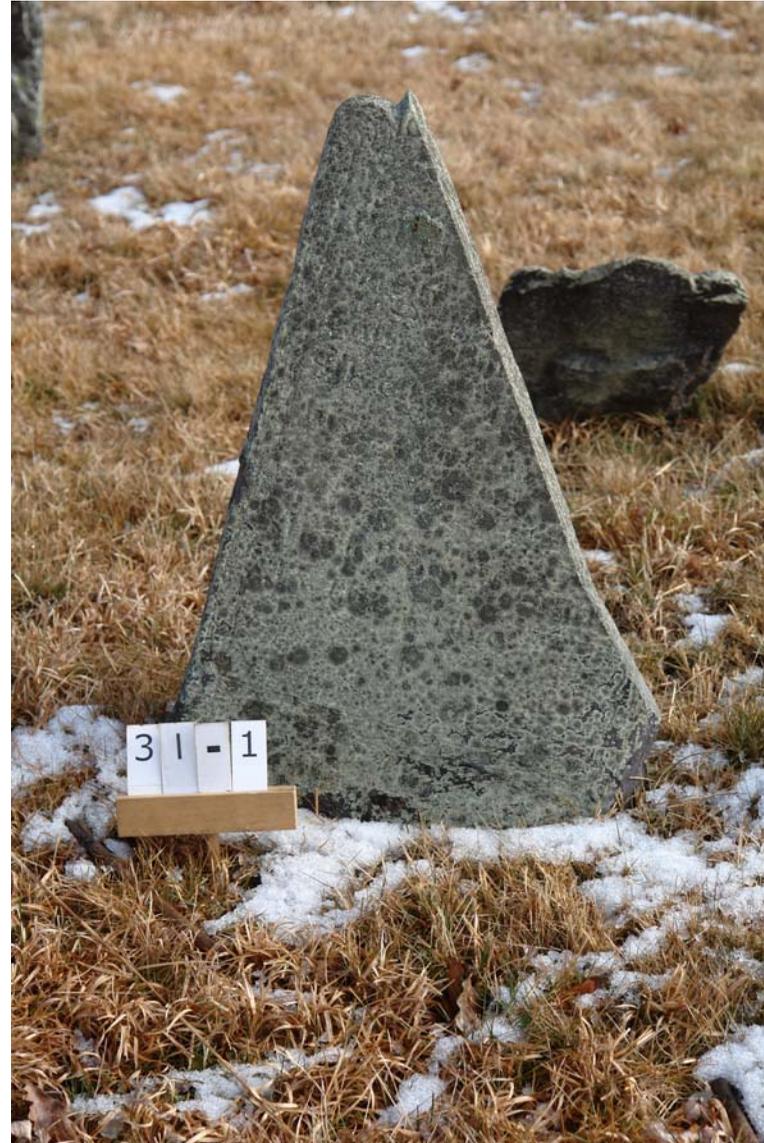
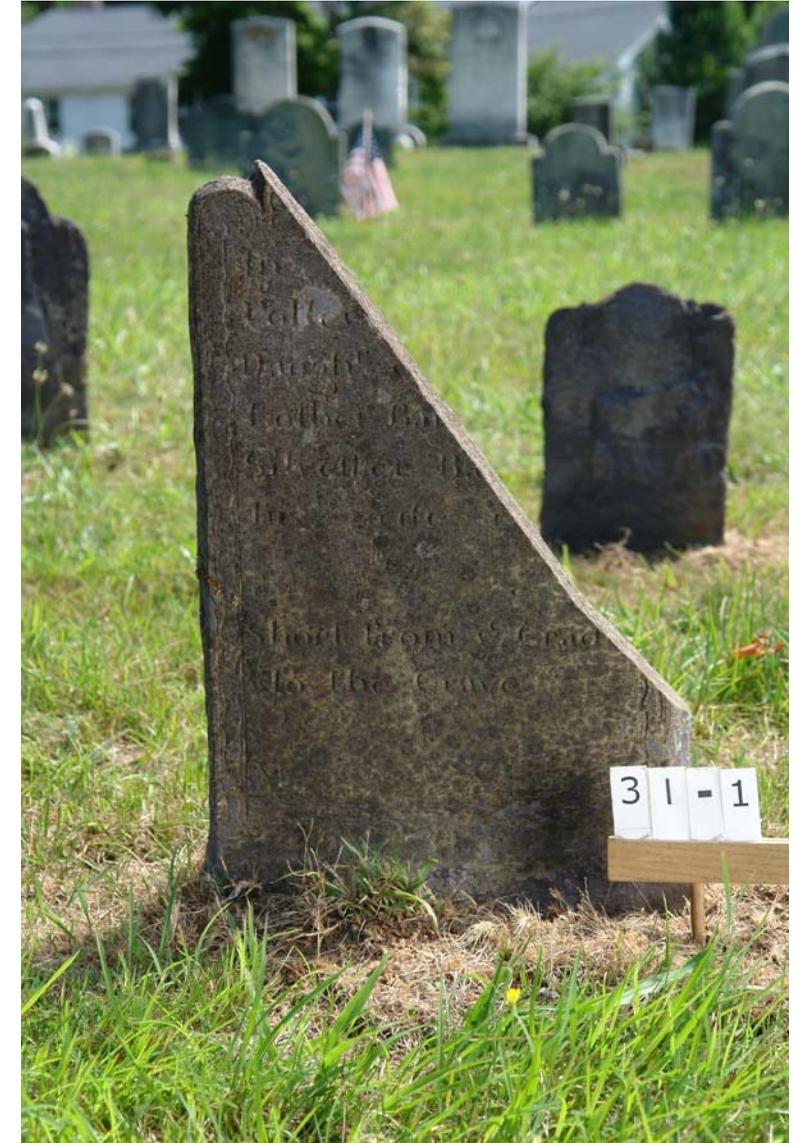
Tilted  
Missing fragments

1. Area probed for missing fragment(s). None found.
2. Marker carefully excavated. Soil around tilted marker removed to an appropriate depth. Marker appears to be sound.
3. When required, marker is removed from the ground.
4. Surface soiling removed by light brushing with nylon brushes and water.
5. When setting area is excavated to sufficient depth stone is re-set plumb and level onto gravel bed, aligned with adjacent markers.
6. Area backfilled around marker with tamped sand and gravel.
7. Disturbed areas re-graded with existing topsoil and sod.

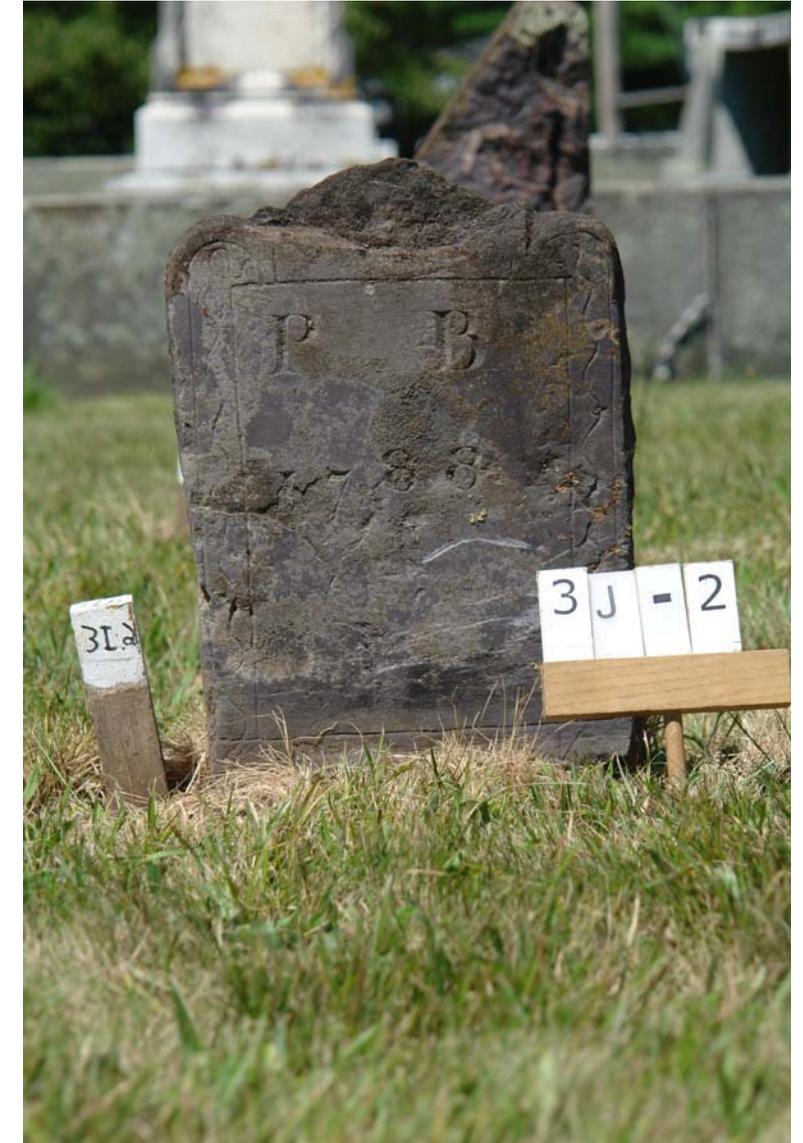
**EXISTING CONDITIONS**

1. Marker carefully excavated. Soil around tilted marker removed to an appropriate depth. Marker appears to be sound.
2. When required, marker is removed from the ground.
3. Surface soiling removed by light brushing with nylon brushes and water.
4. When setting area is excavated to sufficient depth stone is re-set plumb and level onto gravel bed, aligned with adjacent markers.
5. Area backfilled around marker with tamped sand and gravel.
6. Disturbed areas re-graded with existing topsoil and sod.
7. Surfaces treated with D/2 biological solution, scrubbed with nylon bristles and fully rinsed with water.

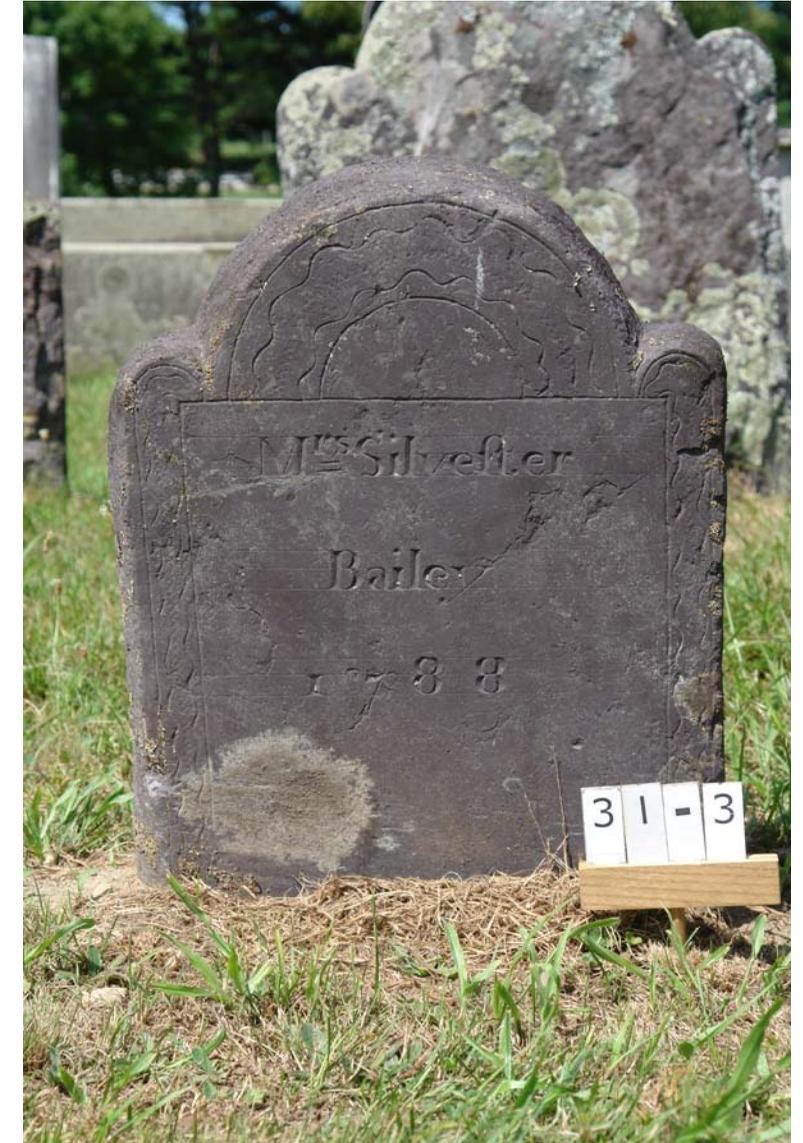
**EXISTING CONDITIONS**

1. Marker carefully excavated. Soil around tilted marker removed to an appropriate depth. Marker appears to be sound.
2. When required, marker is removed from the ground.
3. Surface soiling removed by light brushing with nylon brushes and water.
4. When setting area is excavated to sufficient depth stone is re-set plumb and level onto gravel bed, aligned with adjacent markers.
5. Area backfilled around marker with tamped sand and gravel.
6. Disturbed areas re-graded with existing topsoil and sod.
7. Surfaces treated with D/2 biological solution, scrubbed with nylon bristles and fully rinsed with water.

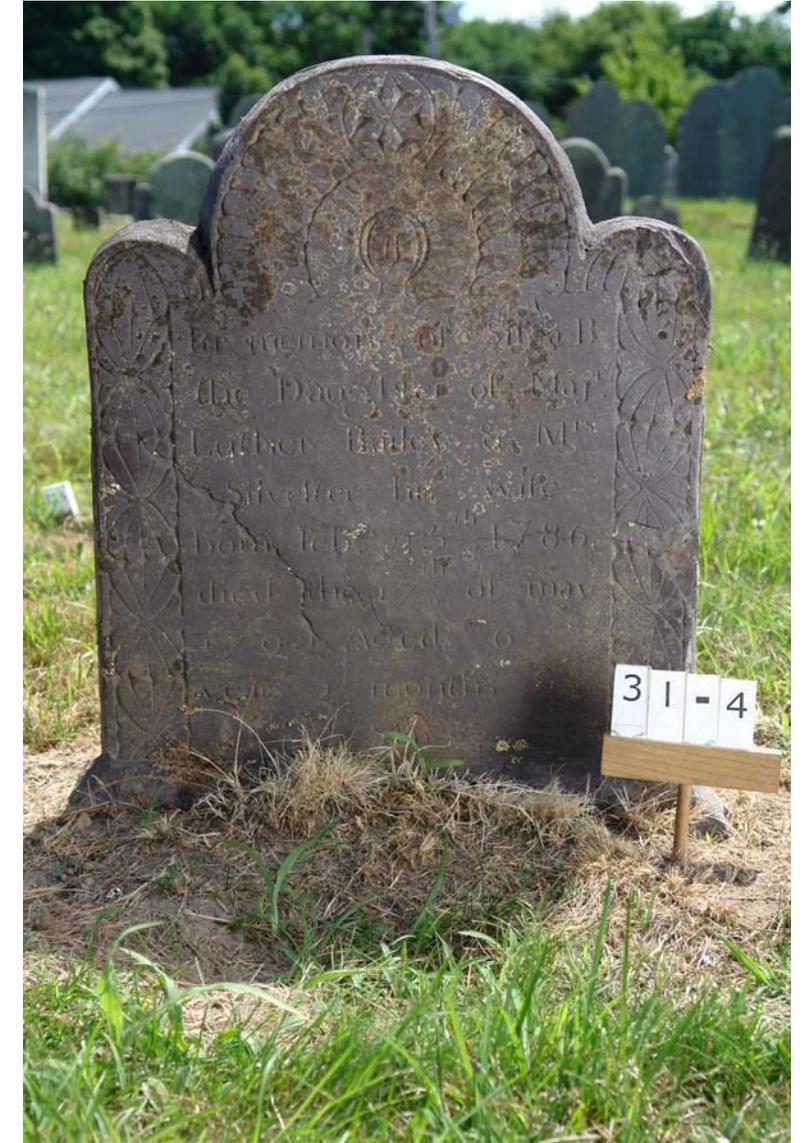
**EXISTING CONDITIONS**

1. Marker carefully excavated. Soil around tilted marker removed to an appropriate depth. When required, marker is removed from the ground. Marker appears to be sound.
2. Soling removed by light brushing with nylon brushes and water.
3. Setting area excavated to sufficient depth and stone re-set plumb at appropriate height and level onto gravel bed, aligned with adjacent markers.
4. Area backfilled around marker with tamped sand and gravel.
5. Disturbed areas re-graded with existing topsoil and sod.
6. Surfaces treated with D/2 biological solution, scrubbed with nylon bristles and fully rinsed with water.
7. All voids caused by splitting or delaminations at top edge of marker filled with a pigmented Sto crack fill. Excess material immediately removed with a damp sponge. Voids along sides of monument left open to allow escape of any accumulation of water.
