STONE CONSERVATION TREATMENTS

Hanover Center Cemetery, Hanover, MA

July, 2012

Documentation of Restorations to Center Cemetery

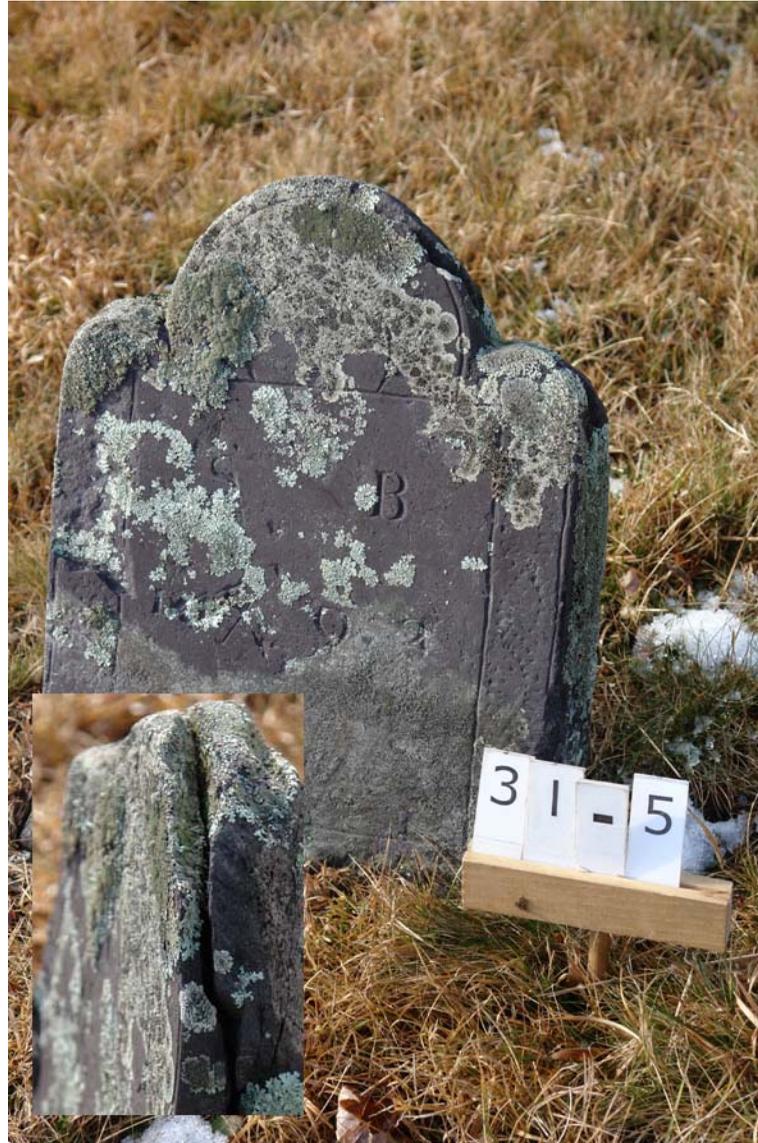
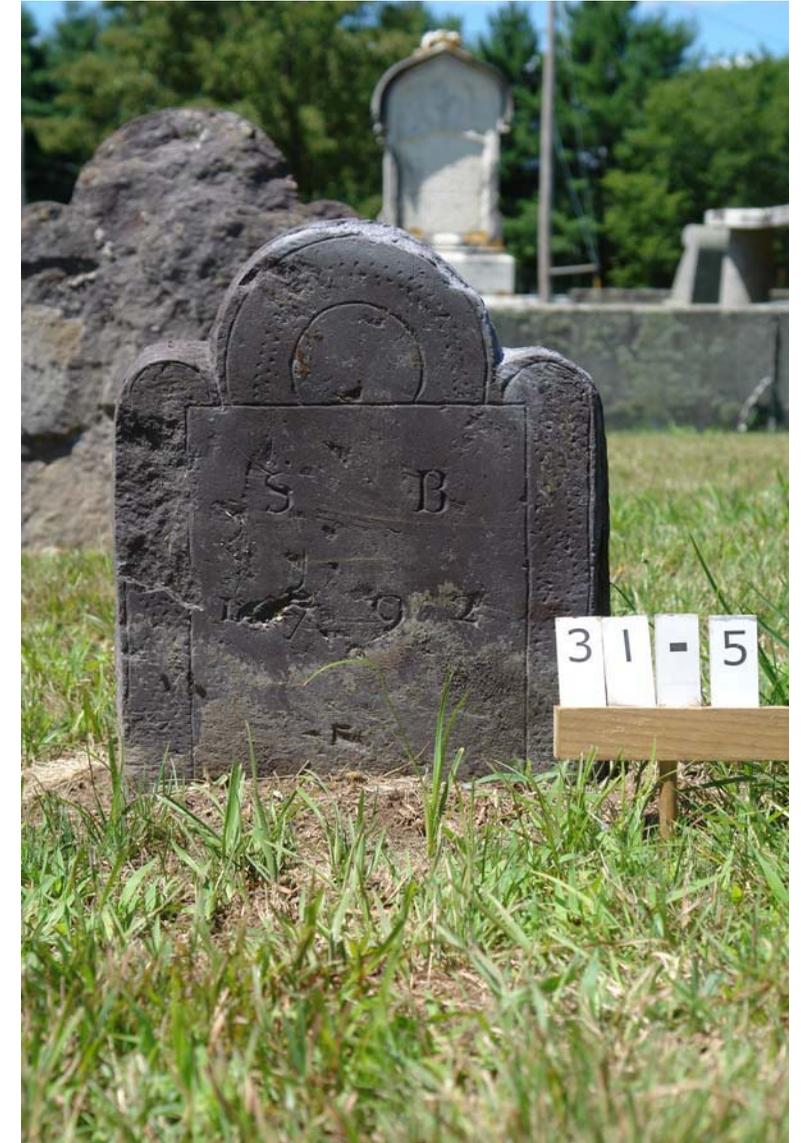
Condition of Inscription: **Decipherable**

1. Marker carefully excavated. Soil around tilted marker removed to an appropriate depth. When required, marker is removed from the ground. Marker appears to be sound.
2. Soling removed by light brushing with nylon brushes and water.
3. Setting area excavated to sufficient depth and stone re-set plumb at appropriate height and level onto gravel bed, aligned with adjacent markers.
4. Area backfilled around marker with tamped sand and gravel.
5. Disturbed areas re-graded with existing topsoil and sod.
6. Surfaces treated with D/2 biological solution, scrubbed with nylon bristles and fully rinsed with water.
7. Small voids at top filled with pigmented RepliCal crack fill, a cementitious hi-cal lime, misted and wrapped for min. 3 days.
8. After partial cure, any excess fill material on adjacent surfaces treated with acetic acid, brushed, and fully rinsed with water.

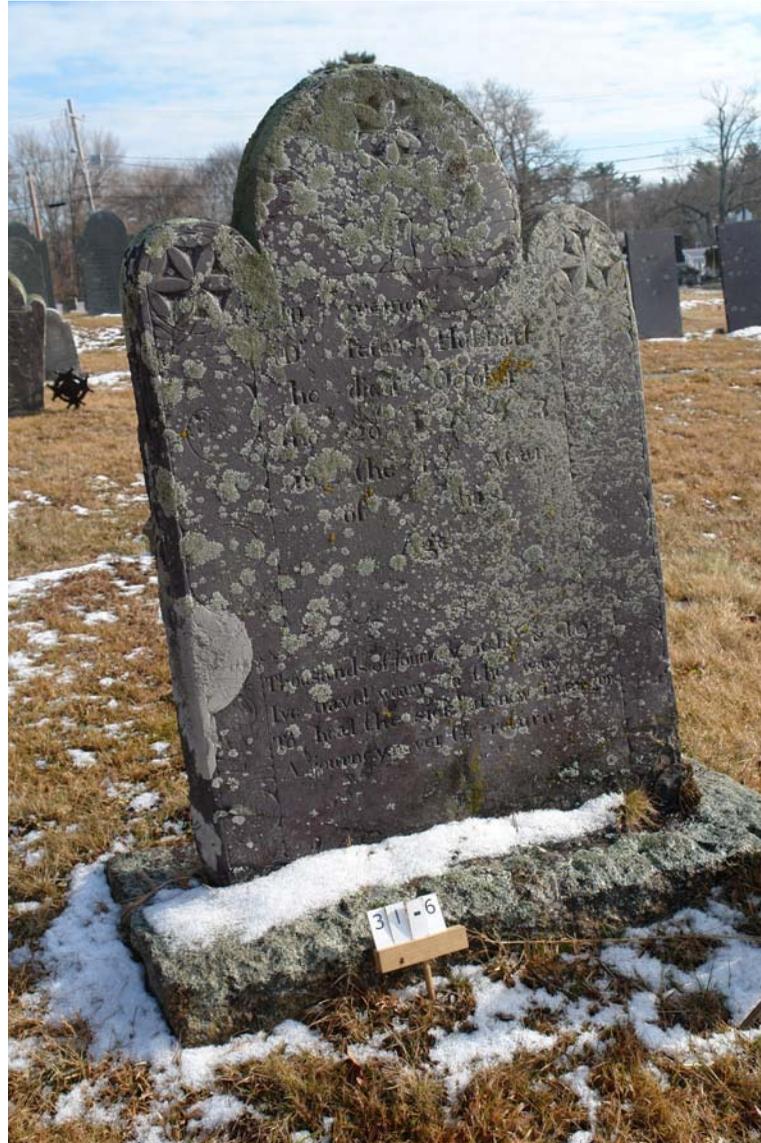
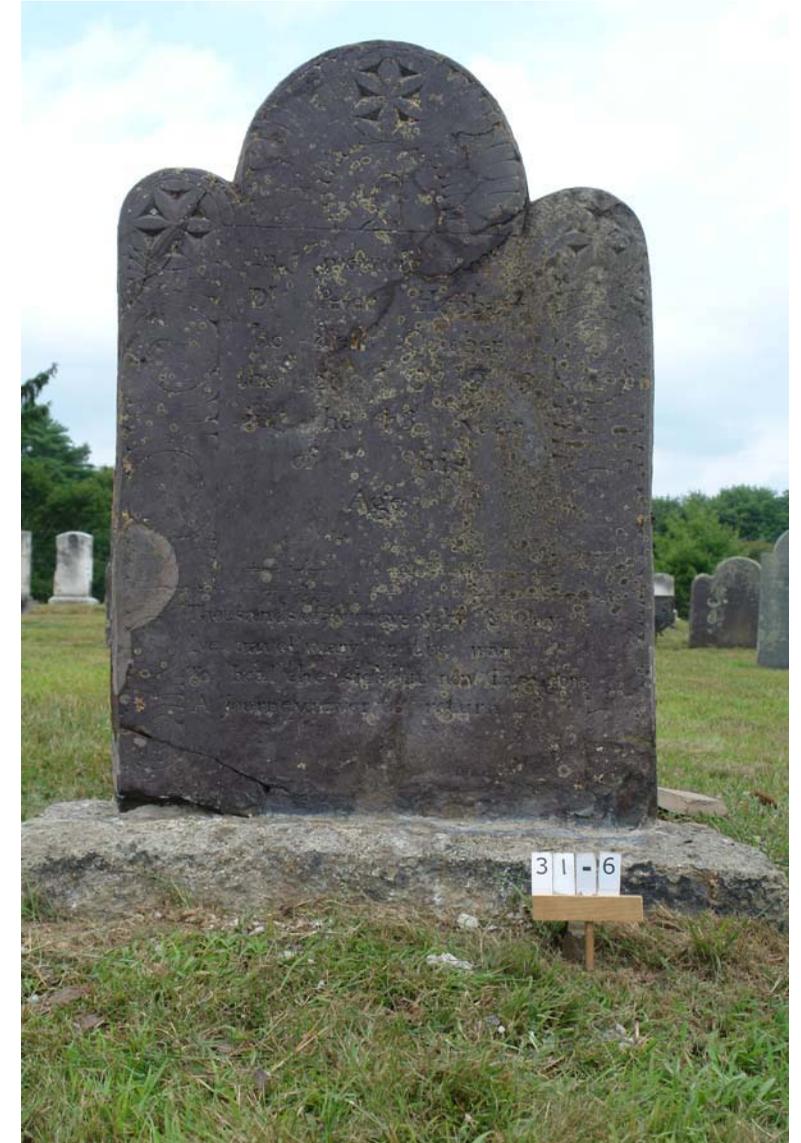
Condition of Inscription: Decipherable

1. Marker removed from setting slot.
2. Failed mortar and debris removed from setting slot.
3. Marker reset plumb into setting slot with flowable 000 grout
4. Excess grout removed and marker braced for 3 days.
5. Surfaces treated with D/2 biological solution, scrubbed with nylon bristles and fully rinsed with water.

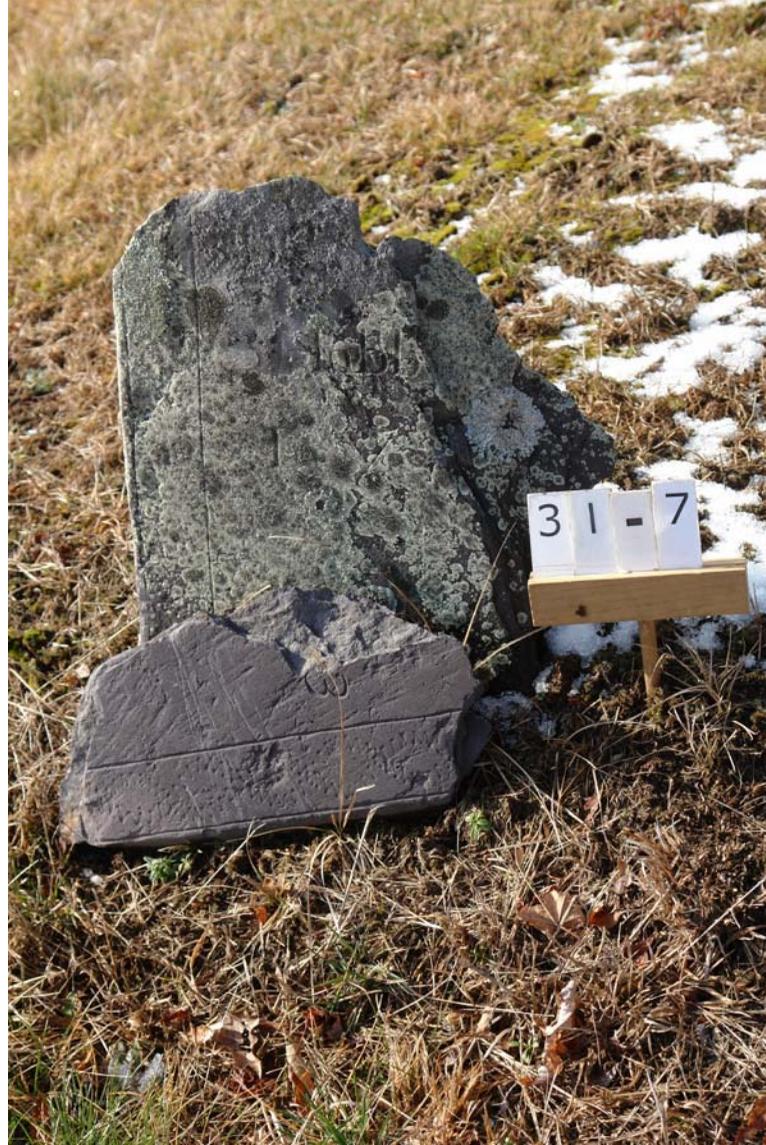
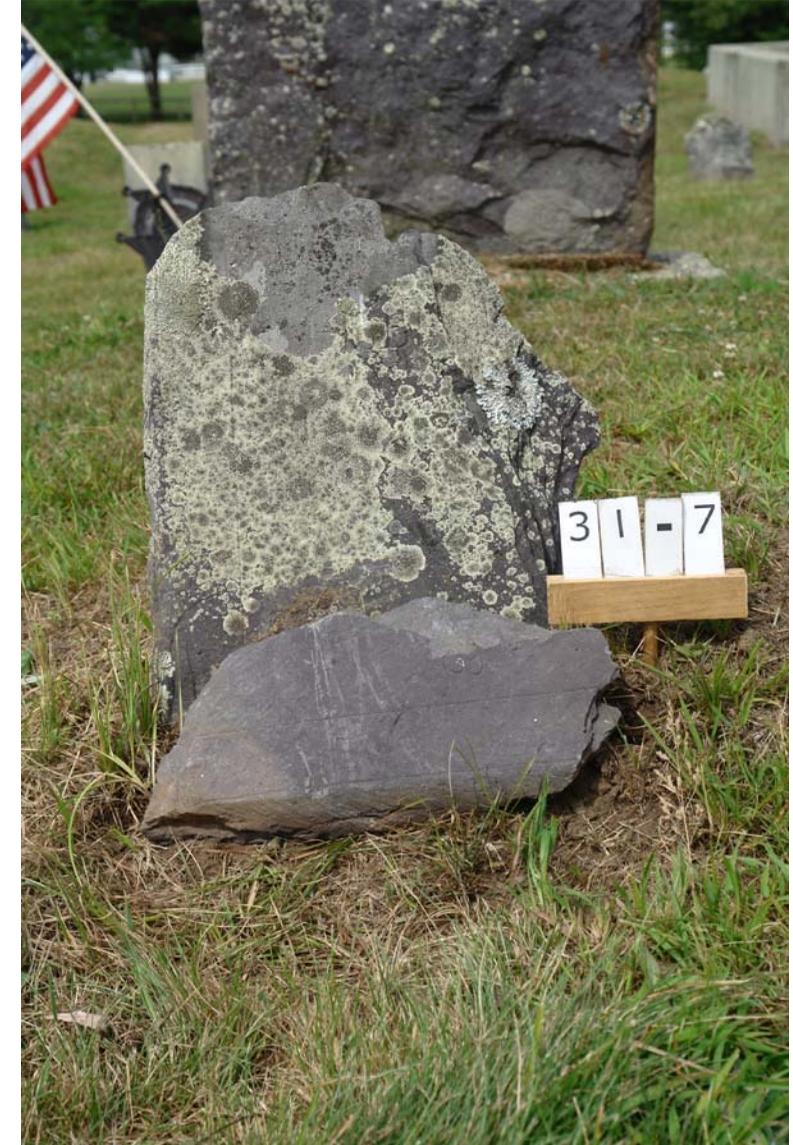
Condition of Inscription: **Missing, partial traces** Material: **Slate**

EXISTING CONDITIONS	CONSERVATION STRATEGY
Tilted	Reset
Fractured	Adhesive repair
Losses	Fill losses

Marker excavated, surrounding area unsuccessfully probed for fragments.  
Not restorable

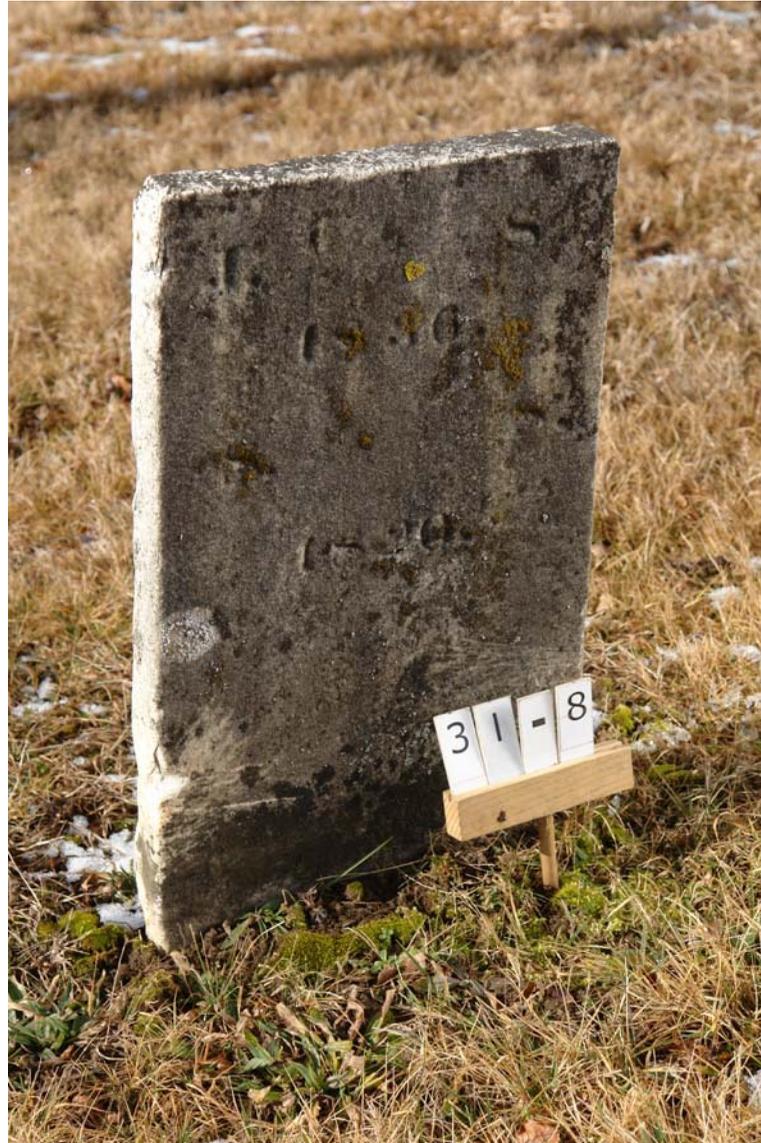
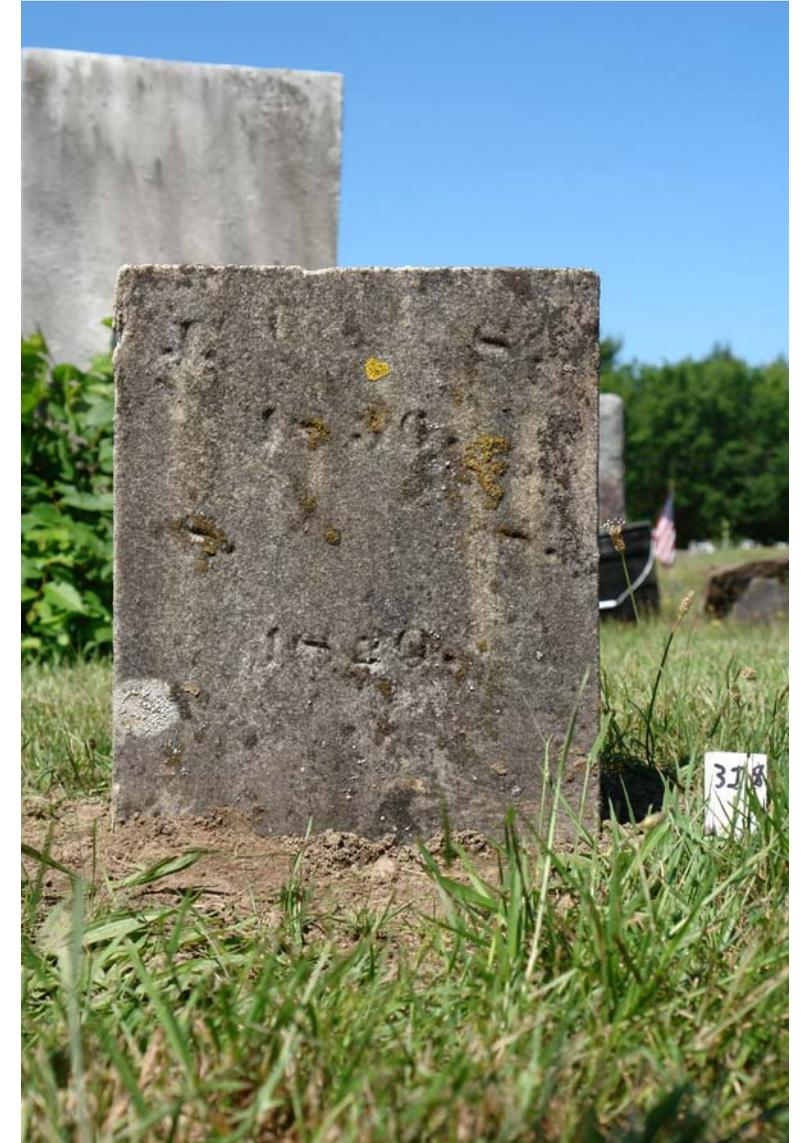
Condition of Inscription: Decipherable Material: Marble

1. Marker carefully excavated. Soil around tilted marker removed to an appropriate depth. Marker appears to be sound.
2. When required, marker is removed from the ground.
3. Surface soiling removed by light brushing with nylon brushes and water.
4. When setting area is excavated to sufficient depth stone is re-set plumb and level onto gravel bed, aligned with adjacent markers.
5. Area backfilled around marker with tamped sand and gravel.
6. Disturbed areas re-graded with existing topsoil and sod.

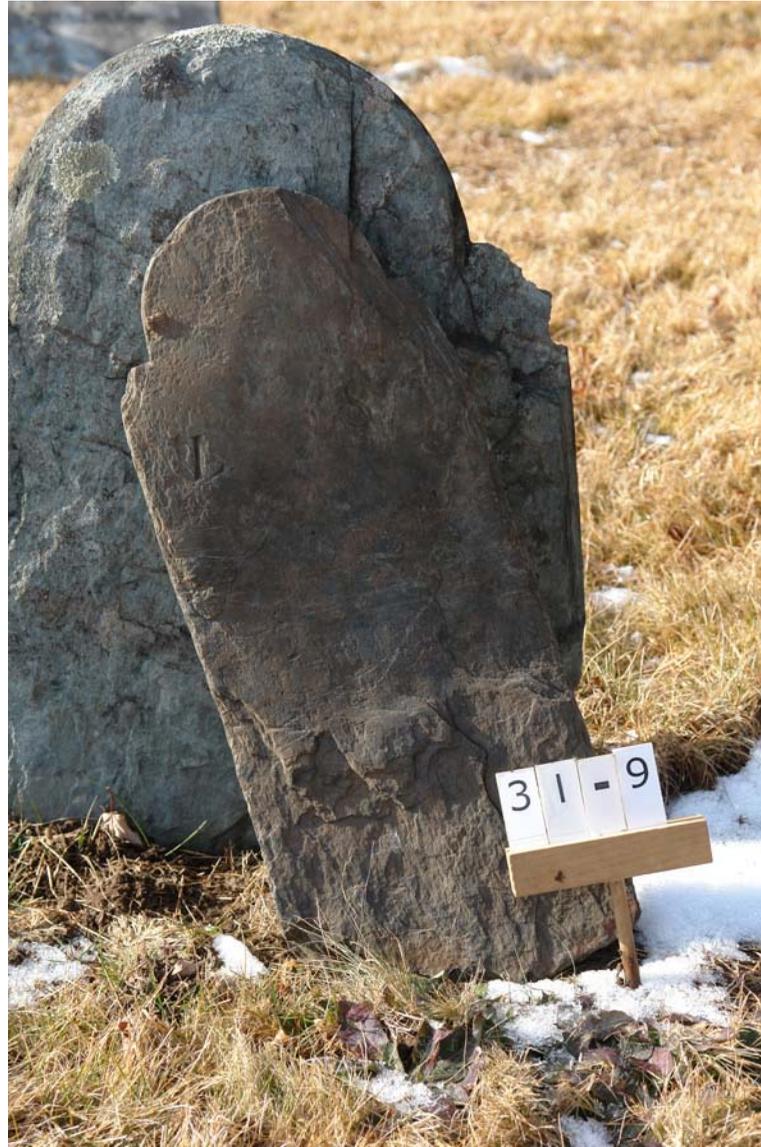
Condition of Inscription: **Decipherable** Material: **Slate**

1. Setting area excavated to sufficient depth and stone re-set plumb at appropriate height and level onto gravel bed, aligned with back of headstone.
2. Area backfilled around footstone with tamped sand and gravel.
3. Disturbed areas re-graded with existing topsoil and sod.

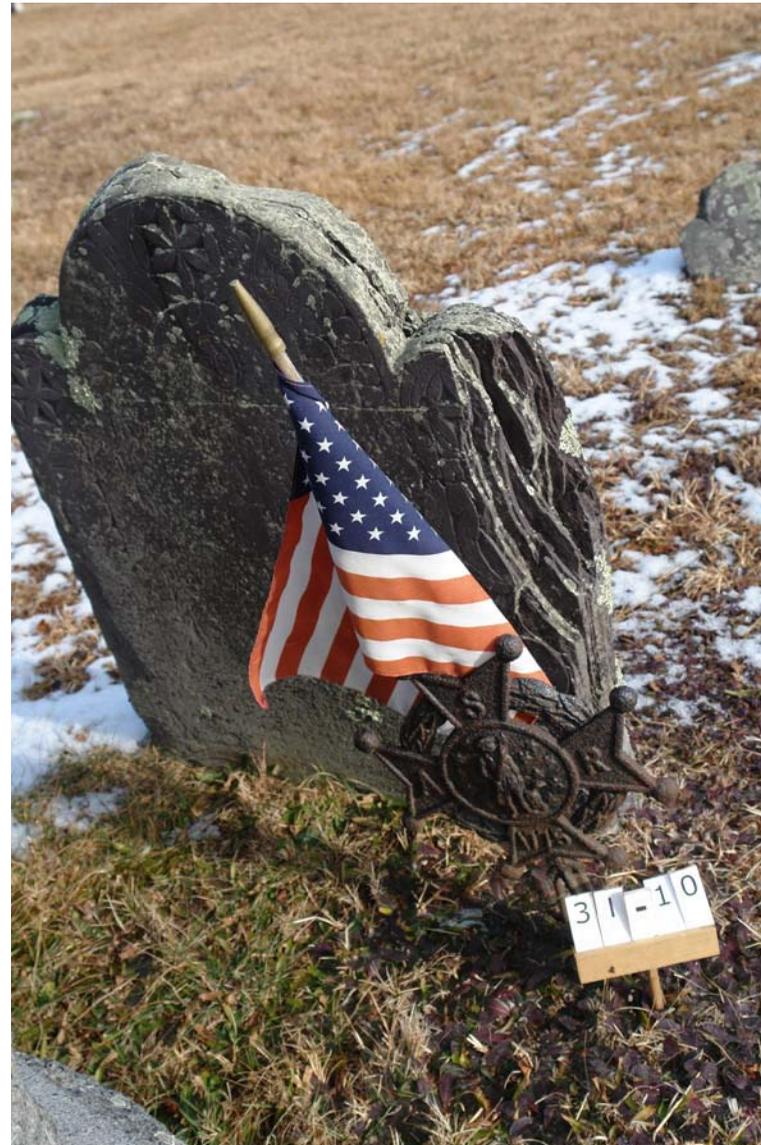
Condition of Inscription: **Partially Decipherable**

1. Marker carefully excavated. Soil around tilted marker removed to an appropriate depth. Marker appears to be sound.
2. When required, marker is removed from the ground.
3. When setting area is excavated to sufficient depth stone is re-set plumb and level onto gravel bed, aligned with adjacent markers.
4. Area backfilled around marker with tamped sand and gravel.
5. Disturbed areas re-graded with existing topsoil and sod.
6. Surface treated with D/2 biological solution, scrubbed with nylon bristles and fully rinsed with water.
7. Interior voids filled with pigmented pourable VoidSpan, misted and wrapped for min. 3 days.
8. Open delaminated areas filled with pigmented Sto crack filler. Excess material immediately removed with a damp sponge. Voids along sides of monument left open to allow escape of any accumulation of water

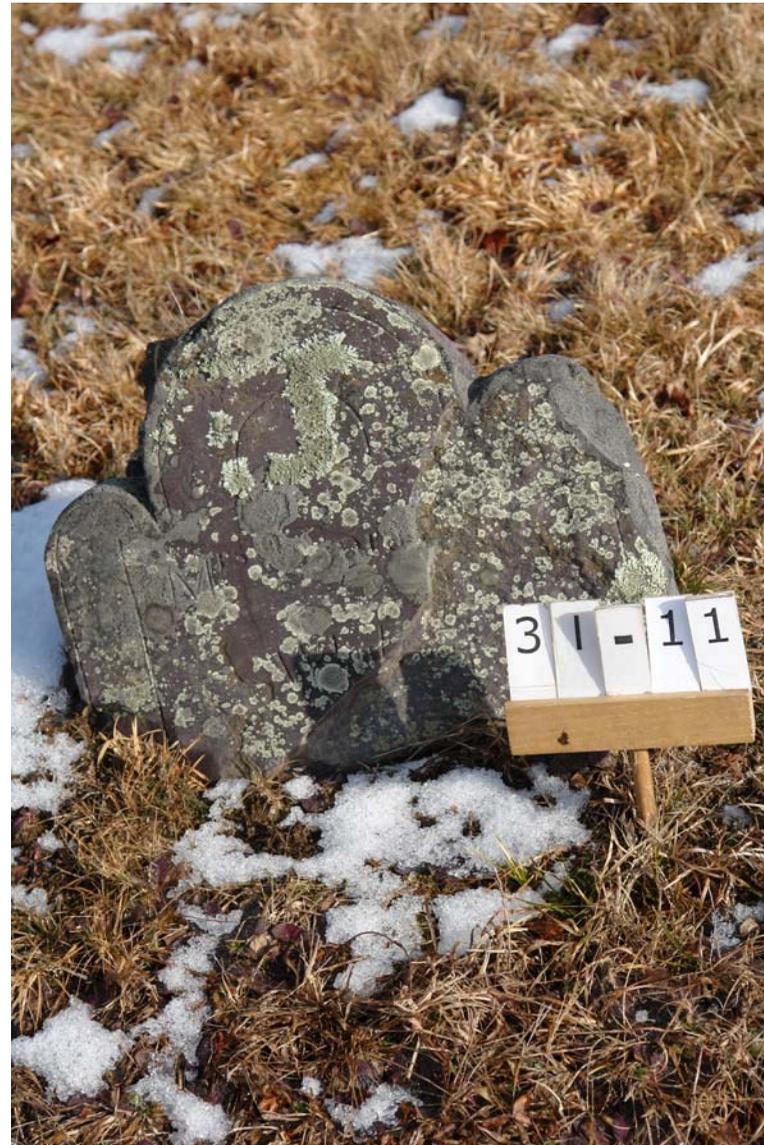
Tilted  
Fractured  
Losses

Note: This marker has been recently fractured (after 1/10/2012)

1. Fragment(s) excavated and area probed for missing pieces.
2. Lower fragment reset plumb at appropriate height, aligned with adjacent markers.
3. All surfaces treated with D/2 biological solution and scrubbed with nylon brushes, then rinsed with water.
4. Fragment(s) attached with structural adhesive, and braced until cured.
5. Cracks and losses filled with RepliCal and Sto crack fill, misted and wrapped min. 3 days.
6. After partial cure, any excess fill material on adjacent surfaces treated with acetic acid, brushed, and fully rinsed with water.

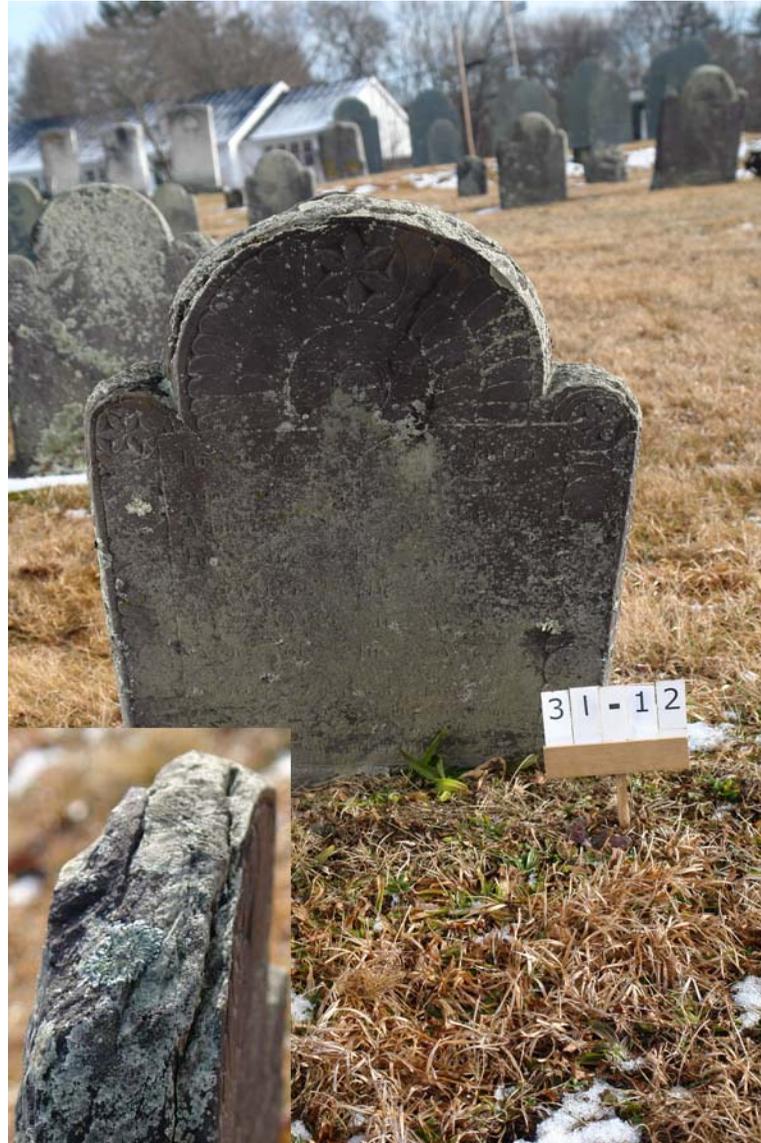
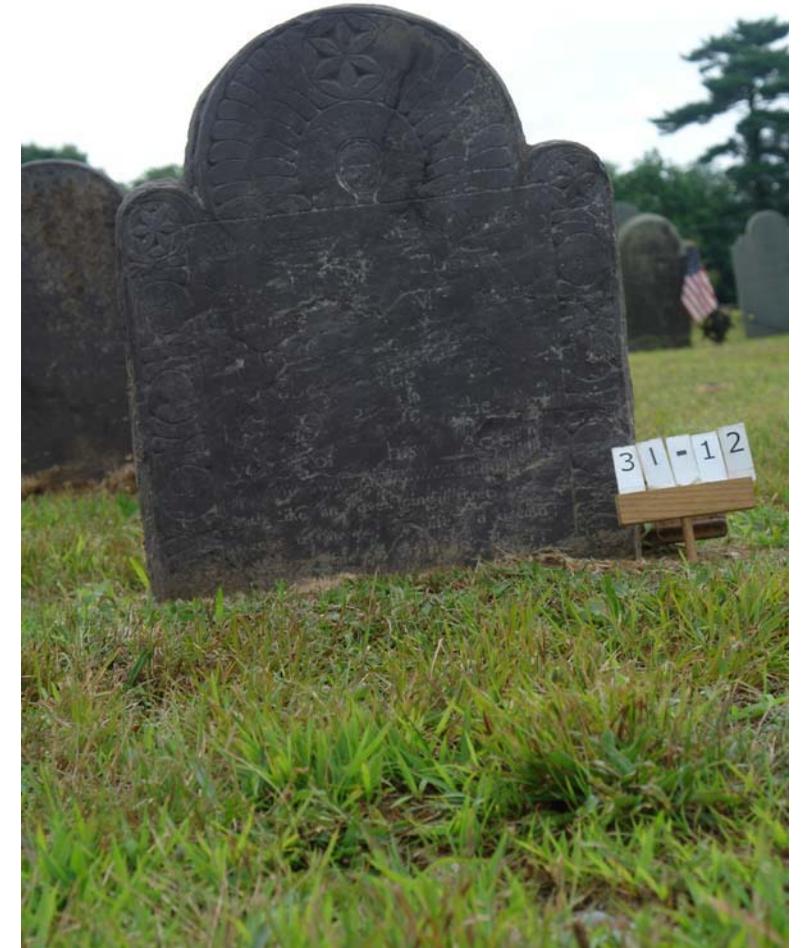
Condition of Inscription: Decipherable Material: Slate

1. Marker carefully excavated. Soil around tilted marker removed to an appropriate depth. When required, marker is removed from the ground. Marker appears to be sound.
  2. Soling removed by light brushing with nylon brushes and water.
  3. Setting area excavated to sufficient depth and stone re-set plumb at appropriate height and level onto gravel bed, aligned with adjacent markers.
  4. Area backfilled around marker with tamped sand and gravel.
  5. Disturbed areas re-graded with existing topsoil and sod.
  6. Surfaces treated with D/2 biological solution, scrubbed with nylon bristles and fully rinsed with water.
  7. All voids caused by splitting or delaminations at top edge of marker filled with a pigmented Sto crack fill. Excess material immediately removed with a damp sponge.
- Voids along sides of monument left open to allow escape of any accumulation of water

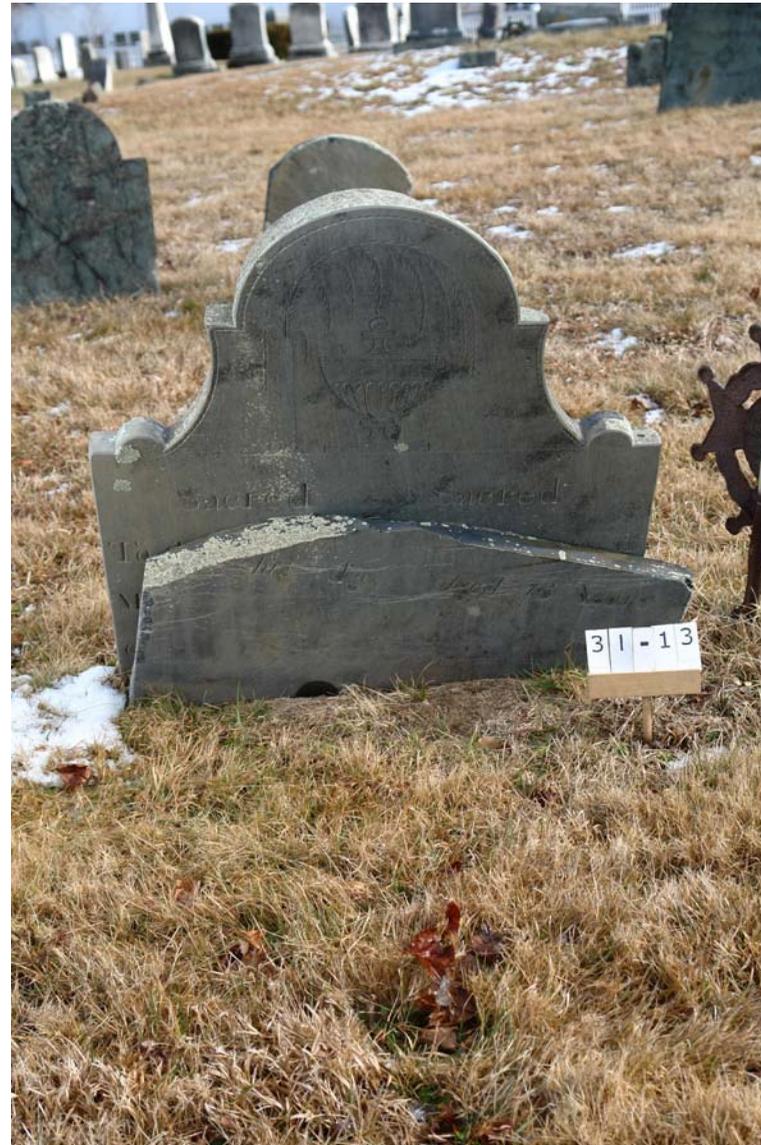
Condition of Inscription: **Decipherable** Material: **Slate**

Tilted  
Fractured

1. Fragment(s) excavated and area probed for missing pieces.
2. Lower fragment reset plumb at appropriate height, aligned with adjacent markers.
3. Any failed adhesives or mortar removed.
4. Mating surfaces of fragment(s) treated with D/2 biological solution and scrubbed with nylon brushes, then rinsed with water.
5. Fragment(s) attached with structural adhesive, and braced until cured.
6. Cracks and losses filled with RepliCal and Jahn products, misted and wrapped min. 3 days.
7. After partial cure, any excess fill material on adjacent surfaces treated with acetic acid, brushed, and fully rinsed with water.

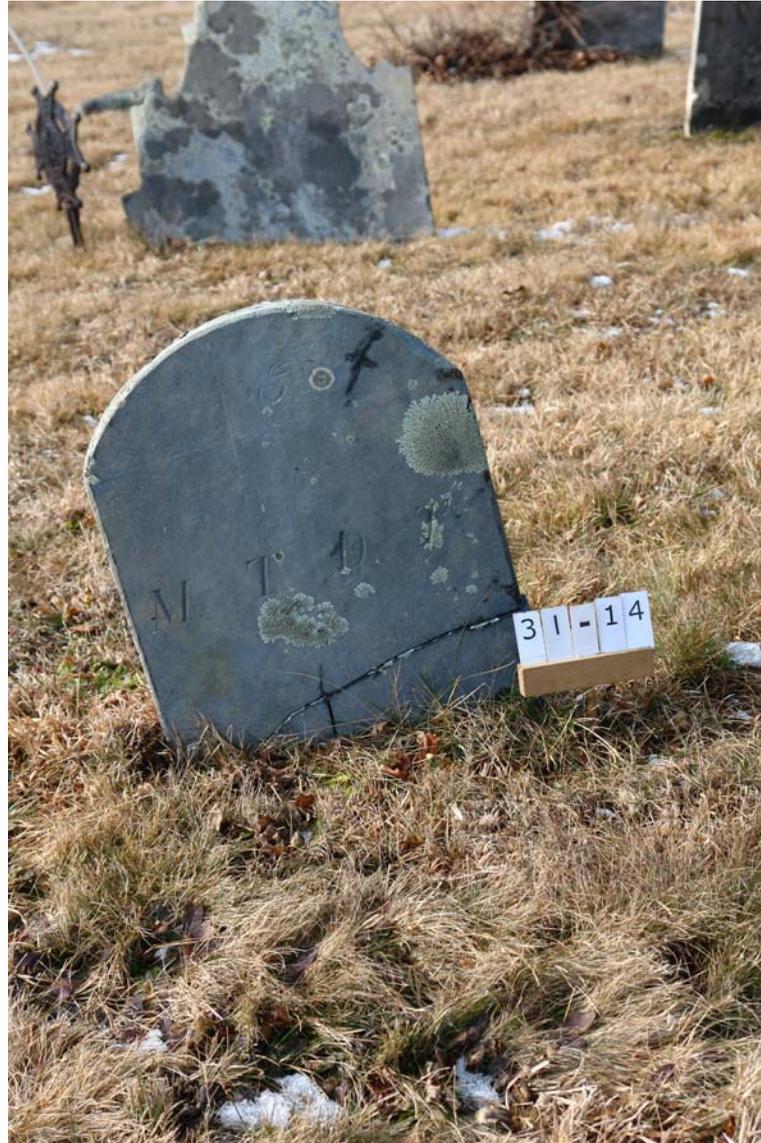
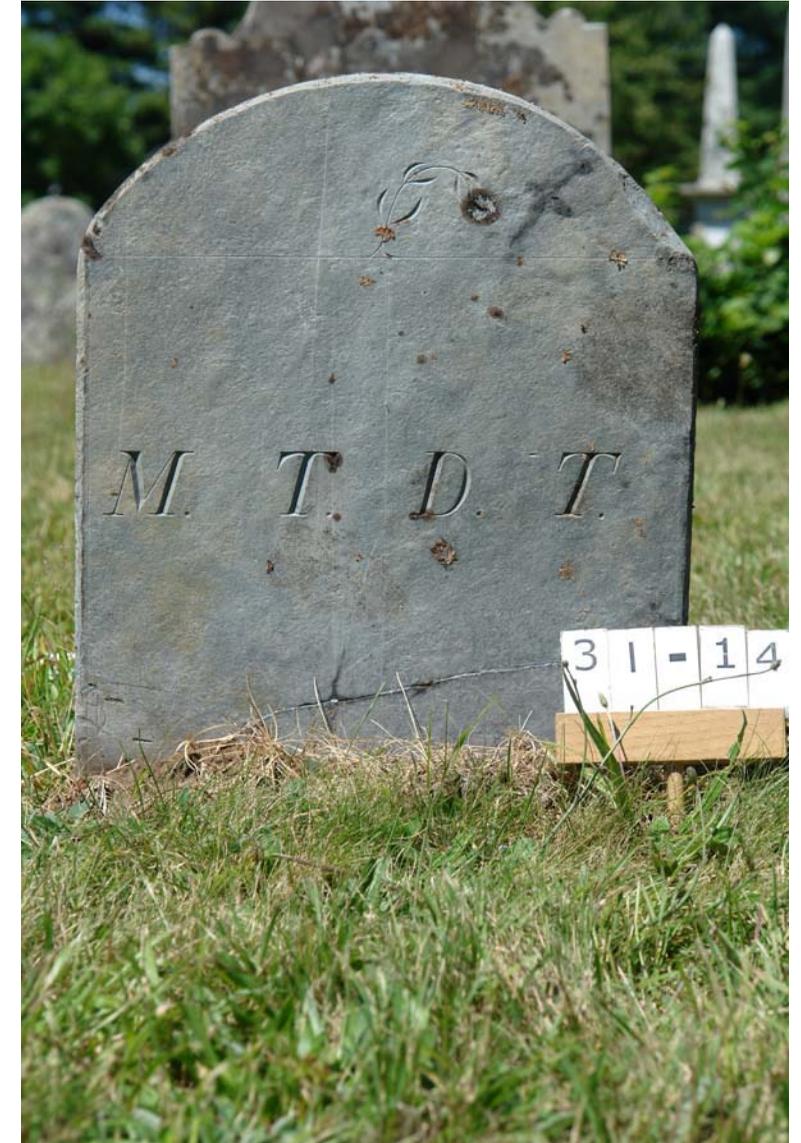
Condition of Inscription: **Decipherable** Material: **Slate**

1. Delaminated fragment(s) excavated and area probed for possible missing pieces.
2. Any failed adhesives or mortar was removed.
3. Mating surfaces of fragment(s) were treated with D/2 biological solution and scrubbed with nylon brushes, then rinsed with water.
4. Fragment(s) attached with structural adhesive, and clamped until cured.
5. Cracks and losses filled with RepliCal misted and wrapped min. 3 days.
6. After partial cure, any excess fill material on adjacent surfaces treated with acetic acid, brushed, and fully rinsed with water.
7. Setting area was excavated to sufficient depth and stone re-set plumb and level onto gravel bed, aligned with adjacent markers.
8. Area backfilled around marker with tamped sand and gravel.
9. Disturbed areas re-graded with existing topsoil and sod.

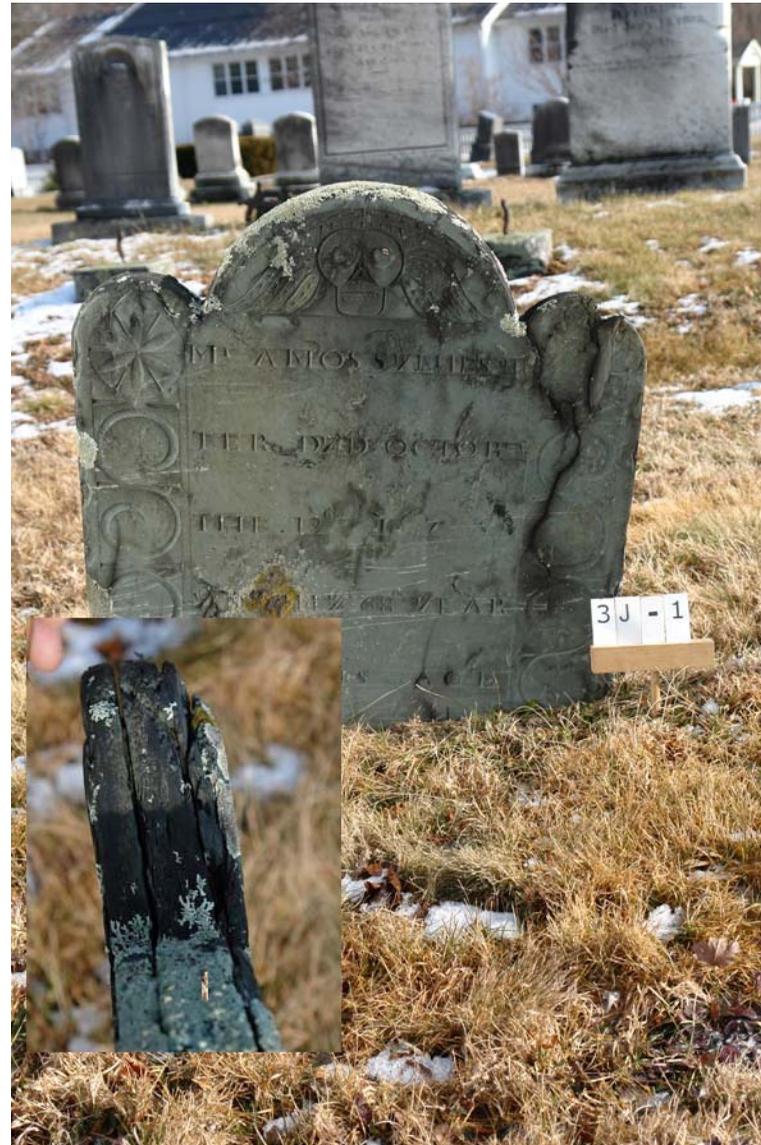
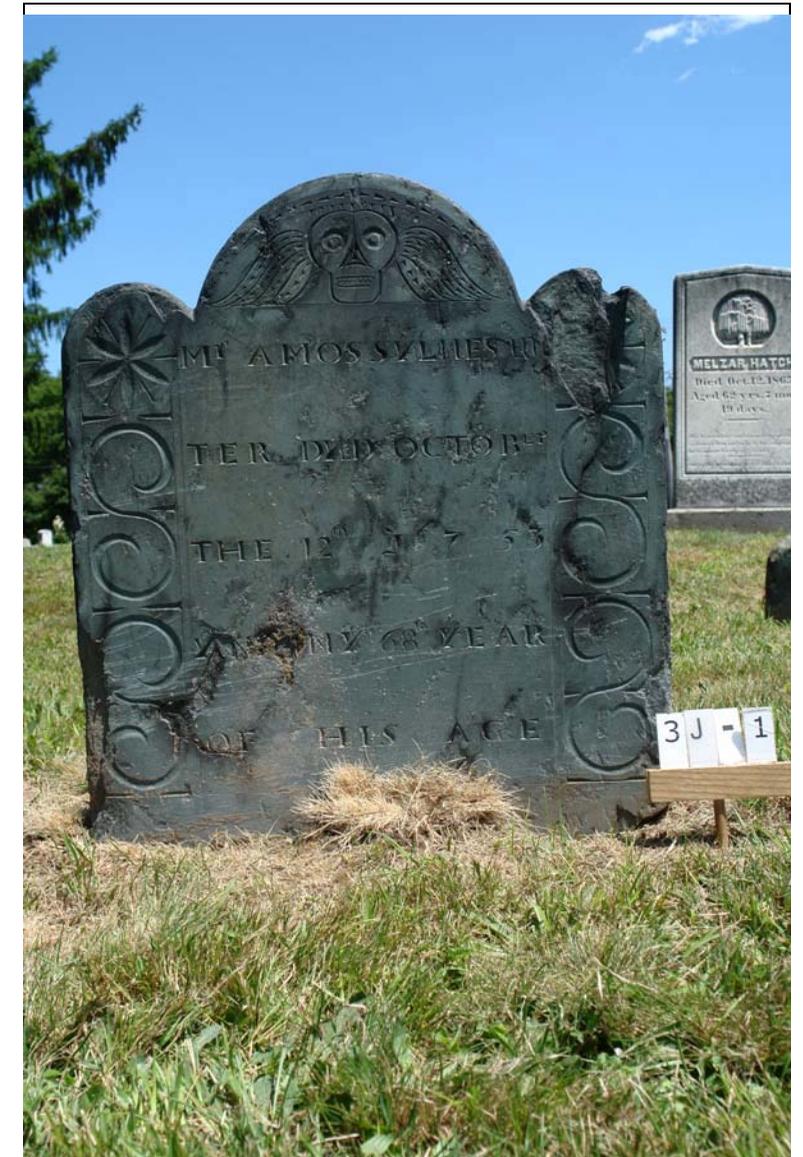
Condition of Inscription: **Decipherable** Material: **Slate**

1. Marker carefully excavated. Soil around tilted marker removed to an appropriate depth. When required, marker is removed from the ground. Marker appears to be sound.
  2. Soling removed by light brushing with nylon brushes and water.
  3. Setting area excavated to sufficient depth and stone re-set plumb at appropriate height and level onto gravel bed, aligned with adjacent markers.
  4. Area backfilled around marker with tamped sand and gravel.
  5. Disturbed areas re-graded with existing topsoil and sod.
  6. Surfaces treated with D/2 biological solution, scrubbed with nylon bristles and fully rinsed with water.
  7. All voids caused by splitting or delaminations at top edge of marker filled with a pigmented Sto crack fill. Excess material immediately removed with a damp sponge.
- Voids along sides of monument left open to allow escape of any accumulation of water

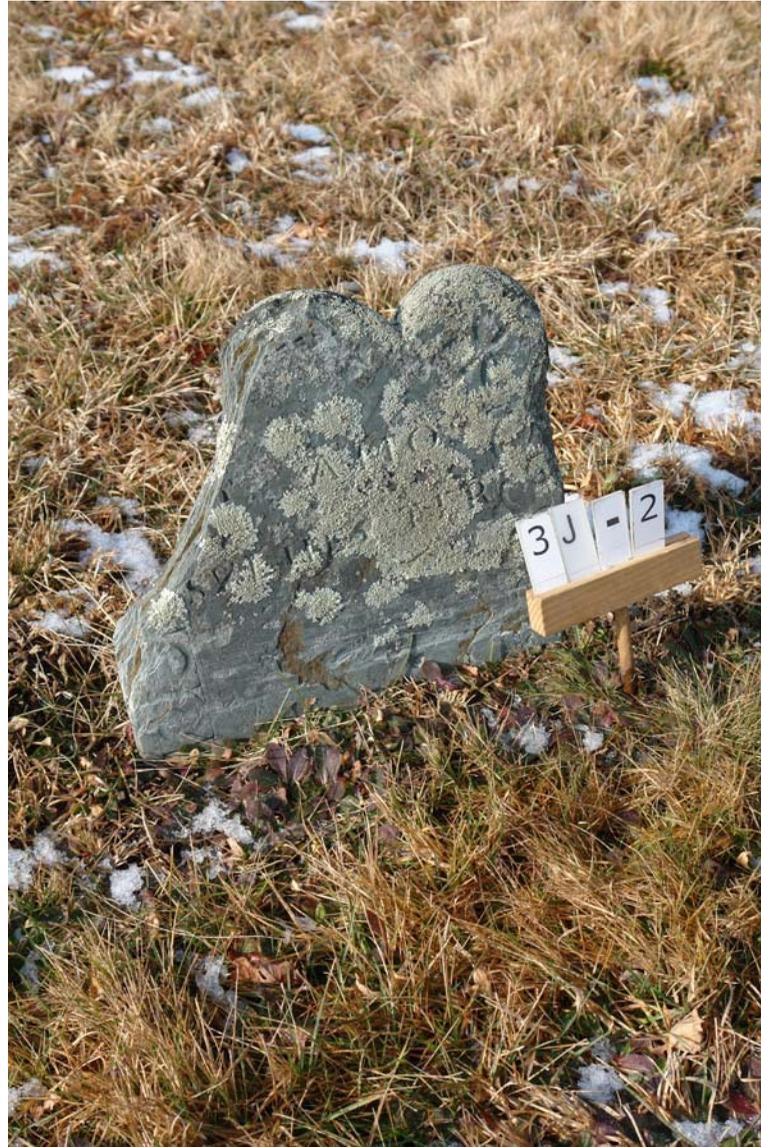
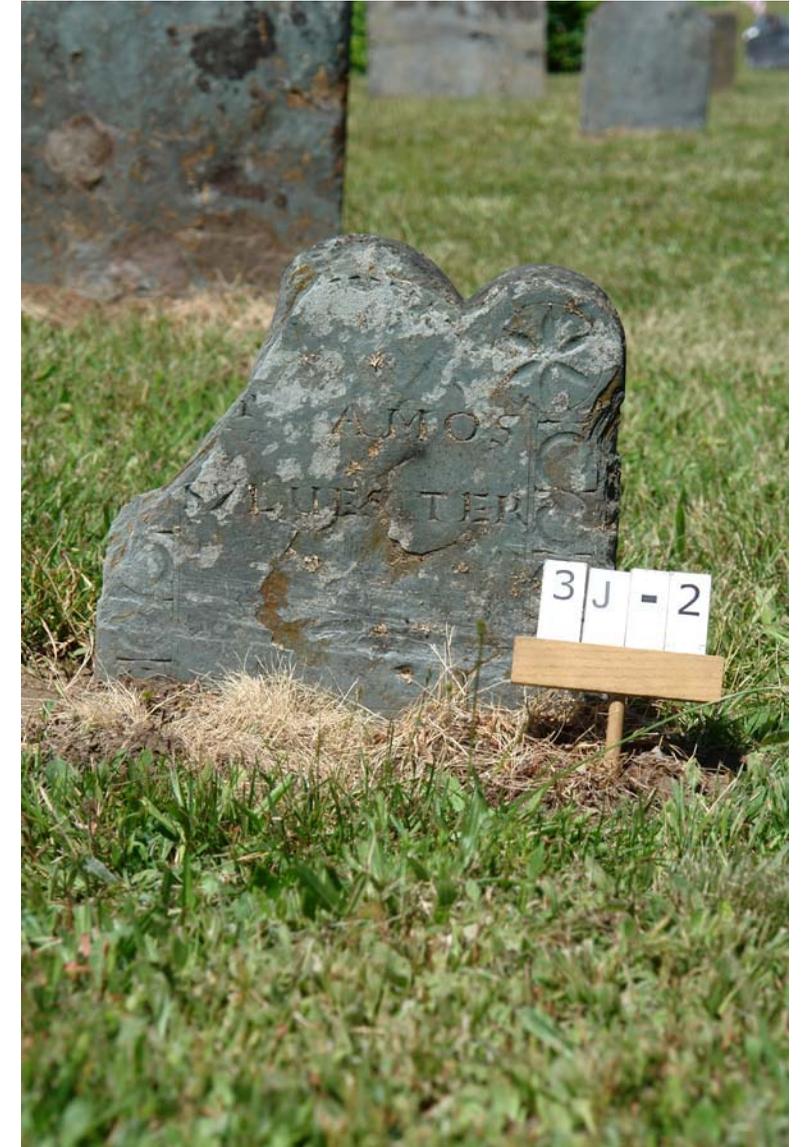
Condition of Inscription: **Decipherable**

1. Marker carefully excavated. Soil around tilted marker removed to an appropriate depth. When required, marker is removed from the ground. Marker appears to be sound.
2. Soling removed by light brushing with nylon brushes and water.
3. Setting area excavated to sufficient depth and stone re-set plumb at appropriate height and level onto gravel bed, aligned with adjacent markers.
4. Area backfilled around marker with tamped sand and gravel.
5. Disturbed areas re-graded with existing topsoil and sod.
6. Surfaces treated with D/2 biological solution, scrubbed with nylon bristles and fully rinsed with water.
7. All voids caused by splitting or delaminations at top edge of marker filled with a pigmented Sto crack fill. Excess material immediately removed with a damp sponge. Voids along sides of monument left open to allow escape of any accumulation of water

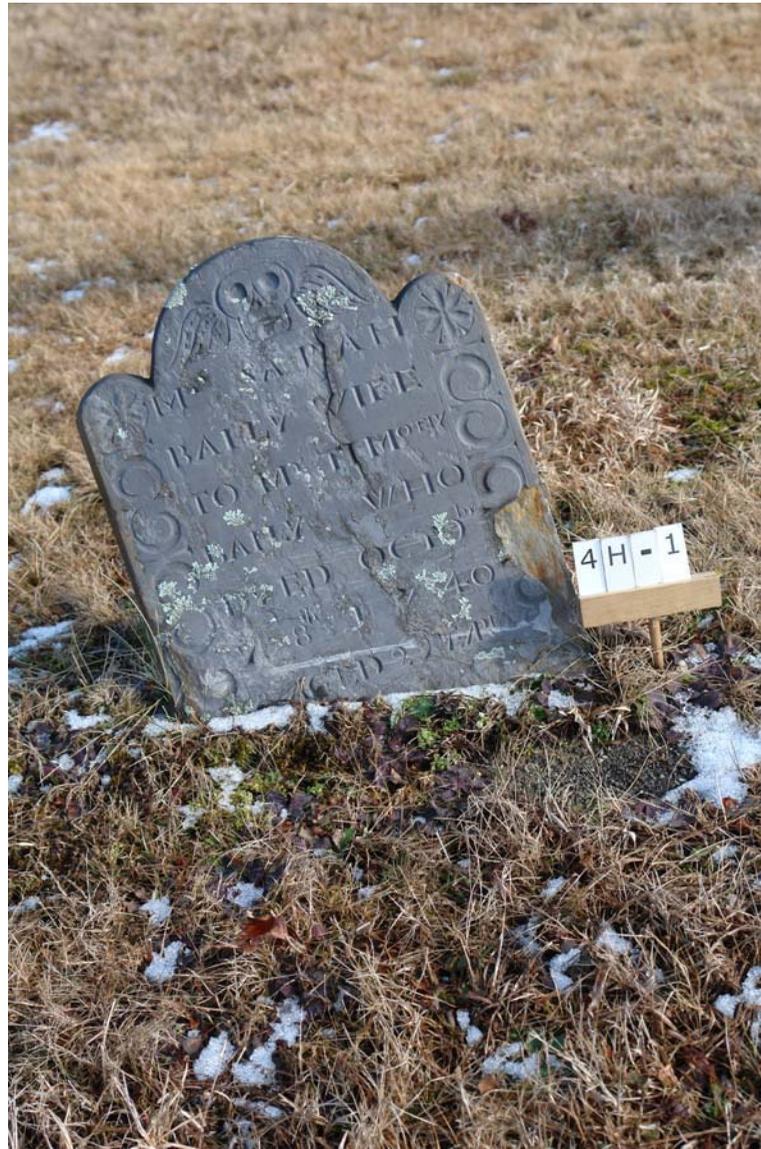
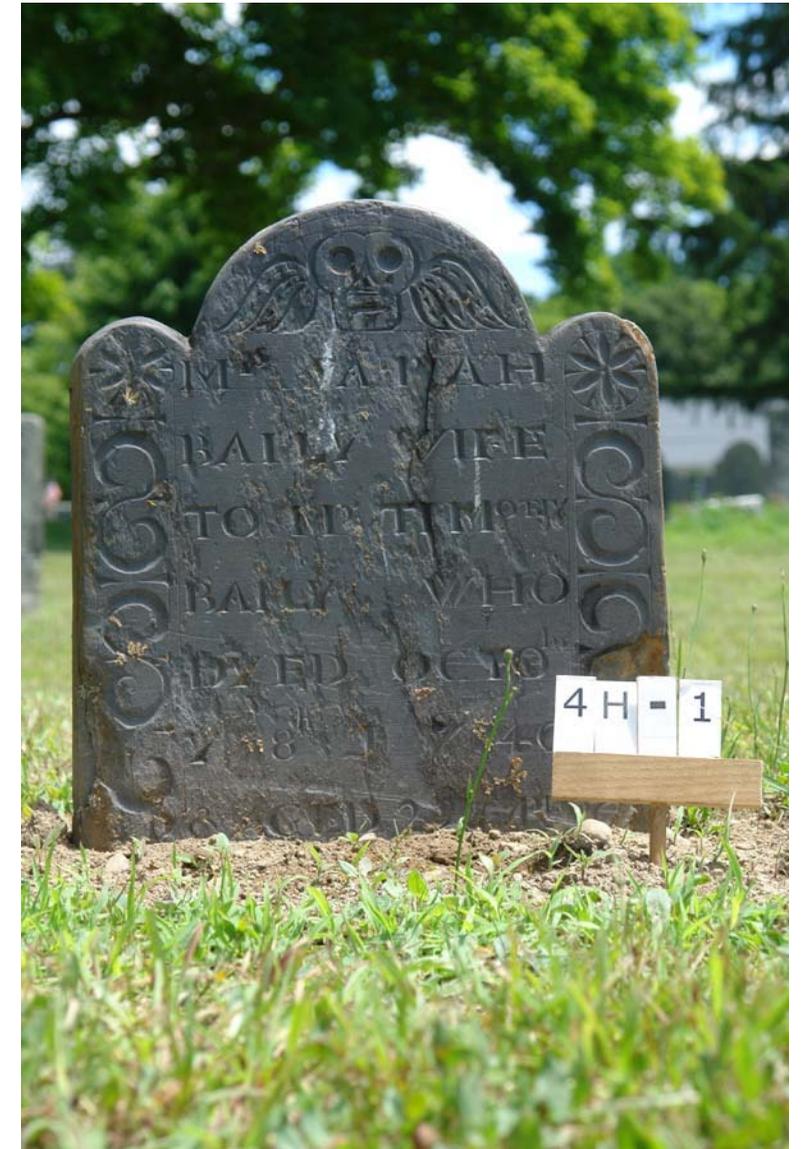
Condition of Inscription: Decipherable

1. Marker carefully excavated. Soil around tilted marker removed to an appropriate depth. Marker appears to be sound.
2. When required, marker is removed from the ground.
3. Surface soiling removed by light brushing with nylon brushes and water.
4. When setting area is excavated to sufficient depth stone is re-set plumb and level onto gravel bed, aligned with adjacent markers.
5. Area backfilled around marker with tamped sand and gravel.
6. Disturbed areas re-graded with existing topsoil and sod.
