STONE CONSERVATION TREATMENTS

Hanover Center Cemetery, Hanover, MA

July, 2012

Documentation of Restorations to Center Cemetery

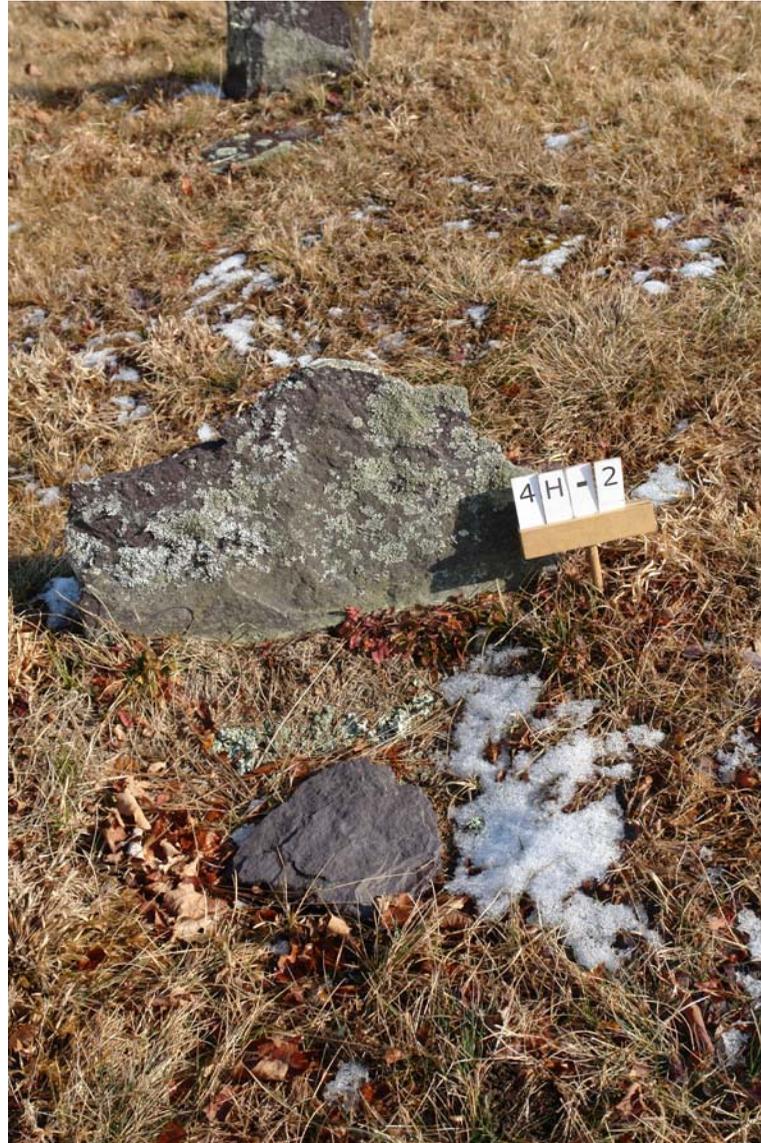
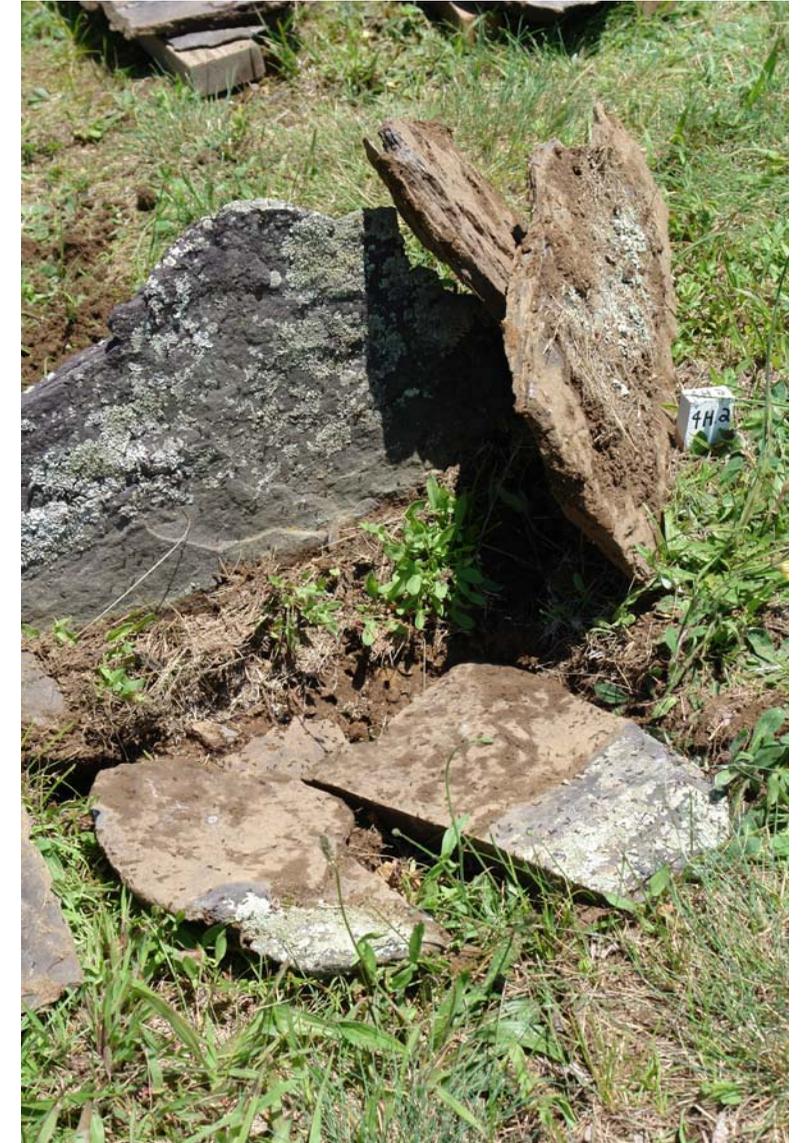
Condition of Inscription: Missing

Fractured

Not restorable, very fragmented with large losses.

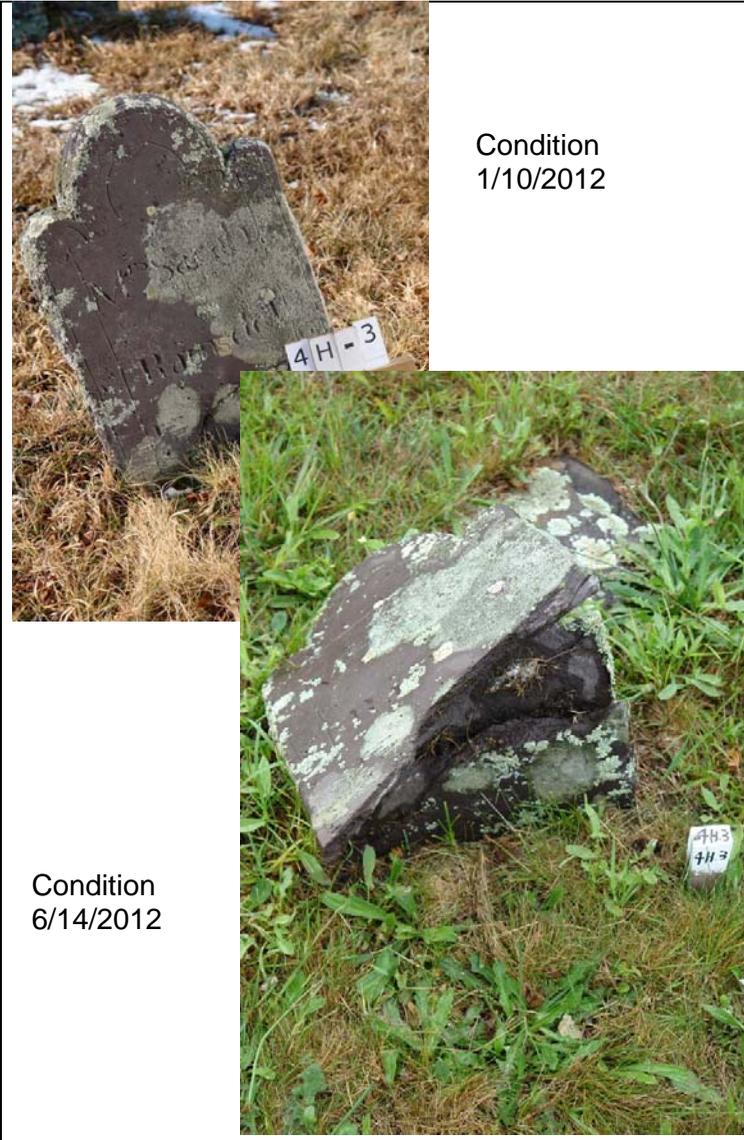
Tilted  
Delaminating  
Fractured

Marker fractured since 1/10/2012

Condition  
1/10/2012

1. Fragment(s) excavated and area probed for missing pieces, if any.
2. Mating surfaces of fragment(s) cleaned and any failed adhesives or mortar removed.
3. Fragment(s) attached with structural adhesive (Abatron 55-22), and braced until cured.
4. Cracks and small losses filled with RepliCal crack fill, a cementitious hi-cal lime. Large losses filled with Jahn restoration mortar. Misted and wrapped min. 3 days.
5. After partial cure, excess fill material on adjacent surfaces was treated with acetic acid, brushed, and fully rinsed with water.
6. Marker reset plumb at appropriate height.

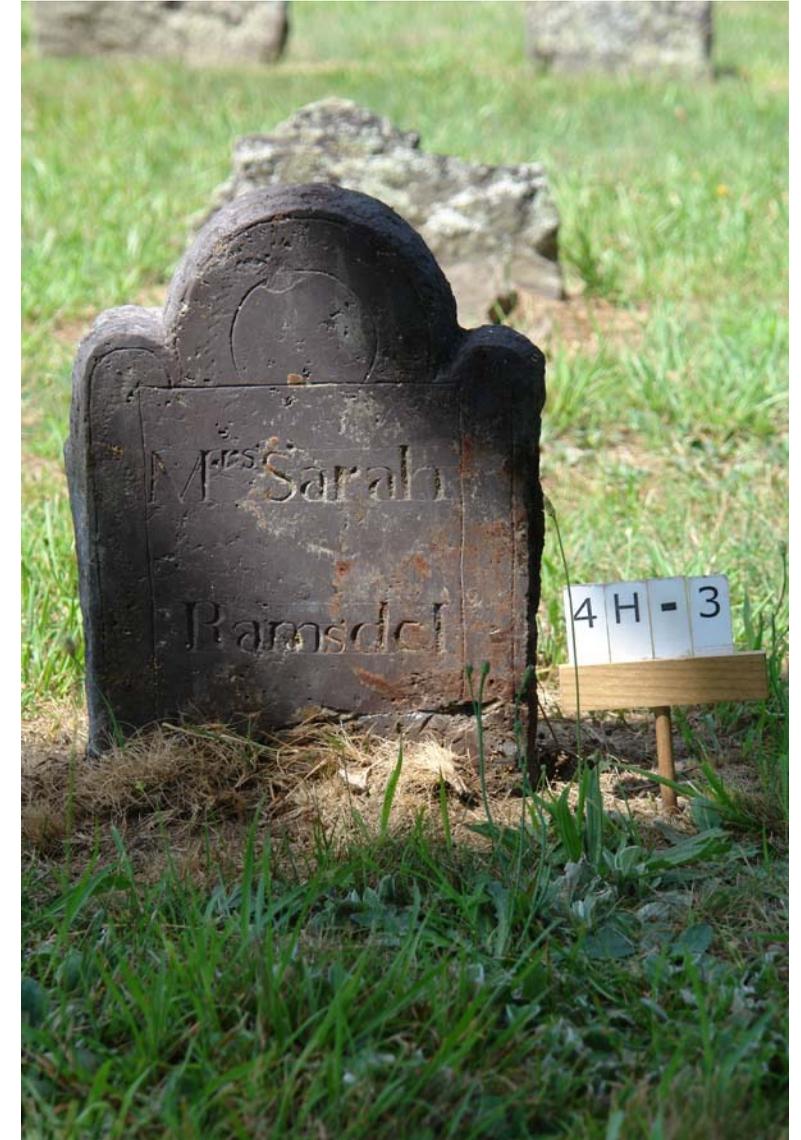
Condition  
6/14/2012

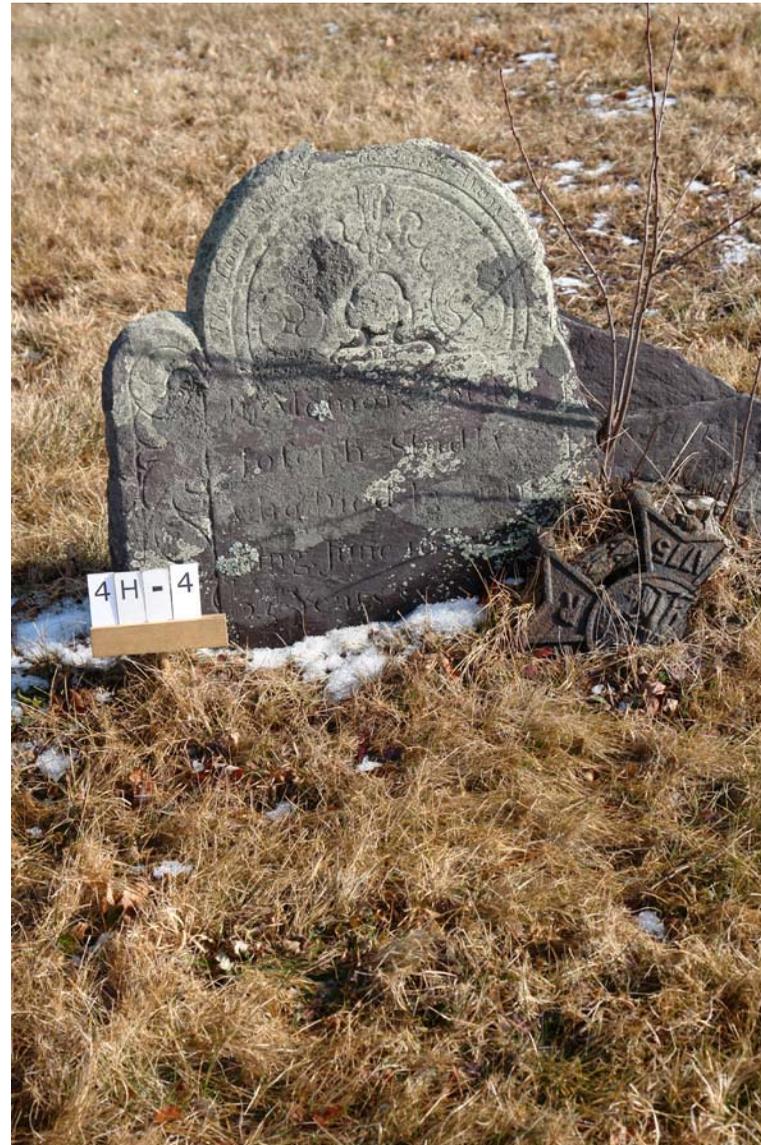
Condition of Inscription: Decipherable

Excavate  
Remove stump  
Reset bottom fragment  
Adhesive repair

1. Marker carefully excavated and area probed for missing fragments
2. Small tree stump removed.
3. Lower fragment reset plumb and aligned with adjacent markers.
4. Any failed adhesives or mortar removed.
5. Surfaces of fragment(s) treated with D/2 biological solution and scrubbed with nylon brushes, then rinsed with water.
6. Fragment(s) attached with structural adhesive, and braced until cured.
7. Cracks and losses filled with RepliCal and Jahn products, misted and wrapped min. 3 days.
8. After partial cure, any excess fill material on adjacent surfaces was treated with acetic acid, brushed, and fully rinsed with water.

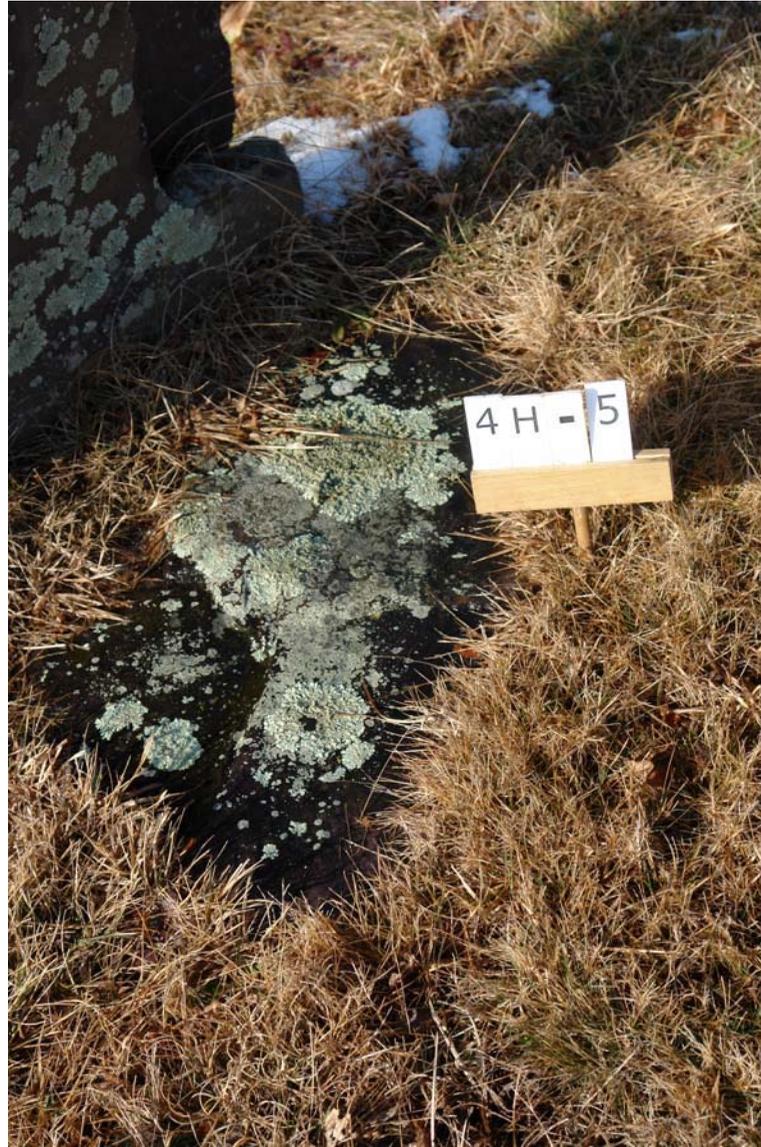
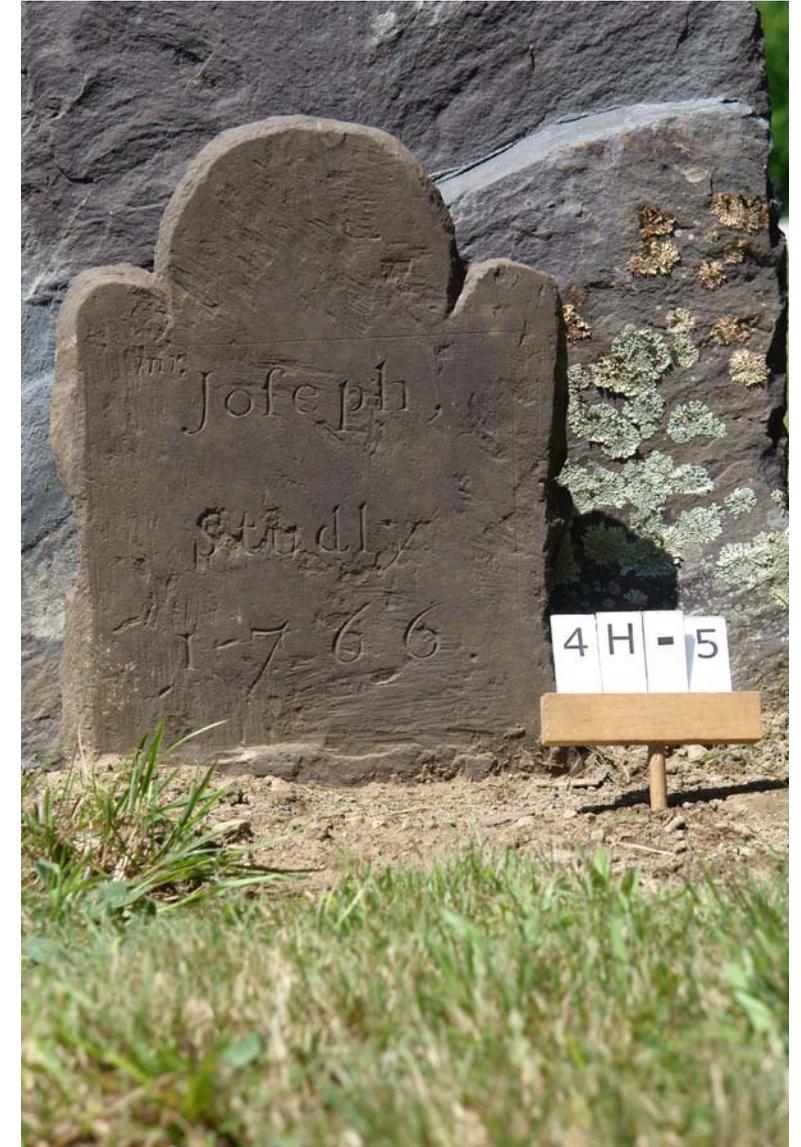
Condition of Inscription: **n.a.**

1. Setting area excavated to sufficient depth and stone re-set plumb at appropriate height and level onto gravel bed, aligned with adjacent markers.
2. Area backfilled around marker with tamped sand and gravel.
3. Disturbed areas re-graded with existing topsoil and sod.

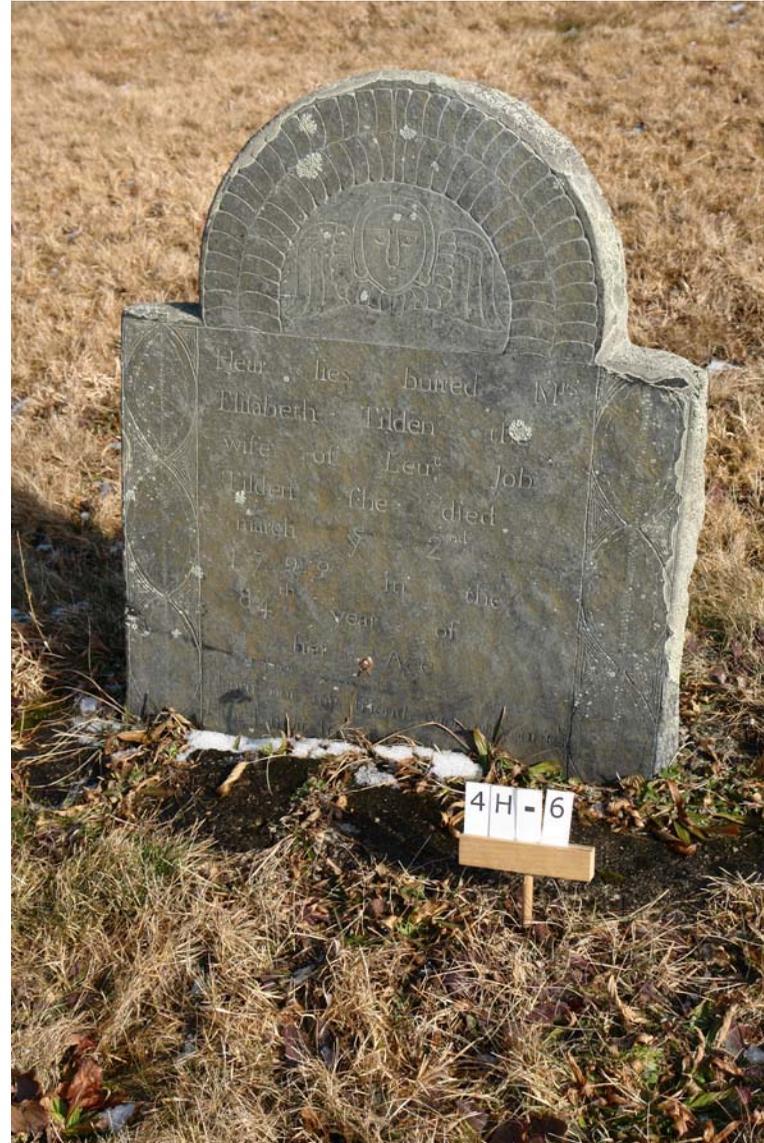
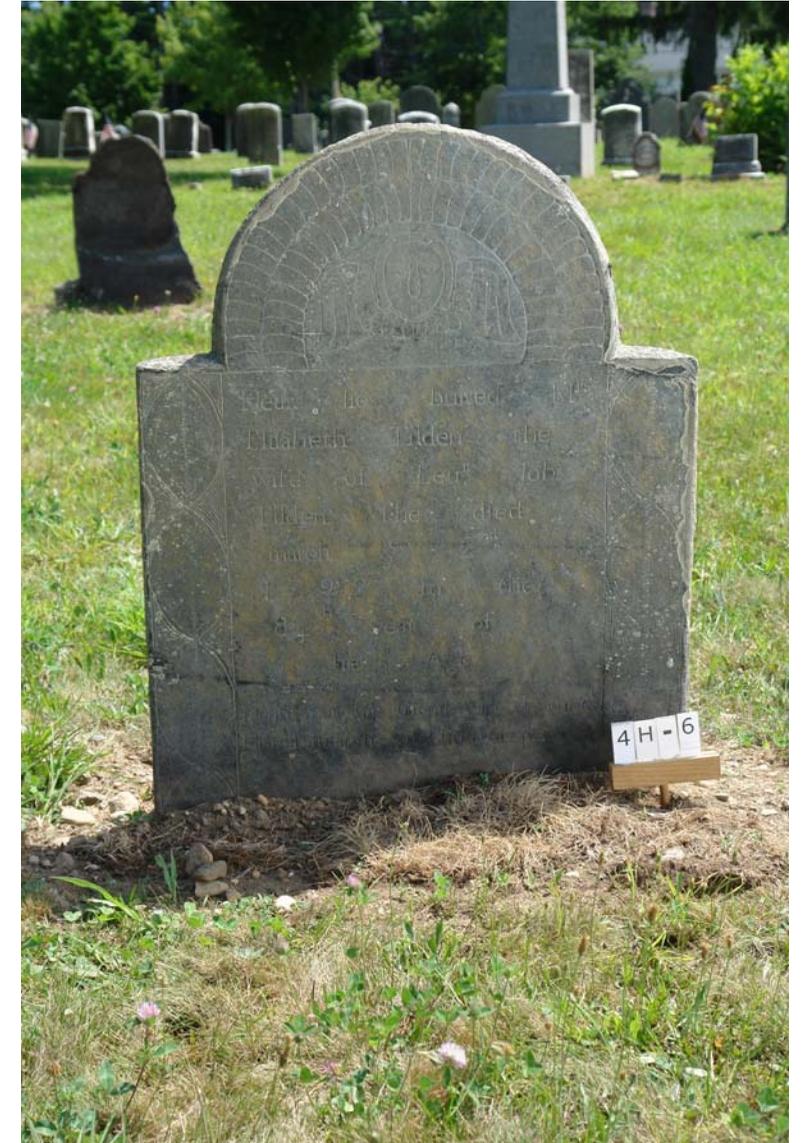
Sunken  
Below grade fracture  
Old conc. base

1. Setting area excavated, no additional fragments or base discovered.
2. A new below grade concrete base cast in place. After partial curing, setting forms were removed and the base backfilled with tamped sand or gravel.
3. When required, lower edge of marker re-squared with minimal loss using a power grinder.
4. Marker reset plumb and level into slot using a cement/lime grout. Braced for min. 5 days.
5. Disturbed areas re-graded with existing topsoil and sod.
6. Surfaces treated with D/2, scrubbed with nylon bristles and fully rinsed with water.

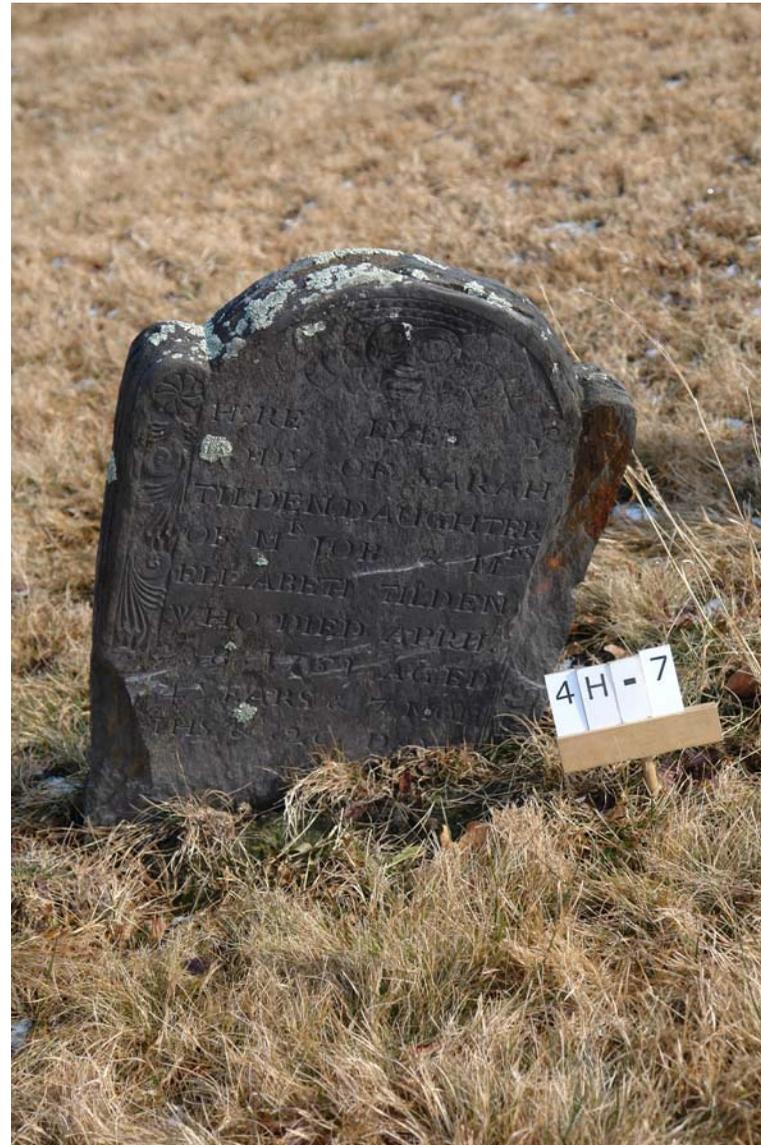
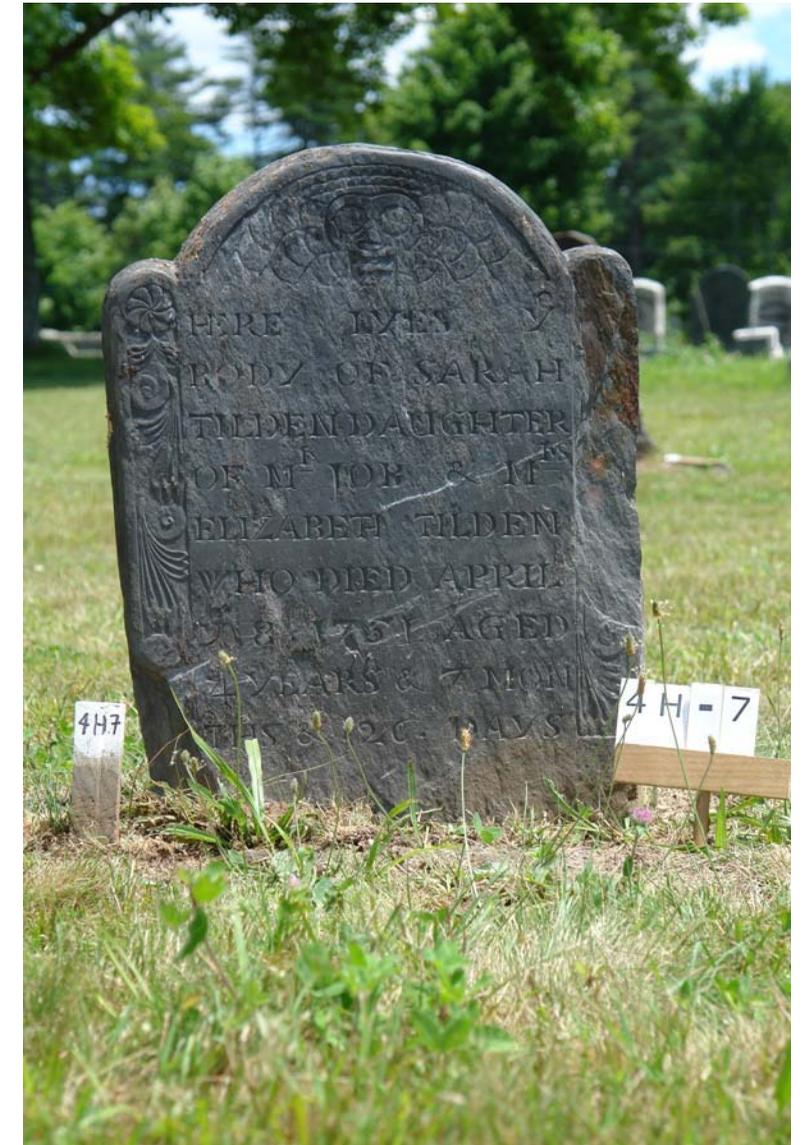
Condition of Inscription: Decipherable

1. Marker carefully excavated. Soil around tilted marker removed to an appropriate depth. When required, marker is removed from the ground. Marker appears to be sound.
2. Soling removed by light brushing with nylon brushes and water.
3. Setting area excavated to sufficient depth and stone re-set plumb at appropriate height and level onto gravel bed, aligned with adjacent markers.
4. Area backfilled around marker with tamped sand and gravel.
5. Disturbed areas re-graded with existing topsoil and sod.
6. Surfaces treated with D/2 biological solution, scrubbed with nylon bristles and fully rinsed with water.
7. All voids caused by splitting or delaminations at top edge of marker filled with a pigmented Sto crack fill. Excess material immediately removed with a damp sponge.  
Voids along sides of monument left open to allow escape of any accumulation of water

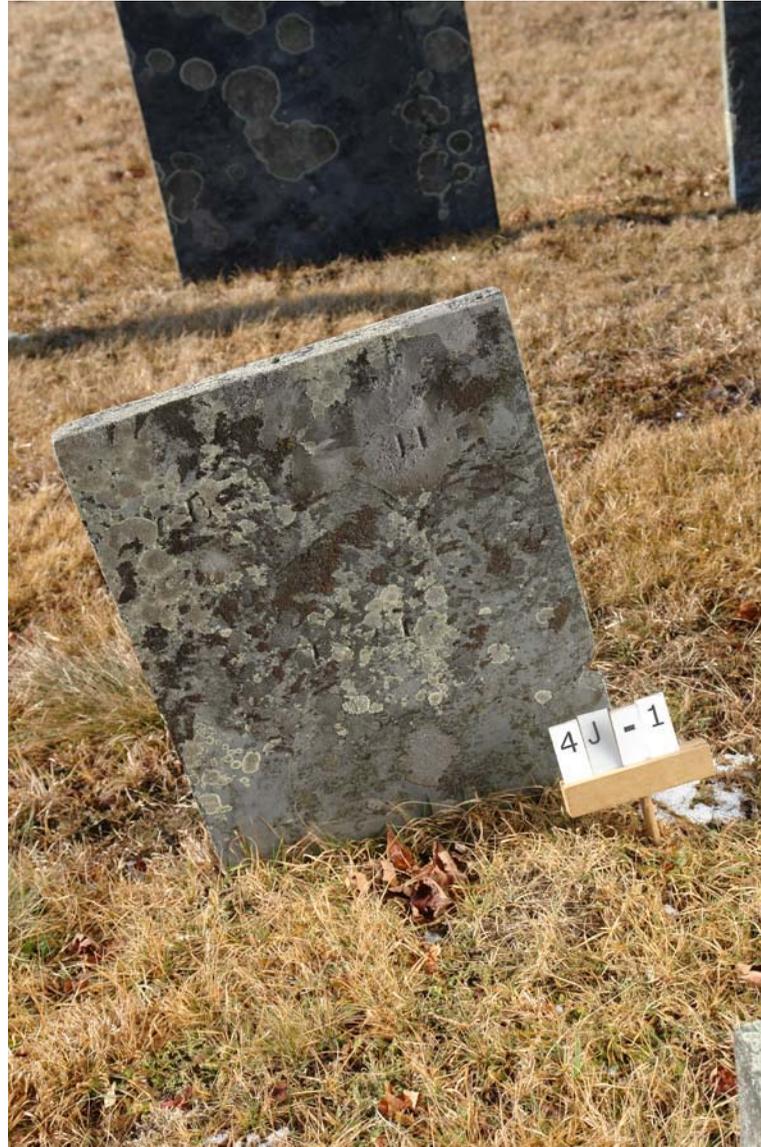
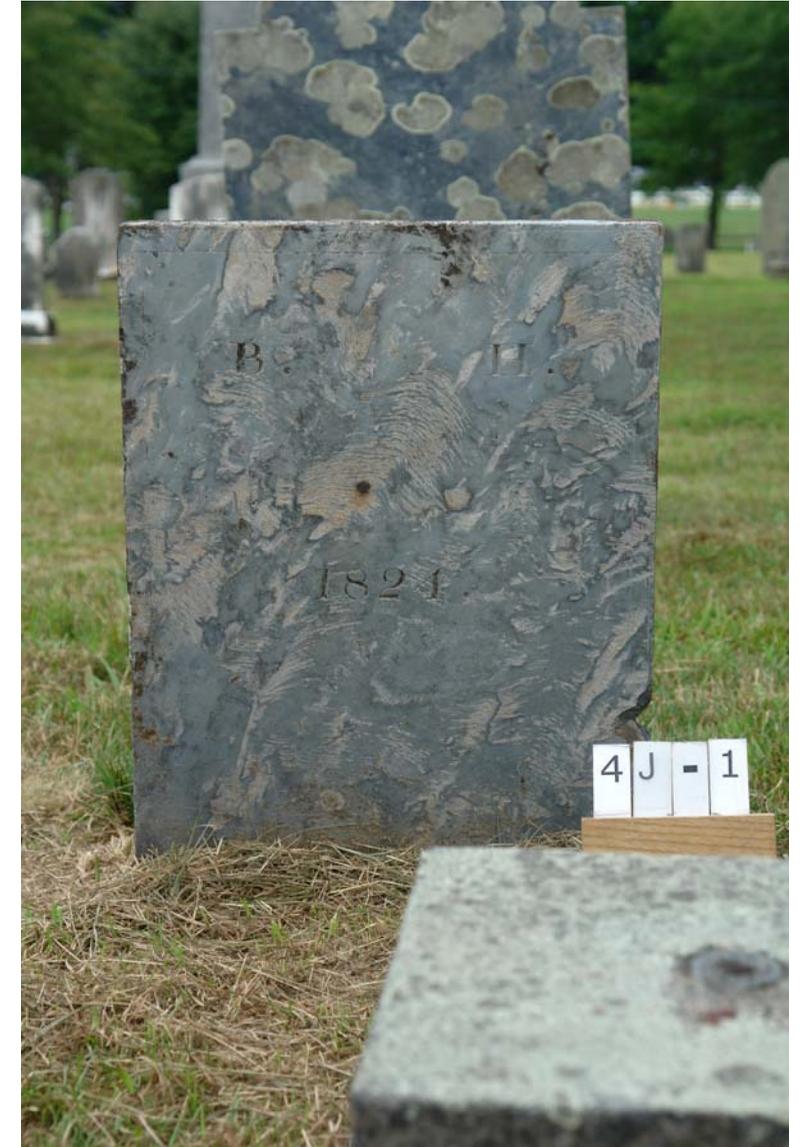
Condition of Inscription: Decipherable

1. Marker carefully excavated. Soil around tilted marker removed to an appropriate depth. Marker appears to be sound.
2. When required, marker is removed from the ground.
3. Surface soiling removed by light brushing with nylon brushes and water.
4. When setting area is excavated to sufficient depth stone is re-set plumb and level onto gravel bed, aligned with adjacent markers.
5. Area backfilled around marker with tamped sand and gravel.
6. Disturbed areas re-graded with existing topsoil and sod.
7. Surfaces treated with D/2 biological solution, scrubbed with nylon bristles and fully rinsed with water.

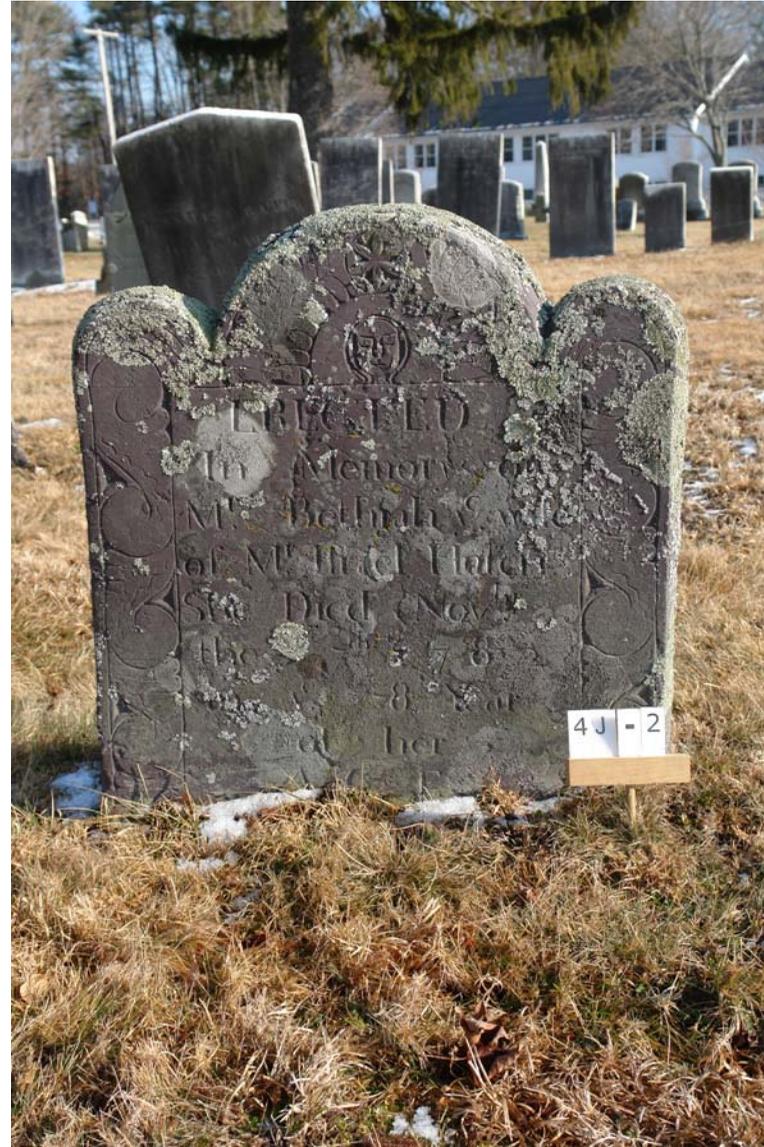
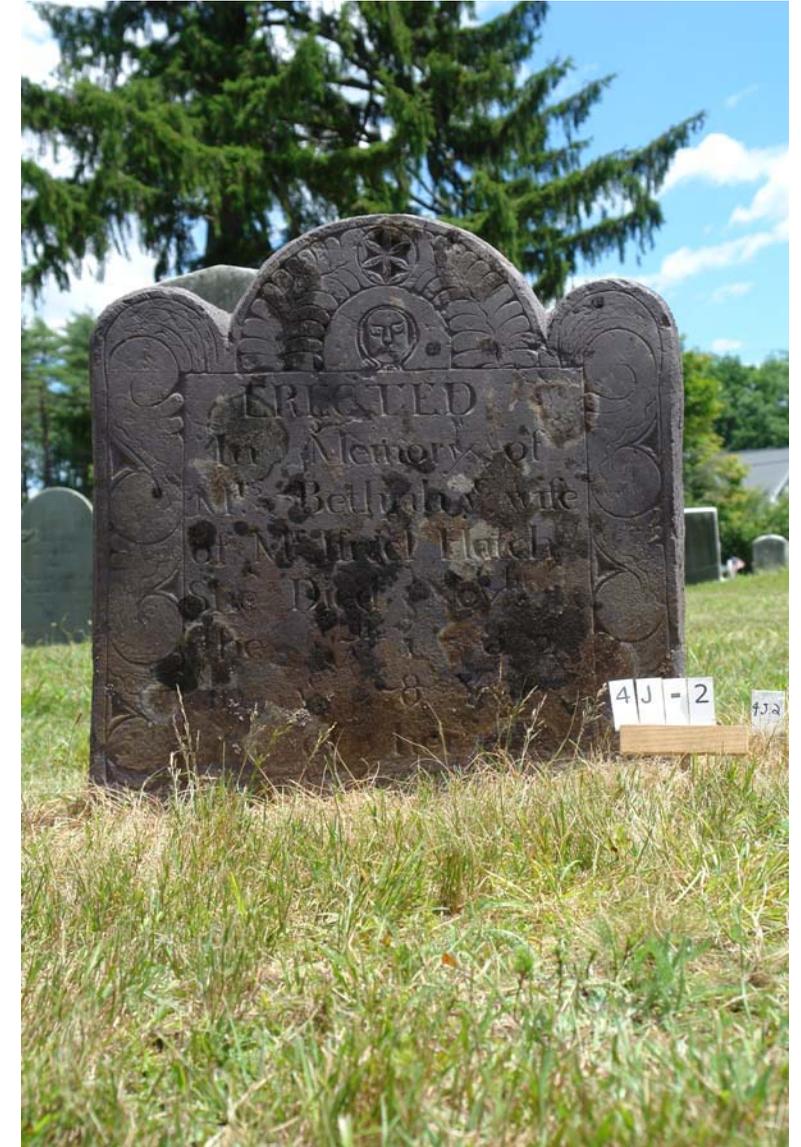
Condition of Inscription: Decipherable

1. Surfaces treated with D/2 biological solution, scrubbed with nylon bristles and fully rinsed with water.
2. Small voids at top filled with pigmented Sto crack fill.
3. Excess material immediately removed with a damp sponge.

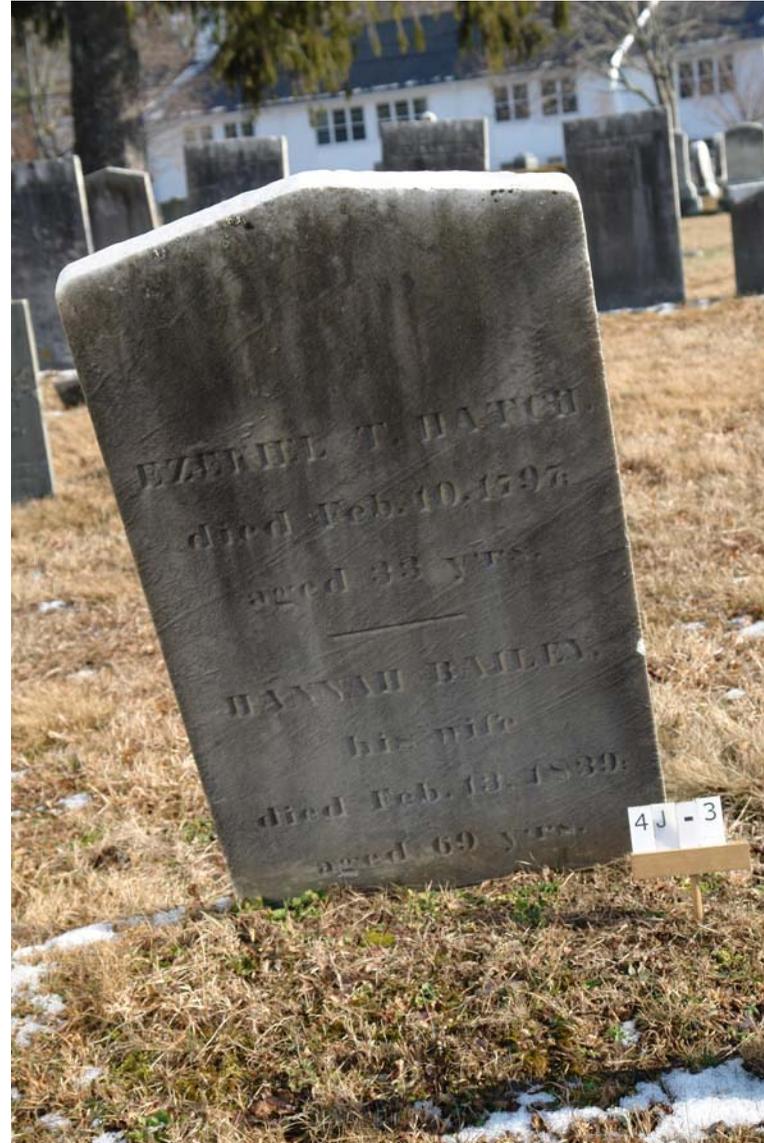
Tilted  
Below grade fracture  
Old conc. base

1. Setting area excavated. During excavation footstone (4J.03.1) was discovered and fractured concrete base.
2. A new below grade concrete base was cast in place. After partial curing, setting forms were removed and the base backfilled with tamped sand or gravel.
3. When required, lower edge of marker re-squared with minimal loss using a power grinder.
4. Marker reset plumb and level into slot using a cement/lime grout. Braced for min. 5 days.
5. Disturbed areas re-graded with existing topsoil and sod.
6. Surfaces treated with D/2, scrubbed with nylon bristles and fully rinsed with water.

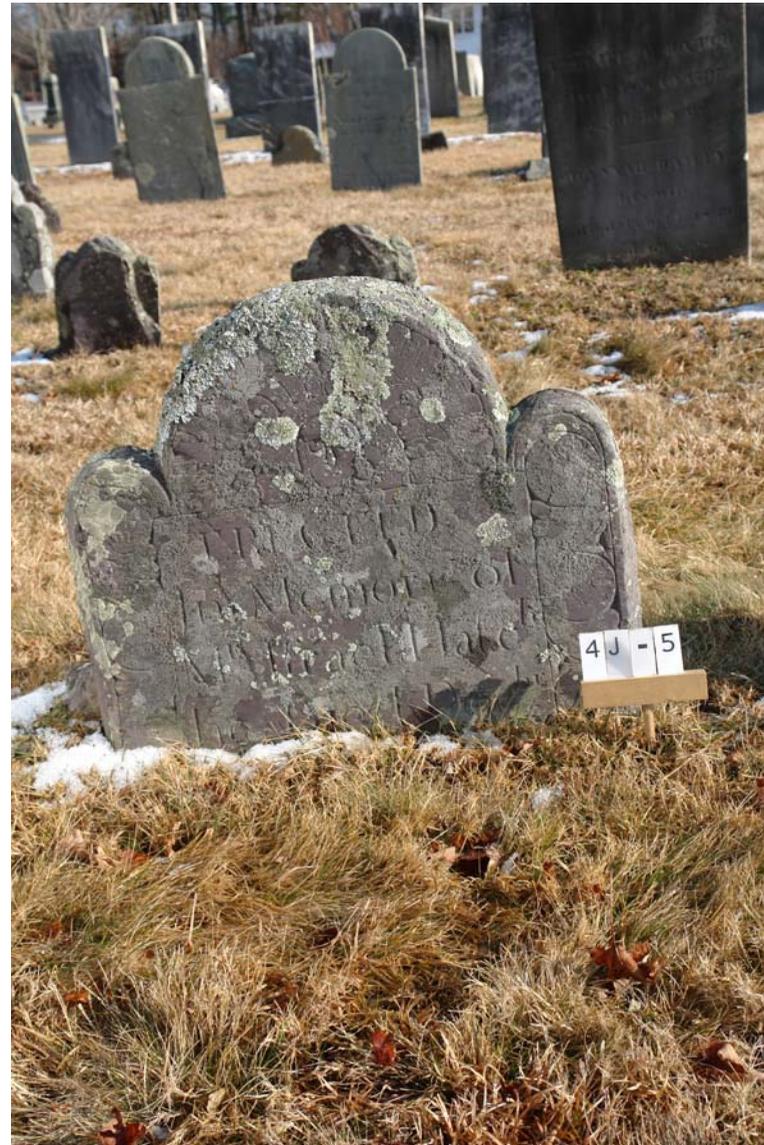
Fractured  
Tilted

1. Fragment(s) excavated and area probed for missing pieces
2. Any failed adhesives or mortar removed.
2. Surfaces of fragment(s) treated with D/2 biological solution and scrubbed with nylon brushes, then rinsed with water.
4. Lower fragment reset plumb at appropriate height, aligned with adjacent markers.
5. Fragment(s) attached with structural adhesive, and braced until cured.
6. Cracks and losses filled with RepliCal and Jahn products, misted and wrapped min. 3 days.
7. After partial cure, any excess fill material on adjacent surfaces treated with acetic acid, brushed, and fully rinsed with water.

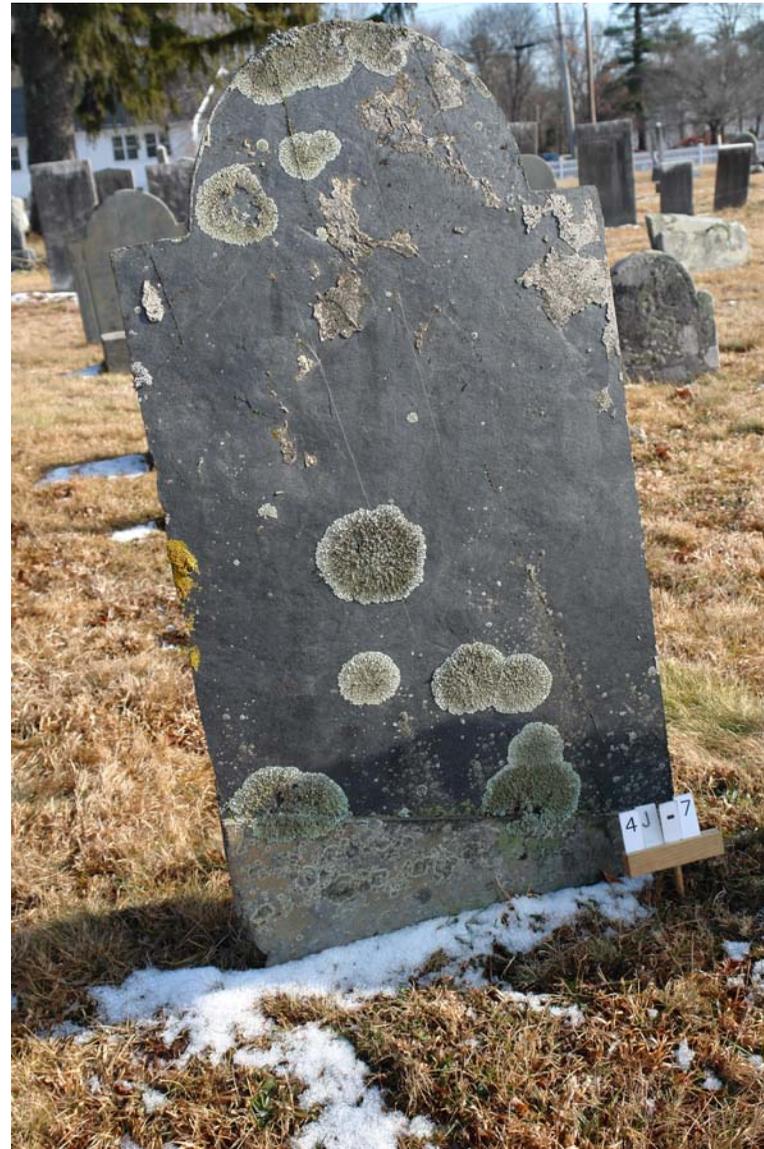
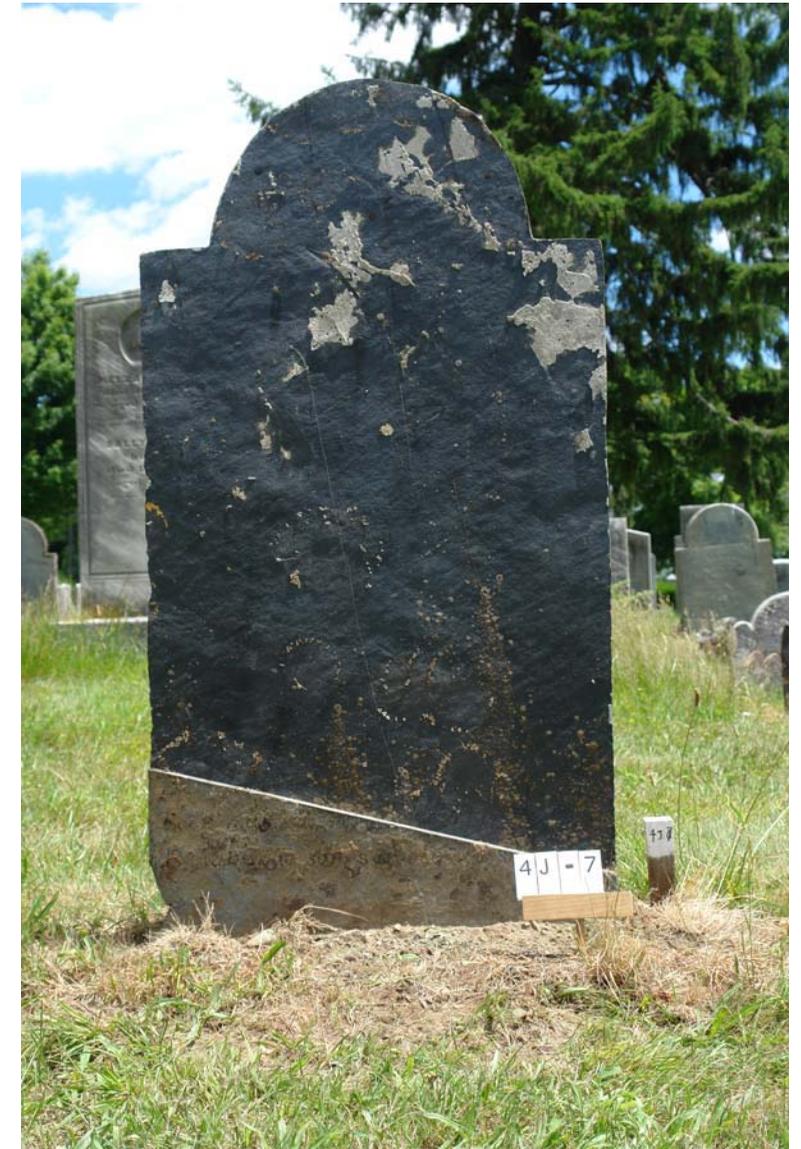
Face fragment was not found.

1. Marker carefully excavated. Soil around tilted marker removed to an appropriate depth. Marker appears to be sound.
2. When required, marker is removed from the ground.
3. Surface soiling removed by light brushing with nylon brushes and water.
4. When setting area is excavated to sufficient depth stone is re-set plumb and level onto gravel bed, aligned with adjacent markers.
5. Area backfilled around marker with tamped sand and gravel.
6. Disturbed areas re-graded with existing topsoil and sod.

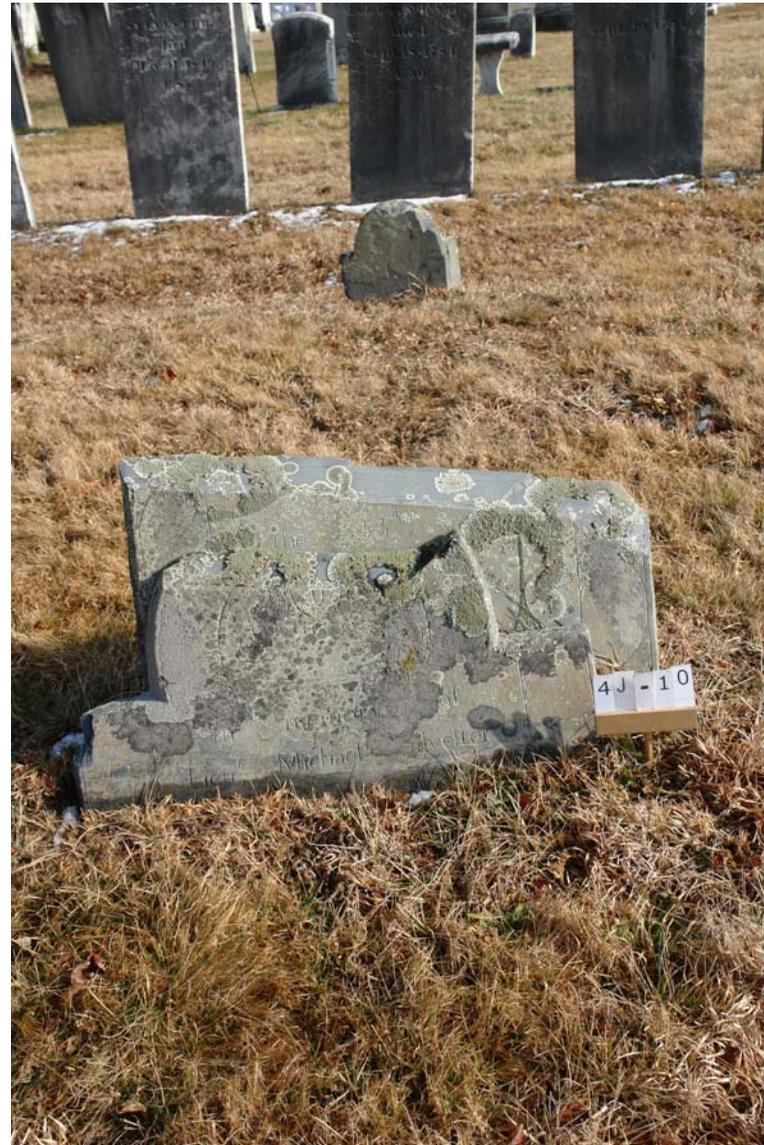
Fractured  
Tilted

Reset lower fragment  
Adhesive repair

1. Fragment(s) excavated and area probed for missing pieces. Top fragment was not found.
2. Any failed adhesives or mortar removed.
3. Mating surfaces of fragment(s) treated with D/2 biological solution and scrubbed with nylon brushes, then rinsed with water.
4. Bottom fragment reset plumb at appropriate height, aligned with adjacent markers
5. Fragment(s) attached with structural adhesive, and braced until cured.
6. Cracks and losses filled with RepliCal and Jahn products, misted and wrapped min. 3 days.
7. After partial cure, any excess fill material on adjacent surfaces treated with acetic acid, brushed, and fully rinsed with water.

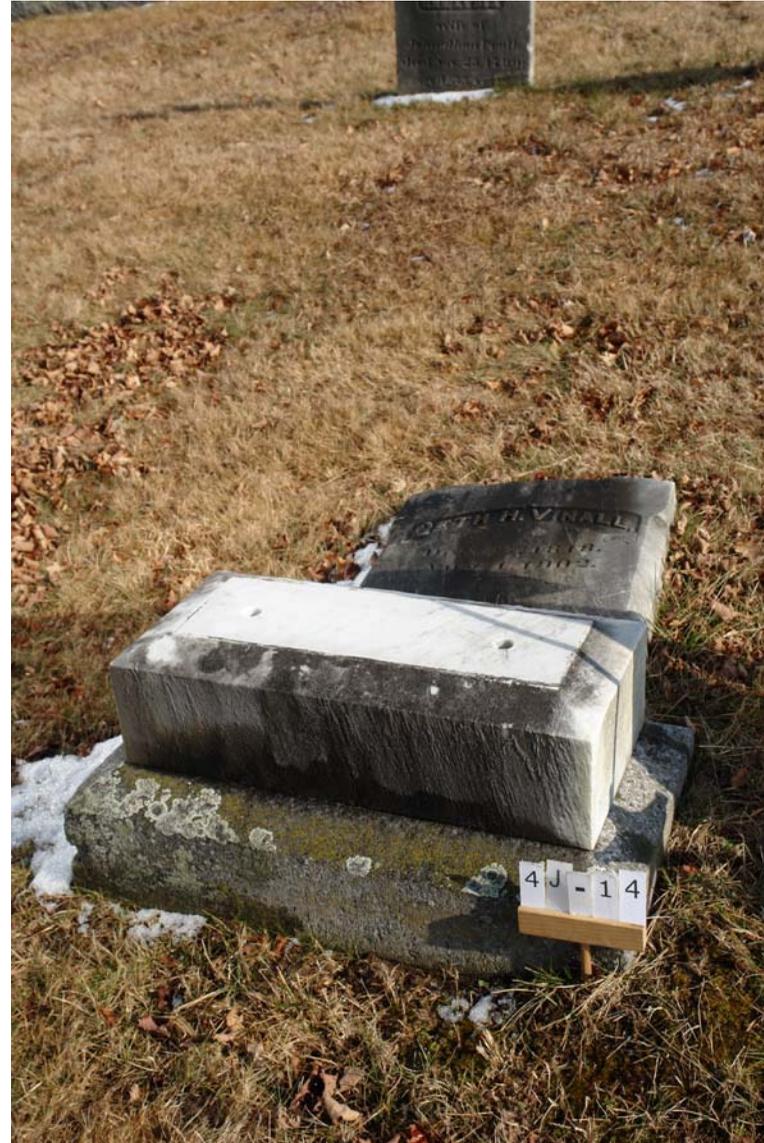
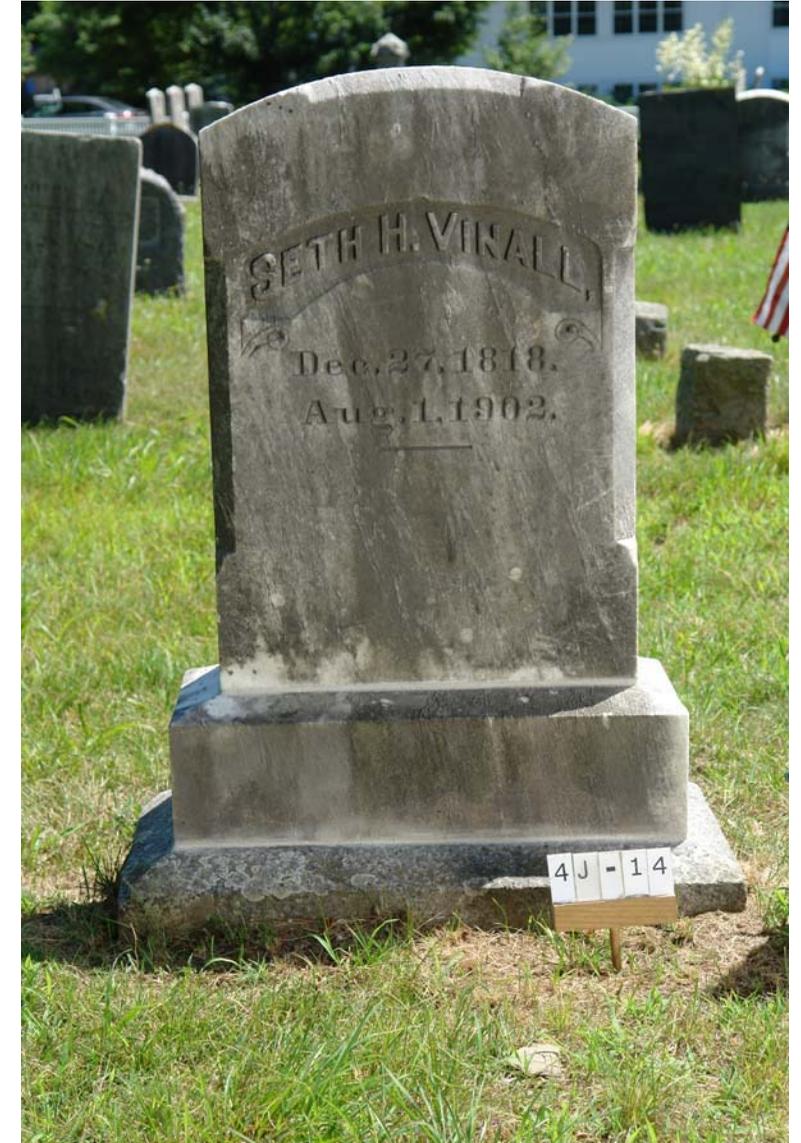
Fallen  
Loose on base

1. Area around bottom base excavated and unit set level.
2. Existing failed mortar and setting materials removed with hand tools.
3. Base reset onto bottom base using a cement/lime grout, joint areas cleaned.
4. When required, existing pins replaced with 4" stainless steel threaded pins set into mortar.
5. Marker reset onto base using a cement/lime grout, joint areas cleaned.
