STONE CONSERVATION TREATMENTS

Hanover Center Cemetery, Hanover, MA

July, 2012

Documentation of Restorations to Center Cemetery

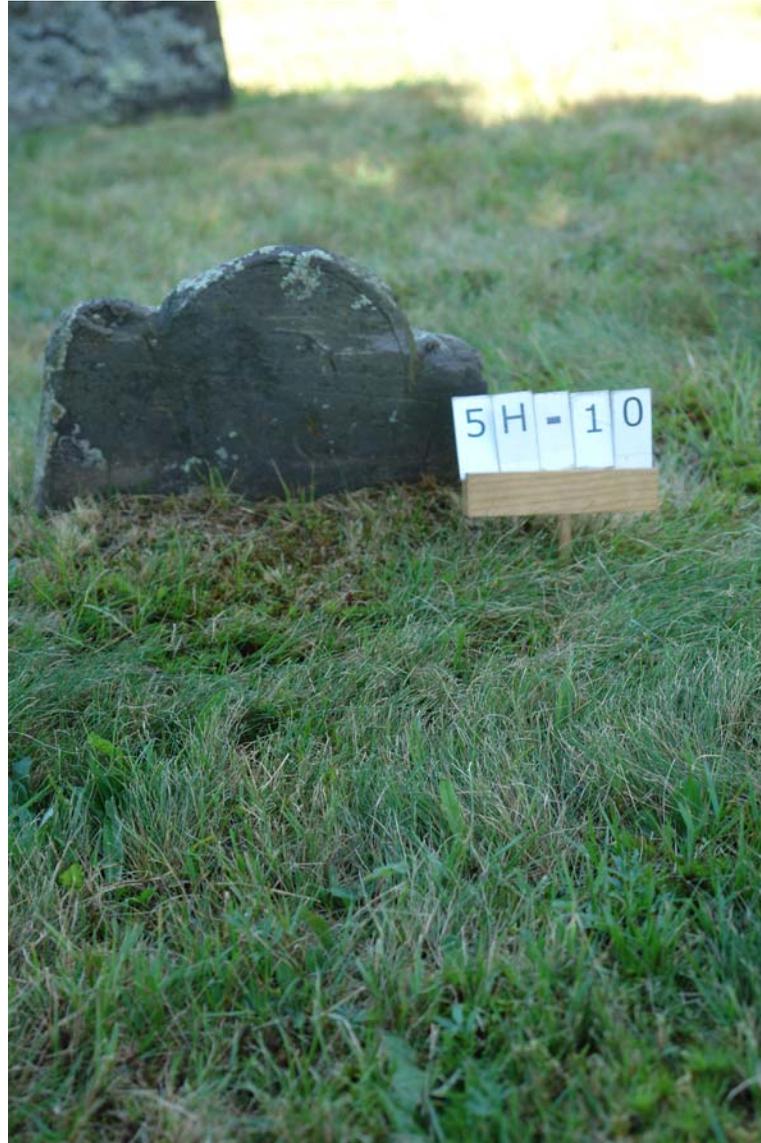
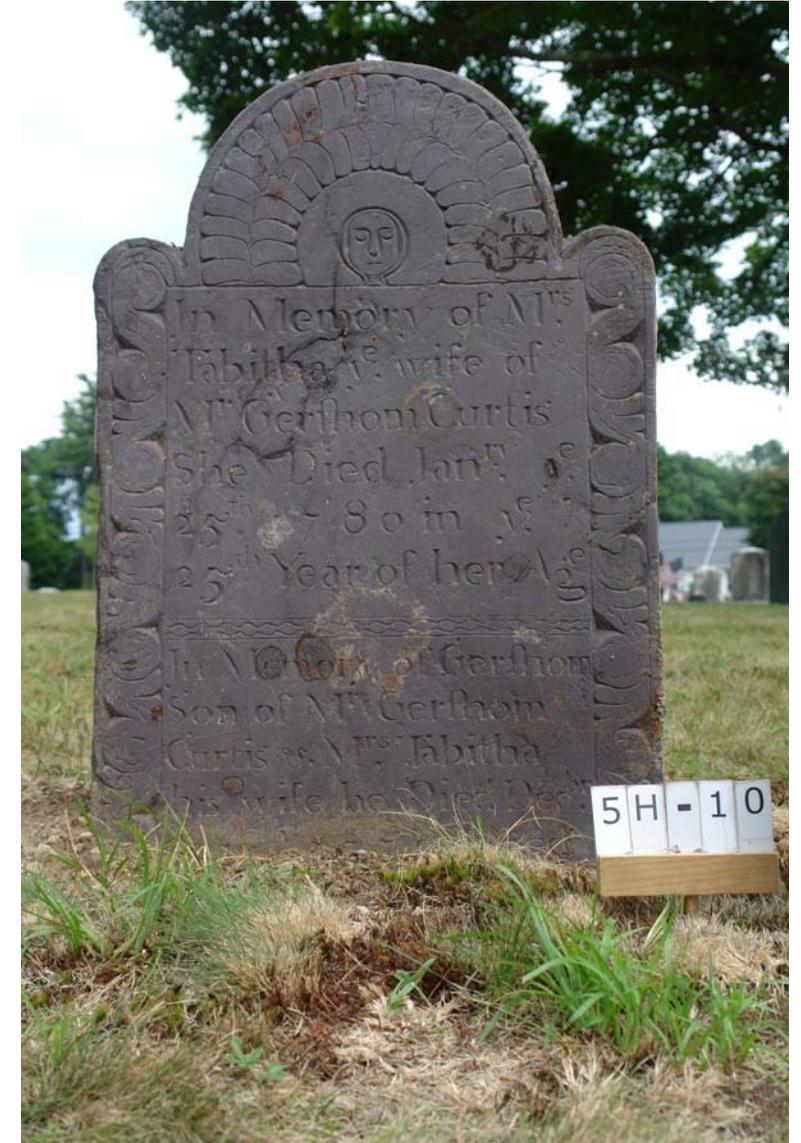
Excavate  
Clean  
Poss new base  
Cap

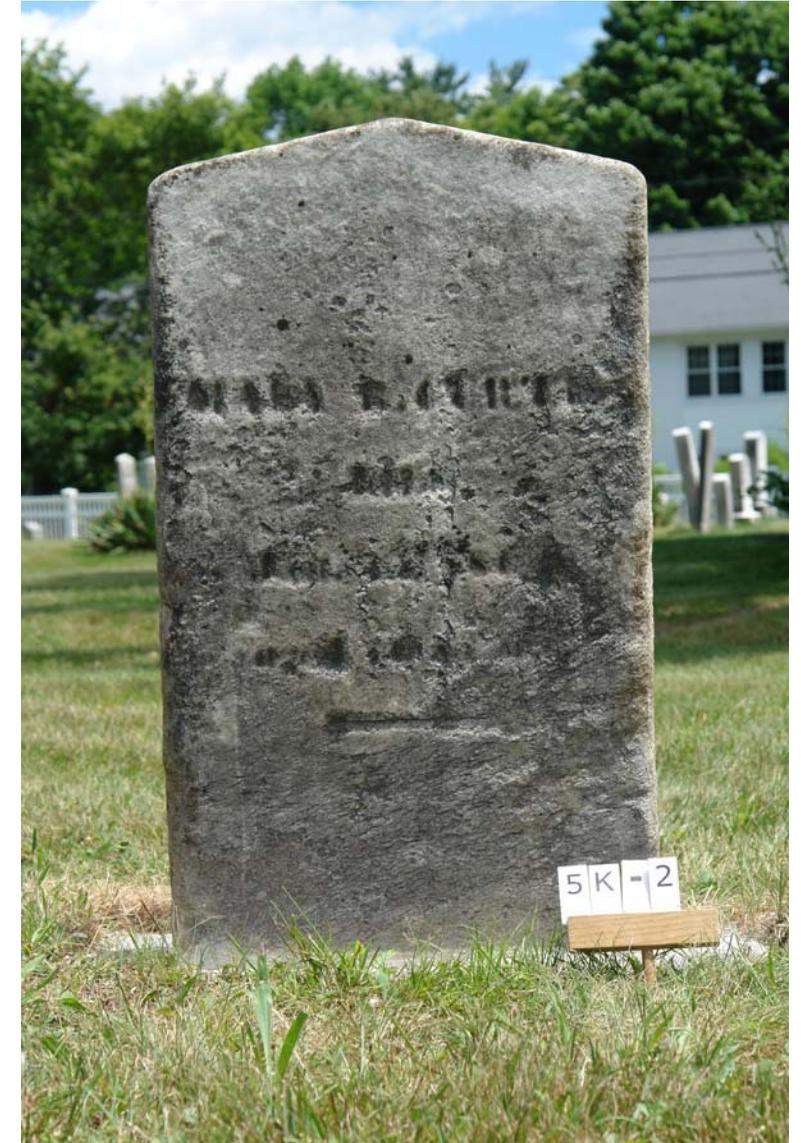
Condition of Inscription: **Partially decipherable** Material: **Marble**

1. Existing base located below grade while excavating for resetting.
2. Base excavated and determined sound and base reset level at appropriate height.
3. Failed setting mortar and/or stone fragments removed from slot, with power tools when required.
3. When required, lower edge of marker re-squared with minimal loss using a power grinder.
4. Marker reset plumb and level into slot using a cement/lime grout. Braced for min. 5 days.
5. Disturbed areas re-graded with existing topsoil and sod.

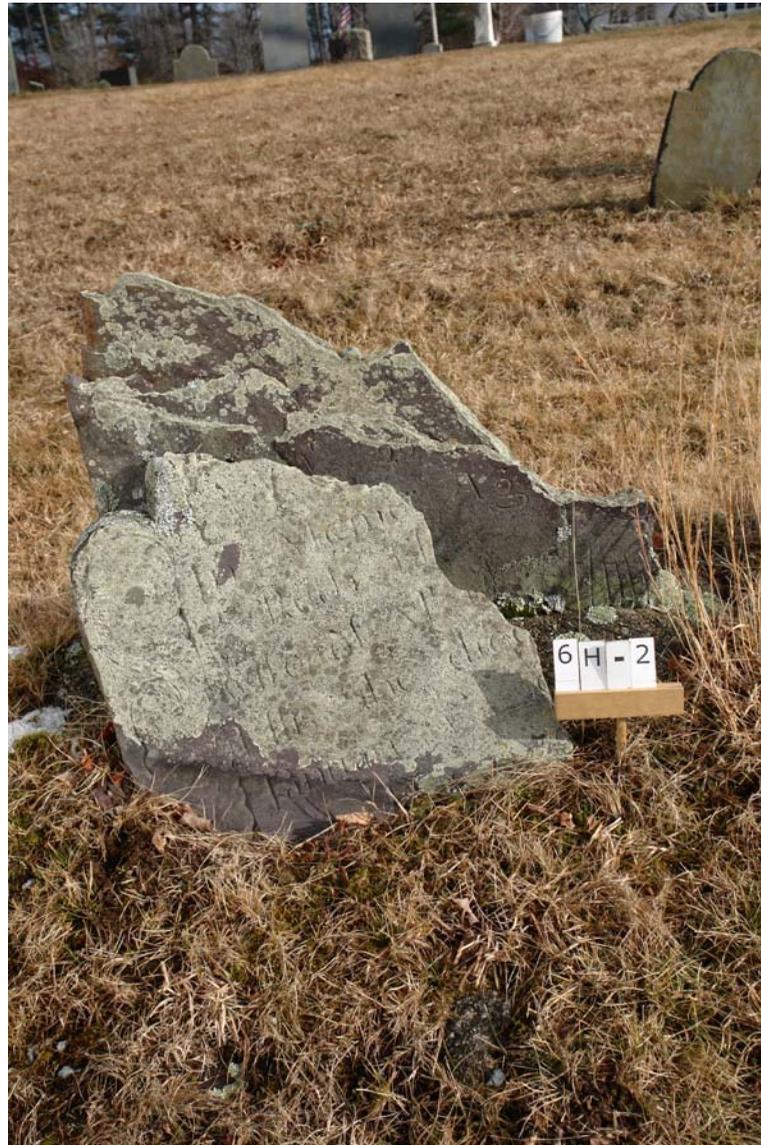
Condition of Inscription: Partially decipherable, missing Material: Slate

Tilted  
Fractured  
Losses

Reset  
Adhesive repair  
Fill losses

1. Fragment(s) excavated and area probed for missing pieces.
2. Lower fragment reset plumb at appropriate height, aligned with adjacent markers.
3. Any failed adhesives or mortar removed.
4. Surfaces of fragment(s) treated with D/2 biological solution and scrubbed with nylon brushes, then rinsed with water.
5. Fragment(s) attached with structural adhesive, and braced until cured.
6. Cracks and losses filled with RepliCal and Jahn products, misted and wrapped min. 3 days.
7. After partial cure, excess fill material on adjacent surfaces was treated with acetic acid, brushed, and fully rinsed with water.

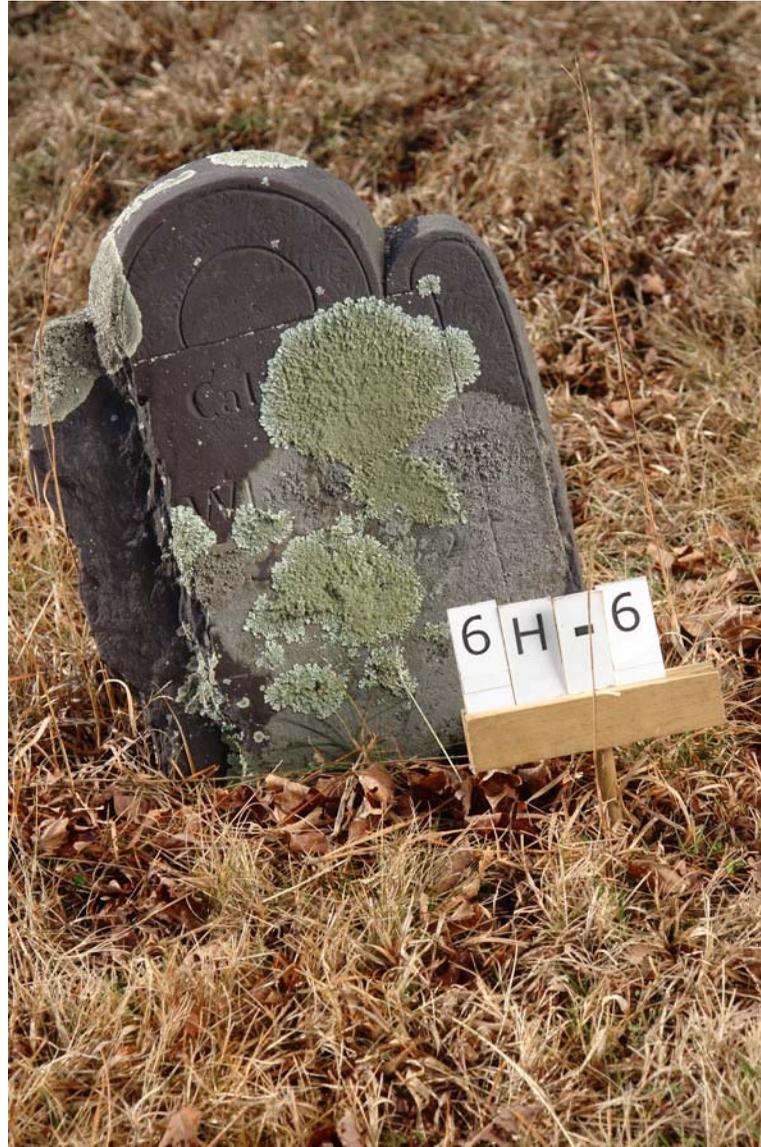
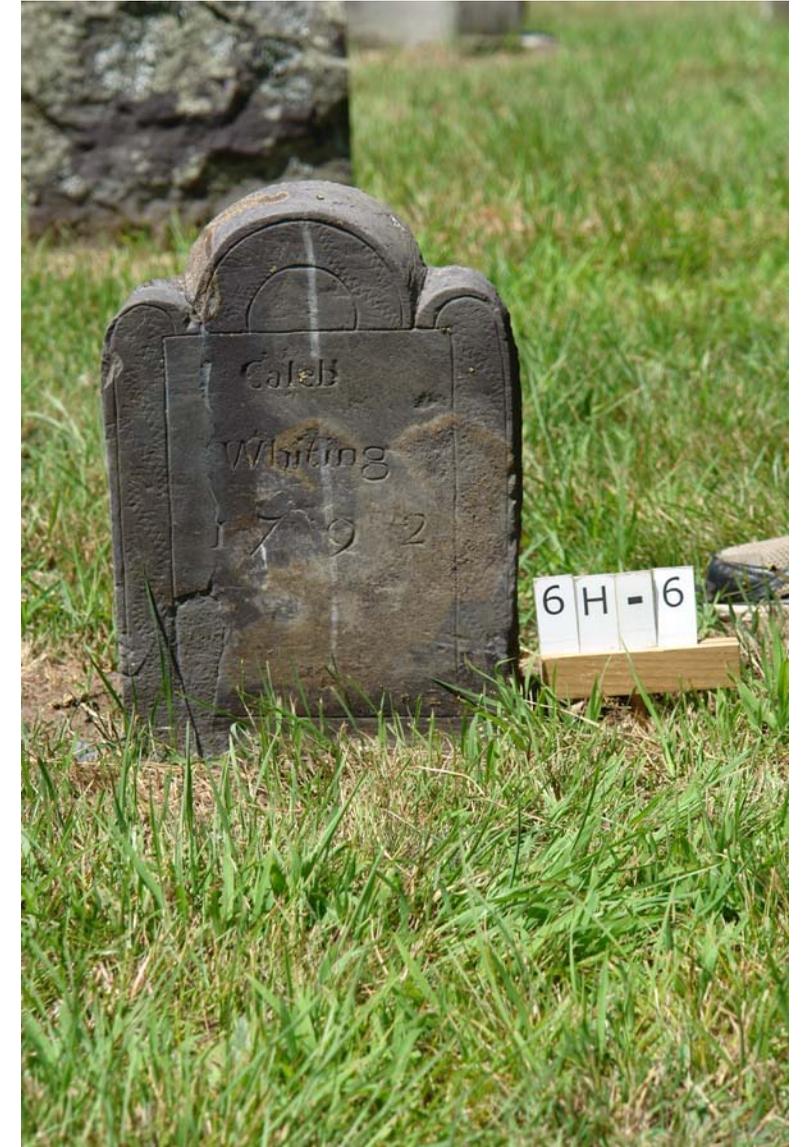
Condition of Inscription: Partially decipherable, missing  
Material: Slate

1. Marker carefully excavated. Soil around tilted marker removed to an appropriate depth. Marker appears to be sound.
2. When required, marker is removed from the ground.
3. Surface soiling removed by light brushing with nylon brushes and water.
4. When setting area is excavated to sufficient depth stone is re-set plumb and level onto gravel bed, aligned with adjacent markers.
5. Area backfilled around marker with tamped sand and gravel.
6. Disturbed areas re-graded with existing topsoil and sod.
7. Surfaces treated with D/2 biological solution, scrubbed with nylon bristles and fully rinsed with water.
8. When excavating, edge fragment found. Fragment cleaned and attached with structural adhesive, then braced until cured.

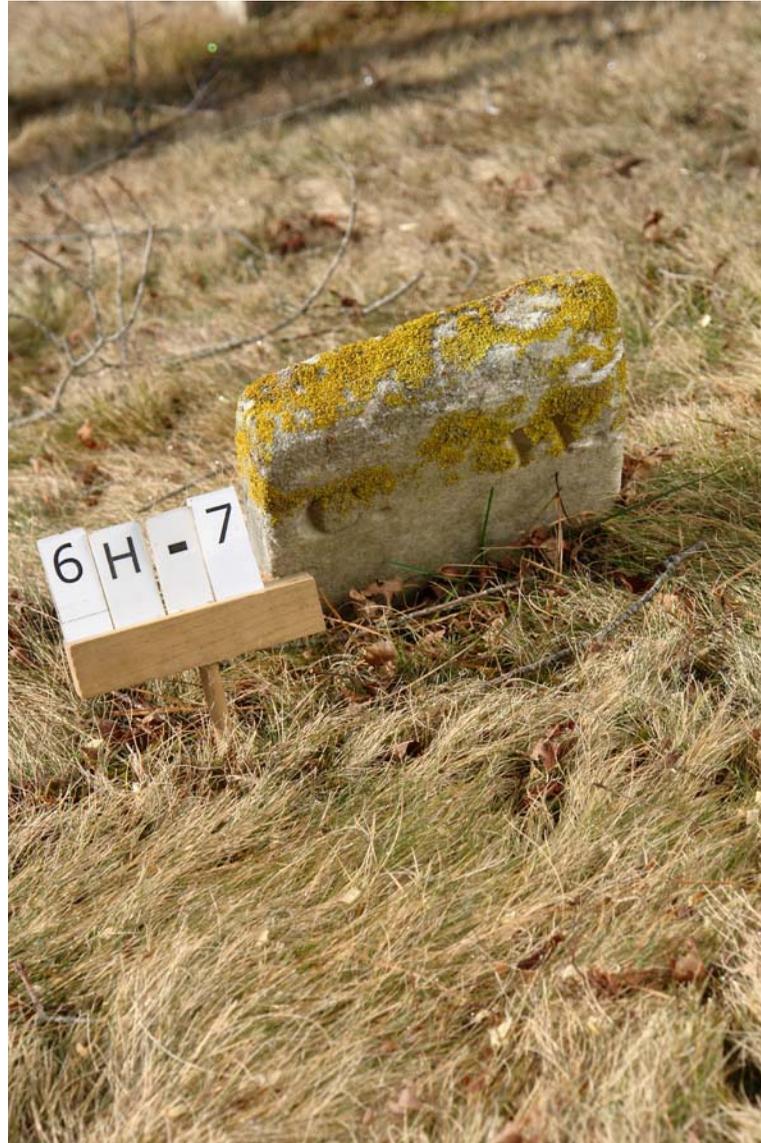
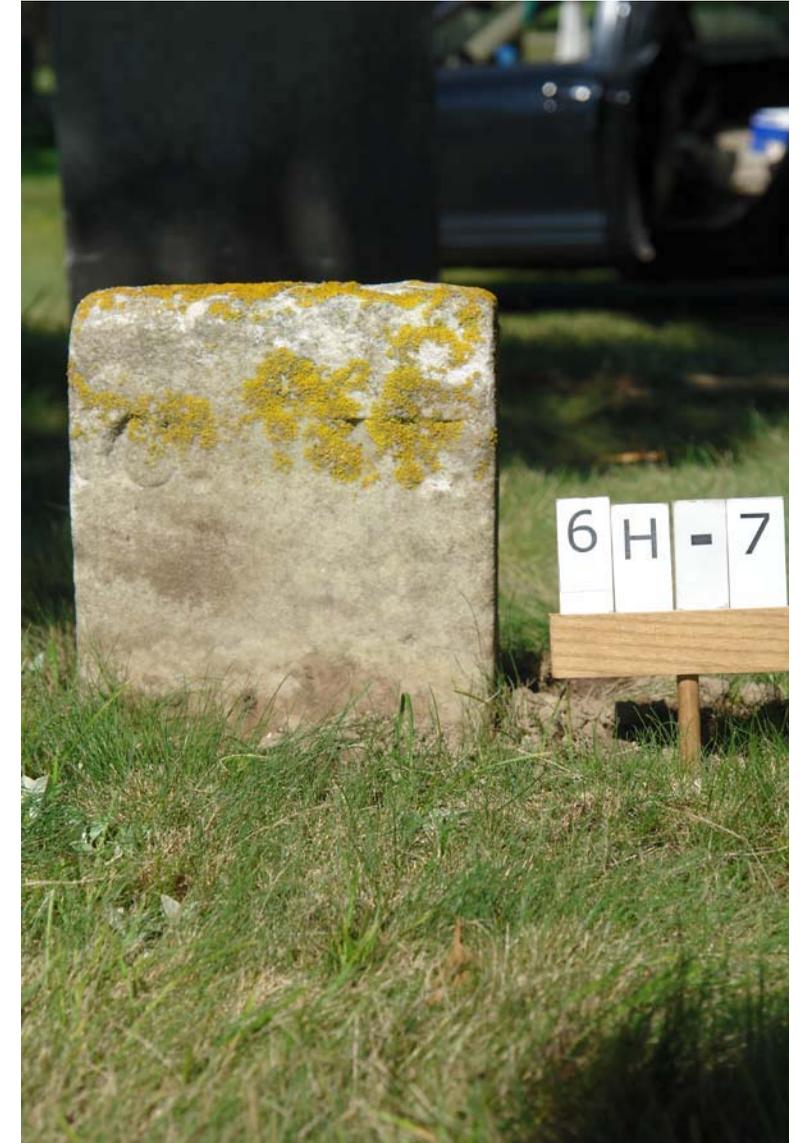
Condition of Inscription: Decipherable

1. Marker carefully excavated. Soil around tilted marker removed to an appropriate depth. Marker appears to be sound.
2. When required, marker is removed from the ground.
3. Surface soiling removed by light brushing with nylon brushes and water.
4. When setting area is excavated to sufficient depth stone is re-set plumb and level onto gravel bed, aligned with adjacent markers.
5. Area backfilled around marker with tamped sand and gravel.
6. Disturbed areas re-graded with existing topsoil and sod.

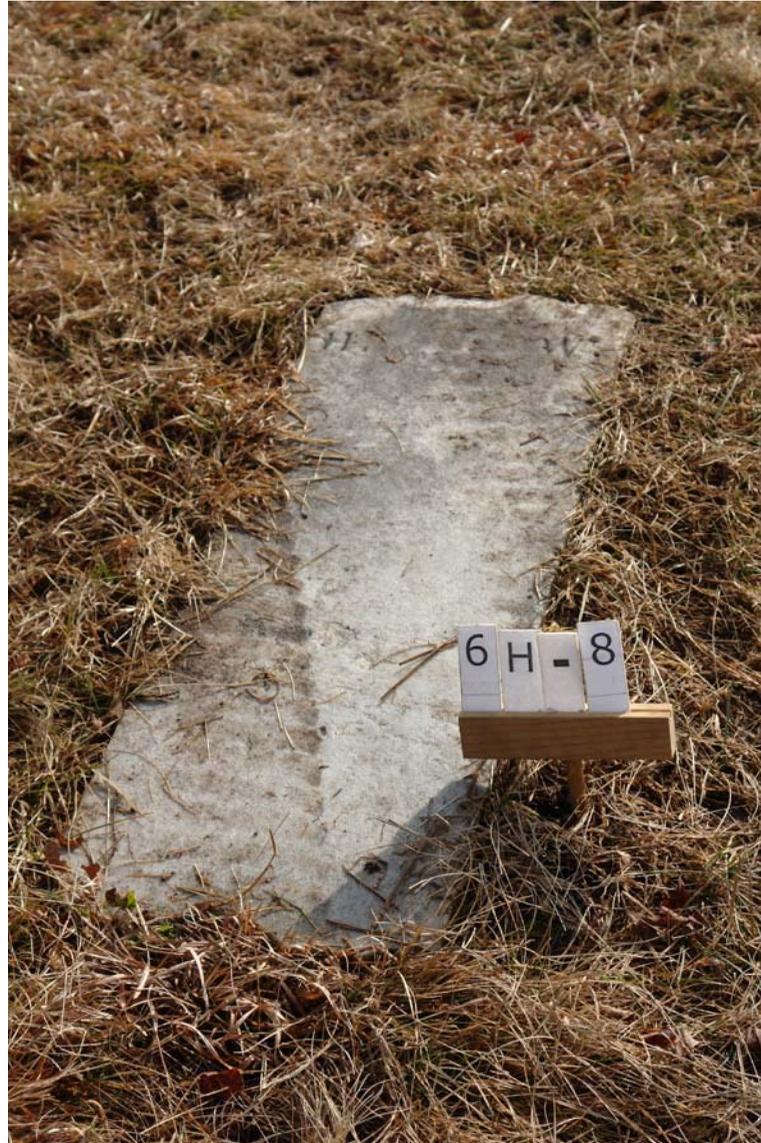
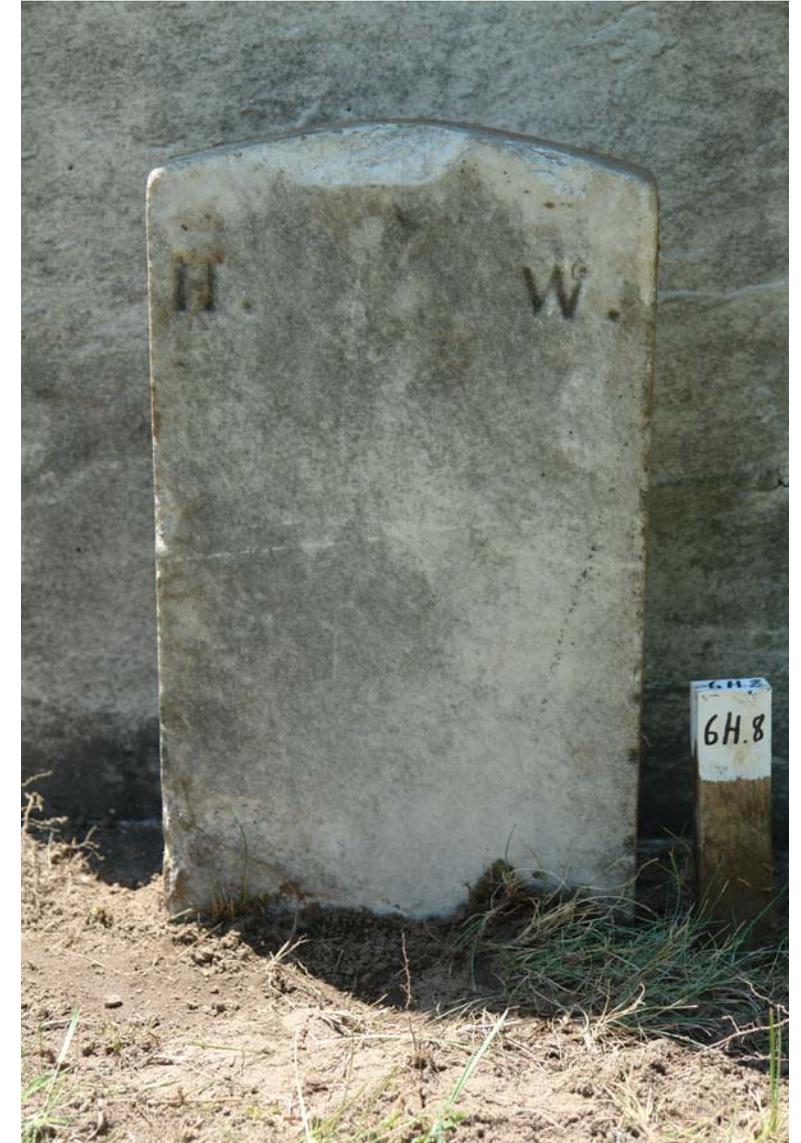
Condition of Inscription: Decipherable

1. Setting area excavated to sufficient depth and stone re-set plumb at appropriate height and level onto gravel bed, aligned with headstone.
2. Area backfilled around footstone with tamped sand and gravel.
3. Disturbed areas re-graded with existing topsoil and sod.

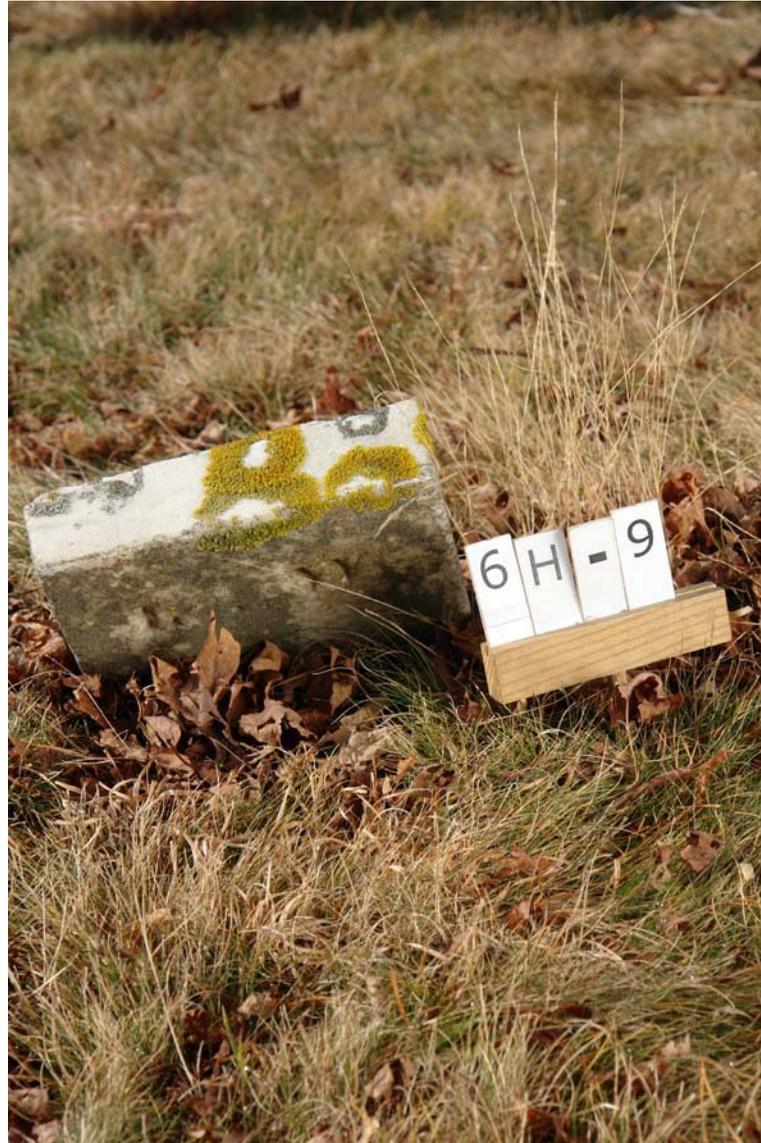
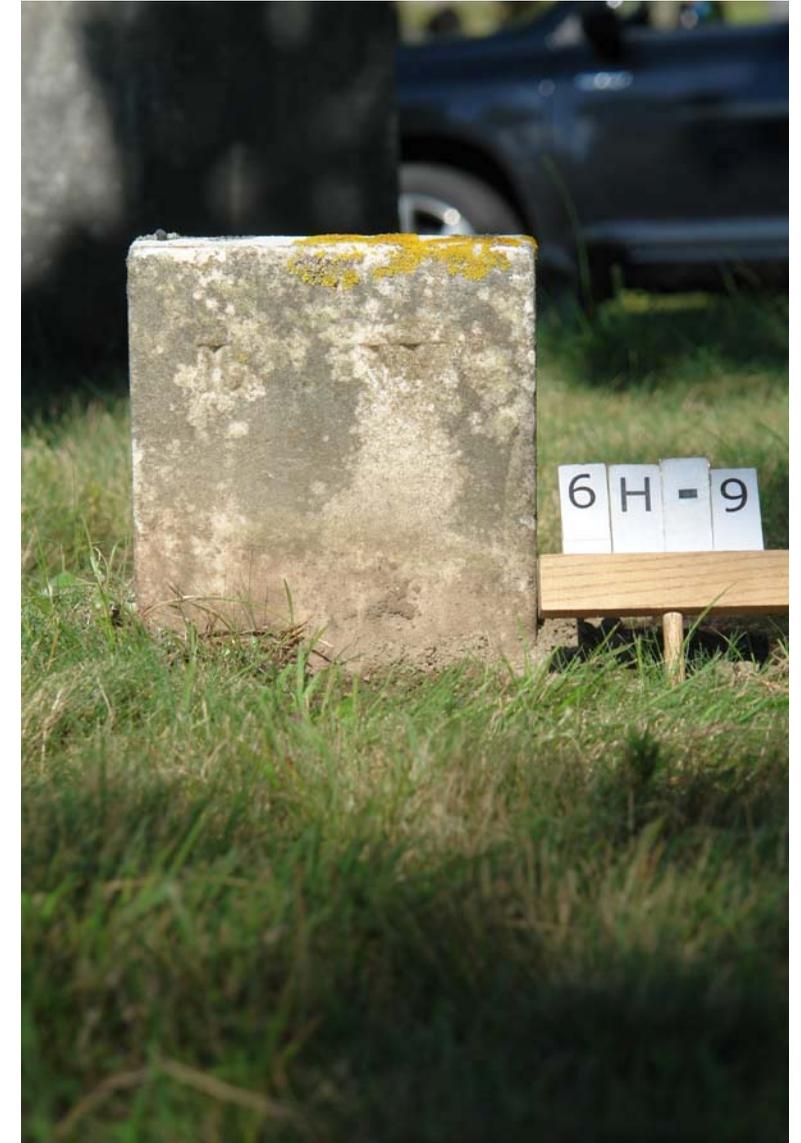
Condition of Inscription: Decipherable Material: Marble

1. Marker carefully excavated. Soil around tilted marker removed to an appropriate depth. Marker appears to be sound.
2. When required, marker is removed from the ground.
3. Surface soiling removed by light brushing with nylon brushes and water.
4. When setting area is excavated to sufficient depth stone is re-set plumb and level onto gravel bed, aligned with adjacent markers.
5. Area backfilled around marker with tamped sand and gravel.
6. Disturbed areas re-graded with existing topsoil and sod.

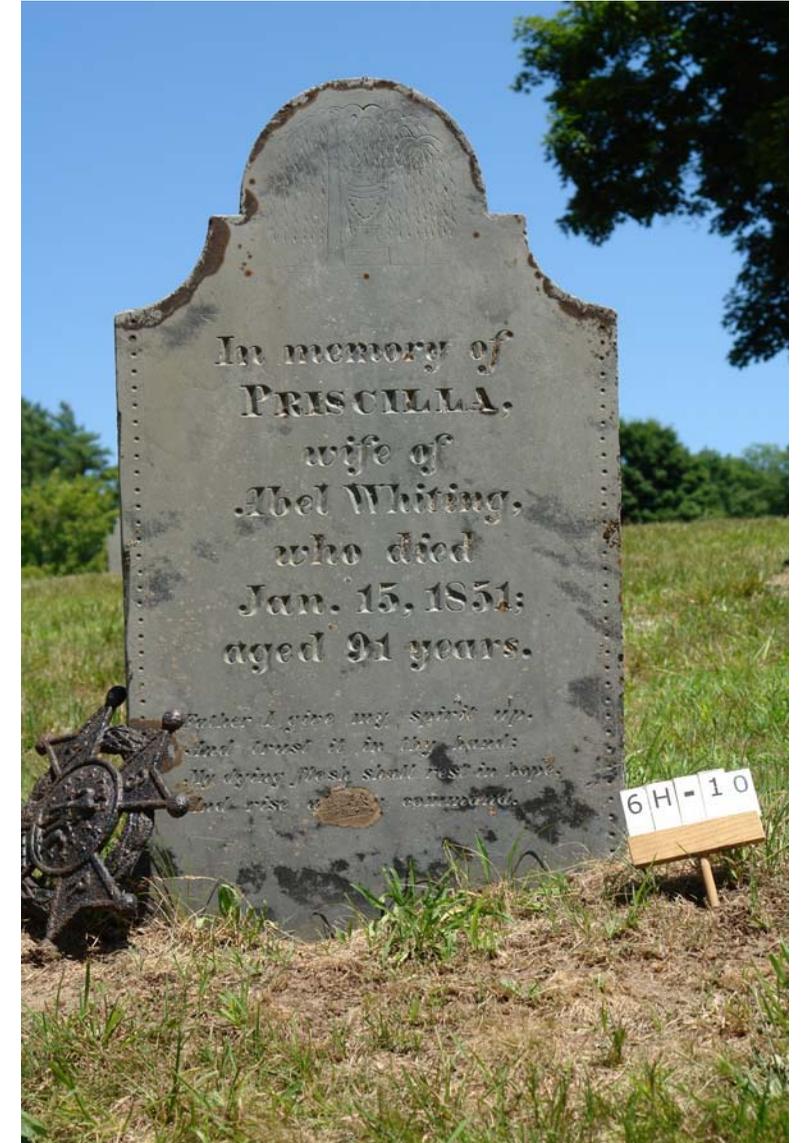
Condition of Inscription: Decipherable

1. Treat surfaces with D/2 biological solution. Loosen any lichens with plastic or wood hand trowels. Brush or spray D/2 and scrub with nylon brushes. Rinse fully with water. Repeat as necessary
2. Flush interior voids with water and remove any loose debris within voids with hand tools.
3. Flush interior of voids with denatured alcohol to aid in drying.
4. After full drying, all voids caused by splitting or delaminations at top edge of marker filled with a pigmented Sto crack fill. Excess material immediately removed with a damp sponge. Voids along sides of monument left open to allow escape of any accumulation of water.

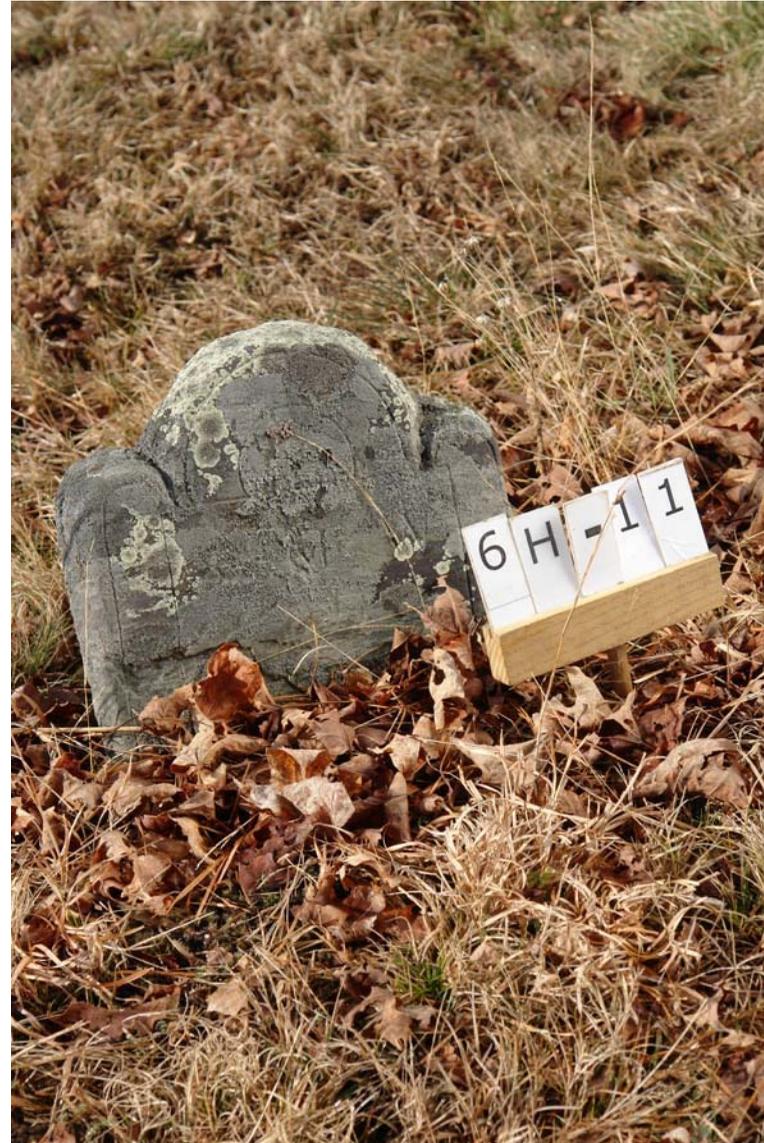
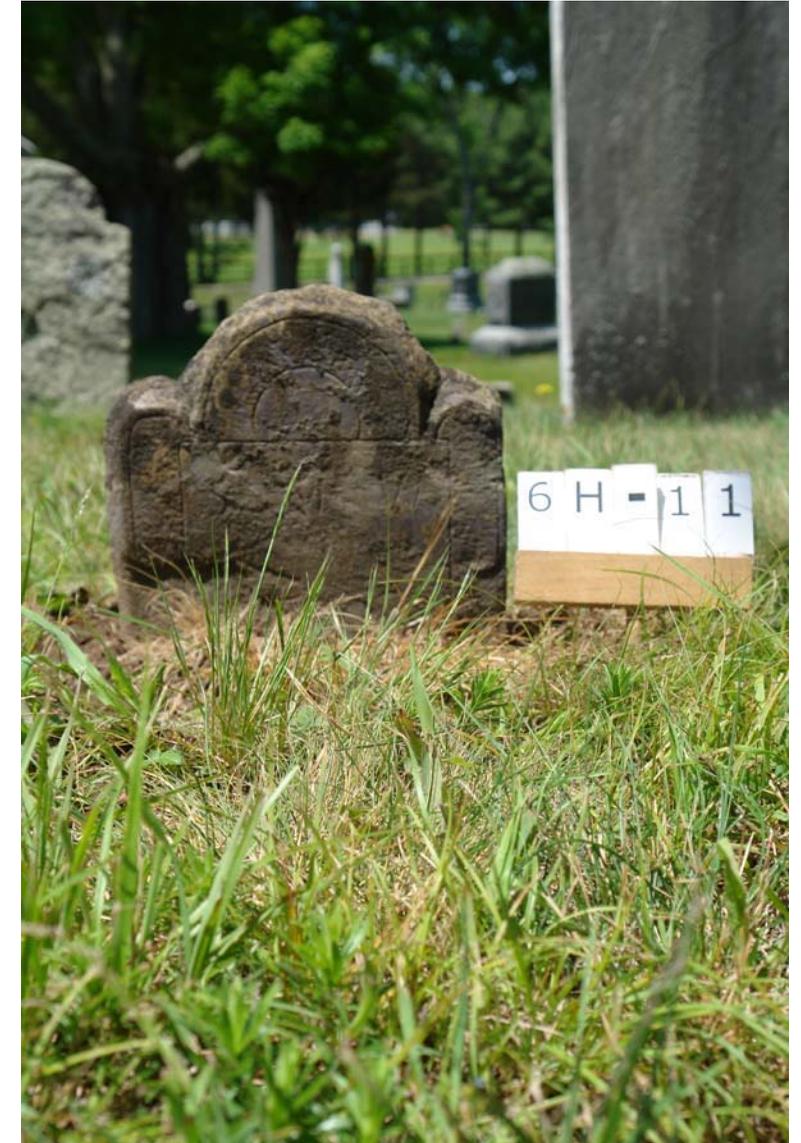
Condition of Inscription: Decipherable Material: Slate

1. Marker carefully excavated. Soil around tilted marker removed to an appropriate depth. When required, marker is removed from the ground. Marker appears to be sound.
2. Soling removed by light brushing with nylon brushes and water.
3. Setting area excavated to sufficient depth and stone re-set plumb at appropriate height and level onto gravel bed, aligned with adjacent markers.
4. Area backfilled around marker with tamped sand and gravel.
5. Disturbed areas re-graded with existing topsoil and sod.
6. Surfaces treated with D/2 biological solution, scrubbed with nylon bristles and fully rinsed with water.

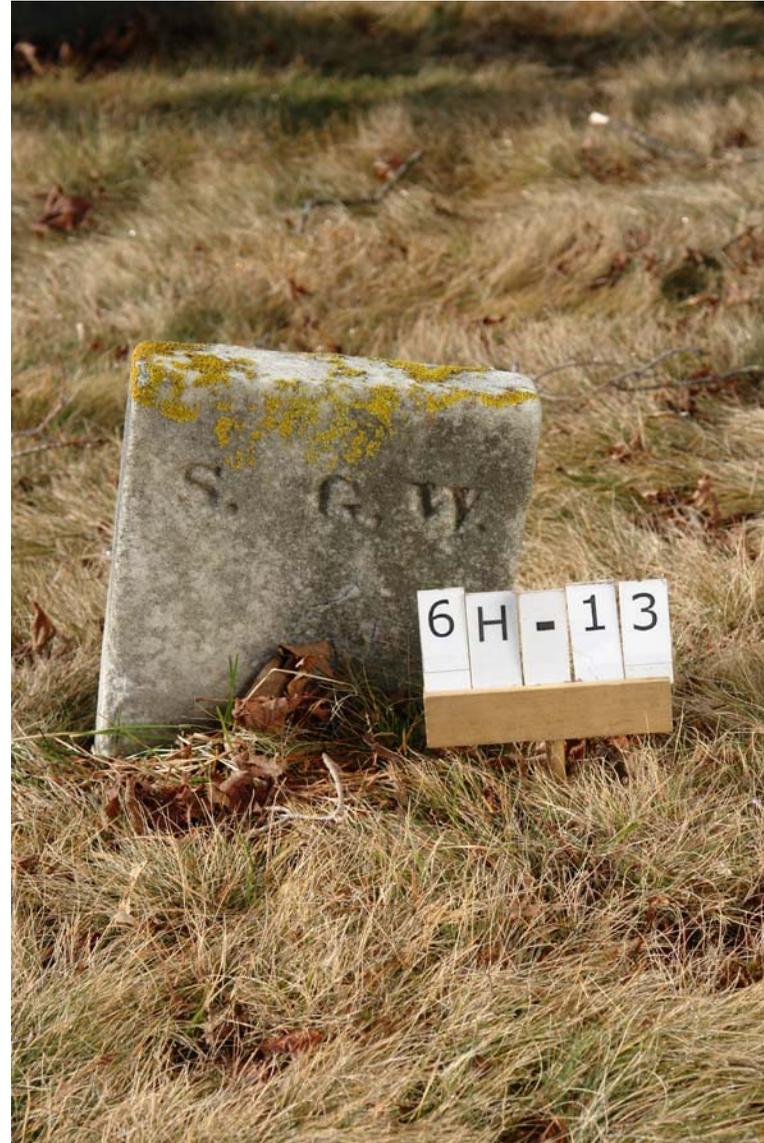
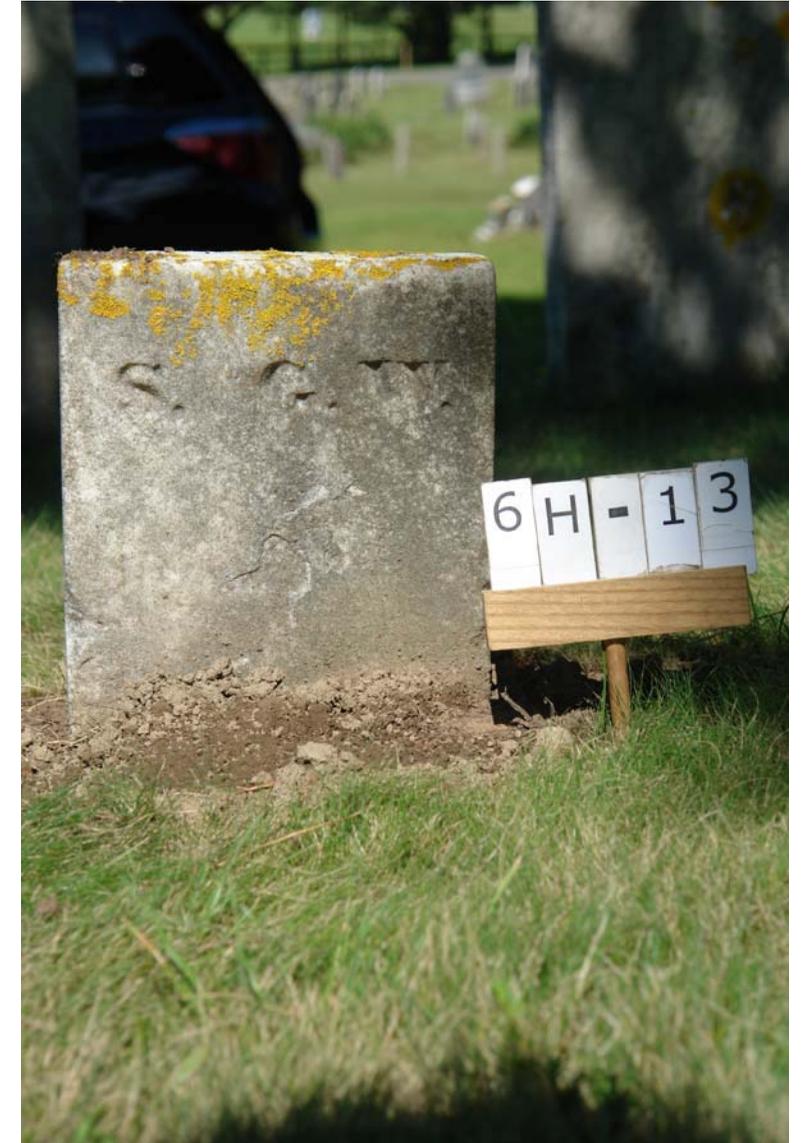
Condition of Inscription: **Decipherable**

1. Marker carefully excavated. Soil around tilted marker removed to an appropriate depth. Marker appears to be sound.
2. When required, marker is removed from the ground.
3. Surface soiling removed by light brushing with nylon brushes and water.
4. When setting area is excavated to sufficient depth stone is re-set plumb and level onto gravel bed, aligned with adjacent markers.
5. Area backfilled around marker with tamped sand and gravel.
6. Disturbed areas re-graded with existing topsoil and sod.

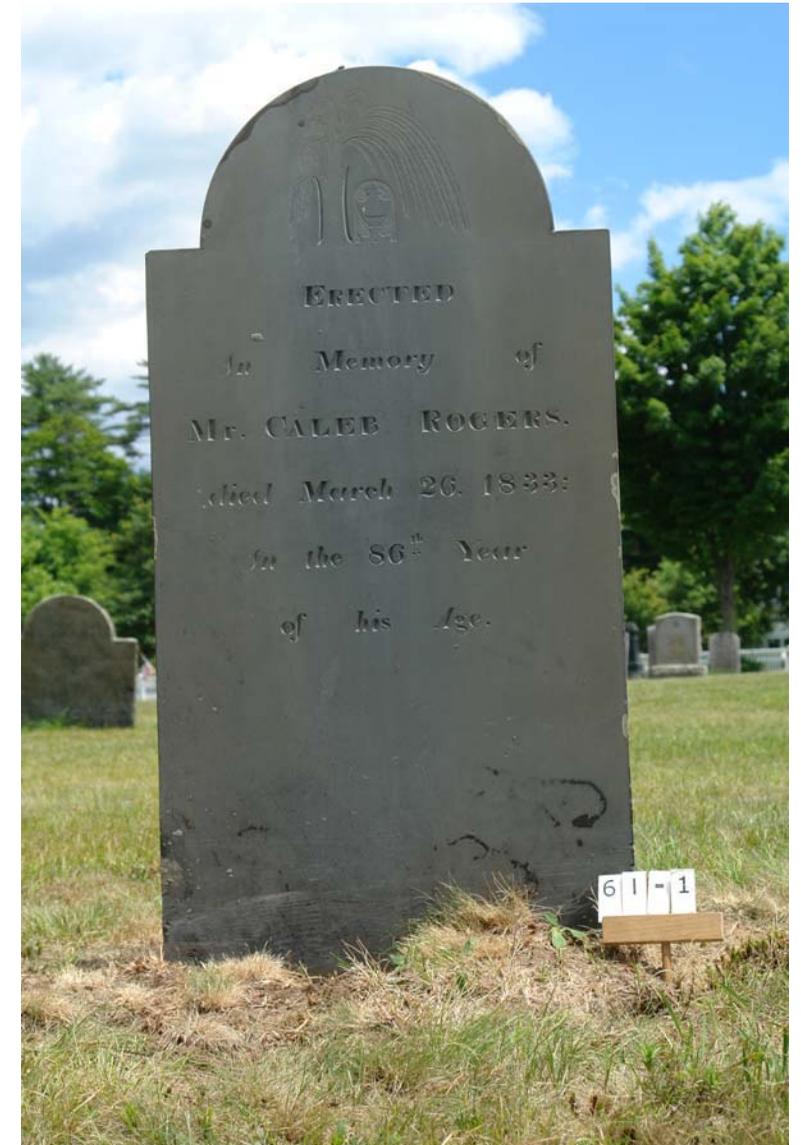
Condition of Inscription: Decipherable

1. Marker carefully excavated. Soil around tilted marker removed to an appropriate depth. Marker appears to be sound.
2. When required, marker is removed from the ground.
3. Surface soiling removed by light brushing with nylon brushes and water.
4. When setting area is excavated to sufficient depth stone is re-set plumb and level onto gravel bed, aligned with adjacent markers.
5. Area backfilled around marker with tamped sand and gravel.
6. Disturbed areas re-graded with existing topsoil and sod.

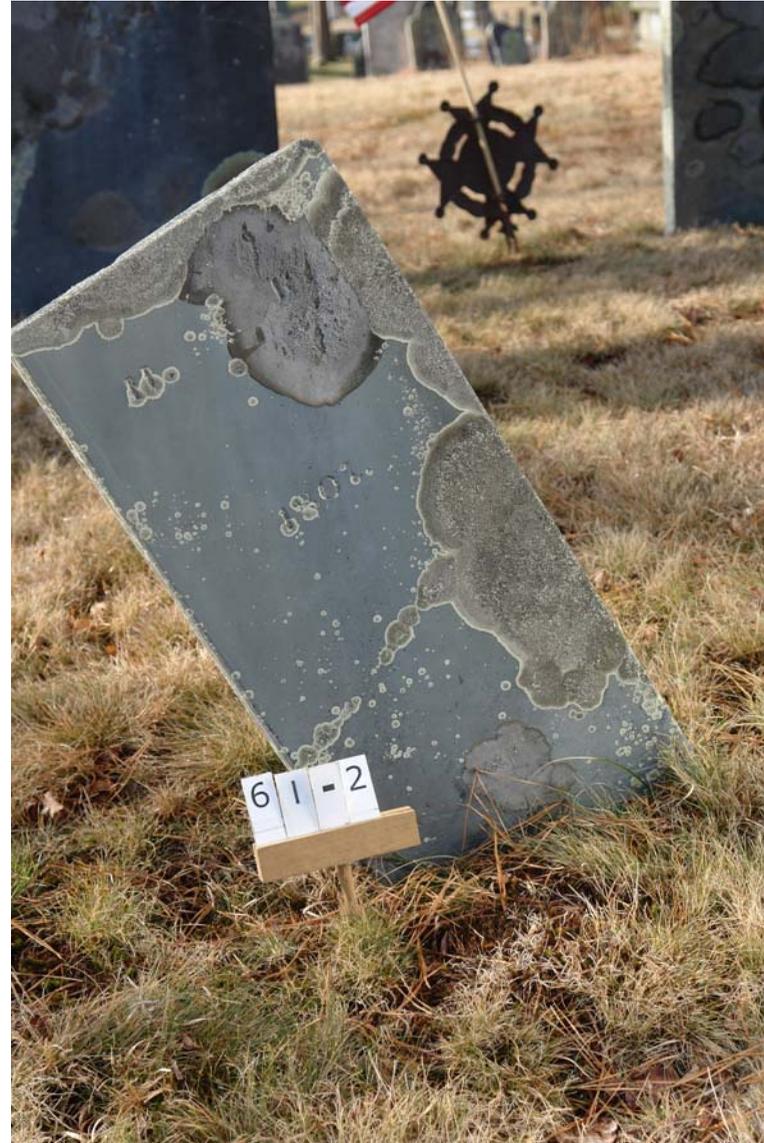
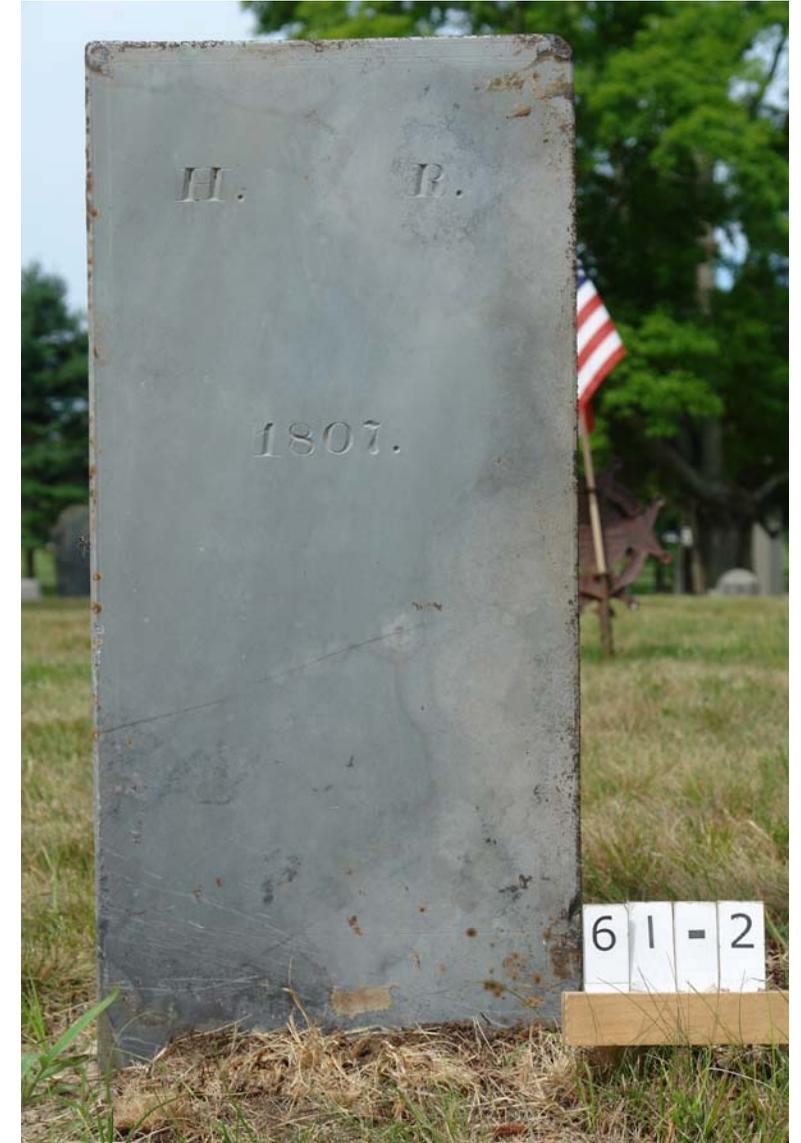
Condition of Inscription: Decipherable

1. Marker carefully excavated. Soil around tilted marker removed to an appropriate depth. Marker appears to be sound.
2. When required, marker is removed from the ground.
3. Surface soiling removed by light brushing with nylon brushes and water.
4. When setting area is excavated to sufficient depth stone is re-set plumb and level onto gravel bed, aligned with adjacent markers.
5. Area backfilled around marker with tamped sand and gravel.
6. Disturbed areas re-graded with existing topsoil and sod.
7. Surfaces treated with D/2 biological solution, scrubbed with nylon bristles and fully rinsed with water.

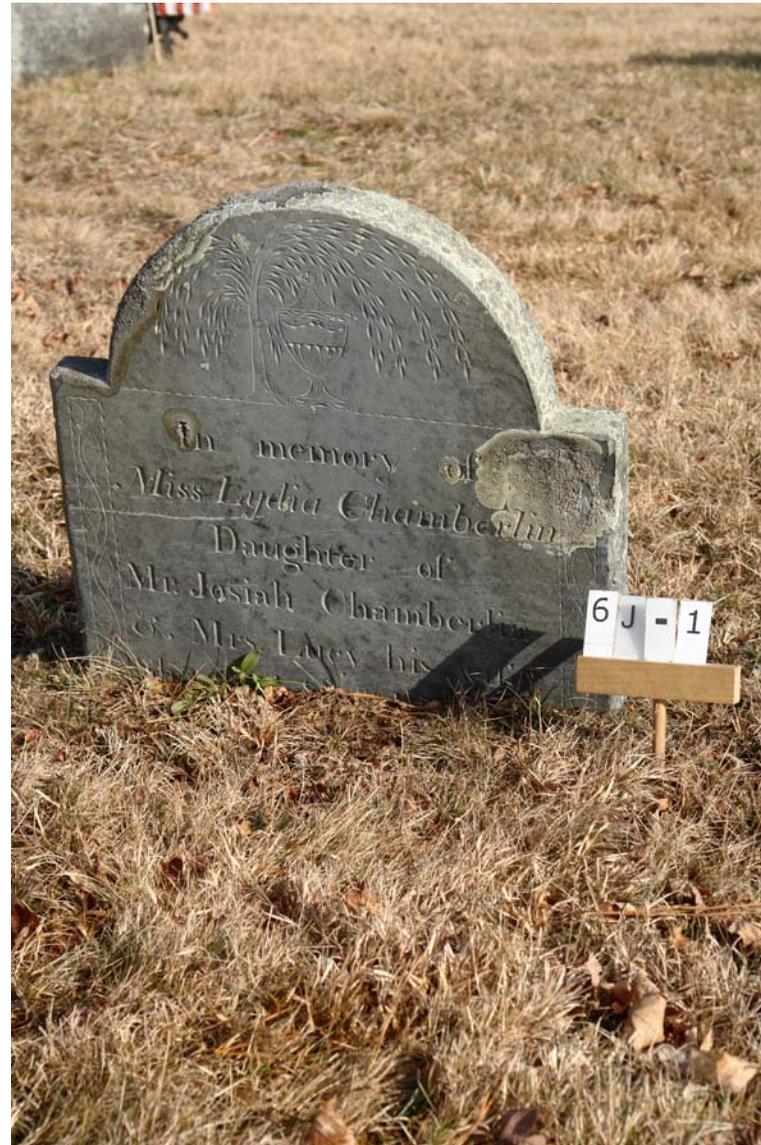
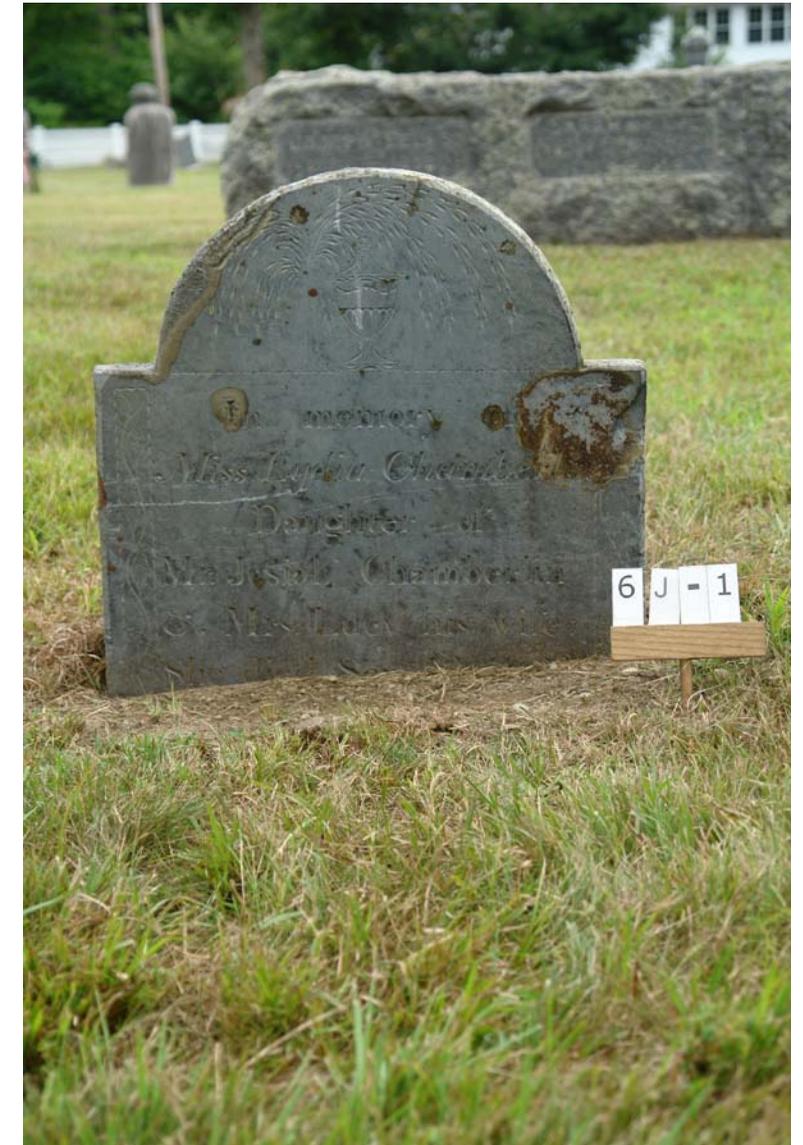
Condition of Inscription: Decipherable

1. Marker carefully excavated. Soil around tilted marker removed to an appropriate depth. Marker appears to be sound.
2. When required, marker is removed from the ground.
3. Surface soiling removed by light brushing with nylon brushes and water.
4. When setting area is excavated to sufficient depth stone is re-set plumb and level onto gravel bed, aligned with adjacent markers.
5. Area backfilled around marker with tamped sand and gravel.
6. Disturbed areas re-graded with existing topsoil and sod.
