STONE CONSERVATION TREATMENTS

Hanover Center Cemetery, Hanover, MA

July, 2012

Documentation of Restorations to Center Cemetery

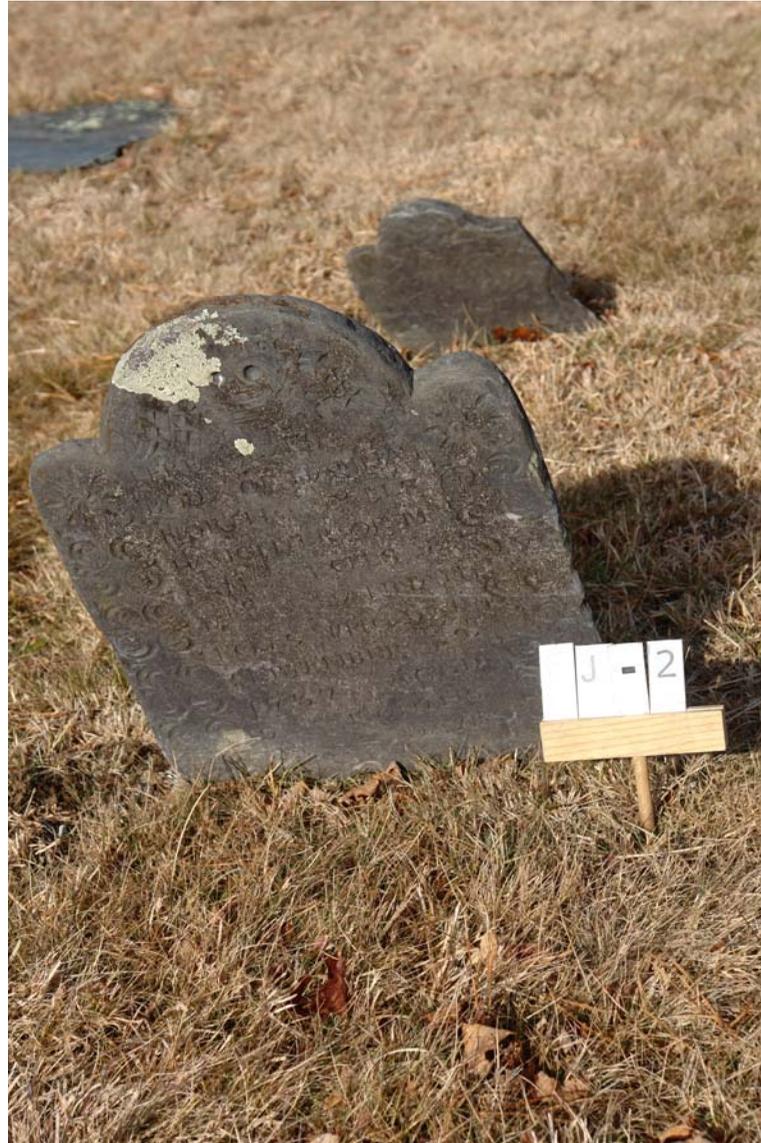
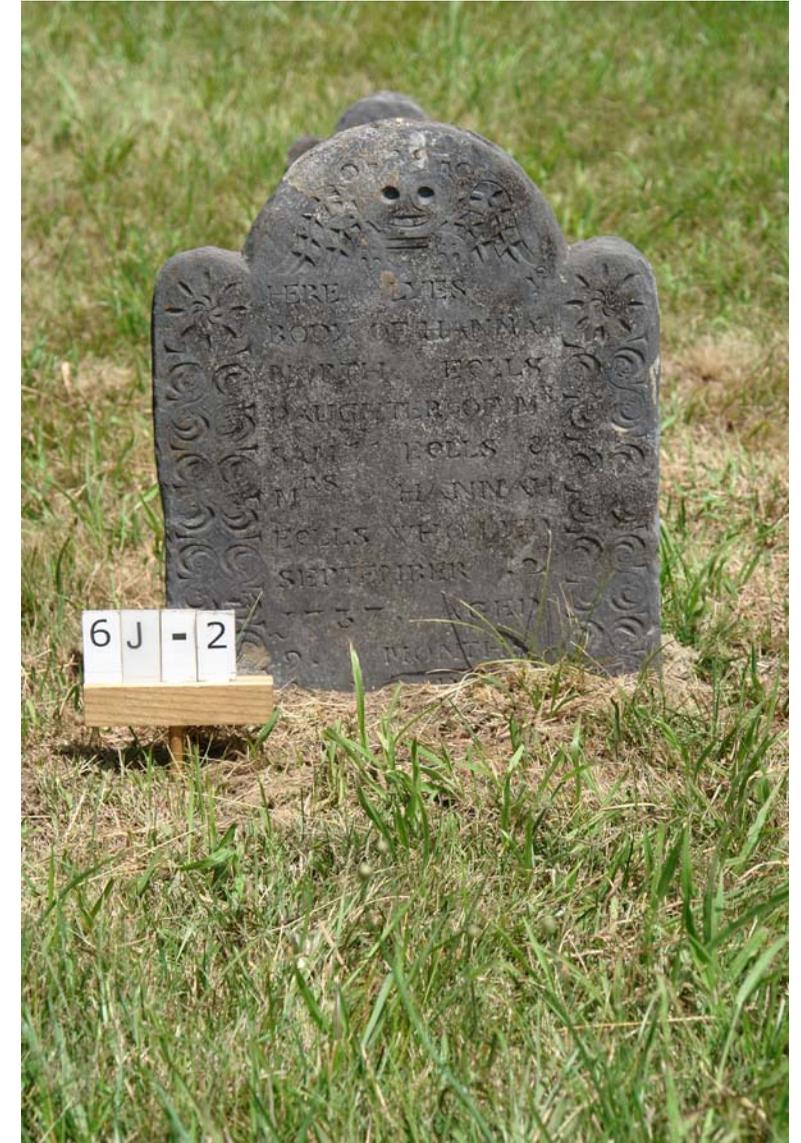
Condition of Inscription: Decipherable

1. Marker carefully excavated. Soil around tilted marker removed to an appropriate depth. Marker appears to be sound.
2. When required, marker is removed from the ground.
3. Surface soiling removed by light brushing with nylon brushes and water.
4. When setting area is excavated to sufficient depth stone is re-set plumb and level onto gravel bed, aligned with adjacent markers.
5. Area backfilled around marker with tamped sand and gravel.
6. Disturbed areas re-graded with existing topsoil and sod.
7. Surfaces treated with D/2 biological solution, scrubbed with nylon bristles and fully rinsed with water.

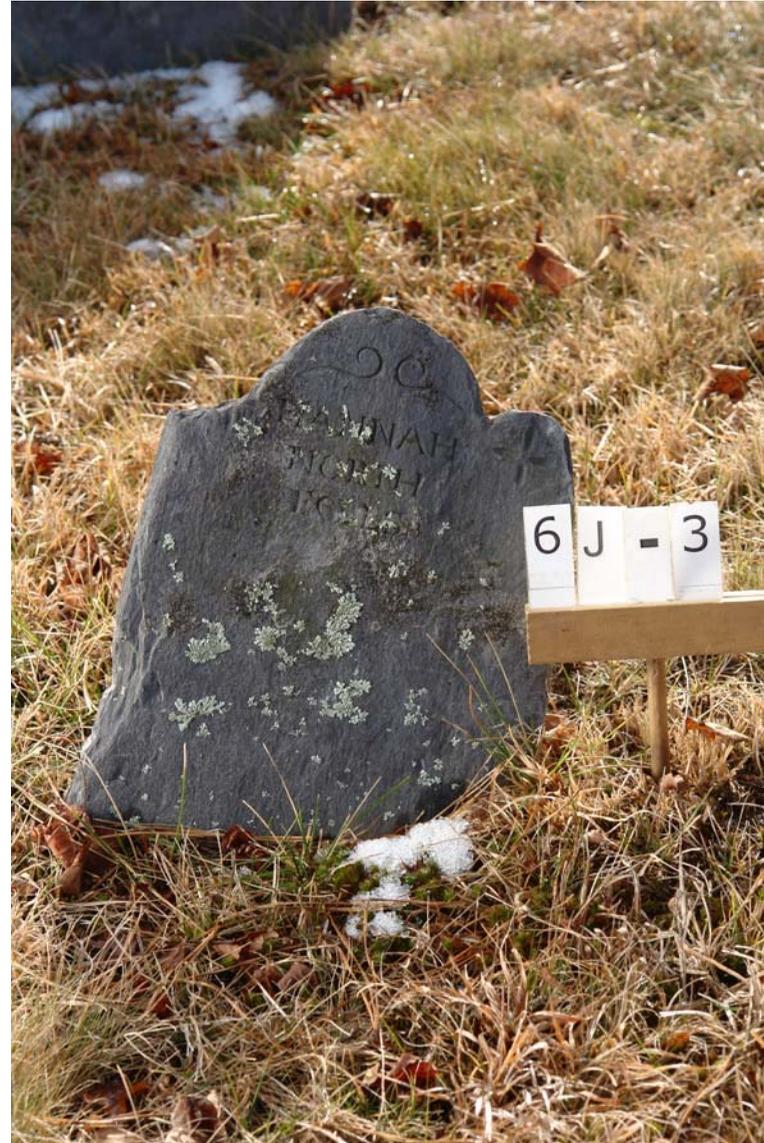
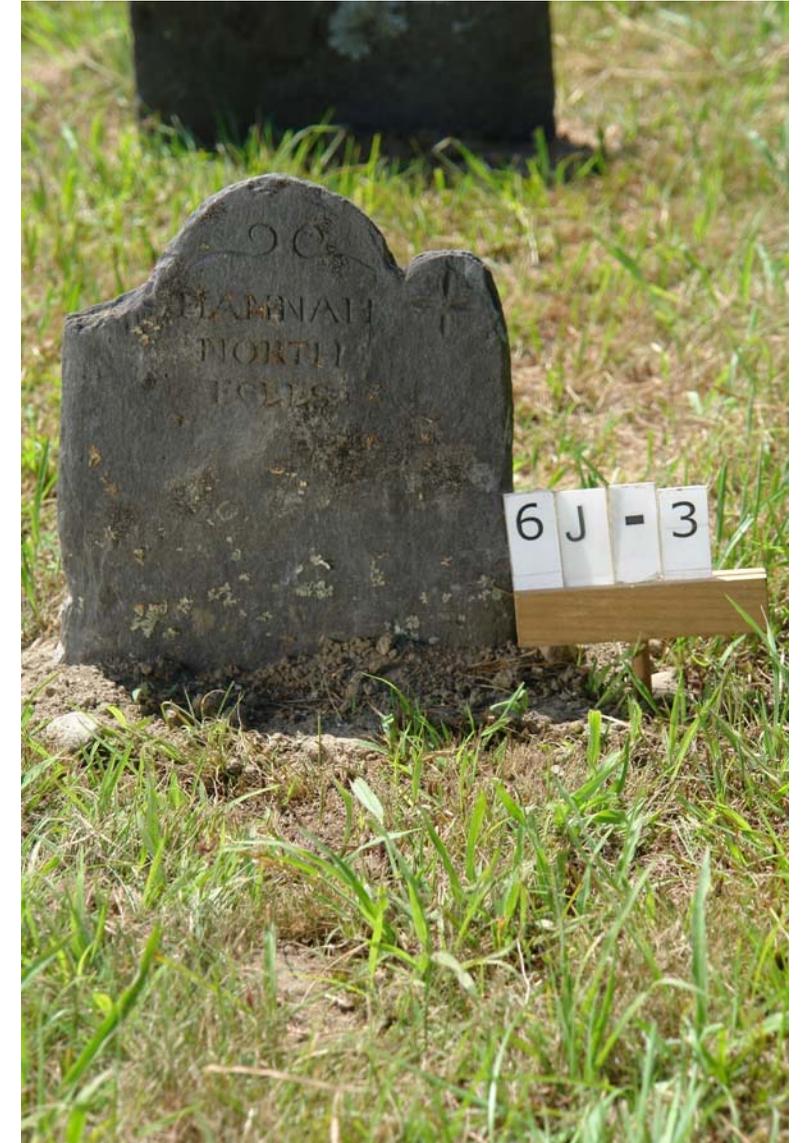
Condition of Inscription: **Decipherable** Material: **Slate**

1. Marker carefully excavated. Soil around tilted marker removed to an appropriate depth. Marker appears to be sound.
2. When required, marker is removed from the ground.
3. Surface soiling removed by light brushing with nylon brushes and water.
4. When setting area is excavated to sufficient depth stone is re-set plumb and level onto gravel bed, aligned with adjacent markers.
5. Area backfilled around marker with tamped sand and gravel.
6. Disturbed areas re-graded with existing topsoil and sod.
7. Surfaces treated with D/2 biological solution, scrubbed with nylon bristles and fully rinsed with water.

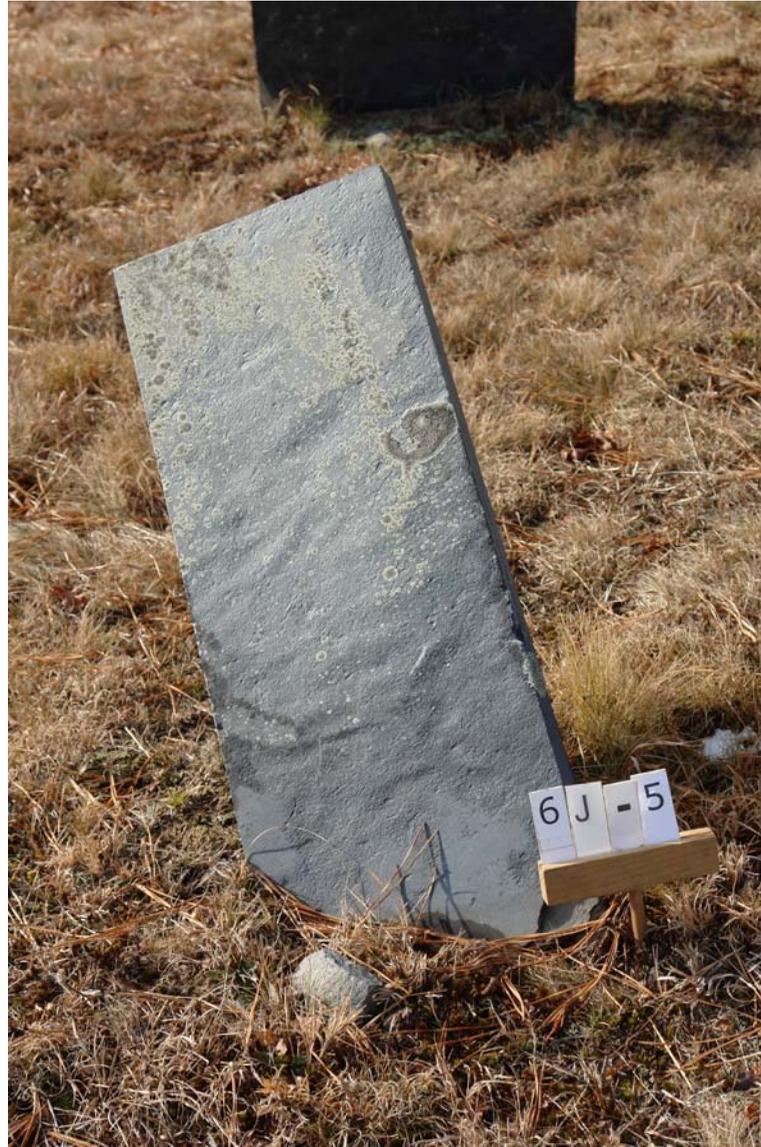
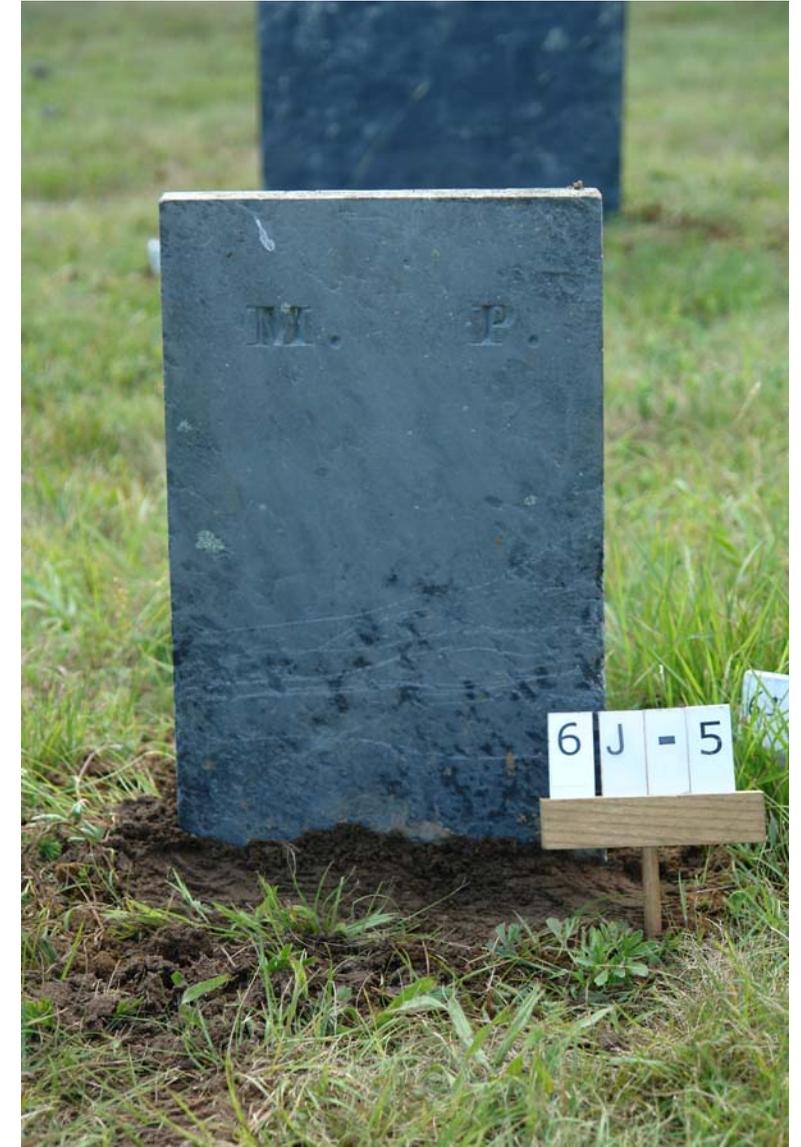
Condition of Inscription: **Decipherable**

1. Marker carefully excavated. Soil around tilted marker removed to an appropriate depth. When required, marker is removed from the ground. Marker appears to be sound.
2. Soling removed by light brushing with nylon brushes and water.
3. Setting area excavated to sufficient depth and stone re-set plumb at appropriate height and level onto gravel bed, aligned with adjacent markers and facing East.
4. Area backfilled around marker with tamped sand and gravel.
5. Disturbed areas re-graded with existing topsoil and sod.

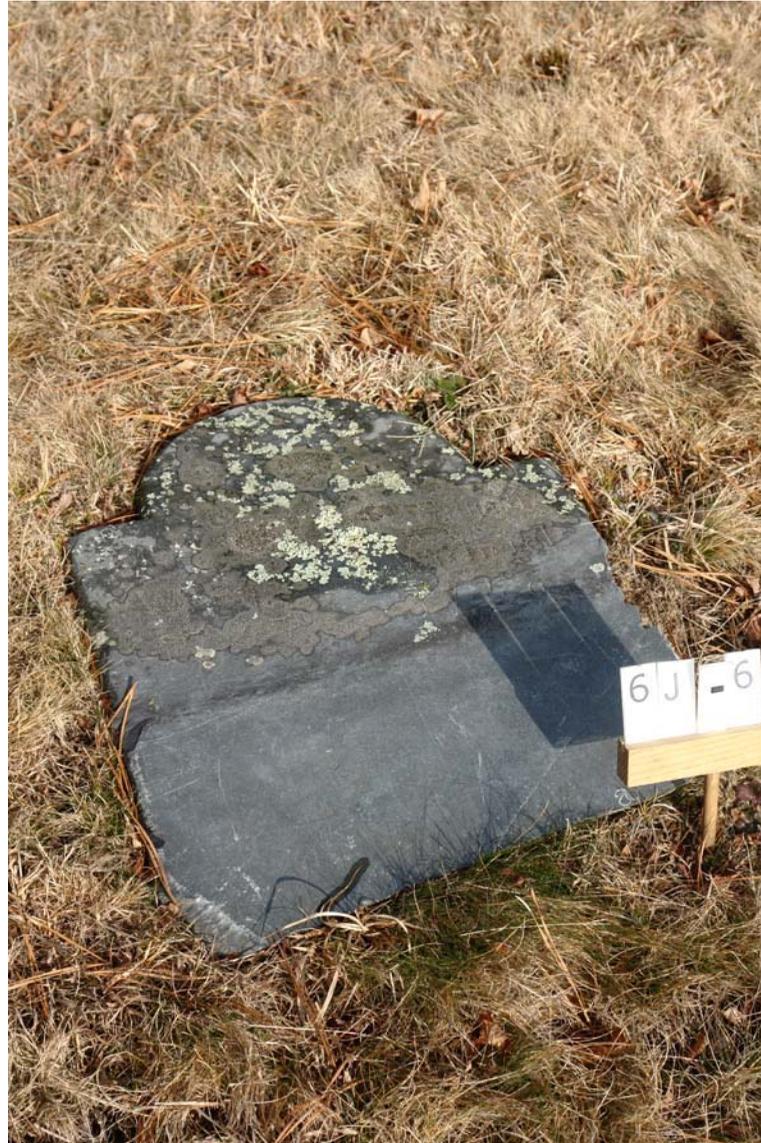
Condition of Inscription: **Decipherable** Material: **Slate**

Fractured below grade

1. Setting area excavated, no additional fragments or base discovered.
2. A new below grade concrete base cast in place. After partial curing, setting forms were removed and the base backfilled with tamped sand or gravel.
3. When required, lower edge of marker re-squared with minimal loss using a power grinder.
4. Marker reset plumb and level into slot using a cement/lime grout. Braced for min. 5 days.
5. Disturbed areas re-graded with existing topsoil and sod.
6. Surfaces treated with D/2, scrubbed with nylon bristles and fully rinsed with water

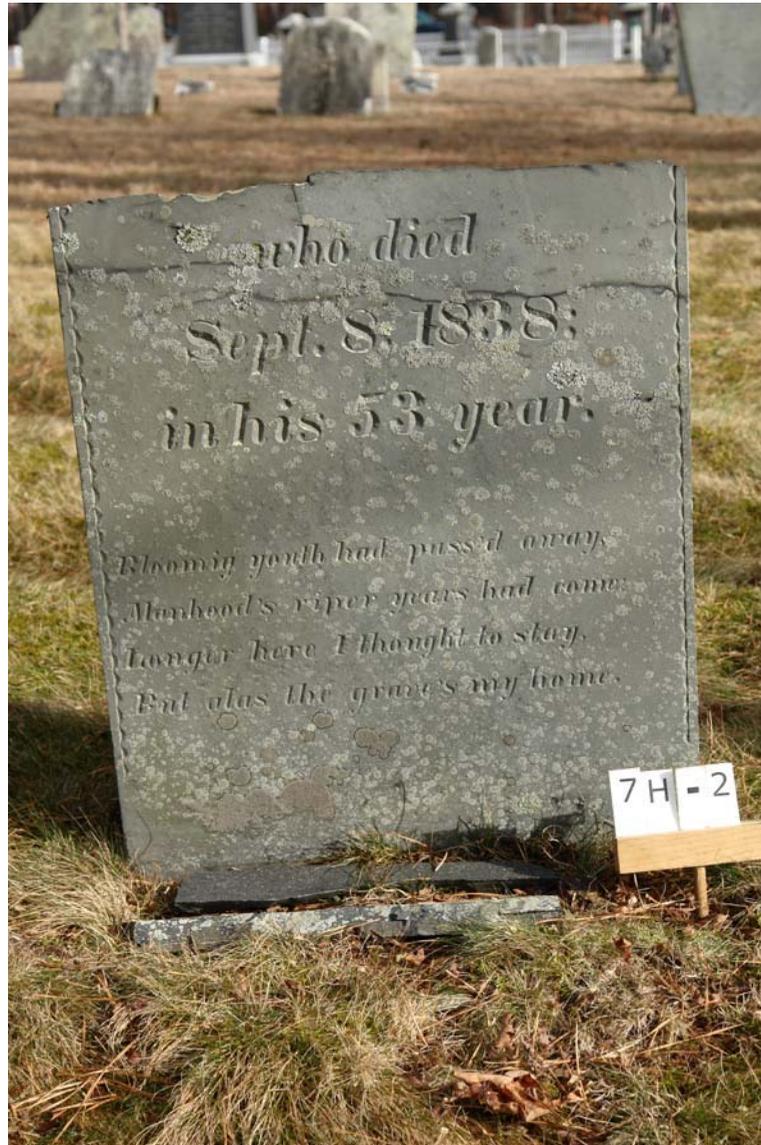
Condition of Inscription: Decipherable, missing Material: Slate

Probe for missing fragments  
Evaluate treatment

1. Marker carefully excavated and area probed for missing fragments. None found.
2. Lower fragment reset plumb and aligned with adjacent markers. Backfill with tamped gravel or sand.

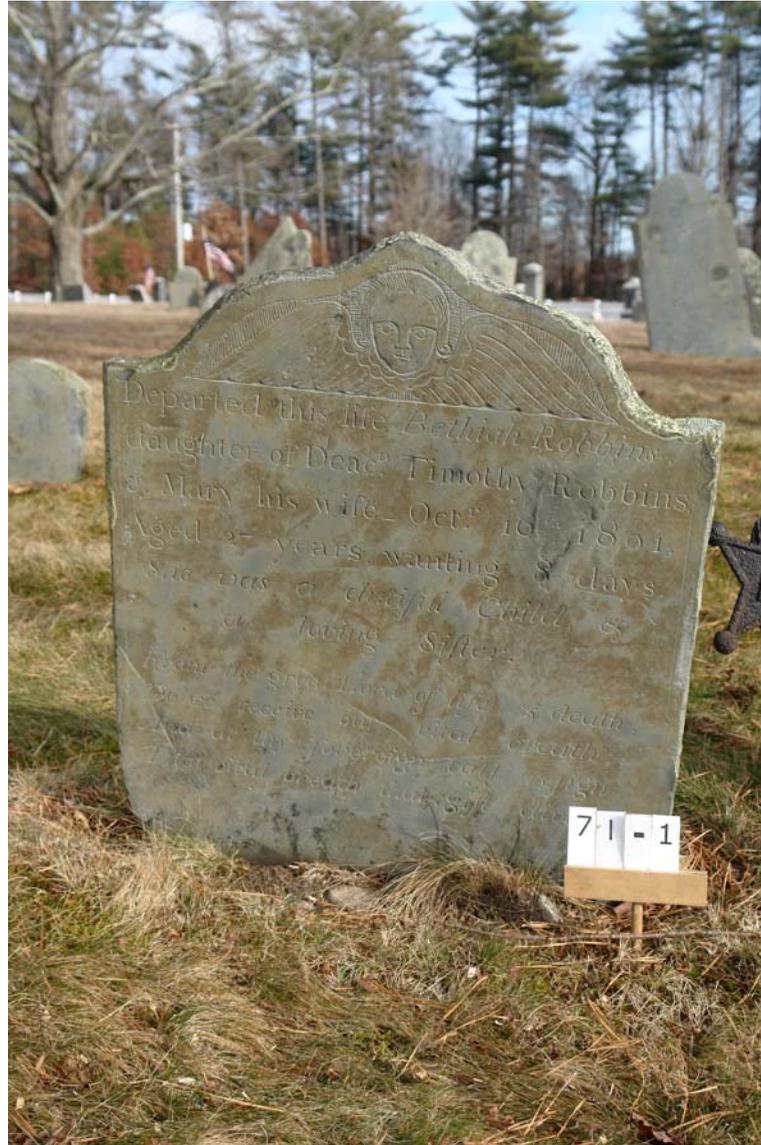
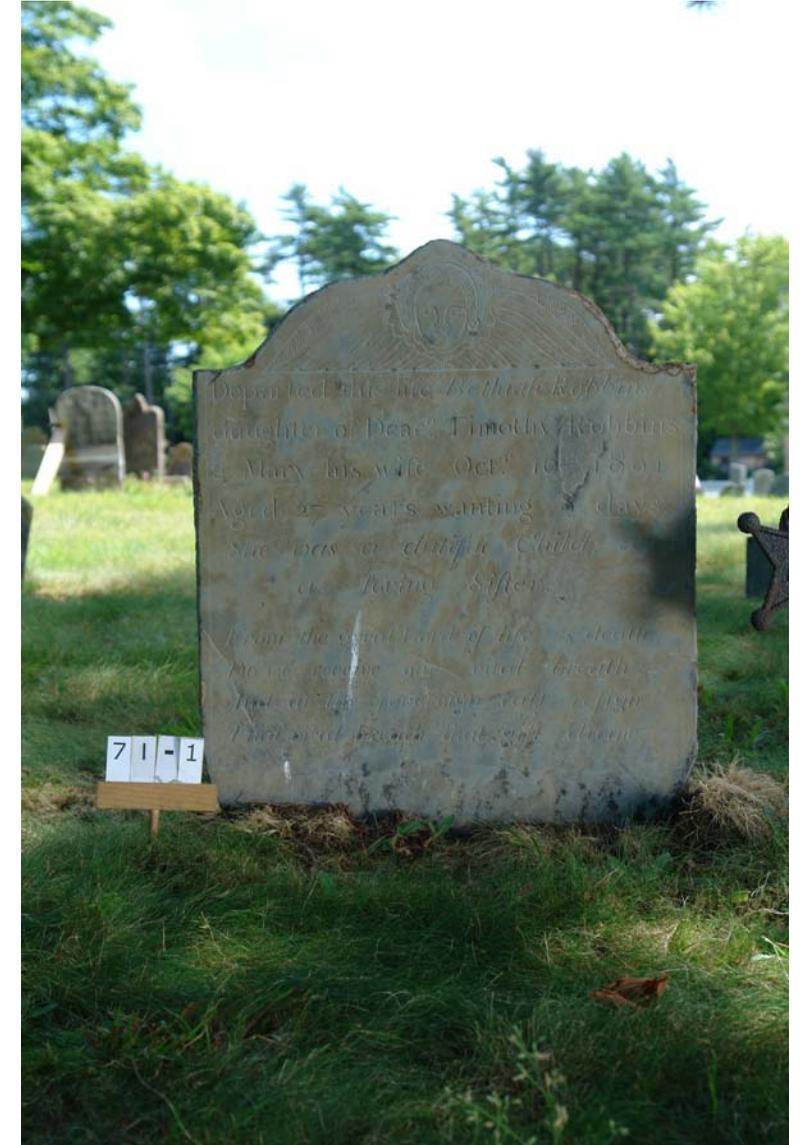
Condition of Inscription: **Decipherable** Material: **Slate**

EXISTING CONDITIONS	CONSERVATION STRATEGY
Tilted	Excavate Clean Reset

1. Marker carefully excavated. Soil around tilted marker removed to an appropriate depth. Marker appears to be sound.
2. When required, marker is removed from the ground.
3. Surface soiling removed by light brushing with nylon brushes and water.
4. When setting area is excavated to sufficient depth stone is re-set plumb and level onto gravel bed, aligned with adjacent markers.
5. Area backfilled around marker with tamped sand and gravel.
6. Disturbed areas re-graded with existing topsoil and sod.
7. Surfaces treated with D/2 biological solution, scrubbed with nylon bristles and fully rinsed with water.

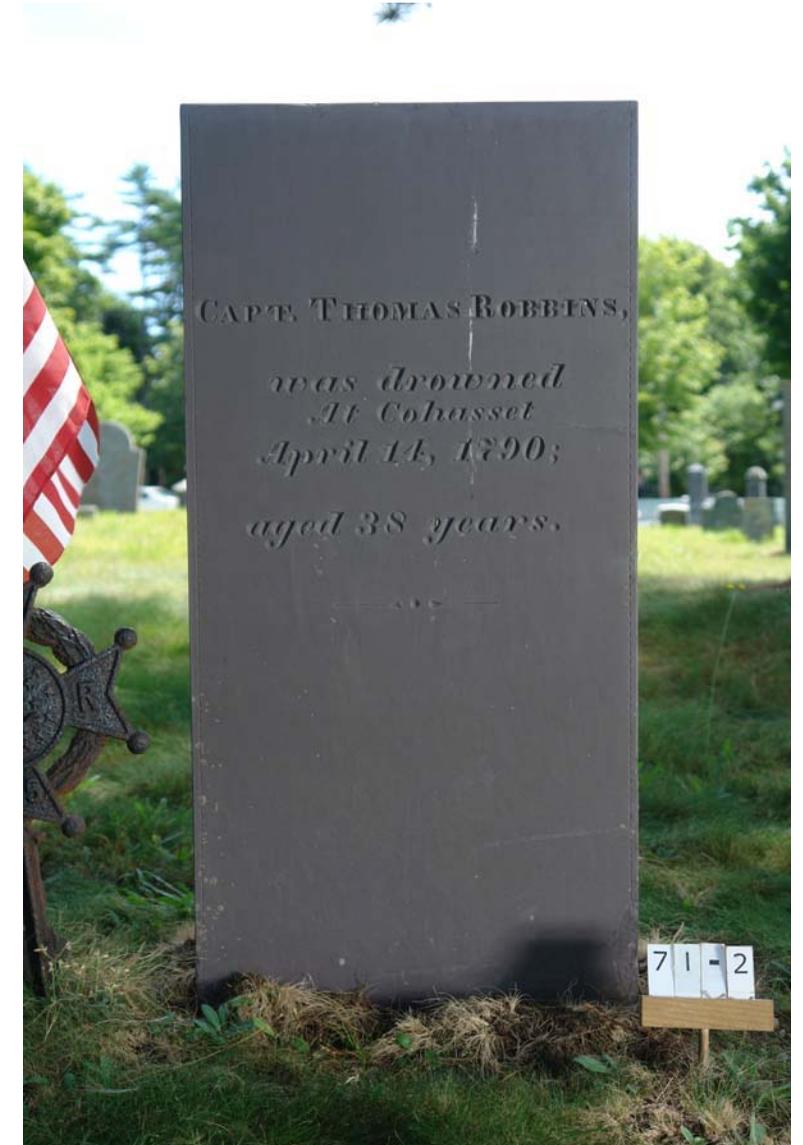
Condition of Inscription: **Decipherable** Material: **Slate**

1. Marker carefully excavated. Soil around tilted marker removed to an appropriate depth. Marker appears to be sound.
2. When required, marker is removed from the ground.
3. Surface soiling removed by light brushing with nylon brushes and water.
4. When setting area is excavated to sufficient depth stone is re-set plumb and level onto gravel bed, aligned with adjacent markers.
5. Area backfilled around marker with tamped sand and gravel.
6. Disturbed areas re-graded with existing topsoil and sod.

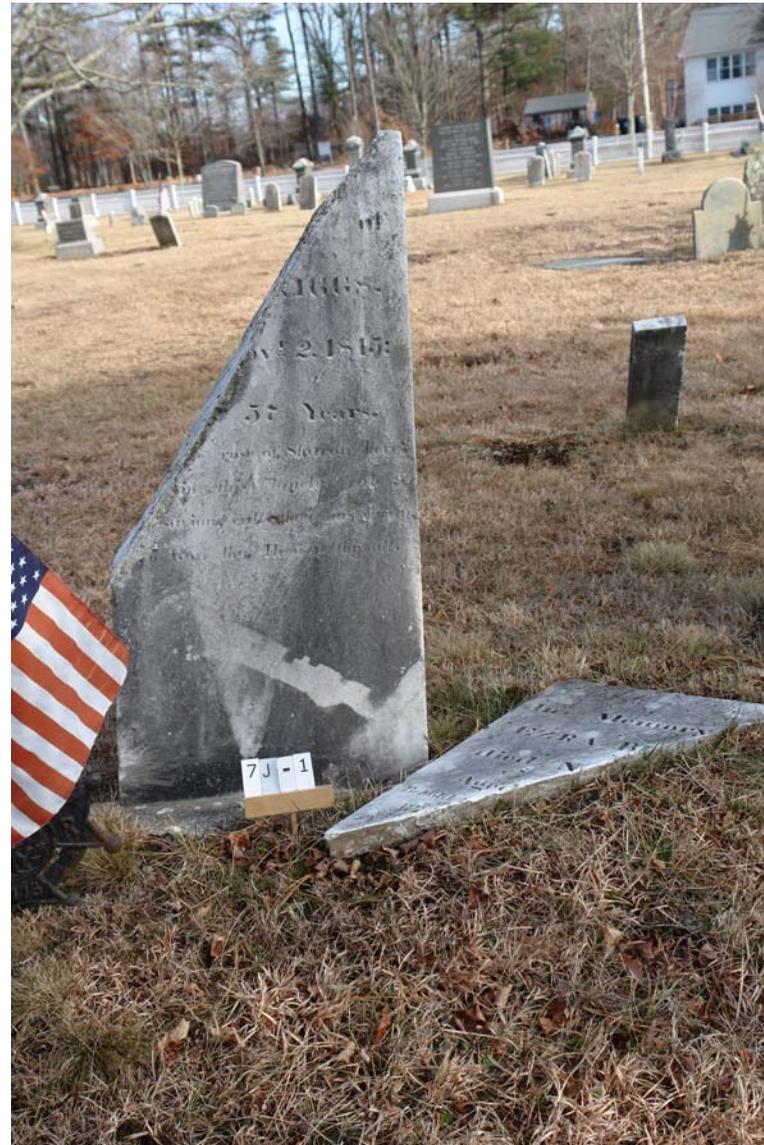
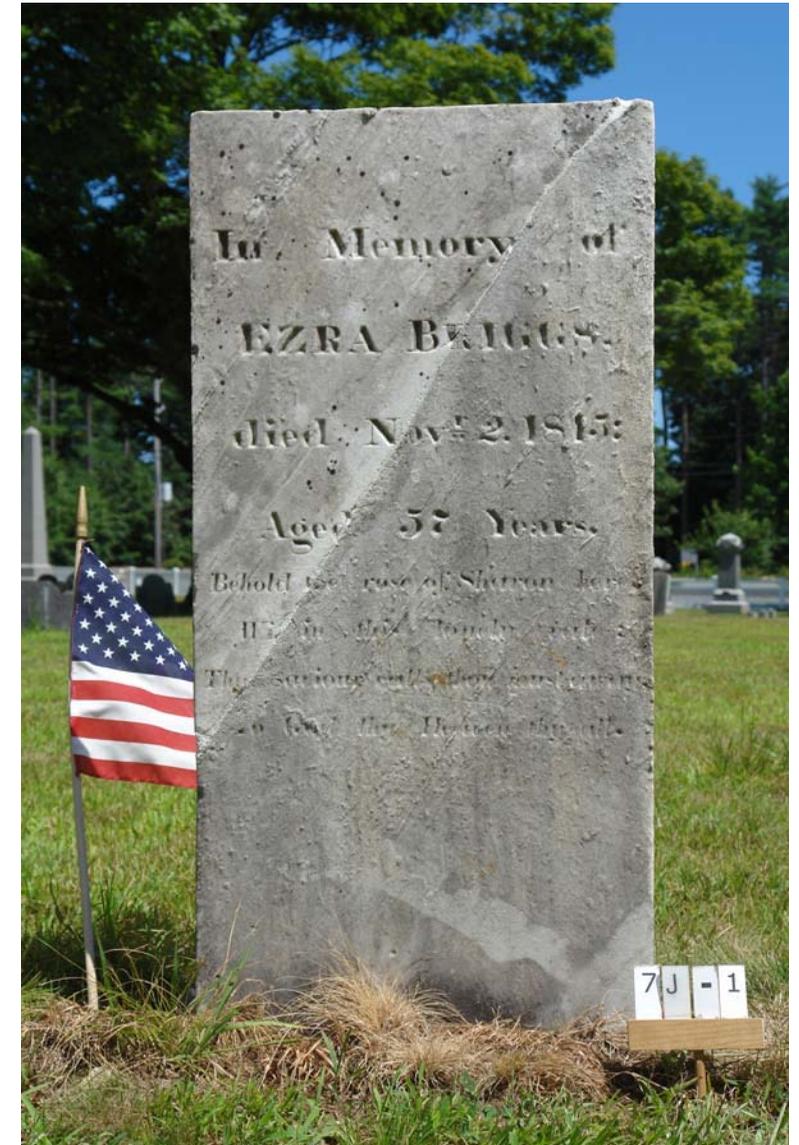
Condition of Inscription: Decipherable

Tilted- set too high  
Fractured

1. Fragment(s) excavated and area probed for missing pieces.
2. Lower fragment in base reset plumb at appropriate height, aligned with adjacent markers.
3. Any failed adhesives or mortar removed.
4. Mating surfaces of fragment(s) treated with D/2 biological solution and scrubbed with nylon brushes, then rinsed with water.
5. Fragment(s) attached with structural adhesive, and braced until cured.
6. Cracks and losses filled with RepliCal and Jahn products, misted and wrapped min. 3 days.
7. After partial cure, any excess fill material on adjacent surfaces treated with acetic acid, brushed, and fully rinsed with water.

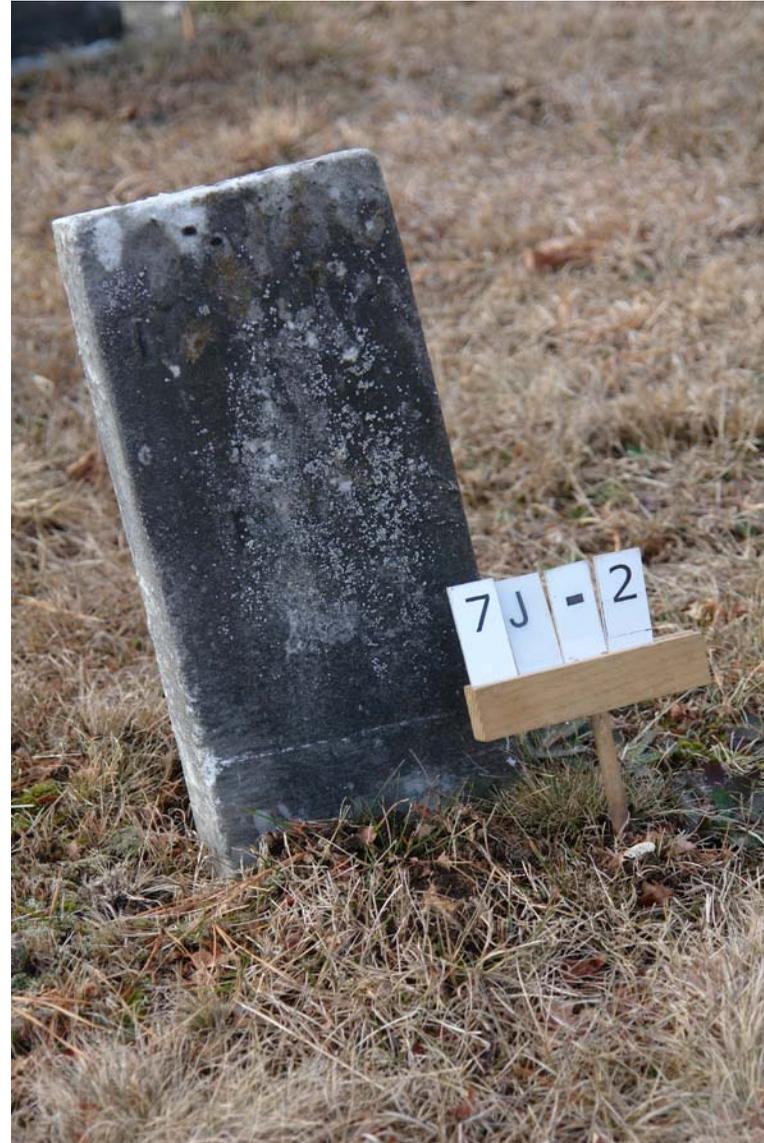
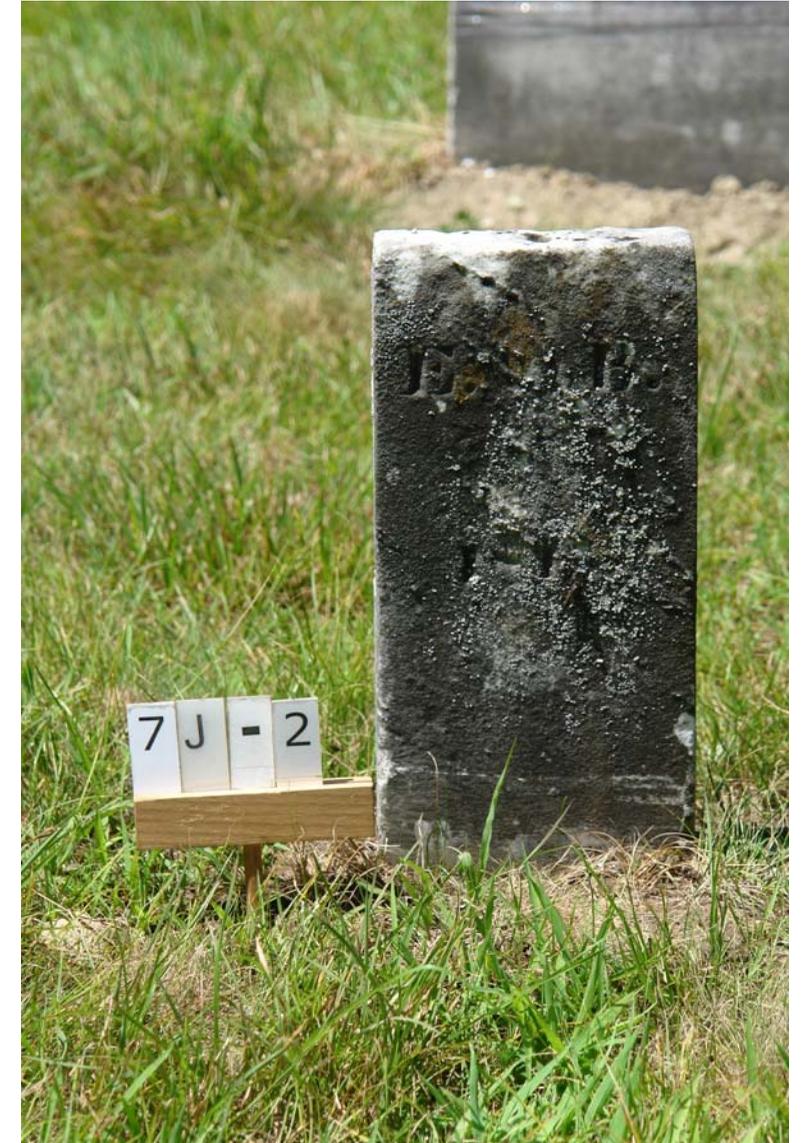
Condition of Inscription: **Decipherable**

1. Marker carefully excavated. Soil around tilted marker removed to an appropriate depth. Marker appears to be sound.
2. When required, marker is removed from the ground.
3. Surface soiling removed by light brushing with nylon brushes and water.
4. When setting area is excavated to sufficient depth stone is re-set plumb and level onto gravel bed, aligned with adjacent markers.
5. Area backfilled around marker with tamped sand and gravel.
6. Disturbed areas re-graded with existing topsoil and sod.

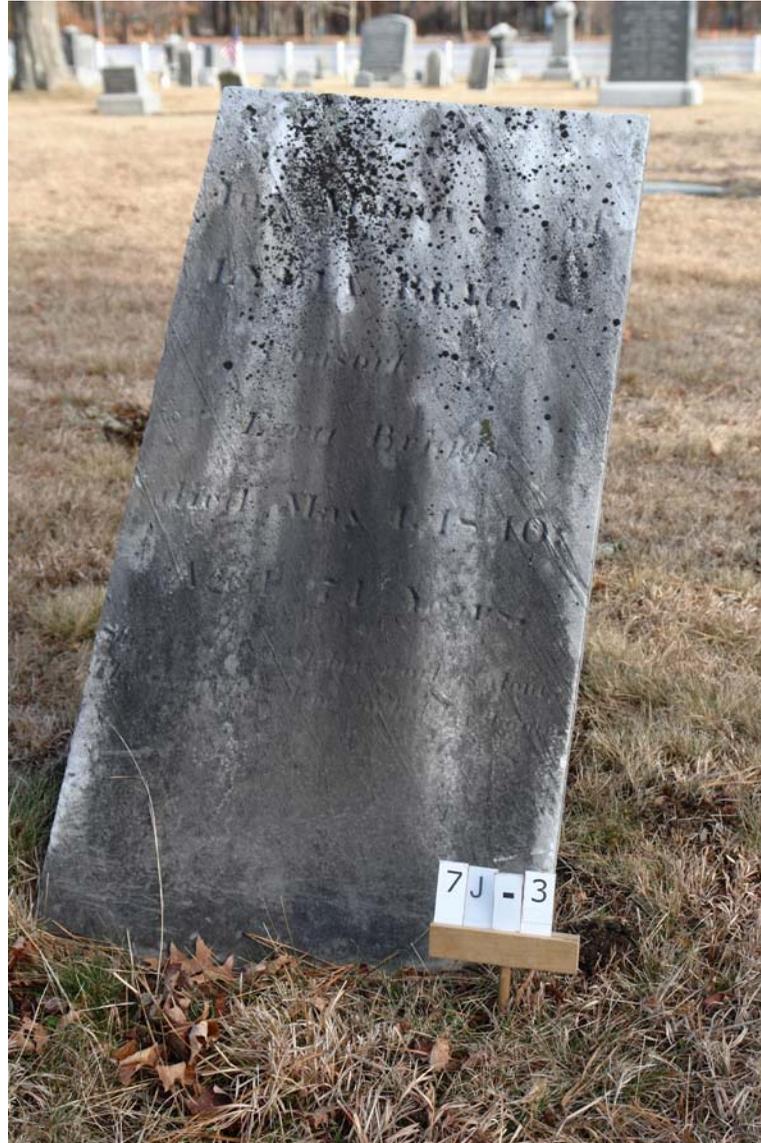
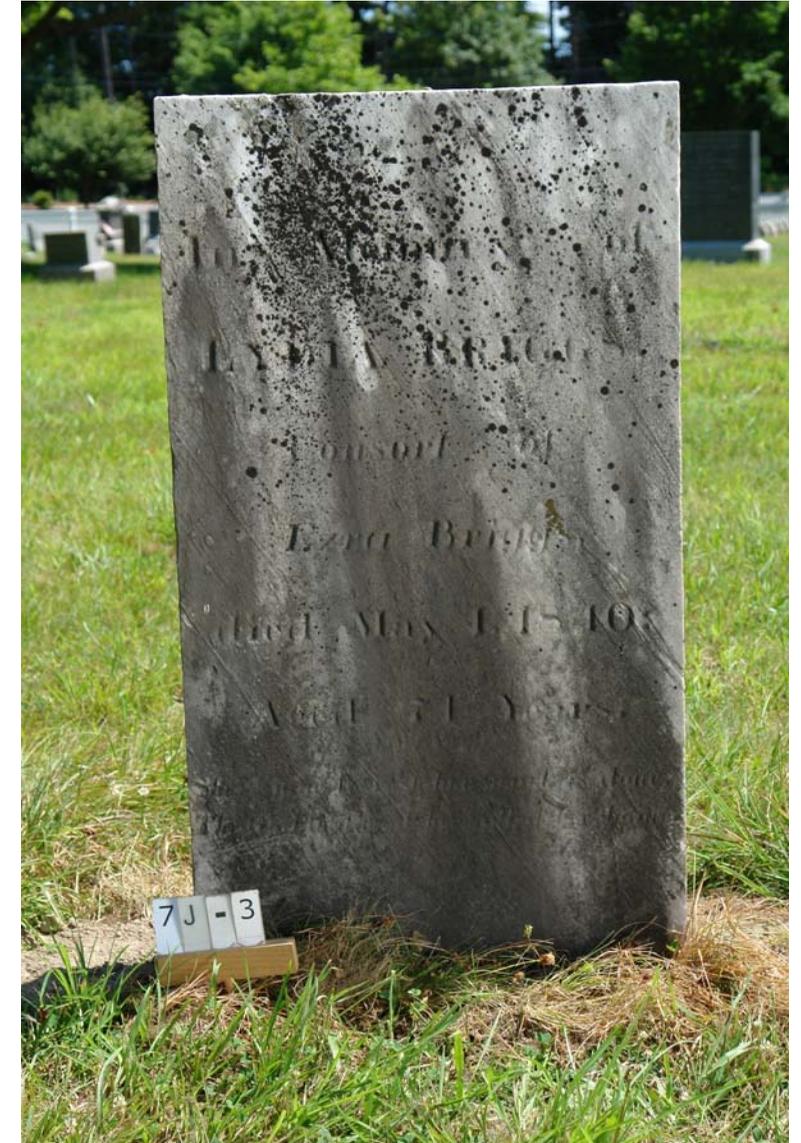
Condition of Inscription: **Decipherable**

1. Marker carefully excavated. The soil around the tilted marker was removed to an appropriate depth. When required, the marker was removed from the ground. Marker appears to be sound.
2. Soling removed by light brushing with nylon brushes and water.
3. Setting area excavated to sufficient depth and stone re-set plumb at appropriate height and level onto gravel bed, aligned with adjacent markers
4. Area backfilled around marker with tamped sand and gravel
5. Disturbed areas re-graded with existing topsoil and sod.

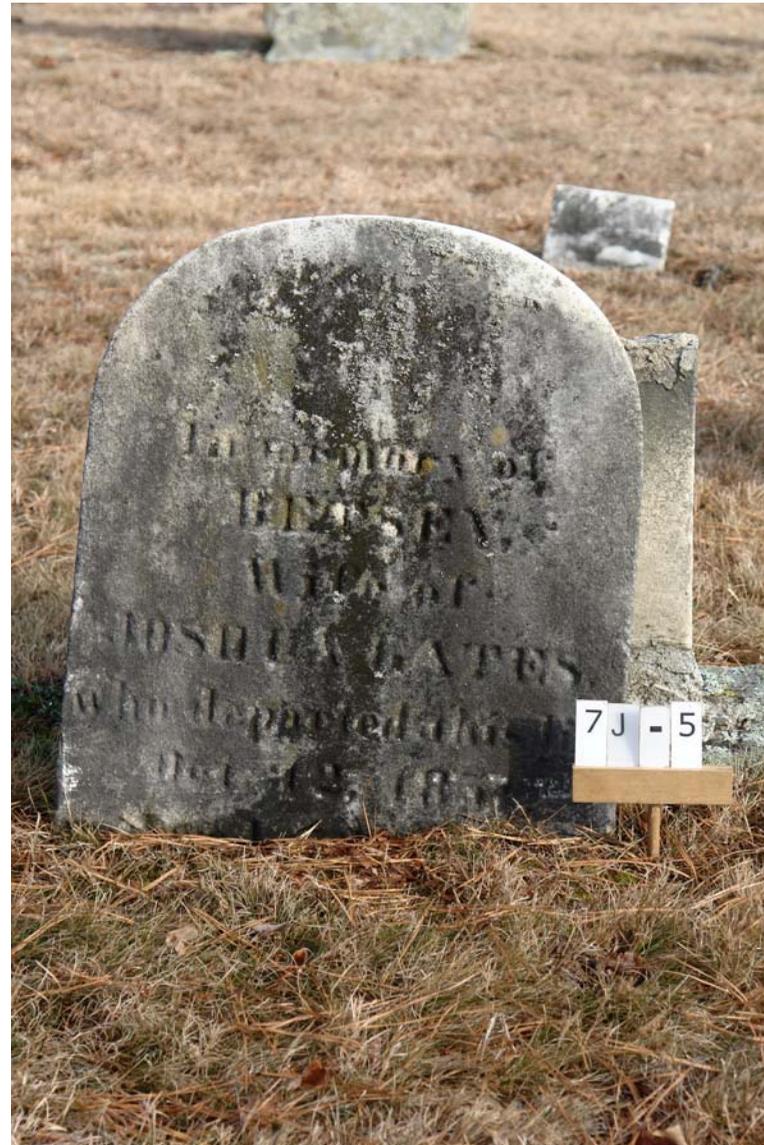
Fractured  
Tilted

1. Area around base excavated and base set level.
2. Mating surfaces cleaned and failed adhesives or mortar removed.
3. Fragment(s) attached with structural adhesive (Abatron 55-22), and braced until cured.
4. Old repairs and fills were not removed as it was determined that it would be detrimental to the sugared marker surface

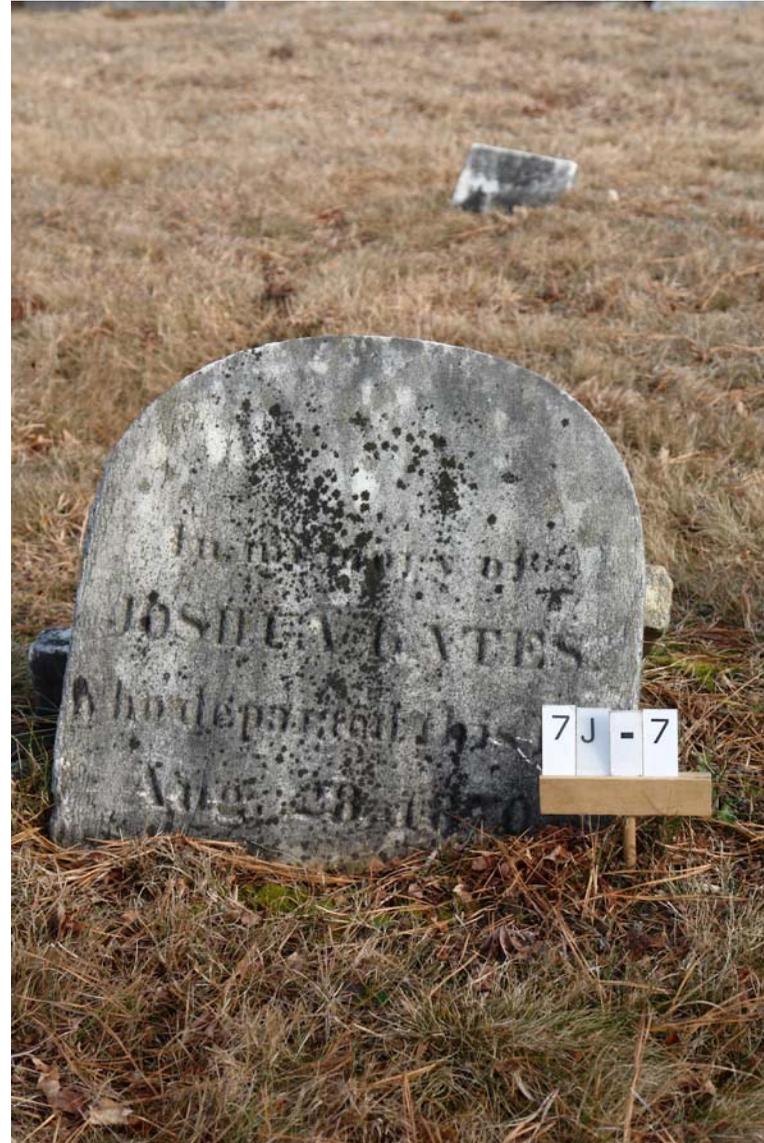
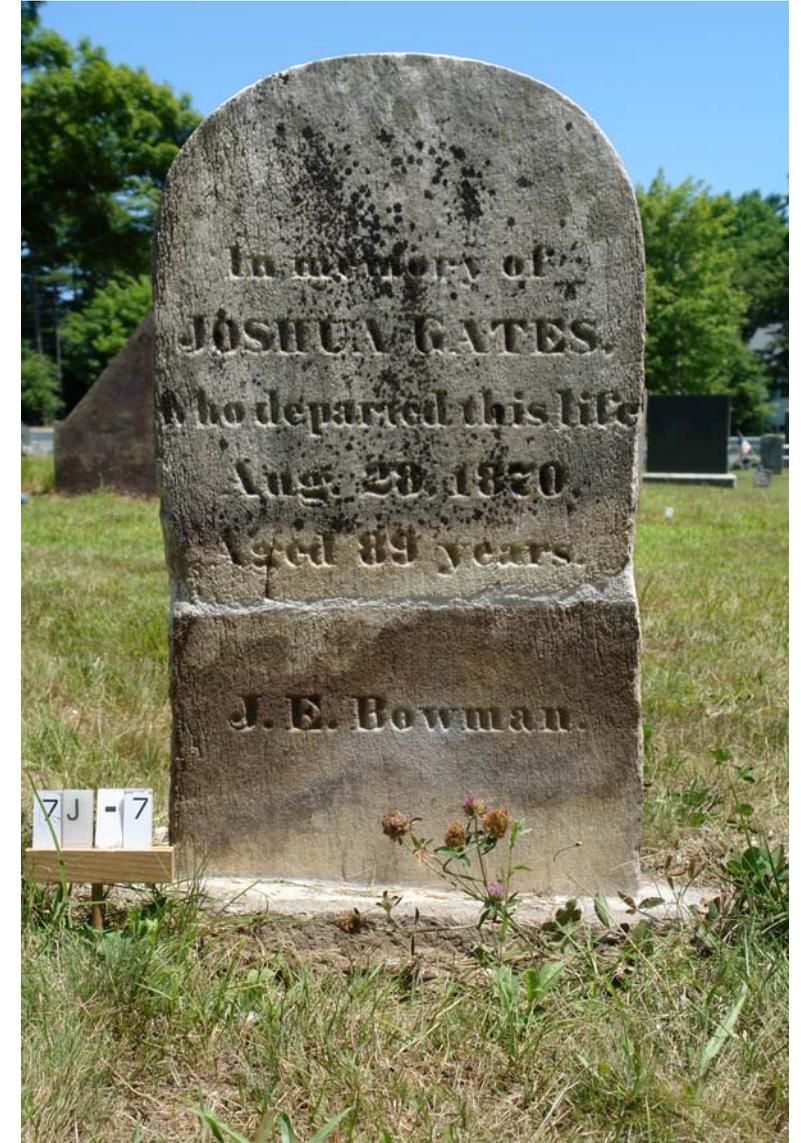
Fractured

1. Fragment(s) excavated and area probed for missing pieces.
1. Area around base excavated and base set level.
2. Mating surfaces cleaned and failed adhesives or mortar removed.
3. Fragment(s) attached with structural adhesive, and braced until cured.
4. Cracks and small losses filled with RepliCal crack fill. Large losses filled with Jahn restoration mortar. Misted and wrapped min. 3 days.
5. After partial cure, any excess fill material on adjacent surfaces treated with acetic acid, brushed, and fully rinsed with water.

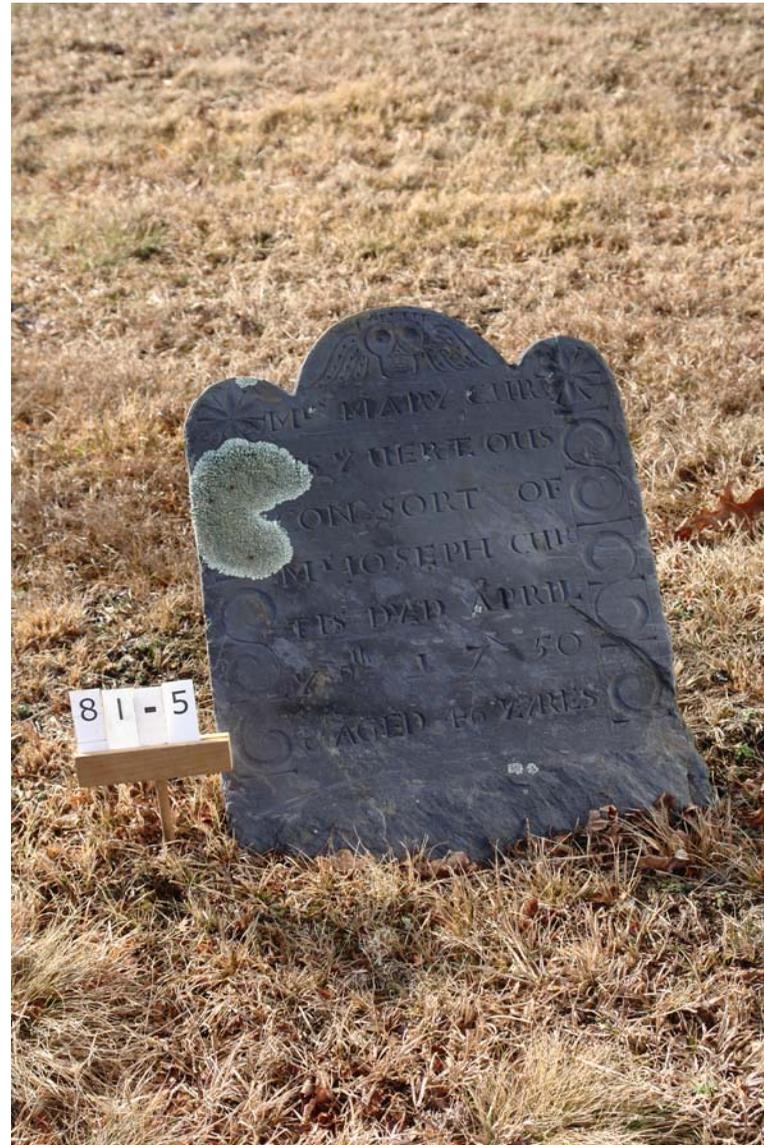
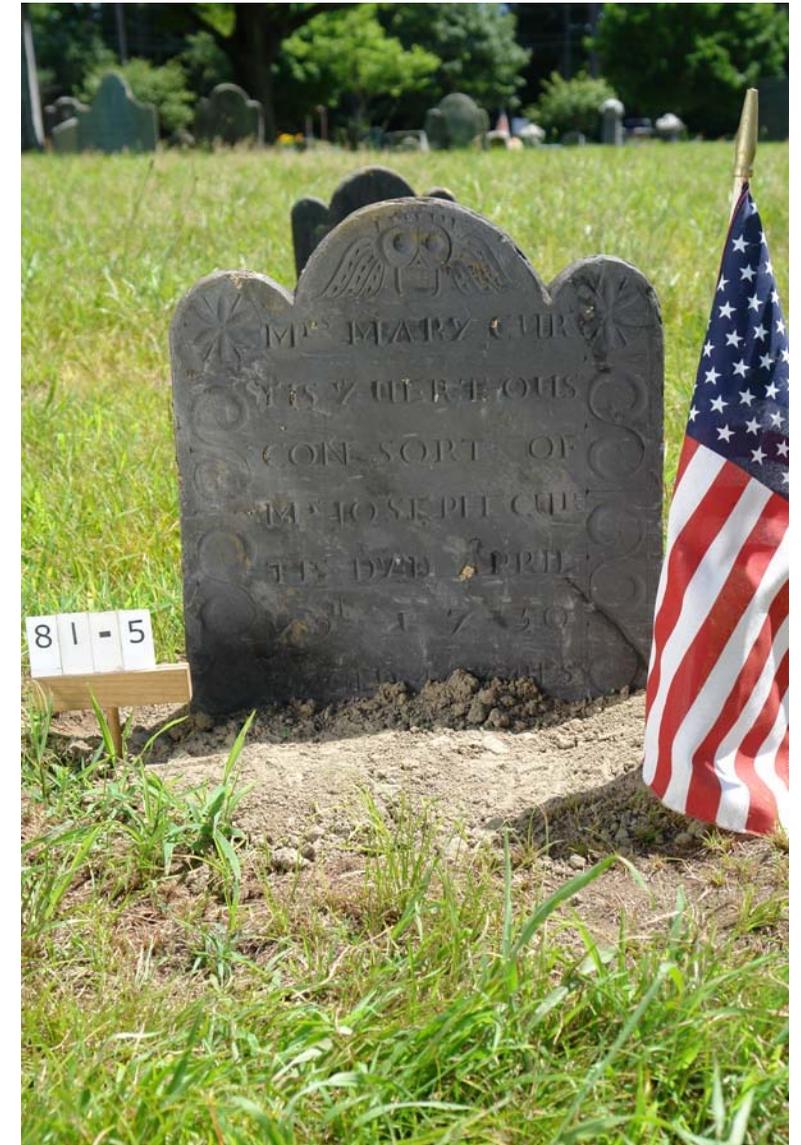
Fractured below grade

1. Marker carefully excavated. The soil around the tilted marker was removed to an appropriate depth. When required, the marker was removed from the ground. Marker appears to be sound and with sufficient height for re-setting.
2. Soling removed by light brushing with nylon brushes and water.
3. Setting area excavated to sufficient depth and stone re-set plumb at appropriate height and level onto gravel bed, aligned with adjacent markers
4. Area backfilled around marker with tamped sand and gravel
5. Disturbed areas re-graded with existing topsoil and sod.
6. Surfaces treated with D/2, scrubbed with nylon bristles and fully rinsed with water
