STONE CONSERVATION TREATMENTS

Hanover Center Cemetery, Hanover, MA

July, 2012

Documentation of Restorations to Center Cemetery

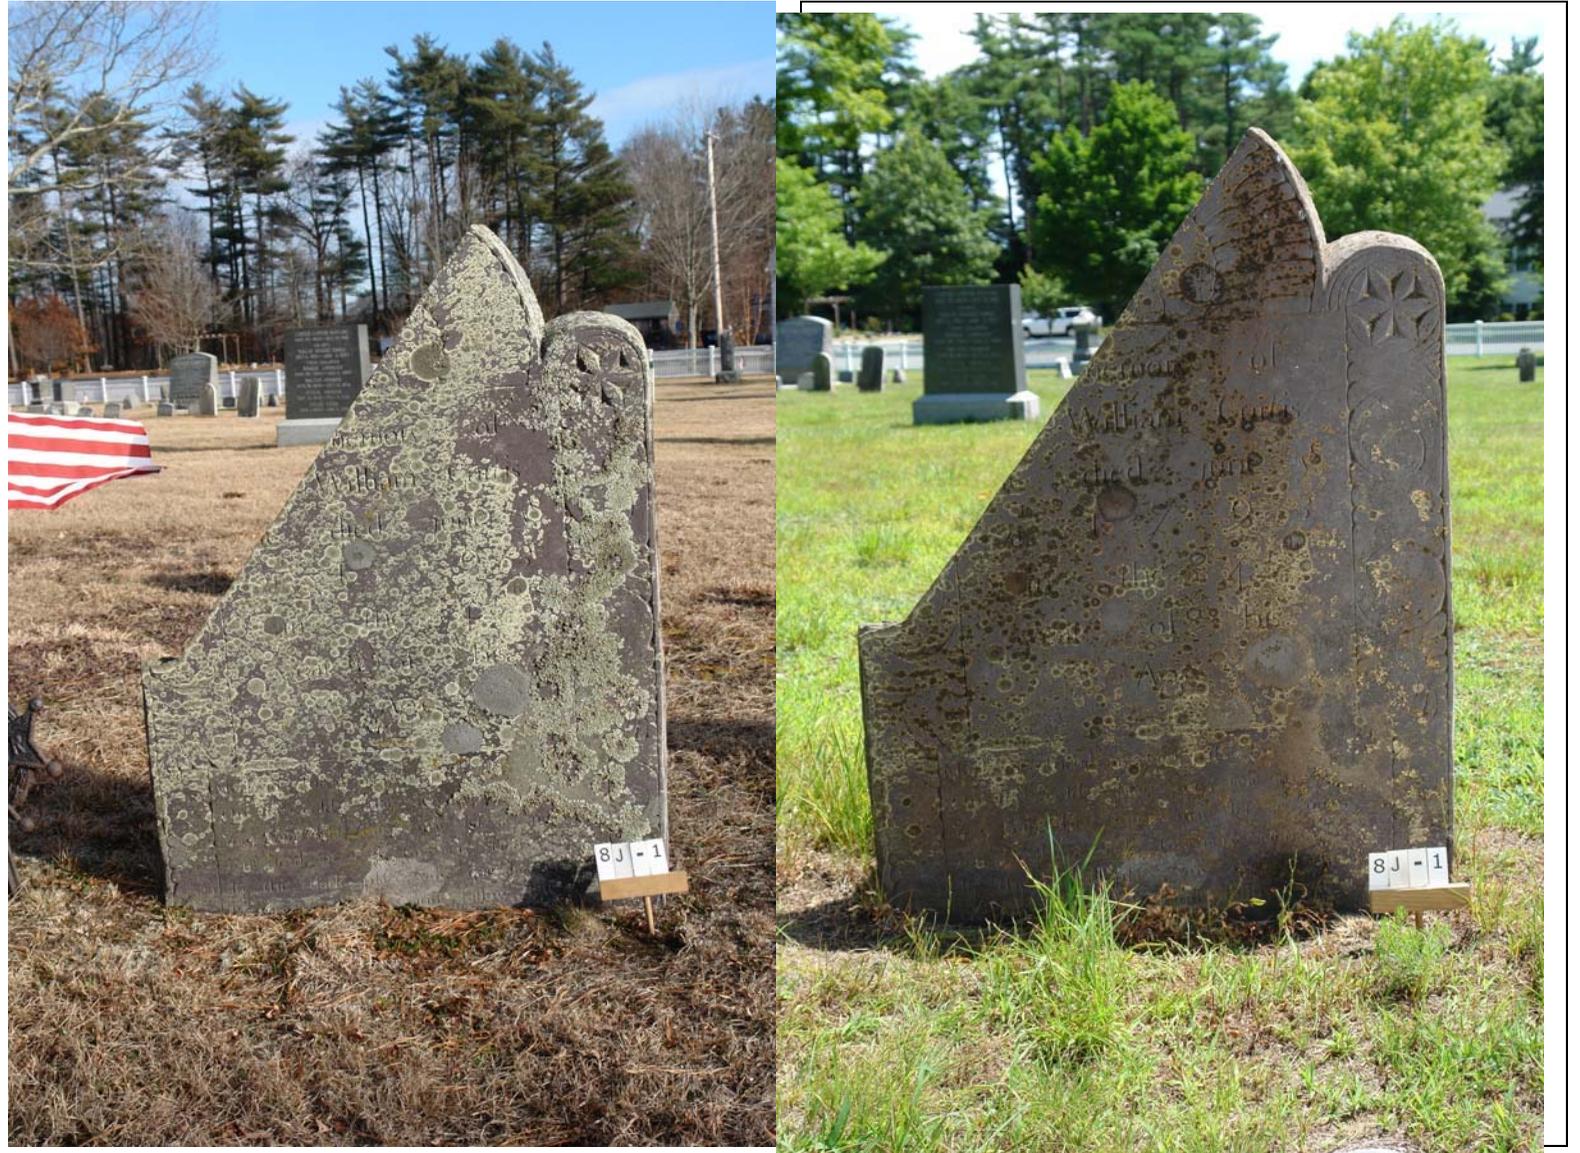
Fractured  
Missing elements

1. No fragments were found after extensive probing and searching in cemetery.
2. Surface treated with D/2 biological solution. Lichens were removed with plastic or wood hand trowels. Application of D/2 was repeated as necessary and scrubbed with nylon brushes. Fully rinsed with water

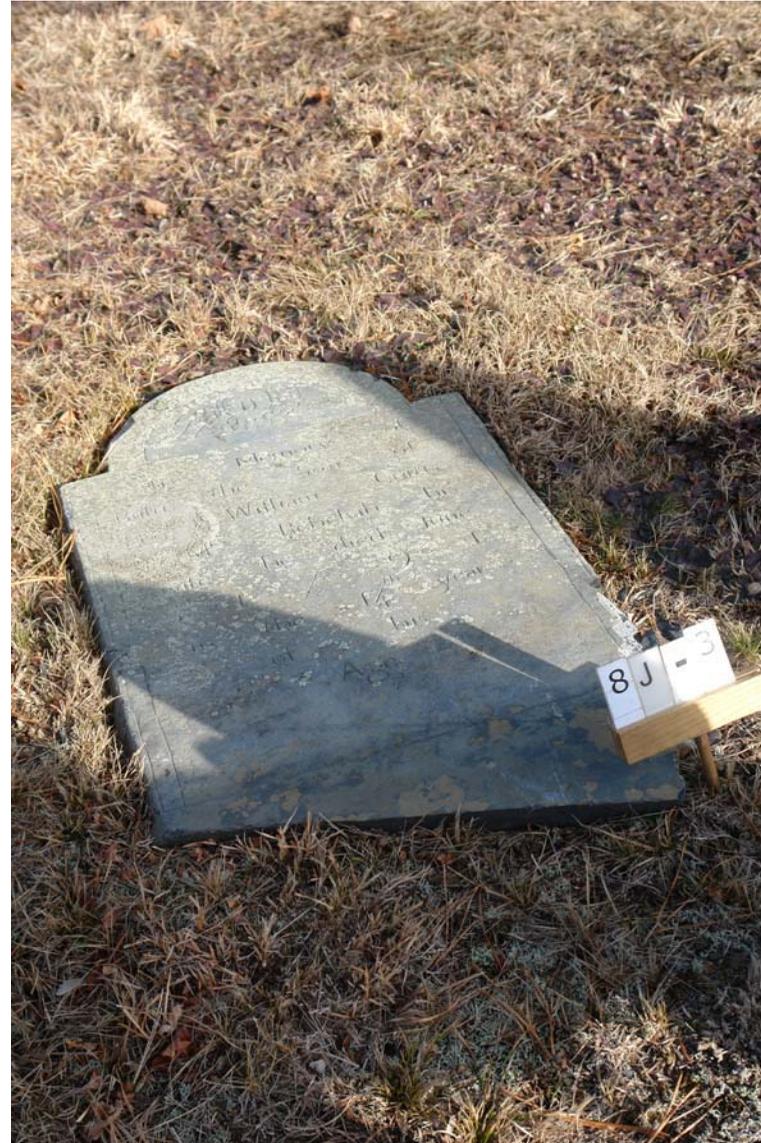
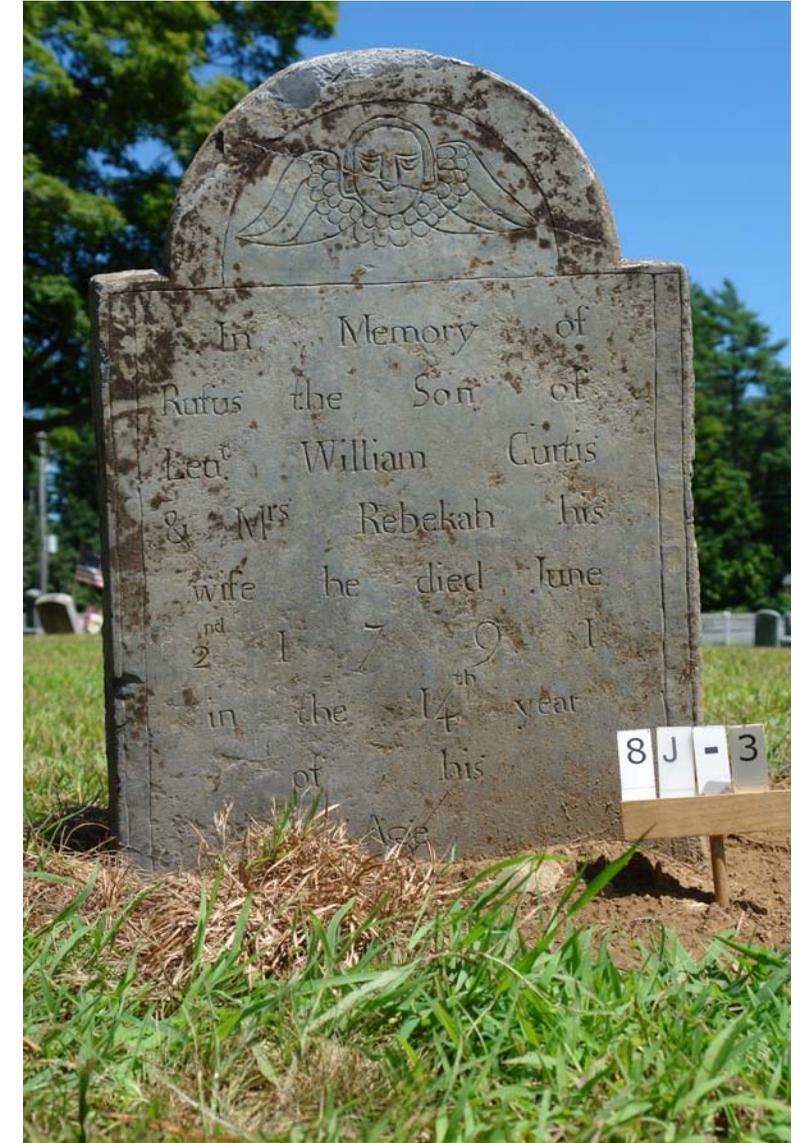
Below grade fracture

1. Setting area excavated, no additional fragments or base discovered.
2. A new below grade concrete base was cast in place. After partial curing, setting forms were removed and the base backfilled with tamped sand or gravel.
3. When required, lower edge of marker re-squared with minimal loss using a power grinder.
4. Marker reset plumb and level into slot using a cement/lime grout. Braced for min. 5 days.
5. Disturbed areas re-graded with existing topsoil and sod.
6. Surfaces treated with D/2, scrubbed with nylon bristles and fully rinsed with water.

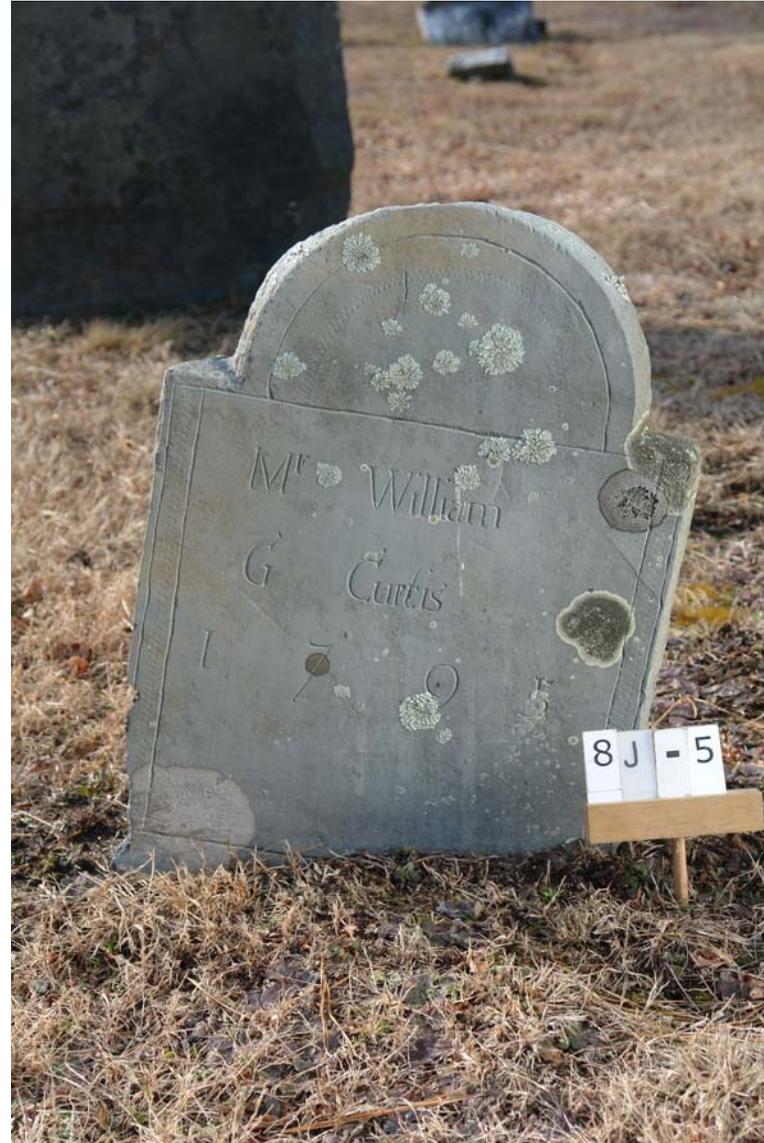
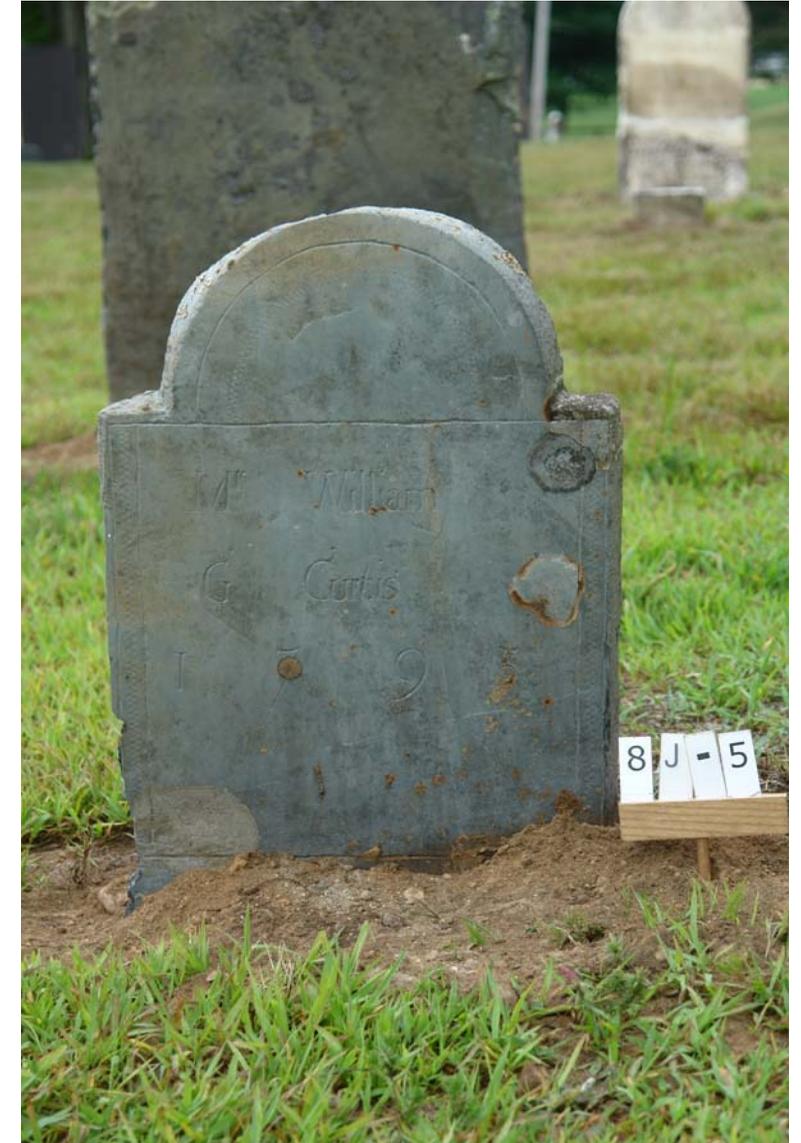
No delaminations discovered

1. Marker carefully excavated. Soil around tilted marker removed to an appropriate depth. Marker appears to be sound.
2. When required, marker is removed from the ground.
3. Surface soiling removed by light brushing with nylon brushes and water.
4. When setting area is excavated to sufficient depth stone is re-set plumb and level onto gravel bed, aligned with adjacent markers.
5. Area backfilled around marker with tamped sand and gravel.
6. Disturbed areas re-graded with existing topsoil and sod.
7. Surfaces treated with D/2 biological solution, scrubbed with nylon bristles and fully rinsed with water

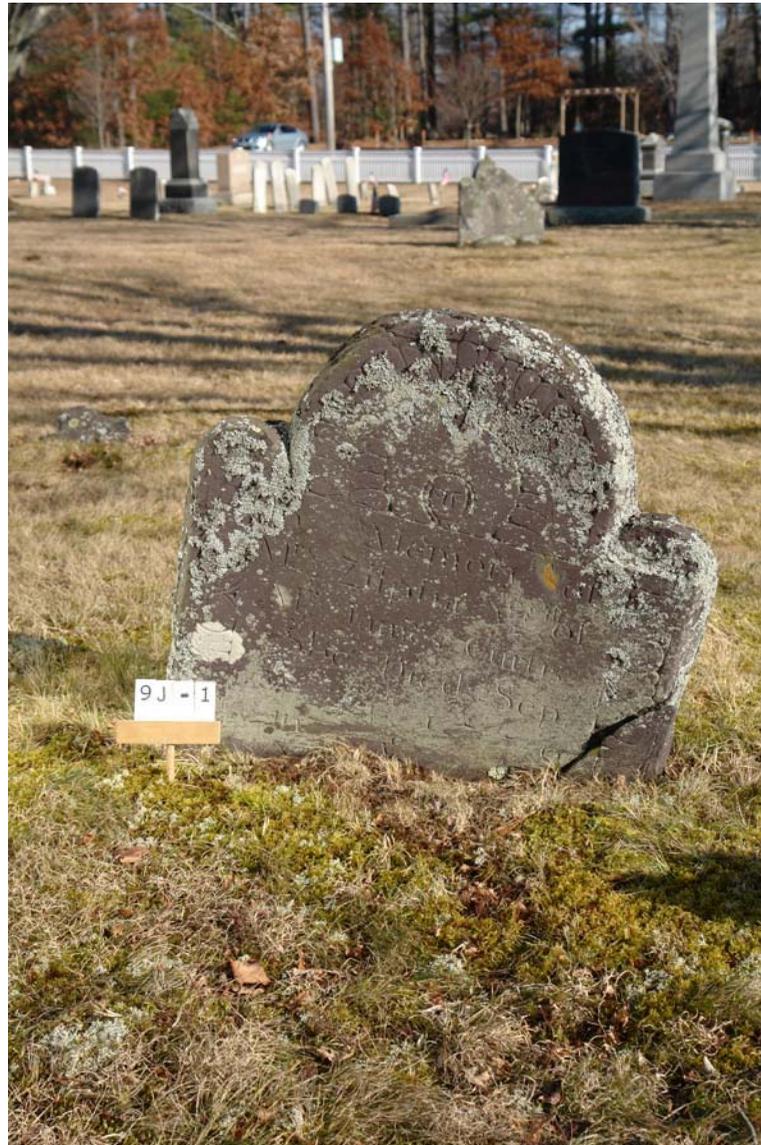
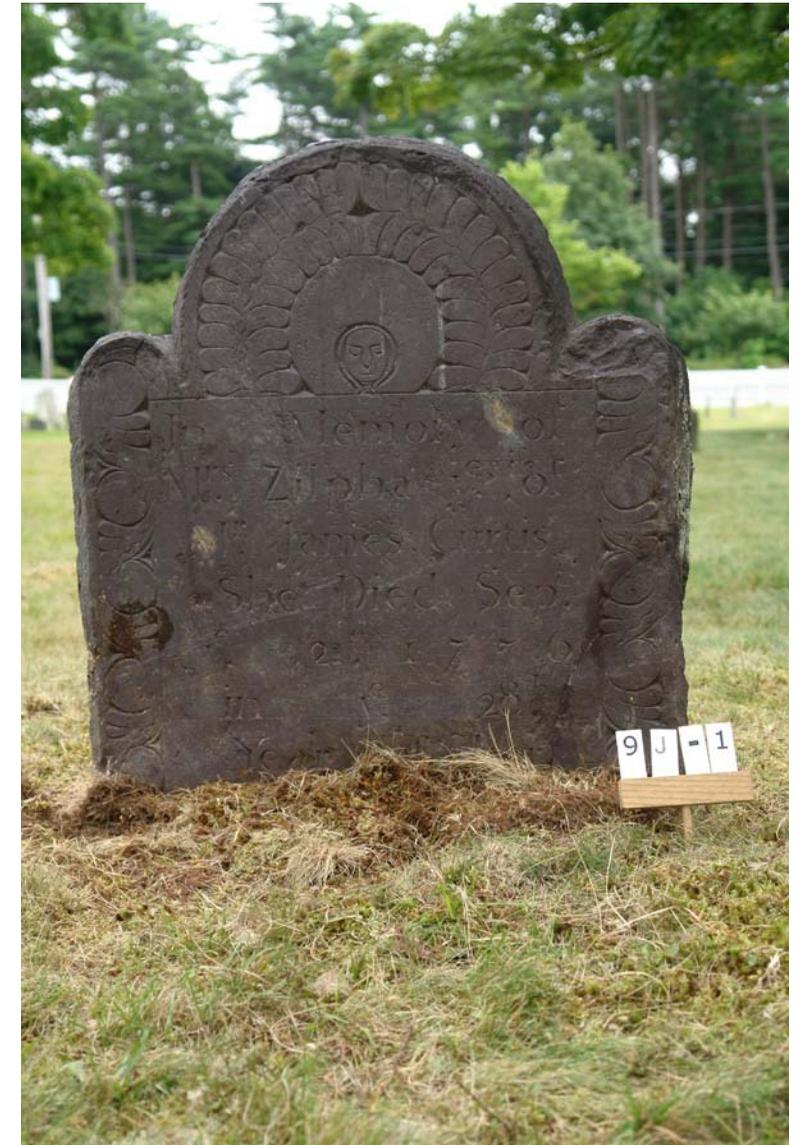
Tilted  
Fractured

1. Fragment(s) excavated and area probed for missing pieces.
2. Lower fragment reset plumb at appropriate height, aligned with adjacent markers.
3. Any failed adhesives or mortar removed.
4. Mating surfaces of fragment(s) treated with D/2 biological solution and scrubbed with nylon brushes, then rinsed with water.
5. Fragment(s) attached with structural adhesive, and braced until cured.
6. Cracks and surface losses filled with pigmented Sto crack fill, excess material immediately removed with a damp sponge

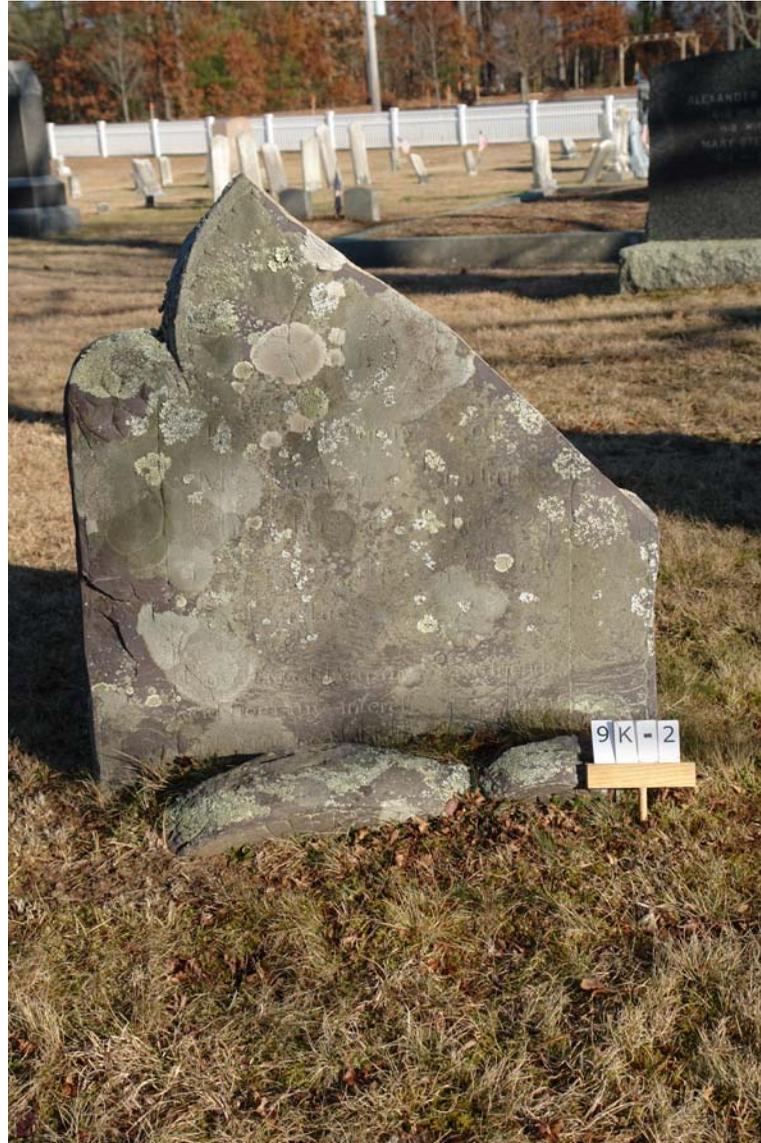
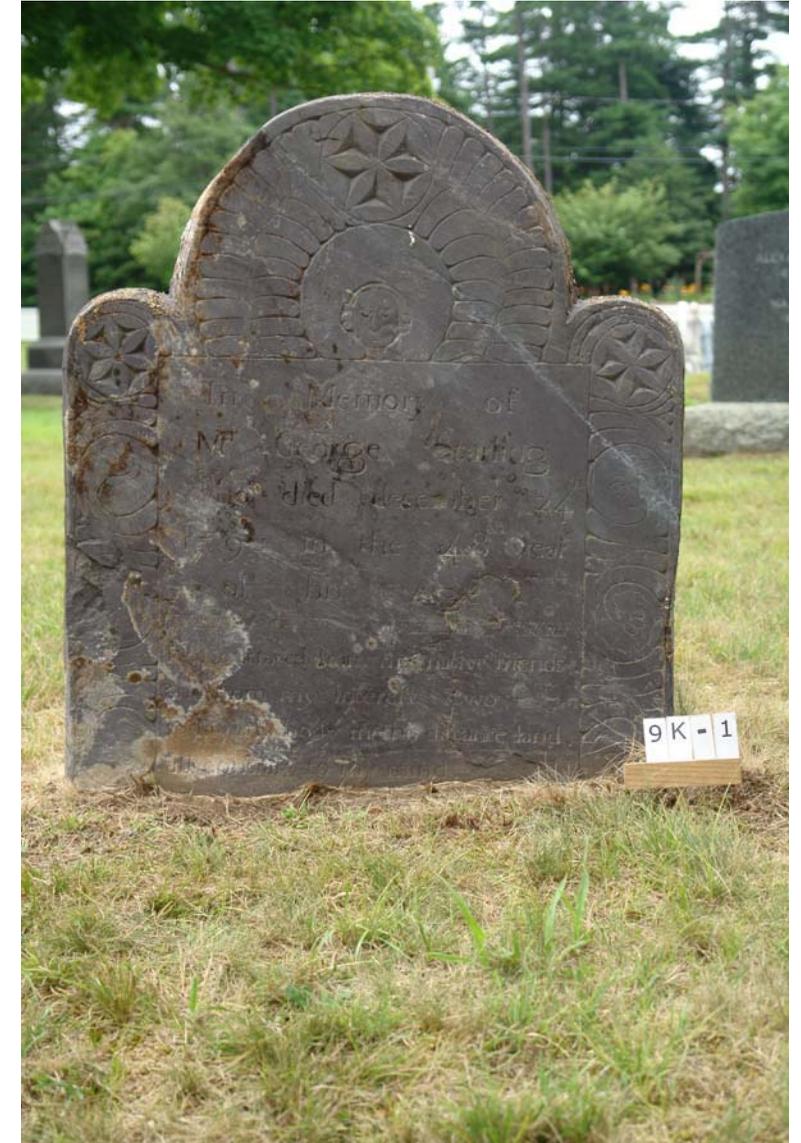
Tilted  
Fractured

1. Fragment(s) excavated and area probed for any missing elements
2. Mating surfaces of fragment(s) cleaned and failed adhesives or mortar removed.
3. All surfaces treated with D/2 biological solution and scrubbed with nylon brushes, then rinsed with water.
4. Fragment(s) attached with structural adhesive (Abatron 55-22), and braced until cured.
5. Cracks and losses filled with pigmented RepliCal and Jahn products, misted and wrapped for min 3 days.
6. Any excess fill material on adjacent surfaces treated with acetic acid, brushed, and fully rinsed with water.

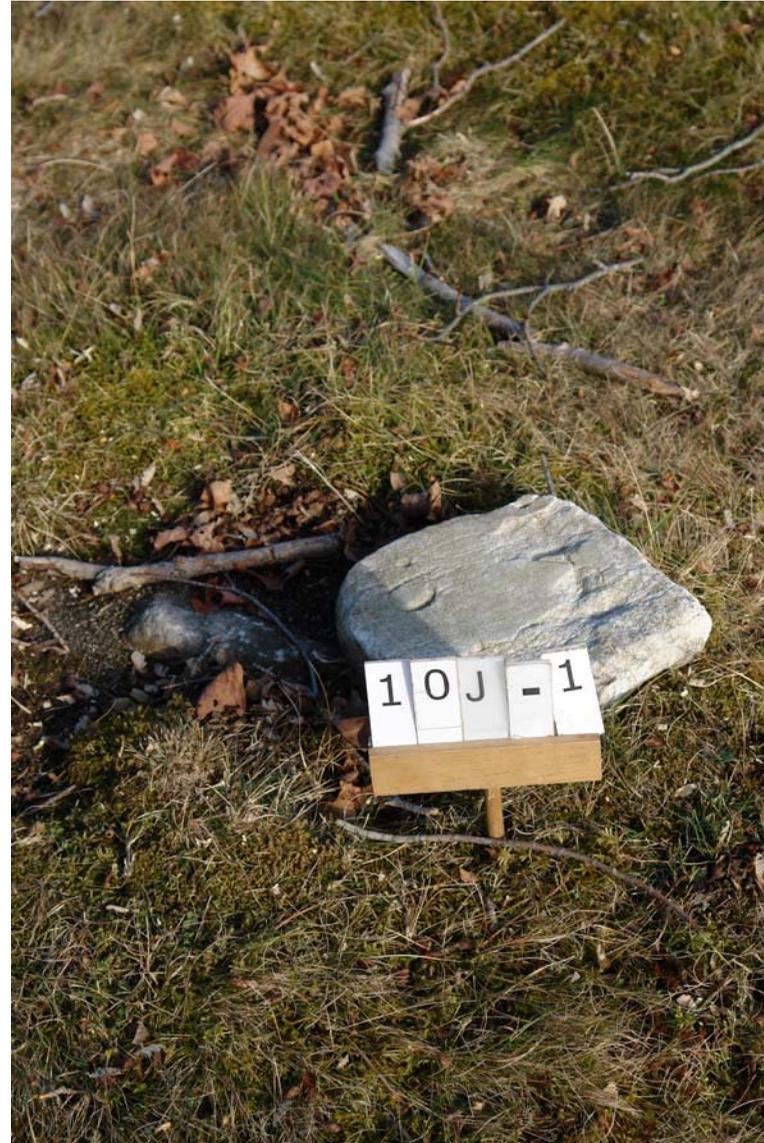
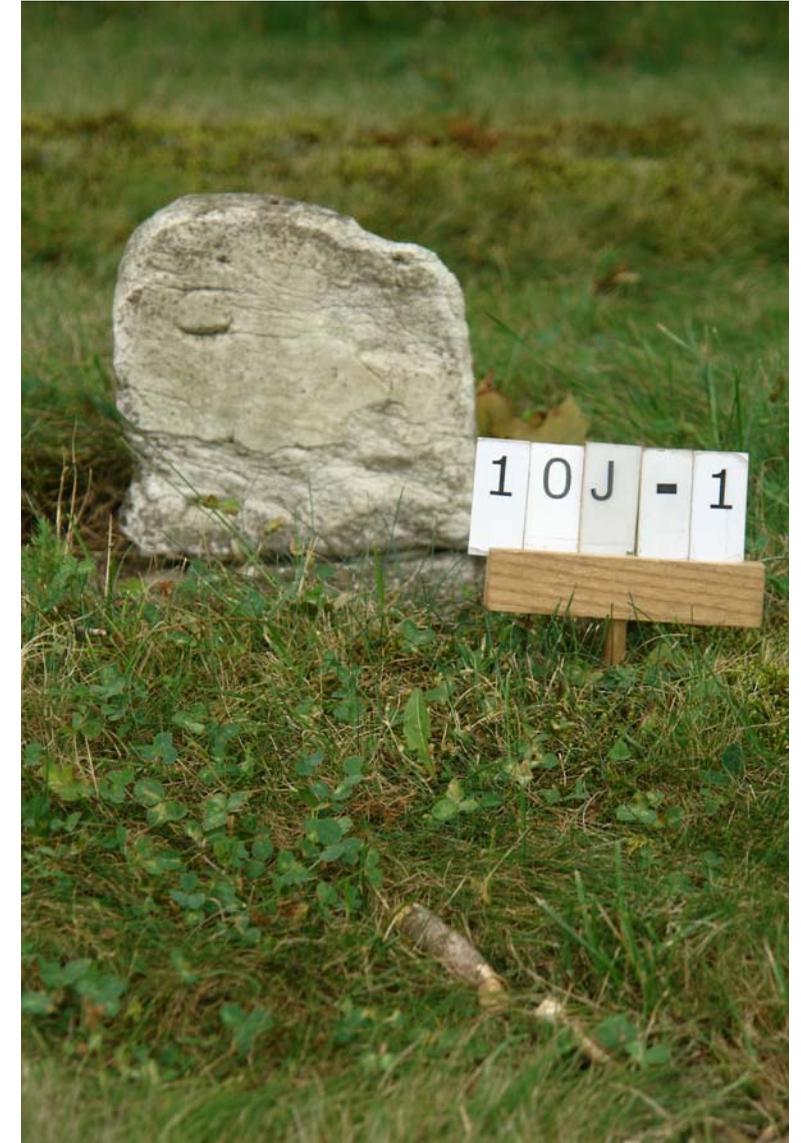
Fractured

Material found to be extensively weathered, sugaring and fragile with limited conservation procedures available.  
1. Fragment attached with structural adhesive.

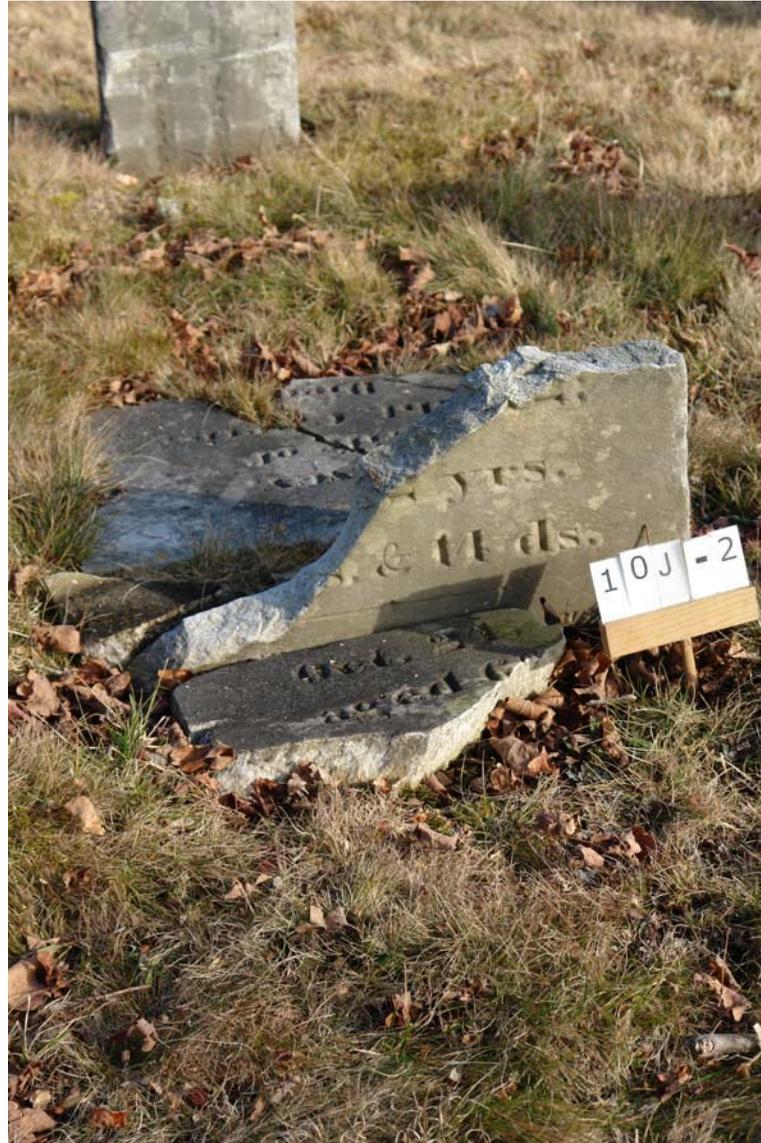
Multiple fractures

Evaluate if marker is restorable. Marker is fragile

1. Clean mating surfaces and remove any failed adhesives or mortar
2. Attach fragments with structural adhesive, brace and clamp until cured.
3. Fill cracks and losses with RepliCal and Jahn products.
4. Mist filled areas with water and cover for 3 days minimum
5. Treat filled surface areas with light acid wash and rinse thoroughly
6. Stone treated with D/2 biological solution. All surfaces rinsed fully with water.

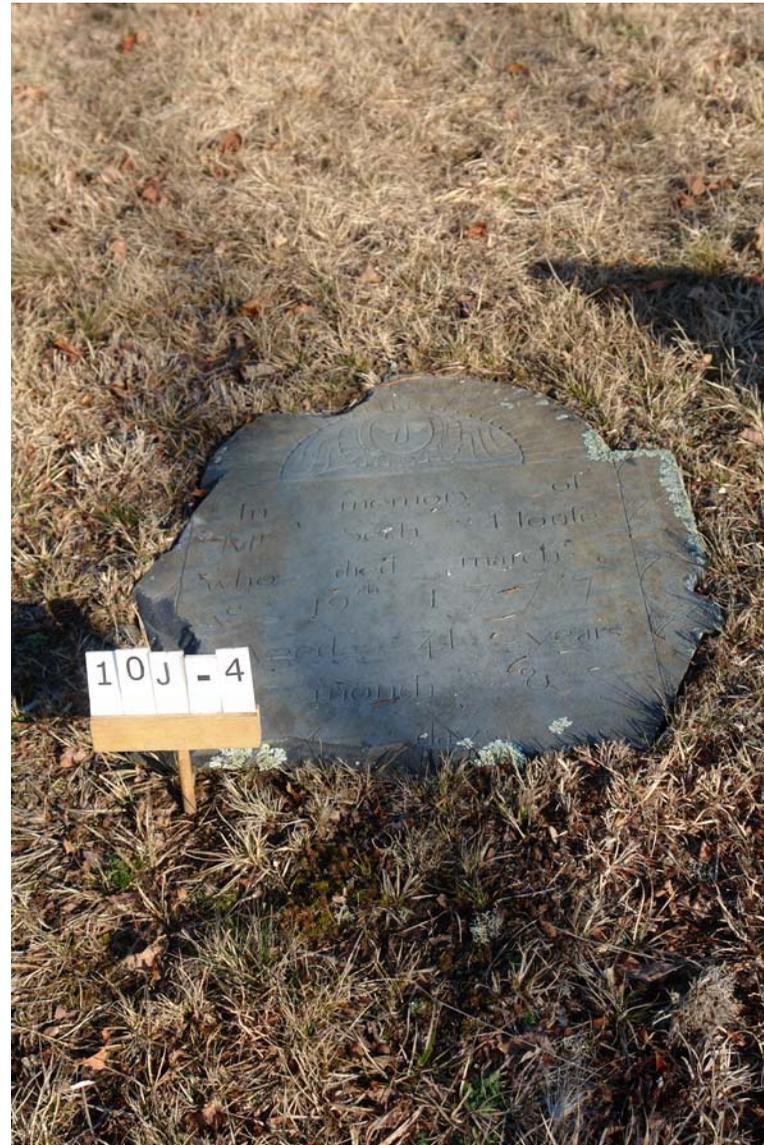
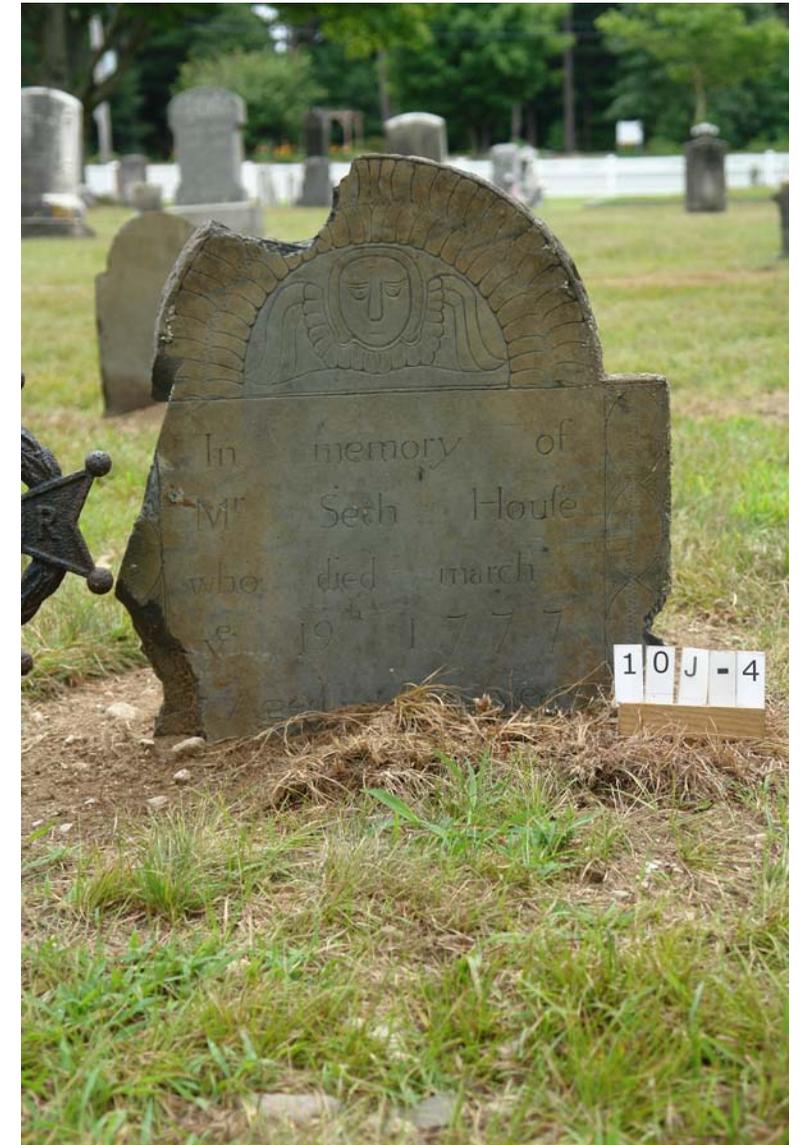
Fractured near grade

1. Setting area excavated, no additional fragments or base discovered.
2. A new below grade concrete base cast in place. After partial curing, setting forms were removed and the base backfilled with tamped sand or gravel.
3. When required, lower edge of marker re-squared with minimal loss using a power grinder.
4. Marker reset plumb and level into slot using a cement/lime grout. Braced for min. 5 days.
5. Disturbed areas re-graded with existing topsoil and sod.
6. Surfaces treated with D/2, scrubbed with nylon bristles and fully rinsed with water

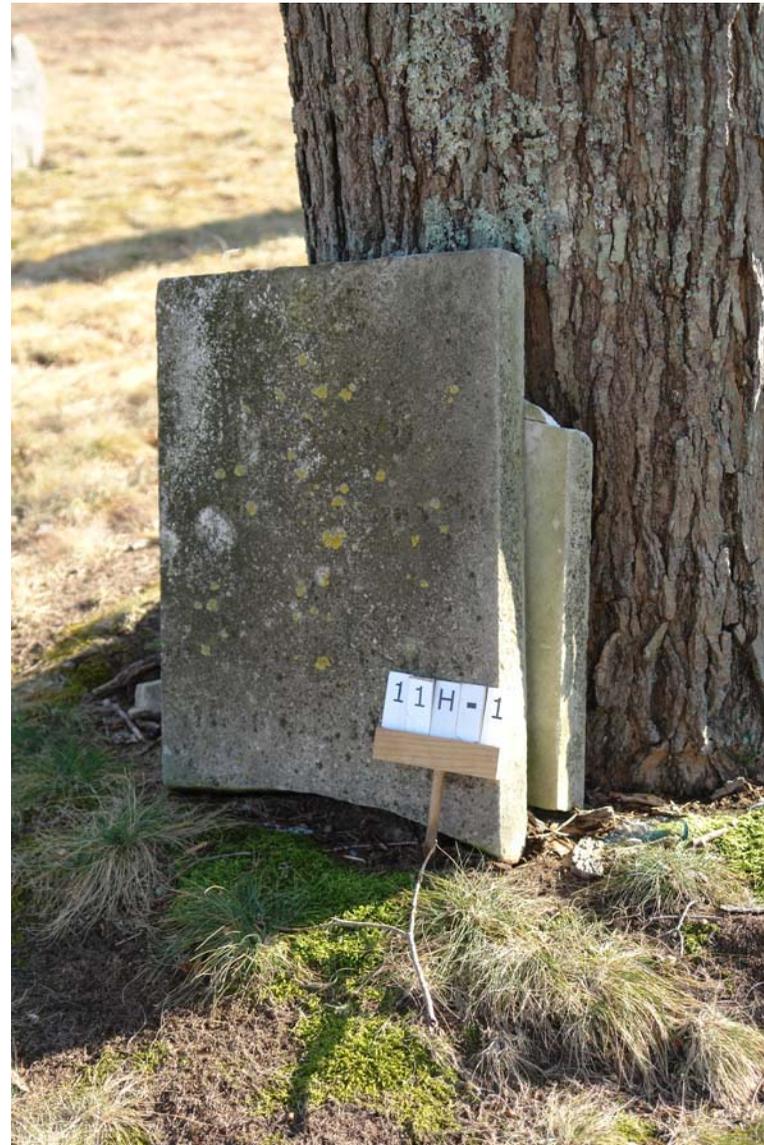
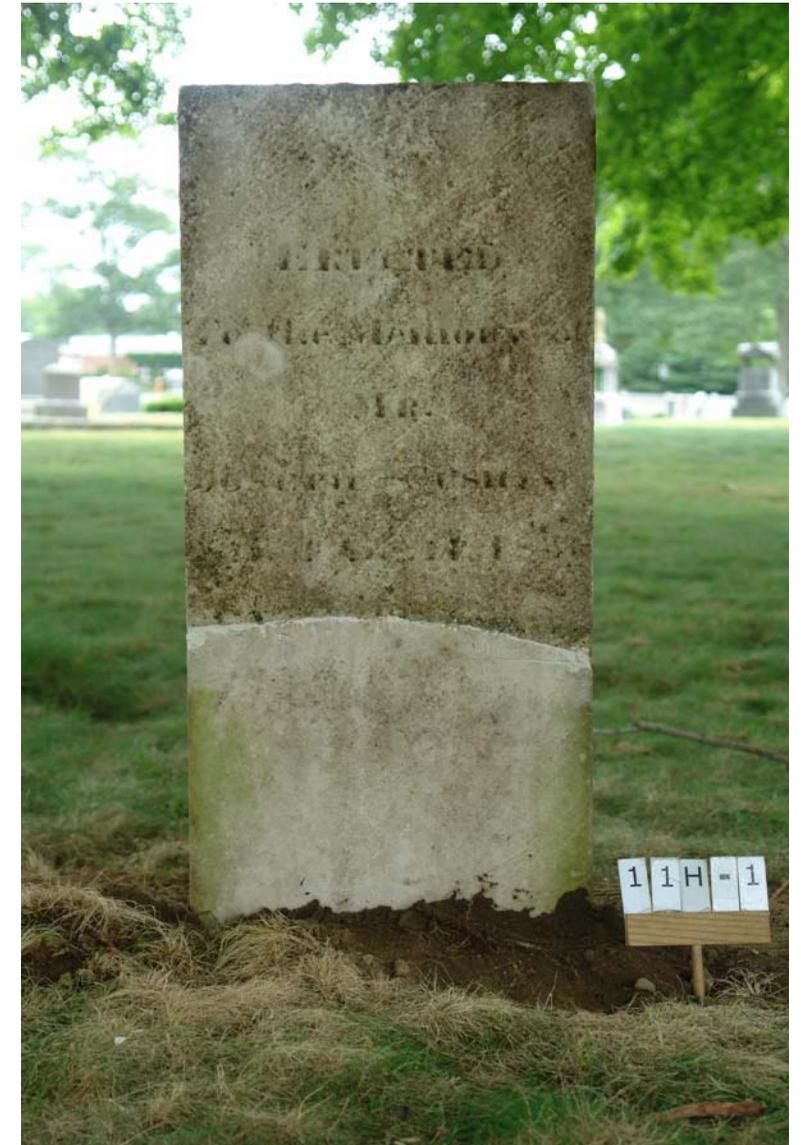
Fractured

1. Upon excavation of in ground fragment, old sandstone base located.
2. Base excavated and determined sound, slot cleaned, and base reset level at a higher elevation.
3. Lower fragment reset plumb and level into slot using a cement/ lime grout. Braced for min. 5 days.
4. Mating surfaces of fragment(s) cleaned and any failed adhesives or mortar removed.
5. Fragment(s) attached with structural adhesive, and braced until cured.
6. Cracks and losses filled with RepliCal and Jahn products, misted and wrapped min. 3 days.
7. After partial cure, any excess fill material on adjacent surfaces treated with acetic acid, brushed, and fully rinsed with water.

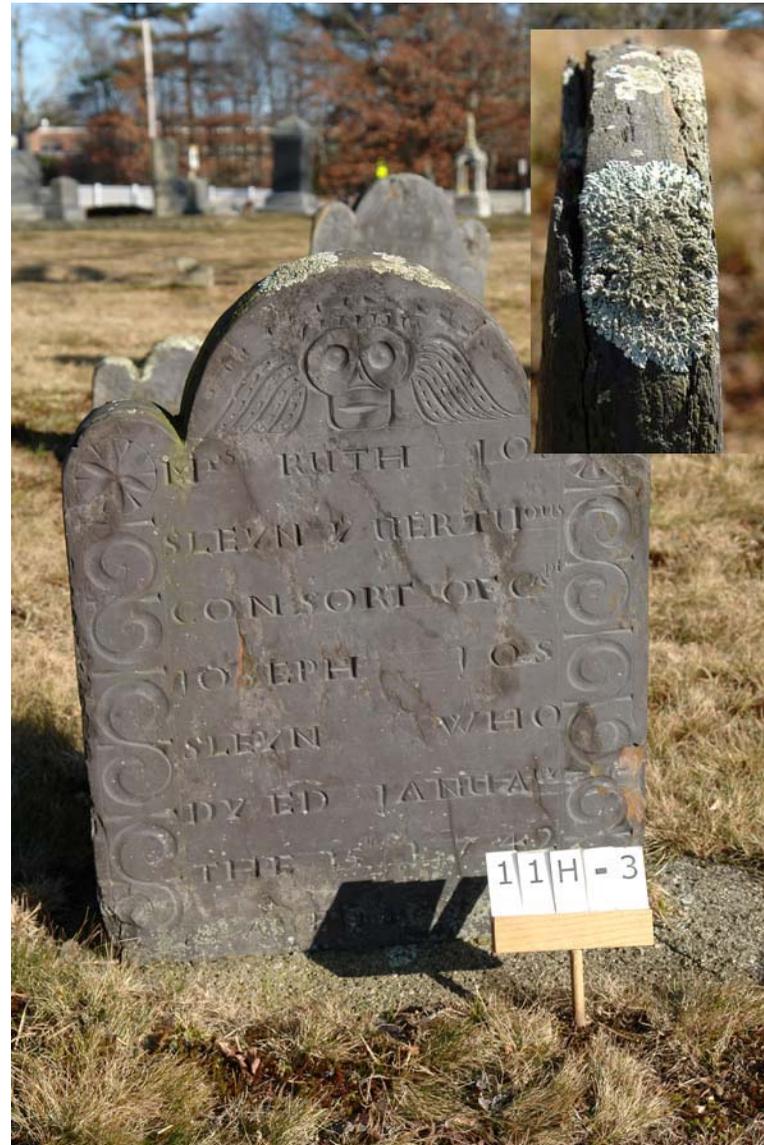
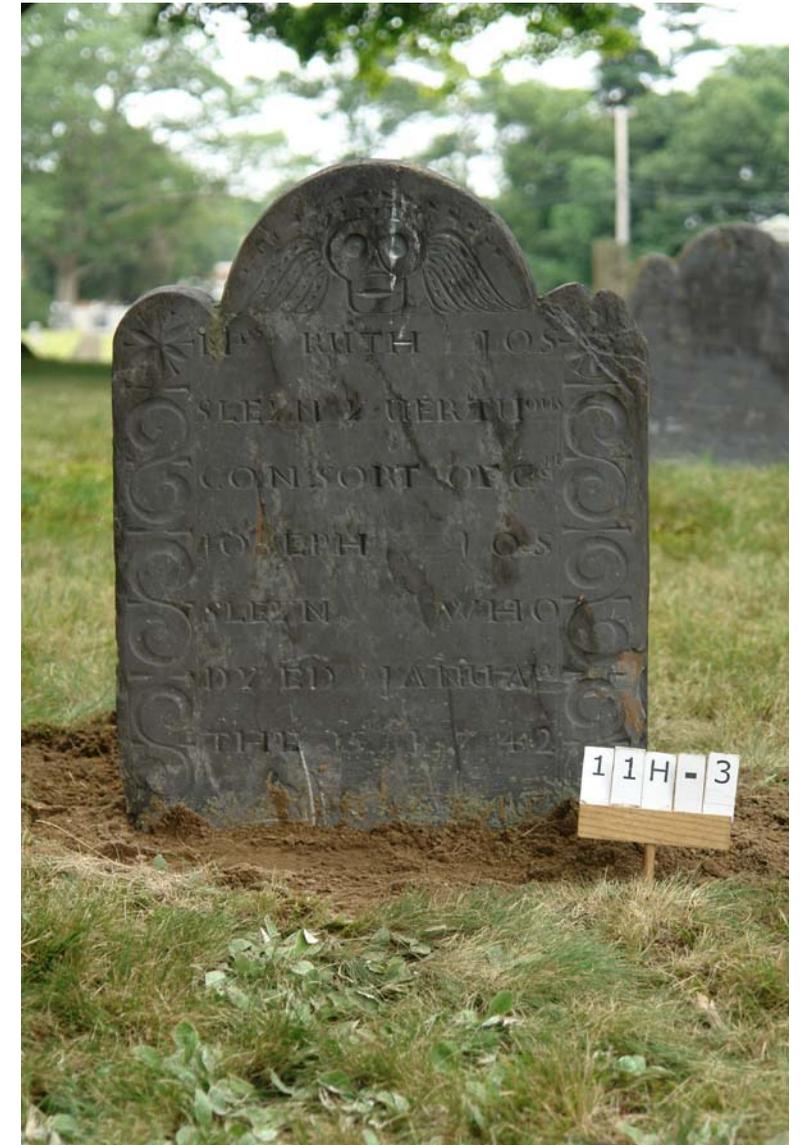
**EXISTING CONDITIONS**

1. Marker carefully excavated. Soil around tilted marker removed to an appropriate depth. When required, marker is removed from the ground. Marker appears to be sound.
2. Soling removed by light brushing with nylon brushes and water.
3. Setting area excavated to sufficient depth and stone re-set plumb at appropriate height and level onto gravel bed, aligned with adjacent markers.
4. Area backfilled around marker with tamped sand and gravel.
5. Disturbed areas re-graded with existing topsoil and sod.
6. Surfaces treated with D/2 biological solution, scrubbed with nylon bristles and fully rinsed with water.
7. All voids caused by splitting or delaminations at top edge of marker filled with a pigmented Sto crack fill. Excess material immediately removed with a damp sponge. Voids along sides of monument left open to allow escape of any accumulation of water.

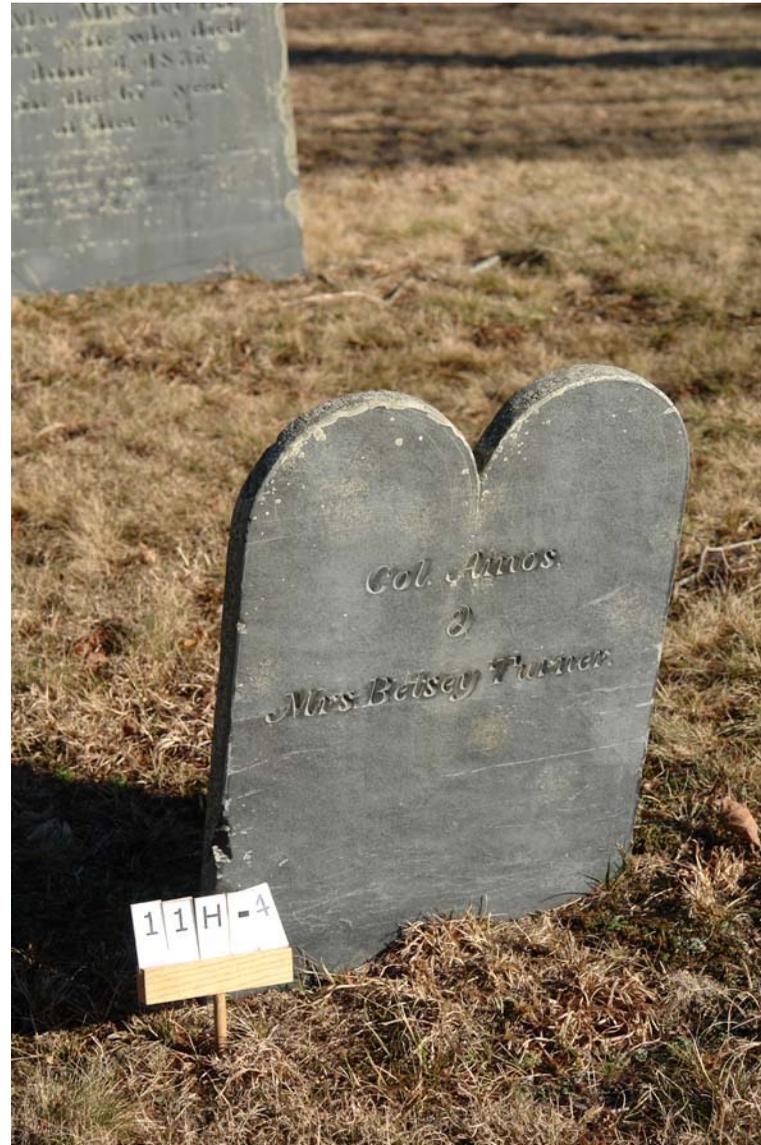
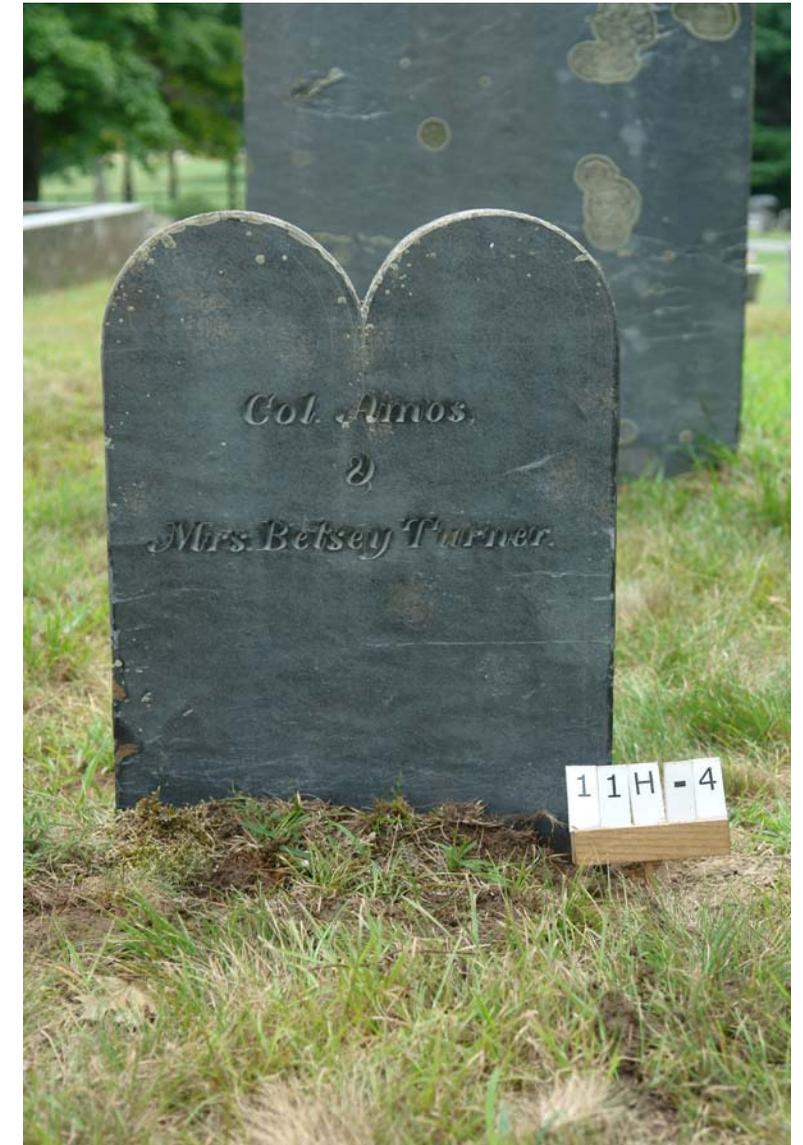
**EXISTING CONDITIONS**

1. Marker carefully excavated. Soil around tilted marker removed to an appropriate depth. Marker appears to be sound.
2. When required, marker is removed from the ground.
3. Surface soiling removed by light brushing with nylon brushes and water.
4. When setting area is excavated to sufficient depth stone is re-set plumb and level onto gravel bed, aligned with adjacent markers, facing East.
5. Area backfilled around marker with tamped sand and gravel.
6. Disturbed areas re-graded with existing topsoil and sod.

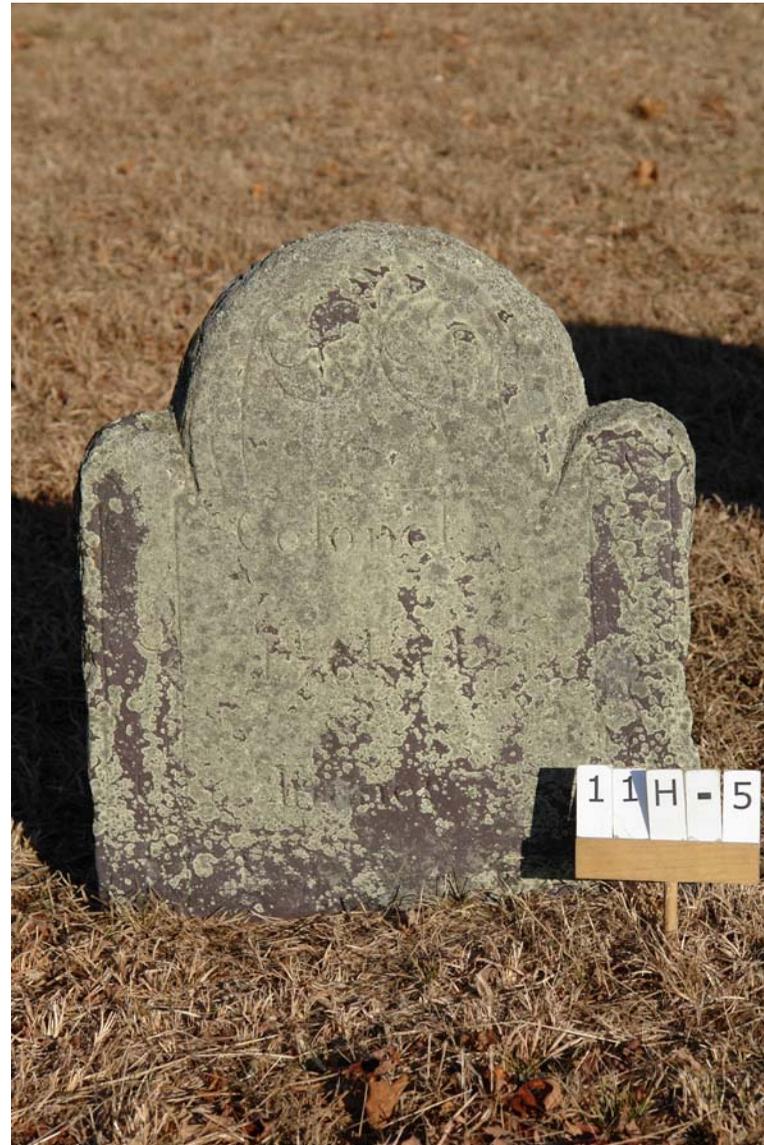
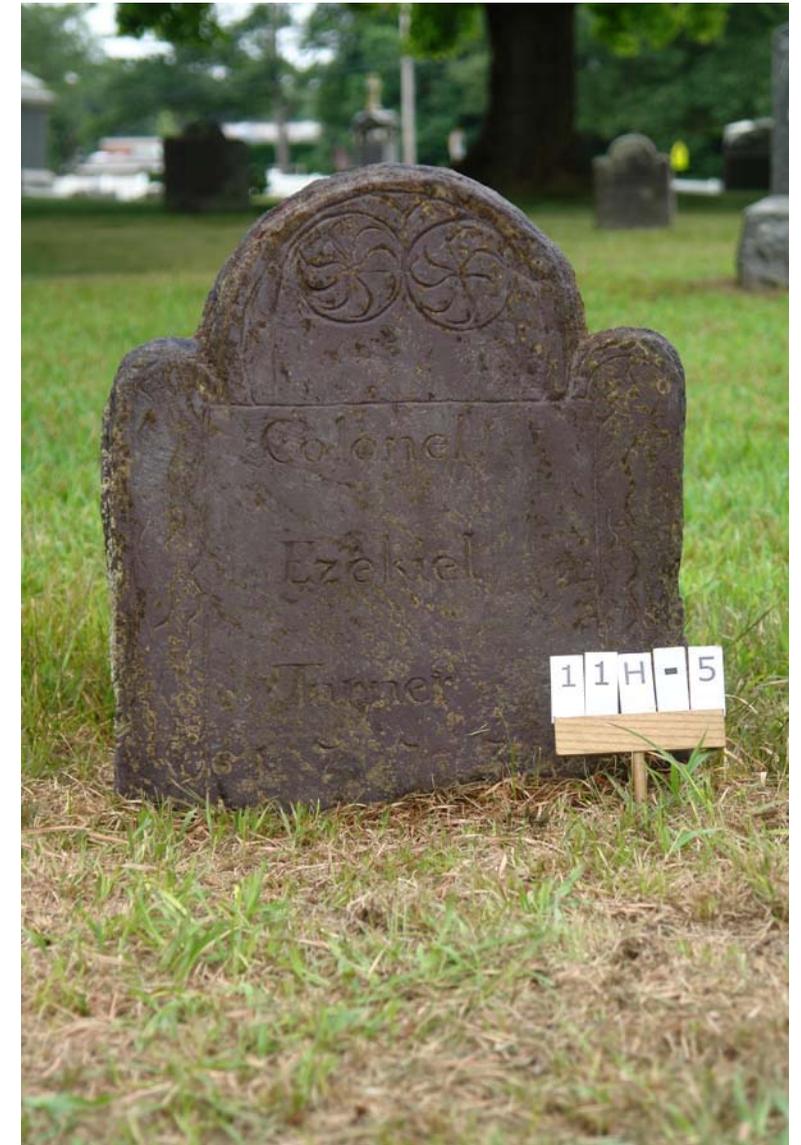
**EXISTING CONDITIONS**

1. Treat surfaces with D/2 biological solution. Loosen any lichens with plastic or wood hand trowels. Brush or spray D/2 and scrub with nylon brushes. Rinse fully with water. Repeat as necessary
2. Interior voids flushed with water and any loose debris within voids removed with hand tools.
3. All voids caused by splitting or delaminations at top edge of marker filled with a pigmented Sto crack fill. Excess material immediately removed with a damp sponge. Voids along sides of monument left open to allow escape of any accumulation of water.
