STONE CONSERVATION TREATMENTS

Hanover Center Cemetery, Hanover, MA

July, 2012

Documentation of Restorations to Center Cemetery

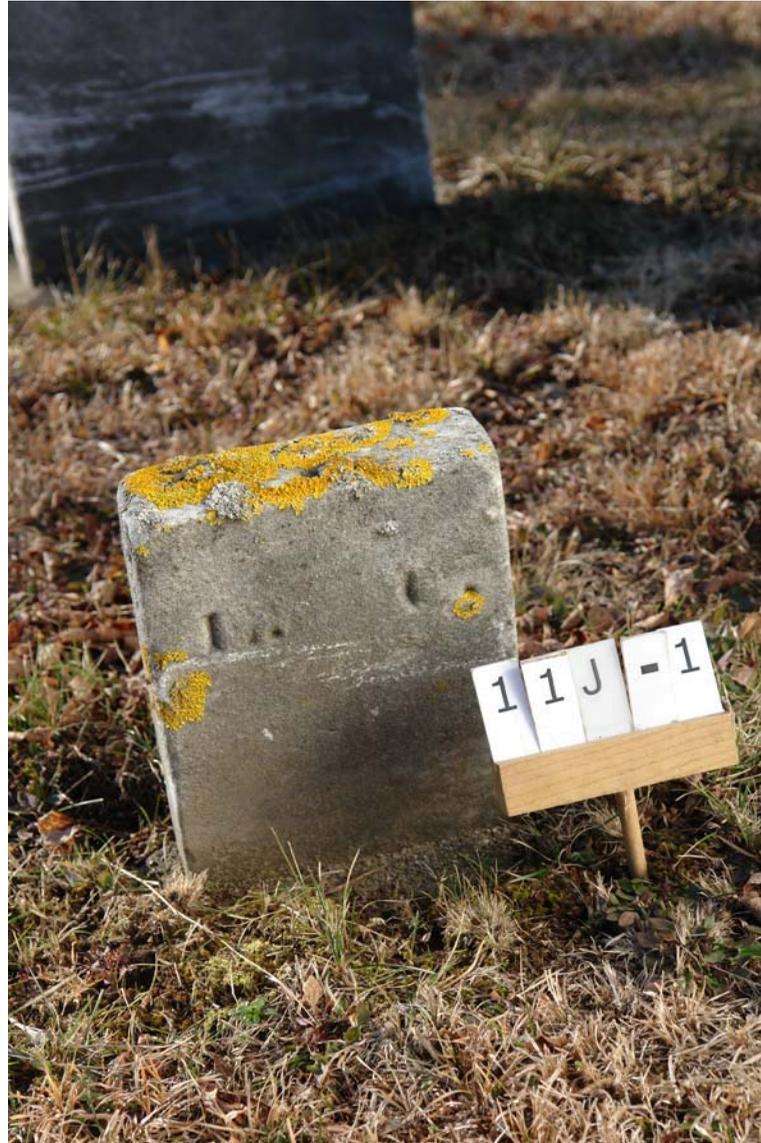
**EXISTING CONDITIONS**

1. Marker carefully excavated. Soil around tilted marker removed to an appropriate depth. Marker appears to be sound.
2. When required, marker is removed from the ground.
3. Surface soiling removed by light brushing with nylon brushes and water.
4. When setting area is excavated to sufficient depth stone is re-set plumb and level onto gravel bed, aligned with adjacent markers.
5. Area backfilled around marker with tamped sand and gravel.
6. Disturbed areas re-graded with existing topsoil and sod.

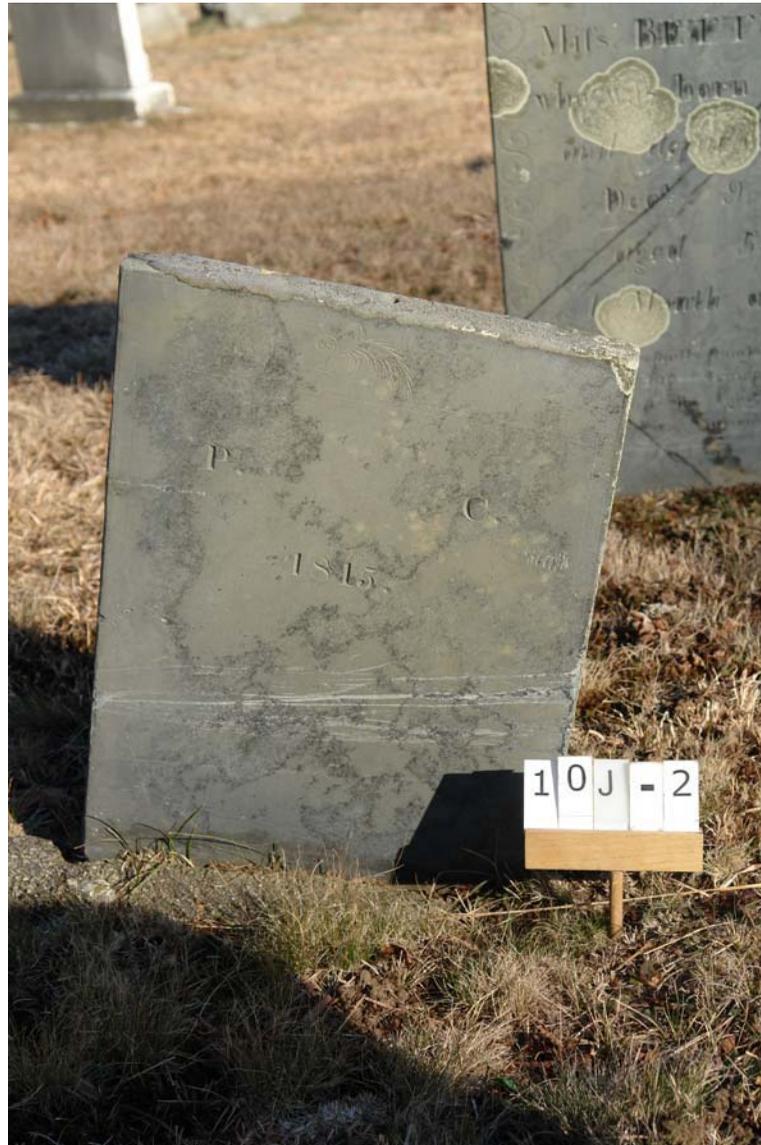
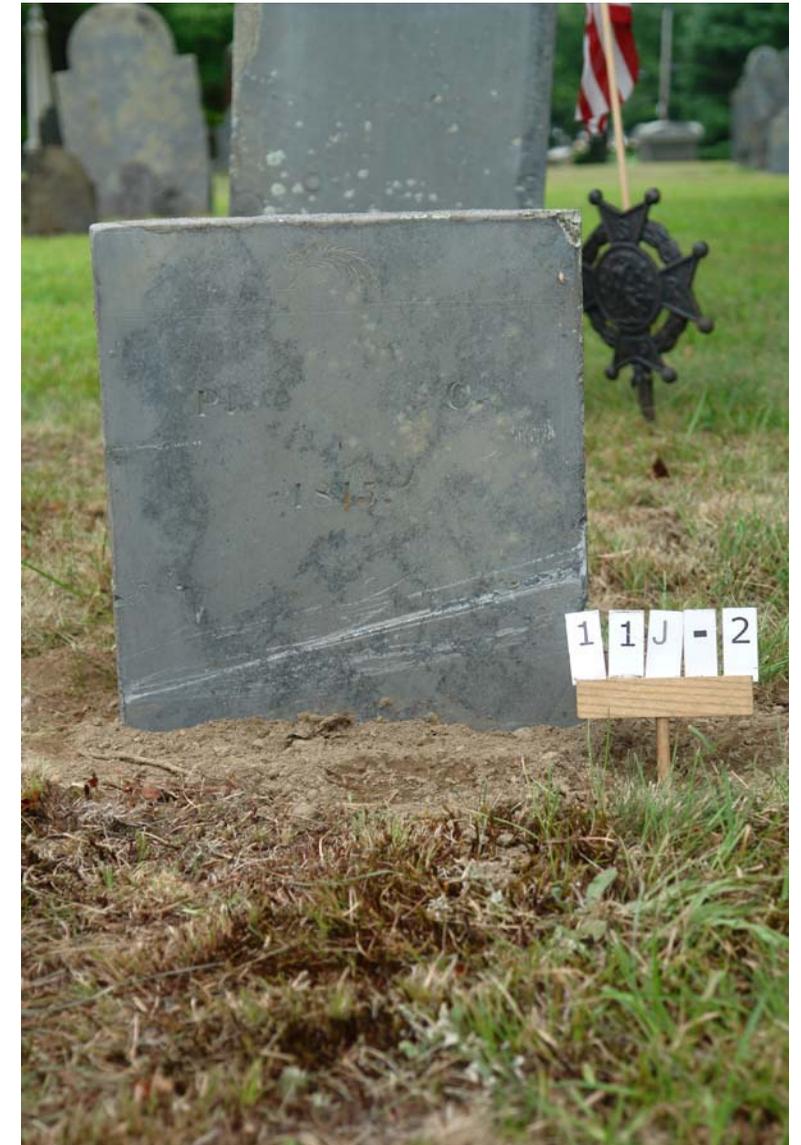
**EXISTING CONDITIONS**

1. Marker carefully excavated. Soil around tilted marker removed to an appropriate depth. Marker appears to be sound.
2. When required, marker is removed from the ground.
3. Surface soiling removed by light brushing with nylon brushes and water.
4. When setting area is excavated to sufficient depth stone is re-set plumb and level onto gravel bed, aligned with adjacent markers, facing East.
5. Area backfilled around marker with tamped sand and gravel.
6. Disturbed areas re-graded with existing topsoil and sod.

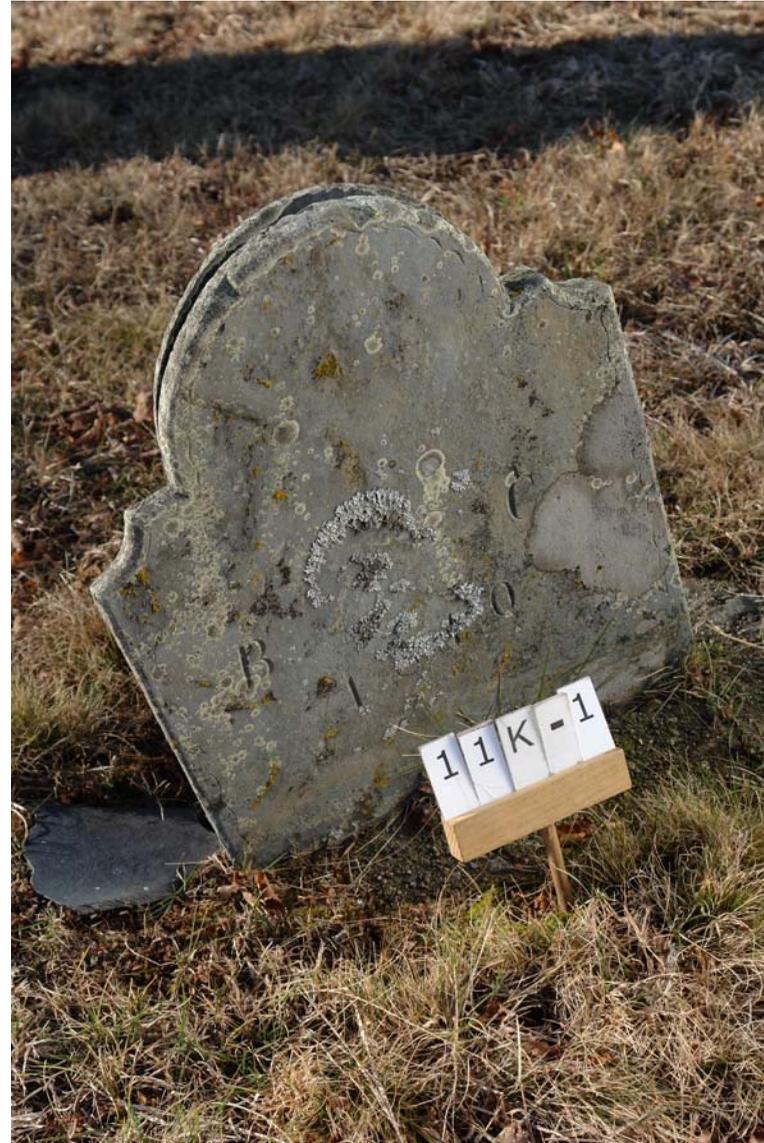
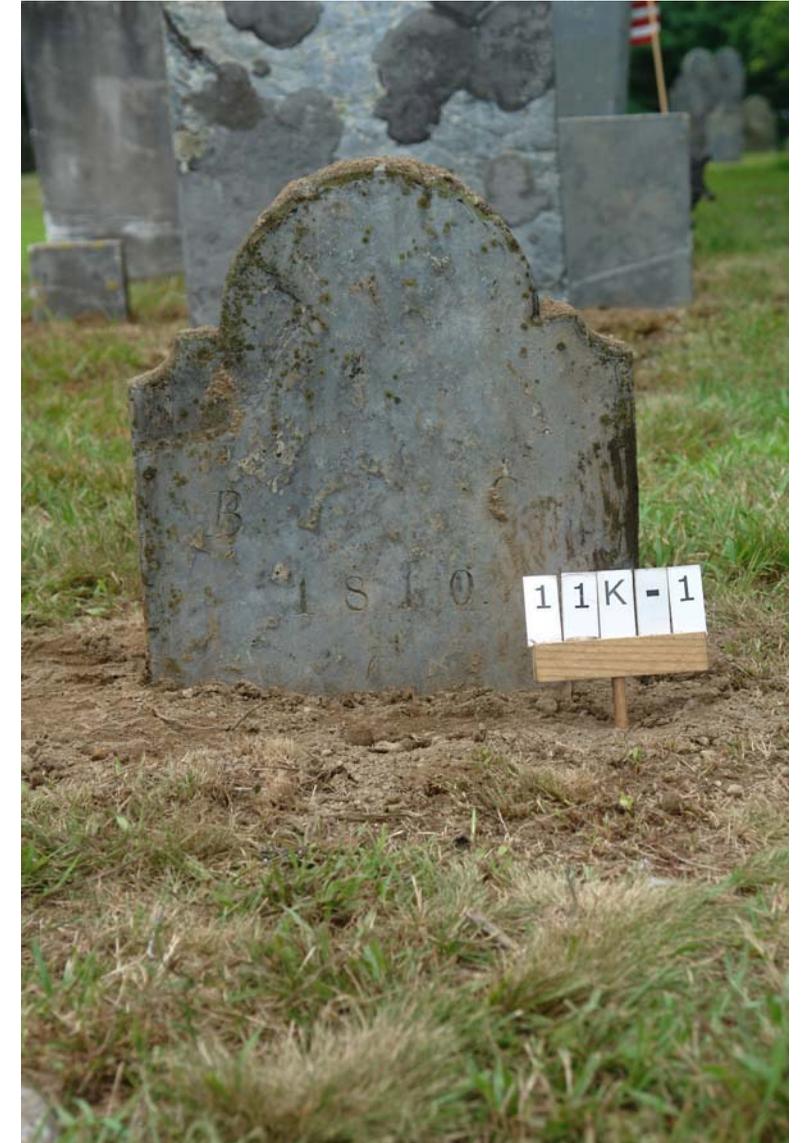
**EXISTING CONDITIONS**

1. Foliated fragments excavated.
2. Failed adhesive removed with hand chisel.
3. Surfaces cleaned with brush and water, small loose foliated surfaces removed.
4. Fragments attached with structural adhesive.
5. When cured, marker reset plumb and aligned with adjacent markers.
