Documentation of Restorations to West Hanover Cemetery

MONUMENT CONSERVATION COLLABORATIVE LLC, NORFOLK, CT

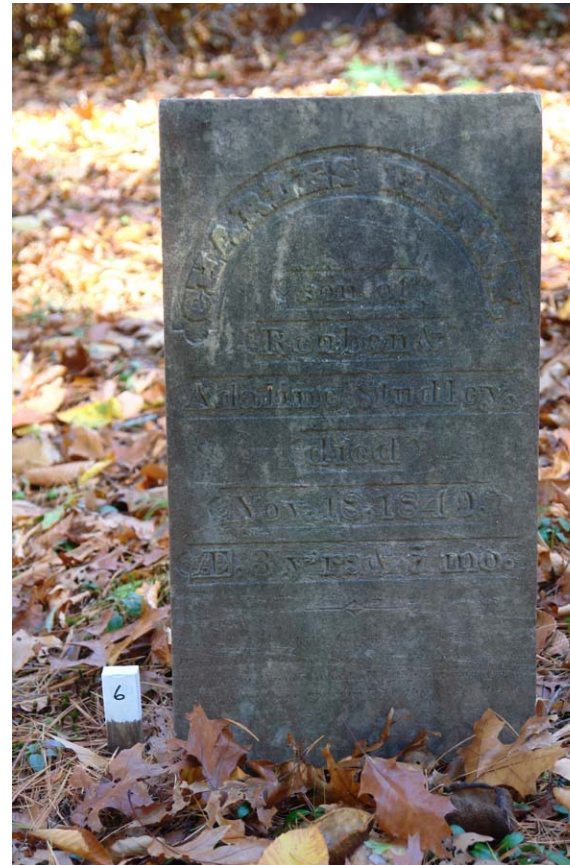
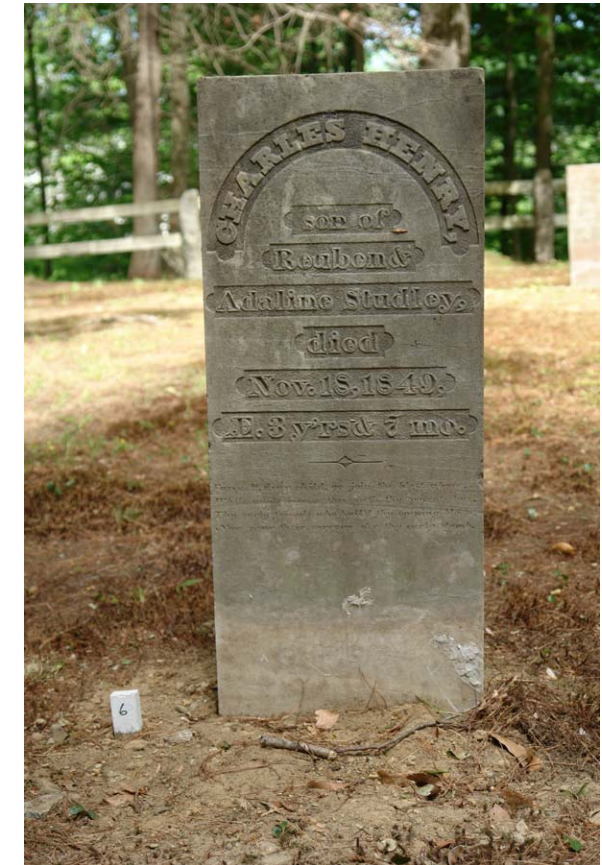
#6, Charles Studley before and after cleaning

Removal of biofilm was with D/2 Biological Solution. It is an aqueous antibacterial solution that also aids in the removal of algae, fungi and other organisms. After application and scrubbing with soft brushes, surfaces are fully rinsed with water. Stubborn, well-attached growths will slowly release their grip in a short amount of time and the stone will appear cleaner.

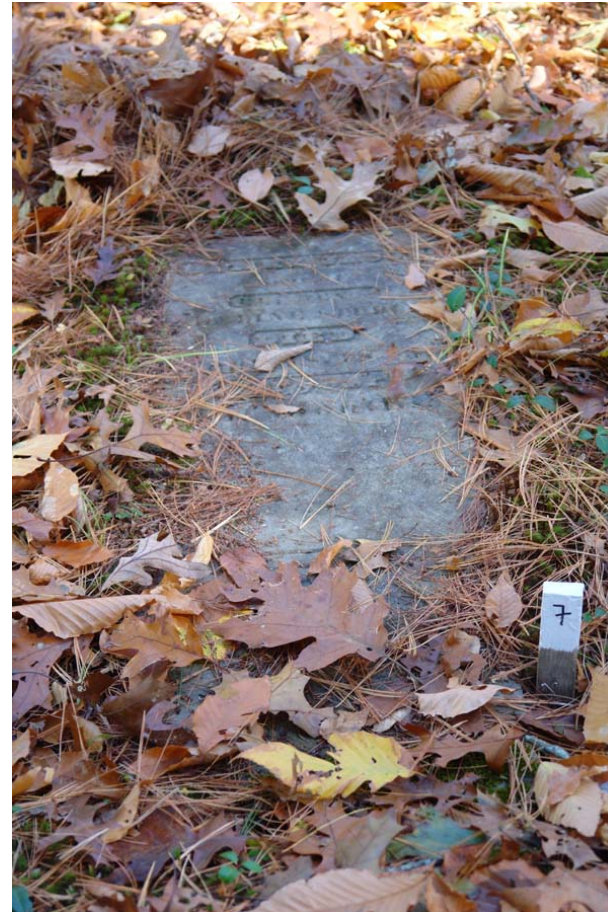
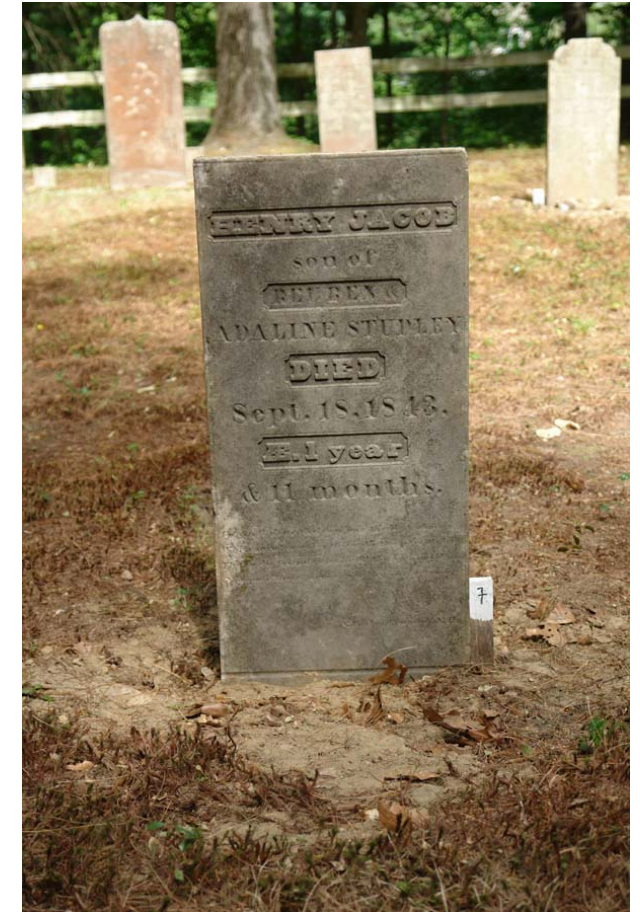
Before and after— Reset into the ground #7 Henry Studley

Earlier gravestones are typically long panels of stone that were set directly into the ground. After determination of the correct location and orientation of the stone, soil was removed to an appropriate depth. Gravel (or broken stone) was introduced to establish a stable base. The stone was made plumb and level, and set in plane with the adjacent markers. Backfilling was done with sand and gravel, wetted and compacted.

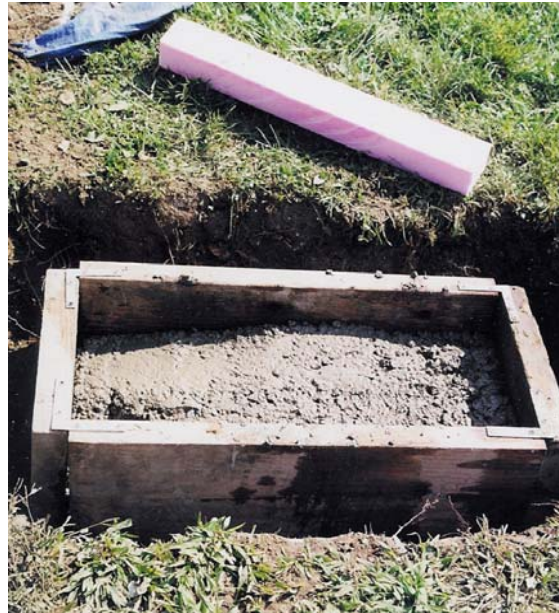
Form for new below grade concrete base

Bases were made on site by casting in place with concrete. The casting is generally 9 to 12 inches deep, and 6 inches greater in both thickness and width than the stone itself. The finished top surface of the base should be entirely below grade. A form for a 2 inch deep setting slot, $\frac{1}{2}$ inch wider and $\frac{1}{2}$ thicker than the stone, was positioned in the concrete. After the base cured, the gravestone was reset into the slot with a cement/lime-based grout. The top of the new base was covered with topsoil.

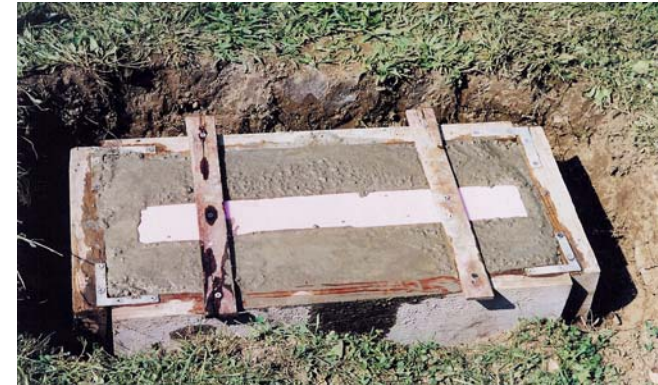
Concrete poured, with form for setting slot in place

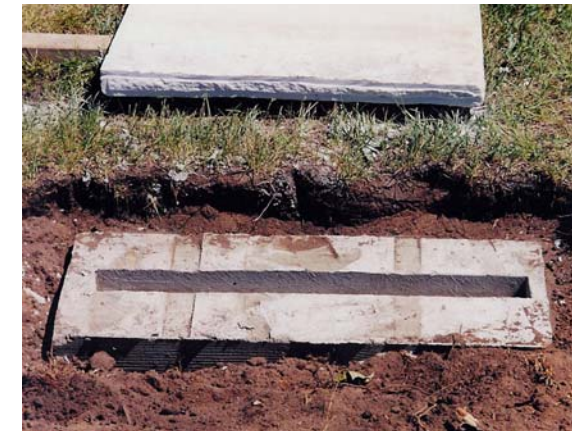
Form removed, ready for resetting marker

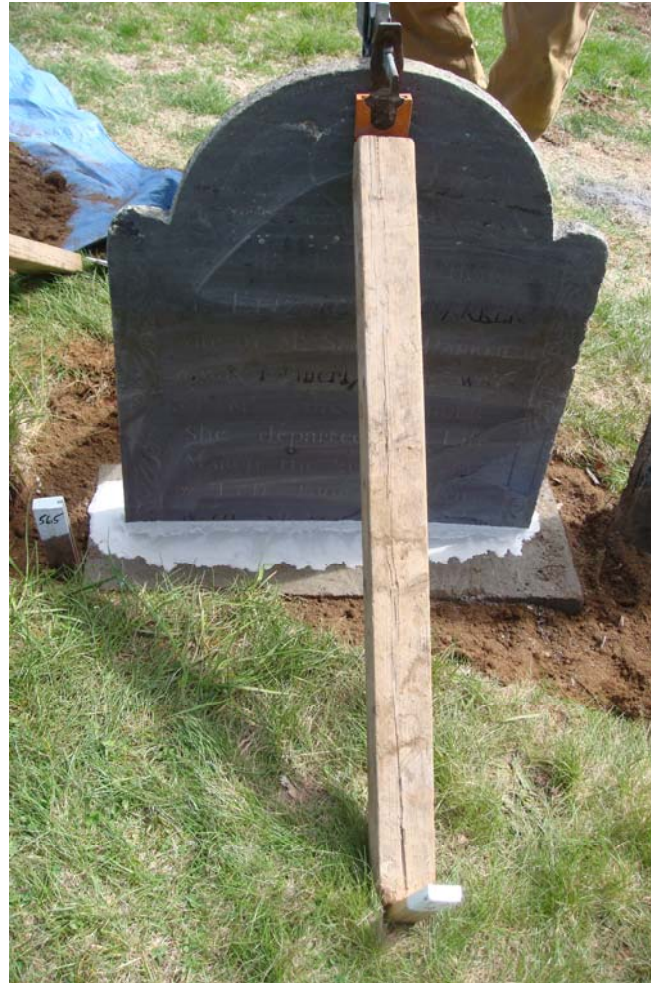
Example of marker reset into slot in new below grade concrete base. Braced for minimum 3 days.

Gravestones that required insertion into existing or new bases were set with a relatively weak cement/lime-based grout (3:2:9:1) with fine aggregates (000), made fluid with a high-range water reducer which ensures a complete fill. This was poured or injected into the base slot. Stones were braced for a minimum of three days to limit movement during curing of the grout.

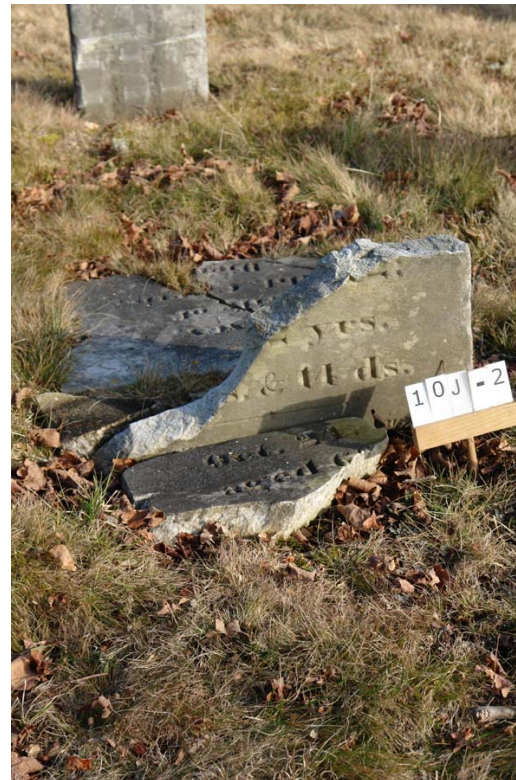
Example of fragmented marker

All fragments were carefully cleaned and dry fitted. A thixotropic, thermosetting structural resin (A-5522, by Abatron, Kenosha, WI or equivalent) was thinly and evenly applied along the bond line only. The fragments were aligned, joined with clamps, and adequately braced during curing, which was typically a period of several days.

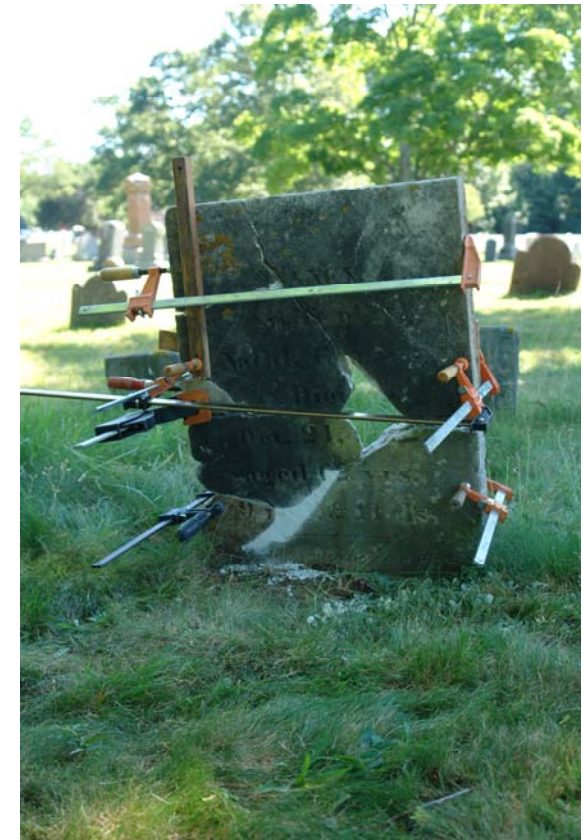
Clamping and bracing in a vertical position allows gravity to help position fragments. Often marble becomes "bowed" or curved with time.

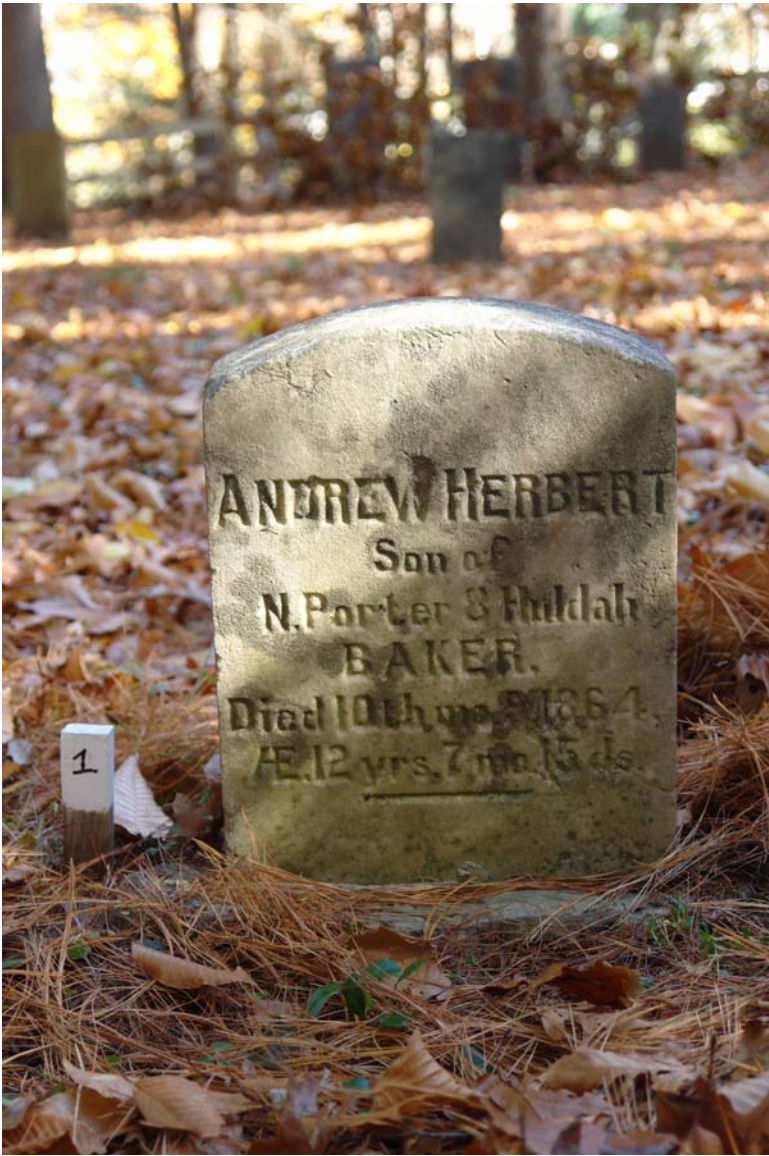
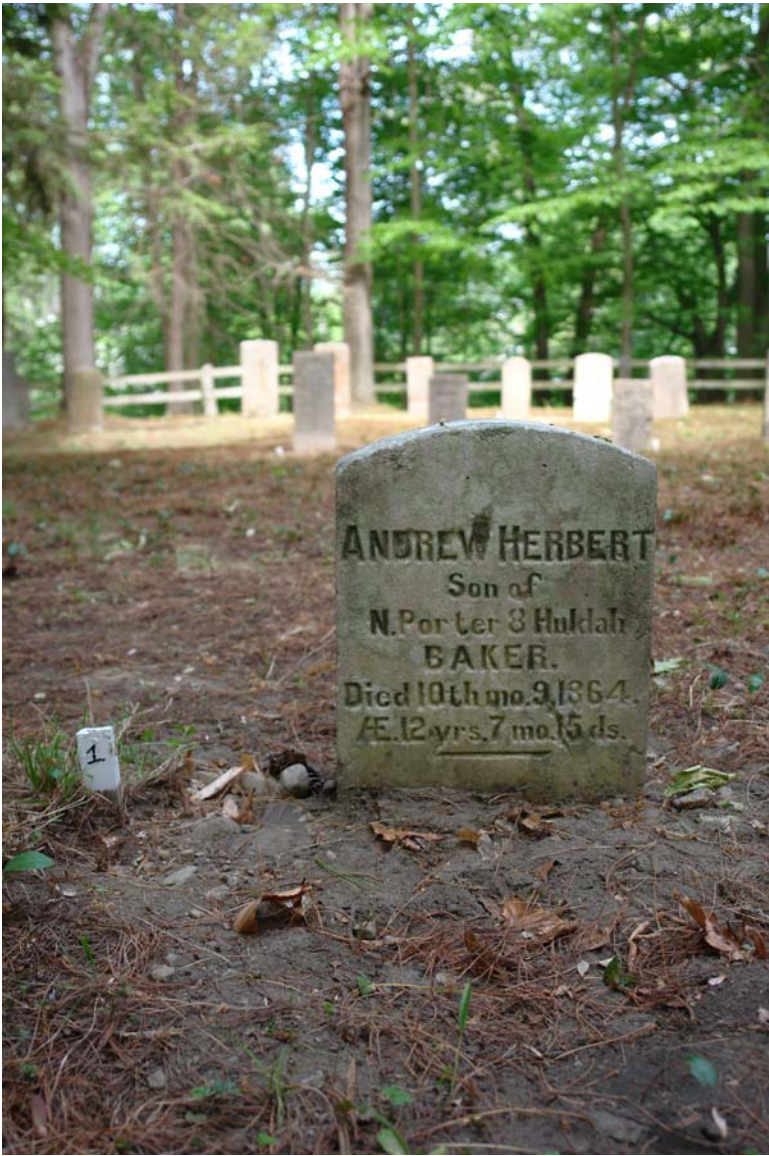
West Hanover/ Darling Cemetery, Hanover, MA
NAME ON MARKER **Andrew Baker**
Death Date: 10/9/1864 Marker Type: Headstone
Cond. of Inscription: Legible Material: Marble

EXISTING CONDITIONS	CONSERVATION STRATEGY
Tilted	Reset base plumb

TREATMENT	Treatment Dates 5/11/2015
Marker appears to be firmly set into base.	
1. Marker and base carefully excavated. Marker appears to be sound.	
2. Soling removed by light brushing with nylon brushes and water.	
3. Setting area excavated to sufficient depth and stone re-set plumb at appropriate height and level onto gravel bed, aligned with adjacent markers	
4. Area backfilled around marker with tamped sand and gravel	
5. Disturbed areas re-graded with existing topsoil and sod.

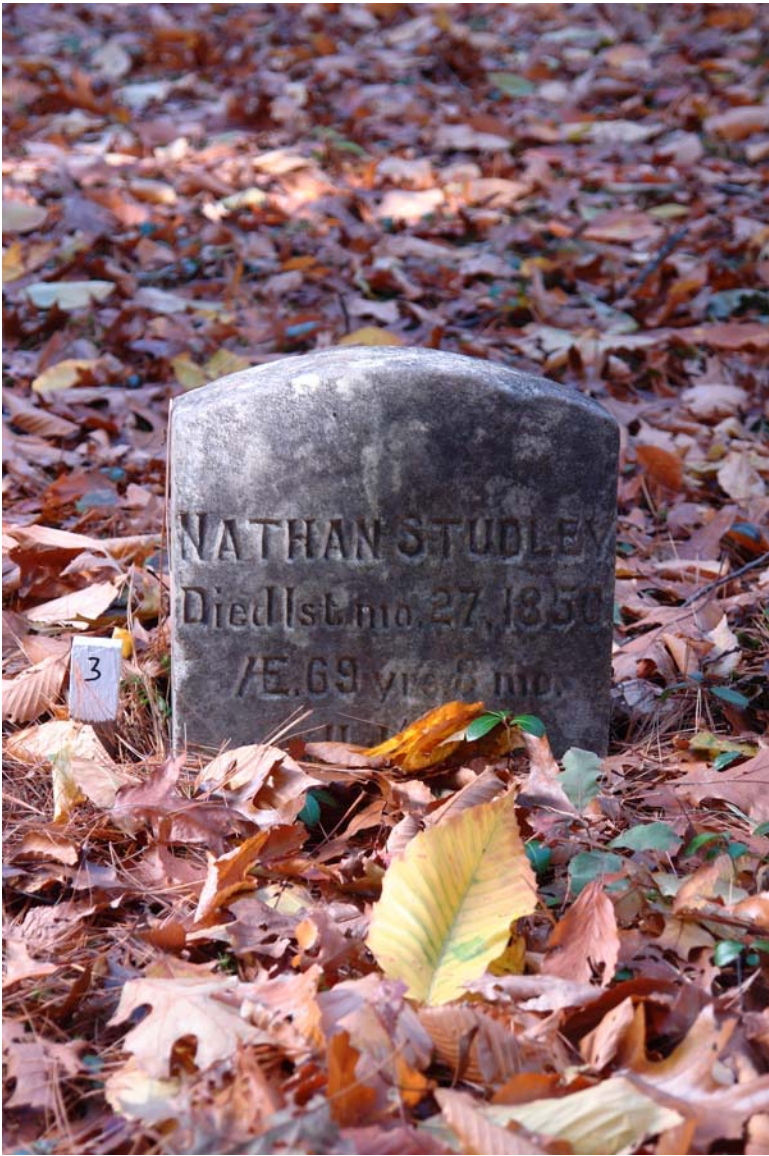
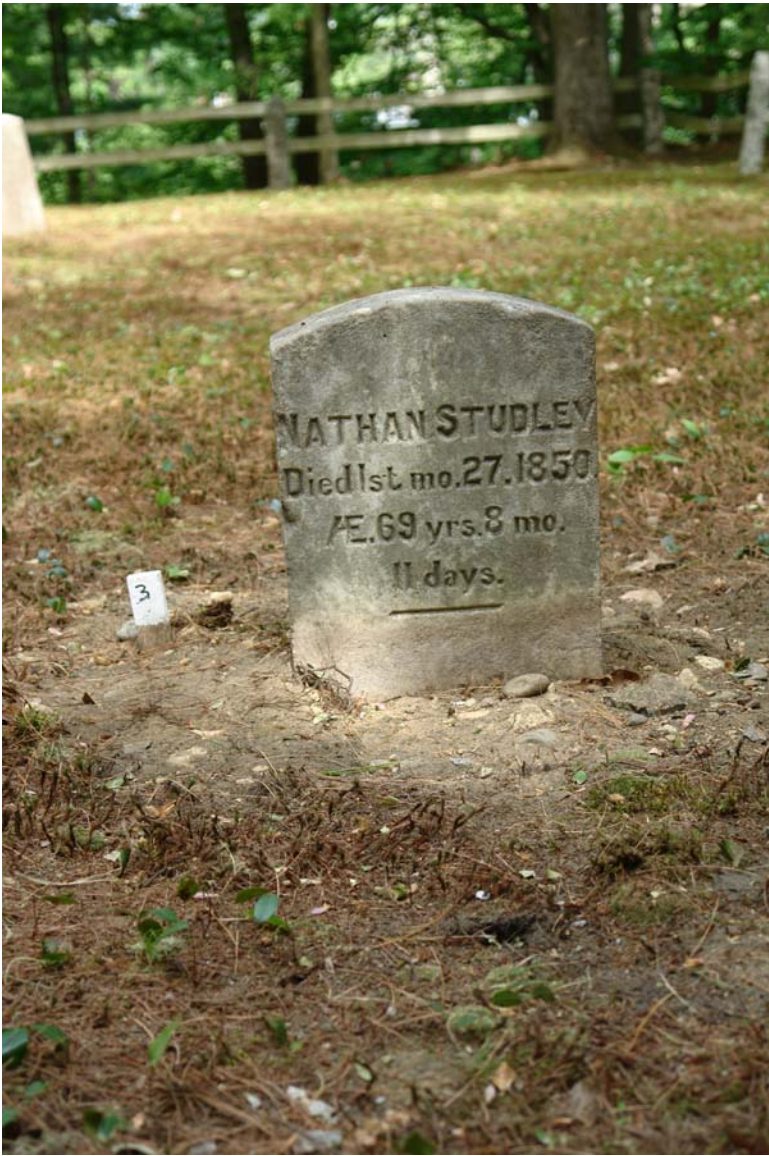
NAME ON MARKER	Nathan Studley		
Death Date:	1/27/1850	Marker Type:	Headstone
Cond. of Inscription:	Legible	Material:	Marble

EXISTING CONDITIONS	CONSERVATION STRATEGY
Tilted, unstable	Reset in new below grade base

TREATMENT	Treatment Dates
1. Marker excavated and found to be sound. Light soiling removed by brushing with nylon brushes and water. 2. Setting area excavated for new below grade cast concrete base sized minimum of 12 inches deep, 12 inches greater in thickness and 6 inches wider than the stone. 3. Wooden forms and setting slot form stabilized and aligned with adjacent markers before concrete is poured 4. When required, the lower edge of marker is re-squared with minimal loss using a power grinder 5. Setting forms are removed after partial curing of the concrete and the base backfilled with tamped sand or gravel 6. Marker reset into setting slot with a cement/lime grout (3/2/9) with 000 sand made fluid with a super plasticizer. 7. Marker set plumb and level, and braced for minimum of 5 days. 8. Disturbed areas backfilled with existing topsoil.	5/11-12/2015

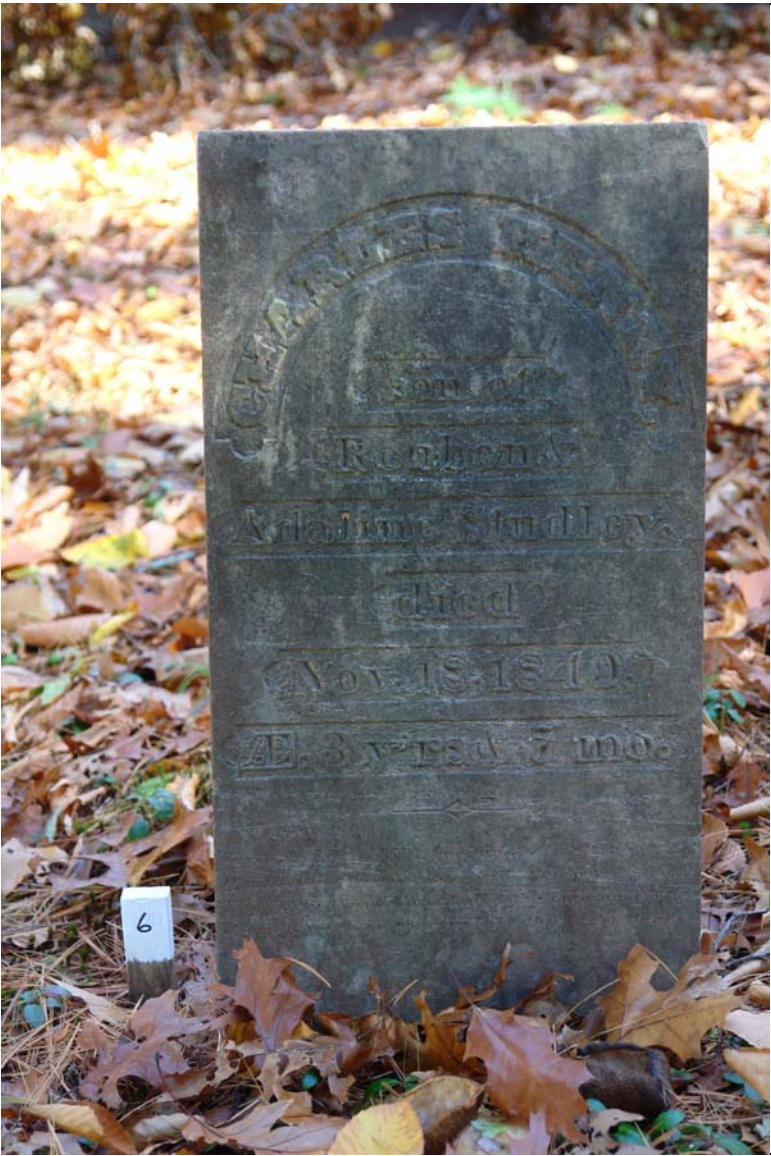
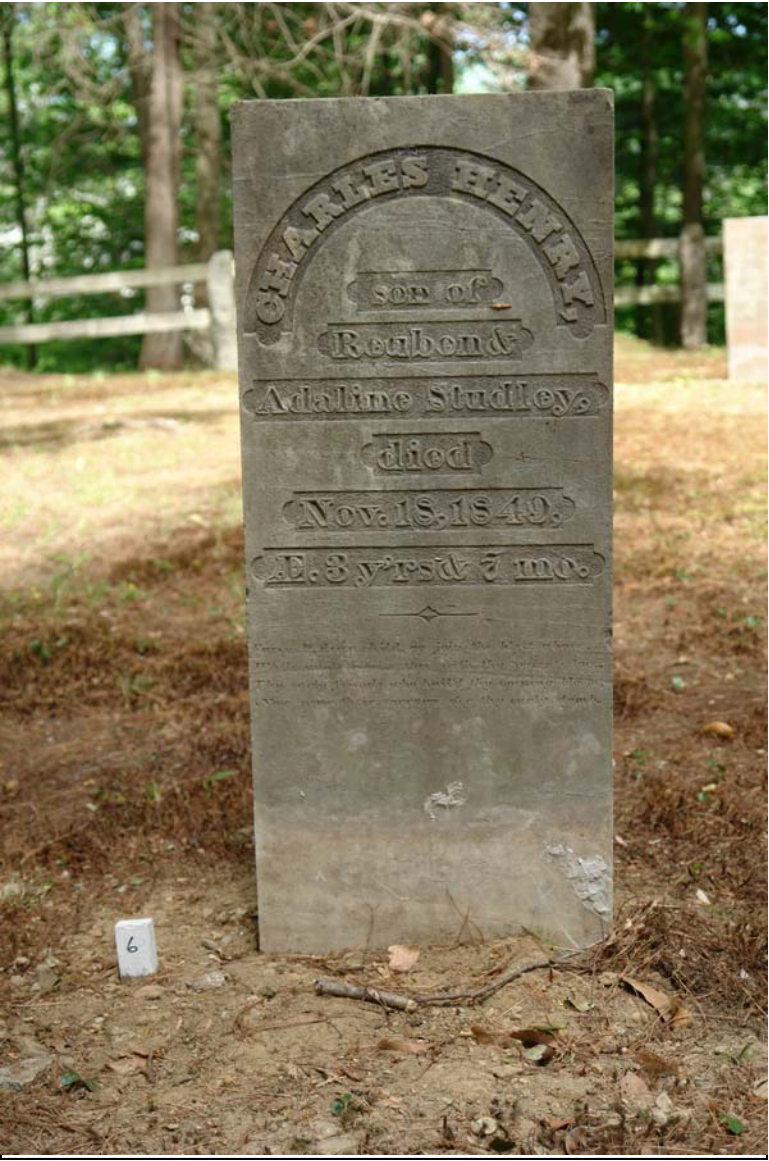
West Hanover/ Darling Cemetery, Hanover, MA
NAME ON MARKER **Charles Studley**
Death Date: 11/18/1849 Marker Type: Headstone
Cond. of Inscription: Legible Material: Marble

EXISTING CONDITIONS	CONSERVATION STRATEGY
Un stable	Reset in new below grade base

TREATMENT	Treatment Dates 5/11-12/2015
<div>1. Marker excavated and found to be sound. Light soiling removed by brushing with nylon brushes and water.</div> <div>2. Setting area excavated for new below grade cast concrete base sized minimum of 12 inches deep, 12 inches greater in thickness and 6 inches wider than the stone.</div> <div>3. Wooden forms and setting slot form stabilized and aligned with adjacent markers before concrete is poured</div> <div>4. When required, the lower edge of marker is re-squared with minimal loss using a power grinder</div> <div>5. Setting forms are removed after partial curing of the concrete and the base backfilled with tamped sand or gravel</div> <div>6. Marker reset into setting slot with a cement/lime grout (3/2/9) with 000 sand made fluid with a super plasticizer.</div> <div>7. Marker set plumb and level, and braced for minimum of 5 days.</div> <div>8. Disturbed areas backfilled with existing topsoil.</div>

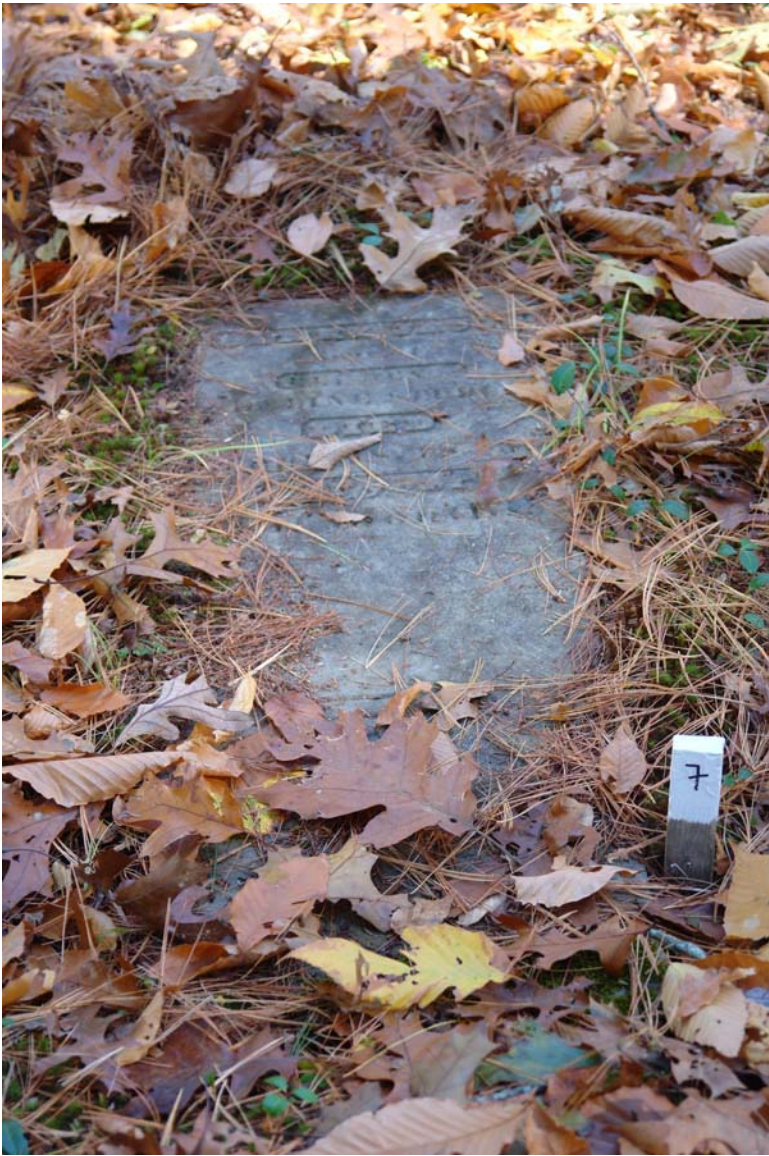
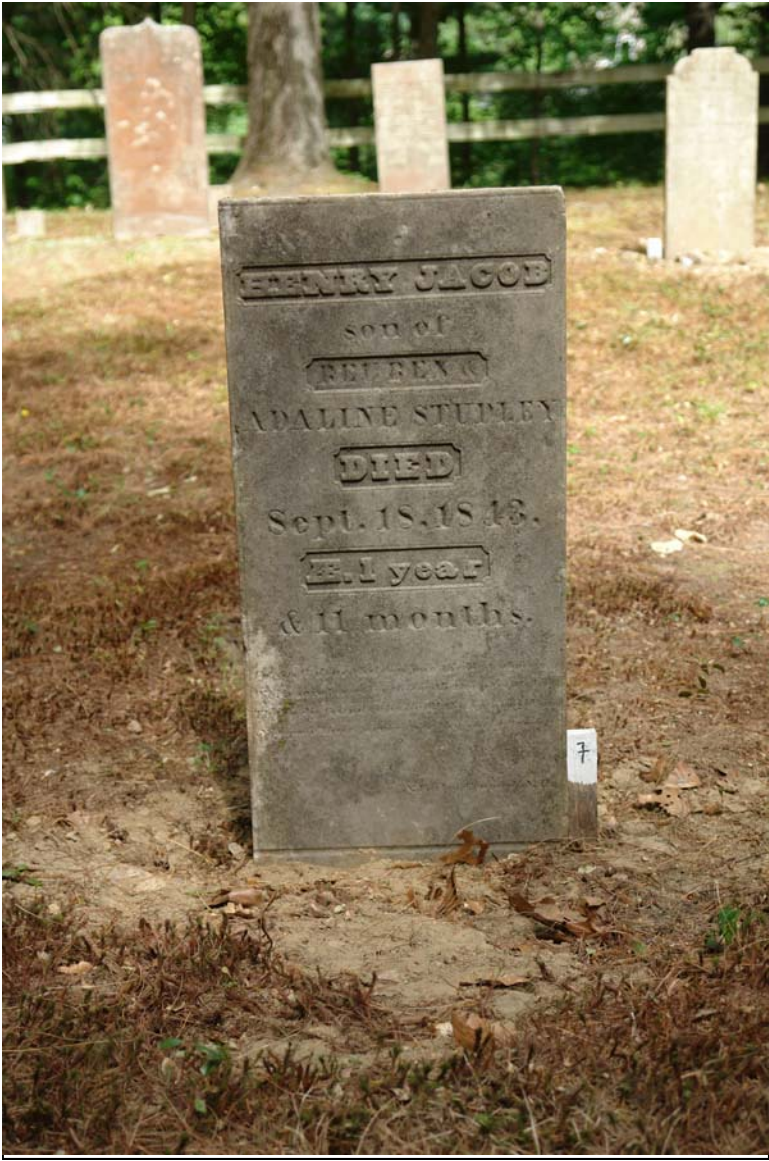
West Hanover/ Darling Cemetery, Hanover, MA
NAME ON MARKER **Henry Studley**
Death Date: 9/18/1843 Marker Type: Headstone
Cond. of Inscription: Legible Material: Marble

EXISTING CONDITIONS	CONSERVATION STRATEGY
Fallen	Reset

TREATMENT	Treatment Dates 5/11/2015
<div>1. Marker carefully excavated. Marker appears to be sound.</div> <div>2. Soling removed by light brushing with nylon brushes and water.</div> <div>3. Setting area excavated to sufficient depth and stone re-set plumb at appropriate height and level onto gravel bed, aligned with adjacent markers</div> <div>4. Area backfilled around marker with tamped sand and gravel</div> <div>5. Disturbed areas re-graded with existing topsoil and sod.</div>

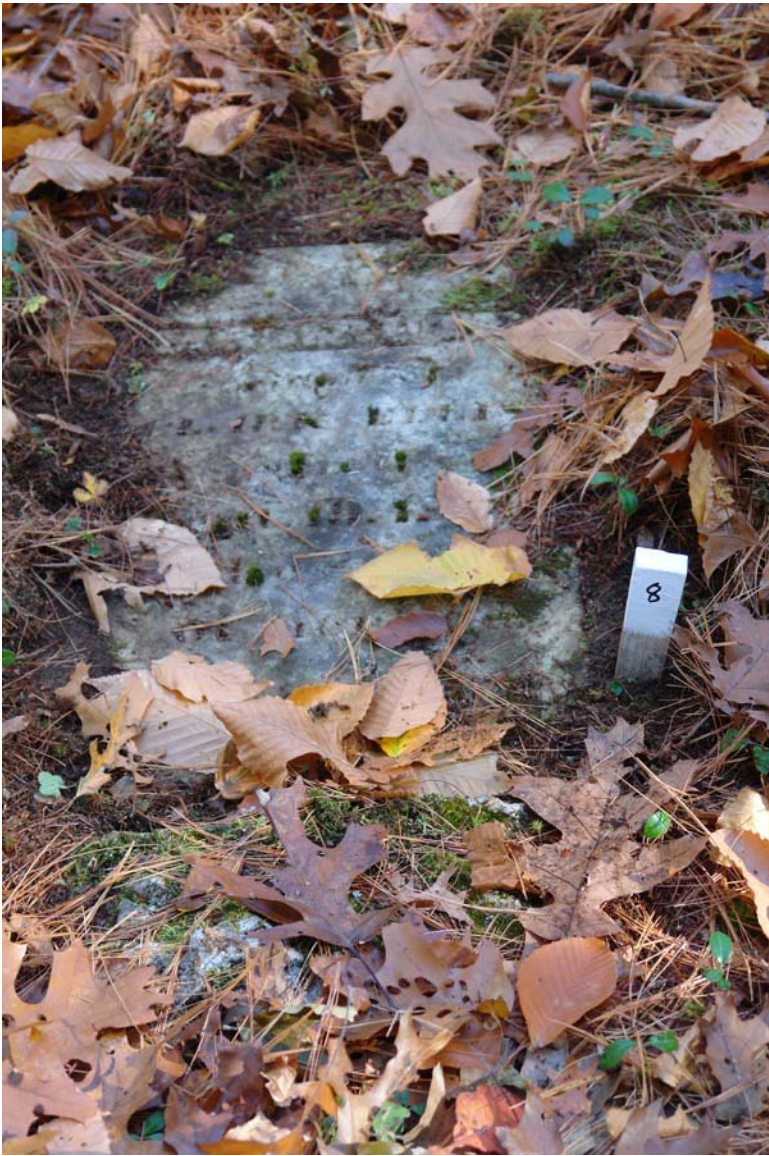
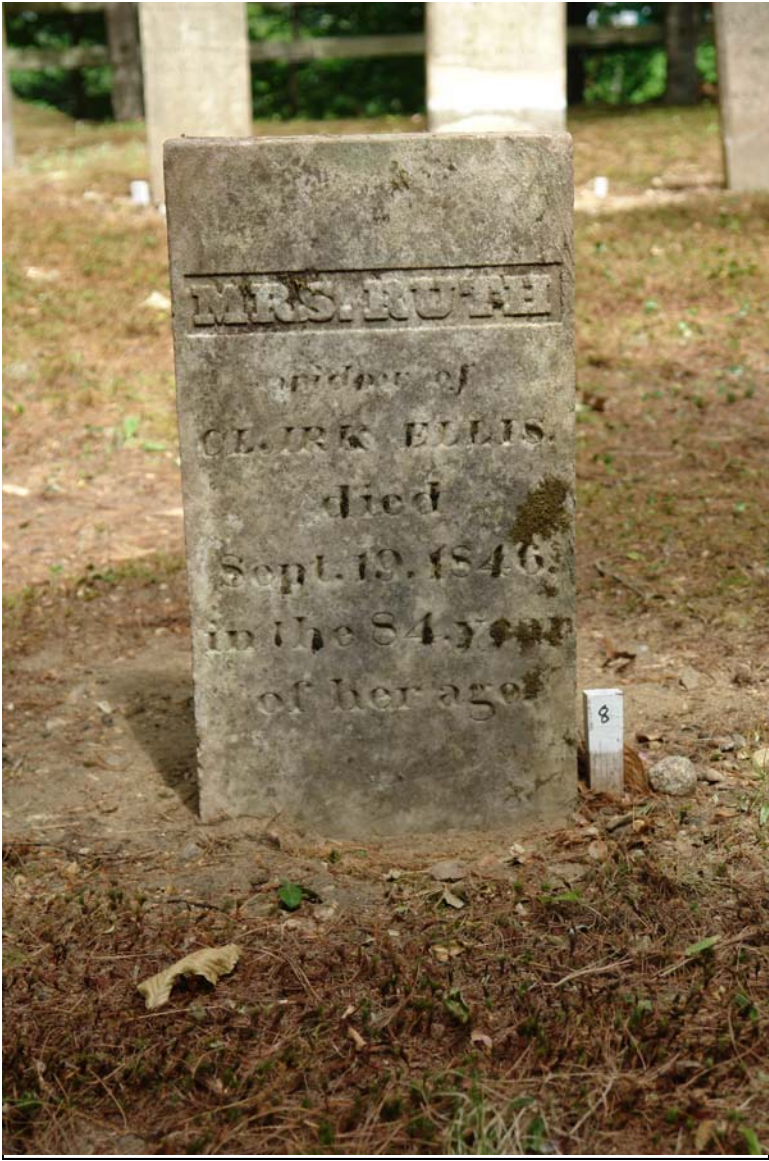
West Hanover/ Darling Cemetery, Hanover, MA
NAME ON MARKER **Ruth Ellis**
Death Date: 9/19/1846 Marker Type: Headstone
Cond. of Inscription: Decipherable Material: Marble

EXISTING CONDITIONS	CONSERVATION STRATEGY
Fallen	Reset in new below grade base

TREATMENT	Treatment Dates 5/11/2015
<div>1. Marker carefully excavated. Marker appears to be sound. 2. Soling removed by light brushing with nylon brushes and wa- ter. 3. Setting area excavated to sufficient depth and stone re-set plumb at appropriate height and level onto gravel bed, aligned with adjacent markers 4. Area backfilled around marker with tamped sand and gravel 5. Disturbed areas re-graded with existing topsoil and sod.</div>

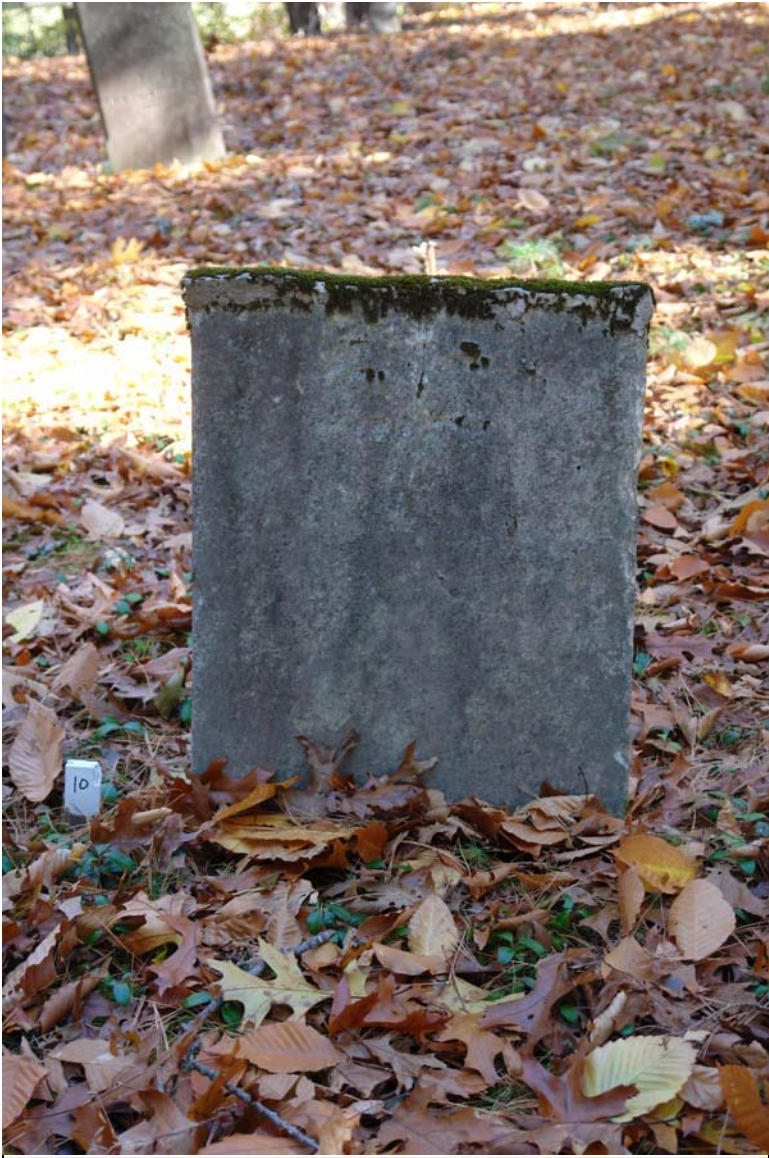
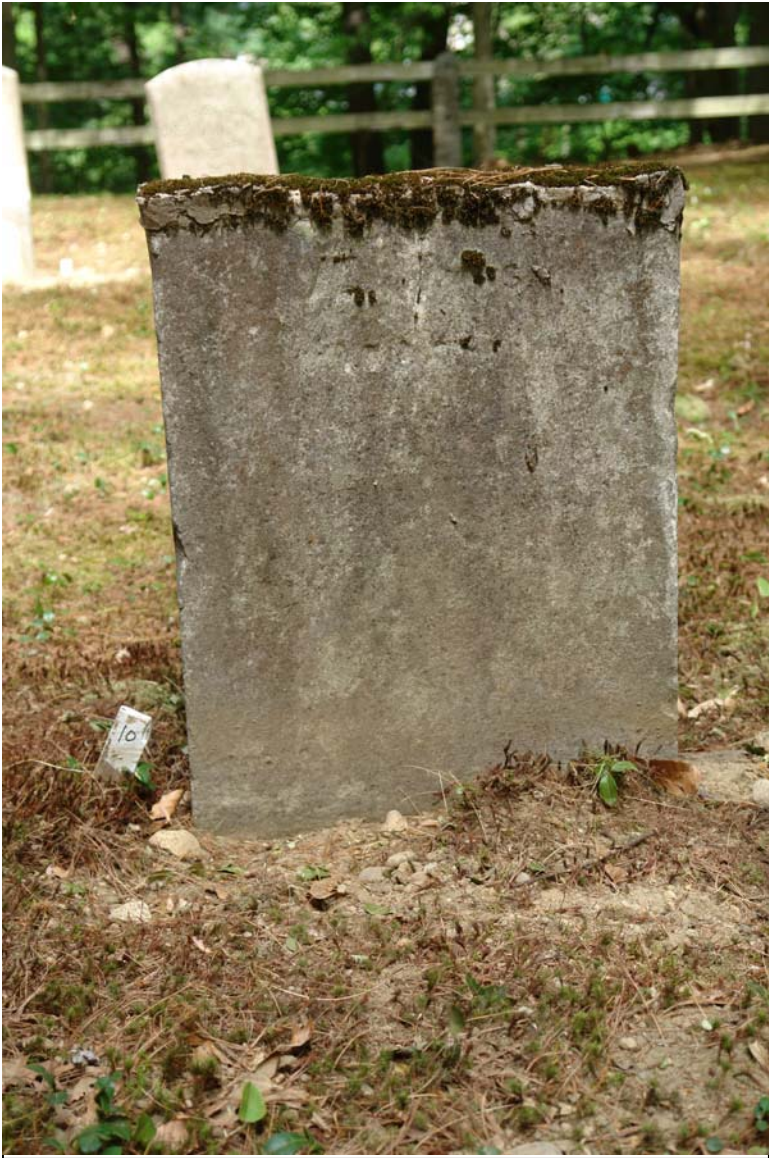
West Hanover/ Darling Cemetery, Hanover, MA
NAME ON MARKER **Spooner Ellis**
Death Date: 1868 Marker Type: Headstone
Cond. of Inscription: Missing Material: Marble

EXISTING CONDITIONS	CONSERVATION STRATEGY
Tilted Fragmented	Probe area for fragments Reset marker

TREATMENT	Treatment Dates 5/11/2015
<p>1. Marker carefully excavated. Area probed and no fragments were found. The soil around tilted markers was removed to an appropriate depth. When required, the marker was removed from the ground. Marker appears to be sound.</p> <p>2. Soling removed by light brushing with nylon brushes and water.</p> <p>3. Setting area excavated to sufficient depth and stone re-set plumb at appropriate height and level onto gravel bed, aligned with adjacent markers</p> <p>4. Area backfilled around marker with tamped sand and gravel</p> <p>5. Disturbed areas re-graded with existing topsoil and sod.</p>

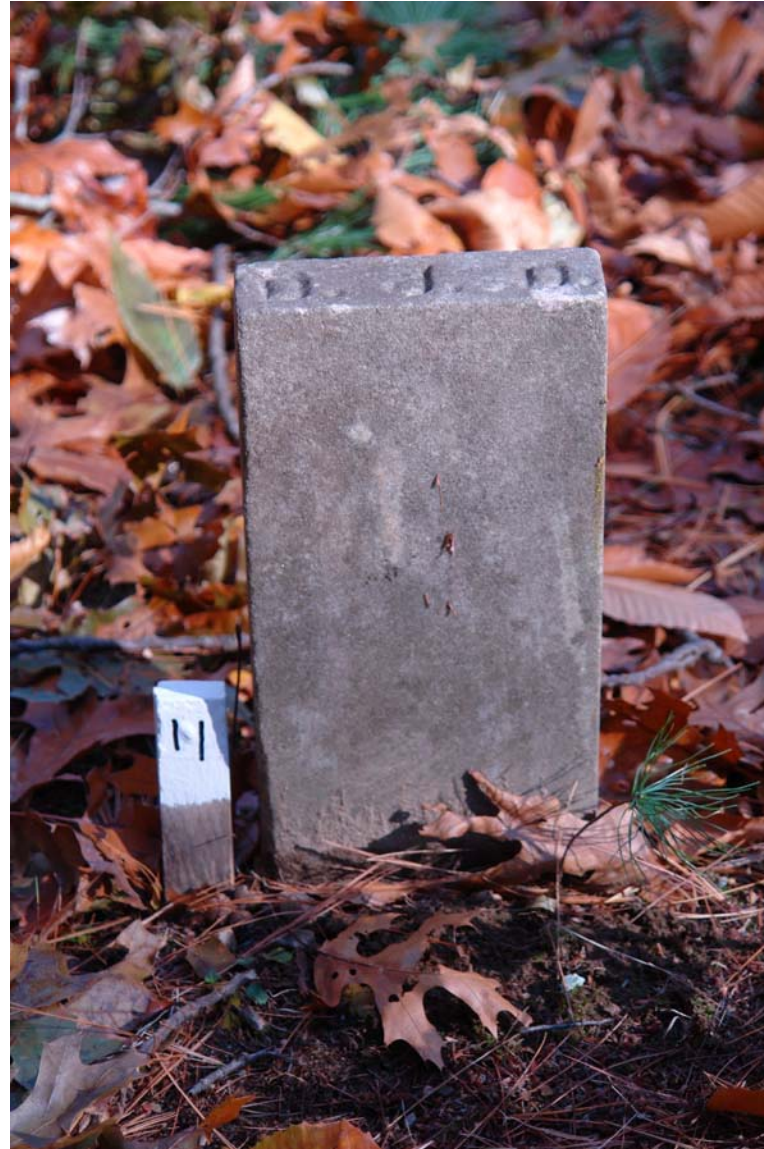
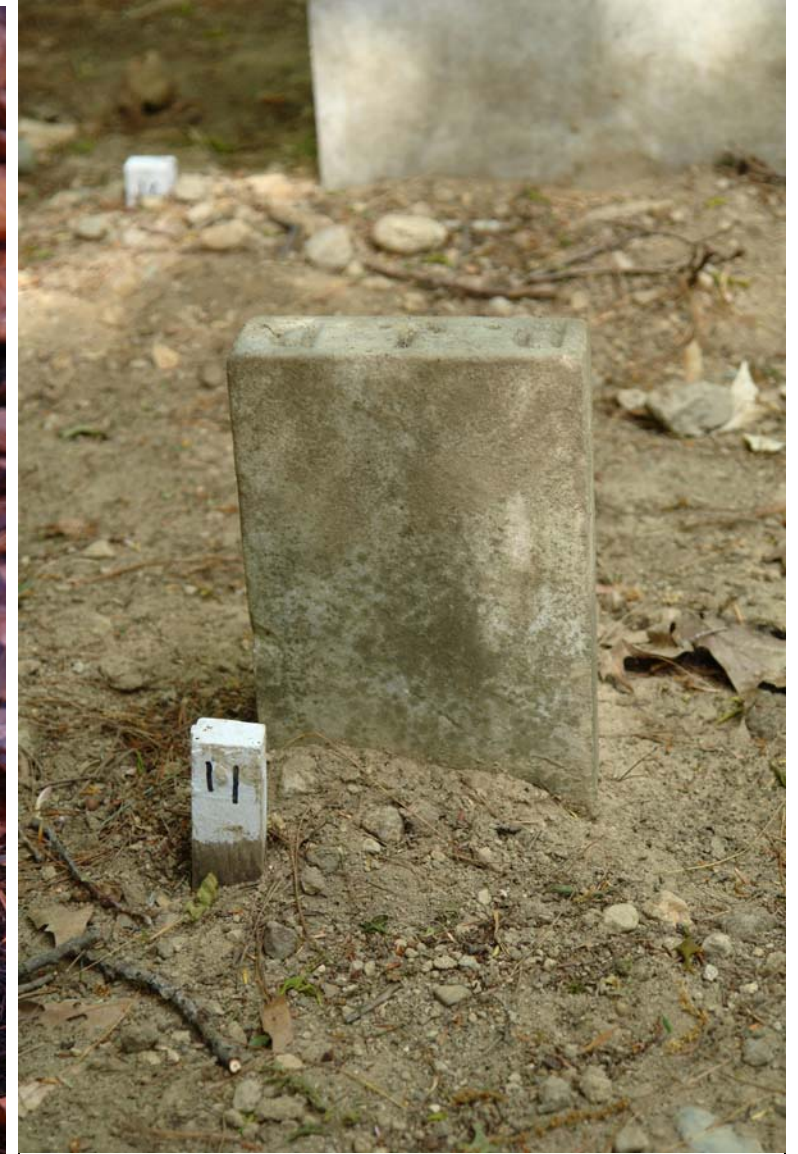
D.J.D (David Davis)

Tilted

1. Marker carefully excavated. The soil around tilted markers was removed to an appropriate depth. When required, the marker was removed from the ground. Marker appears to be sound.
2. Soling removed by light brushing with nylon brushes and water.
3. Setting area excavated to sufficient depth and stone re-set plumb at appropriate height and level onto gravel bed, aligned with adjacent markers
4. Area backfilled around marker with tamped sand and gravel
5. Disturbed areas re-graded with existing topsoil and sod.

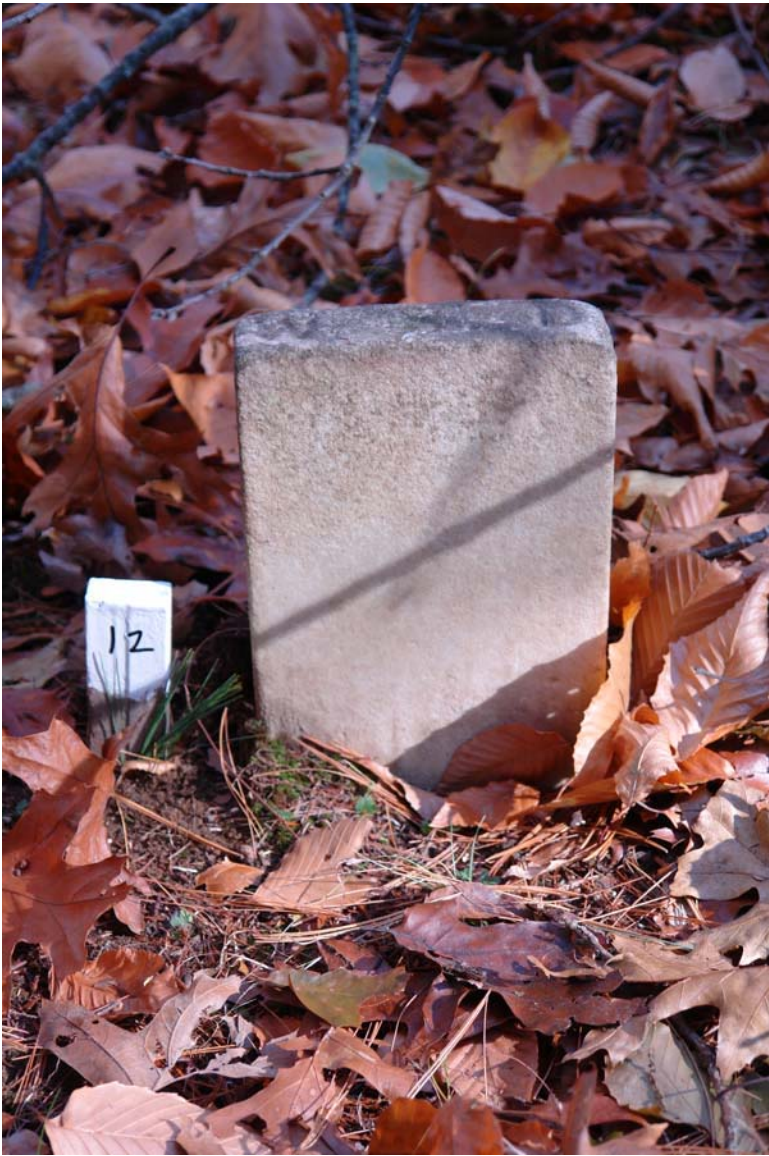
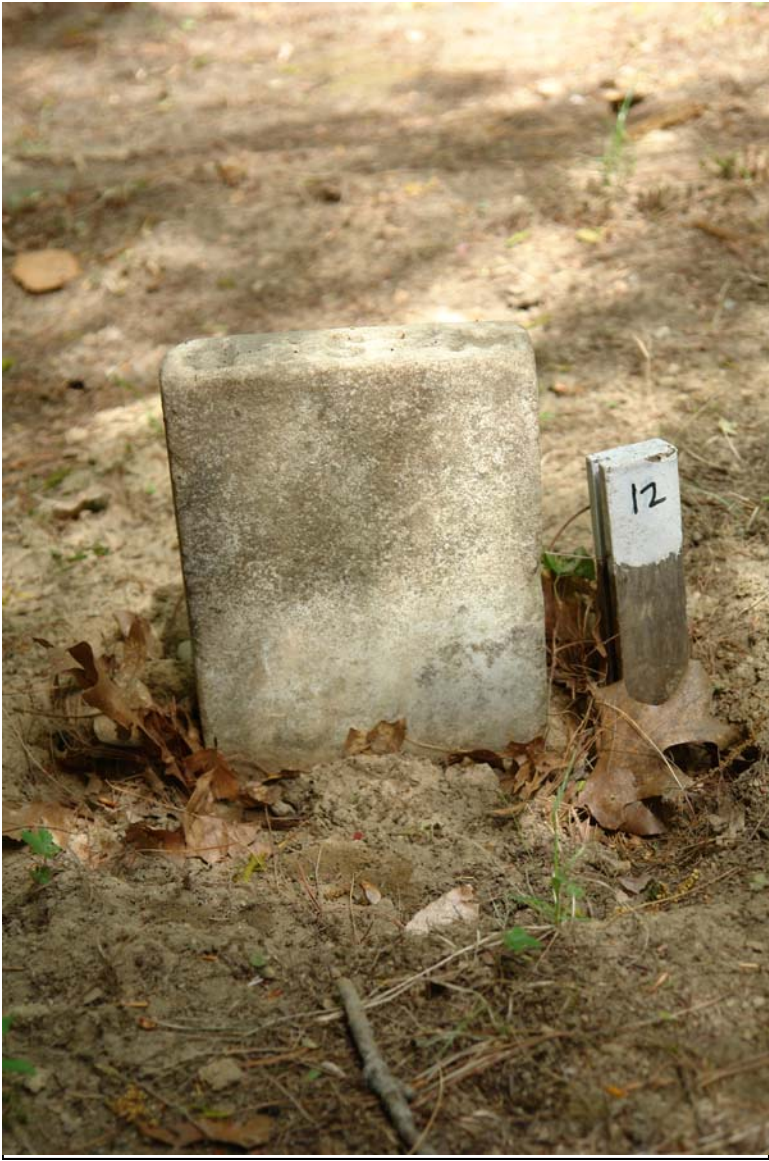
West Hanover/ Darling Cemetery, Hanover, MA
NAME ON MARKER **W.S.D. (William S. Davis)**
Death Date: 6/15/1861 Marker Type: Footstone
Cond. of Inscription: Legible Material: Marble

EXISTING CONDITIONS	CONSERVATION STRATEGY
Tilted, sunken Facing wrong way	Reset marker facing East

TREATMENT	Treatment Dates 5/11/2015
1. Marker carefully excavated. The soil around tilted markers was removed to an appropriate depth. When required, the marker was removed from the ground. Marker appears to be sound. 2. Soling removed by light brushing with nylon brushes and water. 3. Setting area excavated to sufficient depth and stone re-set plumb at appropriate height and level onto gravel bed, aligned with adjacent markers 4. Area backfilled around marker with tamped sand and gravel 5. Disturbed areas re-graded with existing topsoil and sod.
