Documentation of Restorations to West Hanover Cemetery

MONUMENT CONSERVATION COLLABORATIVE LLC, NORFOLK, CT

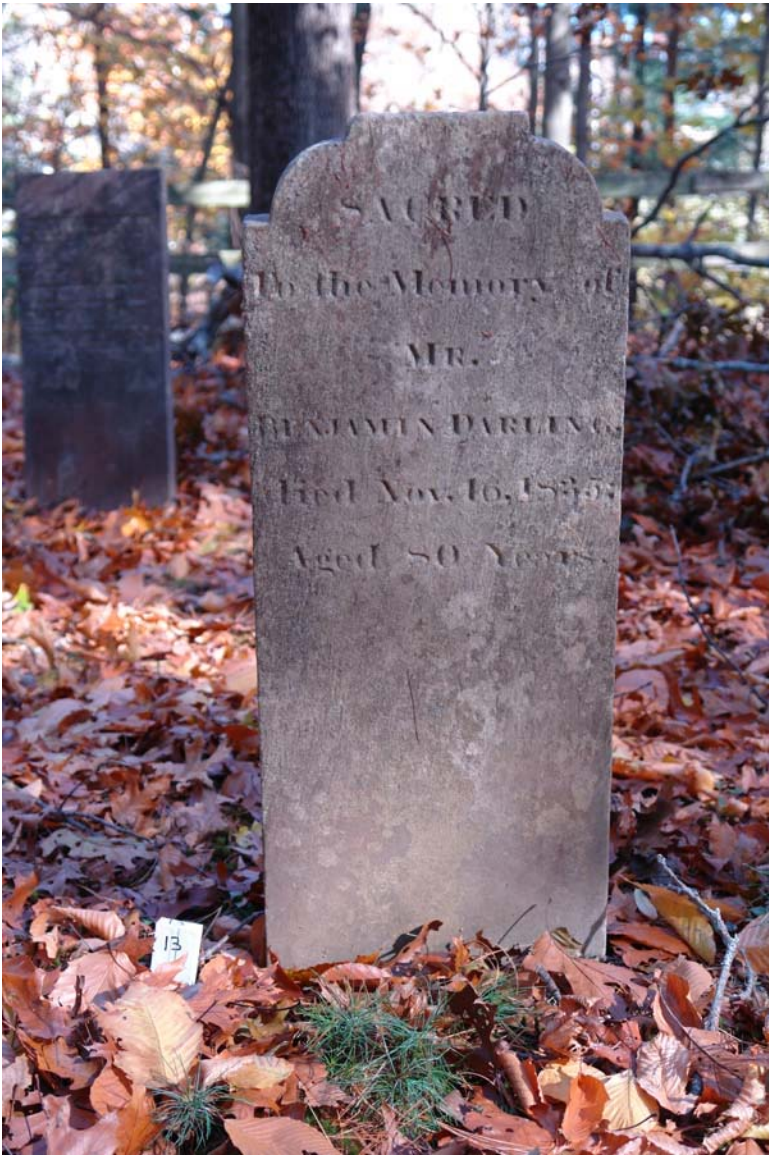
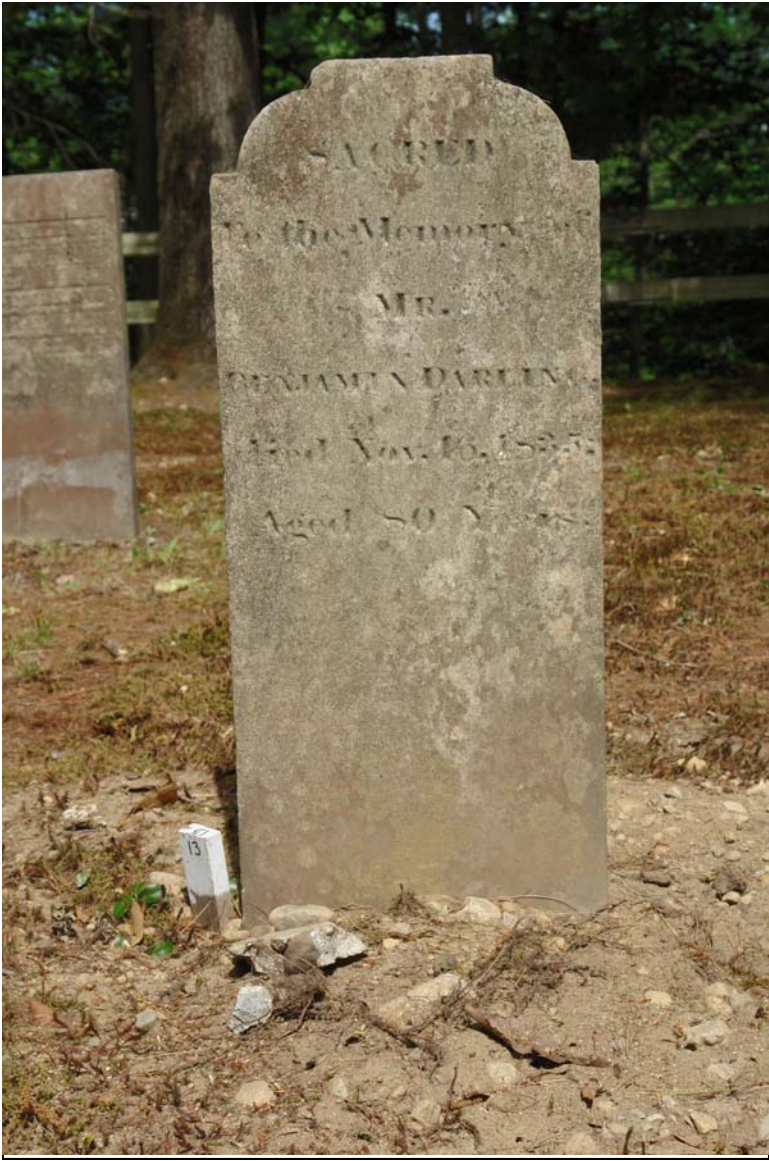
NAME ON MARKER	Benjamin Darling		
Death Date:	11/16/1835	Marker Type:	Headstone
Cond. of Inscription:	Legible	Material:	Marble

EXISTING CONDITIONS	CONSERVATION STRATEGY
Set too high	Reset lower

TREATMENT	Treatment Dates 5/11/2015
<div>1. Marker carefully excavated. The soil around tilted markers was removed to an appropriate depth. When required, the marker was removed from the ground. Marker appears to be sound.</div> <div>2. Soling removed by light brushing with nylon brushes and water.</div> <div>3. Setting area excavated to sufficient depth and stone re-set plumb at appropriate height and level onto gravel bed, aligned with adjacent markers</div> <div>4. Area backfilled around marker with tamped sand and gravel</div> <div>5. Disturbed areas re-graded with existing topsoil and sod.</div>

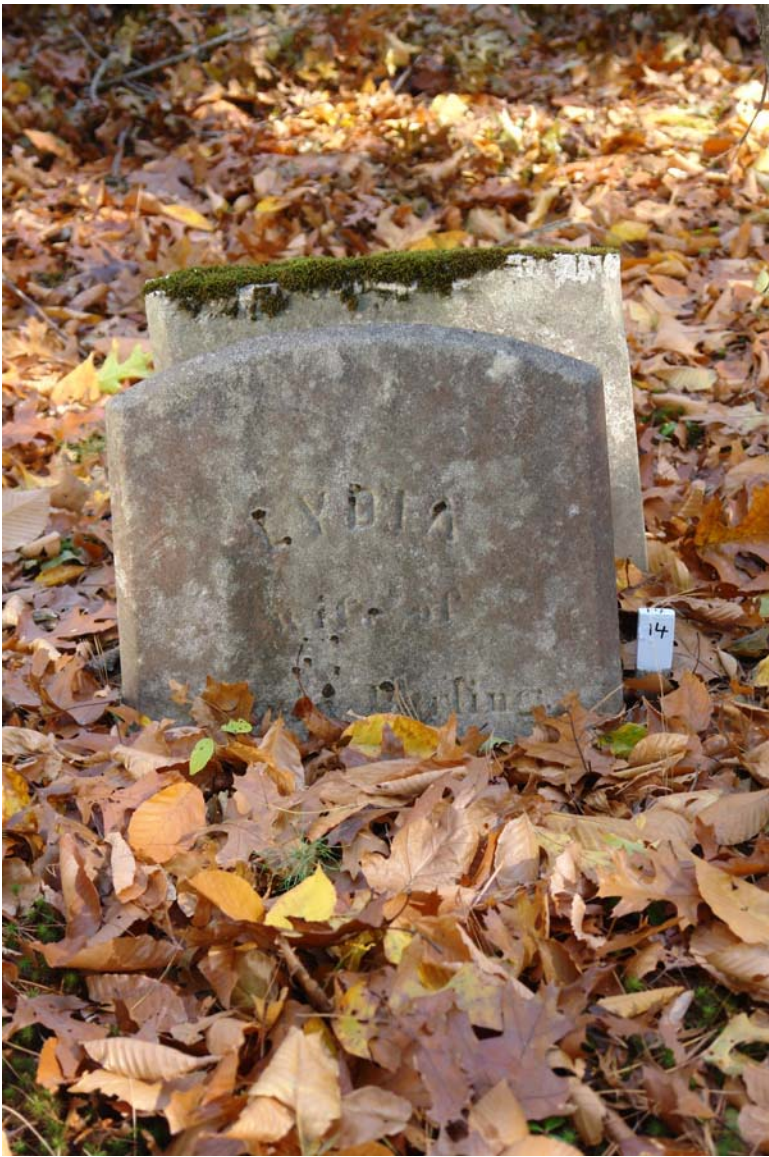
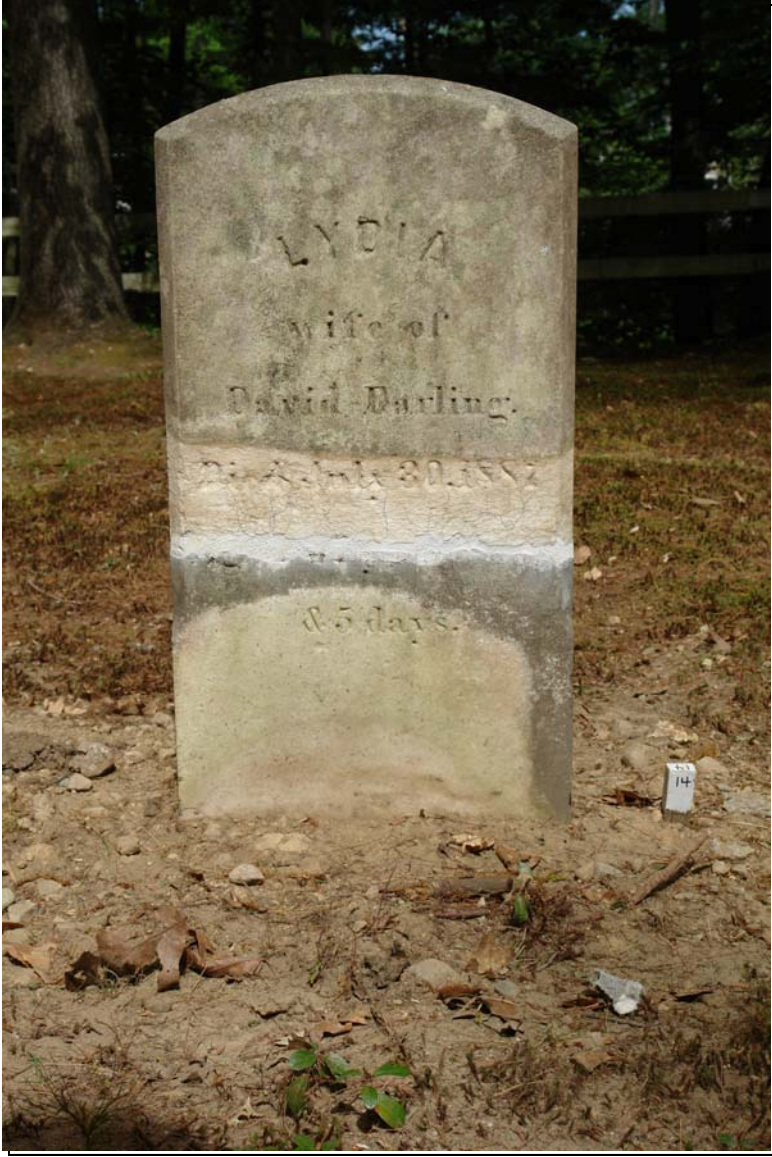
West Hanover/ Darling Cemetery, Hanover, MA
 NAME ON MARKER Lydia Darling
 Death Date: 7/30/1887 Marker Type: Headstone
 Cond. of Inscription: Legible Material: Marble

EXISTING CONDITIONS	CONSERVATION STRATEGY
Tilted Fractured	Reset to leveled base Attach fragment with structural adhesive

TREATMENT	Treatment Dates 5/11-12/2015
1. Area around lower fragment carefully excavated and inspected for soundness. 2. Area probed and buried or overgrown fragments carefully excavated and inspected for soundness. 3. Lower fragment re-set plumb at appropriate height and level onto gravel bed, aligned with adjacent markers 4. Area backfilled around marker with tamped sand and gravel 5. All mating edges of fragments cleaned with water and any failed adhesives removed with hand tools 6. Fragments attached with structural adhesive (Abatron 55-22), clamped and braced until cured. Epoxy removed with hand chisels within 24 hours. 7. Cracks and losses filled with RepliCal products, misted with water and covered for 3 days min. 8. Filled surface areas treated with light acid wash rinsed thoroughly with water.

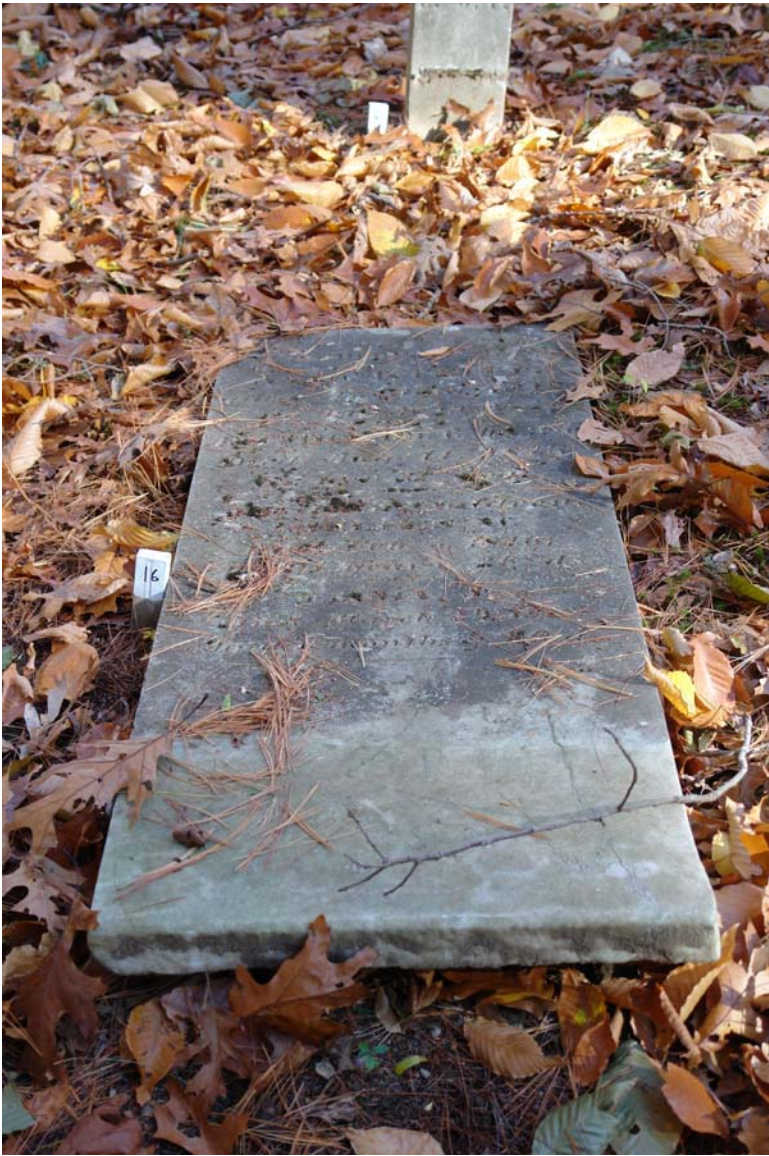
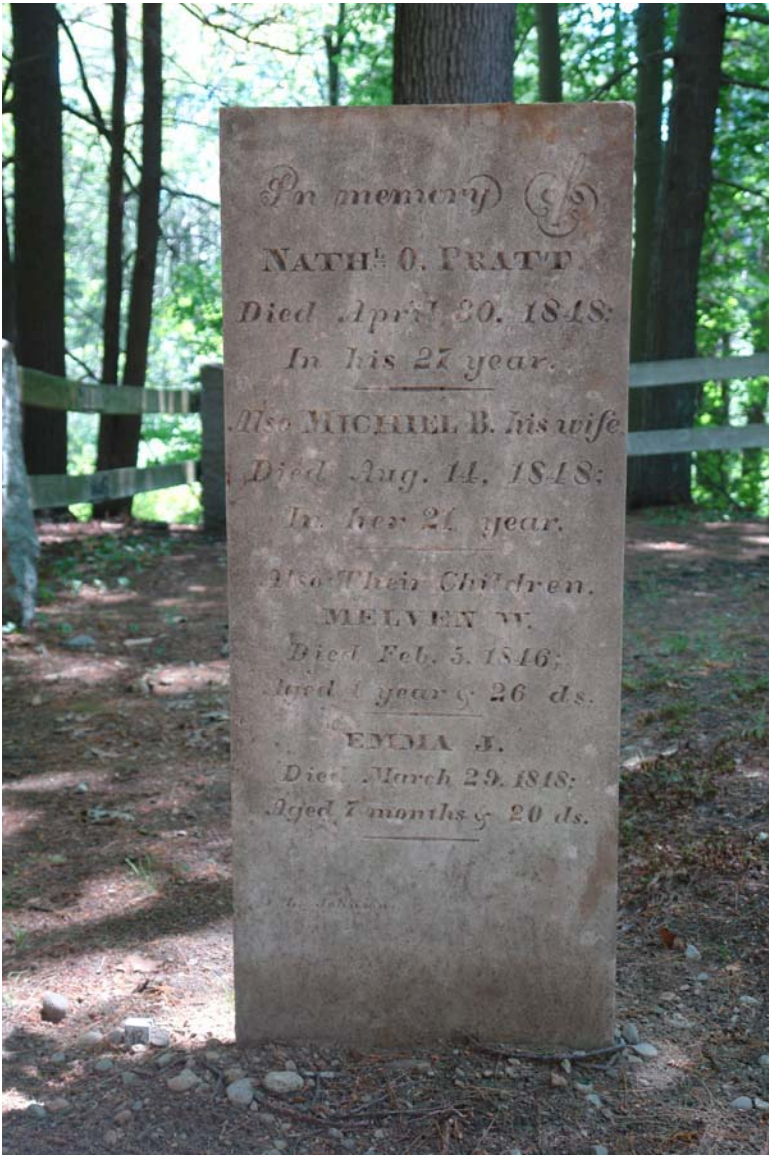
West Hanover/ Darling Cemetery, Hanover, MA
NAME ON MARKER **Nathaniel Pratt**
Death Date: 4/30/1848 Marker Type: Headstone
Cond. of Inscription: Legible Material: Marble

EXISTING CONDITIONS	CONSERVATION STRATEGY
Fallen	Reset in new below grade base

TREATMENT	Treatment Dates 5/11-12/2015
<div>1. Marker excavated and found to be sound. Light soiling removed by brushing with nylon brushes and water.</div> <div>2. Setting area excavated for new below grade cast concrete base sized minimum of 12 inches deep, 12 inches greater in thickness and 6 inches wider than the stone.</div> <div>3. Wooden forms and setting slot form stabilized and aligned with adjacent markers before concrete is poured</div> <div>4. When required, the lower edge of marker is re-squared with minimal loss using a power grinder</div> <div>5. Setting forms are removed after partial curing of the concrete and the base backfilled with tamped sand or gravel</div> <div>6. Marker reset into setting slot with a cement/lime grout (3/2/9) with 000 sand made fluid with a super plasticizer.</div> <div>7. Marker set plumb and level, and braced for minimum of 5 days.</div> <div>8. Disturbed areas backfilled with existing topsoil.</div>

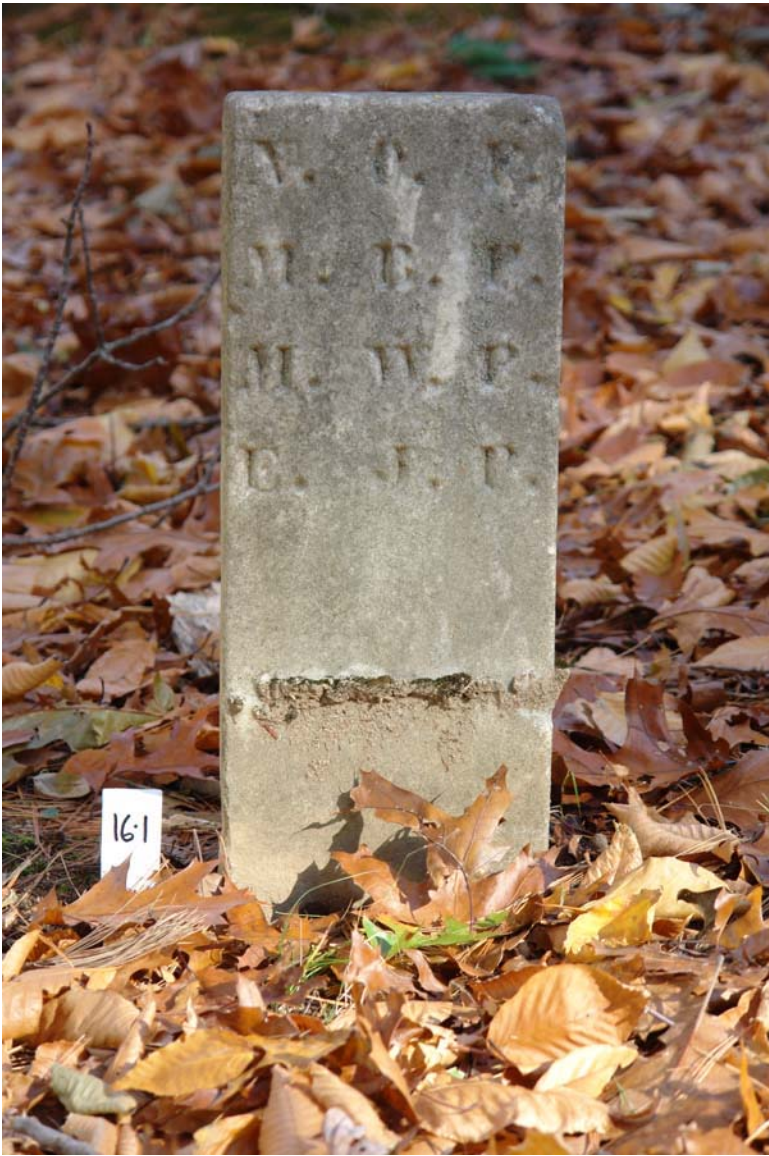
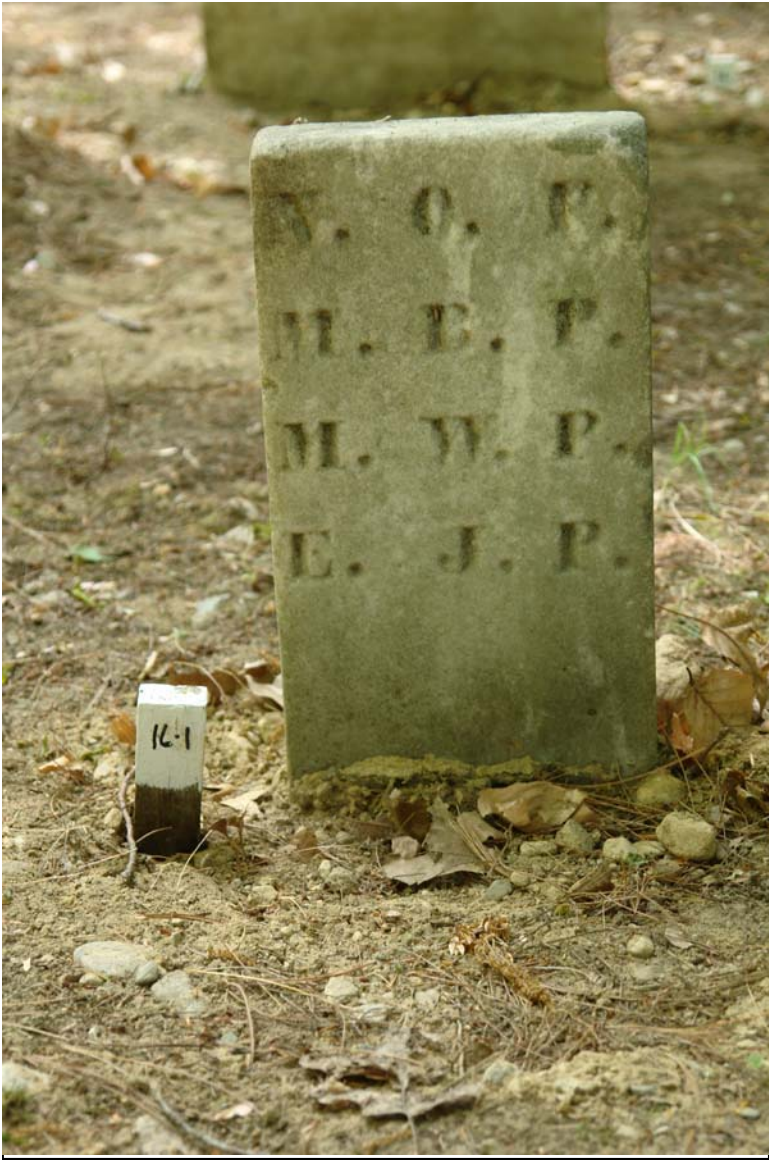
West Hanover/ Darling Cemetery, Hanover, MA
NAME ON MARKER **N.O.P (Nathaniel Pratt)**
Death Date: Marker Type: Footstone
Cond. of Inscription: Legible Material: Marble

EXISTING CONDITIONS	CONSERVATION STRATEGY
Tilted, facing wrong way	Reset facing East

TREATMENT	Treatment Dates 5/11/2015
1. Marker carefully excavated. The soil around tilted markers was removed to an appropriate depth. When required, the marker was removed from the ground. Marker appears to be sound. 2. Soling removed by light brushing with nylon brushes and water. 3. Setting area excavated to sufficient depth and stone re-set plumb at appropriate height and level onto gravel bed, aligned with adjacent markers 4. Area backfilled around marker with tamped sand and gravel 5. Disturbed areas re-graded with existing topsoil and sod.

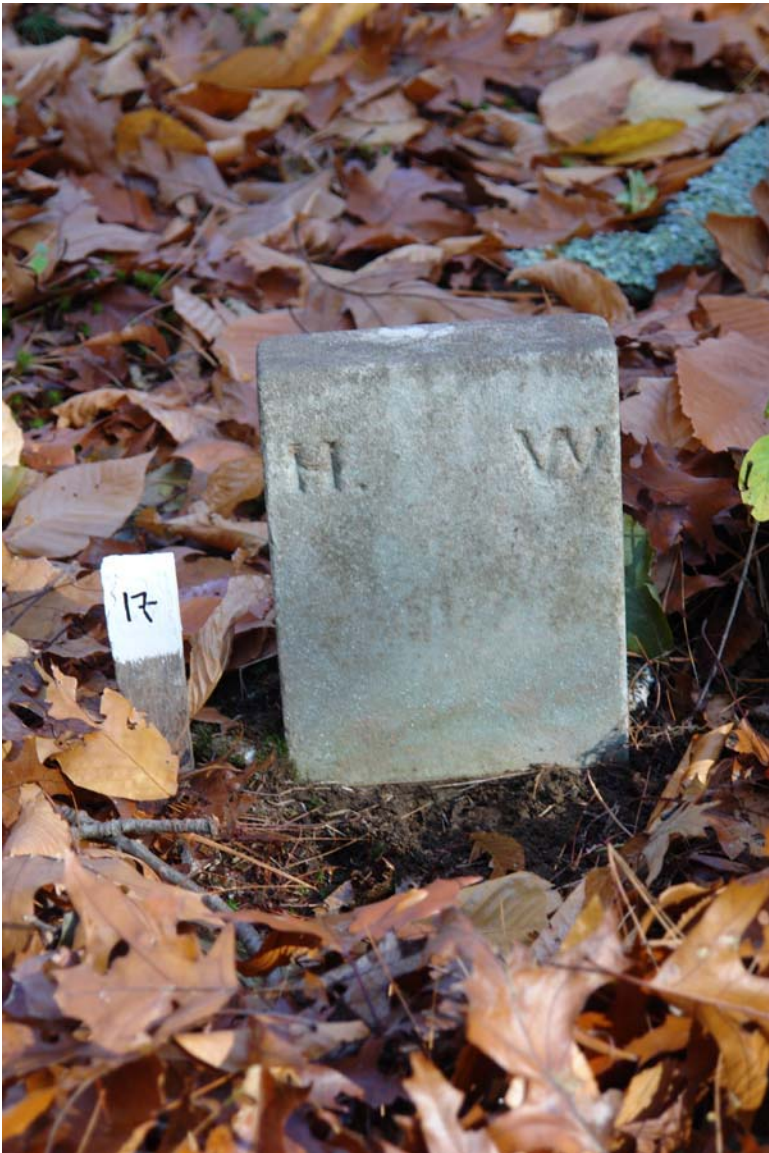
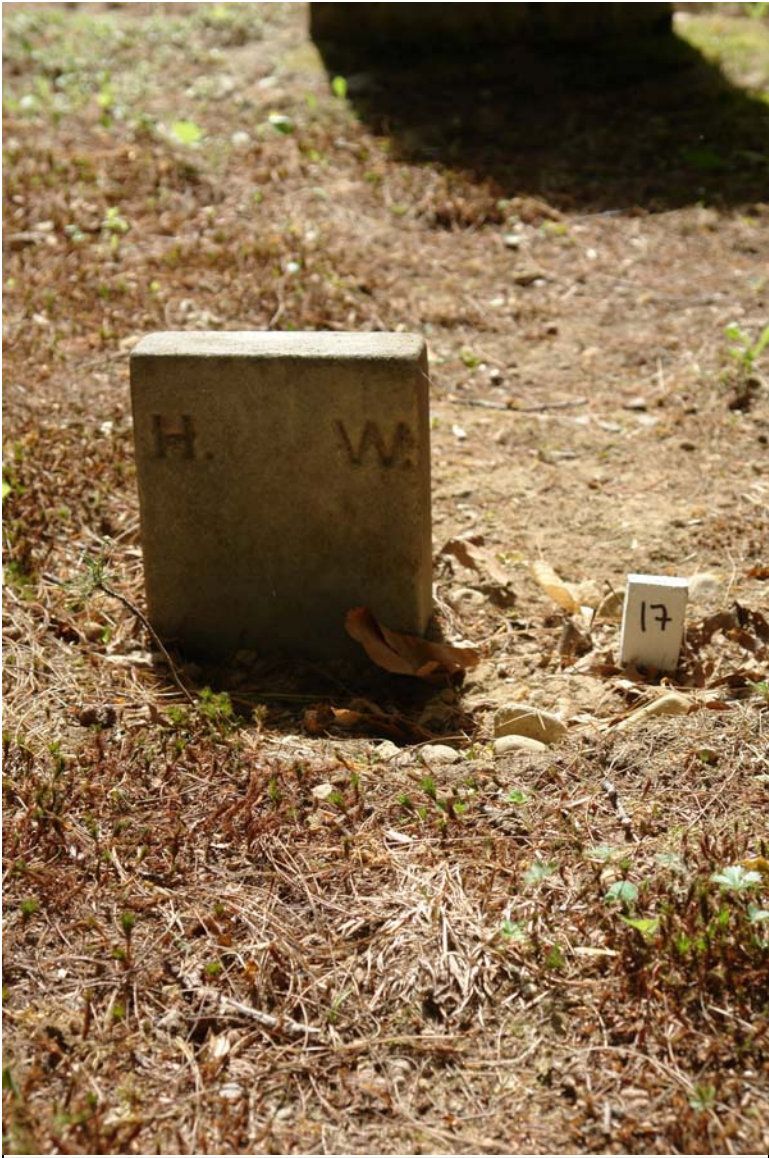
West Hanover/ Darling Cemetery, Hanover, MA
NAME ON MARKER **H. W. (Harriet Winslow)**
Death Date: 11/29/1836 Marker Type: Footstone
Cond. of Inscription: Legible Material: Marble

EXISTING CONDITIONS	CONSERVATION STRATEGY
Tilted, sunken Facing wrong direction	Reset facing East Possible new base required

TREATMENT	Treatment Dates 5/11/2015
1. Marker carefully excavated. The soil around tilted markers was removed to an appropriate depth. When required, the marker was removed from the ground. Marker appears to be sound. 2. Soling removed by light brushing with nylon brushes and water. 3. Setting area excavated to sufficient depth and stone re-set plumb at appropriate height and level onto gravel bed, aligned with adjacent markers 4. Area backfilled around marker with tamped sand and gravel 5. Disturbed areas re-graded with existing topsoil and sod.

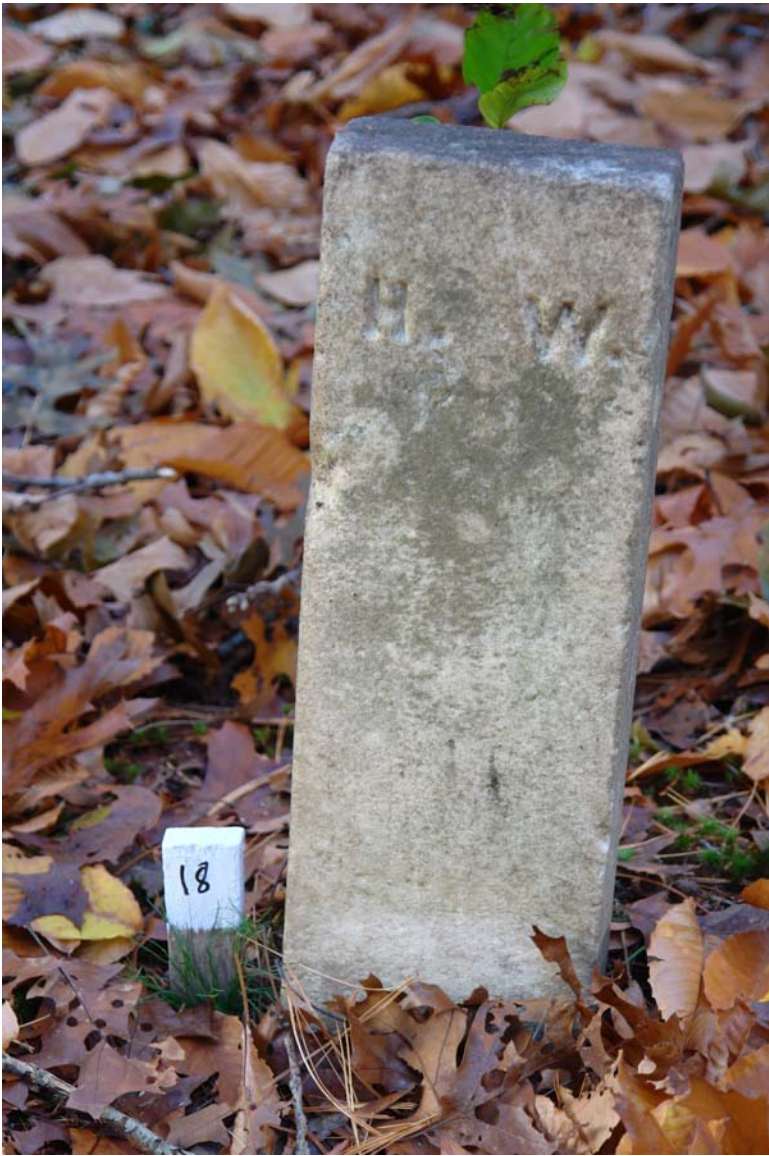
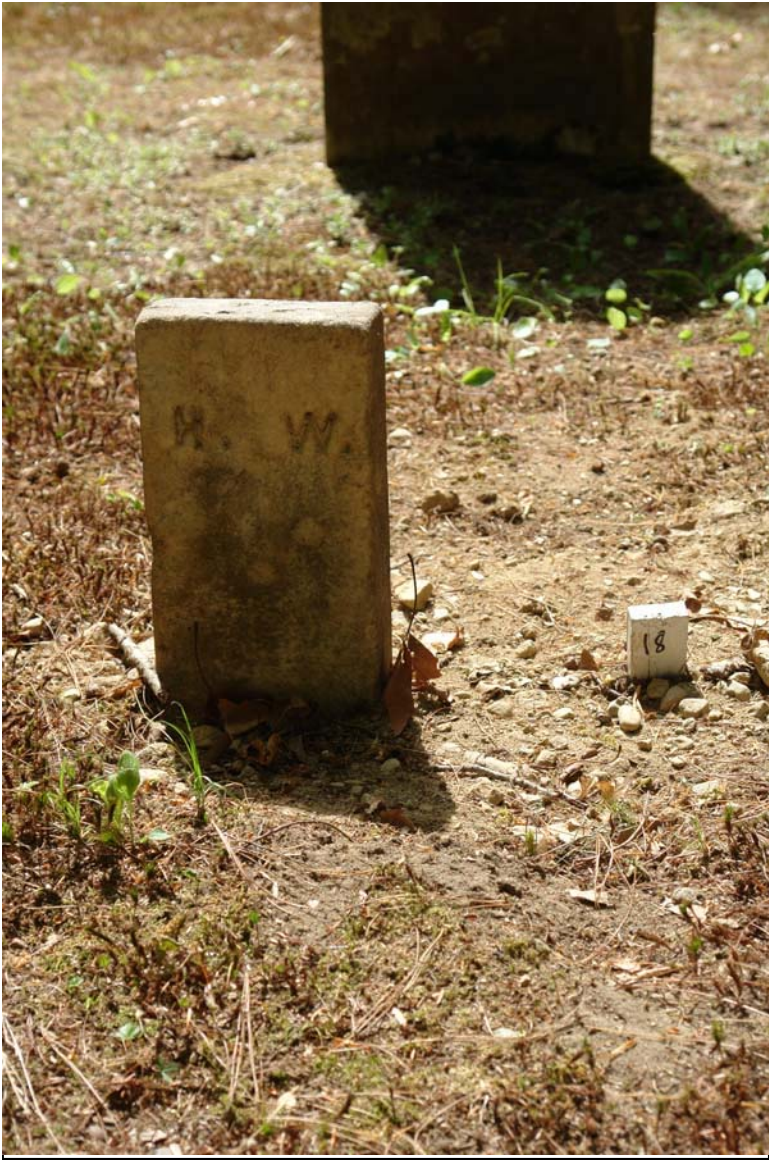
West Hanover/ Darling Cemetery, Hanover, MA
NAME ON MARKER **H. W. (Henry Winslow)**
Death Date: 1/29/1858 Marker Type: Footstone
Cond. of Inscription: Legible Material: Marble

EXISTING CONDITIONS	CONSERVATION STRATEGY
Tilted Facing wrong way Marker too high	Reset marker in ground facing East

TREATMENT	Treatment Dates 5/11/2015
1. Marker carefully excavated. The soil around tilted markers was removed to an appropriate depth. When required, the marker was removed from the ground. Marker appears to be sound. 2. Soling removed by light brushing with nylon brushes and water. 3. Setting area excavated to sufficient depth and stone re-set plumb at appropriate height and level onto gravel bed, aligned with adjacent markers 4. Area backfilled around marker with tamped sand and gravel 5. Disturbed areas re-graded with existing topsoil and sod.
