Historical Commission Hearing

733 Main Street - Application for Demolition

Siegel Associates conducted a walk-through inspection of the main house at 733 Main St., Hanover, MA on April 27th. This inspection was conducted at your request, in order to observe the condition of existing foundations and framing, and discuss approaches to repair, reinforce, and/or replace damaged, underperforming, or non-compliant building structure. For the purposes of this report, Main Street will be considered to run north-south, and the observed building is to the east of Main Street.

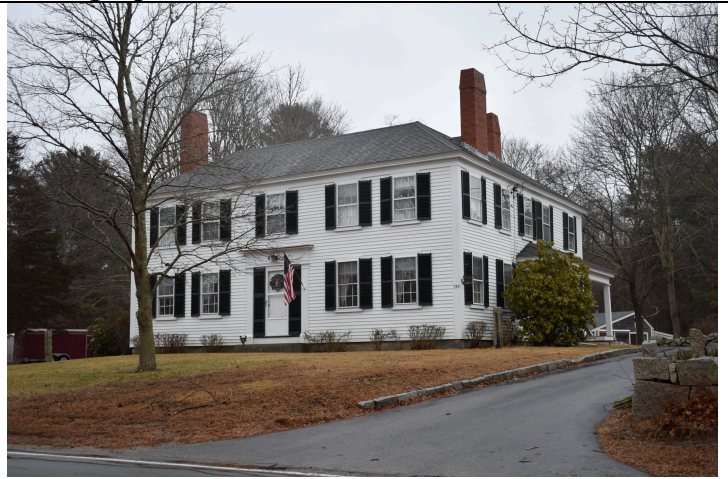
Photo 1. 733 Main Street, view northeast.

The house has a hip roof clad in asphalt shingles. The walls are surfaced in wood clapboard with wood corner boards and rest on a granite foundation. Paired interior-end chimneys pierce the front wing's north and south slopes. A single chimney pierces the ridgeline of the rear wing. The facade (west) elevation of the front wing is a symmetrical center hall plan, with a central entrance flanked by two windows. Five windows are set in the second story of the facade. The entrance consists of a wood surround with wide pilasters supporting a wood entablature and is filled with a three-panel wood door and aluminum storm door. The doors are framed by operable wood shutters and are reached by a single granite step. The south elevation contains a three-bay wood porch, with two windows to the west, and five windows in the second story. The north elevation contains a single window in each story. The two-story rear wing contains one window at each story and a single-story enclosed porch is to the east of this addition. Fenestration consists primarily of six-over-six, double-hung, wood sash windows in wide wood surrounds with rectangular sills and modern, metal storm windows. The windows have operable louvered wood shutters.

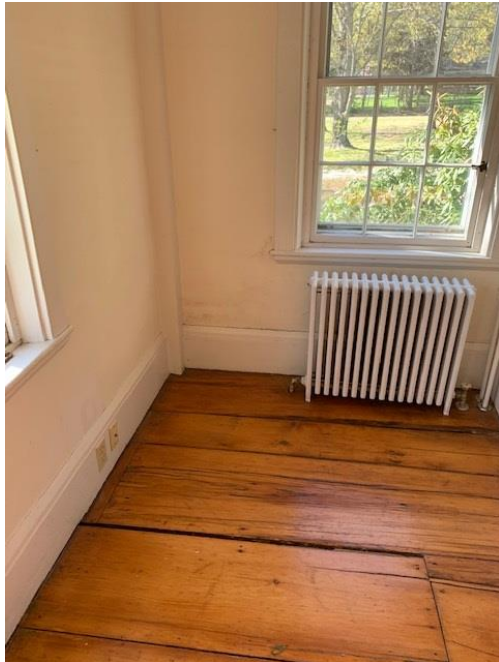
Image 1 -- Floor drop in the NW corner of the first level

First Floor Structure: The first floor surface is uneven, heel-drops reveal considerable bounce, and the northwest corner drops by a few inches relative to the most regular floor surface elevation (See Image #1). We expect this drop results from sill damage since the foundations look sound from the exterior.

First Floor Framing: Within the el, we recommend the removal and replacement of the timber sills with pressure-treated stock, and the removal and replacement of all floor joists. Only framing over the small basement area can be addressed from below; we expect that the balance of reframing efforts will need to be done from above after removing the first floor sheathing.

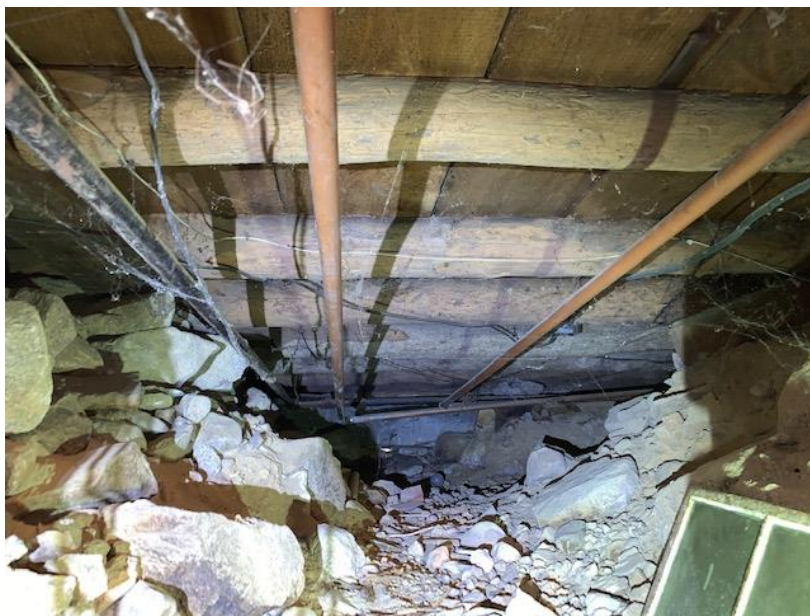
Image #2 – Very shallow crawl space beneath first floor framing

A full basement is found beneath the southeast wing of the el only. From this basement a close physical inspection of first floor framing is possible, and framing beneath the southwest portion of the el and beneath the newer infill floor can also be observed via foundation wall openings into adjacent, very shallow crawl spaces (See Image #2).

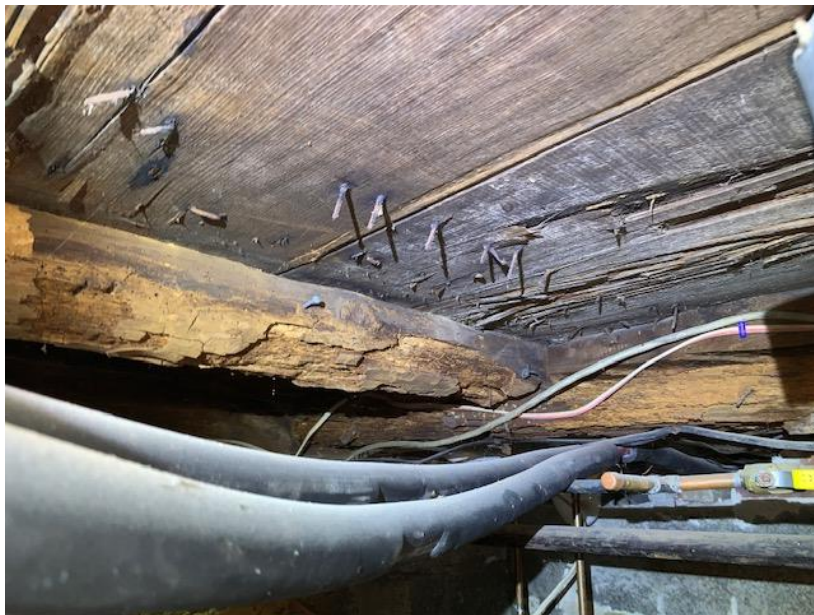
Image #3 – Dry rot and powder post beetle damage in first floor framing

Joists beneath the southeast wing of the el vary considerably in size from piece to piece, ranging from 5x5 square members to 4", 5", and 6" diameter logs. Joist spacing varies from 24" to 30" on center. Nearly every observed joist suffers from significant powder post beetle damage, termite damage, and dry rot (degradation of the cellulose and hemicellulose that gives wood strength and resilience, caused by fungi) (See Image #3). Outer layers of the log joists can be pulled apart by hand, and a sharp steel probe can be readily pushed deep into the cores of many joists.

Joists beneath the southwest portion of the el are made of logs in the 4-5" diameter range. These joists appear to be degraded similarly to joists beneath the southeast wing.

We expect that restoration of this building frame for continued safe, code-compliant use will require the complete replacement of all first floor wood joists, beams and sills; we expect the second floor framing will need to be reinforced or replaced; the roof framing must be reinforced. Stone foundations should be repointed and remortared as necessary, and any damaged wall studs should be reinforced or replaced.

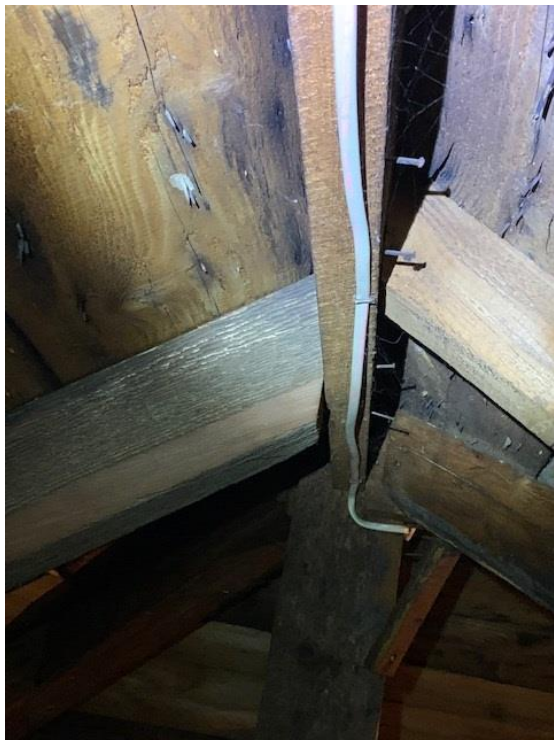
Image #5 – 2x ridge board, likely indicating an early 20th century roof frame replacement

Roof rafters over the el are variable in size and spacing, but the most typical condition is 3x4 rafters at 30" on center. Rafters are positioned over and are carried by attic floor joists that span the width of the el. 1x and 2x ridge boards (see Image #5), some clean milled rafters, and some very old rafters with ghost notches and pegs (See Image #6), all are evidence that much or all of the roof framing is not original even though some of it is older. Much of the roof sheathing is of a thickness, cut, and condition that suggest it may not be older than the beginning of the last century.

Roof Framing: The roof framing of the el is accessible through the attic. As noted above the framing is very undersized, and is further compromised by rot and insect damage. New framing can be inserted alongside and in between existing rafters, and the overall roof structure can be made safe, code-compliant, and durable.
