MONUMENT CONSERVATION COLLABORATIVE LLC, NORFOLK, CT

DOCUMENTATION OF STONE CONSERVATION TREATMENTS TO ASSINIPPI CEMETERY, HANOVER, MA June 2015

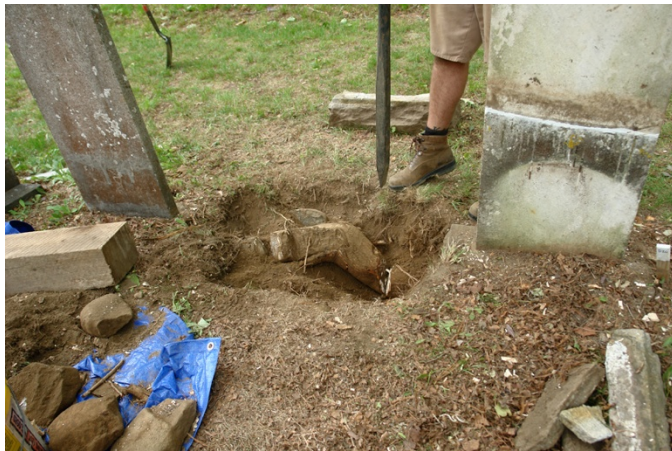
A common cause of tilted markers are roots from nearby trees

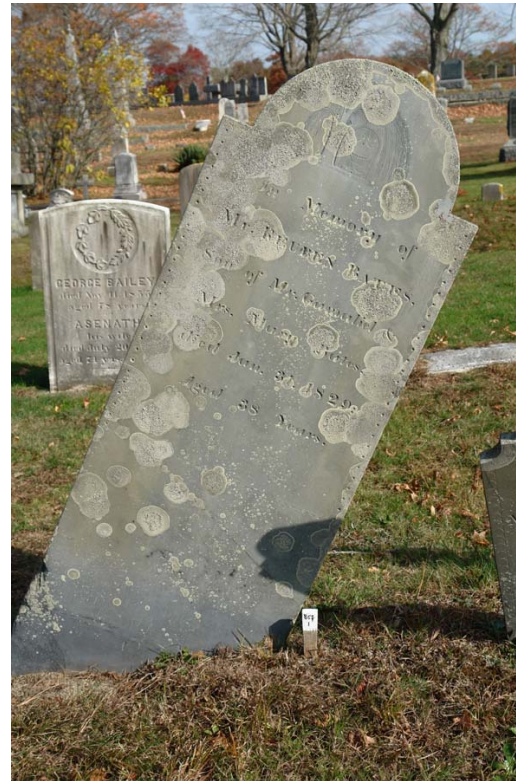
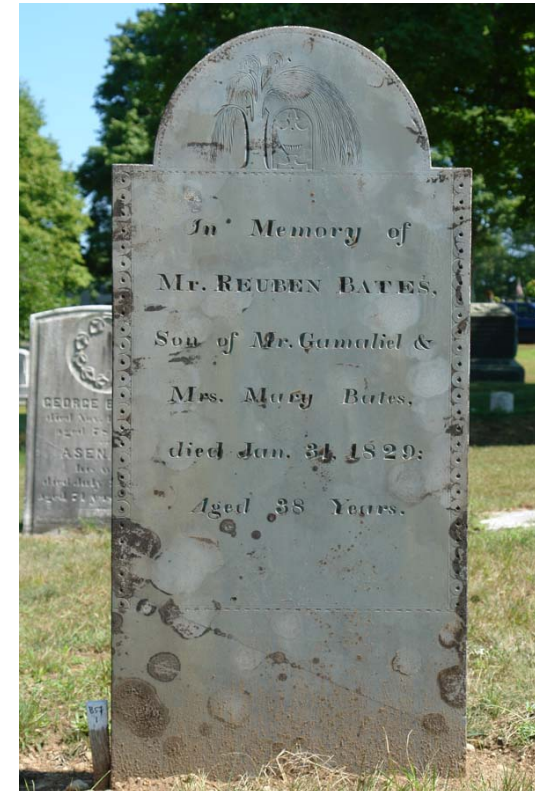
*B. 57.1 Rueben Bates Before and after— severely tilted .
Early slates and marbles were often set as deeply in the ground as what
appeared above the ground.*

Earlier gravestones are typically long panels of stone that were set directly into the ground. After determination of the correct location and orientation of the stone, soil was removed to an appropriate depth. Gravel (or broken stone) was introduced to establish a stable base. The stone was made plumb and level, and set in plane with the adjacent markers. Backfilling was done with sand and gravel, wetted and compacted. Every effort was to replace disturbed areas with existing topsoil and turf, however additional topsoil was required at a number of sites.

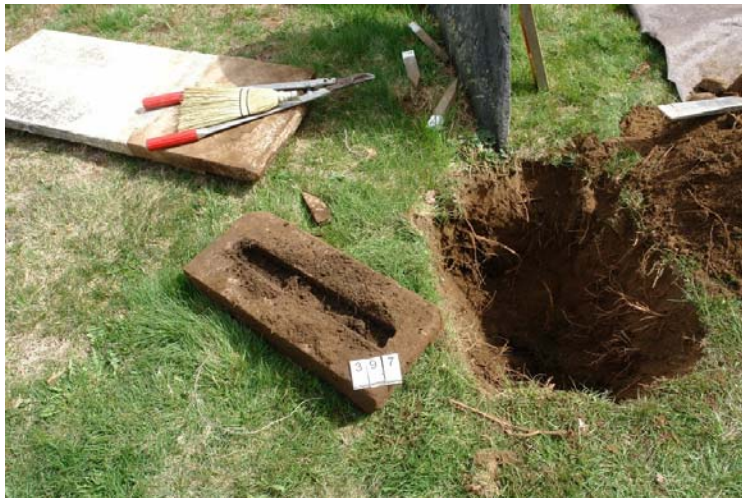
When excavating for resetting often original, or old bases are discovered

In many cases, fallen markers had been originally set into below grade sandstone bases. When discovered, these bases were often uncommonly deep, more than one foot. Bases were excavated, examined for soundness and reset level at a higher elevation and aligned with adjacent markers.

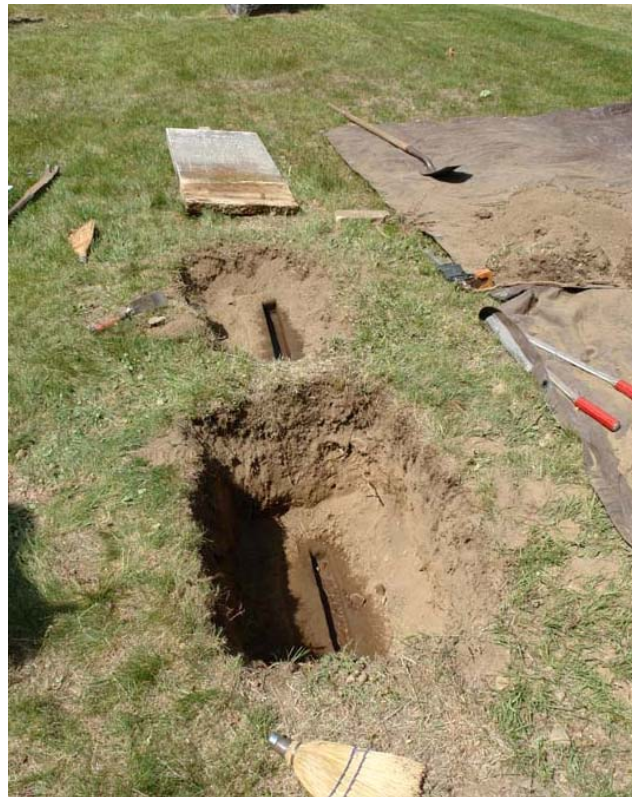
Original bases were raised to an appropriate level, aligned with adjacent markers and set plumb before resetting the markers.

Gravestones that required insertion into existing bases were set with a relatively weak cement/lime-based grout (3:2:9:1) with fine aggregates (000), made fluid with a high-range water reducer which ensures a complete fill. This was poured or injected into the base slot. Stones were braced for a minimum of three days to limit movement during curing of the grout.

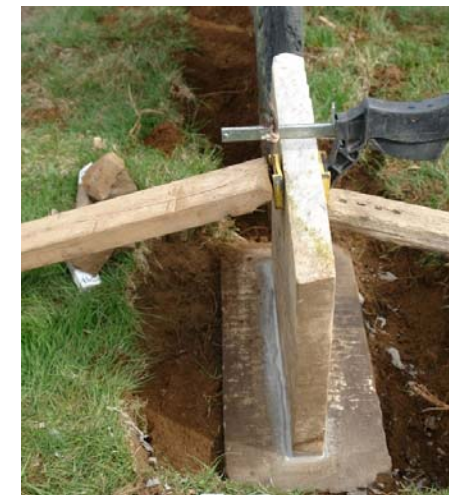
Lower fragment of fractured marker first reset into slot and braced. Top fragment will be attached with structural adhesive after grout has sufficiently cured.

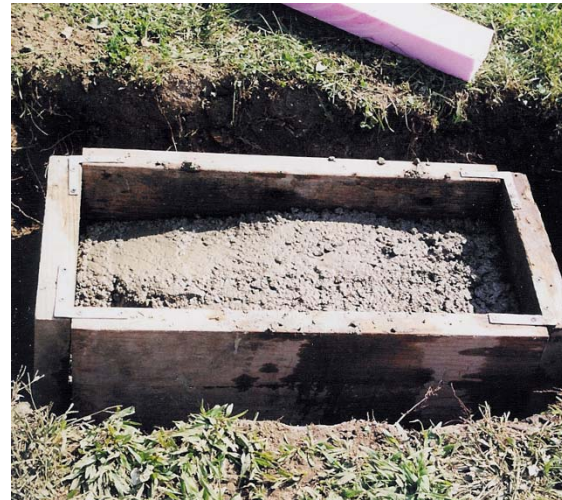
Form for new below grade concrete base

Bases were made on site by casting in place with concrete. The casting is generally 9 to 12 inches deep, and 6 inches greater in both thickness and width than the stone itself. The finished top surface of the base should be entirely below grade. A form for a 1 inch deep setting slot, $\frac{1}{2}$ inch wider and $\frac{1}{2}$ thicker than the stone, was positioned in the concrete. After the base cured, the gravestone was reset into the slot with a cement/lime-based grout as previously described. The top of the new base was covered with topsoil.

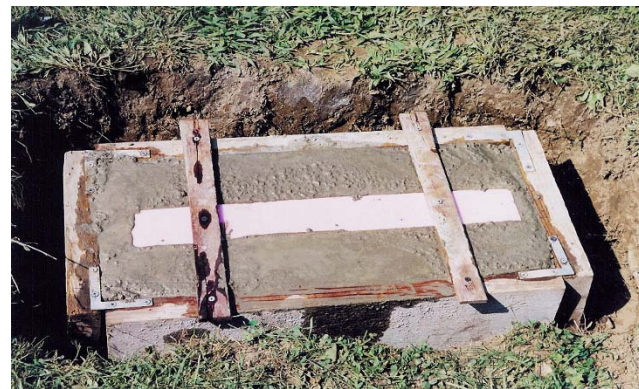
Concrete poured, with form for setting slot in place

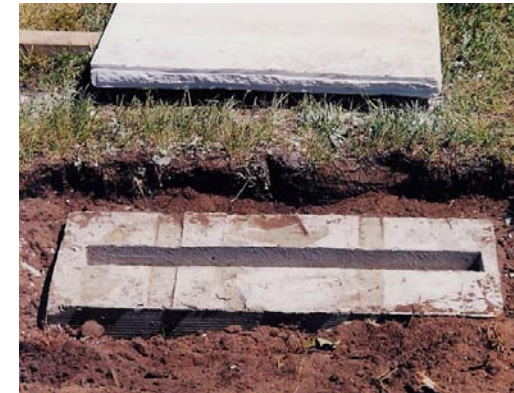
Form removed, ready for resetting marker

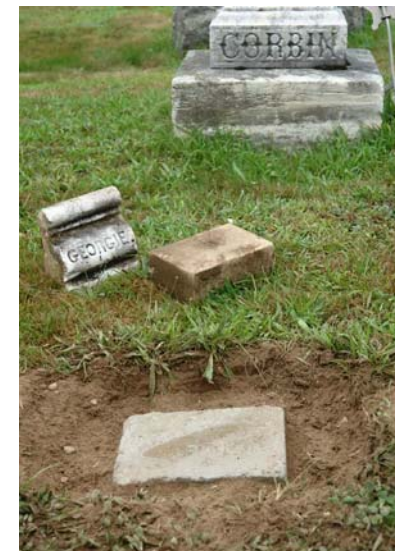
G.50.2 George Corbin— New foundation

New foundations were cast when the original foundations were missing or failed.

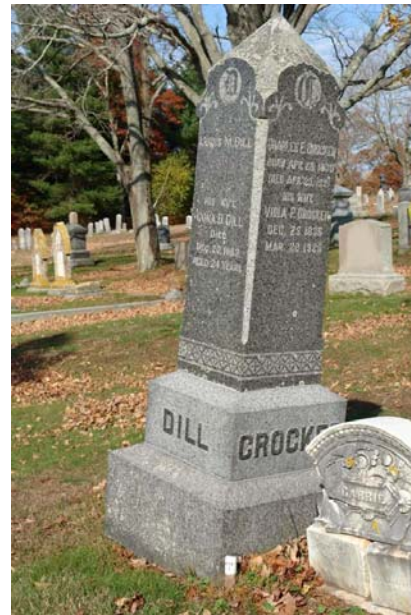
Over time the shifting of dry laid foundation stones due to frost heaves or tree roots can cause the larger monuments to tilt. These heavy monuments required mechanical assistance with hydraulic jacks or chain hoists and tripods to be reset.

They were typically reset level and stable with stone shims.

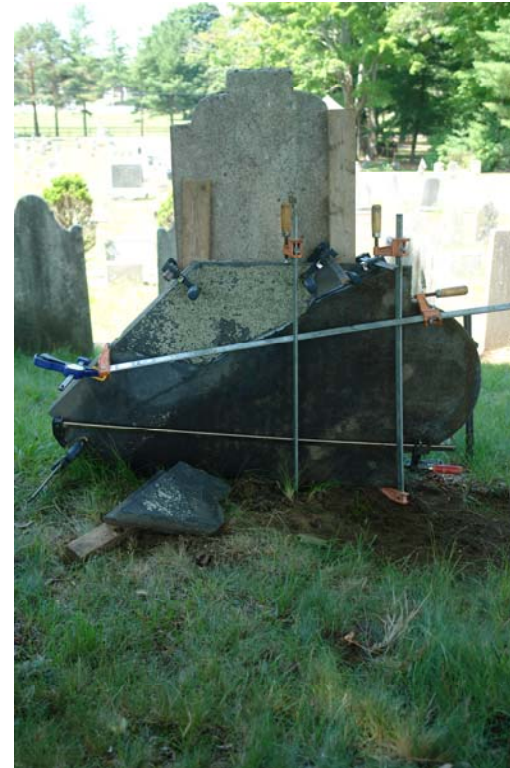
Clamping and bracing in a vertical position allows gravity to help position fragments.

All fragments were carefully cleaned and dry fitted. A thixotropic, thermosetting structural resin (A-5522, by Abatron, Kenosha, WI or equivalent) was thinly and evenly applied along the bond line only. A thixotropic adhesive is a Vaseline-like consistency which does not drip or run, and only moves with pressure. The fragments were aligned, joined with clamps, and adequately braced during curing, which was typically a period of several days depending on the temperature. Excess epoxy is trimmed off with hand tools when partially cured, usually after a day.

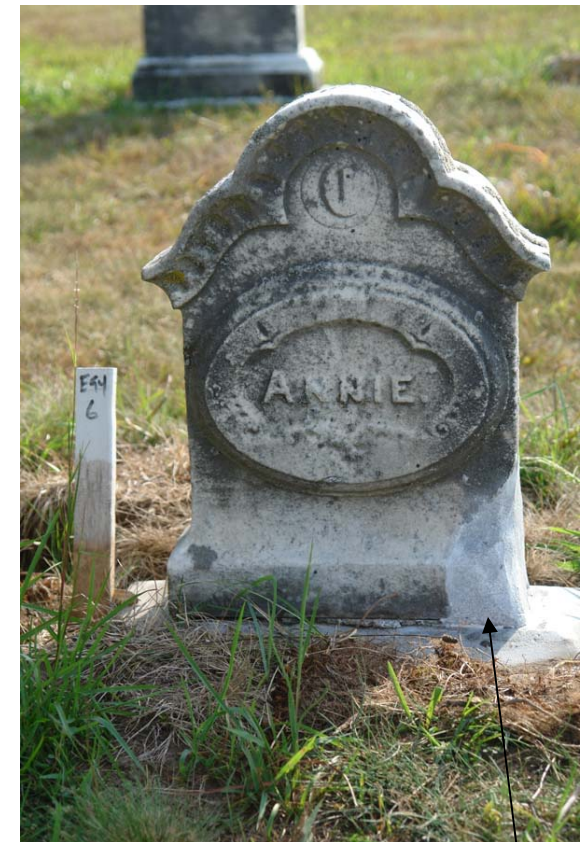
Jahn M70 mortar patch, with artificial weathering

Fills and patches are made to look weathered when necessary. Where lettering and inscriptions are lost, they are not replaced. In these areas the filled plane is kept slightly back from the stone surface to indicate that there is a loss. Areas where there are no inscriptions can be filled level with the original stone.

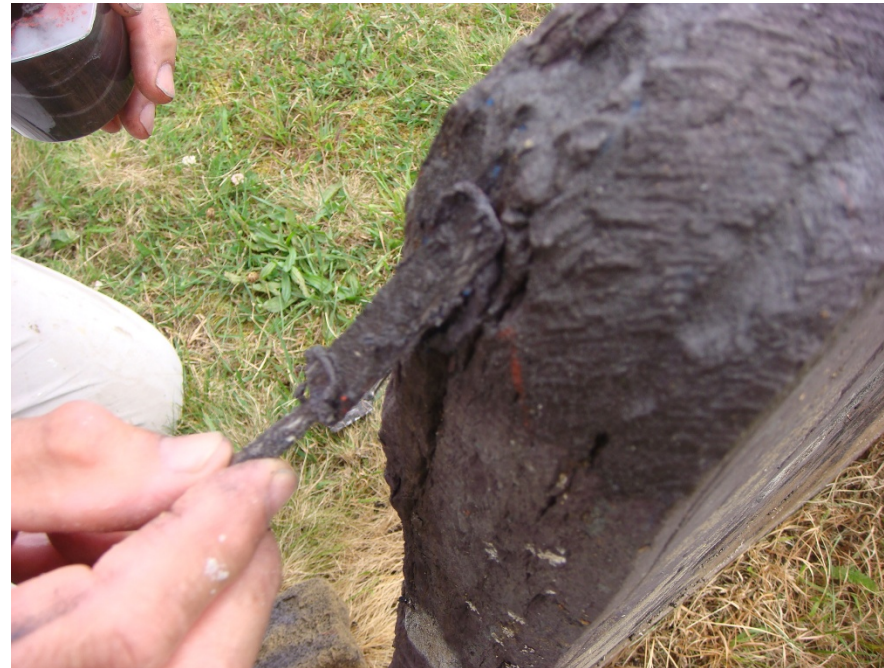
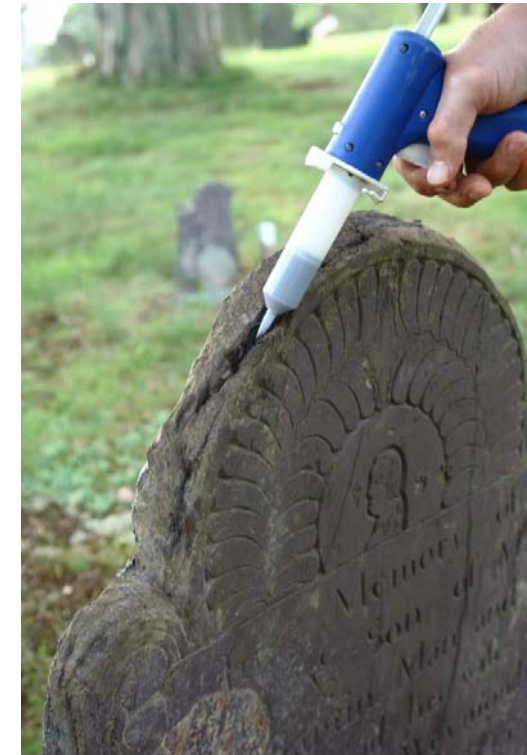
Filling top cavities with a pigmented crack filler by Sto. Material can be applied by trowel or injection. Excess material is immediately wiped off with damp sponging

Open joints along the top were filled with a pigmented flexible industrial “crack filler” by Sto. Excess grout is immediately removed with damp sponging.

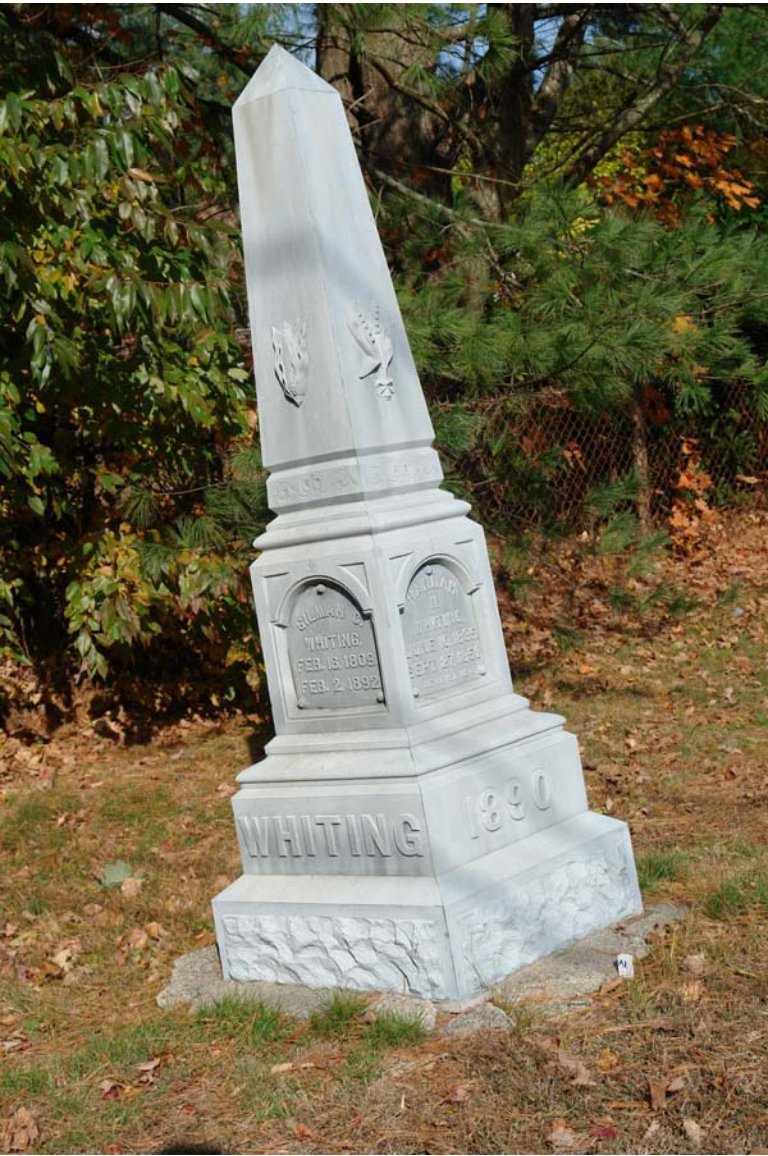
Hanover Center Cemetery, Hanover MA
NAME ON MARKER **John Dwelley**
Death Date: 1/10/1907 Marker Type: Headstone/conc. base
Cond. of Inscription: Legible Material: Marble

EXISTING CONDITIONS	CONSERVATION STRATEGY
Loose in base	Reset into new below grade concrete base

TREATMENT	Treatment Dates
1. Marker excavated and found to be sound. Light soiling removed by brushing with nylon brushes and water. 2. Setting area excavated for new below grade cast concrete base sized minimum of 12 inches deep, 12 inches greater in thickness and 6 inches wider than the stone. 3. Wooden forms and setting slot form stabilized and aligned with adjacent markers before concrete is poured 4. When required, the lower edge of marker is re-squared with minimal loss using a power grinder 5. Setting forms are removed after partial curing of the concrete and the base backfilled with tamped sand or gravel 6. Marker reset into setting slot with a cement/lime grout (3/2/9) with 000 sand made fluid with a super plasticizer. 7. Marker set plumb and level, and braced for minimum of 5 days. 8. Disturbed areas backfilled with existing topsoil.	6/11-16/2015

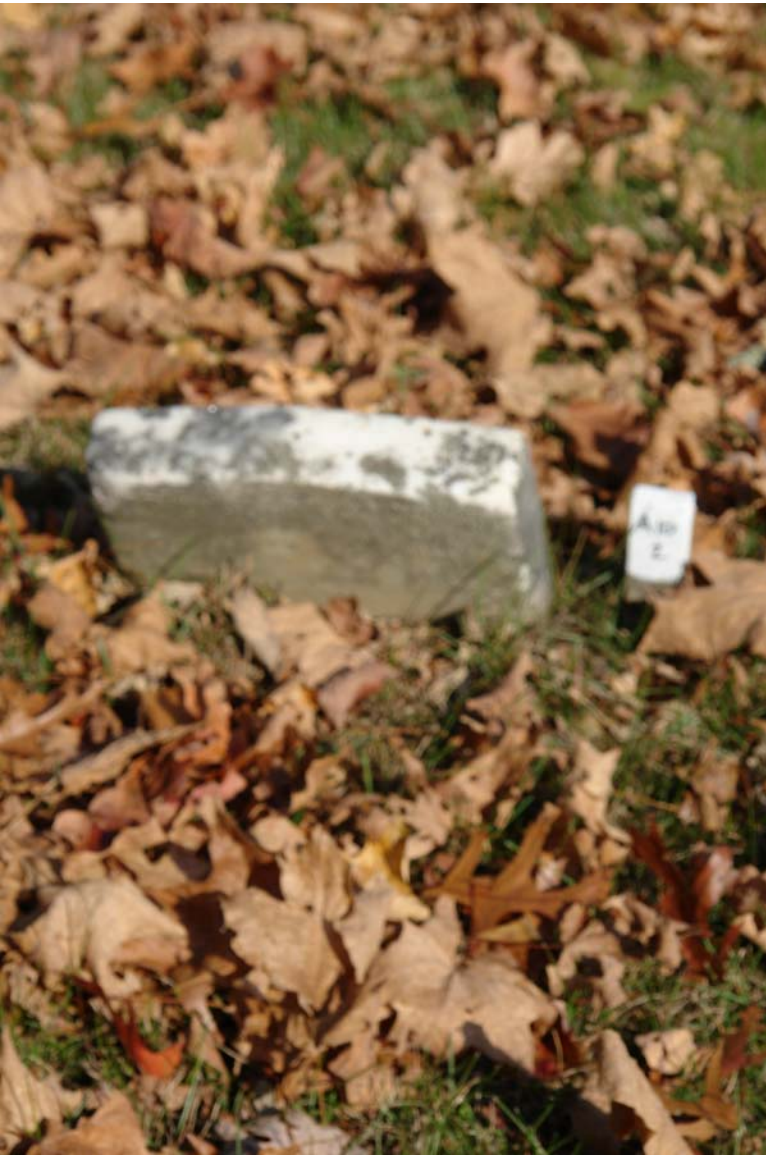
Hanover Center Cemetery, Hanover MA
NAME ON MARKER **Ruth Whiting**
Death Date: 7/15/1895 Marker Type: Sm die/pinned base
Cond. of Inscription: Legible Material: Marble

EXISTING CONDITIONS	CONSERVATION STRATEGY
Tilted base	Reset base with marker plumb

TREATMENT	Treatment Dates
1. Elements removed from setting bases and inspected for soundness. 2. Area excavated to an appropriate depth removing any roots or large stones. 3. Base is aligned with adjacent markers and re-set level. 4. Area around base was backfilled with tamped gravel and re-graded with existing topsoil 5. Failed mortar removed from setting area and bottom of marker 6. When required, any existing pins were inspected, and if necessary, replaced with stainless steel threaded pins 7. Setting surfaces primed with Acryl 60 diluted 1:3 with water. 8. Marker reset plumb onto base with cement/lime mortar (3/2/9) with 000 sand. 9. Excess grout removed and joint area cleaned. .	6/11/2015

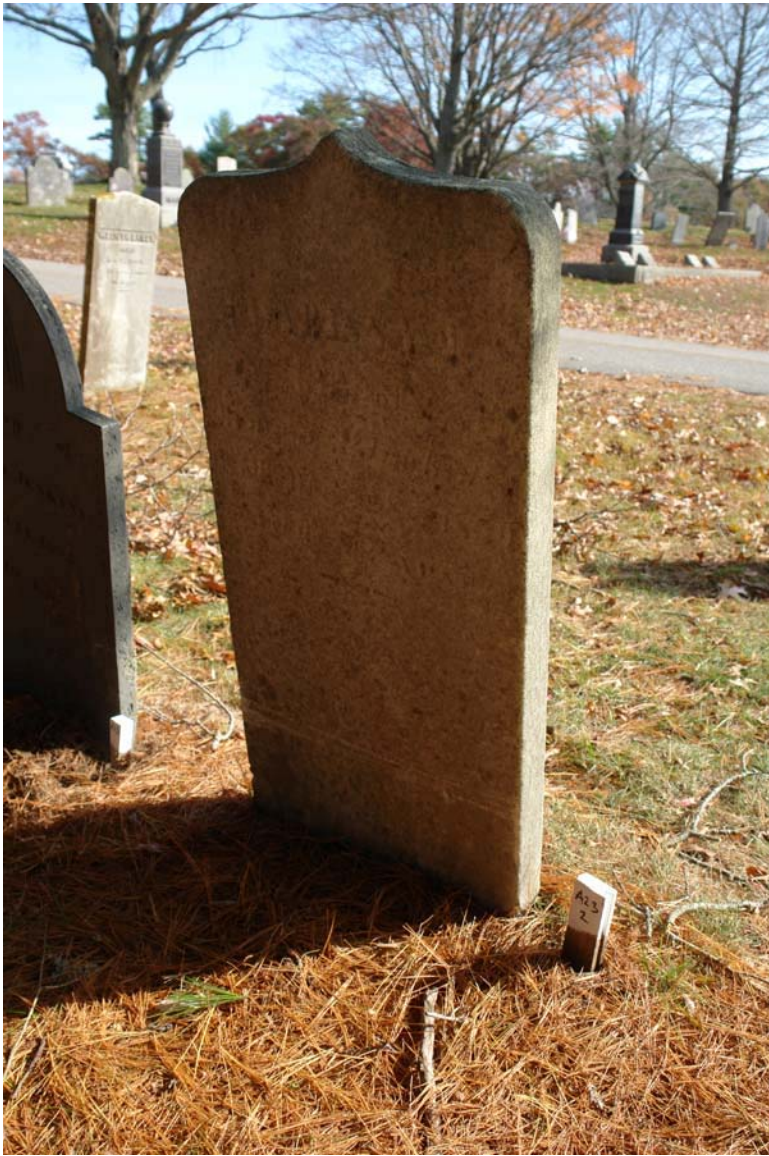
Hanover Center Cemetery, Hanover MA	
NAME ON MARKER	W. Elwyn Bailey
Death Date: 5/17/1869	Marker Type: Headstone
Cond. of Inscription: Legible	Material: Marble
EXISTING CONDITIONS	CONSERVATION STRATEGY
Marker loose in slot	Reset base level Reset marker plumb into setting slot

TREATMENT	Treatment Dates 6/12/2015
<div>1. Existing base located below grade while excavating for resetting. Area excavated to an appropriate depth removing any roots or large stones.</div> <div>2. Base inspected and found to be sound and re-useable</div> <div>3. Base is aligned with adjacent markers and re-set level.</div> <div>4. Area around base was backfilled with tamped gravel and re-graded with existing topsoil</div> <div>5. Debris removed from setting slot. When required, power grinders were used to facilitate removal of stone fragments.</div> <div>6. When required, the lower setting edge was re-squared by power grinder with minimal loss.</div> <div>7. Marker reset plumb and level into setting slot with cement/lime grout (3/2/9) with 000 sand made fluid with a super plasticizer.</div> <div>8. Excess grout removed and joint area cleaned.</div> <div>9. Marker braced for a minimum 3 days</div>

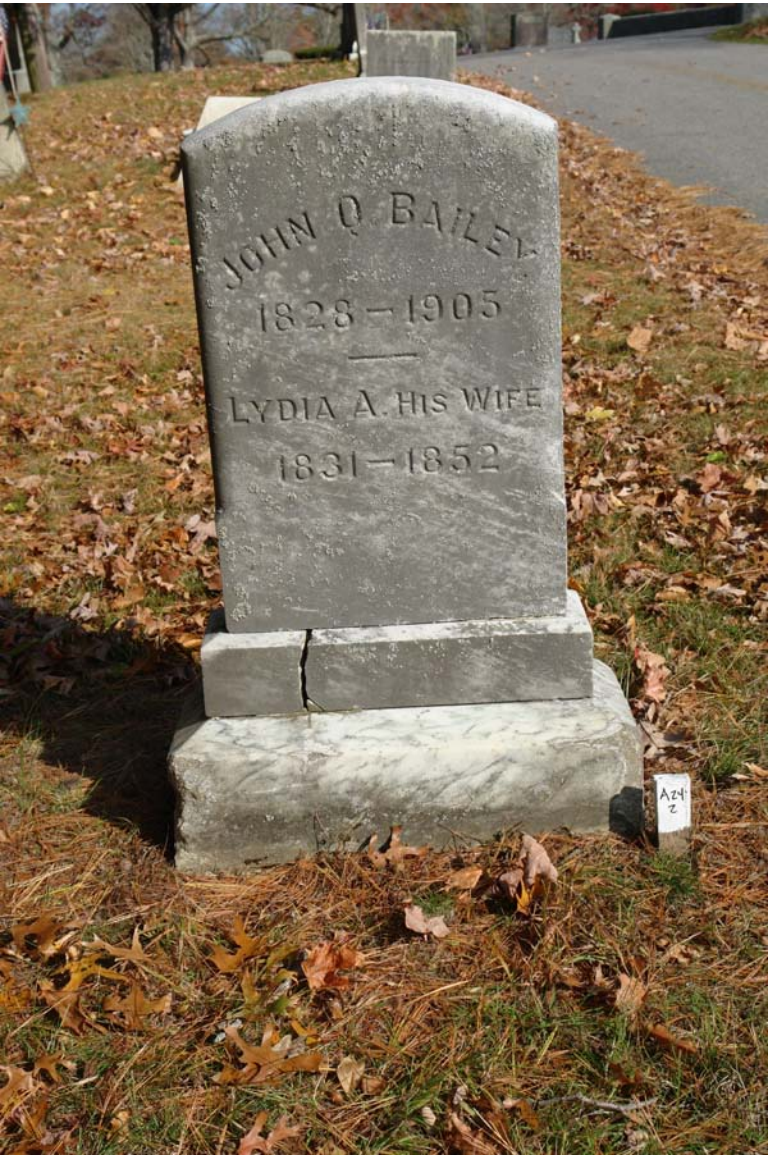
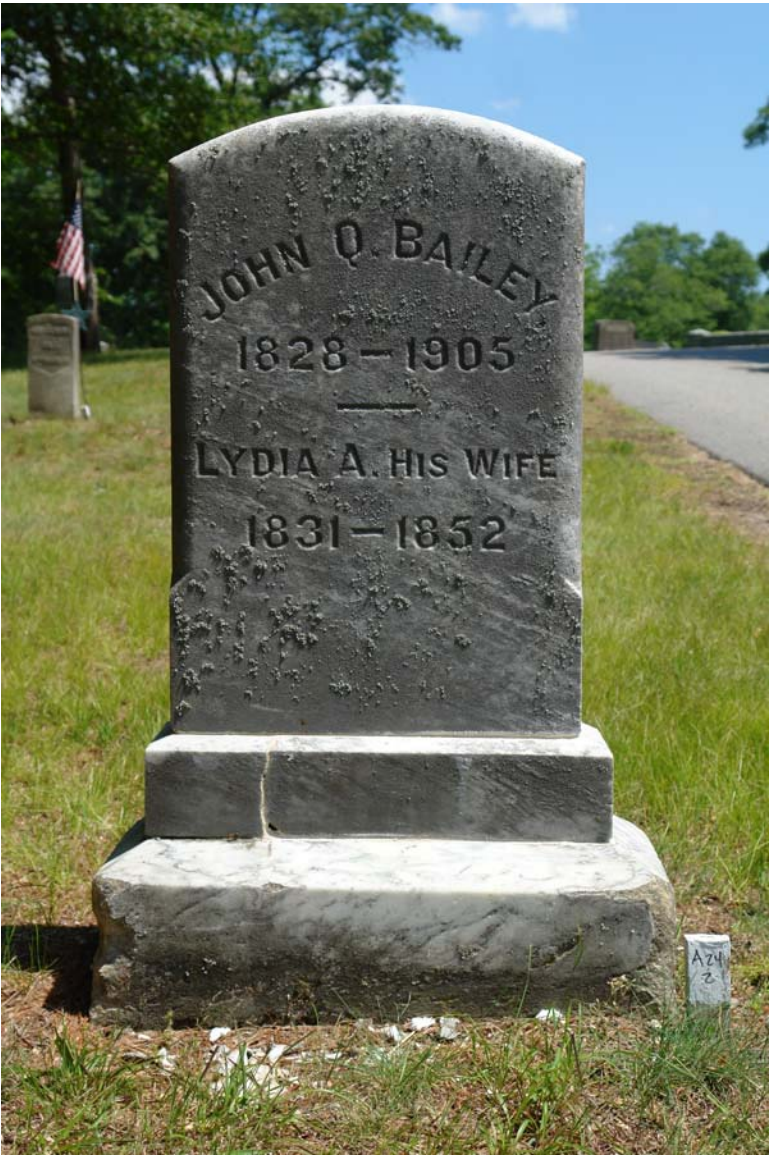
EXISTING CONDITIONS	CONSERVATION STRATEGY
Newly Unstable	Reset elements

1. Marker and base found to be in sound condition.

2. In ground base found to be level.

3. Failed mortar removed from setting area and bottom of marker

4. When required, any existing pins were inspected, and if necessary, replaced with stainless steel threaded pins

7. Excess grout removed and joint area cleaned.

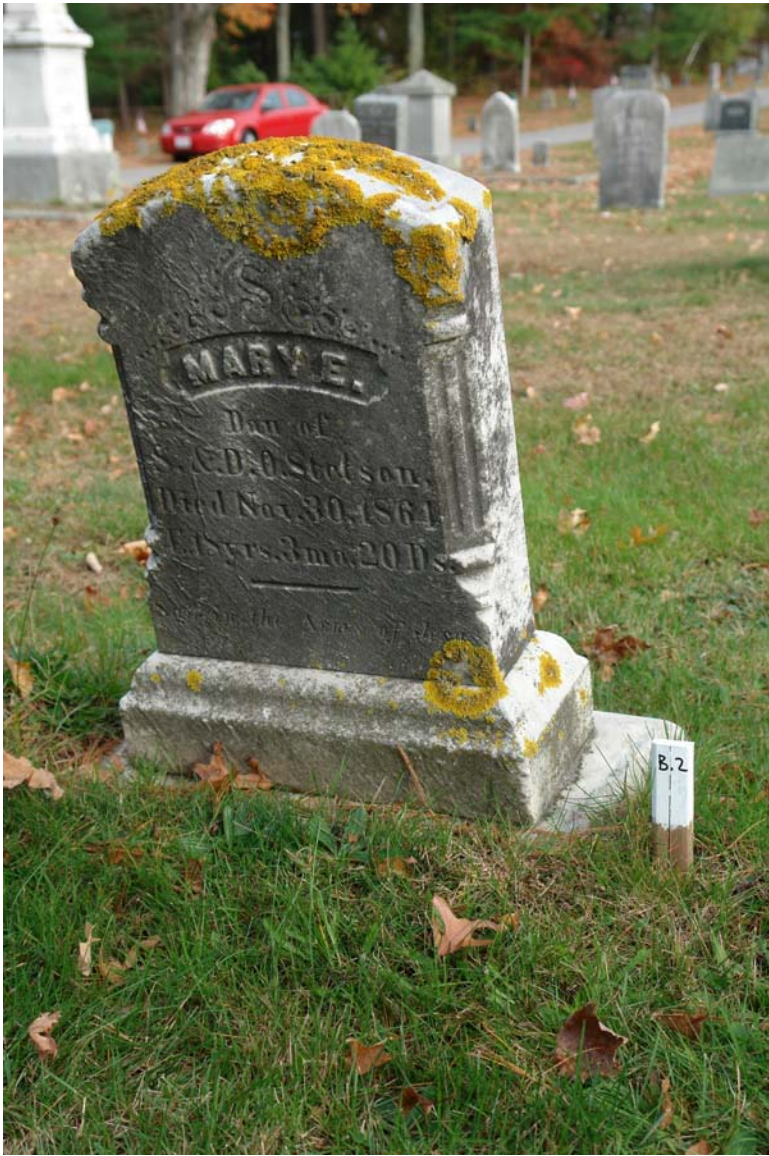
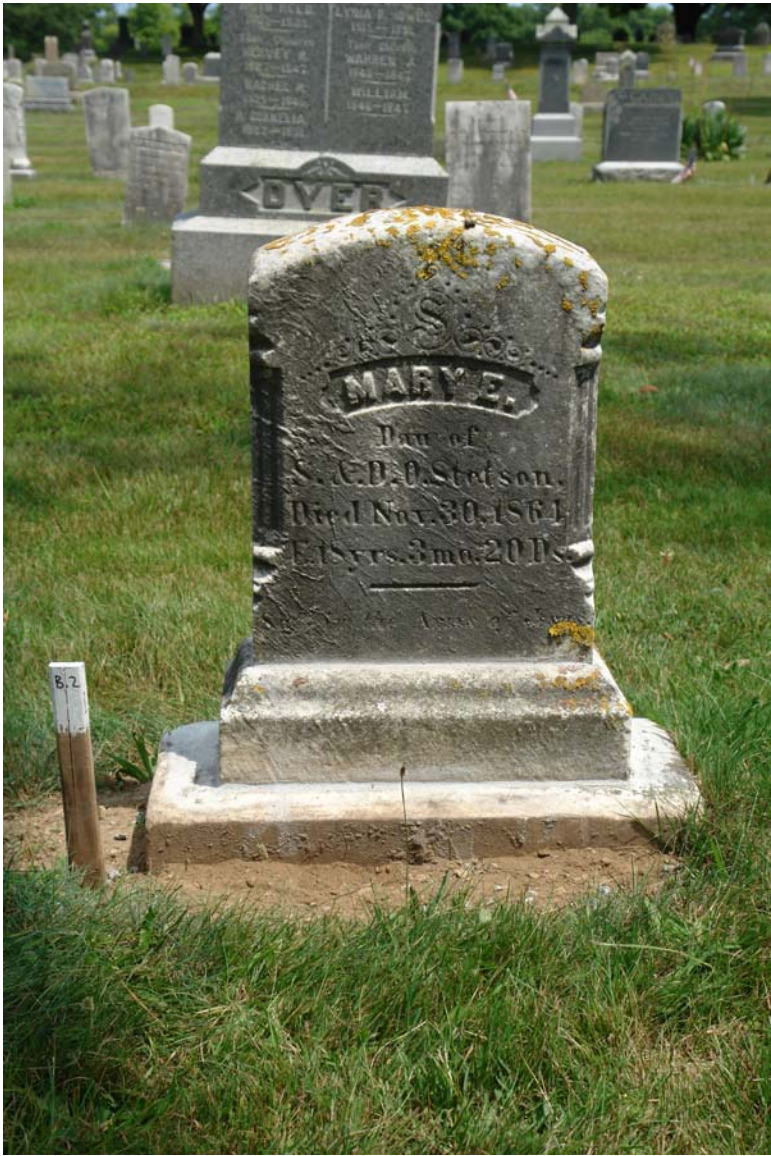
EXISTING CONDITIONS	CONSERVATION STRATEGY
<div>Tilted</div> <div>Loose on base</div>	<div>Reset base level</div> <div>Reset elements</div>

5. Failed mortar removed from setting area and bottom of marker

6. When required, any existing pins were inspected, and if necessary, replaced with stainless steel threaded pins

9. Excess grout removed and joint area cleaned.

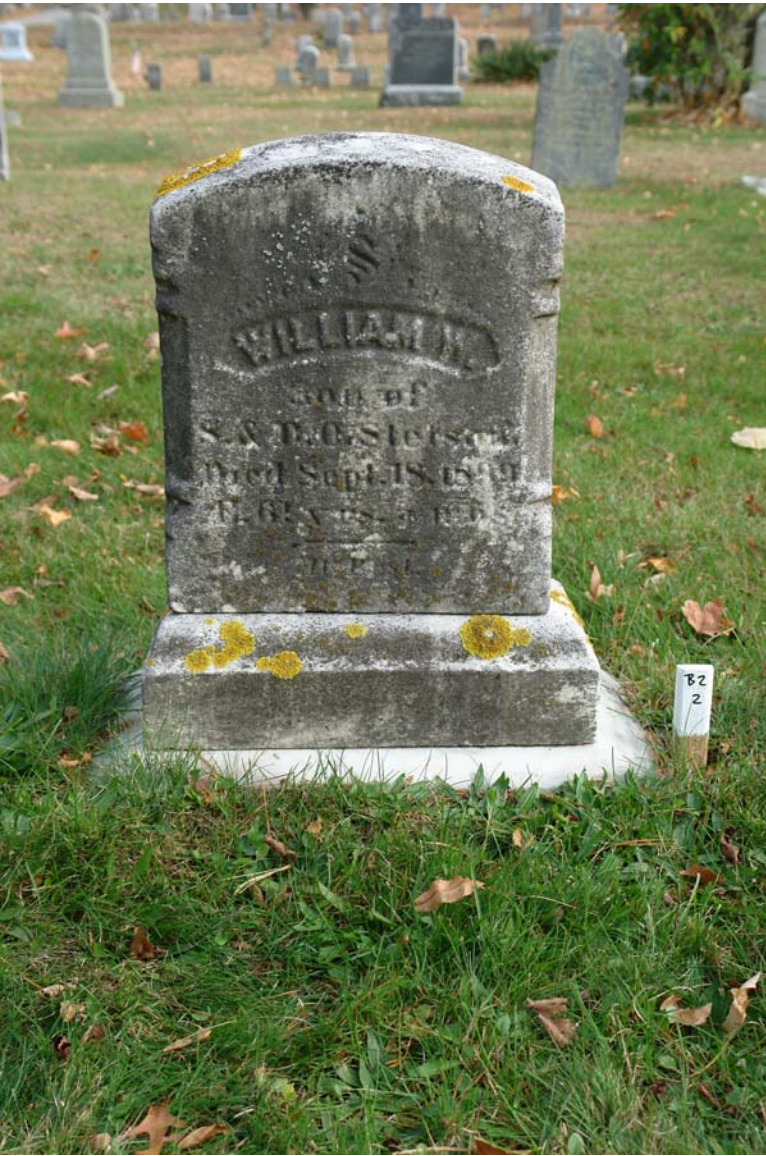
Hanover Center Cemetery, Hanover MA	
NAME ON MARKER	Joseph Damon
Death Date: 8/9/1870	Marker Type: Headstone/base
Cond. of Inscription: Legible	Material: Marble
EXISTING CONDITIONS	CONSERVATION STRATEGY
Tilted base	Reset base with marker plumb
TREATMENT	
Treatment Dates 7/15/2015	
<div>1. Area excavated to an appropriate depth removing any roots or large stones.</div> <div>2. Base inspected and found to be sound and re-useable</div> <div>3. Base is aligned with adjacent markers and re-set level.</div> <div>4. Area around base was backfilled with tamped gravel and re-graded with existing topsoil</div> <div>5. Debris removed from setting slot. When required, power grinders were used to facilitate removal of stone fragments.</div> <div>6. When required, the lower setting edge was re-squared by power grinder with minimal loss.</div> <div>7. Marker reset plumb and level into setting slot with cement/lime grout (3/2/9) with 000 sand made fluid with a super plasticizer.</div> <div>8. Excess grout removed and joint area cleaned.</div> <div>9. Marker braced for a minimum 3 days</div>

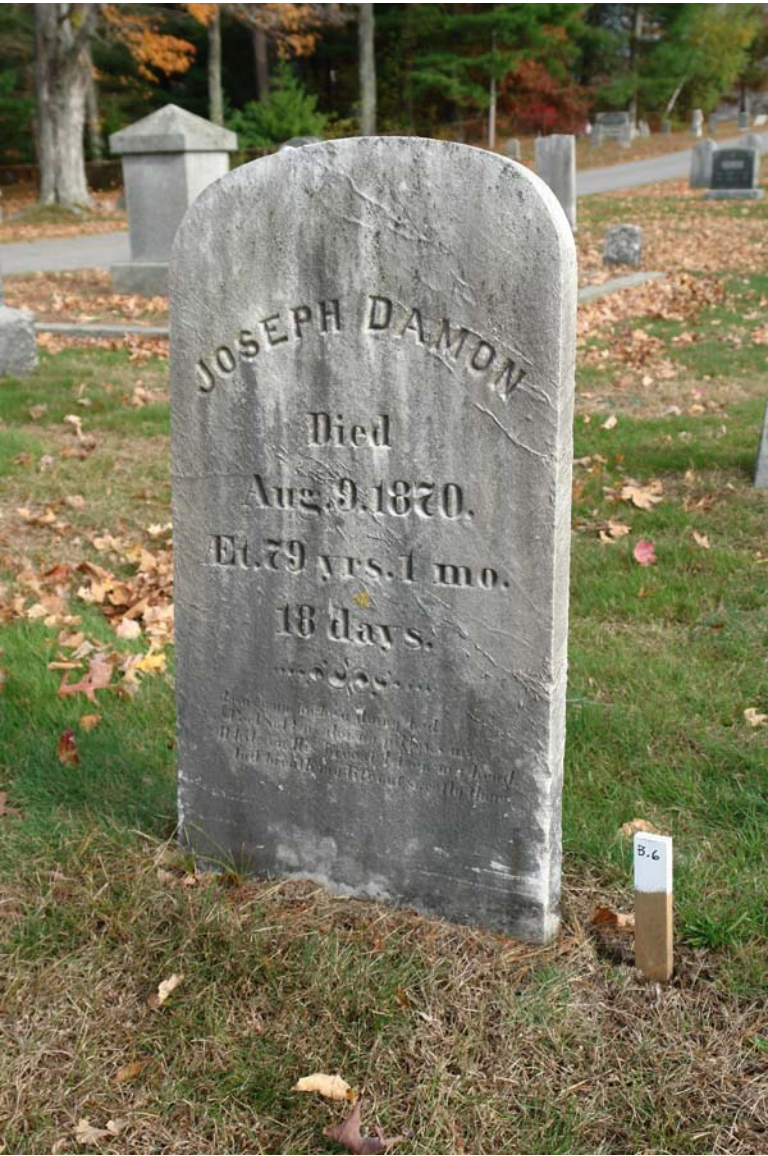
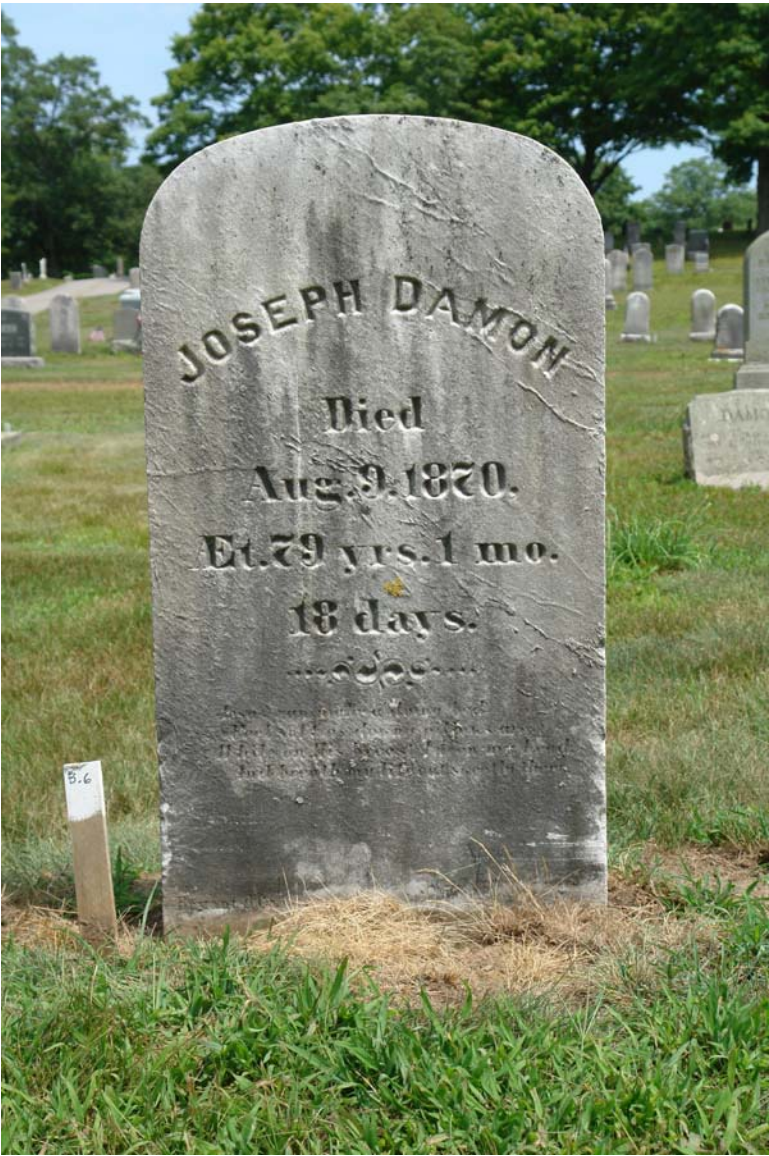
Hanover Center Cemetery, Hanover MA	
NAME ON MARKER	Martin Lindsey
Death Date: 7/9/1871	Marker Type: Headstone/base
Cond. of Inscription: Legible	Material: Marble

EXISTING CONDITIONS	CONSERVATION STRATEGY
Fallen, fractured	Attach fragments with structural adhesive

TREATMENT	Treatment Dates 7/311/2015
<p>1. Marker and fragments excavated. When required, area probed for missing fragments.</p> <p>2. Mating surfaces were treated with D/2 Biological Solution, scrubbed with nylon brushes and water. Rinsed fully with water. any failed adhesives or mortar removed with hand tools.</p> <p>3. Fractured elements were dry fitted to ascertain final soundness and to check for large losses at mating areas.</p> <p>4. Dry fragments attached with structural adhesive (Abatron 55-22), clamped and braced until cured. Excess epoxy removed by hand chisels</p> <p>5. Cracks and voids filled with RepliCal products. Any large losses filled with Jahn cementitious mortar.</p> <p>6. Filled areas misted with water and covered for 3 days minimum</p> <p>7. Filled surface areas treated with light acid wash and rinsed thoroughly.</p>

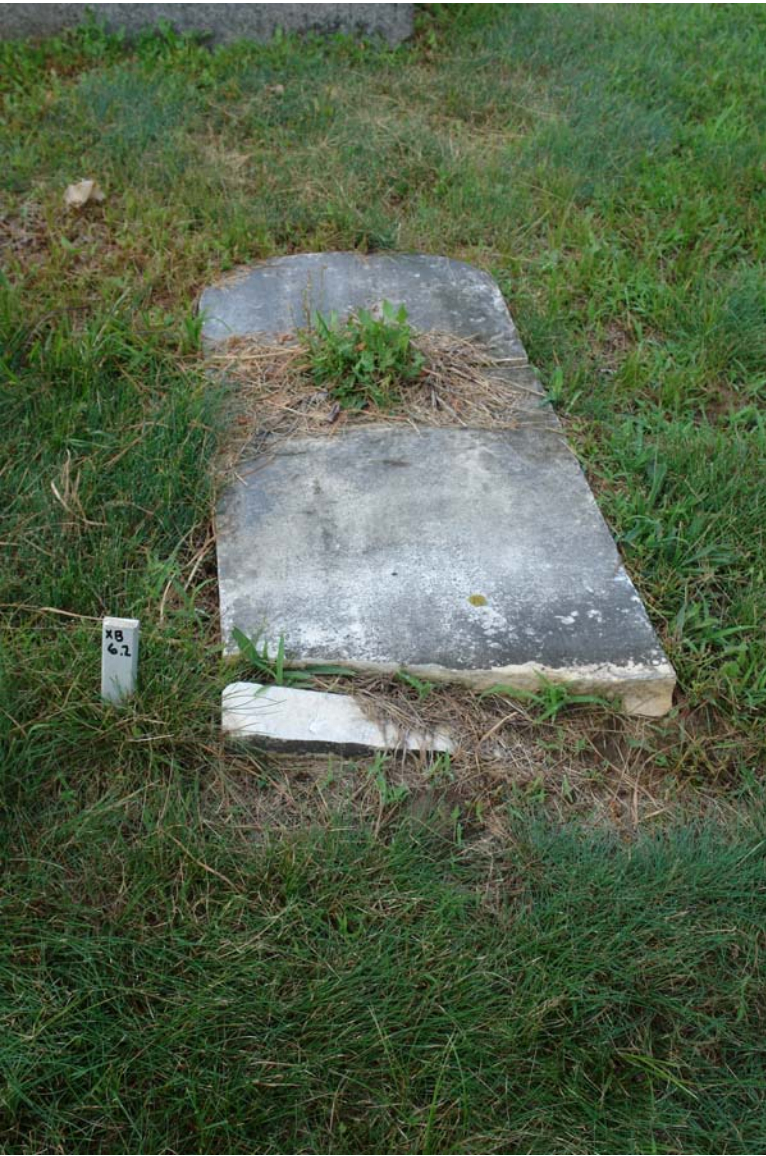
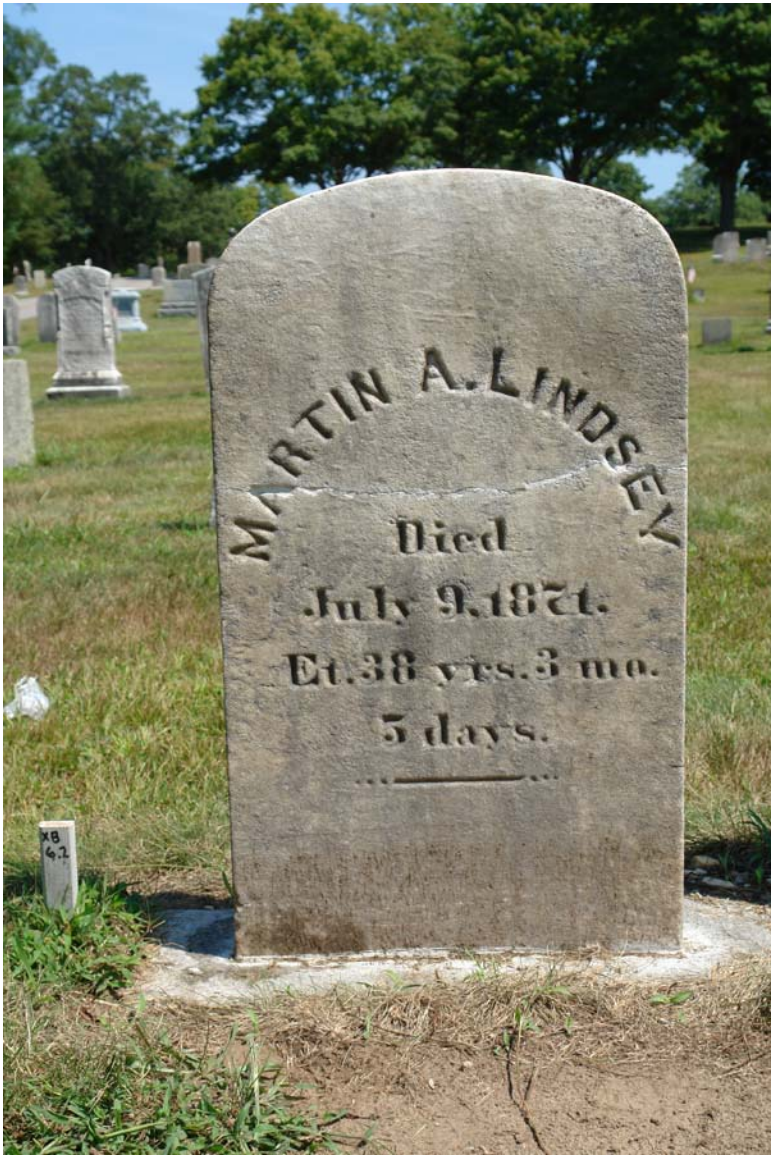
EXISTING CONDITIONS	CONSERVATION STRATEGY
Fallen	Level base Reset to base

2. Base inspected and found to be sound and re-useable

9. Marker braced for a minimum 3 days

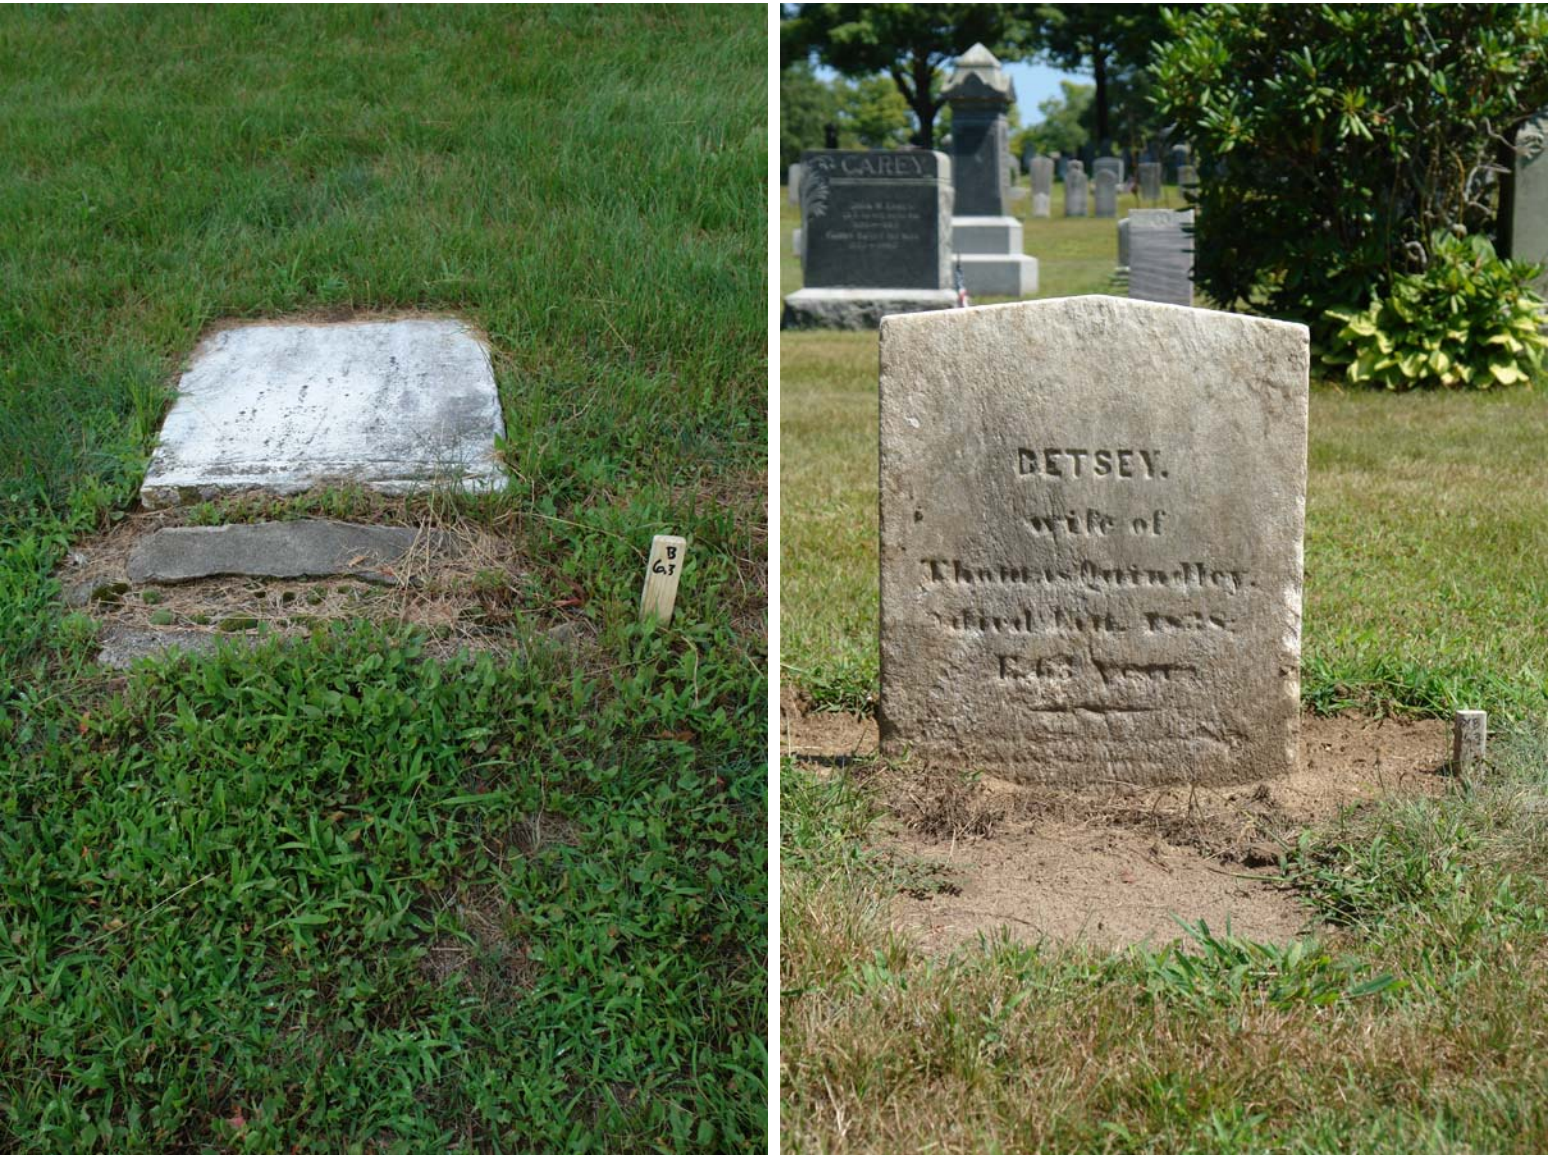
Hanover Center Cemetery, Hanover MA	
NAME ON MARKER	Elmer Turner
Death Date: 6/14/1865	Marker Type: Headstone
Cond. of Inscription: n.a.	Material: Marble
EXISTING CONDITIONS	CONSERVATION STRATEGY
Appears to be deteriorated beyond repair	Evaluate Bury in place?

TREATMENT	Treatment Dates 7/14/2015
1. Area unsuccessfully probed for additional fragments . 2. Marker fragment found to be sugaring and is not restorable.

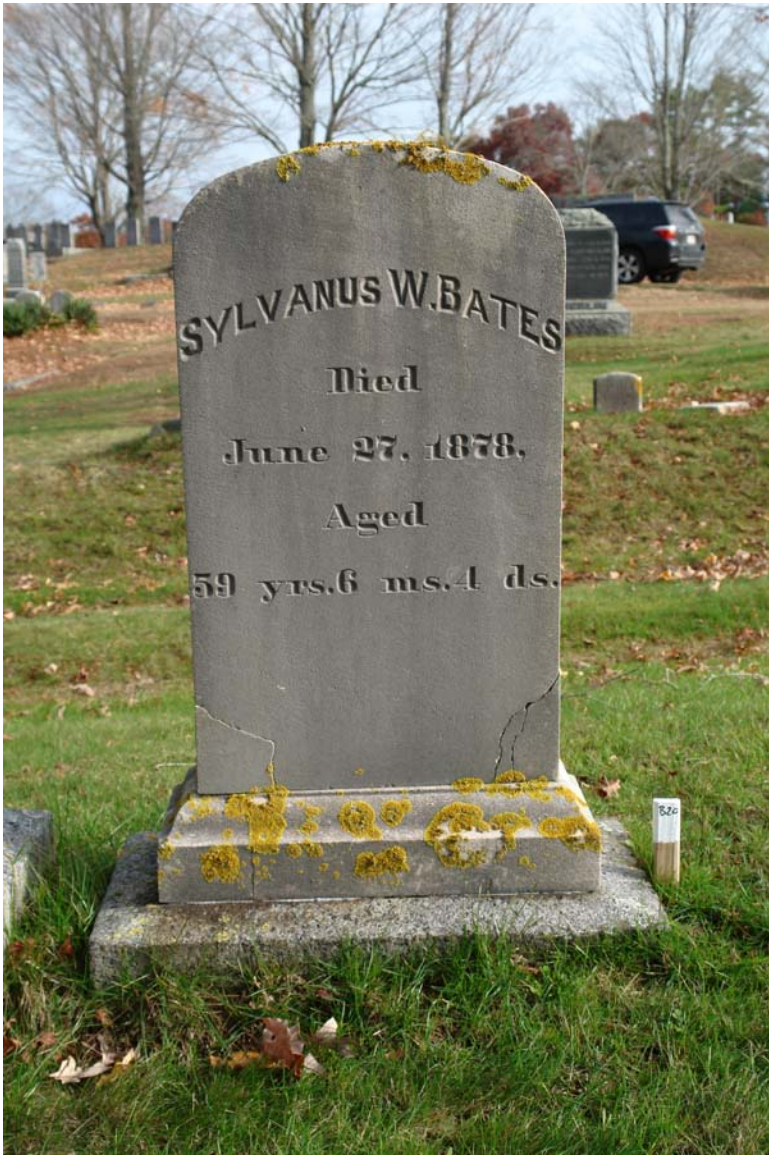
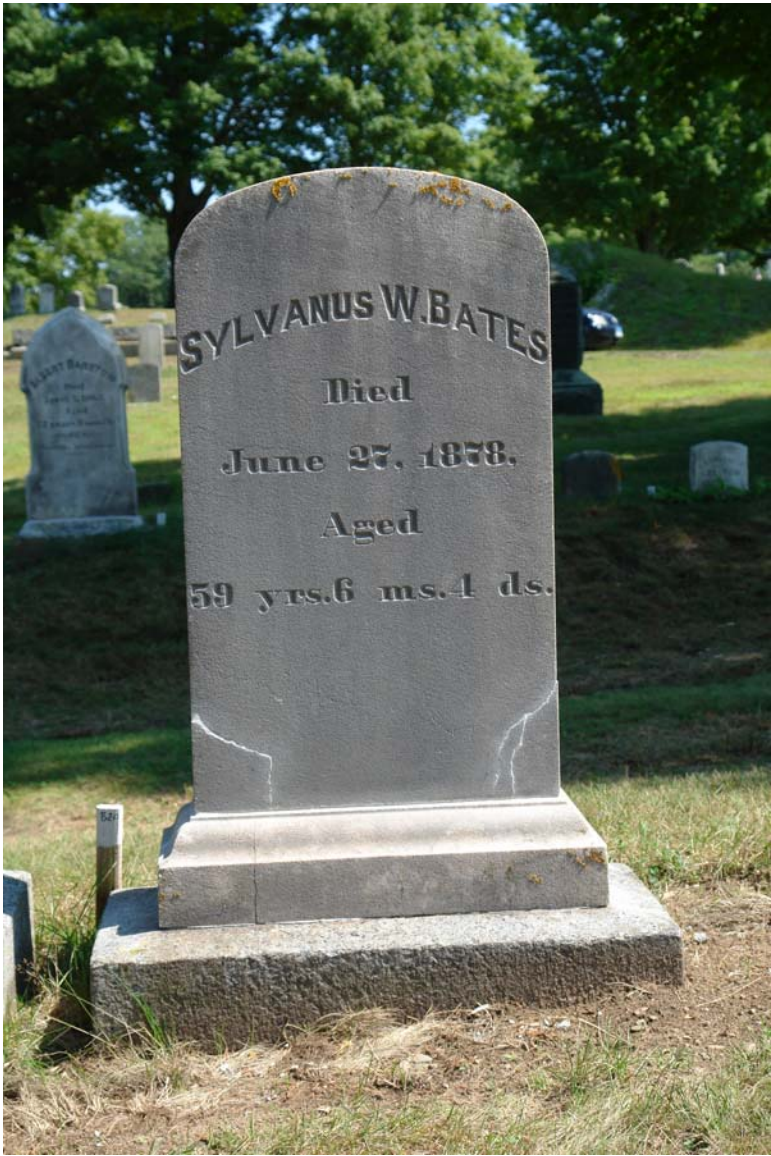
Hanover Center Cemetery, Hanover MA
NAME ON MARKER **Hannah, Elijah Randall**
Death Date: 8/15/1809 Marker Type: Headstone/conc. base
Cond. of Inscription: Decipherable Material: Slate

EXISTING CONDITIONS	CONSERVATION STRATEGY
Fractured	Attach fragments with structural adhesive

TREATMENT	Treatment Dates
1. Marker and fragments excavated. When required, area probed for missing fragments. 2. Mating surfaces were treated with D/2 Biological Solution, scrubbed with nylon brushes and water. Rinsed fully with water. any failed adhesives or mortar removed with hand tools. 3. Fractured elements were dry fitted to ascertain final soundness and to check for large losses at mating areas. 4. Dry fragments attached with structural adhesive (Abatron 55-22), clamped and braced until cured. Excess epoxy removed by hand chisels 5. Cracks and voids filled with RepliCal products. Any large losses filled with Jahn cementitious mortar. 6. Filled areas misted with water and covered for 3 days minimum 7. Filled surface areas treated with light acid wash and rinsed thoroughly.	7/29-8/17/2015
