MONUMENT CONSERVATION COLLABORATIVE LLC, NORFOLK, CT

DOCUMENTATION OF STONE CONSERVATION TREATMENTS TO ASSINIPPI CEMETERY, HANOVER, MA June 2015

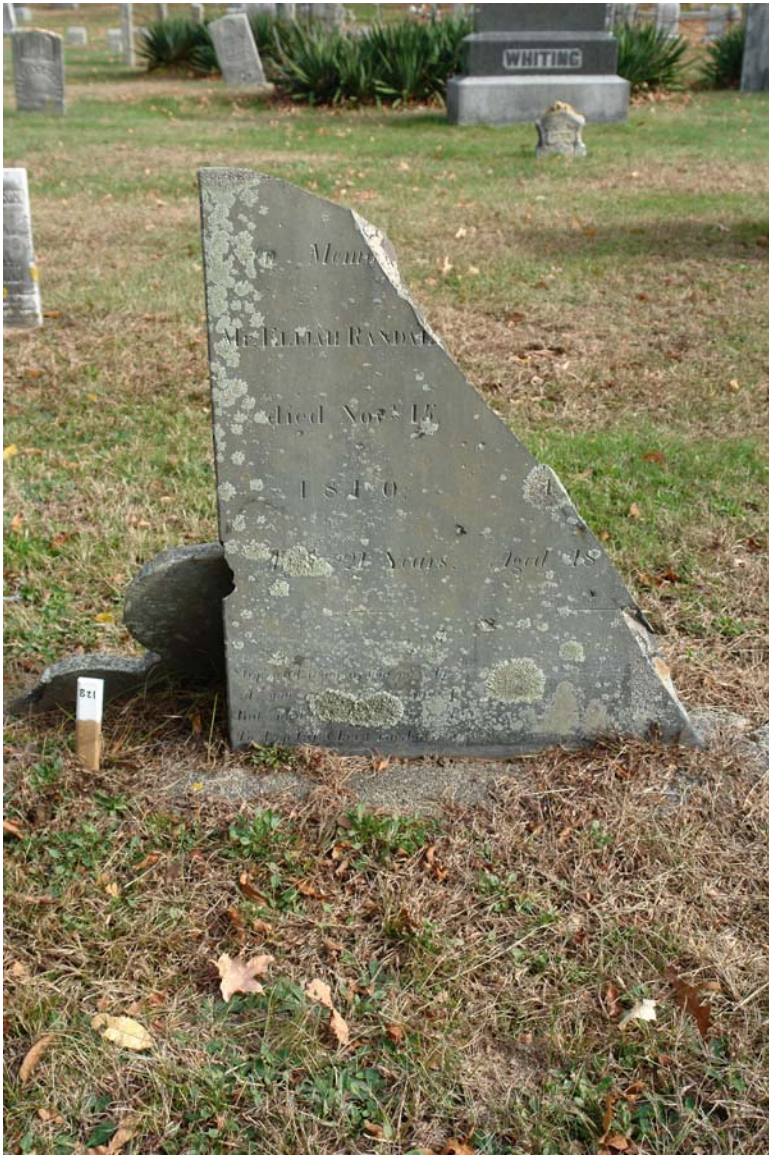
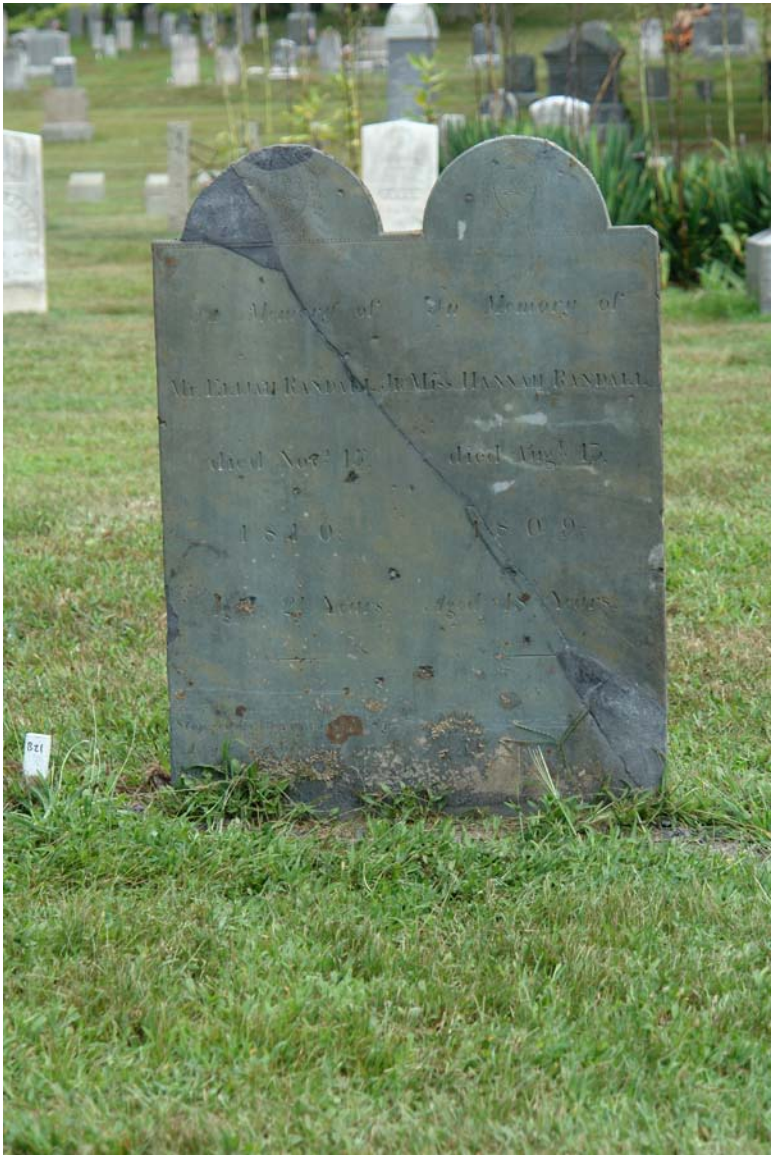
Hanover Center Cemetery, Hanover MA	
NAME ON MARKER	Nathaniel Stetson
Death Date:	7/19/1846
Marker Type:	Headstone/base
Cond. of Inscription:	Partially legible
Material:	Marble

EXISTING CONDITIONS	CONSERVATION STRATEGY
Fallen	Evaluate resetting options Possible new below grade concrete base

TREATMENT	Treatment Dates 7/20/2015
<div>1. Marker appears to be firmly set into base.</div> <div>2. Area excavated to an appropriate depth. Base is aligned with adj. markers and reset level at appropriate height.</div> <div>3. Cracks and losses filled with RepliCal Marble products, filled areas misted with water and covered for 3 days minimum</div> <div>4. Filled areas treated with light acid wash and rinsed thoroughly</div>

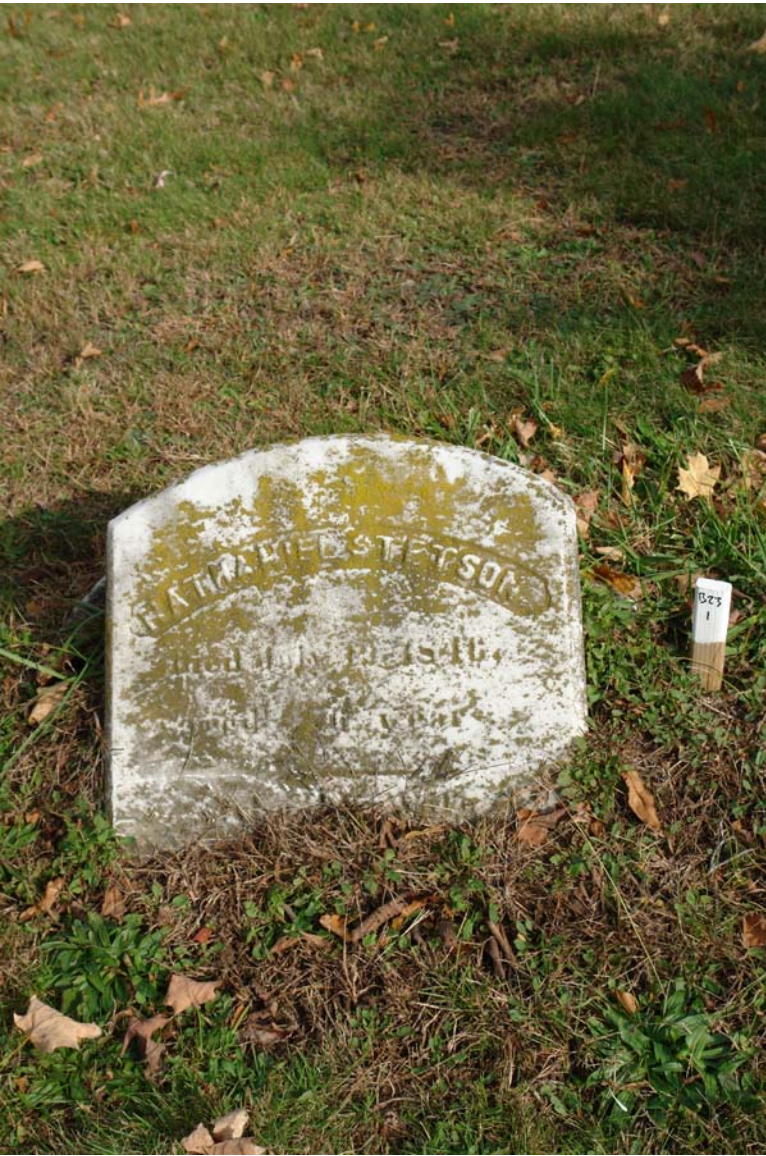
Hanover Center Cemetery, Hanover MA					
NAME ON MARKER	Betsy Stetson				
Death Date: 9/25/1881	Marker Type: Headstone/base				
Cond. of Inscription: Decipherable	Material: Marble				
EXISTING CONDITIONS	CONSERVATION STRATEGY				
Tilted base	Reset base with marker plumb				
<table><tr><td>TREATMENT</td><td>Treatment Dates 7/20/2015</td></tr><tr><td colspan="2"><div>1. Shrubs and roots removed by DPW</div><div>2. Elements removed from setting bases and inspected for soundness.</div><div>3. Setting area excavated to an appropriate depth removing any roots or large stones.</div><div>4. Base is aligned with adjacent markers and re-set level.</div><div>5. Area around base was backfilled with tamped gravel and re-graded with existing topsoil</div><div>6. Failed mortar removed from setting area and bottom of marker</div><div>7. When required, any existing pins were inspected, and if necessary, replaced with stainless steel threaded pins</div><div>8. Setting surfaces primed with Acryl 60 diluted 1:3 with water.</div><div>9. Marker reset plumb onto base with cement/lime mortar (3/2/9) with 000 sand.</div><div>10. Excess grout removed and joint area cleaned.</div></td></tr></table>		TREATMENT	Treatment Dates 7/20/2015	<div>1. Shrubs and roots removed by DPW</div> <div>2. Elements removed from setting bases and inspected for soundness.</div> <div>3. Setting area excavated to an appropriate depth removing any roots or large stones.</div> <div>4. Base is aligned with adjacent markers and re-set level.</div> <div>5. Area around base was backfilled with tamped gravel and re-graded with existing topsoil</div> <div>6. Failed mortar removed from setting area and bottom of marker</div> <div>7. When required, any existing pins were inspected, and if necessary, replaced with stainless steel threaded pins</div> <div>8. Setting surfaces primed with Acryl 60 diluted 1:3 with water.</div> <div>9. Marker reset plumb onto base with cement/lime mortar (3/2/9) with 000 sand.</div> <div>10. Excess grout removed and joint area cleaned.</div>	
TREATMENT	Treatment Dates 7/20/2015				
<div>1. Shrubs and roots removed by DPW</div> <div>2. Elements removed from setting bases and inspected for soundness.</div> <div>3. Setting area excavated to an appropriate depth removing any roots or large stones.</div> <div>4. Base is aligned with adjacent markers and re-set level.</div> <div>5. Area around base was backfilled with tamped gravel and re-graded with existing topsoil</div> <div>6. Failed mortar removed from setting area and bottom of marker</div> <div>7. When required, any existing pins were inspected, and if necessary, replaced with stainless steel threaded pins</div> <div>8. Setting surfaces primed with Acryl 60 diluted 1:3 with water.</div> <div>9. Marker reset plumb onto base with cement/lime mortar (3/2/9) with 000 sand.</div> <div>10. Excess grout removed and joint area cleaned.</div>

Comments: **Shrubs to be removed**

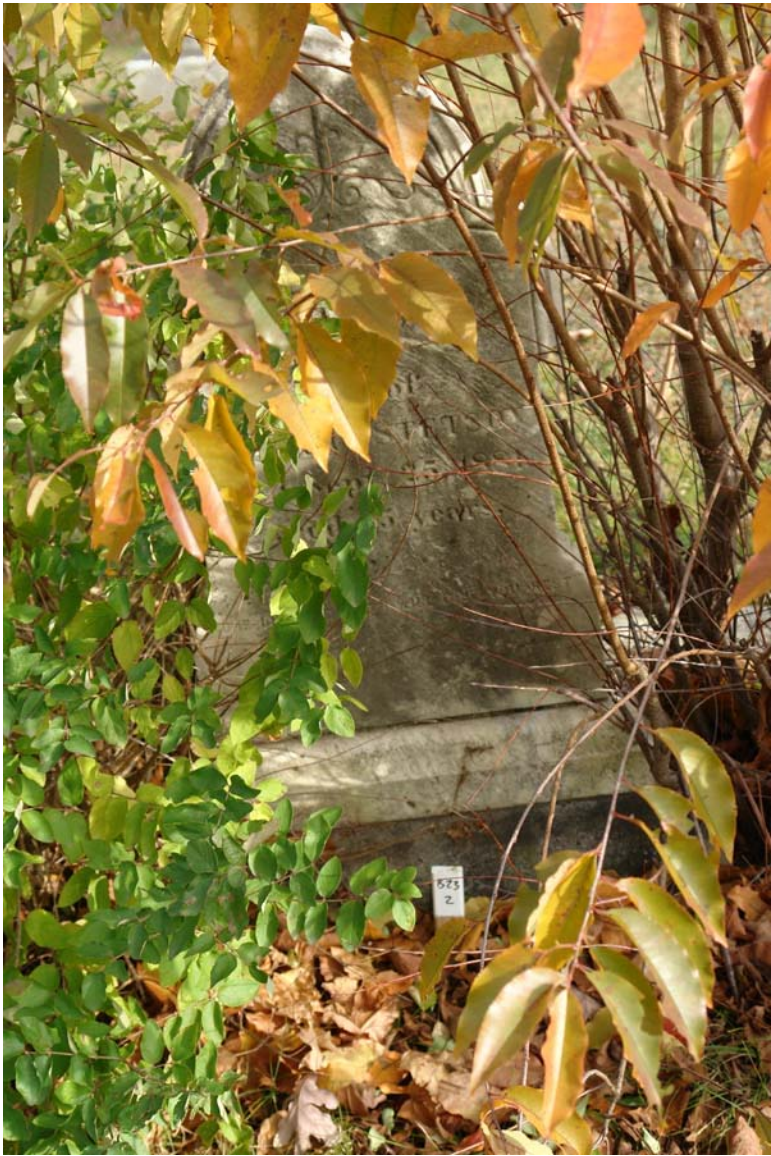
Hanover Center Cemetery, Hanover MA	
NAME ON MARKER	Albert Stetson
Death Date: 3/27/1845	Marker Type: Headstone/base
Cond. of Inscription: Decipherable	Material: Marble
EXISTING CONDITIONS	CONSERVATION STRATEGY
Fallen	Reset into new below grade concrete base
TREATMENT	
Treatment Dates 7/20-21/2015

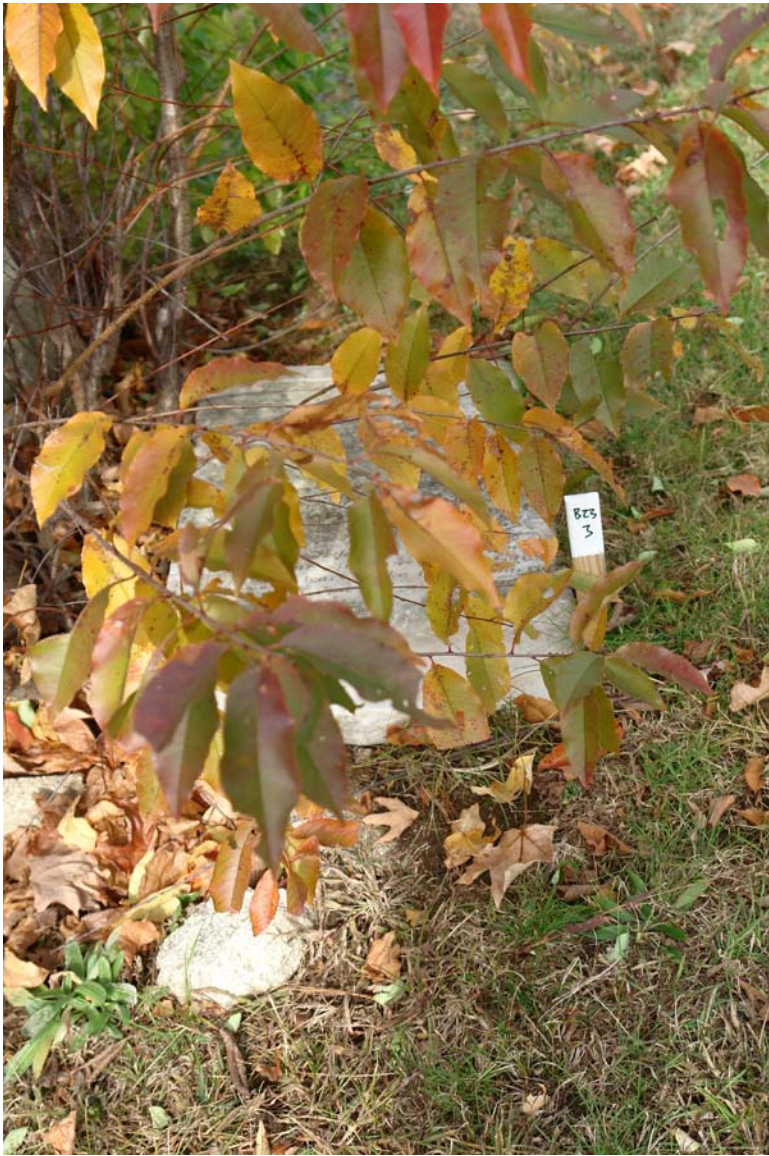
Hanover Center Cemetery, Hanover MA		
NAME ON MARKER		Capt Daniel Barstow
Death Date:	2/24/1842	Marker Type: Headstone/base
Cond. of Inscription:	Decipherable	Material: Marble
EXISTING CONDITIONS		CONSERVATION STRATEGY
Unstable		Evaluate resetting options Possible new below grade concrete base
TREATMENT		
Treatment Dates		7/21/2015

1. Elements removed from setting bases and inspected for soundness. 2. Area excavated to an appropriate depth removing any roots or large stones. 3. Base is aligned with adjacent markers and re-set level. 4. Area around base was backfilled with tamped gravel and re-graded with existing topsoil 5. Failed mortar removed from setting area and bottom of marker 6. When required, any existing pins were inspected, and if necessary, replaced with stainless steel threaded pins 7. Setting surfaces primed with Acryl 60 diluted 1:3 with water. 8. Marker reset plumb onto base with cement/lime mortar (3/2/9) with 000 sand. 9. Excess grout removed and joint area cleaned.

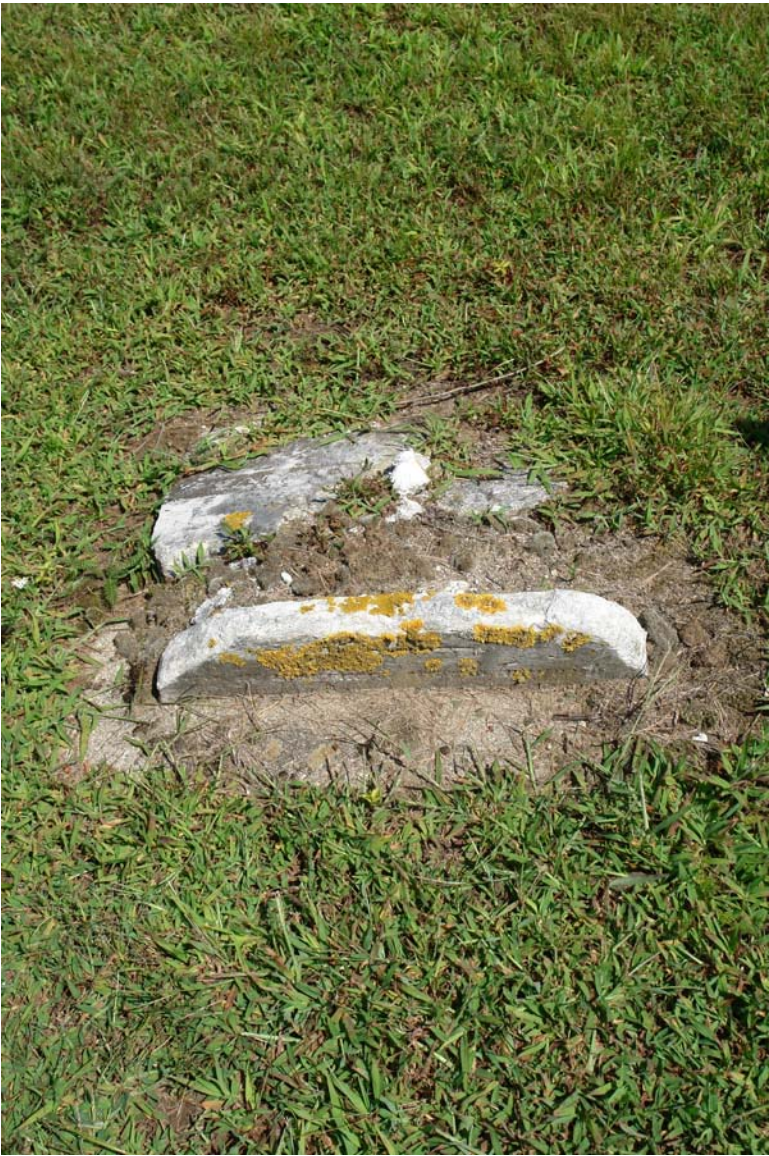
EXISTING CONDITIONS	CONSERVATION STRATEGY
Severe deterioration	May be infeasible to repair

2. Marker fragment found to be sugaring and is not restorable.

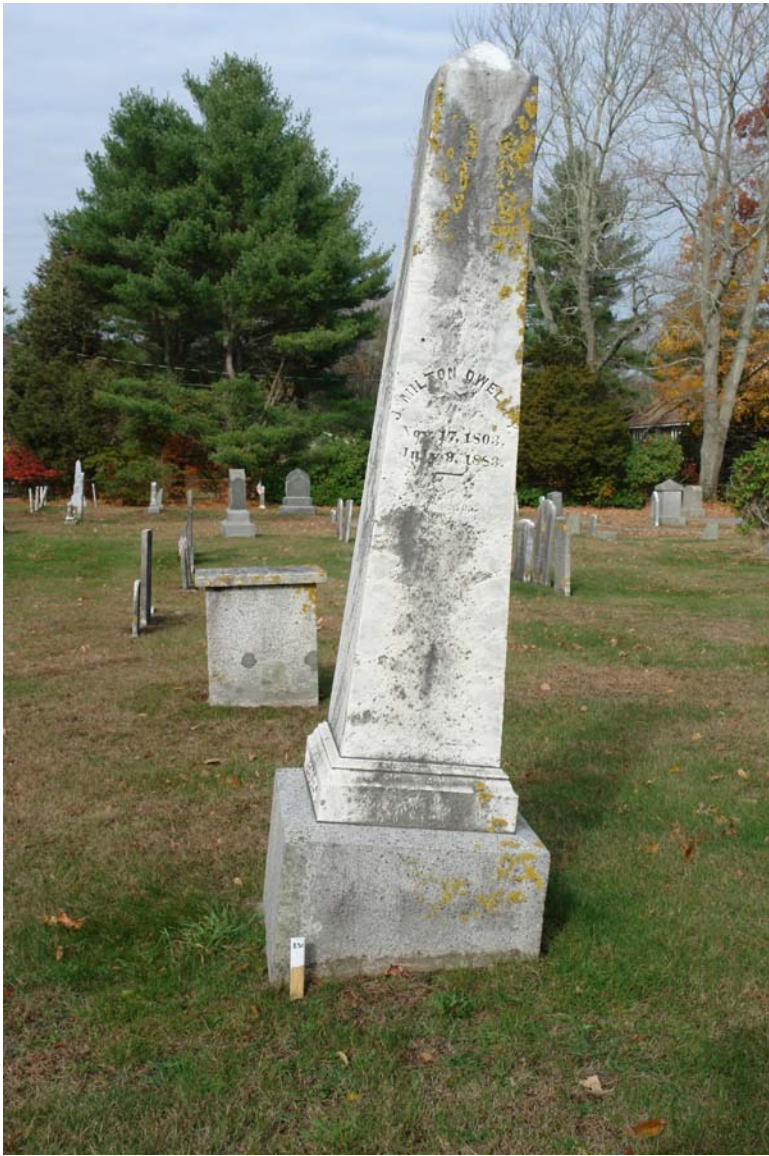
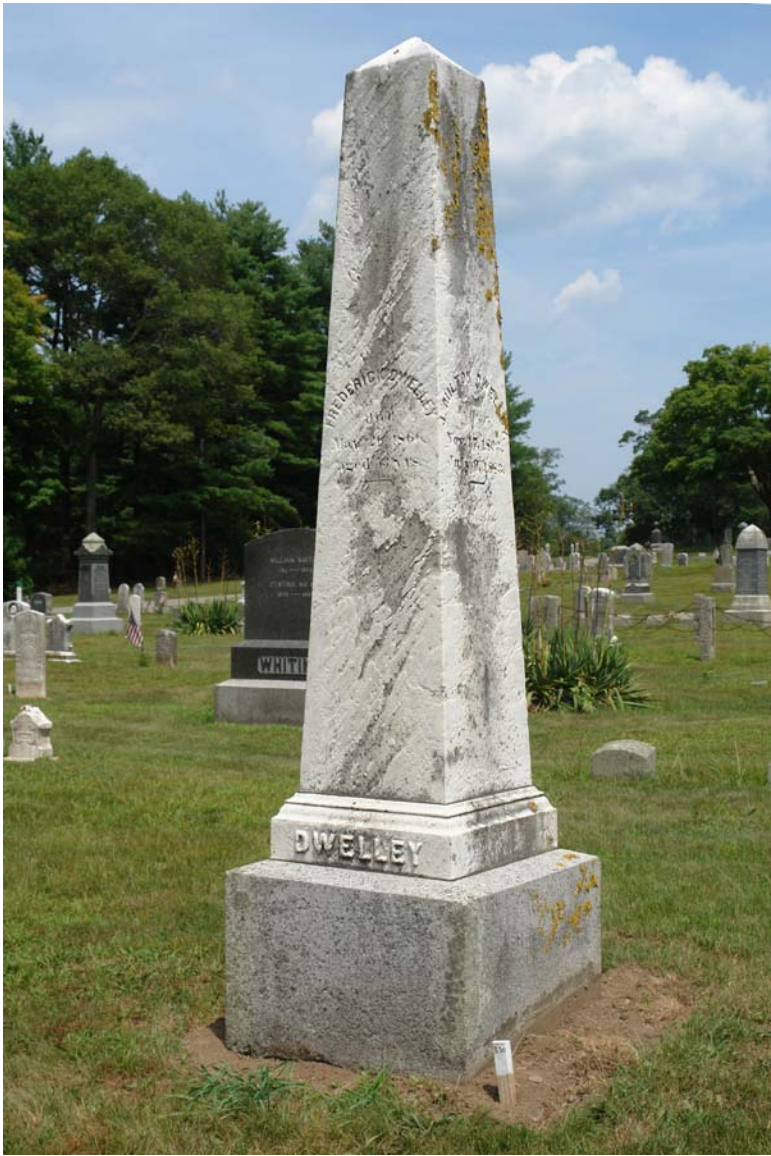
Hanover Center Cemetery, Hanover MA					
NAME ON MARKER	Milton Dwelley				
Death Date: 7/9/1883	Marker Type: Obelsik				
Cond. of Inscription: Decipherable	Material: Marble				
EXISTING CONDITIONS	CONSERVATION STRATEGY				
Tilted	Reset plumb				
<table><tr><td>TREATMENT</td><td>Treatment Dates 7/20/2015</td></tr><tr><td colspan="2"><div>1. Obelisk and base found to be in sound condition with monu- ment securely attached to base. 2. Soil removed around base unit and base raised up with hydrau- lic jacks to level. 3. Existing foundation stones exposed and built up to support base unit. 4. Base re-set plumb at appropriate height and level 5. Area beneath and around base backfilled with tamped sand and gravel 6. Disturbed areas re-graded with existing topsoil.</div></td></tr></table>		TREATMENT	Treatment Dates 7/20/2015	<div>1. Obelisk and base found to be in sound condition with monu- ment securely attached to base. 2. Soil removed around base unit and base raised up with hydrau- lic jacks to level. 3. Existing foundation stones exposed and built up to support base unit. 4. Base re-set plumb at appropriate height and level 5. Area beneath and around base backfilled with tamped sand and gravel 6. Disturbed areas re-graded with existing topsoil.</div>	
TREATMENT	Treatment Dates 7/20/2015				
<div>1. Obelisk and base found to be in sound condition with monu- ment securely attached to base. 2. Soil removed around base unit and base raised up with hydrau- lic jacks to level. 3. Existing foundation stones exposed and built up to support base unit. 4. Base re-set plumb at appropriate height and level 5. Area beneath and around base backfilled with tamped sand and gravel 6. Disturbed areas re-graded with existing topsoil.</div>

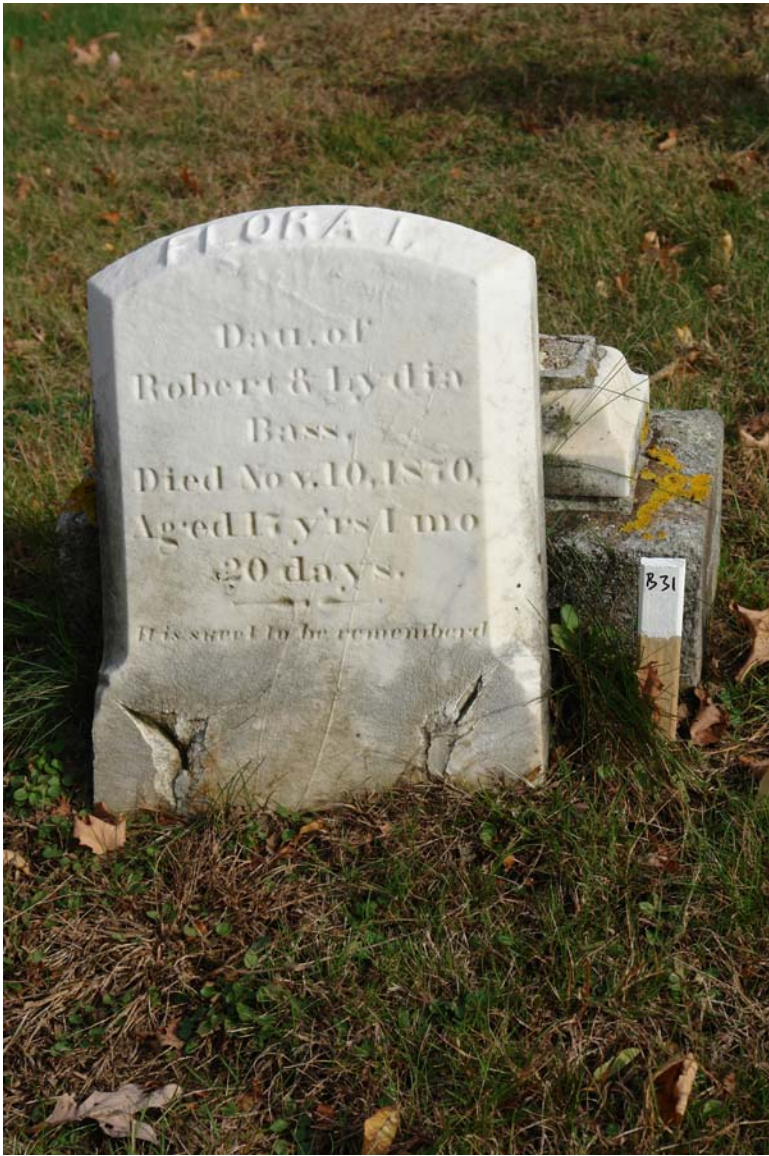
EXISTING CONDITIONS	CONSERVATION STRATEGY
Fractures Loose on base	Attach fragments with structural adhesive Reset elements

TREATMENT	Treatment Dates	7/21/2015
<div>1. Elements disassembled and previous repair materials and failed mortar removed from setting surfaces with hand tools.</div> <div>2. In-ground base reset level. Replace setting pins with threaded stainless pins if required.</div> <div>3. Fragments attached with structural adhesive (Abatron 55-22), clamped and braced until cured.</div> <div>4. Cracks and losses filled with RepliCal Marble or Jahn restoration mortar, misted with water and covered for 3 days min.</div> <div>5. Filled surface areas treated w/ light acid wash, rinsed thoroughly with water.</div> <div>6. Setting surfaces primed with Acryl 60 diluted 1:3 with water.</div> <div>7. Elements reset with 2:1:9 cementitious high cal lime mortar using fine (00 or 000) sand.</div> <div>8. Excess mortar removed from joints and braced for a min 3 days</div> <div>9.. Surfaces treated with D/2 biological solution, scrubbed with nylon brushes, and fully rinsed with water.</div>

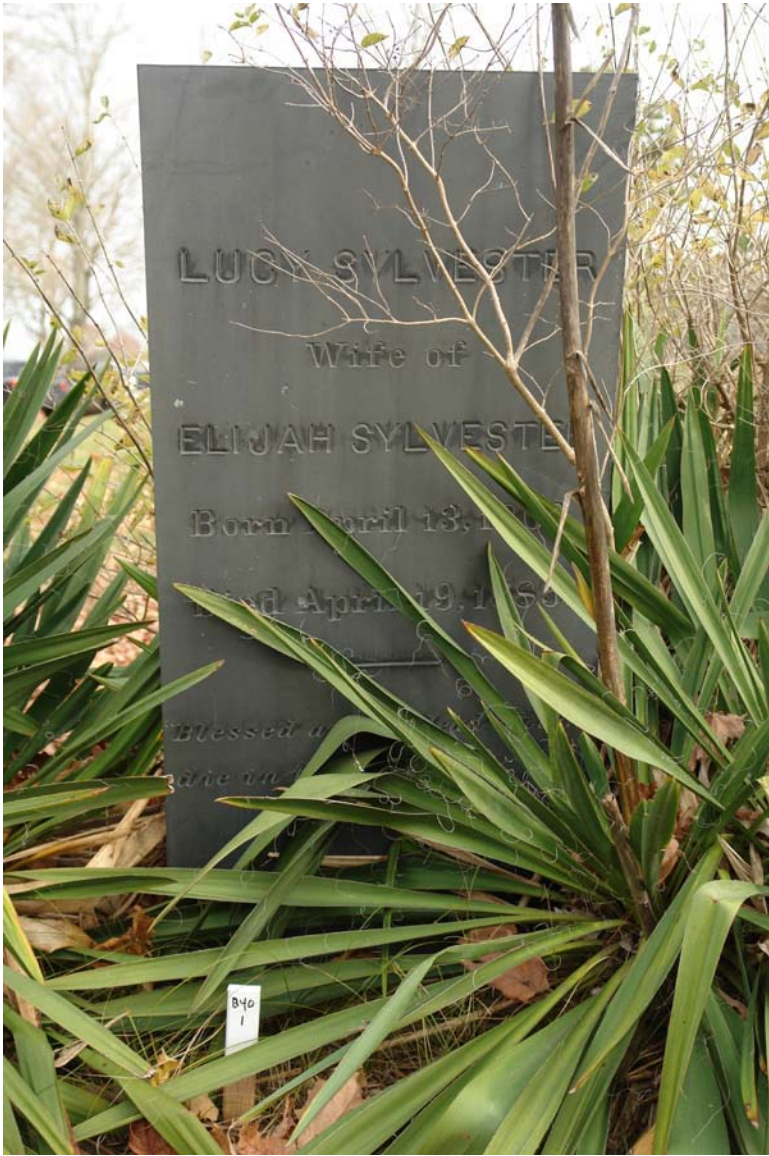
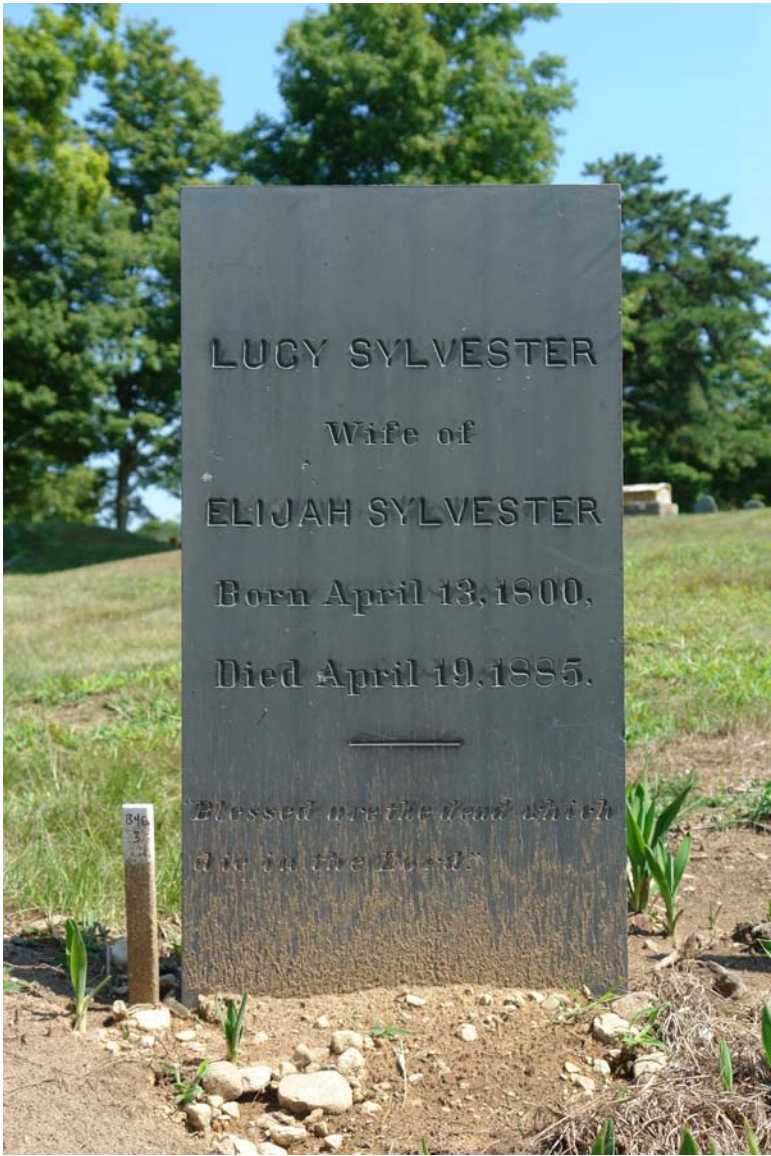
Hanover Center Cemetery, Hanover MA
NAME ON MARKER **Lucy Sylvester**
Death Date: 4/19/1885 Marker Type: Headstone/conc. base
Cond. of Inscription: Legible Material: Slate

EXISTING CONDITIONS	CONSERVATION STRATEGY
Unstable	Evaluate resetting options Possible new below grade concrete base

TREATMENT	Treatment Dates
1. Shrubs removed by DPW 2. Marker carefully excavated old failed concrete collar removed with hand tools. 3. Setting area excavated to sufficient depth and stone re-set plumb at appropriate height and level onto gravel bed, aligned with adjacent markers 4. Area backfilled around marker with tamped sand and gravel 5. Disturbed areas re-graded with existing topsoil and sod.	7/21/2015

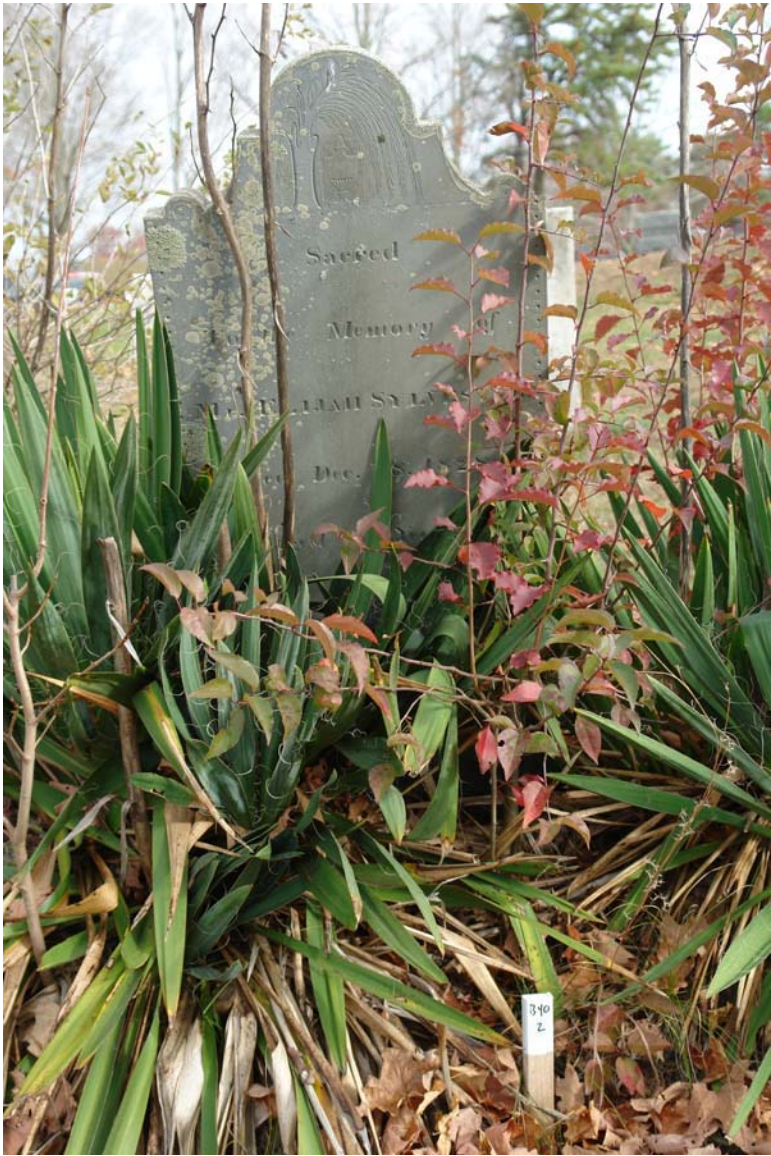
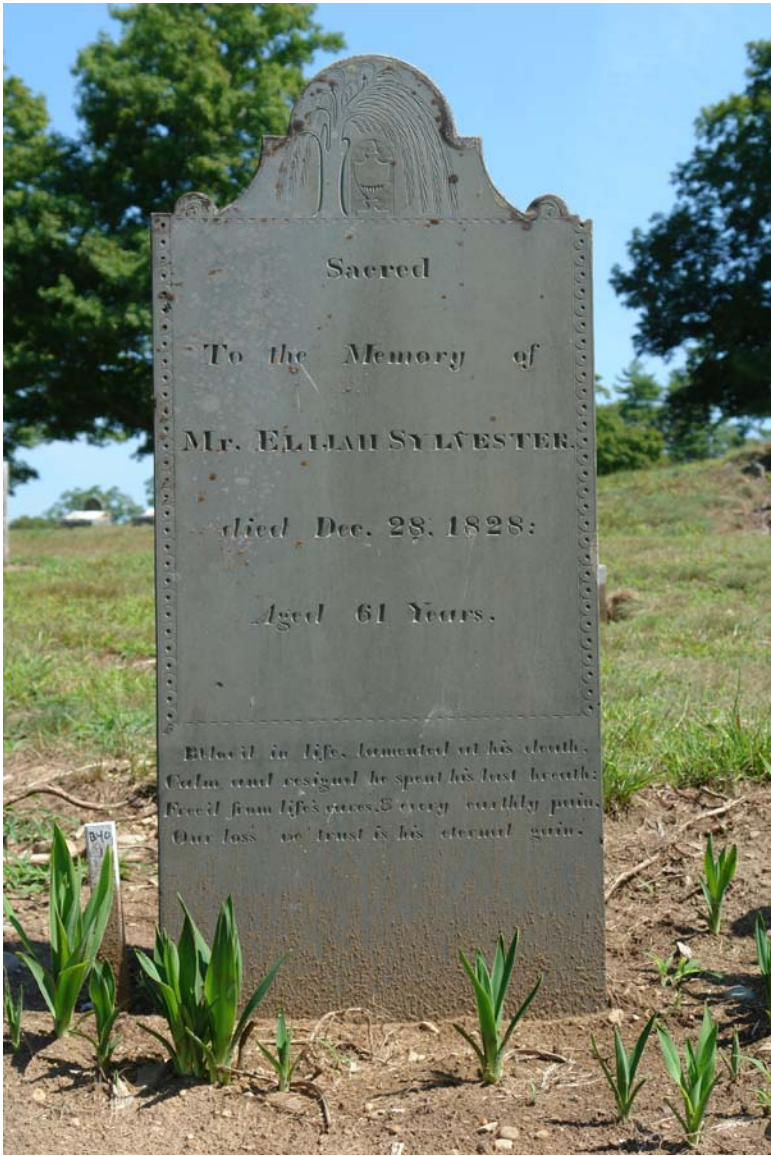
Hanover Center Cemetery, Hanover MA
NAME ON MARKER **Elijah Sylvester**
Death Date: 12/28/1828 Marker Type: Headstone/conc. base
Cond. of Inscription: Legible Material: Slate

EXISTING CONDITIONS	CONSERVATION STRATEGY
Unstable	Evaluate resetting options Possible new below grade concrete base

TREATMENT	Treatment Dates
1. Shrubs removed by DPW 2. Marker carefully excavated old failed concrete collar removed with hand tools. 3. Setting area excavated to sufficient depth and stone re-set plumb at appropriate height and level onto gravel bed, aligned with adjacent markers 4. Area backfilled around marker with tamped sand and gravel 5. Disturbed areas re-graded with existing topsoil and sod. 6. Surfaces treated with D/2, scrubbed with nylon brushes and rinsed with water	7/21/2015

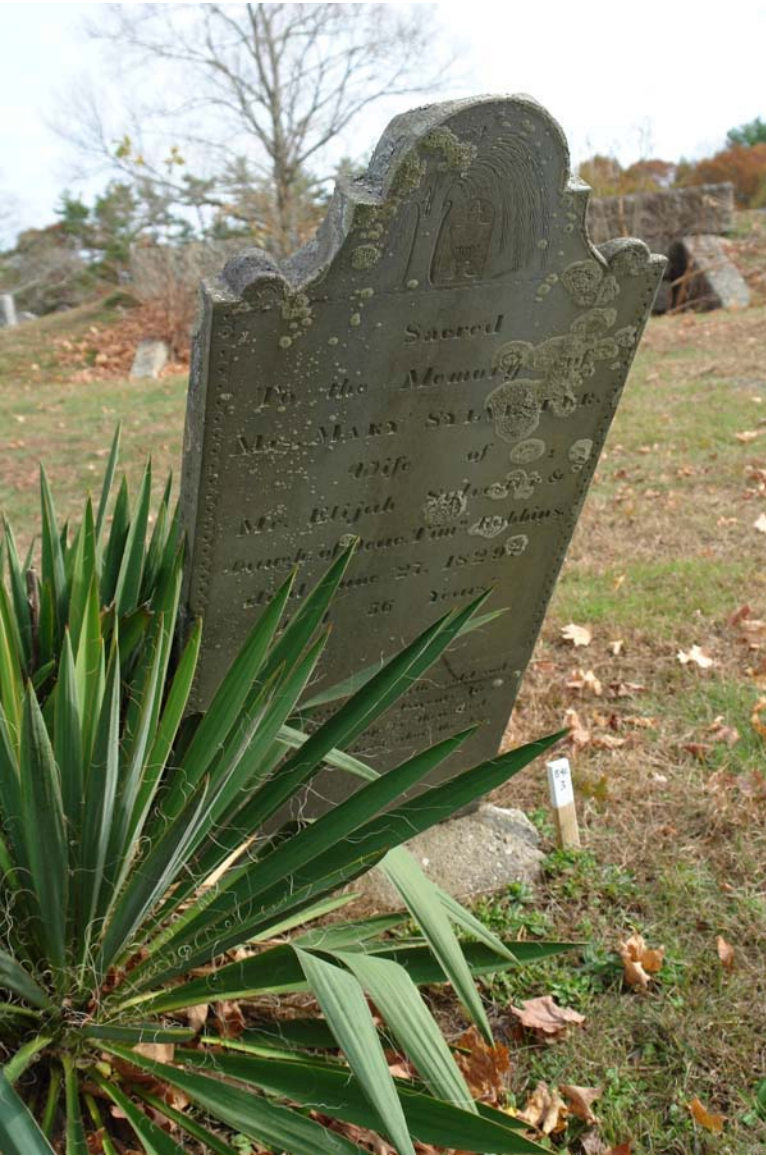
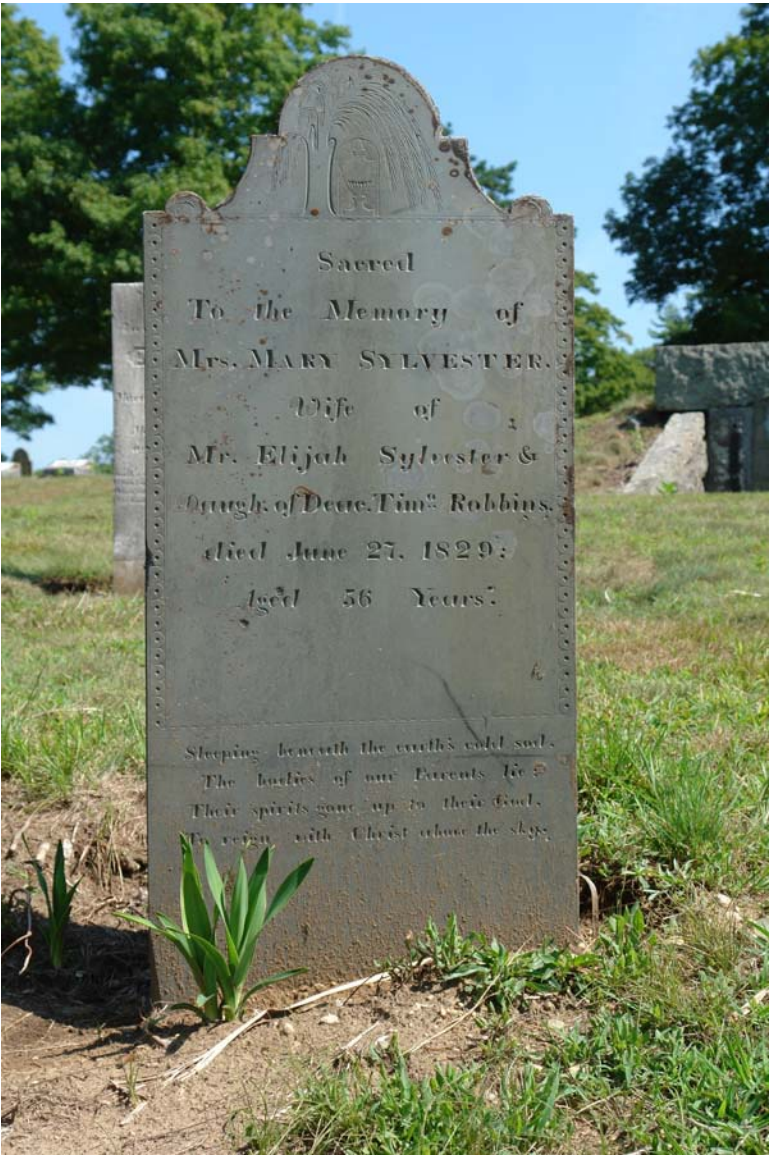
Hanover Center Cemetery, Hanover MA
NAME ON MARKER **Mary Sylvester**
Death Date: 6/27/1829 Marker Type: Headstone/conc. base
Cond. of Inscription: Legible Material: Slate

EXISTING CONDITIONS	CONSERVATION STRATEGY
Tilted	Evaluate resetting options Possible new below grade concrete base

TREATMENT	Treatment Dates
1. Shrubs removed by DPW 2. Marker carefully excavated old failed concrete collar removed with hand tools. 3. Setting area excavated to sufficient depth and stone re-set plumb at appropriate height and level onto gravel bed, aligned with adjacent markers 4. Area backfilled around marker with tamped sand and gravel 5. Disturbed areas re-graded with existing topsoil and sod. 6. Surfaces treated with D/2, scrubbed with nylon brushes and rinsed with water	7/21/2015

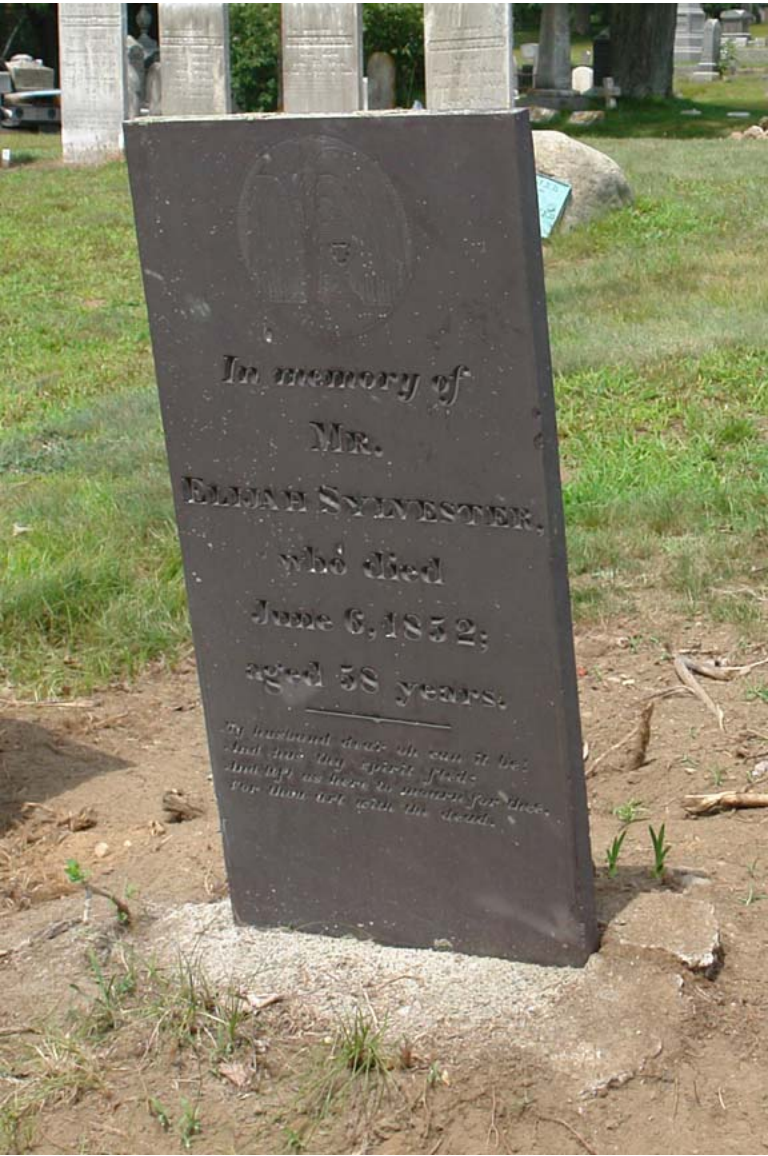
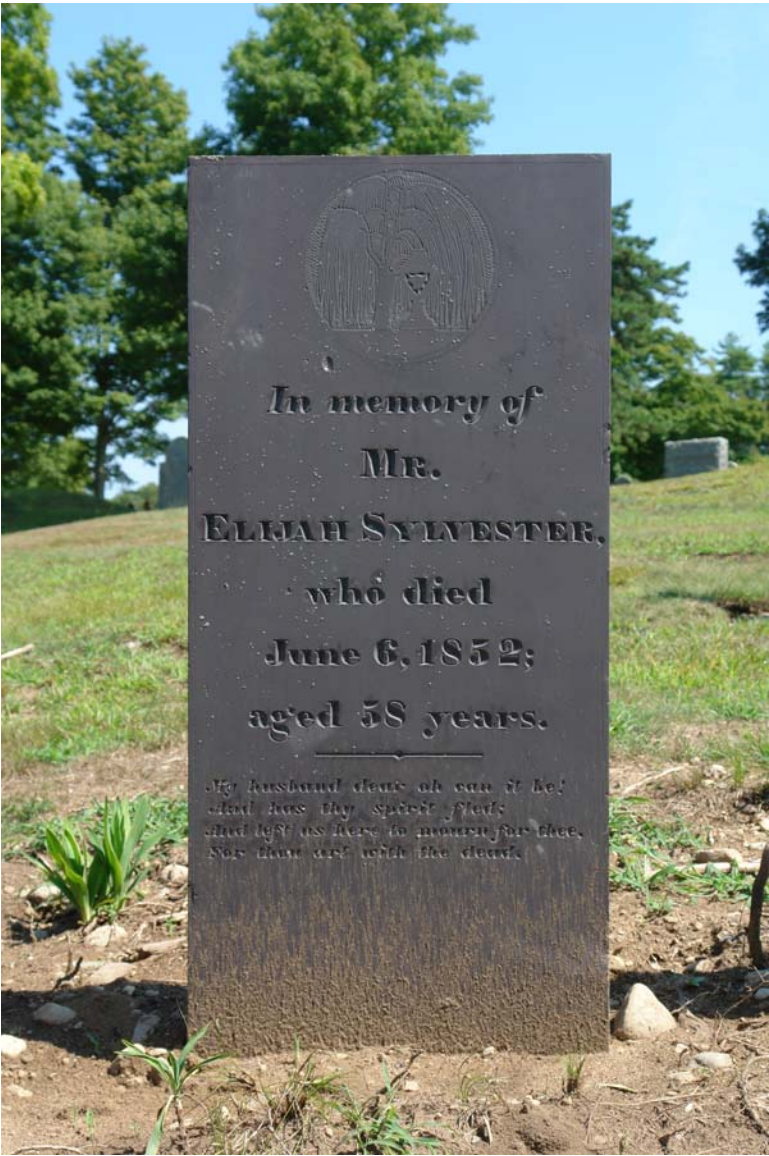
Hanover Center Cemetery, Hanover MA
NAME ON MARKER **Elijah Sylvester**
Death Date: 6/6/1852 Marker Type: Headstone/conc. base
Cond. of Inscription: Legible Material: Slate

EXISTING CONDITIONS	CONSERVATION STRATEGY
Tilted	Evaluate resetting options Possible new below grade concrete base

TREATMENT	Treatment Dates
8/14/2015 1. Shrubs removed by DPW 2. Marker carefully excavated old failed concrete collar removed with hand tools. 3. Setting area excavated to sufficient depth and stone re-set plumb at appropriate height and level onto gravel bed, aligned with adjacent markers 4. Area backfilled around marker with tamped sand and gravel 5. Disturbed areas re-graded with existing topsoil and sod. 6. Surfaces treated with D/2, scrubbed with nylon brushes and rinsed with water

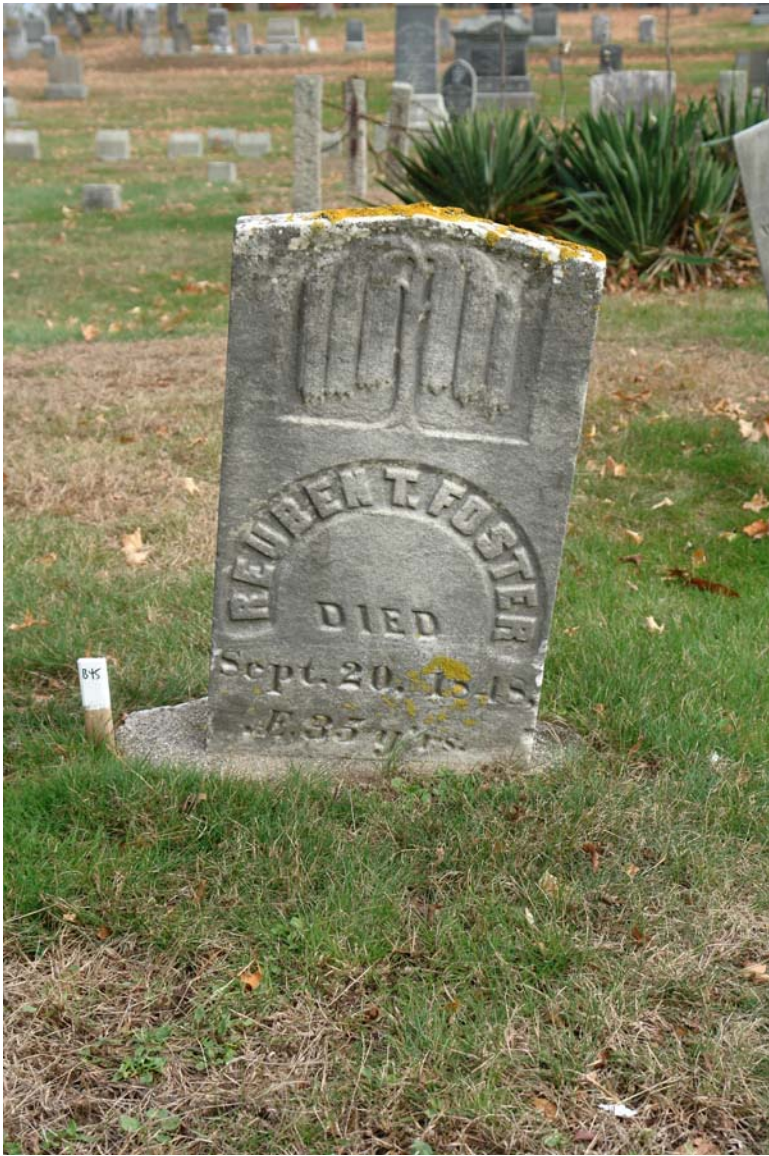
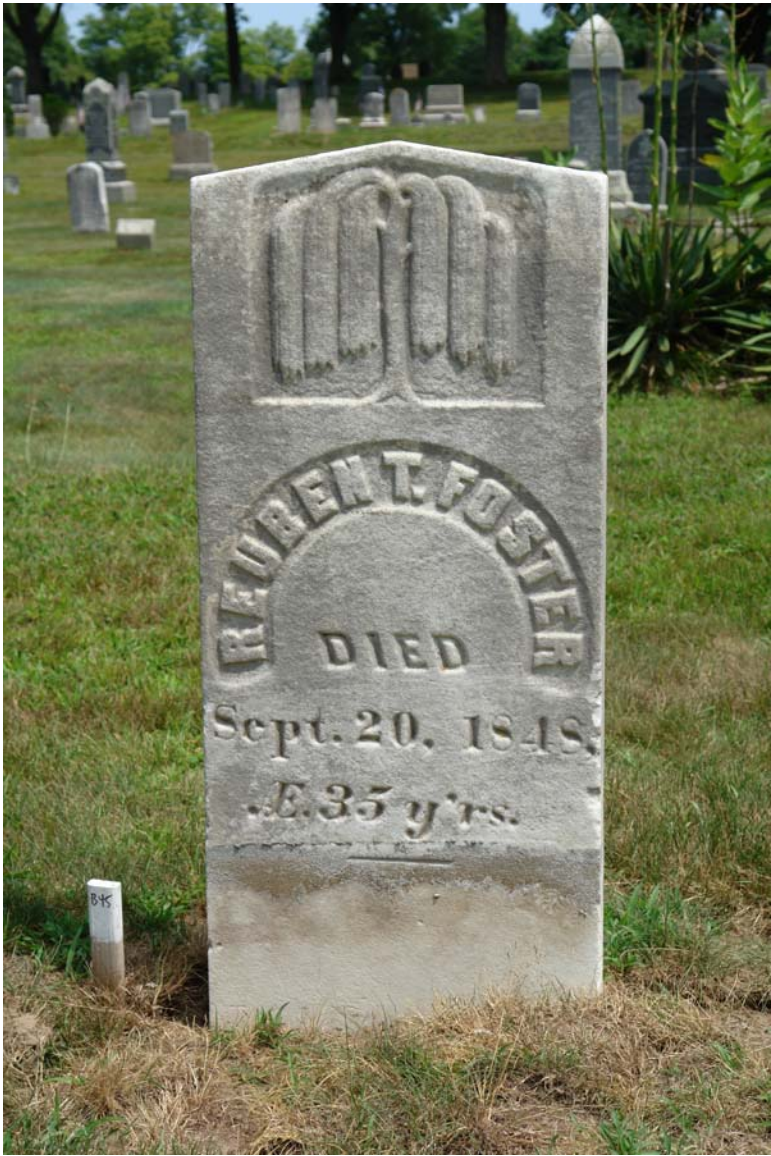
Hanover Center Cemetery, Hanover MA
NAME ON MARKER **Rueben Foster**
Death Date: 9/20/1848 Marker Type: Headstone/conc. base
Cond. of Inscription: Legible Material: Marble

EXISTING CONDITIONS	CONSERVATION STRATEGY
Tilted base	Reset base with marker plumb

TREATMENT	Treatment Dates
1. Existing base located below grade while excavating for resetting. Area excavated to an appropriate depth removing any roots or large stones. 2. Base inspected and found to be sound and re-useable 3. Base is aligned with adjacent markers and re-set level. 4. Area around base was backfilled with tamped gravel and re-graded with existing topsoil 5. Debris removed from setting slot. When required, power grinders were used to facilitate removal of stone fragments. 6. When required, the lower setting edge was re-squared by power grinder with minimal loss. 7. Marker reset plumb and level into setting slot with cement/lime grout (3/2/9) with 000 sand made fluid with a super plasticizer. 8. Excess grout removed and joint area cleaned. 9. Marker braced for a minimum 3 days	7/13-14/2015

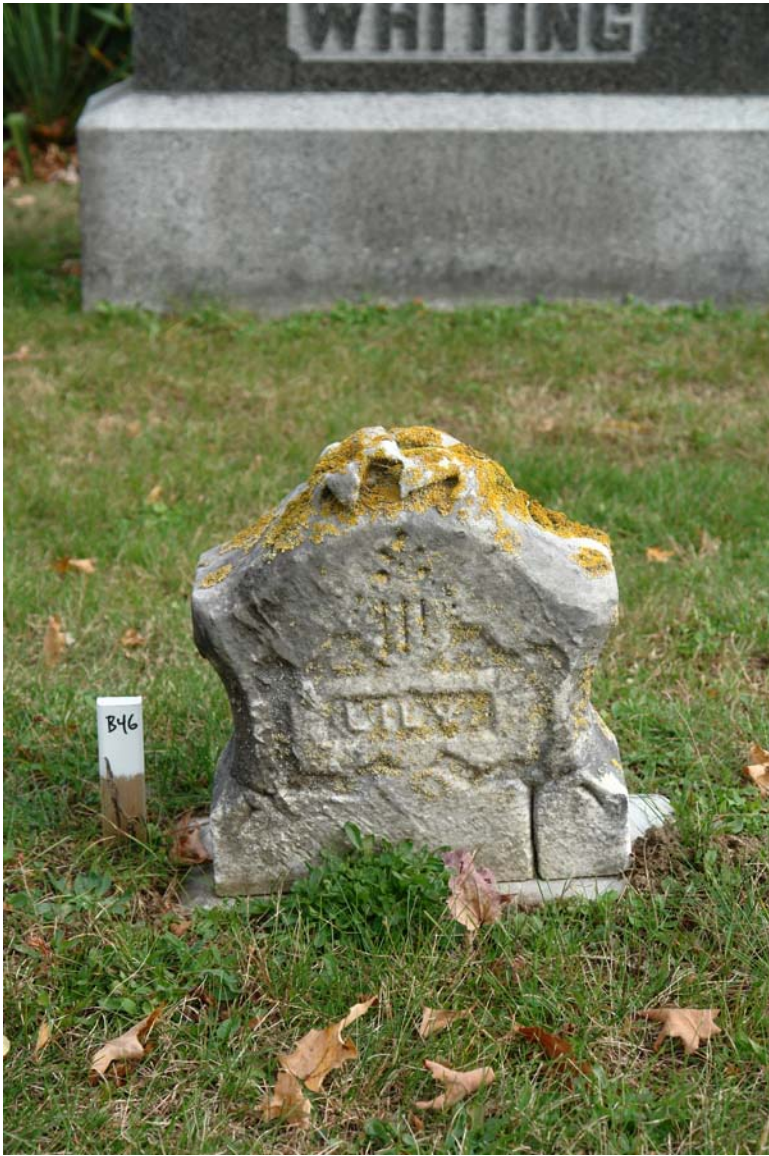
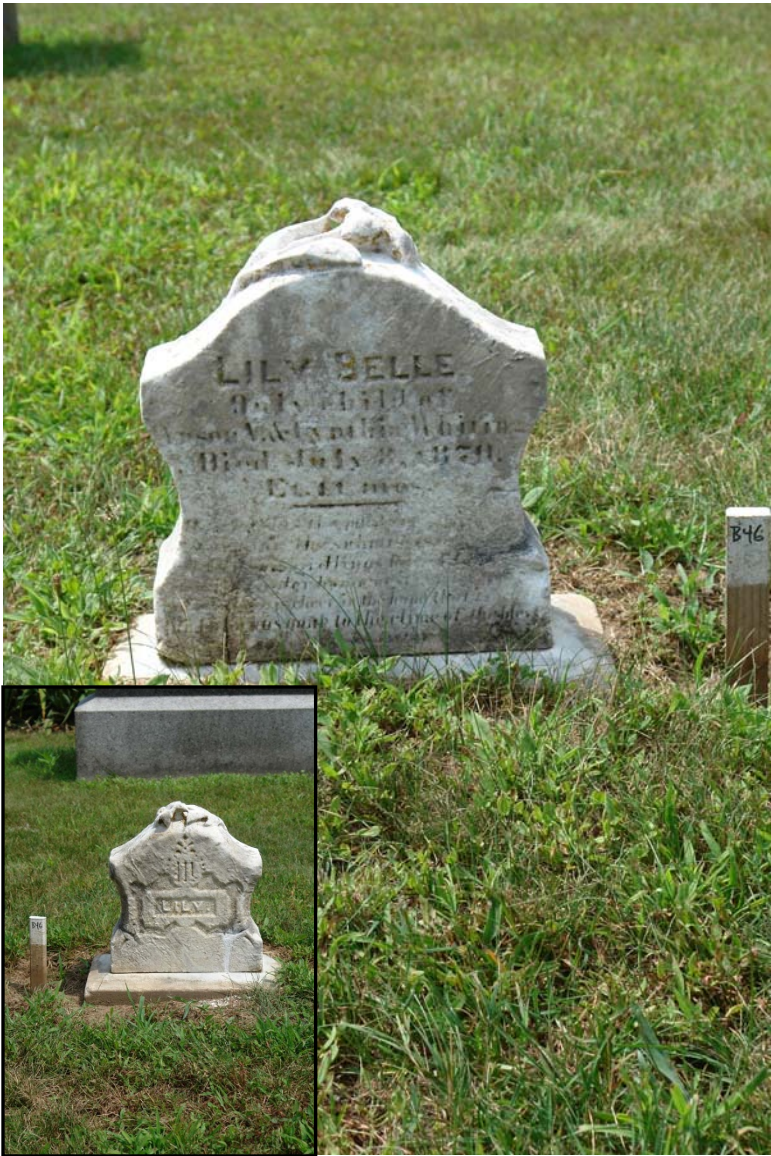
Hanover Center Cemetery, Hanover MA
NAME ON MARKER **Lily Whiting**
Death Date: 7/8/1870 Marker Type: Headstone/pinned
Cond. of Inscription: Decipherable Material: Marble

EXISTING CONDITIONS	CONSERVATION STRATEGY
Fractures Loose on base	Attach fragments with structural adhesive Reset elements

TREATMENT	Treatment Dates
1. Elements disassembled and previous repair materials and failed mortar removed from setting surfaces with hand tools. 2. In-ground base reset level. Replace setting pins with threaded stainless pins if required. 3. Fragments attached with structural adhesive (Abatron 55-22), clamped and braced until cured. 4. Cracks and losses filled with RepliCal Marble or Jahn restoration mortar, misted with water and covered for 3 days min. 5. Filled surface areas treated w/ light acid wash, rinsed thoroughly with water. 6. Setting surfaces primed with Acryl 60 diluted 1:3 with water. 7. Elements reset with 2:1:9 cementitious high cal lime mortar using fine (00 or 000) sand. 8. Excess mortar removed from joints and braced for a min 3 days 9.. Surfaces treated with D/2 biological solution, scrubbed with nylon brushes, and fully rinsed with water.	7/6-13/2015
