MONUMENT CONSERVATION COLLABORATIVE LLC, NORFOLK, CT

DOCUMENTATION OF STONE CONSERVATION TREATMENTS TO ASSINIPPI CEMETERY, HANOVER, MA June 2015

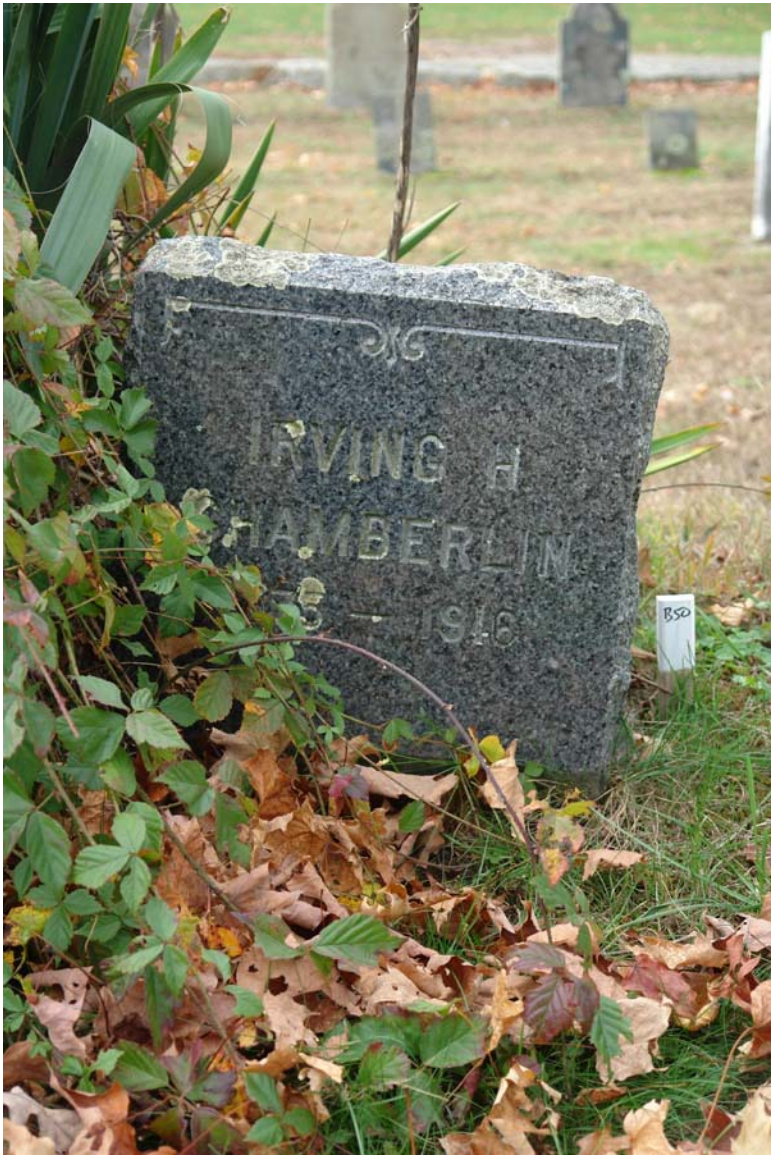
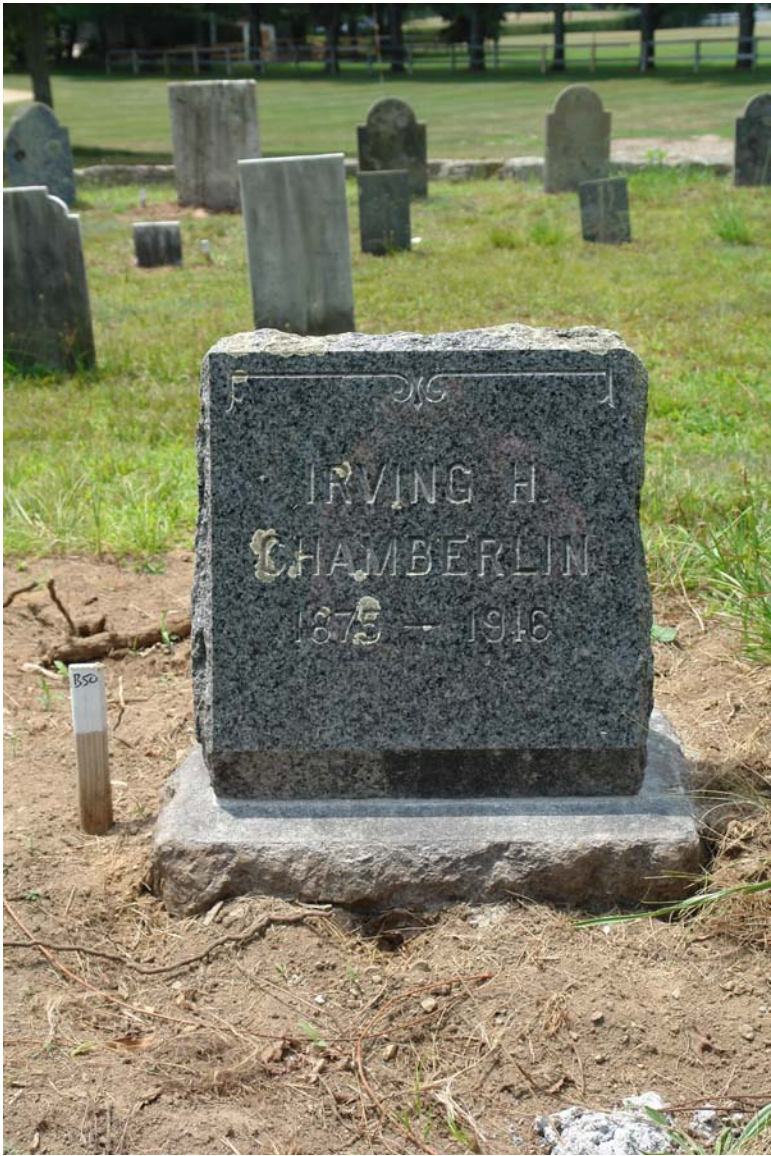
Hanover Center Cemetery, Hanover MA	
NAME ON MARKER	Irving Chamber
Death Date: 1916	Marker Type: Marker/ slanted
Cond. of Inscription: Legible	Material: Granite
EXISTING CONDITIONS	CONSERVATION STRATEGY
Tilted base	Reset base with marker plumb
TREATMENT	
Treatment Dates 7/15/2015	
<div>1. Overgrowth removed by DPW</div> <div>2. Elements removed from setting bases and area excavated to an appropriate depth removing any roots or large stones.</div> <div>3. Base is aligned with adjacent markers and re-set level.</div> <div>4. Area around base was backfilled with tamped gravel and re-graded with existing topsoil</div> <div>5. Failed mortar removed from setting area and bottom of marker</div> <div>6. When required, any existing pins were inspected, and if necessary, replaced with stainless steel threaded pins</div> <div>7. Setting surfaces primed with Acryl 60 diluted 1:3 with water.</div> <div>8. Marker reset plumb onto base with cement/lime mortar (3/2/9) with 000 sand.</div> <div>9. Excess grout removed and joint area cleaned.</div>

Comments: **Shrubs to be removed**

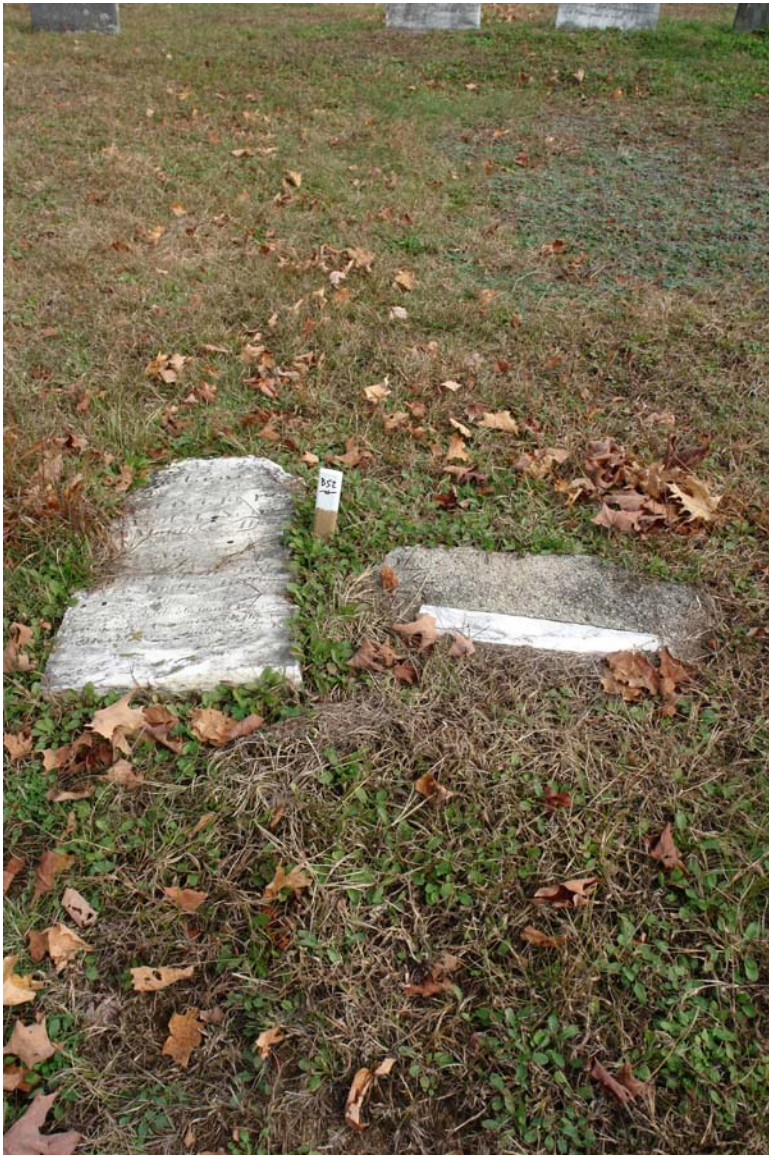
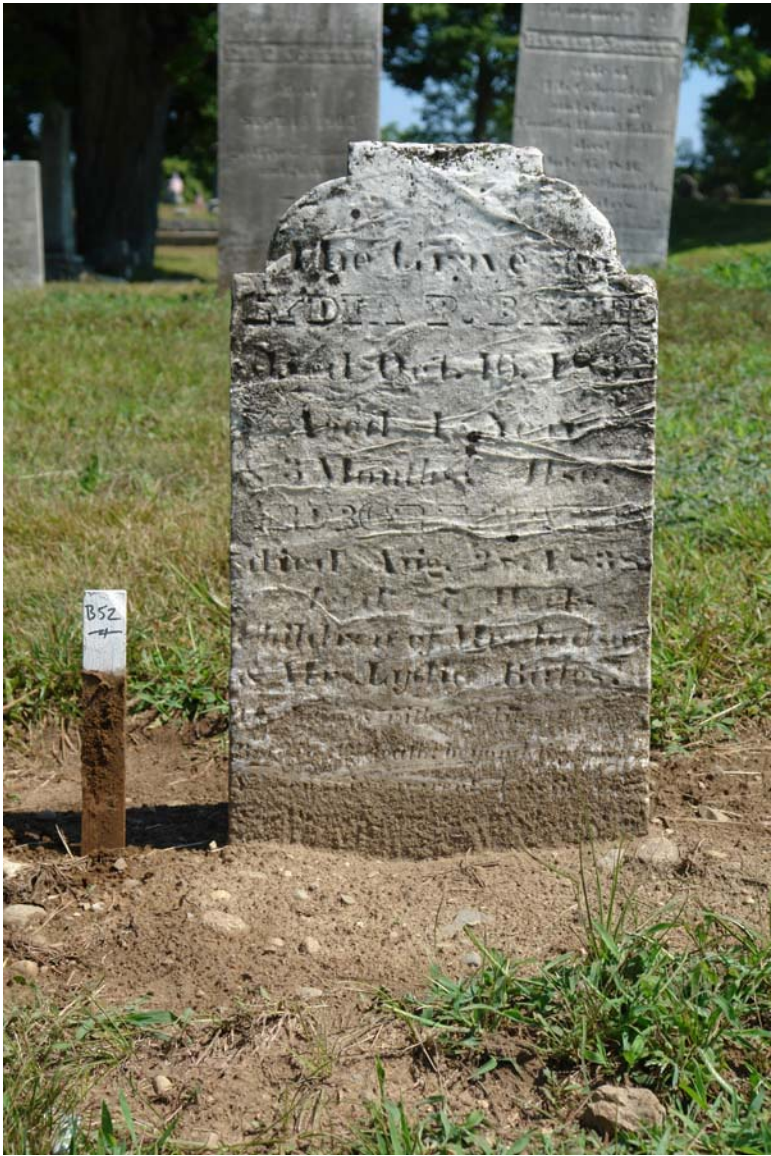
Hanover Center Cemetery, Hanover MA
NAME ON MARKER **Lydia Bates**
Death Date: 10/16/1837 Marker Type: Headstone/conc. base
Cond. of Inscription: Decipherable Material: Marble

EXISTING CONDITIONS	CONSERVATION STRATEGY
Fallen	Evaluate resetting options Possible new below grade concrete base

TREATMENT	Treatment Dates
7/22-29/2015	
1. Marker excavated and found to be sound. Light soiling removed by brushing with nylon brushes and water. 2. Setting area excavated for new below grade cast concrete base sized minimum of 12 inches deep, 12 inches greater in thickness and 6 inches wider than the stone. 3. Wooden forms and setting slot form stabilized and aligned with adjacent markers before concrete is poured 4. When required, the lower edge of marker is re-squared with minimal loss using a power grinder 5. Setting forms are removed after partial curing of the concrete and the base backfilled with tamped sand or gravel 6. Marker reset into setting slot with a cement/lime grout (3/2/9) with 000 sand made fluid with a super plasticizer. 7. Marker set plumb and level, and braced for minimum of 5 days. 8. Disturbed areas backfilled with existing topsoil.

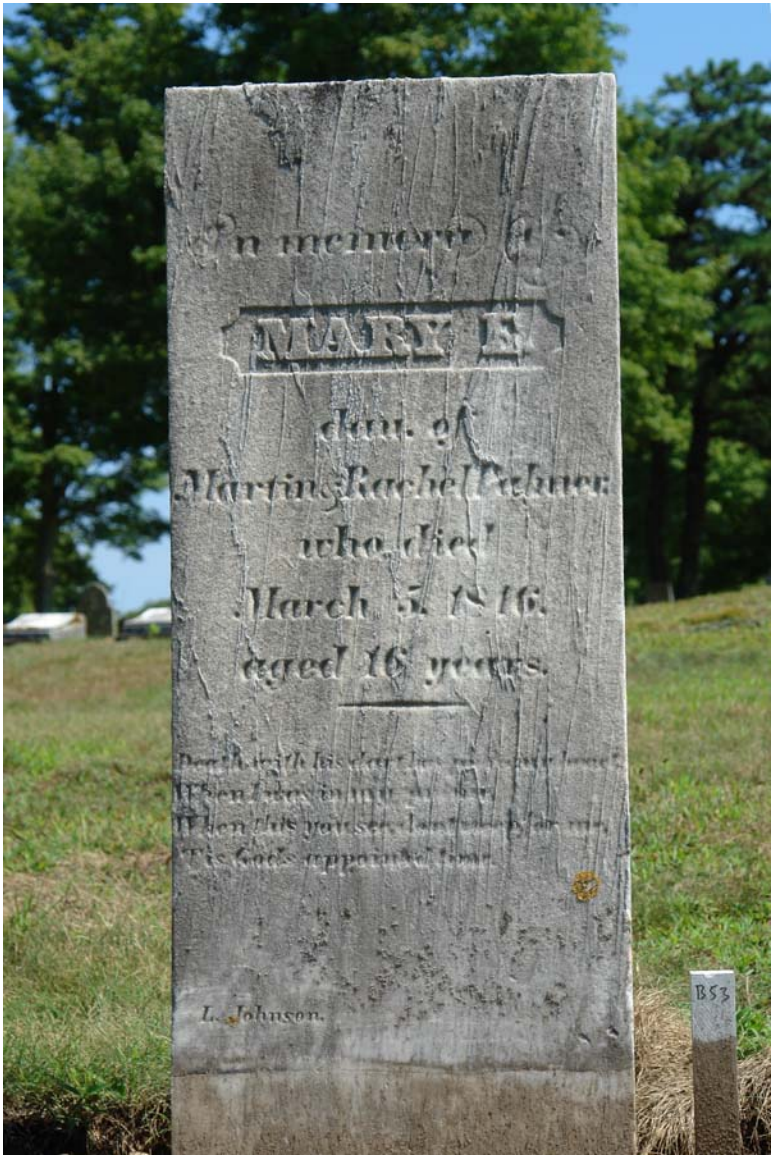
Hanover Center Cemetery, Hanover MA
NAME ON MARKER **Mary Palmer**
Death Date: 3/5/1846 Marker Type: Headstone/conc. base
Cond. of Inscription: Legible Material: Marble

EXISTING CONDITIONS	CONSERVATION STRATEGY
Tilted Marker loose in slot	Reset base level Reset marker plumb into setting slot

TREATMENT	Treatment Dates 7/22-29/2015
<div>1. Marker excavated and found to be sound. Old concrete collar removed with hand tools.</div> <div>2. Setting area excavated for new below grade cast concrete base sized minimum of 12 inches deep, 12 inches greater in thickness and 6 inches wider than the stone.</div> <div>3. Wooden forms and setting slot form stabilized and aligned with adjacent markers before concrete is poured</div> <div>4. When required, the lower edge of marker is re-squared with minimal loss using a power grinder</div> <div>5. Setting forms are removed after partial curing of the concrete and the base backfilled with tamped sand or gravel</div> <div>6. Marker reset into setting slot with a cement/lime grout (3/2/9) with 000 sand made fluid with a super plasticizer.</div> <div>7. Marker set plumb and level, and braced for minimum of 5 days.</div> <div>8. Disturbed areas backfilled with existing topsoil.</div>

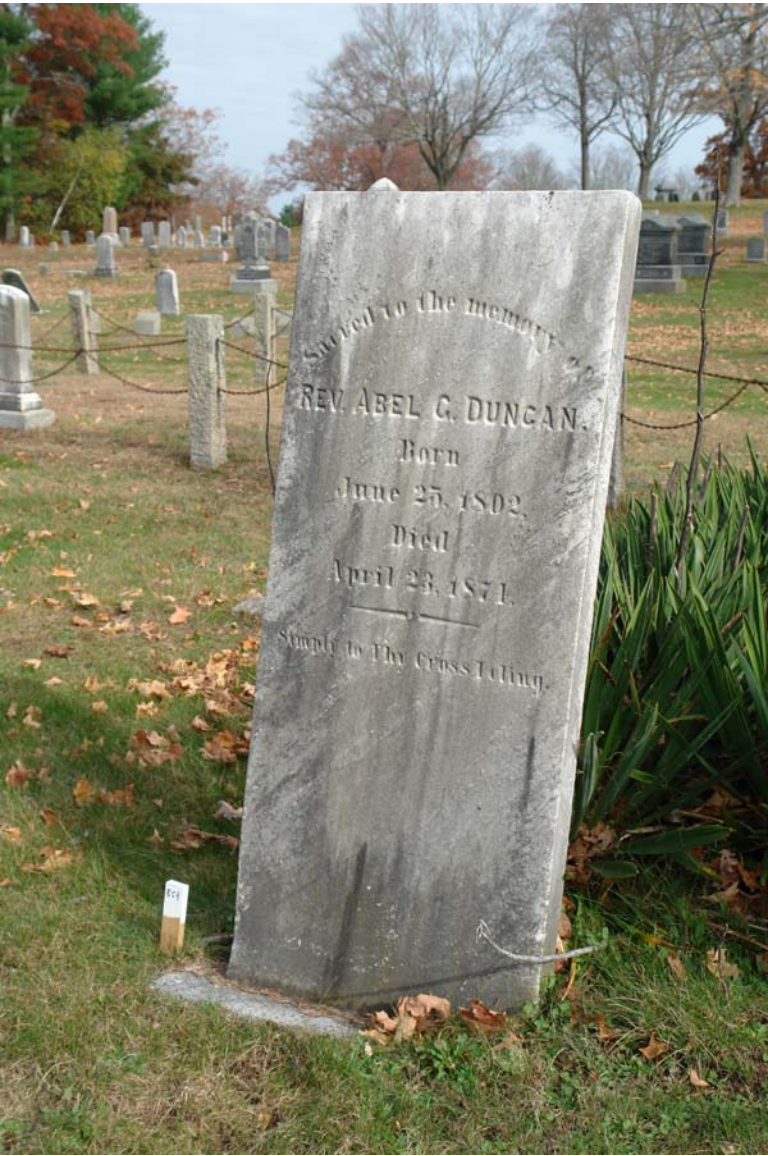
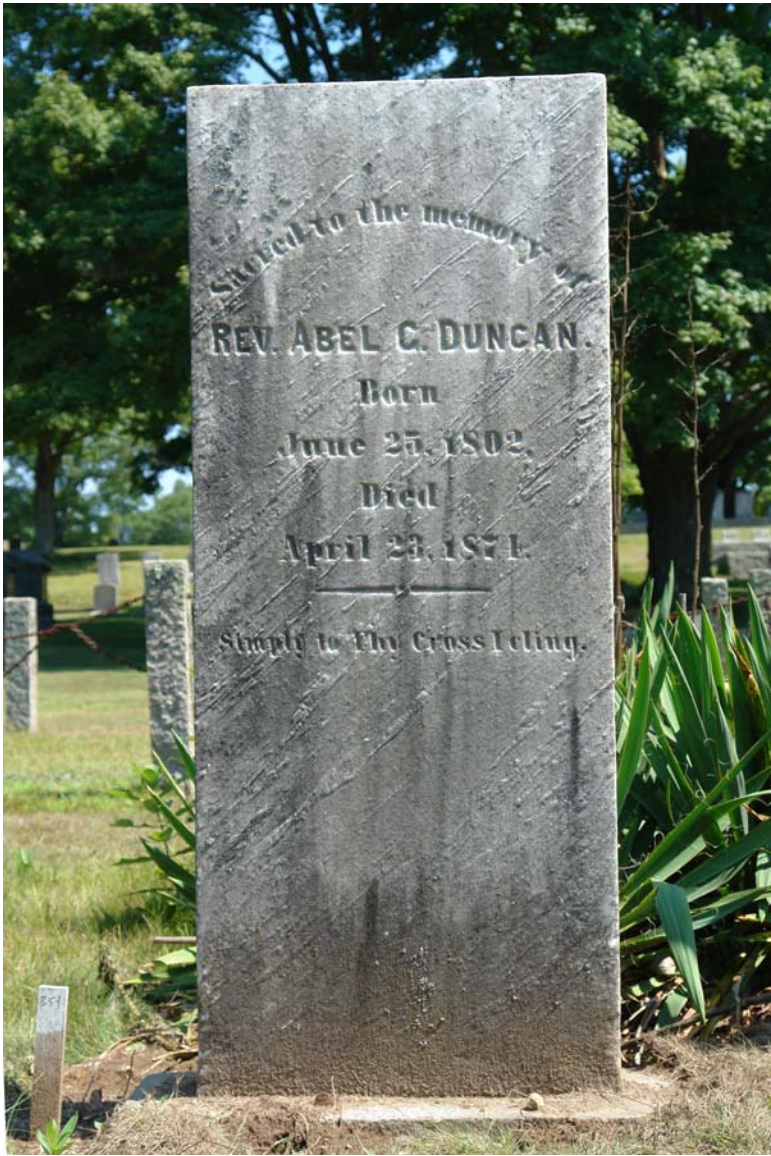
Hanover Center Cemetery, Hanover MA	
NAME ON MARKER	Rev. Abel Duncan
Death Date: 4/23/1871	Marker Type: Headstone/base
Cond. of Inscription: Legible	Material: Marble
EXISTING CONDITIONS	CONSERVATION STRATEGY
Tilted Marker loose in slo	Reset base level Reset marker plumb into setting slot t
TREATMENT	
Treatment Dates 7/30/2015

1. Area excavated to an appropriate depth removing any roots or large stones. 2. Base inspected and found to be sound and re-useable 3. Base is aligned with adjacent markers and re-set level. 4. Area around base was backfilled with tamped gravel and re-graded with existing topsoil 5. Debris removed from setting slot. When required, power grinders were used to facilitate removal of stone fragments. 6. When required, the lower setting edge was re-squared by power grinder with minimal loss. 7. Marker reset plumb and level into setting slot with cement/lime grout (3/2/9) with 000 sand made fluid with a super plasticizer. 8. Excess grout removed and joint area cleaned. 9. Marker braced for a minimum 3 days

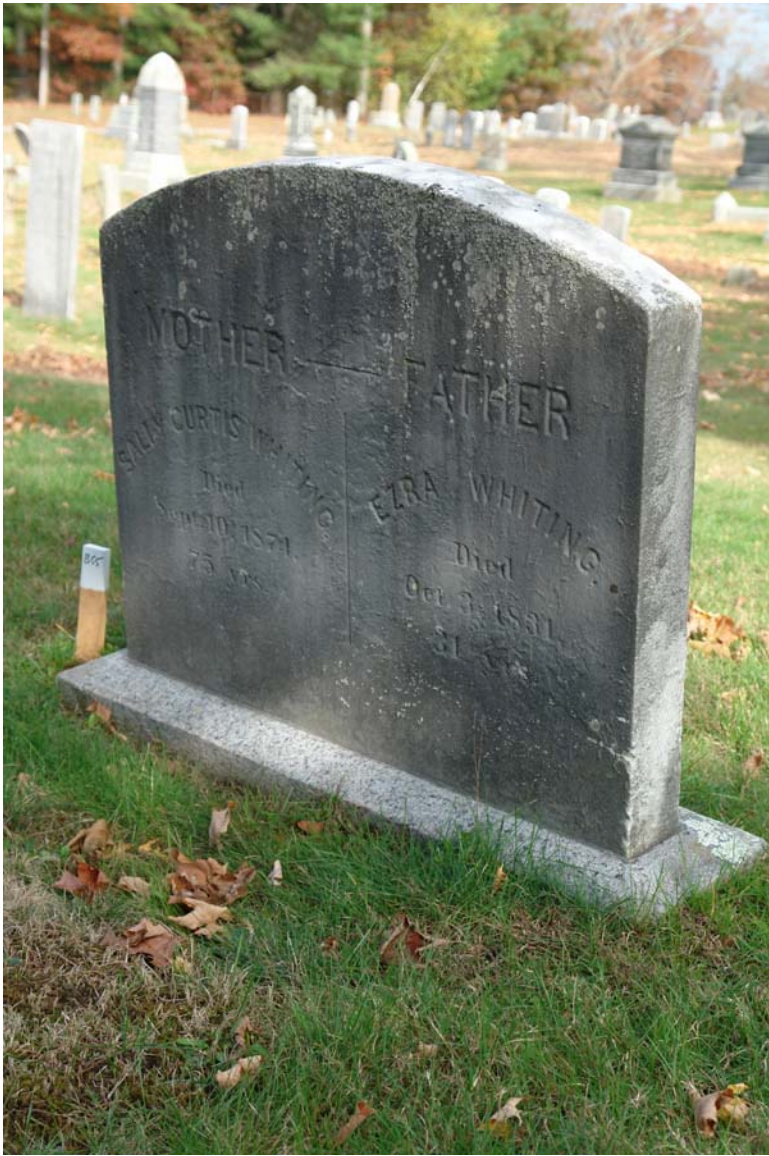
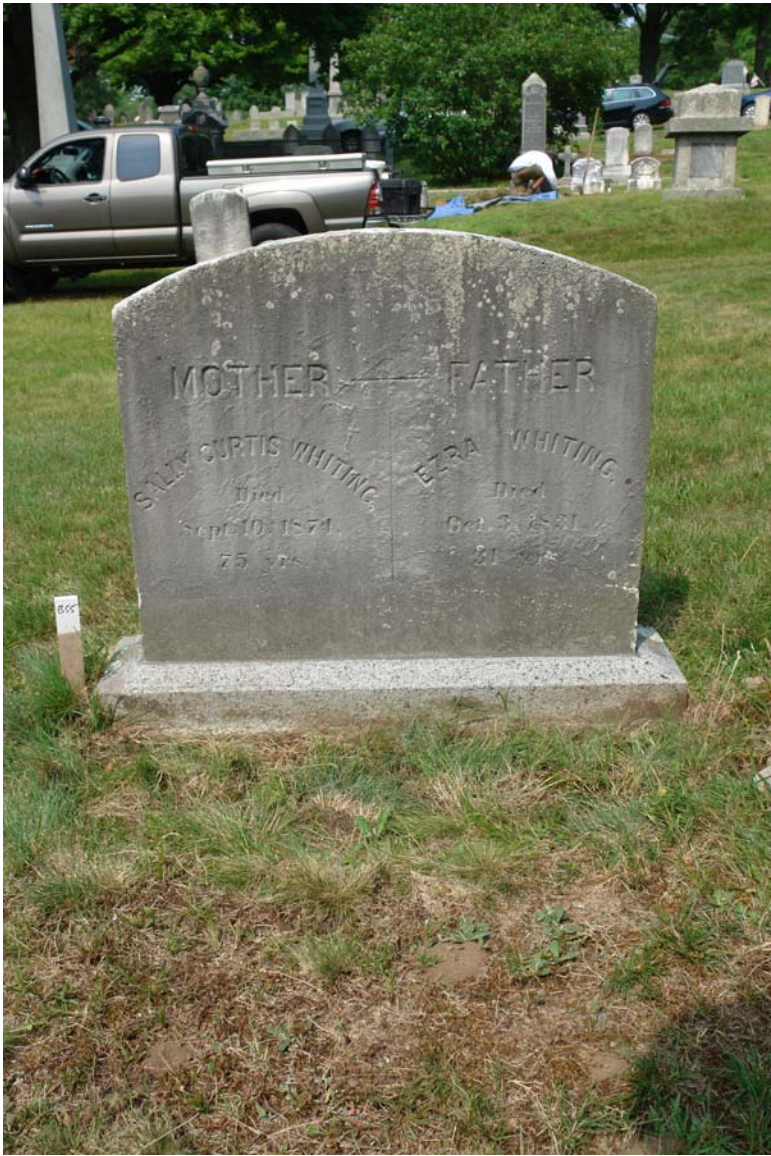
EXISTING CONDITIONS	CONSERVATION STRATEGY
Tilted base	Reset base with marker plumb

TREATMENT	Treatment Dates
1. Marker and base found to be in sound condition with marker securely attached to base. 2. Area excavated to an appropriate depth removing any roots or large stones. 3. Base is aligned with adjacent markers and re-set level. 4. Area around base was backfilled with tamped gravel and re-graded with existing topsoil	7/8/2015

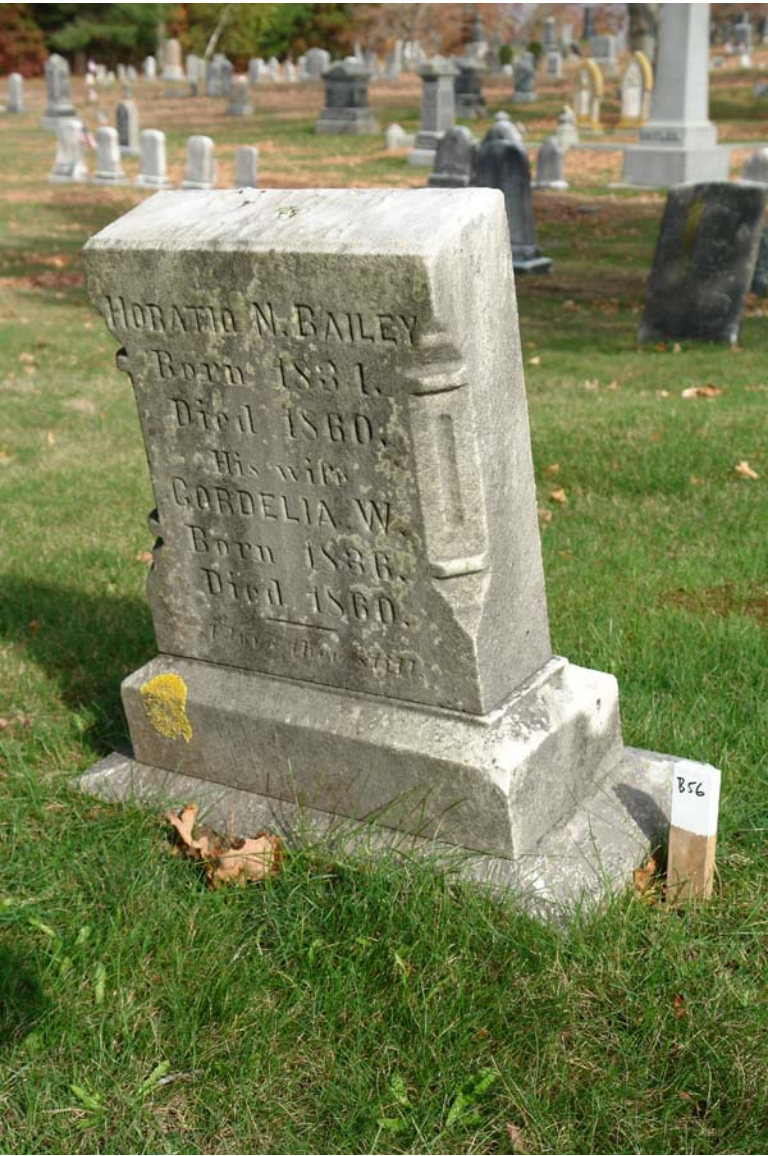
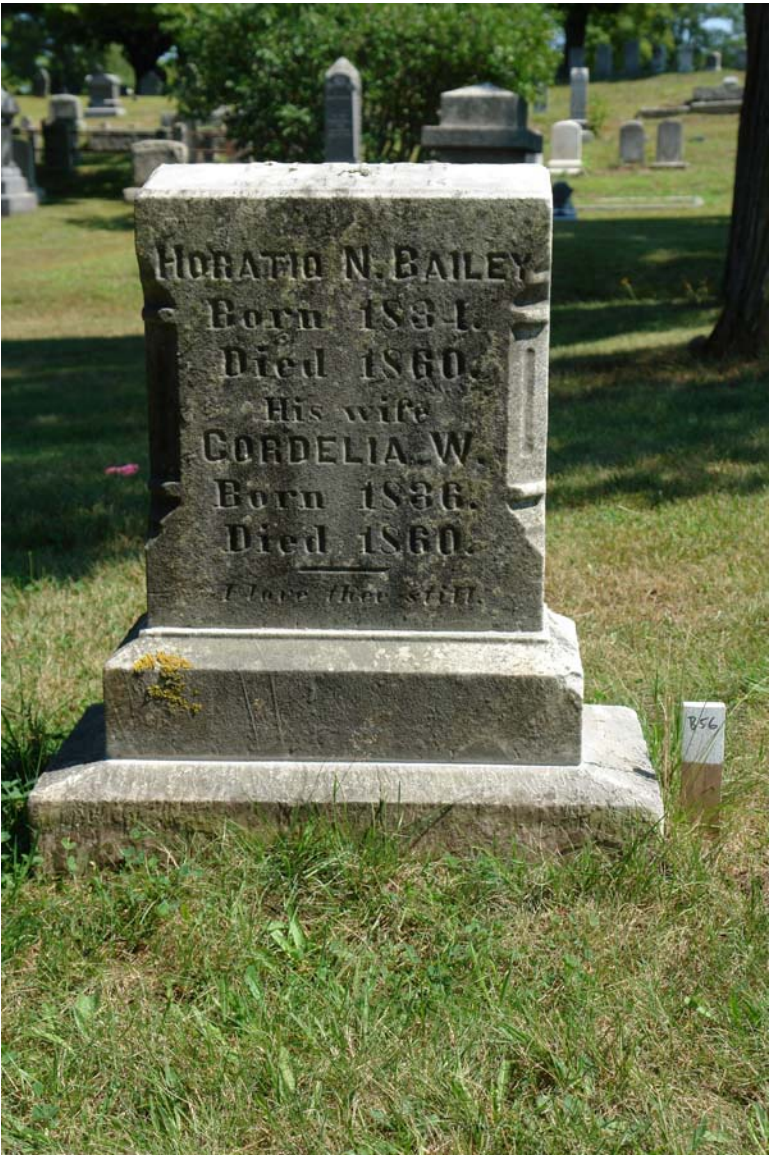
Height 28 Width 34 Thickness 4 Marker# **B.55.1**

Hanover Center Cemetery, Hanover MA	
NAME ON MARKER	Horatio Bailey
Death Date: 1860	Marker Type: Headstone/pinned
Cond. of Inscription: Legible	Material: Marble
EXISTING CONDITIONS	CONSERVATION STRATEGY
Tilted Marker loose on base	Check base for level Reset marker plumb
TREATMENT	
Treatment Dates 7/8/2015

1. Elements removed from setting bases and inspected for soundness. 2. Area excavated to an appropriate depth removing any roots or large stones. 3. Base is aligned with adjacent markers and re-set level. 4. Area around base was backfilled with tamped gravel and re-graded with existing topsoil 5. Failed mortar removed from setting area and bottom of marker 6. When required, any existing pins were inspected, and if necessary, replaced with stainless steel threaded pins 7. Setting surfaces primed with Acryl 60 diluted 1:3 with water. 8. Marker reset plumb onto base with cement/lime mortar (3/2/9) with 000 sand. 9. Excess grout removed and joint area cleaned.

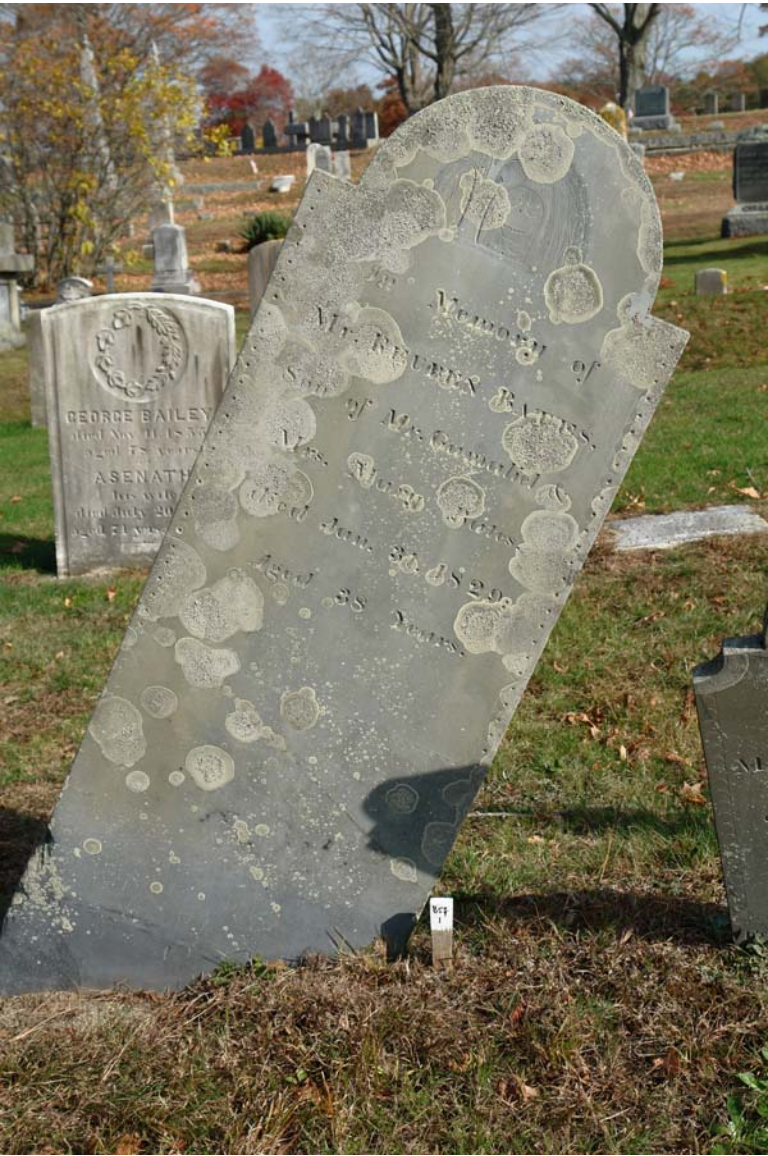
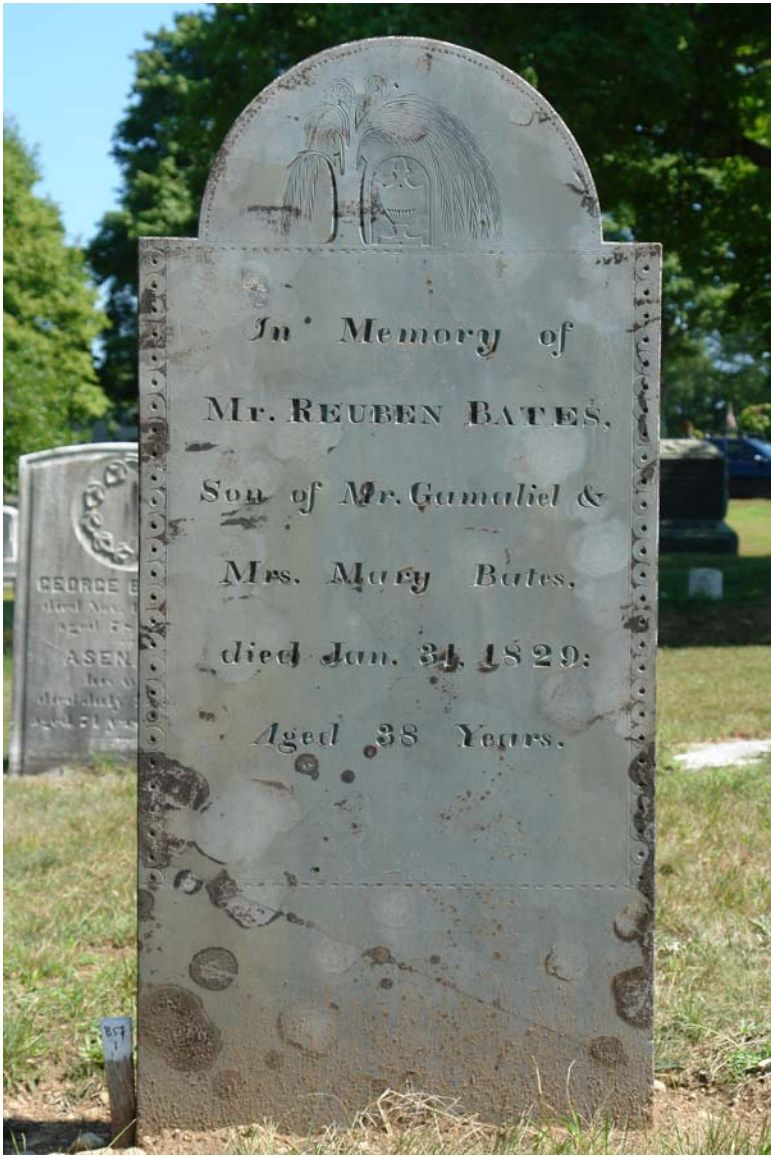
Hanover Center Cemetery, Hanover MA	
NAME ON MARKER	Reuben Bates
Death Date: 1/13/1829	Marker Type: Headstone
Cond. of Inscription: Legible	Material: Slate
EXISTING CONDITIONS	CONSERVATION STRATEGY
Tilted	Reset plumb
TREATMENT	
Treatment Dates 7/13/2015	
<div>1. Marker carefully excavated. The soil around tilted markers was removed to an appropriate depth. When required, the marker was removed from the ground. Marker appears to be sound.</div> <div>2. Soling removed by light brushing with nylon brushes and water.</div> <div>3. Setting area excavated to sufficient depth and stone re-set plumb at appropriate height and level onto gravel bed, aligned with adjacent markers</div> <div>4. Area backfilled around marker with tamped sand and gravel</div> <div>5. Disturbed areas re-graded with existing topsoil and sod.</div> <div>6. Surfaces treated with D/2, scrubbed with nylon brushes and rinsed with water</div>

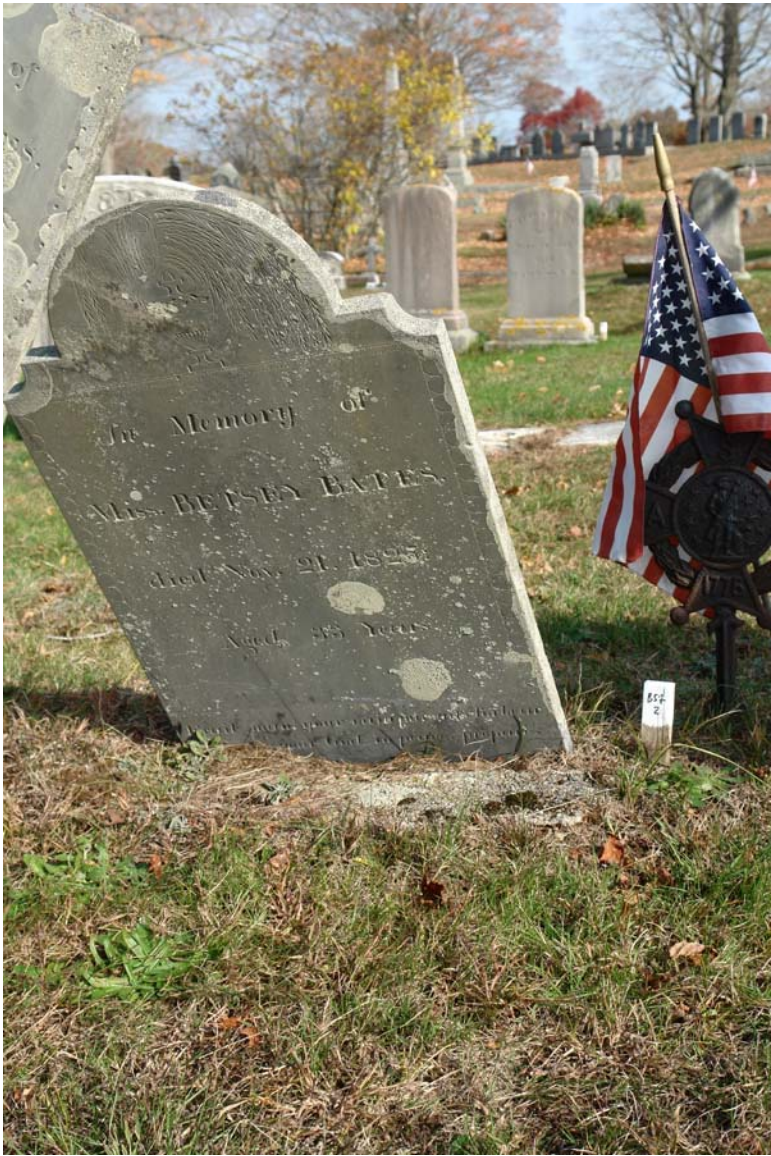
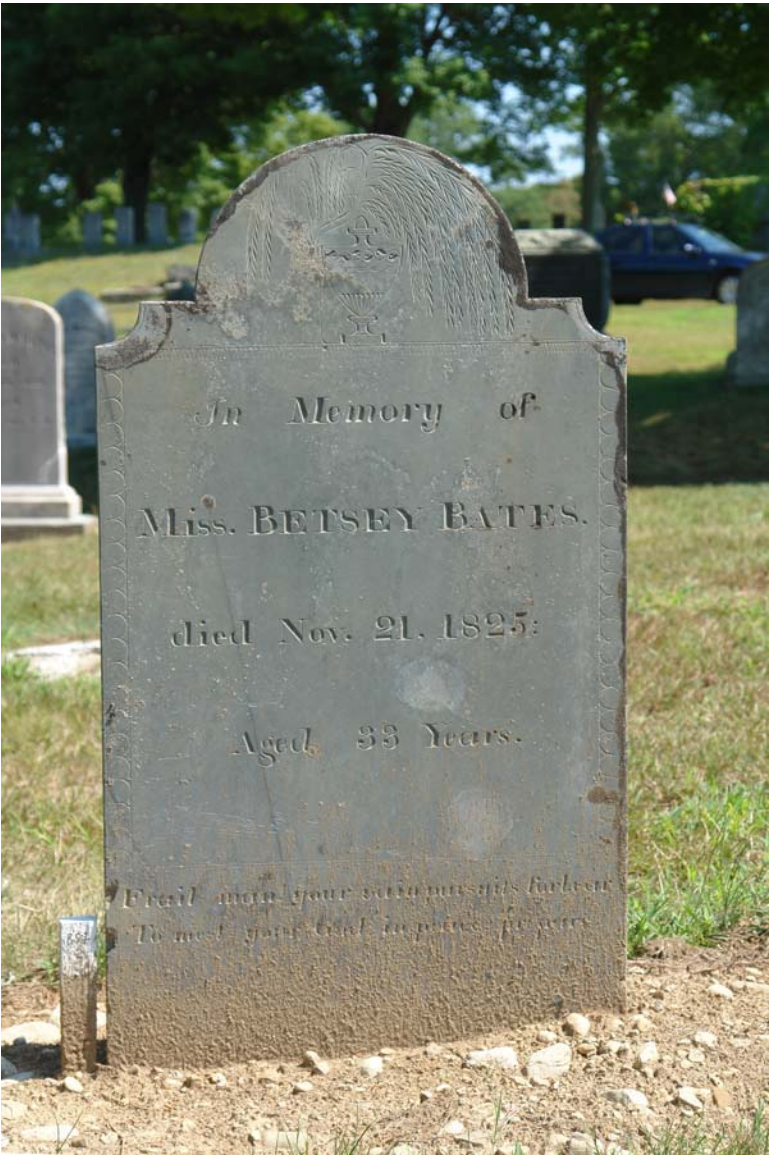
Hanover Center Cemetery, Hanover MA
NAME ON MARKER **Betsey Bates**
Death Date: 11/21/1825 Marker Type: Headstone/conc. base
Cond. of Inscription: Legible Material: Slate

EXISTING CONDITIONS	CONSERVATION STRATEGY
Loose in base	Reset into new below grade concrete base

TREATMENT	Treatment Dates
1. Marker excavated and found to be sound. Light soiling removed by brushing with nylon brushes and water. 2. Setting area excavated for new below grade cast concrete base sized minimum of 12 inches deep, 12 inches greater in thickness and 6 inches wider than the stone. 3. Wooden forms and setting slot form stabilized and aligned with adjacent markers before concrete is poured 4. When required, the lower edge of marker is re-squared with minimal loss using a power grinder 5. Setting forms are removed after partial curing of the concrete and the base backfilled with tamped sand or gravel 6. Marker reset into setting slot with a cement/lime grout (3/2/9) with 000 sand made fluid with a super plasticizer. 7. Marker set plumb and level, and braced for minimum of 5 days. 8. Disturbed areas backfilled with existing topsoil.	7/13-15/2015

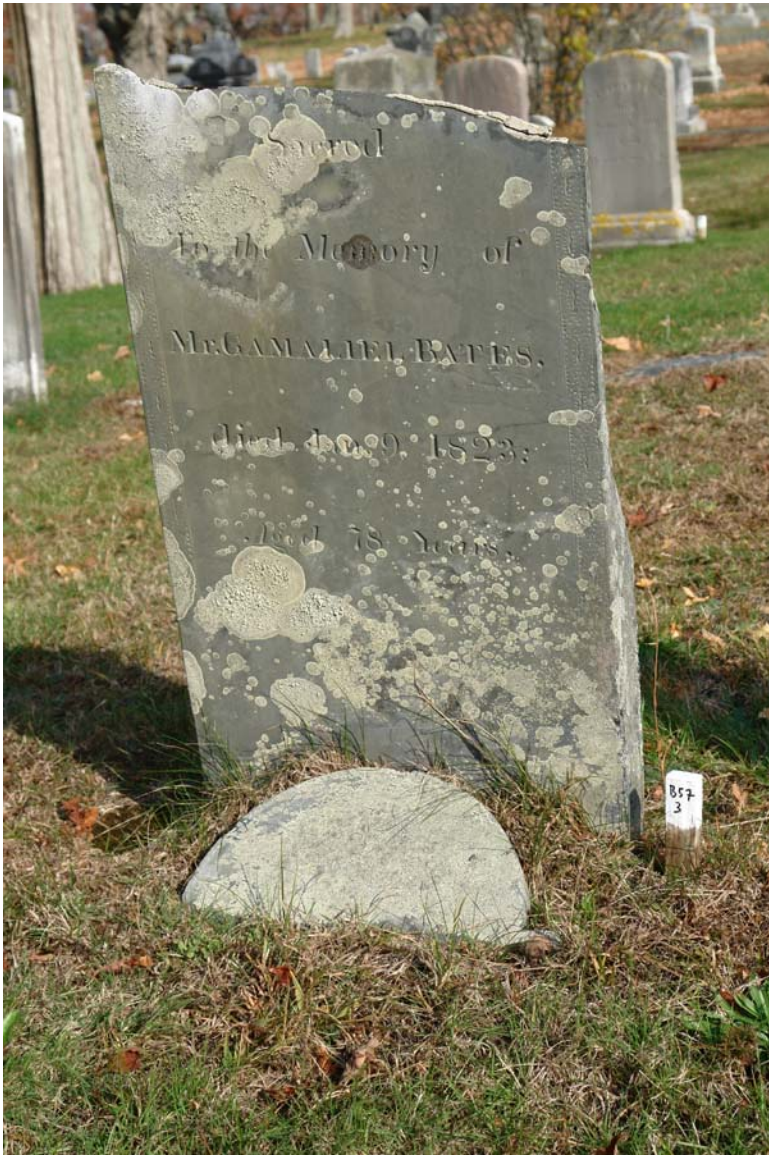
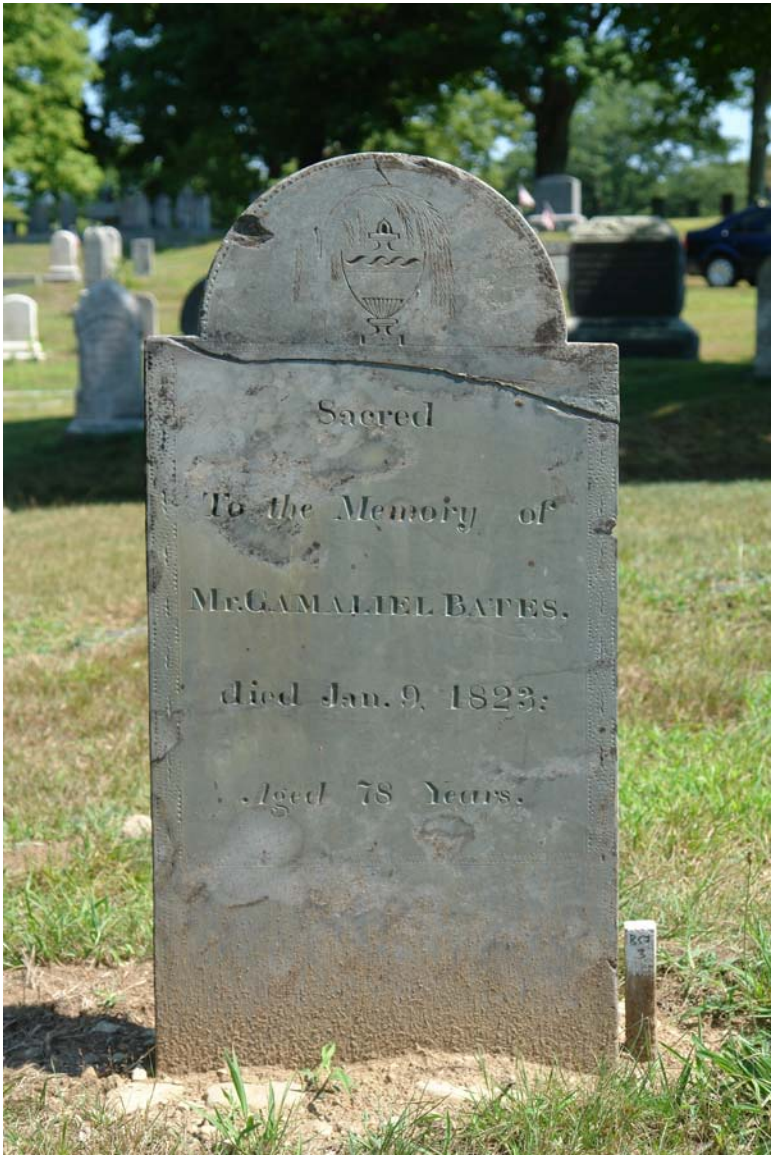
Hanover Center Cemetery, Hanover MA
NAME ON MARKER **Gamaliel Bates**
Death Date: 1/9/1823 Marker Type: Headstone/conc. base
Cond. of Inscription: Missing, legible Material: Slate

EXISTING CONDITIONS	CONSERVATION STRATEGY
Tilted Fractured	Reset plumb Attach fragments with structural adhesive

TREATMENT	Treatment Dates
1. Area around lower fragment carefully excavated and inspected for soundness. Area probed for existing fragments. 2. Lower fragment re-set plumb at appropriate height and level onto gravel bed, aligned with adjacent markers 3. Area backfilled around marker with tamped sand and gravel 4. Failed adhesives removed with hand tools 5. Fragments attached with structural adhesive (Abatron 55-22), clamped and braced until cured. Epoxy removed with hand chisels within 24 hours. 6. Cracks and losses filled with RepliCal products, misted with water and covered for 3 days min. 7. Surfaces treated with D/2 Biological Solution, scrubbed with nylon brushes and water. Rinsed fully with water	7/13-15/2015

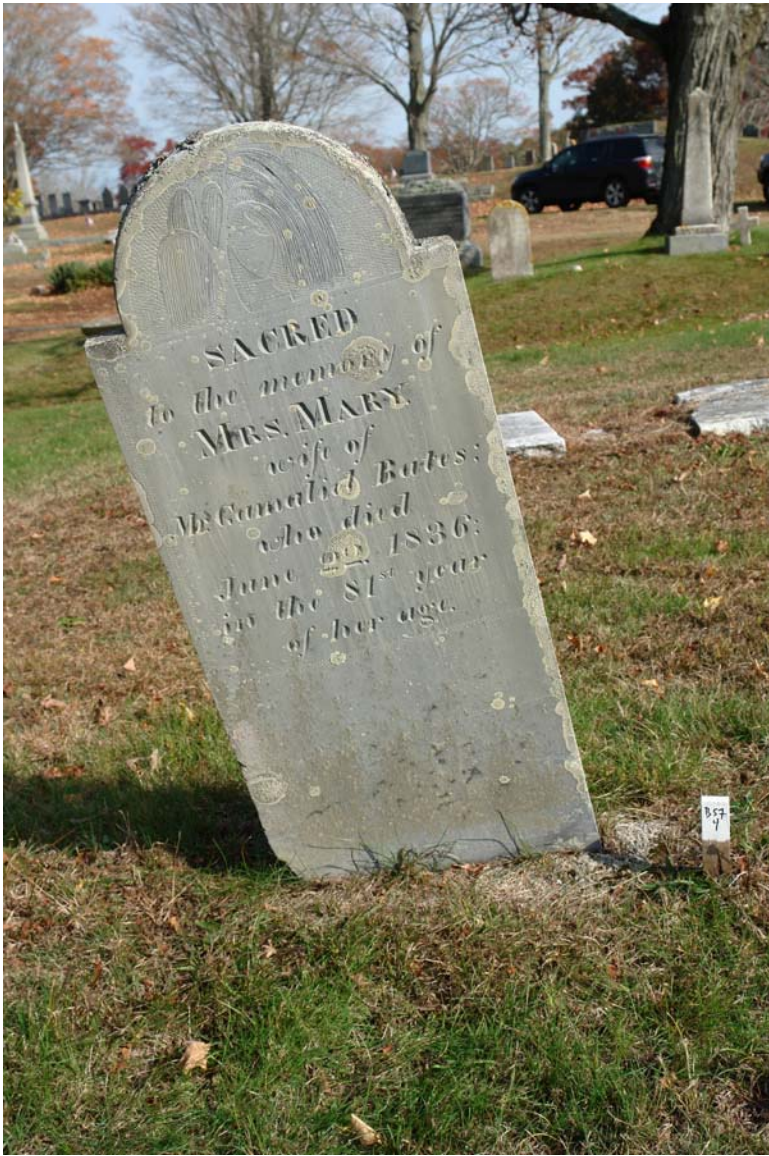
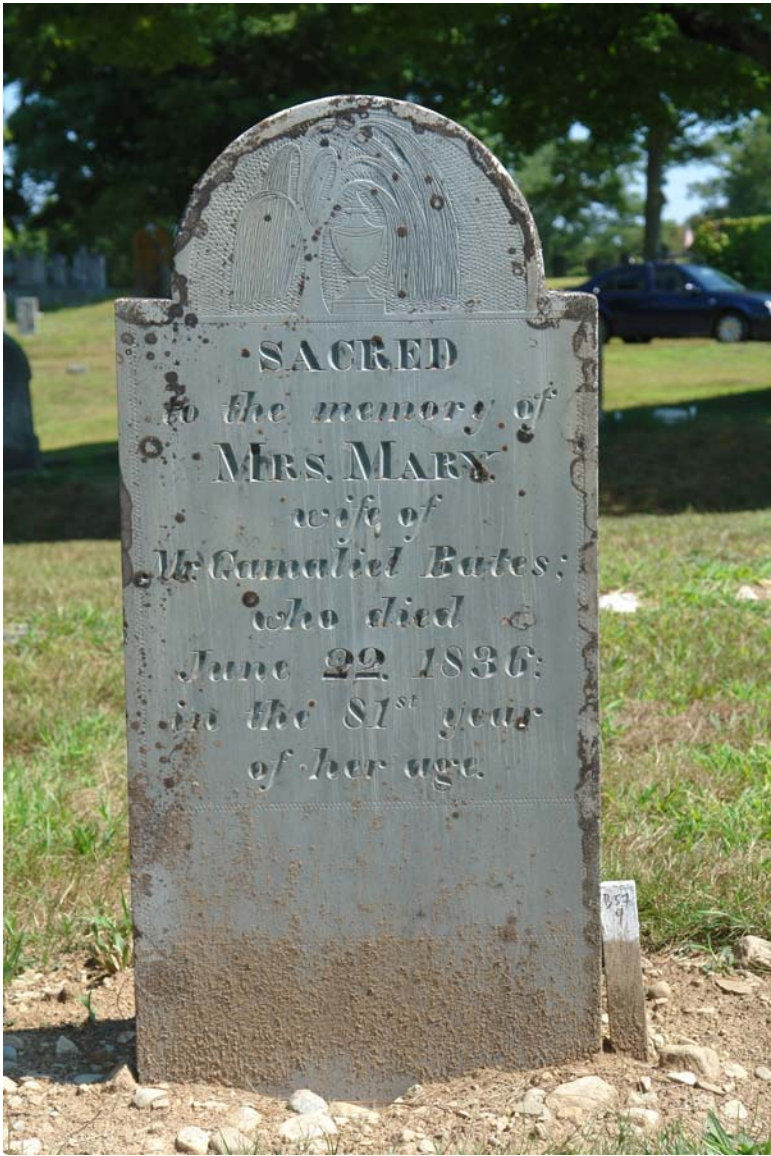
EXISTING CONDITIONS	CONSERVATION STRATEGY
Tilted	New below base required

TREATMENT	Treatment Dates
1. Marker excavated and found to be sound. Light soiling removed by brushing with nylon brushes and water. 2. Setting area excavated for new below grade cast concrete base sized minimum of 12 inches deep, 12 inches greater in thickness and 6 inches wider than the stone. 3. Wooden forms and setting slot form stabilized and aligned with adjacent markers before concrete is poured 4. When required, the lower edge of marker is re-squared with minimal loss using a power grinder 5. Setting forms are removed after partial curing of the concrete and the base backfilled with tamped sand or gravel 6. Marker reset into setting slot with a cement/lime grout (3/2/9) with 000 sand made fluid with a super plasticizer. 7. Marker set plumb and level, and braced for minimum of 5 days. 8. Disturbed areas backfilled with existing topsoil.	7/13-15/2015

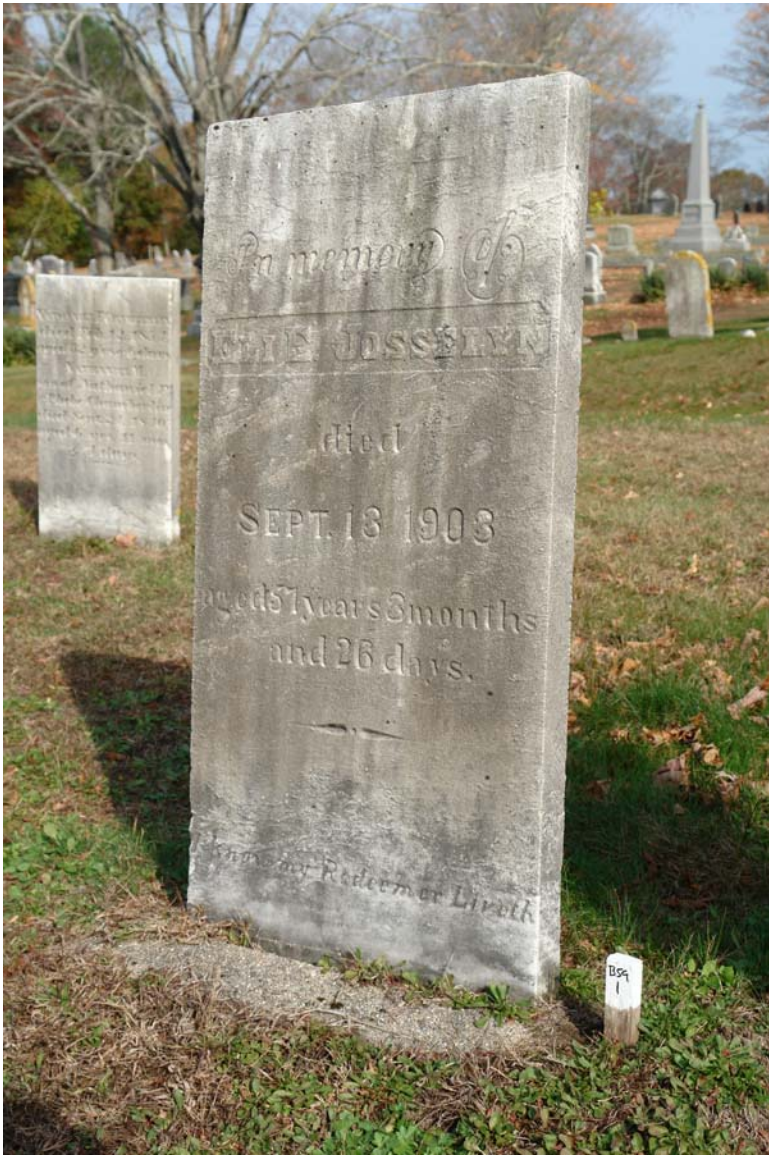
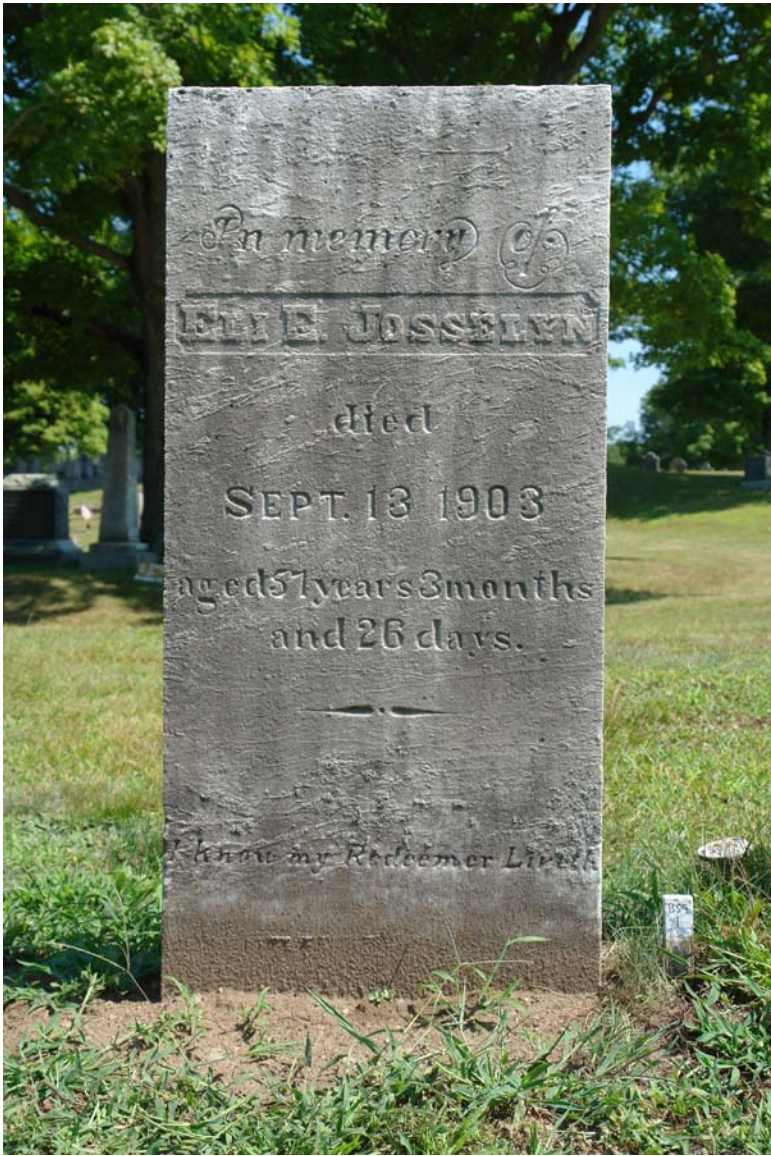
Hanover Center Cemetery, Hanover MA
NAME ON MARKER **Eli Josselyn**
Death Date: 9/13/1903 Marker Type: Headstone/conc. base
Cond. of Inscription: Legible Material: Marble

EXISTING CONDITIONS	CONSERVATION STRATEGY
Tilted	Reset plumb

TREATMENT	Treatment Dates
	7/14/2015
<div>1. Area excavated to an appropriate depth removing any roots or large stones.</div> <div>2. Base inspected and found to be sound and re-useable</div> <div>3. Base is aligned with adjacent markers and re-set level.</div> <div>4. Area around base was backfilled with tamped gravel and re-graded with existing topsoil</div> <div>5. Debris removed from setting slot. When required, power grinders were used to facilitate removal of stone fragments.</div> <div>6. When required, the lower setting edge was re-squared by power grinder with minimal loss.</div> <div>7. Marker reset plumb and level into setting slot with cement/lime grout (3/2/9) with 000 sand made fluid with a super plasticizer.</div> <div>8. Excess grout removed and joint area cleaned.</div> <div>9. Marker braced for a minimum 3 days</div>
