MONUMENT CONSERVATION COLLABORATIVE LLC, NORFOLK, CT

DOCUMENTATION OF STONE CONSERVATION TREATMENTS TO ASSINIPPI CEMETERY, HANOVER, MA June 2015

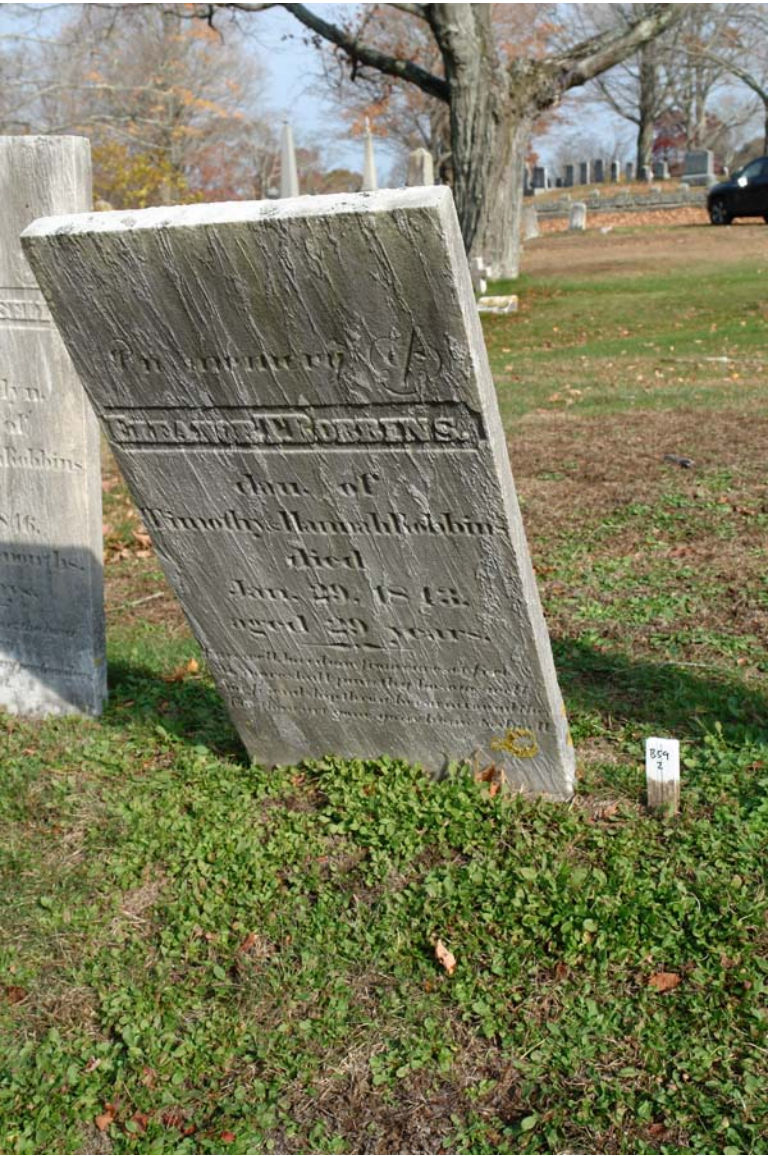
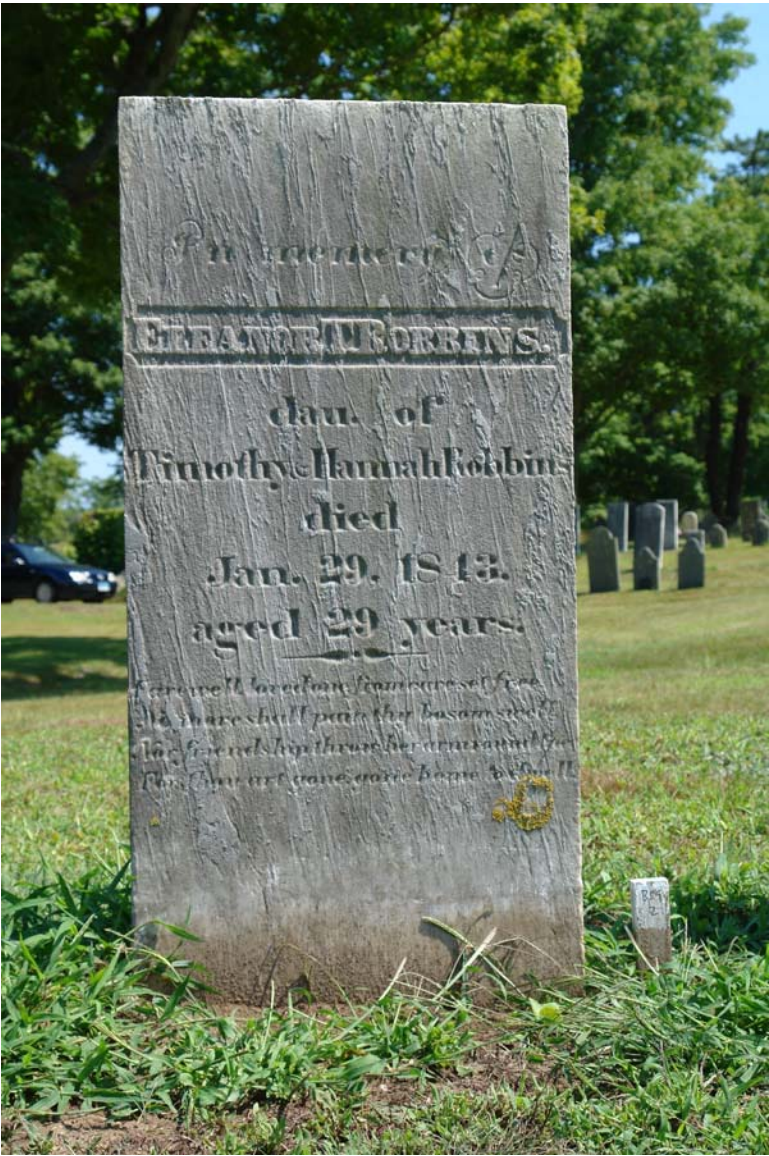
Hanover Center Cemetery, Hanover MA
NAME ON MARKER **Eleanor Robbins**
Death Date: 1/29/1843 Marker Type: Headstone/conc. base
Cond. of Inscription: Legible Material: Marble

EXISTING CONDITIONS	CONSERVATION STRATEGY
Loose in base	Reset into new below grade concrete base

TREATMENT	Treatment Dates 7/14/2015
<div>1. Existing base located below grade while excavating for resetting. Area excavated to an appropriate depth removing any roots or large stones.</div> <div>2. Base inspected and found to be sound and re-useable</div> <div>3. Base is aligned with adjacent markers and re-set level.</div> <div>4. Area around base was backfilled with tamped gravel and re-graded with existing topsoil</div> <div>5. Debris removed from setting slot. When required, power grinders were used to facilitate removal of stone fragments.</div> <div>6. When required, the lower setting edge was re-squared by power grinder with minimal loss.</div> <div>7. Marker reset plumb and level into setting slot with cement/lime grout (3/2/9) with 000 sand made fluid with a super plasticizer.</div> <div>8. Excess grout removed and joint area cleaned.</div> <div>9. Marker braced for a minimum 3 days</div>

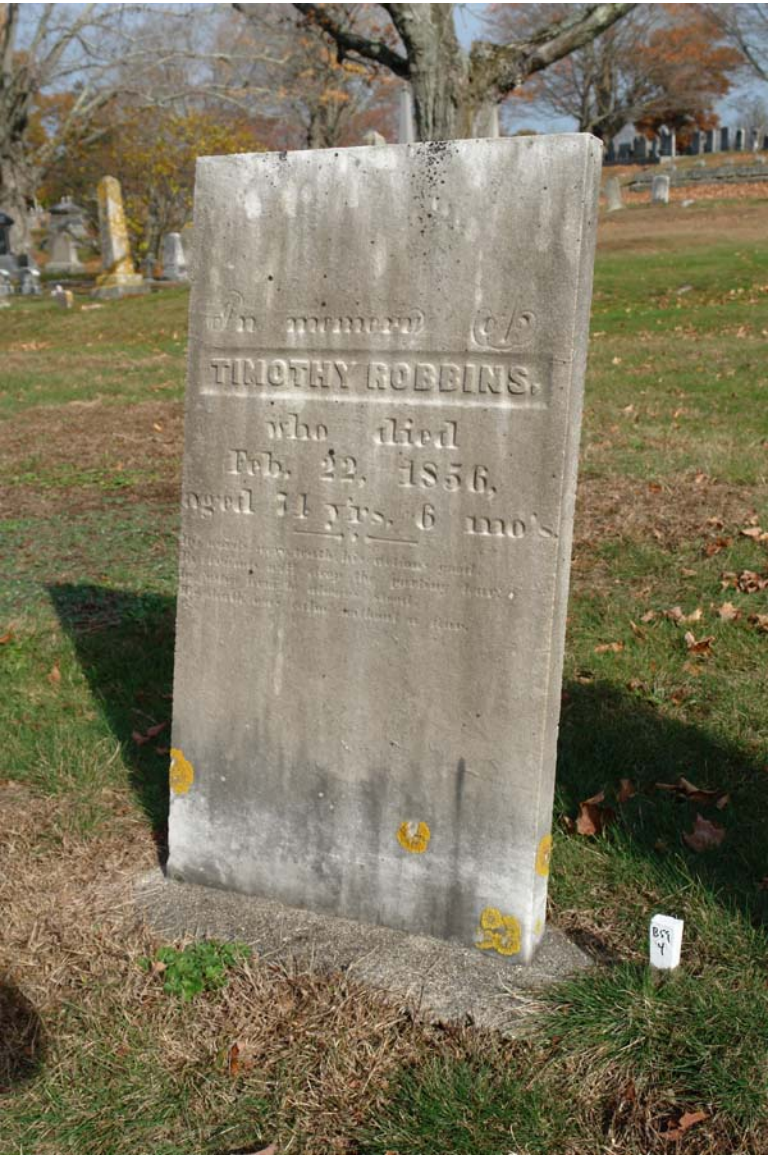
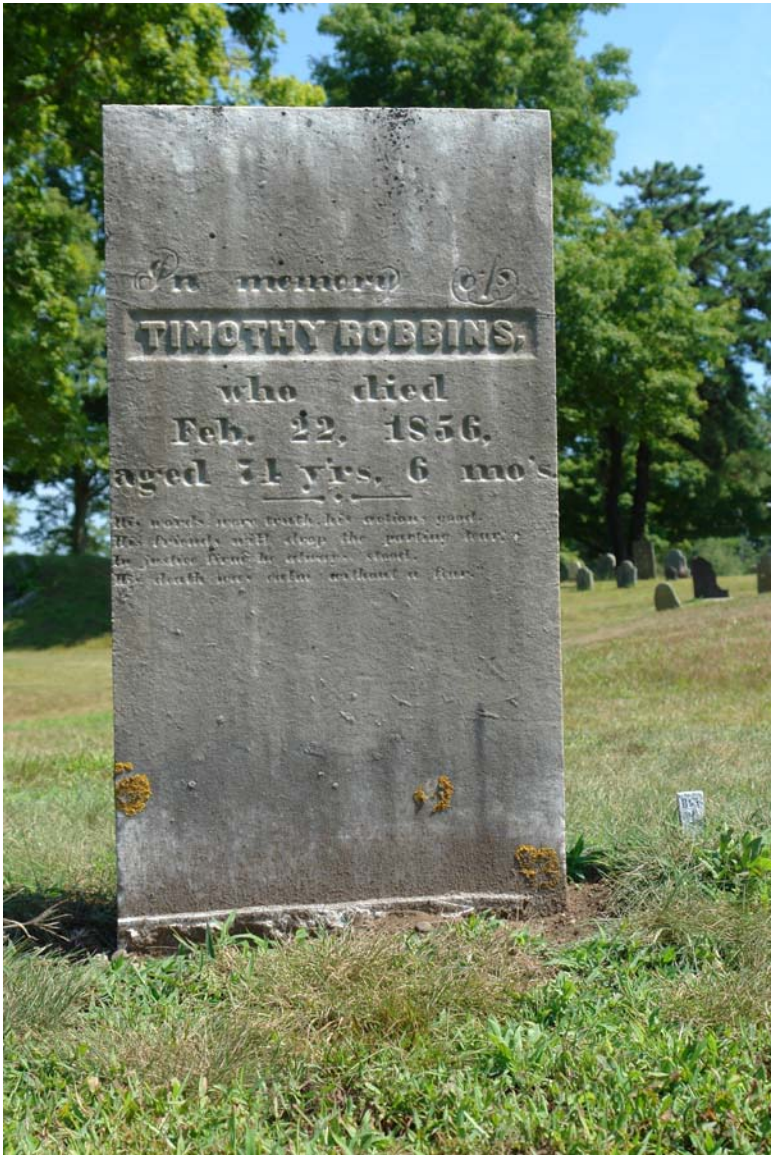
EXISTING CONDITIONS	CONSERVATION STRATEGY
Tilted	Evaluate resetting options Possible new below grade concrete base

TREATMENT	Treatment Dates
1. Existing base located below grade while excavating for resetting 2. Base inspected and found to be sound and re-useable 3. Base is aligned with adjacent markers and re-set level. 4. Area around base was backfilled with tamped gravel and re-graded with existing topsoil 5. Debris removed from setting slot. Old concrete collar remove from marker with hand tools. . 6. When required, the lower setting edge was re-squared by power grinder with minimal loss. 7. Marker reset plumb and level into setting slot with cement/lime grout (3/2/9) with 000 sand made fluid with a super plasticizer. 8. Excess grout removed and joint area cleaned. 9. Marker braced for a minimum 3 days	7/22/2015

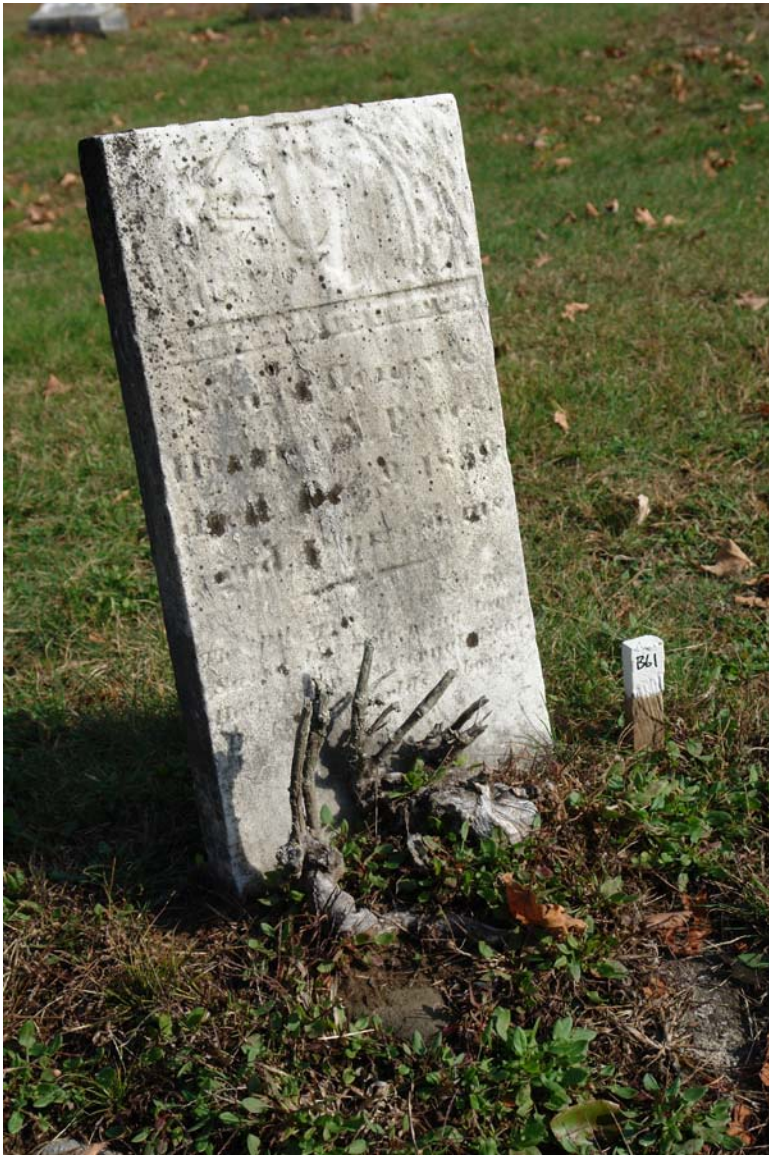
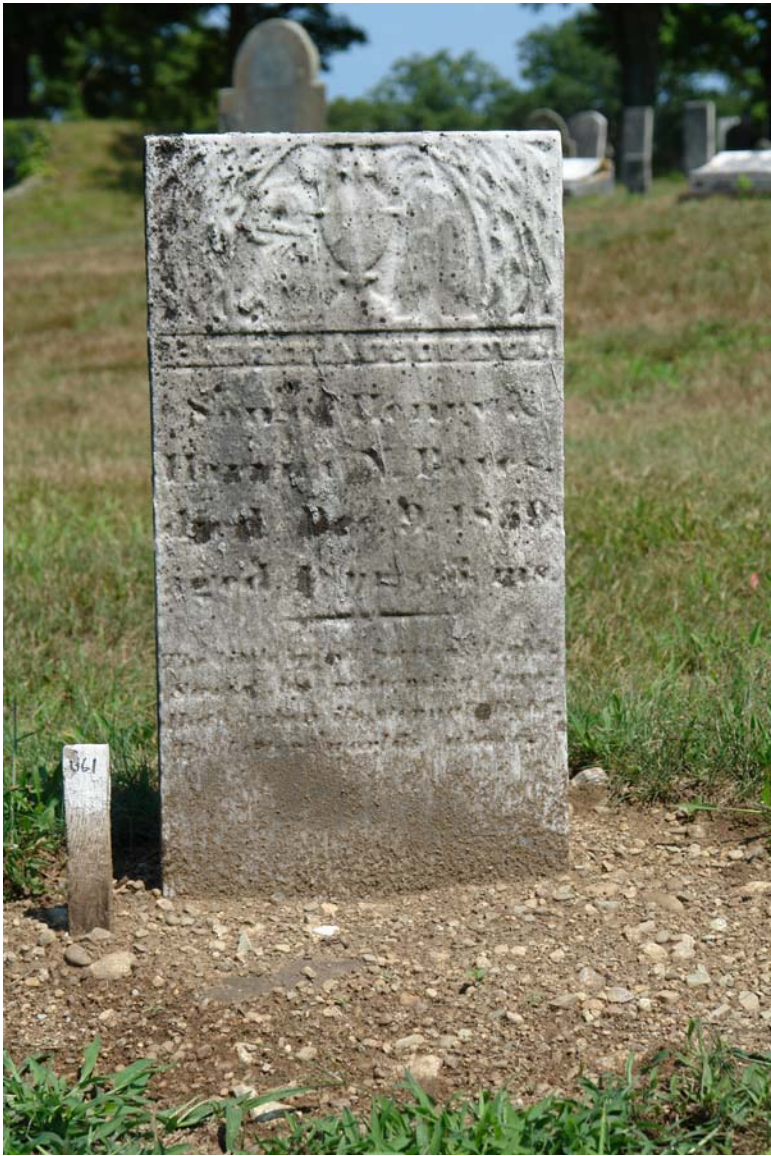
Hanover Center Cemetery, Hanover MA
NAME ON MARKER **Henry Bates**
Death Date: 12/9/1839 Marker Type: Headstone/conc. base
Cond. of Inscription: Partially decipherable Material: Marble

EXISTING CONDITIONS	CONSERVATION STRATEGY
Tilted	Reset into new below grade concrete base

TREATMENT	Treatment Dates 7/22/2015
<div>1. Existing base located below grade while excavating for resetting. Area excavated to an appropriate depth removing any roots or large stones.</div> <div>2. Base inspected and found to be sound and re-useable</div> <div>3. Base is aligned with adjacent markers and re-set level.</div> <div>4. Area around base was backfilled with tamped gravel and re-graded with existing topsoil</div> <div>5. Debris removed from setting slot. When required, power grinders were used to facilitate removal of stone fragments.</div> <div>6. When required, the lower setting edge was re-squared by power grinder with minimal loss.</div> <div>7. Marker reset plumb and level into setting slot with cement/lime grout (3/2/9) with 000 sand made fluid with a super plasticizer.</div> <div>8. Excess grout removed and joint area cleaned.</div> <div>9. Marker braced for a minimum 3 days</div>

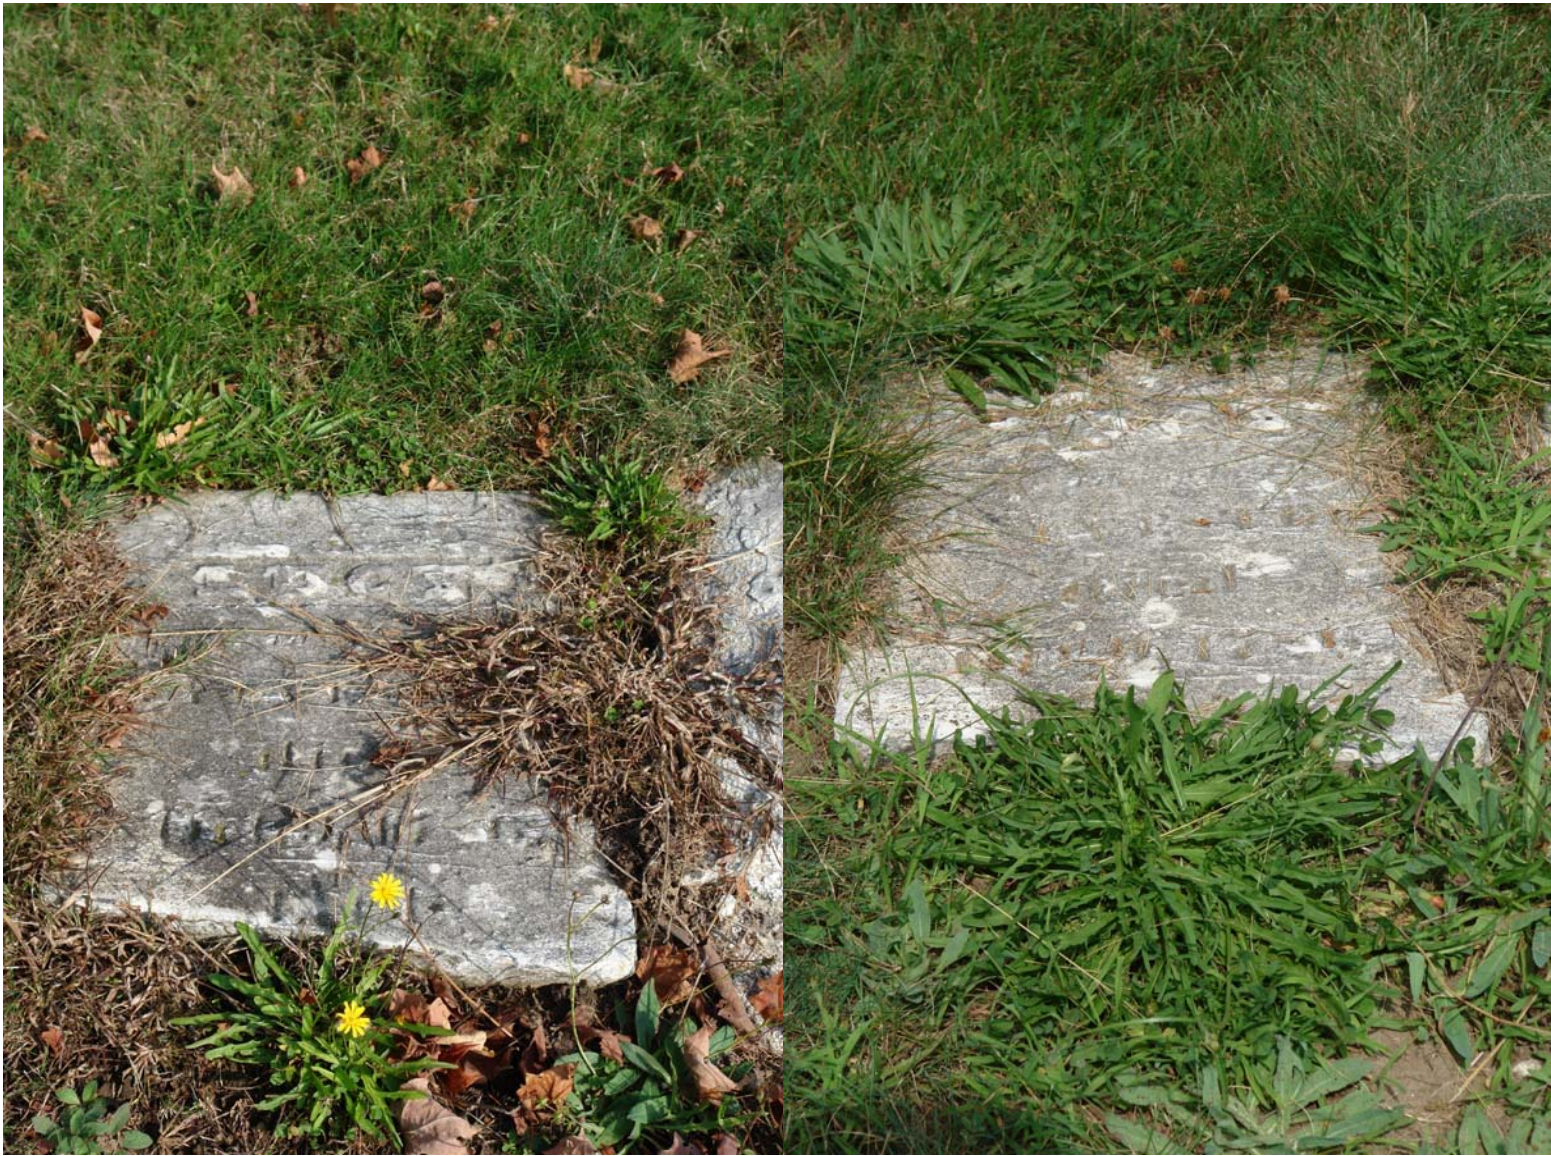
NAME ON MARKER **Lucy Sylvester**

EXISTING CONDITIONS	CONSERVATION STRATEGY
Part of a group of misc. stones, found by maintenance workers, grouped together, and set flat years ago	Locate setting location Evaluate

TREATMENT	Treatment Dates
The proper setting location for this group of unrelated markers and fragments is unknown. Until the approximate original setting location can be discovered MCC has suggested leaving this group of stones intact and “as is”.	7/8/2015

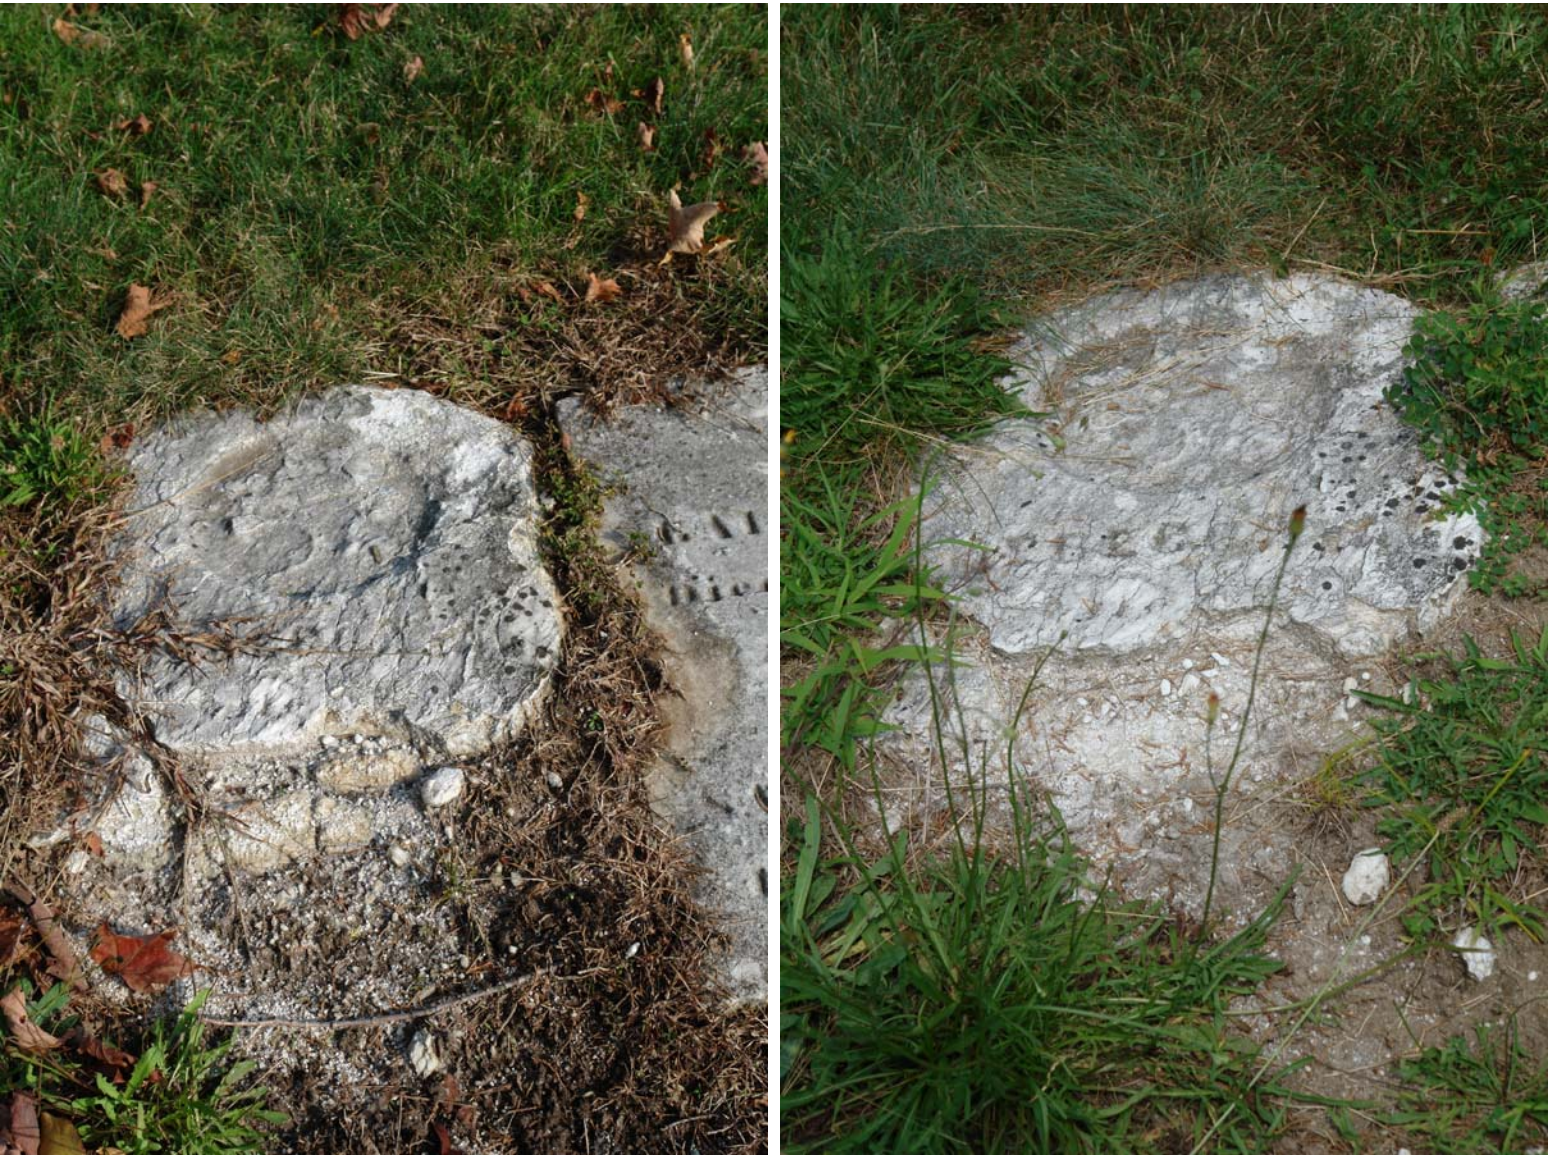
EXISTING CONDITIONS	CONSERVATION STRATEGY
Part of a group of misc. stones, found by maintenance workers, grouped together, and set flat years ago	Locate setting location Evaluate

The proper setting location for this group of unrelated markers and fragments is unknown. Until the approximate original setting location can be discovered MCC has suggested leaving this group of stones intact and “as is”.

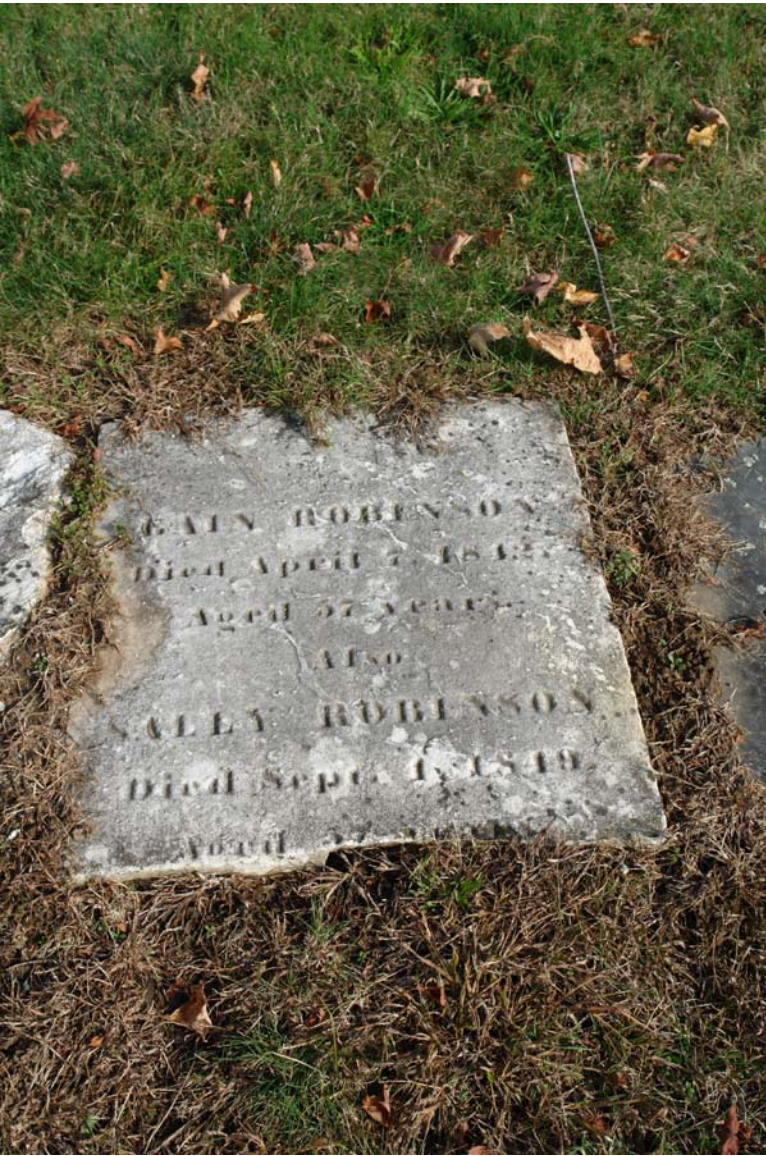
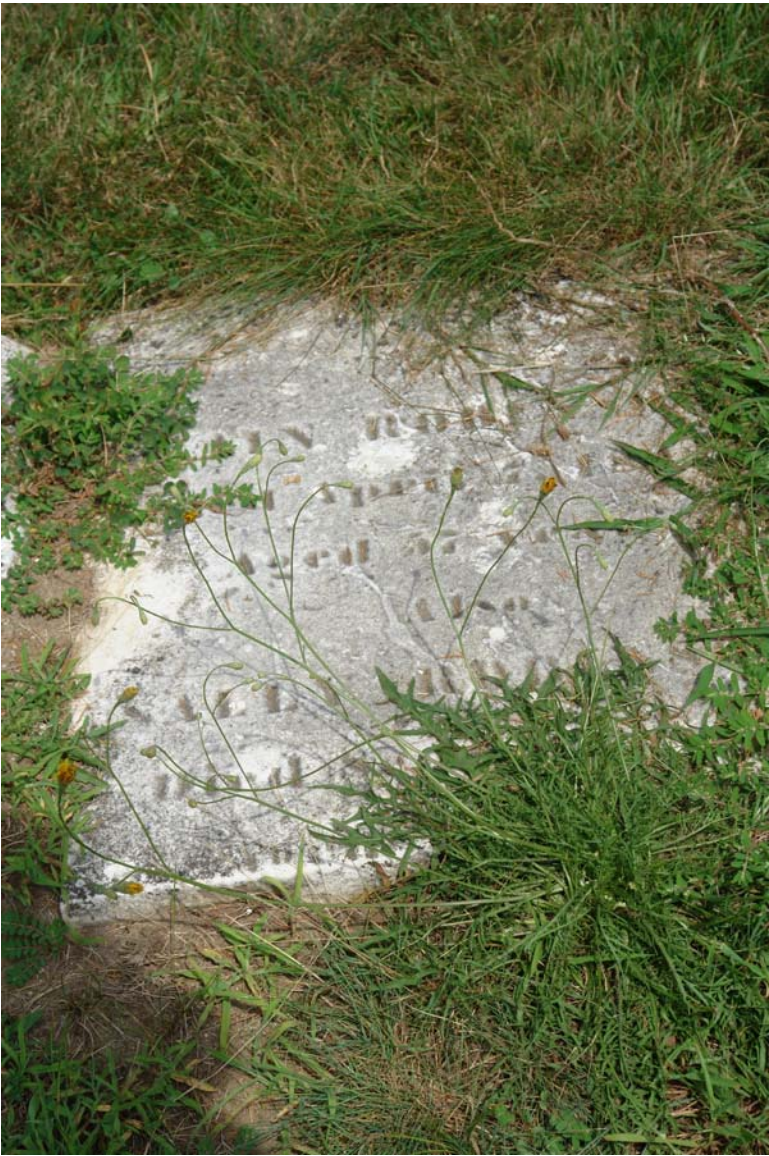
NAME ON MARKER **Gain Robinson**

EXISTING CONDITIONS	CONSERVATION STRATEGY
Part of a group of misc. stones, found by maintenance workers, grouped together, and set flat years ago	Locate setting location Evaluate

TREATMENT	Treatment Dates	7/8/2015
The proper setting location for this group of unrelated markers and fragments is unknown. Until the approximate original setting location can be discovered MCC has suggested leaving this group of stones intact and “as is”.

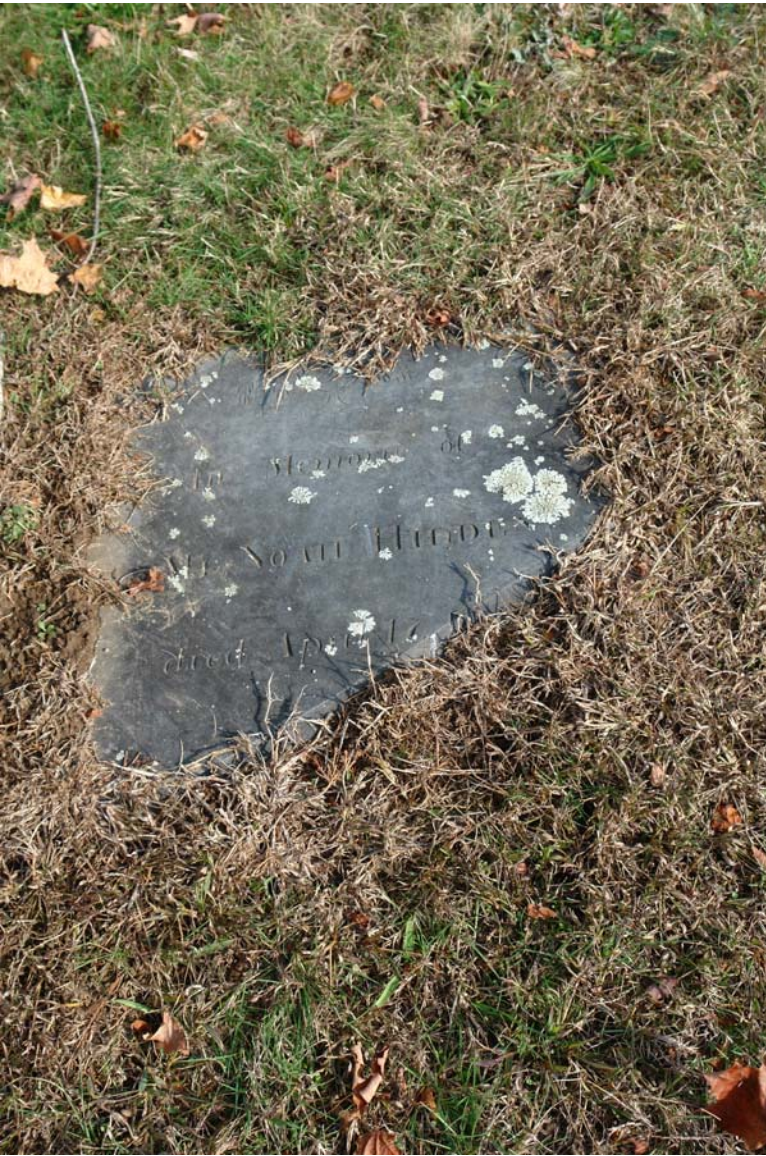
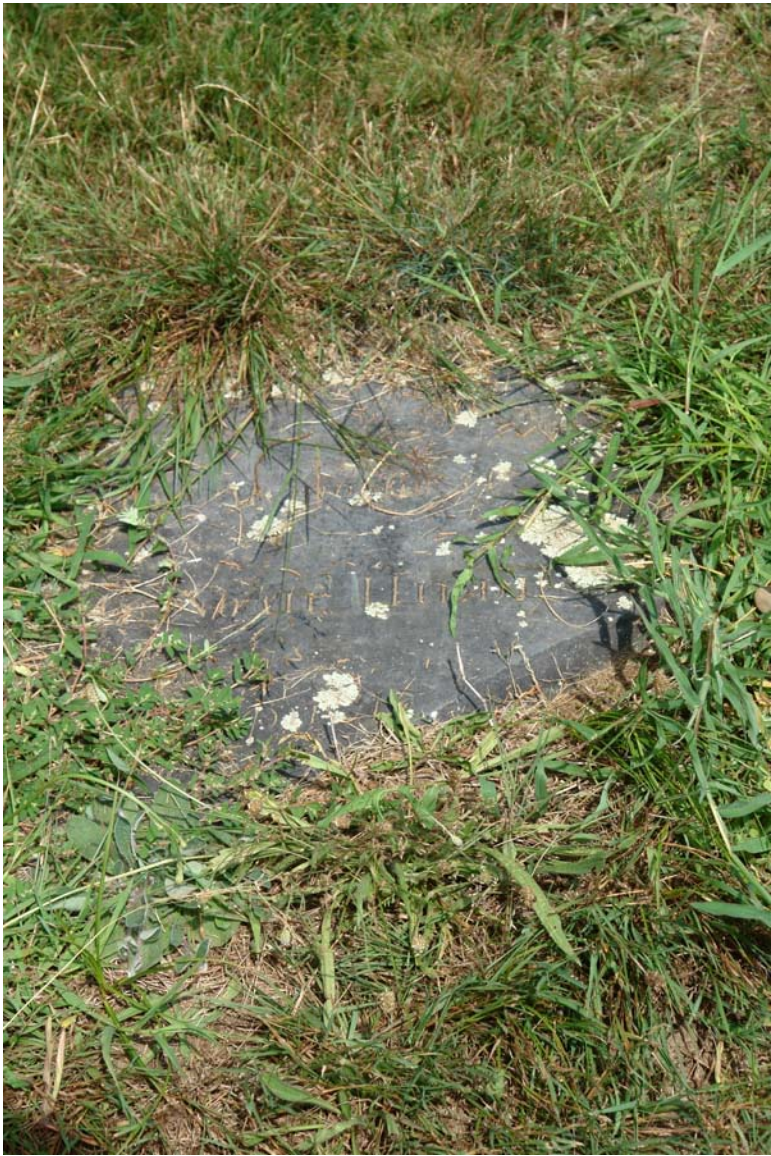
Hanover Center Cemetery, Hanover MA	
NAME ON MARKER	Noah Hidden
Death Date: 4/17/1822	Marker Type: Headstone
Cond. of Inscription: Partial	Material: Slate
EXISTING CONDITIONS	CONSERVATION STRATEGY
Part of a group of misc. stones, found by maintenance workers, grouped together, and set flat years ago	Locate setting location Evaluate
TREATMENT	
Treatment Dates 7/8/2015	
The proper setting location for this group of unrelated markers and fragments is unknown. Until the approximate original setting location can be discovered MCC has suggested leaving this group of stones intact and “as is”.

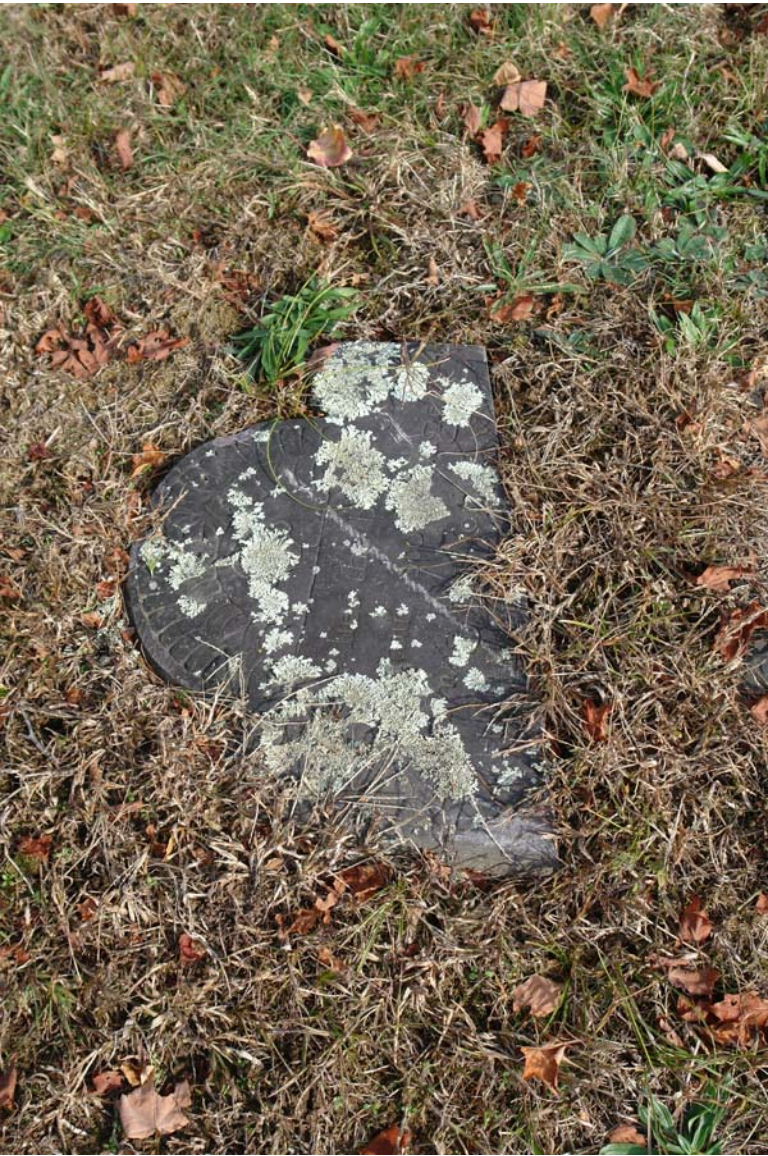
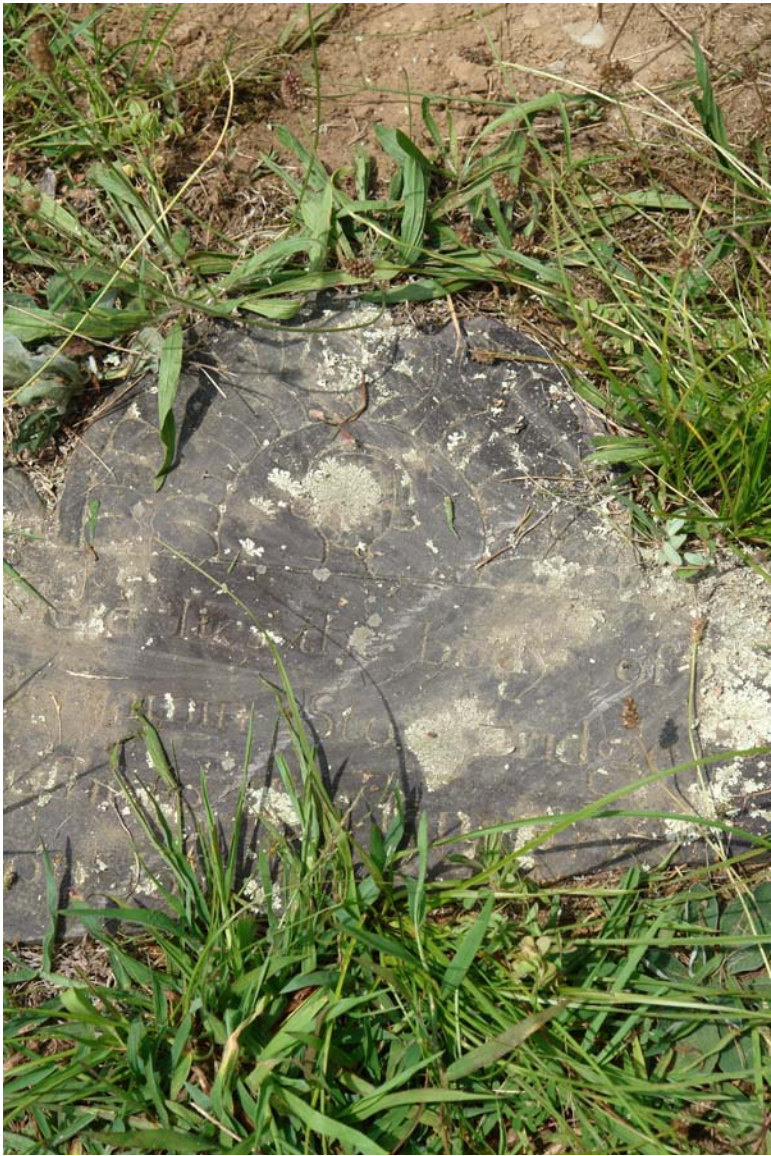
Hanover Center Cemetery, Hanover MA	
NAME ON MARKER	Benjamin Cushing
Death Date: n.a.	Marker Type: Headstone
Cond. of Inscription: Partial	Material: Slate

EXISTING CONDITIONS	CONSERVATION STRATEGY
Part of a group of misc. stones, found by maintenance workers, grouped together, and set flat years ago	Locate setting location Evaluate

TREATMENT	Treatment Dates 7/8/2015
The proper setting location for this group of unrelated markers and fragments is unknown. Until the approximate original setting location can be discovered MCC has suggested leaving this group of stones intact and “as is”.

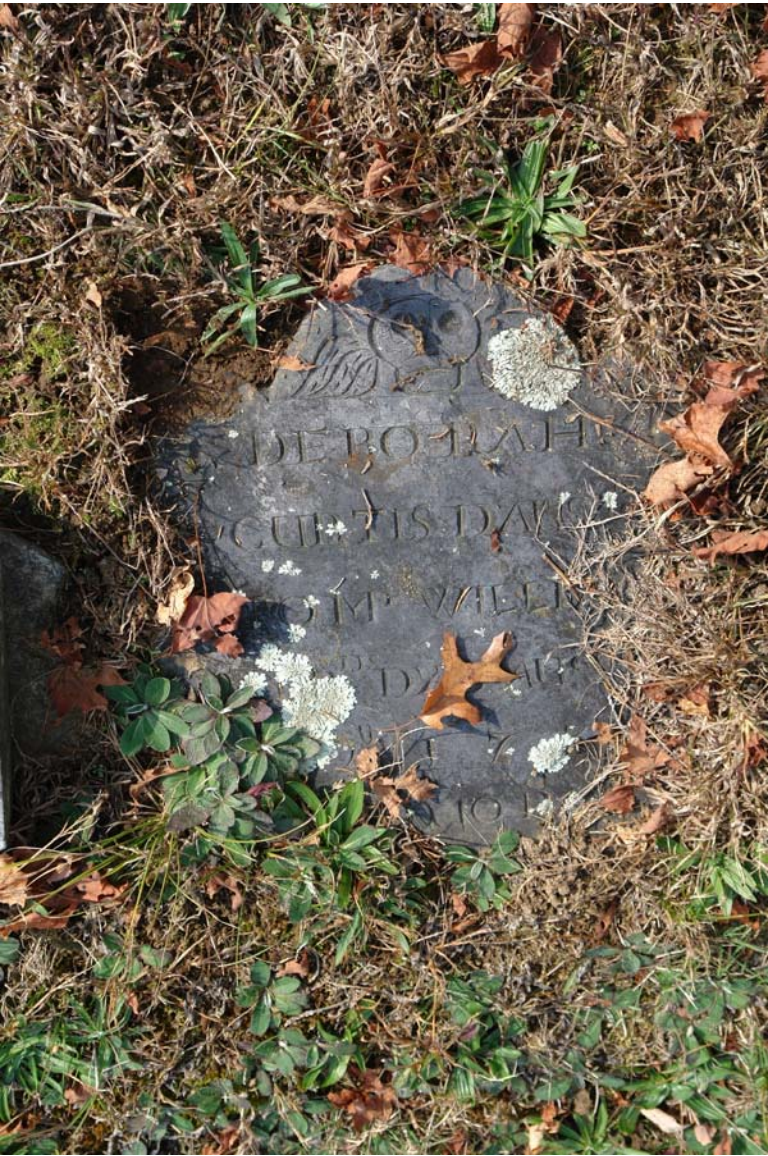
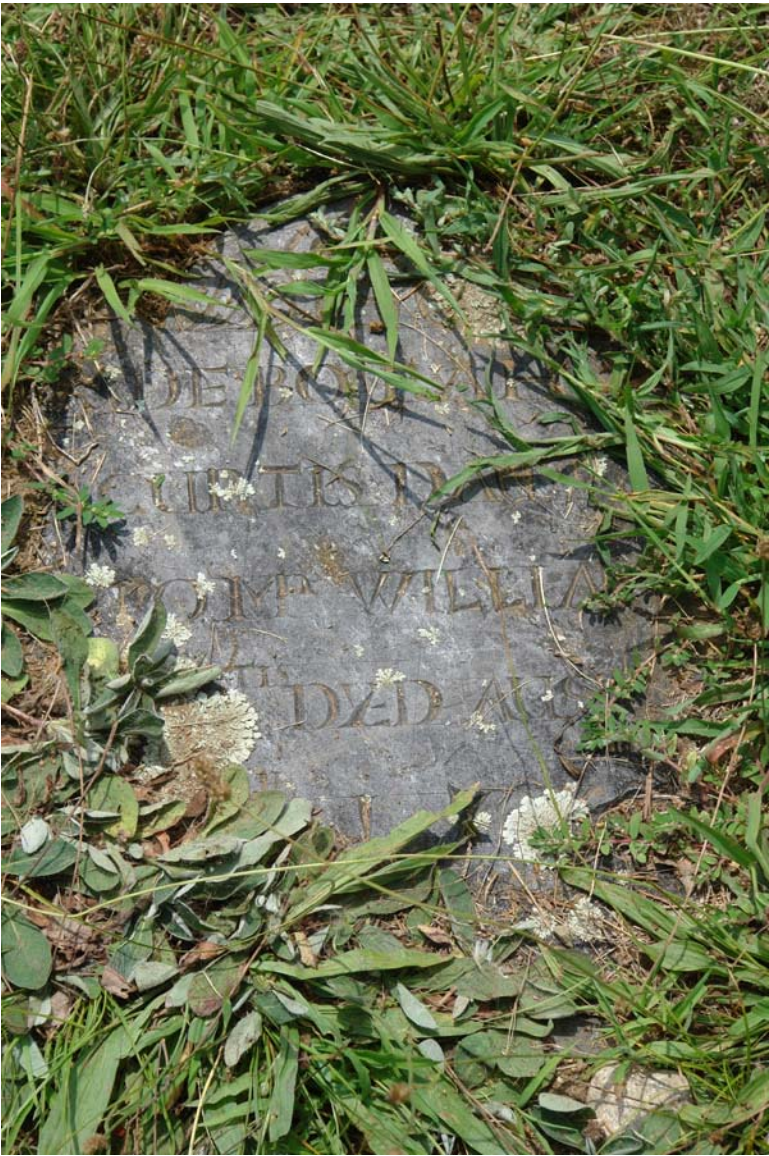
Hanover Center Cemetery, Hanover MA		
NAME ON MARKER		Deborah Curtis
Death Date:	8/12/1738	Marker Type: Headstone
Cond. of Inscription:	Partial	Material: Slate
EXISTING CONDITIONS		CONSERVATION STRATEGY
Part of a group of misc. stones, found by maintenance workers, grouped together, and set flat years ago		Locate setting location Evaluate
TREATMENT		
Treatment Dates		7/8/2015
The proper setting location for this group of unrelated markers and fragments is unknown. Until the approximate original setting location can be discovered MCC has suggested leaving this group of stones intact and “as is”.

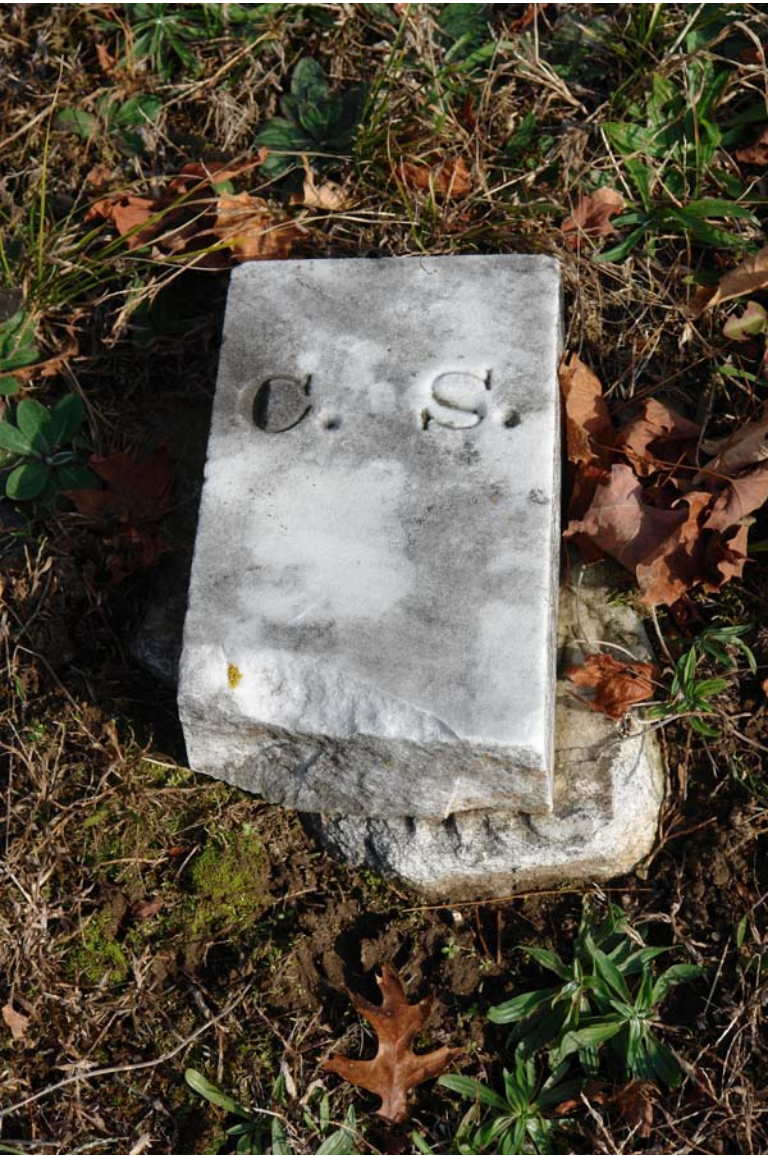
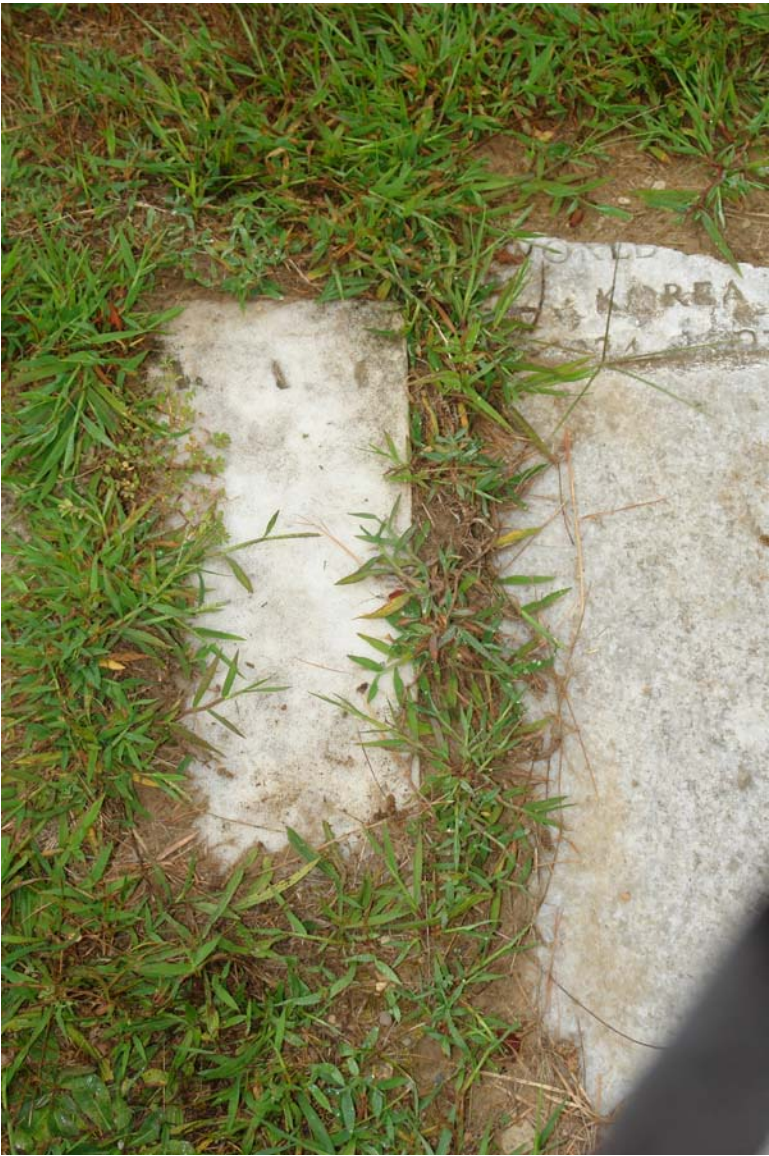
Hanover Center Cemetery, Hanover MA	
NAME ON MARKER C.S.	
Death Date: n.a.	Marker Type: Footstone
Cond. of Inscription: Legible	Material: Marble

EXISTING CONDITIONS	CONSERVATION STRATEGY
Part of a group of misc. stones, found by maintenance workers, grouped together, and set flat years ago	Locate setting location Evaluate

TREATMENT	Treatment Dates 7/8/2015
The proper setting location for this group of unrelated markers and fragments is unknown. Until the approximate original setting location can be discovered MCC has suggested leaving this group of stones intact and “as is”.

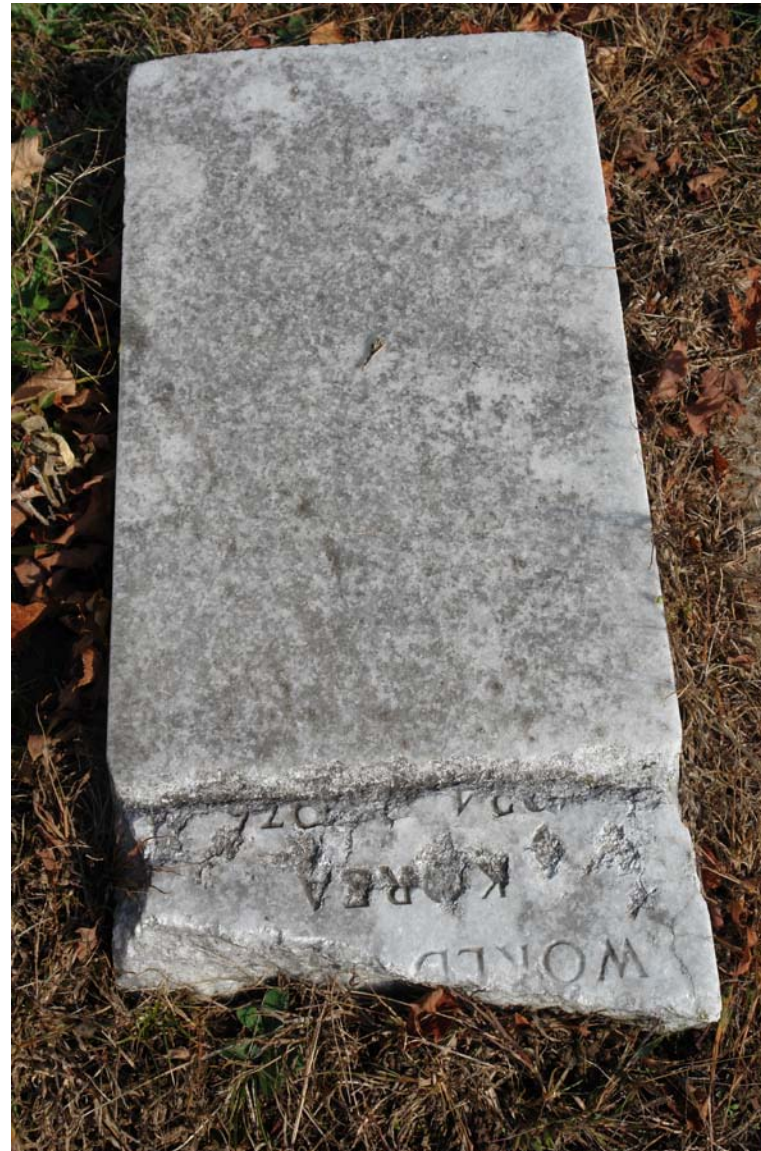
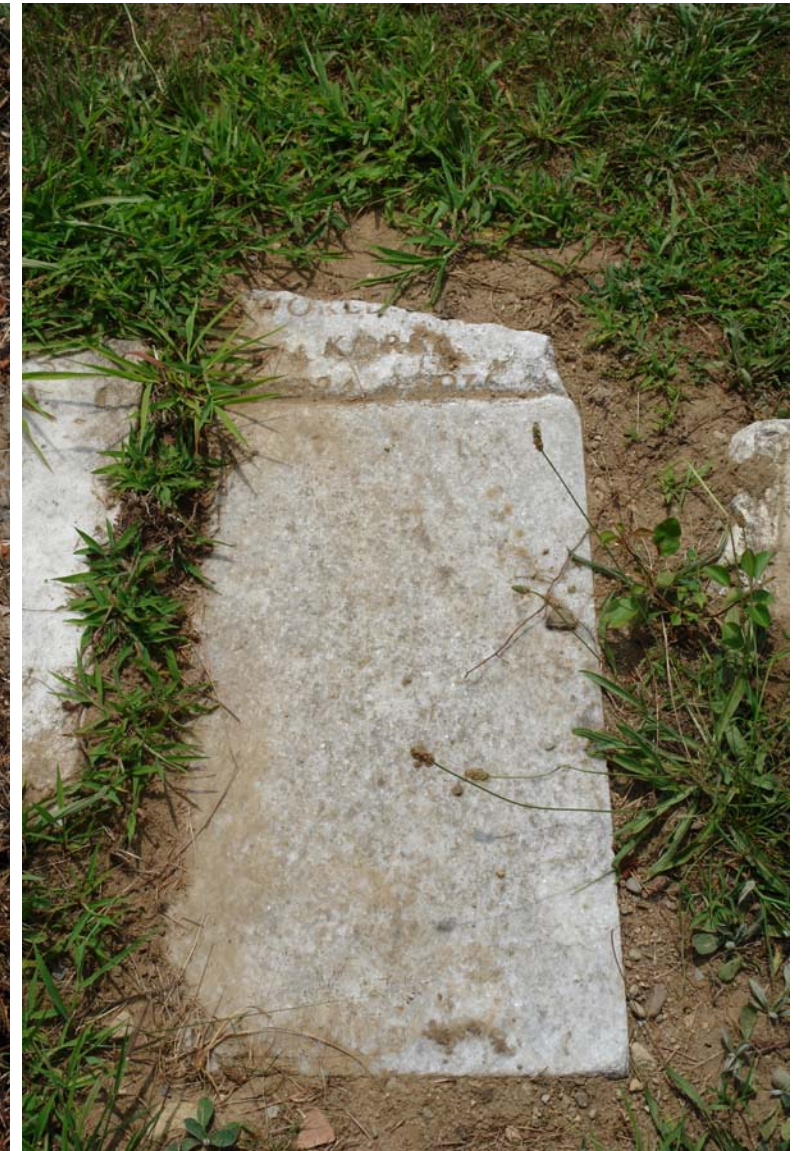
Part of a group of misc. stones, found by maintenance workers, grouped together, and set flat years ago

The proper setting location for this group of unrelated markers and fragments is unknown. Until the approximate original setting location can be discovered MCC has suggested leaving this group of stones intact and “as is”.
