MONUMENT CONSERVATION COLLABORATIVE LLC, NORFOLK, CT

DOCUMENTATION OF STONE CONSERVATION TREATMENTS TO ASSINIPPI CEMETERY, HANOVER, MA June 2015

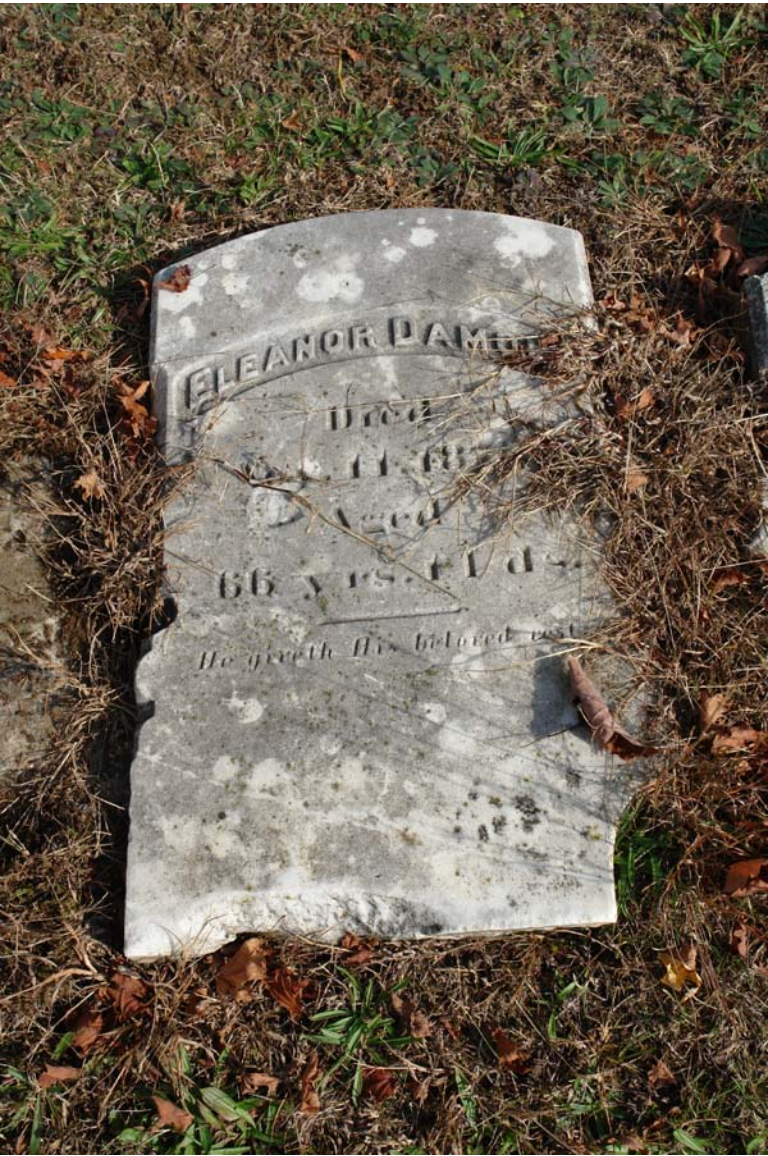
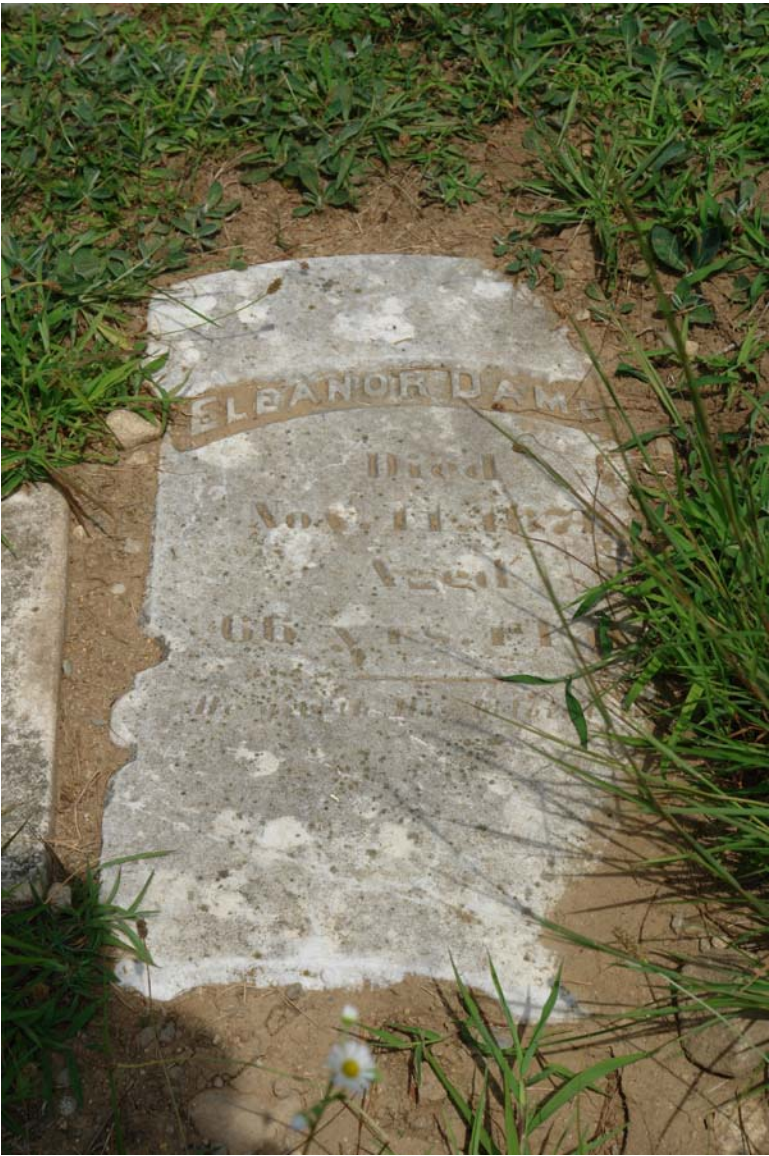
Hanover Center Cemetery, Hanover MA		
NAME ON MARKER		Eleanor Damon
Death Date:	11/11/1876	Marker Type: Headstone
Cond. of Inscription:	Legible	Material: Marble
EXISTING CONDITIONS		CONSERVATION STRATEGY
Part of a group of misc. stones, found by maintenance workers, grouped together, and set flat years ago		Locate setting location Evaluate
TREATMENT		
		Treatment Dates 7/8/2015
The proper setting location for this group of unrelated markers and fragments is unknown. Until the approximate original setting location can be discovered MCC has suggested leaving this group of stones intact and “as is”.

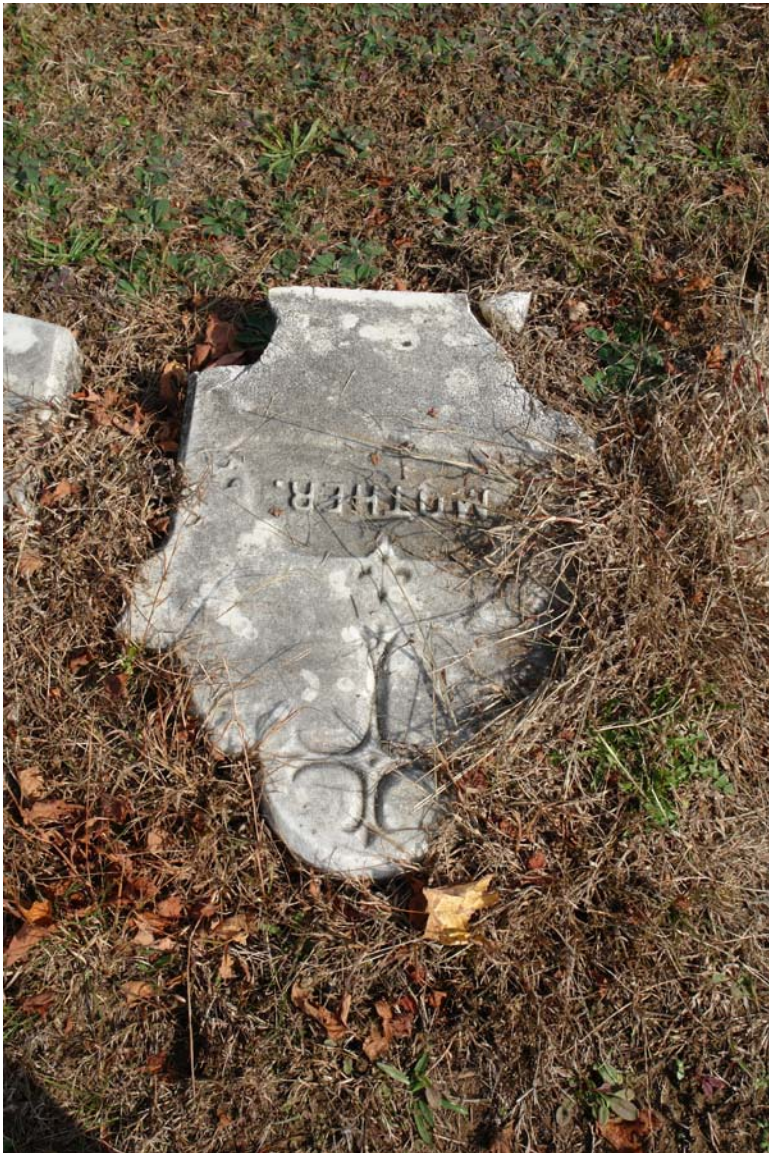
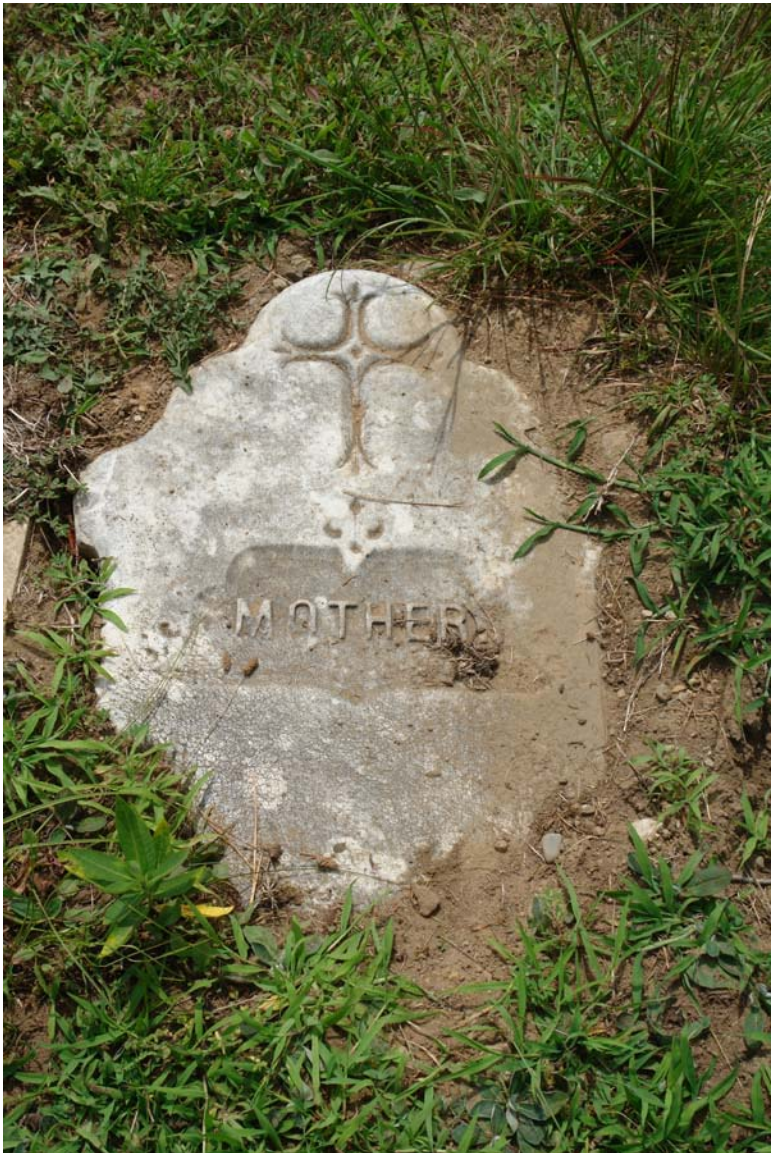
Hanover Center Cemetery, Hanover MA
NAME ON MARKER **Mother (Susan Jacob)**
Death Date: 6/1/1865 Marker Type: Headstone
Cond. of Inscription: Legible Material: Marble

EXISTING CONDITIONS	CONSERVATION STRATEGY
Part of a group of misc. stones, found by maintenance workers, grouped together, and set flat years ago	Locate setting location Evaluate

TREATMENT	Treatment Dates
The proper setting location for this group of unrelated markers and fragments is unknown. Until the approximate original setting location can be discovered MCC has suggested leaving this group of stones intact and “as is”.	7/8/2015

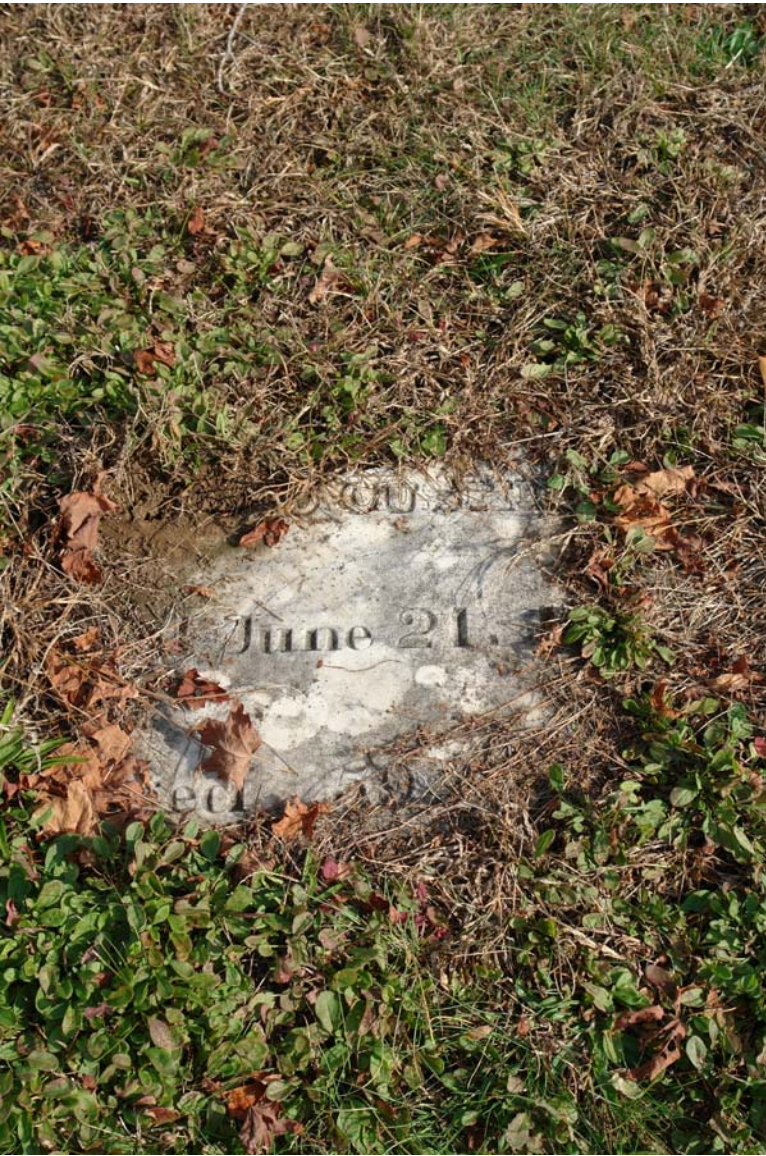
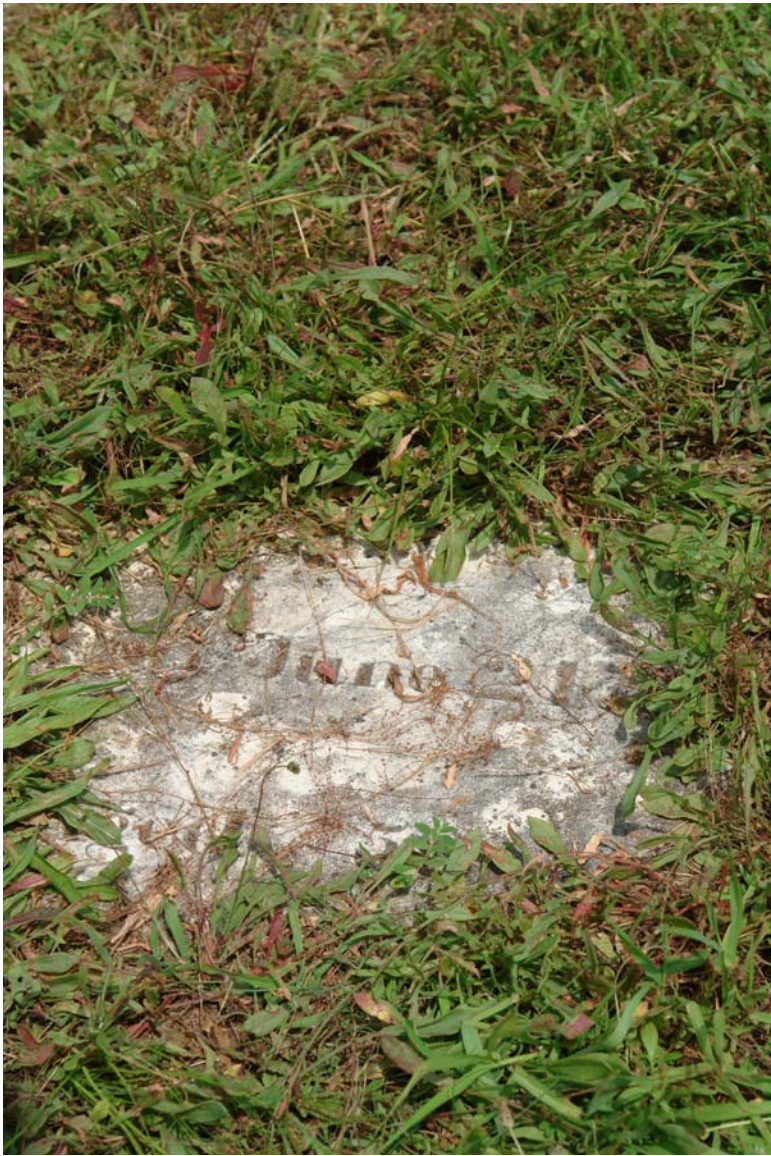
Hanover Center Cemetery, Hanover MA	
NAME ON MARKER	Horatio Cushing
Death Date: 6/21/1836	Marker Type: Headstone
Cond. of Inscription: Partial	Material: Marble
EXISTING CONDITIONS	CONSERVATION STRATEGY
Part of a group of misc. stones, found by maintenance workers, grouped together, and set flat years ago	Locate setting location Evaluate
TREATMENT	
Treatment Dates 7/8/2015	
The proper setting location for this group of unrelated markers and fragments is unknown. Until the approximate original setting location can be discovered MCC has suggested leaving this group of stones intact and “as is”.

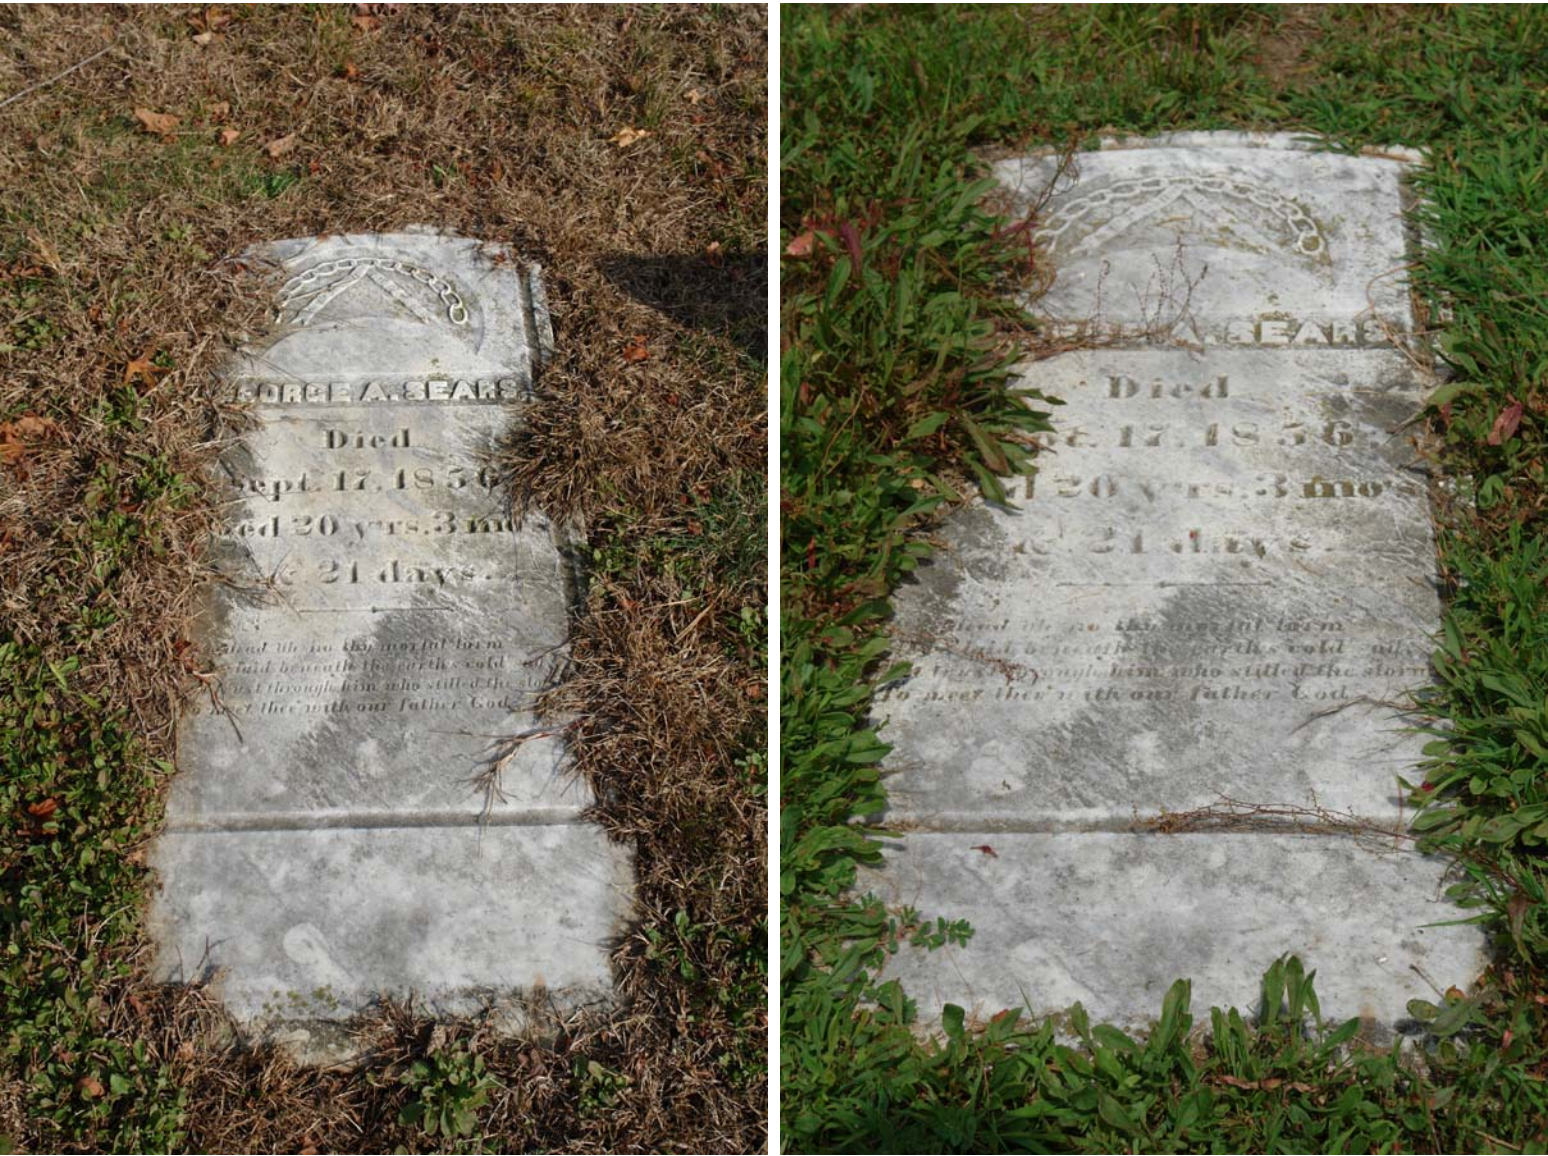
Hanover Center Cemetery, Hanover MA	
NAME ON MARKER	John Estes
Death Date: 8/11/1872	Marker Type: Headstone/base
Cond. of Inscription: Mostly decipherable	Material: Marble
EXISTING CONDITIONS	CONSERVATION STRATEGY
Tilted Marker loose in slot	Reset base level Reset marker plumb into setting slot
TREATMENT	
Treatment Dates 6/23-24/2015

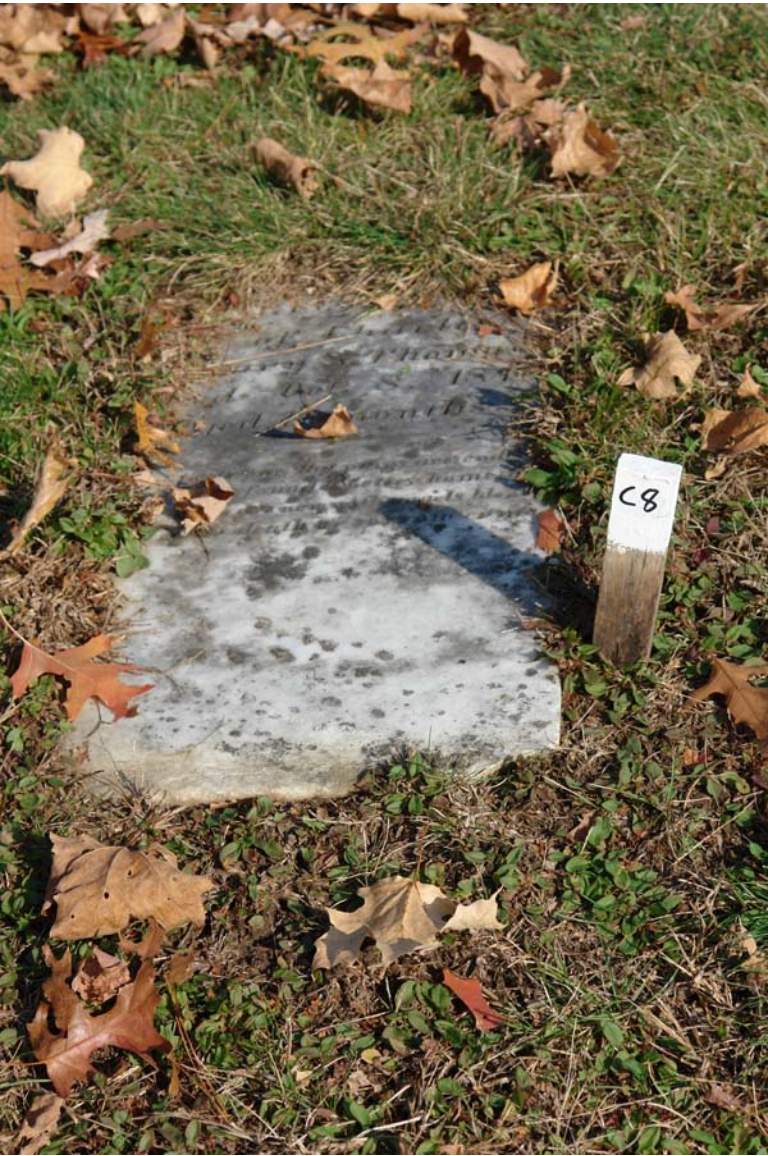
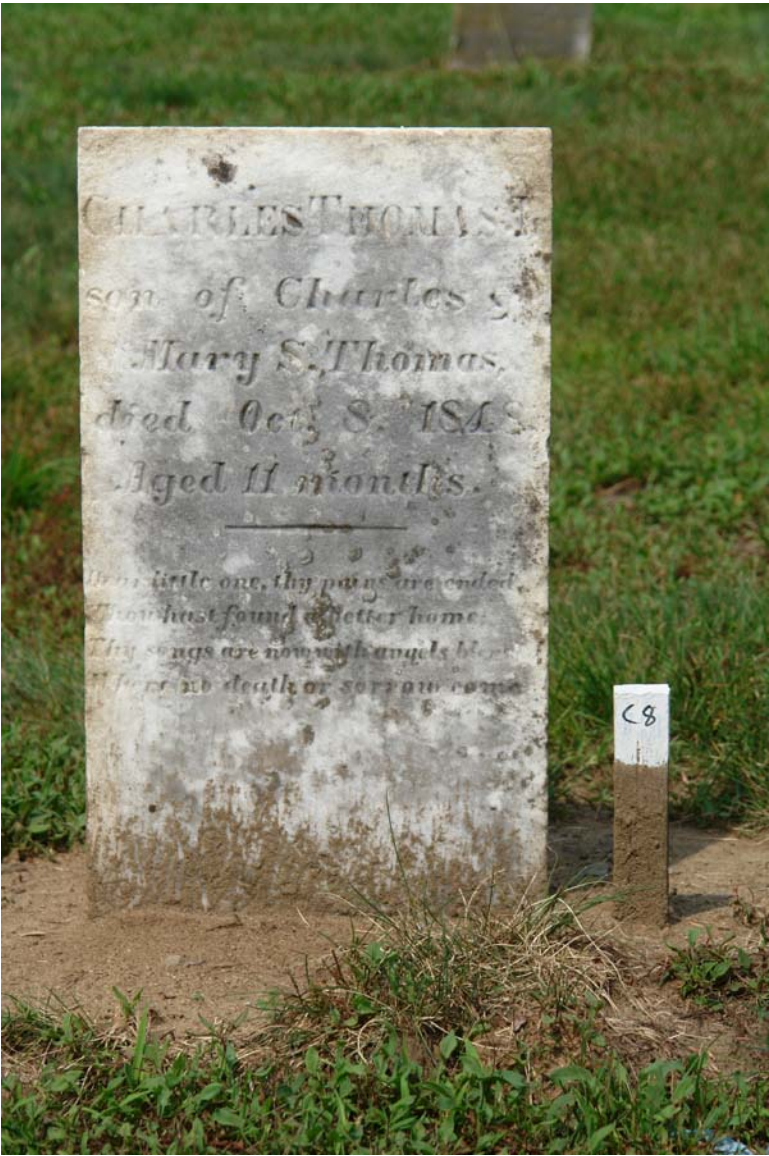
Hanover Center Cemetery, Hanover MA		
NAME ON MARKER		Charles Thomas
Death Date:	10/8/1848	Marker Type: Headstone
Cond. of Inscription: Mostly decipherable		Material: Marble
<hr/>		
EXISTING CONDITIONS		CONSERVATION STRATEGY
Fallen		Reset to new below grade base
<hr/>		
TREATMENT		
Treatment Dates		6/24-29/2015
<div>1. Marker excavated and found to be sound. Light soiling removed by brushing with nylon brushes and water.</div> <div>2. Setting area excavated for new below grade cast concrete base sized minimum of 12 inches deep, 12 inches greater in thickness and 6 inches wider than the stone.</div> <div>3. Wooden forms and setting slot form stabilized and aligned with adjacent markers before concrete is poured</div> <div>4. When required, the lower edge of marker is re-squared with minimal loss using a power grinder</div> <div>5. Setting forms are removed after partial curing of the concrete and the base backfilled with tamped sand or gravel</div> <div>6. Marker reset into setting slot with a cement/lime grout (3/2/9) with 000 sand made fluid with a super plasticizer.</div> <div>7. Marker set plumb and level, and braced for minimum of 5 days.</div> <div>8. Disturbed areas backfilled with existing topsoil.</div>

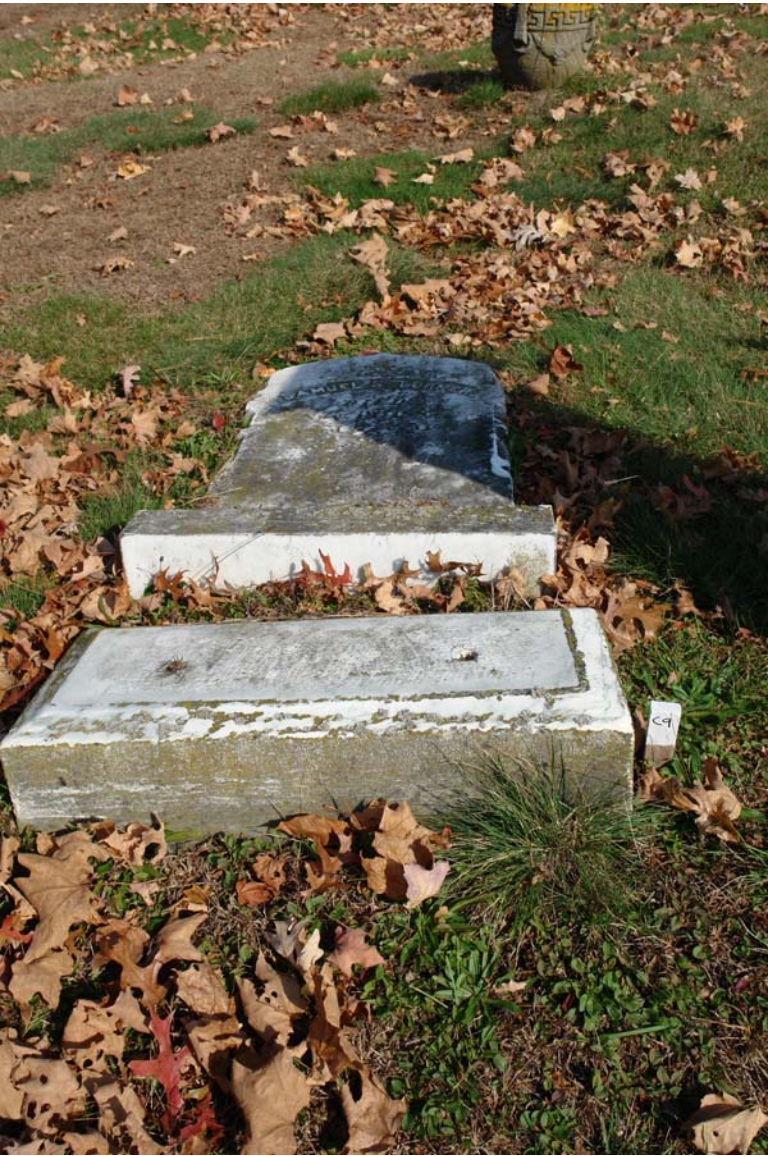
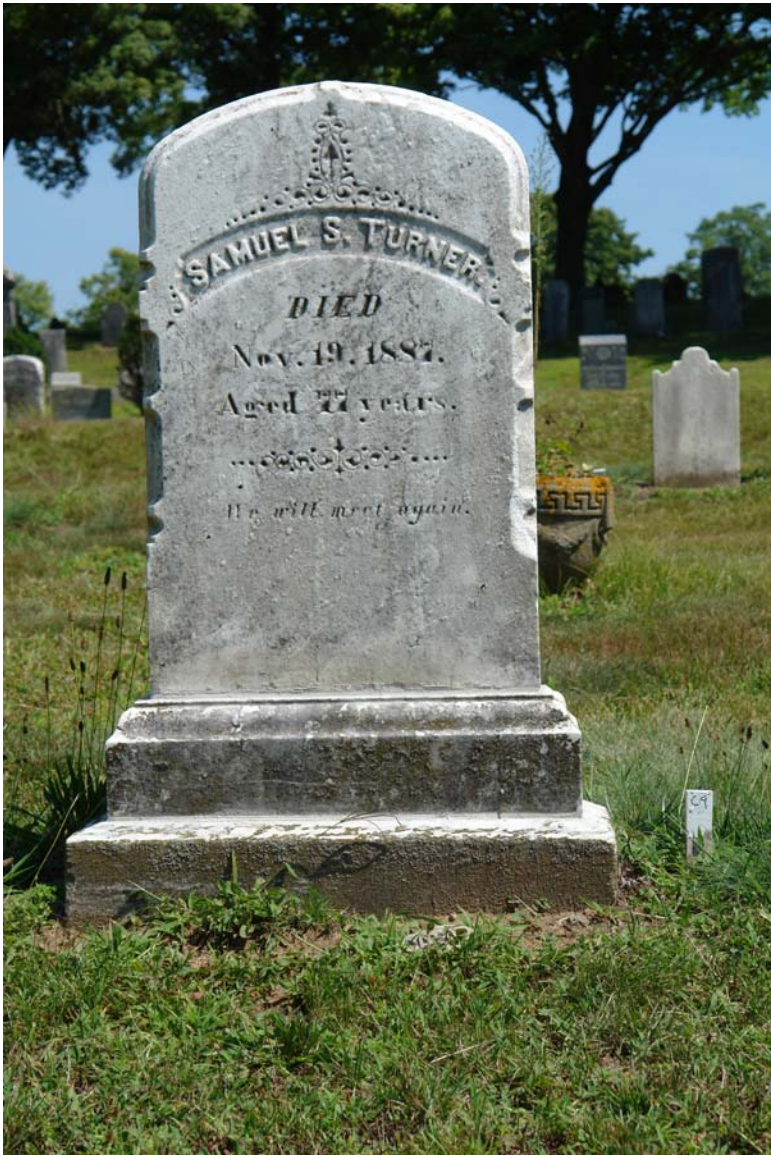
Hanover Center Cemetery, Hanover MA
NAME ON MARKER **Samuel Turner**
Death Date: 11/19/1887 Marker Type: Headstone/pinned base
Cond. of Inscription: Legible Material: Marble

EXISTING CONDITIONS	CONSERVATION STRATEGY
Fallen off base	Level base if required Reset elements

TREATMENT	Treatment Dates
1. Elements removed from setting bases and inspected for soundness. 2. Area excavated to an appropriate depth removing any roots or large stones. 3. Base is aligned with adjacent markers and re-set level. 4. Area around base was backfilled with tamped gravel and re-graded with existing topsoil 5. Failed mortar removed from setting area and bottom of marker 6. When required, any existing pins were inspected, and if necessary, replaced with stainless steel threaded pins 7. Setting surfaces primed with Acryl 60 diluted 1:3 with water. 8. Marker reset plumb onto base with cement/lime mortar (3/2/9) with 000 sand. 9. Excess grout removed and joint area cleaned.	6/23-24/2015

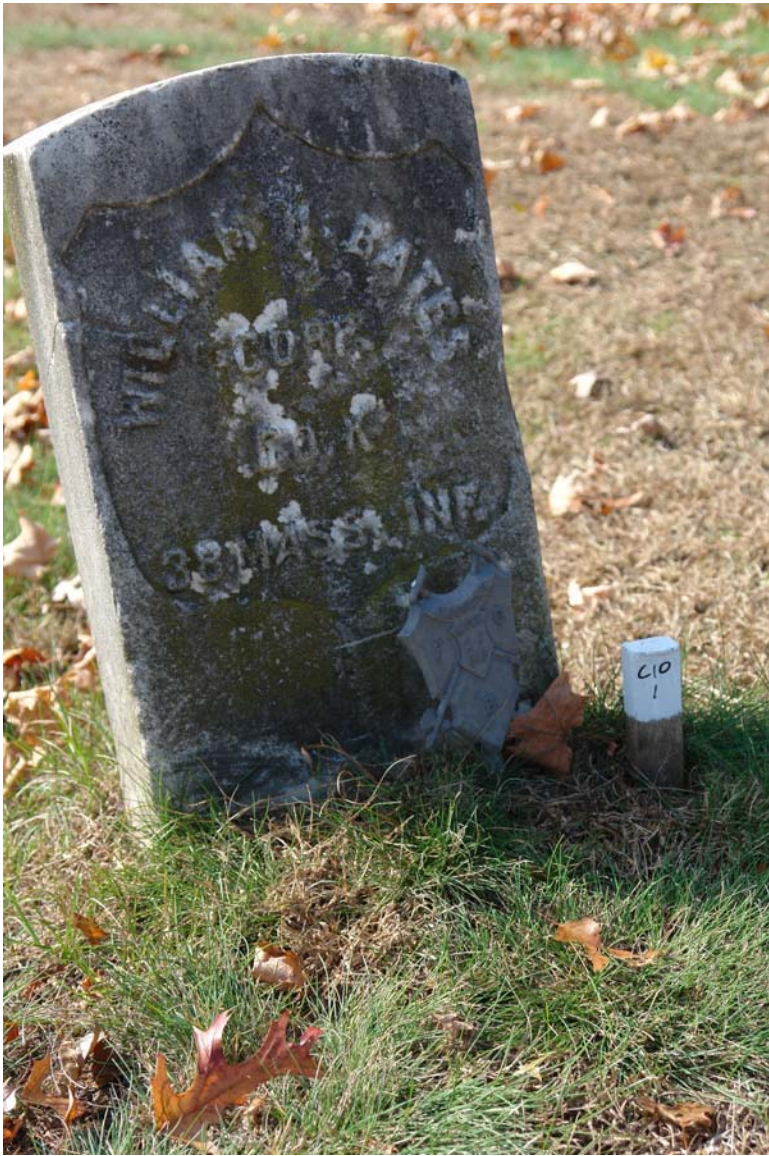
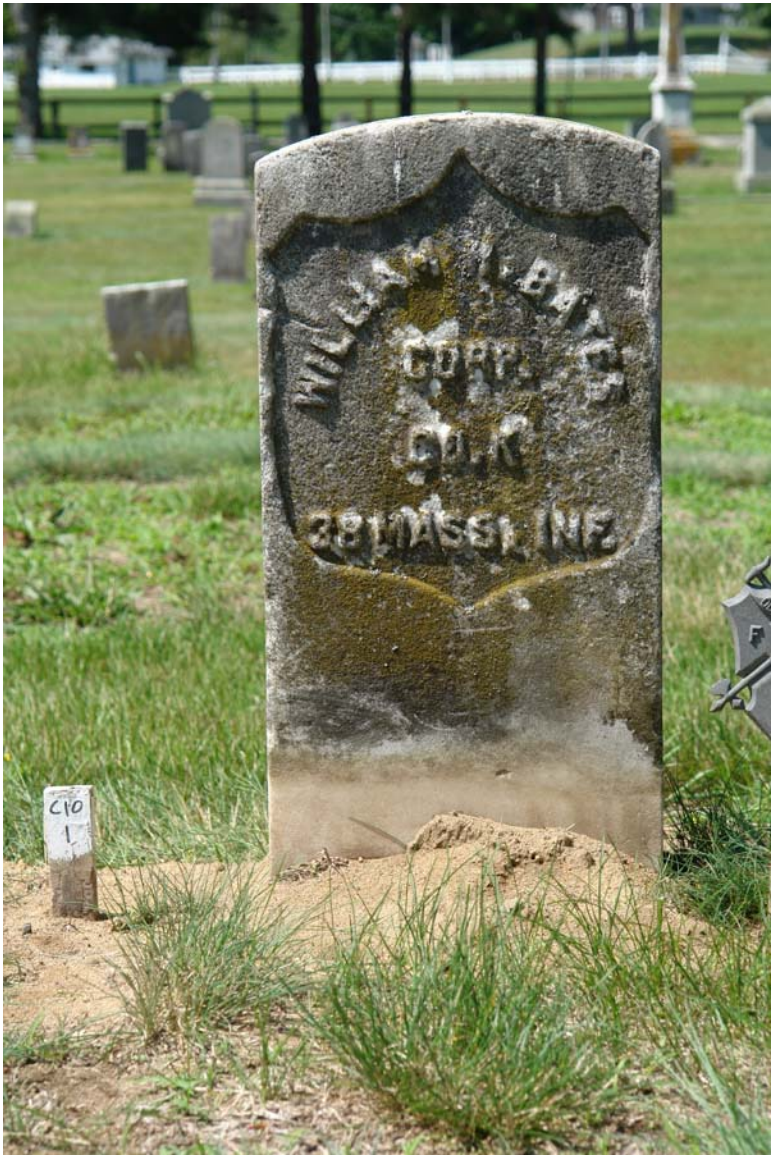
EXISTING CONDITIONS	CONSERVATION STRATEGY
Tilted	Reset plumb

5. Disturbed areas re-graded with existing topsoil and sod.

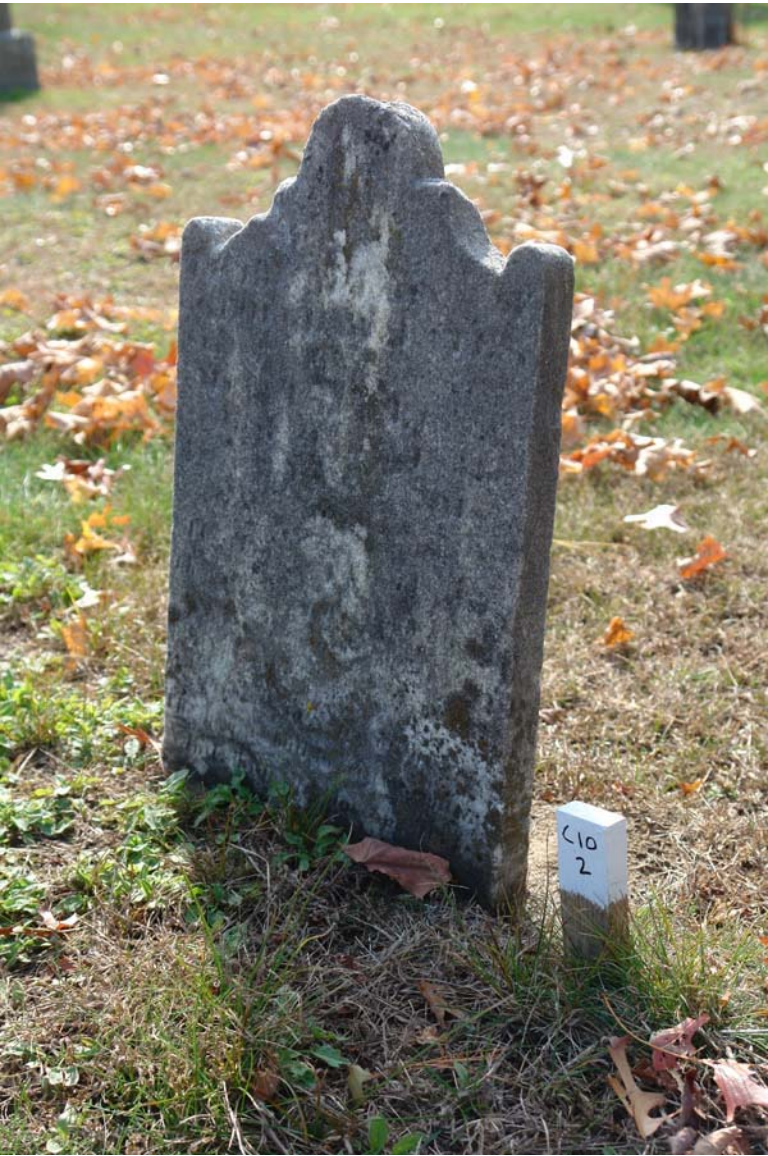
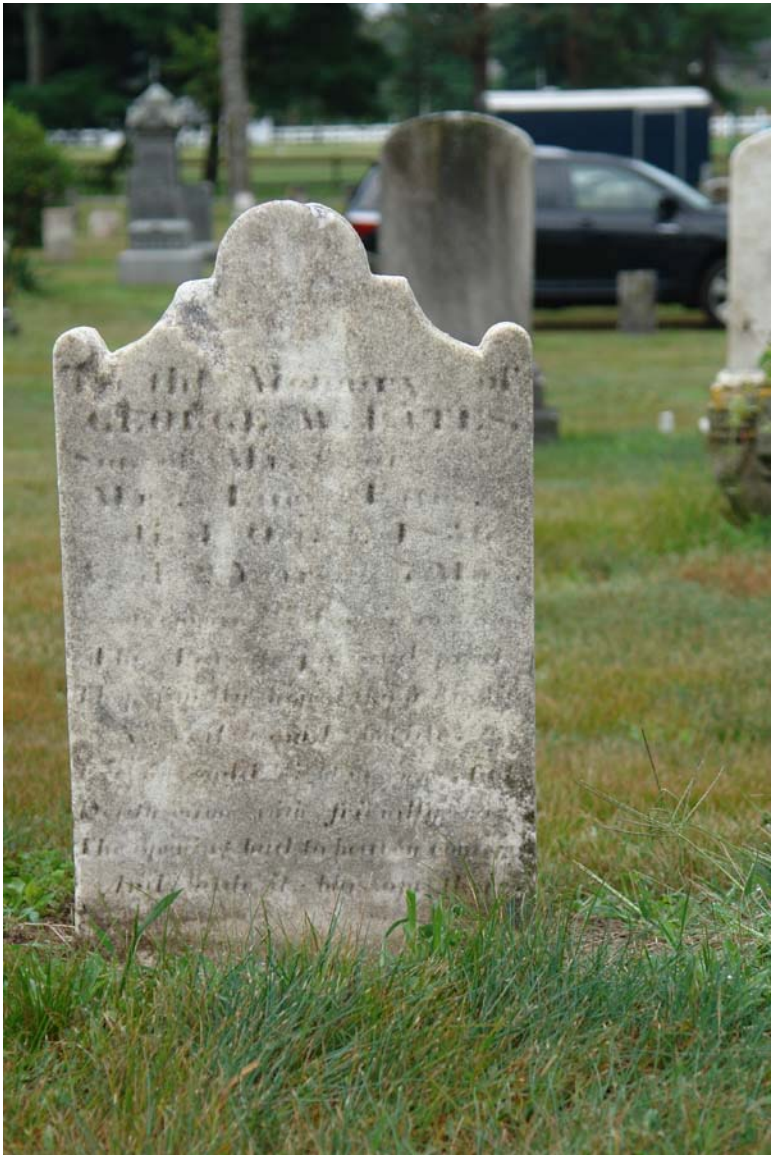
Hanover Center Cemetery, Hanover MA	
NAME ON MARKER	George Bates
Death Date: n.a.	Marker Type: Headstone
Cond. of Inscription: Partially decipherable Material: Marble	
EXISTING CONDITIONS	CONSERVATION STRATEGY
Fractured at grade	Reset into new below grade concrete base
TREATMENT	
Treatment Dates 6/23/2015	
<div>1. Existing base located below grade while excavating for resetting. Area excavated to an appropriate depth removing any roots or large stones.</div> <div>2. Base inspected and found to be sound and re-useable</div> <div>3. Base is aligned with adjacent markers and re-set level.</div> <div>4. Area around base was backfilled with tamped gravel and re-graded with existing topsoil</div> <div>5. Debris removed from setting slot. When required, power grinders were used to facilitate removal of stone fragments.</div> <div>6. When required, the lower setting edge was re-squared by power grinder with minimal loss.</div> <div>7. Marker reset plumb and level into setting slot with cement/lime grout (3/2/9) with 000 sand made fluid with a super plasticizer.</div> <div>8. Excess grout removed and joint area cleaned.</div> <div>9. Marker braced for a minimum 3 days</div>

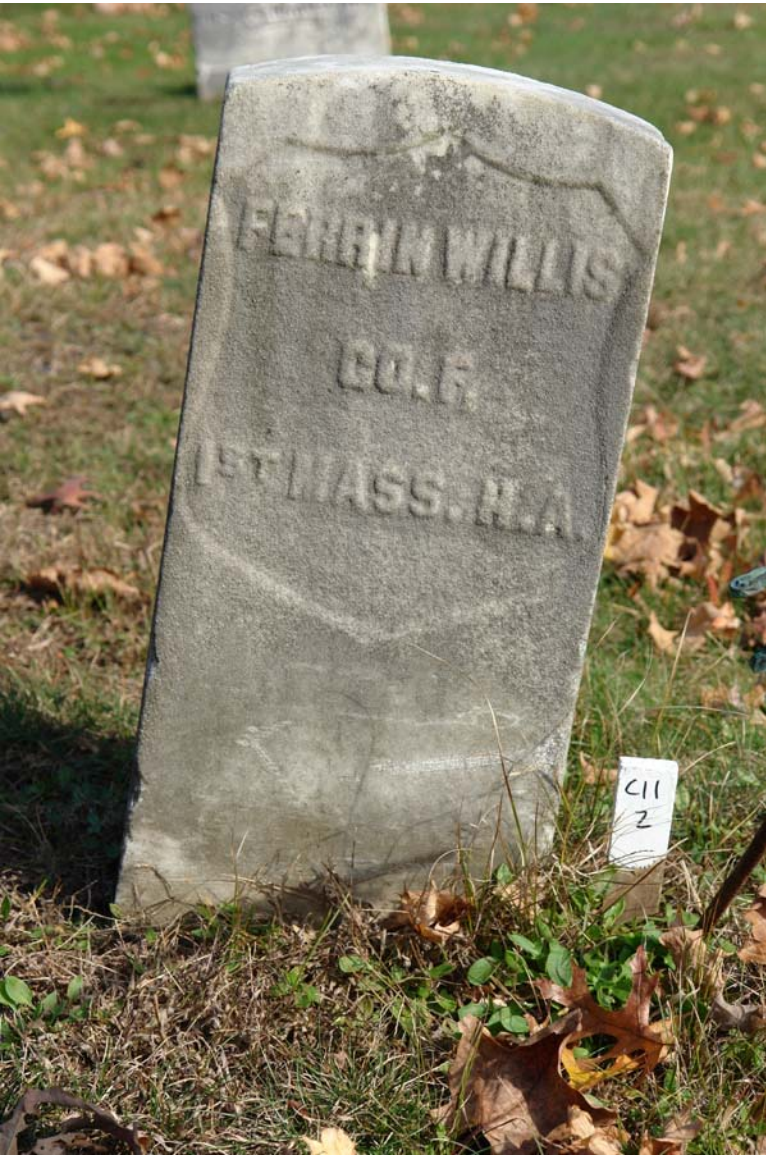
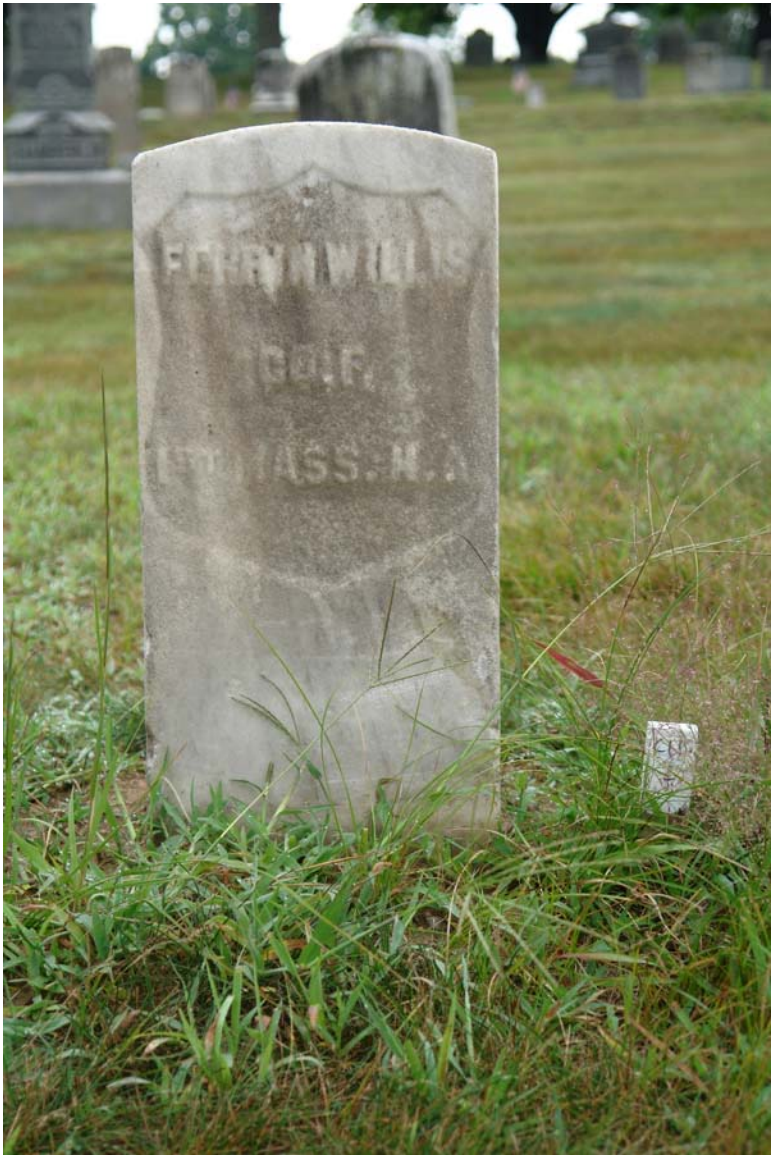
Hanover Center Cemetery, Hanover MA
NAME ON MARKER **Lucy Ellis**
Death Date: 6/7/1859 Marker Type: Headstone/conc base
Cond. of Inscription: Legible Material: Marble

EXISTING CONDITIONS	CONSERVATION STRATEGY
Tilted	Evaluate resetting options Possible new below grade concrete base

TREATMENT	Treatment Dates
1. Existing base located below grade while excavating for resetting. Area excavated to an appropriate depth removing any roots or large stones. 2. Base inspected and found to be sound and re-useable 3. Base is aligned with adjacent markers and re-set level. 4. Area around base was backfilled with tamped gravel and re-graded with existing topsoil 5. Debris removed from setting slot. When required, power grinders were used to facilitate removal of stone fragments. 6. When required, the lower setting edge was re-squared by power grinder with minimal loss. 7. Marker reset plumb and level into setting slot with cement/lime grout (3/2/9) with 000 sand made fluid with a super plasticizer. 8. Excess grout removed and joint area cleaned. 9. Marker braced for a minimum 3 days	6/29/2015

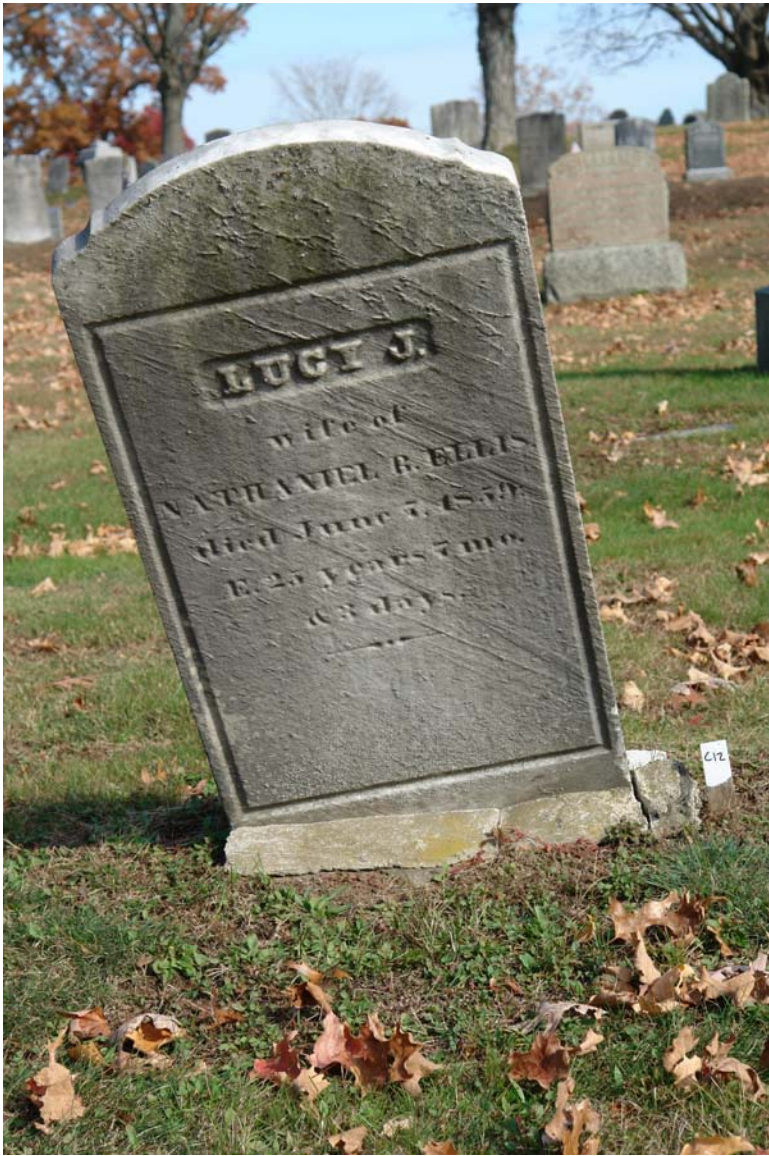
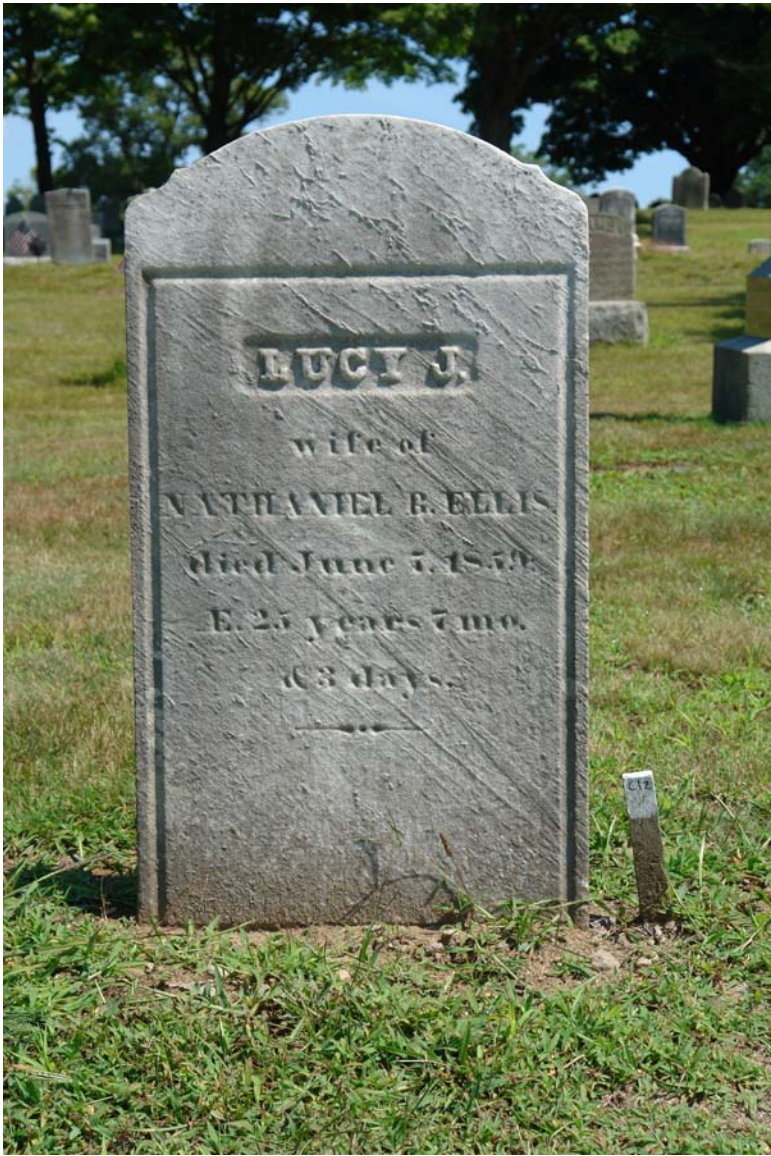
Hanover Center Cemetery, Hanover MA	
NAME ON MARKER Mary Iris	
Death Date: 5/2/1866	Marker Type: Headstone/ base
Cond. of Inscription: Legible	Material: Marble

EXISTING CONDITIONS	CONSERVATION STRATEGY
Unstable	Reset plumb

TREATMENT	Treatment Dates 7/31/2015
<div>1. Elements removed from setting bases and inspected for sound- ness.</div> <div>2. Area excavated to an appropriate depth removing any roots or large stones.</div> <div>3. Base is aligned with adjacent markers and re-set level.</div> <div>4. Area around base was backfilled with tamped gravel and re- graded with existing topsoil</div> <div>5. Failed mortar removed from setting area and bottom of marker</div> <div>6. When required, any existing pins were inspected, and if neces- sary, replaced with stainless steel threaded pins</div> <div>7. Setting surfaces primed with Acryl 60 diluted 1:3 with water.</div> <div>8. Marker reset plumb onto base with cement/lime mortar (3/2/9) with 000 sand.</div> <div>9. Excess grout removed and joint area cleaned.</div>

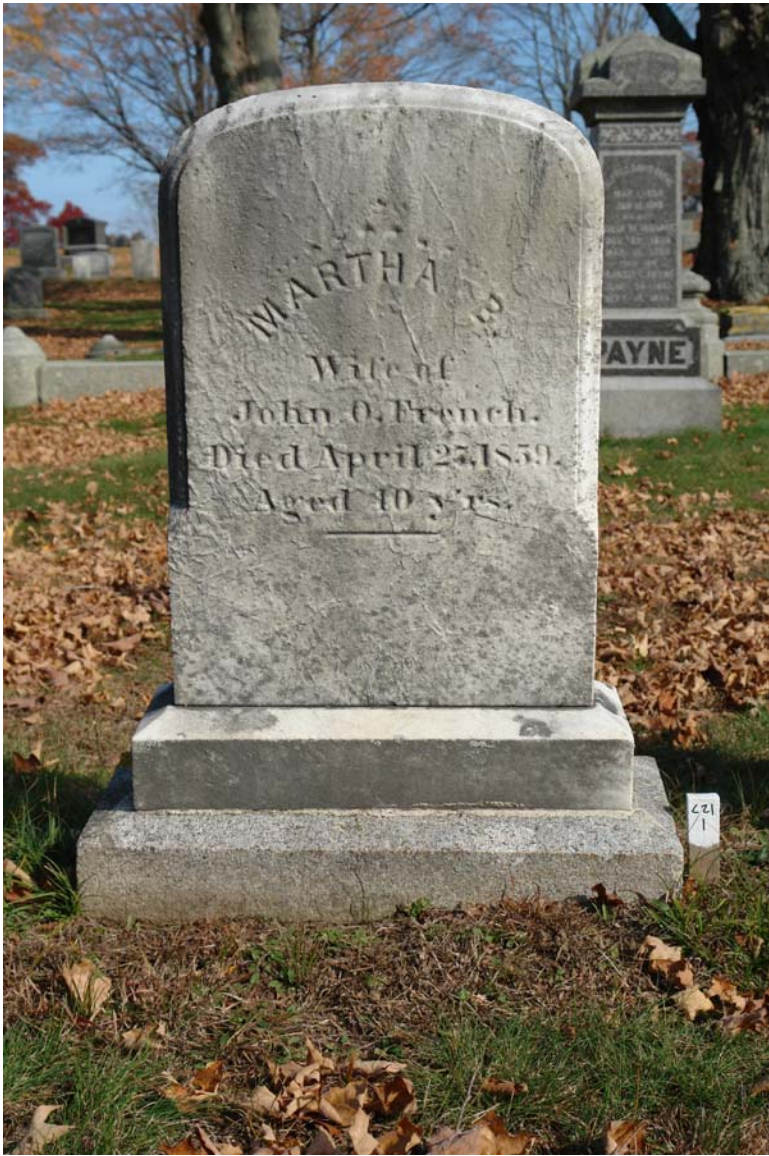
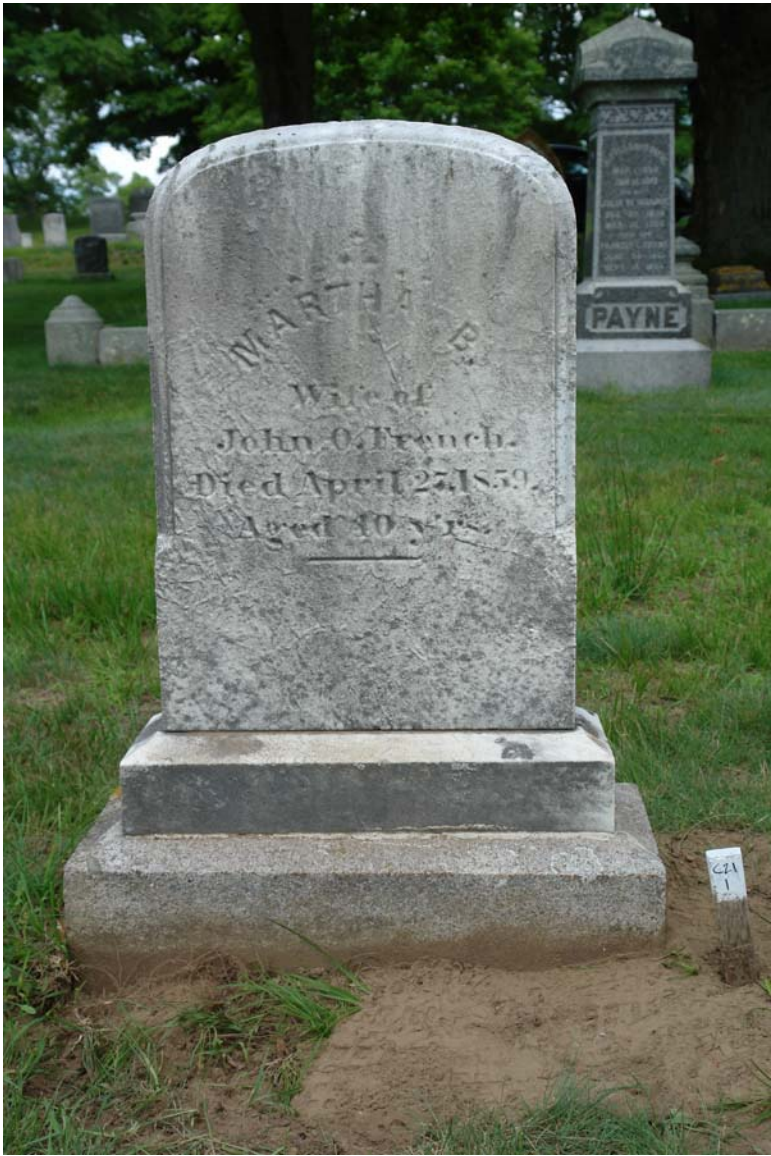
EXISTING CONDITIONS	CONSERVATION STRATEGY
Tilted base	Reset base with marker plumb

TREATMENT	Treatment Dates
1. Elements removed from setting bases and inspected for soundness. 2. Area excavated to an appropriate depth removing any roots or large stones. 3. Base is aligned with adjacent markers and re-set level. 4. Area around base was backfilled with tamped gravel and re-graded with existing topsoil 5. Failed mortar removed from setting area and bottom of marker 6. When required, any existing pins were inspected, and if necessary, replaced with stainless steel threaded pins 7. Setting surfaces primed with Acryl 60 diluted 1:3 with water. 8. Marker reset plumb onto base with cement/lime mortar (3/2/9) with 000 sand. 9. Excess grout removed and joint area cleaned.	7/7/2015
