MONUMENT CONSERVATION COLLABORATIVE LLC, NORFOLK, CT

DOCUMENTATION OF STONE CONSERVATION TREATMENTS TO ASSINIPPI CEMETERY, HANOVER, MA June 2015

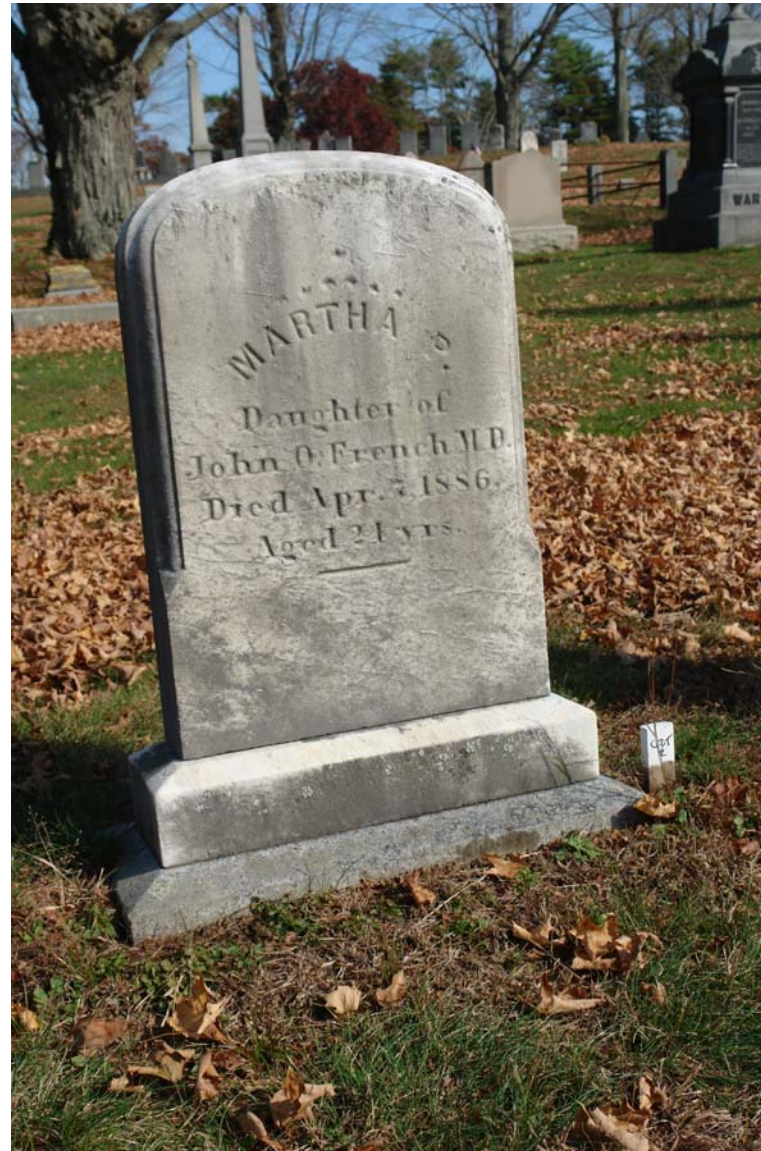
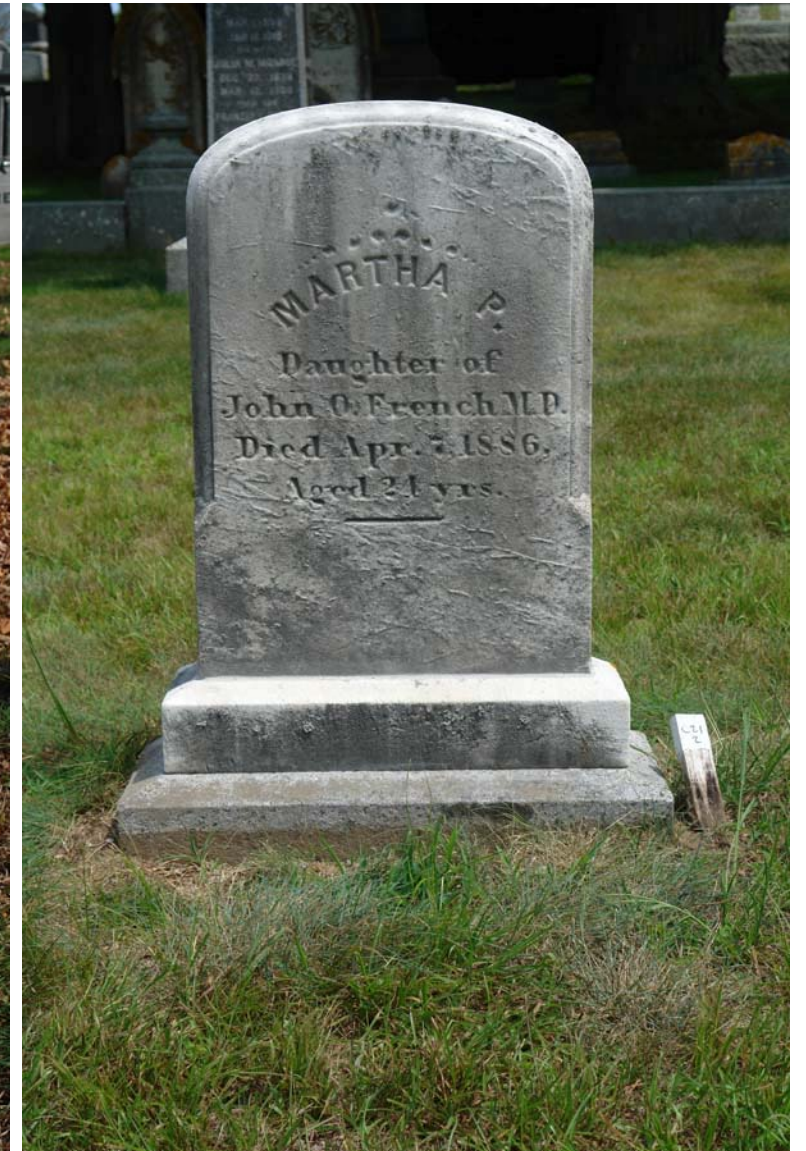
**Tilted
Marker loose on base**

1. Elements removed from setting bases and inspected for soundness.
2. Area excavated to an appropriate depth removing any roots or large stones.
3. Base is aligned with adjacent markers and re-set level.
4. Area around base was backfilled with tamped gravel and re-graded with existing topsoil
5. Failed mortar removed from setting area and bottom of marker
6. When required, any existing pins were inspected, and if necessary, replaced with stainless steel threaded pins
7. Setting surfaces primed with Acryl 60 diluted 1:3 with water.
8. Marker reset plumb onto base with cement/lime mortar (3/2/9) with 000 sand.
9. Excess grout removed and joint area cleaned.

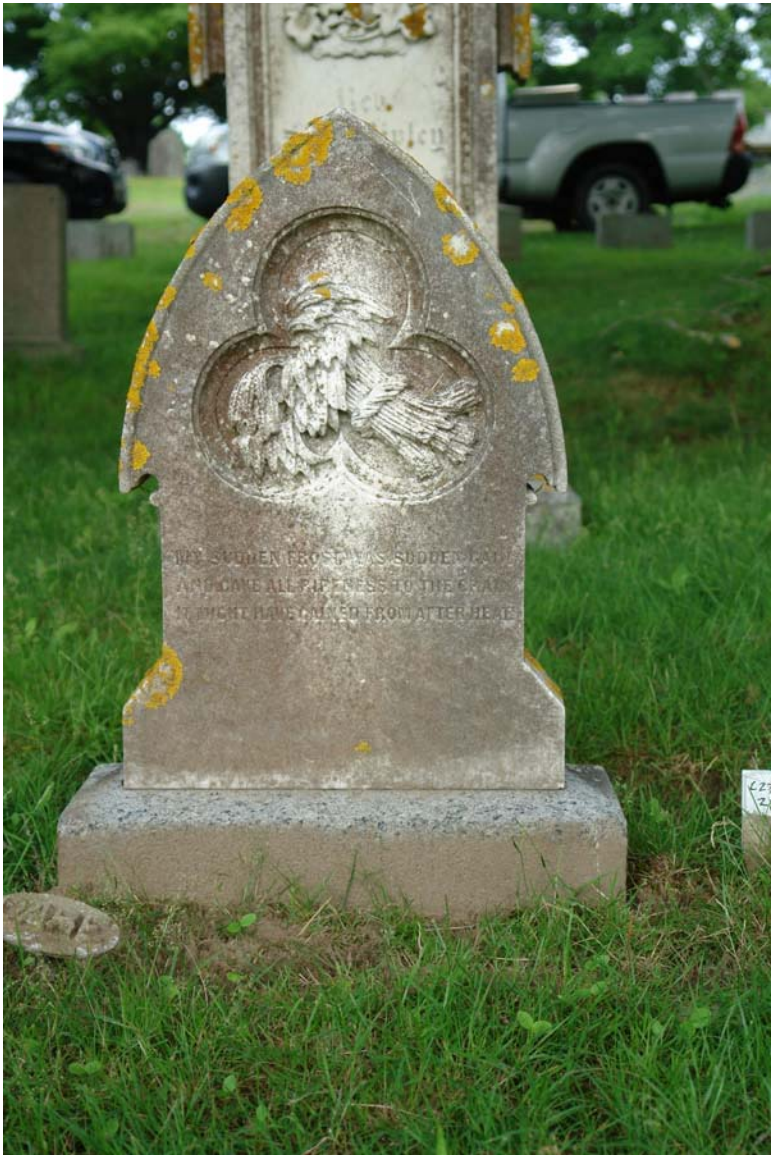
Hanover Center Cemetery, Hanover MA
NAME ON MARKER **Silas Ripley**
Death Date: 5/7/1868 Marker Type: Headstone/pinned base
Cond. of Inscription: Legible Material: Marble

EXISTING CONDITIONS	CONSERVATION STRATEGY
Tilted Loose on base	Reset base level Reset elements

TREATMENT	Treatment Dates
1. Marker and base found to be in sound condition with marker securely attached to base. 2. Area excavated to an appropriate depth removing any roots or large stones. 3. Base is aligned with adjacent markers and re-set level. 4. Area around base was backfilled with tamped gravel and re-graded with existing topsoil	6/23/2015

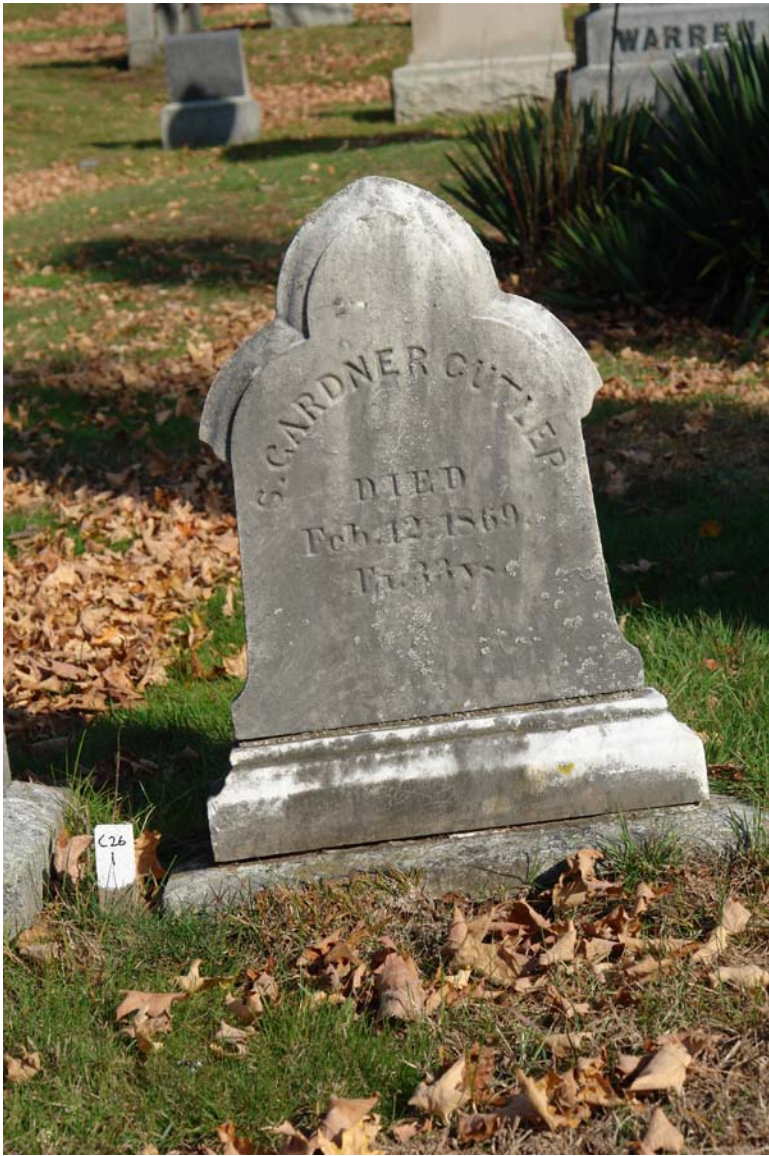
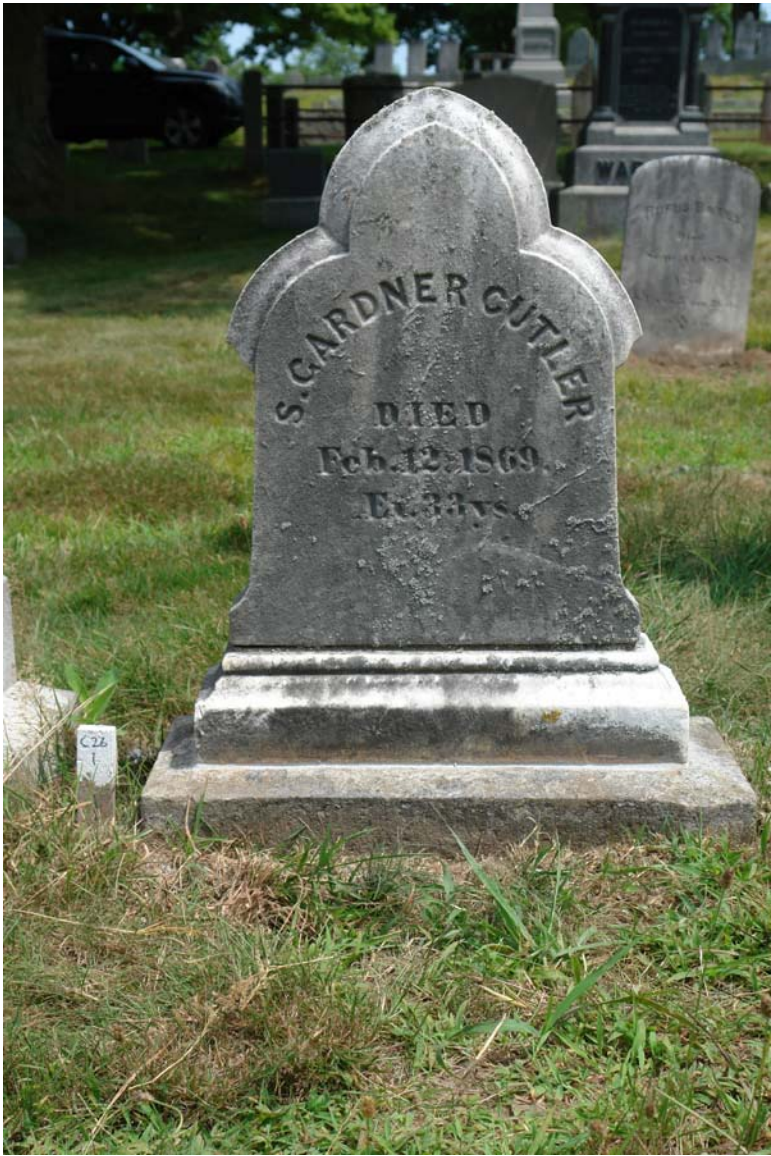
Hanover Center Cemetery, Hanover MA
NAME ON MARKER **Gardner Cutler**
Death Date: 2/12/1869 Marker Type: Headstone/pinned base
Cond. of Inscription: Legible Material: Marble

EXISTING CONDITIONS	CONSERVATION STRATEGY
Tilted Loose on base	Reset base level Reset elements

TREATMENT	Treatment Dates
1. Elements removed from setting bases and inspected for soundness. 2. Area excavated to an appropriate depth removing any roots or large stones. 3. Base is aligned with adjacent markers and re-set level. 4. Area around base was backfilled with tamped gravel and re-graded with existing topsoil 5. Failed mortar removed from setting area and bottom of marker 6. When required, any existing pins were inspected, and if necessary, replaced with stainless steel threaded pins 7. Setting surfaces primed with Acryl 60 diluted 1:3 with water. 8. Marker reset plumb onto base with cement/lime mortar (3/2/9) with 000 sand. 9. Excess grout removed and joint area cleaned.	7/7/2015

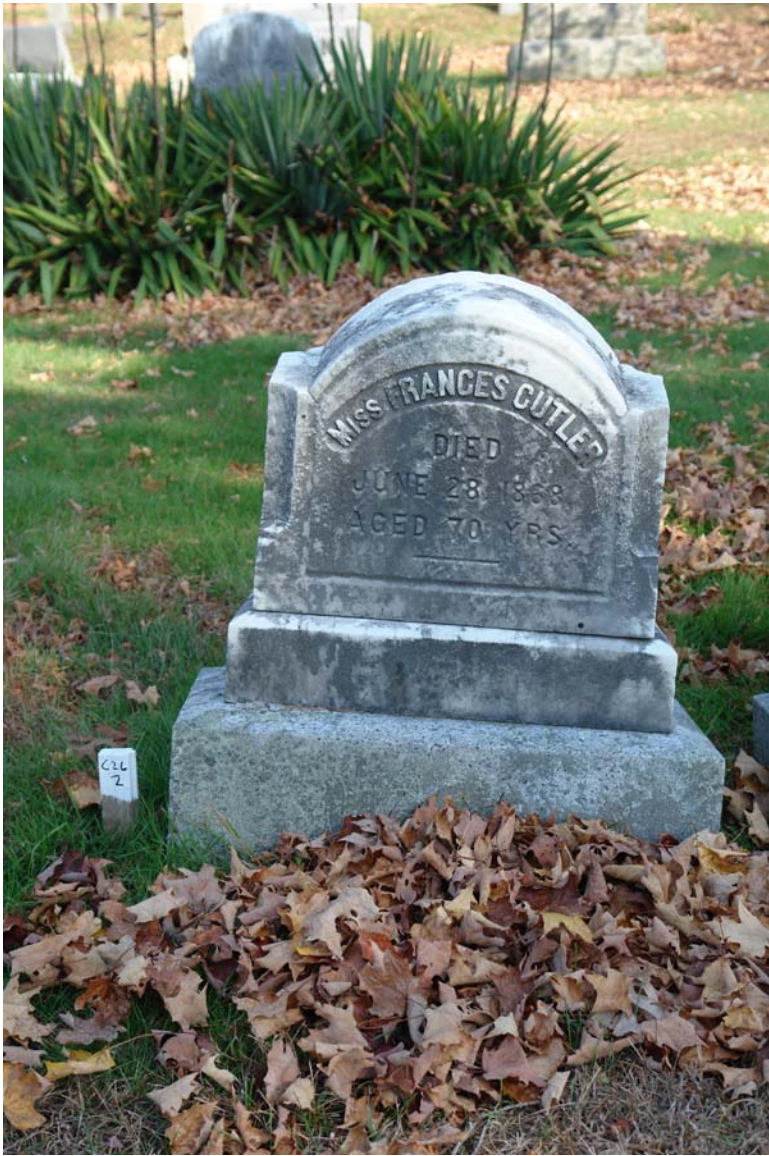
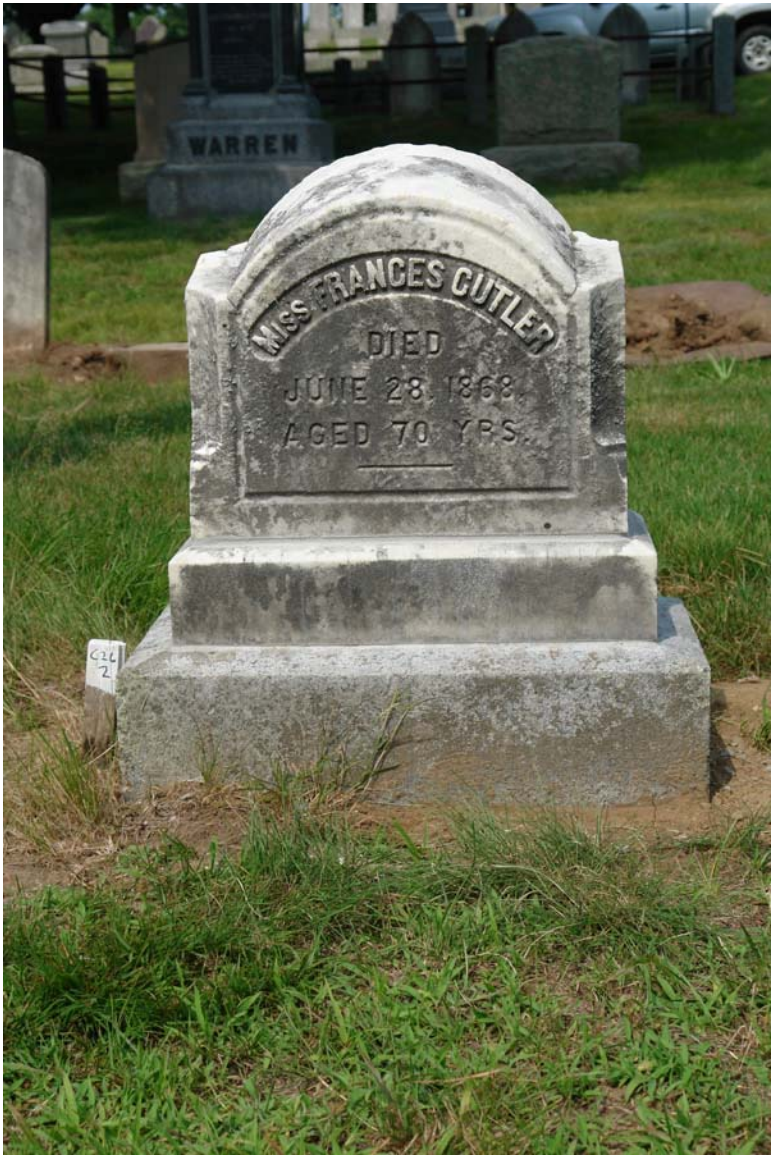
NAME ON MARKER **Frances Cutler**

EXISTING CONDITIONS	CONSERVATION STRATEGY
Tilted Loose on base	Reset base level Reset elements

TREATMENT	Treatment Dates
	7/6/2015
1. Elements removed from setting bases and inspected for soundness. 2. Area excavated to an appropriate depth removing any roots or large stones. 3. Base is aligned with adjacent markers and re-set level. 4. Area around base was backfilled with tamped gravel and re-graded with existing topsoil 5. Failed mortar removed from setting area and bottom of marker 6. When required, any existing pins were inspected, and if necessary, replaced with stainless steel threaded pins 7. Setting surfaces primed with Acryl 60 diluted 1:3 with water. 8. Marker reset plumb onto base with cement/lime mortar (3/2/9) with 000 sand. 9. Excess grout removed and joint area cleaned.

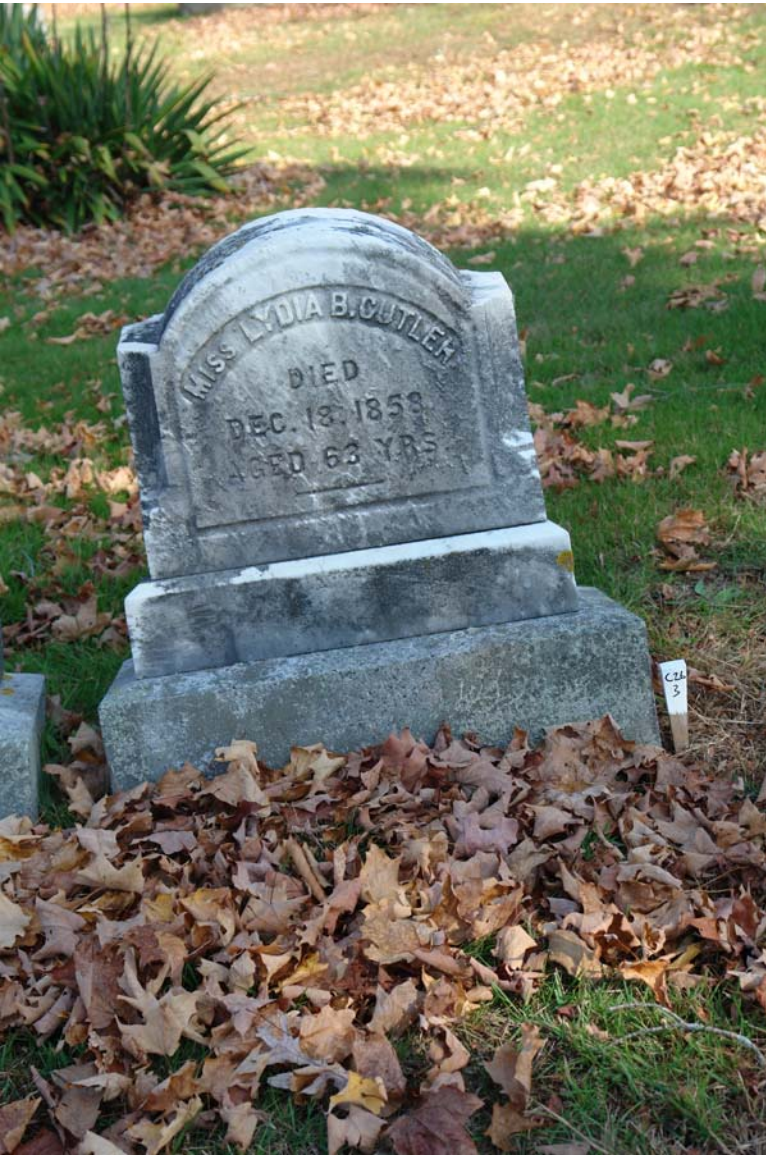
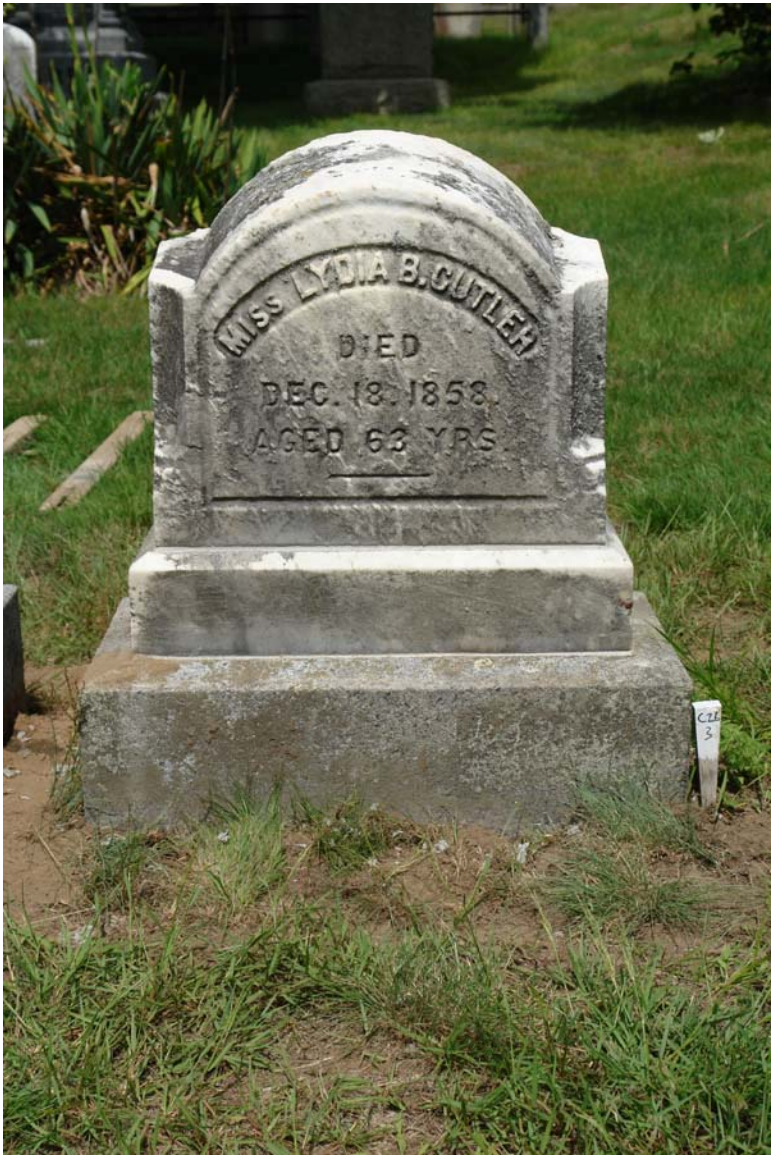
Hanover Center Cemetery, Hanover MA
NAME ON MARKER **Lydia Cutler**
Death Date: 12/18/1858 Marker Type: Headstone/pinned base
Cond. of Inscription: Legible Material: Marble

EXISTING CONDITIONS	CONSERVATION STRATEGY
Tilted Loose on base	Reset base level Reset elements

TREATMENT	Treatment Dates
1. Elements removed from setting bases and inspected for soundness. 2. Area excavated to an appropriate depth removing any roots or large stones. 3. Base is aligned with adjacent markers and re-set level. 4. Area around base was backfilled with tamped gravel and re-graded with existing topsoil 5. Failed mortar removed from setting area and bottom of marker 6. When required, any existing pins were inspected, and if necessary, replaced with stainless steel threaded pins 7. Setting surfaces primed with Acryl 60 diluted 1:3 with water. 8. Marker reset plumb onto base with cement/lime mortar (3/2/9) with 000 sand. 9. Excess grout removed and joint area cleaned.	7/6/2015

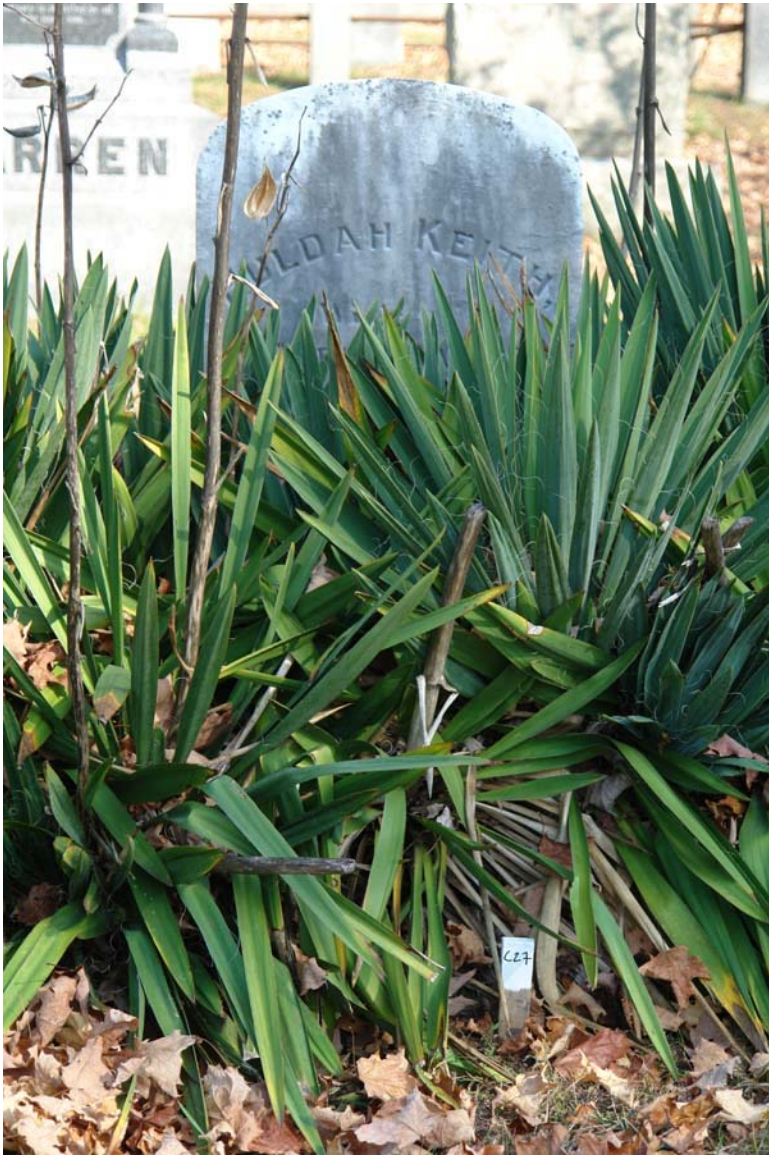
Hanover Center Cemetery, Hanover MA
NAME ON MARKER **HulDAH Bates**
Death Date: 1/4/1874 Marker Type: Headstone/pinned base
Cond. of Inscription: Legible Material: Marble

EXISTING CONDITIONS	CONSERVATION STRATEGY
Tilted base	Reset base with marker plumb

Comments: **Shrubs to be removed**

TREATMENT	Treatment Dates
1. Overgrowth removed by DPW 2. Elements removed from setting bases and area excavated to an appropriate depth removing any roots or large stones. 3. Base is aligned with adjacent markers and re-set level. 4. Area around base was backfilled with tamped gravel and re-graded with existing topsoil 5. Failed mortar removed from setting area and bottom of marker 6. When required, any existing pins were inspected, and if necessary, replaced with stainless steel threaded pins 7. Setting surfaces primed with Acryl 60 diluted 1:3 with water. 8. Marker reset plumb onto base with cement/lime mortar (3/2/9) with 000 sand. 9. Excess grout removed and joint area cleaned.	7/13-14/2015

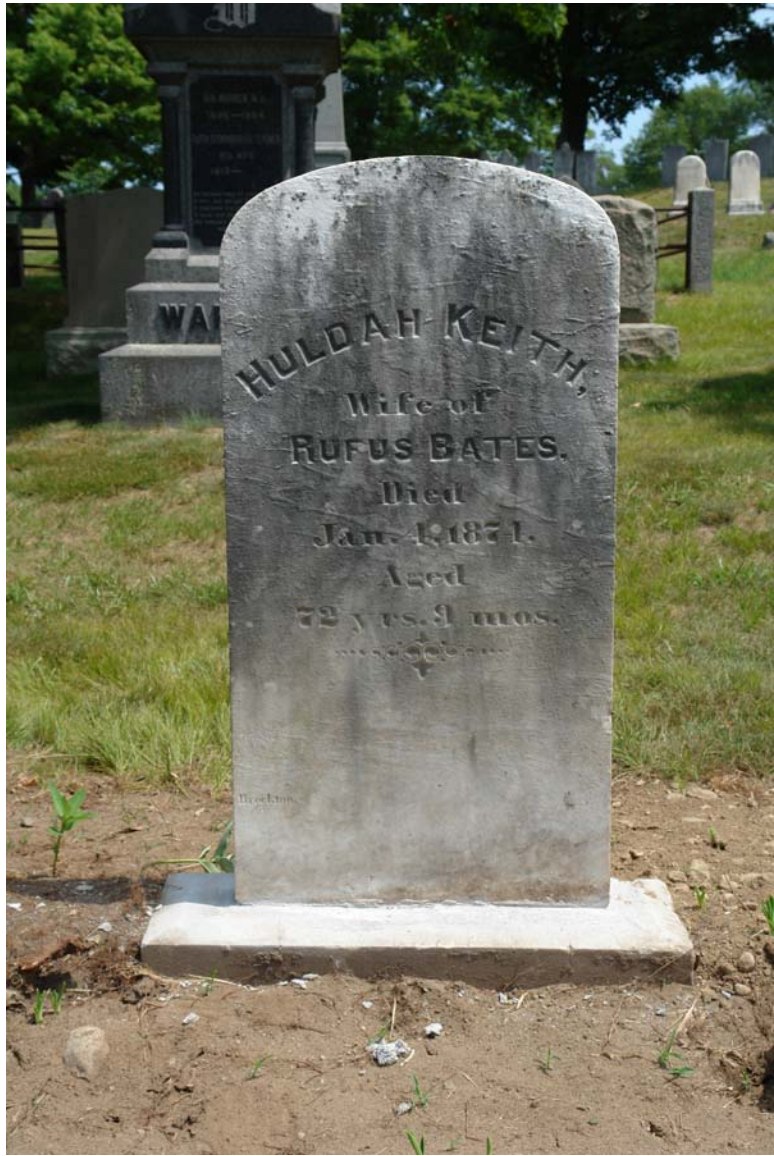
Hanover Center Cemetery, Hanover MA		
NAME ON MARKER		Charles Crocker
Death Date:	4/23/1921	Marker Type: Obelisk
Cond. of Inscription:	Legible	Material: Granite
EXISTING CONDITIONS		CONSERVATION STRATEGY
Tilted		Reset plumb
TREATMENT		
Treatment Dates		7/13/2015
1. Soil removed around base unit and base raised up with hydraulic jacks to level.		
2. Existing foundation stones exposed and built up to support base unit.		
3. Base re-set plumb at appropriate height and level		
4. Area beneath and around base backfilled with tamped sand and gravel		
5. Disturbed areas re-graded with existing topsoil.

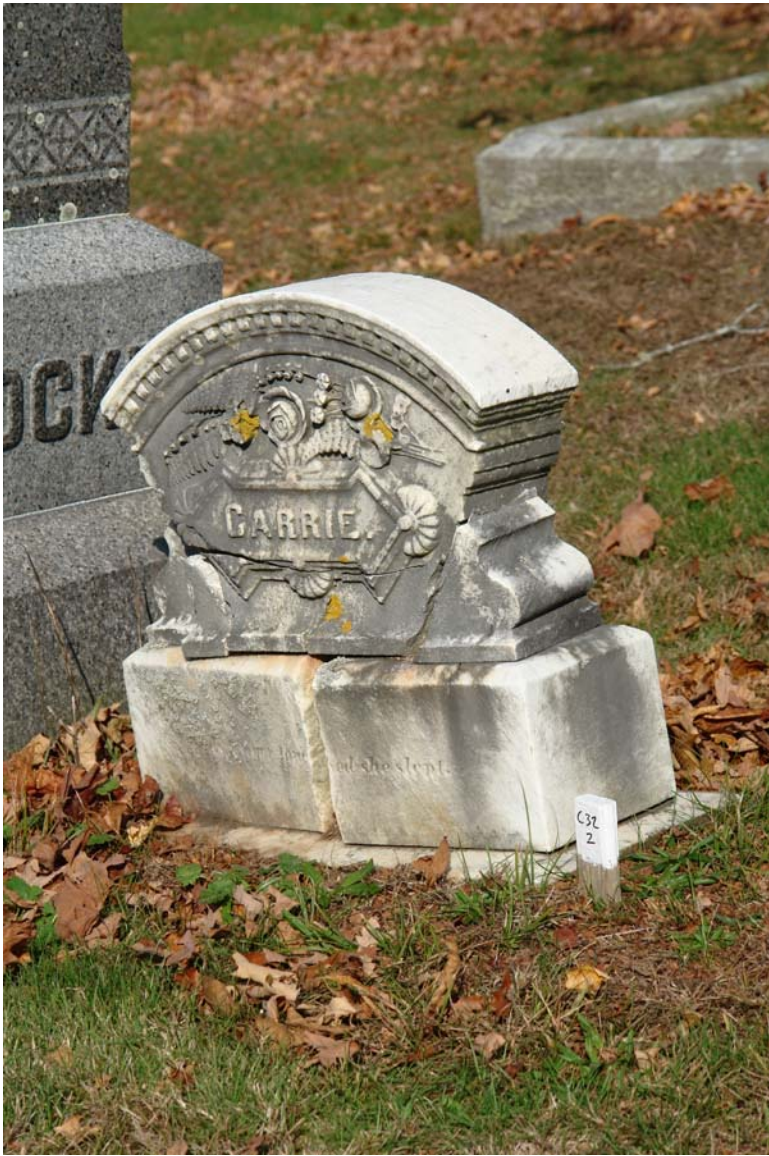
Hanover Center Cemetery, Hanover MA
NAME ON MARKER **Carrie (Crocker)**
Death Date: Marker Type: Sm. monument pinned
Cond. of Inscription: Legible Material: Marble

EXISTING CONDITIONS	CONSERVATION STRATEGY
Fractures Loose on base	Attach fragments with structural adhesive Reset elements

TREATMENT	Treatment Dates
1. Elements disassembled and previous repair materials and failed mortar removed from setting surfaces with hand tools. 2. In-ground base reset level. Replace setting pins with threaded stainless pins if required. 3. Fragments attached with structural adhesive (Abatron 55-22), clamped and braced until cured. 4. Cracks and losses filled with RepliCal Marble or Jahn restoration mortar, misted with water and covered for 3 days min. 5. Filled surface areas treated w/ light acid wash, rinsed thoroughly with water. 6. Setting surfaces primed with Acryl 60 diluted 1:3 with water. 7. Elements reset with 2:1:9 cementitious high cal lime mortar using fine (00 or 000) sand. 8. Excess mortar removed from joints and braced for a min 3 days 9.. Surfaces treated with D/2 biological solution, scrubbed with nylon brushes, and fully rinsed with water.	7/6-13/2015

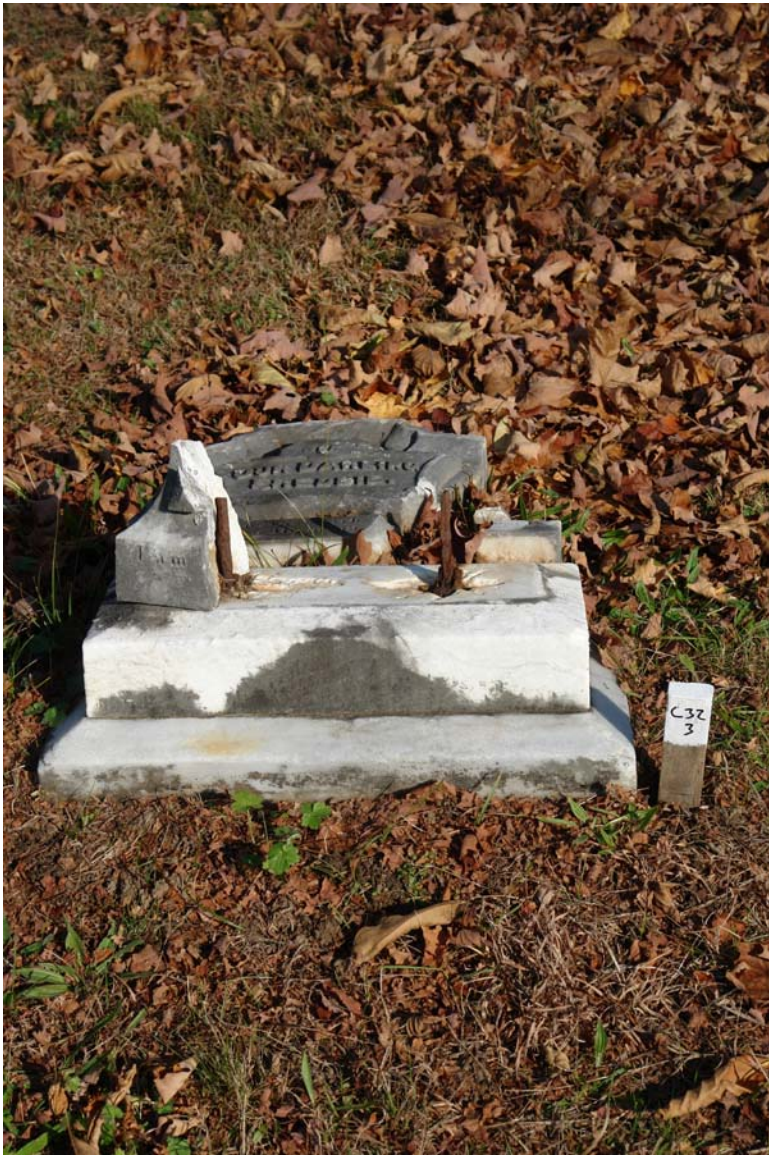
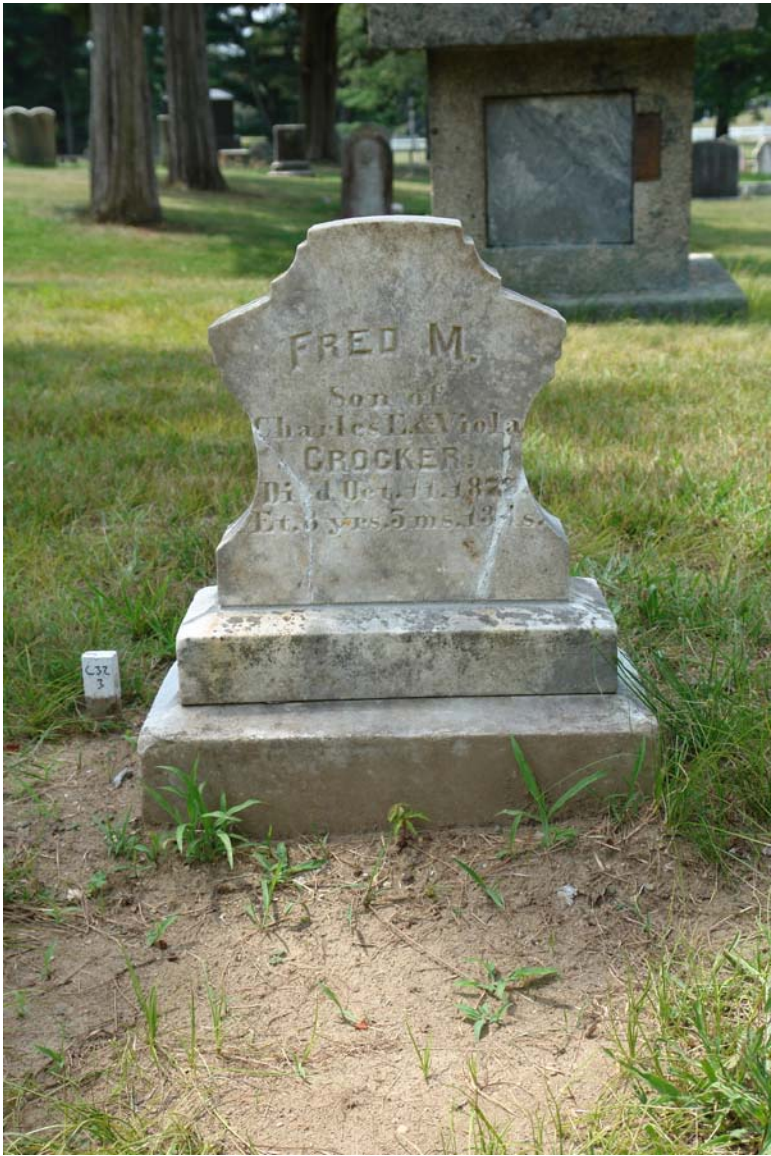
Hanover Center Cemetery, Hanover MA
NAME ON MARKER **Our Darling Freddie** “Fred Crocker”
Death Date: 10/11/1878 Marker Type: Sm monument pinned
Cond. of Inscription: Legible Material: Marble

EXISTING CONDITIONS	CONSERVATION STRATEGY
Fractures Loose on base	Attach fragments with structural adhesive Reset elements

TREATMENT	Treatment Dates
1. Elements disassembled and previous repair materials and failed mortar removed from setting surfaces with hand tools. 2. In-ground base reset level. Replace setting pins with threaded stainless pins if required. 3. Fragments attached with structural adhesive (Abatron 55-22), clamped and braced until cured. 4. Cracks and losses filled with RepliCal Marble or Jahn restoration mortar, misted with water and covered for 3 days min. 5. Filled surface areas treated w/ light acid wash, rinsed thoroughly with water. 6. Setting surfaces primed with Acryl 60 diluted 1:3 with water. 7. Elements reset with 2:1:9 cementitious high cal lime mortar using fine (00 or 000) sand. 8. Excess mortar removed from joints and braced for a min 3 days 9.. Surfaces treated with D/2 biological solution, scrubbed with nylon brushes, and fully rinsed with water.	76/6-14/2015

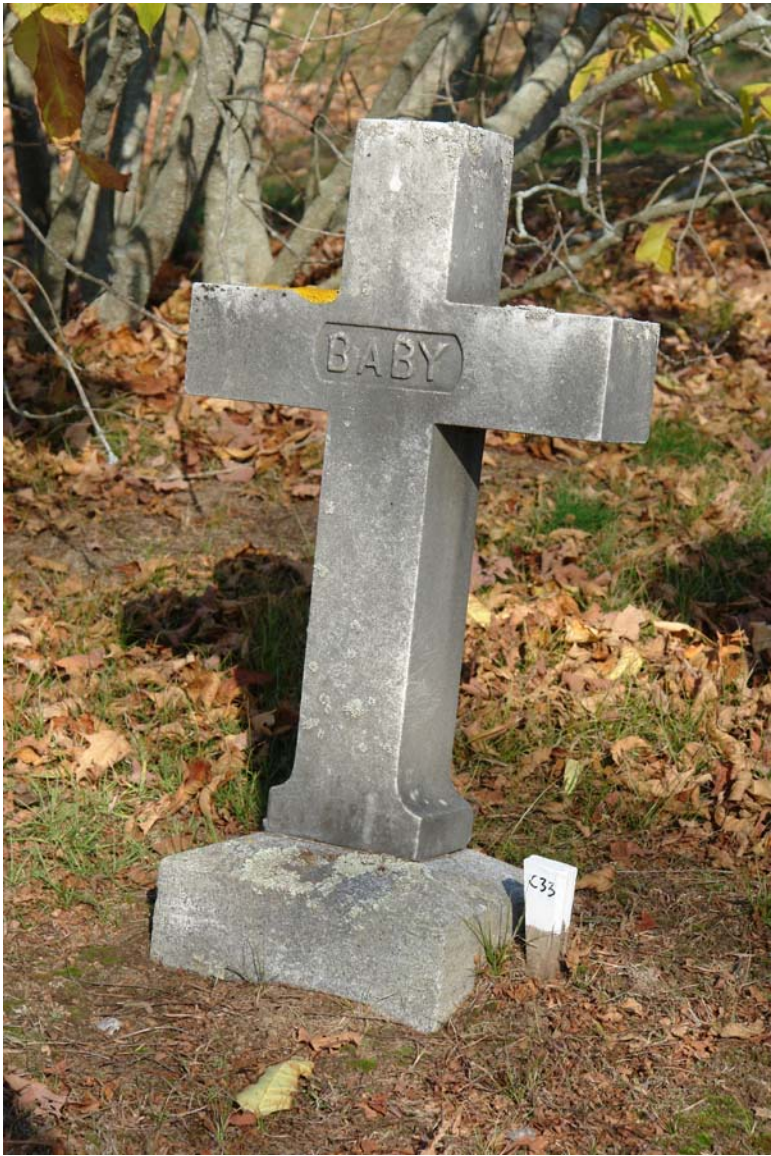
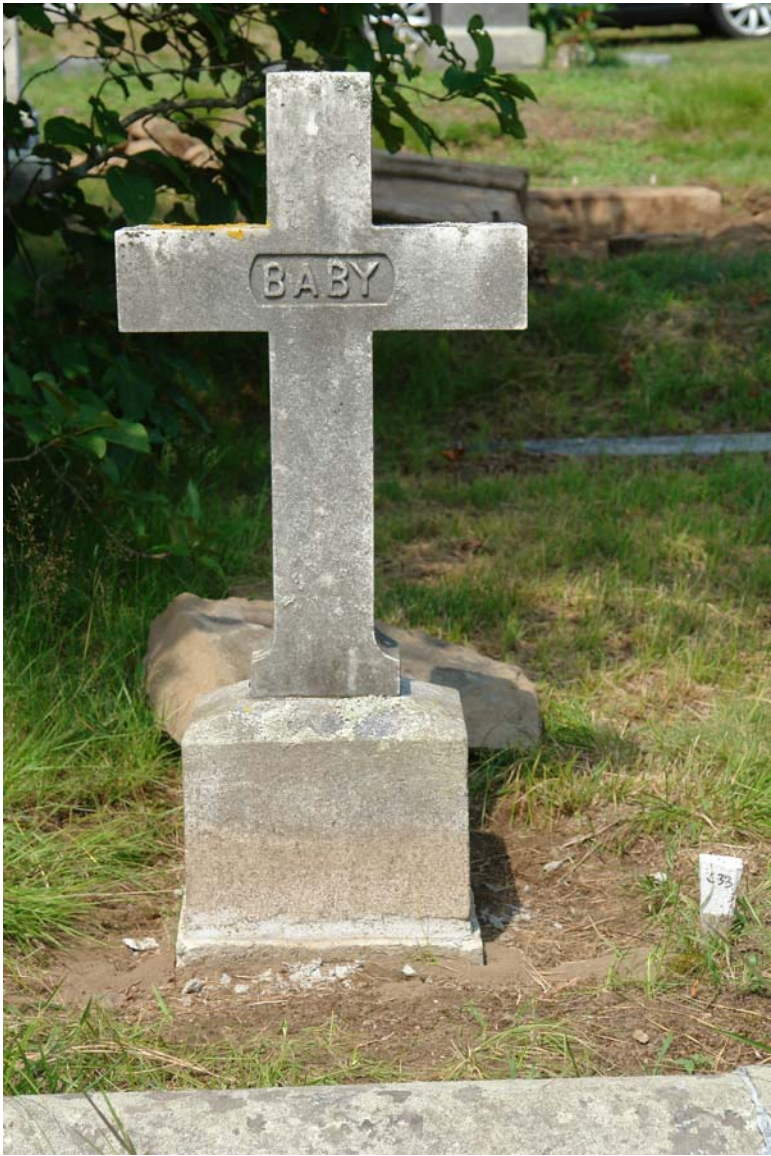
Hanover Center Cemetery, Hanover MA	
NAME ON MARKER	Baby (Phinney)
Death Date: n.a.	Marker Type: Cross
Cond. of Inscription: Legible	Material: Marble
EXISTING CONDITIONS	CONSERVATION STRATEGY
Tilted base	Reset base with marker plumb New base required
TREATMENT	
Treatment Dates 7/6/2015

1. Marker excavated and found to be sound. Light soiling removed by brushing with nylon brushes and water.	
2. Setting area excavated for new below grade cast concrete base sized minimum of 12 inches deep,

7. Disturbed areas backfilled with existing topsoil.

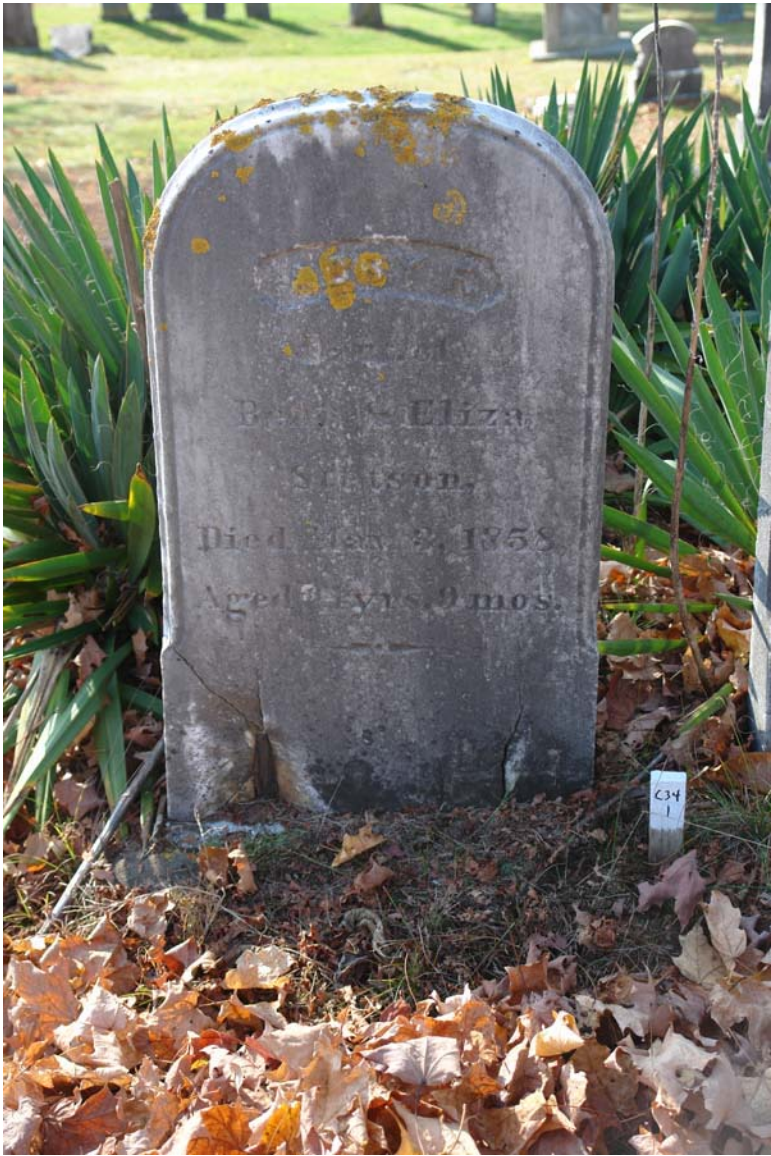
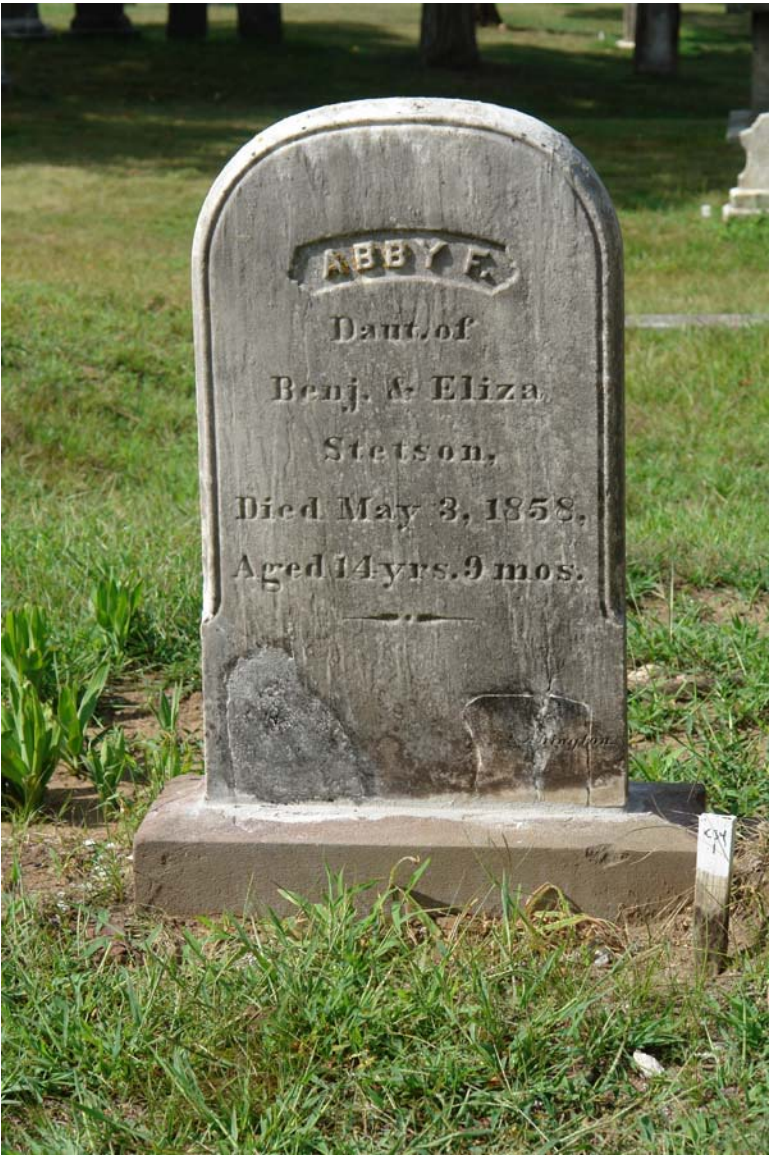
Hanover Center Cemetery, Hanover MA		
NAME ON MARKER		Abby Stetson
Death Date:	5/3/1858	Marker Type: Headstone
Cond. of Inscription:	Decipherable	Material: Marble
EXISTING CONDITIONS		CONSERVATION STRATEGY
Fractures Loose on base		Attach fragments with structural adhesive Reset elements
TREATMENT		
Treatment Dates		7/13-30/2015

1. Area excavated to an appropriate depth removing any roots or large stones aligning base with adjacent markers and re-set level.		
2. Setting surfaces cleaned with water and any failed adhesives or mortar removed with hand tools from setting area and bottom of marker

3. When required, any existing pins were inspected, and if necessary, replaced with stainless steel threaded pins		
4. Setting surfaces primed with Acryl 60 diluted 1:3 with water.

5. Marker reset plumb and level onto base with cement/lime grout (3/2/9) with 000 sand. Braced for min 3 days. Excess grout removed.		
6. Losses filled with Jahn restoration mortar.

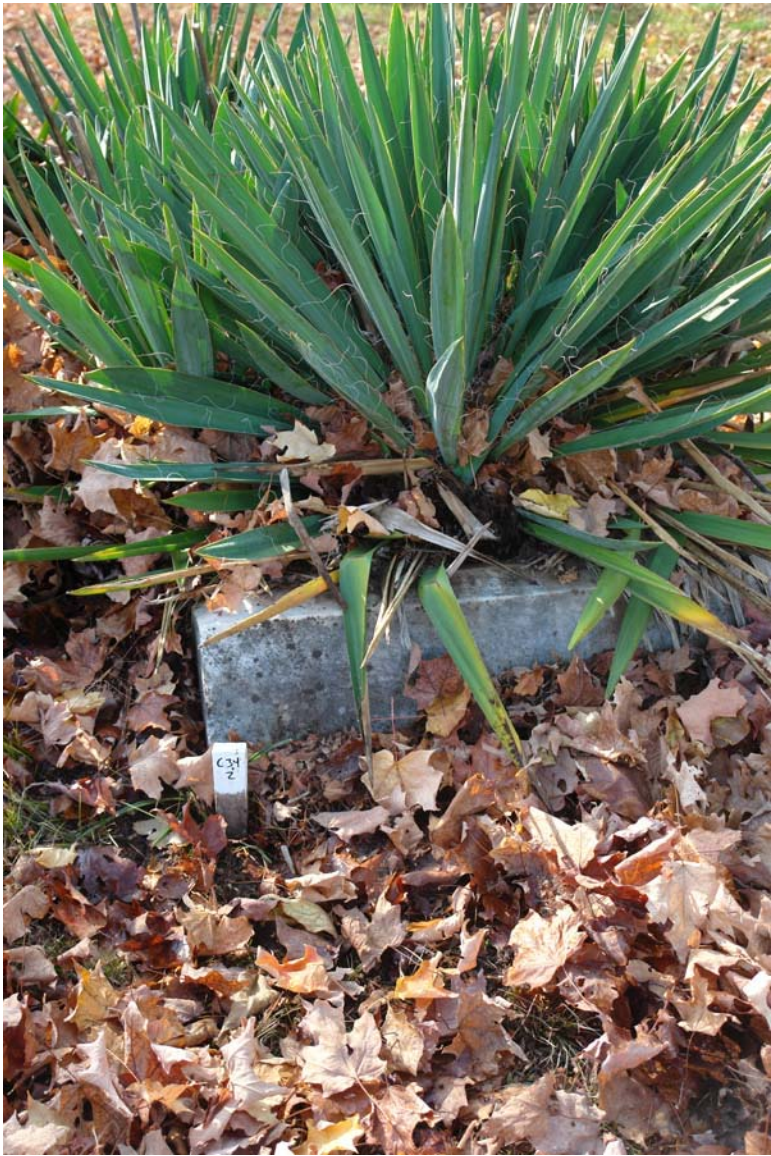
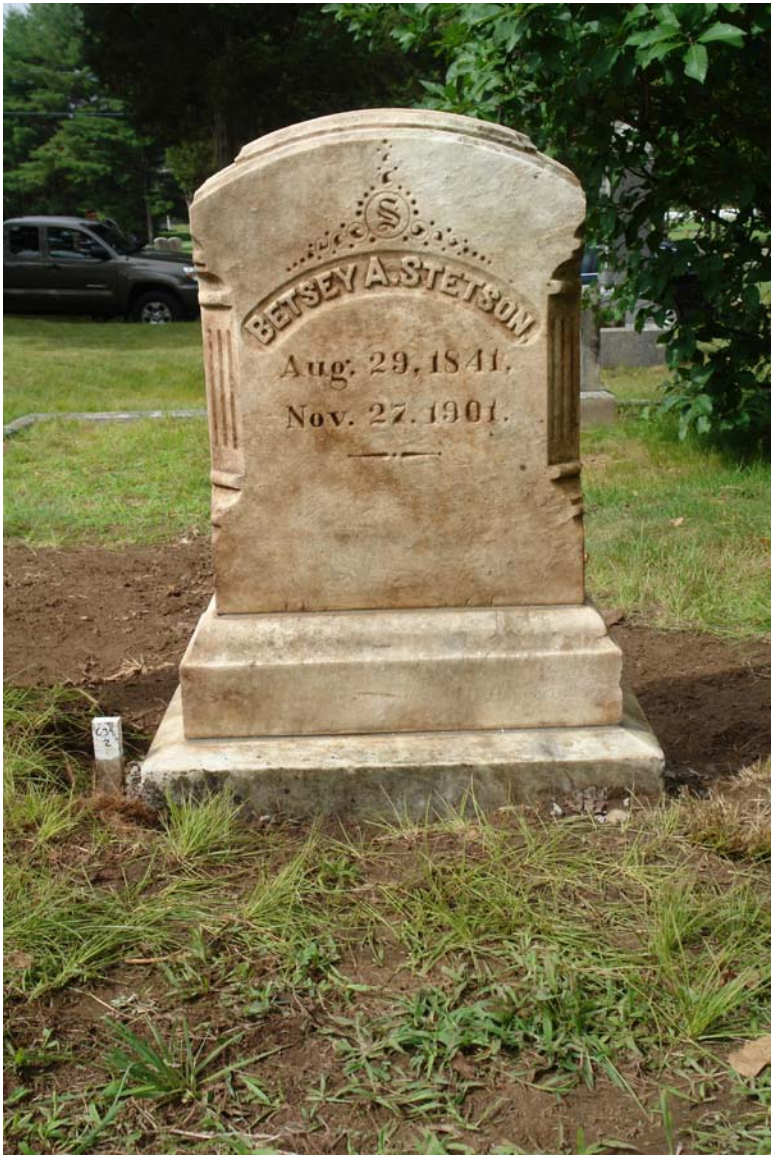
EXISTING CONDITIONS	CONSERVATION STRATEGY
Tilted Loose on ba	Reset base level Reset elements se

5. Failed mortar removed from setting area and bottom of marker

6. When required, any existing pins were inspected, and if necessary, replaced with stainless steel threaded pins

10. All surfaces treated with D/2 Biological Solution, scrubbed with nylon brushes and water. Rinsed fully with water

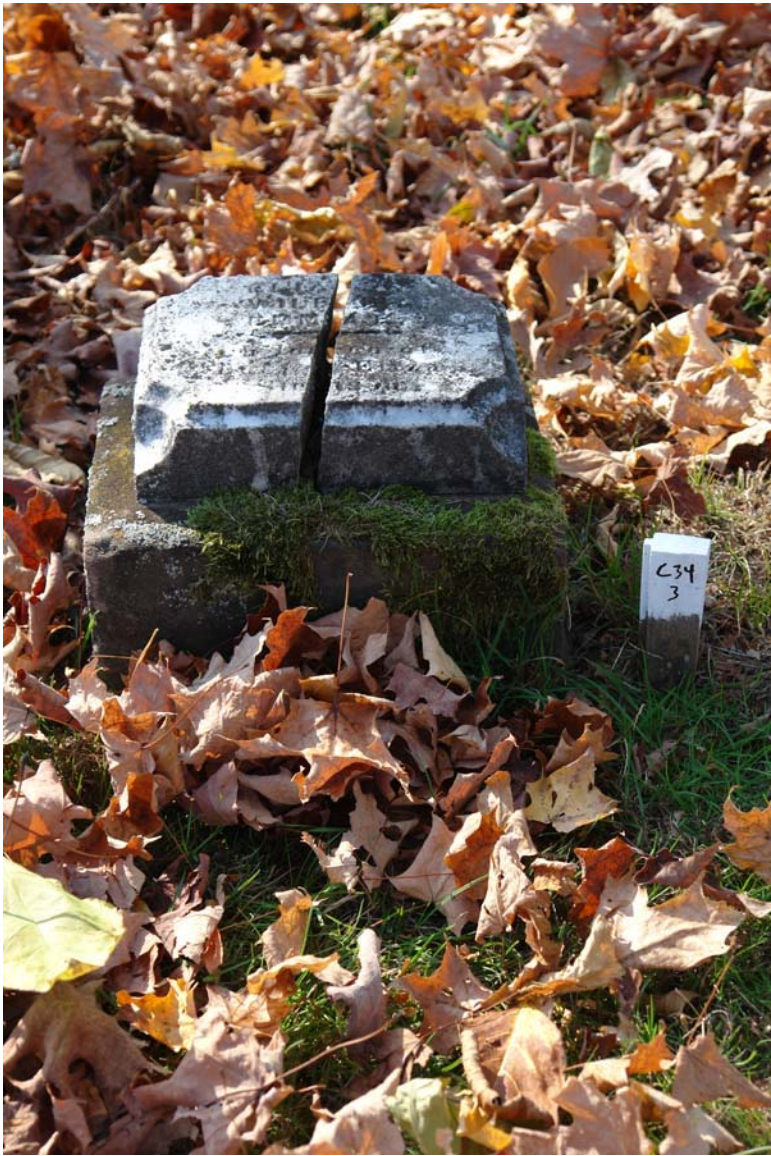
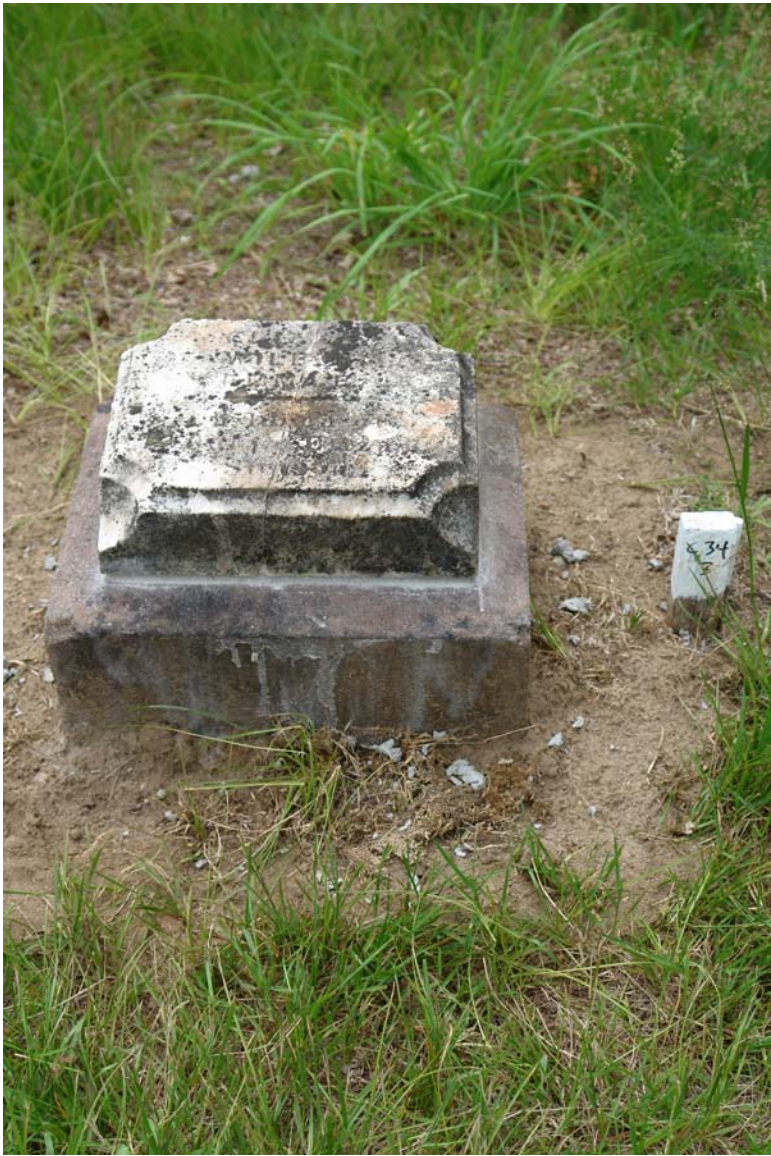
Hanover Center Cemetery, Hanover MA	
NAME ON MARKER	Children Stetson
Death Date:	Marker Type: Sm. Marker/base
Cond. of Inscription: Partially decipherable Material: Marble	
EXISTING CONDITIONS	CONSERVATION STRATEGY
Fractures Loose on base	Attach fragments with structural adhesive Reset elements
TREATMENT	
Treatment Dates 6/30-7/6/2015	
<div>1. Elements disassembled and previous repair materials and failed mortar removed from setting surfaces with hand tools.</div> <div>2. In-ground base reset level. Replace setting pins with threaded stainless pins if required.</div> <div>3. Fragments attached with structural adhesive (Abatron 55-22), clamped and braced until cured.</div> <div>4. Cracks and losses filled with RepliCal Marble or Jahn restoration mortar, misted with water and covered for 3 days min.</div> <div>5. Filled surface areas treated w/ light acid wash, rinsed thoroughly with water.</div> <div>6. Setting surfaces primed with Acryl 60 diluted 1:3 with water.</div> <div>7. Elements reset with 2:1:9 cementitious high cal lime mortar using fine (00 or 000) sand.</div> <div>8. Excess mortar removed from joints and braced for a min 3 days</div> <div>9.. Surfaces treated with D/2 biological solution, scrubbed with nylon brushes, and fully rinsed with water.</div>
