MONUMENT CONSERVATION COLLABORATIVE LLC, NORFOLK, CT

DOCUMENTATION OF STONE CONSERVATION TREATMENTS TO ASSINIPPI CEMETERY, HANOVER, MA June 2015

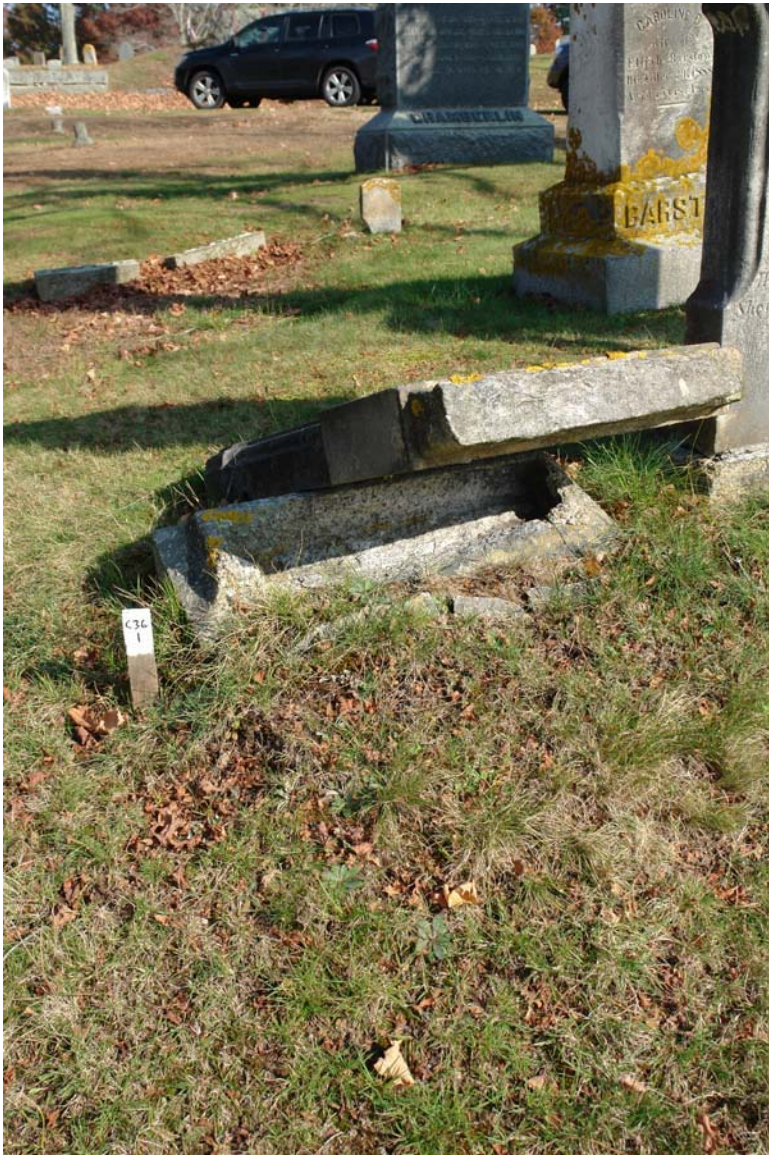
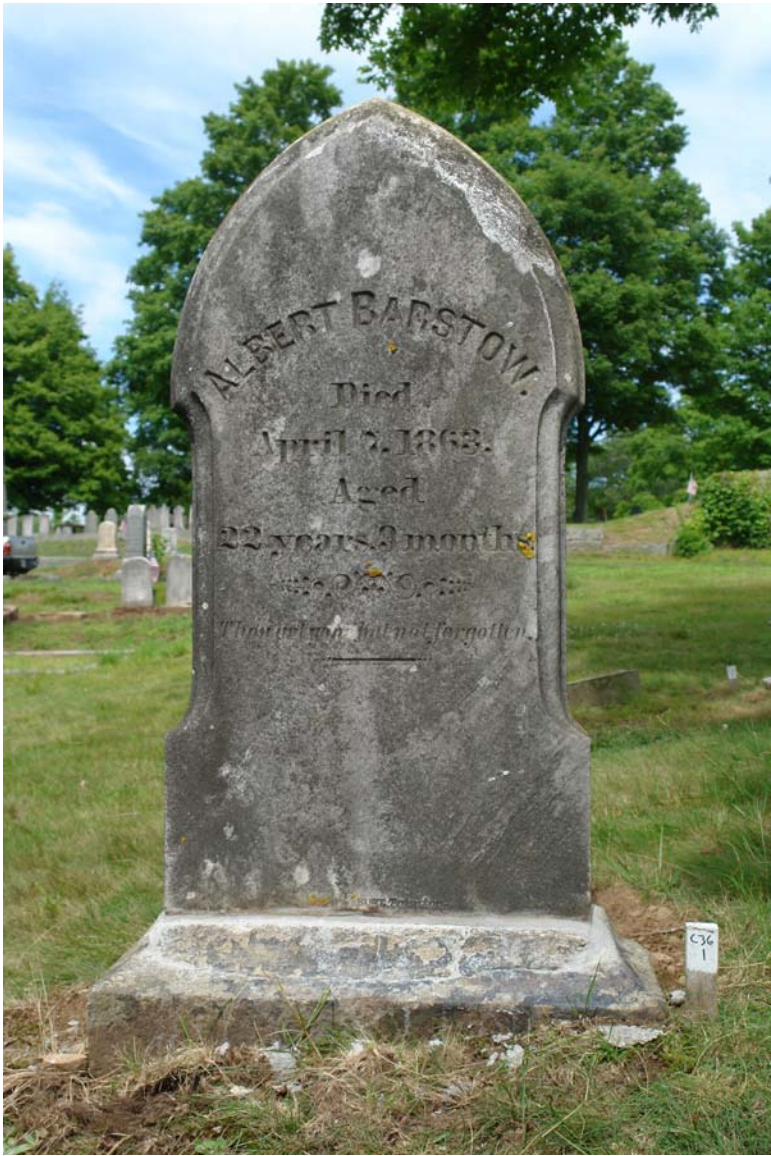
Hanover Center Cemetery, Hanover MA
NAME ON MARKER **Albert Barstow**
Death Date: 4/7/1863 Marker Type: Headstone/slot base
Cond. of Inscription: legible Material: Marble

EXISTING CONDITIONS	CONSERVATION STRATEGY
Fallen	Reset into new below grade concrete base

TREATMENT	Treatment Dates
1. Base found to be fragmented and sound. Failed mortar removed from setting slot with hand tools. 2. In-ground base reset level. 3. Base fragments attached with structural adhesive (Abatron 55-22), clamped and braced until cured. 4. Marker reset plumb and level into setting slot with cement/lime grout (3/2/9) with 000 sand made fluid with a super plasticizer. 5. Excess grout removed and joint area cleaned. 6. Marker braced for a minimum 3 days	7/13-14/2015

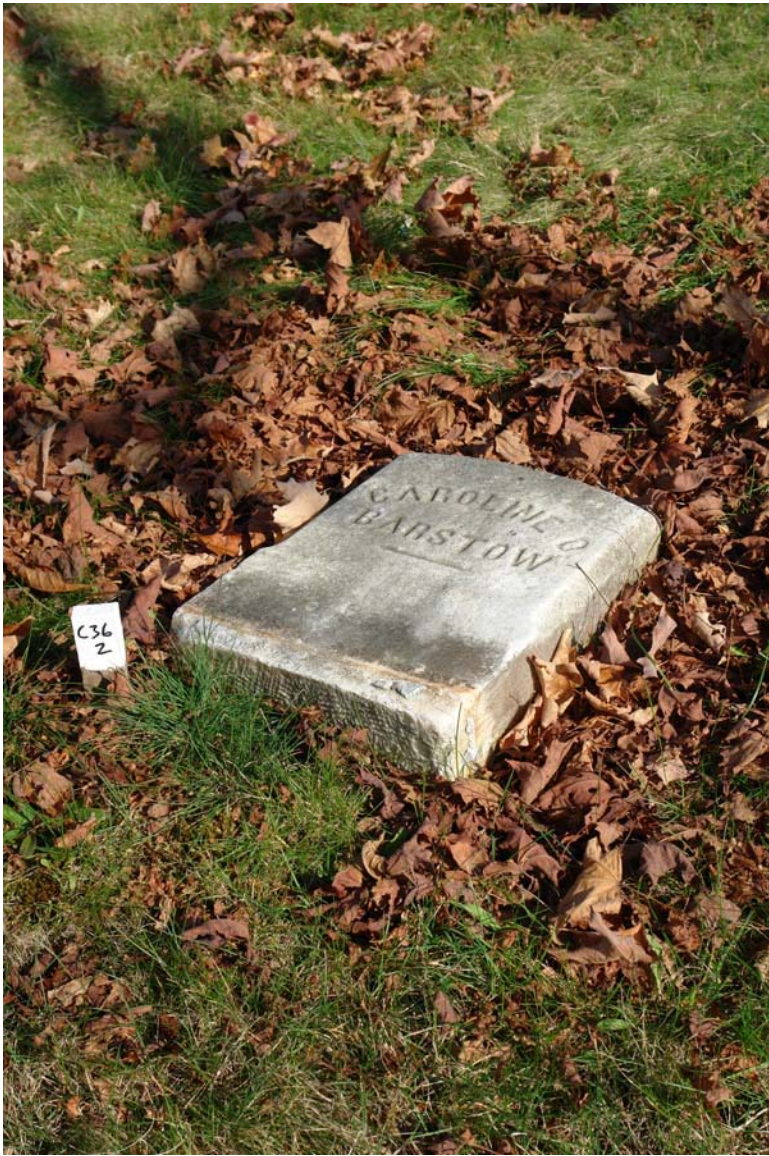
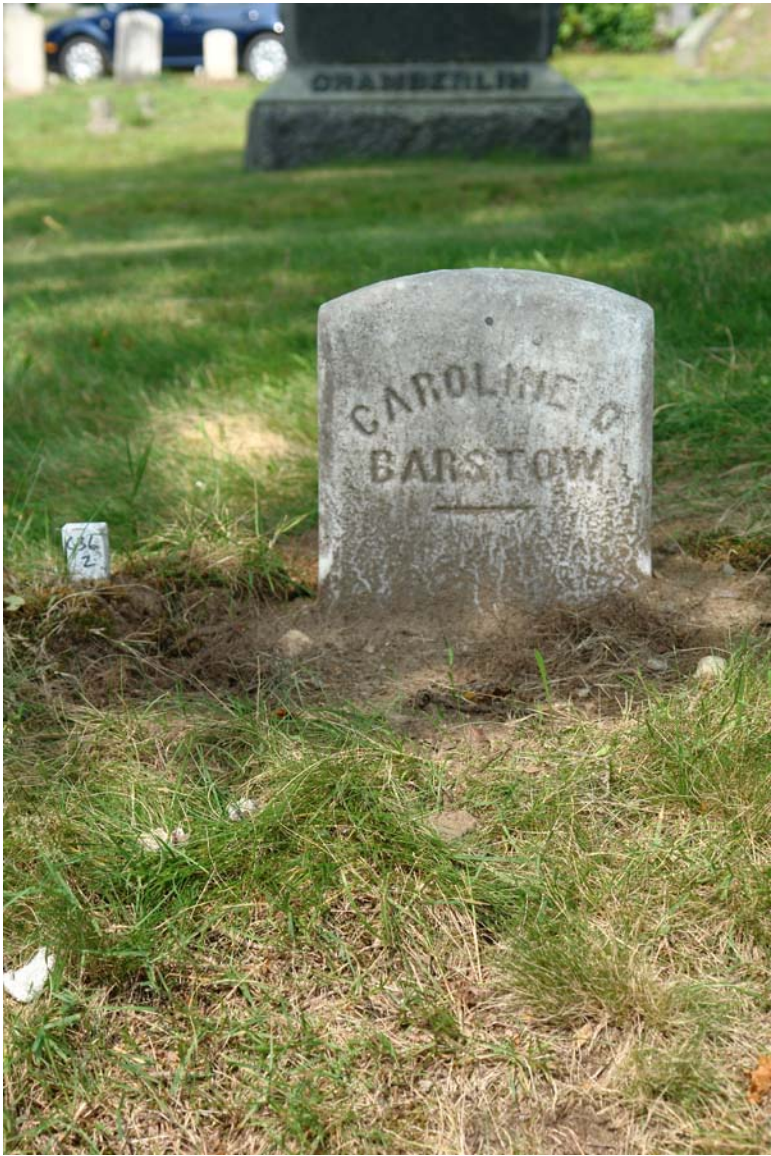
Hanover Center Cemetery, Hanover MA		
NAME ON MARKER		
Caroline Barstow		
Death Date: -		
Marker Type: Headstone/base		
Cond. of Inscription: Legible		
Material: Marble		
EXISTING CONDITIONS		CONSERVATION STRATEGY
Fallen		Reset into new below grade concrete base
TREATMENT		
		Treatment Dates 6/30-7/6/2015

1. Marker excavated and found to be sound. Light soiling removed by brushing with nylon brushes and water.		
2. Setting area excavated for new below grade cast concrete base sized minimum of 12 inches deep, 12 inches greater in thickness and 6 inches wider than the stone.

7. Disturbed areas backfilled with existing topsoil.

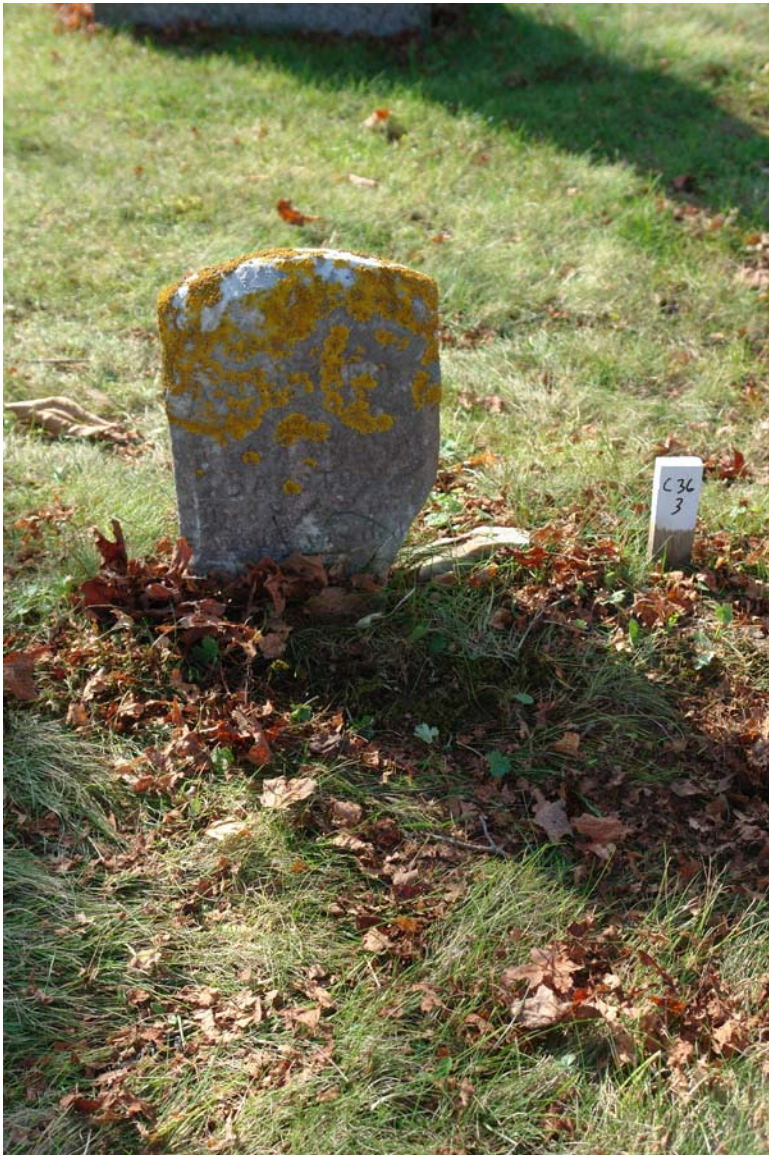
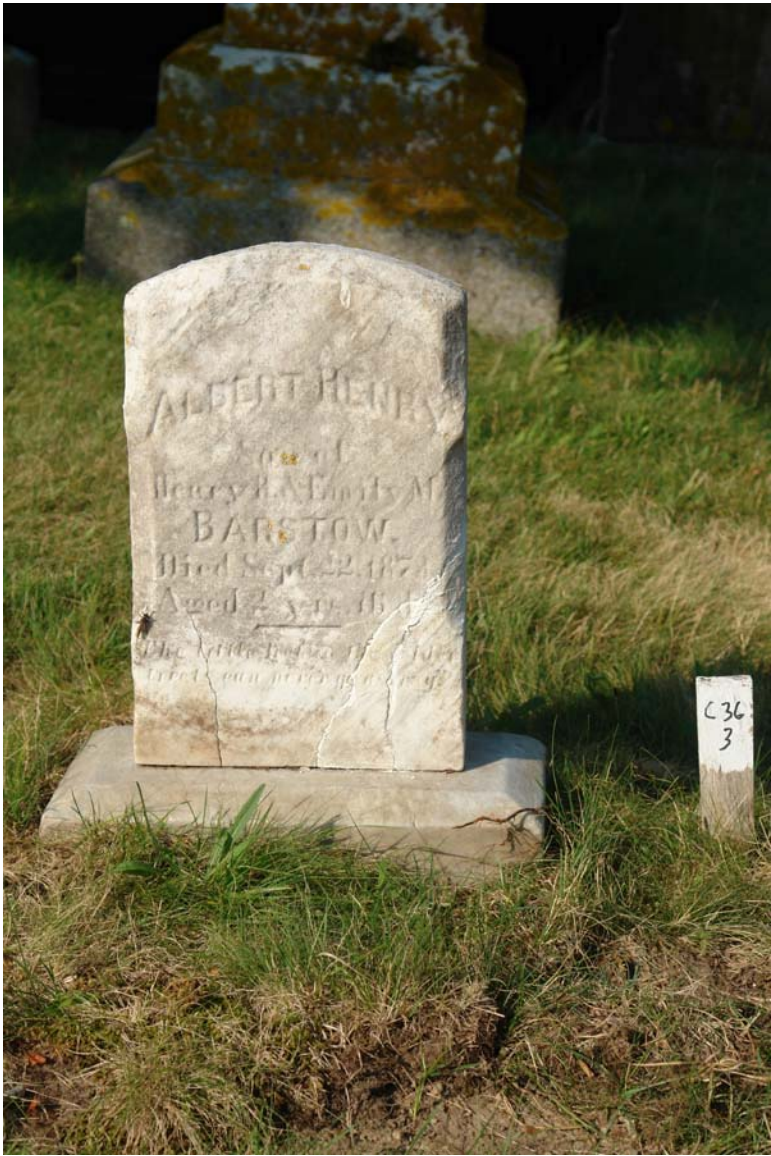
Hanover Center Cemetery, Hanover MA
NAME ON MARKER **Albert Barstow**
Death Date: 9/22/1873 Marker Type: Headstone
Cond. of Inscription: Partially decipherable Material: Marble

EXISTING CONDITIONS	CONSERVATION STRATEGY
Fractures Loose on base	Reset into new below grade concrete base Fill losses

TREATMENT	Treatment Dates
1. Setting area excavated for new below grade cast concrete base 2. A new concrete base sized min. 12" deep, 12" greater in thickness and 6" wider than the stone is cast. The finished top to be below grade. A form for a setting slot 1" wider than the marker is placed in the concrete. 3. Setting forms are removed after partial curing of the concrete and the base backfilled with tamped sand or gravel 4. Marker was reset plumb and level into slot using a cement/lime grout (3/2/9) with 000 sand. Braced for min 3 days 5. Losses filled with Jahn restoration mortar 6. All surfaces treated with D/2 Biological Solution, scrubbed with nylon brushes and water. Rinsed fully with water	7/6-7/2015

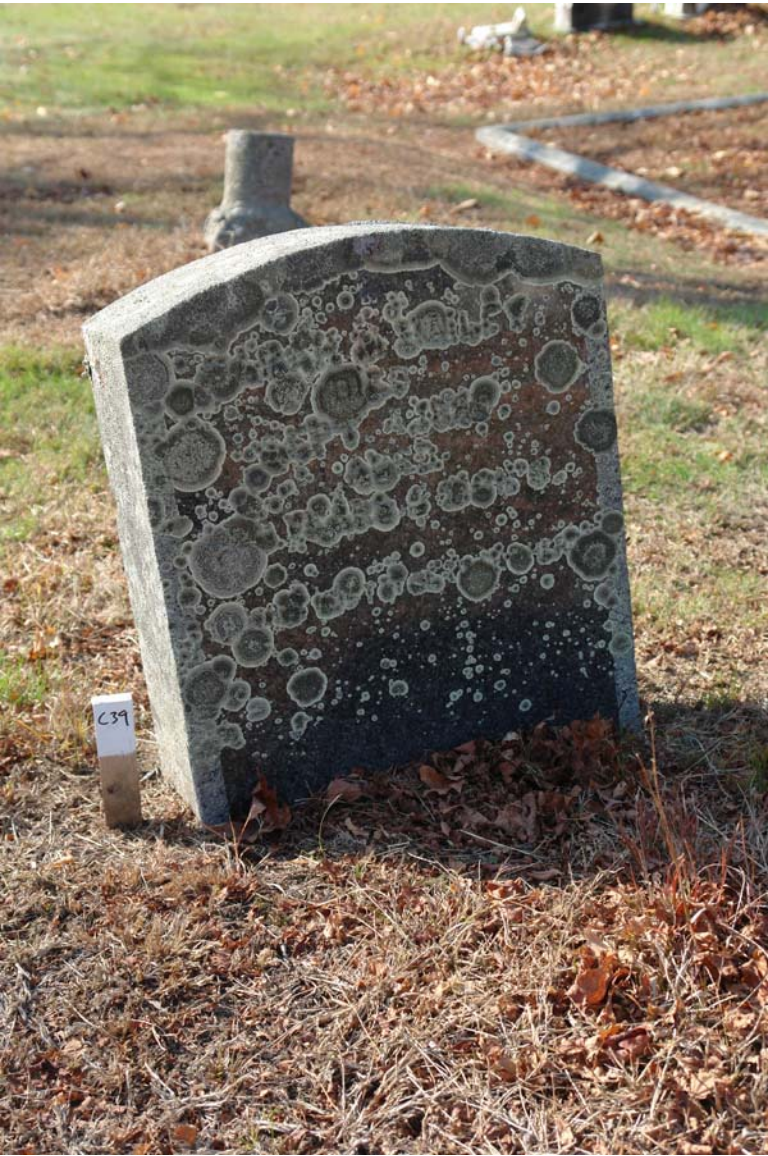
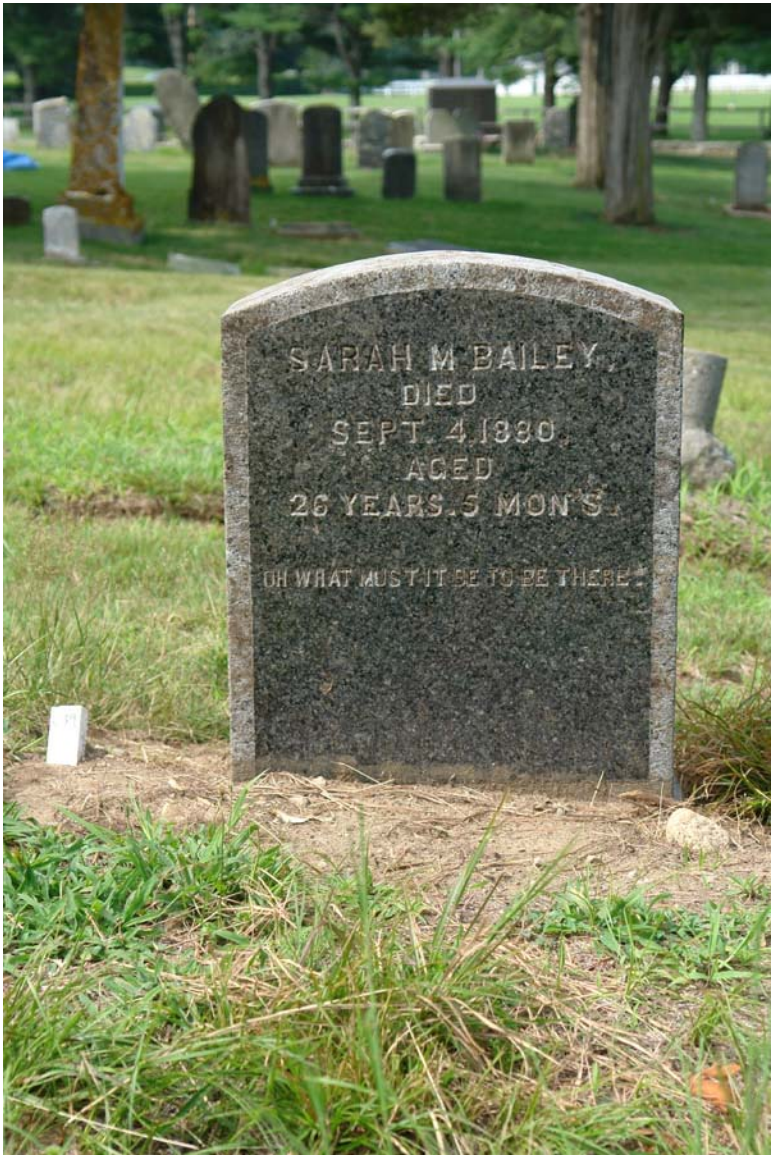
Hanover Center Cemetery, Hanover MA	
NAME ON MARKER	Elijah Sylvester
Death Date: 5/14/1864	Marker Type: Headstone/base
Cond. of Inscription: Legible	Material: Marble
EXISTING CONDITIONS	CONSERVATION STRATEGY
Fallen	Reset into new below grade concrete base
TREATMENT	
Treatment Dates 6/30-7/6/2015

1. Marker excavated and found to be sound. Light soiling removed by brushing with nylon brushes and water.	
2. Setting area excavated for new below grade cast concrete base sized minimum of 12 inches deep, 12 inches greater in thickness and 6 inches wider than the stone.

7. Disturbed areas backfilled with existing topsoil.	
8. Surface treated with D/2 Biological solution, brushed with nylon brushes and fully rinsed with water.

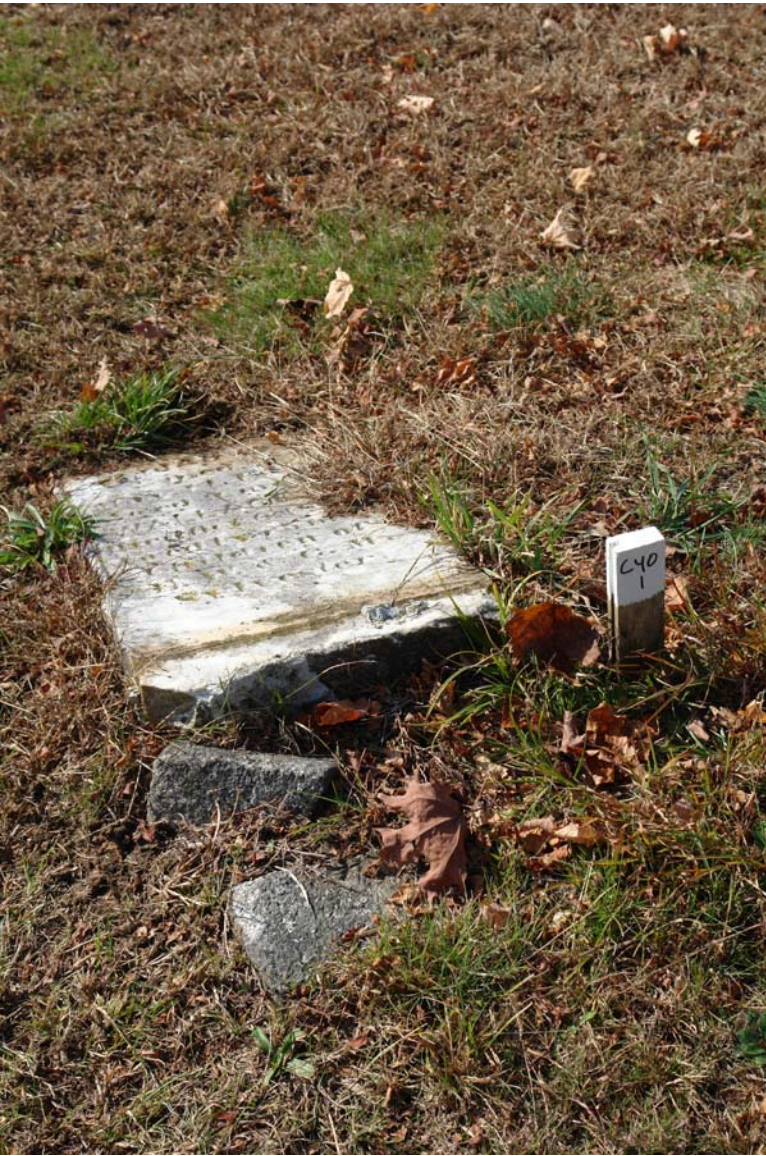
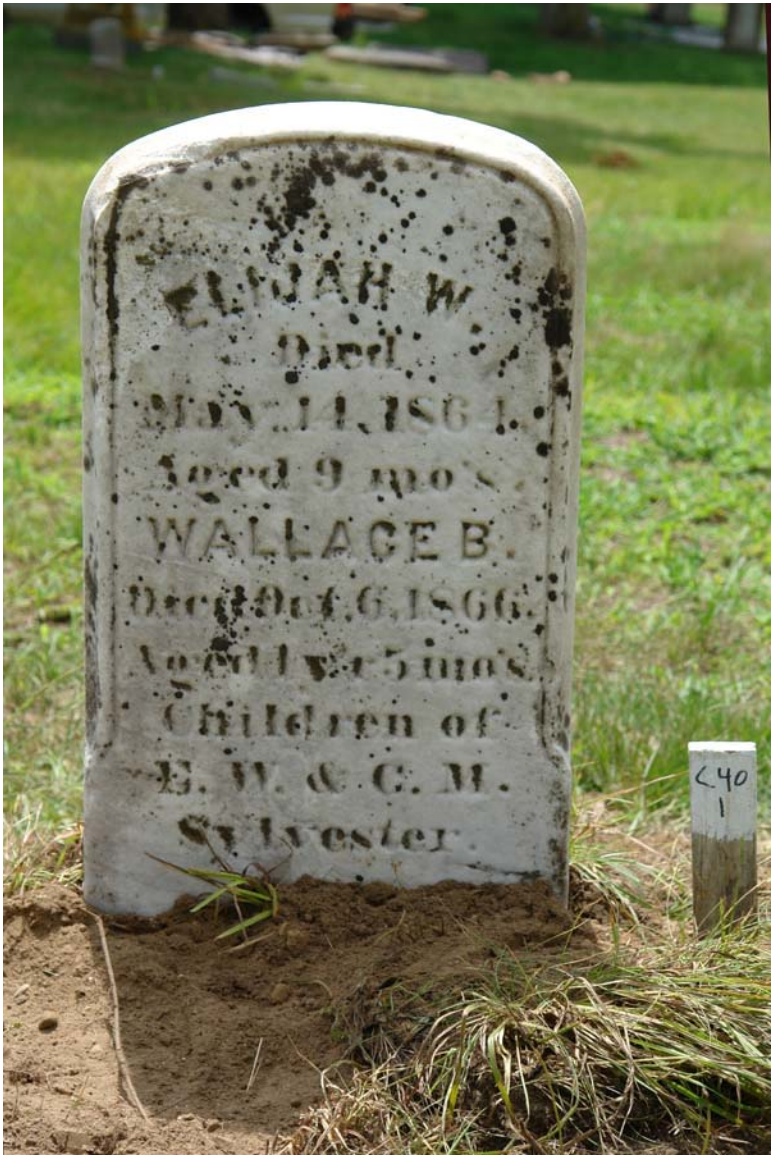
Hanover Center Cemetery, Hanover MA		
NAME ON MARKER		Elijah Sylvester
Death Date:	8/26/1906	Marker Type: Headstone/slot
Cond. of Inscription:	Decipherable	Material: Marble
EXISTING CONDITIONS		CONSERVATION STRATEGY
Tilted Marker loose in slot		Reset base level Reset marker plumb into setting slot
TREATMENT		
Treatment Dates		6/30/2015

1. Elements removed from setting bases and inspected for soundness.		
2. Area excavated to an appropriate depth removing any roots or large stones.		
3. Base is aligned with adjacent markers and re-set level.

4. Area around base was backfilled with tamped gravel and re-graded with existing topsoil		
5. Failed mortar removed from setting area and bottom of marker

6. When required, any existing pins were inspected, and if necessary, replaced with stainless steel threaded pins		
7. Setting surfaces primed with Acryl 60 diluted 1:3 with water.

8. Marker reset plumb onto base with cement/lime mortar (3/2/9) with 000 sand.		
9. Excess grout removed and joint area cleaned.

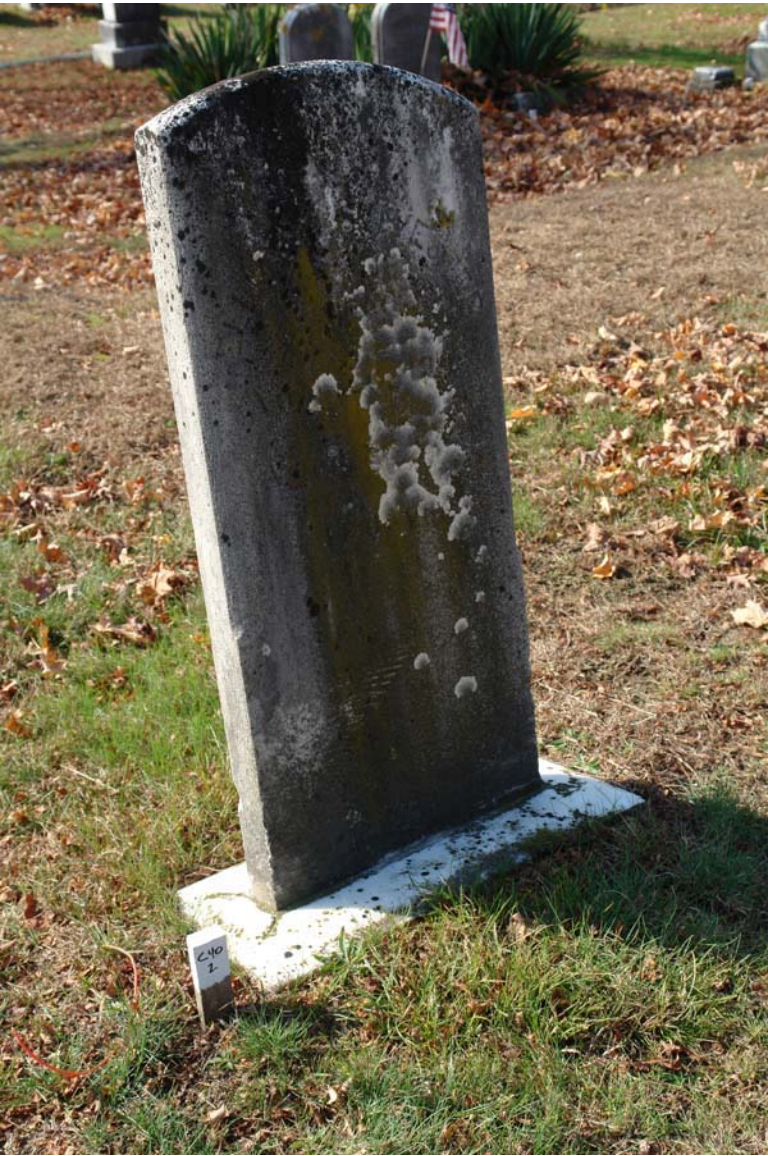
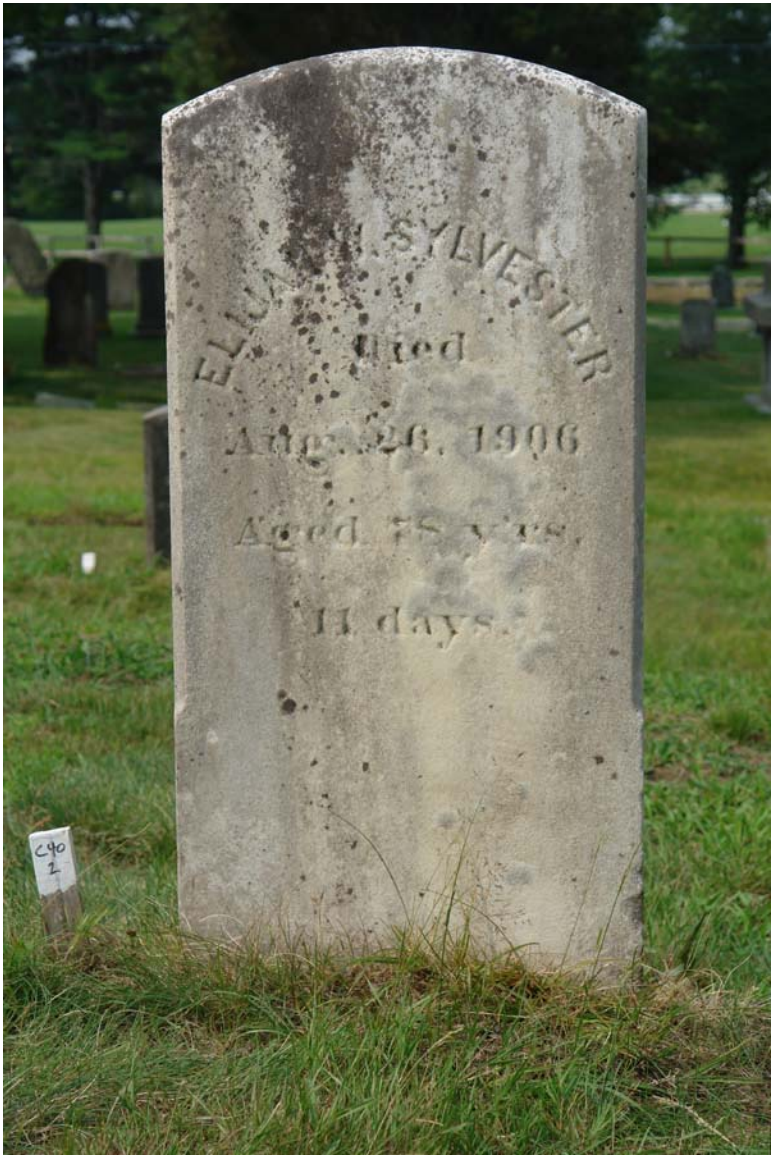
Hanover Center Cemetery, Hanover MA	
NAME ON MARKER	Mary Rumney
Death Date: 3/25/1866	Marker Type: Headstone/slot
Cond. of Inscription: Decipherable	Material: Marble
EXISTING CONDITIONS	CONSERVATION STRATEGY
Tilted Marker loose in slot	Reset base level Reset marker plumb into setting slot
TREATMENT	
Treatment Dates 6/30/2015

1. Area excavated to an appropriate depth removing any roots or large stones.	
2. Base inspected and found to be sound and re-useable	
3. Base is aligned with adjacent markers and re-set level.

8. Excess grout removed and joint area cleaned.	
9. Marker braced for a minimum 3 days

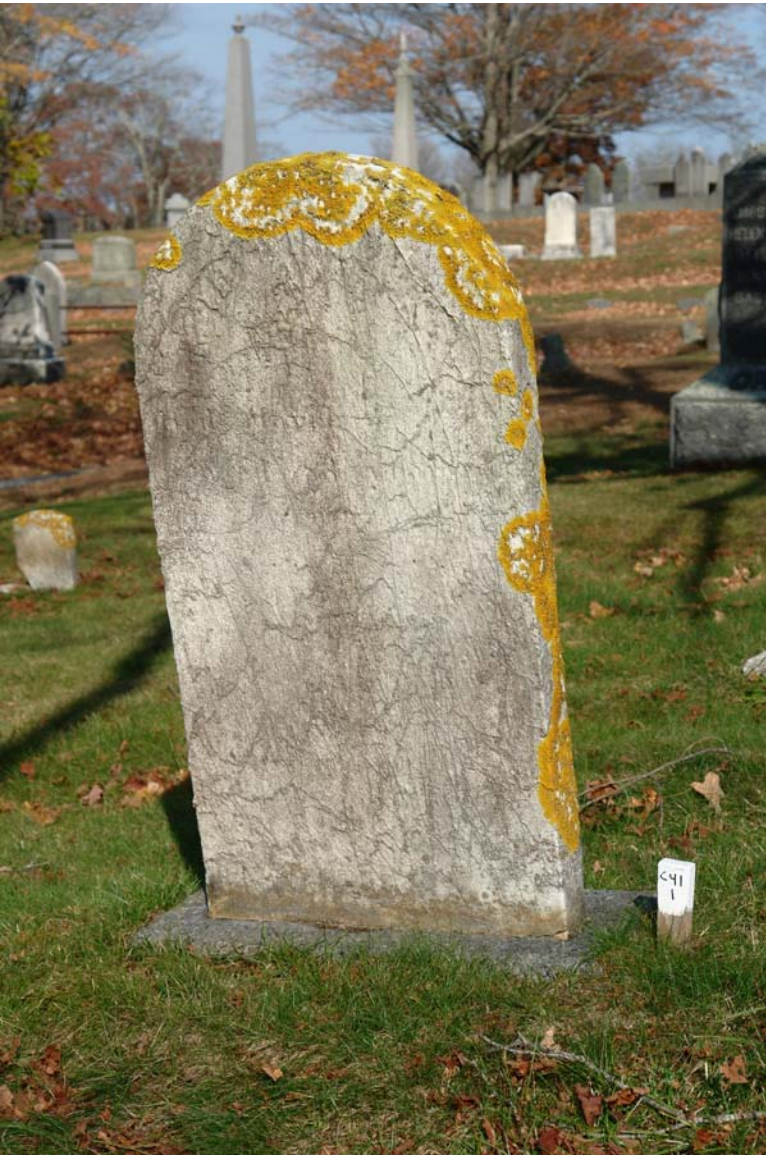
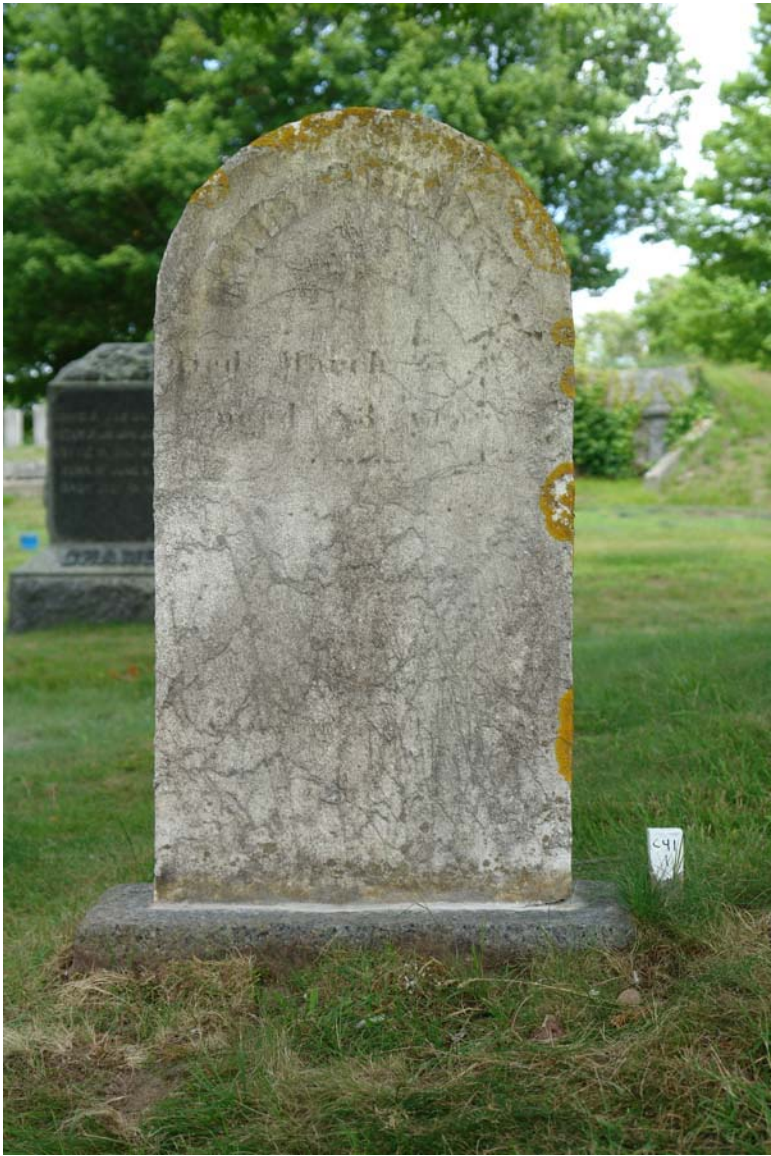
Hanover Center Cemetery, Hanover MA
NAME ON MARKER **Etta Barstow**
Death Date: 10/6/1870 Marker Type: Sm. Marker/pinned
Cond. of Inscription: Partial Material: Marble

EXISTING CONDITIONS	CONSERVATION STRATEGY
Loose on post	Inspect base unit Reset into new below grade concrete base

TREATMENT	Treatment Dates
	7/6-7/2015
1. Elements removed from setting bases and inspected for soundness. Below grade base not discovered. 2. Area excavated to an appropriate depth removing any roots or large stones and a sonotube form was placed at the appropriate height and filled with concrete to act as a new base. 3. Area around base was backfilled with tamped gravel and re-graded with existing topsoil 4. Failed mortar removed from setting area and bottom of marker 5. When required, any existing pins were inspected, and if necessary, replaced with stainless steel threaded pins 6. Setting surfaces primed with Acryl 60 diluted 1:3 with water. 7. Marker reset plumb onto base with cement/lime mortar (3/2/9) with 000 sand. Excess grout removed and joint area cleaned. 8. Surface treated with D/2 Biological solution, brushed with nylon brushes and fully rinsed with water.

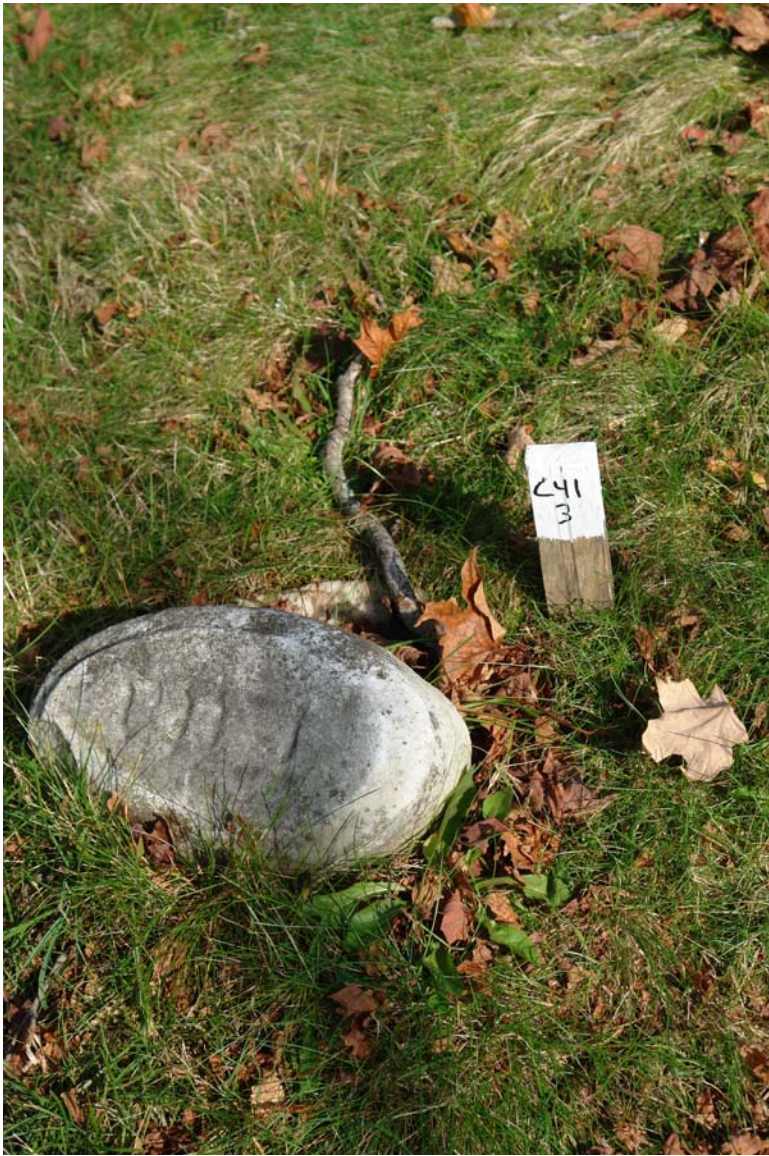
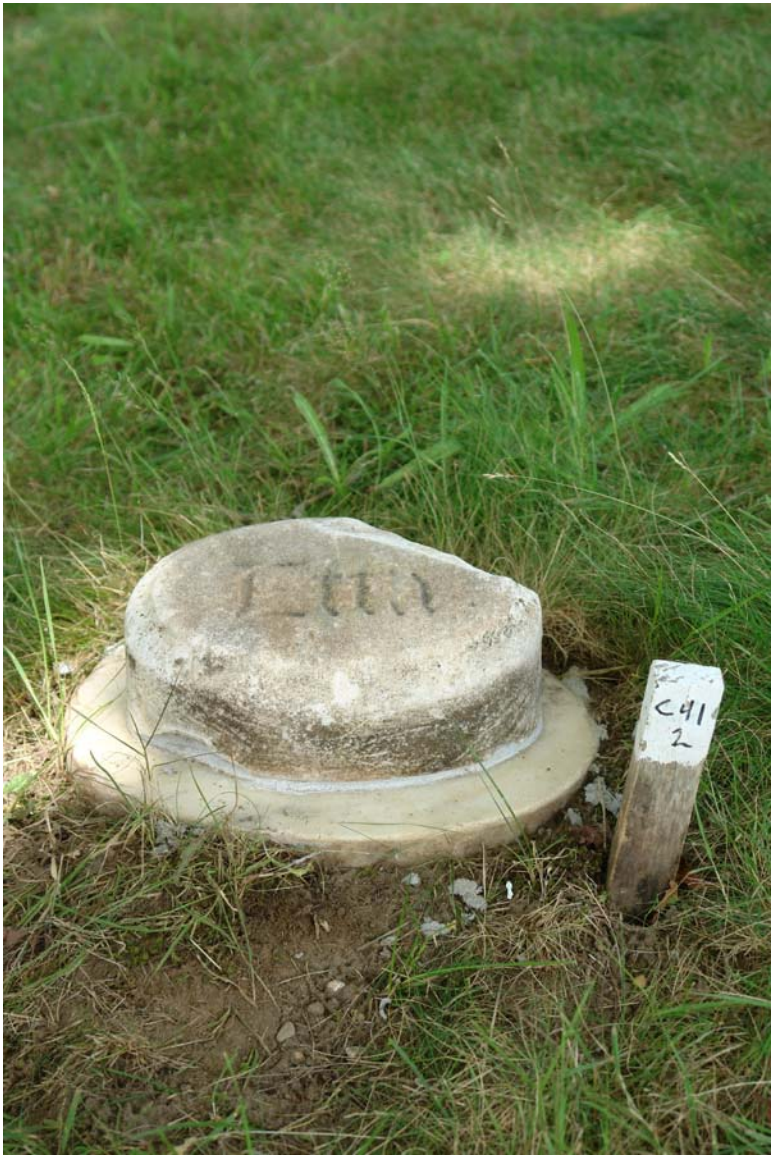
Hanover Center Cemetery, Hanover MA
NAME ON MARKER **Mary Rumney**
Death Date: - Marker Type: Sm. Marker/pinned
Cond. of Inscription: Partial Material: Marble

EXISTING CONDITIONS	CONSERVATION STRATEGY
Loose on base	Evaluate resetting options Possible new below grade concrete base

TREATMENT	Treatment Dates
	6/30/2015
1. Elements removed from setting bases and inspected for sound- ness. 2. Area excavated to an appropriate depth removing any roots or large stones. 3. Base is aligned with adjacent markers and re-set level. 4. Area around base was backfilled with tamped gravel and re- graded with existing topsoil 5. Failed mortar removed from setting area and bottom of marker 6. When required, any existing pins were inspected, and if neces- sary, replaced with stainless steel threaded pins 7. Setting surfaces primed with Acryl 60 diluted 1:3 with water. 8. Marker reset plumb onto base with cement/lime mortar (3/2/9) with 000 sand. Excess grout removed and joint area cleaned 9. Surface treated with D/2 Biological solution, brushed and fully rinsed with water.

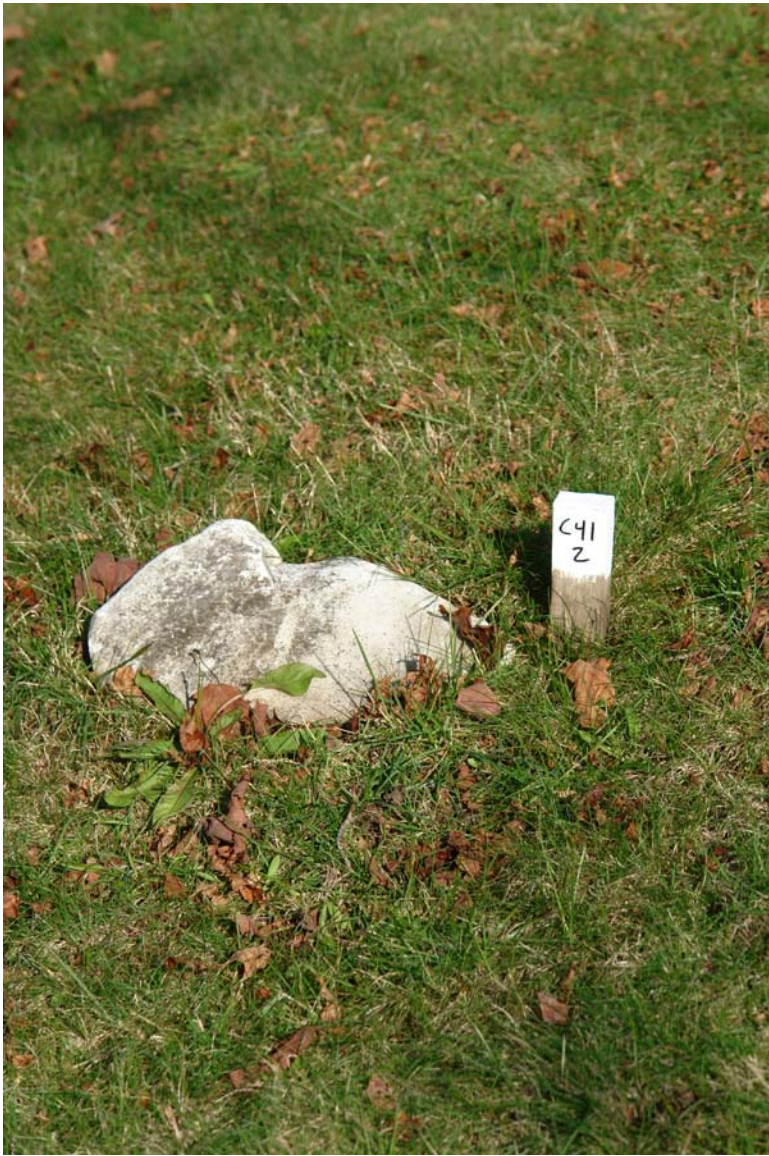
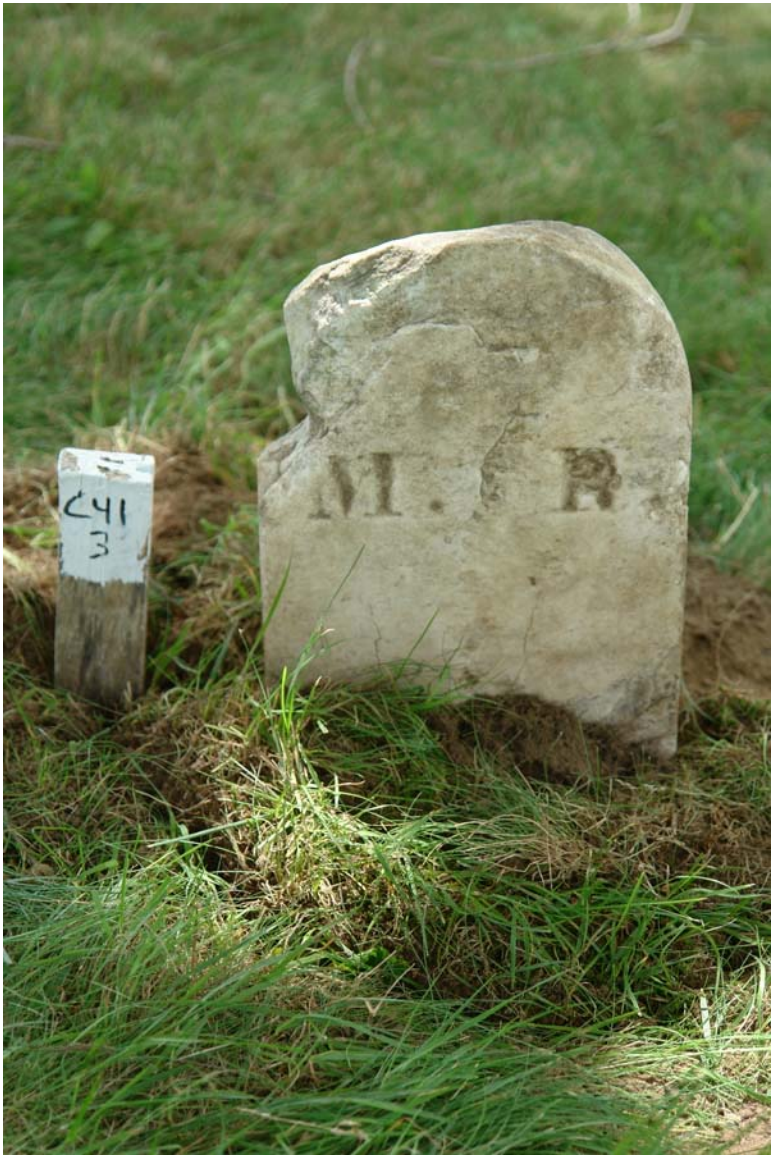
Hanover Center Cemetery, Hanover MA	
NAME ON MARKER	Grace Barstow
Death Date:	Marker Type: Sm marker/pinned
Cond. of Inscription: Decipherable	Material: Marble
EXISTING CONDITIONS	CONSERVATION STRATEGY
Loose on post	Inspect base unit Reset marker to post

TREATMENT	Treatment Dates 6/30/2015
<div>1. Elements removed from setting bases and inspected for soundness.</div> <div>2. Area excavated to an appropriate depth removing any roots or large stones.</div> <div>3. Base is aligned with adjacent markers and re-set level.</div> <div>4. Area around base was backfilled with tamped gravel and re-graded with existing topsoil</div> <div>5. Failed mortar removed from setting area and bottom of marker</div> <div>6. When required, any existing pins were inspected, and if necessary, replaced with stainless steel threaded pins</div> <div>7. Setting surfaces primed with Acryl 60 diluted 1:3 with water.</div> <div>8. Marker reset plumb onto base with cement/lime mortar (3/2/9) with 000 sand. Excess grout removed and joint area cleaned</div> <div>9. Surface treated with D/2 Biological solution, brushed and fully rinsed with water.</div>

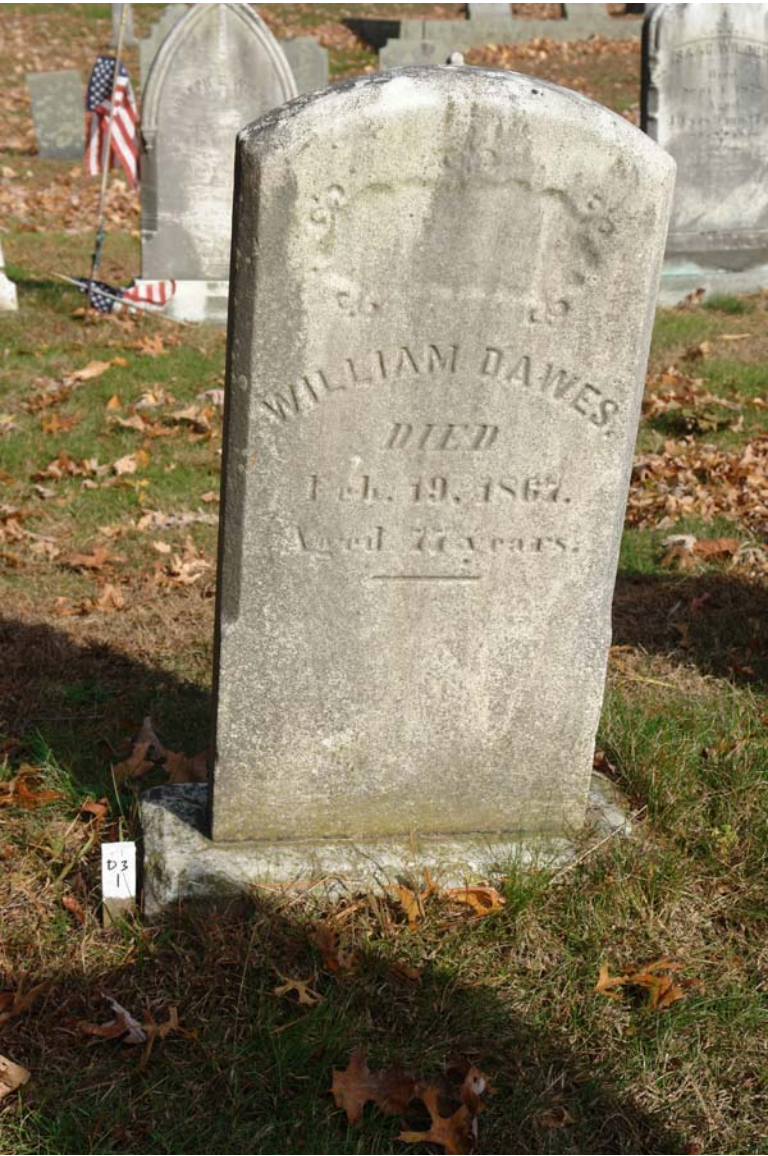
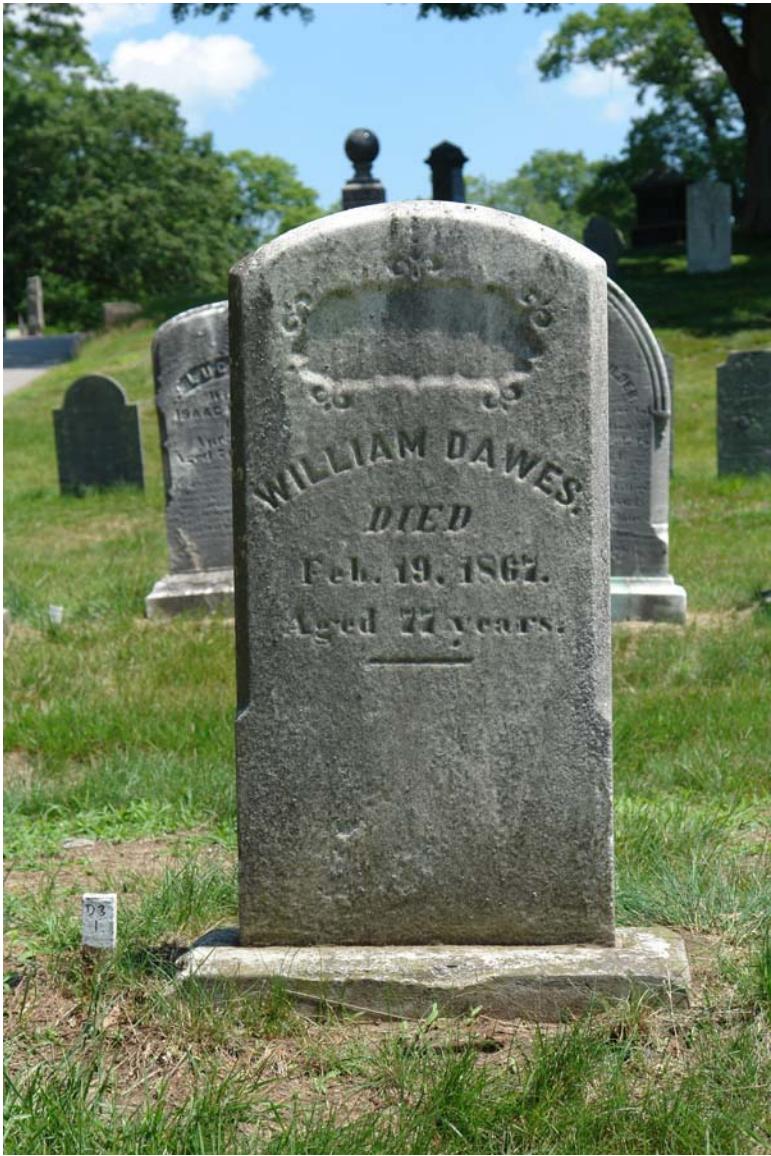
Hanover Center Cemetery, Hanover MA		
NAME ON MARKER		Amy Dawes
Death Date:	8/29/1855	Marker Type: Headstone/slotted
Cond. of Inscription:	Legible	Material: Marble
EXISTING CONDITIONS		CONSERVATION STRATEGY
Tilted		Reset plumb
TREATMENT		
Treatment Dates		6/16/2015
<div>1. Existing base located below grade while excavating for resetting. Area excavated to an appropriate depth removing any roots or large stones.</div> <div>2. Base inspected and found to be sound and re-useable</div> <div>3. Base is aligned with adjacent markers and re-set level.</div> <div>4. Area around base was backfilled with tamped gravel and re-graded with existing topsoil</div> <div>5. Debris removed from setting slot. When required, power grinders were used to facilitate removal of stone fragments.</div> <div>6. When required, the lower setting edge was re-squared by power grinder with minimal loss.</div> <div>7. Marker reset plumb and level into setting slot with cement/lime grout (3/2/9) with 000 sand made fluid with a super plasticizer.</div> <div>8. Excess grout removed and joint area cleaned.</div> <div>9. Marker braced for a minimum 3 days</div>

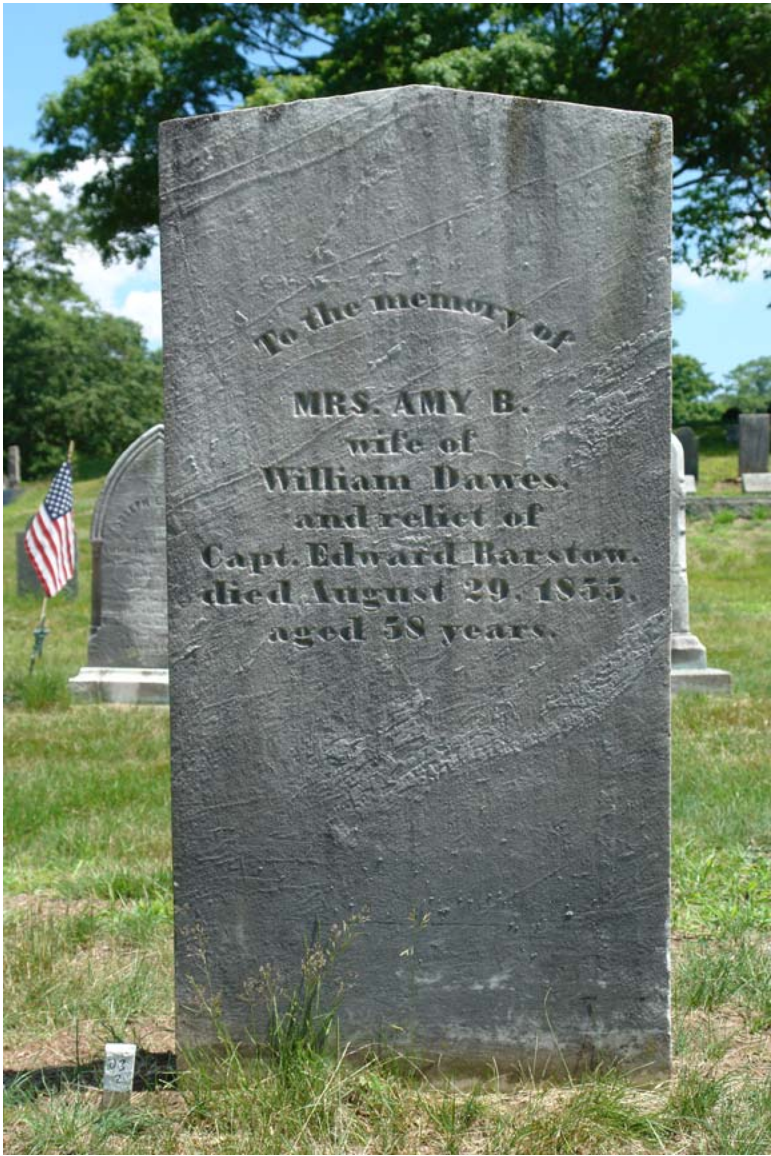
Hanover Center Cemetery, Hanover MA
NAME ON MARKER **George Tolman**
Death Date: 1887 Marker Type: Headstone/pinned
Cond. of Inscription: Legible Material: Marble

EXISTING CONDITIONS	CONSERVATION STRATEGY
Fallen off base	Level base if required Reset elements

TREATMENT	Treatment Dates
1. Elements removed from setting bases and inspected for soundness. 2. Area excavated to an appropriate depth removing any roots or large stones. 3. Base is aligned with adjacent markers and re-set level. 4. Area around base was backfilled with tamped gravel and re-graded with existing topsoil 5. Failed mortar removed from setting area and bottom of marker 6. When required, any existing pins were inspected, and if necessary, replaced with stainless steel threaded pins 7. Setting surfaces primed with Acryl 60 diluted 1:3 with water. 8. Marker reset plumb onto base with cement/lime mortar (3/2/9) with 000 sand. 9. Excess grout removed and joint area cleaned.	6/17/2015
