MONUMENT CONSERVATION COLLABORATIVE LLC, NORFOLK, CT

DOCUMENTATION OF STONE CONSERVATION TREATMENTS TO ASSINIPPI CEMETERY, HANOVER, MA June 2015

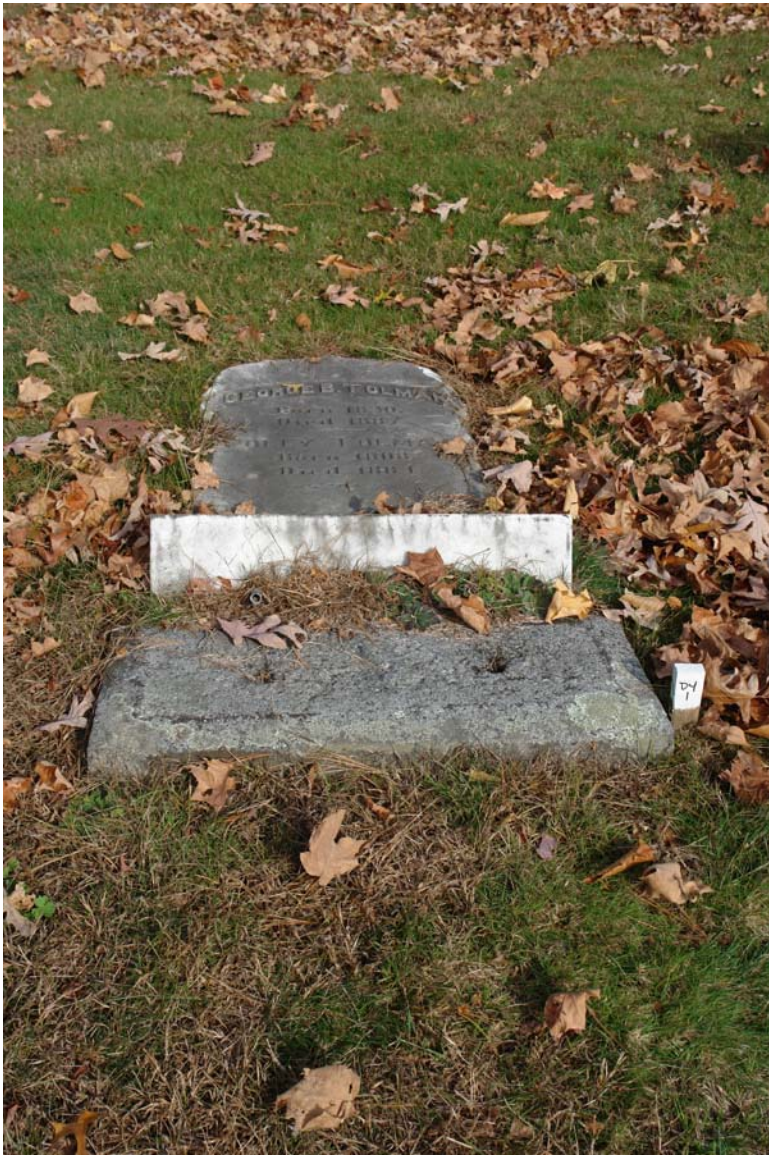
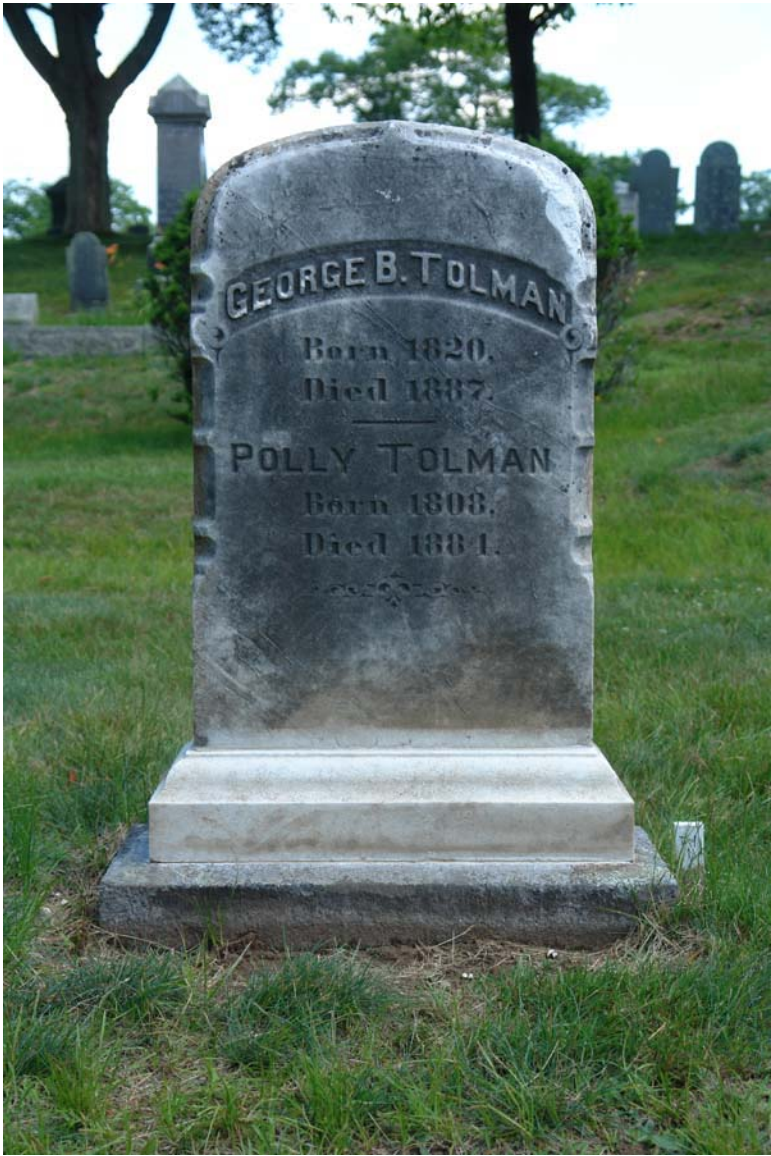
Hanover Center Cemetery, Hanover MA	
NAME ON MARKER Sarah Wilder	
Death Date: 9/28/1836	Marker Type: Headstone/pinned
Cond. of Inscription: Legible	Material: Marble
EXISTING CONDITIONS	CONSERVATION STRATEGY
Loose on base	Level base if required Reset elements
TREATMENT	
Treatment Dates 6/17/2015	
<div>1. Inspect marker for soundness , restore as necessary.</div> <div>2. If base is tilted, excavate area around in-ground base. Align base with adjacent markers and re-set level at appropriate height onto a gravel bed. Backfill with tamped gravel and re-grade area.</div> <div>3. Remove any failed mortar from setting surfaces w/ hand tools.</div> <div>4. If required, replace setting pins with threaded stainless pins.</div> <div>5. If necessary, treat setting surfaces with D/2 biological solution, scrub with nylon brushes, and fully rinse with water</div> <div>6. Prime setting surfaces with Acryl 60 diluted 1:3 with water.</div> <div>7. Re-set base elements and reset marker plumb onto base with 2:1:8 cementitious high cal lime mortar using fine (00 or 000) sand. Use lead shims if necessary to plumb marker.</div> <div>8. Remove excess mortar from joints.</div>

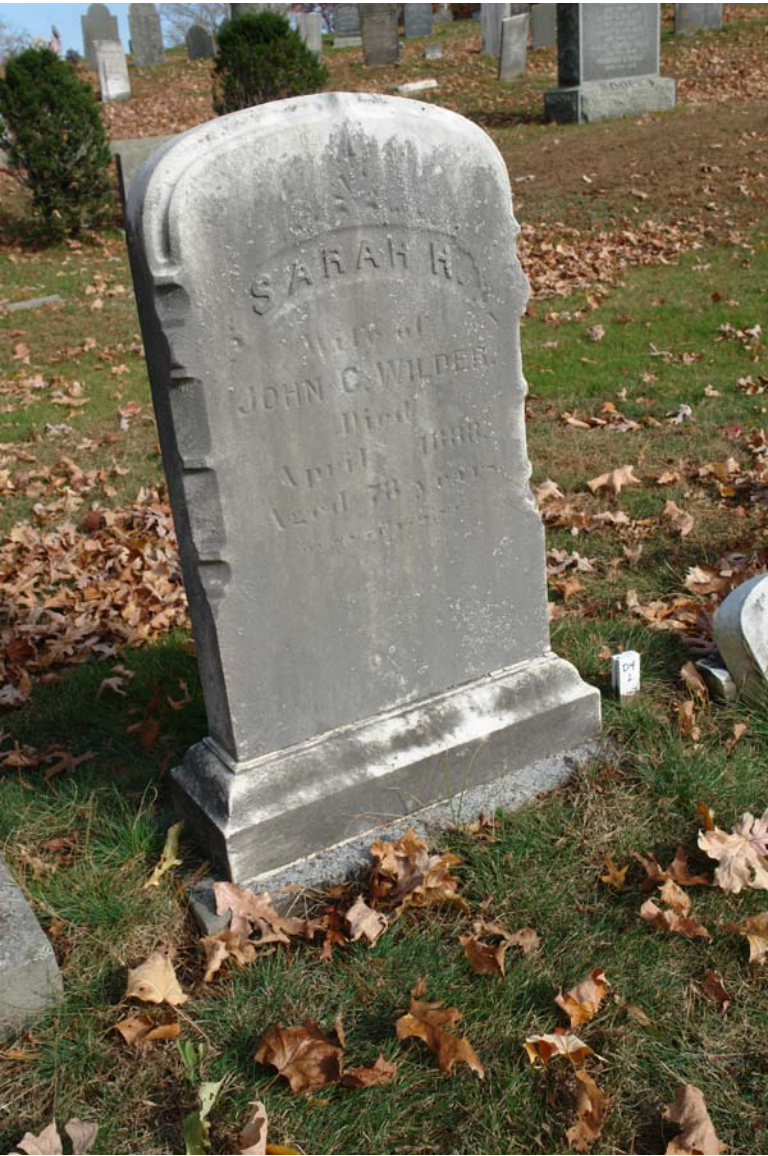
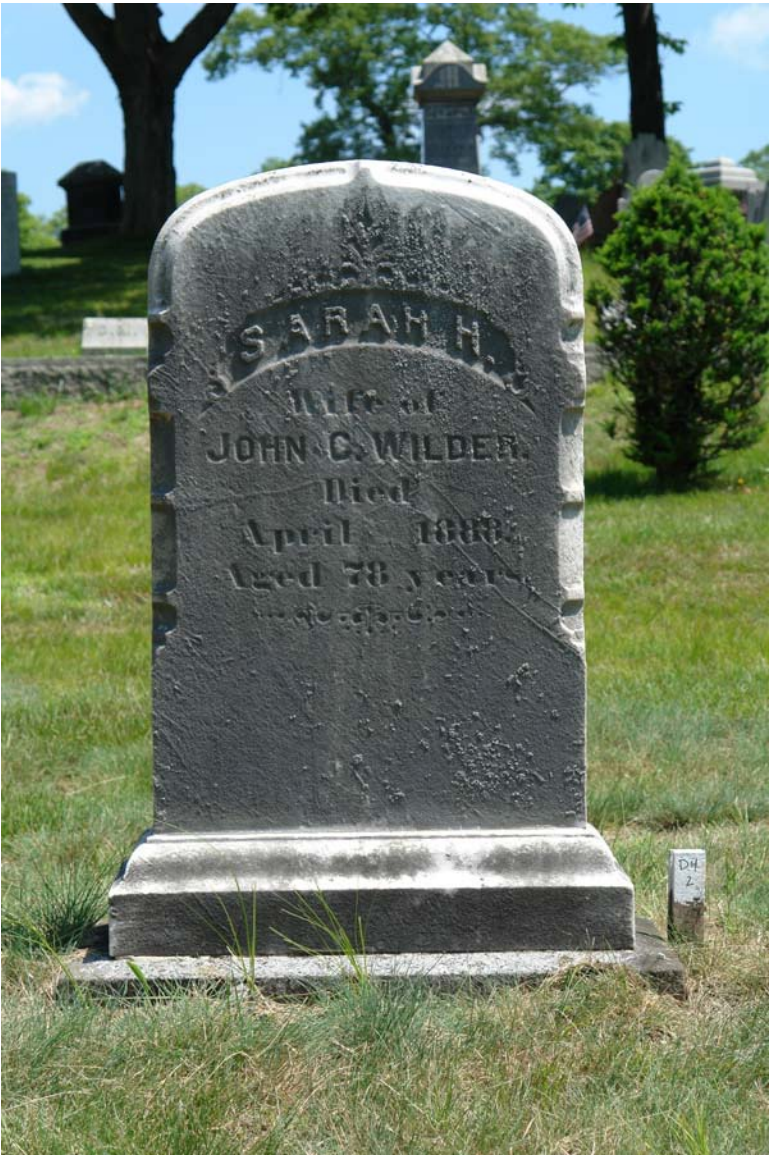
Hanover Center Cemetery, Hanover MA					
NAME ON MARKER	Lucinda Wilder				
Death Date: 8/2/1871	Marker Type: Sm mon./pinned				
Cond. of Inscription: Legible	Material: Marble				
EXISTING CONDITIONS	CONSERVATION STRATEGY				
Tilted base	Reset base with marker plumb				
<table><tr><td>TREATMENT</td><td>Treatment Dates 6/17/2015</td></tr><tr><td colspan="2"><div>1. Elements removed from setting bases and inspected for soundness.</div><div>2. Area excavated to an appropriate depth removing any roots or large stones.</div><div>3. Base is aligned with adjacent markers and re-set level.</div><div>4. Area around base was backfilled with tamped gravel and re-graded with existing topsoil</div><div>5. Failed mortar removed from setting area and bottom of marker</div><div>6. When required, any existing pins were inspected, and if necessary, replaced with stainless steel threaded pins</div><div>7. Setting surfaces primed with Acryl 60 diluted 1:3 with water.</div><div>8. Marker reset plumb onto base with cement/lime mortar (3/2/9) with 000 sand.</div><div>9. Excess grout removed and joint area cleaned.</div></td></tr></table>		TREATMENT	Treatment Dates 6/17/2015	<div>1. Elements removed from setting bases and inspected for soundness.</div> <div>2. Area excavated to an appropriate depth removing any roots or large stones.</div> <div>3. Base is aligned with adjacent markers and re-set level.</div> <div>4. Area around base was backfilled with tamped gravel and re-graded with existing topsoil</div> <div>5. Failed mortar removed from setting area and bottom of marker</div> <div>6. When required, any existing pins were inspected, and if necessary, replaced with stainless steel threaded pins</div> <div>7. Setting surfaces primed with Acryl 60 diluted 1:3 with water.</div> <div>8. Marker reset plumb onto base with cement/lime mortar (3/2/9) with 000 sand.</div> <div>9. Excess grout removed and joint area cleaned.</div>	
TREATMENT	Treatment Dates 6/17/2015				
<div>1. Elements removed from setting bases and inspected for soundness.</div> <div>2. Area excavated to an appropriate depth removing any roots or large stones.</div> <div>3. Base is aligned with adjacent markers and re-set level.</div> <div>4. Area around base was backfilled with tamped gravel and re-graded with existing topsoil</div> <div>5. Failed mortar removed from setting area and bottom of marker</div> <div>6. When required, any existing pins were inspected, and if necessary, replaced with stainless steel threaded pins</div> <div>7. Setting surfaces primed with Acryl 60 diluted 1:3 with water.</div> <div>8. Marker reset plumb onto base with cement/lime mortar (3/2/9) with 000 sand.</div> <div>9. Excess grout removed and joint area cleaned.</div>

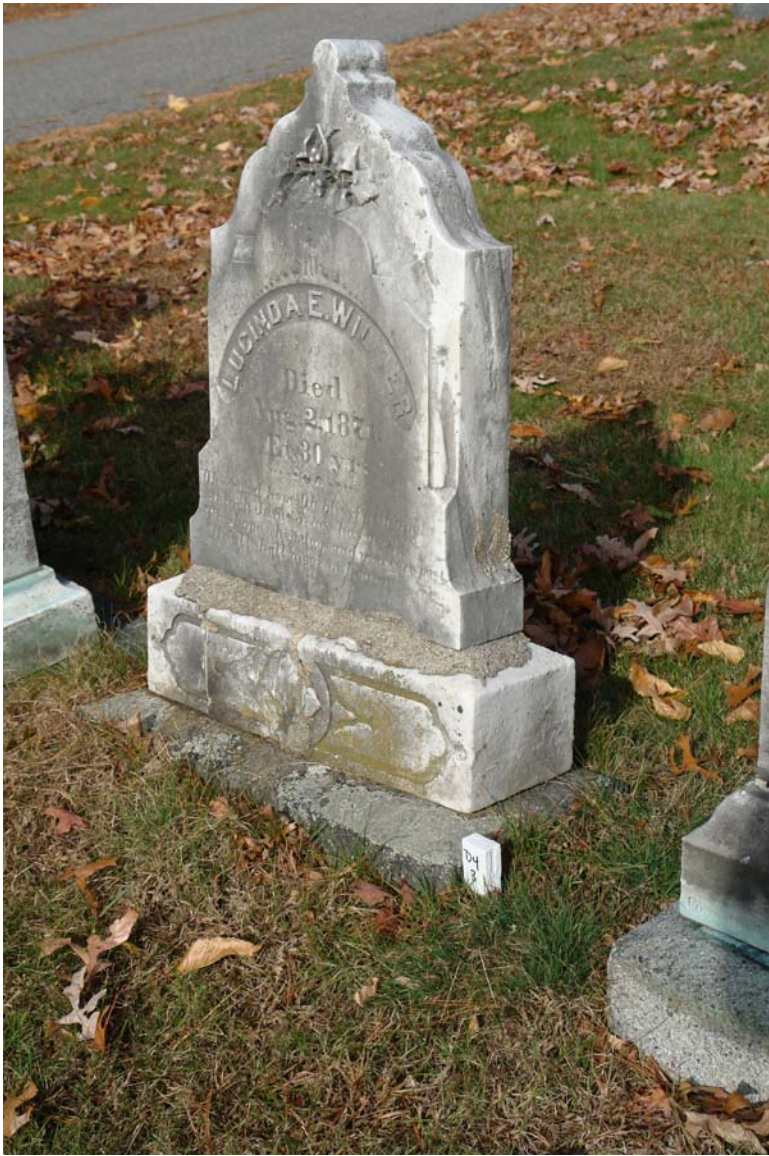
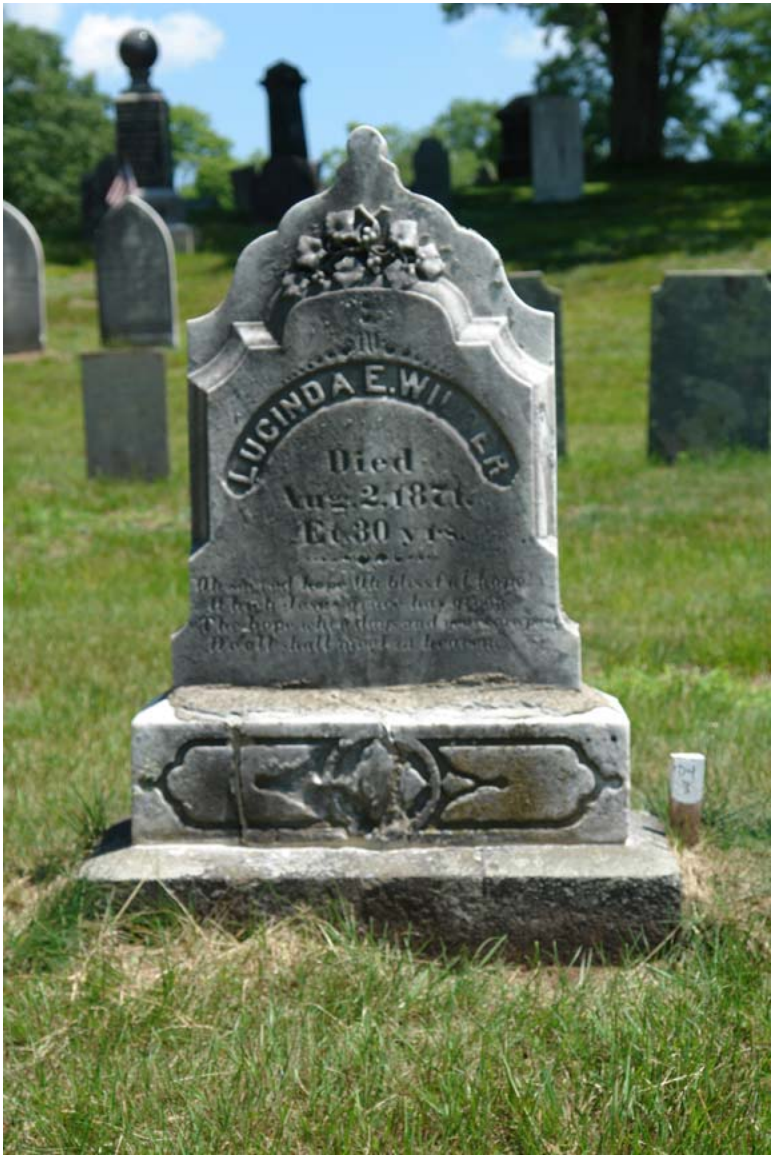
Hanover Center Cemetery, Hanover MA
NAME ON MARKER **Isaac Wilder**
Death Date: 7/1/1879 Marker Type: Headstone/pinned
Cond. of Inscription: Legible Material: Marble

EXISTING CONDITIONS	CONSERVATION STRATEGY
Fallen off base	Level base if required Reset elements

TREATMENT	Treatment Dates
6/17/2015	
<div>1. Elements removed from setting bases and inspected for soundness.</div> <div>2. Area excavated to an appropriate depth removing any roots or large stones.</div> <div>3. Base is aligned with adjacent markers and re-set level.</div> <div>4. Area around base was backfilled with tamped gravel and re-graded with existing topsoil</div> <div>5. Failed mortar removed from setting area and bottom of marker</div> <div>6. When required, any existing pins were inspected, and if necessary, replaced with stainless steel threaded pins</div> <div>7. Setting surfaces primed with Acryl 60 diluted 1:3 with water.</div> <div>8. Marker reset plumb onto base with cement/lime mortar (3/2/9) with 000 sand.</div> <div>9. Excess grout removed and joint area cleaned.</div>

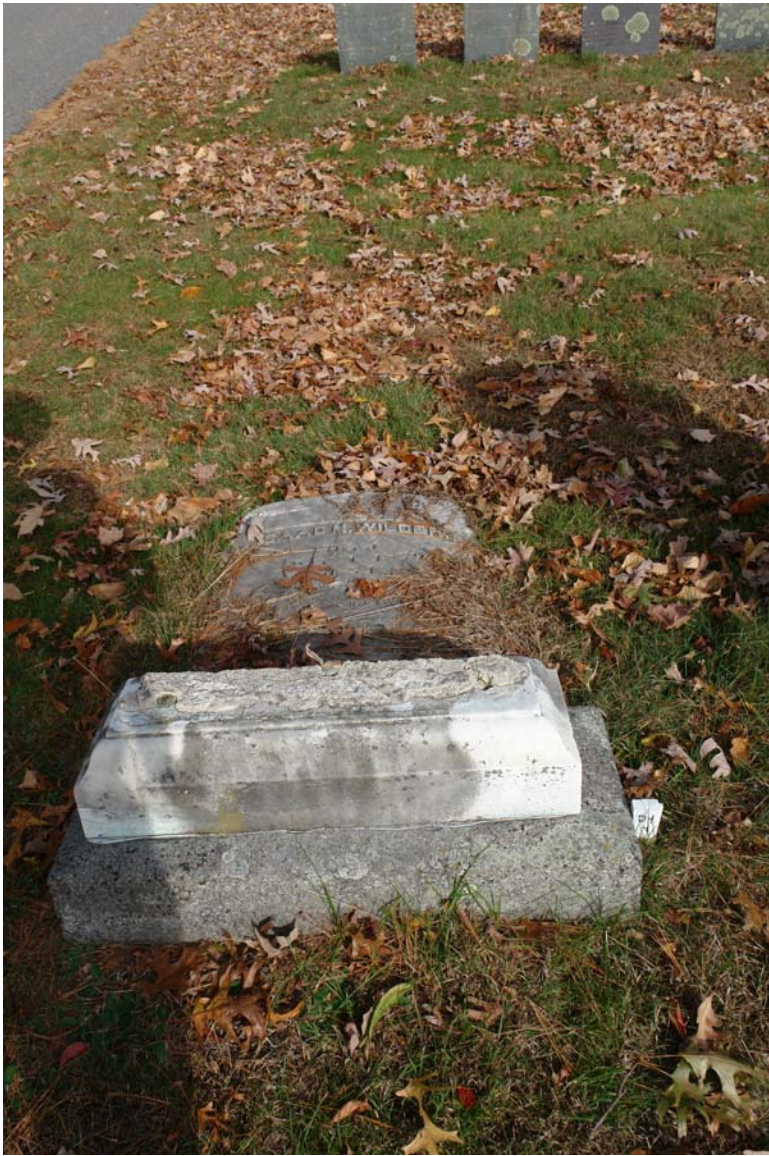
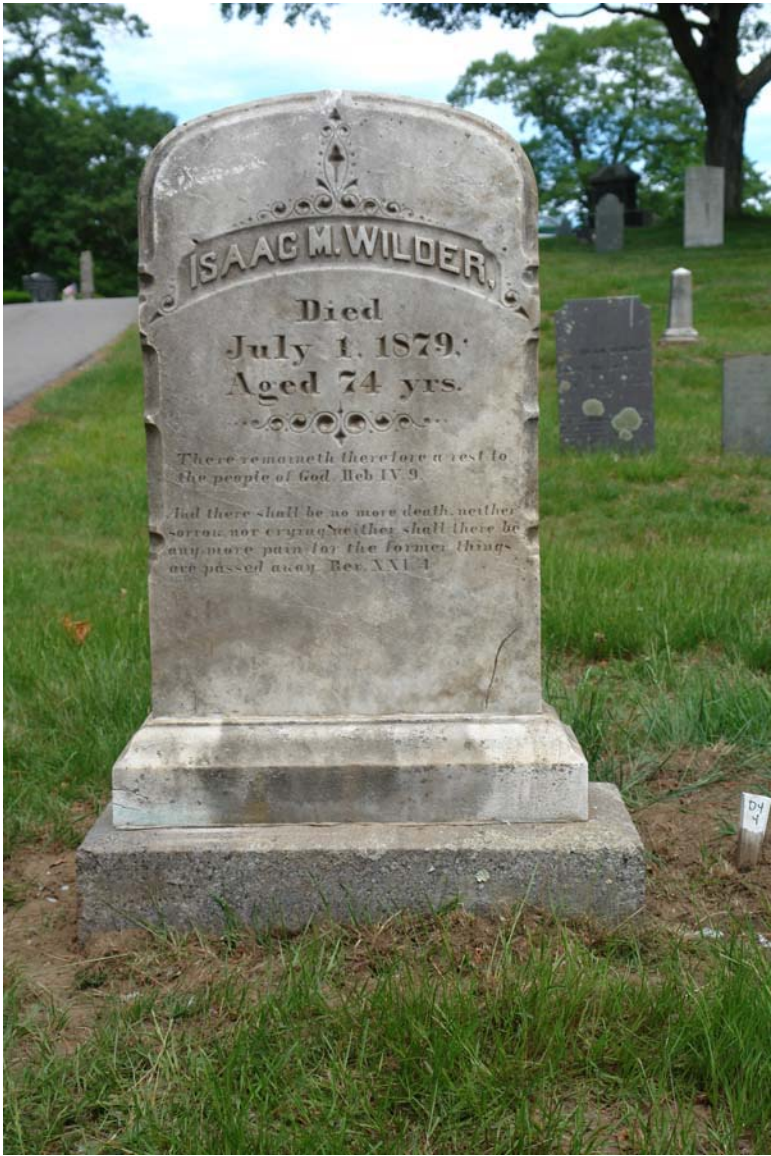
Hanover Center Cemetery, Hanover MA	
NAME ON MARKER	Caleb Wilder
Death Date: 5/22/1818	Marker Type: Headstone/conc
Cond. of Inscription: Legible	Material: Slate
EXISTING CONDITIONS	CONSERVATION STRATEGY
Fractured at grade	Reset into new below grade concrete base
TREATMENT	
Treatment Dates 6/12/2015

1. Existing base located below grade while excavating for resetting. Area excavated to an appropriate depth..	
2. Base inspected and found to be sound and re-useable

8. Excess grout removed and joint area cleaned.	
9. Marker braced for a minimum 3 days	
10. Surface treated with D/2, scrubbed with soft brushes and rinsed with water.

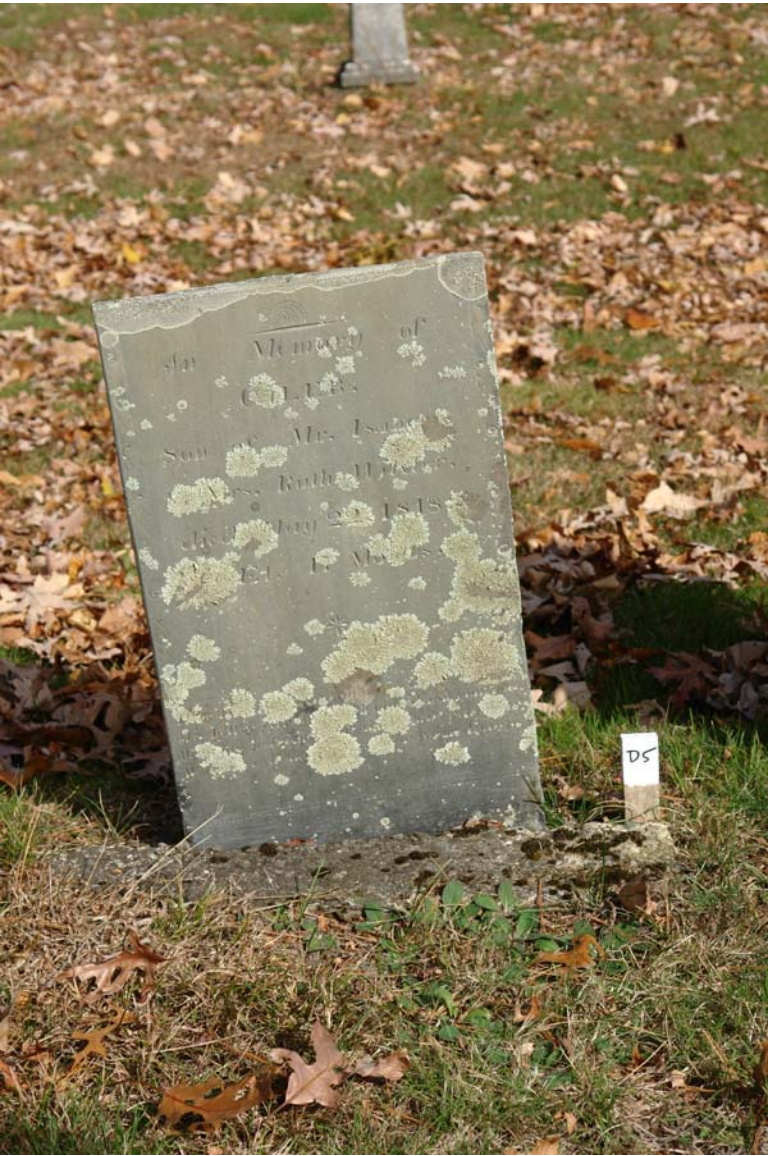
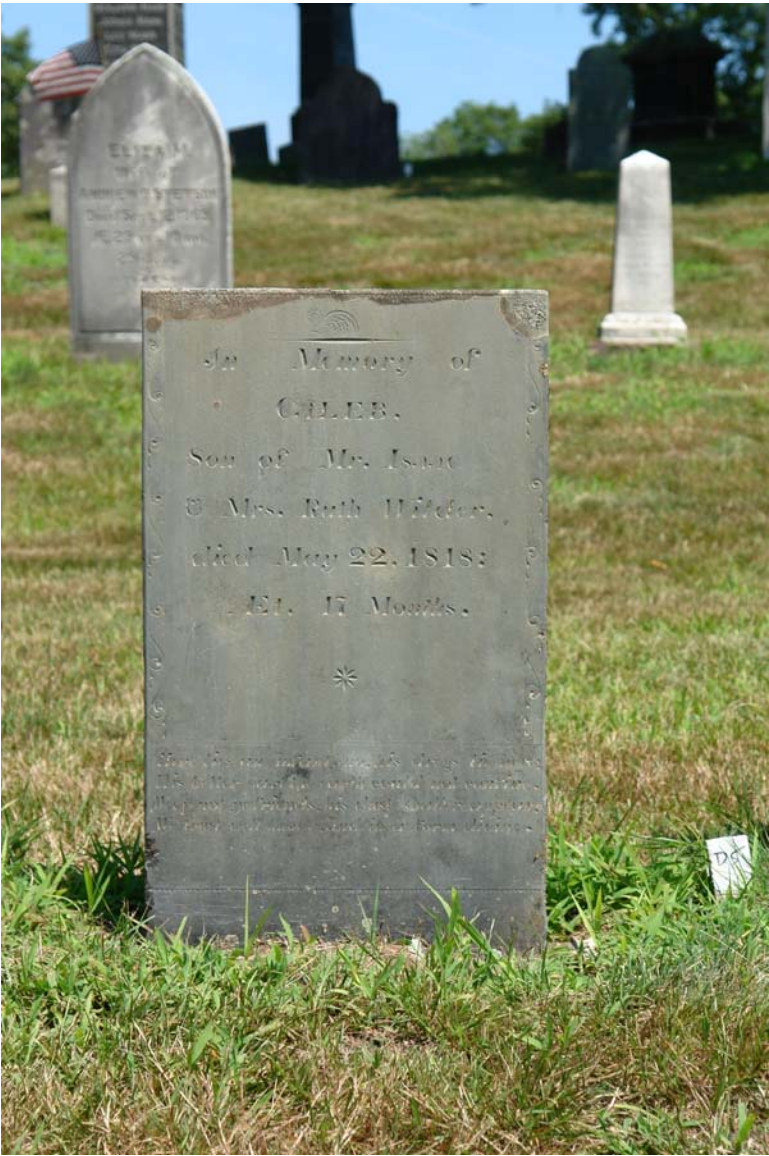
Hanover Center Cemetery, Hanover MA
NAME ON MARKER **Cordelia Stetson**
Death Date: 8/22/1860 Marker Type: Headstone/slotted
Cond. of Inscription: Legible Material: Marble

EXISTING CONDITIONS	CONSERVATION STRATEGY
Tilted Marker loose on base	Check base for level Reset marker plumb

TREATMENT	Treatment Dates
1. Area excavated to an appropriate depth removing any roots or large stones. 2. Base inspected and found to be sound and re-useable 3. Base is aligned with adjacent markers and re-set level. 4. Area around base was backfilled with tamped gravel and re-graded with existing topsoil 5. Debris removed from setting slot. When required, power grinders were used to facilitate removal of stone fragments. 6. When required, the lower setting edge was re-squared by power grinder with minimal loss. 7. Marker reset plumb and level into setting slot with cement/lime grout (3/2/9) with 000 sand made fluid with a super plasticizer. 8. Excess grout removed and joint area cleaned. 9. Marker braced for a minimum 3 days	6/16/2015

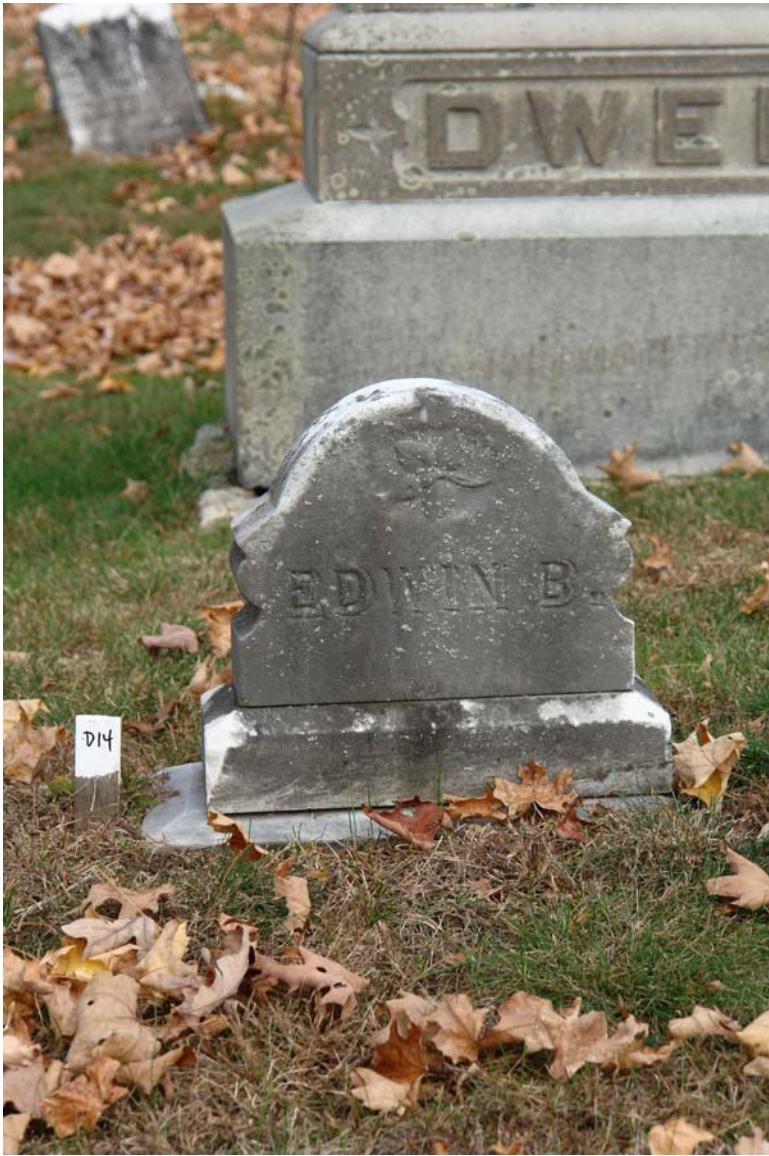
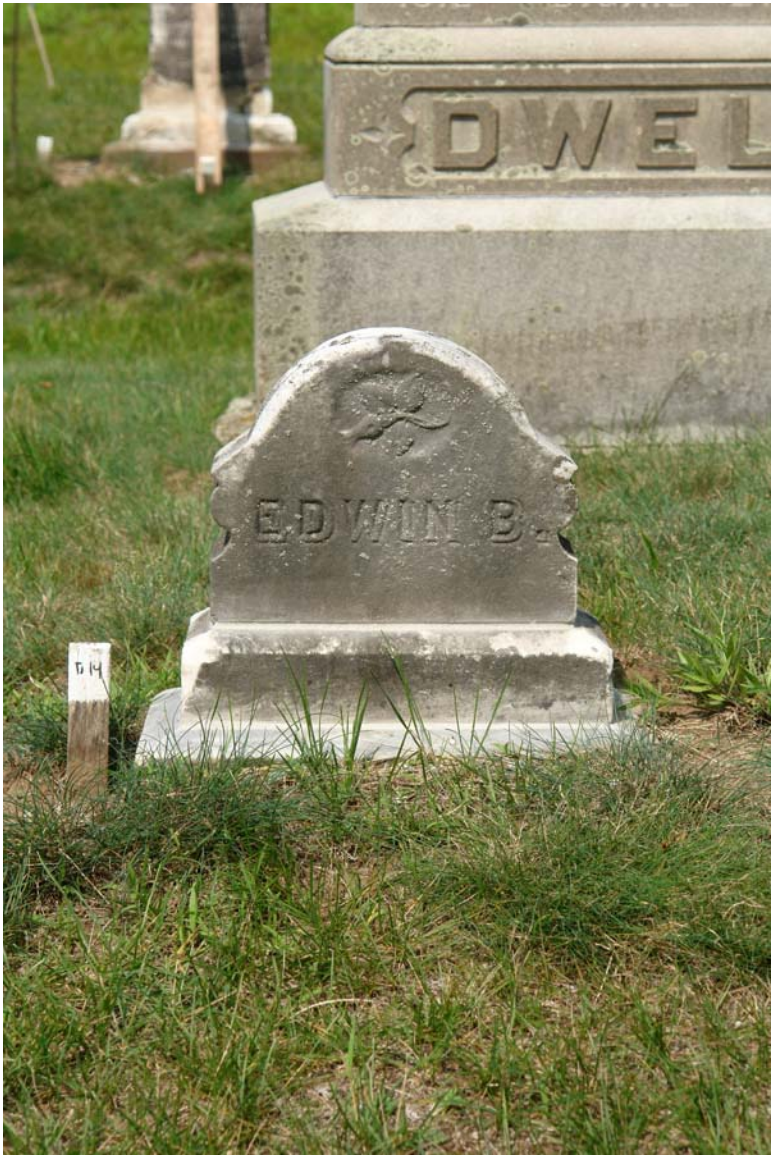
Hanover Center Cemetery, Hanover MA	
NAME ON MARKER	Edwin B. (Dwelly)
Death Date: -	Marker Type: Sm marker/base
Cond. of Inscription: Legible	Material: Marble

EXISTING CONDITIONS	CONSERVATION STRATEGY
Tilted Marker loose on base	Check base for level Reset marker plumb

TREATMENT	Treatment Dates 6/23/2015
<div>1. Elements removed from setting bases and inspected for soundness.</div> <div>2. Area excavated to an appropriate depth removing any roots or large stones.</div> <div>3. Base is aligned with adjacent markers and re-set level.</div> <div>4. Area around base was backfilled with tamped gravel and re-graded with existing topsoil</div> <div>5. Failed mortar removed from setting area and bottom of marker</div> <div>6. When required, any existing pins were inspected, and if necessary, replaced with stainless steel threaded pins</div> <div>7. Setting surfaces primed with Acryl 60 diluted 1:3 with water.</div> <div>8. Marker reset plumb onto base with cement/lime mortar (3/2/9) with 000 sand.</div> <div>9. Excess grout removed and joint area cleaned.</div>

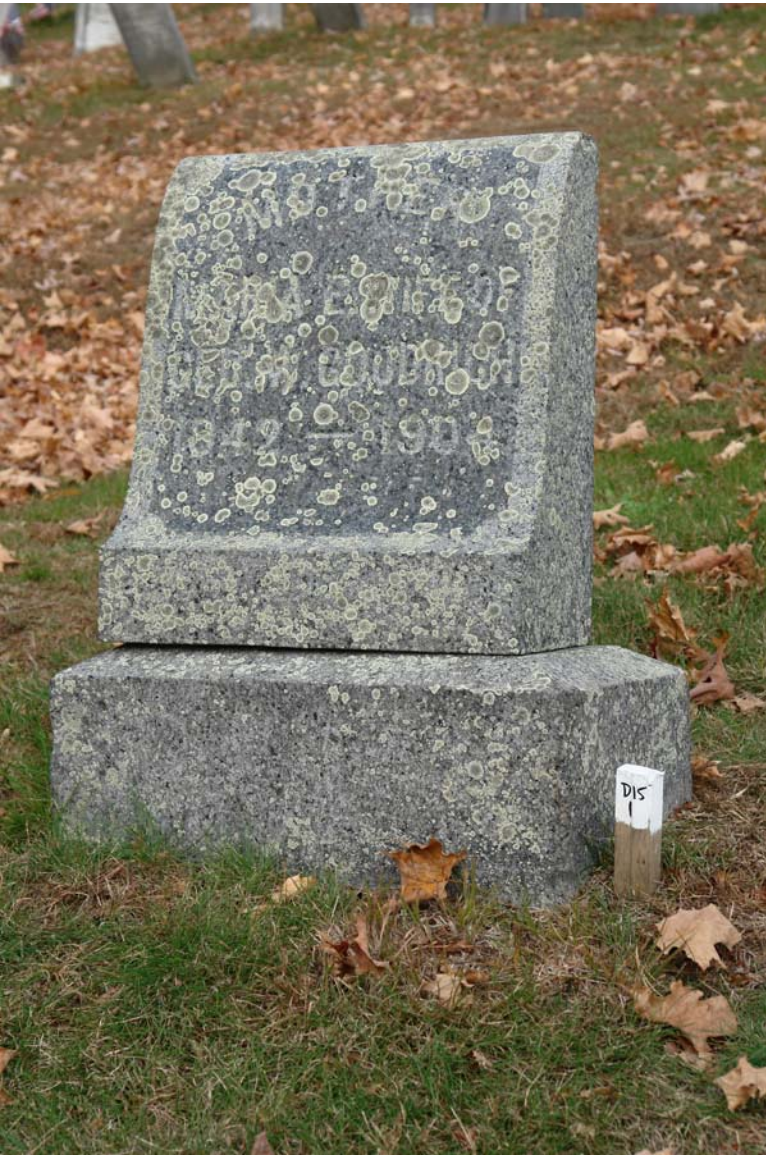
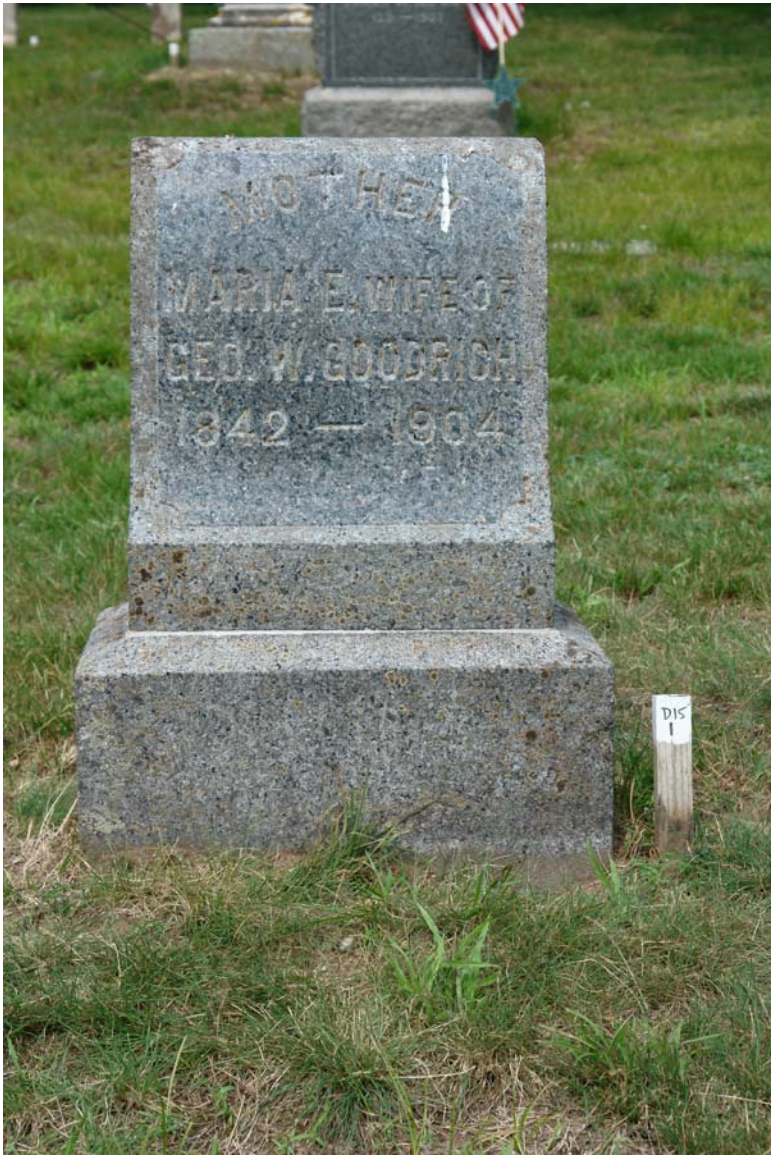
Hanover Center Cemetery, Hanover MA

EXISTING CONDITIONS	CONSERVATION STRATEGY
Tilted base	Reset base with marker plumb

5. Failed mortar removed from setting area and bottom of marker

6. When required, any existing pins were inspected, and if necessary, replaced with stainless steel threaded pins

9. Excess grout removed and joint area cleaned.

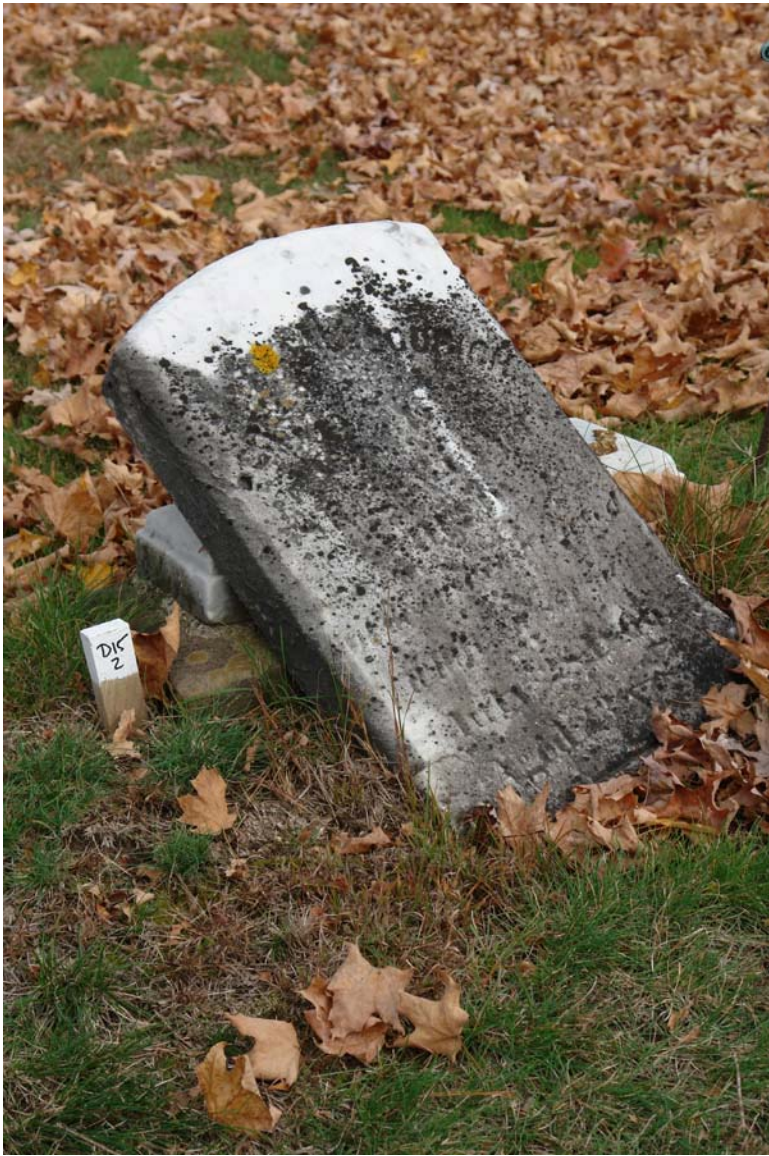
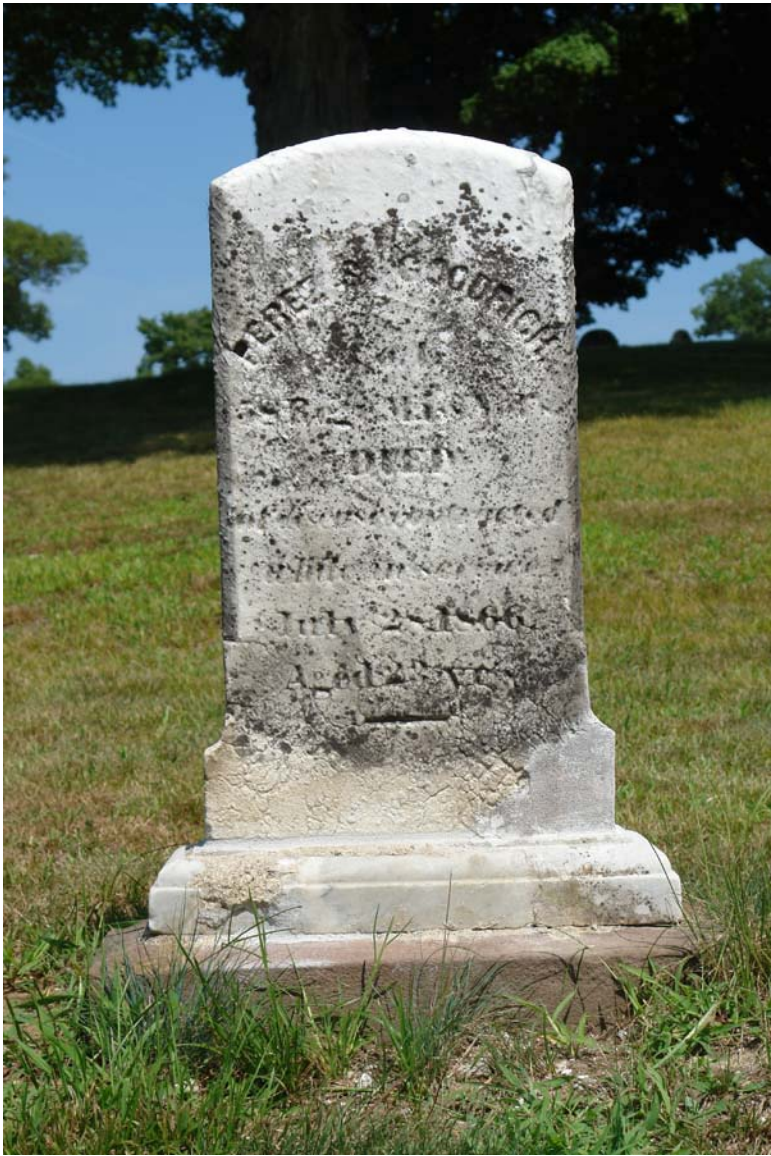
Hanover Center Cemetery, Hanover MA	
NAME ON MARKER	George Goodrich
Death Date: 7/28/1866	Marker Type: Headstone/base
Cond. of Inscription: Mostly decipherable Material: Marble	
EXISTING CONDITIONS	CONSERVATION STRATEGY
Fallen off base	Level base if required Reset elements

TREATMENT	Treatment Dates 6/22-7/7/2015
<div>1. Area excavated to an appropriate depth removing any roots or large stones aligning base with adjacent markers and re-set level.</div> <div>2. Setting surfaces cleaned with water and any failed adhesives or mortar removed with hand tools from setting area and bottom of marker</div> <div>3. When required, any existing pins were inspected, and if necessary, replaced with stainless steel threaded pins</div> <div>4. Setting surfaces primed with Acryl 60 diluted 1:3 with water.</div> <div>5. Marker reset plumb and level onto base with cement/lime grout (3/2/9) with 000 sand. Braced for min 3 days. Excess grout removed.</div> <div>6. Losses filled with Jahn restoration mortar.</div>

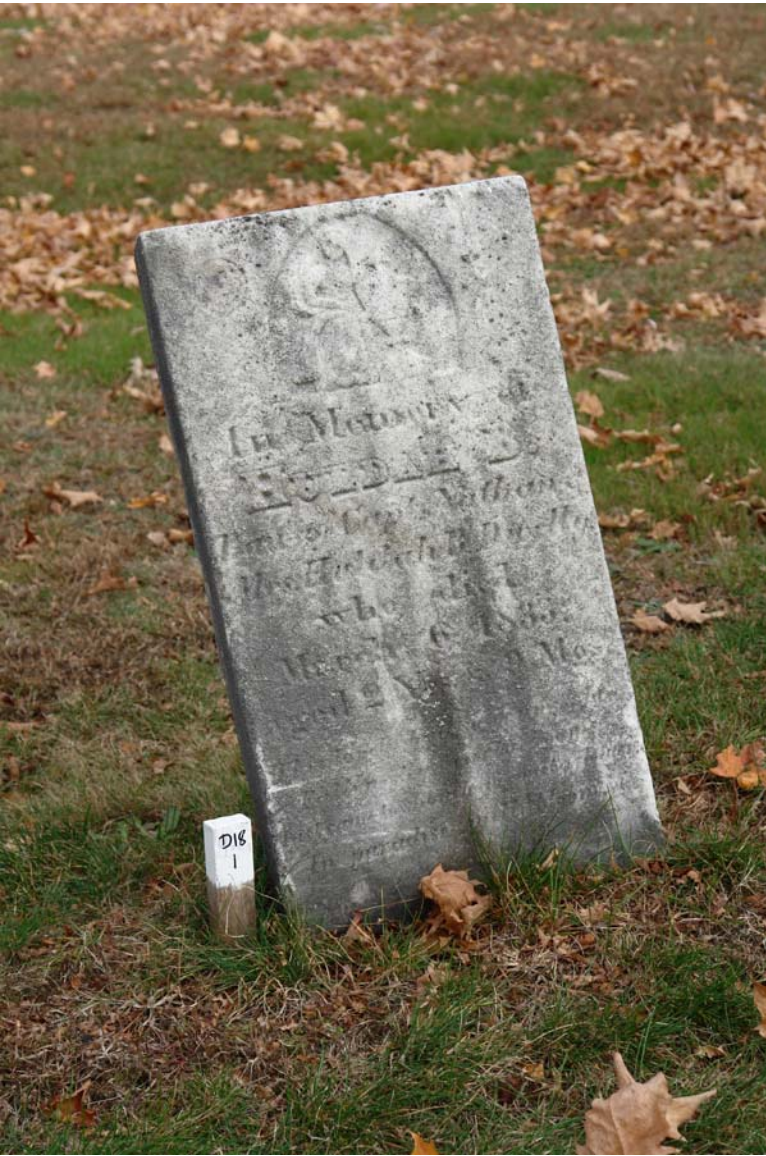
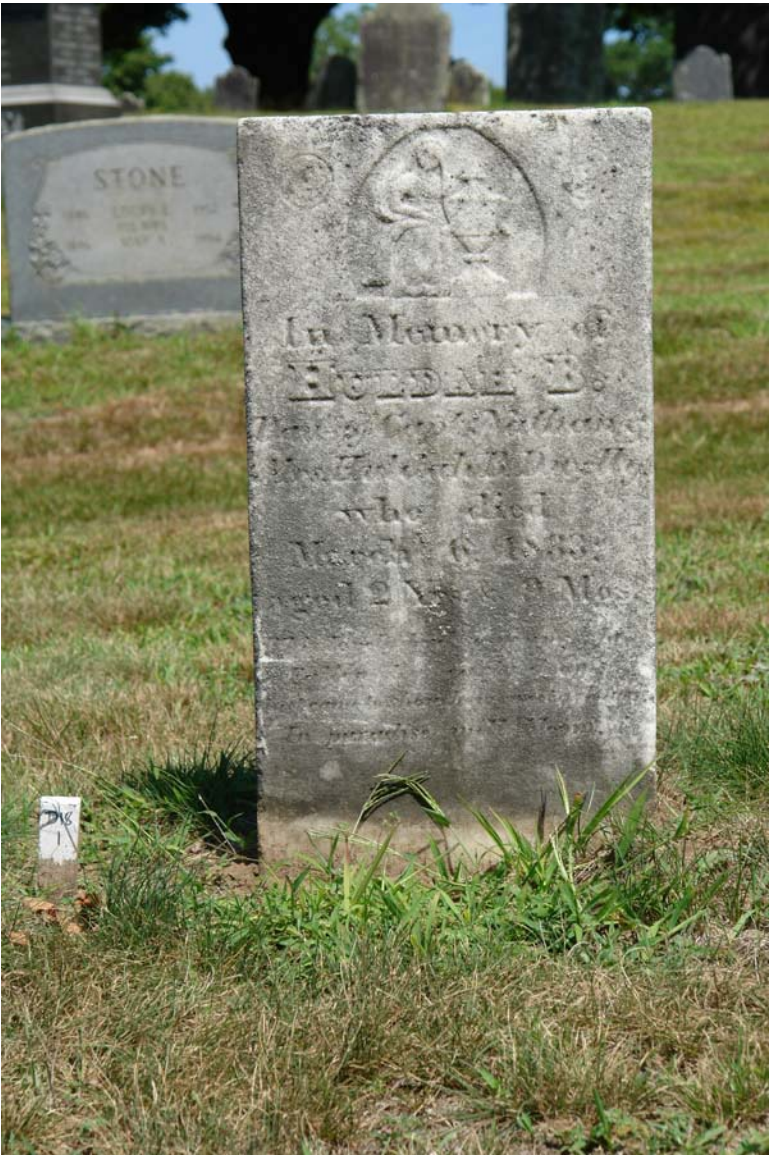
Hanover Center Cemetery, Hanover MA
NAME ON MARKER **Huldah Dwelly**
Death Date: 3/6/1883 Marker Type: Headstone/slotted base
Cond. of Inscription: Mostly decipherable Material: Marble

EXISTING CONDITIONS	CONSERVATION STRATEGY
Tilted	Reset plumb

TREATMENT	Treatment Dates 6/23/2015
<div>1. Existing base located below grade while excavating for resetting. Area excavated to an appropriate depth removing any roots or large stones.</div> <div>2. Base inspected and found to be sound and re-useable</div> <div>3. Base is aligned with adjacent markers and re-set level.</div> <div>4. Area around base was backfilled with tamped gravel and re-graded with existing topsoil</div> <div>5. Debris removed from setting slot. When required, power grinders were used to facilitate removal of stone fragments.</div> <div>6. When required, the lower setting edge was re-squared by power grinder with minimal loss.</div> <div>7. Marker reset plumb and level into setting slot with cement/lime grout (3/2/9) with 000 sand made fluid with a super plasticizer.</div> <div>8. Excess grout removed and joint area cleaned.</div> <div>9. Marker braced for a minimum 3 days</div>

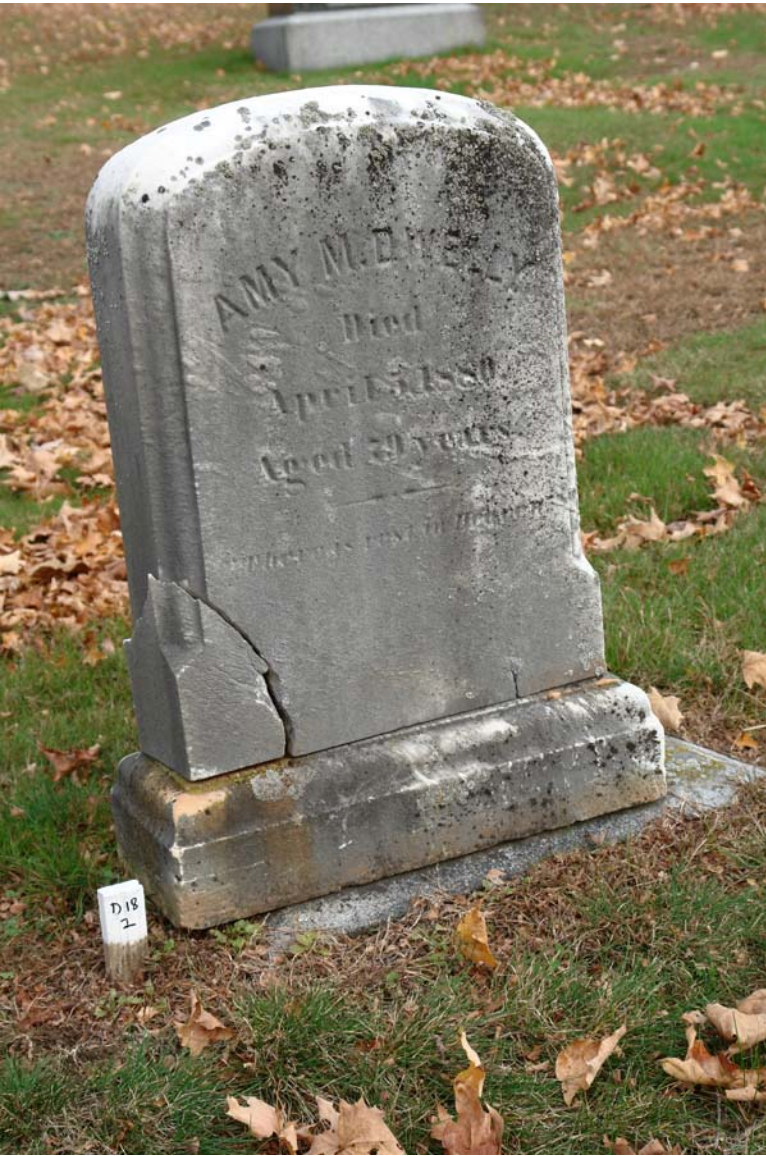
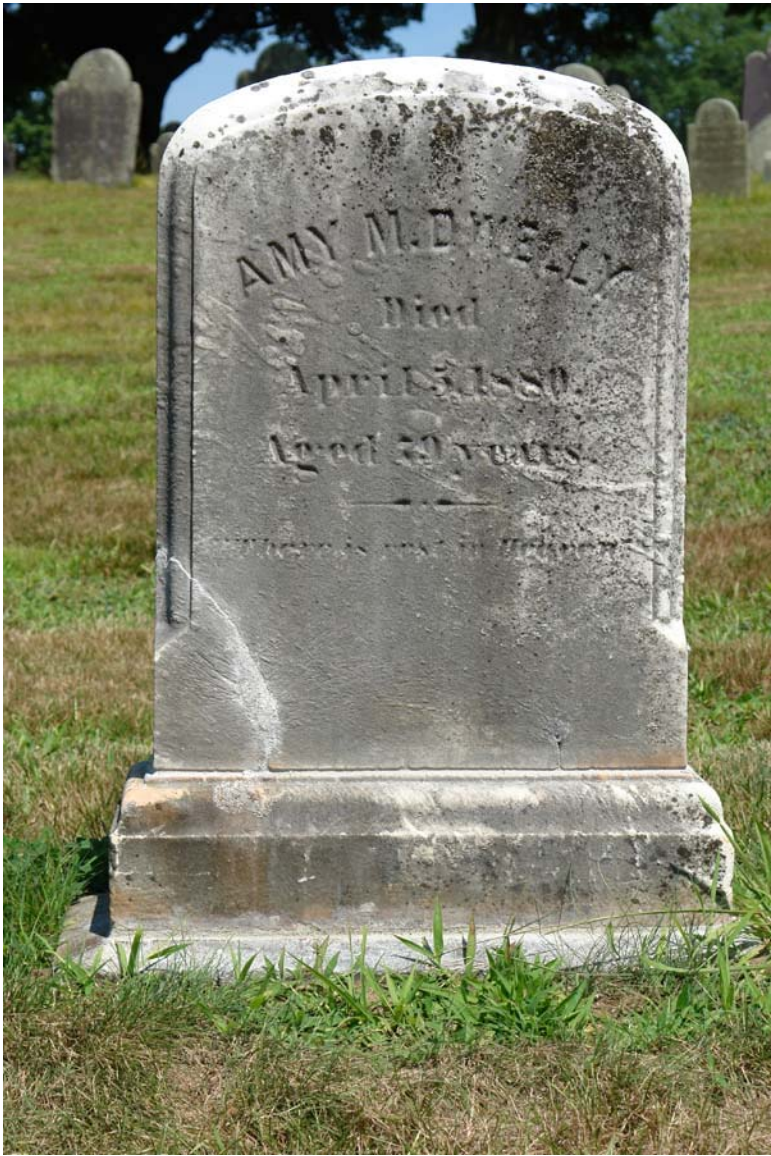
Hanover Center Cemetery, Hanover MA

EXISTING CONDITIONS	CONSERVATION STRATEGY
Fractures Loose on base	Attach fragments with structural adhesive Reset elements

2. Setting surfaces cleaned with water and any failed adhesives or mortar removed with hand tools from setting area and bottom of marker

4. When required, any existing pins were inspected, and if necessary, replaced with stainless steel threaded pins

7. Cracks and losses filled with RepliCal Marble products or Jahn restoration mortar.

9. Filled surface areas treated with light acid wash and rinsed thoroughly

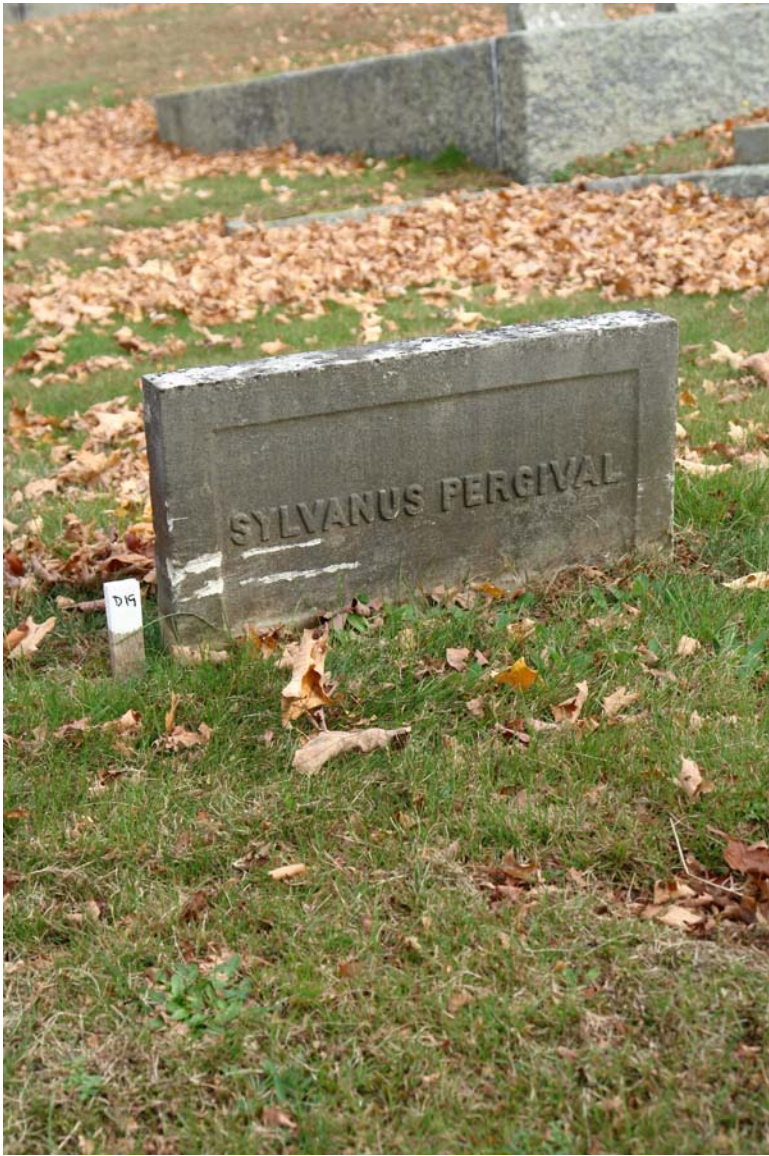
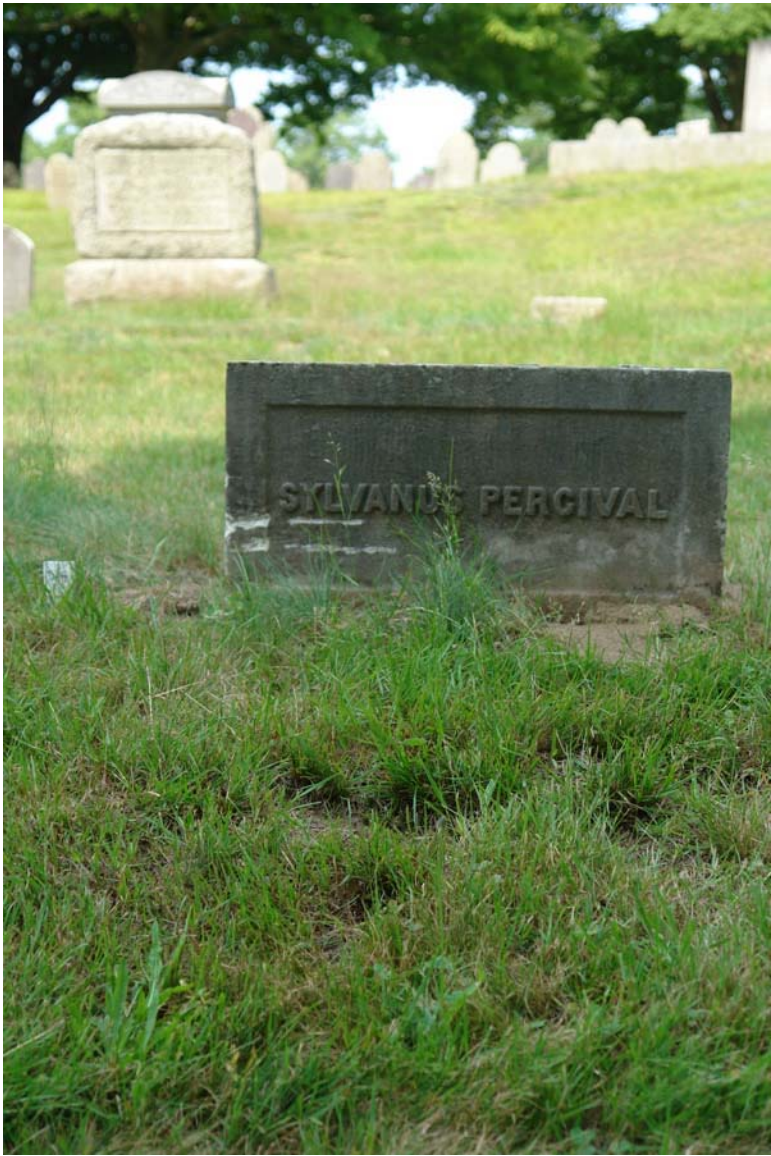
Hanover Center Cemetery, Hanover MA
NAME ON MARKER **Sylvanus Percival**
Death Date: n.a. Marker Type: Headstone
Cond. of Inscription: Legible/Buried Material: Marble

EXISTING CONDITIONS	CONSERVATION STRATEGY
Sunken	Evaluate resetting options Possible new below grade concrete base

TREATMENT	Treatment Dates
1. Existing base located below grade while excavating for resetting. Area excavated to an appropriate depth removing any roots or large stones. 2. Base inspected and found to be sound and re-useable 3. Base is aligned with adjacent markers and re-set level. 4. Area around base was backfilled with tamped gravel and re-graded with existing topsoil 5. Debris removed from setting slot. When required, power grinders were used to facilitate removal of stone fragments. 6. When required, the lower setting edge was re-squared by power grinder with minimal loss. 7. Marker reset plumb and level into setting slot with cement/lime grout (3/2/9) with 000 sand made fluid with a super plasticizer. 8. Excess grout removed and joint area cleaned. 9. Marker braced for a minimum 3 days	6/29/2015
