MONUMENT CONSERVATION COLLABORATIVE LLC, NORFOLK, CT

DOCUMENTATION OF STONE CONSERVATION TREATMENTS TO ASSINIPPI CEMETERY, HANOVER, MA June 2015

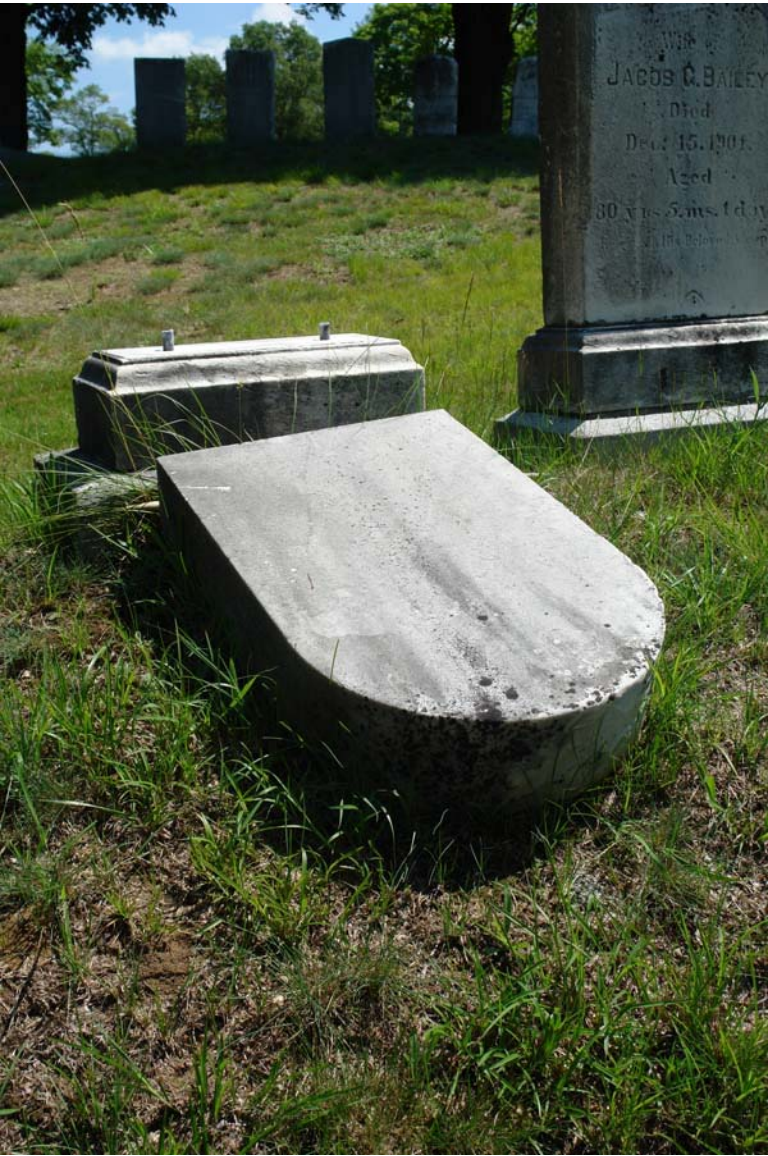
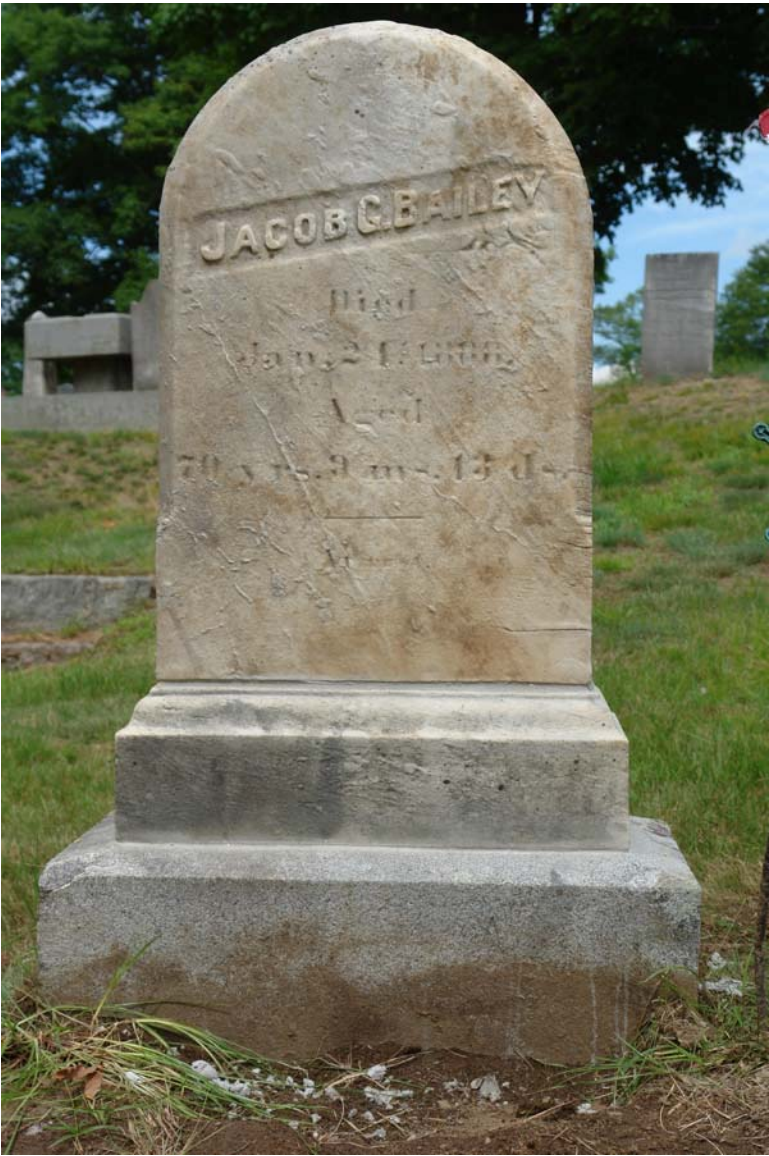
Hanover Center Cemetery, Hanover MA
NAME ON MARKER **Jacob Bailey**
Death Date: 1/21/1888 Marker Type: Headstone on base
Cond. of Inscription: Legible Material: Marble

EXISTING CONDITIONS	CONSERVATION STRATEGY
Stone recently fallen	Level base Reset elements

TREATMENT	Treatment Dates 7/14/2015
<div>1. Elements removed from setting bases and inspected for soundness. 2. Area excavated to an appropriate depth removing any roots or large stones. 3. Base is aligned with adjacent markers and re-set level. 4. Area around base was backfilled with tamped gravel and re-graded with existing topsoil 5. Failed mortar removed from setting area and bottom of marker 6. When required, any existing pins were inspected, and if necessary, replaced with stainless steel threaded pins 7. Setting surfaces primed with Acryl 60 diluted 1:3 with water. 8. Marker reset plumb onto base with cement/lime mortar (3/2/9) with 000 sand. 9. Excess grout removed and joint area cleaned.</div>

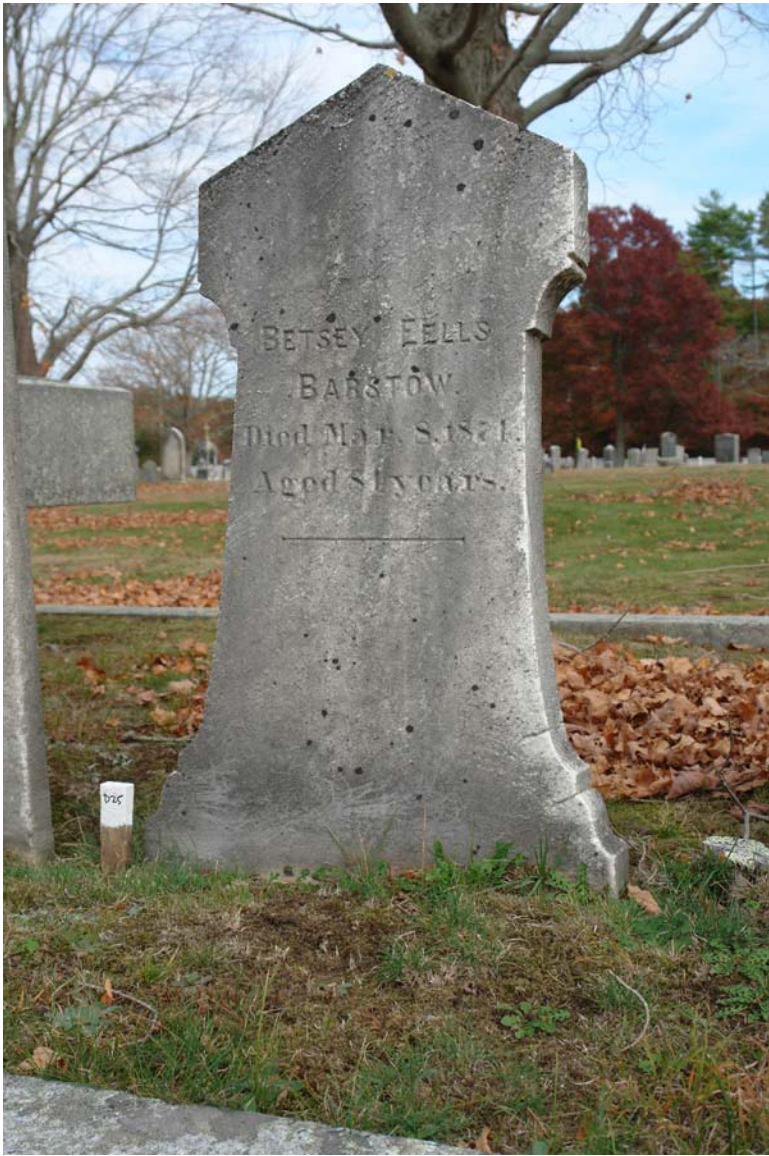
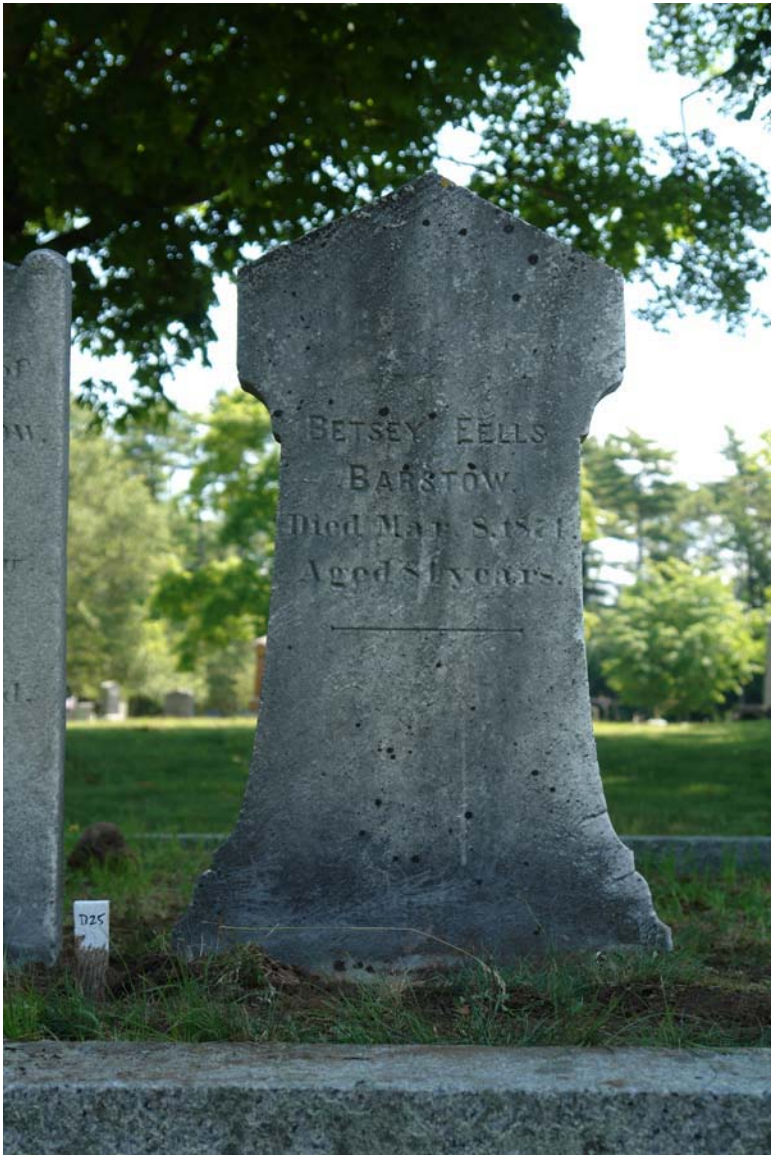
Hanover Center Cemetery, Hanover MA		
NAME ON MARKER		Betsey Bartsow
Death Date:	3/8/1871	Marker Type: Headstone
Cond. of Inscription:	Legible	Material: Marble
EXISTING CONDITIONS		CONSERVATION STRATEGY
Tilted		Reset plumb
TREATMENT		
Treatment Dates		6/30/2015
1. Marker and base found to be in sound condition with marker securely attached to base.		
2. Area excavated to an appropriate depth removing any roots or large stones.		
3. Base is aligned with adjacent markers and re-set level.		
4. Area around base was backfilled with tamped gravel and re-graded with existing topsoil

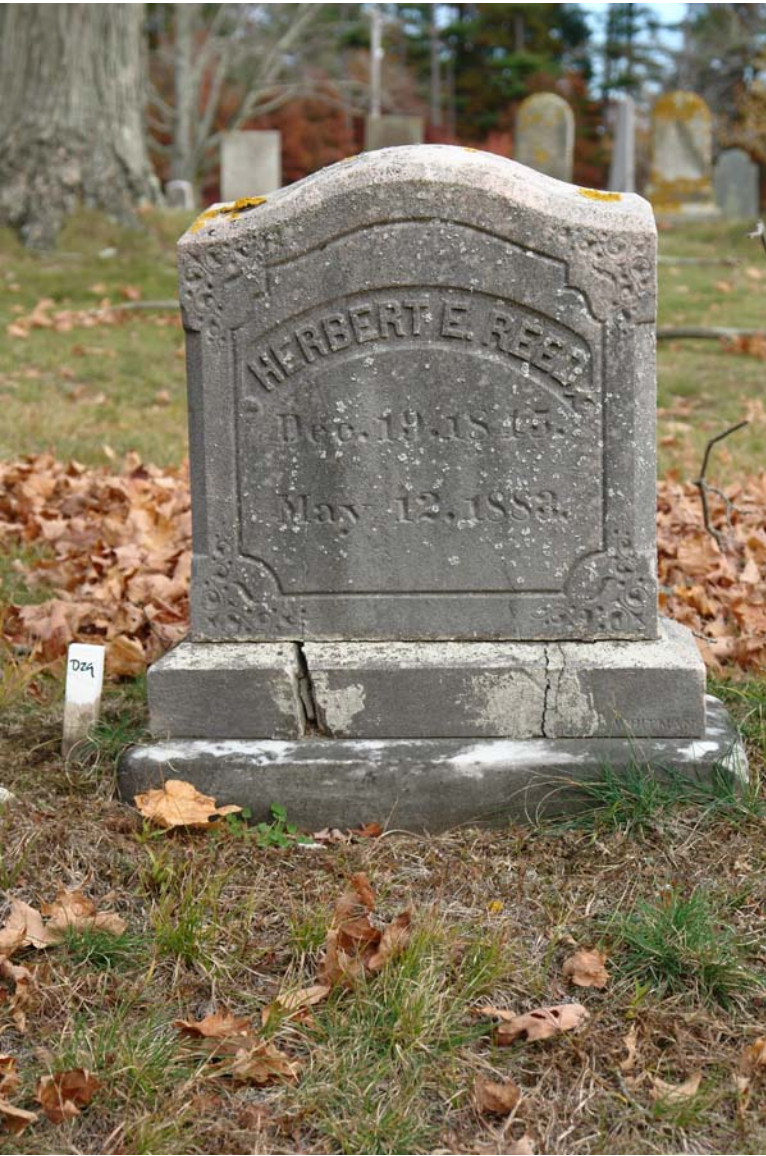
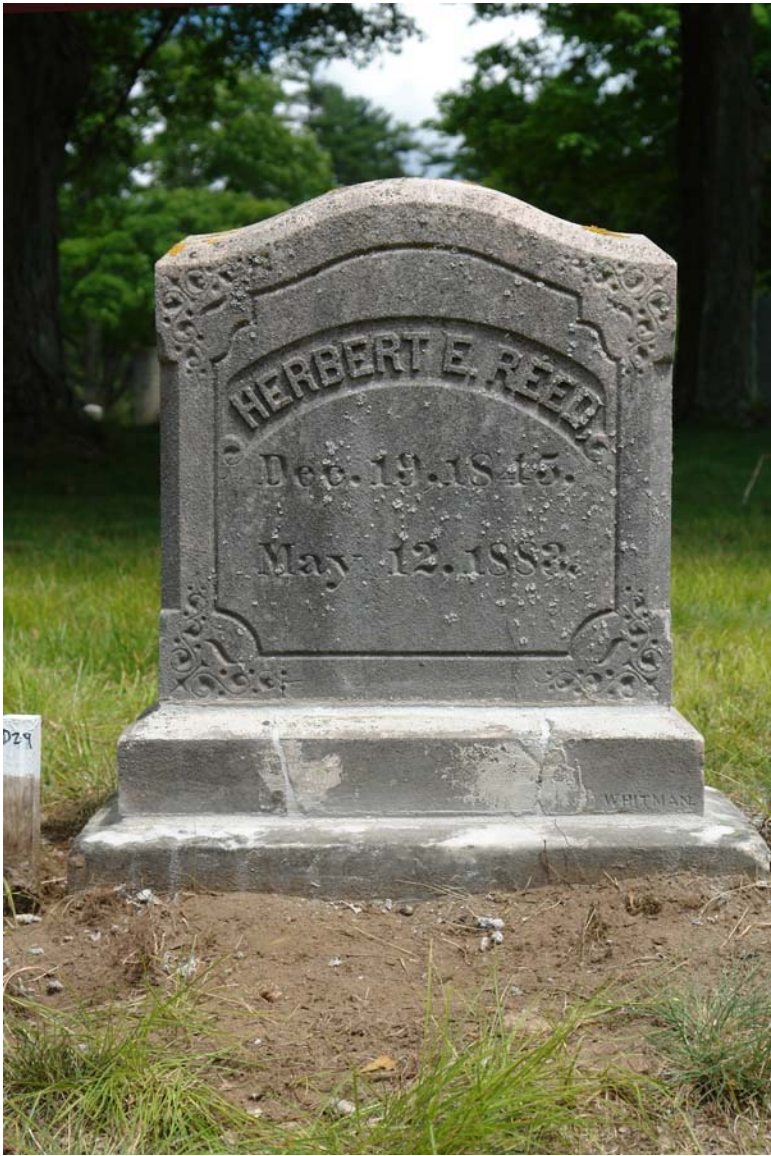
Hanover Center Cemetery, Hanover MA	
NAME ON MARKER Herbert Reed	
Death Date: 5/12/1883	Marker Type: Sm. Mon/pinned
Cond. of Inscription: Decipherable	Material: Marble
EXISTING CONDITIONS	CONSERVATION STRATEGY
Fractures Loose on base	Attach fragments with structural adhesive Reset elements
TREATMENT	
Treatment Dates 7/6-7/2015	
<div>1. Area excavated to an appropriate depth removing any roots or large stones aligning base with adjacent markers and re-set level.</div> <div>2. Setting surfaces cleaned with water and any failed adhesives or mortar removed with hand tools from setting area and bottom of marker</div> <div>3. Fragments attached with structural adhesive, clamped and braced until cured. Epoxy removed with hand chisels within 24 hours.</div> <div>4. When required, any existing pins were inspected, and if necessary, replaced with stainless steel threaded pins</div> <div>5. Setting surfaces primed with Acryl 60 diluted 1:3 with water.</div> <div>6. Marker reset plumb and level onto base with cement/lime grout (3/2/9) with 000 sand. Braced for min 3 days. Excess grout removed.</div> <div>7. Cracks and losses filled with RepliCal Marble products or Jahn restoration mortar.</div> <div>8. Filled areas misted with water and covered for 3 days minimum</div> <div>9. Filled surface areas treated with light acid wash and rinsed thoroughly</div>

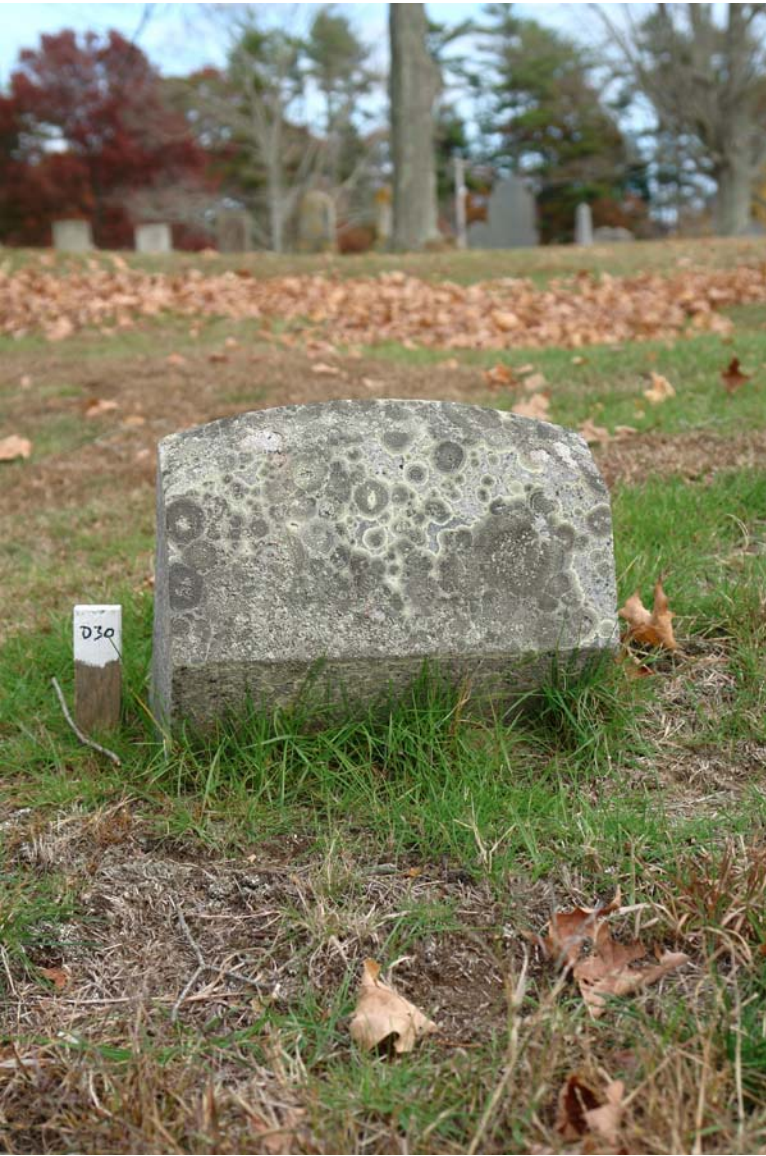
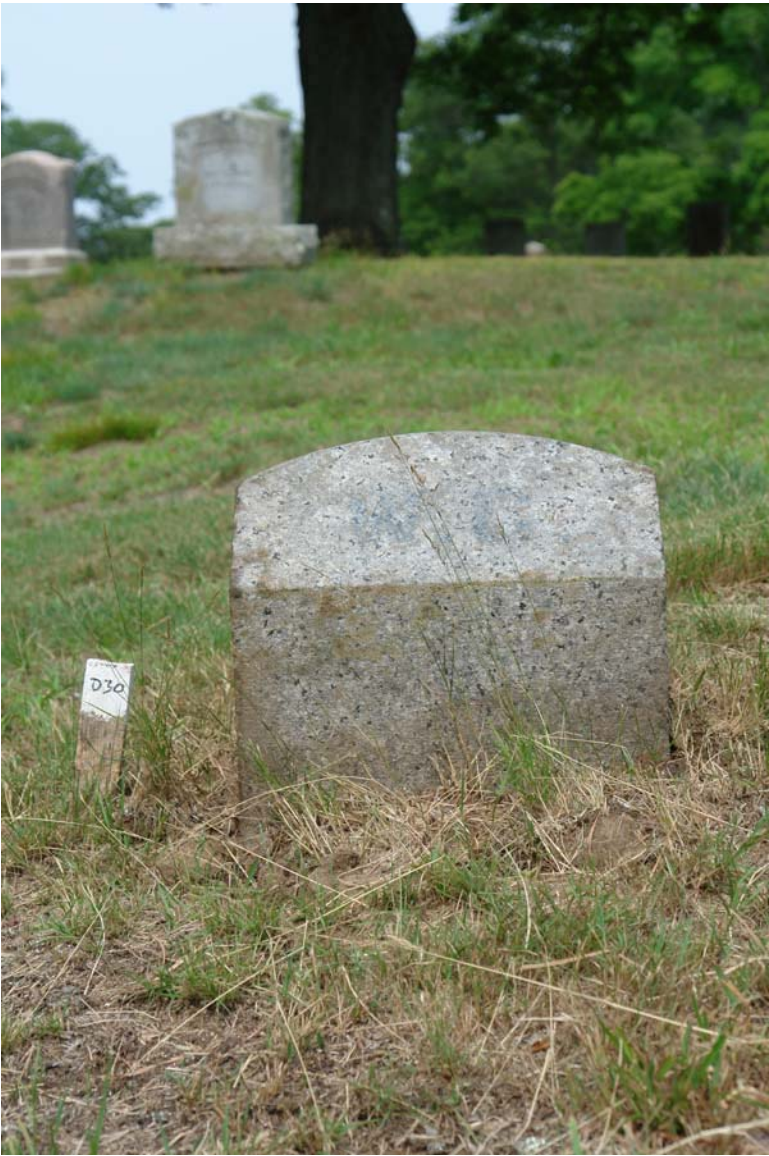
Hanover Center Cemetery, Hanover MA

EXISTING CONDITIONS	CONSERVATION STRATEGY
Tilted base	Reset base with marker plumb

6. Surface treated with D/2 Biological solution, brushed with nylon brushes and fully rinsed with water.

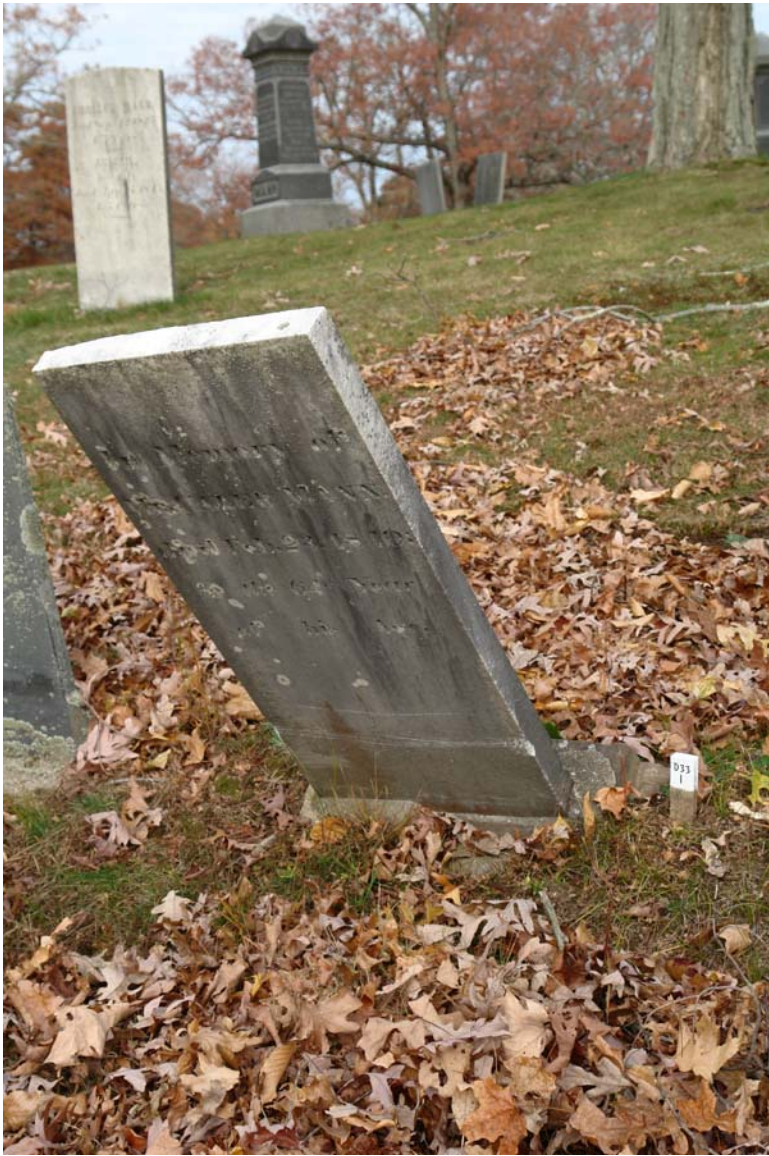
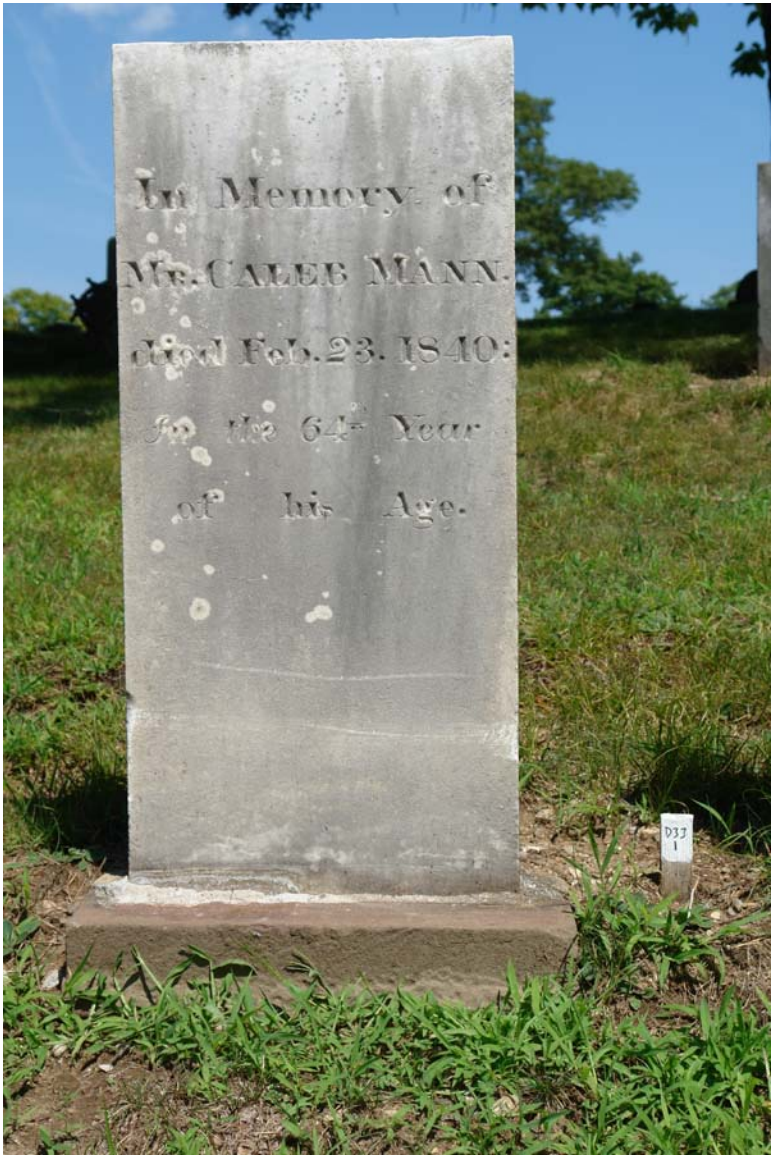
Hanover Center Cemetery, Hanover MA
NAME ON MARKER **Caleb Mann**
Death Date: 2/23/1840 Marker Type: Headstone/slotted base
Cond. of Inscription: Legible Material: Marble

EXISTING CONDITIONS	CONSERVATION STRATEGY
Tilted base	Reset base with marker plumb

TREATMENT	Treatment Dates
1. Marker and base found to be in sound condition with marker securely attached to base. 2. Area excavated to an appropriate depth removing any roots or large stones. 3. Base is aligned with adjacent markers and re-set level. 4. Area around base was backfilled with tamped gravel and re-graded with existing topsoil	6/17/2015

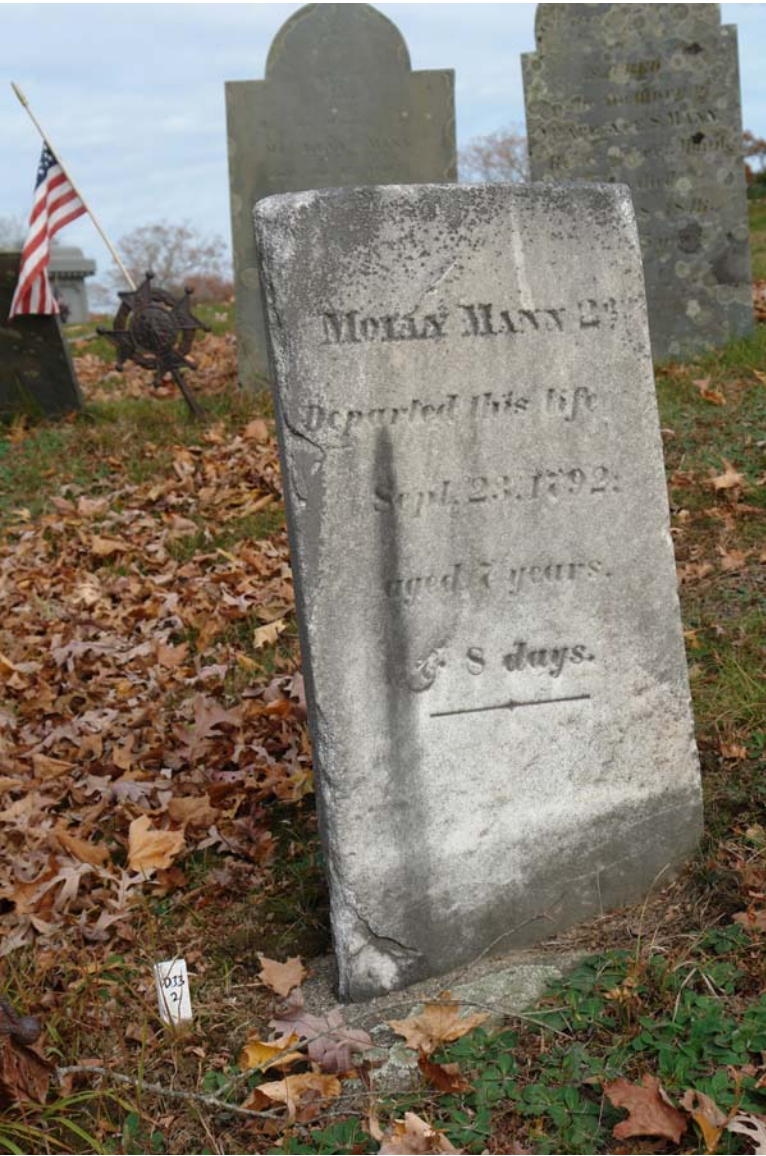
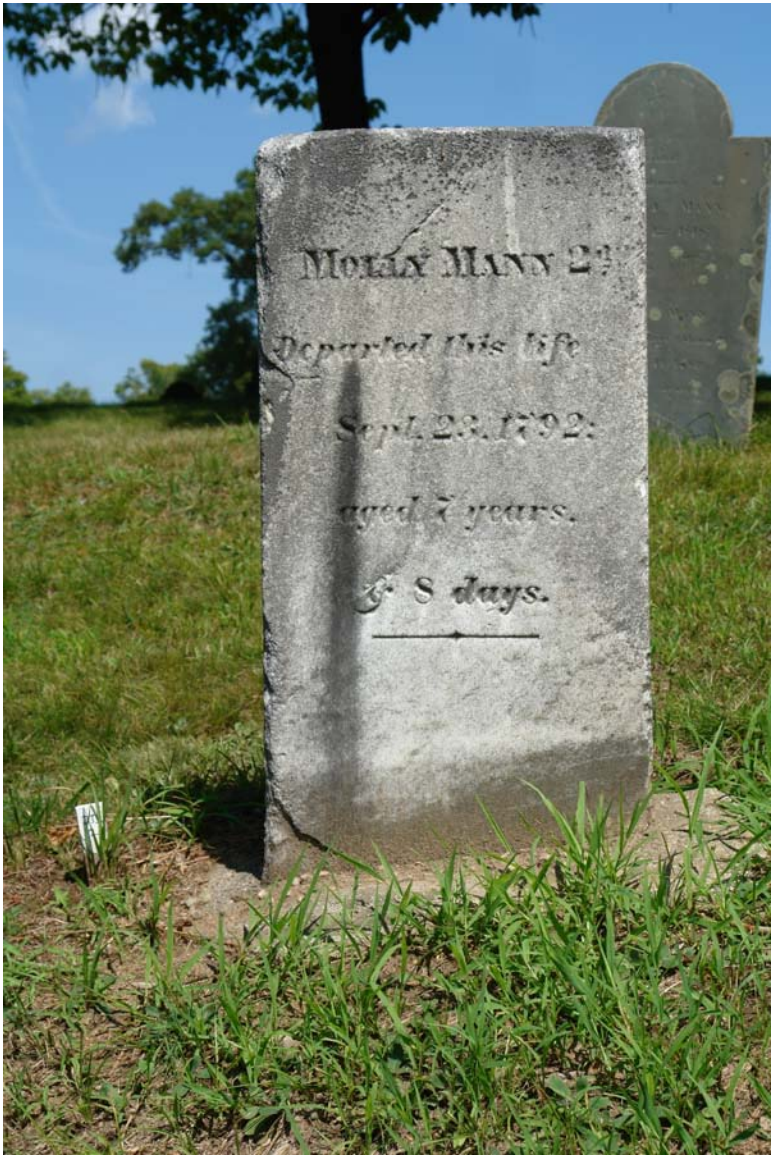
Hanover Center Cemetery, Hanover MA
NAME ON MARKER **Molly Mann**
Death Date: 9/23/1792 Marker Type: Headstone/concrete
Cond. of Inscription: Legible Material: Marble

EXISTING CONDITIONS	CONSERVATION STRATEGY
Tilted base	Reset base with marker plumb

TREATMENT	Treatment Dates
1. Marker and base found to be in sound condition with marker securely attached to base. 2. Area excavated to an appropriate depth removing any roots or large stones. 3. Base is aligned with adjacent markers and re-set level. 4. Area around base was backfilled with tamped gravel and re-graded with existing topsoil	6/17/2015

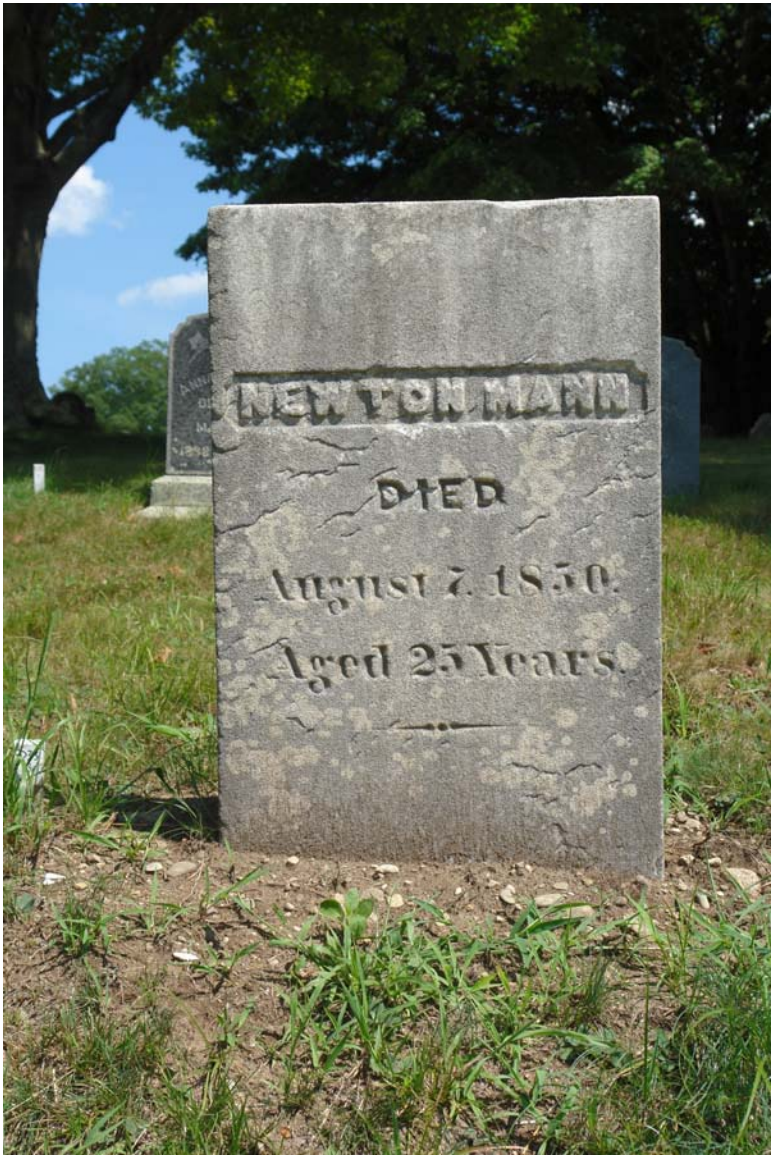
Hanover Center Cemetery, Hanover MA
NAME ON MARKER **Newton Mann**
Death Date: 8/7/1850 Marker Type: Headstone/conc base
Cond. of Inscription: Legible Material: Marble

EXISTING CONDITIONS	CONSERVATION STRATEGY
Loose in base	Evaluate resetting options Reset into new below grade concrete base

TREATMENT	Treatment Dates
6/17-22/2015	
1. Marker excavated and found to be sound. Light soiling removed by brushing with nylon brushes and water. 2. Setting area excavated for new below grade cast concrete base sized minimum of 12 inches deep, 12 inches greater in thickness and 6 inches wider than the stone. 3. Wooden forms and setting slot form stabilized and aligned with adjacent markers before concrete is poured 4. When required, the lower edge of marker is re-squared with minimal loss using a power grinder 5. Setting forms are removed after partial curing of the concrete and the base backfilled with tamped sand or gravel 6. Marker reset into setting slot with a cement/lime grout (3/2/9) with 000 sand made fluid with a super plasticizer. 7. Marker set plumb and level, and braced for minimum of 5 days. 8. Disturbed areas backfilled with existing topsoil.

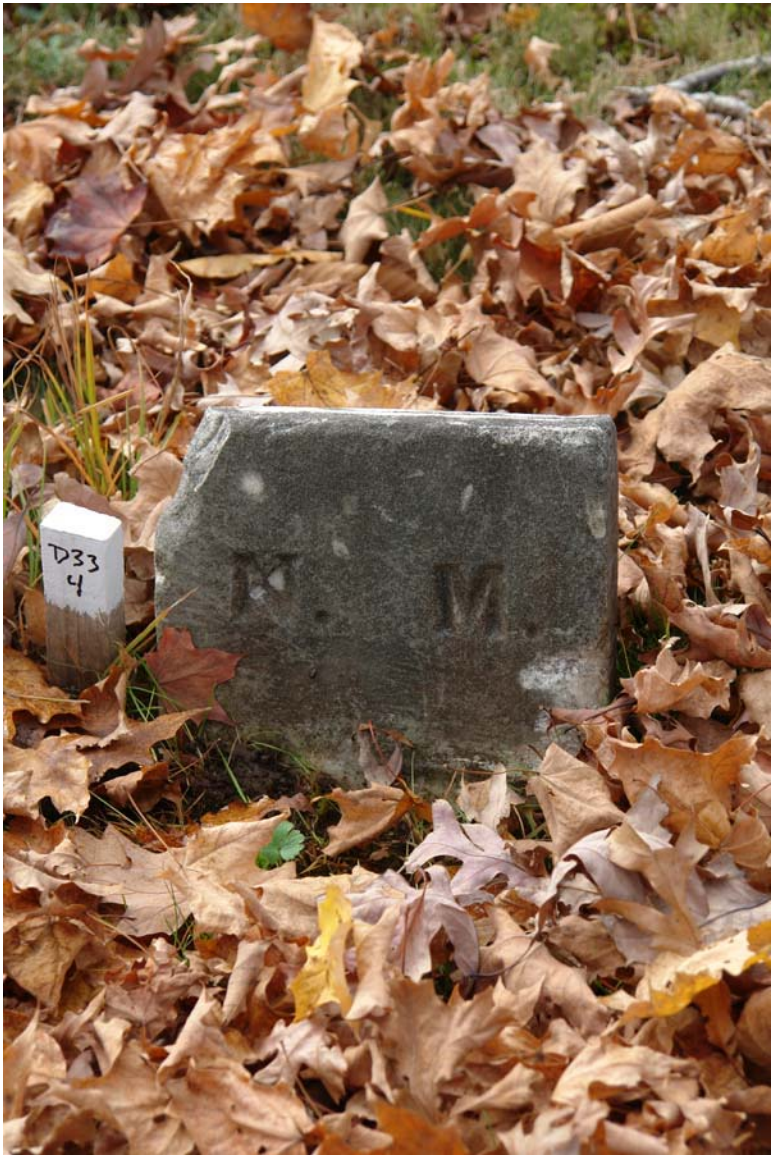
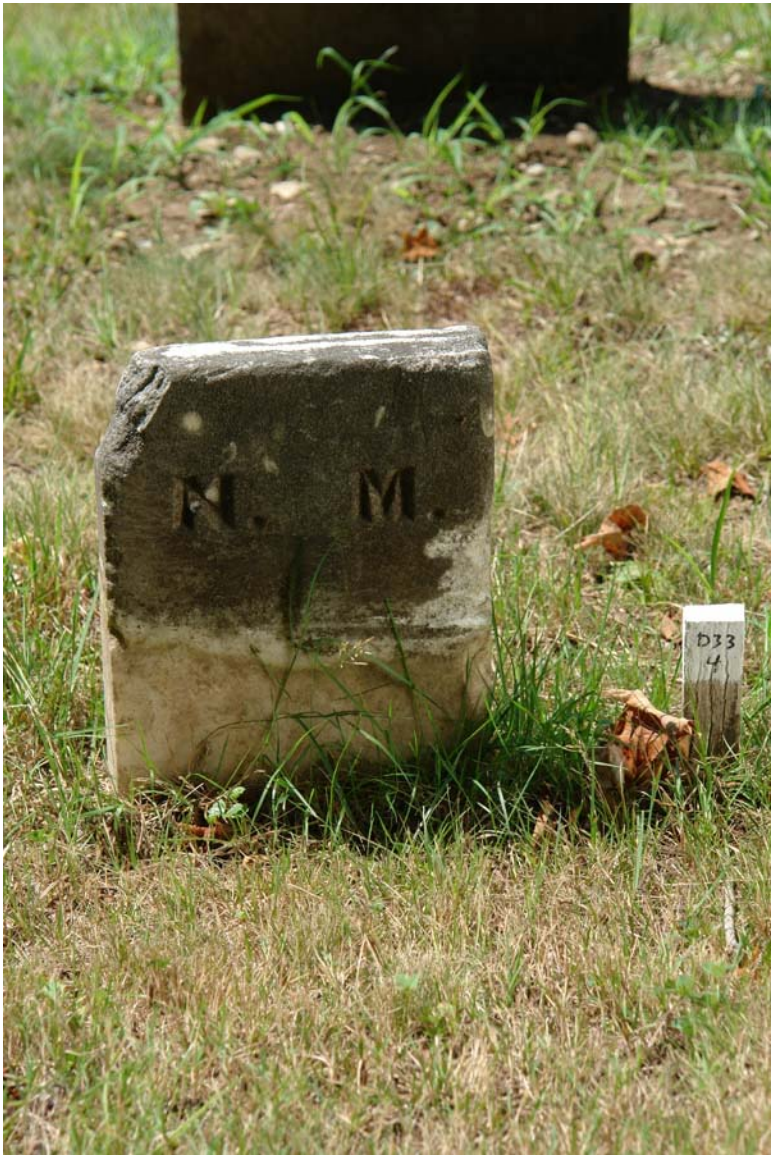
Hanover Center Cemetery, Hanover MA	
NAME ON MARKER	N.M. (Newton Mann)
Death Date:	Marker Type: Footstone
Cond. of Inscription: Legible	Material: Marble
EXISTING CONDITIONS	CONSERVATION STRATEGY
Tilted	Reset plumb
TREATMENT	
Treatment Dates 6/17/2015	
1. Marker carefully excavated. The soil around tilted markers was removed to an appropriate depth. When required, the marker was removed from the ground. Marker appears to be sound.	
2. Soling removed by light brushing with nylon brushes and water.	
3. Setting area excavated to sufficient depth and stone re-set plumb at appropriate height and level onto gravel bed, aligned with adjacent markers	
4. Area backfilled around marker with tamped sand and gravel	
5. Disturbed areas re-graded with existing topsoil and sod.

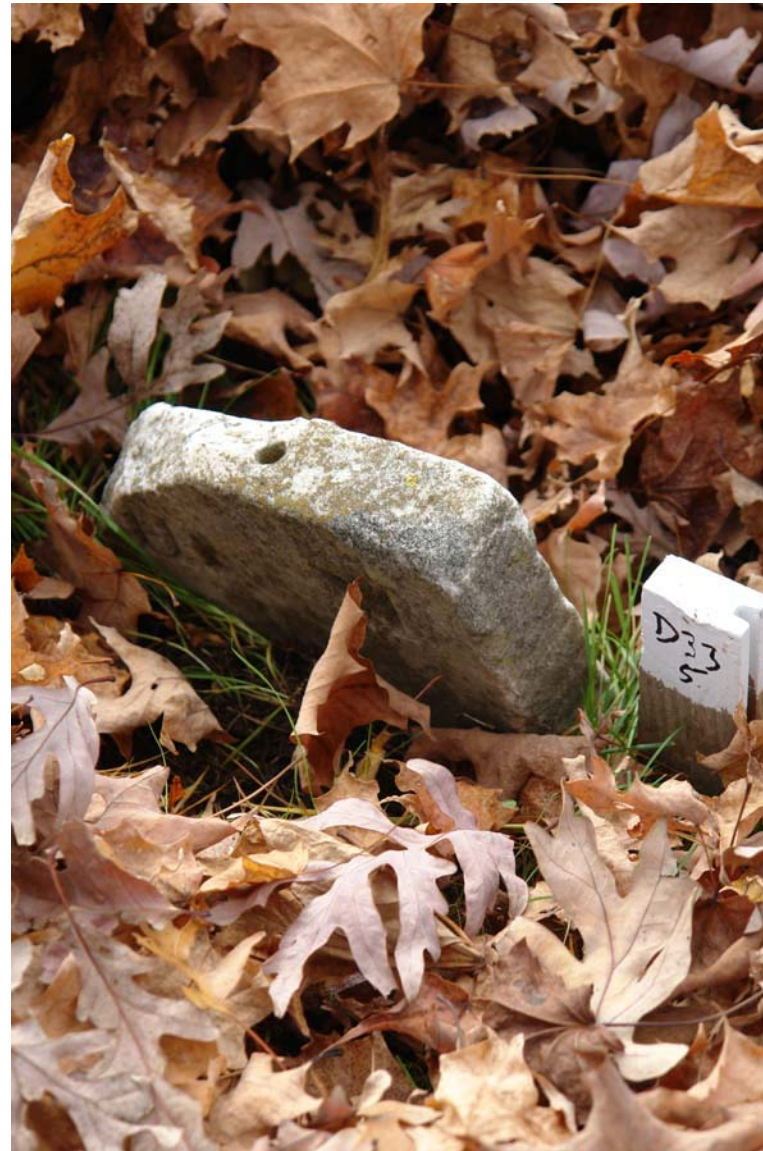
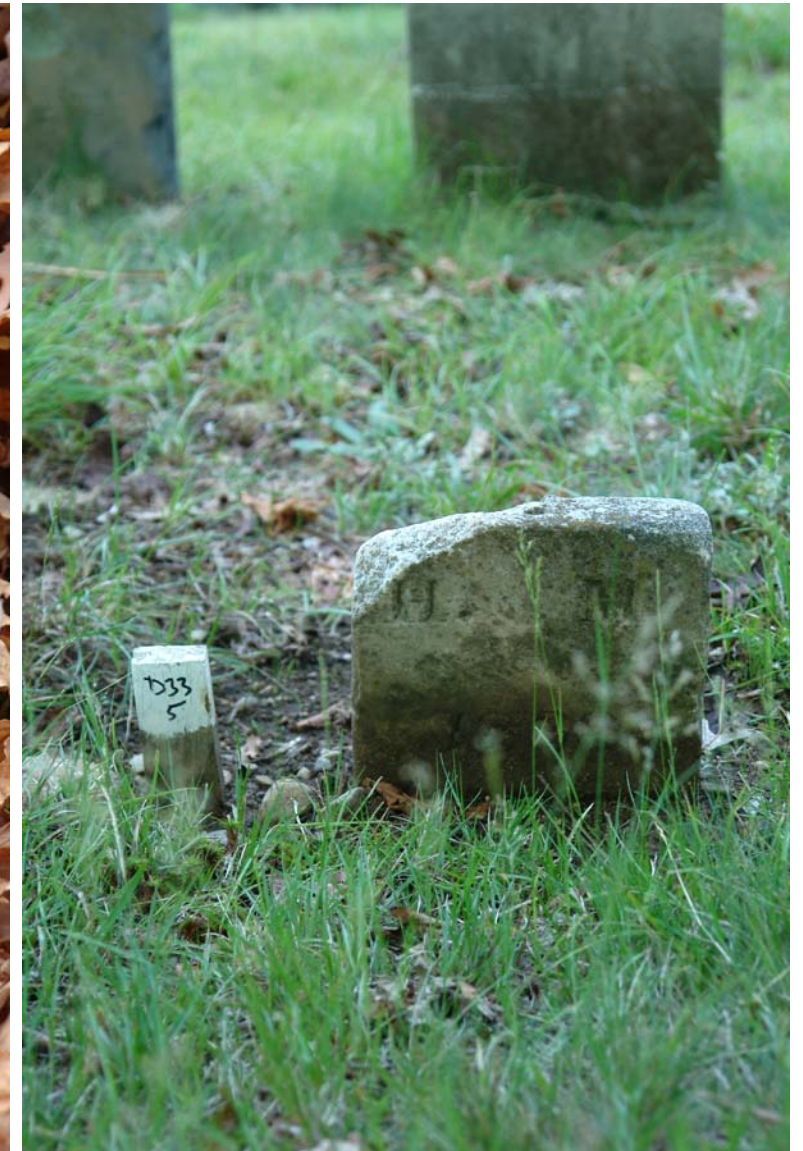
Loose in base

1. Marker carefully excavated. The soil around tilted markers was removed to an appropriate depth. When required, the marker was removed from the ground. Marker appears to be sound.
2. Soling removed by light brushing with nylon brushes and water.
3. Setting area excavated to sufficient depth and stone re-set plumb at appropriate height and level onto gravel bed, aligned with adjacent markers
4. Area backfilled around marker with tamped sand and gravel
5. Disturbed areas re-graded with existing topsoil and sod.

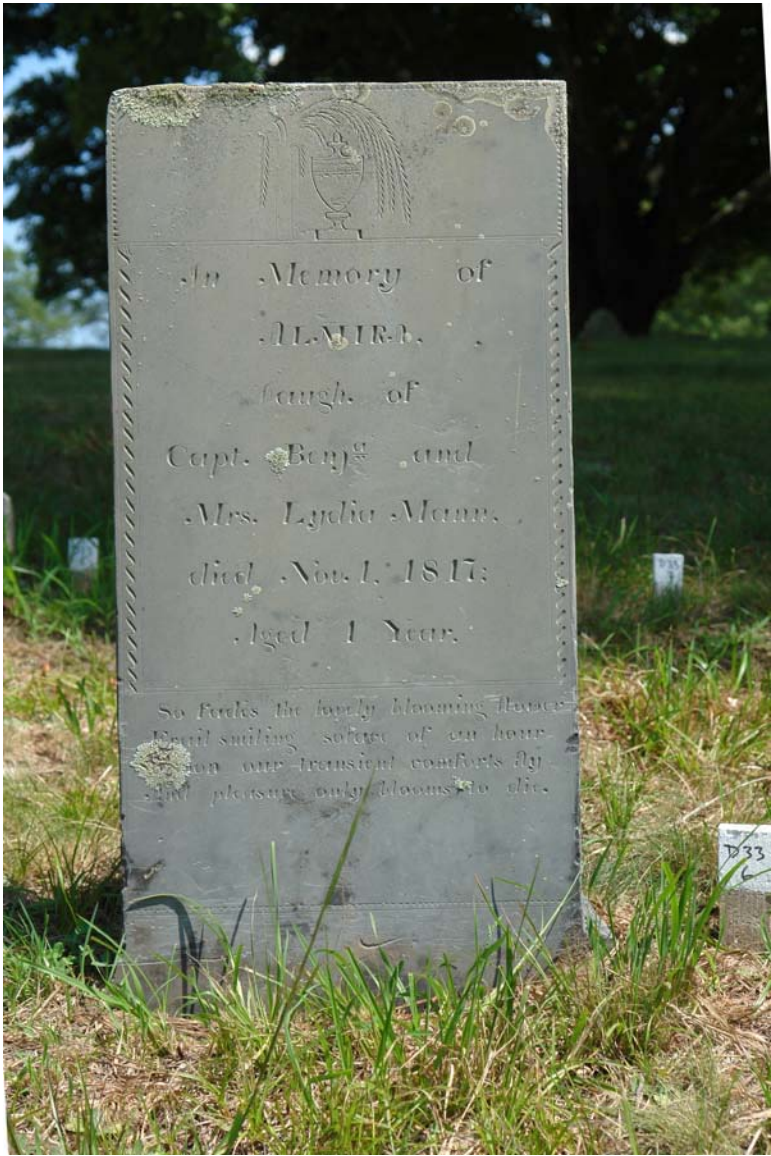
Hanover Center Cemetery, Hanover MA	
NAME ON MARKER	Almira Mann
Death Date: 11/1/1817	Marker Type: Headstone
Cond. of Inscription: Legible	Material: Slate
EXISTING CONDITIONS	CONSERVATION STRATEGY
Tilted	Reset plumb
TREATMENT	
Treatment Dates 6/17/2015	
1. Marker carefully excavated. The soil around tilted markers was removed to an appropriate depth. When required, the marker was removed from the ground. Marker appears to be sound.	
2. Soling removed by light brushing with nylon brushes and water.	
3. Setting area excavated to sufficient depth and stone re-set plumb at appropriate height and level onto gravel bed, aligned with adjacent markers	
4. Area backfilled around marker with tamped sand and gravel	
5. Disturbed areas re-graded with existing topsoil and sod.

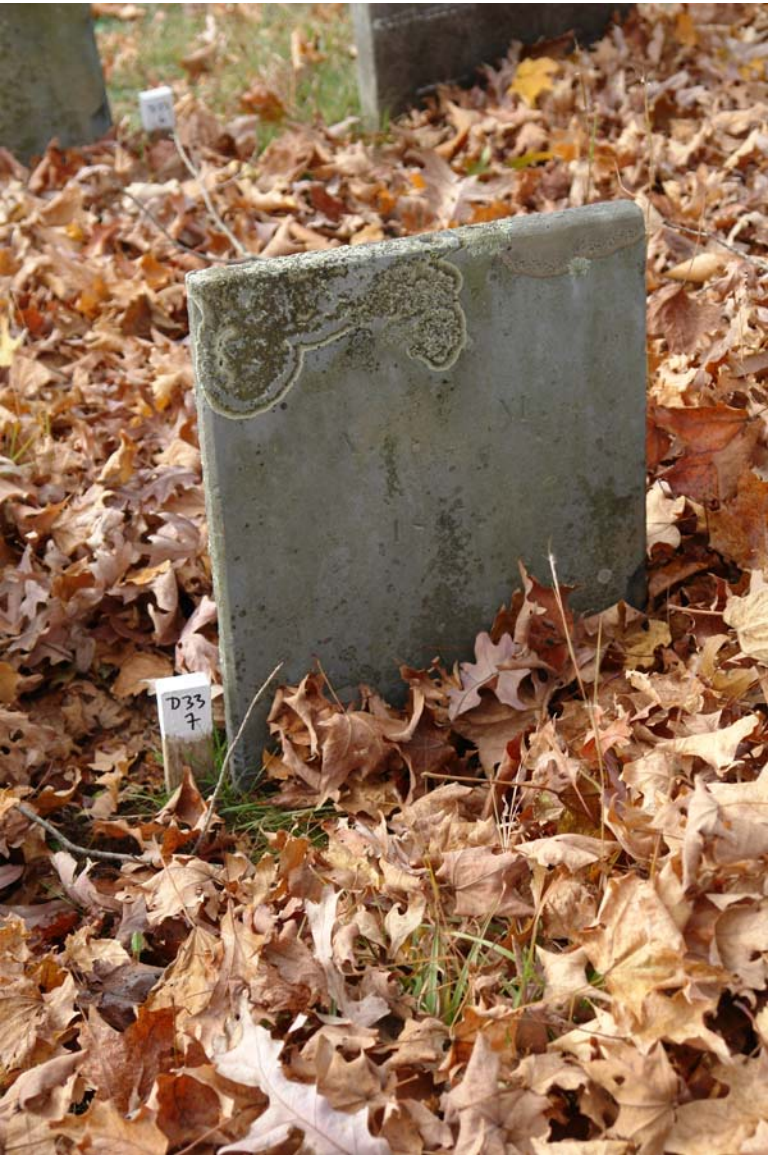
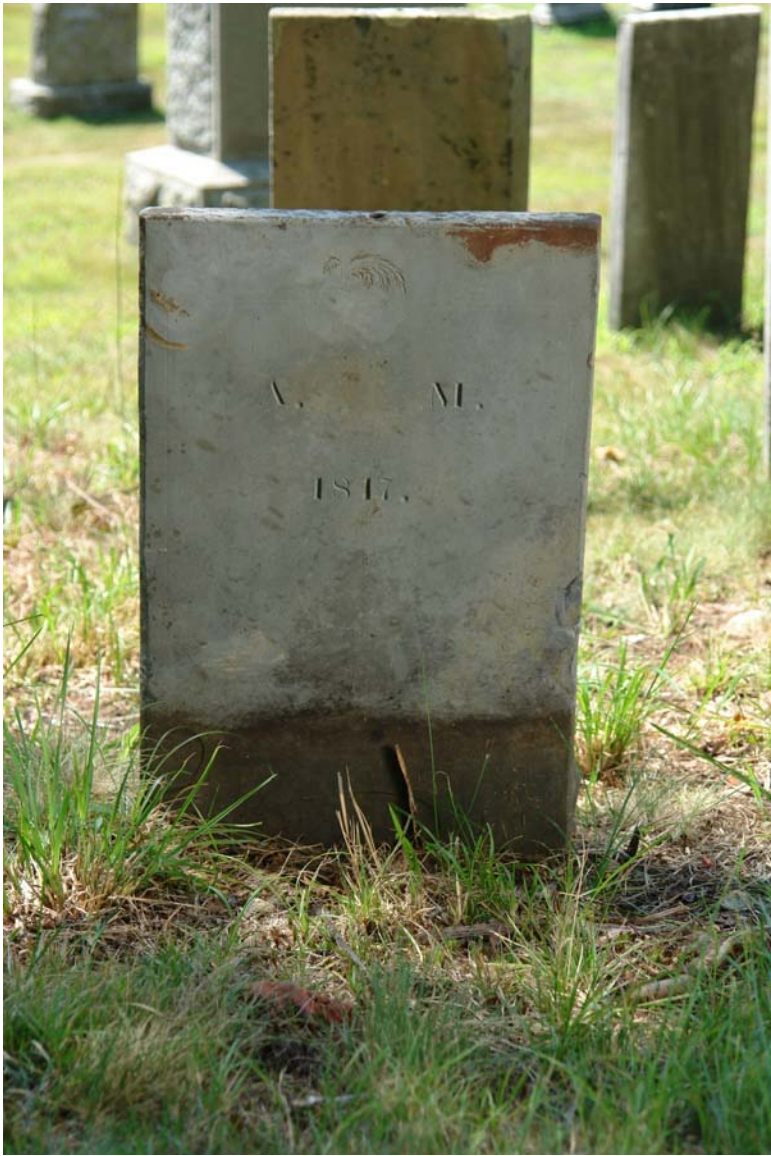
Hanover Center Cemetery, Hanover MA

EXISTING CONDITIONS	CONSERVATION STRATEGY
Tilted	Reset plumb

6. Surface treated with D/2 Biological solution, brushed with nylon brushes and fully rinsed with water.

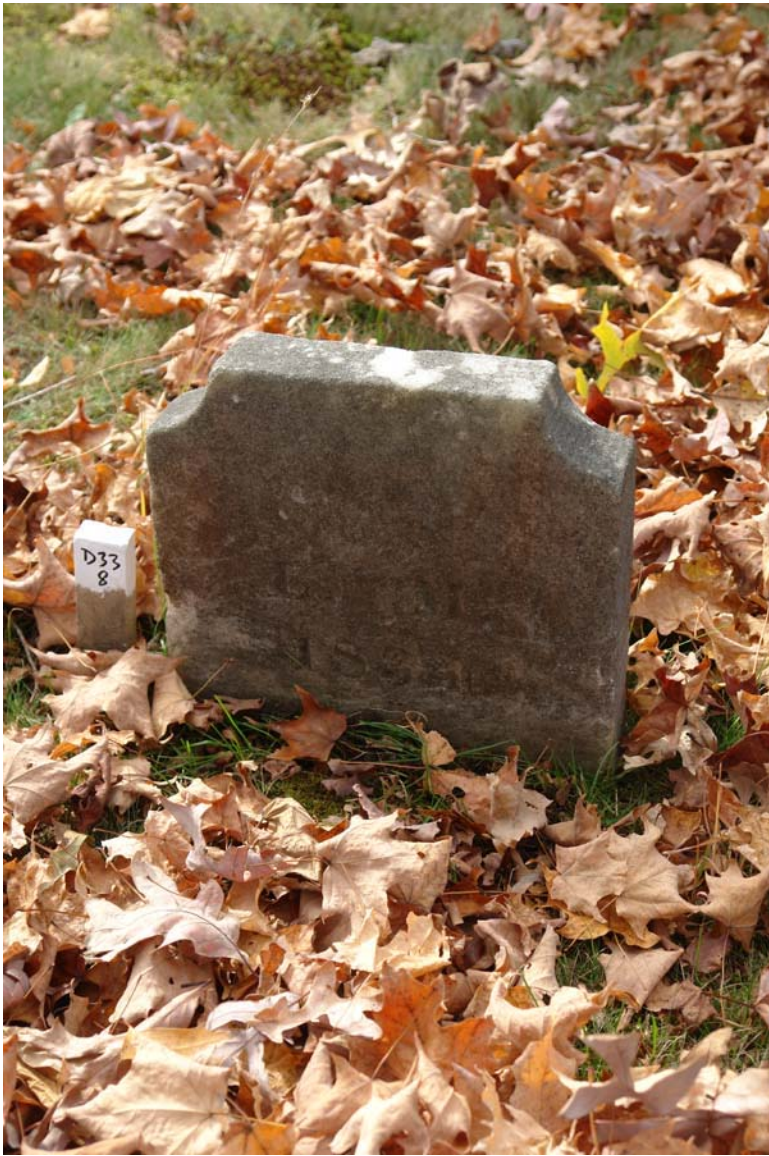
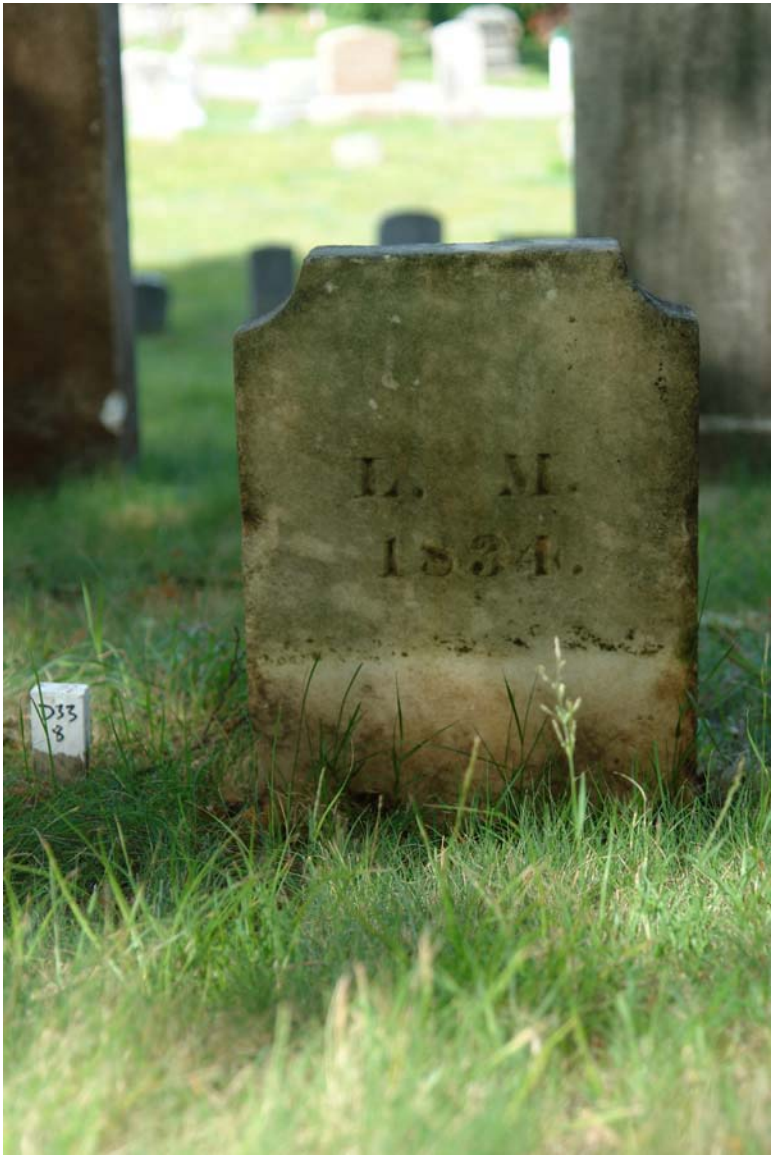
Hanover Center Cemetery, Hanover MA
NAME ON MARKER **L. M. (Lydia Mann)**
Death Date: 1834 Marker Type: Footstone
Cond. of Inscription: Legible Material: Marble

EXISTING CONDITIONS	CONSERVATION STRATEGY
Tilted	Reset plumb

TREATMENT	Treatment Dates 6/17/2015
<p>1. Marker carefully excavated. The soil around tilted markers was removed to an appropriate depth. When required, the marker was removed from the ground. Marker appears to be sound.</p> <p>2. Soling removed by light brushing with nylon brushes and water.</p> <p>3. Setting area excavated to sufficient depth and stone re-set plumb at appropriate height and level onto gravel bed, aligned with adjacent markers</p> <p>4. Area backfilled around marker with tamped sand and gravel</p> <p>5. Disturbed areas re-graded with existing topsoil and sod.</p> <p>6. Surface treated with D/2 Biological solution, brushed with nylon brushes and fully rinsed with water.</p>
