MONUMENT CONSERVATION COLLABORATIVE LLC, NORFOLK, CT

DOCUMENTATION OF STONE CONSERVATION TREATMENTS TO ASSINIPPI CEMETERY, HANOVER, MA June 2015

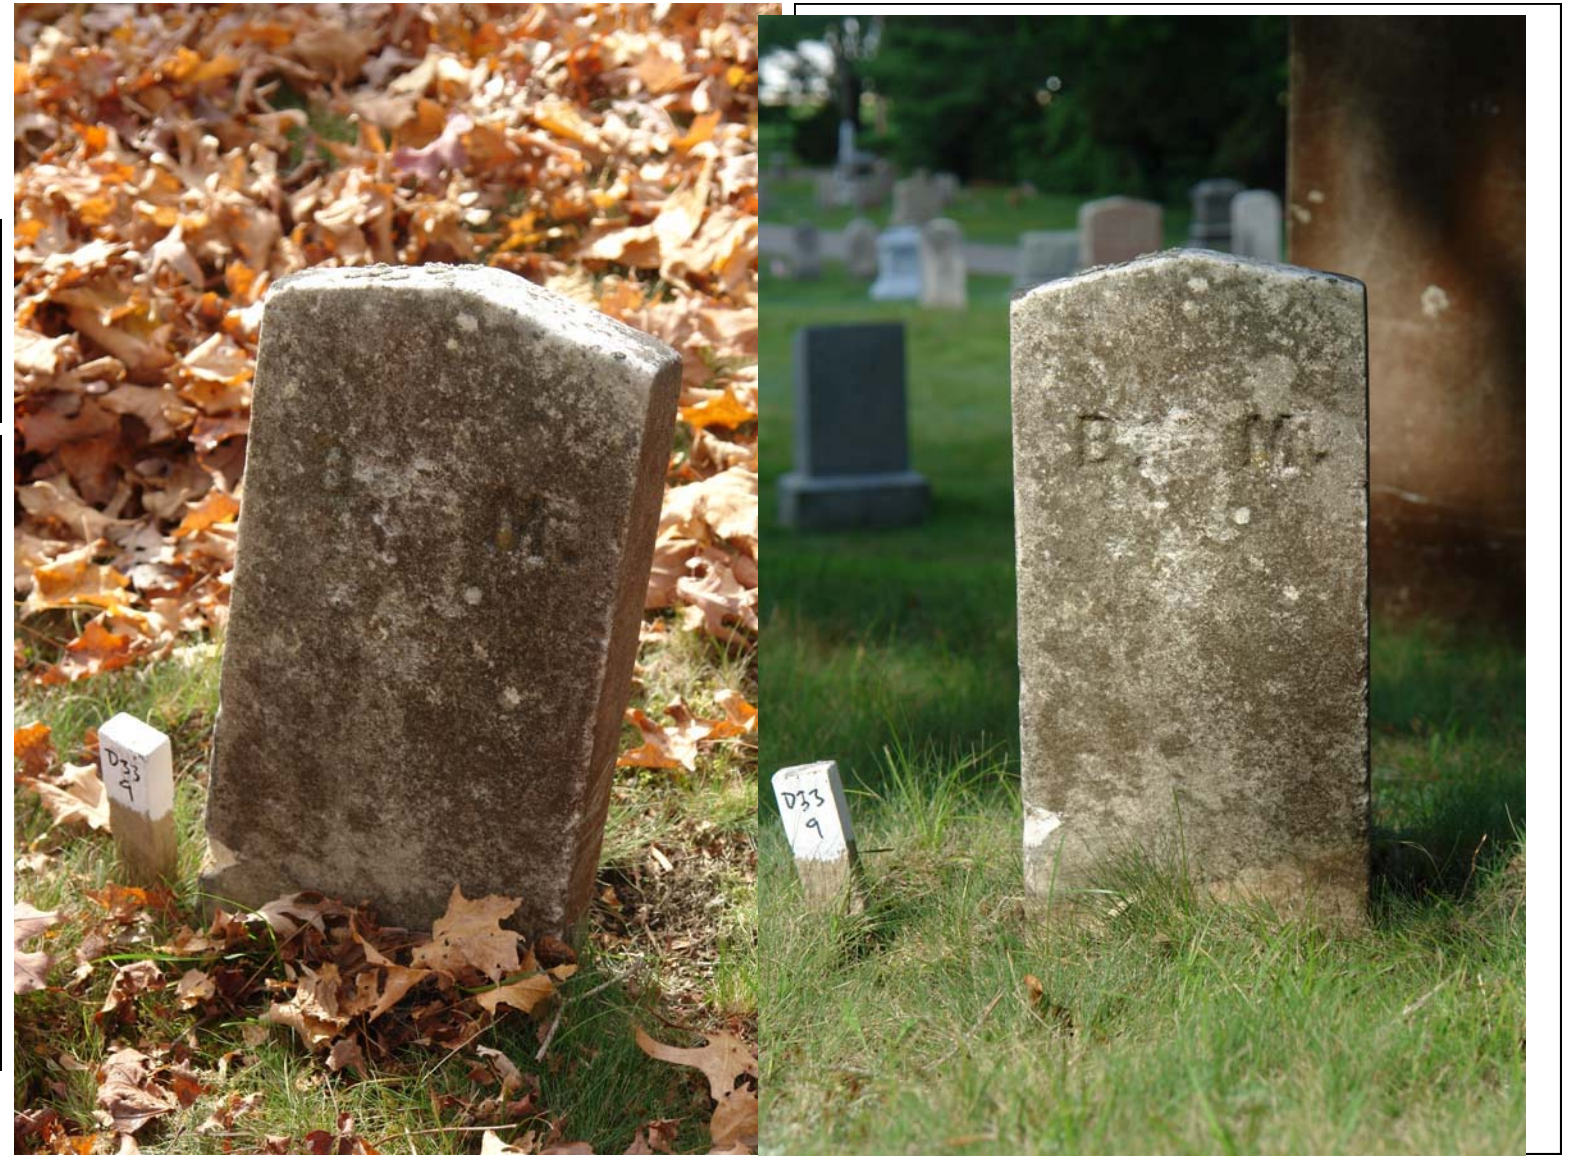
EXISTING CONDITIONS

1. Marker carefully excavated. The soil around tilted markers was removed to an appropriate depth. When required, the marker was removed from the ground. Marker appears to be sound.
2. Soling removed by light brushing with nylon brushes and water.
3. Setting area excavated to sufficient depth and stone re-set plumb at appropriate height and level onto gravel bed, aligned with adjacent markers
4. Area backfilled around marker with tamped sand and gravel
5. Disturbed areas re-graded with existing topsoil and sod.
6. Surface treated with D/2 Biological solution, brushed with nylon brushes and fully rinsed with water.

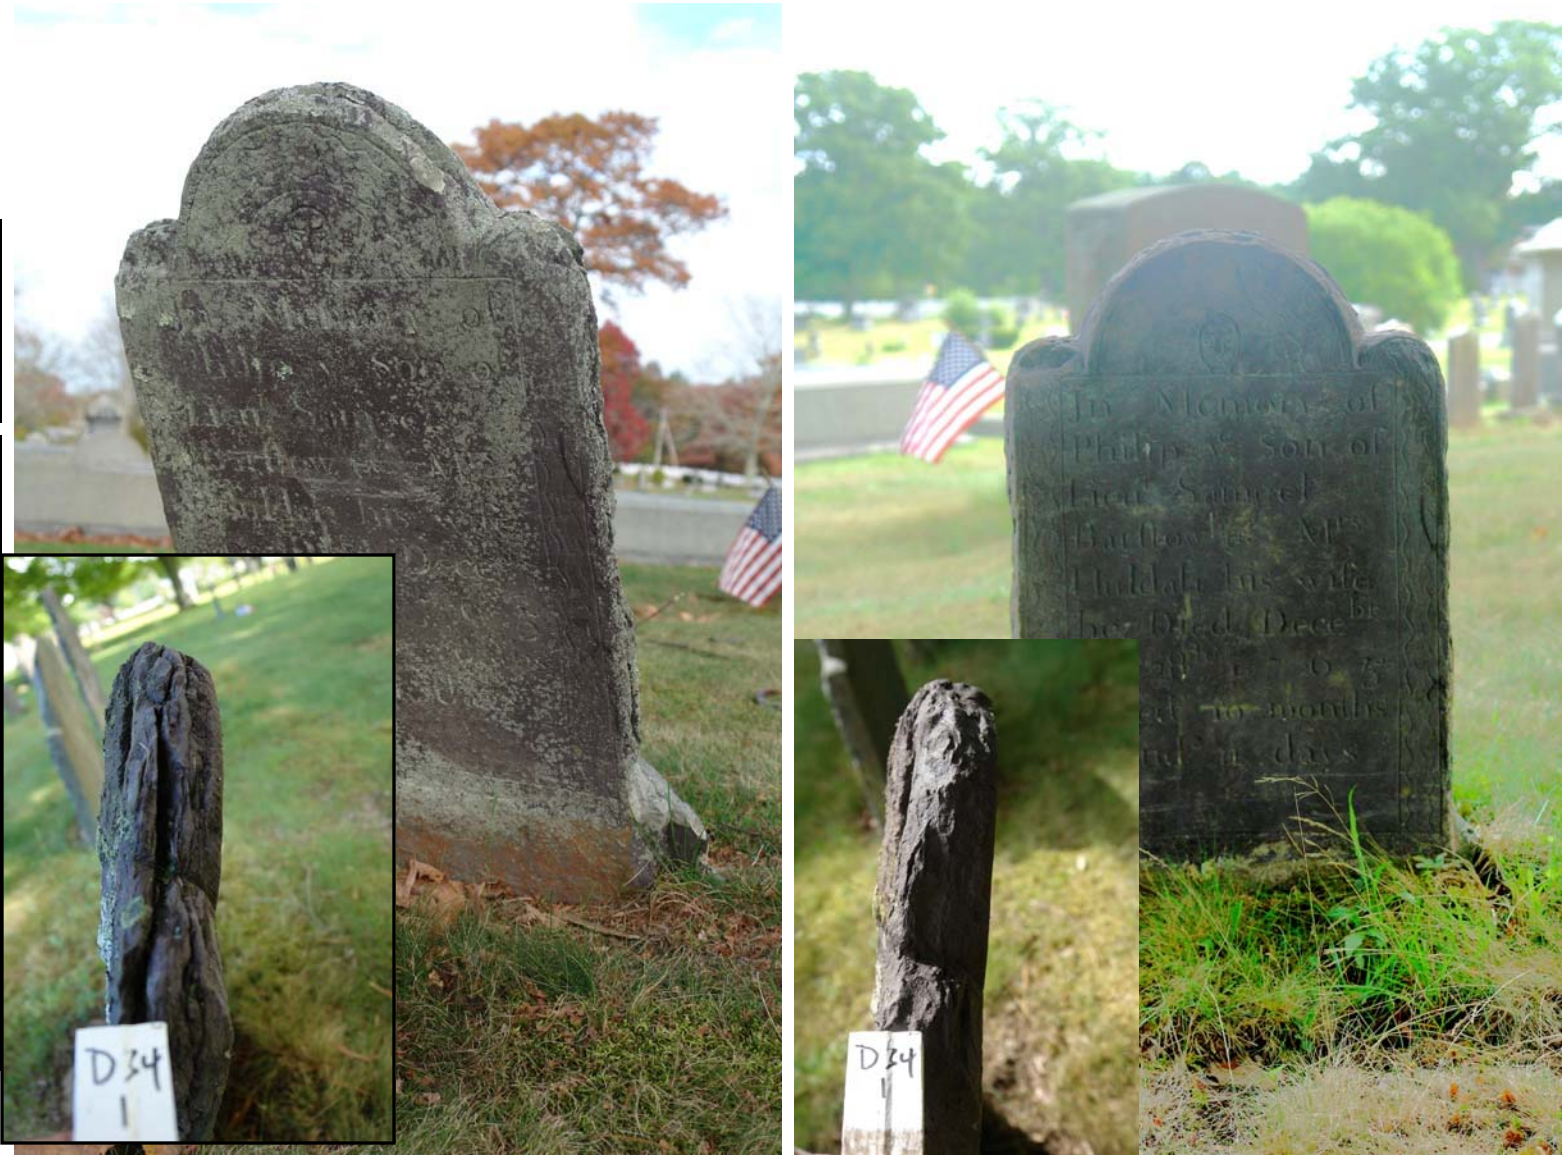
Hanover Center Cemetery, Hanover MA	
NAME ON MARKER	Deborah House
Death Date: 7/25/1762	Marker Type: Headstone
Cond. of Inscription: Decipherable	Material: Slate
EXISTING CONDITIONS	CONSERVATION STRATEGY
Tilting Delaminating	Reset plumb Fill voids caused by delaminations
TREATMENT	
Treatment Dates 6/17-18/2015	
<p>1. Marker carefully excavated. The soil around tilted markers was removed to an appropriate depth. When required, the marker was removed from the ground. Marker appears to be sound.</p> <p>2. Setting area excavated to sufficient depth and stone re-set plumb at appropriate height and level, aligned w/ adjacent markers</p> <p>3. Area backfilled around marker with tamped sand and gravel and re-graded with existing topsoil and sod.</p> <p>4. Delaminated areas treated with D/2 Biological Solution and brushed into stone with nylon brushes and rinsed fully with water</p> <p>5. Interior voids flushed with water and any lichens and/or debris removed with hand tools.</p> <p>6. After full drying, all voids caused by splitting or delaminations at top edge of marker filled with a pigmented Sto Crack Filler using injection syringes and/or trowels. Voids along sides of monument typically left open to allow escape of any water which may enter.</p> <p>7. Excess crack filler immediately removed with repeated damp sponge-</p>

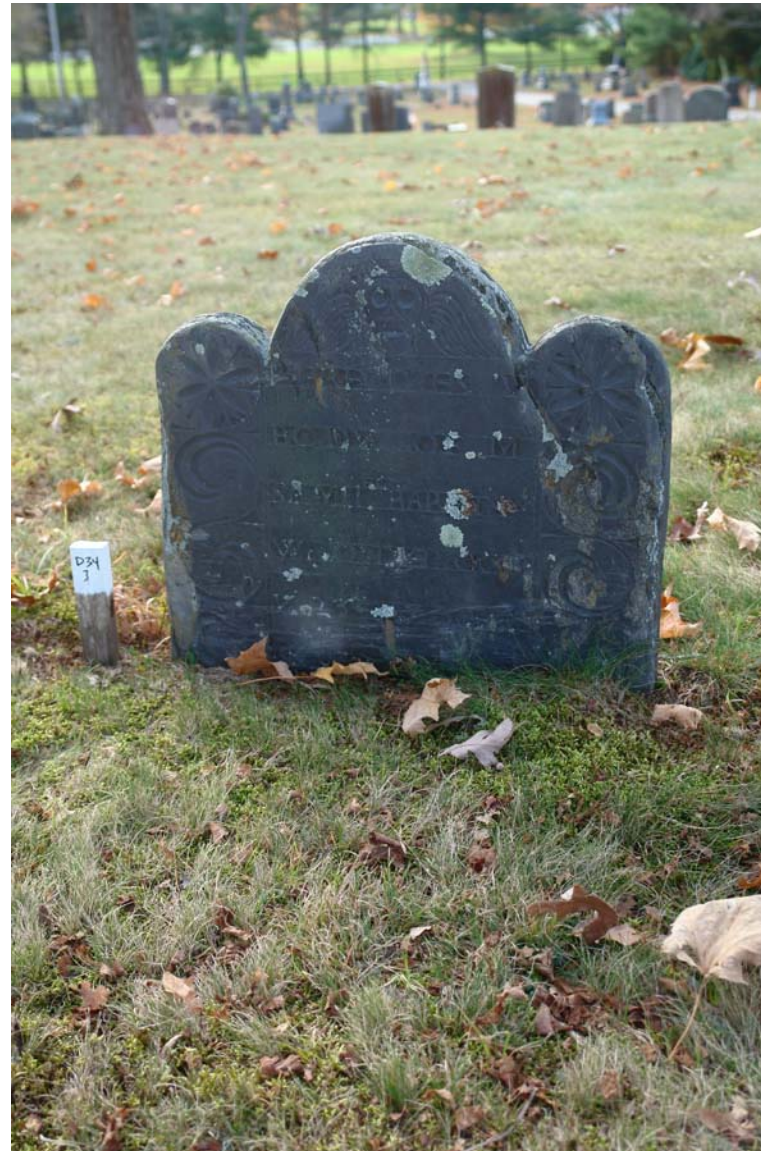
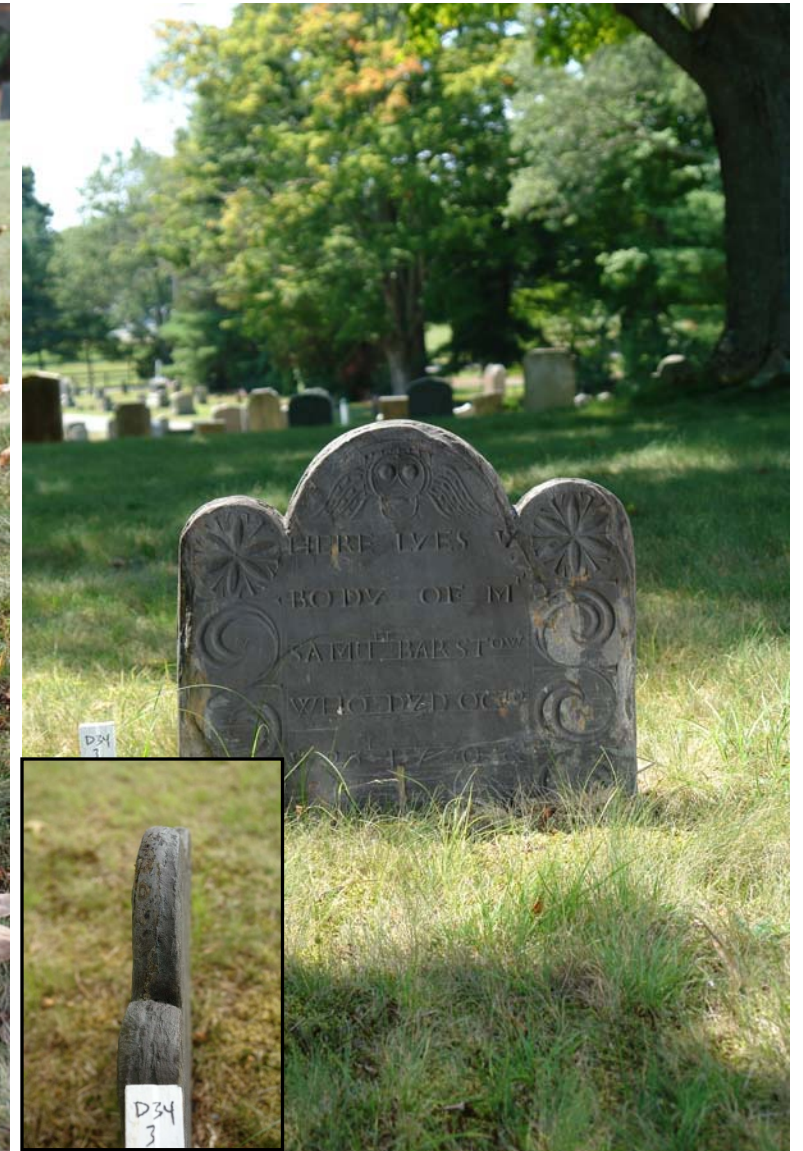
Height 17 Width 19 Thickness 2 Marker# **D.34.3**

Cap voids caused by delaminations.

1. Delaminated areas treated with D/2 Biological Solution and brushed into stone with nylon brushes and rinsed fully with water
2. Interior voids flushed with water and any lichens and/or debris removed with hand tools.
3. After full drying, all voids caused by splitting or delaminations at top edge of marker filled with a pigmented Sto Crack Filler using injection syringes and/or trowels. Voids along sides of monument typically left open to allow escape of any water which may enter.
4. Excess crack filler immediately removed with repeated damp sponging.

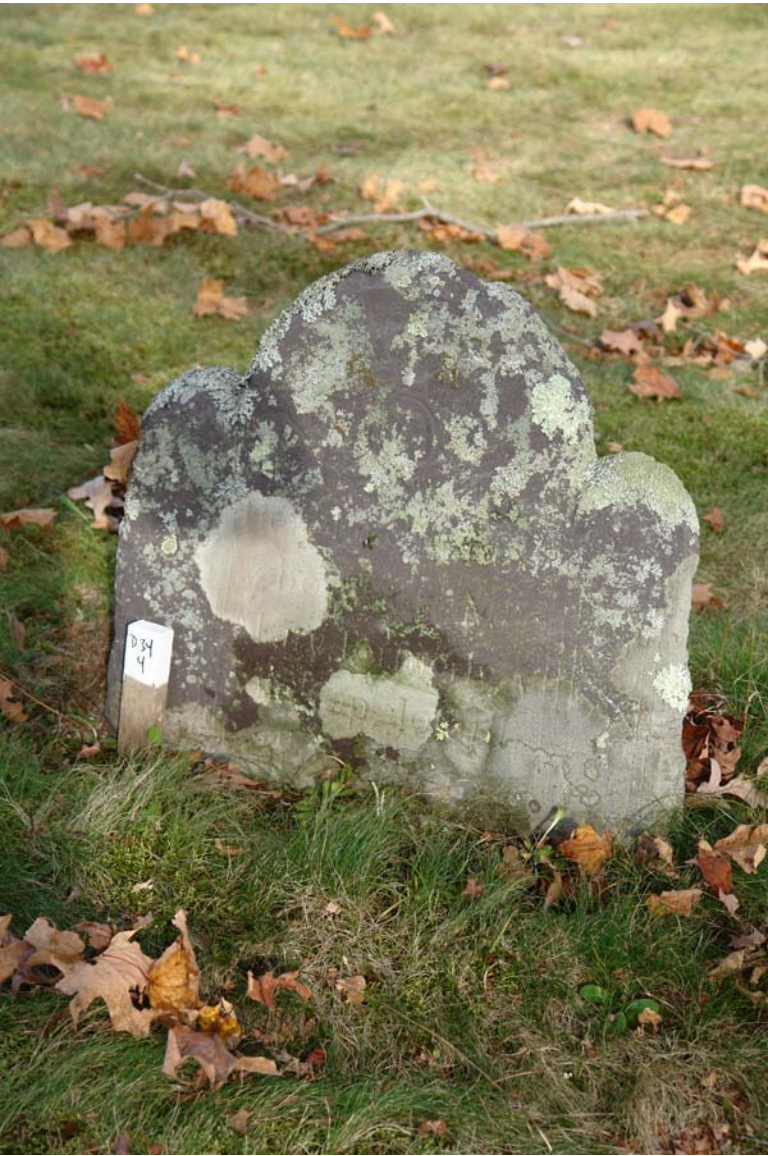
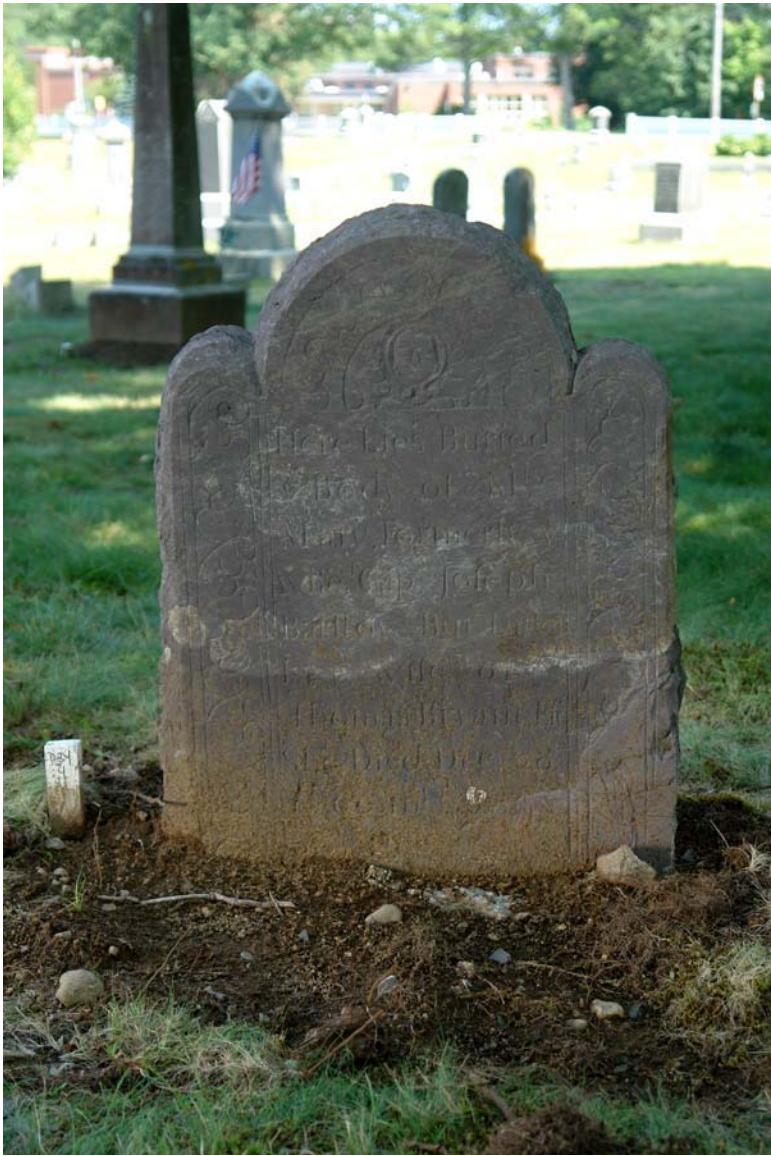
EXISTING CONDITIONS	CONSERVATION STRATEGY
Tilted	Reset plumb

TREATMENT	Treatment Dates 7/14-30/2015
<p>1. Setting area excavated for new below grade cast concrete base</p> <p>2. A new concrete base sized min. 12" deep, 12" greater in thick-ness and 6" wider than the stone is cast. The finished top to be below grade. A form for a setting slot 1" wider than the marker is placed in the concrete.</p> <p>3. Setting forms are removed after partial curing of the concrete and the base backfilled with tamped sand or gravel</p> <p>4. Lower losses filled with pigmented Jahn restoration mortar. Af-ter 7 day cure marker was reset plumb and level into slot using a cement/lime grout (3/2/9) with 000 sand. Braced for min 3 days</p> <p>5. All surfaces treated with D/2 Biological Solution, scrubbed with nylon brushes and water. Rinsed fully with water</p>

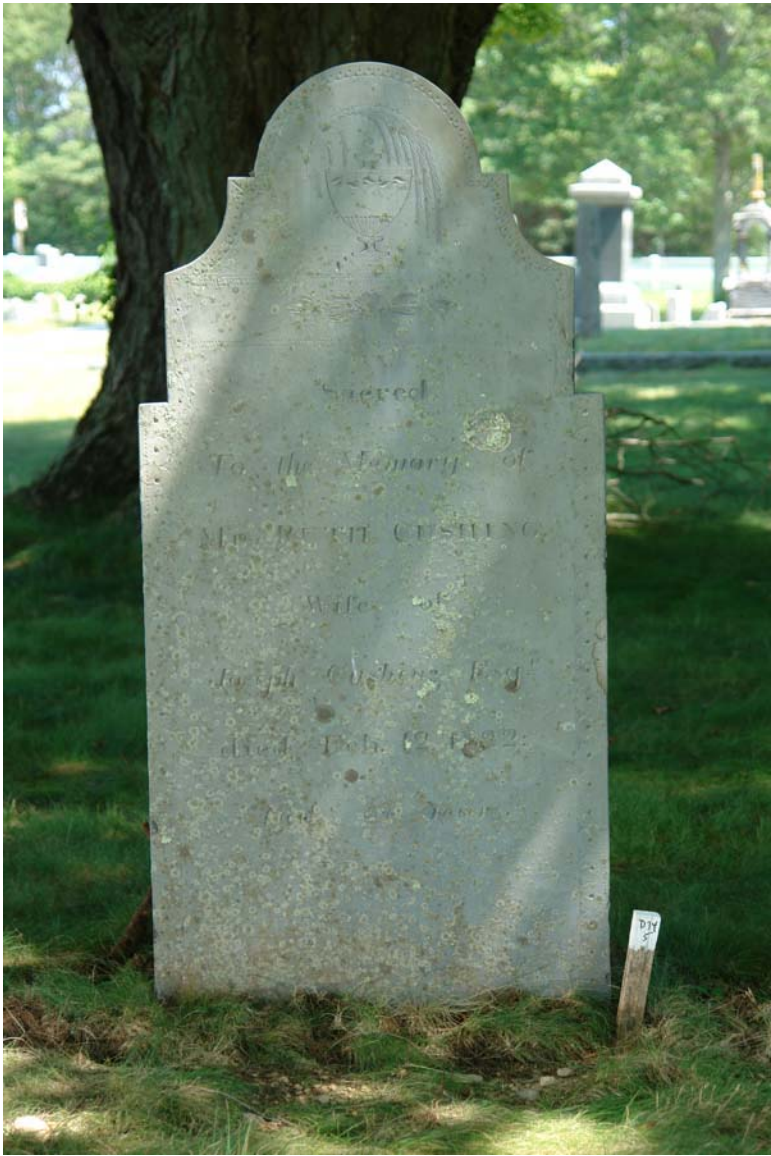
Hanover Center Cemetery, Hanover MA	
NAME ON MARKER	Ruth Cushing
Death Date: 2/12/1822	Marker Type: Headstone
Cond. of Inscription: Legible	Material: Slate
EXISTING CONDITIONS	CONSERVATION STRATEGY
Tilted	Reset plumb
TREATMENT	
Treatment Dates 7/14/2015	
1. Marker carefully excavated. The soil around tilted markers was removed to an appropriate depth. When required, the marker was removed from the ground. Marker appears to be sound.	
2. Soling removed by light brushing with nylon brushes and water.	
3. Setting area excavated to sufficient depth and stone re-set plumb at appropriate height and level onto gravel bed, aligned with adjacent markers	
4. Area backfilled around marker with tamped sand and gravel	
5. Disturbed areas re-graded with existing topsoil and sod.

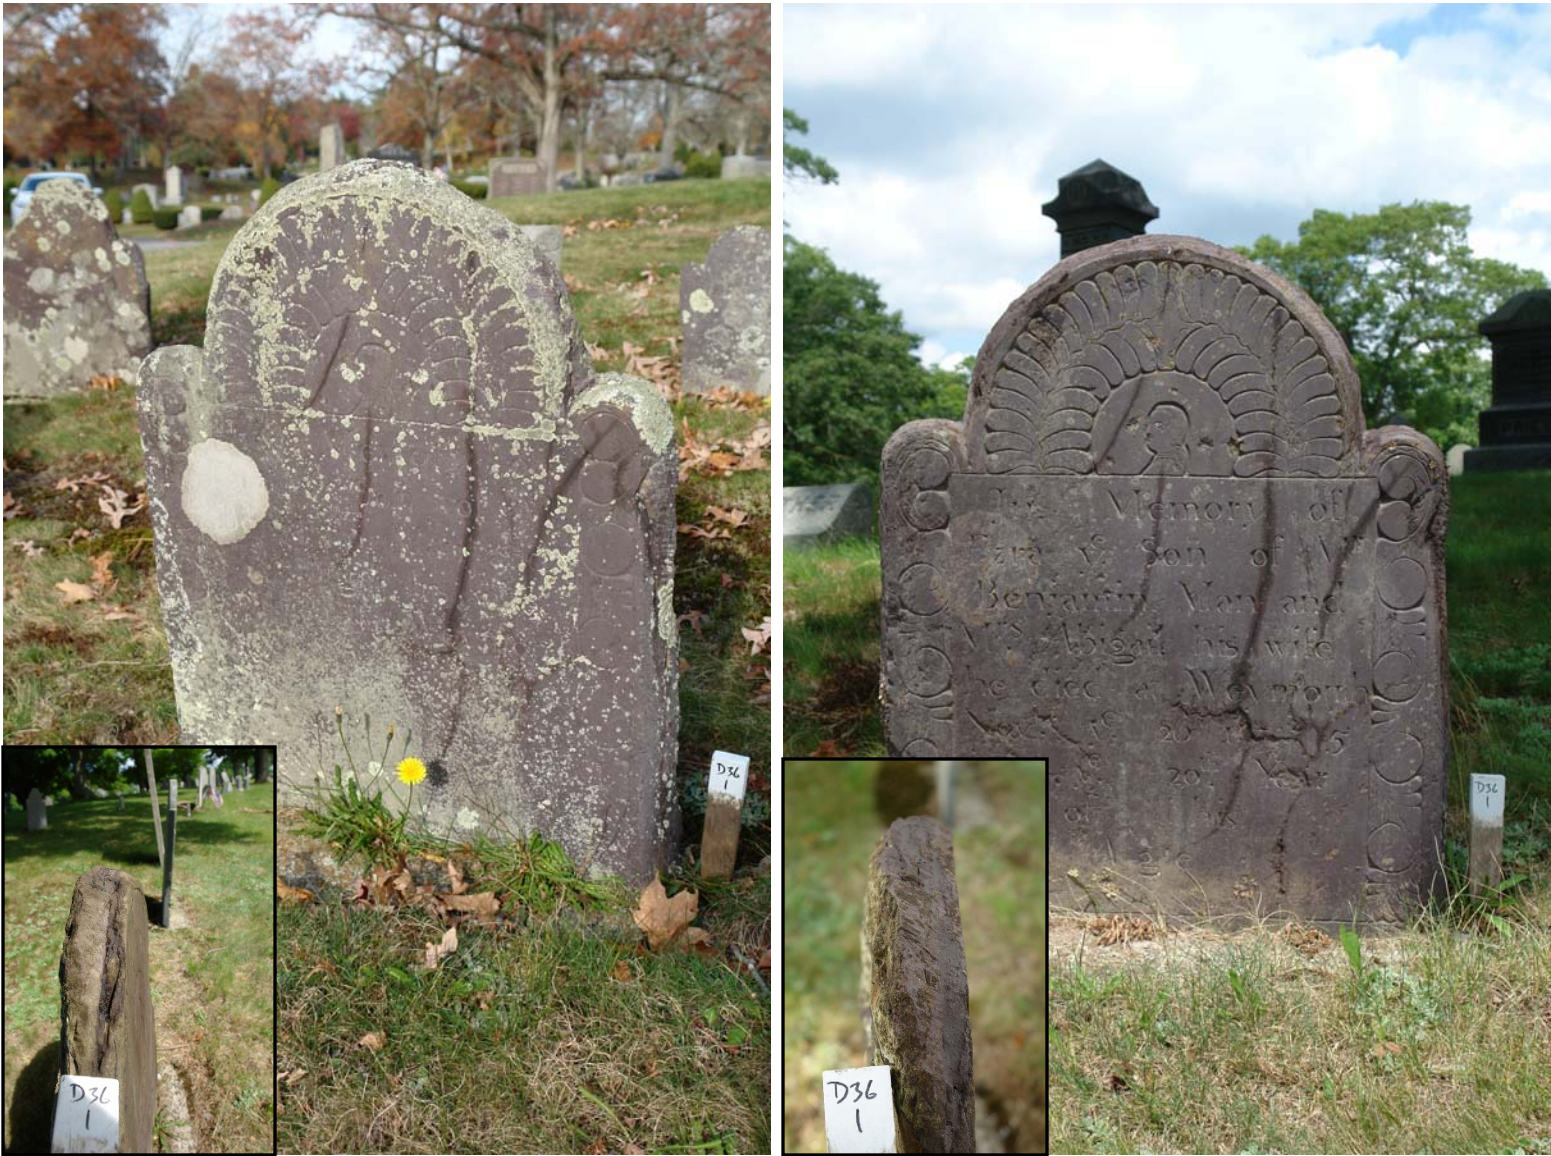
NAME ON MARKER **Ezra Mann**

EXISTING CONDITIONS	CONSERVATION STRATEGY
Voids caused by delaminating	Cap voids caused by delaminations.

TREATMENT	Treatment Dates 6/17-18/2015
<p>1. Delaminated areas treated with D/2 Biological Solution and brushed into stone with nylon brushes and rinsed fully with water</p> <p>2. Interior voids flushed with water and any lichens and/or debris removed with hand tools.</p> <p>3. After full drying, all voids caused by splitting or delaminations at top edge of marker filled with a pigmented Sto Crack Filler using injection syringes and/or trowels. Voids along sides of monument typically left open to allow escape of any water which may enter.</p> <p>4. Excess crack filler immediately removed with repeated damp sponging.</p>

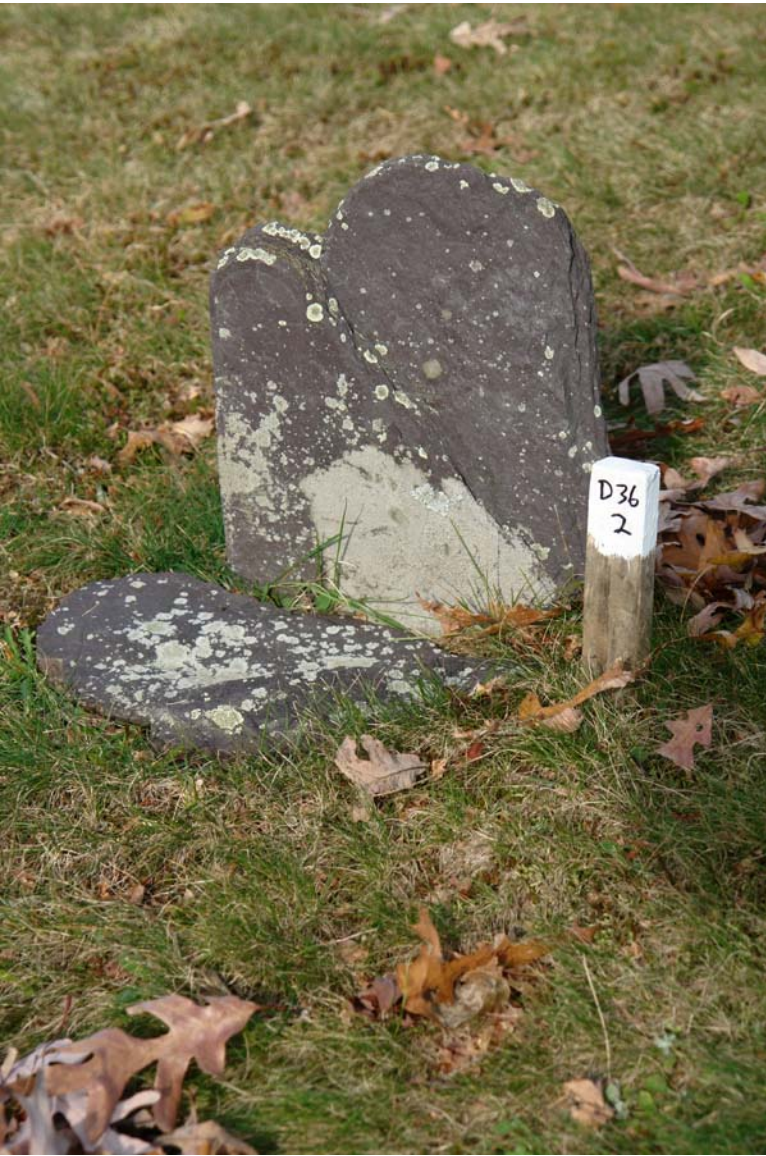
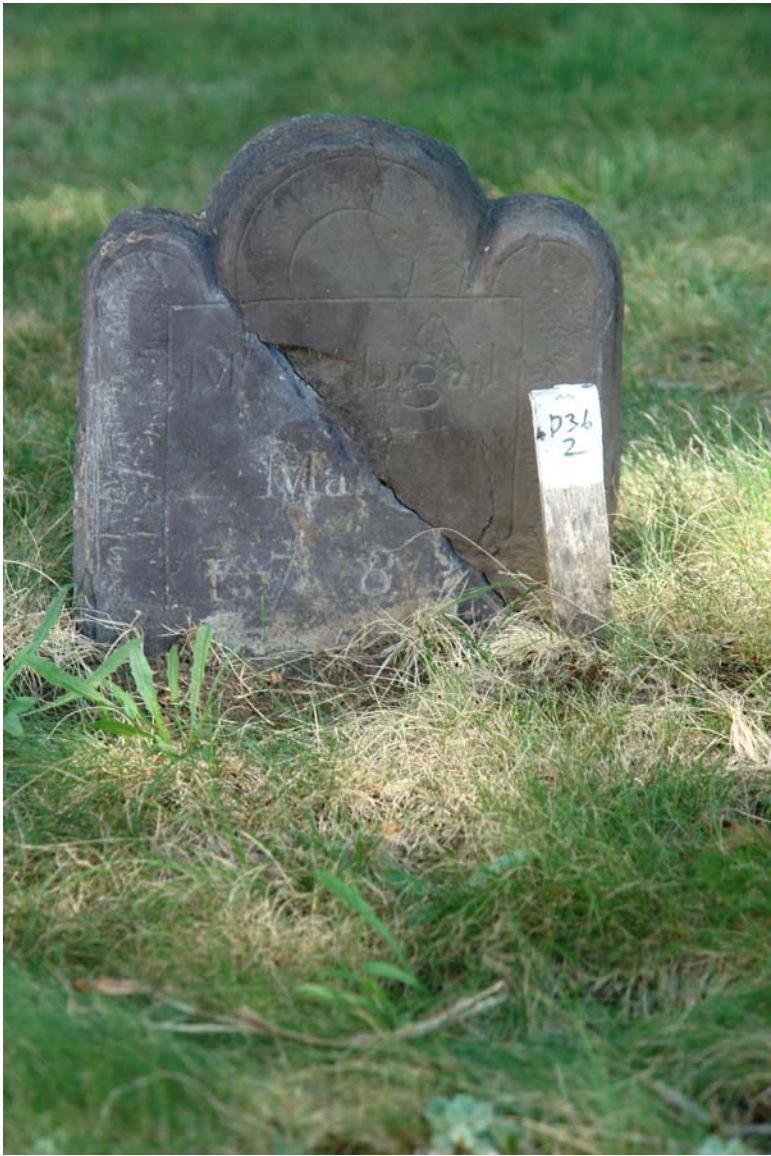
Height 30 Width 24 Thickness 3 Marker# **D.36.1**

Hanover Center Cemetery, Hanover MA	
NAME ON MARKER	Abigail Mann
Death Date: 1785	Marker Type: Footstone
Cond. of Inscription: Decipherable	Material: Slate

EXISTING CONDITIONS	CONSERVATION STRATEGY
Complete delaminations, fragmented	Evaluate detachment, attach cementitious binder

TREATMENT	Treatment Dates 6/29-7/13/2105
<p>1. All surfaces treated with D/2 Biological Solution, scrubbed with nylon brushes and water. Rinsed fully with water</p> <p>2. Fractured elements were dry fitted to ascertain final soundness and to check for large losses at mating areas.</p> <p>3. Dry fragments attached with structural adhesive (Abatron 55-22), clamped and braced until cured. Excess epoxy removed by hand chisels</p> <p>4. Top edge of marker filled with a pigmented Sto Crack Filler using injection syringes and/or trowels. Voids along sides of monument typically left open to allow escape of any water which may enter.</p> <p>5. Excess crack filler immediately removed with repeated damp sponging.</p>

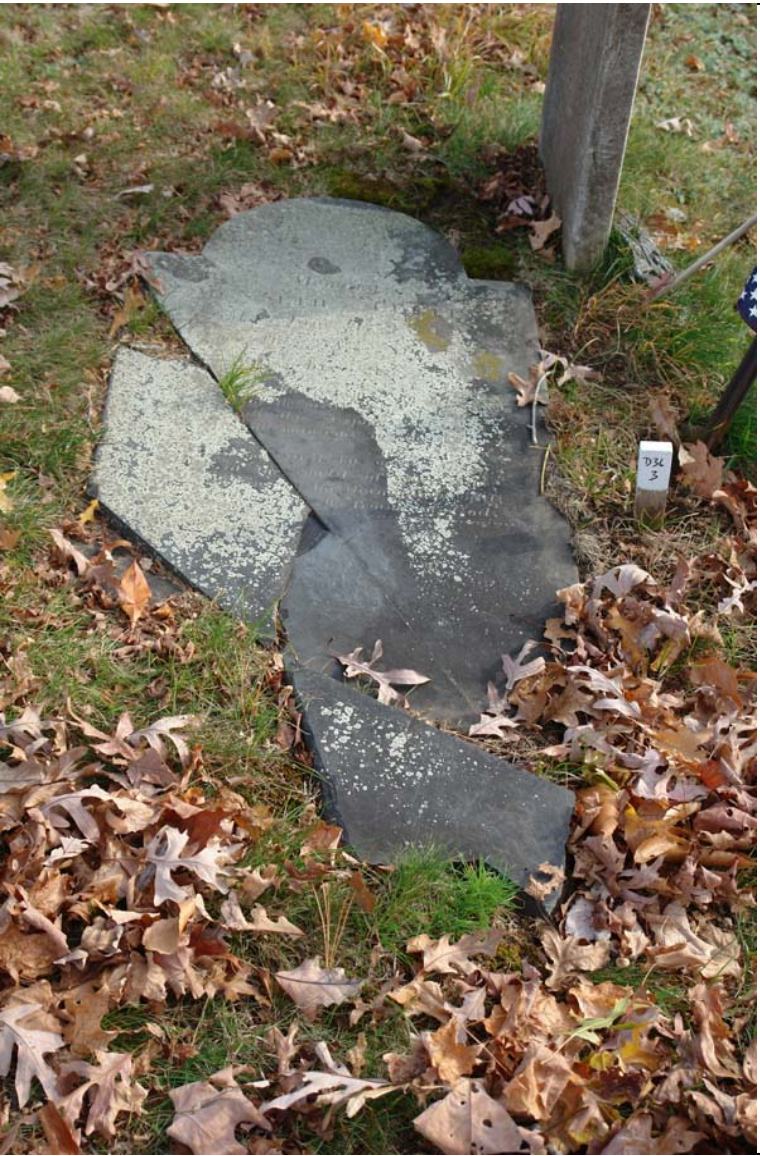
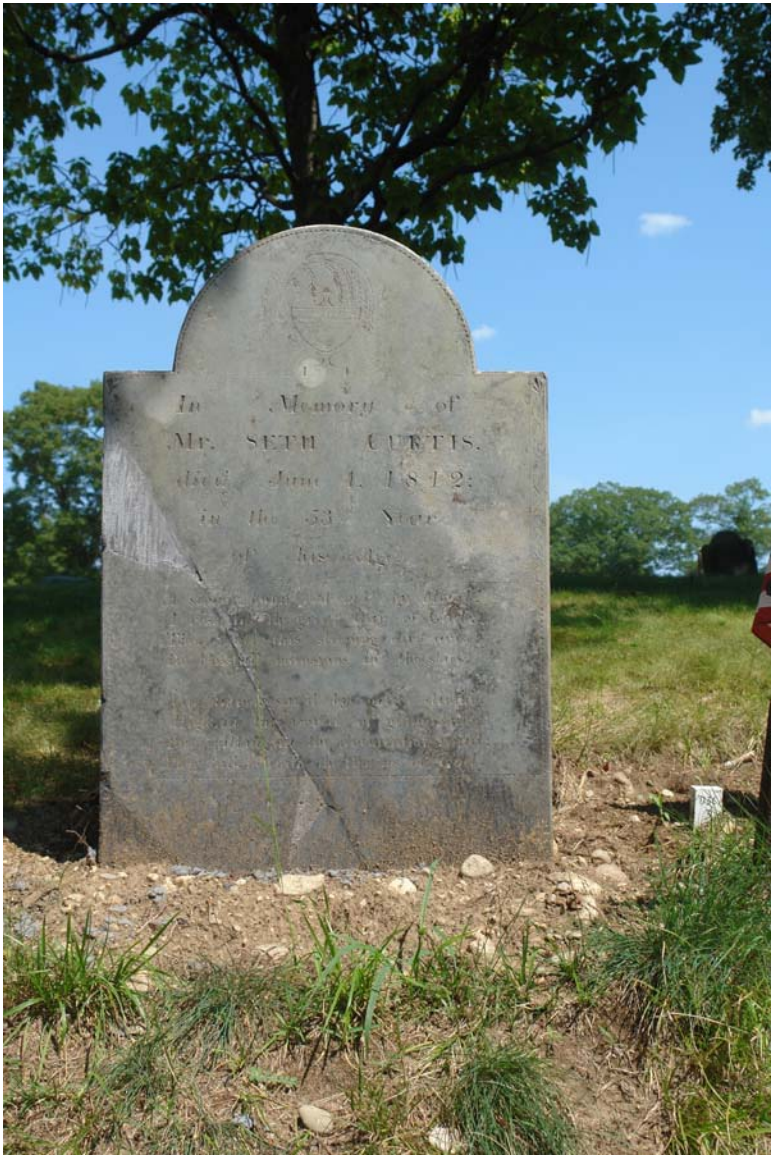
Hanover Center Cemetery, Hanover MA	
NAME ON MARKER	Seth Curtis
Death Date: 6/4/1812	Marker Type: Headstone
Cond. of Inscription: Partially decipherable	Material: Slate
EXISTING CONDITIONS	CONSERVATION STRATEGY
Multiple fractures	Attach fragments with structural adhesive Reset into new below grade concrete base
TREATMENT	
Treatment Dates 6/30-7/13/2015	
<div>1. Setting area excavated for new below grade cast concrete base. Missing fragments were not discovered</div> <div>2. A new concrete base sized min. 12" deep, 12" greater in thickness and 6" wider than the stone was cast. The finished top to be below grade. A form for a setting slot 1" wider than the marker is placed in the concrete.</div> <div>3. Setting forms are removed after partial curing of the concrete and the base backfilled with tamped sand or gravel</div> <div>4. All surfaces treated with D/2 Biological Solution, scrubbed with nylon brushes and water. Rinsed fully with water</div> <div>5. When dry, fragments attached with structural adhesive and braced.</div> <div>6. After 7 day cure marker was reset plumb and level into slot using a cement/lime grout (3/2/9) with 000 sand and braced.</div> <div>7. Losses filled with pigmented Jahn restoration mortar.</div>

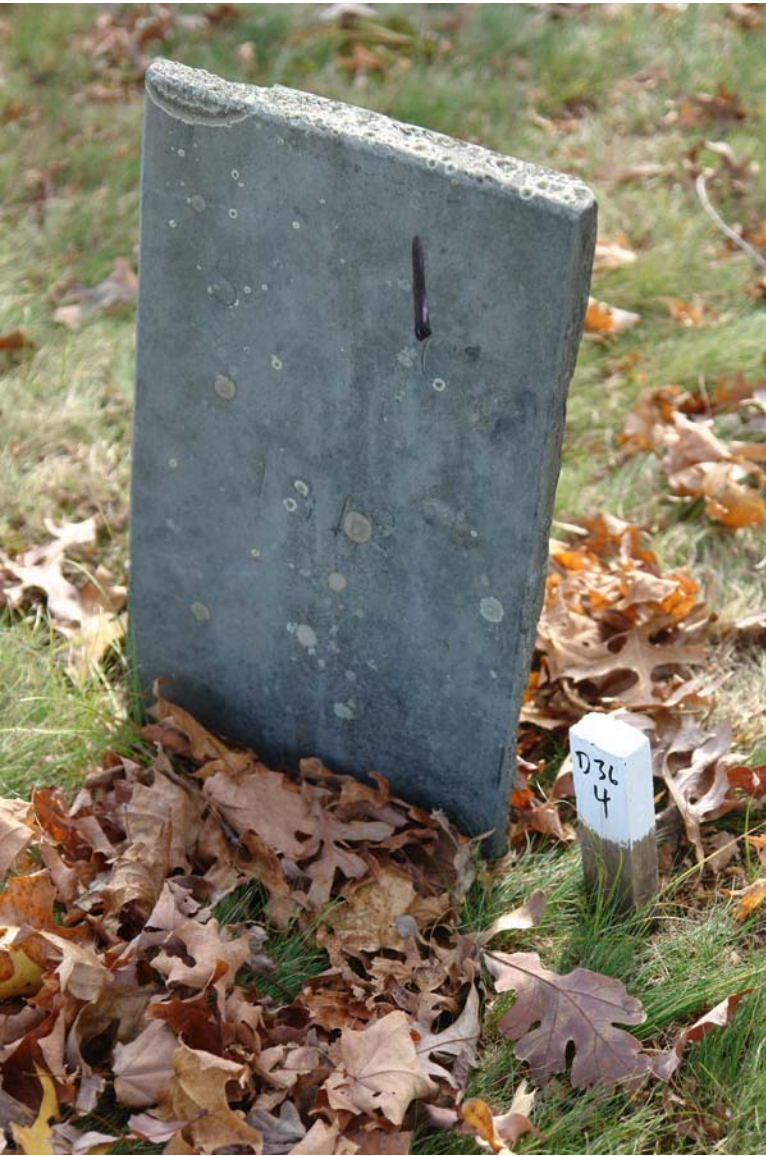
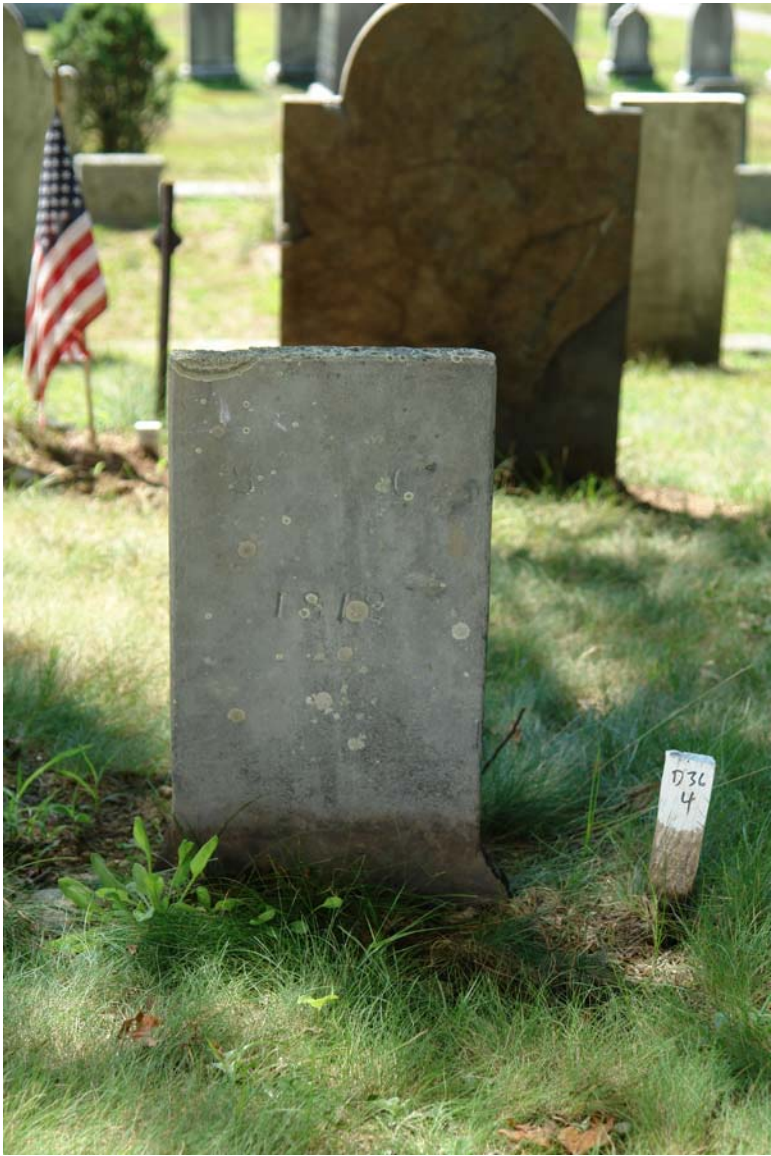
EXISTING CONDITIONS	CONSERVATION STRATEGY
Tilted	Reset plumb

5. Disturbed areas re-graded with existing topsoil and sod.

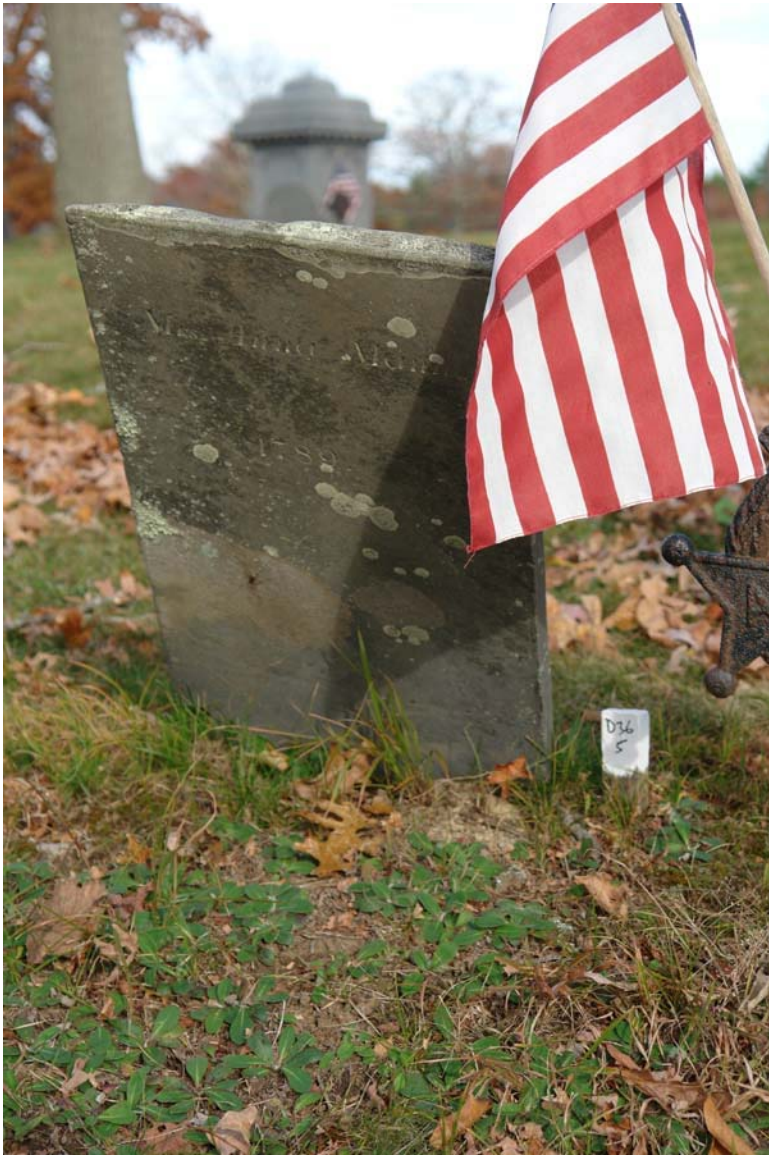
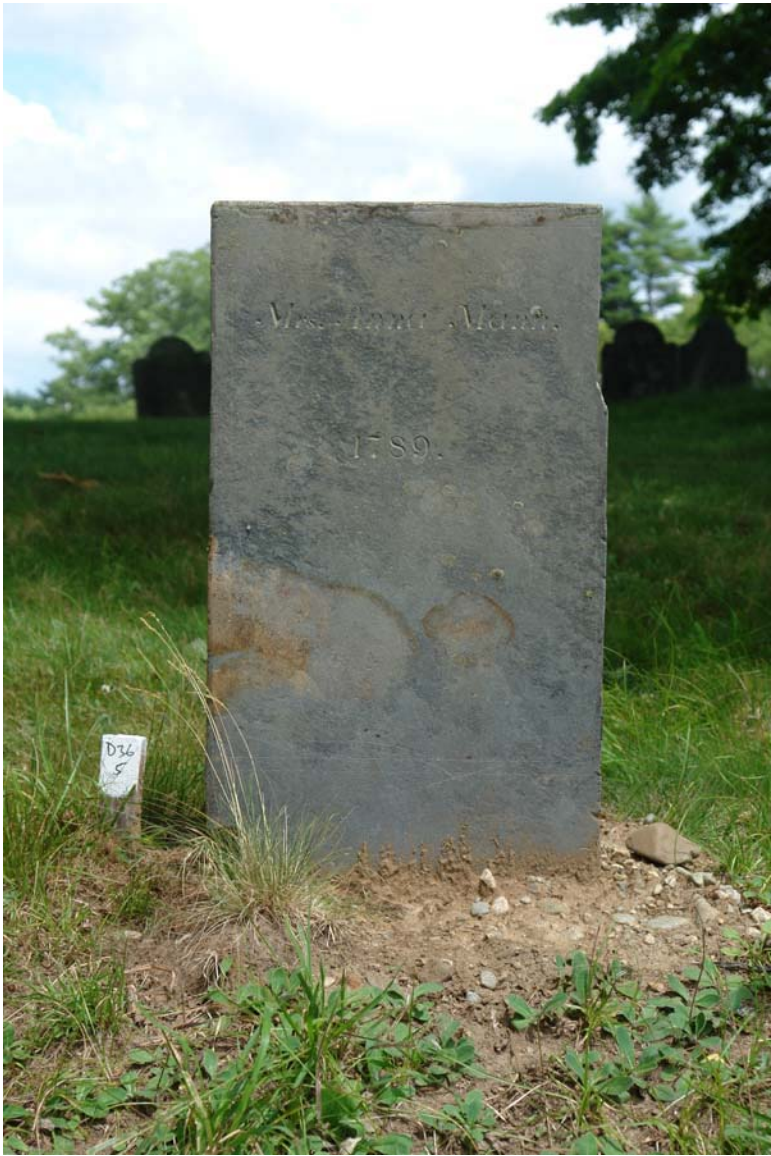
Hanover Center Cemetery, Hanover MA
NAME ON MARKER **Anna Mann**
Death Date: 3/14/1789 Marker Type: Headstone/ conc. base
Cond. of Inscription: Legible Material: Marble

EXISTING CONDITIONS	CONSERVATION STRATEGY
Tilted	Reset plumb

TREATMENT	Treatment Dates
1. Marker carefully excavated. The soil around tilted markers was removed to an appropriate depth. When required, the marker was removed from the ground. Marker appears to be sound. 2. Soling removed by light brushing with nylon brushes and water. 3. Setting area excavated to sufficient depth and stone re-set plumb at appropriate height and level onto gravel bed, aligned with adjacent markers 4. Area backfilled around marker with tamped sand and gravel 5. Disturbed areas re-graded with existing topsoil and sod. 6. Surface treated with D/2 Biological solution, brushed with nylon brushes and fully rinsed with water.	6/18/2015

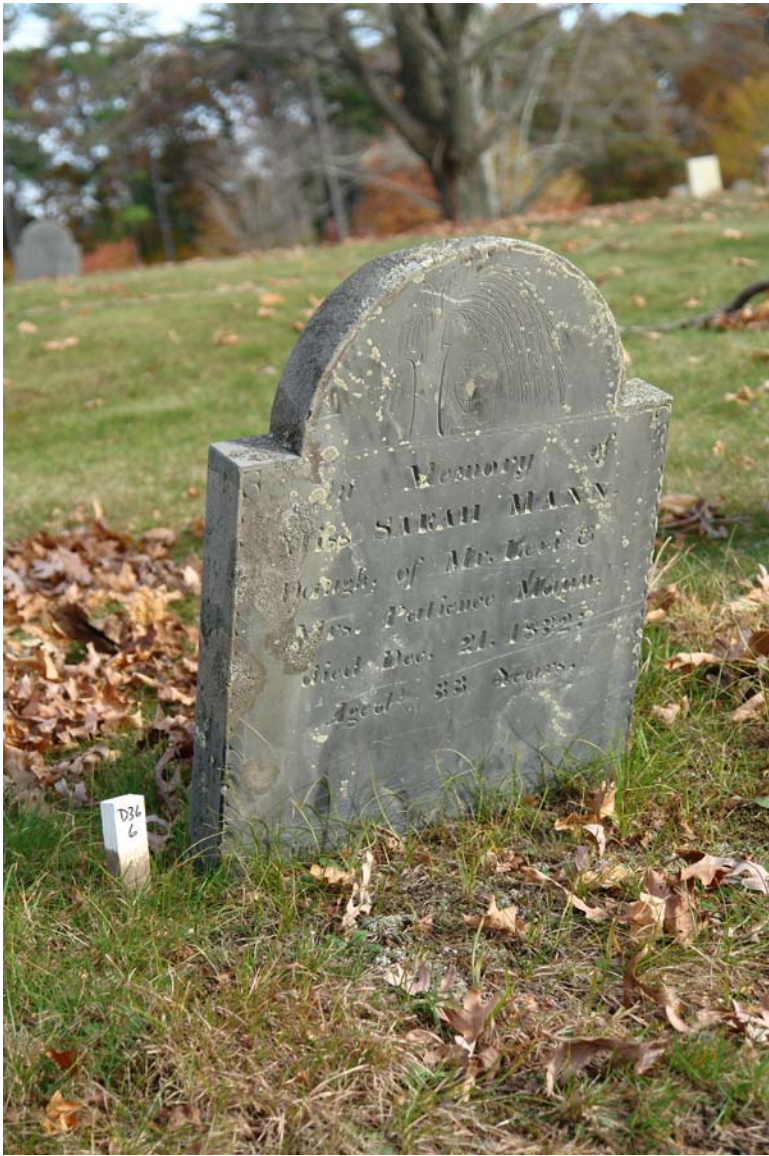
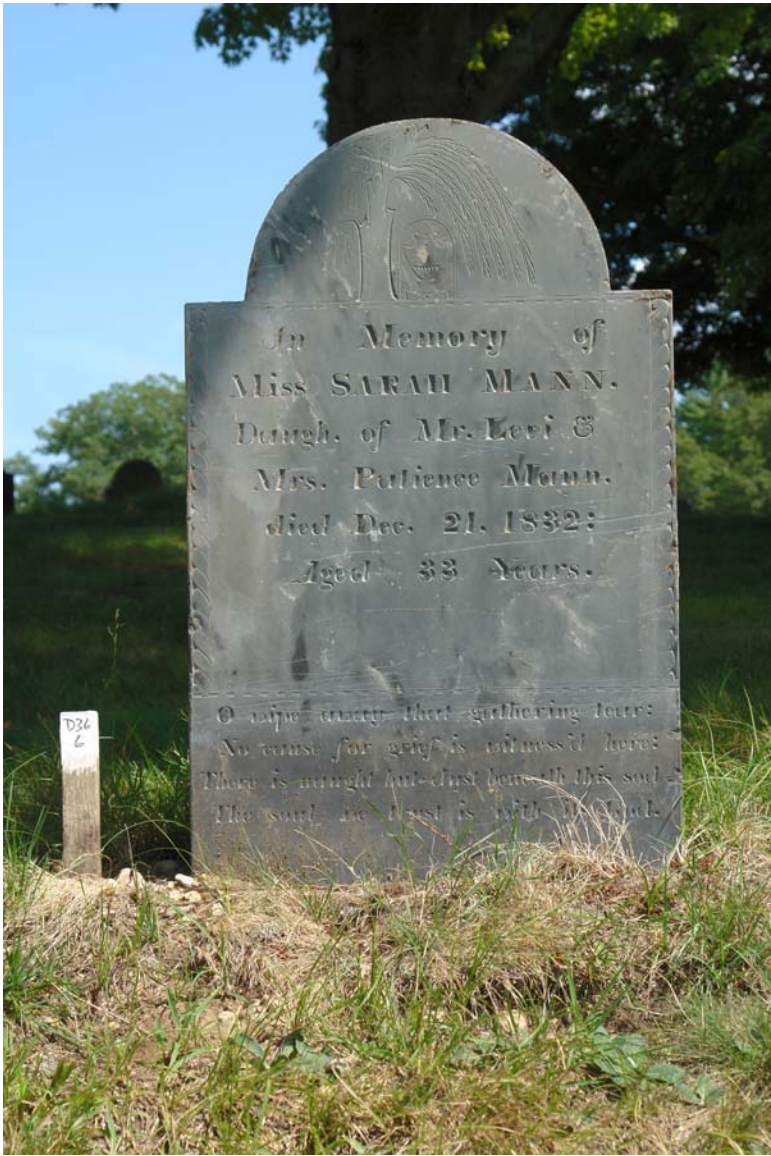
Hanover Center Cemetery, Hanover MA		
NAME ON MARKER		Sarah Mann
Death Date:	12/2/1832	Marker Type: Headstone
Cond. of Inscription:	Legible	Material: Slate
EXISTING CONDITIONS		CONSERVATION STRATEGY
Tilted		Reset into new below grade concrete base
TREATMENT		
Treatment Dates		6/18-22/2015
<div>1. Marker excavated and found to be sound. Light soiling removed by brushing with nylon brushes and water.</div> <div>2. Setting area excavated for new below grade cast concrete base sized minimum of 12 inches deep, 12 inches greater in thickness and 6 inches wider than the stone.</div> <div>3. Wooden forms and setting slot form stabilized and aligned with adjacent markers before concrete is poured</div> <div>4. When required, the lower edge of marker is re-squared with minimal loss using a power grinder</div> <div>5. Setting forms are removed after partial curing of the concrete and the base backfilled with tamped sand or gravel</div> <div>6. Marker reset into setting slot with a cement/lime grout (3/2/9) with 000 sand made fluid with a super plasticizer.</div> <div>7. Marker set plumb and level, and braced for minimum of 5 days.</div> <div>8. Disturbed areas backfilled with existing topsoil.</div>
