MONUMENT CONSERVATION COLLABORATIVE LLC, NORFOLK, CT

DOCUMENTATION OF STONE CONSERVATION TREATMENTS TO ASSINIPPI CEMETERY, HANOVER, MA June 2015

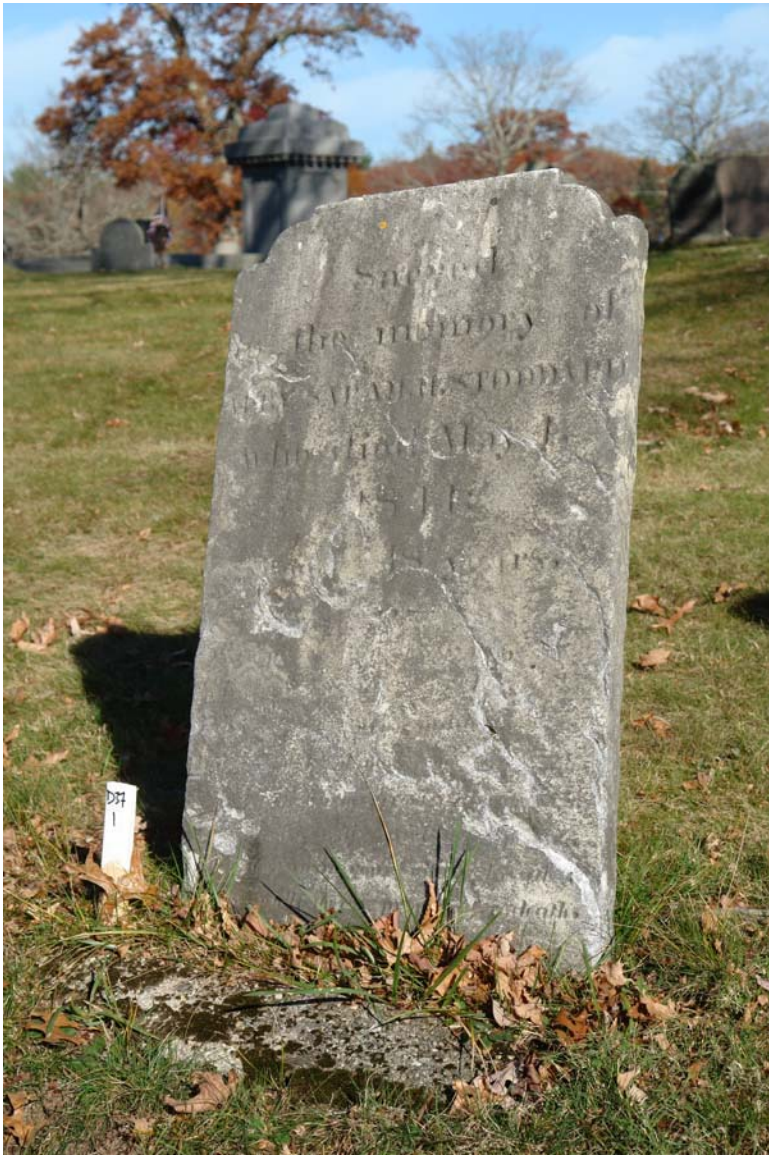
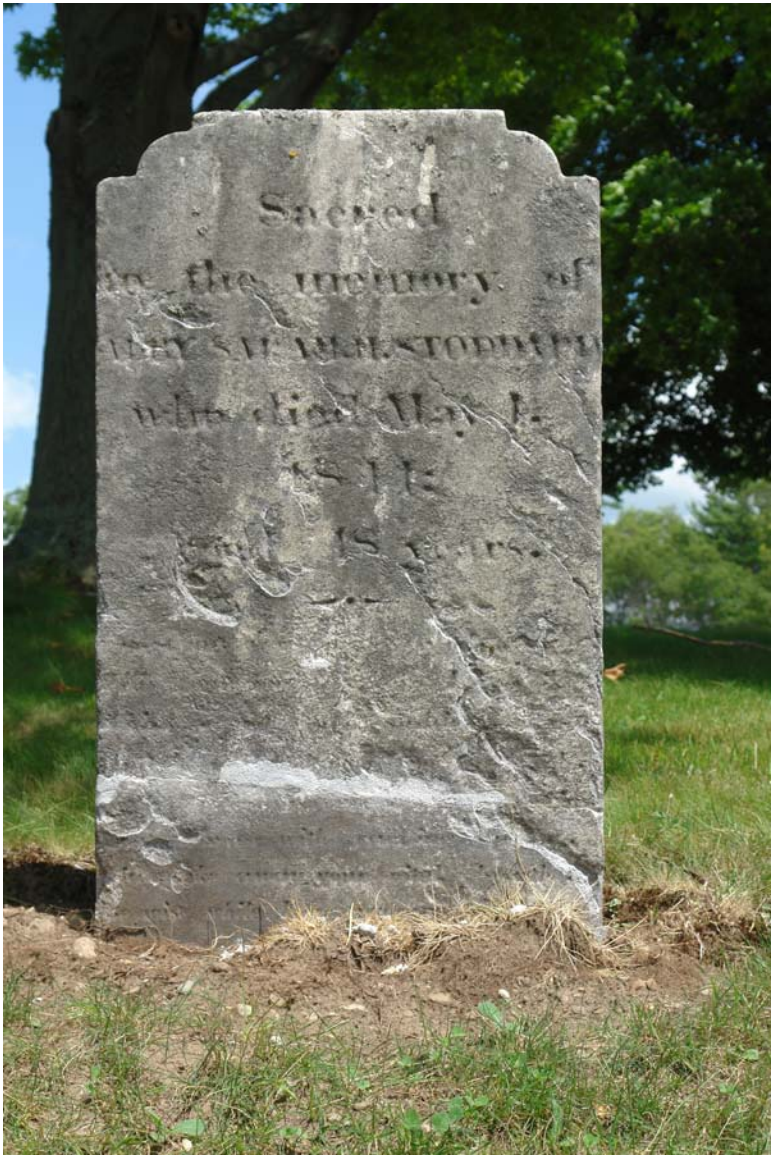
Hanover Center Cemetery, Hanover MA
NAME ON MARKER **Sarah Stoddard**
Death Date: 5/4/1844 Marker Type: Headstone/conc. base
Cond. of Inscription: Decipherable Material: Marble

EXISTING CONDITIONS	CONSERVATION STRATEGY
Fractured at grade	Reset into new below grade concrete base

TREATMENT	Treatment Dates
1. Setting area excavated for new below grade cast concrete base 2. A new concrete base sized min. 12" deep, 12" greater in thickness and 6" wider than the stone is cast. The finished top to be below grade. A form for a setting slot 1" wider than the marker is placed in the concrete. 3. Setting forms are removed after partial curing of the concrete and the base backfilled with tamped sand or gravel 4. Lower fragment was reset plumb and level into slot using a cement/ lime grout (3/2/9) with 000 sand. Braced for min 3 days 5. All mating edges of fragments cleaned with water 6. Fragments attached with structural adhesive (Abatron 55-22), clamped and braced until cured. Excess epoxy removed with hand chisels within 24 hours. 7. All surfaces treated with D/2 Biological Solution, scrubbed with nylon brushes and water. Rinsed fully with water	6/18-29/2015

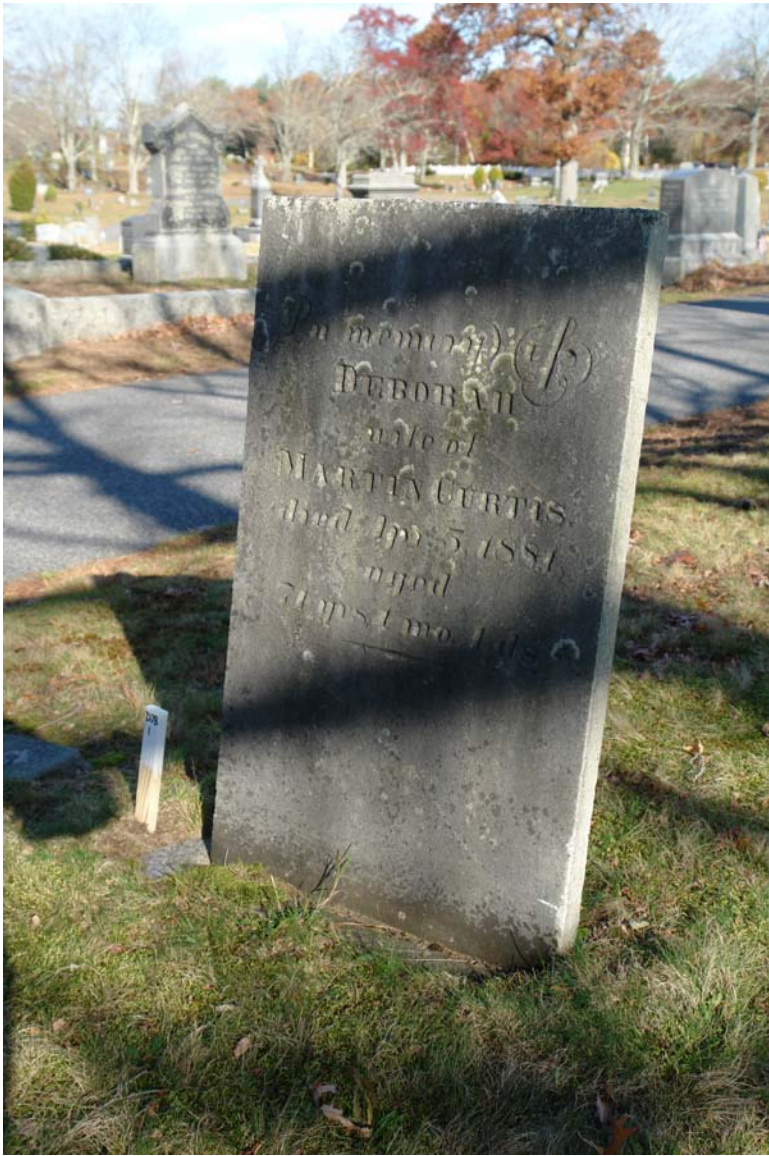
Hanover Center Cemetery, Hanover MA
NAME ON MARKER **Deborah Curtis**
Death Date: 4/5/1881 Marker Type: Headstone/conc. base
Cond. of Inscription: Legible Material: Marble

EXISTING CONDITIONS	CONSERVATION STRATEGY
Tilted	Reset plumb

TREATMENT	Treatment Dates
1. Elements removed from setting bases and inspected for soundness. 2. Area excavated to an appropriate depth removing any roots or large stones. 3. Base is aligned with adjacent markers and re-set level. 4. Area around base was backfilled with tamped gravel and re-graded with existing topsoil 5. Failed mortar removed from setting area and bottom of marker 6. When required, any existing pins were inspected, and if necessary, replaced with stainless steel threaded pins 7. Setting surfaces primed with Acryl 60 diluted 1:3 with water. 8. Marker reset plumb onto base with cement/lime mortar (3/2/9) with 000 sand. 9. Excess grout removed and joint area cleaned.	7/14/2015

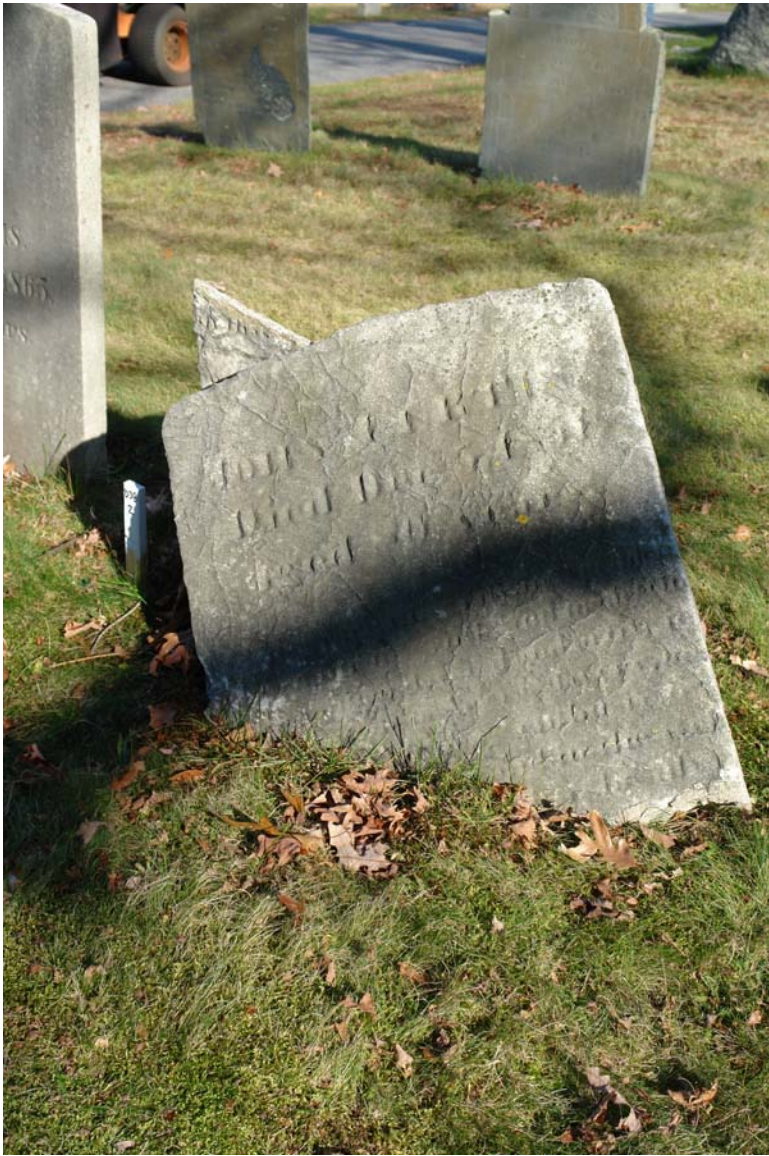
Hanover Center Cemetery, Hanover MA
NAME ON MARKER **John Curtis**
Death Date: 12/5/1851 Marker Type: Headstone/conc.base
Cond. of Inscription: Decipherable Material: Marble

EXISTING CONDITIONS	CONSERVATION STRATEGY
Fractured	Attach fragments with structural adhesive

Comments: **Condition of the marker is fragile**

TREATMENT	Treatment Dates
1. Failed mortar found to be firmly attached to fragments and areas of fracture sugaring. Because of the condition of the marble, losses and amount of old mortar it was determined to leave the mortar and attach the fragments. 2. Fractured elements were dry fitted to ascertain final soundness and to check for large losses at mating areas. 3. Dry fragments attached with structural adhesive (Abatron 55-22), clamped and braced until cured. Excess epoxy removed by hand chisels 4. Cracks and voids filled with Jahn cementitious mortar. 5. All surfaces treated with D/2 Biological Solution, scrubbed with nylon brushes and water. Rinsed fully with water	7/7-13/2015

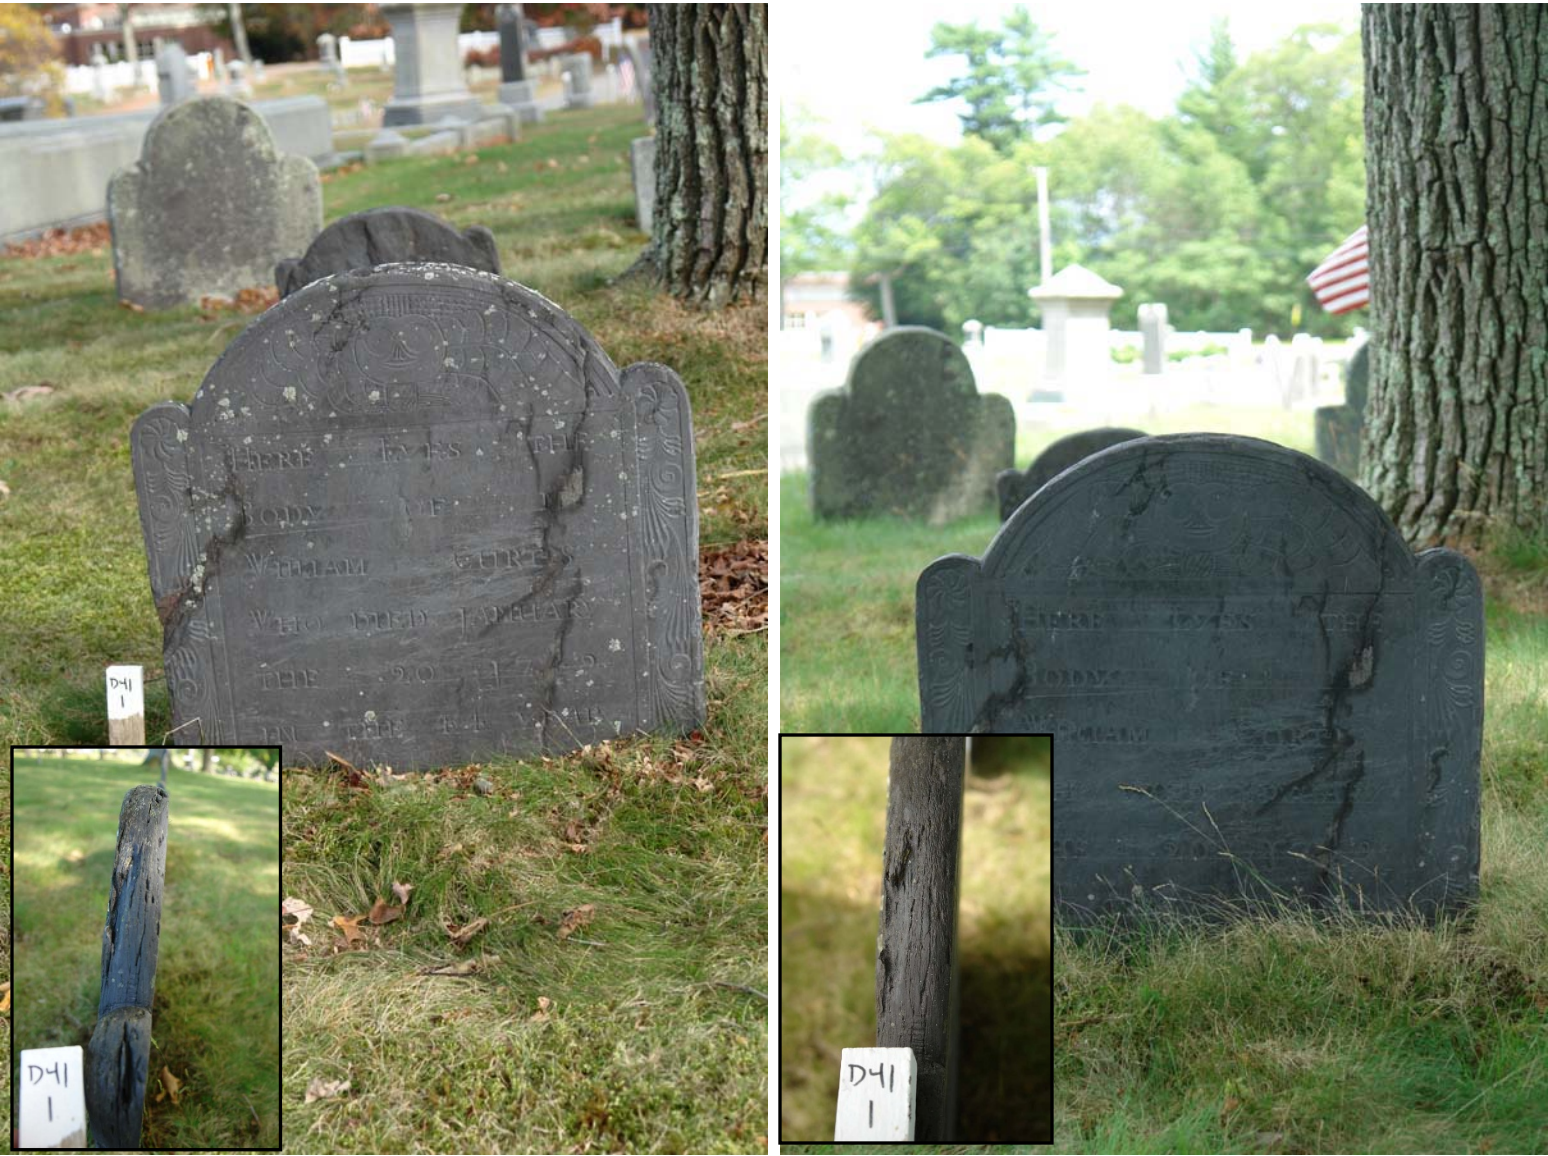
EXISTING CONDITIONS	CONSERVATION STRATEGY
Voids caused by delaminating	Cap voids caused by delaminations.

3. After full drying, all voids caused by splitting or delaminations at top edge of marker filled with a pigmented Sto Crack Filler using injection syringes and/or trowels. Voids along sides of monument typically left open to allow escape of any water which may enter.

4. Excess crack filler immediately removed with repeated damp sponging.

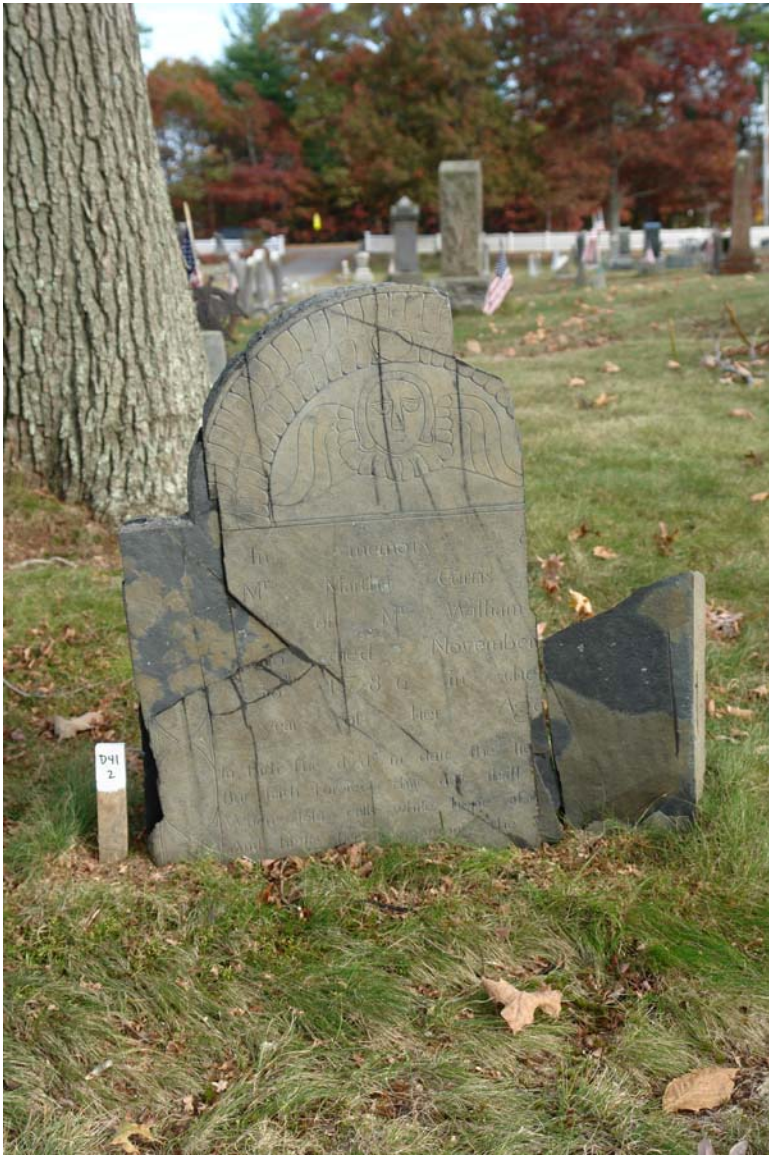
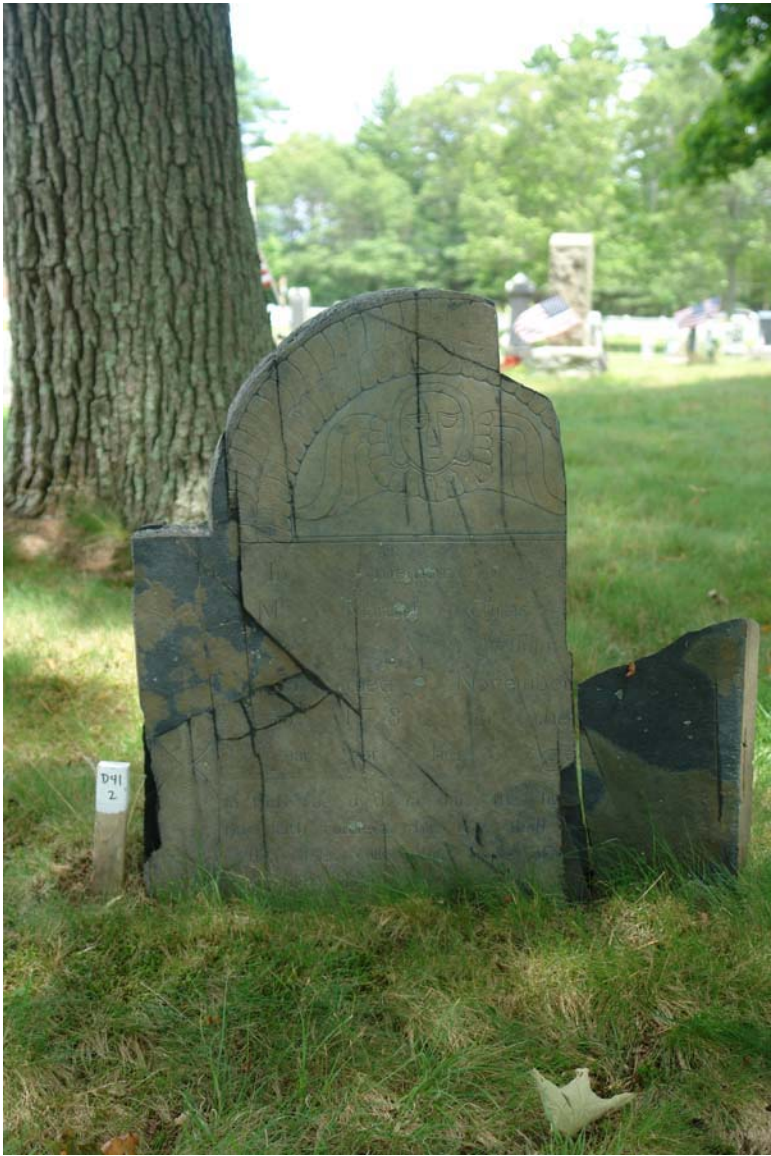
EXISTING CONDITIONS	CONSERVATION STRATEGY
Voids caused by delaminating	Cap voids caused by delaminations.

TREATMENT	Treatment Dates	n.a.
1. Fragments missing 2. Face delaminations are cracks and not large enough to treat.

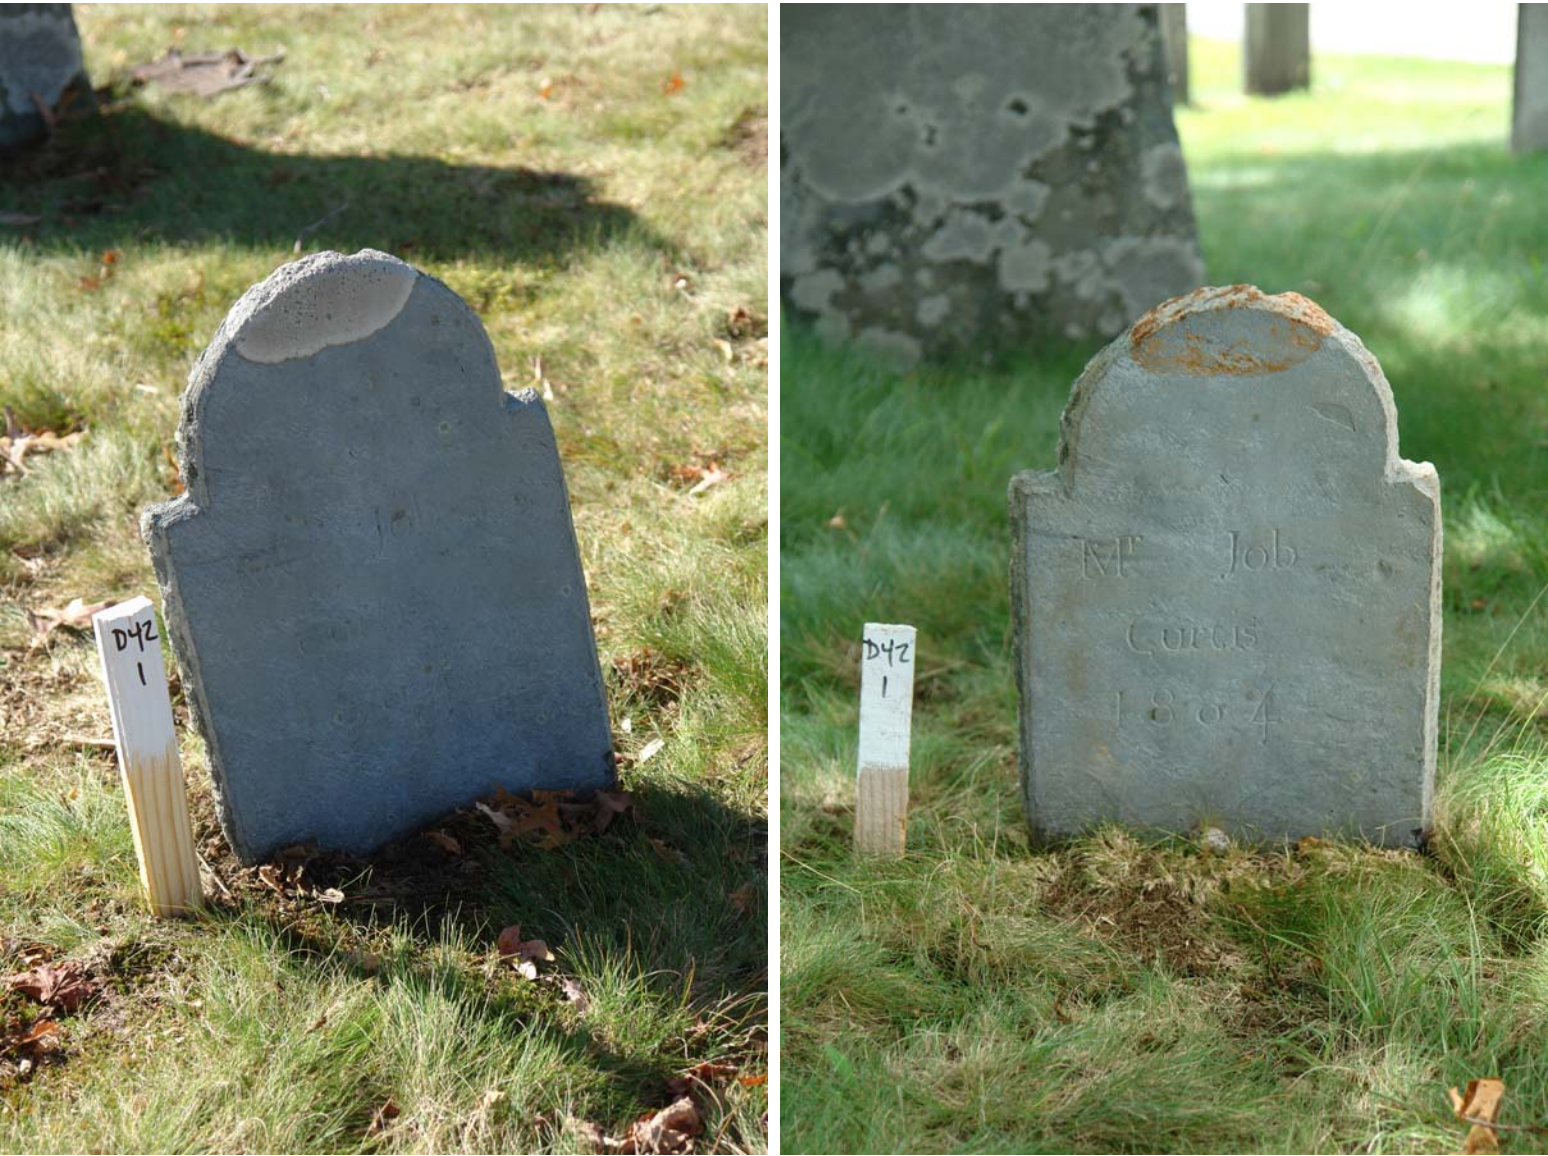
Height 22 Width 22 Thickness 1.5 Marker# **D.41.2**

EXISTING CONDITIONS	CONSERVATION STRATEGY
Tilted	Reset plumb

5. Disturbed areas re-graded with existing topsoil and sod.

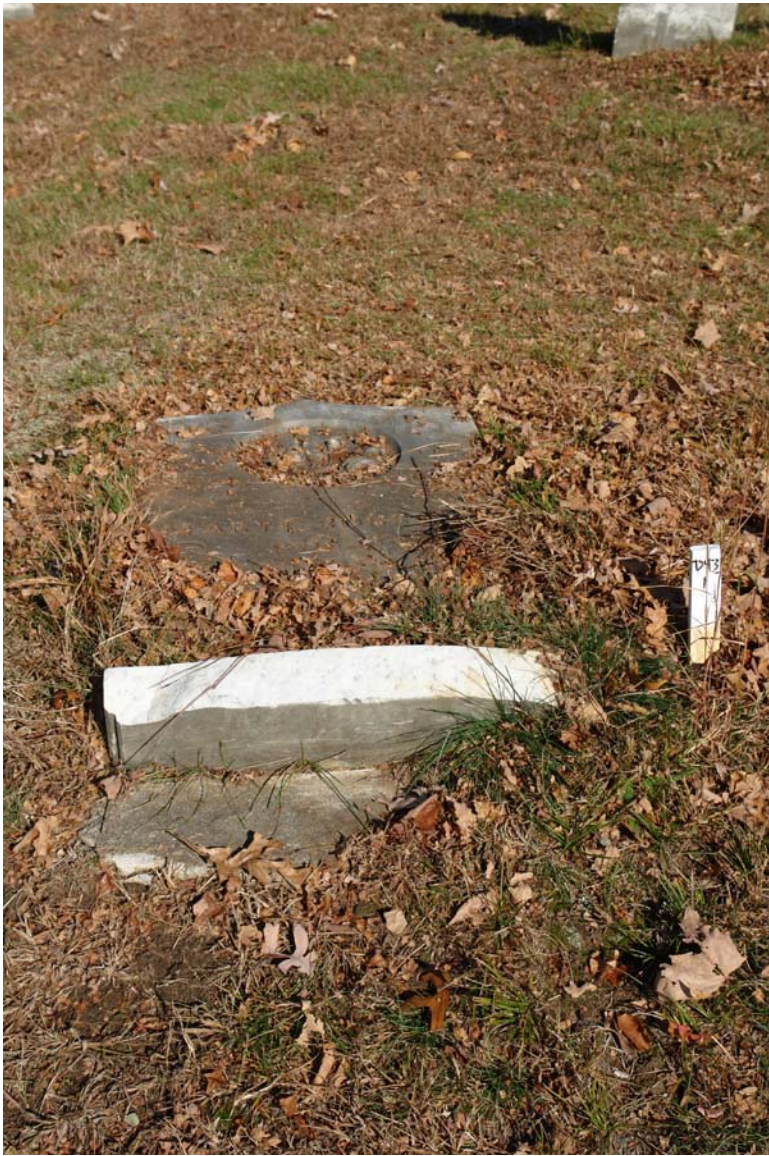
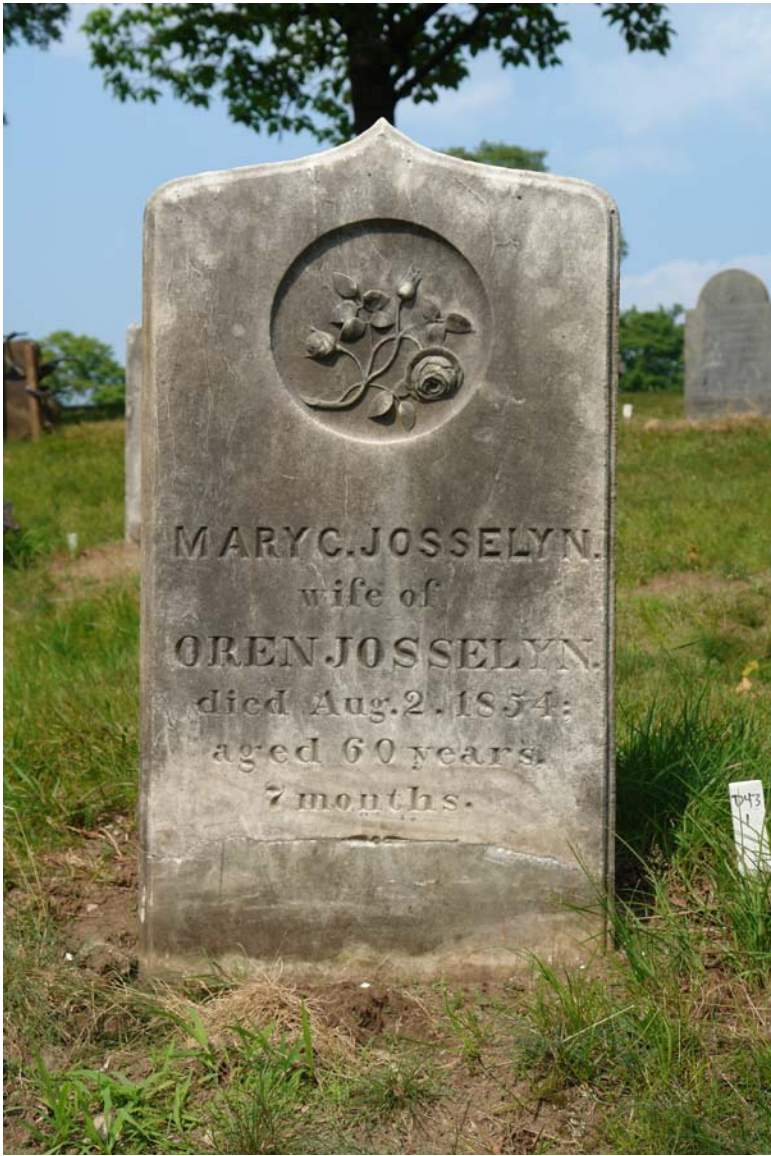
NAME ON MARKER **Mary Josselyn**

EXISTING CONDITIONS	CONSERVATION STRATEGY
Fallen	Evaluate resetting options Possible new below grade concrete base

TREATMENT	Treatment Dates 6/17-18/2015
<div>1. Existing base located below grade and found to be sound.</div> <div>2. Area excavated to an appropriate depth and base was aligned with adjacent markers and re-set level and backfilled with tamped gravel.</div> <div>3. Setting slot cleaned of debris or failed mortar</div> <div>4. Lower fragment reset plumb and level into slot using a cement/lime grout (3/2/9) with 000 sand. Braced for min 3 days</div> <div>5. All mating edges of fragments cleaned with water and any failed adhesives removed with hand tools</div> <div>6. Fragments attached with structural adhesive (Abatron 55-22), clamped and braced until cured. Excess epoxy removed with hand chisels within 24 hours.</div> <div>7. Cracks and losses filled with RepliCal Marble products .</div> <div>8. Filled areas misted with water and covered for 3 days minimum</div> <div>9. Filled surface areas treated with light acid wash rinsed thoroughly</div> <div>10. When required, all surfaces treated with D/2 Biological Solution, scrubbed with nylon brushes and water. Rinsed fully with water</div>

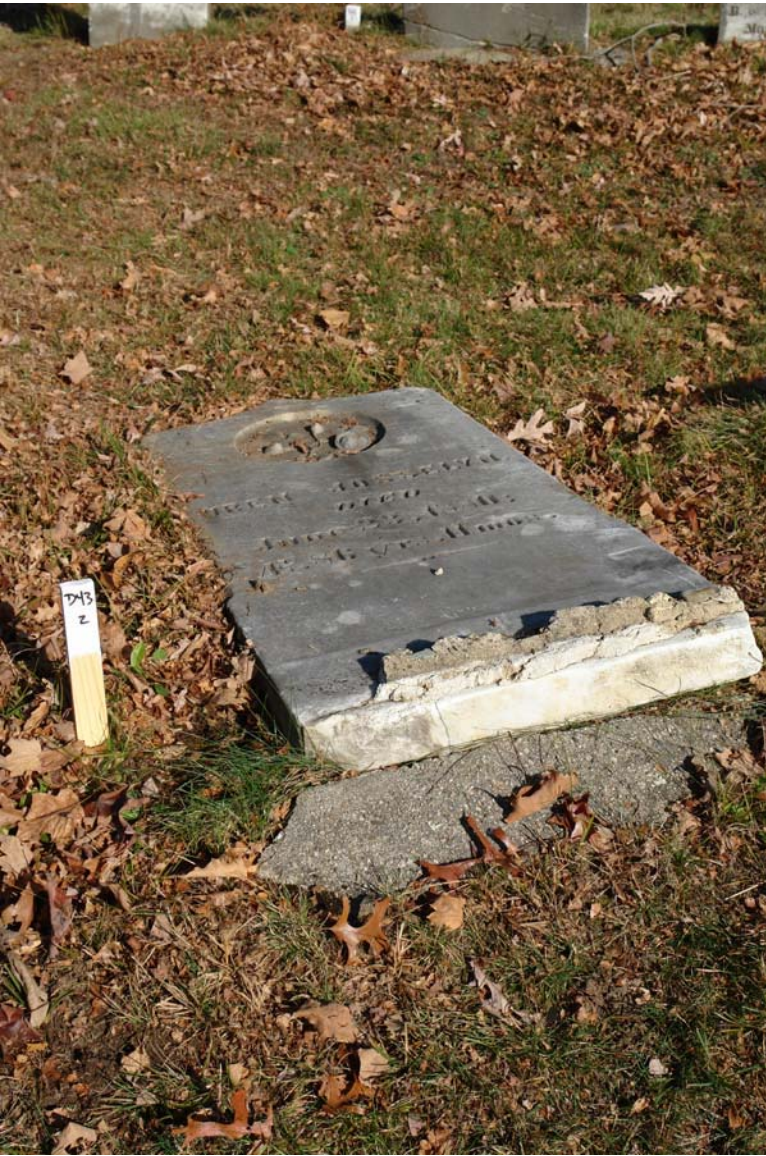
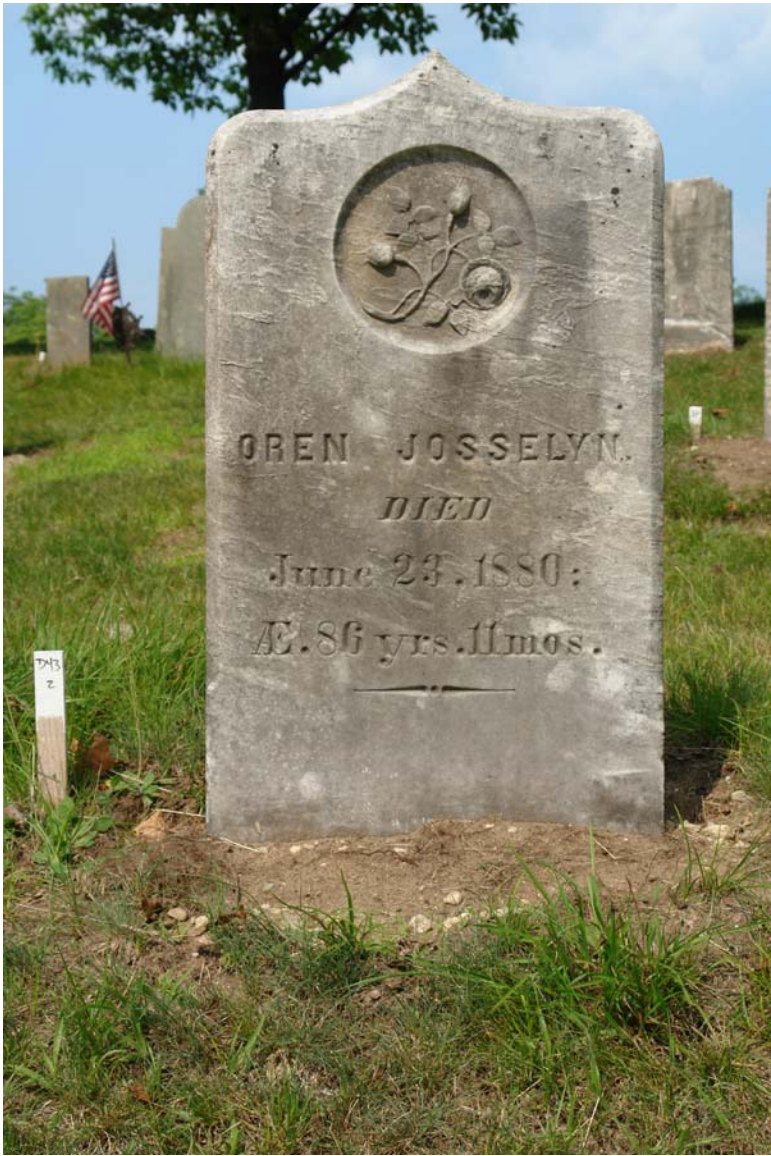
Hanover Center Cemetery, Hanover MA
NAME ON MARKER **Oren Josselyn**
Death Date: 6/23/1880 Marker Type: Headstone/conc.base
Cond. of Inscription: Legible Material: Marble

EXISTING CONDITIONS	CONSERVATION STRATEGY
Fallen	Evaluate resetting options Possible new below grade concrete base

TREATMENT	Treatment Dates 6/16/2015
<div>1. Existing base located below grade while excavating for resetting. Area excavated to an appropriate depth removing any roots or large stones.</div> <div>2. Base inspected and found to be sound and re-useable</div> <div>3. Base is aligned with adjacent markers and re-set level.</div> <div>4. Area around base was backfilled with tamped gravel and re-graded with existing topsoil</div> <div>5. Debris removed from setting slot. When required, power grinders were used to facilitate removal of stone fragments.</div> <div>6. When required, the lower setting edge was re-squared by power grinder with minimal loss.</div> <div>7. Marker reset plumb and level into setting slot with cement/lime grout (3/2/9) with 000 sand made fluid with a super plasticizer.</div> <div>8. Excess grout removed and joint area cleaned.</div> <div>9. Marker braced for a minimum 3 days</div>

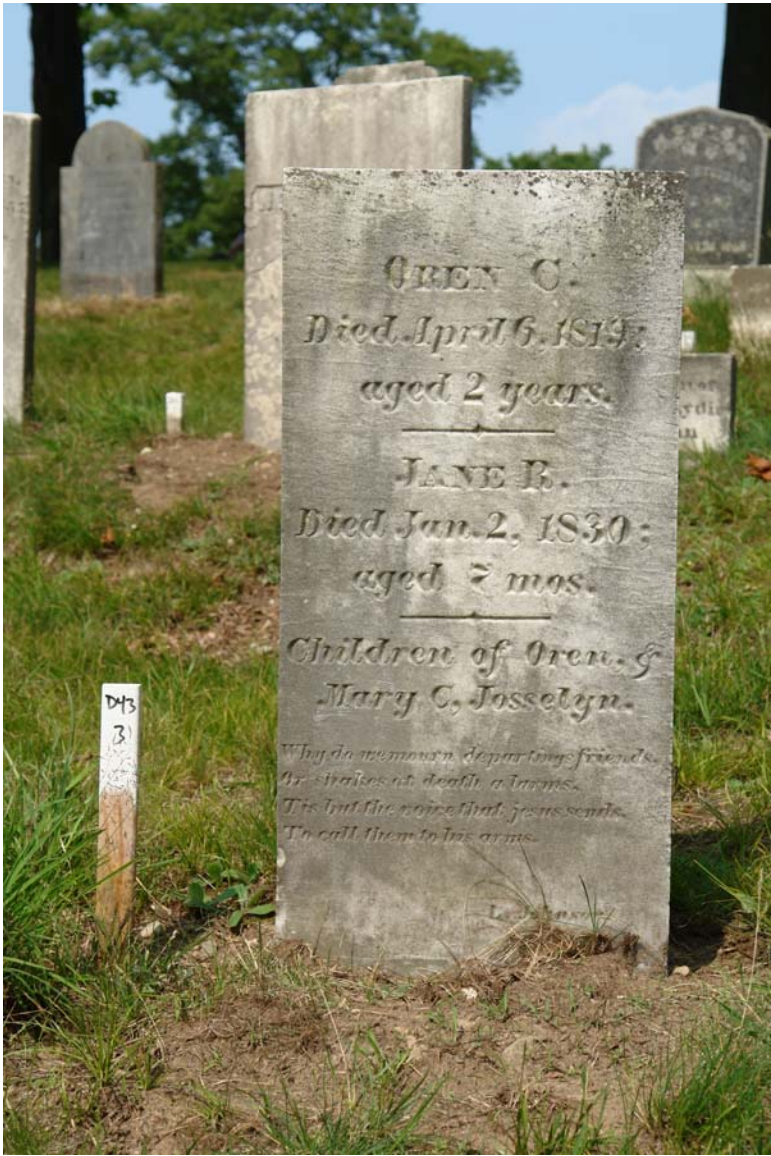
Hanover Center Cemetery, Hanover MA
NAME ON MARKER **Oren C. Josselyn**
Death Date: 4/6/1819 Marker Type: Headstone/conc.base
Cond. of Inscription: Legible Material: Marble

EXISTING CONDITIONS	CONSERVATION STRATEGY
Loose in base	Reset into new below grade concrete base

TREATMENT	Treatment Dates
1. Marker carefully excavated. The soil around tilted markers was removed to an appropriate depth. When required, the marker was removed from the ground. Marker appears to be sound. 2. Failed concrete at base removed with hand tools. 3. Setting area excavated to sufficient depth and stone re-set plumb at appropriate height and level onto gravel bed, aligned with adjacent markers 4. Area backfilled around marker with tamped sand and gravel 5. Disturbed areas re-graded with existing topsoil and sod.	6/16/2015

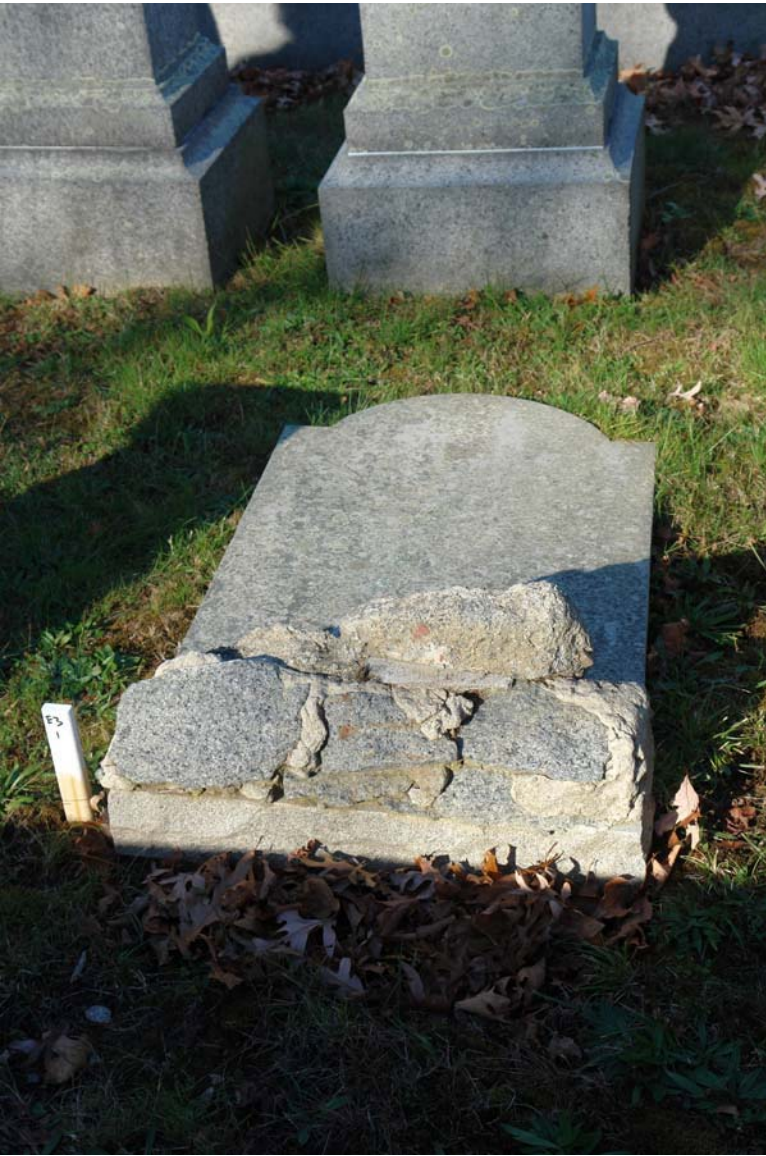
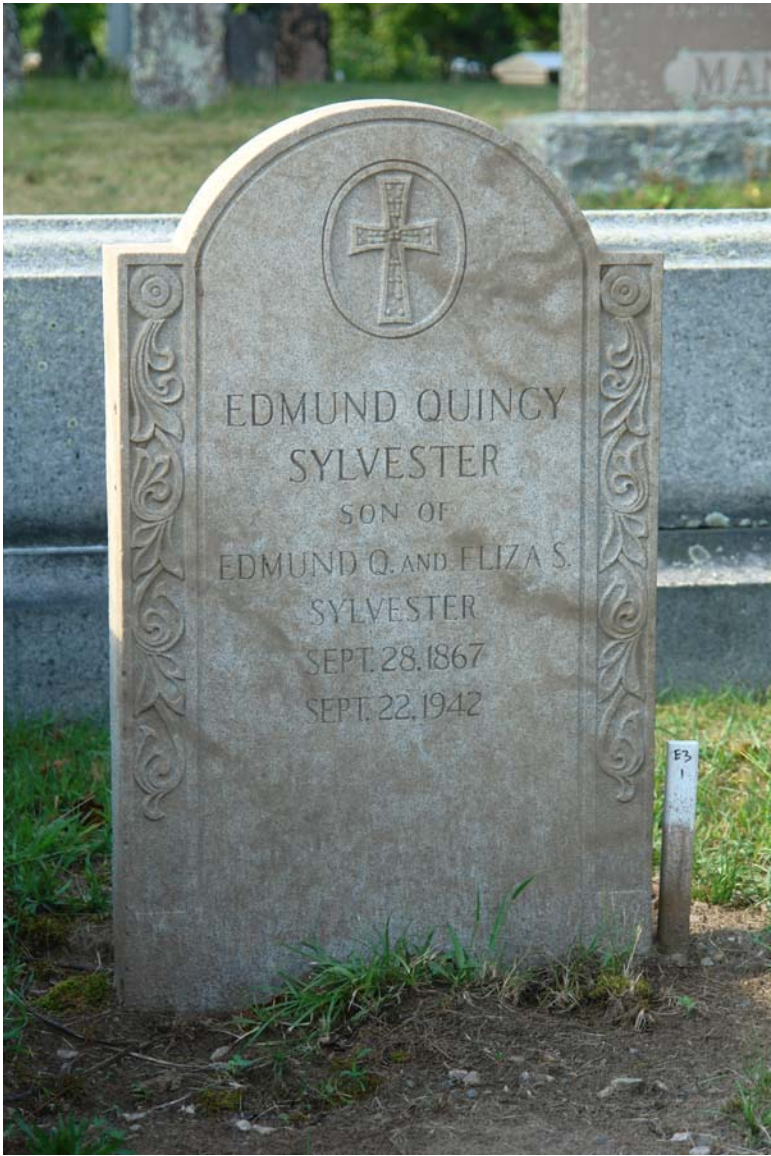
Hanover Center Cemetery, Hanover MA	
NAME ON MARKER	Edmund Sylvester
Death Date: 9/22/1942	Marker Type: Headstone
Cond. of Inscription: Legible	Material: Granite
EXISTING CONDITIONS	CONSERVATION STRATEGY
Fallen	Reset into new below grade concrete base
TREATMENT	
Treatment Dates /29/2015	
<div>1. Existing base located below grade while excavating for resetting. Area excavated to an appropriate depth removing any roots or large stones.</div> <div>2. Base inspected and found to be sound and re-useable</div> <div>3. Base is aligned with adjacent markers and re-set level.</div> <div>4. Area around base was backfilled with tamped gravel and re-graded with existing topsoil</div> <div>5. Debris removed from marker with hand tools.</div> <div>6. Marker reset plumb and level into setting slot with cement/lime grout (3/2/9) with 000 sand made fluid with a super plasticizer.</div> <div>7. Excess grout removed and joint area cleaned.</div> <div>8. Marker braced for a minimum 3 days</div>

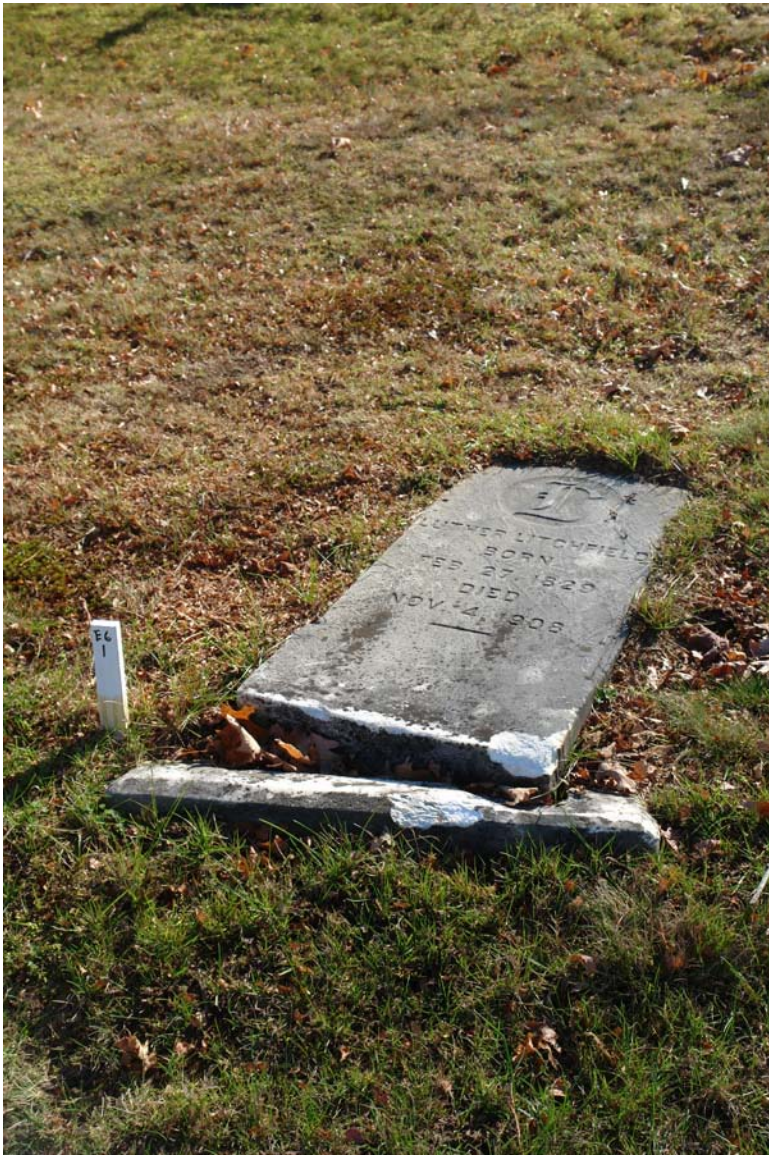
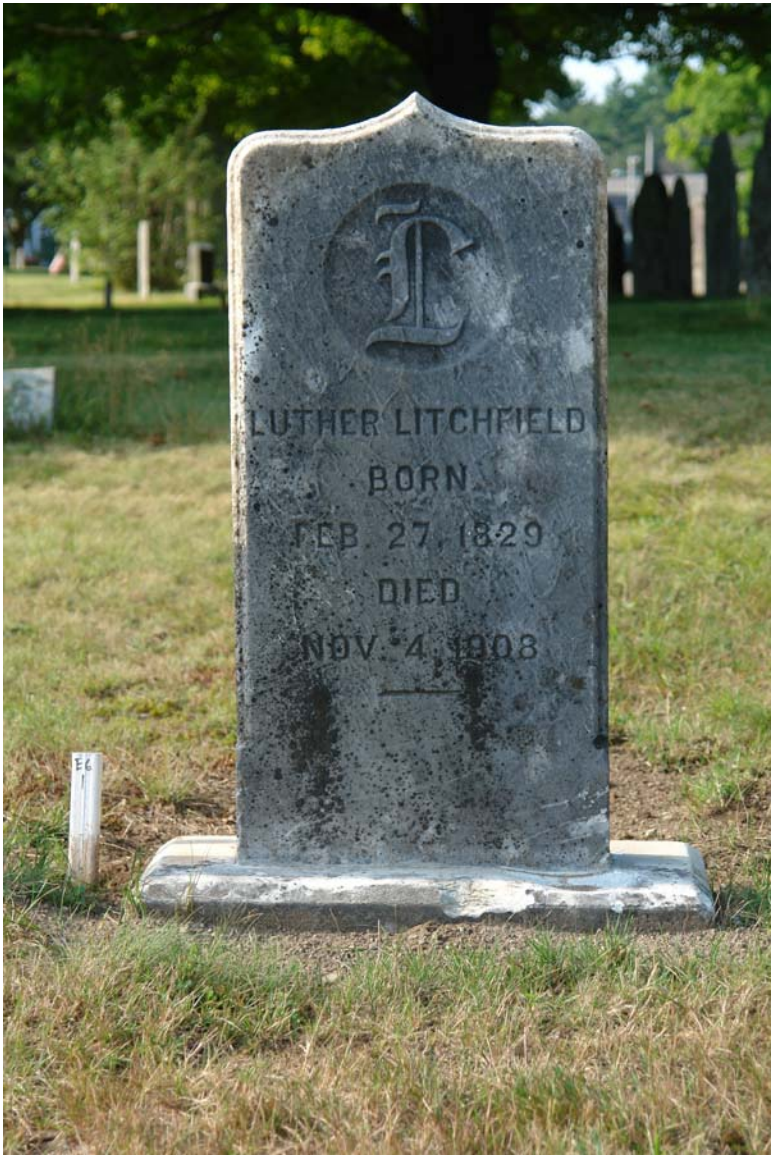
EXISTING CONDITIONS	CONSERVATION STRATEGY
Fallen	Evaluate resetting options Possible new below grade concrete base

2. Base inspected and found to be sound and re-useable

9. Marker braced for a minimum 3 days

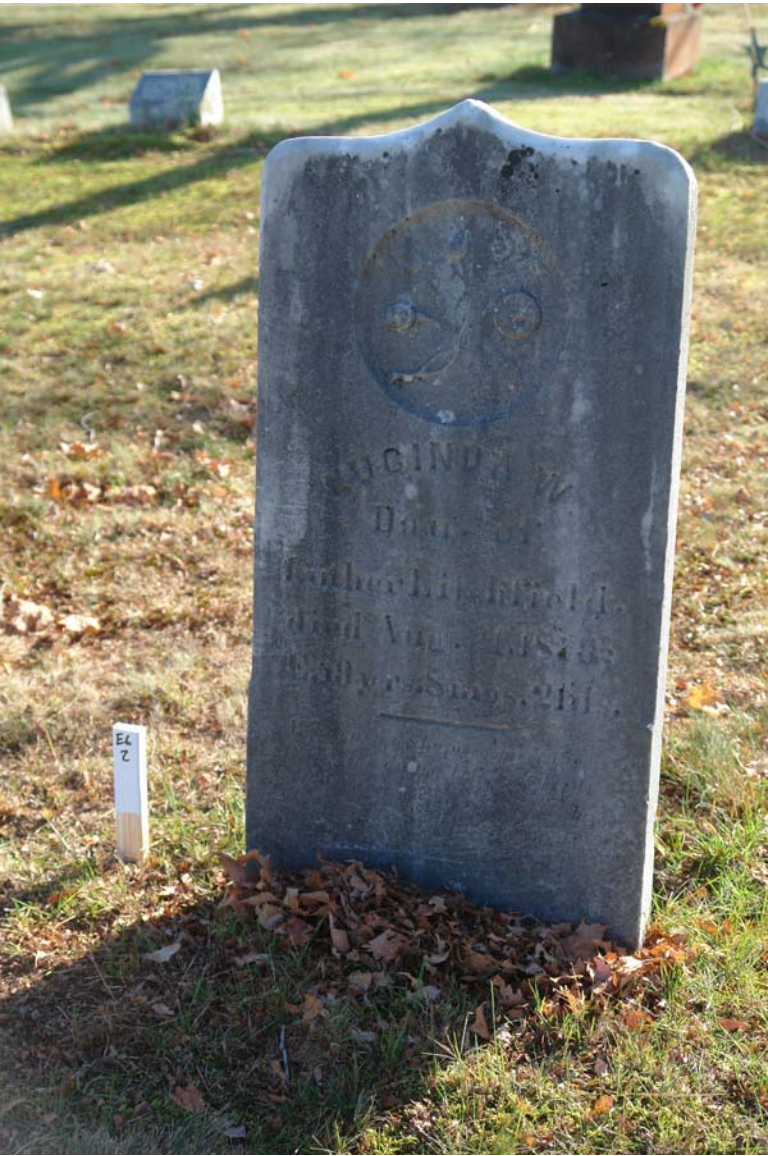
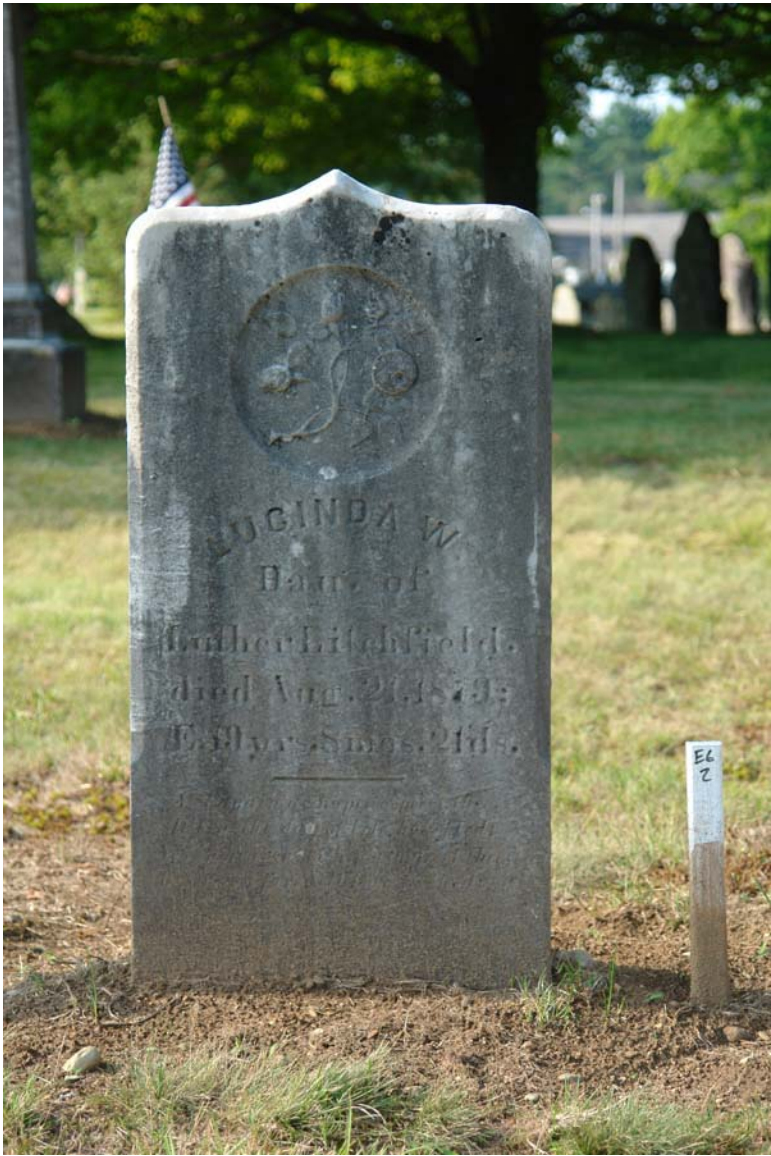
Hanover Center Cemetery, Hanover MA
NAME ON MARKER **Lucinda Litchfield**
Death Date: 8/21/1879 Marker Type: Headstone/slotted base
Cond. of Inscription: Legible Material: Marble

EXISTING CONDITIONS	CONSERVATION STRATEGY
Tilted	Reset plumb

TREATMENT	Treatment Dates
	7/29-30/2015
<div>1. Marker excavated and found to be sound. Light soiling removed by brushing with nylon brushes and water.</div> <div>2. Setting area excavated for new below grade cast concrete base sized minimum of 12 inches deep, 12 inches greater in thickness and 6 inches wider than the stone.</div> <div>3. Wooden forms and setting slot form stabilized and aligned with adjacent markers before concrete is poured</div> <div>4. When required, the lower edge of marker is re-squared with minimal loss using a power grinder</div> <div>5. Setting forms are removed after partial curing of the concrete and the base backfilled with tamped sand or gravel</div> <div>6. Marker reset into setting slot with a cement/lime grout (3/2/9) with 000 sand made fluid with a super plasticizer.</div> <div>7. Marker set plumb and level, and braced for minimum of 5 days.</div> <div>8. Disturbed areas backfilled with existing topsoil.</div>
