MONUMENT CONSERVATION COLLABORATIVE LLC, NORFOLK, CT

DOCUMENTATION OF STONE CONSERVATION TREATMENTS TO ASSINIPPI CEMETERY, HANOVER, MA June 2015

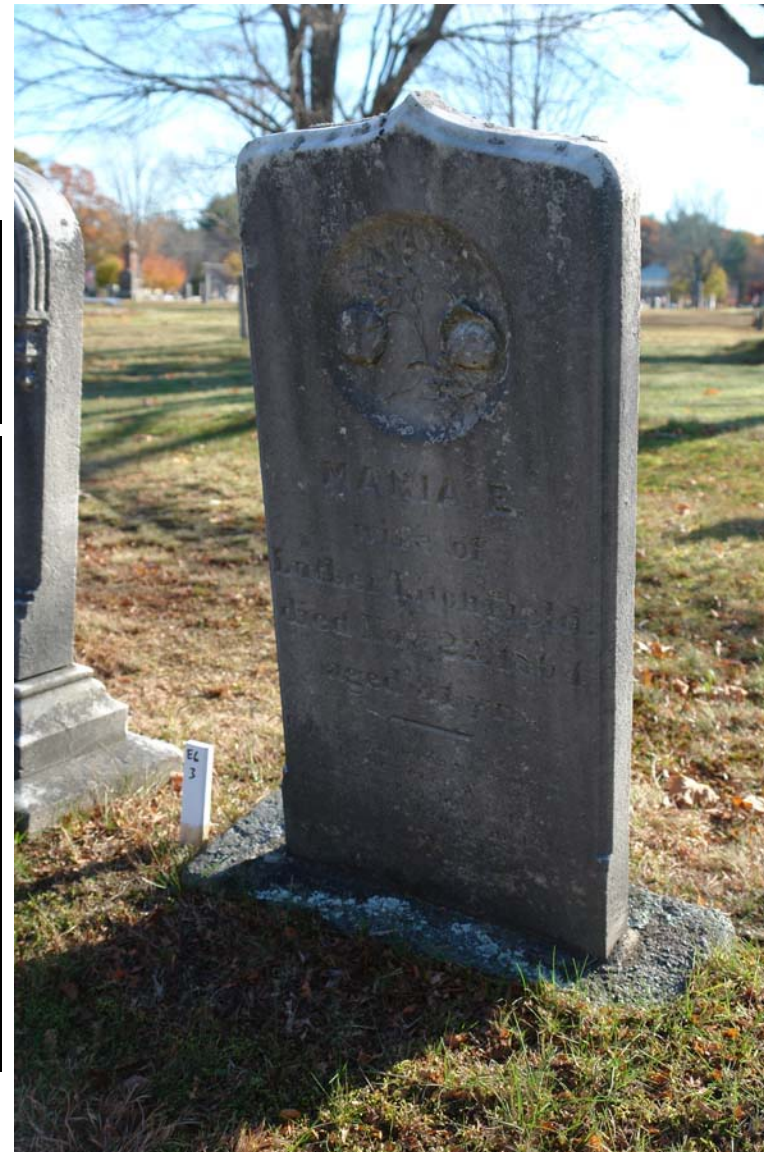
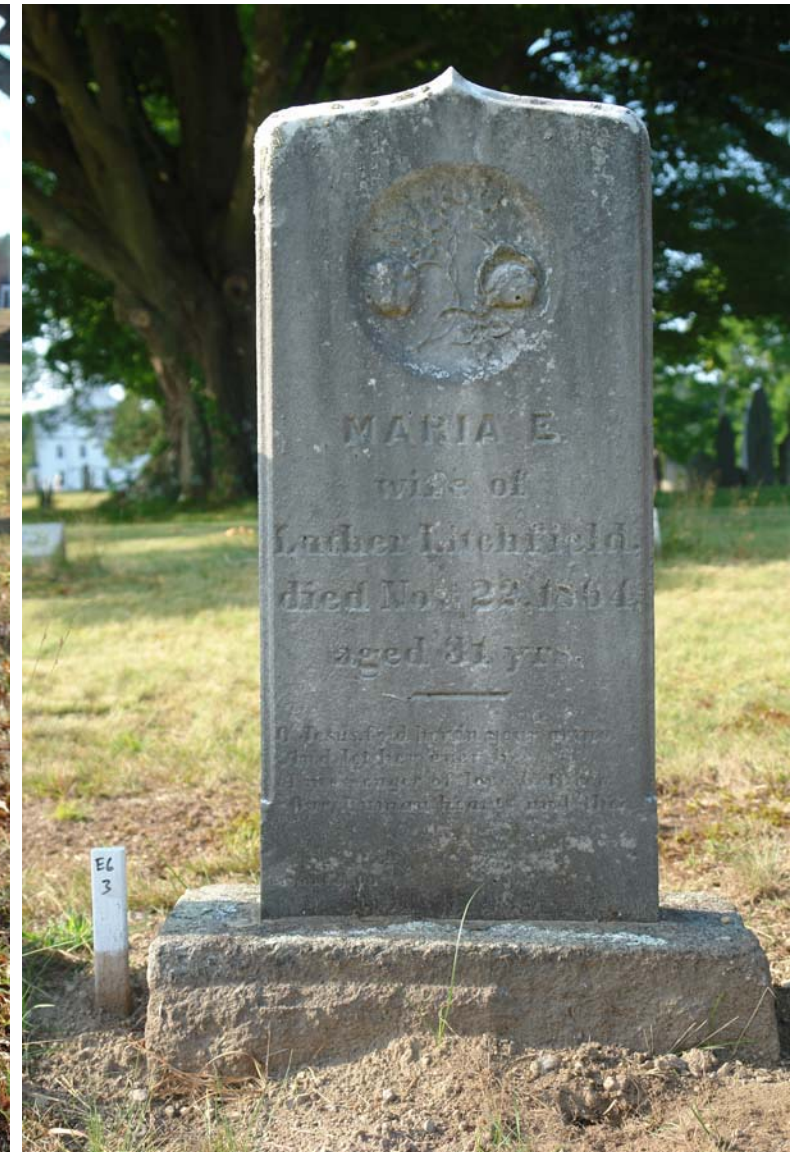
Height 32 Width 15 Thickness 2.5 Marker# **E.6.3**

EXISTING CONDITIONS

1. Elements removed from setting bases and inspected for soundness.
2. Area excavated to an appropriate depth removing any roots or large stones.
3. Base is aligned with adjacent markers and re-set level.
4. Area around base was backfilled with tamped gravel and re-graded with existing topsoil
5. Failed mortar removed from setting area and bottom of marker
6. When required, any existing pins were inspected, and if necessary, replaced with stainless steel threaded pins
7. Setting surfaces primed with Acryl 60 diluted 1:3 with water.
8. Marker reset plumb onto base with cement/lime mortar (3/2/9) with 000 sand.
9. Excess grout removed and joint area cleaned.

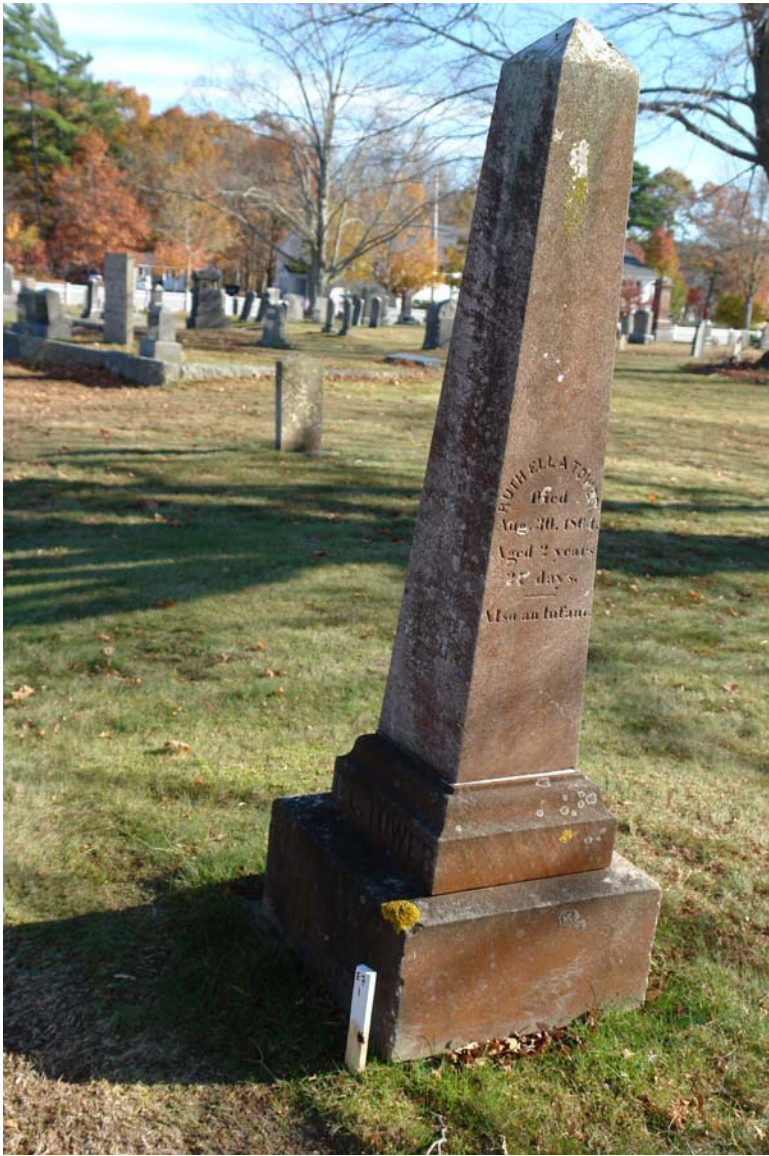
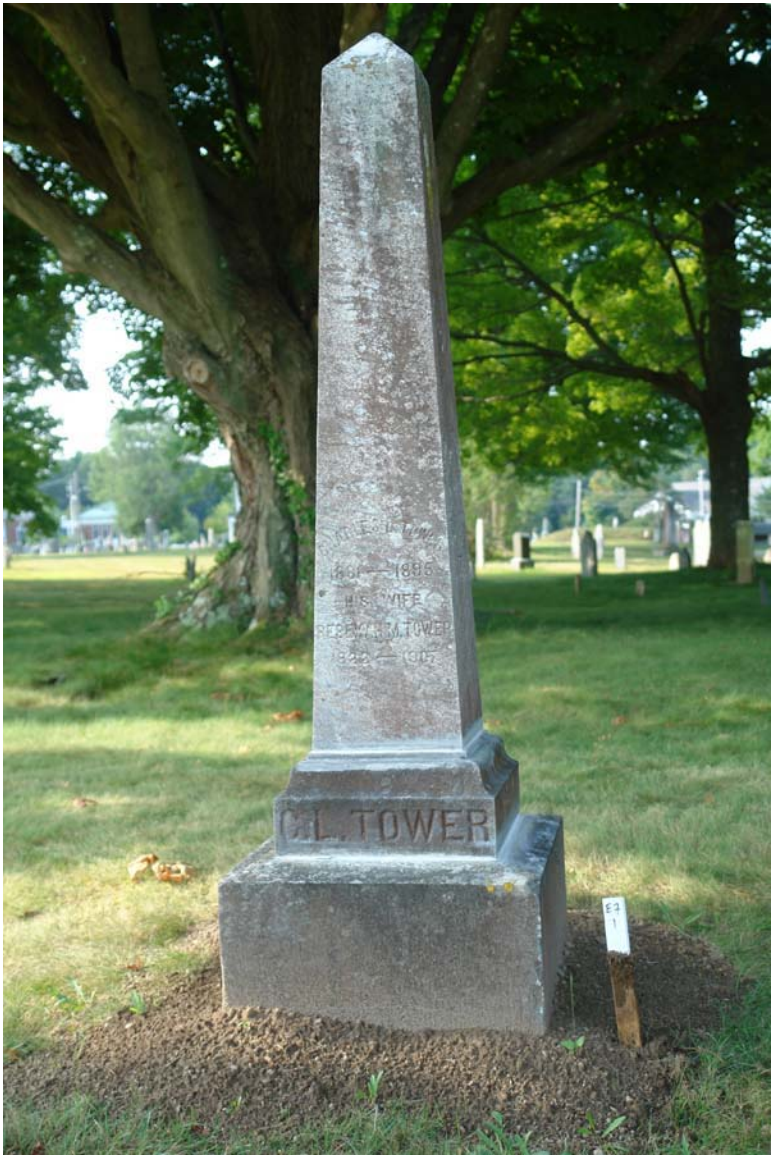
Hanover Center Cemetery, Hanover MA	
NAME ON MARKER	Charles Tower
Death Date: 1895	Marker Type: Obelisk
Cond. of Inscription: Legible	Material: Marble
EXISTING CONDITIONS	CONSERVATION STRATEGY
Tilted	Reset plumb
TREATMENT	
Treatment Dates 7/21-22/2015	
<div>1. Marker excavated and found to be sound. Light soiling removed by brushing with nylon brushes and water.</div> <div>2. Setting area excavated for new below grade cast concrete base sized minimum of 12 inches deep, 12 inches greater in thickness and 6 inches wider than the stone.</div> <div>3. Wooden forms and setting slot form stabilized and aligned with adjacent markers before concrete is poured</div> <div>4. When required, the lower edge of marker is re-squared with minimal loss using a power grinder</div> <div>5. Setting forms are removed after partial curing of the concrete and the base backfilled with tamped sand or gravel</div> <div>6. Marker reset into setting slot with a cement/lime grout (3/2/9) with 000 sand made fluid with a super plasticizer.</div> <div>7. Marker set plumb and level, and braced for minimum of 5 days.</div> <div>8. Disturbed areas backfilled with existing topsoil.</div>

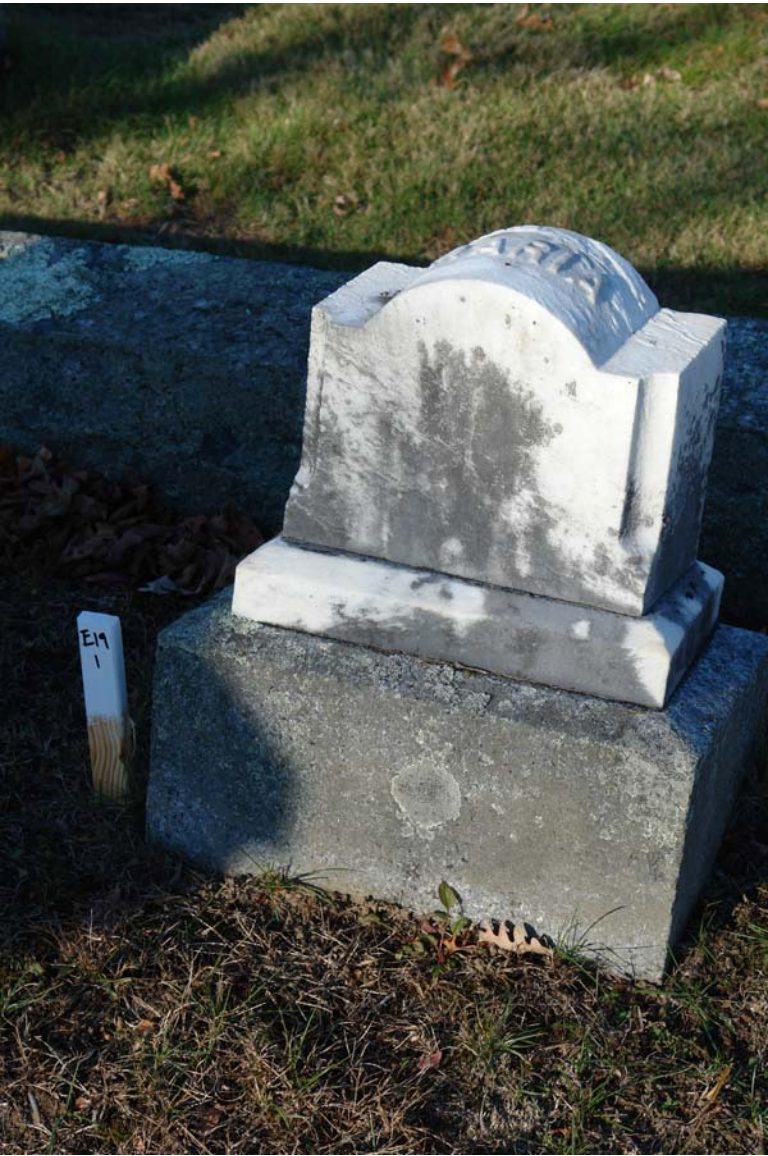
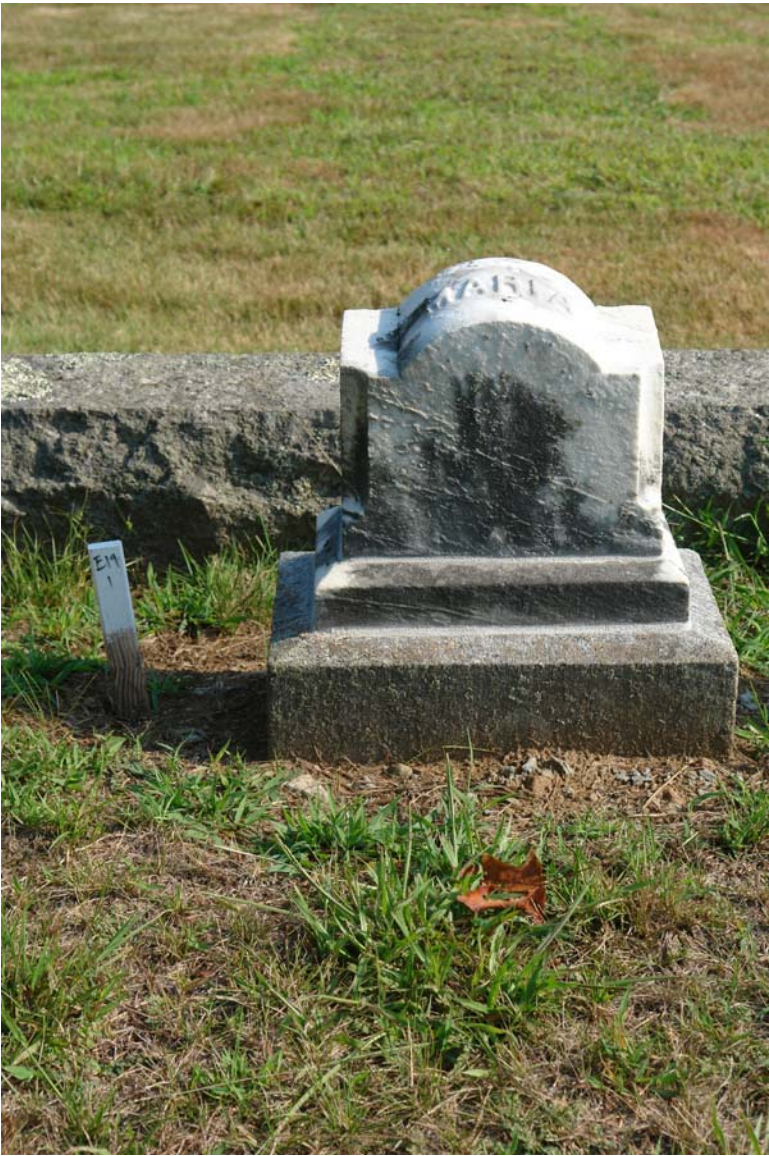
Hanover Center Cemetery, Hanover MA	
NAME ON MARKER	Maria (Dyer)
Death Date:	Marker Type: Sm marker/base
Cond. of Inscription: Legible	Material: Marble

EXISTING CONDITIONS	CONSERVATION STRATEGY
Tilted Marker loose on base	Check base for level Reset marker plumb

TREATMENT	Treatment Dates 7/21-22/2015
<div>1. Elements removed from setting bases and inspected for soundness.</div> <div>2. Area excavated to an appropriate depth removing any roots or large stones.</div> <div>3. Base is aligned with adjacent markers and re-set level.</div> <div>4. Area around base was backfilled with tamped gravel and re-graded with existing topsoil</div> <div>5. Failed mortar removed from setting area and bottom of marker</div> <div>6. When required, any existing pins were inspected, and if necessary, replaced with stainless steel threaded pins</div> <div>7. Setting surfaces primed with Acryl 60 diluted 1:3 with water.</div> <div>8. Marker reset plumb onto base with cement/lime mortar (3/2/9) with 000 sand.</div> <div>9. Excess grout removed and joint area cleaned.</div>

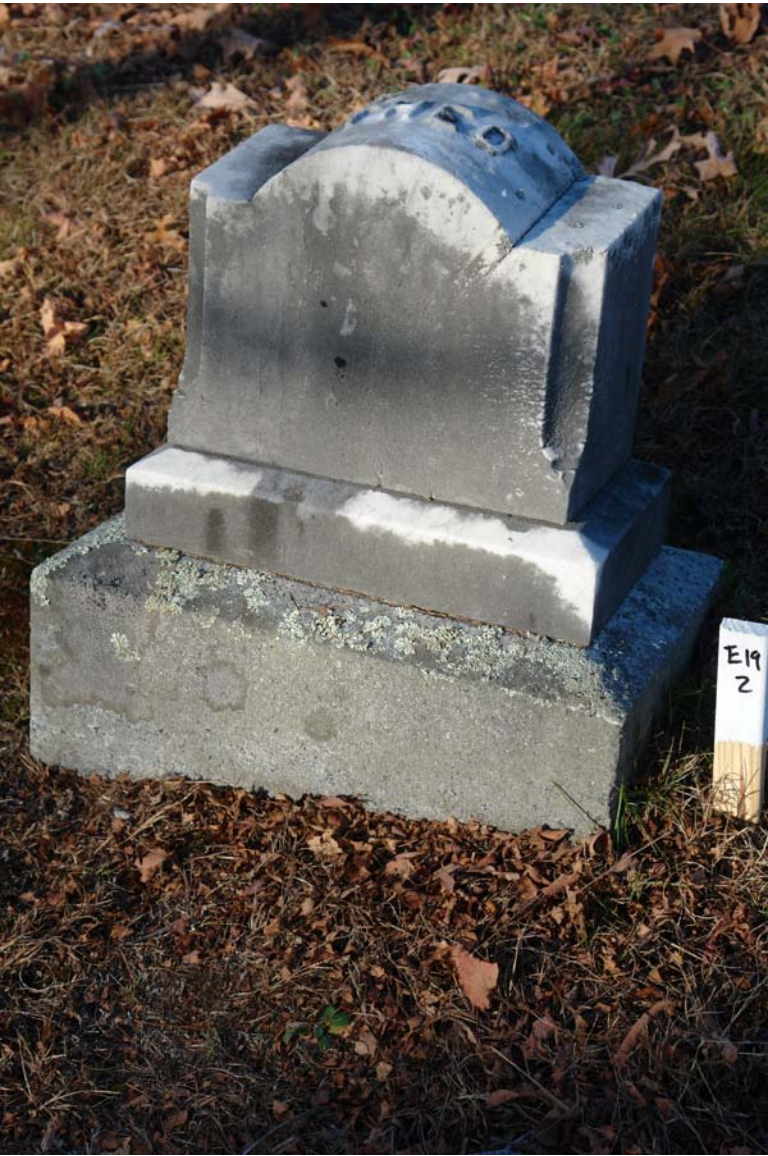
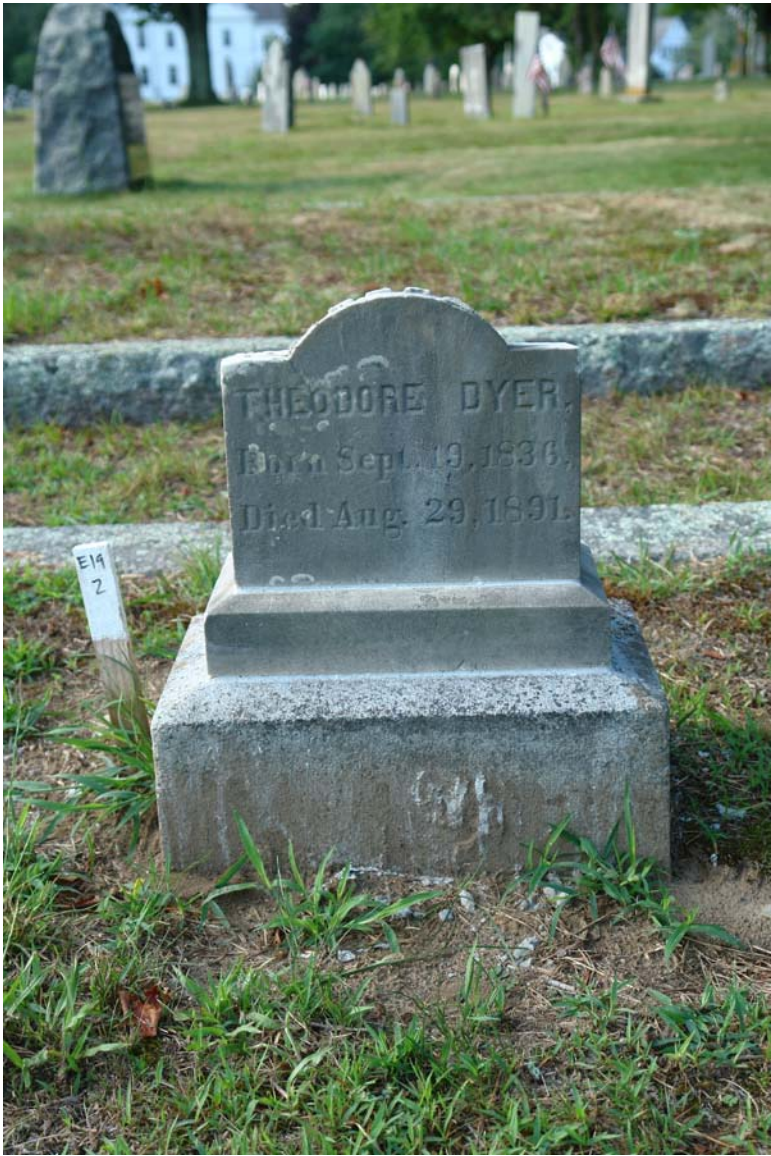
Hanover Center Cemetery, Hanover MA	
NAME ON MARKER Theodore (Dyer)	
Death Date:	Marker Type: Sm marker/base
Cond. of Inscription: Legible	Material: Marble

EXISTING CONDITIONS	CONSERVATION STRATEGY
Tilted Marker loose on base	Check base for level Reset marker plumb

TREATMENT	Treatment Dates 7/20/2015
<div>1. Elements removed from setting bases and inspected for soundness.</div> <div>2. Area excavated to an appropriate depth removing any roots or large stones.</div> <div>3. Base is aligned with adjacent markers and re-set level.</div> <div>4. Area around base was backfilled with tamped gravel and re-graded with existing topsoil</div> <div>5. Failed mortar removed from setting area and bottom of marker</div> <div>6. When required, any existing pins were inspected, and if necessary, replaced with stainless steel threaded pins</div> <div>7. Setting surfaces primed with Acryl 60 diluted 1:3 with water.</div> <div>8. Marker reset plumb onto base with cement/lime mortar (3/2/9) with 000 sand.</div> <div>9. Excess grout removed and joint area cleaned.</div>

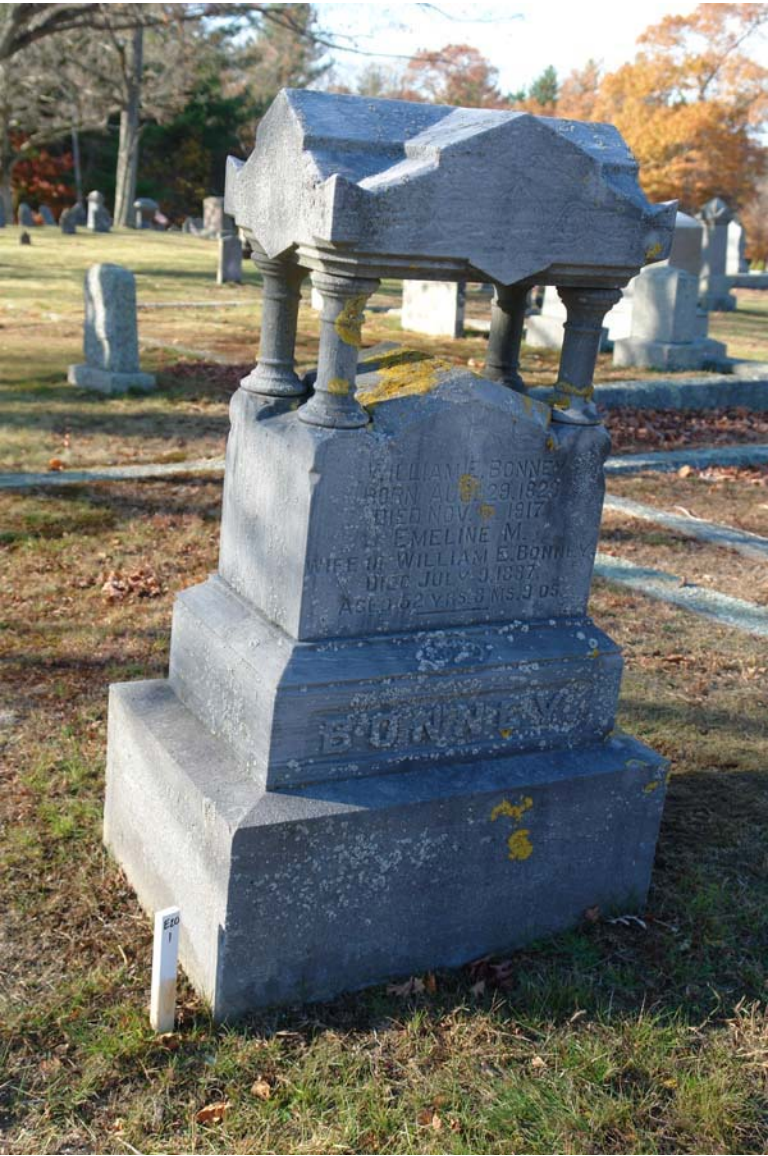
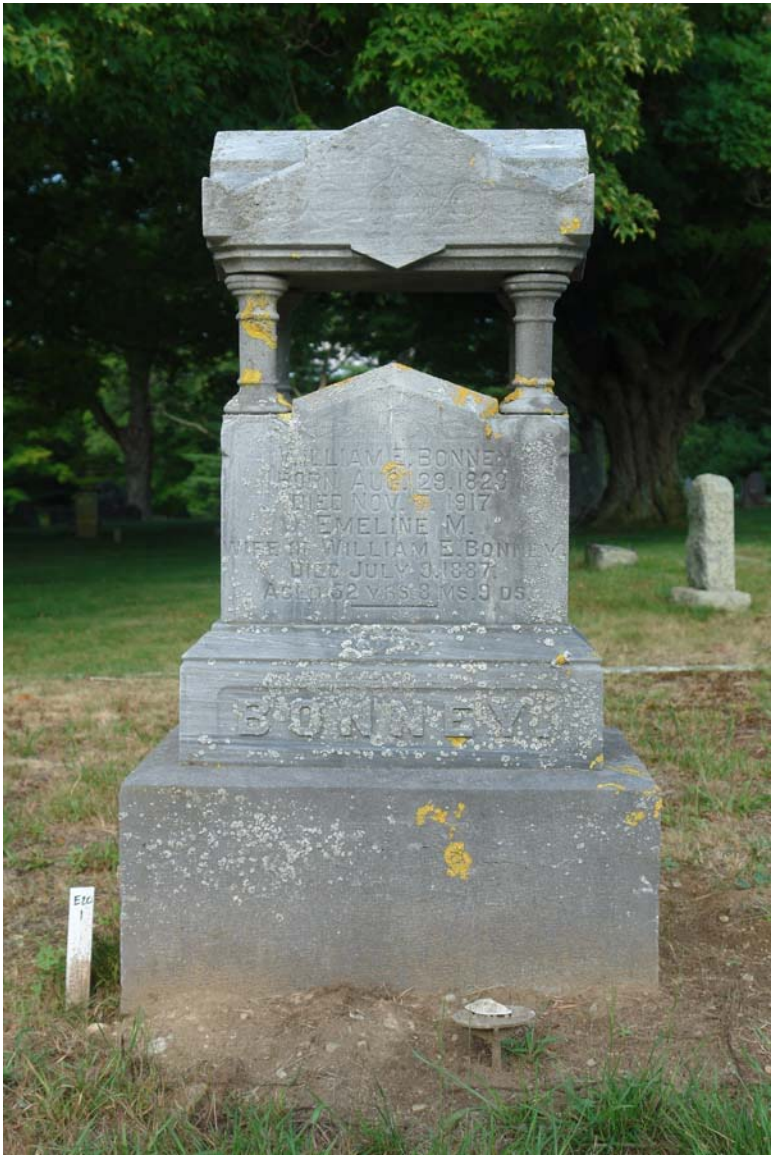
Hanover Center Cemetery, Hanover MA	
NAME ON MARKER	William Bonney
Death Date: 11/7/1917	Marker Type: Monument
Cond. of Inscription: Legible	Material: Marble
EXISTING CONDITIONS	CONSERVATION STRATEGY
Tilted	Reset plumb
TREATMENT	
Treatment Dates 7/20/2015	
1. Soil removed around base unit and base jacked up (or lowered) to level. 2. Existing foundation stones exposed and built up to support base unit. 3. Base re-set plumb at appropriate height and level, aligned with adjacent markers 4. Area beneath and around base backfilled with tamped sand and gravel. Disturbed areas re-graded with existing topsoil.

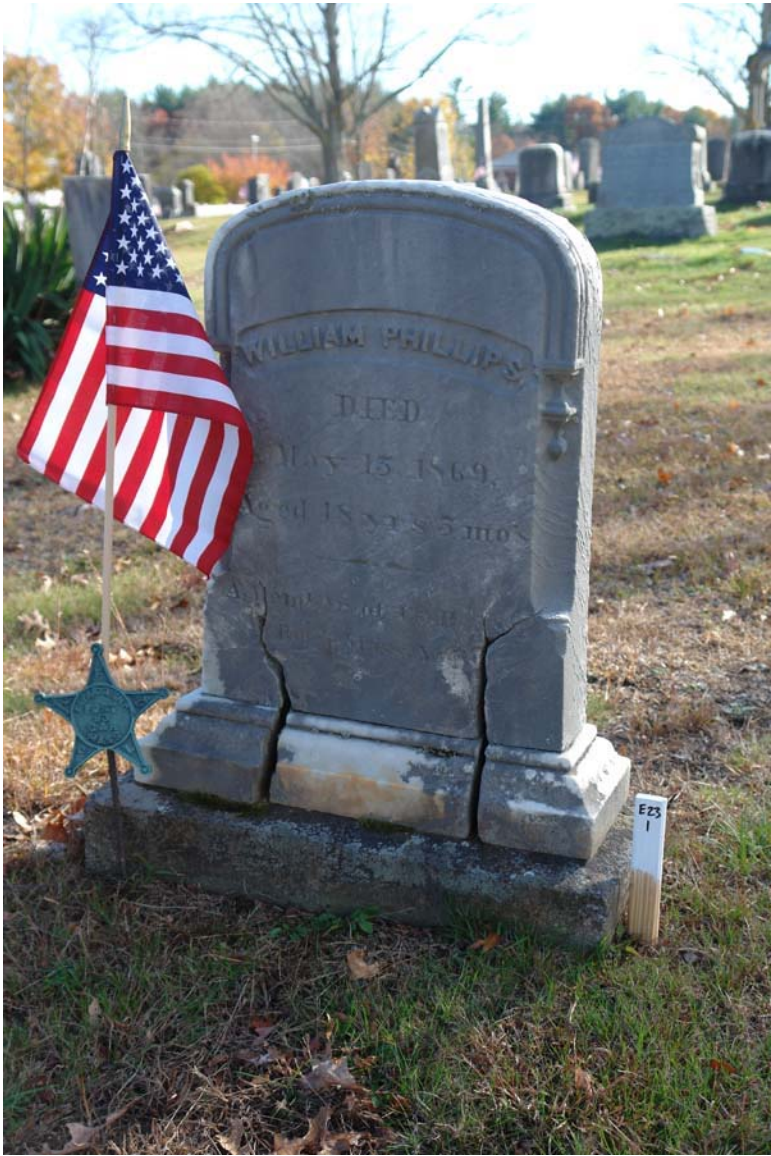
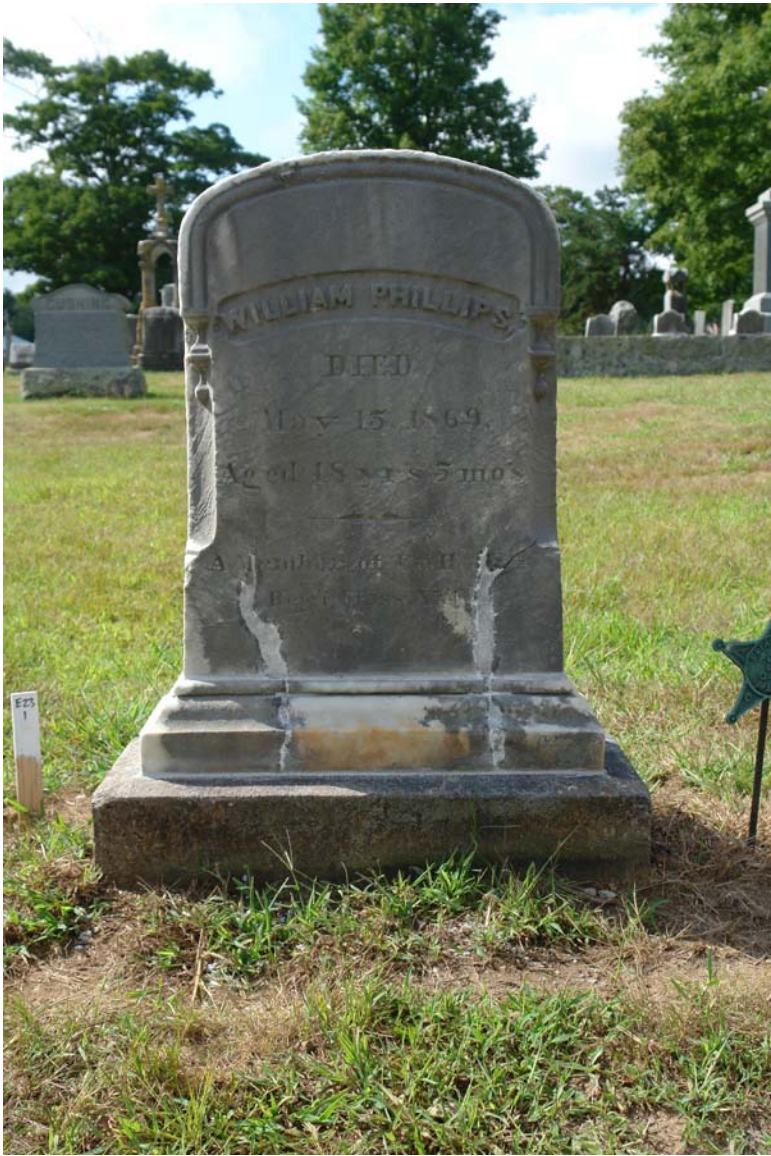
Hanover Center Cemetery, Hanover MA	
NAME ON MARKER	William Philips
Death Date: 5/15/1869	Marker Type: Headstone/pinned
Cond. of Inscription: Legible	Material: Marble
EXISTING CONDITIONS	CONSERVATION STRATEGY
Fractures Loose on base	Attach fragments with structural adhesive Reset elements
TREATMENT	
Treatment Dates 8/12-17/2015

1. Elements disassembled and previous repair materials and failed mortar removed from setting surfaces with hand tools. 2. In-ground base reset level. Replace setting pins with threaded stainless pins if required. 3. Setting surfaces primed with Acryl 60 diluted 1:3 with water. 4. Elements reset with 2:1:9 cementitious high cal lime mortar using fine (00 or 000) sand. 5. Excess mortar removed from joints and braced for a min 3 days 6. Cracks and losses filled with RepliCal Marble or Jahn restoration mortar, misted with water and covered for 3 days min. 7. Filled surface areas treated w/ light acid wash, rinsed thoroughly with water.

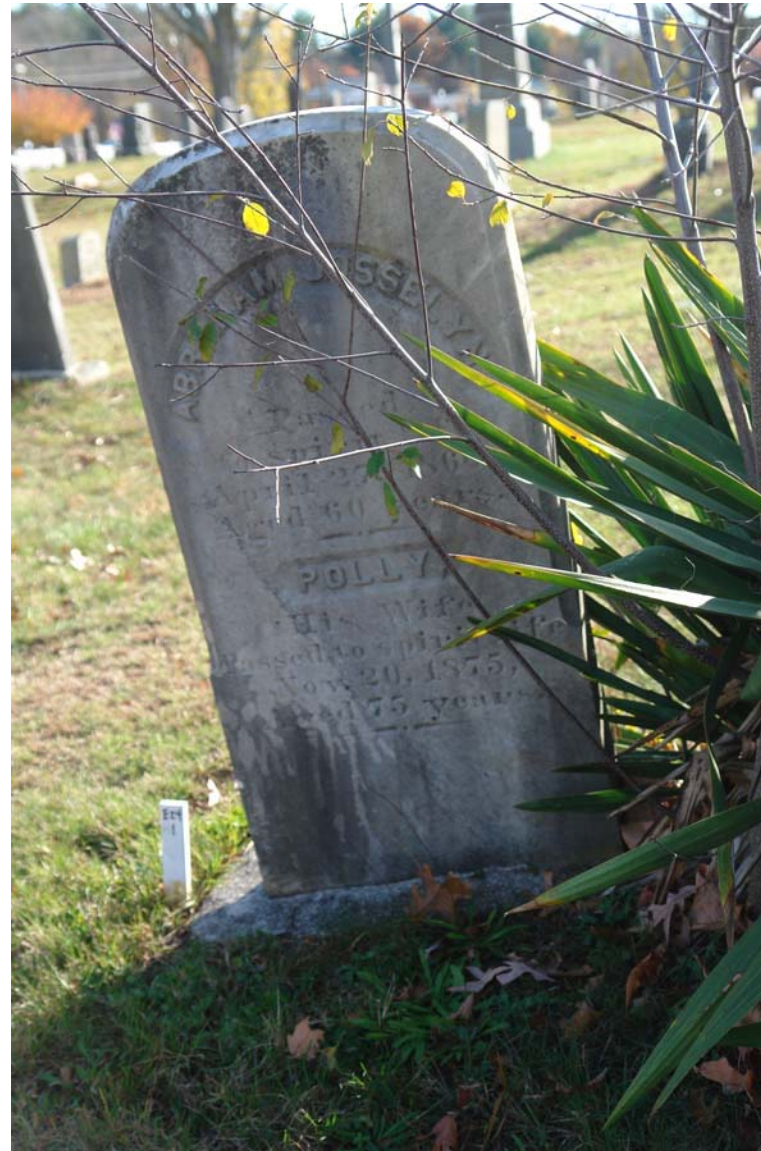
Comments: **Shrubs to be removed**

1. Overgrowth removed by DPW
2. Elements removed from setting bases and area excavated to an appropriate depth removing any roots or large stones.
3. Base is aligned with adjacent markers and re-set level.
4. Area around base was backfilled with tamped gravel and re-graded with existing topsoil
5. Failed mortar removed from setting area and bottom of marker
6. When required, any existing pins were inspected, and if necessary, replaced with stainless steel threaded pins
7. Setting surfaces primed with Acryl 60 diluted 1:3 with water.
8. Marker reset plumb onto base with cement/lime mortar (3/2/9) with 000 sand. When required, lead shims were used to facilitate leveling.
9. Excess grout removed and joint area cleaned.

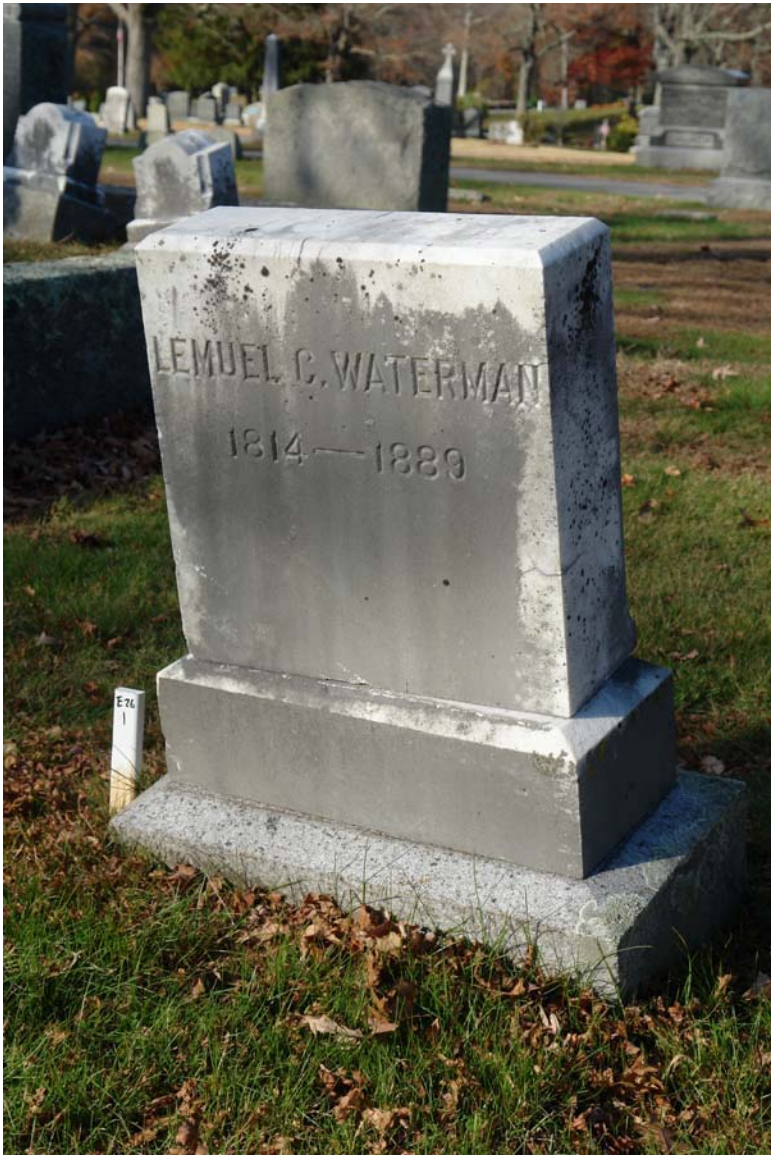
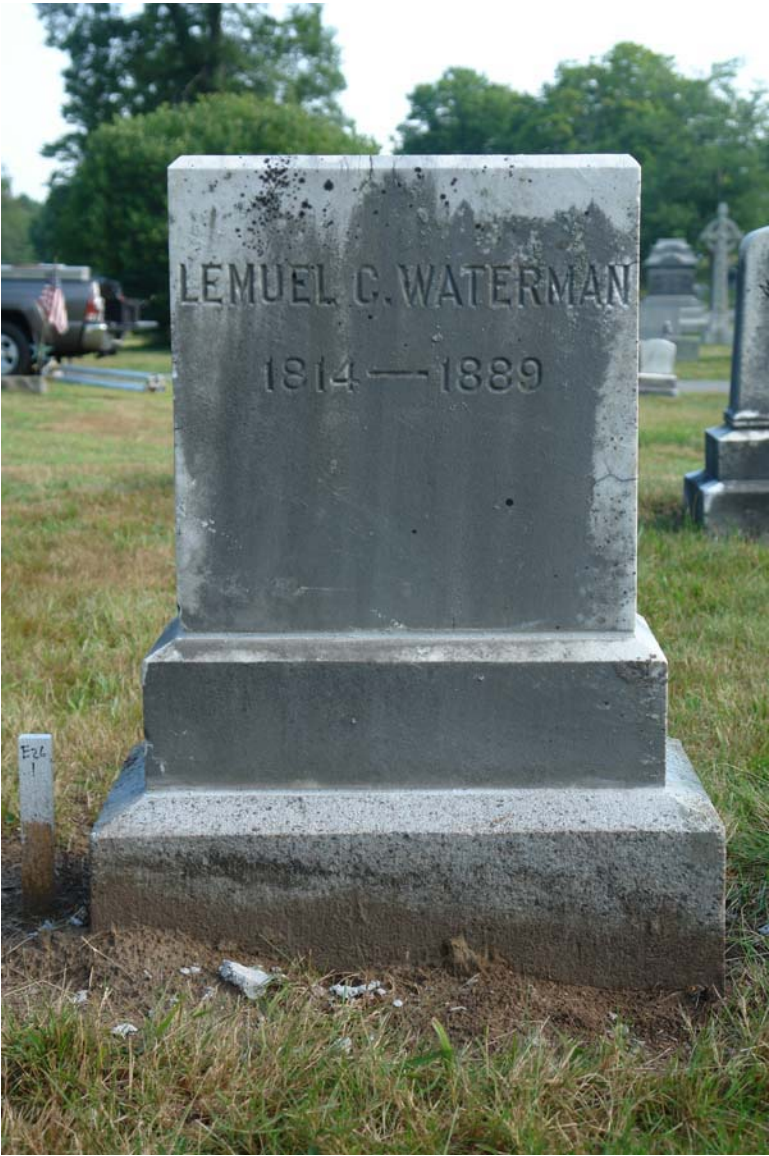
Height 36 Width 18 Thickness 3 Marker# **E.24**

EXISTING CONDITIONS	CONSERVATION STRATEGY
Tilted base	Reset base with marker plumb

TREATMENT	Treatment Dates 8/12-13/2015
<div>1. Elements removed from setting bases and inspected for soundness. 2. Area excavated to an appropriate depth removing any roots or large stones. 3. Base is aligned with adjacent markers and re-set level. 4. Area around base was backfilled with tamped gravel and re-graded with existing topsoil 5. Failed mortar removed from setting area and bottom of marker 6. When required, any existing pins were inspected, and if necessary, replaced with stainless steel threaded pins 7. Setting surfaces primed with Acryl 60 diluted 1:3 with water. 8. Marker reset plumb onto base with cement/lime mortar (3/2/9) with 000 sand. When required, lead shims were used to facilitate leveling. 9. Excess grout removed and joint area cleaned.</div>

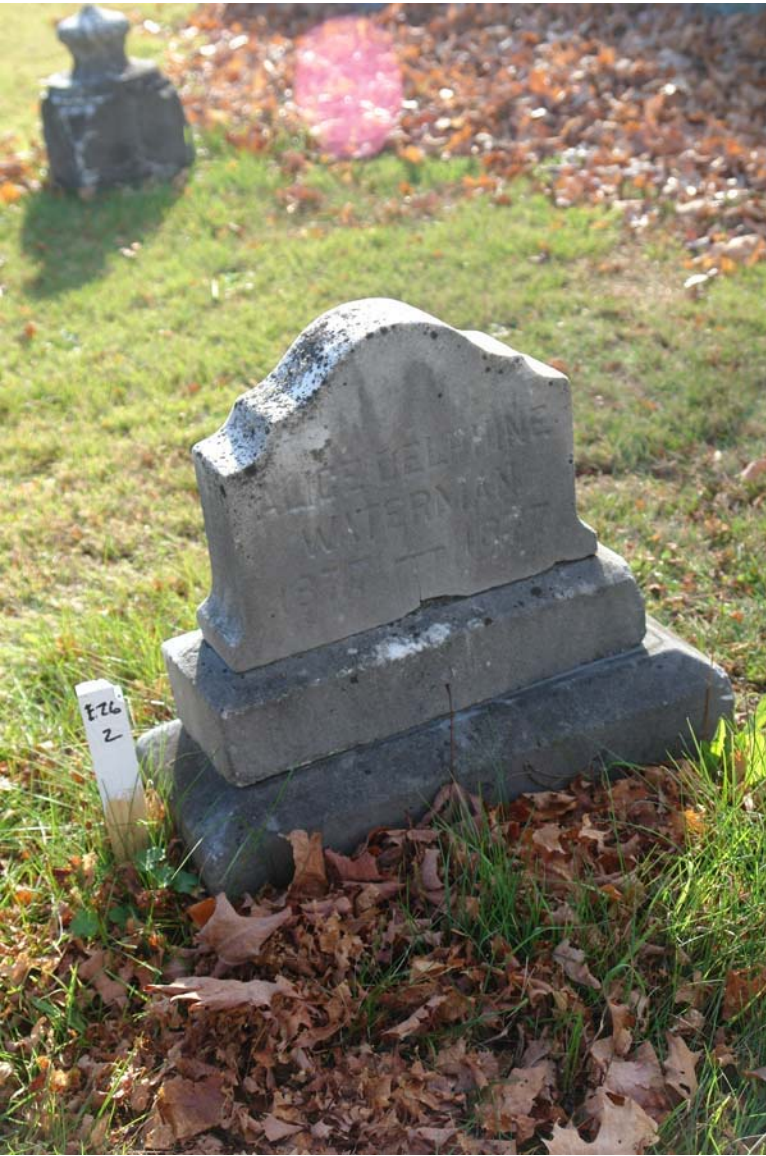
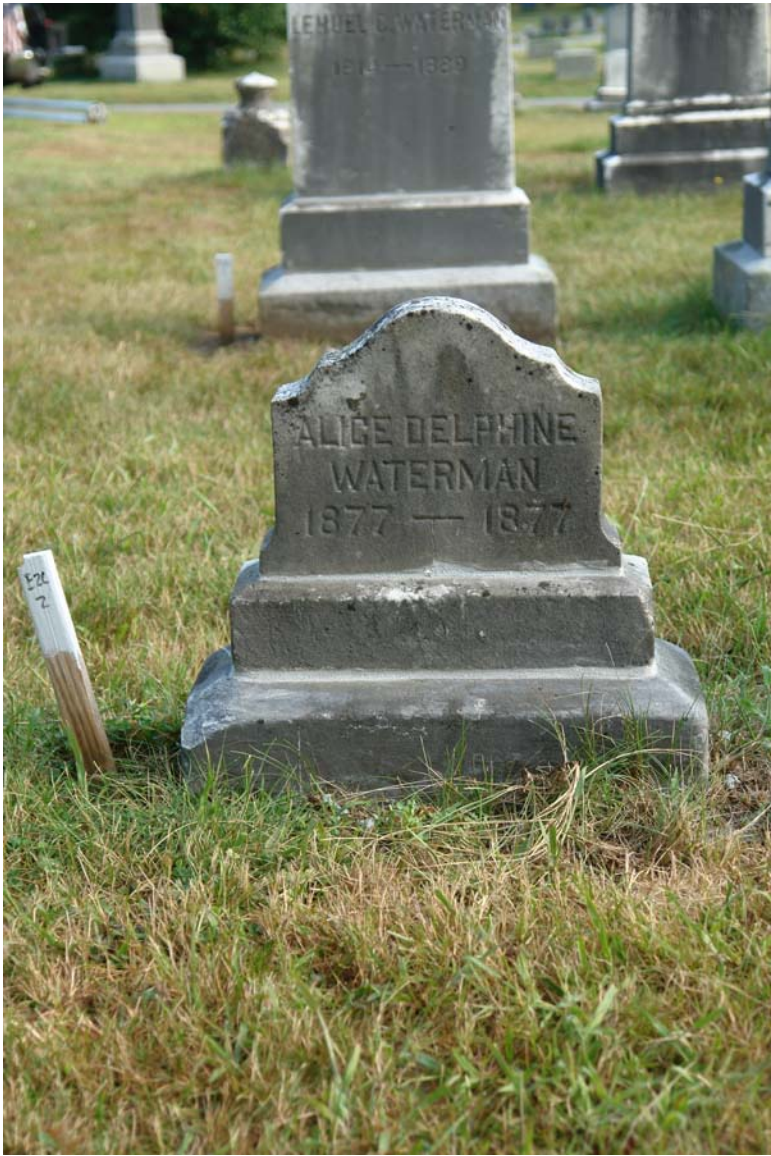
Hanover Center Cemetery, Hanover MA
NAME ON MARKER **Alice Waterman**
Death Date: 1877 Marker Type: Headstone/pinned base
Cond. of Inscription: Legible Material: Marble

EXISTING CONDITIONS	CONSERVATION STRATEGY
Tilted Loose on base	Reset base level Reset elements

TREATMENT	Treatment Dates
1. Elements removed from setting bases and inspected for soundness. 2. Area excavated to an appropriate depth removing any roots or large stones. 3. Base is aligned with adjacent markers and re-set level. 4. Area around base was backfilled with tamped gravel and re-graded with existing topsoil 5. Failed mortar removed from setting area and bottom of marker 6. When required, any existing pins were inspected, and if necessary, replaced with stainless steel threaded pins 7. Setting surfaces primed with Acryl 60 diluted 1:3 with water. 8. Marker reset plumb onto base with cement/lime mortar (3/2/9) with 000 sand. When required, lead shims were used to facilitate leveling. 9. Excess grout removed and joint area cleaned.	8/12-13/2015

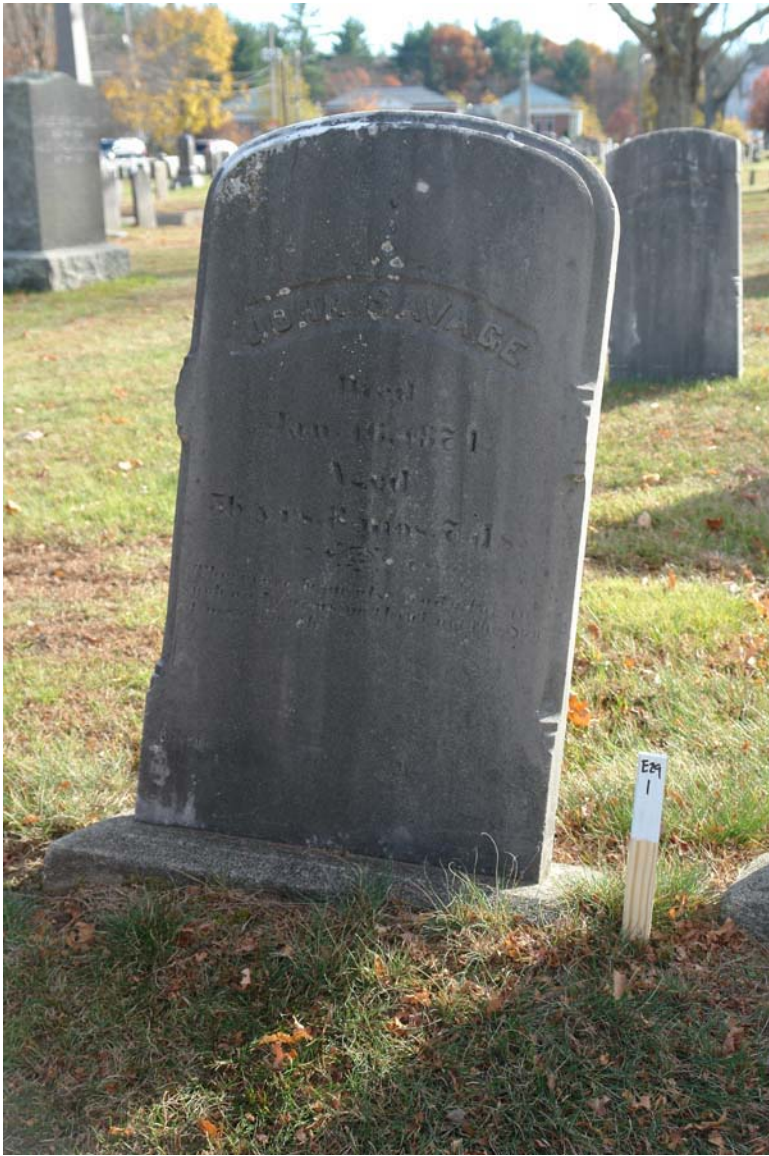
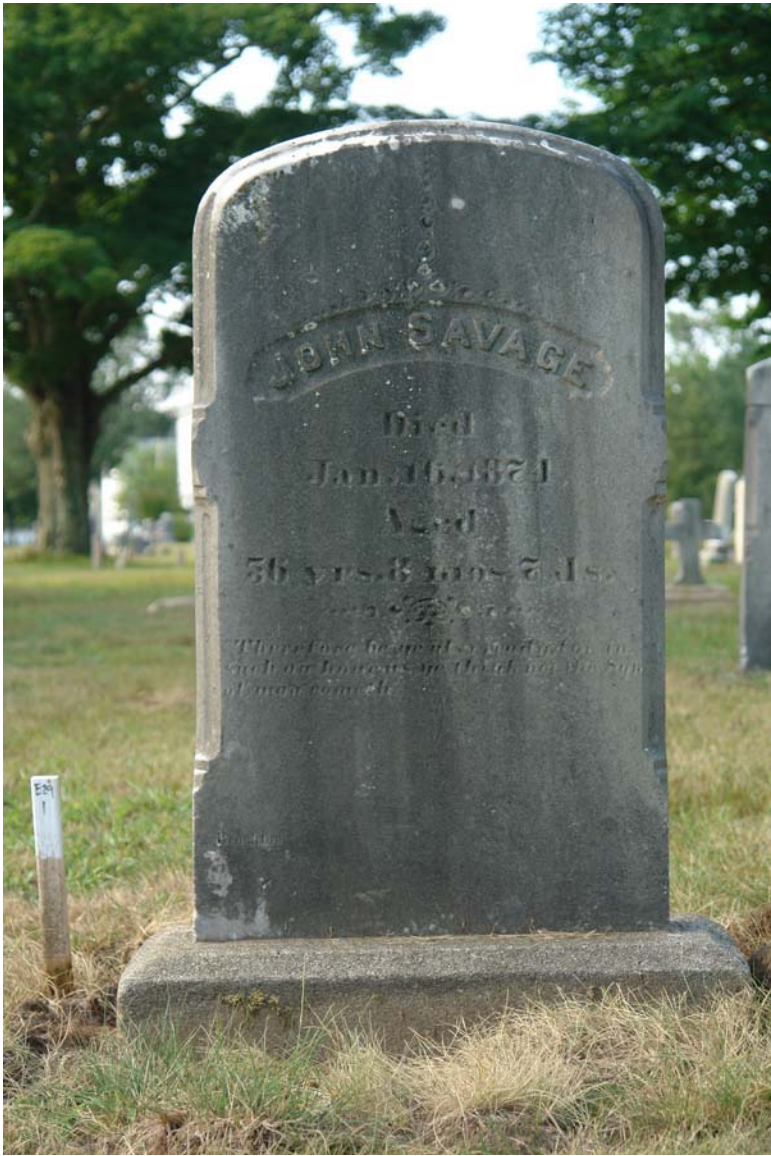
Hanover Center Cemetery, Hanover MA
NAME ON MARKER **John Savage**
Death Date: 1/16/1874 Marker Type: Headstone/conc.base
Cond. of Inscription: Legible Material: Marble

EXISTING CONDITIONS	CONSERVATION STRATEGY
Tilted base	Reset base with marker plumb

TREATMENT	Treatment Dates
1. Area excavated to an appropriate depth removing any roots or large stones. 2. Base inspected and found to be sound and re-useable 3. Base is aligned with adjacent markers and re-set level. 4. Area around base was backfilled with tamped gravel and re-graded with existing topsoil 5. Debris removed from setting slot. When required, power grinders were used to facilitate removal of stone fragments. 6. When required, the lower setting edge was re-squared by power grinder with minimal loss. 7. Marker reset plumb and level into setting slot with cement/lime grout (3/2/9) with 000 sand made fluid with a super plasticizer. 8. Excess grout removed and joint area cleaned. 9. Marker braced for a minimum 3 days	8/4/2015

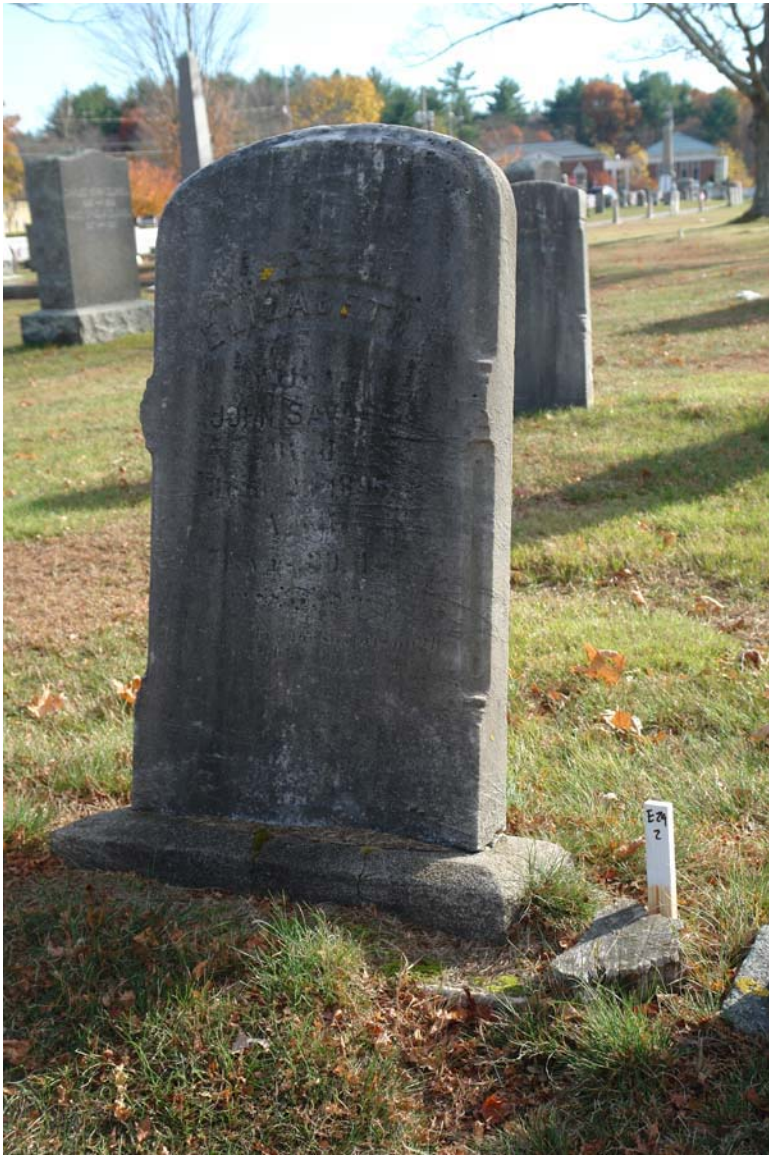
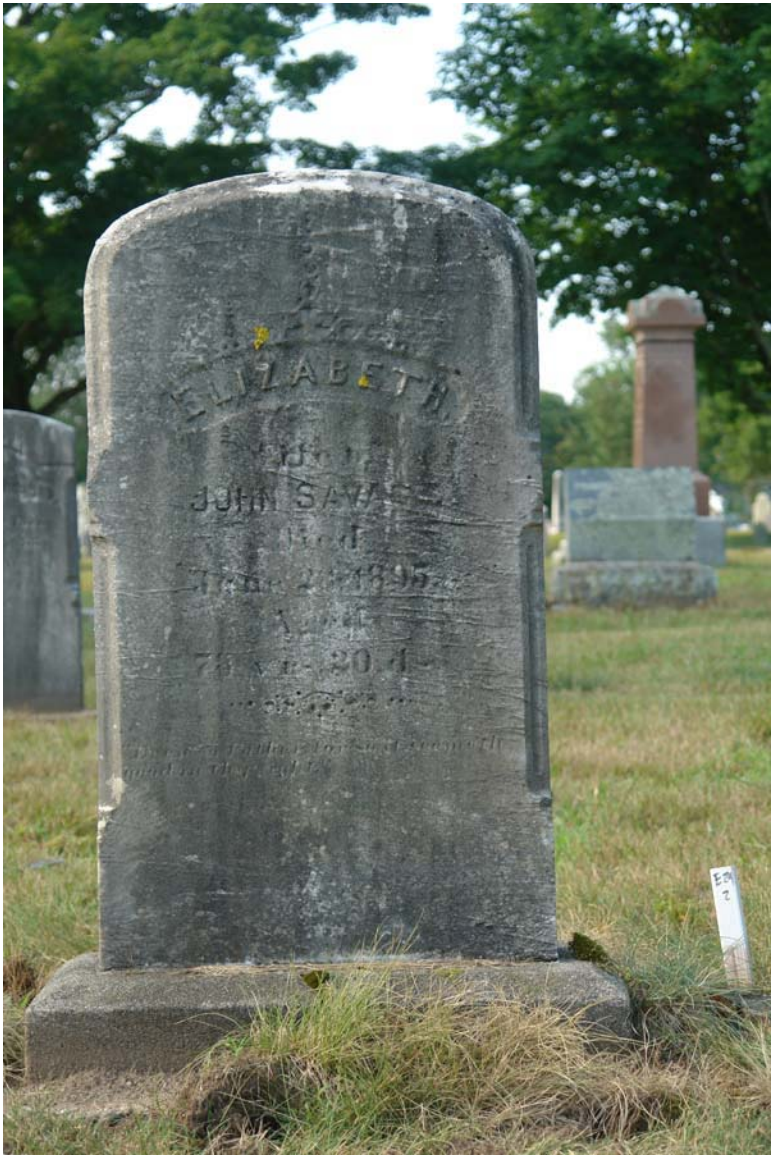
EXISTING CONDITIONS	CONSERVATION STRATEGY
Tilted base	Reset base with marker plumb

TREATMENT	Treatment Dates
8/4/2015	
<div>1. Area excavated to an appropriate depth removing any roots or large stones.</div> <div>2. Base inspected and found to be sound and re-useable</div> <div>3. Base is aligned with adjacent markers and re-set level.</div> <div>4. Area around base was backfilled with tamped gravel and re-graded with existing topsoil</div> <div>5. Debris removed from setting slot. When required, power grinders were used to facilitate removal of stone fragments.</div> <div>6. When required, the lower setting edge was re-squared by power grinder with minimal loss.</div> <div>7. Marker reset plumb and level into setting slot with cement/lime grout (3/2/9) with 000 sand made fluid with a super plasticizer.</div> <div>8. Excess grout removed and joint area cleaned.</div> <div>9. Marker braced for a minimum 3 days</div>
