MONUMENT CONSERVATION COLLABORATIVE LLC, NORFOLK, CT

DOCUMENTATION OF STONE CONSERVATION TREATMENTS TO ASSINIPPI CEMETERY, HANOVER, MA June 2015

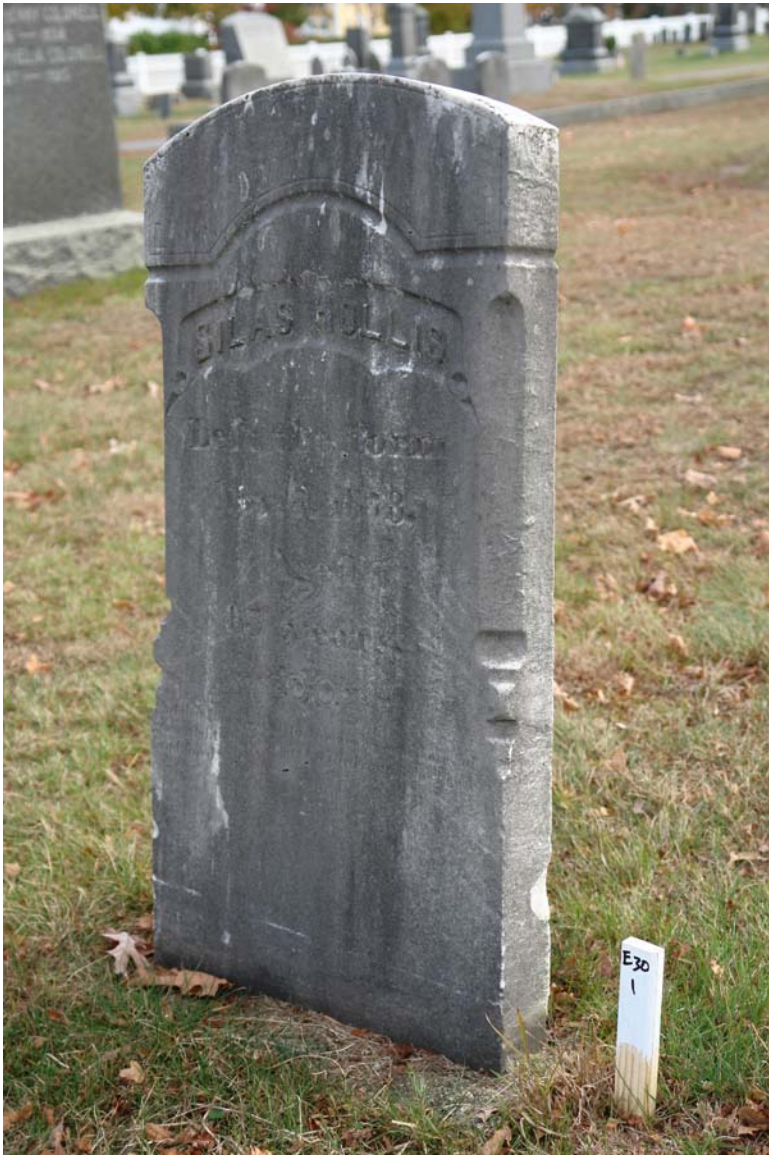
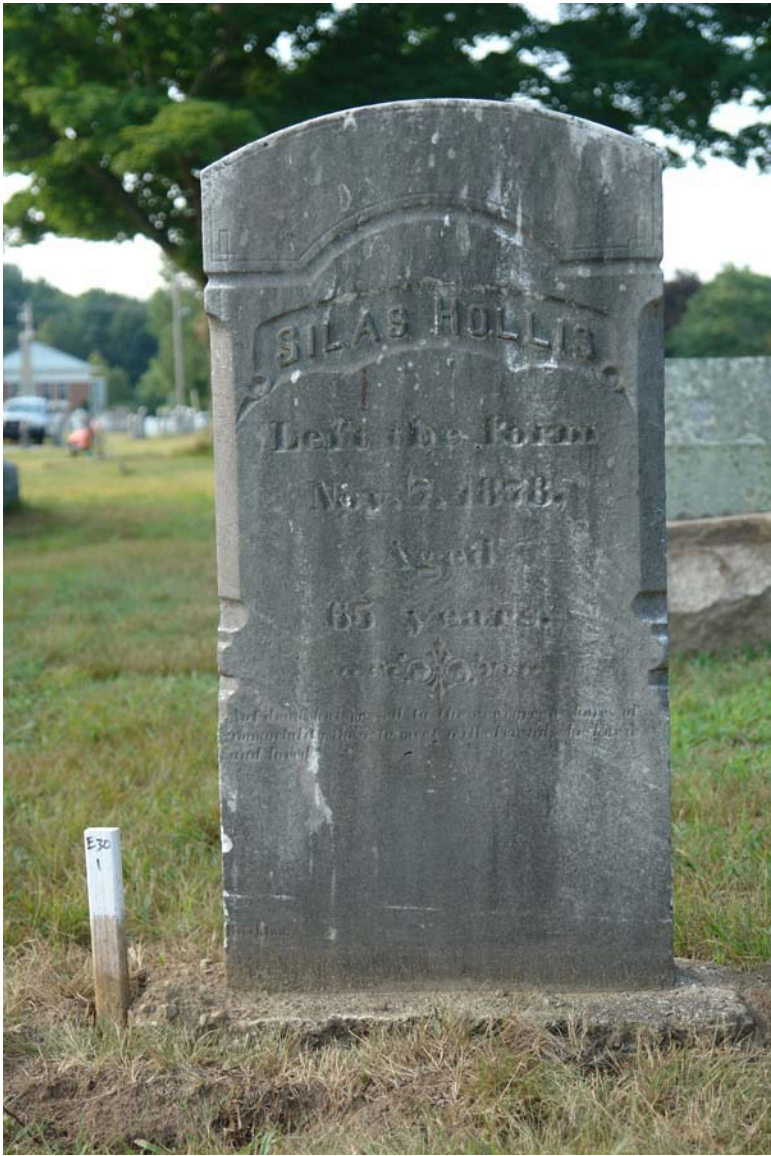
Height 36 Width 21 Thickness 3 Marker# **E.29.2**

EXISTING CONDITIONS	CONSERVATION STRATEGY
Tilted base	Reset base with marker plumb

TREATMENT	Treatment Dates
1. Area excavated to an appropriate depth removing any roots or large stones. 2. Base inspected and found to be sound and re-useable 3. Base is aligned with adjacent markers and re-set level. 4. Area around base was backfilled with tamped gravel and re-graded with existing topsoil 5. Debris removed from setting slot. When required, power grinders were used to facilitate removal of stone fragments. 6. When required, the lower setting edge was re-squared by power grinder with minimal loss. 7. Marker reset plumb and level into setting slot with cement/lime grout (3/2/9) with 000 sand made fluid with a super plasticizer. 8. Excess grout removed and joint area cleaned. 9. Marker braced for a minimum 3 days	8/4/2015

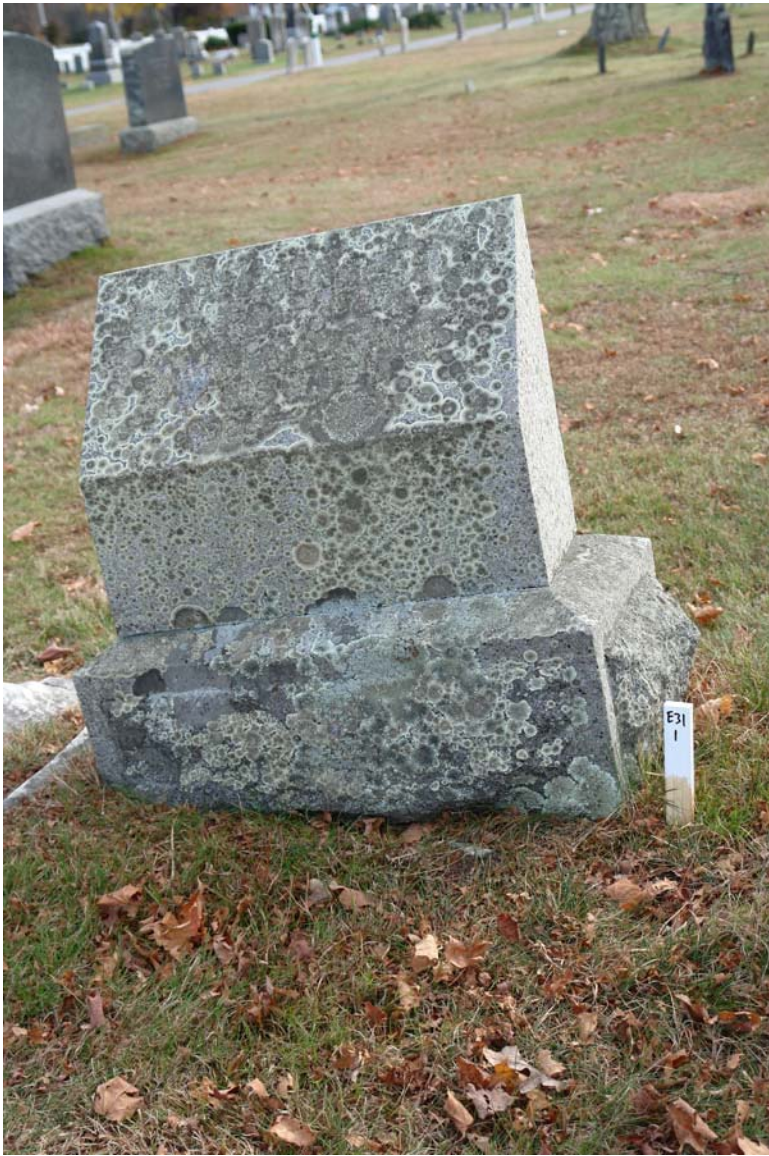
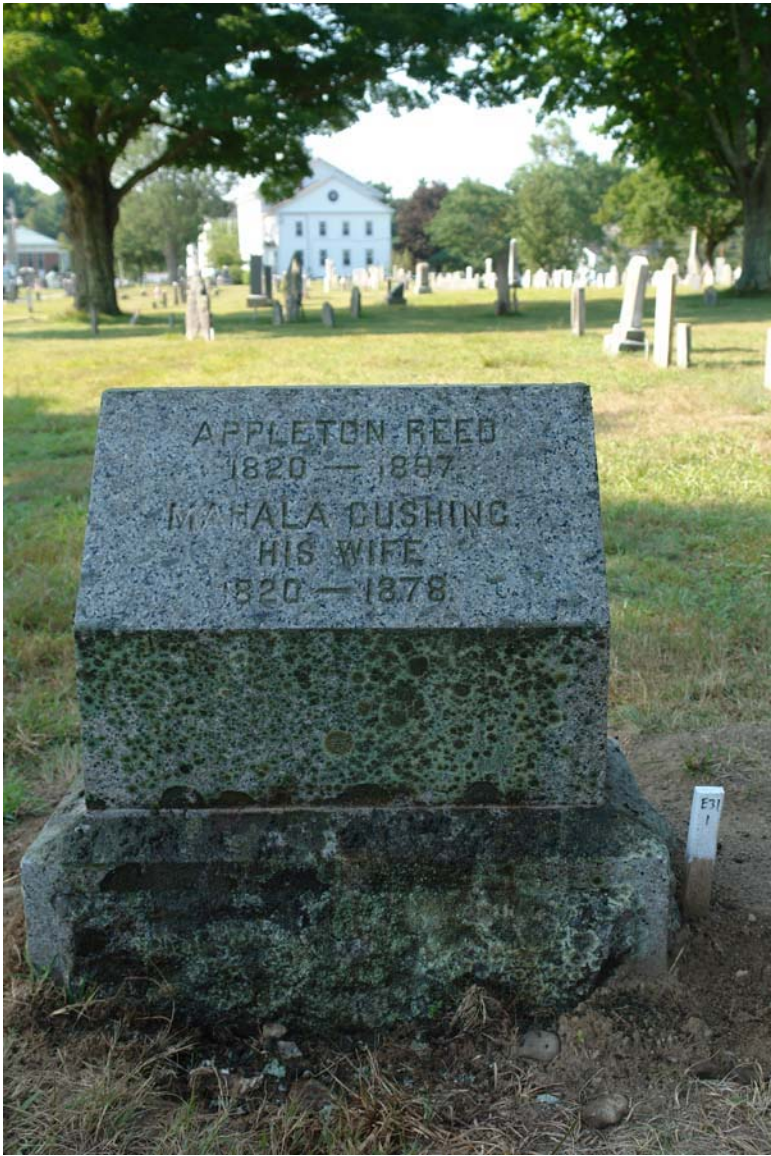
Hanover Center Cemetery, Hanover MA	
NAME ON MARKER	Appleton Reed
Death Date: 1897	Marker Type: Marker/slanted
Cond. of Inscription: Decipherable	Material: Granite
EXISTING CONDITIONS	CONSERVATION STRATEGY
Tilted base	Reset base with marker plumb

TREATMENT	Treatment Dates 8/5/2015
<div>1. Soil removed around base unit and base jacked up to level.</div> <div>2. Existing foundation stones exposed and built up to support base unit.</div> <div>3. Base re-set plumb at appropriate height and level, aligned with adjacent markers</div> <div>4. Area beneath and around base backfilled with tamped sand and gravel</div> <div>5. Disturbed areas re-graded with existing topsoil.</div>

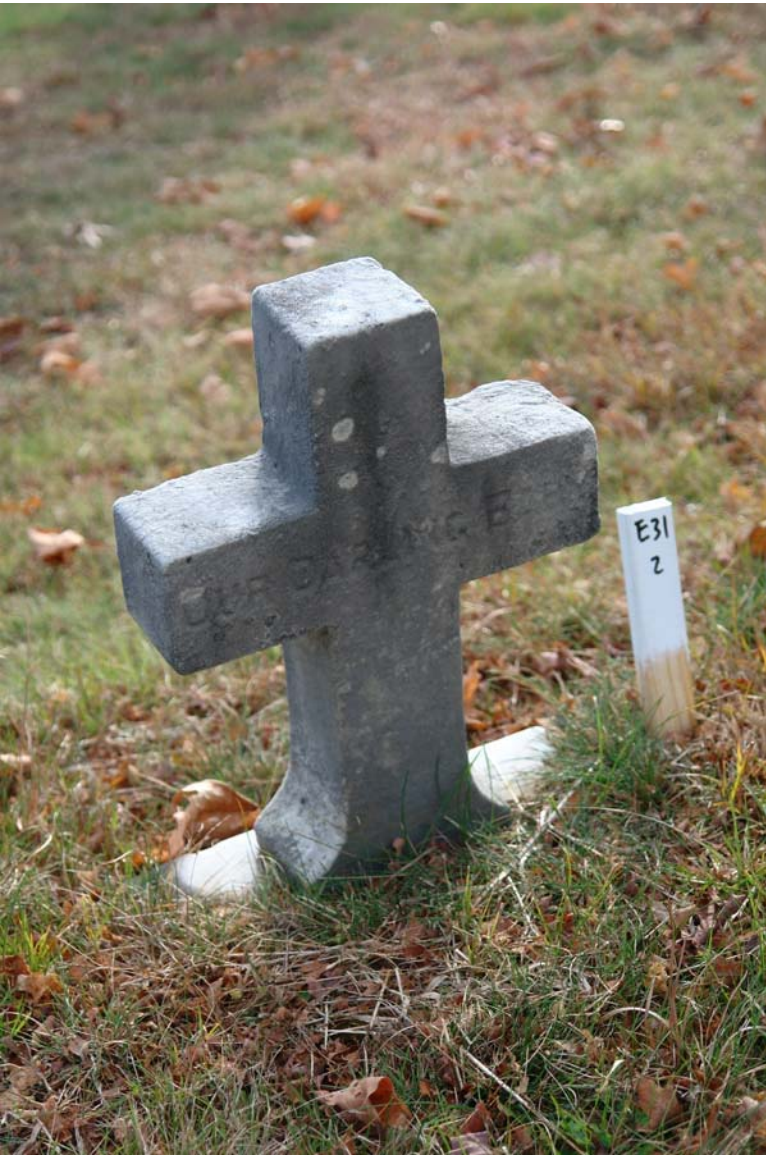
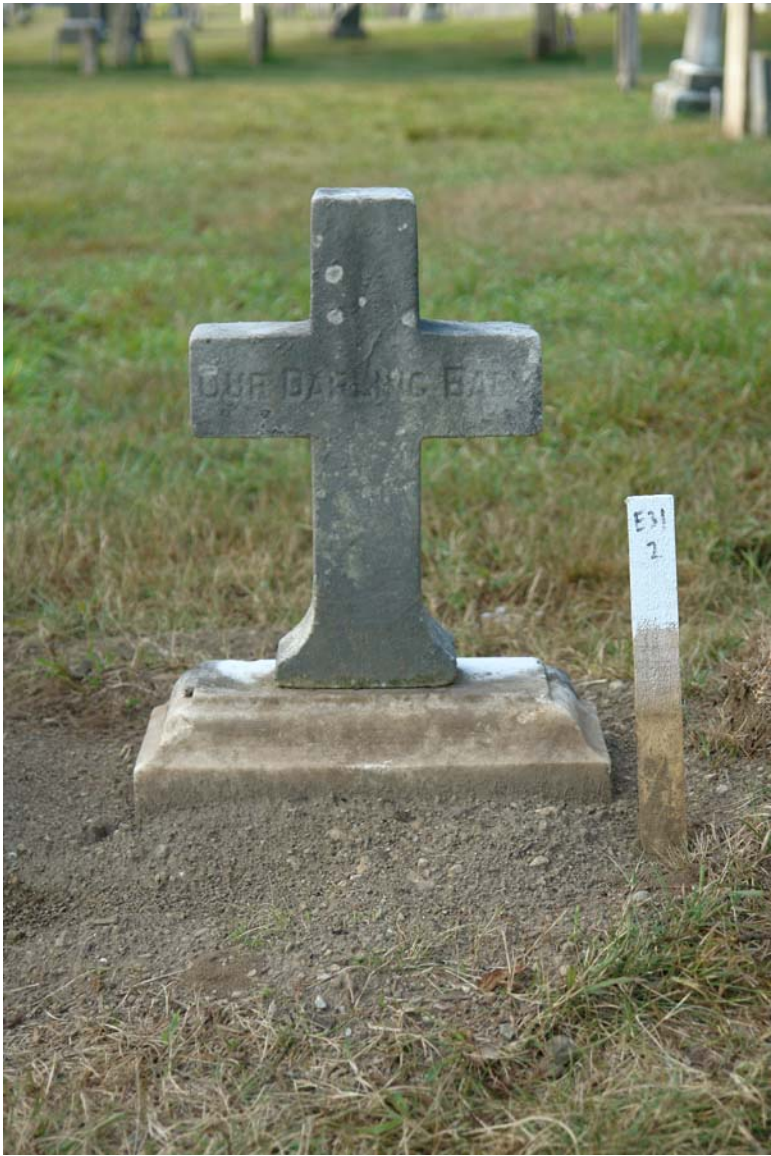
Hanover Center Cemetery, Hanover MA	
NAME ON MARKER	Ruth Bartlett
Death Date: 8/20/1910	Marker Type: Cross
Cond. of Inscription: Legible	Material: Marble
EXISTING CONDITIONS	CONSERVATION STRATEGY
Tilted base	Reset base with marker plumb

TREATMENT	Treatment Dates 8/12-13/2015
<div>1. Marker excavated and found to be sound. Light soiling removed by brushing with nylon brushes and water.</div> <div>2. Setting area excavated for new below grade cast concrete base sized minimum of 12 inches deep,</div> <div>3. Wooden forms stabilized and aligned with adjacent markers before concrete is poured</div> <div>4. Setting forms are removed after partial curing of the concrete and the base backfilled with tamped sand or gravel</div> <div>5. Setting surfaces primed with acryl 60 diluted 1:3 and marker reset with a cement/lime grout (3/2/9) with 000 sand..</div> <div>6. Marker set plumb and level, and braced for minimum of 3 days.</div> <div>7. Disturbed areas backfilled with existing topsoil.</div>

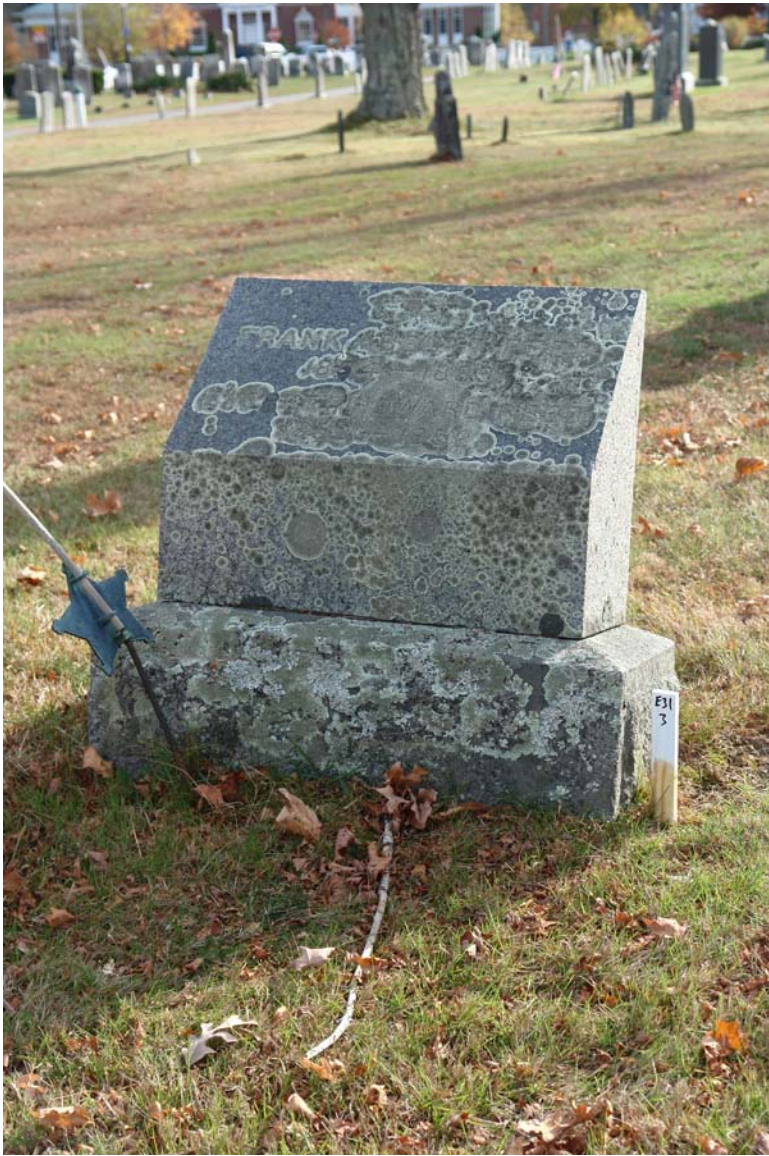
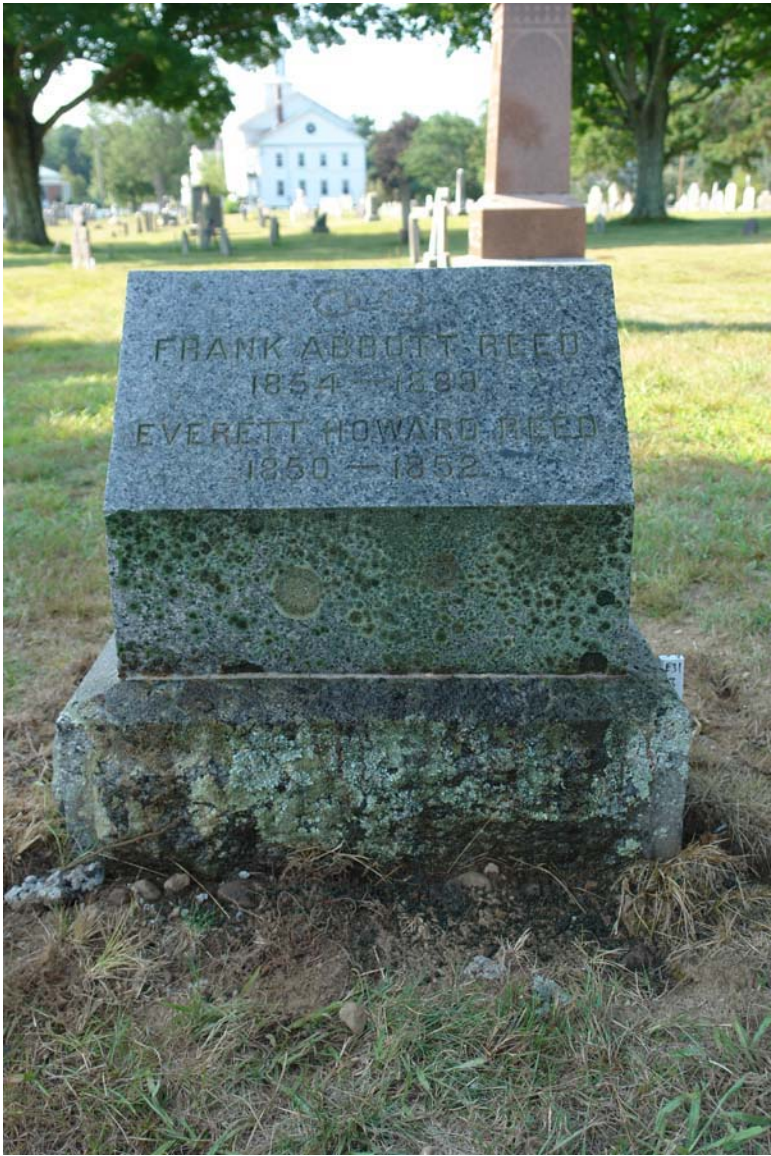
Hanover Center Cemetery, Hanover MA	
NAME ON MARKER	
Frank Reed	
Death Date: 1889	Marker Type: Marker, slanted
Cond. of Inscription: Decipherable	Material: Granite
EXISTING CONDITIONS	CONSERVATION STRATEGY
Tilted base	Reset base with marker plumb
TREATMENT	
Treatment Dates 8/5/2015	
1. Soil removed around base unit and base jacked up to level. 2. Existing foundation stones exposed and built up to support base unit. 3. Base re-set plumb at appropriate height and level, aligned with adjacent markers 4. Area beneath and around base backfilled with tamped sand and gravel 5. Disturbed areas re-graded with existing topsoil.

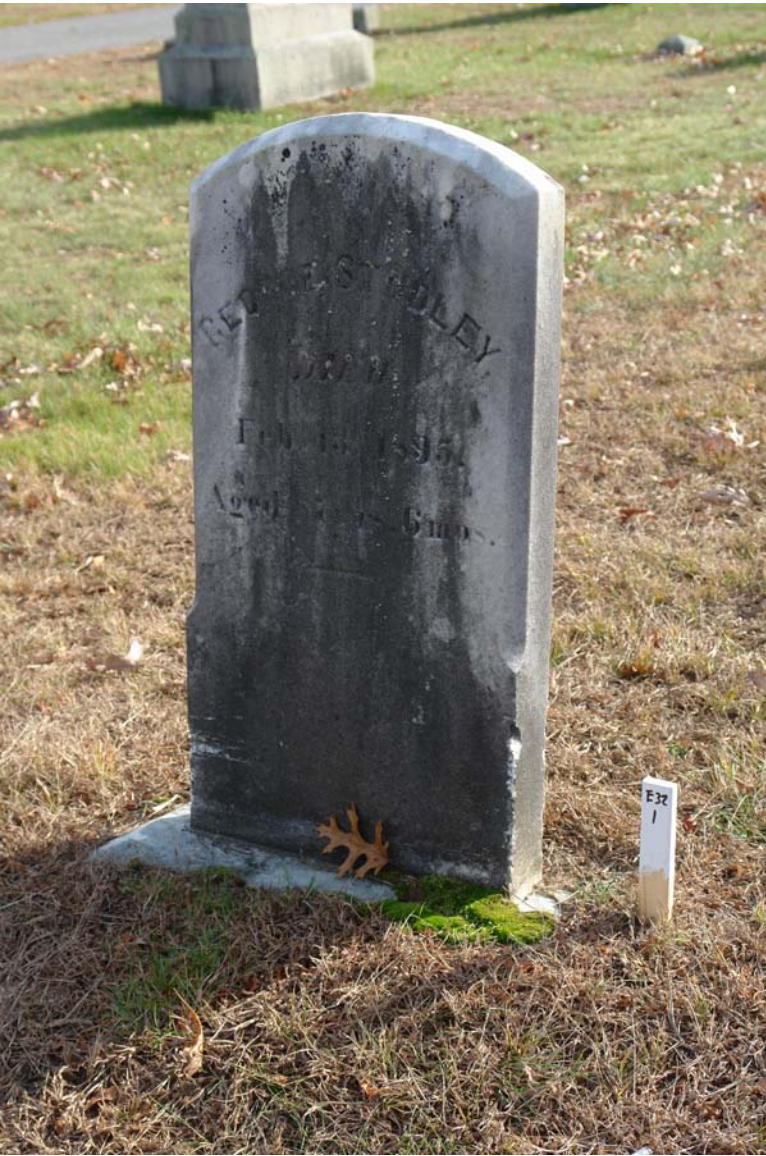
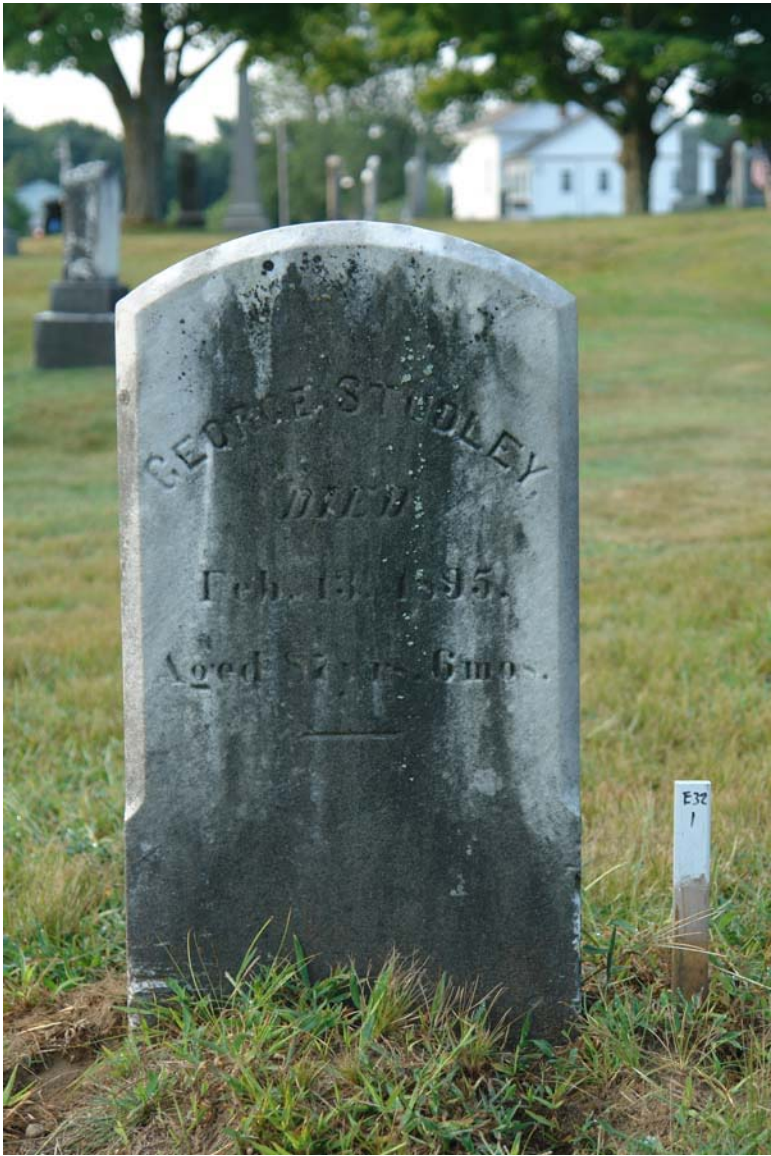
Hanover Center Cemetery, Hanover MA					
NAME ON MARKER	George Studley				
Death Date: 2/13/1895	Marker Type: Headstone/base				
Cond. of Inscription: Legible	Material: Marble				
EXISTING CONDITIONS	CONSERVATION STRATEGY				
Tilted base	Reset base with marker plumb				
<table><tr><td>TREATMENT</td><td>Treatment Dates 8/13/2015</td></tr><tr><td colspan="2"><div>1. Area excavated to an appropriate depth removing any roots or large stones.</div><div>2. Base inspected and found to be sound and re-useable</div><div>3. Base is aligned with adjacent markers and re-set level.</div><div>4. Area around base was backfilled with tamped gravel and re-graded with existing topsoil</div><div>5. Debris removed from setting slot. When required, power grinders were used to facilitate removal of stone fragments.</div><div>6. When required, the lower setting edge was re-squared by power grinder with minimal loss.</div><div>7. Marker reset plumb and level into setting slot with cement/lime grout (3/2/9) with 000 sand made fluid with a super plasticizer.</div><div>8. Excess grout removed and joint area cleaned.</div><div>9. Marker braced for a minimum 3 days</div></td></tr></table>		TREATMENT	Treatment Dates 8/13/2015	<div>1. Area excavated to an appropriate depth removing any roots or large stones.</div> <div>2. Base inspected and found to be sound and re-useable</div> <div>3. Base is aligned with adjacent markers and re-set level.</div> <div>4. Area around base was backfilled with tamped gravel and re-graded with existing topsoil</div> <div>5. Debris removed from setting slot. When required, power grinders were used to facilitate removal of stone fragments.</div> <div>6. When required, the lower setting edge was re-squared by power grinder with minimal loss.</div> <div>7. Marker reset plumb and level into setting slot with cement/lime grout (3/2/9) with 000 sand made fluid with a super plasticizer.</div> <div>8. Excess grout removed and joint area cleaned.</div> <div>9. Marker braced for a minimum 3 days</div>	
TREATMENT	Treatment Dates 8/13/2015				
<div>1. Area excavated to an appropriate depth removing any roots or large stones.</div> <div>2. Base inspected and found to be sound and re-useable</div> <div>3. Base is aligned with adjacent markers and re-set level.</div> <div>4. Area around base was backfilled with tamped gravel and re-graded with existing topsoil</div> <div>5. Debris removed from setting slot. When required, power grinders were used to facilitate removal of stone fragments.</div> <div>6. When required, the lower setting edge was re-squared by power grinder with minimal loss.</div> <div>7. Marker reset plumb and level into setting slot with cement/lime grout (3/2/9) with 000 sand made fluid with a super plasticizer.</div> <div>8. Excess grout removed and joint area cleaned.</div> <div>9. Marker braced for a minimum 3 days</div>

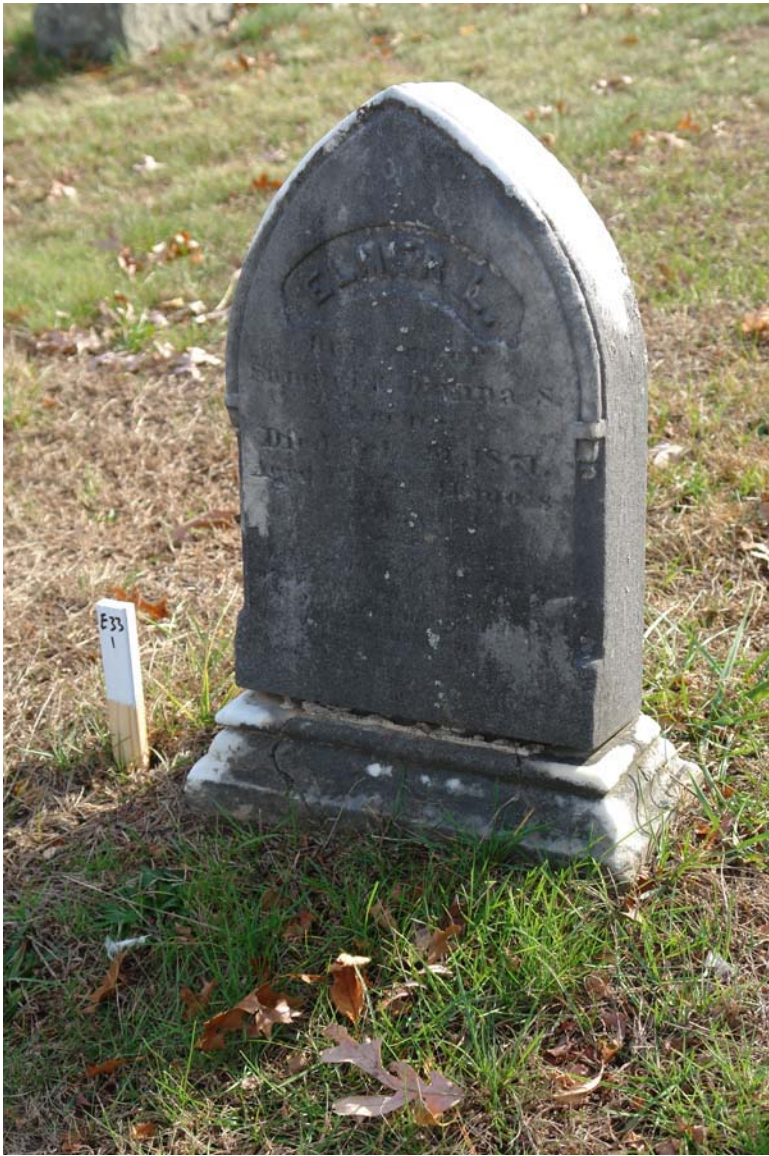
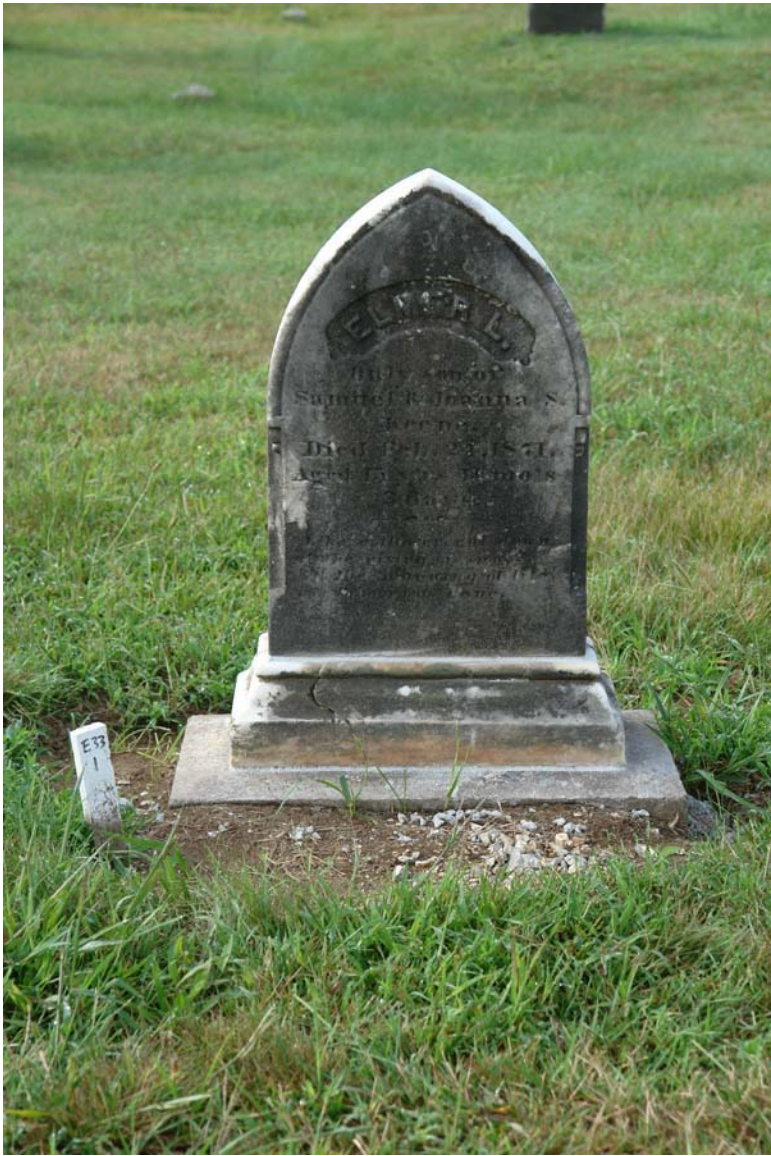
Hanover Center Cemetery, Hanover MA
NAME ON MARKER **Elmer Keene**
Death Date: 2/24/1851 Marker Type:Headstone/pinned base
Cond. of InscriptionLegible Material: Marble

EXISTING CONDITIONS	CONSERVATION STRATEGY
Fractures Loose on base	Attach fragments with structural adhesive Reset elements

TREATMENT	Treatment Dates 8/13-25/2015
<div>1. Elements disassembled and previous repair materials and failed mortar removed from setting surfaces with hand tools.</div> <div>2. In-ground base reset level. Replace setting pins with threaded stainless pins if required.</div> <div>3. Cracks and losses filled with RepliCal Marble or Jahn restoration mortar, misted with water and covered for 3 days min.</div> <div>4. Filled surface areas treated w/ light acid wash, rinsed thoroughly with water.</div> <div>5. Setting surfaces primed with Acryl 60 diluted 1:3 with water.</div> <div>6. Elements reset with 2:1:9 cementitious high cal lime mortar using fine (00 or 000) sand.</div> <div>7. Excess mortar removed from joints and braced for a min 3 days</div>

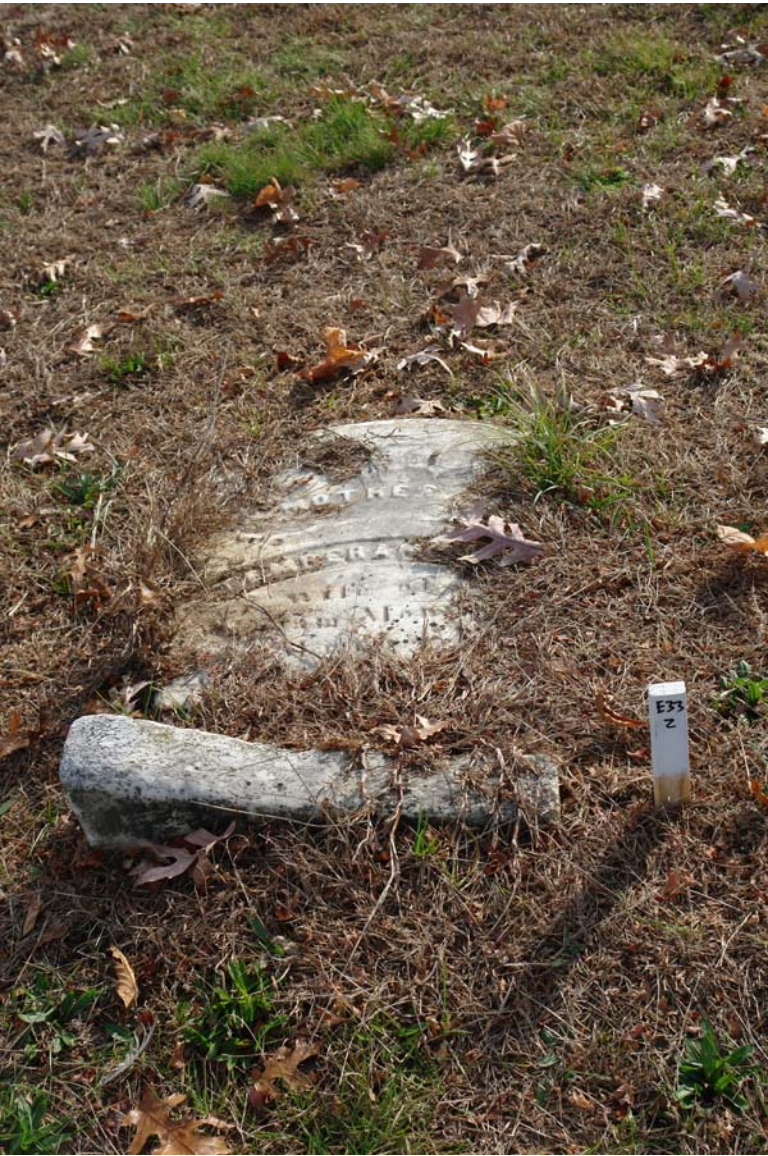
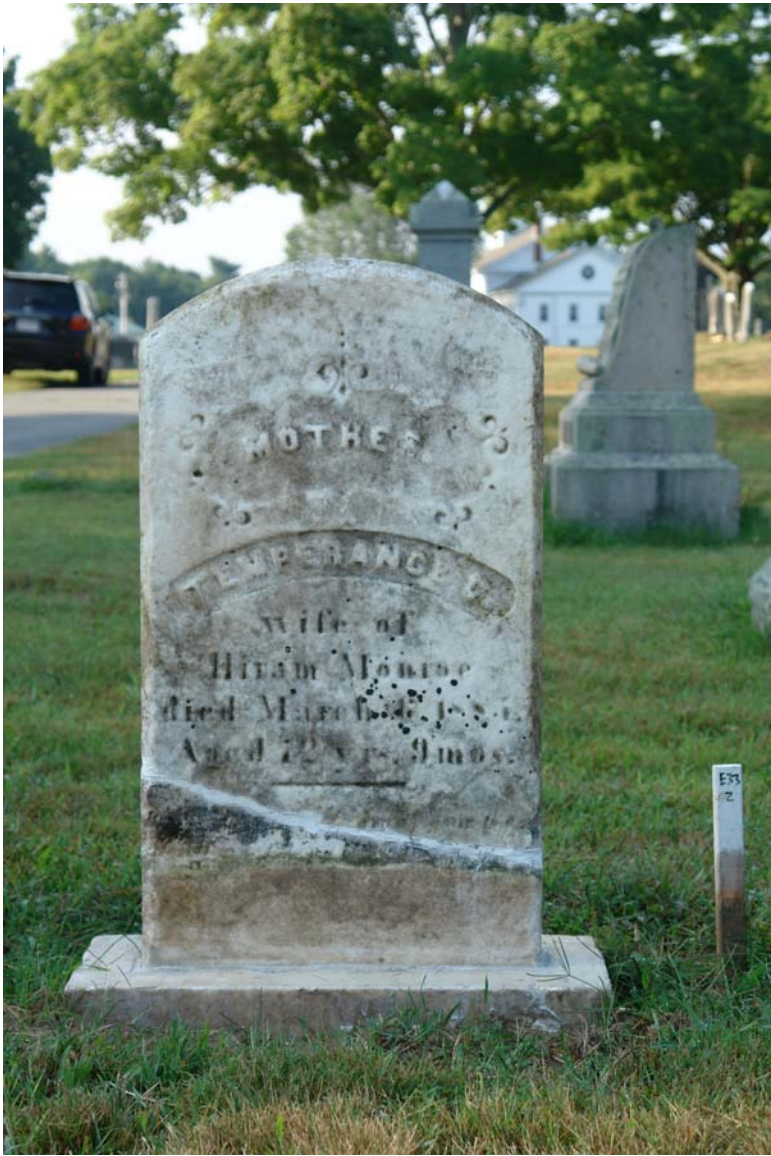
EXISTING CONDITIONS	CONSERVATION STRATEGY
Fractured at grade	Reset into new below grade concrete base

2. Setting slot cleaned of debris or failed mortar and bottom fragment reset plumb and level into setting slot with a cement/lime grout (3/2/9) with 000 sand made fluid with a super plasticizer. Excess grout removed and joint area cleaned.

4. All mating edges of fragments cleaned with water and any failed adhesives removed with hand tools

6. Cracks and losses filled with RepliCal Marble products, filled areas misted with water and covered for 3 days minimum

7. Filled areas treated with light acid wash and rinsed thoroughly.

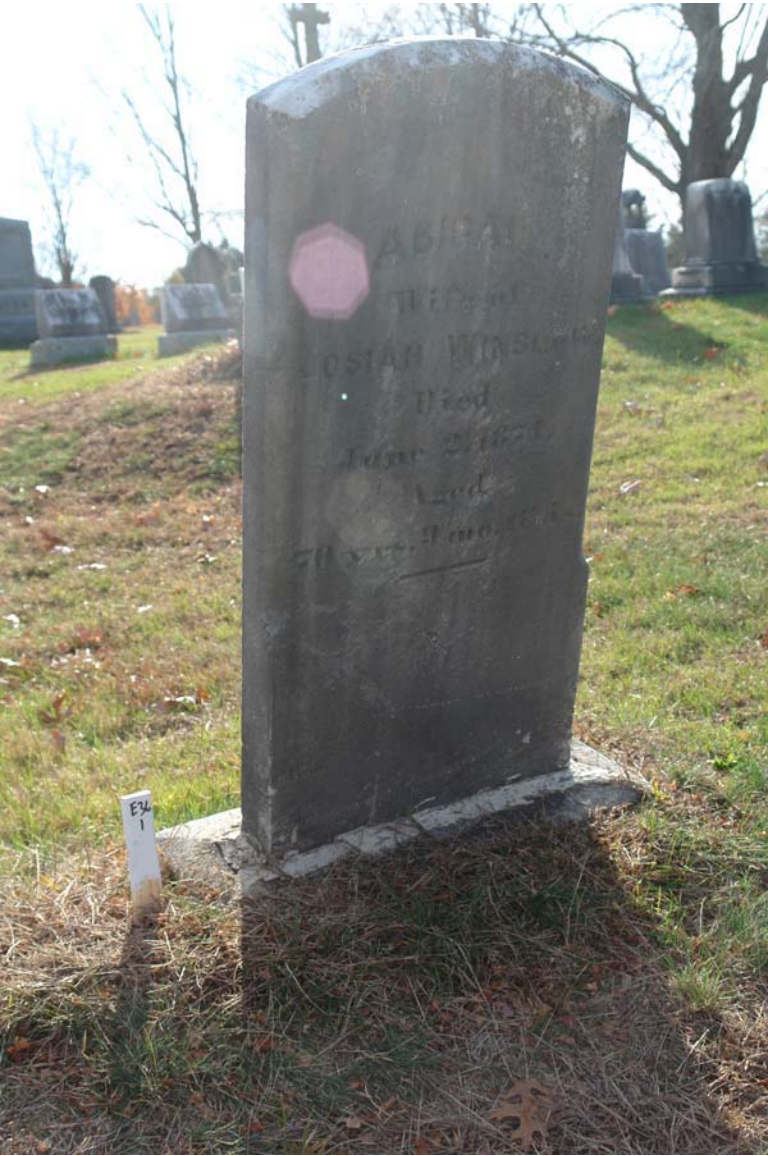
Hanover Center Cemetery, Hanover MA
NAME ON MARKER **Abigail Winslow**
Death Date: 6/2/1877 Marker Type: Headstone/slotted base
Cond. of Inscription: Legible Material: Marble

EXISTING CONDITIONS	CONSERVATION STRATEGY
Tilted base	Reset base with marker plumb

TREATMENT	Treatment Dates
1. Marker and base found to be in sound condition with marker securely attached to base. 2. Area excavated to an appropriate depth removing any roots or large stones. 3. Base is aligned with adjacent markers and re-set level. 4. Area around base was backfilled with tamped gravel and re-graded with existing topsoil	8/5/2015

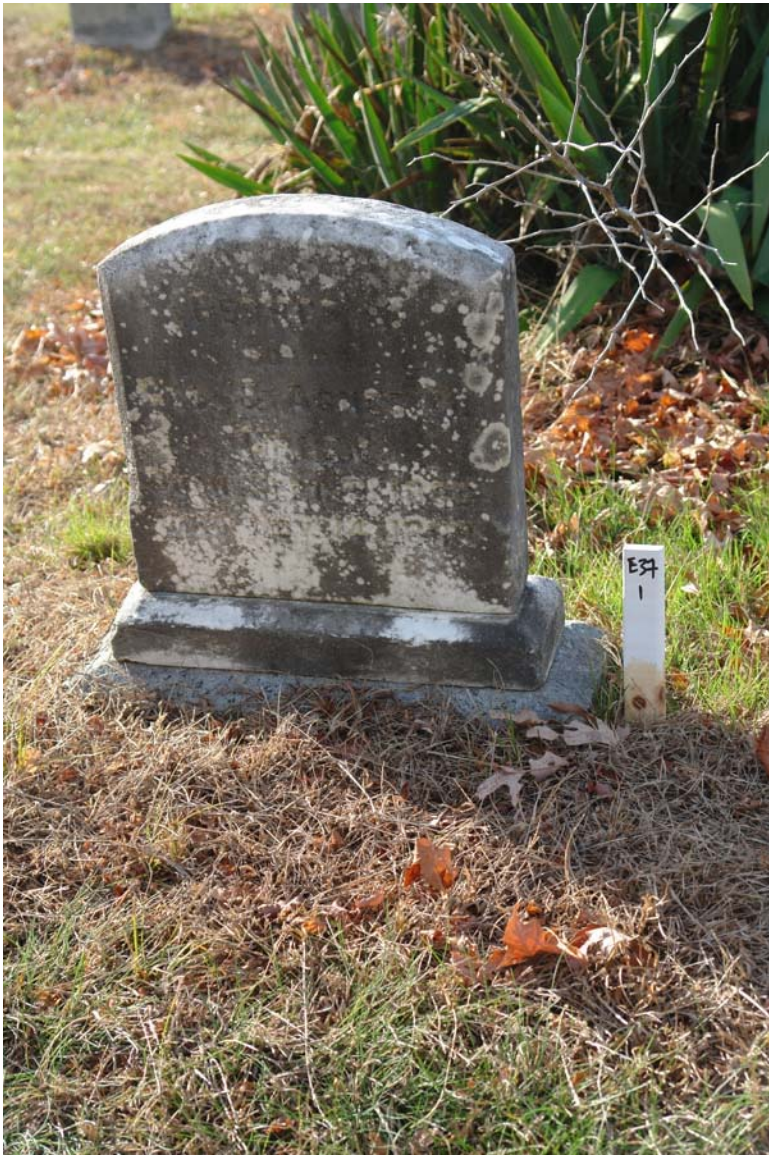
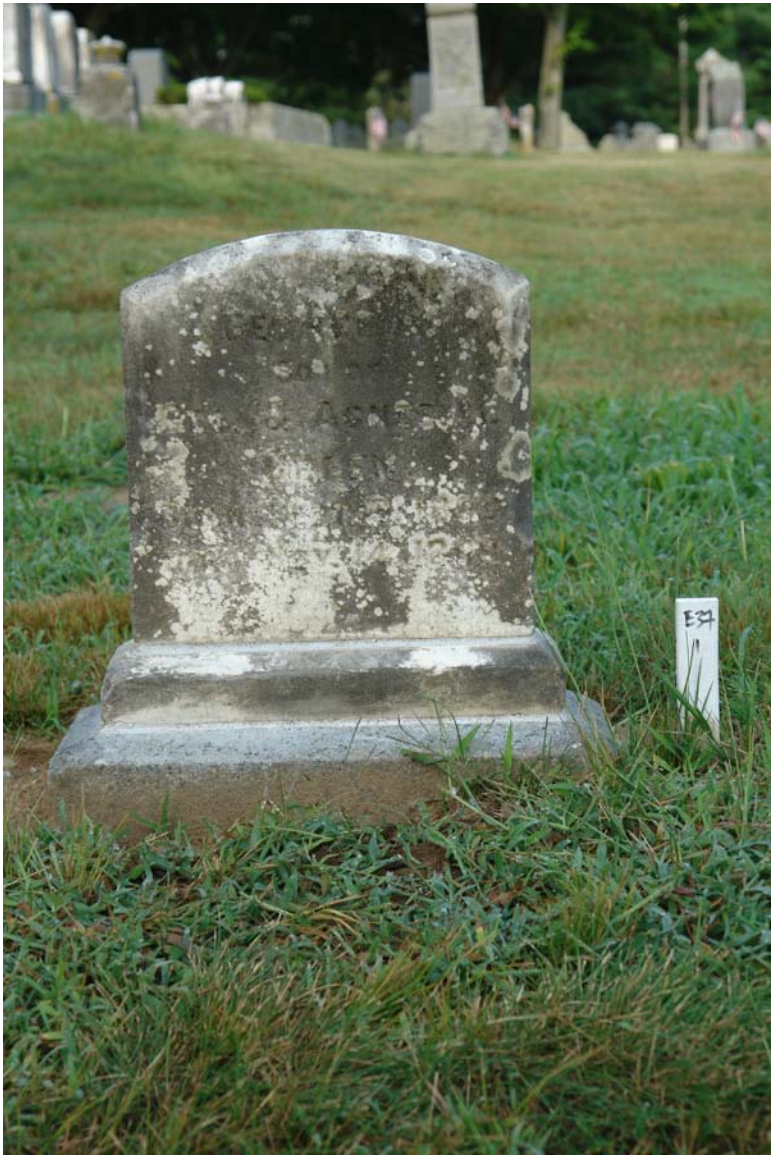
EXISTING CONDITIONS	CONSERVATION STRATEGY
Tilted Loose on base	Reset base level Reset elements

TREATMENT	Treatment Dates 8/12/2015
<div>1. Elements removed from setting bases and inspected for soundness.</div> <div>2. Area excavated to an appropriate depth removing any roots or large stones.</div> <div>3. Base is aligned with adjacent markers and re-set level.</div> <div>4. Area around base was backfilled with tamped gravel and re-graded with existing topsoil</div> <div>5. Failed mortar removed from setting area and bottom of marker</div> <div>6. When required, any existing pins were inspected, and if necessary, replaced with stainless steel threaded pins</div> <div>7. Setting surfaces primed with Acryl 60 diluted 1:3 with water.</div> <div>8. Marker reset plumb onto base with cement/lime mortar (3/2/9) with 000 sand. When required, lead shims were used to facilitate leveling.</div> <div>9. Excess grout removed and joint area cleaned.</div>

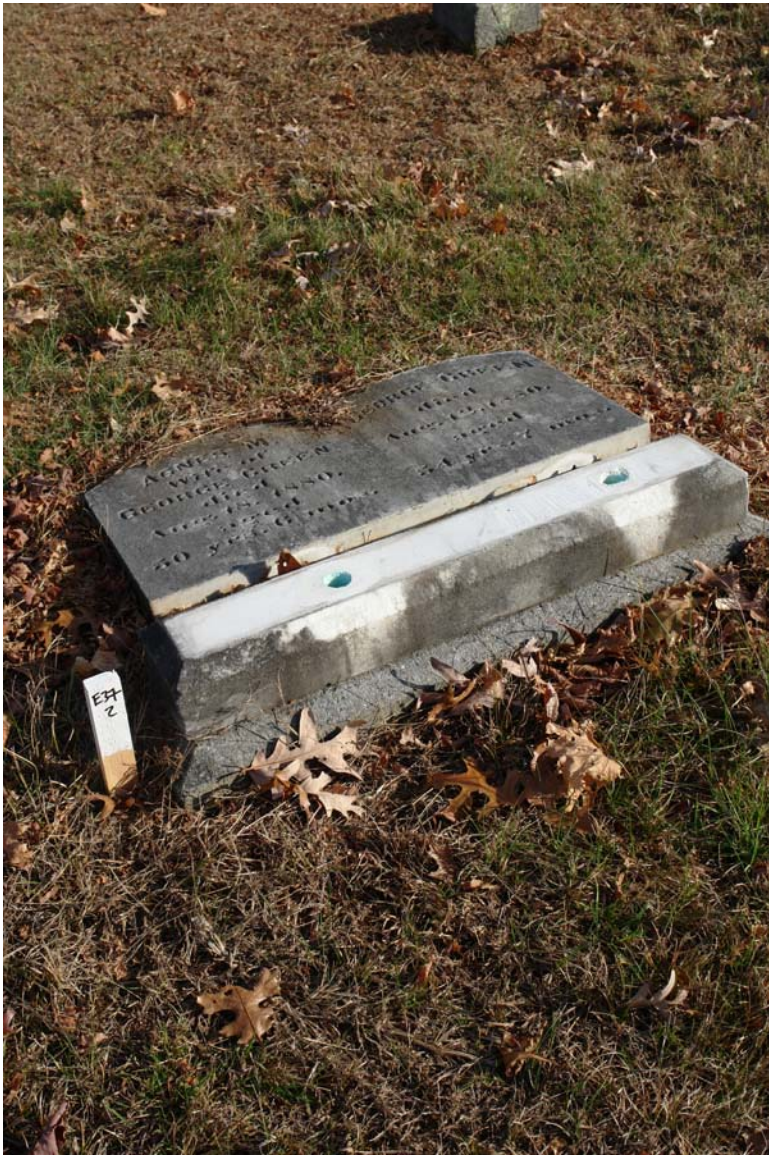
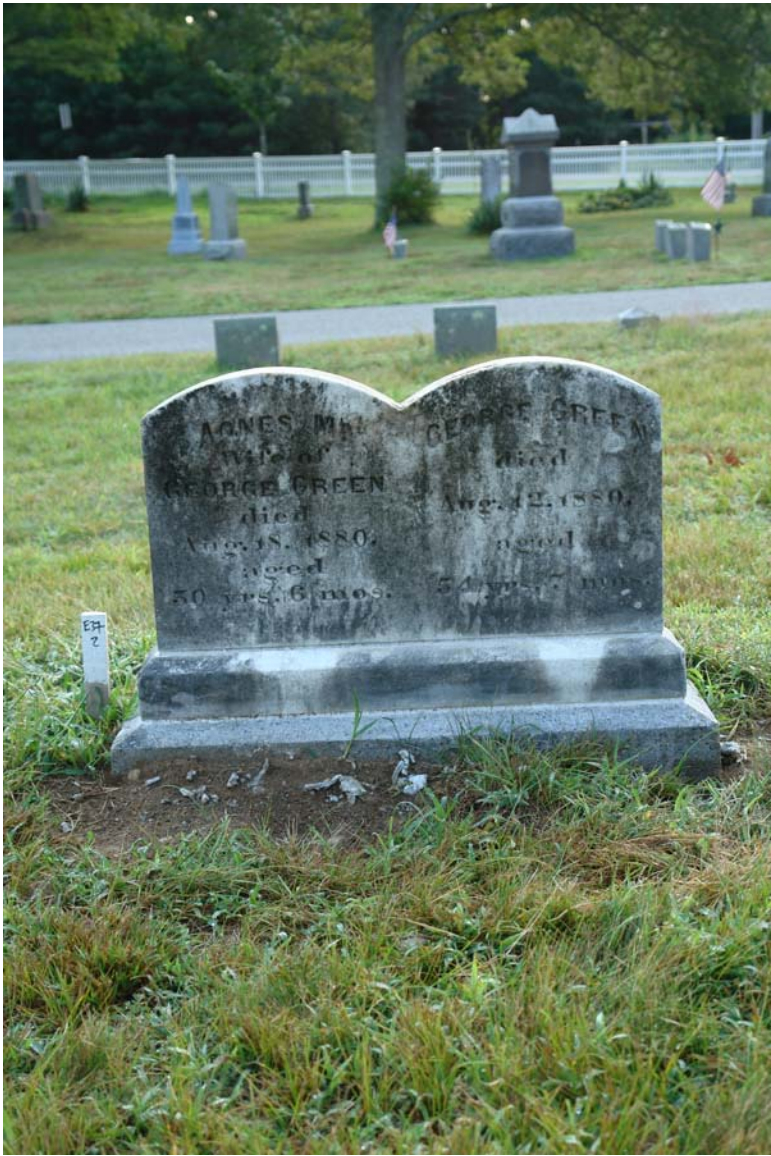
Hanover Center Cemetery, Hanover MA
NAME ON MARKER **George Green**
Death Date: 8/12/1880 Marker Type: Double headstone/base
Cond. of Inscription: Legible Material: Marble

EXISTING CONDITIONS	CONSERVATION STRATEGY
Tilted Loose on bas	Reset base level Reset elements e

TREATMENT	Treatment Dates 8/12/2015
<div>1. Elements removed from setting bases and inspected for sound- ness. 2. Area excavated to an appropriate depth removing any roots or large stones. 3. Base is aligned with adjacent markers and re-set level. 4. Area around base was backfilled with tamped gravel and re- graded with existing topsoil 5. Failed mortar removed from setting area and bottom of marker 6. When required, any existing pins were inspected, and if neces- sary, replaced with stainless steel threaded pins 7. Setting surfaces primed with Acryl 60 diluted 1:3 with water. 8. Marker reset plumb onto base with cement/lime mortar (3/2/9) with 000 sand. When required, lead shims were used to facilitate leveling. 9. Excess grout removed and joint area cleaned.</div>

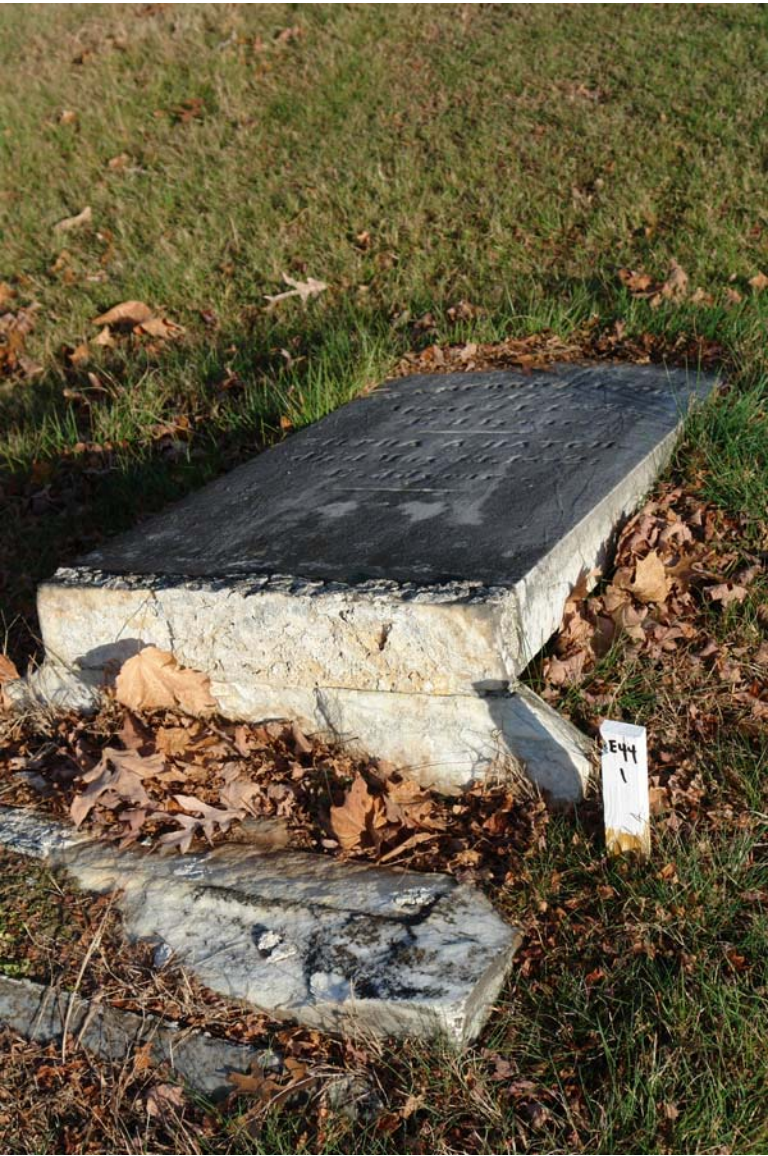
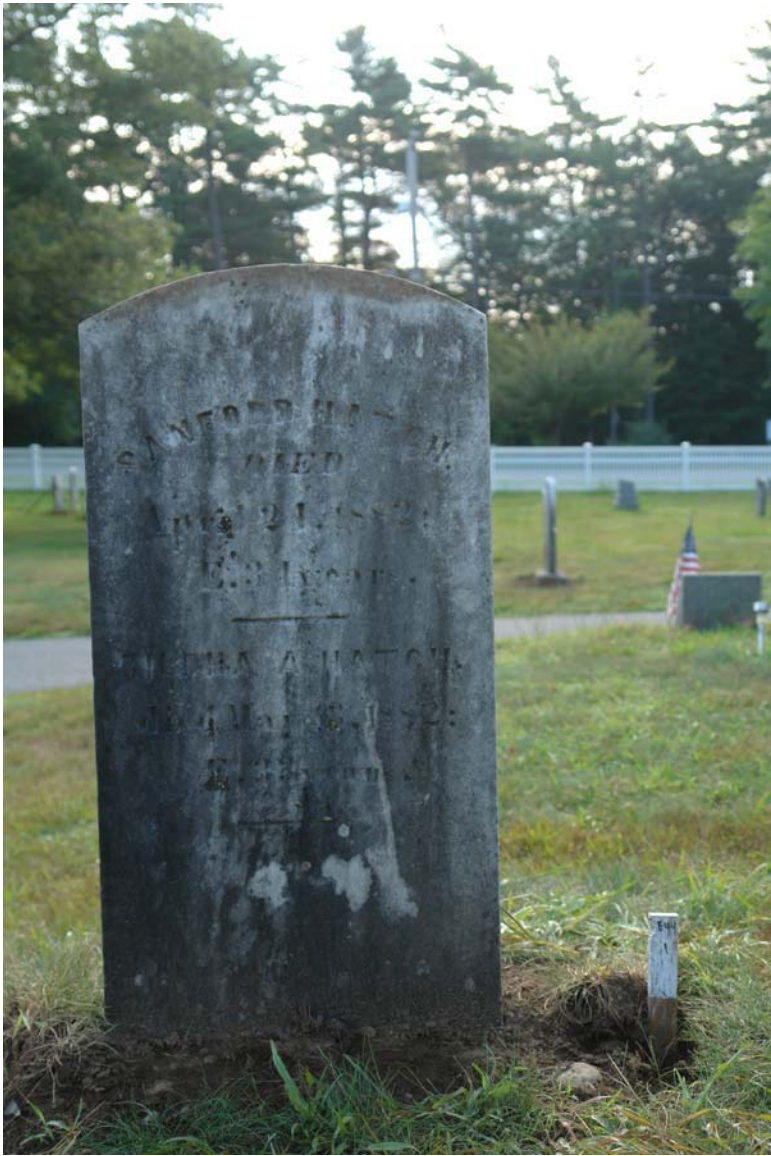
Hanover Center Cemetery, Hanover MA		
NAME ON MARKER		Sanford Hatch
Death Date:	4/24/1882	Marker Type: Headstone/base
Cond. of Inscription:	Legible	Material: Marble
EXISTING CONDITIONS		CONSERVATION STRATEGY
Fallen		Evaluate resetting options Possible new below grade concrete base
TREATMENT		
Treatment Dates		8/13-14/2015
<div>1. Marker excavated and found to be sound. Light soiling removed by brushing with nylon brushes and water.</div> <div>2. Setting area excavated for new below grade cast concrete base sized minimum of 12 inches deep, 12 inches greater in thickness and 6 inches wider than the stone.</div> <div>3. Wooden forms and setting slot form stabilized and aligned with adjacent markers before concrete is poured</div> <div>4. When required, the lower edge of marker is re-squared with minimal loss using a power grinder</div> <div>5. Setting forms are removed after partial curing of the concrete and the base backfilled with tamped sand or gravel</div> <div>6. Marker reset into setting slot with a cement/lime grout (3/2/9) with 000 sand made fluid with a super plasticizer.</div> <div>7. Marker set plumb and level, and braced for minimum of 5 days.</div> <div>8. Disturbed areas backfilled with existing topsoil.</div>
