MONUMENT CONSERVATION COLLABORATIVE LLC, NORFOLK, CT

DOCUMENTATION OF STONE CONSERVATION TREATMENTS TO ASSINIPPI CEMETERY, HANOVER, MA June 2015

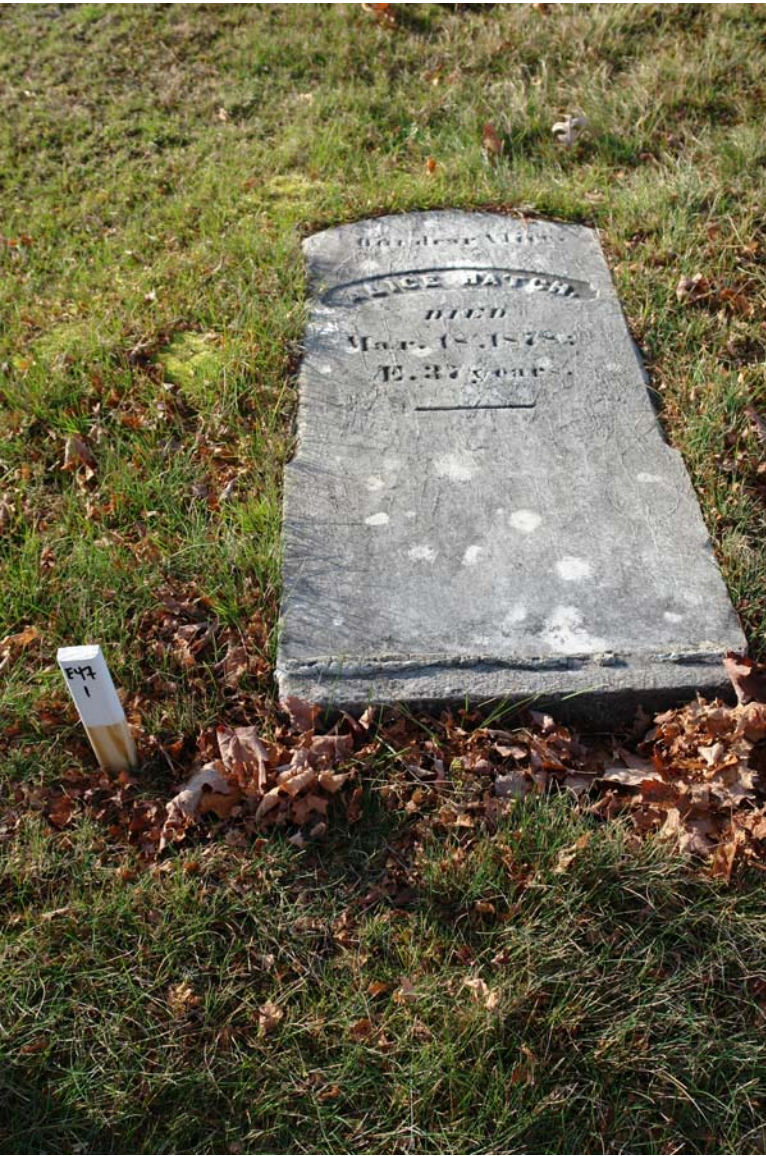
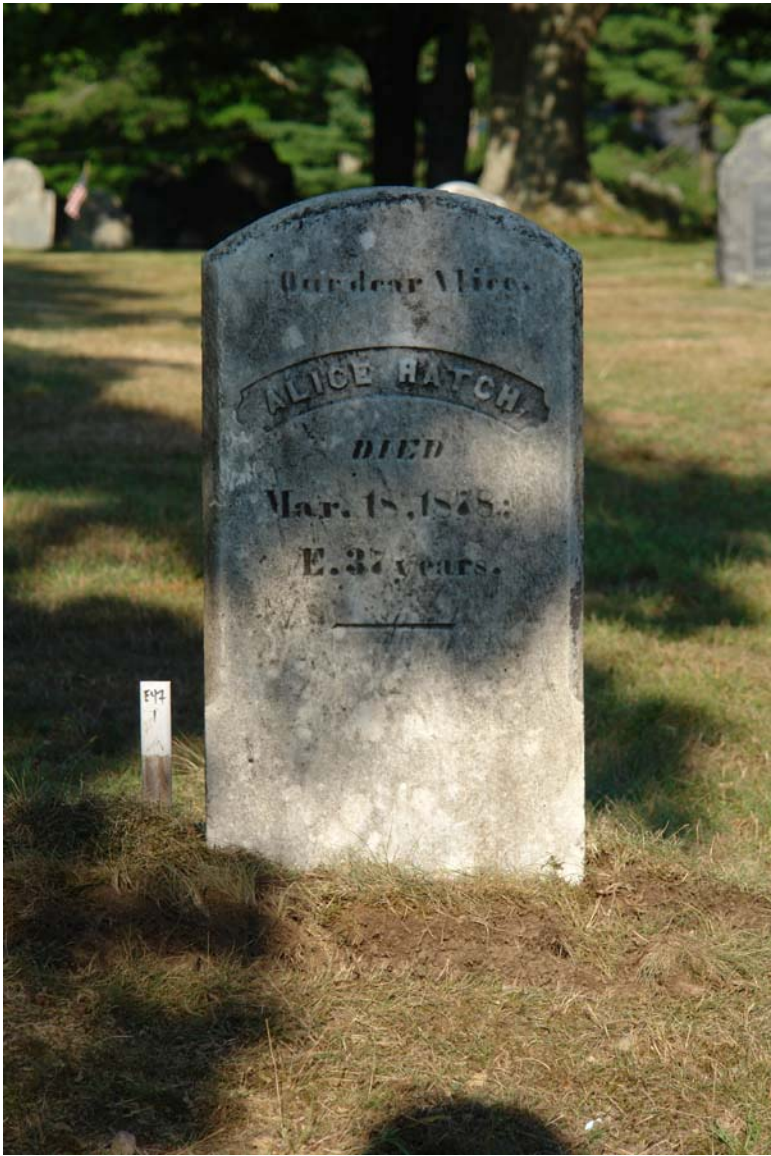
EXISTING CONDITIONS	CONSERVATION STRATEGY
Fallen	Evaluate resetting options Possible new below grade concrete base

TREATMENT	Treatment Dates
1. Marker excavated and found to be sound. Light soiling removed by brushing with nylon brushes and water. 2. Setting area excavated for new below grade cast concrete base sized minimum of 12 inches deep, 12 inches greater in thickness and 6 inches wider than the stone. 3. Wooden forms and setting slot form stabilized and aligned with adjacent markers before concrete is poured 4. When required, the lower edge of marker is re-squared with minimal loss using a power grinder 5. Setting forms are removed after partial curing of the concrete and the base backfilled with tamped sand or gravel 6. Marker reset into setting slot with a cement/lime grout (3/2/9) with 000 sand made fluid with a super plasticizer. 7. Marker set plumb and level, and braced for minimum of 5 days. 8. Disturbed areas backfilled with existing topsoil.	8/26-31/2015

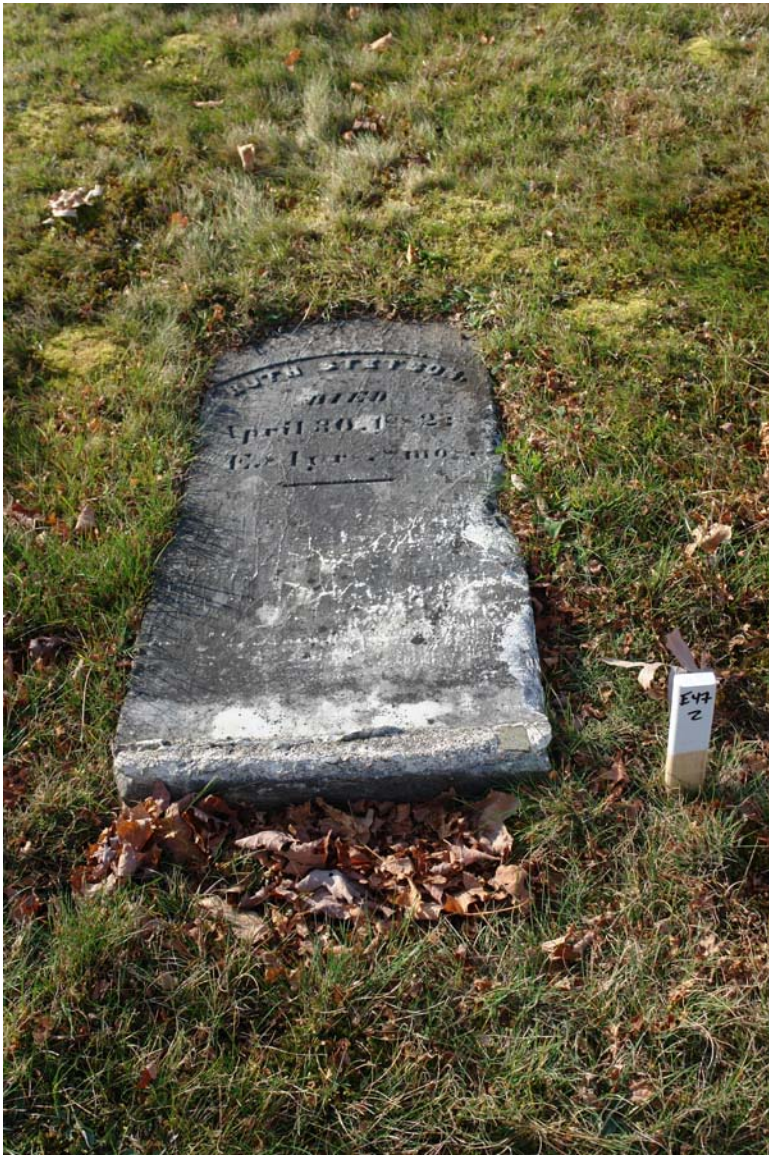
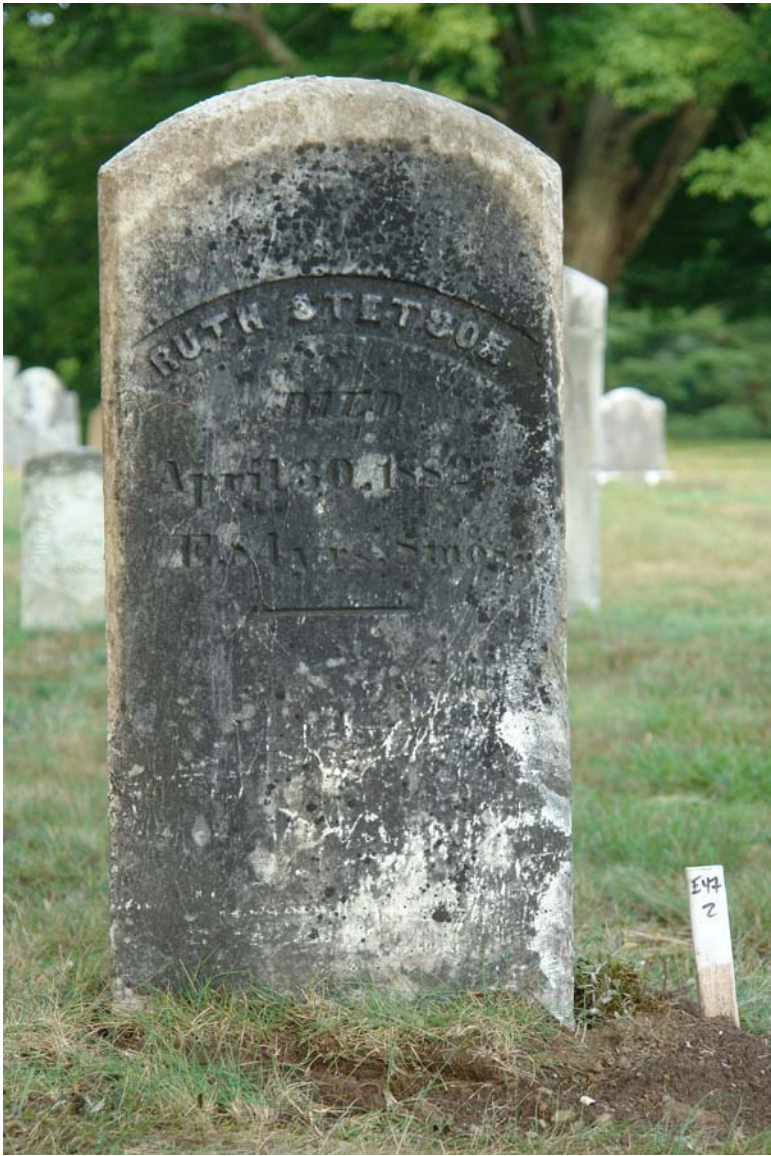
NAME ON MARKER **Ruth Stetson**

EXISTING CONDITIONS	CONSERVATION STRATEGY
Fallen	Evaluate resetting options Possible new below grade concrete base

TREATMENT	Treatment Dates 8/13-14/2015
<div>1. Marker excavated and found to be sound. Light soiling removed by brushing with nylon brushes and water.</div> <div>2. Setting area excavated for new below grade cast concrete base sized minimum of 12 inches deep, 12 inches greater in thickness and 6 inches wider than the stone.</div> <div>3. Wooden forms and setting slot form stabilized and aligned with adjacent markers before concrete is poured</div> <div>4. When required, the lower edge of marker is re-squared with minimal loss using a power grinder</div> <div>5. Setting forms are removed after partial curing of the concrete and the base backfilled with tamped sand or gravel</div> <div>6. Marker reset into setting slot with a cement/lime grout (3/2/9) with 000 sand made fluid with a super plasticizer.</div> <div>7. Marker set plumb and level, and braced for minimum of 5 days.</div> <div>8. Disturbed areas backfilled with existing topsoil.</div>

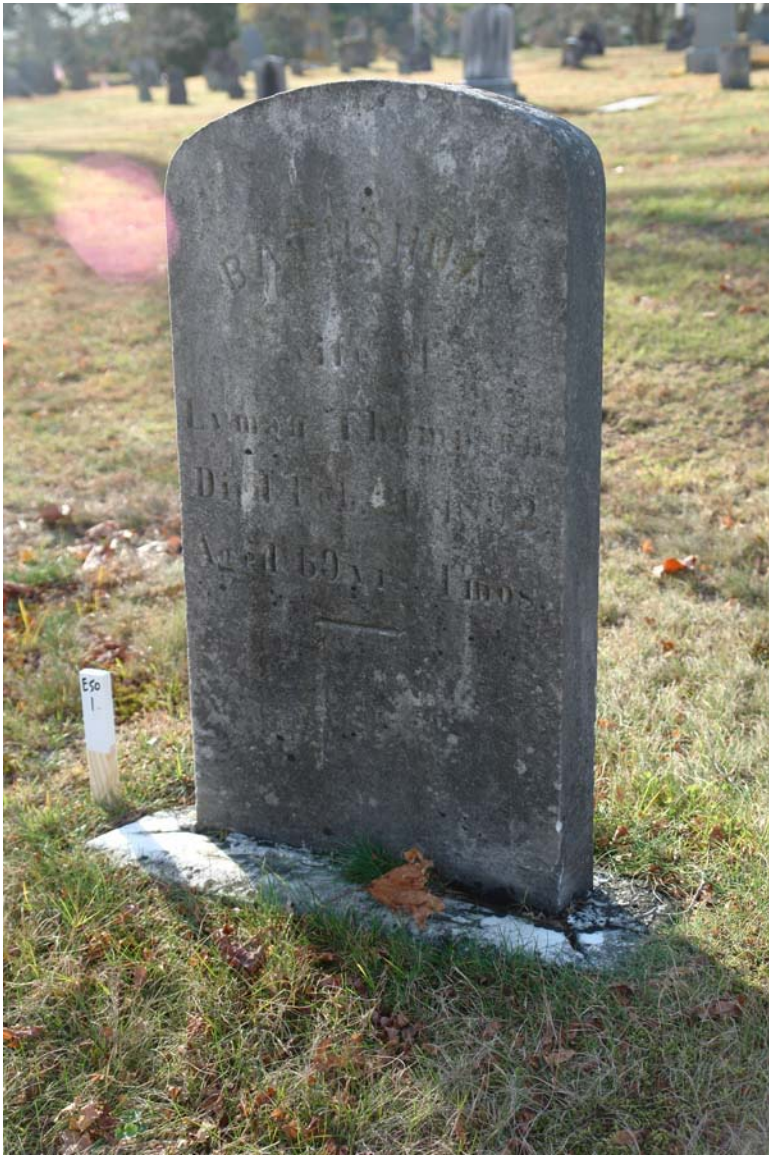
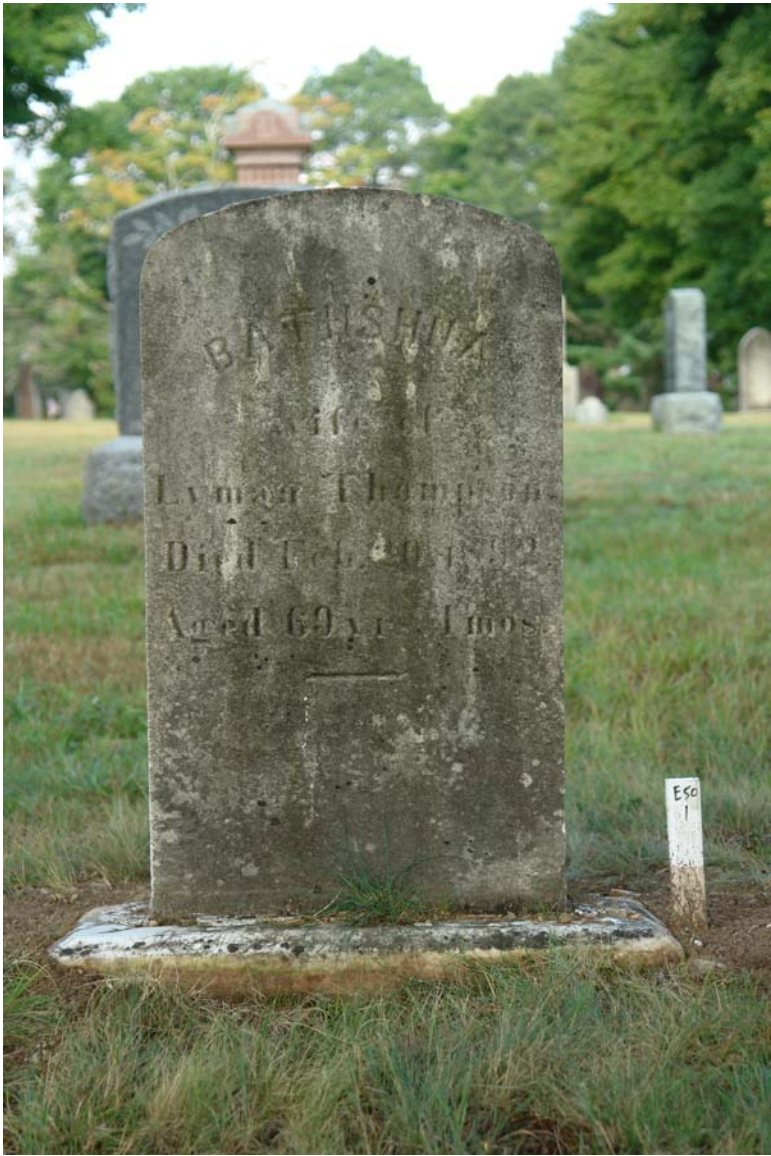
Hanover Center Cemetery, Hanover MA	
NAME ON MARKER	Bathshua Thompson
Death Date: 2/20/1892	Marker Type: Headstone/base
Cond. of Inscription: Decipherable	Material: Marble
EXISTING CONDITIONS	CONSERVATION STRATEGY
Tilted base	Reset base with marker plumb
TREATMENT	
Treatment Dates 8/5/2015	
<div>1. Area excavated to an appropriate depth removing any roots or large stones.</div> <div>2. Base inspected and found to be sound and re-useable</div> <div>3. Base is aligned with adjacent markers and re-set level.</div> <div>4. Area around base was backfilled with tamped gravel and re-graded with existing topsoil</div> <div>5. Debris removed from setting slot. When required, power grinders were used to facilitate removal of stone fragments.</div> <div>6. When required, the lower setting edge was re-squared by power grinder with minimal loss.</div> <div>7. Marker reset plumb and level into setting slot with cement/lime grout (3/2/9) with 000 sand made fluid with a super plasticizer.</div> <div>8. Excess grout removed and joint area cleaned.</div> <div>9. Marker braced for a minimum 3 days</div>

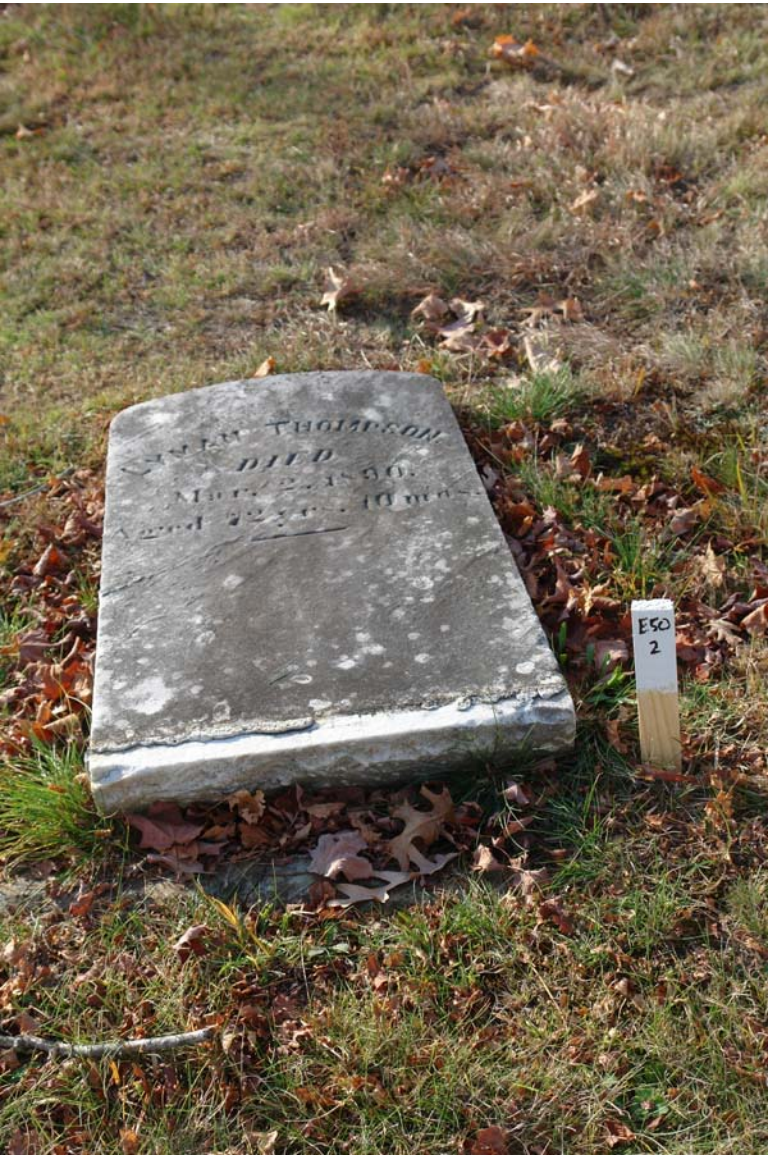
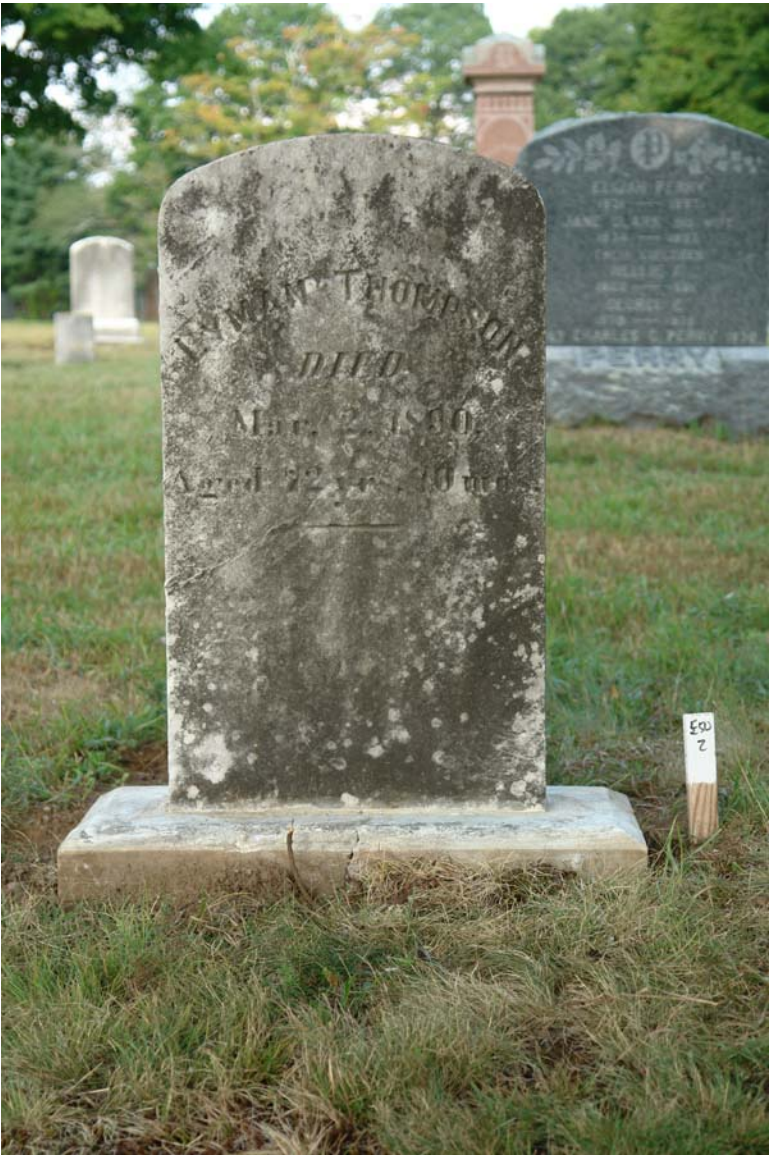
Hanover Center Cemetery, Hanover MA					
NAME ON MARKER	Lyman Thompson				
Death Date: 3/2/1890	Marker Type: Headstone/base				
Cond. of Inscription: Legible	Material: Marble				
EXISTING CONDITIONS	CONSERVATION STRATEGY				
Tilted Marker loose in slot	Reset base level Reset marker plumb into setting slot				
<table><tr><td>TREATMENT</td><td>Treatment Dates 7/23-8/5/2015</td></tr><tr><td colspan="2"><div>1. Area excavated to an appropriate depth removing any roots or large stones Base removed from ground. .</div><div>2. Base surfaces cleaned with water and any failed adhesives or mortar removed with hand tools from setting area and bottom of marker</div><div>3. Base fragments attached with structural adhesive, clamped and braced until cured. Epoxy removed with hand chisels within 24 hours.</div><div>4. Base aligned with adjacent markers and re-set level. Area around base was backfilled with tamped gravel and re-graded with existing top-soil</div><div>5. Debris removed from setting slot. When required, power grinders were used to facilitate removal of stone fragments.</div><div>6. When required, the lower setting edge was re-squared by power grinder with minimal loss.</div><div>7. Marker reset plumb and level into setting slot with cement/lime grout (3/2/9) with 000 sand made fluid with a super plasticizer.</div><div>8. Marker braced for a minimum 3 days</div></td></tr></table>		TREATMENT	Treatment Dates 7/23-8/5/2015	<div>1. Area excavated to an appropriate depth removing any roots or large stones Base removed from ground. .</div> <div>2. Base surfaces cleaned with water and any failed adhesives or mortar removed with hand tools from setting area and bottom of marker</div> <div>3. Base fragments attached with structural adhesive, clamped and braced until cured. Epoxy removed with hand chisels within 24 hours.</div> <div>4. Base aligned with adjacent markers and re-set level. Area around base was backfilled with tamped gravel and re-graded with existing top-soil</div> <div>5. Debris removed from setting slot. When required, power grinders were used to facilitate removal of stone fragments.</div> <div>6. When required, the lower setting edge was re-squared by power grinder with minimal loss.</div> <div>7. Marker reset plumb and level into setting slot with cement/lime grout (3/2/9) with 000 sand made fluid with a super plasticizer.</div> <div>8. Marker braced for a minimum 3 days</div>	
TREATMENT	Treatment Dates 7/23-8/5/2015				
<div>1. Area excavated to an appropriate depth removing any roots or large stones Base removed from ground. .</div> <div>2. Base surfaces cleaned with water and any failed adhesives or mortar removed with hand tools from setting area and bottom of marker</div> <div>3. Base fragments attached with structural adhesive, clamped and braced until cured. Epoxy removed with hand chisels within 24 hours.</div> <div>4. Base aligned with adjacent markers and re-set level. Area around base was backfilled with tamped gravel and re-graded with existing top-soil</div> <div>5. Debris removed from setting slot. When required, power grinders were used to facilitate removal of stone fragments.</div> <div>6. When required, the lower setting edge was re-squared by power grinder with minimal loss.</div> <div>7. Marker reset plumb and level into setting slot with cement/lime grout (3/2/9) with 000 sand made fluid with a super plasticizer.</div> <div>8. Marker braced for a minimum 3 days</div>

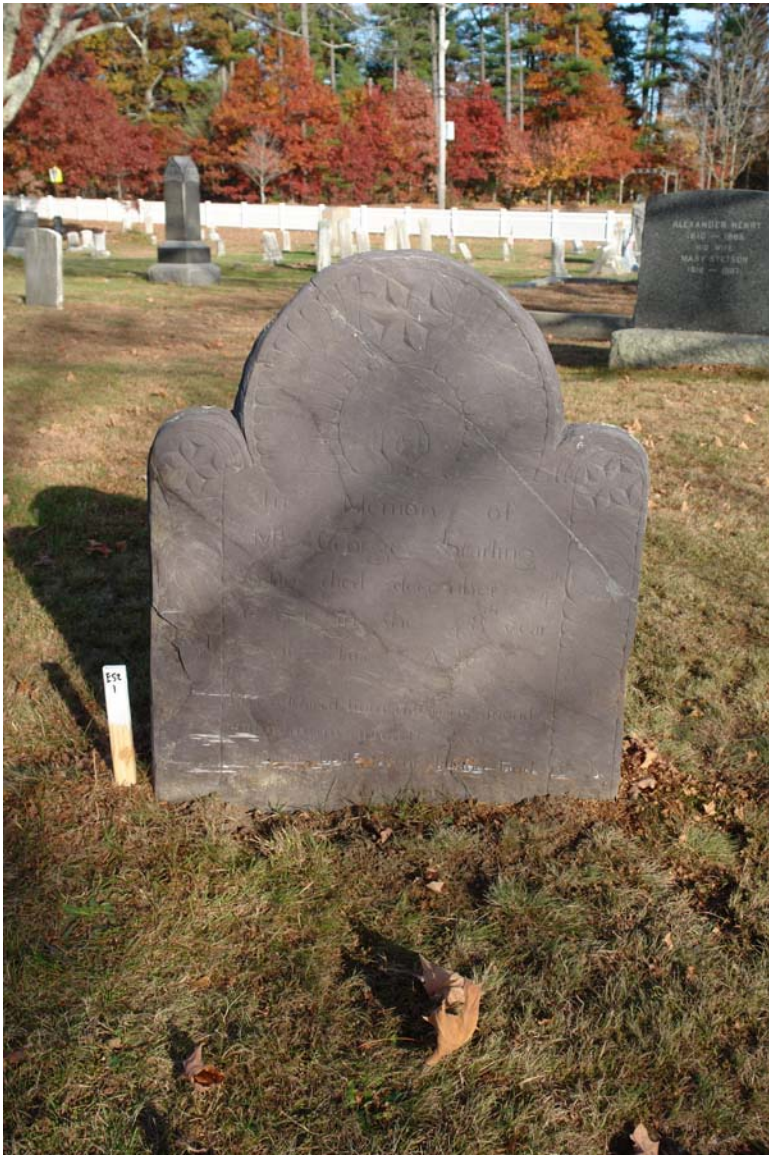
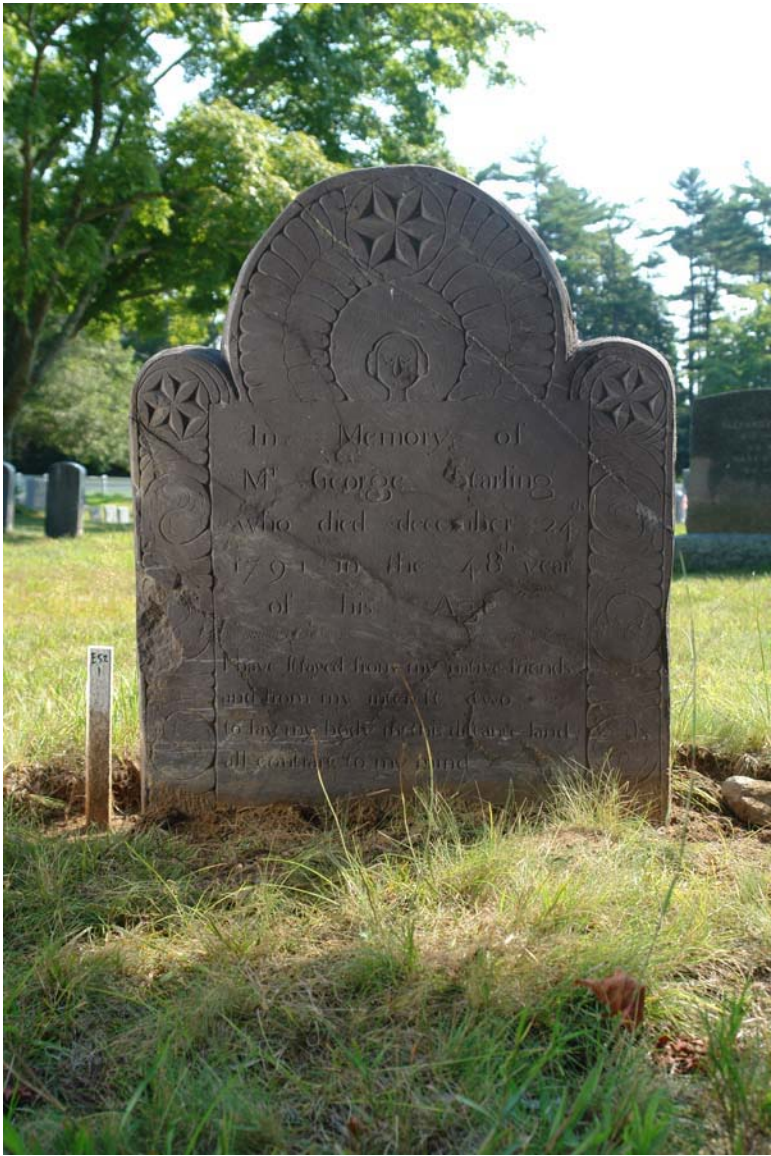
Hanover Center Cemetery, Hanover MA	
NAME ON MARKER	George Starling
Death Date: 12/24/1791	Marker Type: Headstone
Cond. of Inscription: Legible	Material: Slate
EXISTING CONDITIONS	CONSERVATION STRATEGY
Tilted	Reset plumb
TREATMENT	
Treatment Dates 8/12/2015	
Note: This fractured marker was restored by MCC in 2012	
<div>1. Marker carefully excavated. The soil around tilted markers was removed to an appropriate depth. When required, the marker was removed from the ground. Marker appears to be sound.</div> <div>2. Soling removed by light brushing with nylon brushes and water.</div> <div>3. Setting area excavated to sufficient depth and stone re-set plumb at appropriate height and level onto gravel bed, aligned with adjacent markers</div> <div>4. Area backfilled around marker with tamped sand and gravel</div> <div>5. Disturbed areas re-graded with existing topsoil and sod.</div>

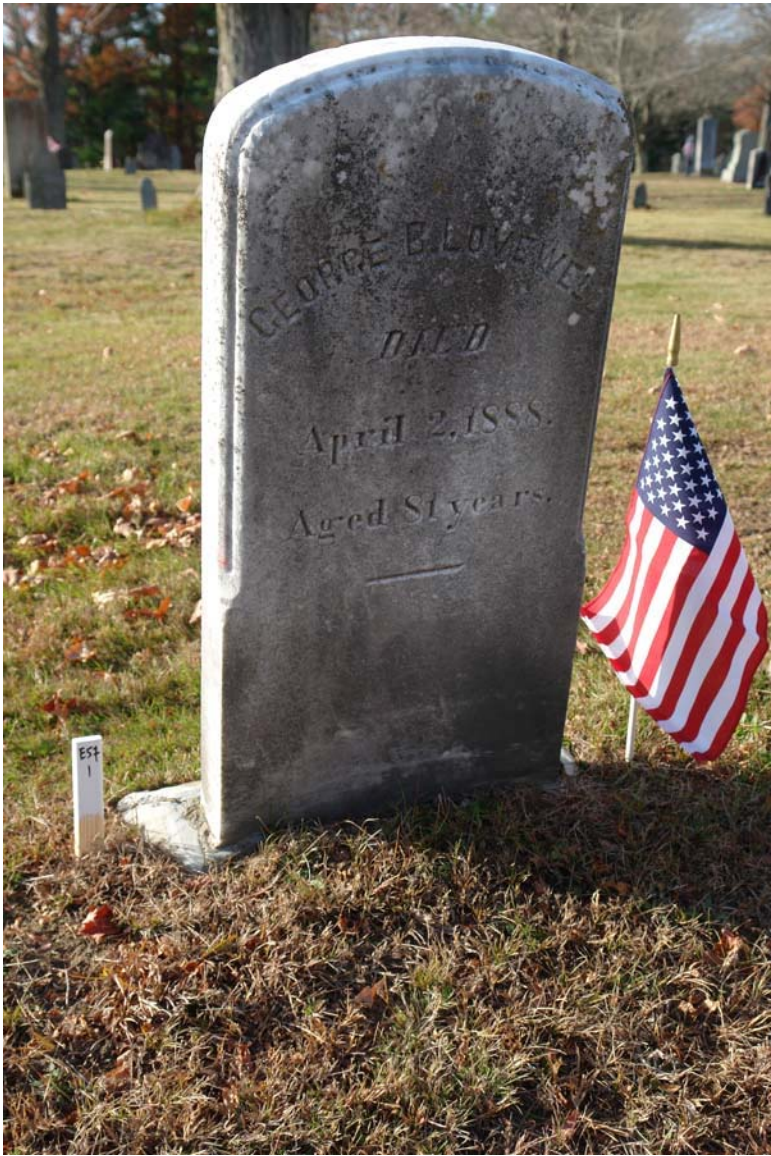
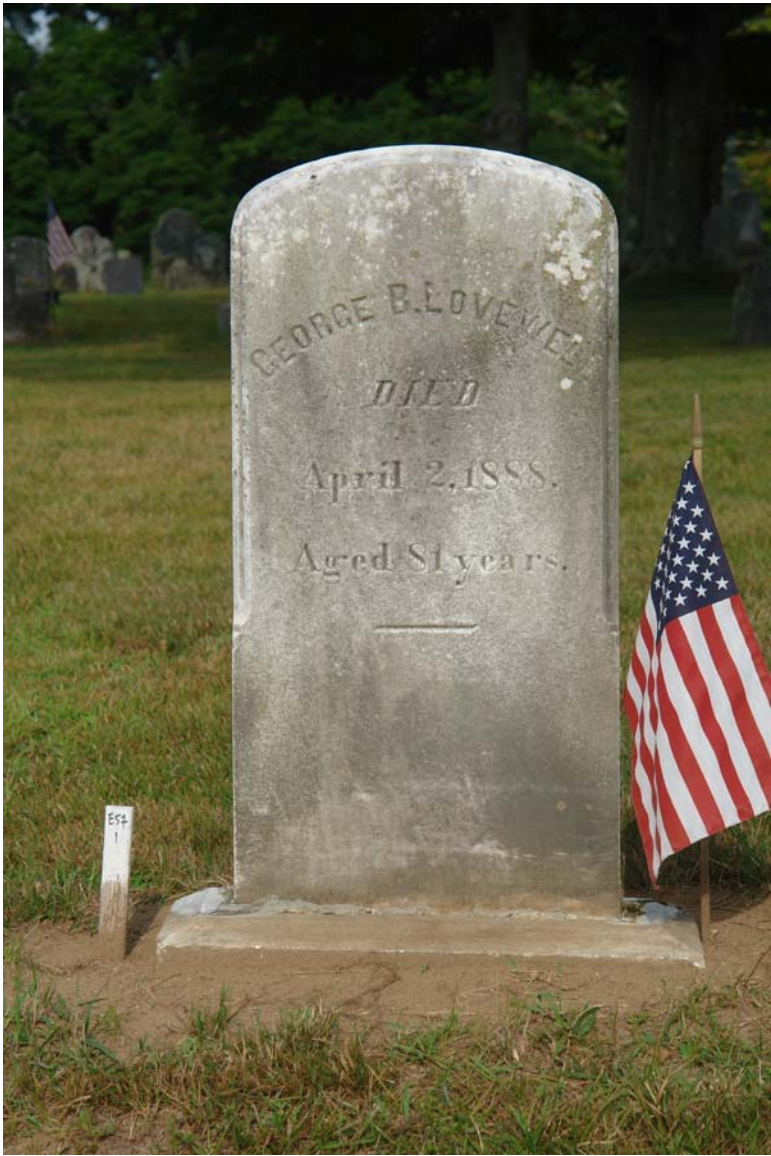
Hanover Center Cemetery, Hanover MA	
NAME ON MARKER	George Lovewell
Death Date: 4/2/1888	Marker Type: Headstone/base
Cond. of Inscription: Legible	Material: Marble
EXISTING CONDITIONS	CONSERVATION STRATEGY
Tilted base	Reset base with marker plumb
TREATMENT	
Treatment Dates 8/5/2015	
<div>1. Area excavated to an appropriate depth removing any roots or large stones.</div> <div>2. Base inspected and found to be sound and re-useable</div> <div>3. Base is aligned with adjacent markers and re-set level.</div> <div>4. Area around base was backfilled with tamped gravel and re-graded with existing topsoil</div> <div>5. Debris removed from setting slot. When required, power grinders were used to facilitate removal of stone fragments.</div> <div>6. When required, the lower setting edge was re-squared by power grinder with minimal loss.</div> <div>7. Marker reset plumb and level into setting slot with cement/lime grout (3/2/9) with 000 sand made fluid with a super plasticizer.</div> <div>8. Excess grout removed and joint area cleaned.</div> <div>9. Marker braced for a minimum 3 days</div>

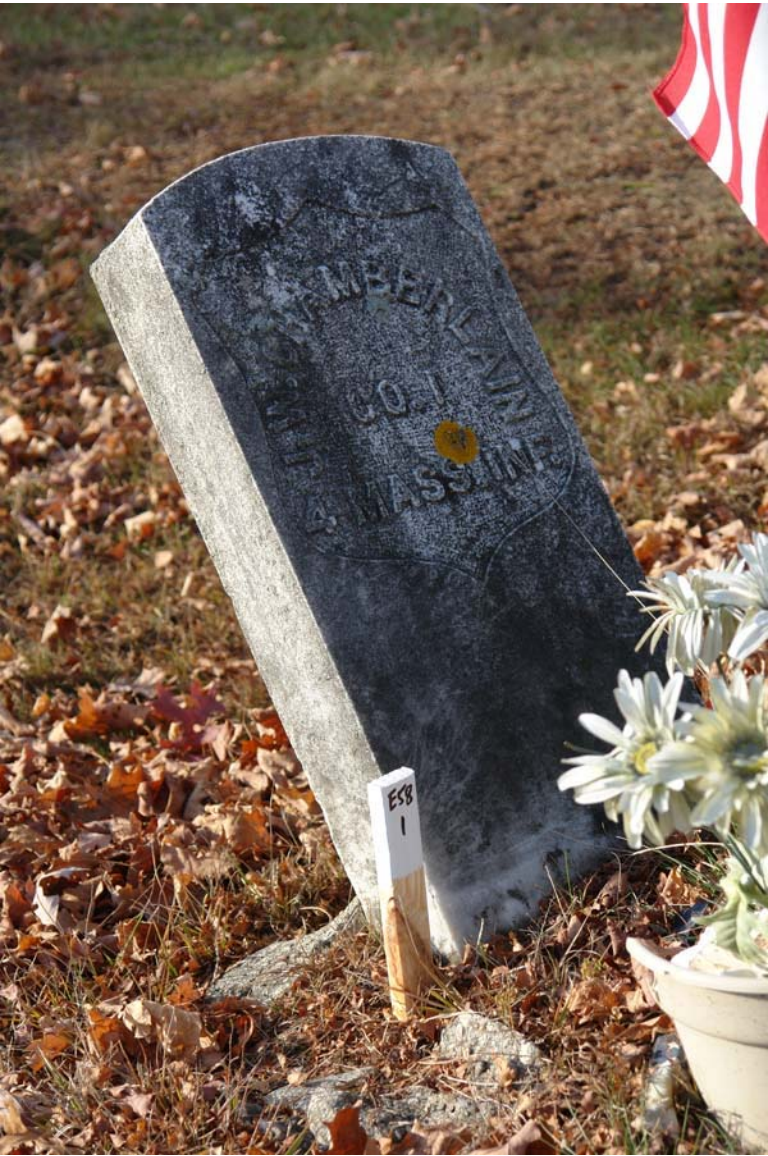
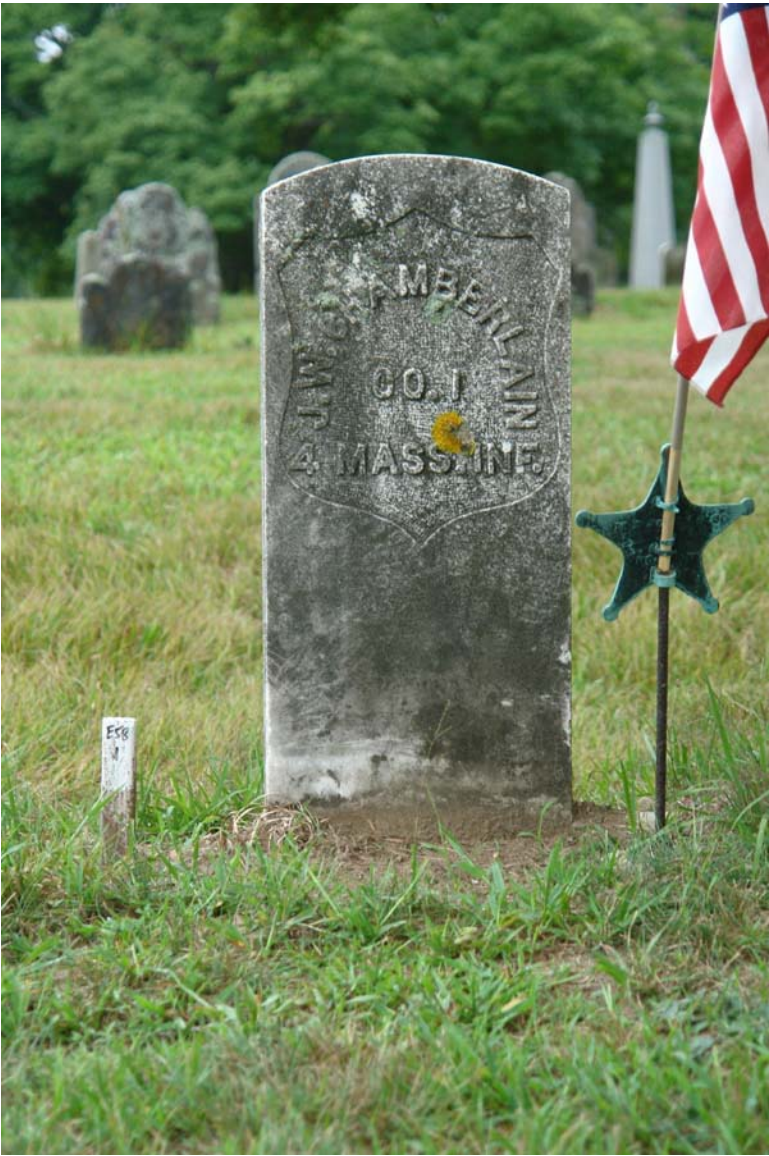
Hanover Center Cemetery, Hanover MA
NAME ON MARKER **J. W. Chamberlain**
Death Date: n.a. Marker Type: Headstone/conc.base
Cond. of Inscription: Legible Material: Marble

EXISTING CONDITIONS	CONSERVATION STRATEGY
Tilted base	Reset base with marker plumb

TREATMENT	Treatment Dates
1. Elements removed from setting bases and inspected for soundness. 2. Area excavated to an appropriate depth removing any roots or large stones. 3. Base is aligned with adjacent markers and re-set level. 4. Area around base was backfilled with tamped gravel and re-graded with existing topsoil 5. Failed mortar removed from setting area and bottom of marker 6. When required, any existing pins were inspected, and if necessary, replaced with stainless steel threaded pins 7. Setting surfaces primed with Acryl 60 diluted 1:3 with water. 8. Marker reset plumb onto base with cement/lime mortar (3/2/9) with 000 sand. 9. Excess grout removed and joint area cleaned.	7/23/2015

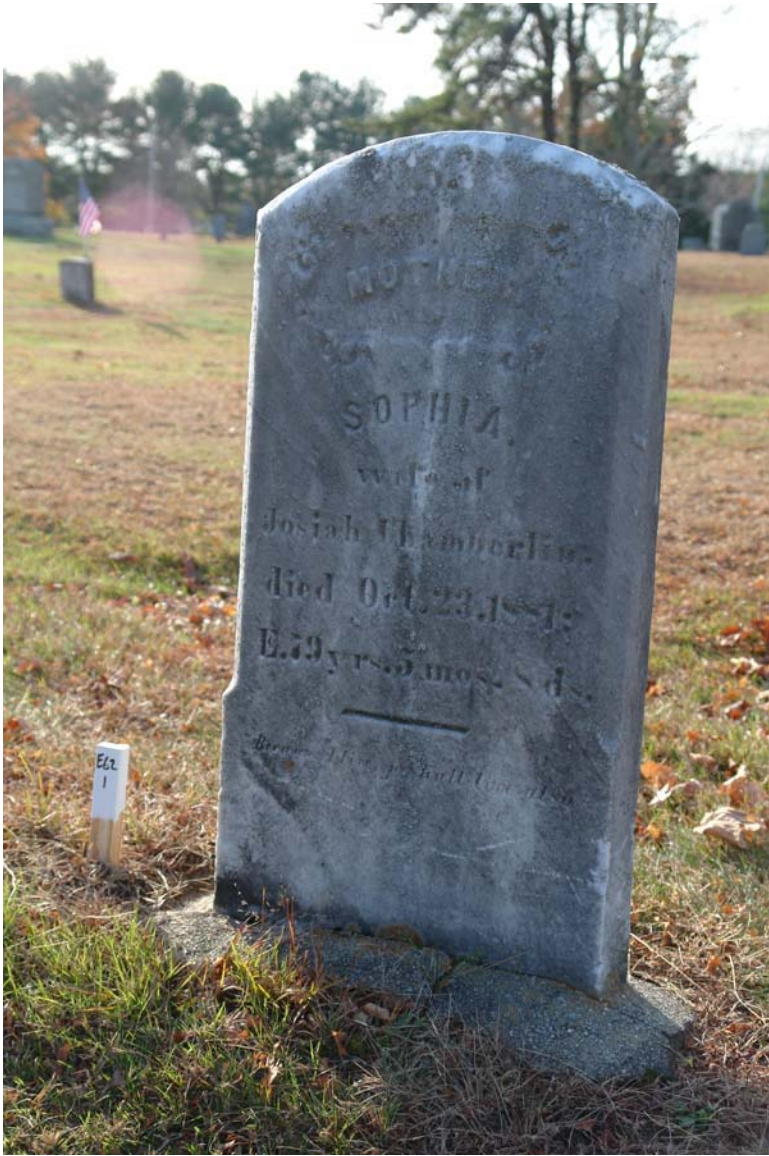
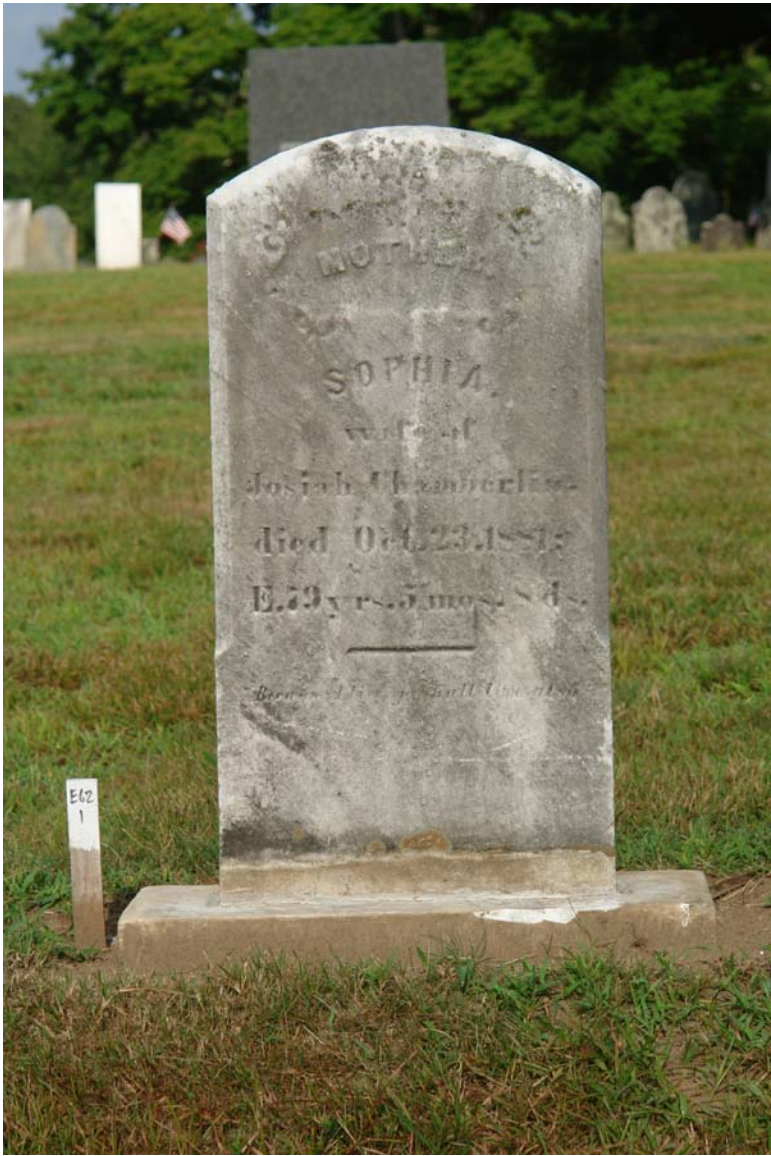
Hanover Center Cemetery, Hanover MA
NAME ON MARKER **Sophia Chamberlain**
Death Date: 10/23/1881 Marker Type: Headstone/conc.base
Cond. of Inscription: Legible Material: Marble

EXISTING CONDITIONS	CONSERVATION STRATEGY
Tilted base	Reset base with marker plumb

TREATMENT	Treatment Dates 8/4/2015
<div>1. Area excavated to an appropriate depth removing any roots or large stones.</div> <div>2. Base inspected and found to be sound and re-useable</div> <div>3. Base is aligned with adjacent markers and re-set level.</div> <div>4. Area around base was backfilled with tamped gravel and re-graded with existing topsoil</div> <div>5. Debris removed from setting slot. When required, power grinders were used to facilitate removal of stone fragments.</div> <div>6. When required, the lower setting edge was re-squared by power grinder with minimal loss.</div> <div>7. Marker reset plumb and level into setting slot with cement/lime grout (3/2/9) with 000 sand made fluid with a super plasticizer.</div> <div>8. Excess grout removed and joint area cleaned.</div> <div>9. Marker braced for a minimum 3 days</div>

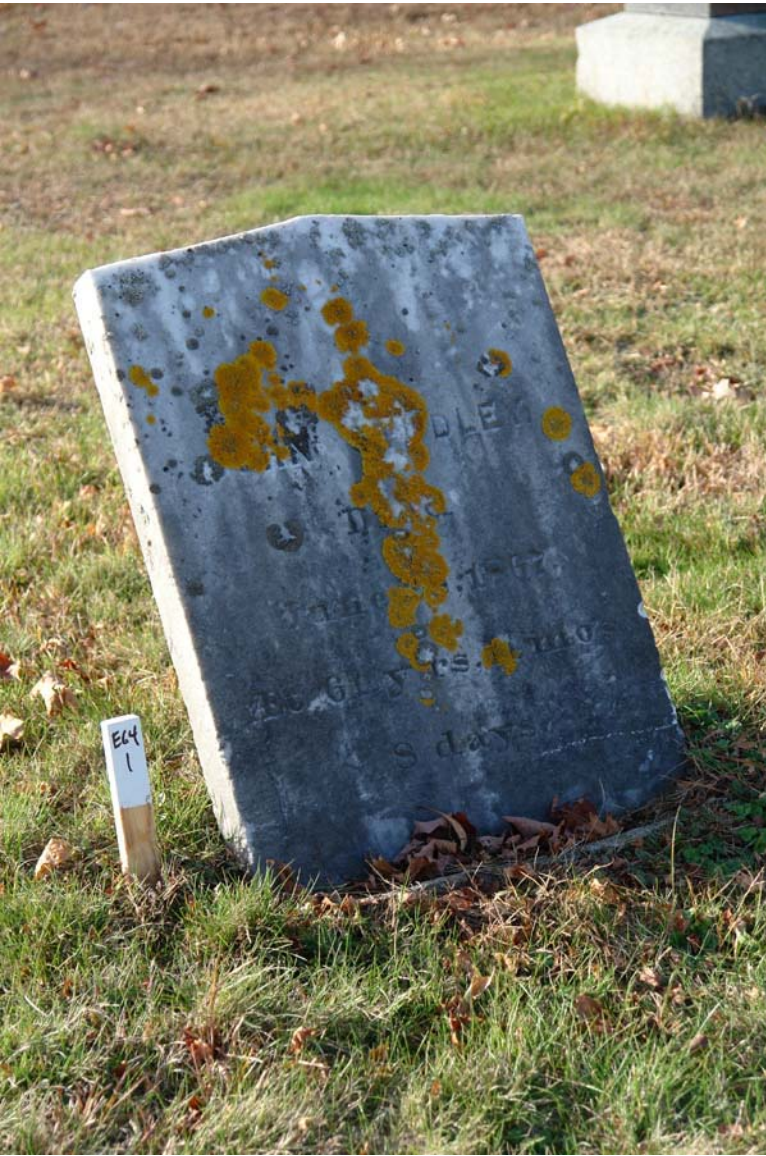
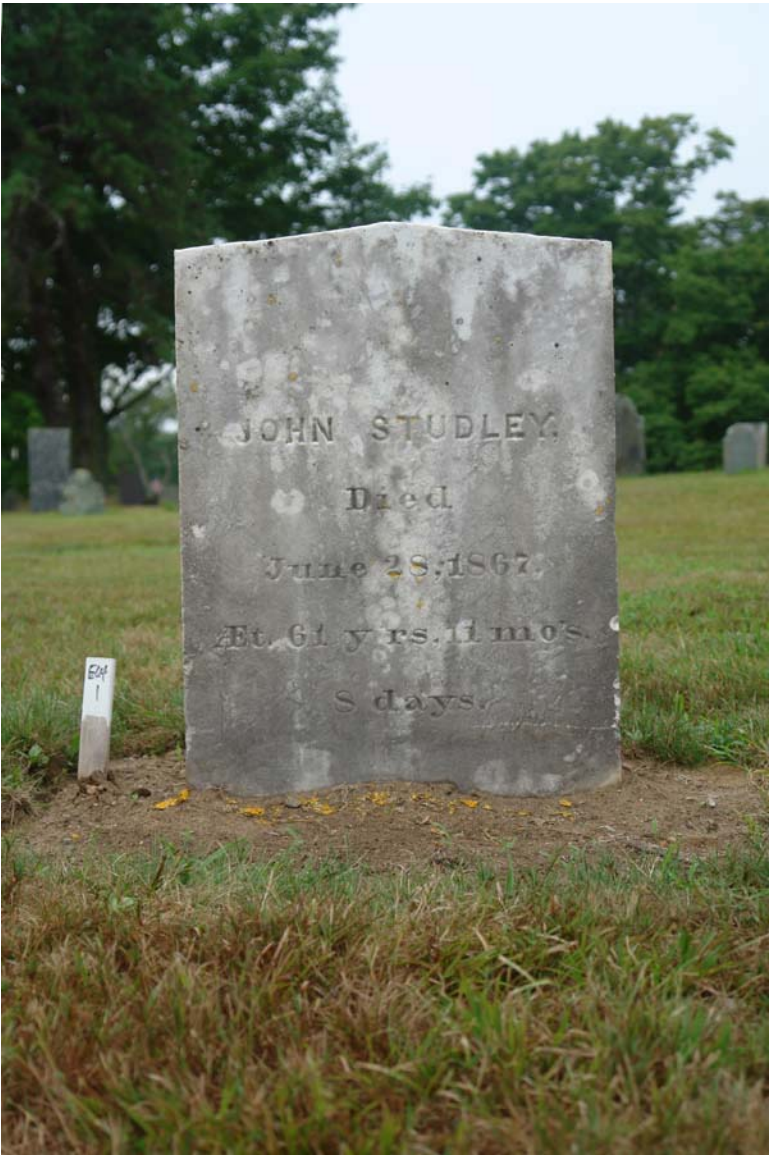
Hanover Center Cemetery, Hanover MA
NAME ON MARKER **John Studley**
Death Date: 6/28/1867 Marker Type: Headstone/conc.base
Cond. of Inscription: Legible Material: Marble

EXISTING CONDITIONS	CONSERVATION STRATEGY
Tilted base	Reset base with marker plumb

TREATMENT	Treatment Dates
	7/30-31/2015
1. Marker excavated and found to be sound. Light soiling removed by brushing with nylon brushes and water.	
2. Setting area excavated for new below grade cast concrete base sized minimum of 12 inches deep, 12 inches greater in thickness and 6 inches wider than the stone.	
3. Wooden forms and setting slot form stabilized and aligned with adjacent markers before concrete is poured	
4. When required, the lower edge of marker is re-squared with minimal loss using a power grinder	
5. Setting forms are removed after partial curing of the concrete and the base backfilled with tamped sand or gravel	
6. Marker reset into setting slot with a cement/lime grout (3/2/9) with 000 sand made fluid with a super plasticizer.	
7. Marker set plumb and level, and braced for minimum of 5 days.	
8. Disturbed areas backfilled with existing topsoil.

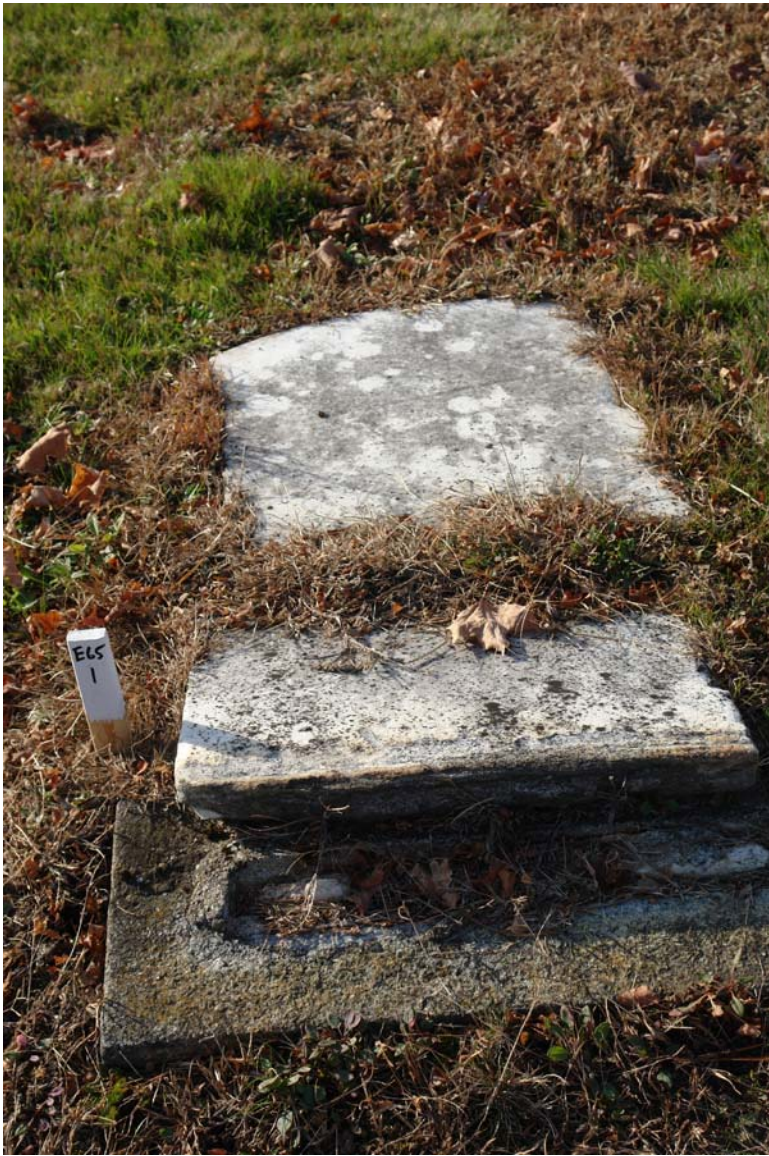
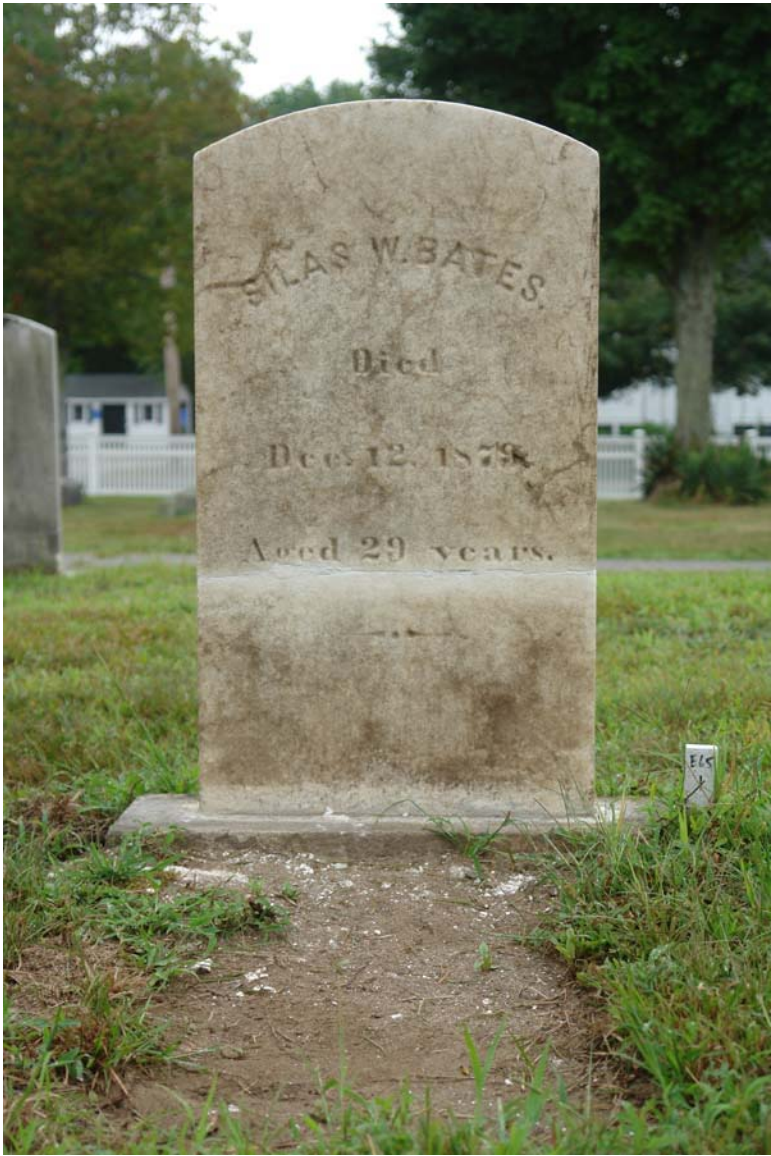
NAME ON MARKER **Silas Bates**

EXISTING CONDITIONS	CONSERVATION STRATEGY
Fallen Fractured	Reset base level Reset marker into setting slot. Attach fragments with structural adhesive

TREATMENT	Treatment Dates
1. Area excavated to an appropriate depth. Base is aligned with adj. markers and reset level at appropriate height. 2. Setting slot cleaned of debris or failed mortar and bottom fragment reset plumb and level into setting slot with a cement/lime grout (3/2/9) with 000 sand made fluid with a super plasticizer. Excess grout removed and joint area cleaned. 3. Marker braced for a minimum 3 days 4. All mating edges of fragments cleaned with water and any failed adhesives removed with hand tools 5. Fragments attached with structural adhesive (Abatron 55-22), clamped and braced until cured. Excess epoxy removed with hand chisels within 24 hours. 6. Cracks and losses filled with RepliCal Marble products, filled areas misted with water and covered for 3 days minimum 7. Filled areas treated with light acid wash and rinsed thoroughly.	8/4-12/2015

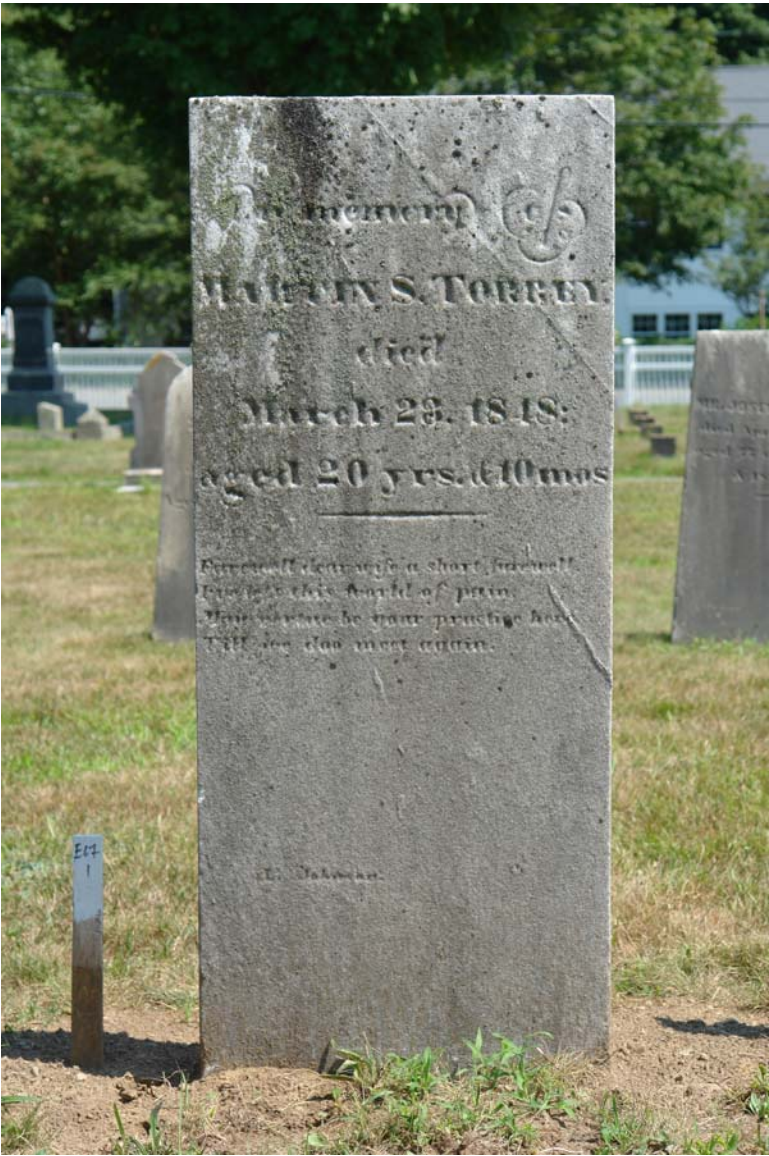
Hanover Center Cemetery, Hanover MA	
NAME ON MARKER	Martin Torrey
Death Date: 3/23/1848	Marker Type: Headstone/base
Cond. of Inscription: Legible	Material: Marble
EXISTING CONDITIONS	CONSERVATION STRATEGY
Tilted	Reset plumb
TREATMENT	
Treatment Dates 8/4/2015	
<div>1. Existing base located below grade while excavating for resetting. Area excavated to an appropriate depth removing any roots or large stones.</div> <div>2. Base inspected and found to be sound and re-useable</div> <div>3. Base is aligned with adjacent markers and re-set level.</div> <div>4. Area around base was backfilled with tamped gravel and re-graded with existing topsoil</div> <div>5. Debris removed from setting slot. When required, power grinders were used to facilitate removal of stone fragments.</div> <div>6. When required, the lower setting edge was re-squared by power grinder with minimal loss.</div> <div>7. Marker reset plumb and level into setting slot with cement/lime grout (3/2/9) with 000 sand made fluid with a super plasticizer.</div> <div>8. Excess grout removed and joint area cleaned.</div> <div>9. Marker braced for a minimum 3 days</div>
