MONUMENT CONSERVATION COLLABORATIVE LLC, NORFOLK, CT

DOCUMENTATION OF STONE CONSERVATION TREATMENTS TO ASSINIPPI CEMETERY, HANOVER, MA June 2015

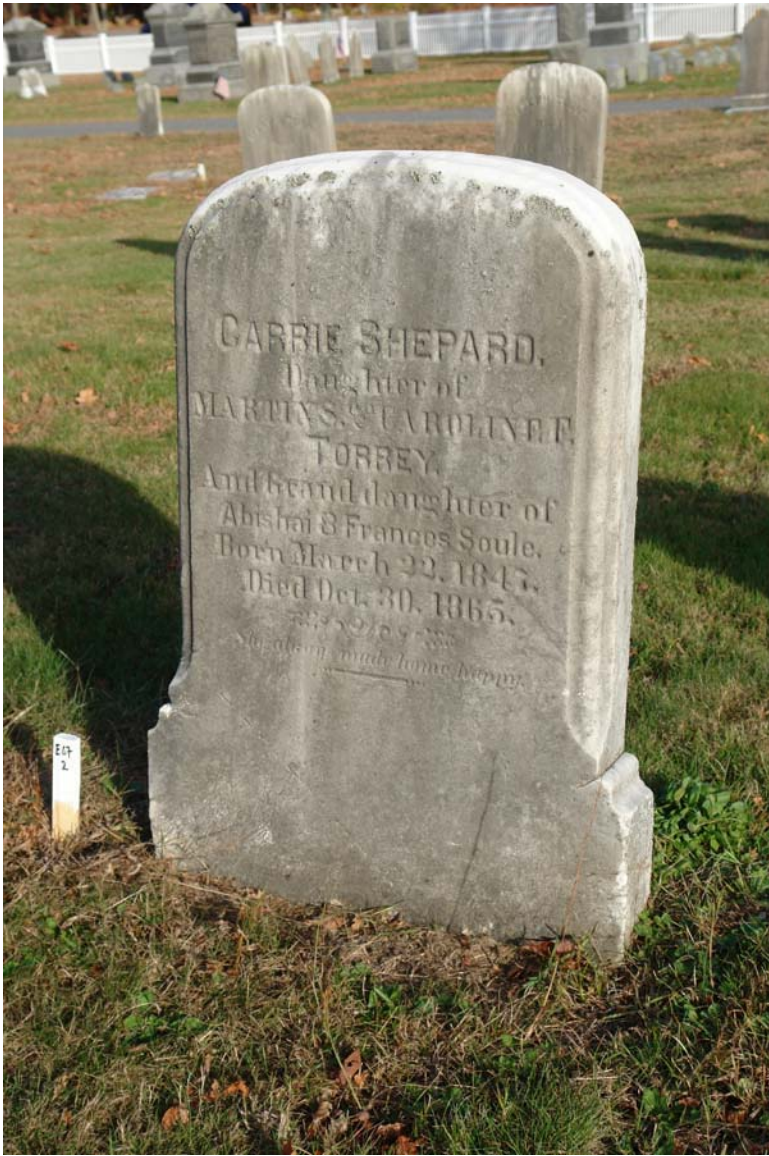
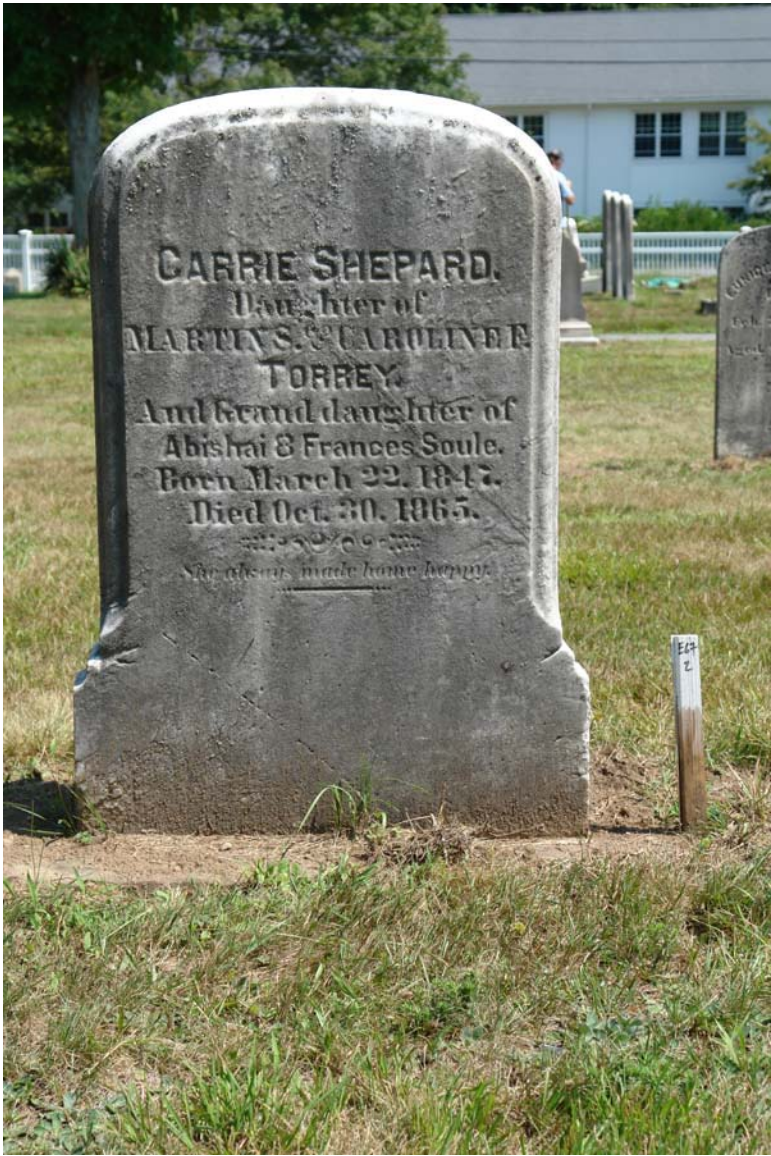
Hanover Center Cemetery, Hanover MA	
NAME ON MARKER	
Carrie Torrey	
Death Date:	10/20/1865
Marker Type:	Headstone/base
Cond. of Inscription:	Legible
Material:	Marble
EXISTING CONDITIONS	CONSERVATION STRATEGY
Tilted base	Reset base with marker plumb
TREATMENT	
Treatment Dates 8/4/2015

1. Elements removed from setting bases and inspected for soundness.	
2. Area excavated to an appropriate depth removing any roots or large stones.	
3. Base is aligned with adjacent markers and re-set level.

4. Area around base was backfilled with tamped gravel and re-graded with existing topsoil	
5. Failed mortar removed from setting area and bottom of marker

6. When required, any existing pins were inspected, and if necessary, replaced with stainless steel threaded pins	
7. Setting surfaces primed with Acryl 60 diluted 1:3 with water.

8. Marker reset plumb onto base with cement/lime mortar (3/2/9) with 000 sand.	
9. Excess grout removed and joint area cleaned.

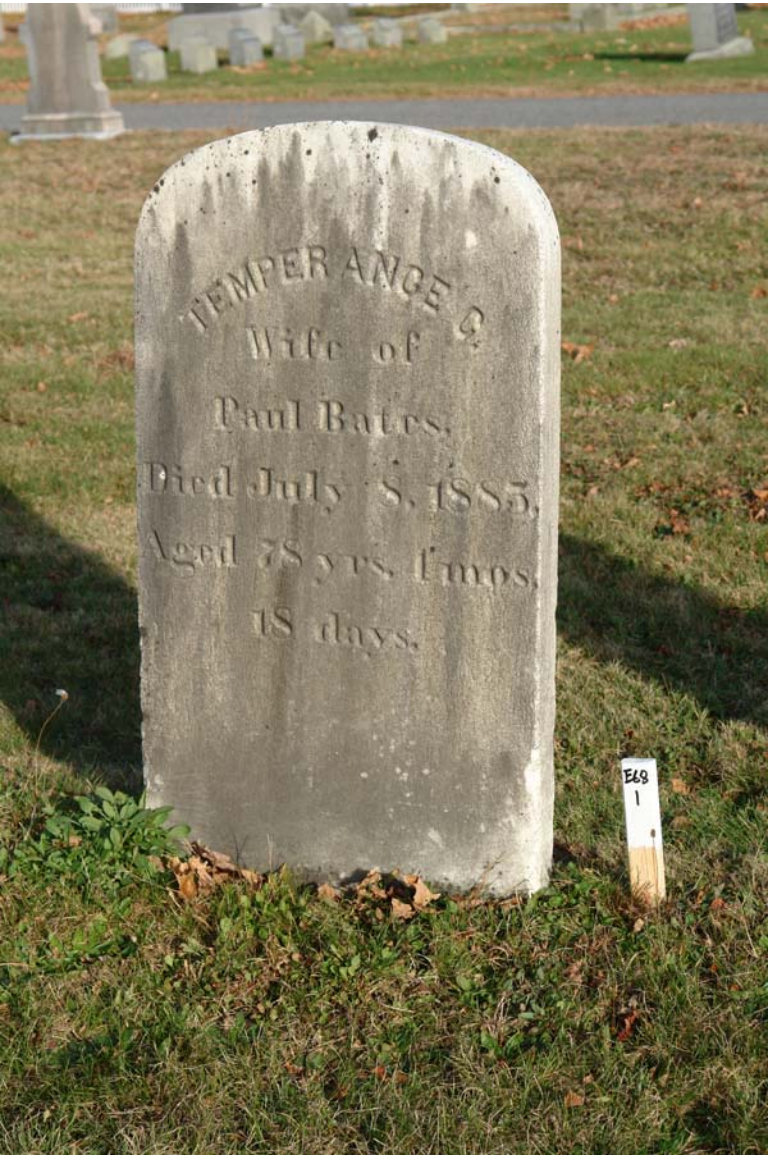
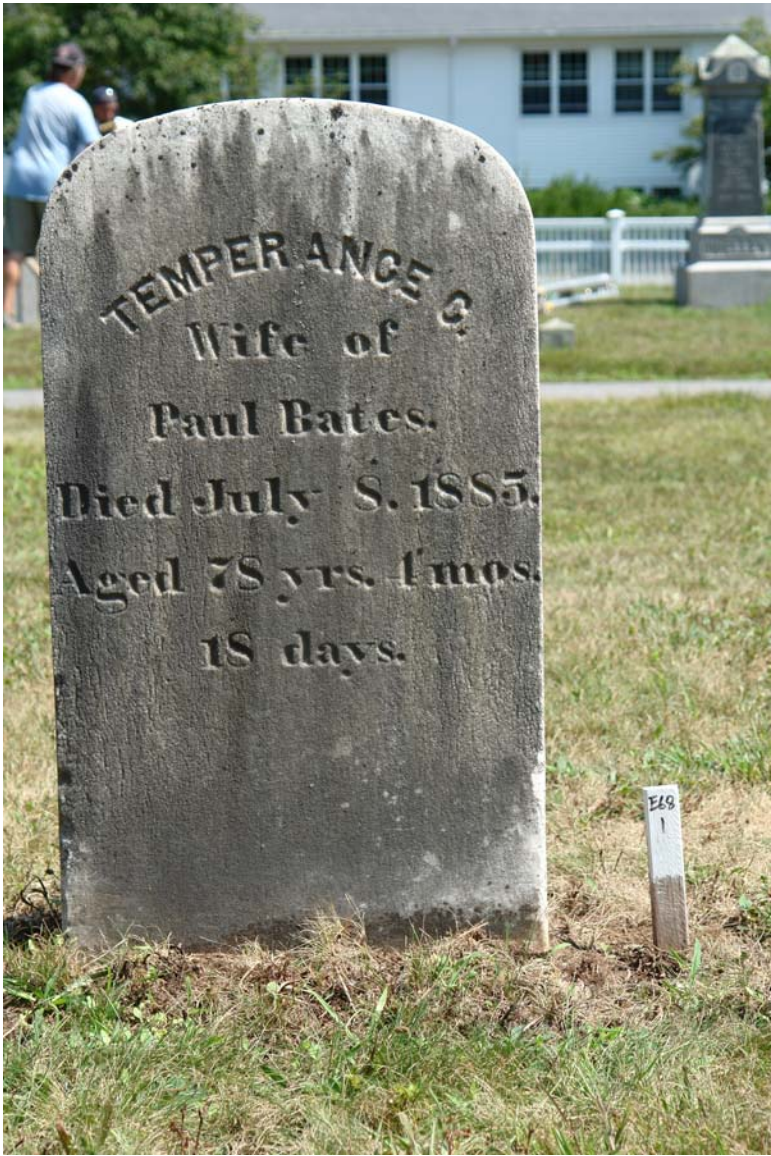
Hanover Center Cemetery, Hanover MA	
NAME ON MARKER	Temperance Bates
Death Date: 7/8/1885	Marker Type: Headstone
Cond. of Inscription: Legible	Material: Marble
EXISTING CONDITIONS	CONSERVATION STRATEGY
Tilted	Reset plumb
TREATMENT	
Treatment Dates 8/3/2015	
<div>1. Existing base located below grade while excavating for resetting. Area excavated to an appropriate depth removing any roots or large stones.</div> <div>2. Base inspected and found to be sound and re-useable</div> <div>3. Base is aligned with adjacent markers and re-set level.</div> <div>4. Area around base was backfilled with tamped gravel and re-graded with existing topsoil</div> <div>5. Debris removed from setting slot. When required, power grinders were used to facilitate removal of stone fragments.</div> <div>6. When required, the lower setting edge was re-squared by power grinder with minimal loss.</div> <div>7. Marker reset plumb and level into setting slot with cement/lime grout (3/2/9) with 000 sand made fluid with a super plasticizer.</div> <div>8. Excess grout removed and joint area cleaned.</div> <div>9. Marker braced for a minimum 3 days</div>

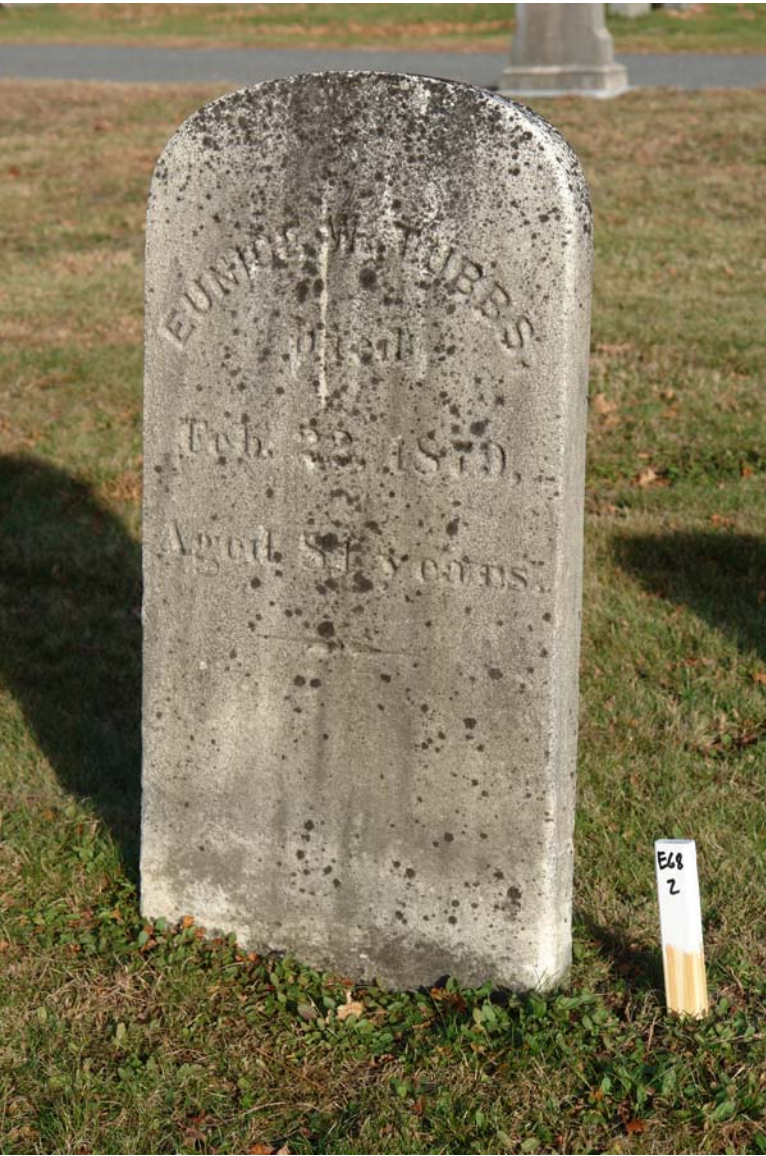
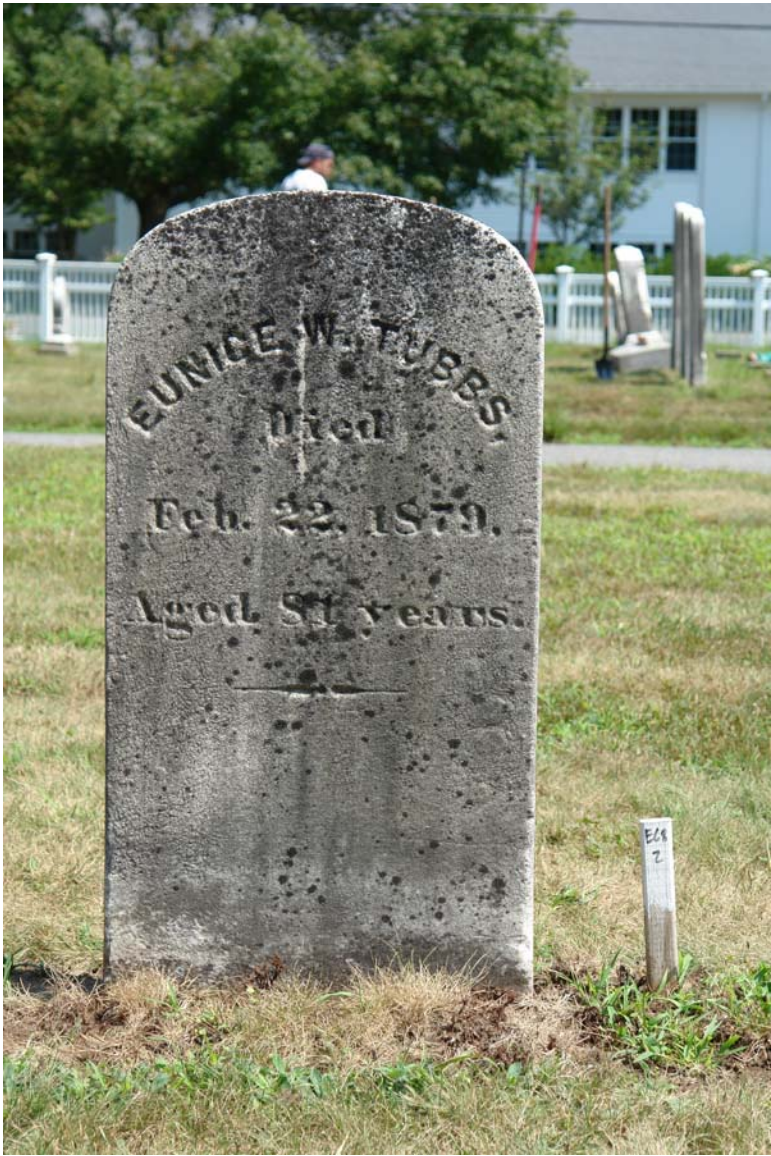
Hanover Center Cemetery, Hanover MA
NAME ON MARKER **Eunice Tubbs**
Death Date: 2/22/1879 Marker Type: Headstone/conc.base
Cond. of Inscription: Legible Material: Marble

EXISTING CONDITIONS	CONSERVATION STRATEGY
Tilted	Reset plumb

TREATMENT	Treatment Dates 8/3/2015
<div>1. Existing base located below grade while excavating for resetting. Area excavated to an appropriate depth removing any roots or large stones.</div> <div>2. Base inspected and found to be sound and re-useable</div> <div>3. Base is aligned with adjacent markers and re-set level.</div> <div>4. Area around base was backfilled with tamped gravel and re-graded with existing topsoil</div> <div>5. Debris removed from setting slot. When required, power grinders were used to facilitate removal of stone fragments.</div> <div>6. When required, the lower setting edge was re-squared by power grinder with minimal loss.</div> <div>7. Marker reset plumb and level into setting slot with cement/lime grout (3/2/9) with 000 sand made fluid with a super plasticizer.</div> <div>8. Excess grout removed and joint area cleaned.</div> <div>9. Marker braced for a minimum 3 days</div>

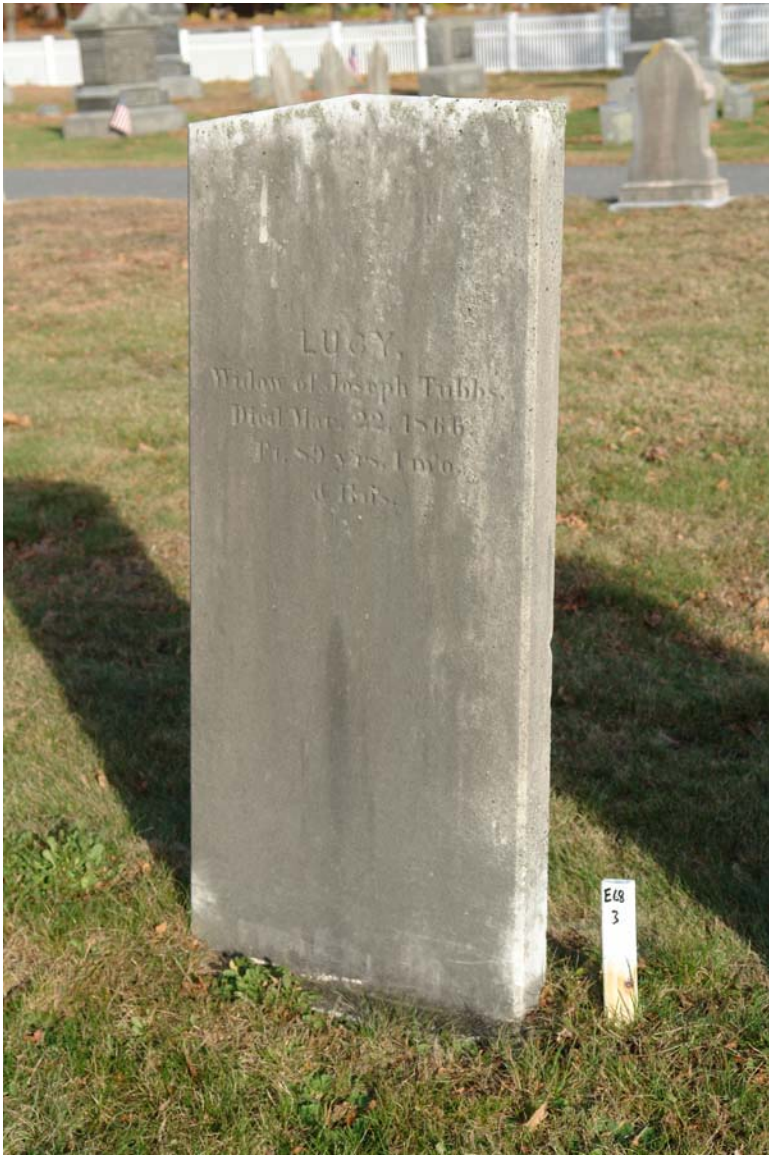
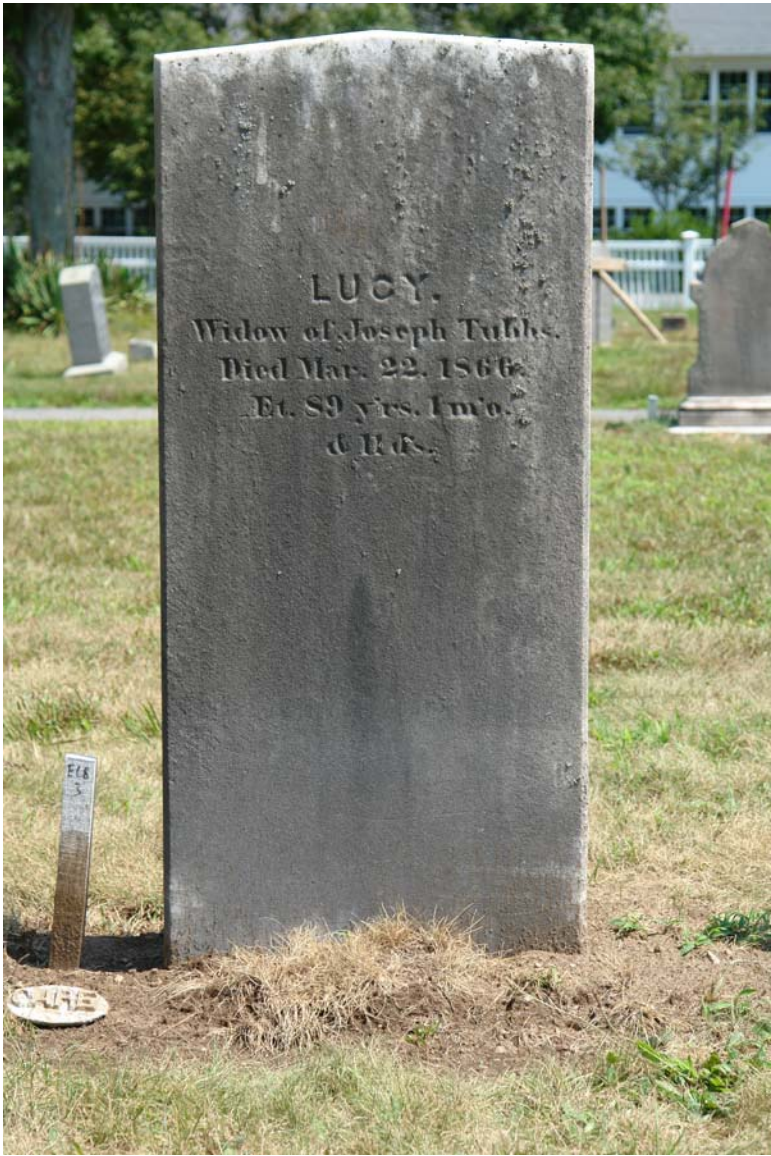
Hanover Center Cemetery, Hanover MA
NAME ON MARKER **Lucy Tubbs**
Death Date: 3/22/1866 Marker Type: Headstone/conc.base
Cond. of Inscription: Legible Material: Marble

EXISTING CONDITIONS	CONSERVATION STRATEGY
Tilted	Reset plumb

TREATMENT	Treatment Dates
8/4/2015	
<div>1. Existing base located below grade while excavating for resetting. Area excavated to an appropriate depth removing any roots or large stones.</div> <div>2. Base inspected and found to be sound and re-useable</div> <div>3. Base is aligned with adjacent markers and re-set level.</div> <div>4. Area around base was backfilled with tamped gravel and re-graded with existing topsoil</div> <div>5. Debris removed from setting slot. When required, power grinders were used to facilitate removal of stone fragments.</div> <div>6. When required, the lower setting edge was re-squared by power grinder with minimal loss.</div> <div>7. Marker reset plumb and level into setting slot with cement/lime grout (3/2/9) with 000 sand made fluid with a super plasticizer.</div> <div>8. Excess grout removed and joint area cleaned.</div> <div>9. Marker braced for a minimum 3 days</div>

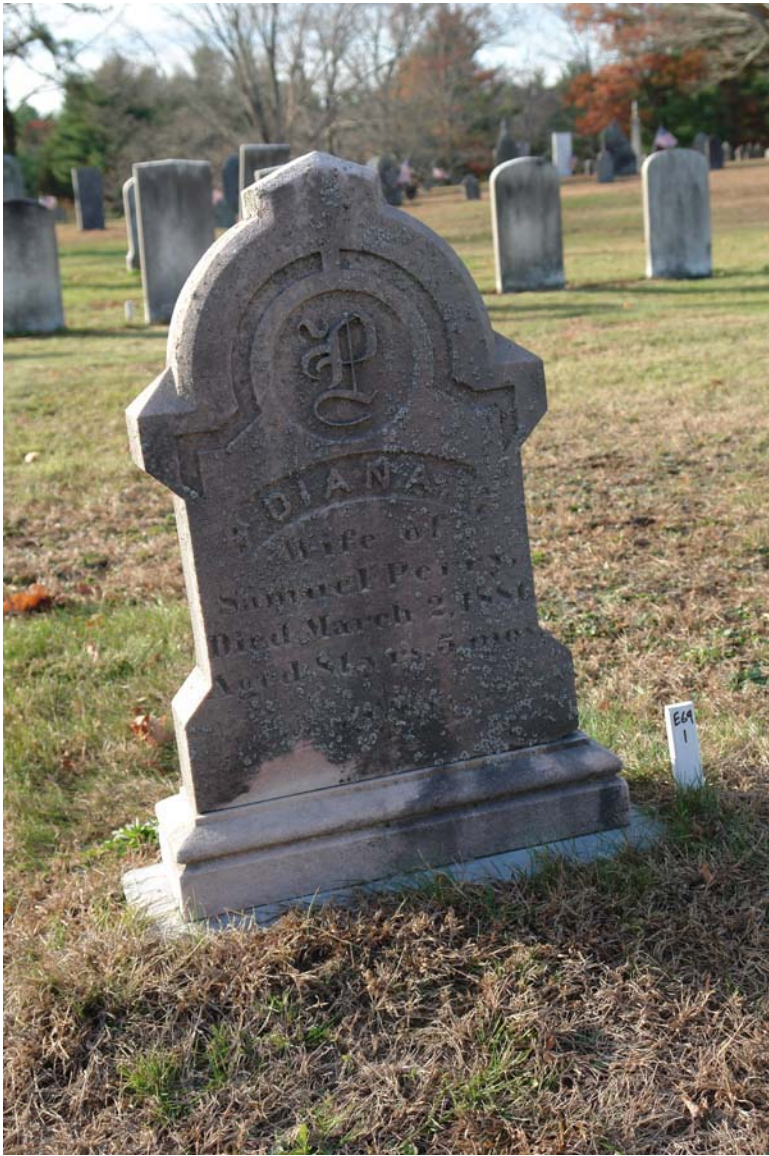
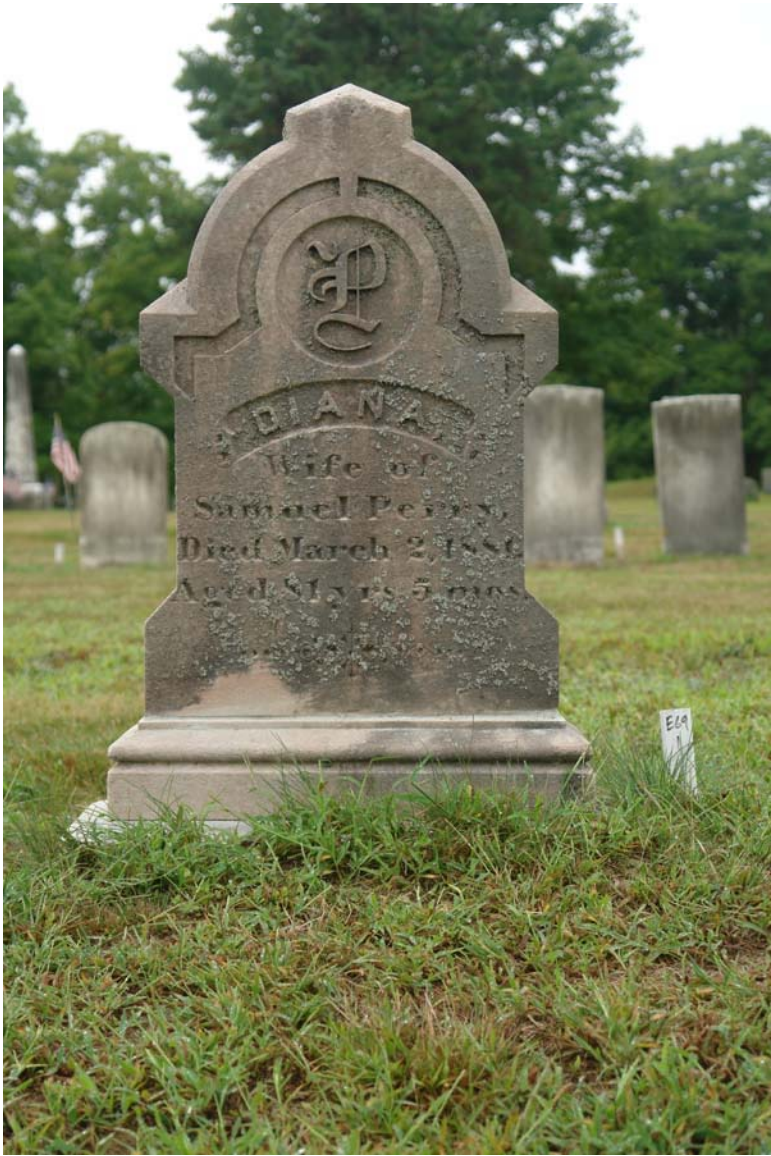
NAME ON MARKER **Diana Perry**

EXISTING CONDITIONS	CONSERVATION STRATEGY
Tilted Loose on base	Reset base level Reset elements

TREATMENT	Treatment Dates 8/4/2015
<div>1. Elements removed from setting bases and inspected for soundness.</div> <div>2. Area excavated to an appropriate depth removing any roots or large stones.</div> <div>3. Base is aligned with adjacent markers and re-set level.</div> <div>4. Area around base was backfilled with tamped gravel and re-graded with existing topsoil</div> <div>5. Failed mortar removed from setting area and bottom of marker</div> <div>6. When required, any existing pins were inspected, and if necessary, replaced with stainless steel threaded pins</div> <div>7. Setting surfaces primed with Acryl 60 diluted 1:3 with water.</div> <div>8. Marker reset plumb onto base with cement/lime mortar (3/2/9) with 000 sand.</div> <div>9. Excess grout removed and joint area cleaned.</div> <div>9. Remove excess mortar from joints.</div>

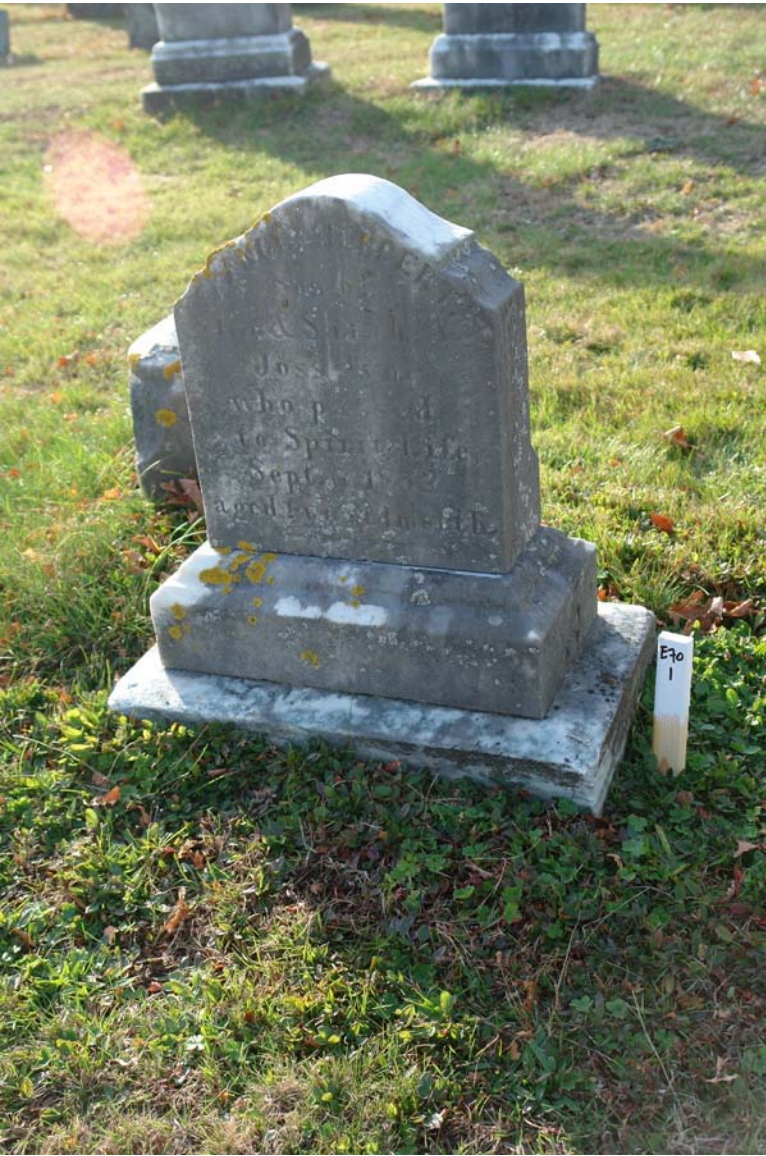
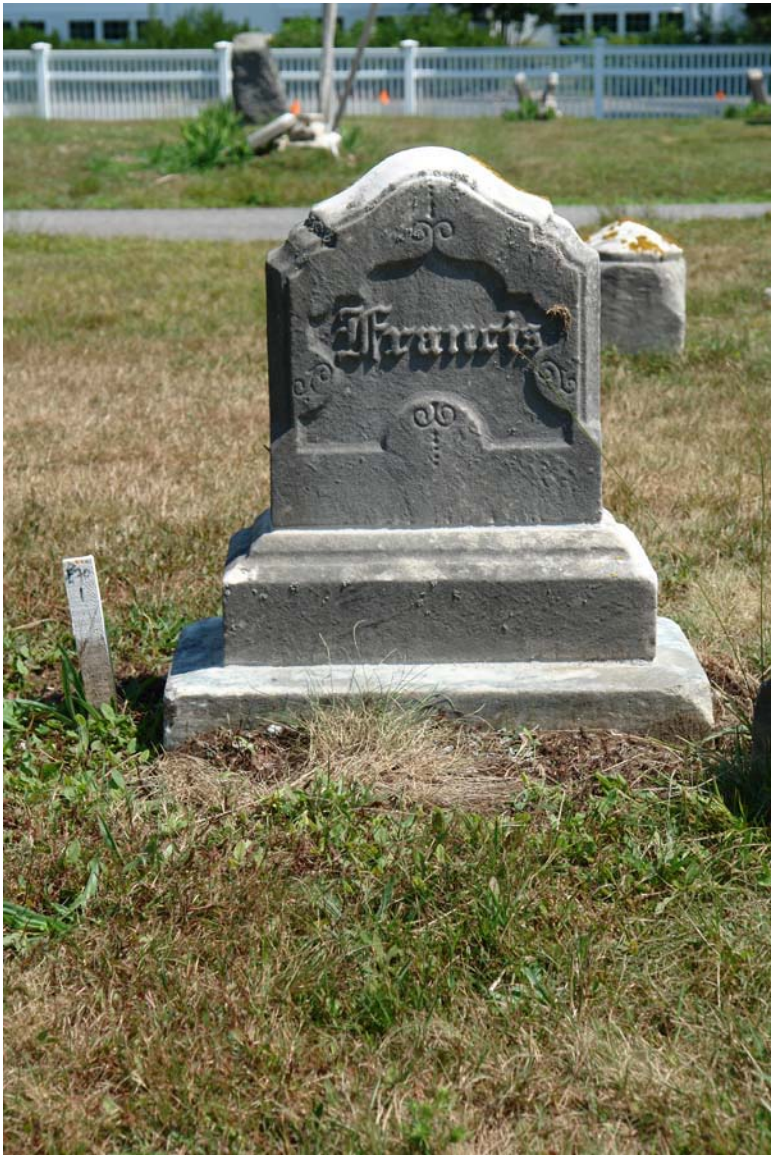
Hanover Center Cemetery, Hanover MA
NAME ON MARKER **Francis Josselyn**
Death Date: 9/7/1852 Marker Type: Headstone/pinned base
Cond. of Inscription: Legible Material: Marble

EXISTING CONDITIONS	CONSERVATION STRATEGY
Tilted Loose on base	Reset base level Reset elements

TREATMENT	Treatment Dates
1. Elements removed from setting bases and inspected for soundness. 2. Area excavated to an appropriate depth removing any roots or large stones. 3. Base is aligned with adjacent markers and re-set level. 4. Area around base was backfilled with tamped gravel and re-graded with existing topsoil 5. Failed mortar removed from setting area and bottom of marker 6. When required, any existing pins were inspected, and if necessary, replaced with stainless steel threaded pins 7. Setting surfaces primed with Acryl 60 diluted 1:3 with water. 8. Marker reset plumb onto base with cement/lime mortar (3/2/9) with 000 sand. 9. Excess grout removed and joint area cleaned.	8/4/2015

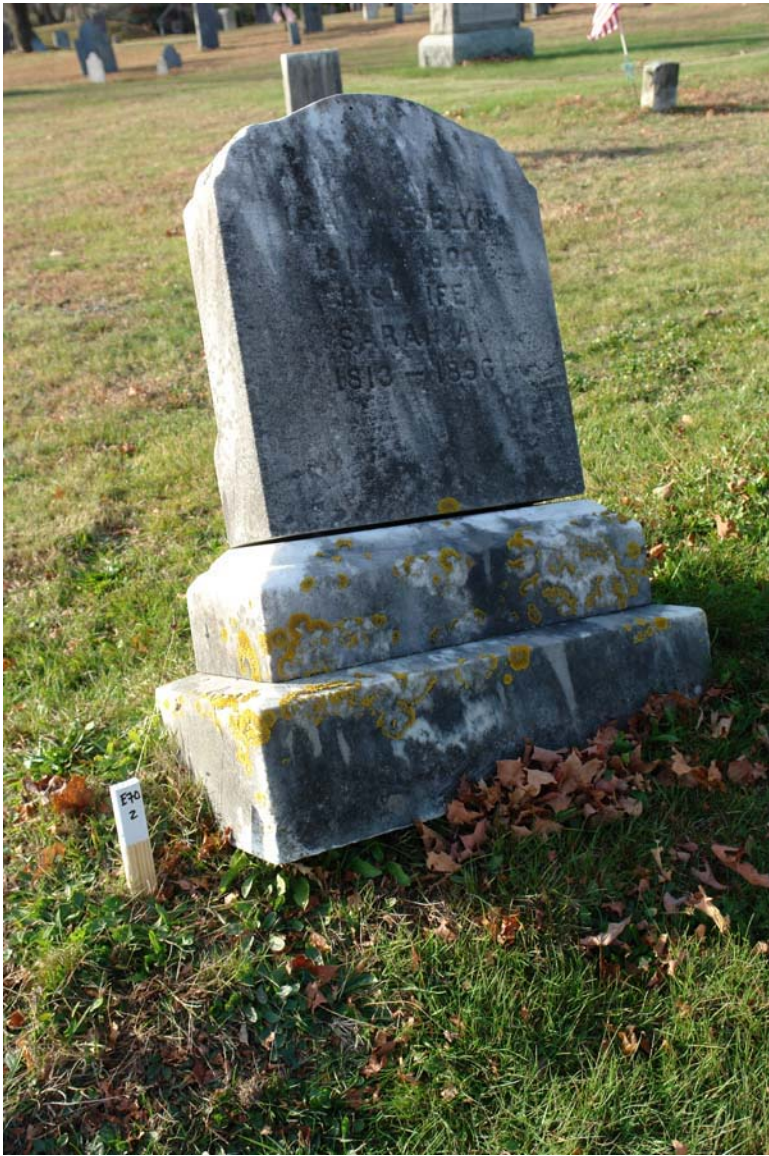
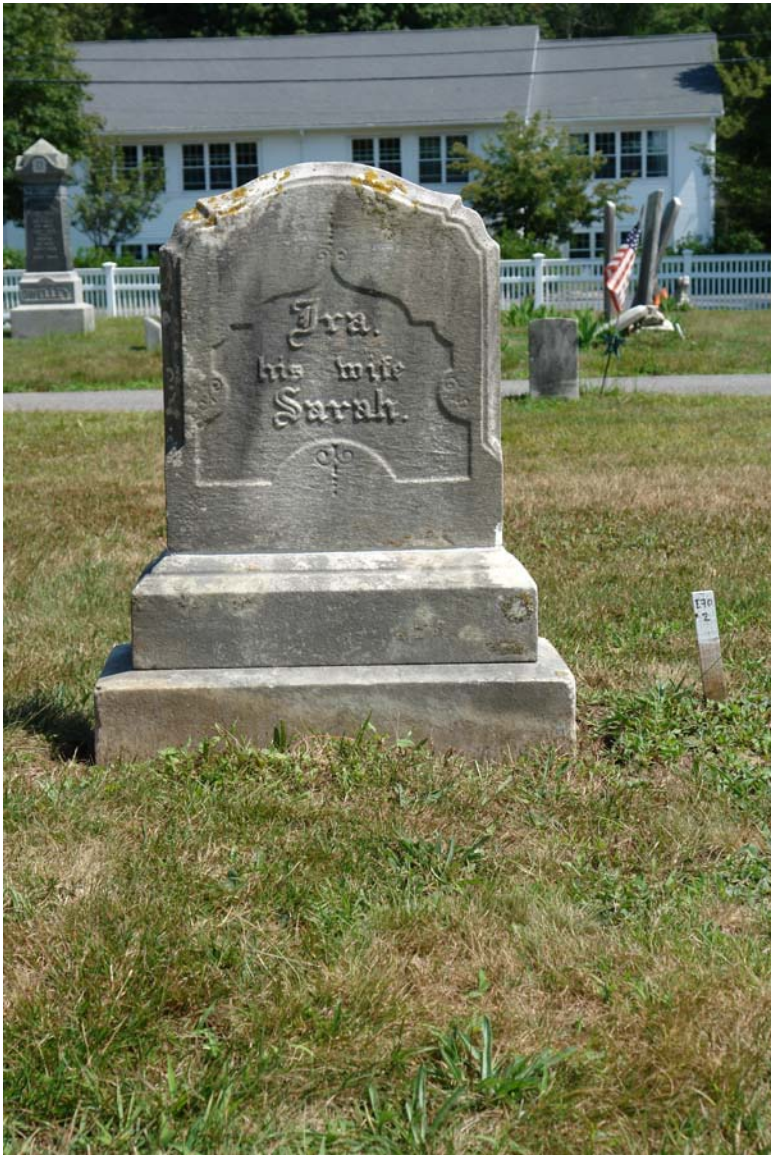
Hanover Center Cemetery, Hanover MA
NAME ON MARKER **Ira and Sarah Josselyn**
Death Date: 1900 Marker Type: Headstone/pinned base
Cond. of Inscription: Legible Material: Marble

EXISTING CONDITIONS	CONSERVATION STRATEGY
Tilted Loose on base	Reset base level Reset elements

TREATMENT	Treatment Dates
1. Elements removed from setting bases and inspected for soundness. 2. Area excavated to an appropriate depth removing any roots or large stones. 3. Base is aligned with adjacent markers and re-set level. 4. Area around base was backfilled with tamped gravel and re-graded with existing topsoil 5. Failed mortar removed from setting area and bottom of marker 6. When required, any existing pins were inspected, and if necessary, replaced with stainless steel threaded pins 7. Setting surfaces primed with Acryl 60 diluted 1:3 with water. 8. Marker reset plumb onto base with cement/lime mortar (3/2/9) with 000 sand. 9. Excess grout removed and joint area cleaned.	8/3-4/2015

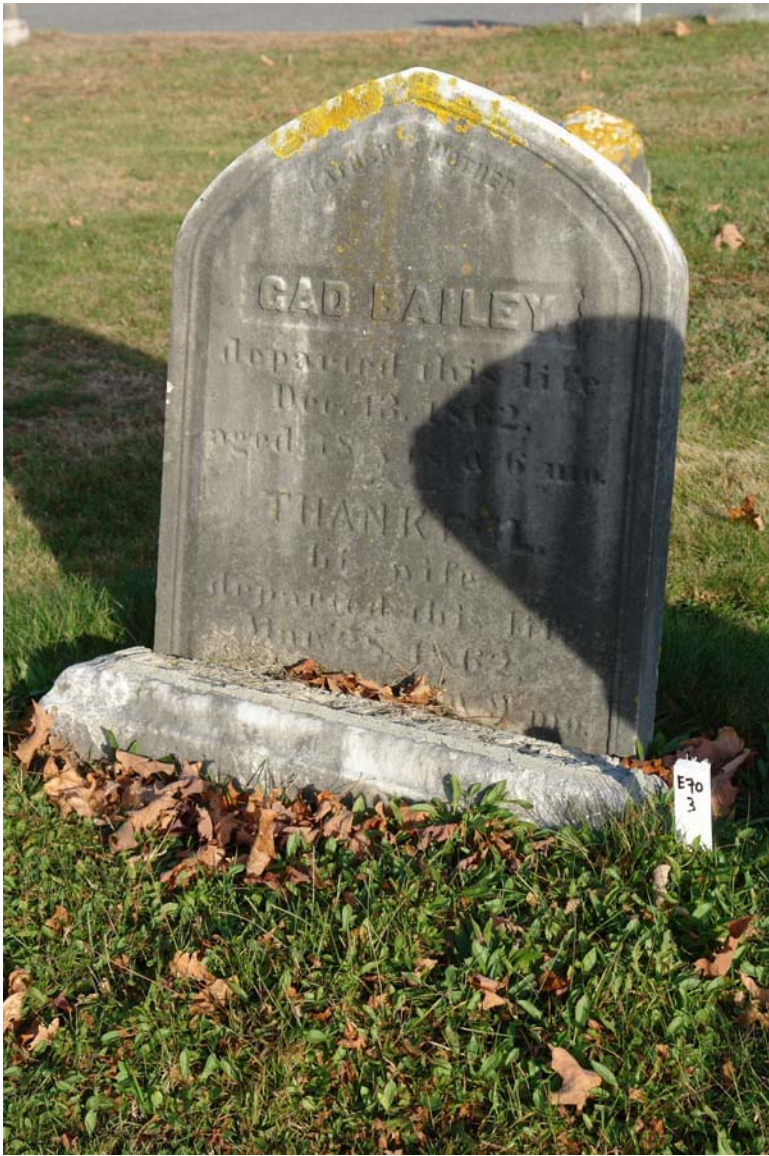
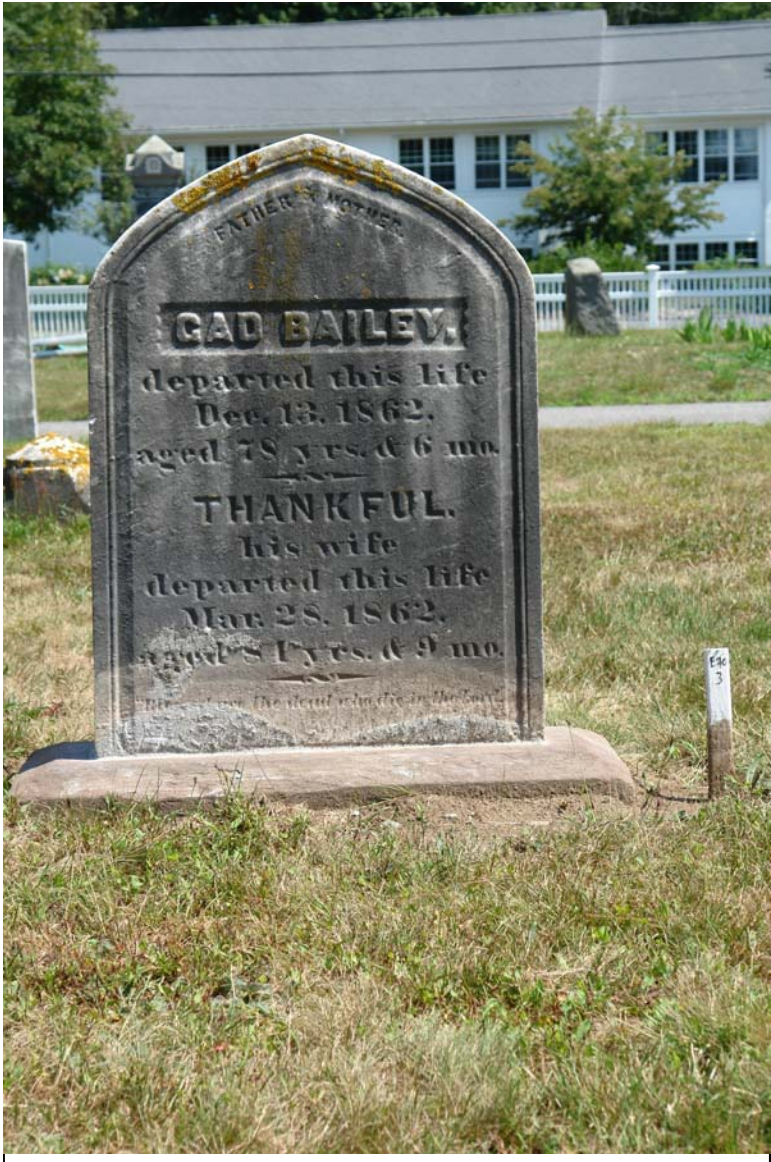
Hanover Center Cemetery, Hanover MA
NAME ON MARKER **Gad and Thankful Bailey**
Death Date: 12/13/1862 Marker Type: Headstone/base
Cond. of Inscription: Legible Material: Marble

EXISTING CONDITIONS	CONSERVATION STRATEGY
Tilted base	Reset base with marker plumb

TREATMENT	Treatment Dates 8/3-4/2015
<div>1. Elements removed from setting bases and inspected for soundness. 2. Area excavated to an appropriate depth removing any roots or large stones. 3. Base is aligned with adjacent markers and re-set level. 4. Area around base was backfilled with tamped gravel and re-graded with existing topsoil 5. Failed mortar removed from setting area and bottom of marker 6. When required, any existing pins were inspected, and if necessary, replaced with stainless steel threaded pins 7. Setting surfaces primed with Acryl 60 diluted 1:3 with water. 8. Marker reset plumb onto base with cement/lime mortar (3/2/9) with 000 sand. 9. Excess grout removed and joint area cleaned.</div>

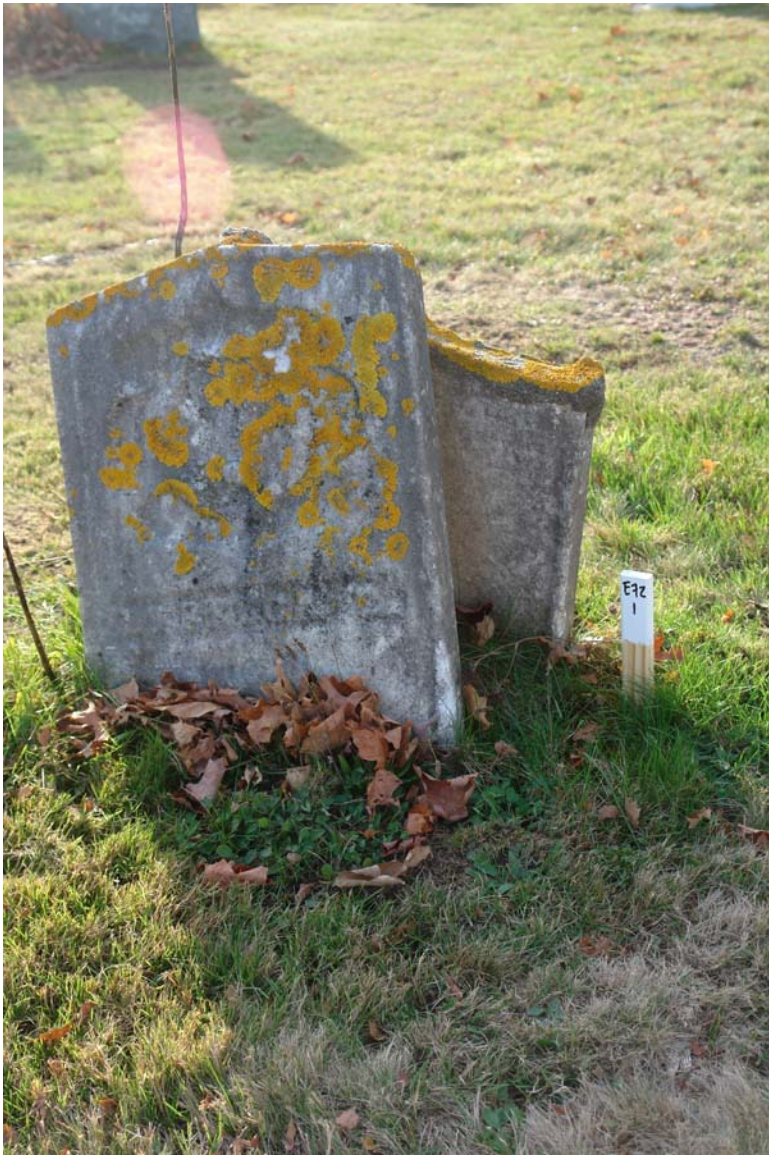
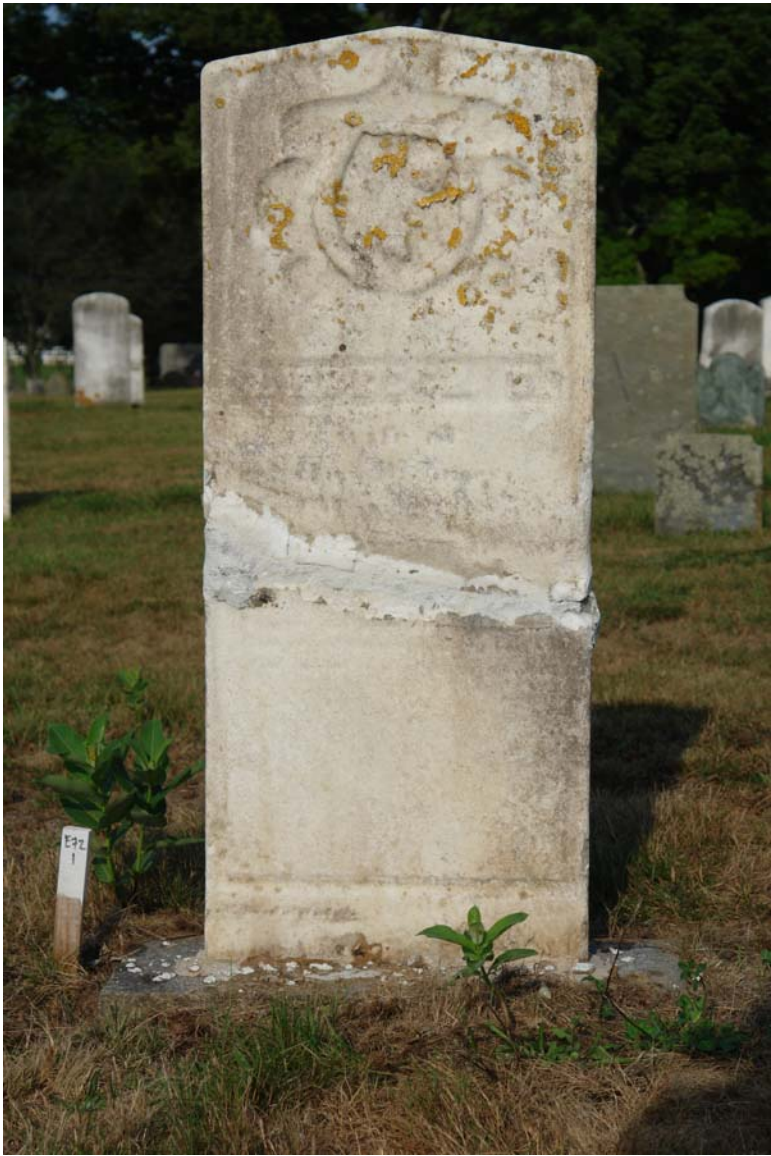
Hanover Center Cemetery, Hanover MA
NAME ON MARKER **Rebecca Jones**
Death Date: 5/13/1853 Marker Type: Headstone/base
Cond. of Inscription: Decipherable Material: Marble

EXISTING CONDITIONS	CONSERVATION STRATEGY
Tilted Fractured	Reset plumb Attach fragments with structural adhesive

TREATMENT	Treatment Dates 7/31-8/31/2015
<p>1. Failed mortar found to be firmly attached to fragments and areas of fracture sugaring. Because of the condition of the marble, losses and amount of old mortar it was determined to leave the mortar and attach the fragments.</p> <p>2. Fractured elements were dry fitted to ascertain final soundness and to check for large losses at mating areas.</p> <p>3. Lower fragment in base reset level</p> <p>4. Partial removal of cement from surface of marker</p> <p>5. Dry fragments attached with structural adhesive (Abatron 55-22), clamped and braced until cured. Excess epoxy removed by hand chisels</p> <p>6. Cracks and voids filled with Jahn cementitious mortar.</p> <p>7. Cement on surface pigmented with Keim silicate paint</p> <p>8. Filled areas misted with water and covered for 3 days minimum</p>

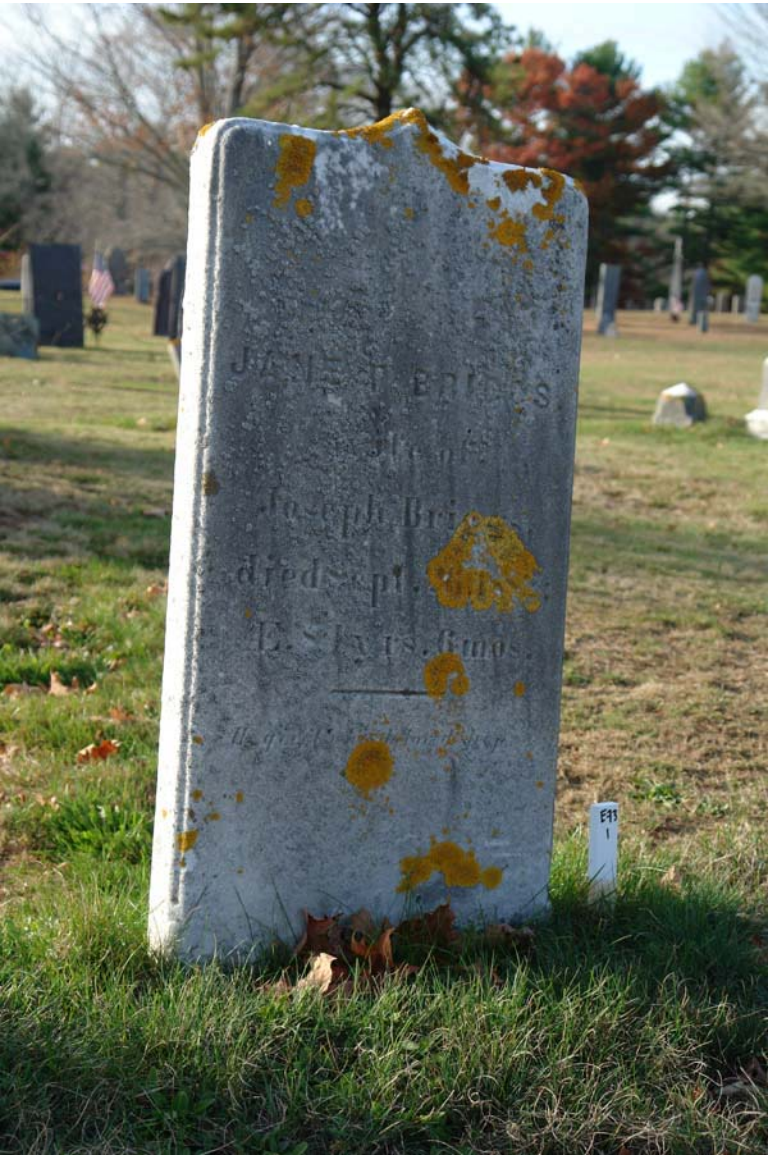
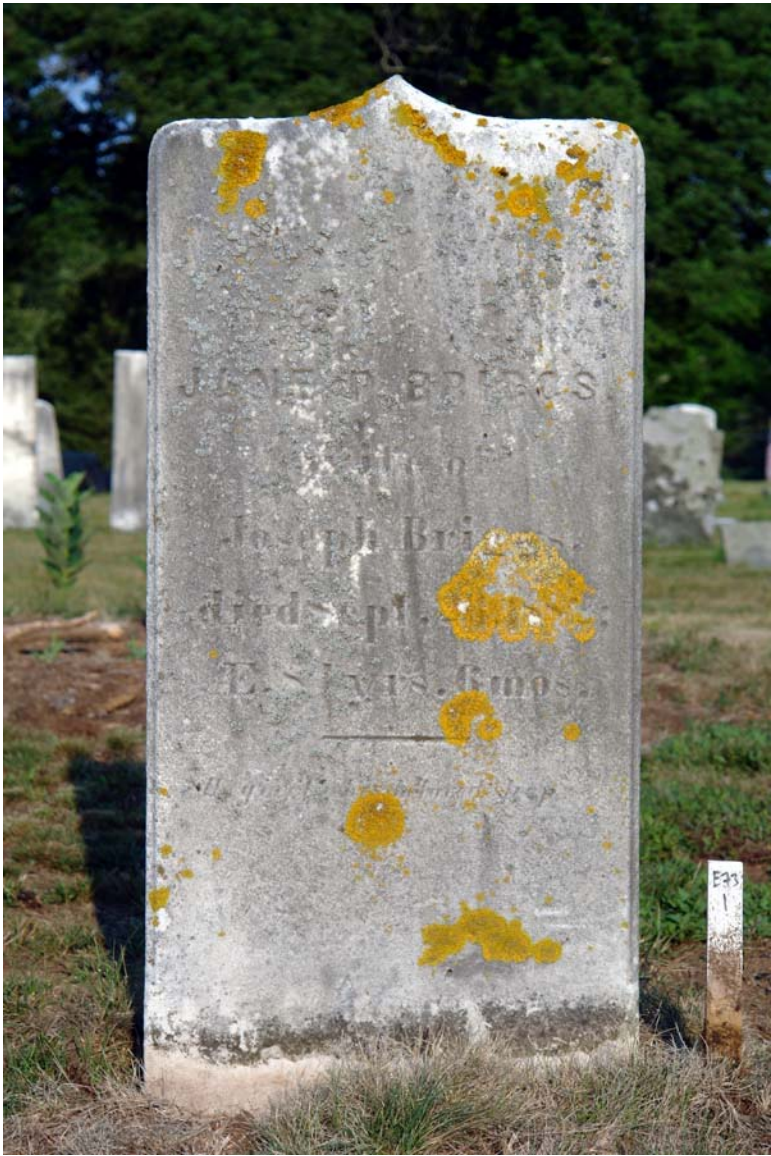
Hanover Center Cemetery, Hanover MA
NAME ON MARKER **Edmund Sylvester**
Death Date: 6/16/1757 Marker Type: Headstone/conc.base
Cond. of Inscription: Legible Material: Marble

EXISTING CONDITIONS	CONSERVATION STRATEGY
Tilted base	Reset base with marker plumb

TREATMENT	Treatment Dates
1. Existing base located below grade while excavating for resetting. Area excavated to an appropriate depth removing any roots or large stones. 2. Base inspected and found to be sound and re-useable 3. Base is aligned with adjacent markers and re-set level. 4. Area around base was backfilled with tamped gravel and re-graded with existing topsoil 5. Debris removed from setting slot. When required, power grinders were used to facilitate removal of stone fragments. 6. When required, the lower setting edge was re-squared by power grinder with minimal loss. 7. Marker reset plumb and level into setting slot with cement/lime grout (3/2/9) with 000 sand made fluid with a super plasticizer. 8. Excess grout removed and joint area cleaned. 9. Marker braced for a minimum 3 days	7/23-30/2015

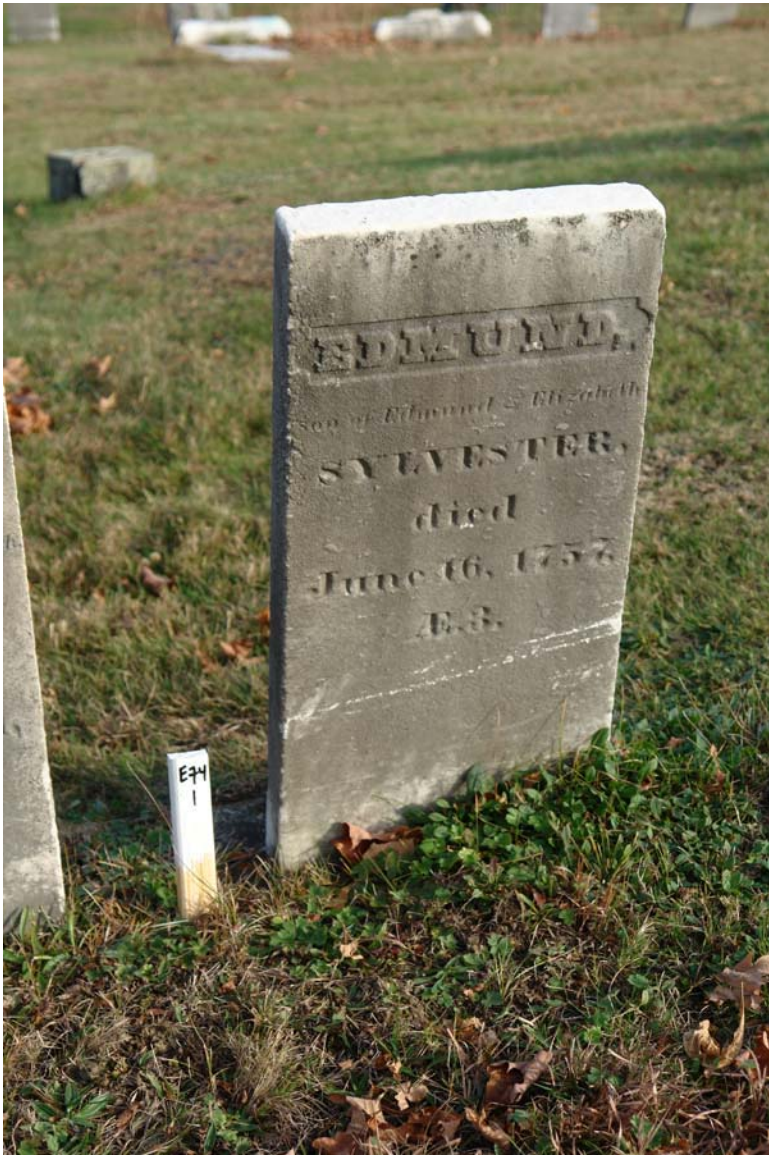
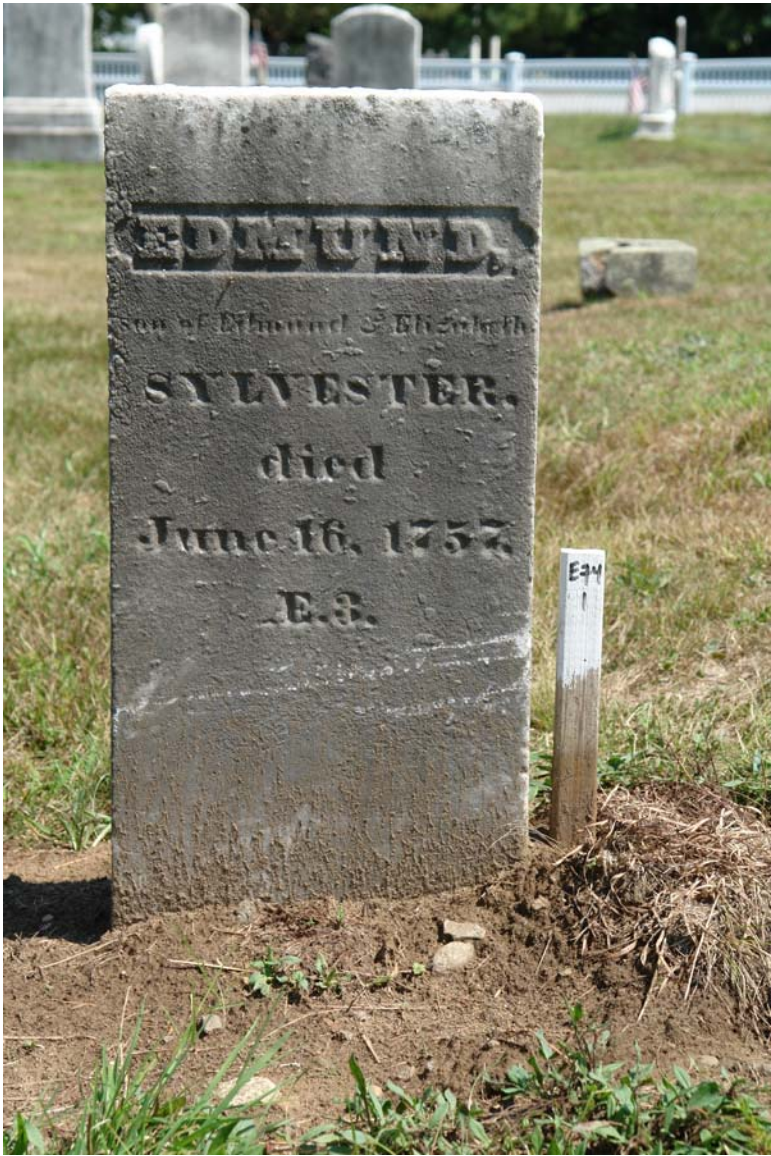
Hanover Center Cemetery, Hanover MA
NAME ON MARKER **Sarah Curtis**
Death Date: 3/15/1854 Marker Type: Headstone/conc.base
Cond. of Inscription: Legible Material: Marble

EXISTING CONDITIONS	CONSERVATION STRATEGY
Tilted	Reset plumb

TREATMENT	Treatment Dates
8/3/2015	
<div>1. Existing base located below grade while excavating for resetting. Area excavated to an appropriate depth removing any roots or large stones.</div> <div>2. Base inspected and found to be sound and re-useable</div> <div>3. Base is aligned with adjacent markers and re-set level.</div> <div>4. Area around base was backfilled with tamped gravel and re-graded with existing topsoil</div> <div>5. Debris removed from setting slot. When required, power grinders were used to facilitate removal of stone fragments.</div> <div>6. When required, the lower setting edge was re-squared by power grinder with minimal loss.</div> <div>7. Marker reset plumb and level into setting slot with cement/lime grout (3/2/9) with 000 sand made fluid with a super plasticizer.</div> <div>8. Excess grout removed and joint area cleaned.</div> <div>9. Marker braced for a minimum 3 days</div>
