MONUMENT CONSERVATION COLLABORATIVE LLC, NORFOLK, CT

DOCUMENTATION OF STONE CONSERVATION TREATMENTS TO ASSINIPPI CEMETERY, HANOVER, MA June 2015

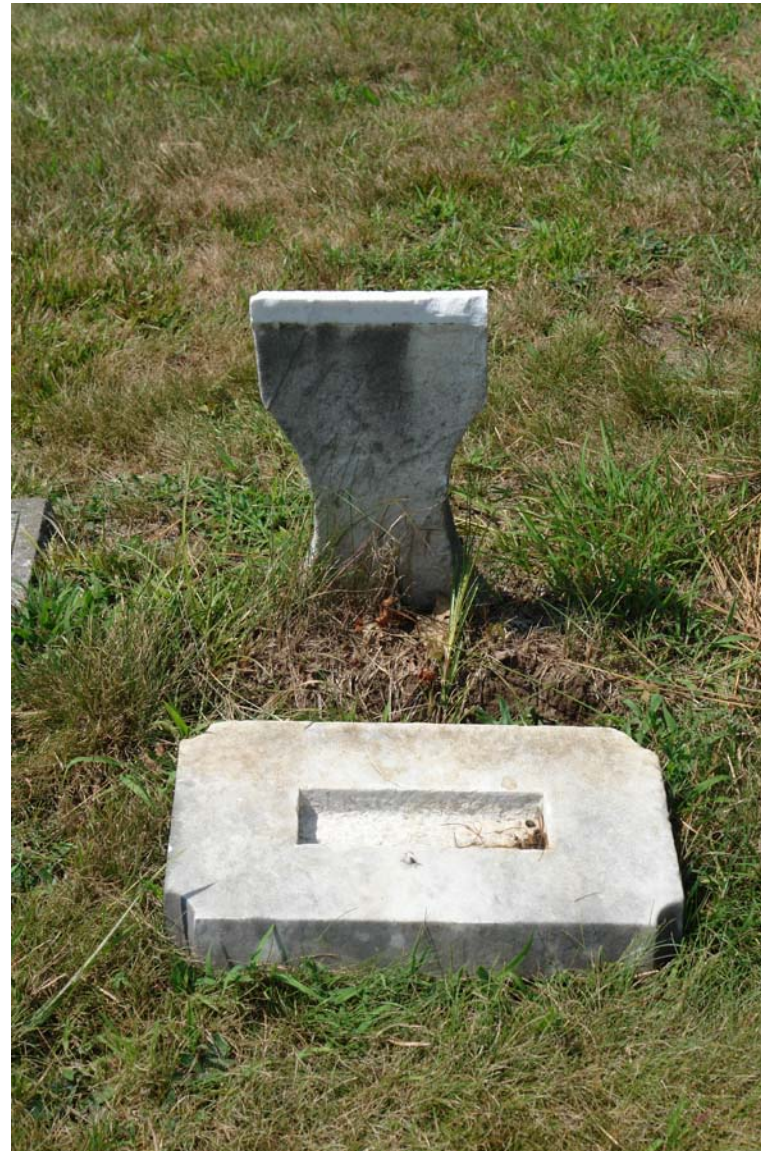
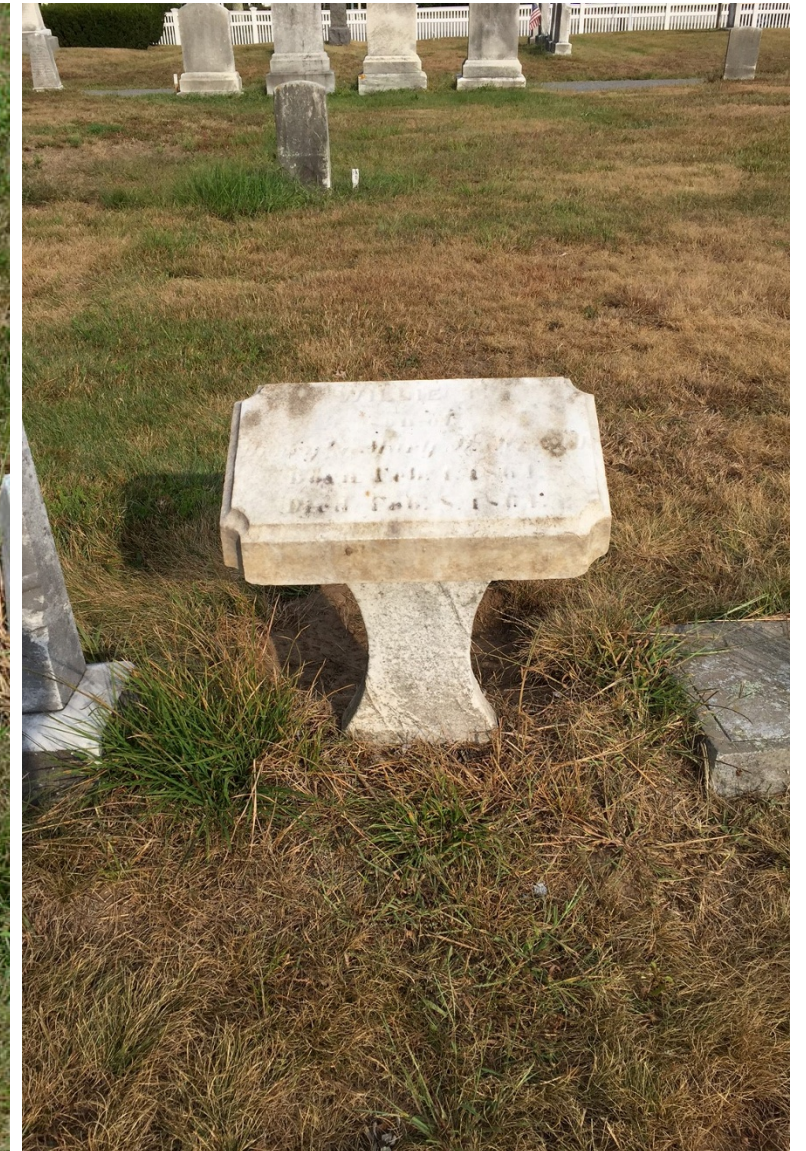
Marker# **EX 75.4**

EXISTING CONDITIONS	CONSERVATION STRATEGY
Loose in base	Evaluate resetting options Possible new below grade concrete base

TREATMENT	Treatment Dates
7/30-31/2015	
<div>1. Existing base located below grade while excavating for resetting. Area excavated to an appropriate depth removing any roots or large stones.</div> <div>2. Base inspected and found to be sound and re-useable</div> <div>3. Base is aligned with adjacent markers and re-set level.</div> <div>4. Area around base was backfilled with tamped gravel and re-graded with existing topsoil</div> <div>5. Debris removed from setting slot. When required, power grinders were used to facilitate removal of stone fragments.</div> <div>6. When required, the lower setting edge was re-squared by power grinder with minimal loss.</div> <div>7. Marker reset plumb and level into setting slot with cement/lime grout (3/2/9) with 000 sand made fluid with a super plasticizer.</div> <div>8. Excess grout removed and joint area cleaned.</div> <div>9. Marker braced for a minimum 3 days</div>

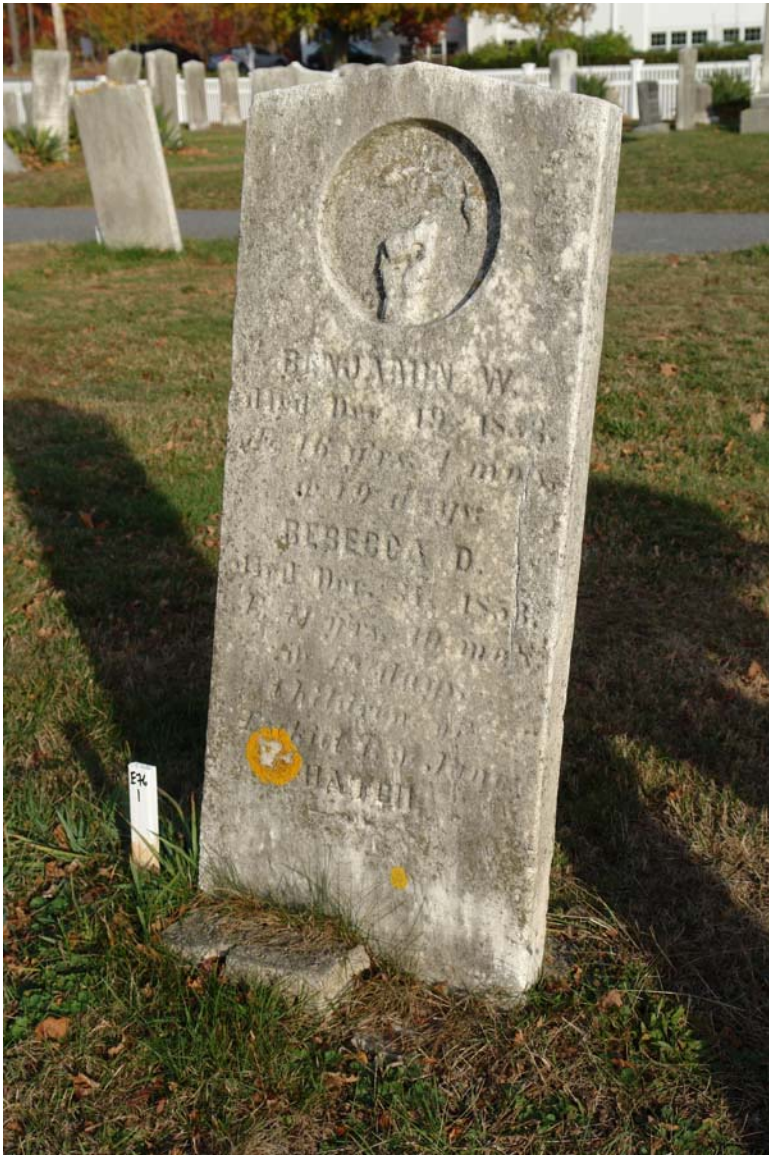
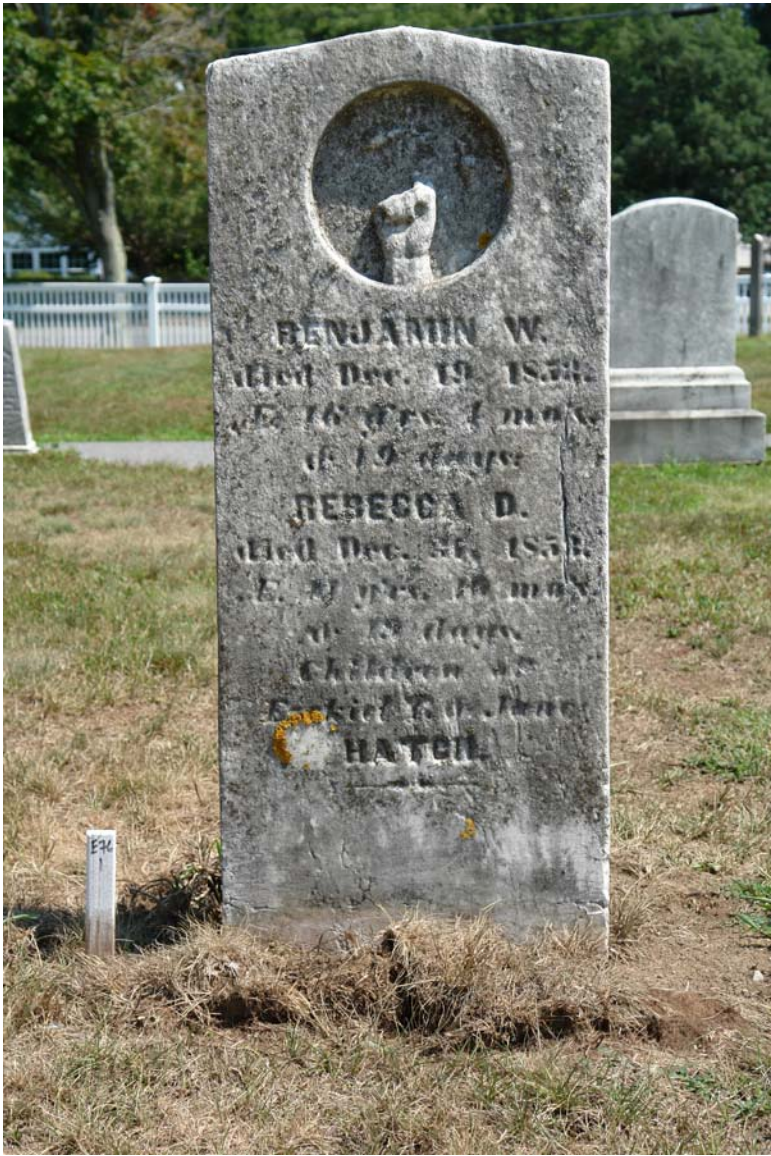
Hanover Center Cemetery, Hanover MA	
NAME ON MARKER Ann Hatch	
Death Date: 1927	Marker Type: Headstone
Cond. of Inscription: Decipherable	Material: Marble
EXISTING CONDITIONS	CONSERVATION STRATEGY
Tilted	Reset plumb
TREATMENT	
Treatment Dates 7/23/2015	
<p>1. Marker carefully excavated. The soil around tilted markers was removed to an appropriate depth. When required, the marker was removed from the ground. Marker appears to be sound.</p> <p>2. Soling removed by light brushing with nylon brushes and water.</p> <p>3. Setting area excavated to sufficient depth and stone re-set plumb at appropriate height and level onto gravel bed, aligned with adjacent markers</p> <p>4. Area backfilled around marker with tamped sand and gravel</p> <p>5. Disturbed areas re-graded with existing topsoil and sod.</p>

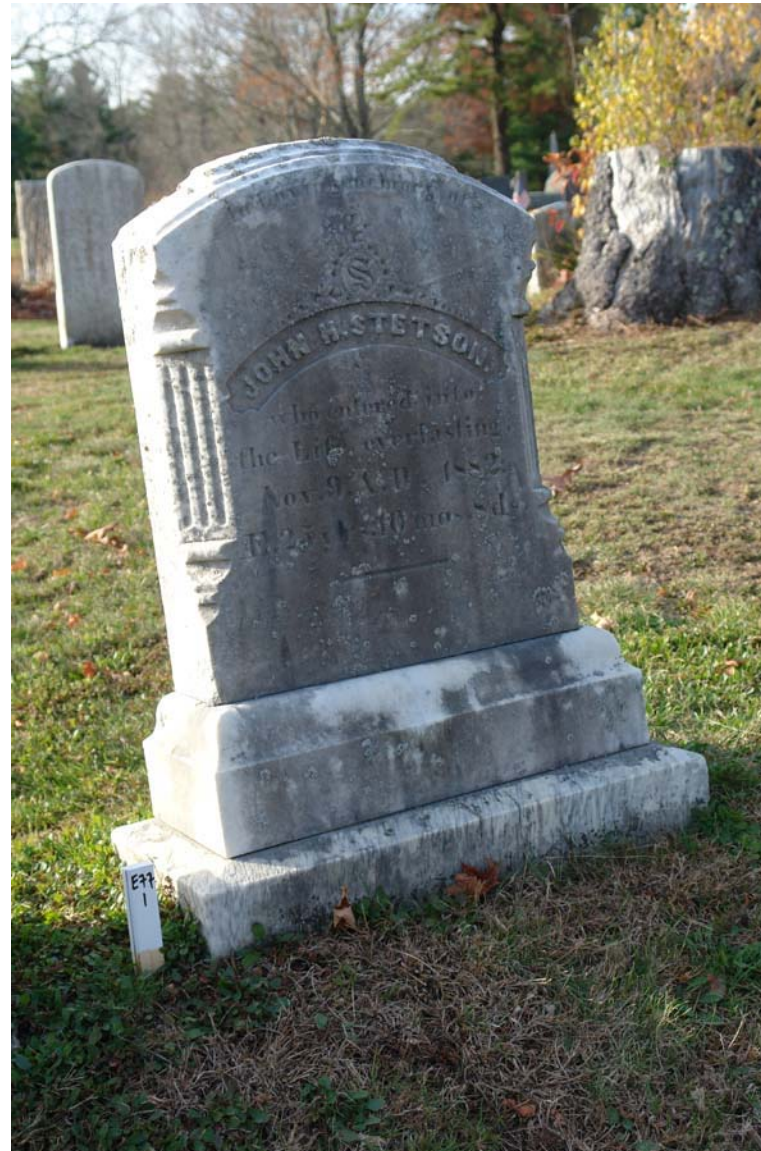
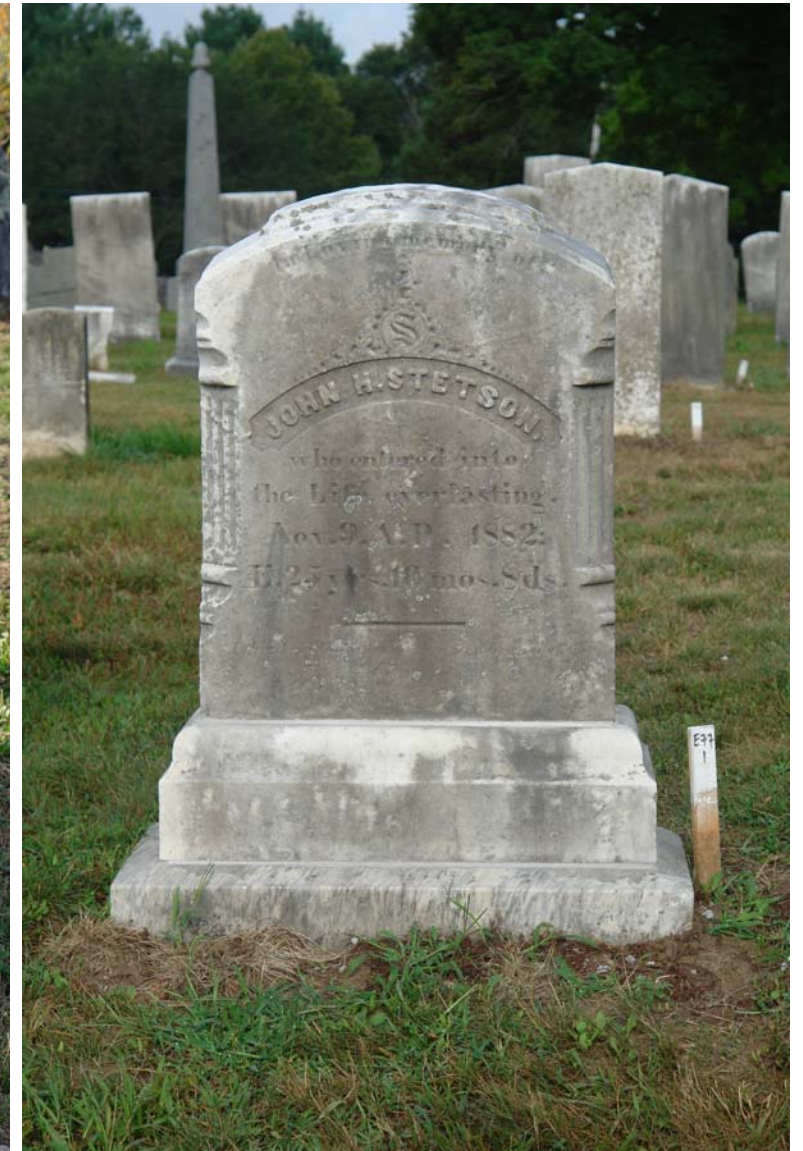
Height 27 Width 20.5 Thickness 6 Marker# **E.77**

EXISTING CONDITIONS	CONSERVATION STRATEGY
Fallen off base	Level base if required Reset elements

TREATMENT	Treatment Dates
1. Elements removed from setting bases and inspected for soundness. 2. Area excavated to an appropriate depth removing any roots or large stones. 3. Base is aligned with adjacent markers and re-set level. 4. Area around base was backfilled with tamped gravel and re-graded with existing topsoil 5. Failed mortar removed from setting area and bottom of marker 6. When required, any existing pins were inspected, and if necessary, replaced with stainless steel threaded pins 7. Setting surfaces primed with Acryl 60 diluted 1:3 with water. 8. Marker reset plumb onto base with cement/lime mortar (3/2/9) with 000 sand. 9. Excess grout removed and joint area cleaned.	7/30-31/2015

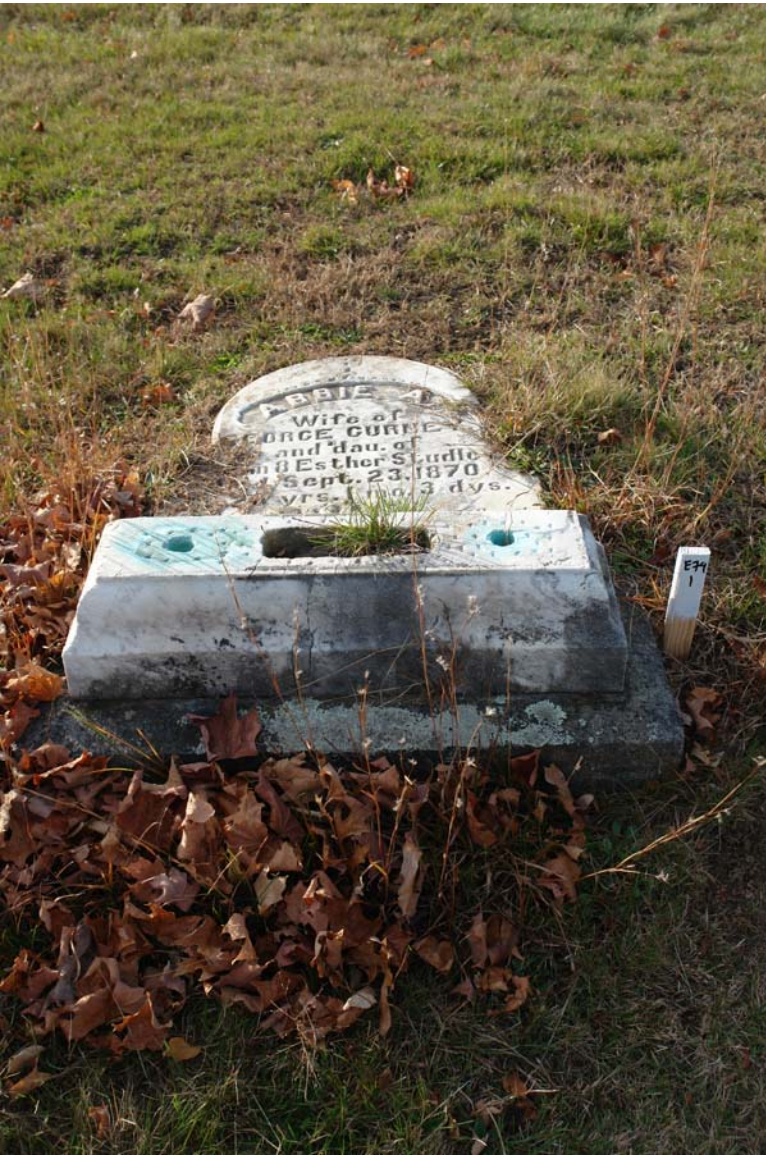
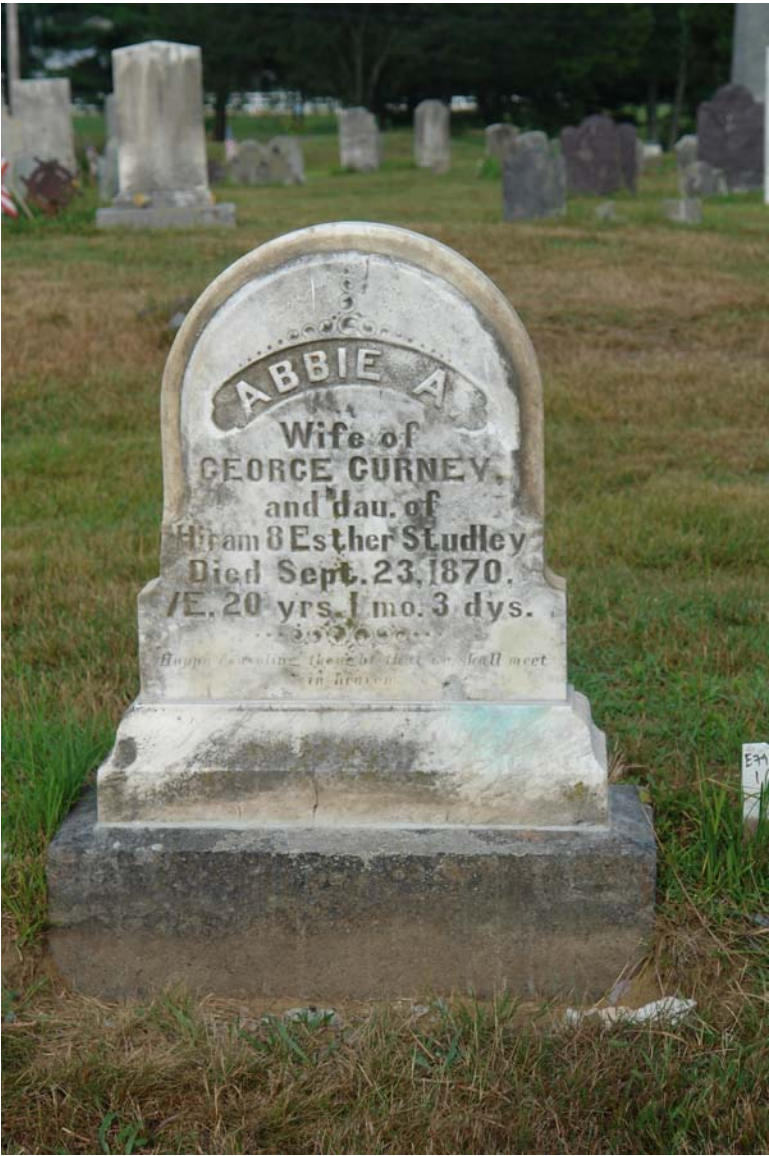
Hanover Center Cemetery, Hanover MA
NAME ON MARKER **Sarah Studley**
Death Date: 7/9/1869 Marker Type: Headstone/pinned base
Cond. of Inscription: Legible Material: Marble

EXISTING CONDITIONS	CONSERVATION STRATEGY
Tilted Marker loose on base	Check base for level Reset marker plumb

TREATMENT	Treatment Dates
1. Area excavated to an appropriate depth. Base is aligned with adj. markers and reset level at appropriate height. 2. All mating edges of fragments cleaned with water and any failed adhesives removed with hand tools 3. Fragments attached with structural adhesive (Abatron 55-22), clamped and braced until cured. Excess epoxy removed with hand chisels within 24 hours. 4. Setting surfaces cleaned of debris or failed mortar and base and market fragment reset plumb and level with a cement/lime grout (3/2/9) with 000 sand. Excess grout removed and joint area cleaned. 5. Marker braced for a minimum 3 days 6. Cracks and losses filled with RepliCal Marble or Jahn restoration mortar. products, filled areas misted with water and covered for 3 days minimum..	7/30-9/1/2015

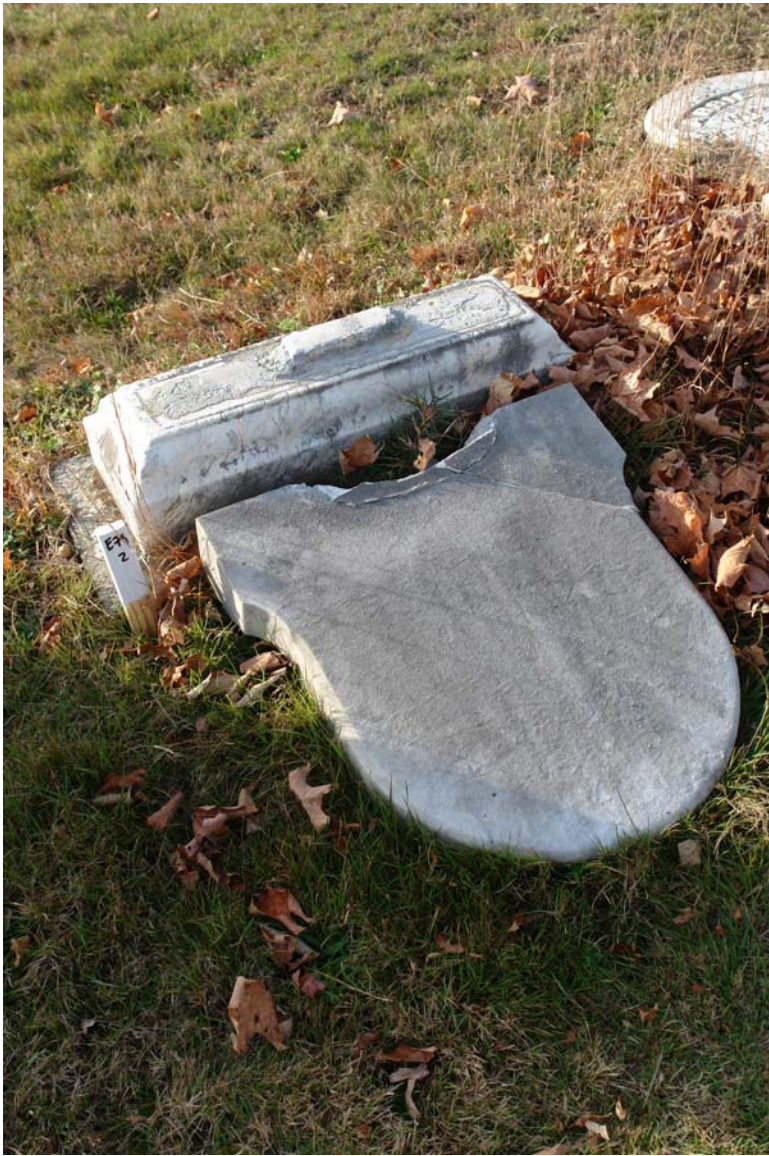
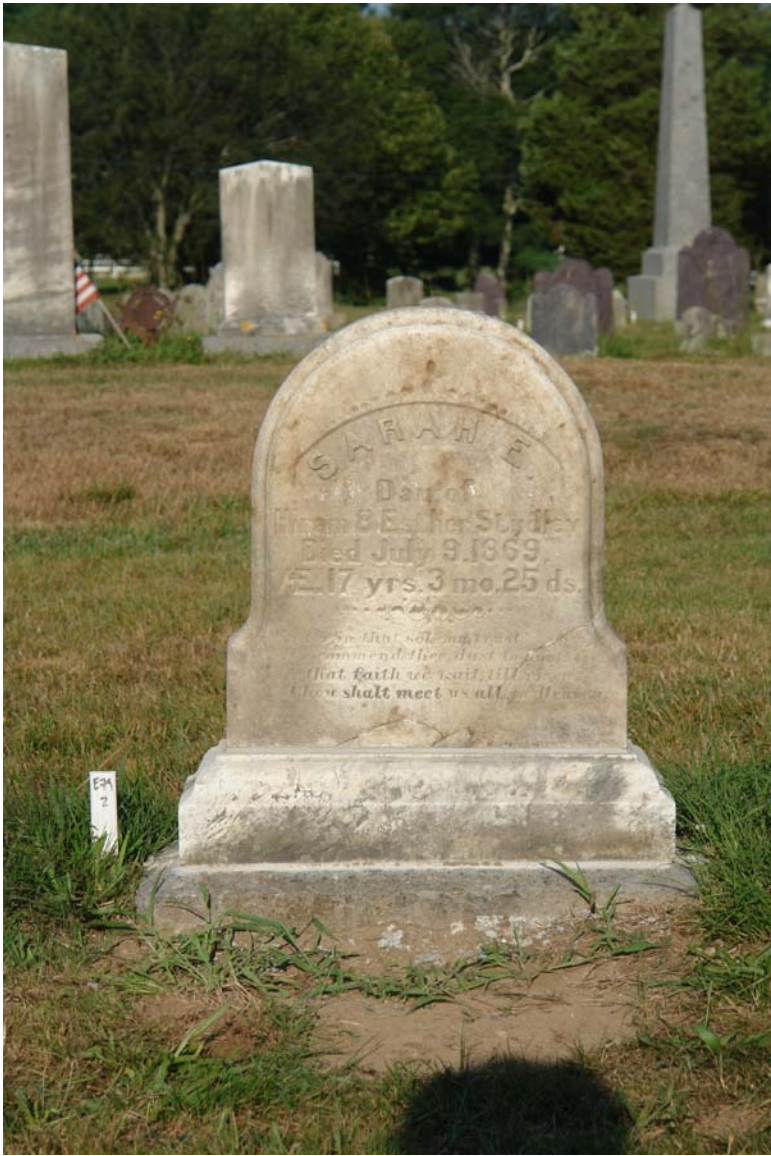
Hanover Center Cemetery, Hanover MA	
NAME ON MARKER	Hiram Studley
Death Date: 9/22/1849	Marker Type: Headstone
Cond. of Inscription: Legible	Material: Marble
EXISTING CONDITIONS	CONSERVATION STRATEGY
Tilted	Reset plumb
TREATMENT	
Treatment Dates 7/30/2015	
<div>1. Existing base located below grade while excavating for resetting. Area excavated to an appropriate depth removing any roots or large stones.</div> <div>2. Base inspected and found to be sound and re-useable</div> <div>3. Base is aligned with adjacent markers and re-set level.</div> <div>4. Area around base was backfilled with tamped gravel and re-graded with existing topsoil</div> <div>5. Debris removed from setting slot. When required, power grinders were used to facilitate removal of stone fragments.</div> <div>6. When required, the lower setting edge was re-squared by power grinder with minimal loss.</div> <div>7. Marker reset plumb and level into setting slot with cement/lime grout (3/2/9) with 000 sand made fluid with a super plasticizer.</div> <div>8. Excess grout removed and joint area cleaned.</div> <div>9. Marker braced for a minimum 3 days</div>

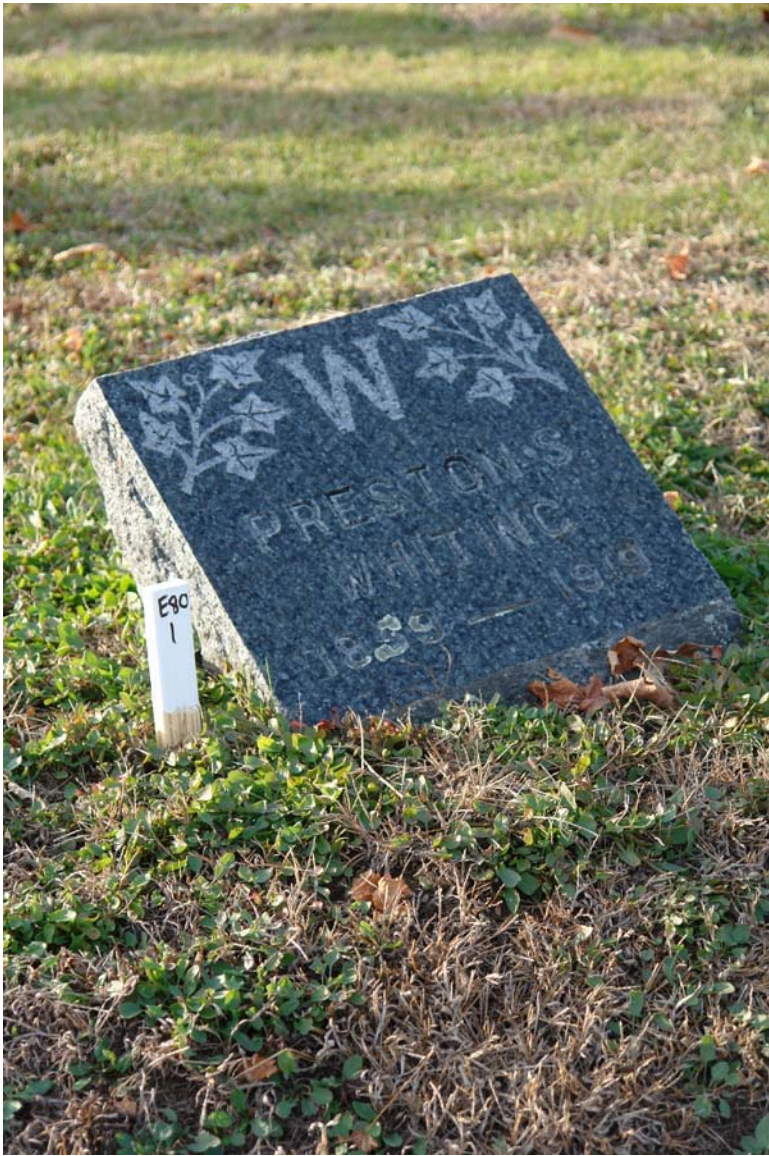
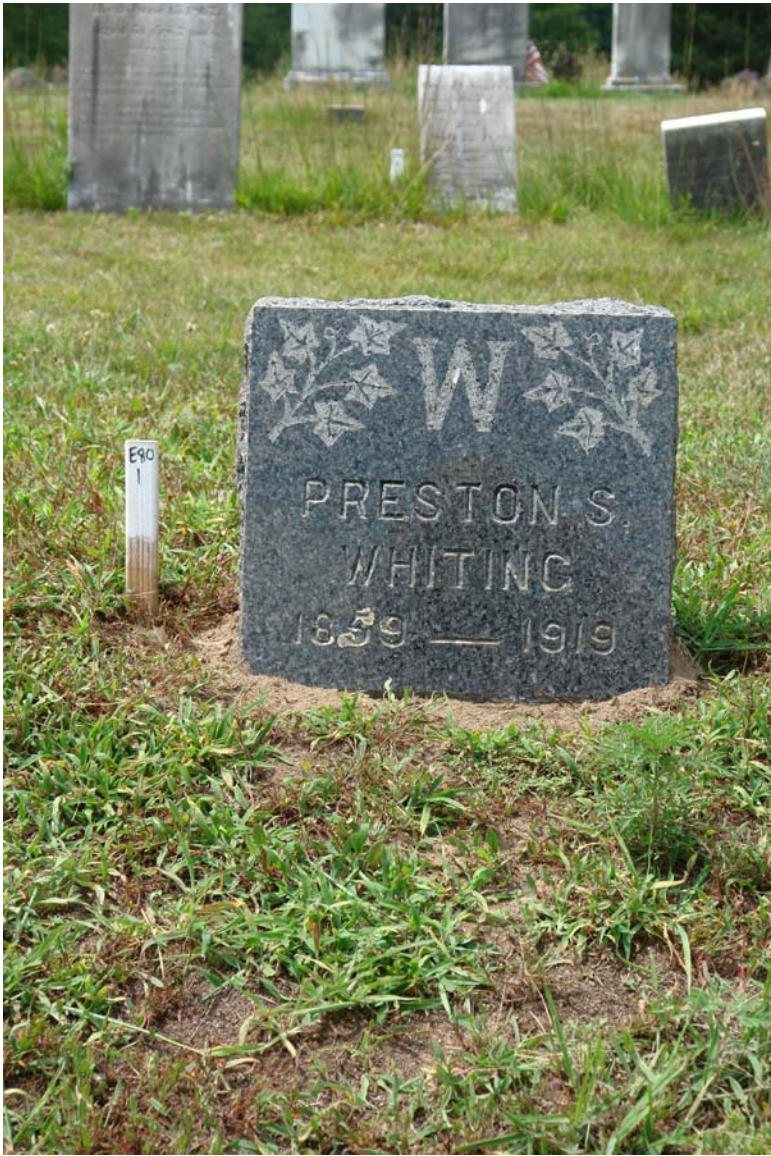
Hanover Center Cemetery, Hanover MA

EXISTING CONDITIONS	CONSERVATION STRATEGY
Voids caused by delaminating	Cap voids caused by delaminations.

3. After full drying, all voids caused by splitting or delaminations at top edge of marker filled with a pigmented Sto Crack Filler using injection syringes and/or trowels. Voids along sides of monument typically left open to allow escape of any water which may enter.

4. Excess crack filler immediately removed with repeated damp sponging.

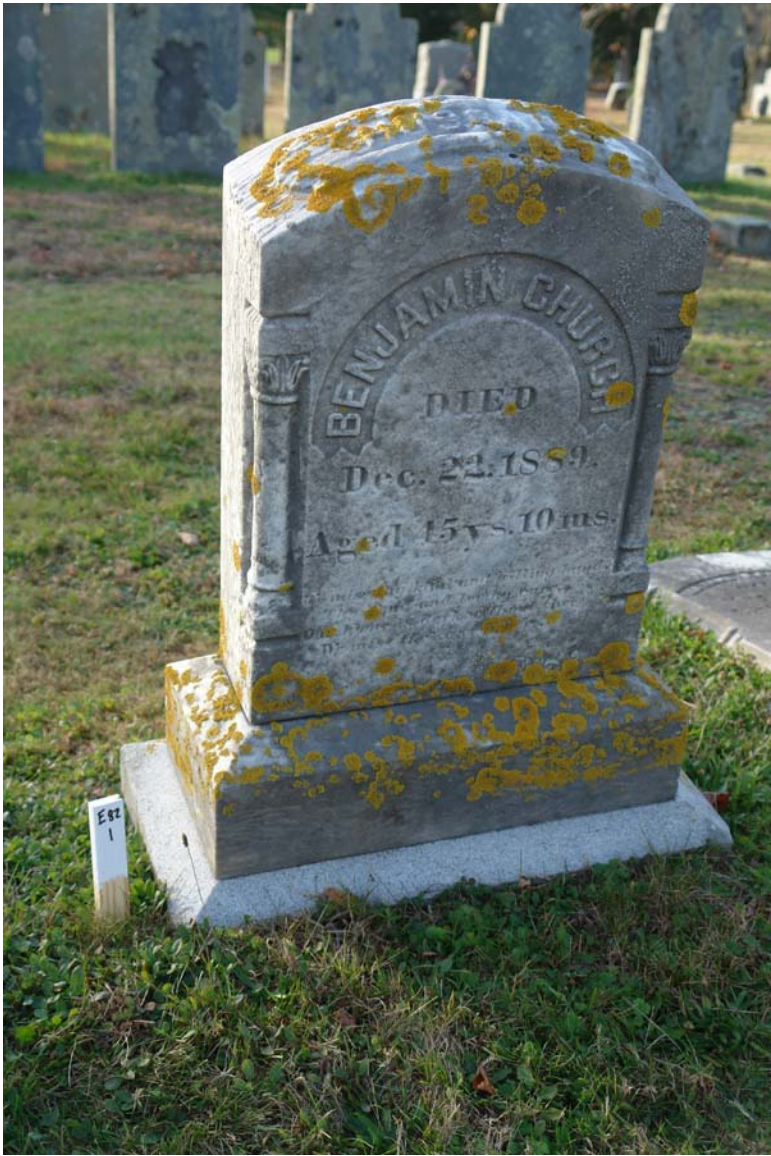
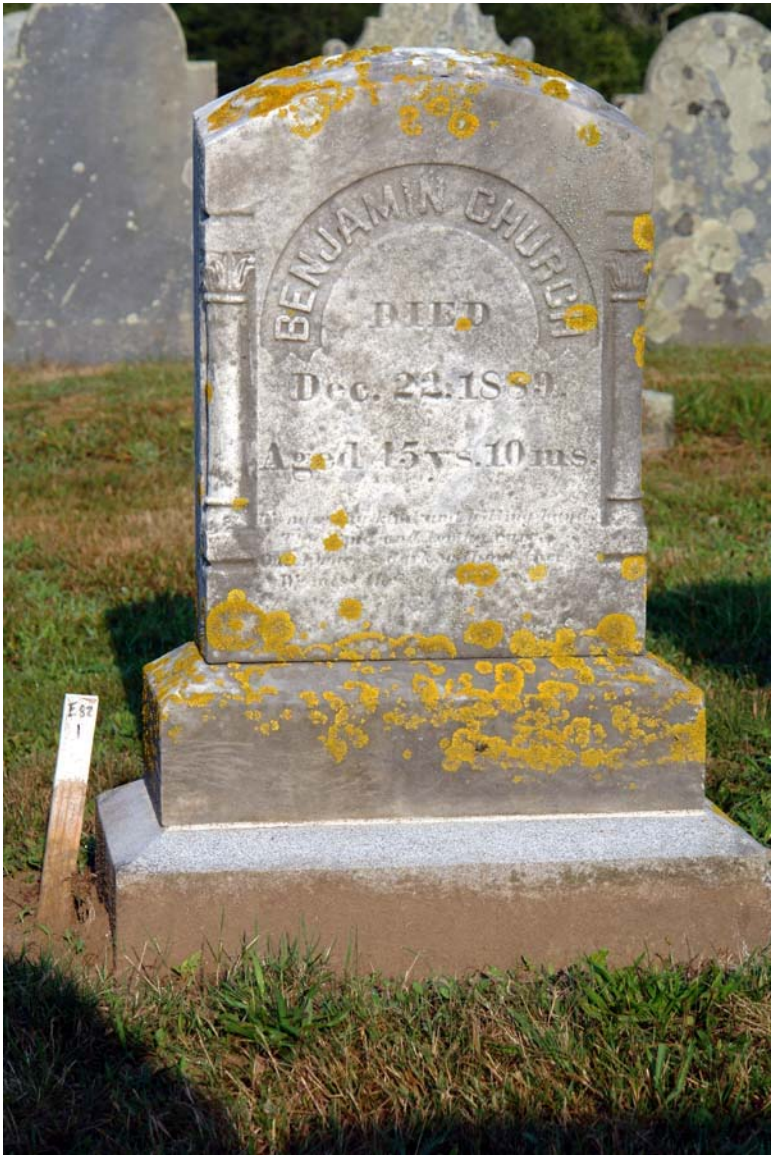
Hanover Center Cemetery, Hanover MA
NAME ON MARKER **Benjamin Church**
Death Date: 12/22/1889 Marker Type: Headstone/pinned base
Cond. of Inscription: Legible Material: Marble

EXISTING CONDITIONS	CONSERVATION STRATEGY
Tilted base	Reset base with marker plumb

TREATMENT	Treatment Dates
1. Elements removed from setting bases and inspected for soundness. 2. Area excavated to an appropriate depth removing any roots or large stones. 3. Base is aligned with adjacent markers and re-set level. 4. Area around base was backfilled with tamped gravel and re-graded with existing topsoil 5. Failed mortar removed from setting area and bottom of marker 6. When required, any existing pins were inspected, and if necessary, replaced with stainless steel threaded pins 7. Setting surfaces primed with Acryl 60 diluted 1:3 with water. 8. Marker reset plumb onto base with cement/lime mortar (3/2/9) with 000 sand. 9. Excess grout removed and joint area cleaned.	7/31/2015

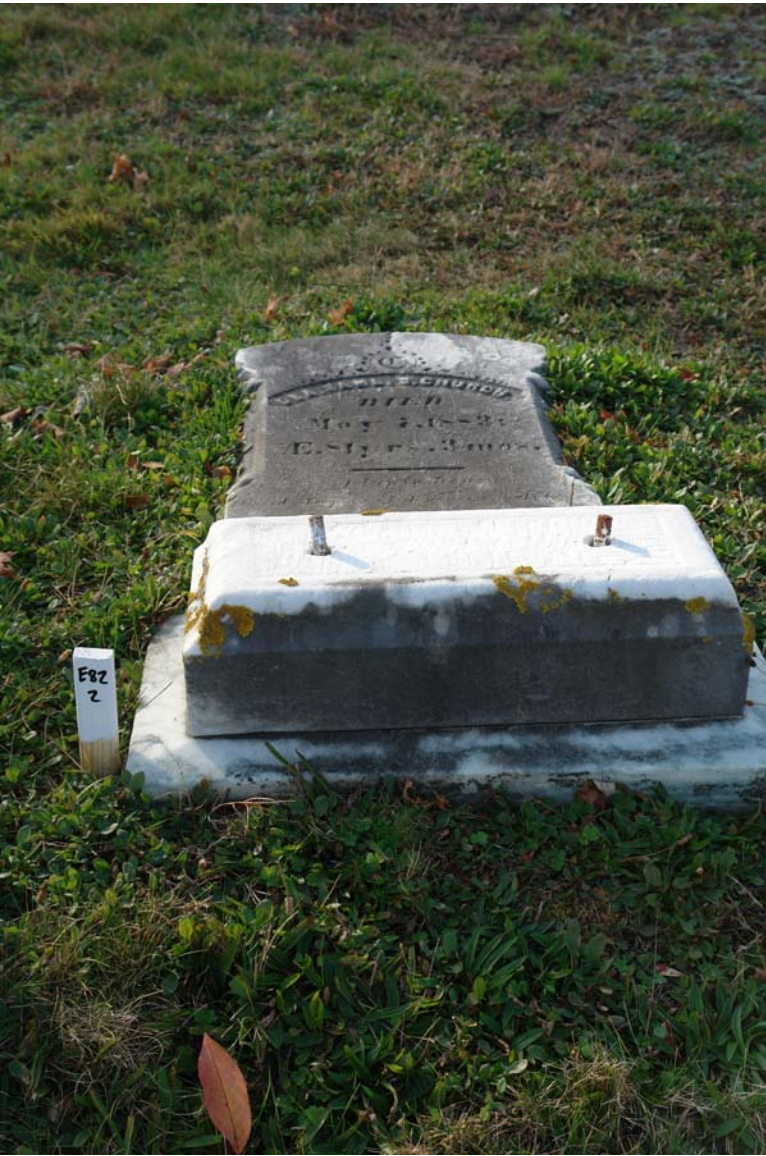
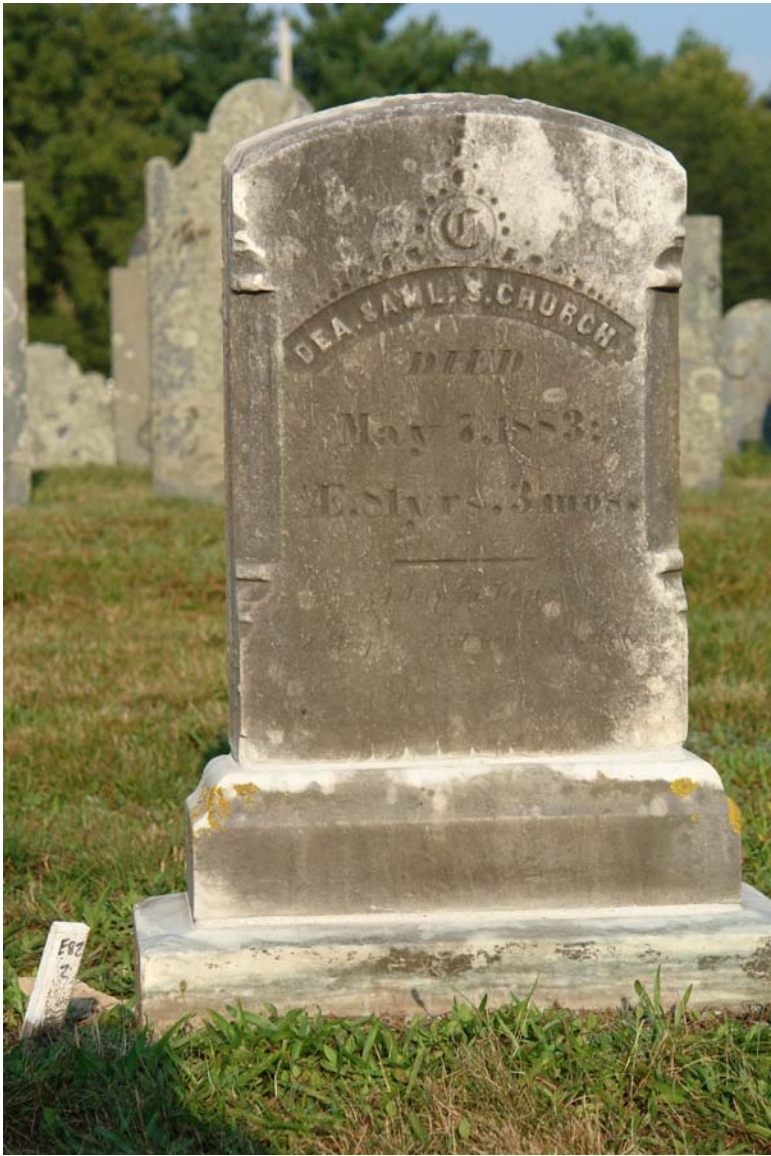
Hanover Center Cemetery, Hanover MA
NAME ON MARKER **Deacon Samuel Church**
Death Date: 5/7/1883 Marker Type: Headstone/pinned base
Cond. of Inscription: Legible Material: Marble

EXISTING CONDITIONS	CONSERVATION STRATEGY
Fallen off base	Level base if required Reset elements

TREATMENT	Treatment Dates
1. Elements removed from setting bases and inspected for soundness. 2. Area excavated to an appropriate depth removing any roots or large stones. 3. Base is aligned with adjacent markers and re-set level. 4. Area around base was backfilled with tamped gravel and re-graded with existing topsoil 5. Failed mortar removed from setting area and bottom of marker 6. When required, any existing pins were inspected, and if necessary, replaced with stainless steel threaded pins 7. Setting surfaces primed with Acryl 60 diluted 1:3 with water. 8. Marker reset plumb onto base with cement/lime mortar (3/2/9) with 000 sand. 9. Excess grout removed and joint area cleaned.	7/23-30/2015

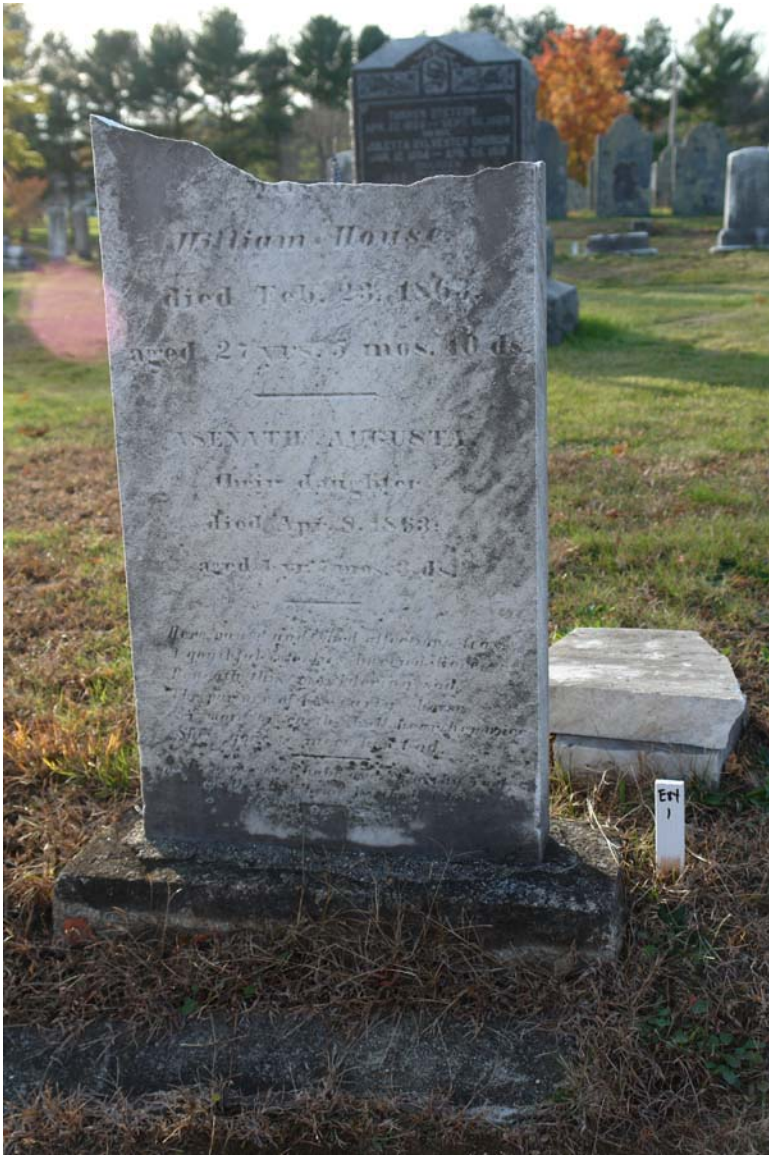
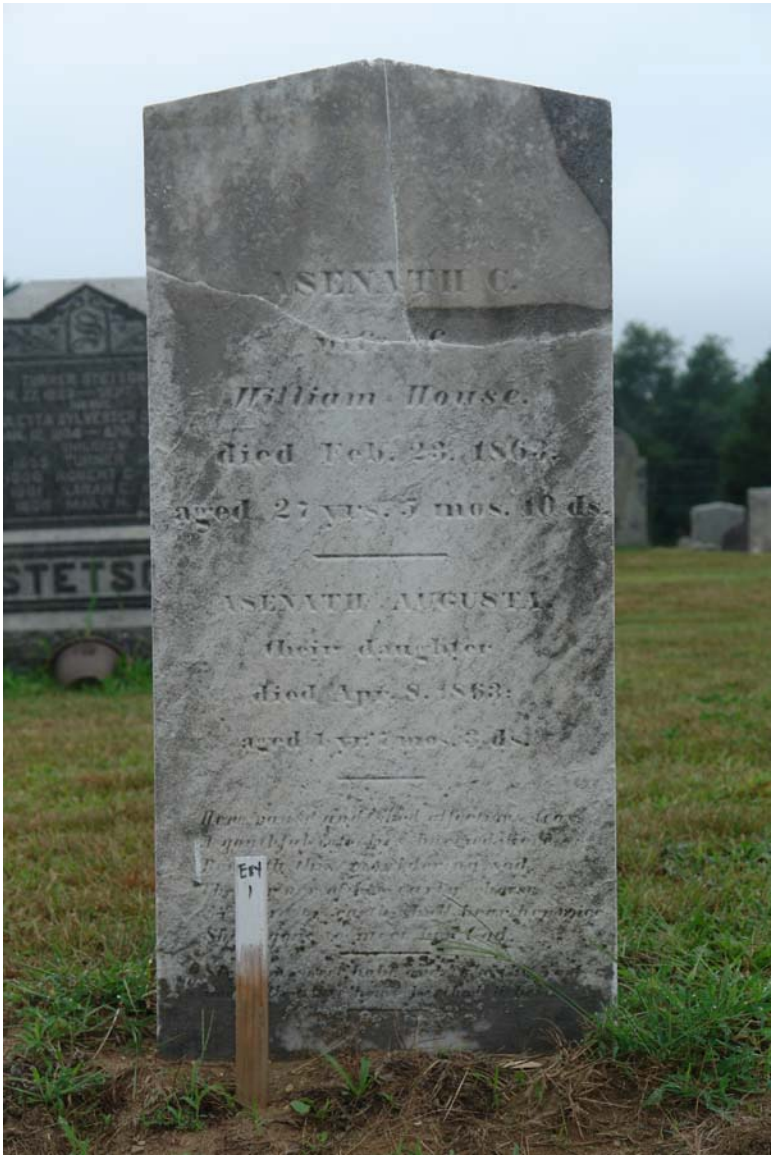
Hanover Center Cemetery, Hanover MA
NAME ON MARKER **Asenath House**
Death Date: 2/23/1863 Marker Type: Headstone/conc.base
Cond. of Inscription: Legible Material: Marble

EXISTING CONDITIONS	CONSERVATION STRATEGY
Tilted Fractured Marker loose in slot	Reset base level Reset marker into setting slot. Attach fragments with structural adhesive

Comments: Recently fractured

TREATMENT	Treatment Dates
1. Area excavated to an appropriate depth. Base is aligned with adj. markers and reset level at appropriate height. 2. Setting slot cleaned of debris or failed mortar and bottom fragment reset plumb and level into setting slot with a cement/lime grout (3/2/9) with 000 sand made fluid with a super plasticizer. Excess grout removed and joint area cleaned. 3. Marker braced for a minimum 3 days 4. All mating edges of fragments cleaned with water and any failed adhesives removed with hand tools 5. Fragments attached with structural adhesive (Abatron 55-22), clamped and braced until cured. Excess epoxy removed with hand chisels within 24 hours. 6. Cracks and losses filled with RepliCal Marble or Jahn restoration mortar. products, filled areas misted with water and covered for 3 days minimum..	8/4-5/2015

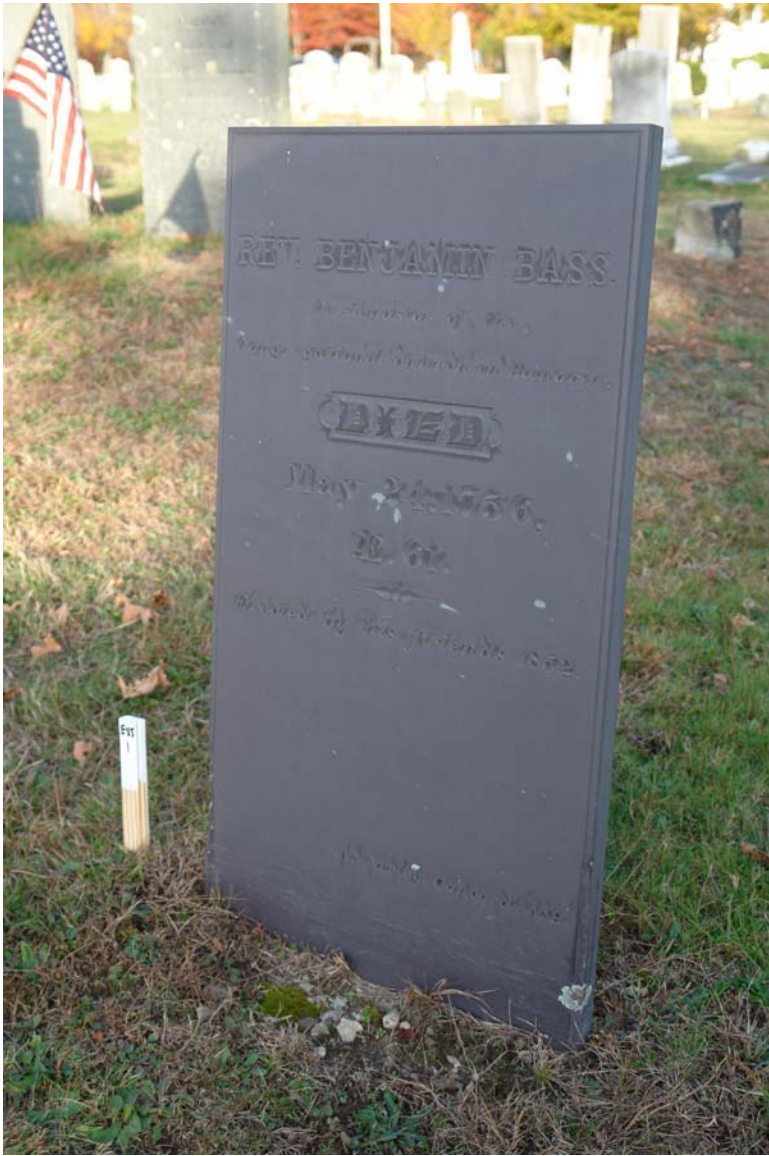
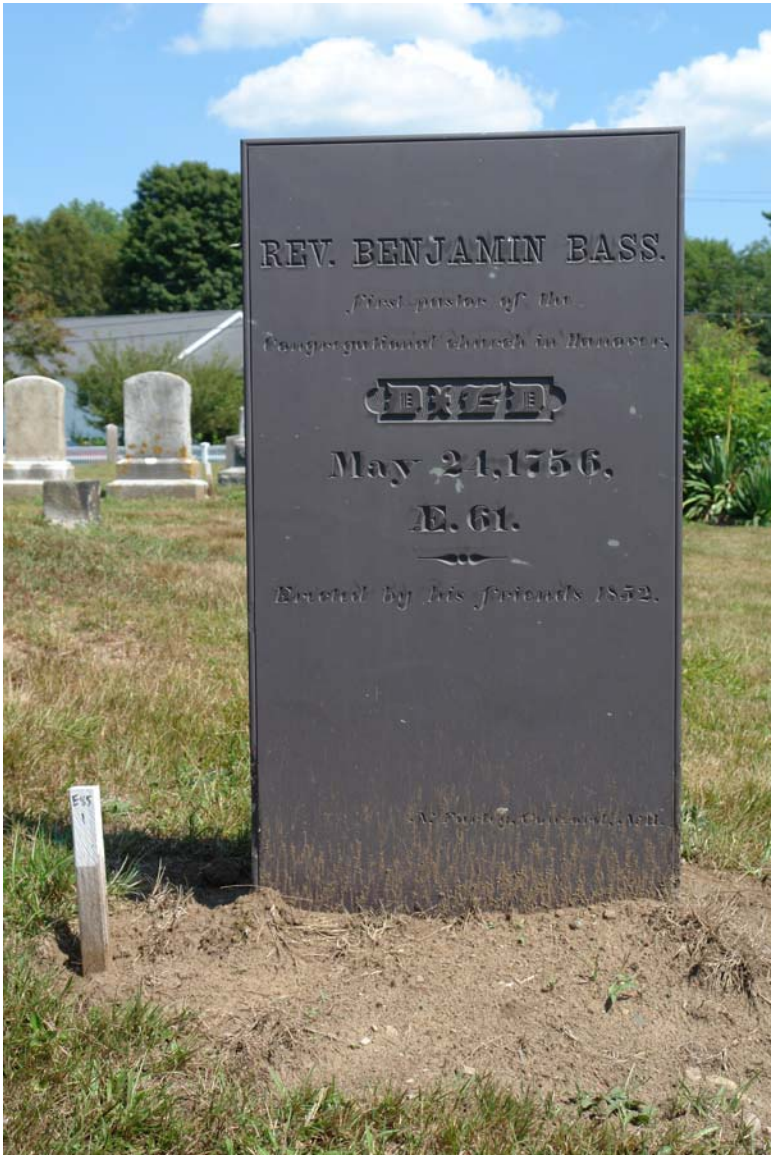
Hanover Center Cemetery, Hanover MA
NAME ON MARKER **Benjamin Bass**
Death Date: 5/24/1856 Marker Type: Headstone/slot base
Cond. of Inscription: Legible Material: Slate

EXISTING CONDITIONS	CONSERVATION STRATEGY
Tilted	Reset

TREATMENT	Treatment Dates
1. Existing base located below grade while excavating for resetting. Area excavated to an appropriate depth removing any roots or large stones. 2. Base inspected and found to be sound and re-useable 3. Base is aligned with adjacent markers and re-set level. 4. Area around base was backfilled with tamped gravel and re-graded with existing topsoil 5. Debris removed from setting slot. When required, power grinders were used to facilitate removal of stone fragments. 6. When required, the lower setting edge was re-squared by power grinder with minimal loss. 7. Marker reset plumb and level into setting slot with cement/lime grout (3/2/9) with 000 sand made fluid with a super plasticizer. 8. Excess grout removed and joint area cleaned. 9. Marker braced for a minimum 3 days	7/30/2015

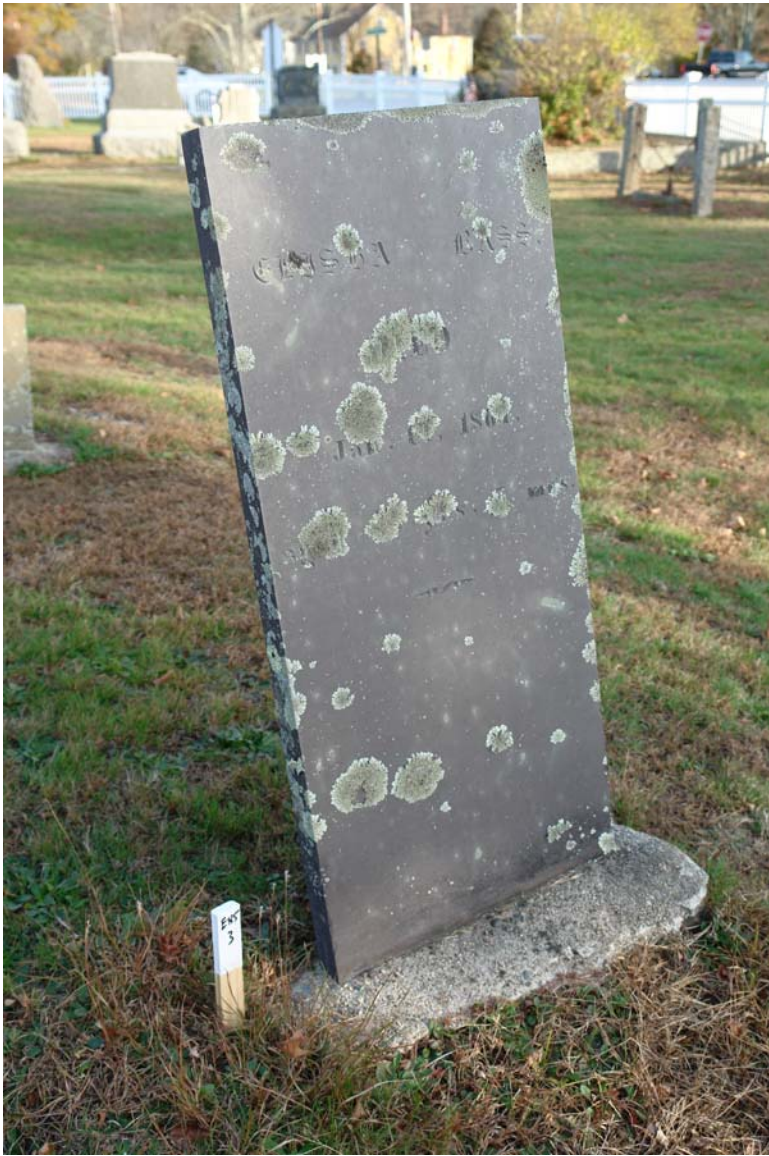
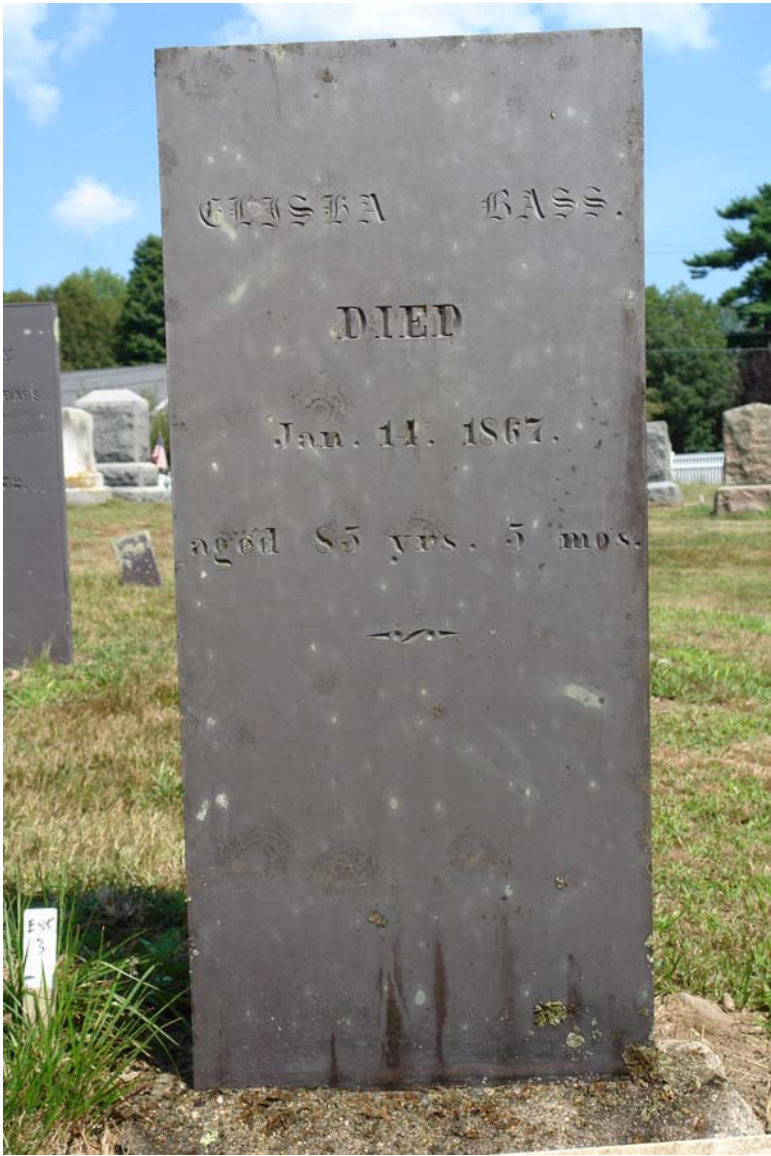
Hanover Center Cemetery, Hanover MA	
NAME ON MARKER	
Elisha Bass	
Death Date: 1/14/1867	Marker Type: Headstone/conc
Cond. of Inscription: Legible	Material: Slate
EXISTING CONDITIONS	CONSERVATION STRATEGY
Tilted base	Reset base with marker plumb
TREATMENT	
Treatment Dates 7/31/2015	
1. Marker carefully excavated old failed concrete collar removed with hand tools.	
2. Setting area excavated to sufficient depth and stone re-set plumb at appropriate height and level onto gravel bed, aligned with adjacent markers	
3. Area backfilled around marker with tamped sand and gravel	
4. Disturbed areas re-graded with existing topsoil and sod.	
5. Surfaces treated with D/2, scrubbed with nylon brushes and rinsed with water
