MONUMENT CONSERVATION COLLABORATIVE LLC, NORFOLK, CT

DOCUMENTATION OF STONE CONSERVATION TREATMENTS TO ASSINIPPI CEMETERY, HANOVER, MA June 2015

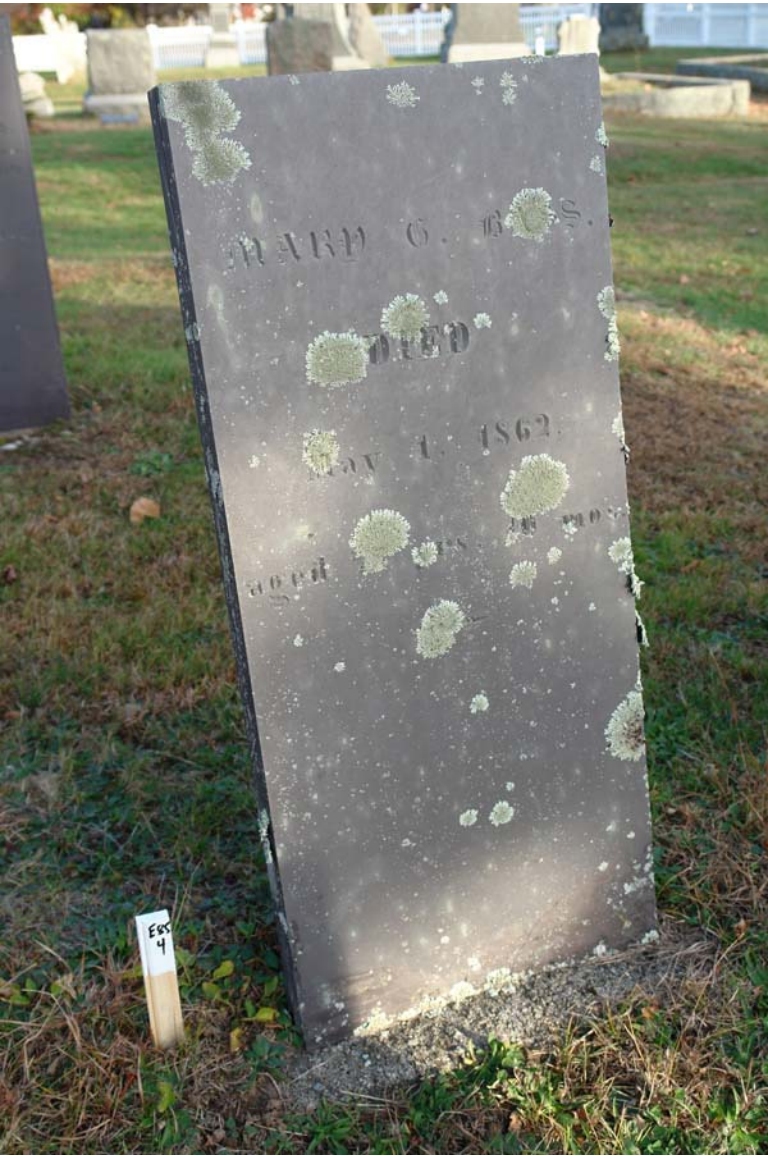
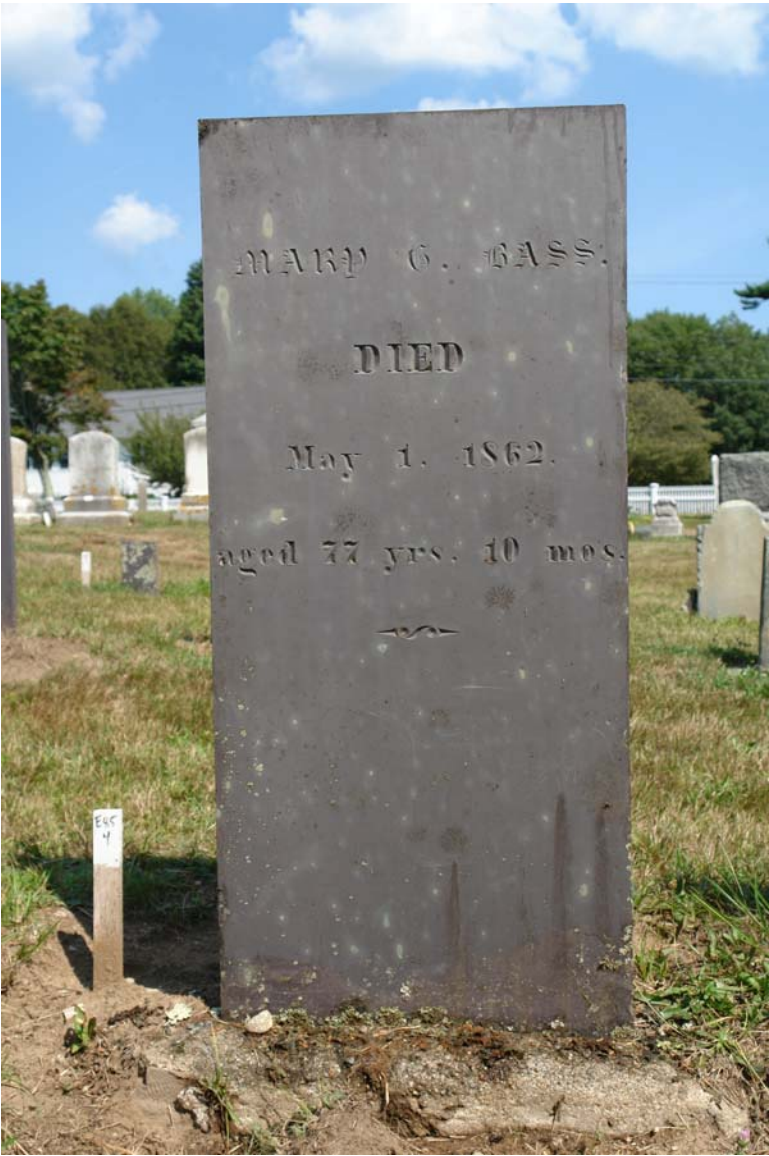
Hanover Center Cemetery, Hanover MA	
NAME ON MARKER	
Mary Bass	
Death Date: 5/1/1862	Marker Type: Headstone
Cond. of Inscription: Legible	Material: Slate
EXISTING CONDITIONS	CONSERVATION STRATEGY
Tilting Delaminating	Reset plumb Fill voids caused by delaminations
TREATMENT	
Treatment Dates 8/6-19/2015

1. Marker carefully excavated. The soil around tilted markers was removed to an appropriate depth. When required, the marker was removed from the ground. Marker appears to be sound.

6. After full drying, all voids caused by splitting or delaminations at top edge of marker filled with a pigmented Sto Crack Filler using injection syringes and/or trowels. Voids along sides of monument typically left open to allow escape of any water which may enter.

7. Excess crack filler immediately removed with repeated damp sponging.

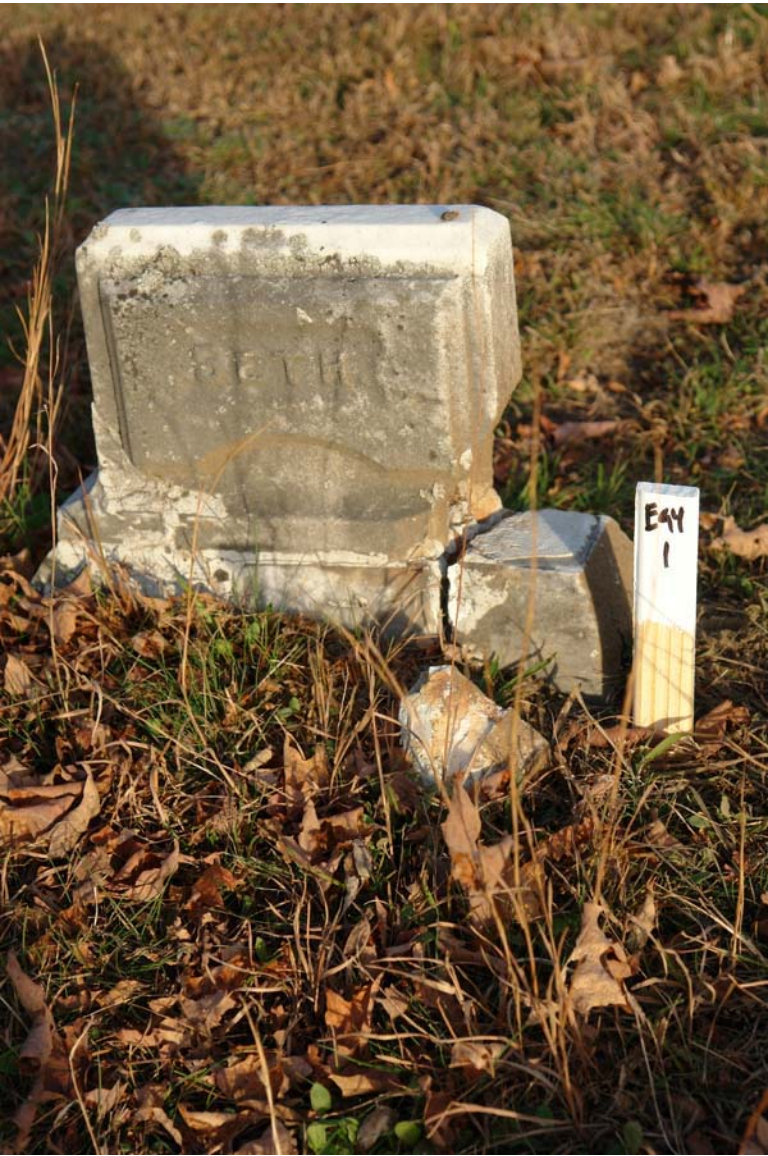
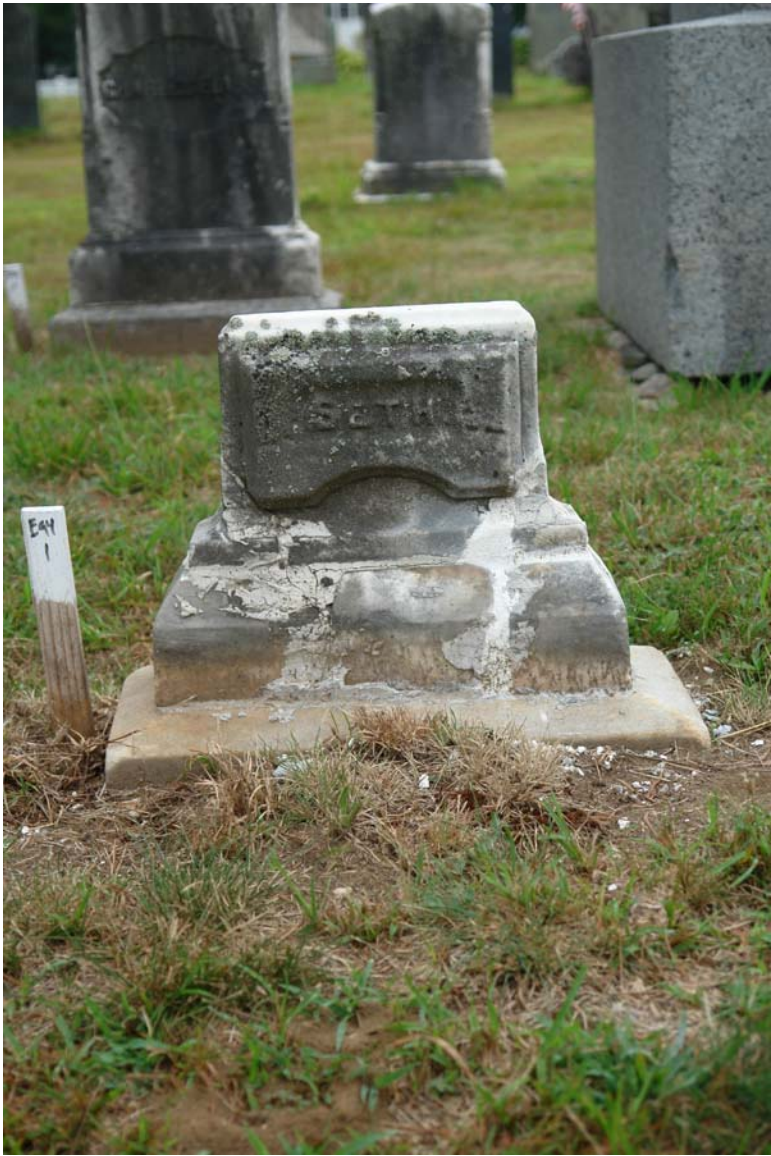
Hanover Center Cemetery, Hanover MA
NAME ON MARKER **Lucy D. (Lucy Rose)**
Death Date: Marker Type: Small marker/base
Cond. of Inscription: Legible Material: Marble

EXISTING CONDITIONS	CONSERVATION STRATEGY
Fractures Loose on base	Attach fragments with structural adhesive Reset elements

Comments: Not prudent to remove old repair

TREATMENT	Treatment Dates
1. Marker carefully excavated. The soil around tilted markers was removed to an appropriate depth. When required, the marker was removed from the ground. Marker appears to be sound. 2. Soling removed by light brushing with nylon brushes and water. 3. Setting area excavated to sufficient depth and stone re-set plumb at appropriate height and level onto gravel bed, aligned with adjacent markers 4. Area backfilled around marker with tamped sand and gravel 5. Disturbed areas re-graded with existing topsoil and sod.	8/3/2015

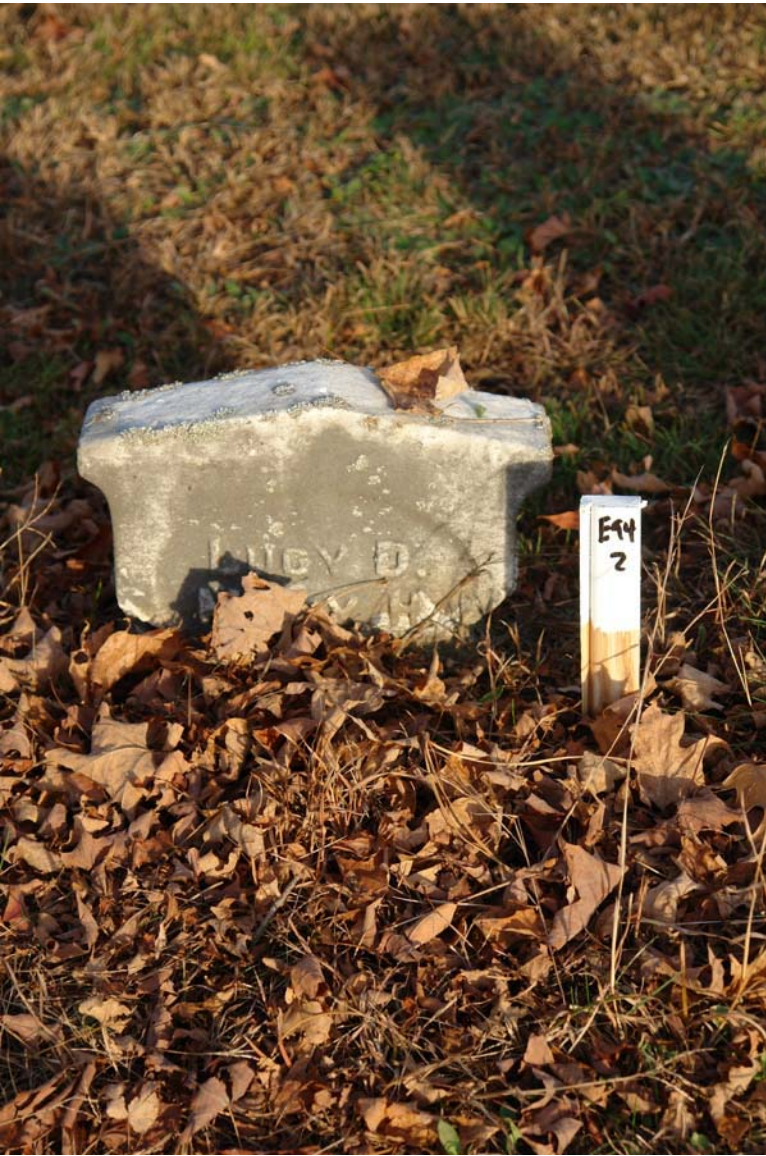
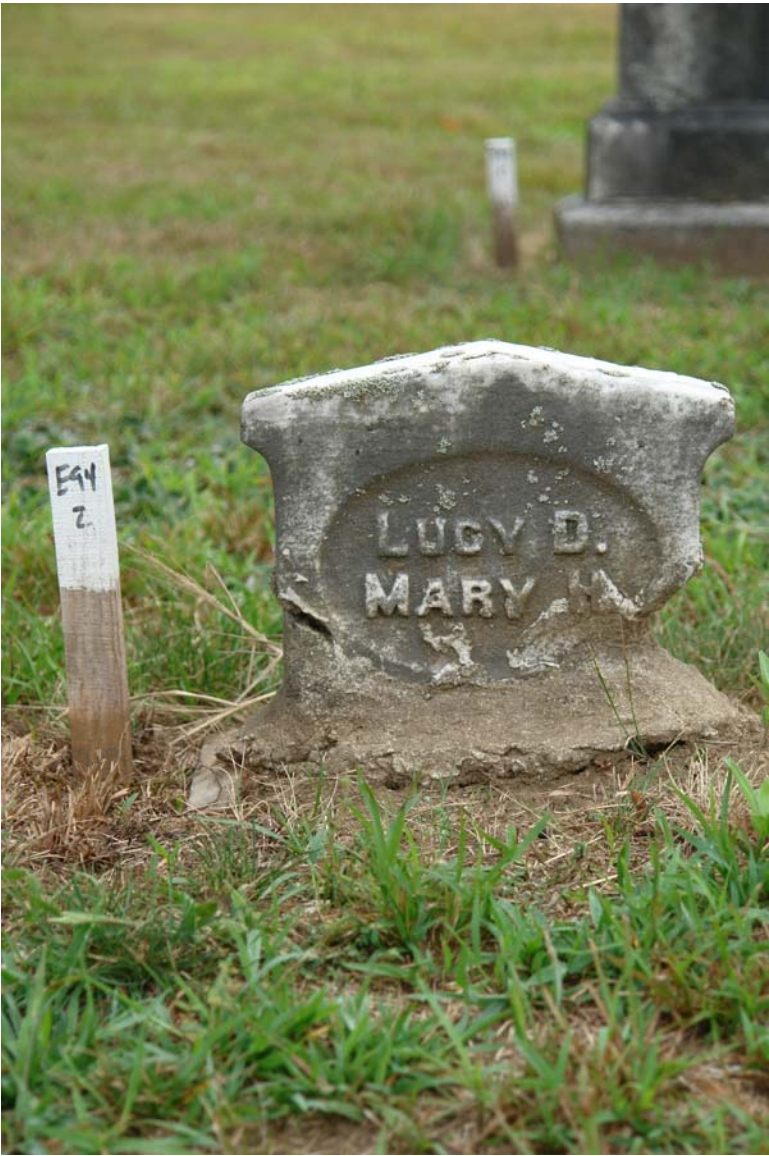
Hanover Center Cemetery, Hanover MA					
NAME ON MARKER	Eliza (Eliza Rose)				
Death Date:	Marker Type: Sm marker/base				
Cond. of Inscription: Legible	Material: Marble				
EXISTING CONDITIONS	CONSERVATION STRATEGY				
Tilted base	Reset base with marker plumb				
<table><tr><td>TREATMENT</td><td>Treatment Dates 8/12-13/2015</td></tr><tr><td colspan="2"><div>1. Marker excavated and found to be sound. Light soiling removed by brushing with nylon brushes and water.</div><div>2. Setting area excavated for new below grade cast concrete base sized minimum of 12 inches deep,</div><div>3. Wooden forms stabilized and aligned with adjacent markers before concrete is poured</div><div>4. Setting forms are removed after partial curing of the concrete and the base backfilled with tamped sand or gravel</div><div>5. Setting surfaces primed with acryl 60 diluted 1:3 and marker reset with a cement/lime grout (3/2/9) with 000 sand..</div><div>6. Marker set plumb and level, and braced for minimum of 3 days.</div><div>7. Disturbed areas backfilled with existing topsoil.</div></td></tr></table>		TREATMENT	Treatment Dates 8/12-13/2015	<div>1. Marker excavated and found to be sound. Light soiling removed by brushing with nylon brushes and water.</div> <div>2. Setting area excavated for new below grade cast concrete base sized minimum of 12 inches deep,</div> <div>3. Wooden forms stabilized and aligned with adjacent markers before concrete is poured</div> <div>4. Setting forms are removed after partial curing of the concrete and the base backfilled with tamped sand or gravel</div> <div>5. Setting surfaces primed with acryl 60 diluted 1:3 and marker reset with a cement/lime grout (3/2/9) with 000 sand..</div> <div>6. Marker set plumb and level, and braced for minimum of 3 days.</div> <div>7. Disturbed areas backfilled with existing topsoil.</div>	
TREATMENT	Treatment Dates 8/12-13/2015				
<div>1. Marker excavated and found to be sound. Light soiling removed by brushing with nylon brushes and water.</div> <div>2. Setting area excavated for new below grade cast concrete base sized minimum of 12 inches deep,</div> <div>3. Wooden forms stabilized and aligned with adjacent markers before concrete is poured</div> <div>4. Setting forms are removed after partial curing of the concrete and the base backfilled with tamped sand or gravel</div> <div>5. Setting surfaces primed with acryl 60 diluted 1:3 and marker reset with a cement/lime grout (3/2/9) with 000 sand..</div> <div>6. Marker set plumb and level, and braced for minimum of 3 days.</div> <div>7. Disturbed areas backfilled with existing topsoil.</div>

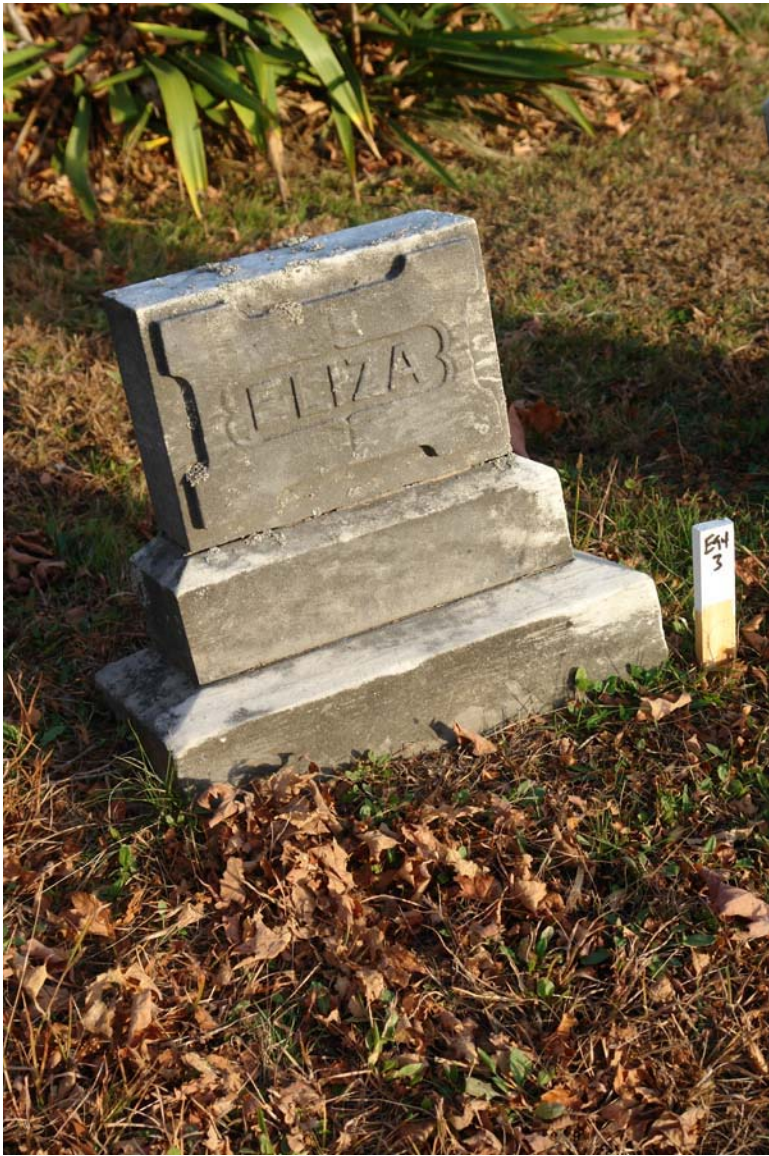
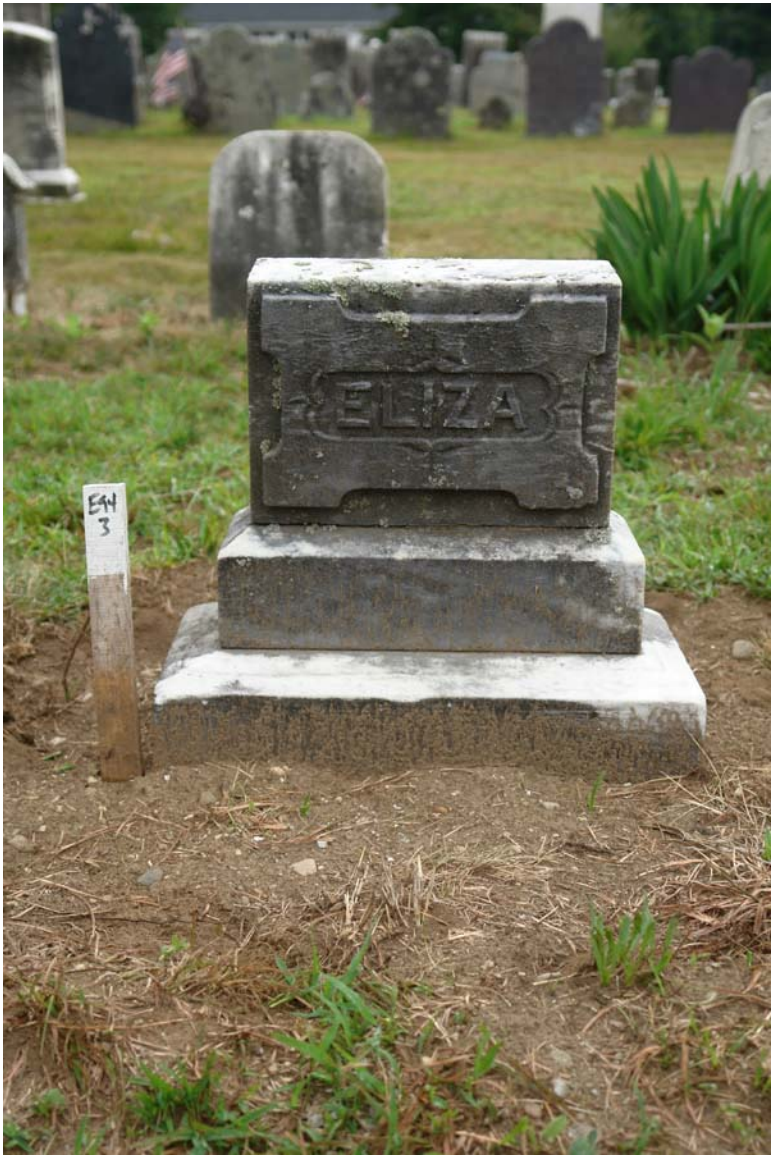
Hanover Center Cemetery, Hanover MA
NAME ON MARKER **Charles (Charles Rose)**
Death Date: Marker Type: Sm marker/base
Cond. of Inscription: Legible Material: Marble

EXISTING CONDITIONS	CONSERVATION STRATEGY
Tilted base	Reset base with marker plumb

TREATMENT	Treatment Dates
1. Elements removed from setting bases and inspected for soundness. 2. Area excavated to an appropriate depth removing any roots or large stones. 3. Base is aligned with adjacent markers and re-set level. 4. Area around base was backfilled with tamped gravel and re-graded with existing topsoil 5. Failed mortar removed from setting area and bottom of marker 6. When required, any existing pins were inspected, and if necessary, replaced with stainless steel threaded pins 7. Setting surfaces primed with Acryl 60 diluted 1:3 with water. 8. Marker reset plumb onto base with cement/lime mortar (3/2/9) with 000 sand. 9. Excess grout removed and joint area cleaned.	8/3-4/2015

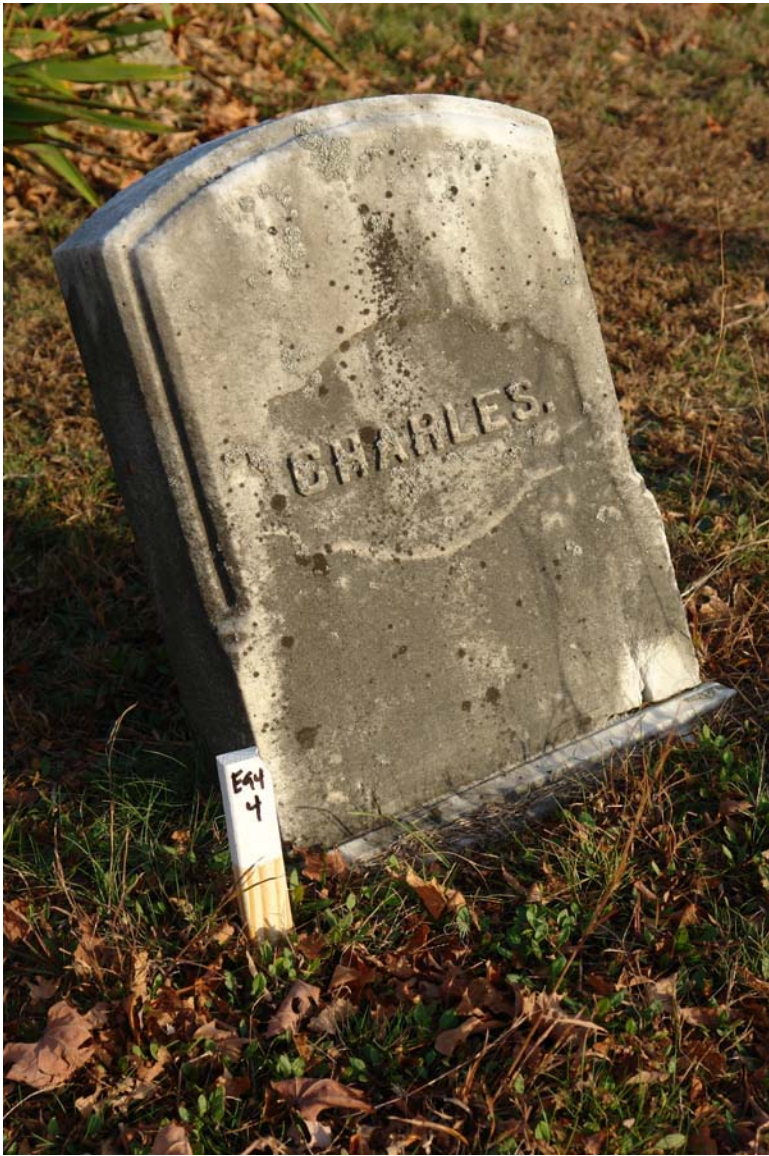
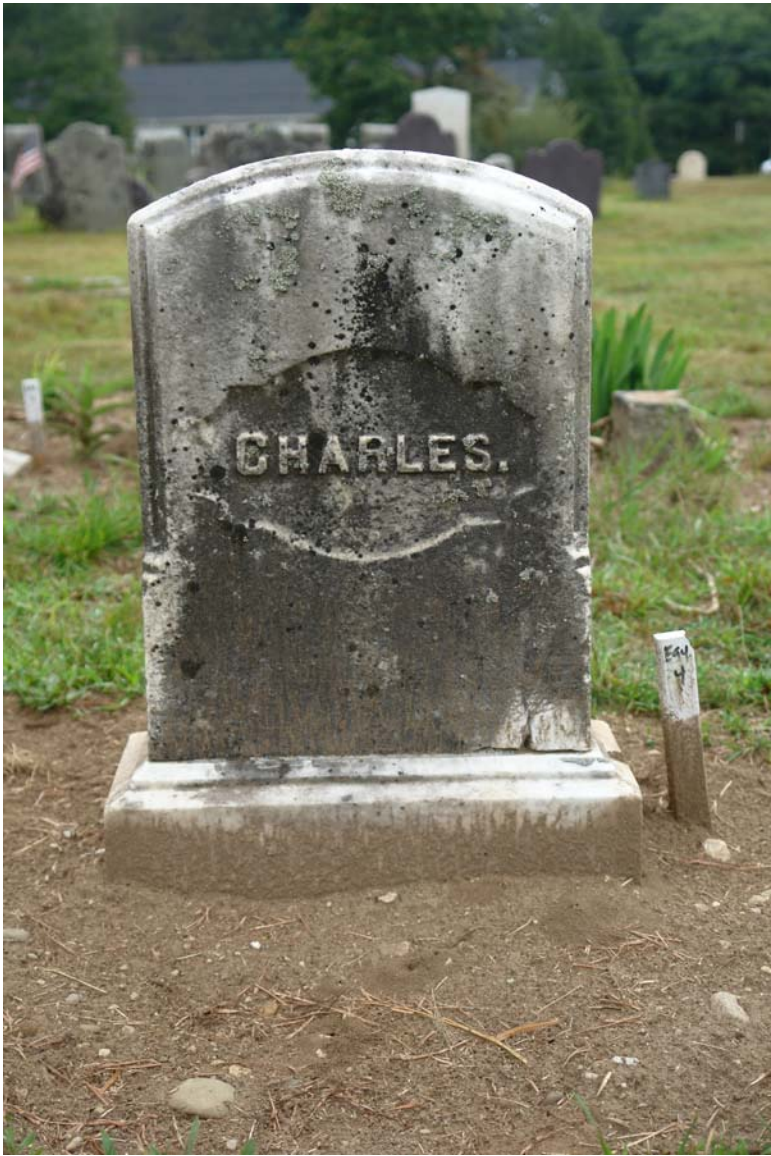
Hanover Center Cemetery, Hanover MA	
NAME ON MARKER	Charles Edwin (Rose)
Death Date:	Marker Type: Sm marker/base
Cond. of Inscription: Legible	Material: Marble

EXISTING CONDITIONS	CONSERVATION STRATEGY
Tilted base	Reset base with marker plumb

TREATMENT	Treatment Dates 8/3/2015
<div>1. Elements removed from setting bases and inspected for soundness.</div> <div>2. Area excavated to an appropriate depth removing any roots or large stones.</div> <div>3. Base is aligned with adjacent markers and re-set level.</div> <div>4. Area around base was backfilled with tamped gravel and re-graded with existing topsoil</div> <div>5. Failed mortar removed from setting area and bottom of marker</div> <div>6. When required, any existing pins were inspected, and if necessary, replaced with stainless steel threaded pins</div> <div>7. Setting surfaces primed with Acryl 60 diluted 1:3 with water.</div> <div>8. Marker reset plumb onto base with cement/lime mortar (3/2/9) with 000 sand.</div> <div>9. Excess grout removed and joint area cleaned.</div>

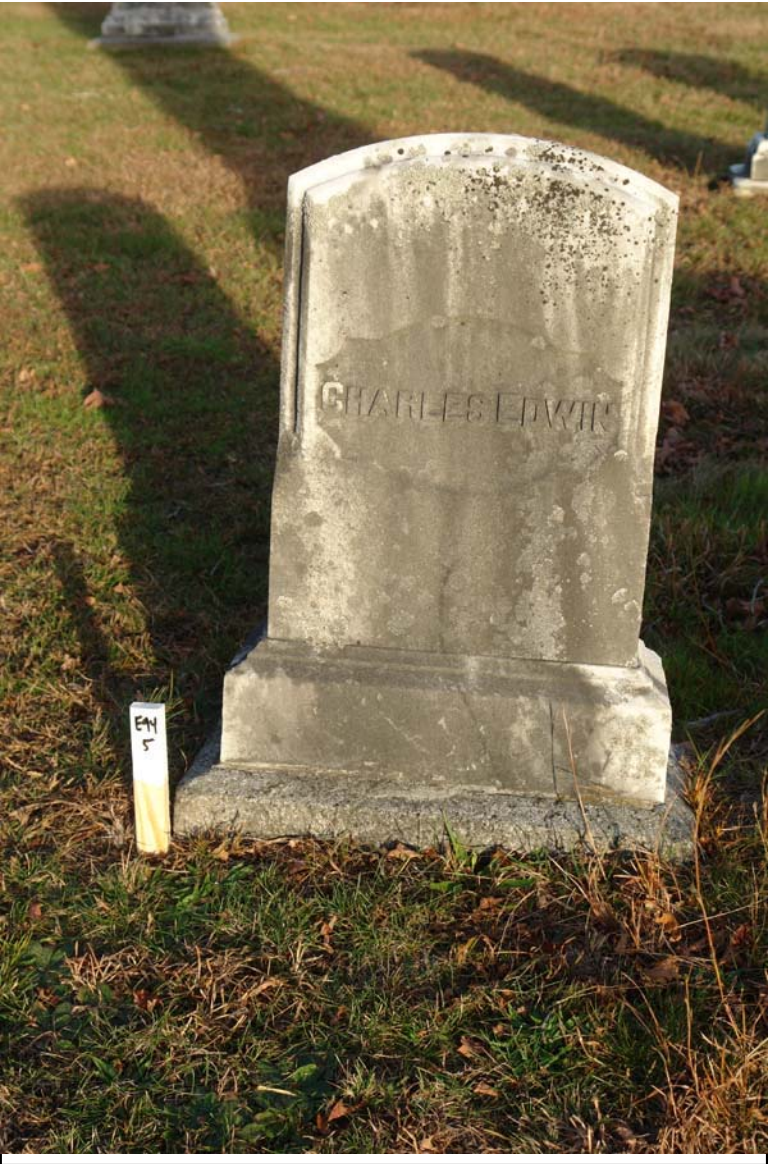
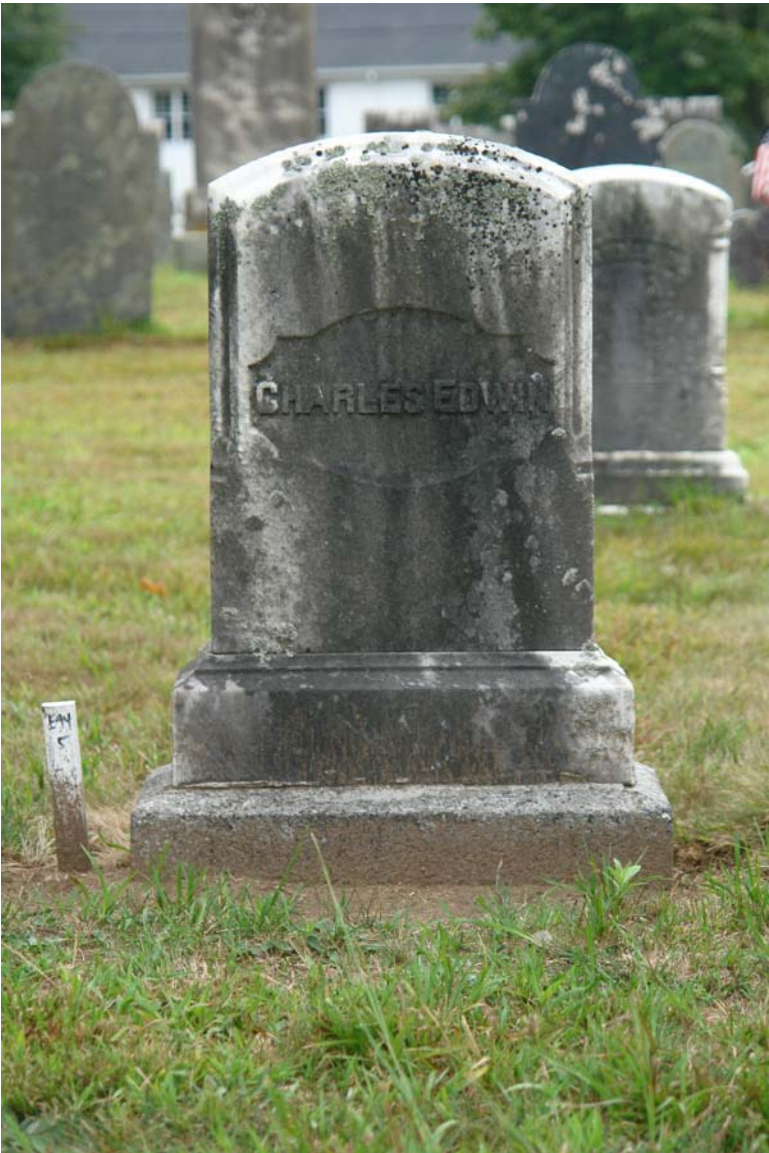
Hanover Center Cemetery, Hanover MA	
NAME ON MARKER	Annie (Chamberlin)
Death Date:	Marker Type: Sm marker/base
Cond. of Inscription: Legible	Material: Marble

EXISTING CONDITIONS	CONSERVATION STRATEGY
Fractures Loose on base	Attach fragments with structural adhesive Reset elements

TREATMENT	Treatment Dates 8/3/2015
<div>1. Elements disassembled and previous repair materials and failed mortar removed from setting surfaces with hand tools.</div> <div>2. In-ground base reset level. Replace setting pins with threaded stainless pins if required.</div> <div>3. Cracks and losses filled with RepliCal Marble or Jahn restoration mortar, misted with water and covered for 3 days min.</div> <div>4. Filled surface areas treated w/ light acid wash, rinsed thoroughly with water.</div> <div>5. Setting surfaces primed with Acryl 60 diluted 1:3 with water.</div> <div>6. Elements reset with 2:1:9 cementitious high cal lime mortar using fine (00 or 000) sand.</div> <div>7. Excess mortar removed from joints and braced for a min 3 days</div>

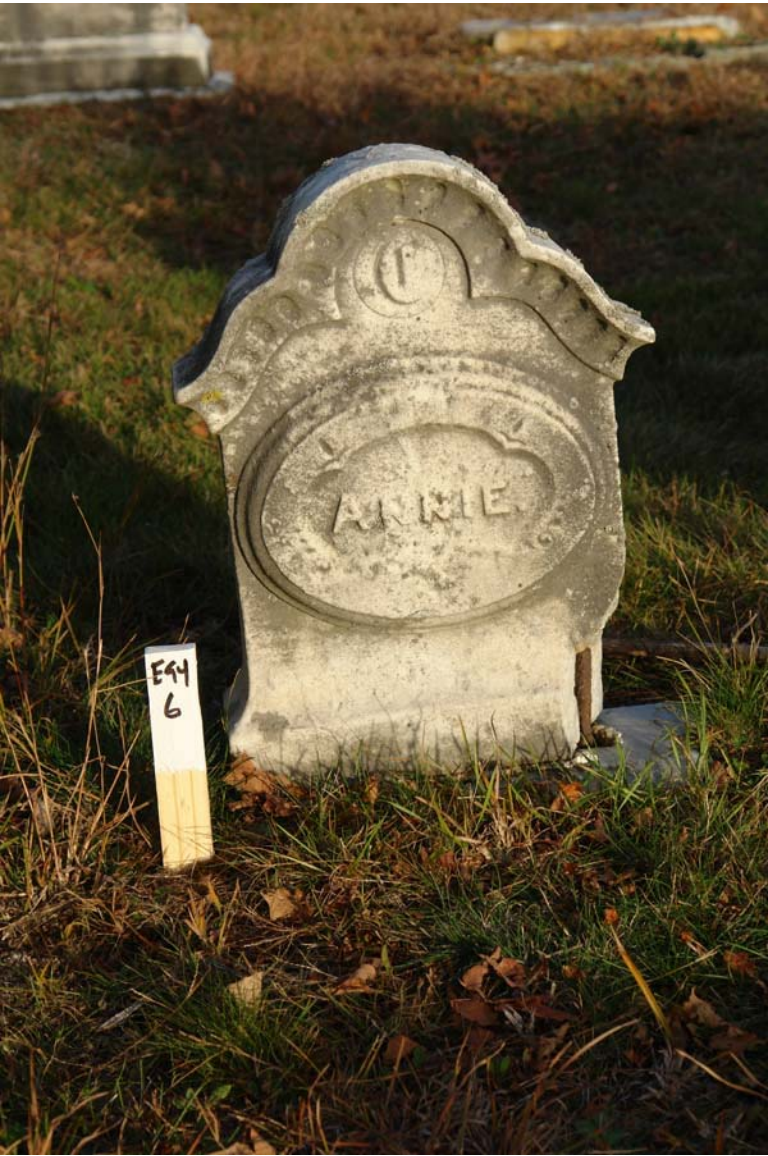
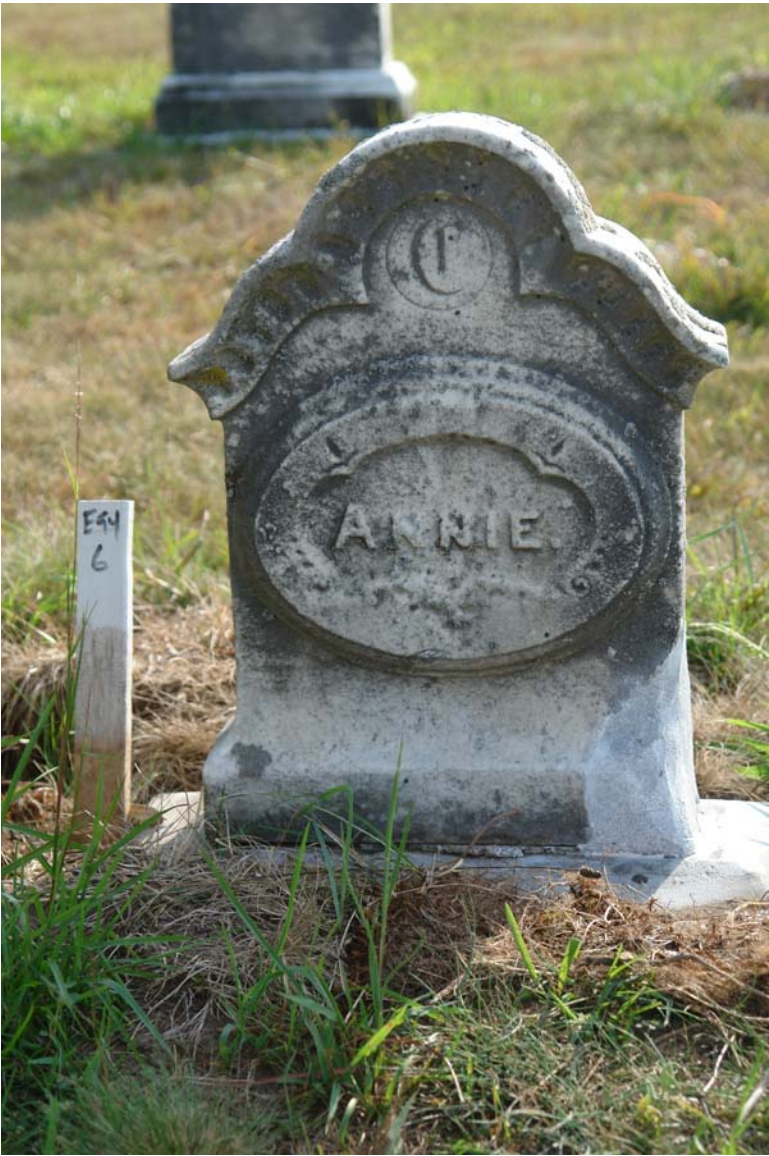
NAME ON MARKER **Ann Rose**

EXISTING CONDITIONS	CONSERVATION STRATEGY
Tilted base	Reset base with marker plumb

Comments: **Shrubs to be removed**

TREATMENT	Treatment Dates
1. Overgrowth removed by DPW 2. Elements removed from setting bases and area excavated to an appropriate depth removing any roots or large stones. 3. Base is aligned with adjacent markers and re-set level. 4. Area around base was backfilled with tamped gravel and re-graded with existing topsoil 5. Failed mortar removed from setting area and bottom of marker 6. When required, any existing pins were inspected, and if necessary, replaced with stainless steel threaded pins 7. Setting surfaces primed with Acryl 60 diluted 1:3 with water. 8. Marker reset plumb onto base with cement/lime mortar (3/2/9) with 000 sand. 9. Excess grout removed and joint area cleaned. 10. All surfaces treated with D/2 Biological Solution, scrubbed with nylon brushes and water. Rinsed fully with water	8/3/2015

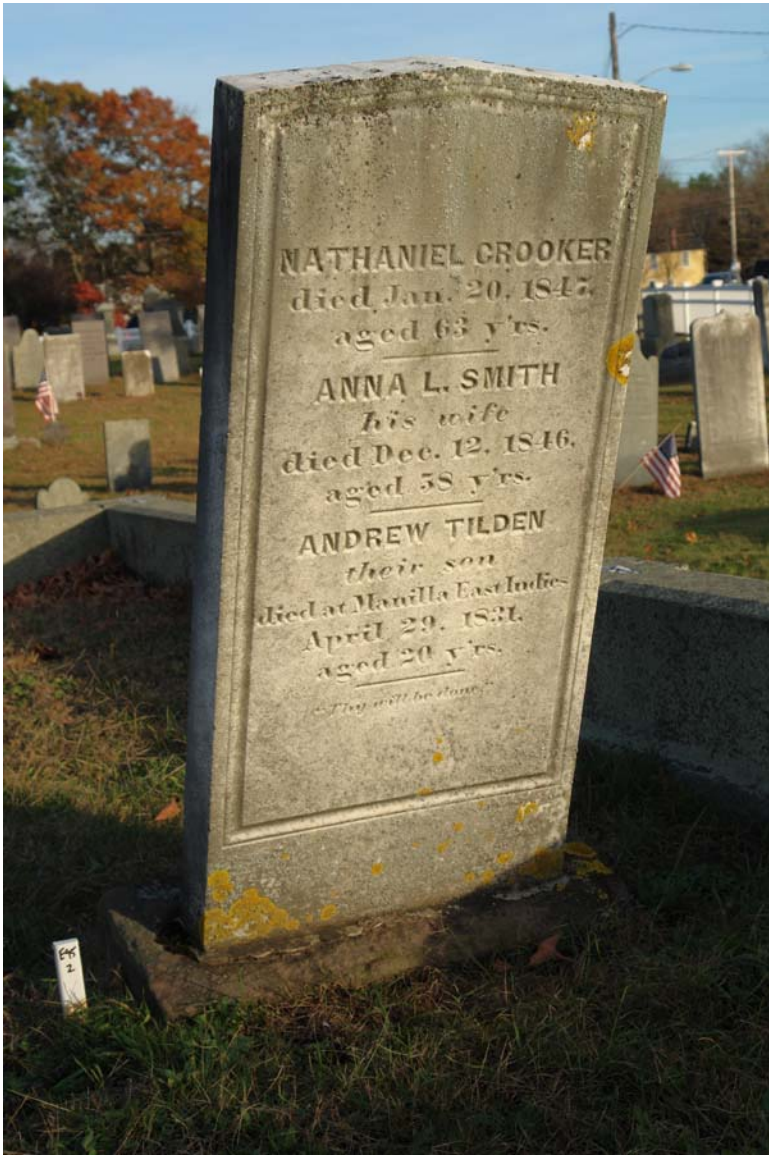
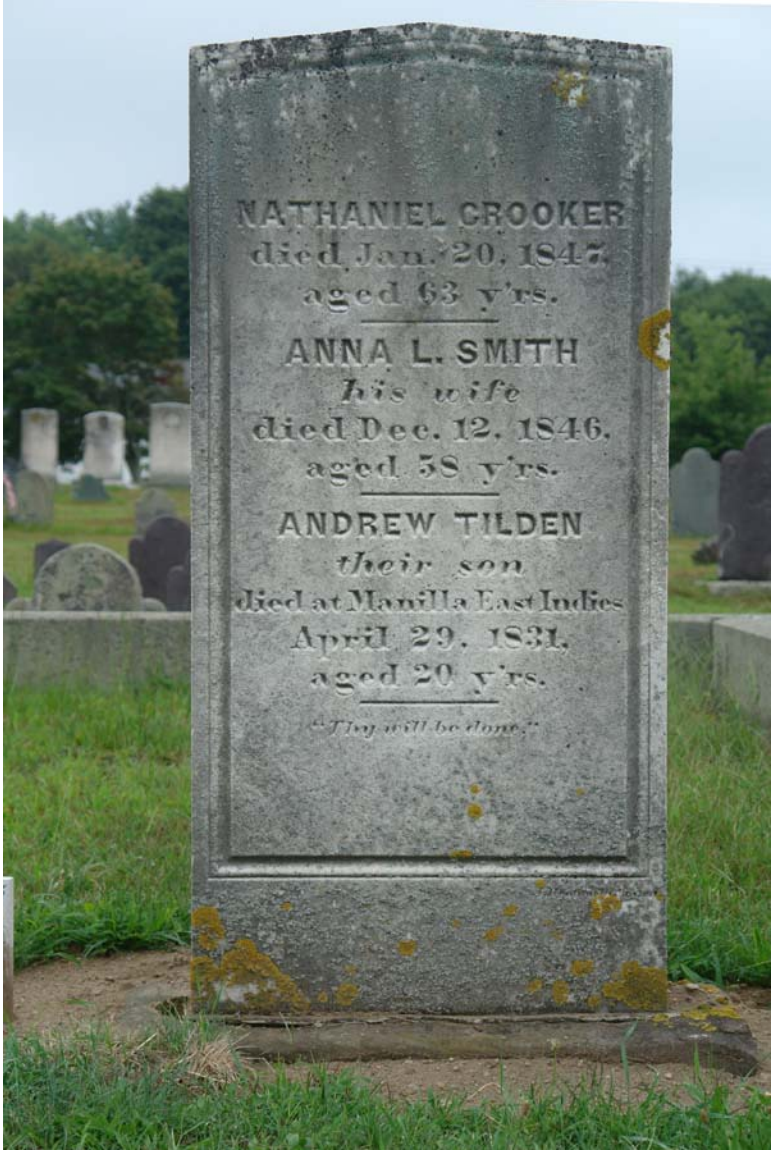
Hanover Center Cemetery, Hanover MA
NAME ON MARKER **Perez Perry**
Death Date: 3/5/1855 Marker Type: Headstone/pinned base
Cond. of Inscription: Legible Material: Marble

EXISTING CONDITIONS	CONSERVATION STRATEGY
Tilted base	Reset base with marker plumb

TREATMENT	Treatment Dates
1. Elements removed from setting bases and inspected for soundness. 2. Area excavated to an appropriate depth removing any roots or large stones. 3. Base is aligned with adjacent markers and re-set level. 4. Area around base was backfilled with tamped gravel and re-graded with existing topsoil 5. Failed mortar removed from setting area and bottom of marker 6. When required, any existing pins were inspected, and if necessary, replaced with stainless steel threaded pins 7. Setting surfaces primed with Acryl 60 diluted 1:3 with water. 8. Marker reset plumb onto base with cement/lime mortar (3/2/9) with 000 sand. 9. Excess grout removed and joint area cleaned.	8/4/2015

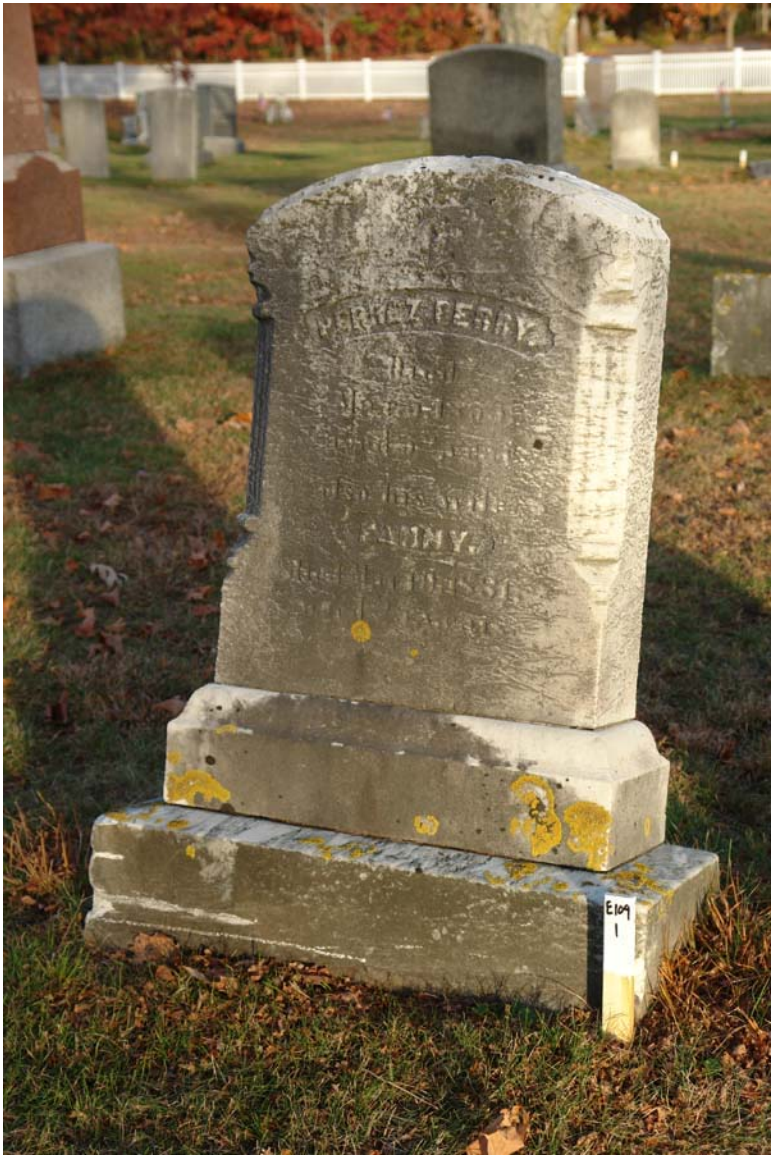
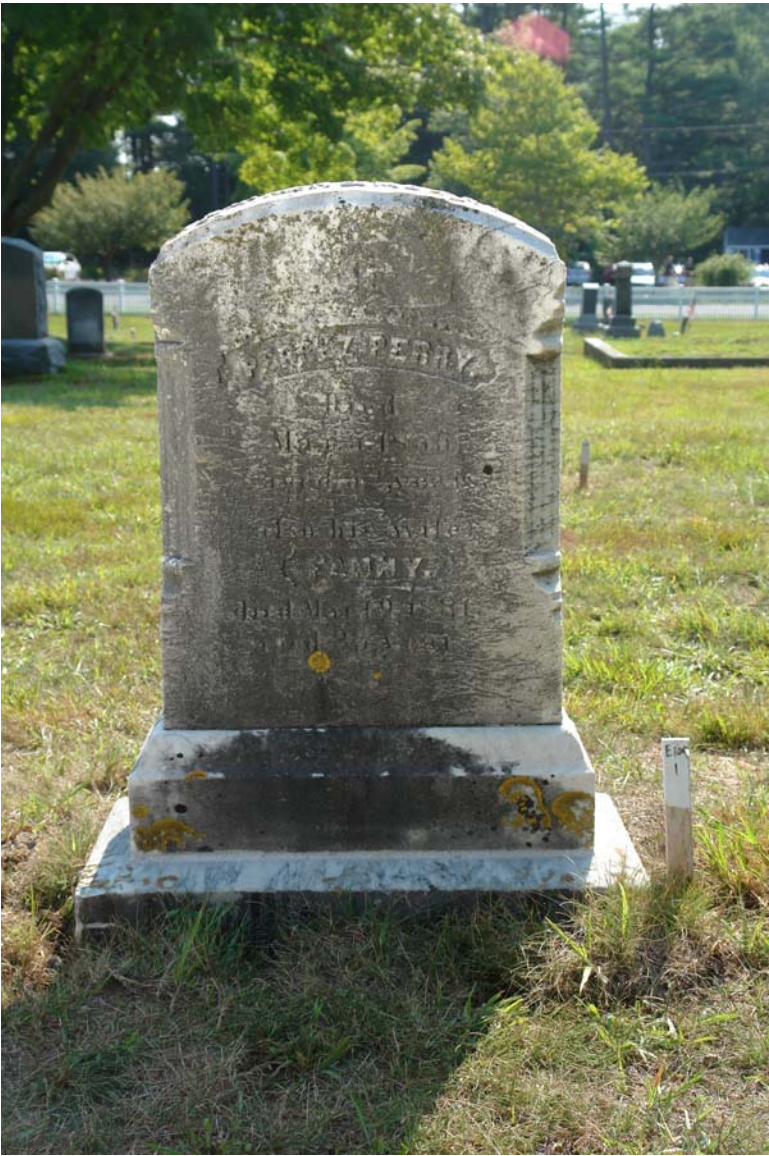
Hanover Center Cemetery, Hanover MA
NAME ON MARKER **Perez E. Perry**
Death Date: 1905 Marker Type: Headstone/pinned base
Cond. of Inscription: Legible Material: Granite

EXISTING CONDITIONS	CONSERVATION STRATEGY
Tilted base	Reset base with marker plumb

TREATMENT	Treatment Dates
	8.4/2015
<div>1. Elements removed from setting bases and inspected for soundness.</div> <div>2. Area excavated to an appropriate depth removing any roots or large stones.</div> <div>3. Base is aligned with adjacent markers and re-set level.</div> <div>4. Area around base was backfilled with tamped gravel and re-graded with existing topsoil</div> <div>5. Failed mortar removed from setting area and bottom of marker</div> <div>6. When required, any existing pins were inspected, and if necessary, replaced with stainless steel threaded pins</div> <div>7. Setting surfaces primed with Acryl 60 diluted 1:3 with water.</div> <div>8. Marker reset plumb onto base with cement/lime mortar (3/2/9) with 000 sand.</div> <div>9. Excess grout removed and joint area cleaned.</div>

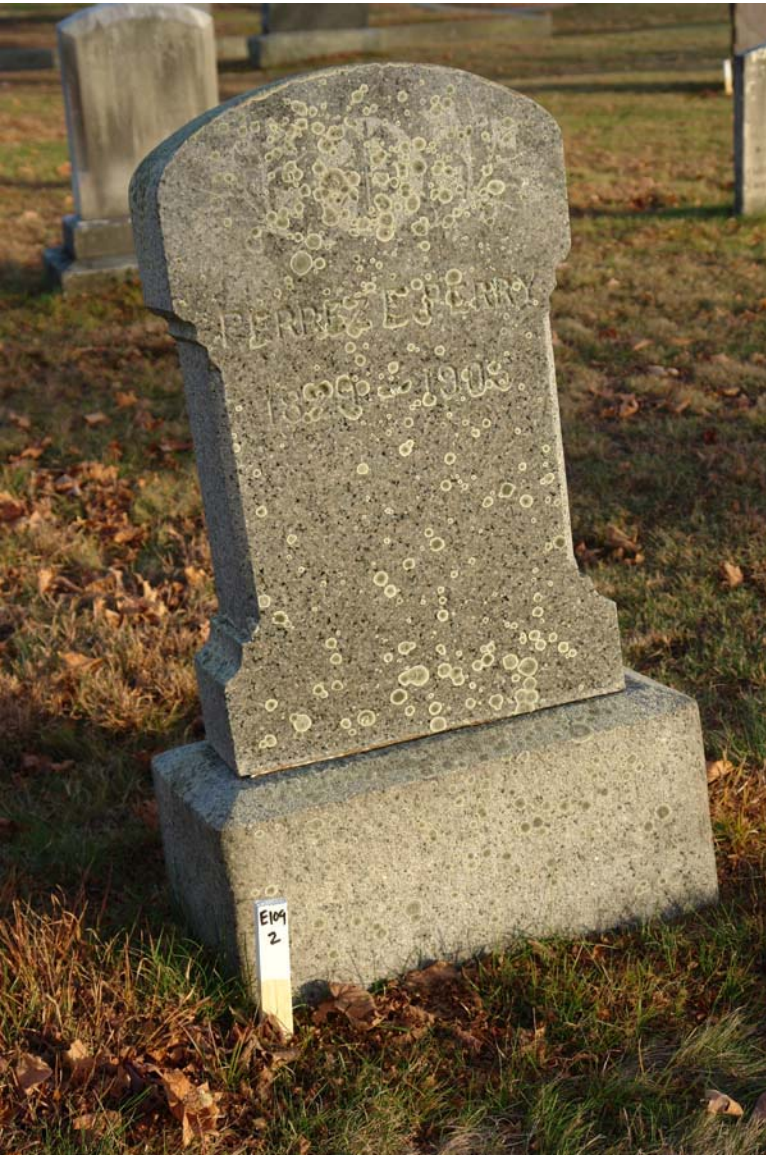
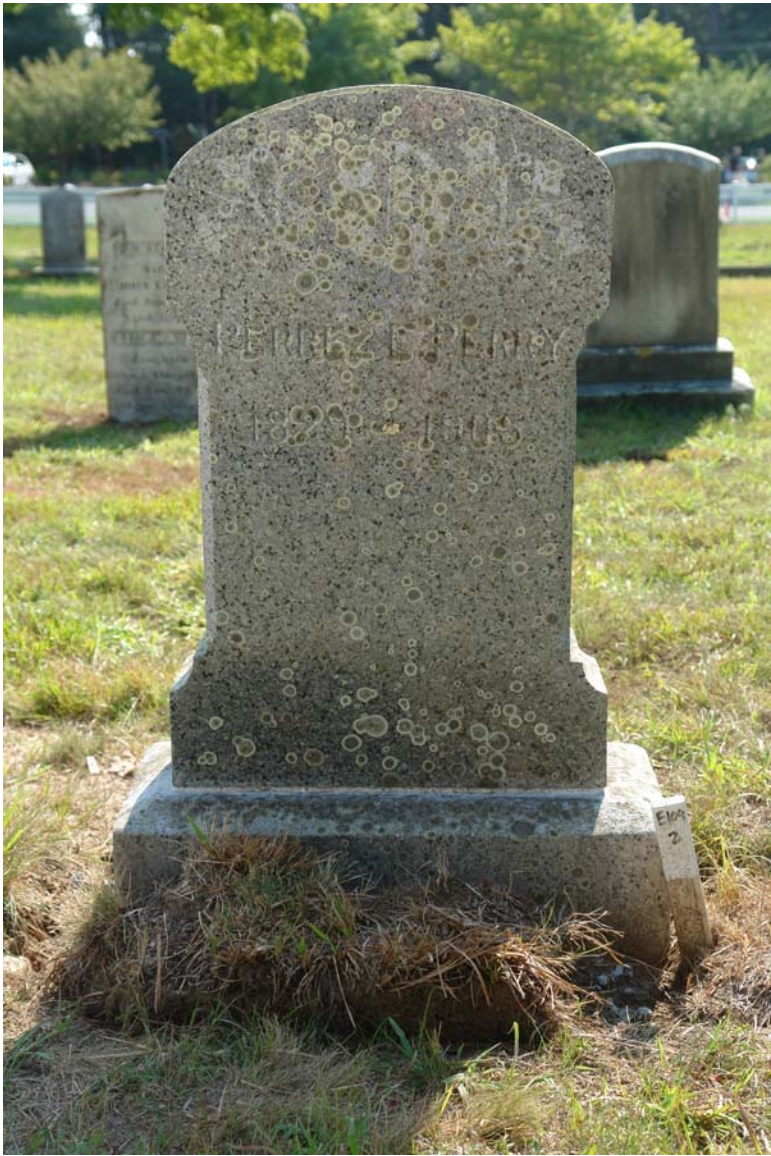
Hanover Center Cemetery, Hanover MA	
NAME ON MARKER	Abigail Little
Death Date: 6/5/1850	Marker Type: Headstone
Cond. of Inscription: Legible	Material: Marble
EXISTING CONDITIONS	CONSERVATION STRATEGY
Fallen	Reset into new below grade concrete base
TREATMENT	
Treatment Dates 8/12-13/2015	
<div>1. Existing base located below grade while excavating for resetting. Area excavated to an appropriate depth removing any roots or large stones.</div> <div>2. Base inspected and found to be sound and re-useable</div> <div>3. Base is aligned with adjacent markers and re-set level.</div> <div>4. Area around base was backfilled with tamped gravel and re-graded with existing topsoil</div> <div>5. Debris removed from setting slot. When required, power grinders were used to facilitate removal of stone fragments.</div> <div>6. When required, the lower setting edge was re-squared by power grinder with minimal loss.</div> <div>7. Marker reset plumb and level into setting slot with cement/lime grout (3/2/9) with 000 sand made fluid with a super plasticizer.</div> <div>8. Excess grout removed and joint area cleaned.</div> <div>9. Marker braced for a minimum 3 days</div>
