MONUMENT CONSERVATION COLLABORATIVE LLC, NORFOLK, CT

DOCUMENTATION OF STONE CONSERVATION TREATMENTS TO ASSINIPPI CEMETERY, HANOVER, MA June 2015

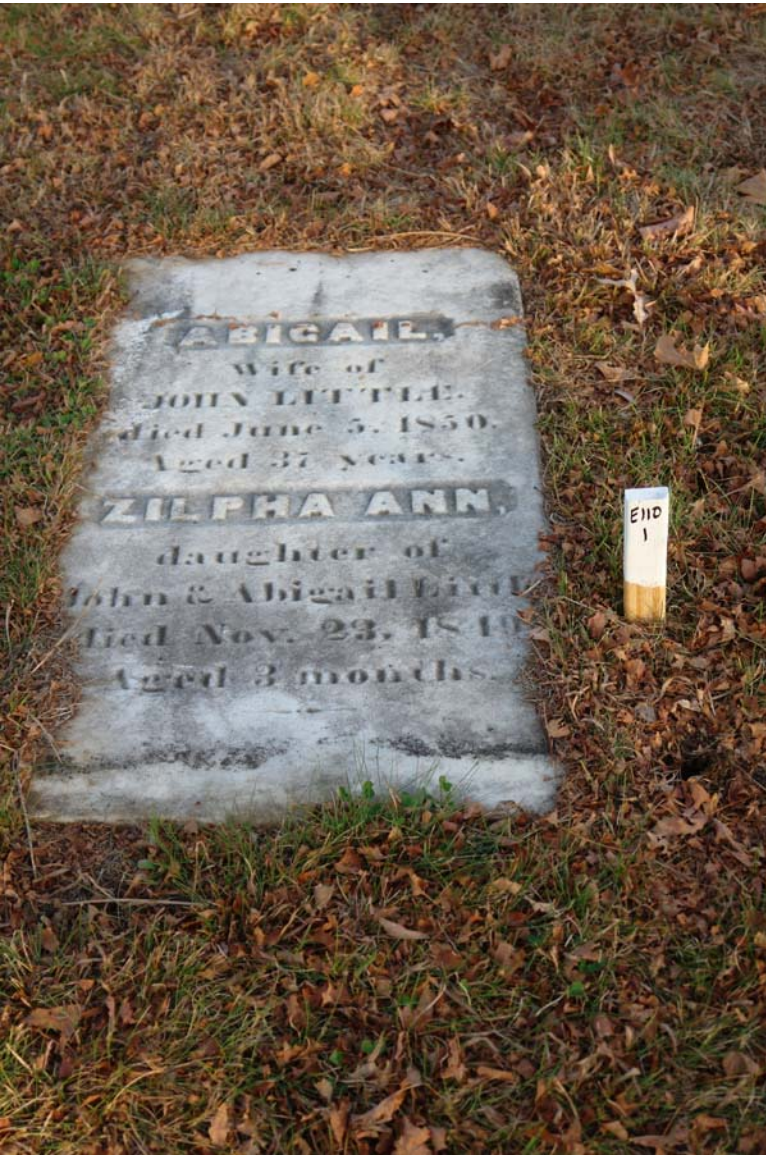
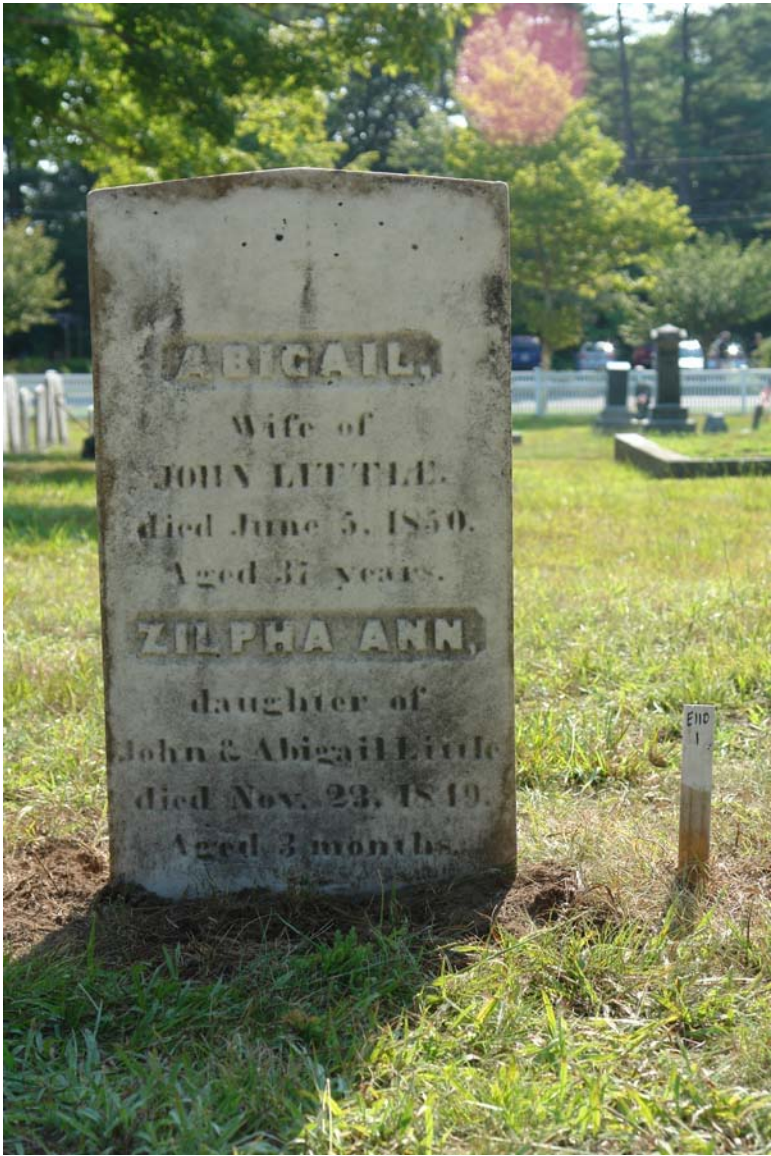
Hanover Center Cemetery, Hanover MA
NAME ON MARKER **Henry Allen**
Death Date: 1/19/1902 Marker Type: Headstone/pinned base
Cond. of Inscription: Legible Material: Marble

EXISTING CONDITIONS	CONSERVATION STRATEGY
Tilted base	Reset base with marker plumb

TREATMENT	Treatment Dates
1. Elements removed from setting bases and inspected for soundness. 2. Area excavated to an appropriate depth removing any roots or large stones. 3. Base is aligned with adjacent markers and re-set level. 4. Area around base was backfilled with tamped gravel and re-graded with existing topsoil 5. Failed mortar removed from setting area and bottom of marker 6. When required, any existing pins were inspected, and if necessary, replaced with stainless steel threaded pins 7. Setting surfaces primed with Acryl 60 diluted 1:3 with water. 8. Marker reset plumb onto base with cement/lime mortar (3/2/9) with 000 sand. 9. Excess grout removed and joint area cleaned.	9/1/2015

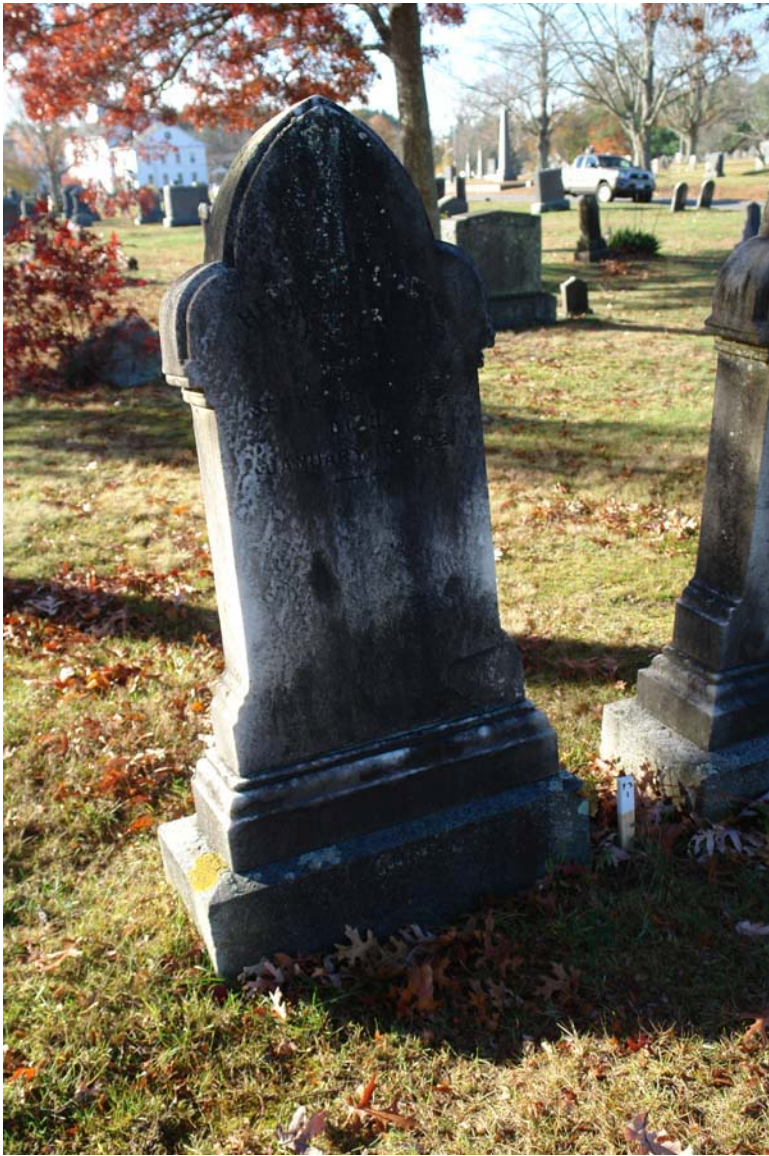
Hanover Center Cemetery, Hanover MA
NAME ON MARKER **Father (Horace Robbins)**
Death Date: Marker Type: Small marker
Cond. of Inscription: Legible Material: Granite

EXISTING CONDITIONS	CONSERVATION STRATEGY
Tilted base	Reset base with marker plumb

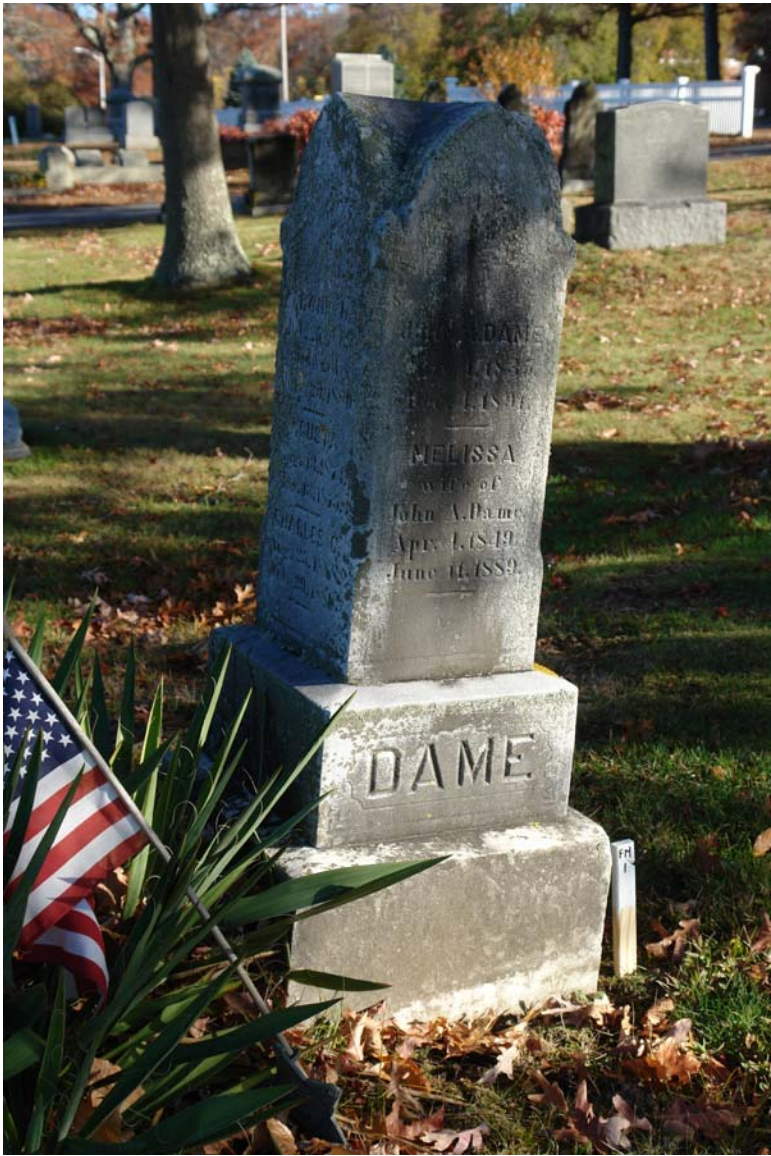
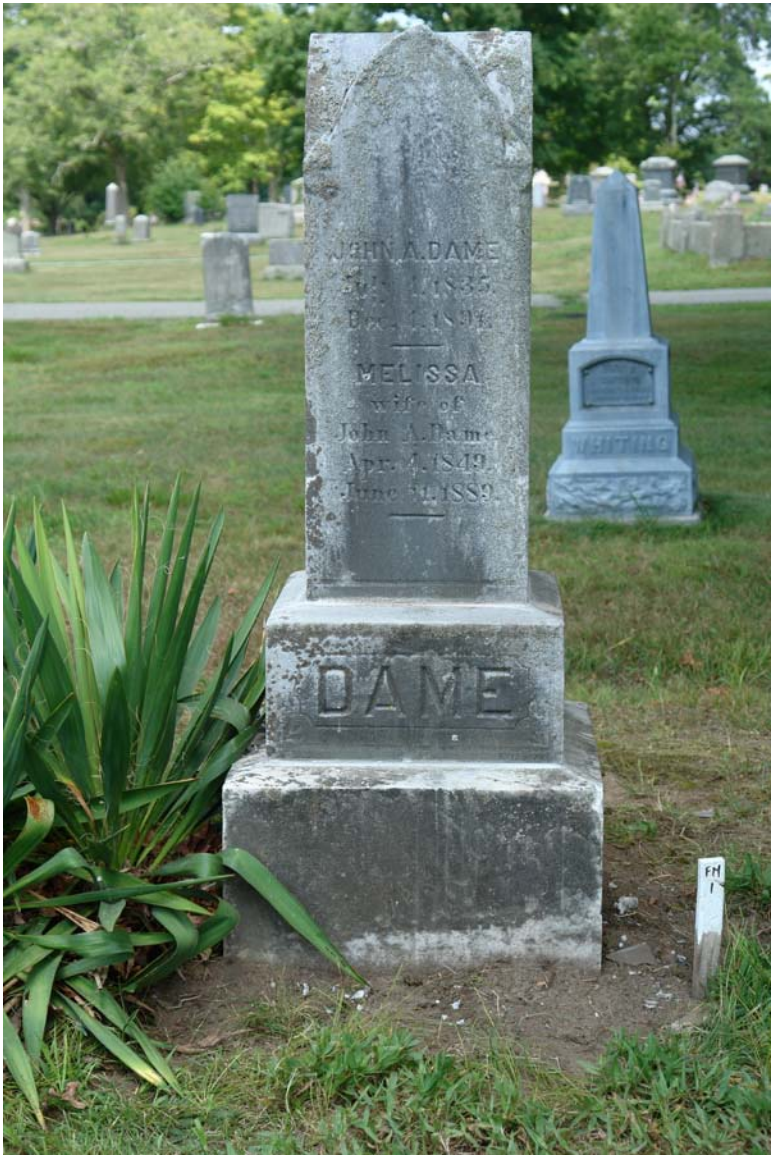
Hanover Center Cemetery, Hanover MA	
NAME ON MARKER	John Dame
Death Date: 12/4/1891	Marker Type: Monument
Cond. of Inscription: Legible	Material: Marble
EXISTING CONDITIONS	CONSERVATION STRATEGY
Tilted	Reset plumb
TREATMENT	
Treatment Dates 8/25/2015	
<div>1. Elements removed from setting bases and inspected for soundness.</div> <div>2. Area excavated to an appropriate depth removing any roots or large stones.</div> <div>3. Base is aligned with adjacent markers and re-set level.</div> <div>4. Area around base was backfilled with tamped gravel and re-graded with existing topsoil</div> <div>5. Failed mortar removed from setting area and bottom of marker</div> <div>6. When required, any existing pins were inspected, and if necessary, replaced with stainless steel threaded pins</div> <div>7. Setting surfaces primed with Acryl 60 diluted 1:3 with water.</div> <div>8. Marker reset plumb onto base with cement/lime mortar (3/2/9) with 000 sand.</div> <div>9. Excess grout removed and joint area cleaned.</div>

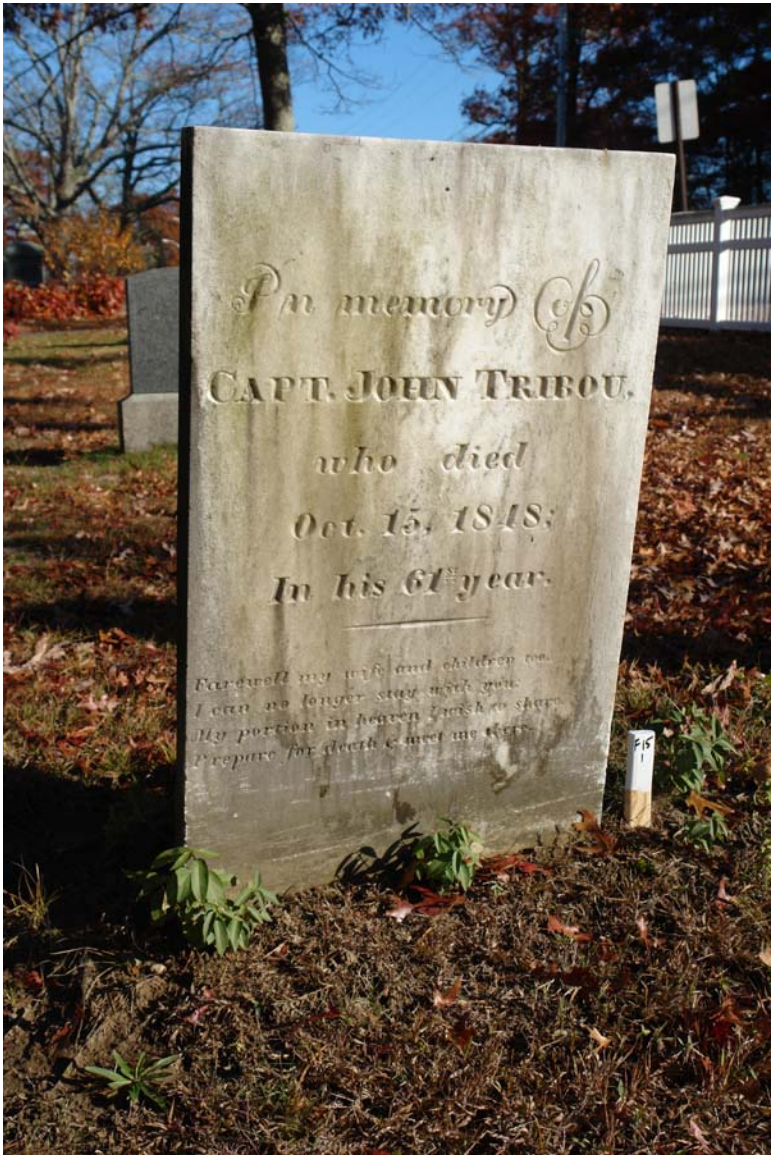
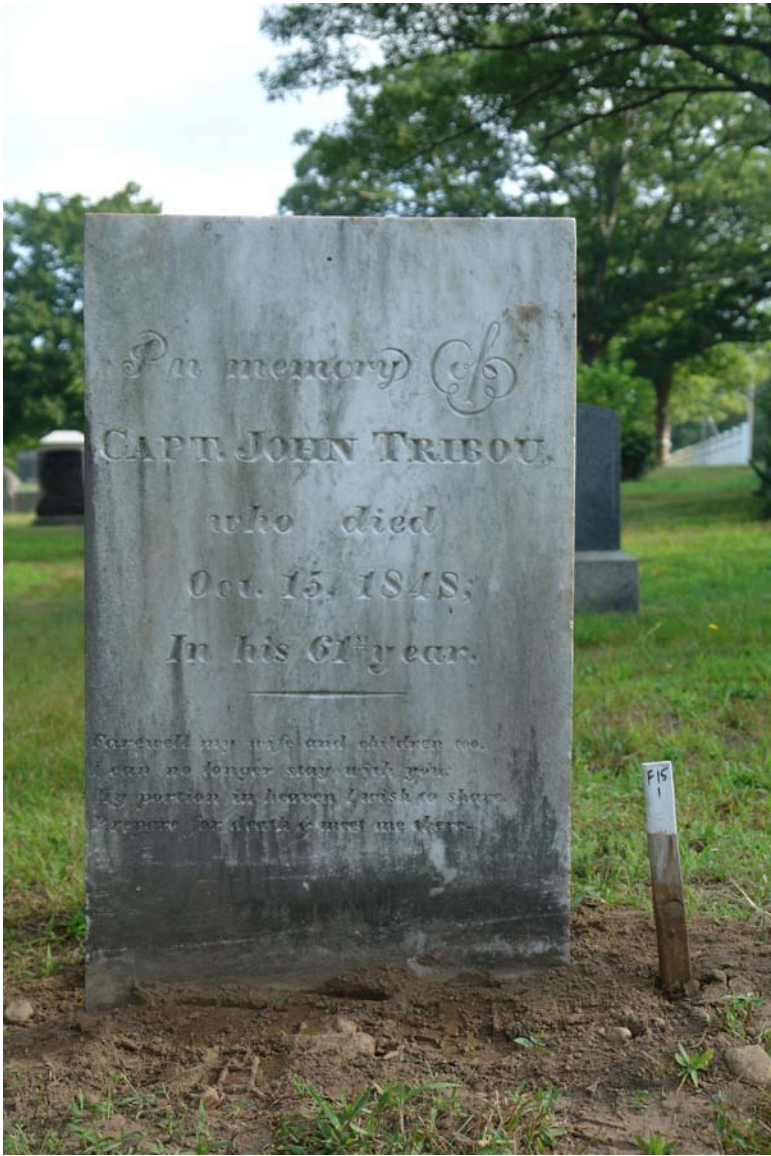
Height 38 Width 12 Thickness 12 Marker# F.14

Hanover Center Cemetery, Hanover MA	
NAME ON MARKER	Capt John Tribou
Death Date: 10/15/1848	Marker Type: Headstone/base
Cond. of Inscription: Legible	Material: Marble
EXISTING CONDITIONS	CONSERVATION STRATEGY
Loose in base	Evaluate resetting options Possible new below grade concrete base
TREATMENT	
Treatment Dates 8/17/2015	
<div>1. Existing base located below grade while excavating for resetting. Area excavated to an appropriate depth removing any roots or large stones.</div> <div>2. Base inspected and found to be sound and re-useable</div> <div>3. Base is aligned with adjacent markers and re-set level.</div> <div>4. Area around base was backfilled with tamped gravel and re-graded with existing topsoil</div> <div>5. Debris removed from setting slot. When required, power grinders were used to facilitate removal of stone fragments.</div> <div>6. When required, the lower setting edge was re-squared by power grinder with minimal loss.</div> <div>7. Marker reset plumb and level into setting slot with cement/lime grout (3/2/9) with 000 sand made fluid with a super plasticizer.</div> <div>8. Excess grout removed and joint area cleaned.</div> <div>9. Marker braced for a minimum 3 days</div>

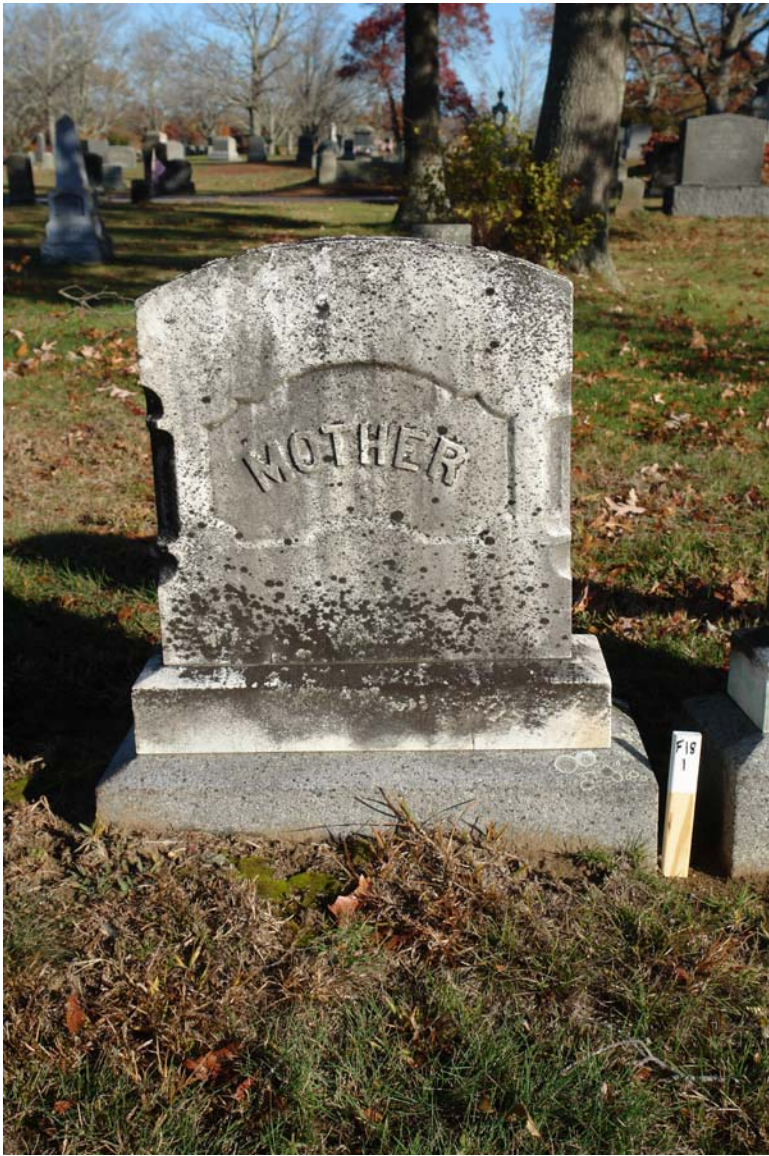
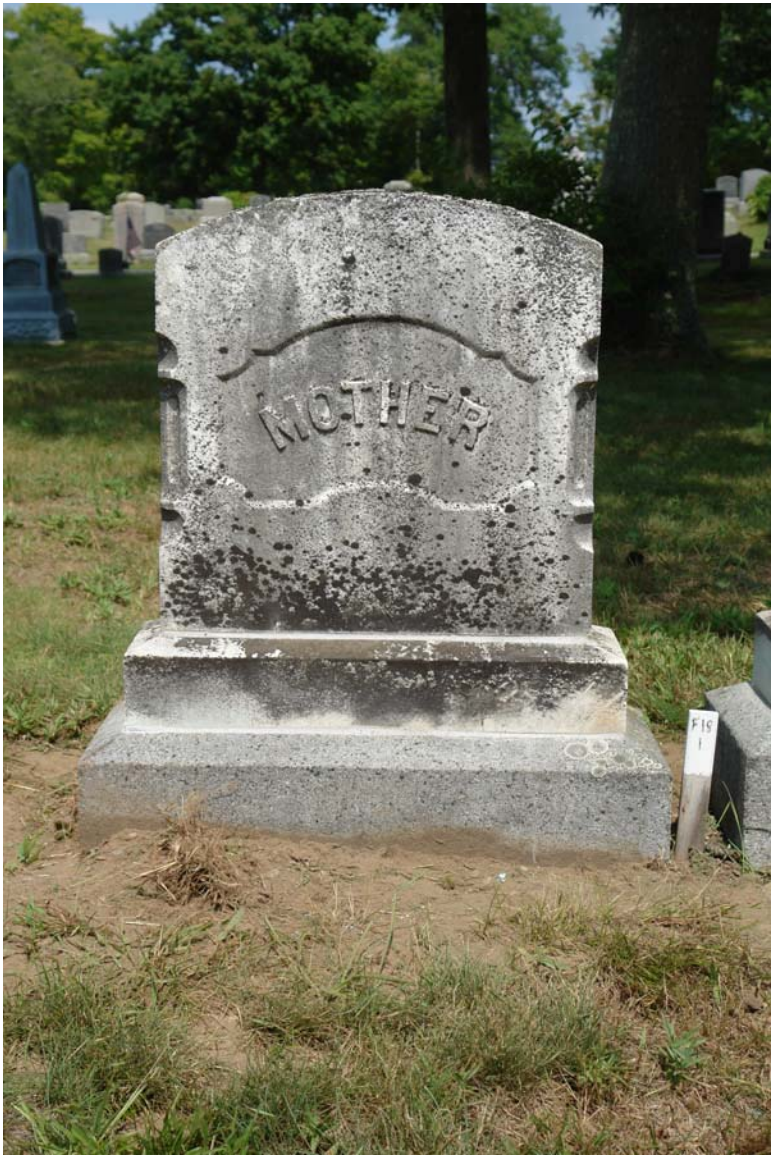
Height 34 Width 21.5 Thickness 2 Marker# F.15

Hanover Center Cemetery, Hanover MA
NAME ON MARKER **Mother (Eunice Leavitt)**
Death Date: Marker Type: Sm marker/pinned base
Cond. of Inscription: Legible Material: Marble

EXISTING CONDITIONS	CONSERVATION STRATEGY
Tilted Loose on base	Reset base level Reset elements

TREATMENT	Treatment Dates
1. . Elements removed from setting bases and inspected for soundness. 2. Area excavated to an appropriate depth removing any roots or large stones. 3. Base is aligned with adjacent markers and re-set level. 4. Area around base was backfilled with tamped gravel and re-graded with existing topsoil 5. Failed mortar removed from setting area and bottom of marker 6. When required, any existing pins were inspected, and if necessary, replaced with stainless steel threaded pins 7. Setting surfaces primed with Acryl 60 diluted 1:3 with water. 8. Marker reset plumb onto base with cement/lime mortar (3/2/9) with 000 sand. 9. Excess grout removed and joint area cleaned.	8/17/2015

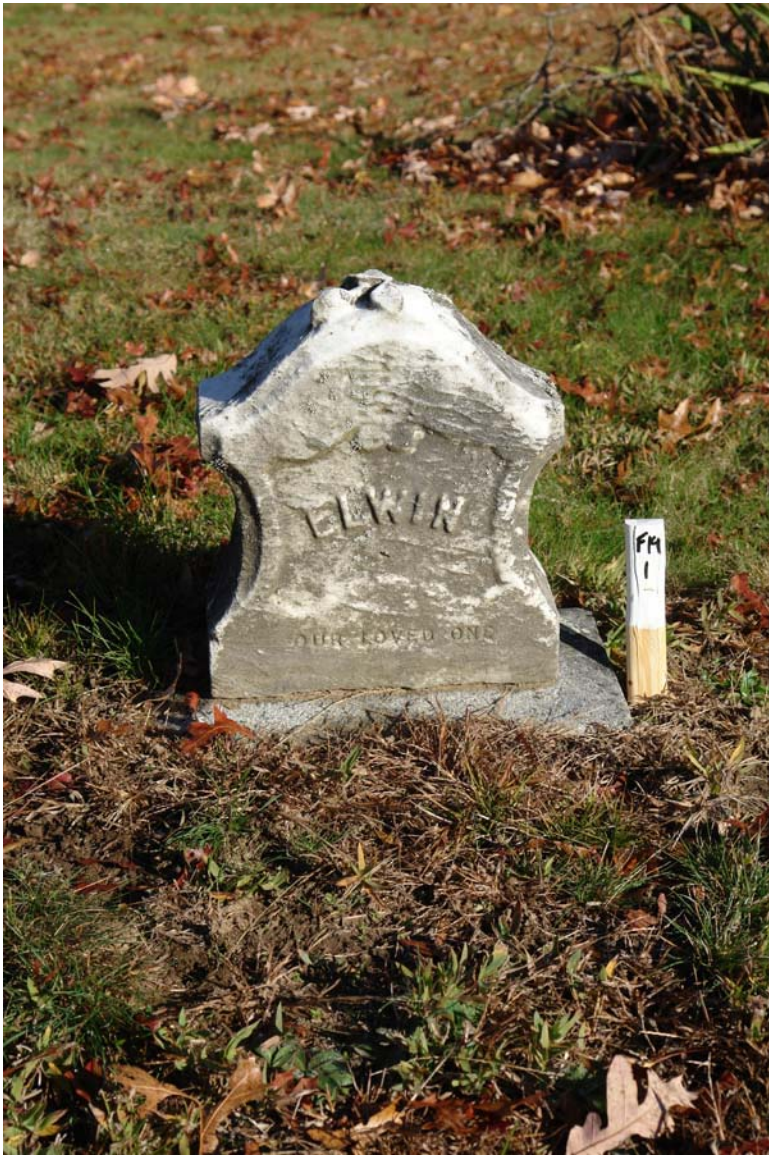
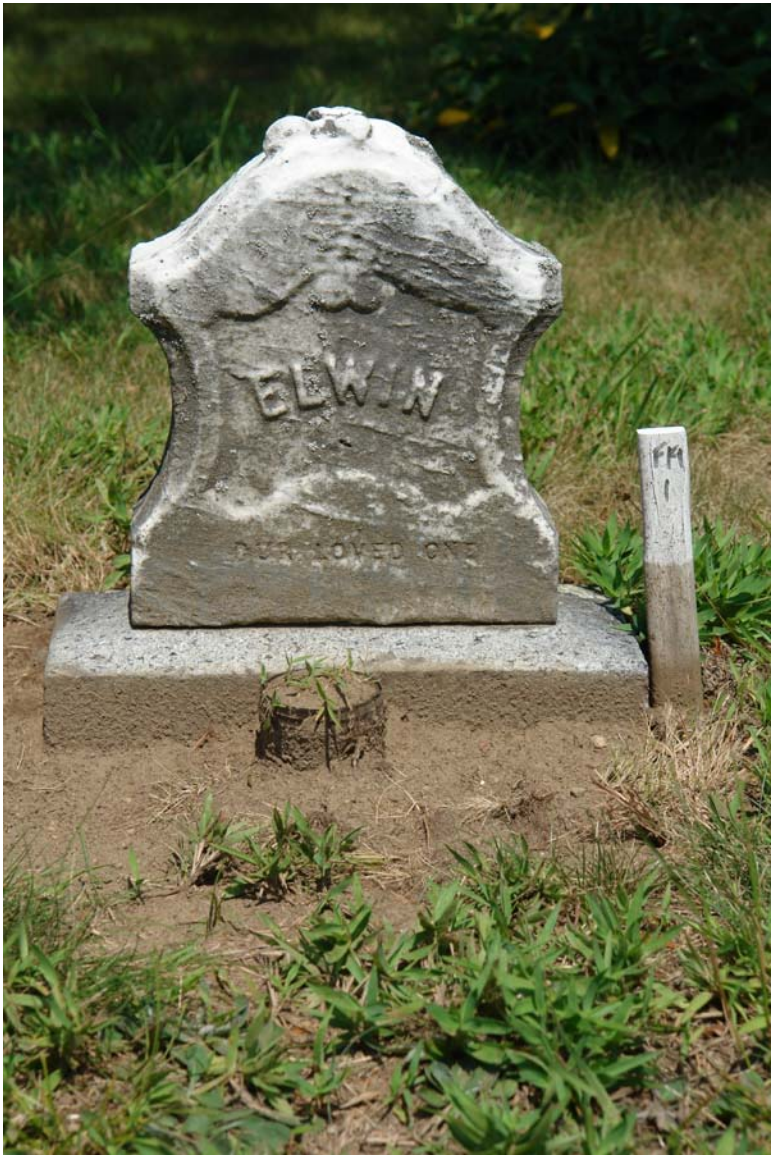
Hanover Center Cemetery, Hanover MA
NAME ON MARKER **Elwin (James Thayer)**
Death Date: Marker Type: Sm marker/base
Cond. of Inscription: Legible Material: Marble

EXISTING CONDITIONS	CONSERVATION STRATEGY
Tilted base	Reset base with marker plumb

TREATMENT	Treatment Dates
1. Marker and base found to be in sound condition with marker securely attached to base. 2. Area excavated to an appropriate depth removing any roots or large stones. 3. Base is aligned with adjacent markers and re-set level. 4. Area around base was backfilled with tamped gravel and re-graded with existing topsoil	8/13/2015

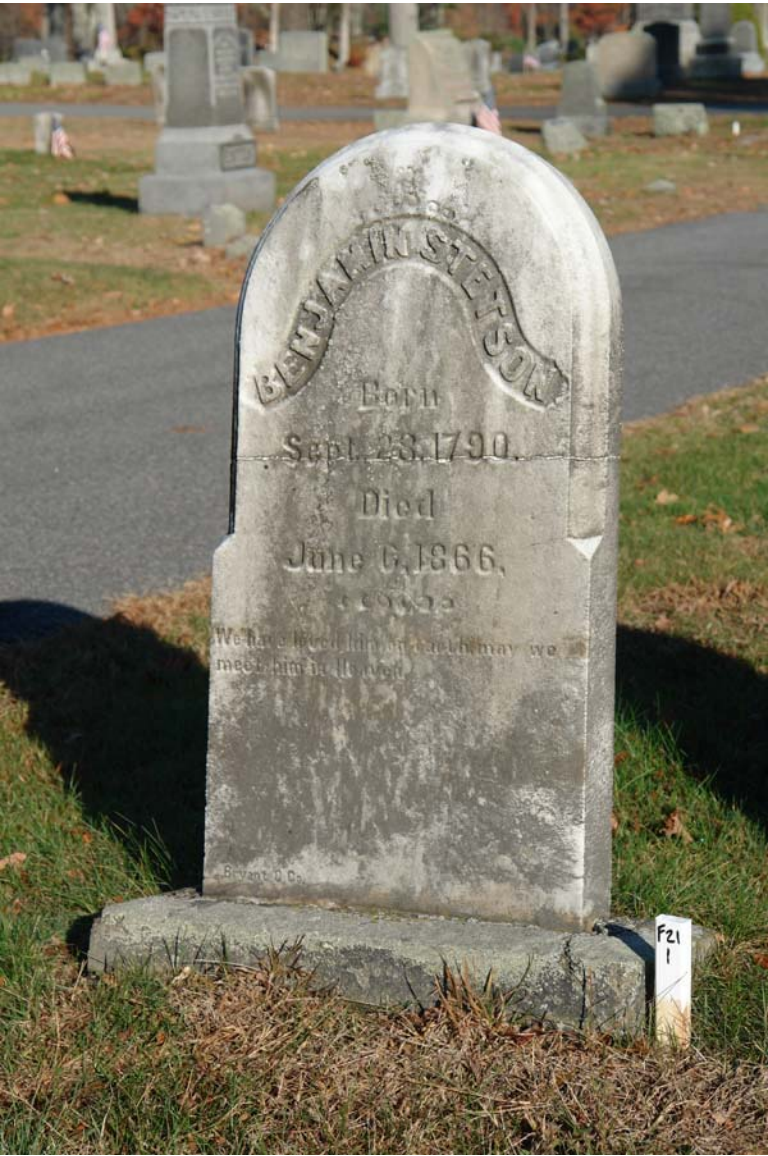
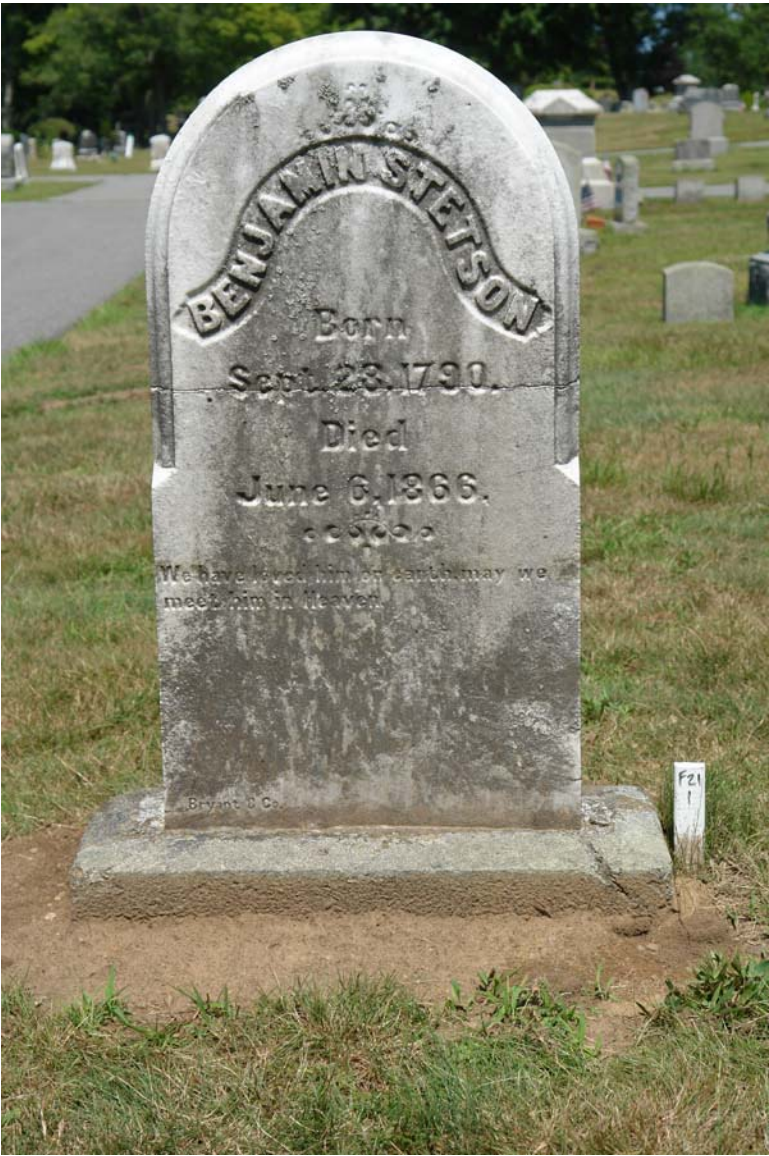
Hanover Center Cemetery, Hanover MA	
NAME ON MARKER	Benjamin Stetson
Death Date: 6/6/1866	Marker Type: Headstone/base
Cond. of Inscription: Legible	Material: Marble
EXISTING CONDITIONS	CONSERVATION STRATEGY
Tilted base	Reset base with marker plumb
TREATMENT	
Treatment Dates 8/13/2015	
<div>1. Area excavated to an appropriate depth removing any roots or large stones.</div> <div>2. Base inspected and found to be sound and re-useable</div> <div>3. Base is aligned with adjacent markers and re-set level.</div> <div>4. Area around base was backfilled with tamped gravel and re-graded with existing topsoil</div> <div>5. Debris removed from setting slot. When required, power grinders were used to facilitate removal of stone fragments.</div> <div>6. When required, the lower setting edge was re-squared by power grinder with minimal loss.</div> <div>7. Marker reset plumb and level into setting slot with cement/lime grout (3/2/9) with 000 sand made fluid with a super plasticizer.</div> <div>8. Excess grout removed and joint area cleaned.</div> <div>9. Marker braced for a minimum 3 days</div>

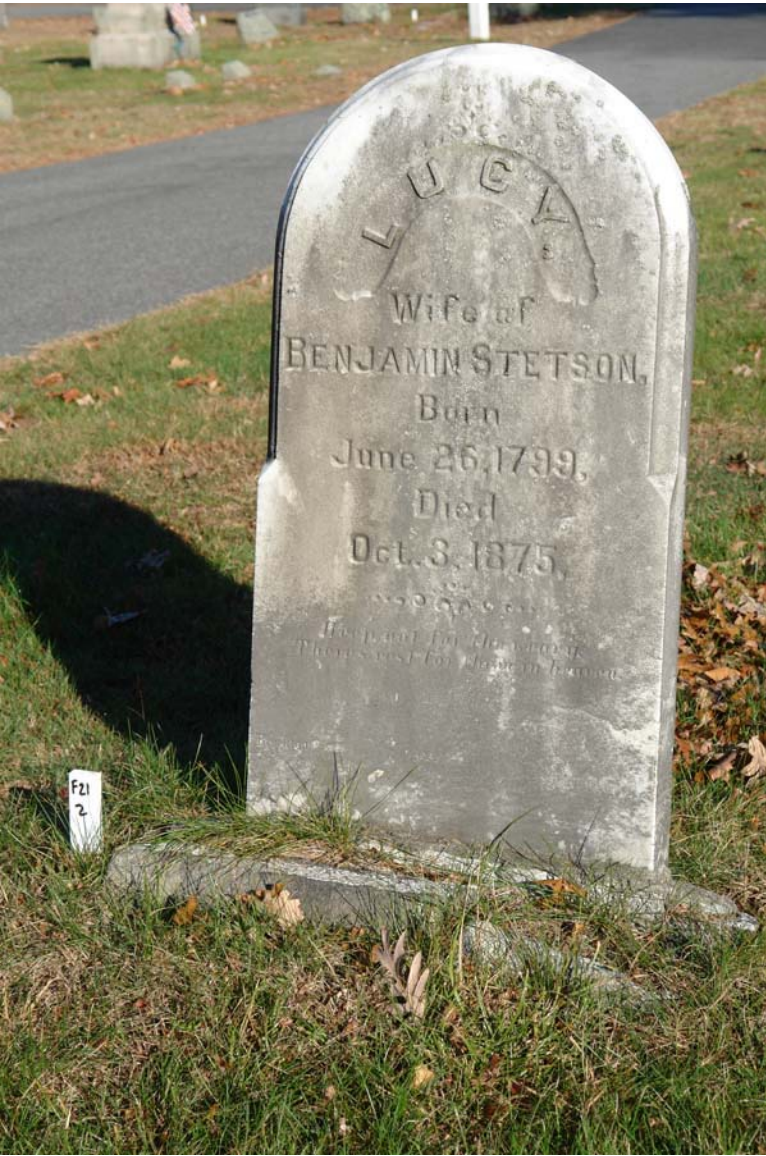
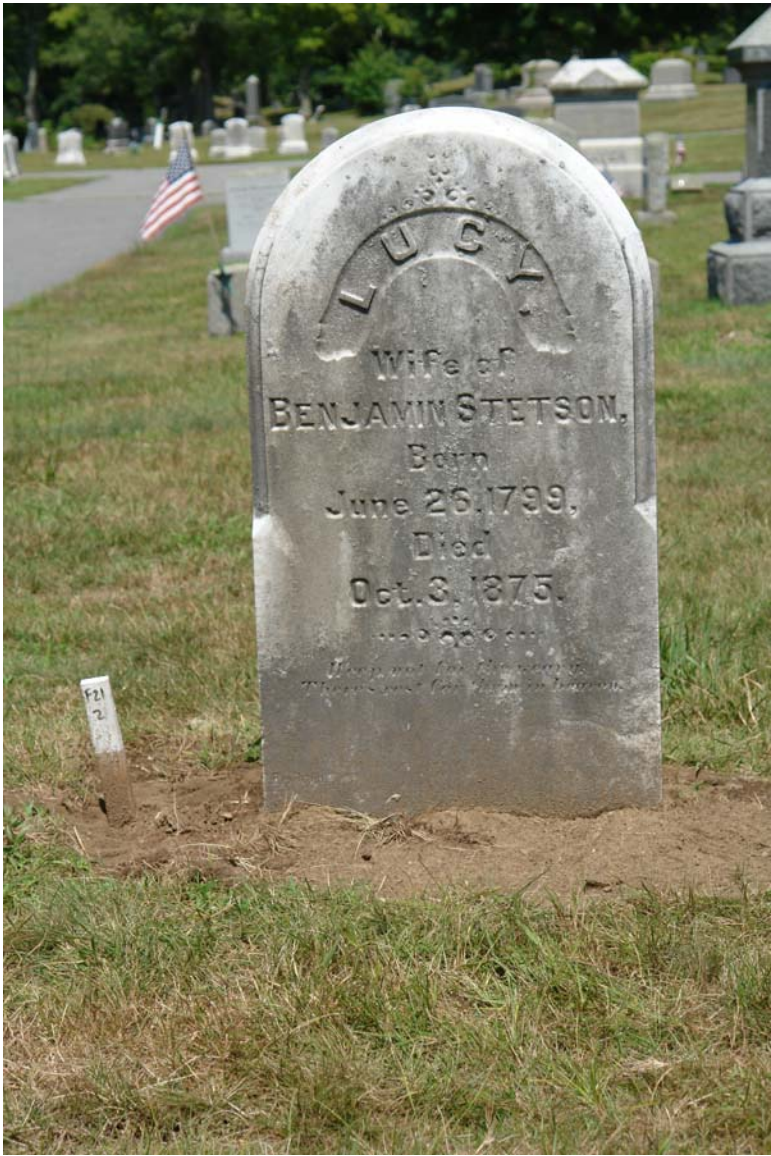
Height 33 Width 18 Thickness 3 Marker# **F.21.1**

Hanover Center Cemetery, Hanover MA	
NAME ON MARKER	Lucy Stetson
Death Date: 10/3/1875	Marker Type: Headstone/base
Cond. of Inscription: Legible	Material: Marble
EXISTING CONDITIONS	CONSERVATION STRATEGY
Tilted, loose in base	Evaluate resetting options Possible new below grade concrete base
TREATMENT	
Treatment Dates 8/13-14/2015

1. Marker excavated and found to be sound. Light soiling removed by brushing with nylon brushes and water.	
2. Setting area excavated for new below grade cast concrete base sized minimum of 12 inches deep, 12 inches greater in thickness and 6 inches wider than the stone.

7. Marker set plumb and level, and braced for minimum of 5 days.	
8. Disturbed areas backfilled with existing topsoil.

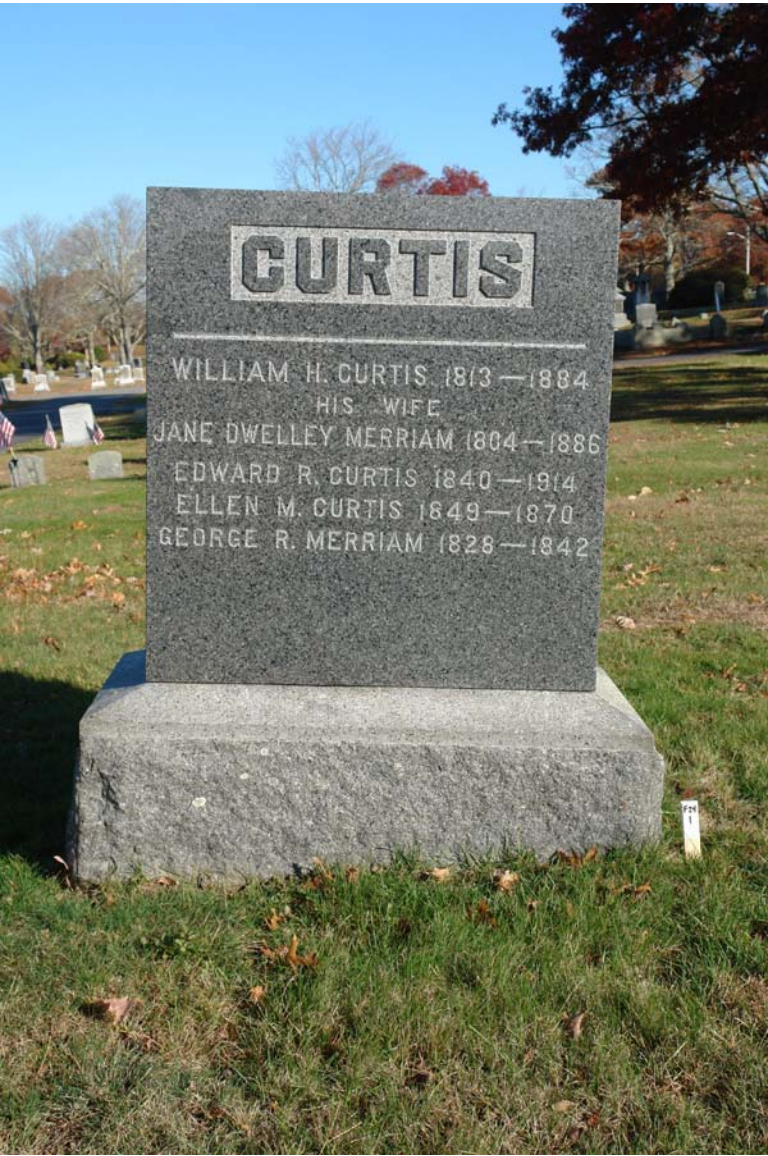
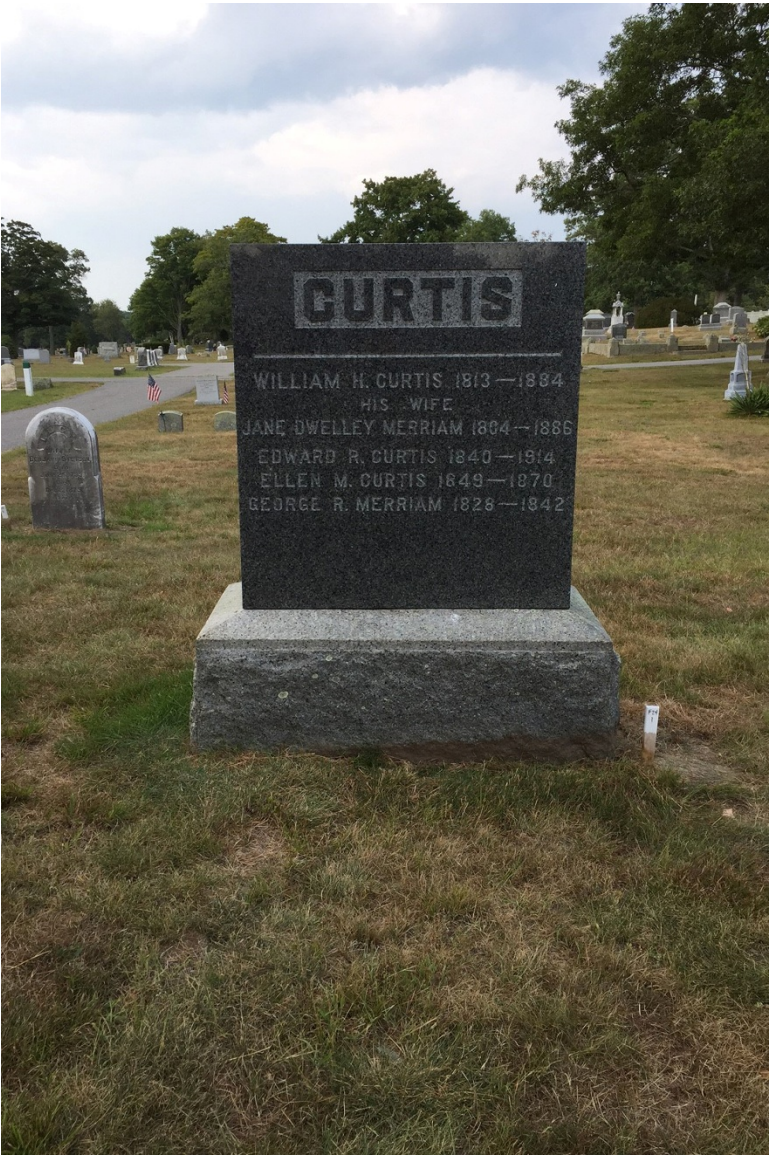
Hanover Center Cemetery, Hanover MA		
NAME ON MARKER		William Curtis
Death Date:	1884	Marker Type: Die
Cond. of Inscription:	Legible	Material: Granite
EXISTING CONDITIONS		CONSERVATION STRATEGY
Tilted base		Reset base with marker plumb
TREATMENT		
Treatment Dates		9/1/2015
1. Die is secure onto base		
2. Soil removed around base unit and base raised up with hydraulic jacks to level.		
3. Existing foundation stones exposed and built up to support base unit.		
4. Base re-set plumb at appropriate height and level		
5. Area beneath and around base backfilled with tamped sand and gravel		
6. Disturbed areas re-graded with existing topsoil.

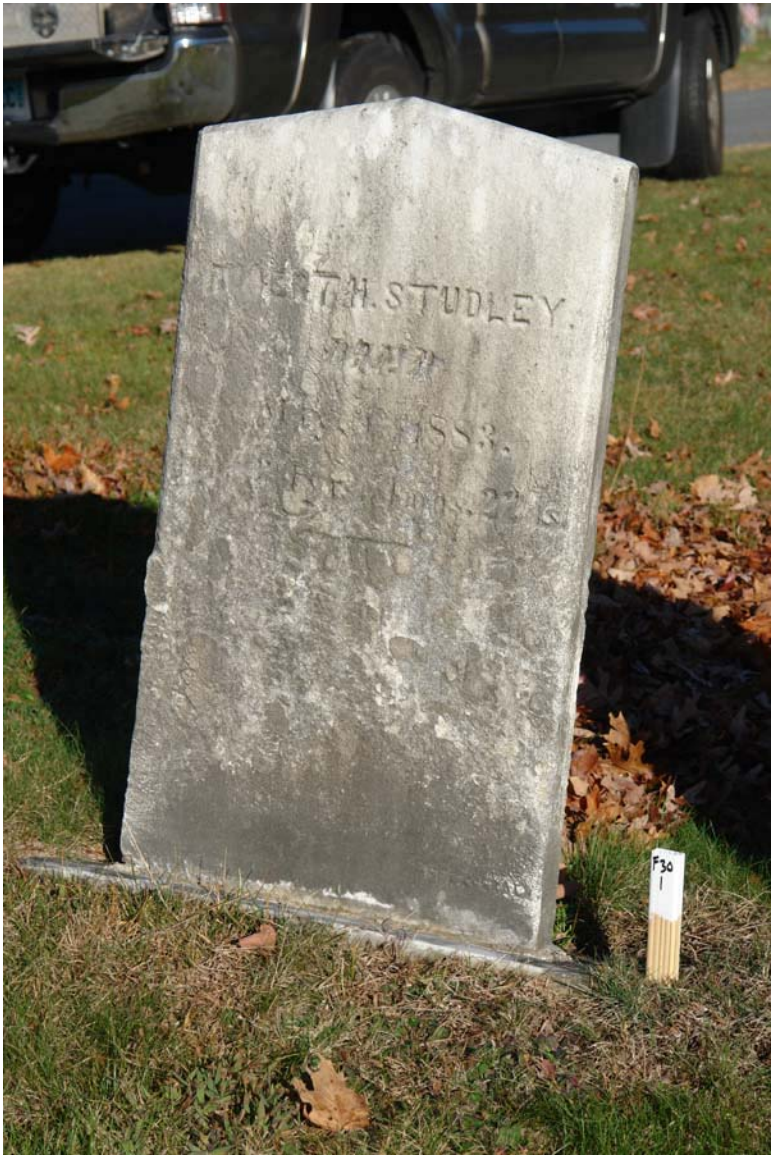
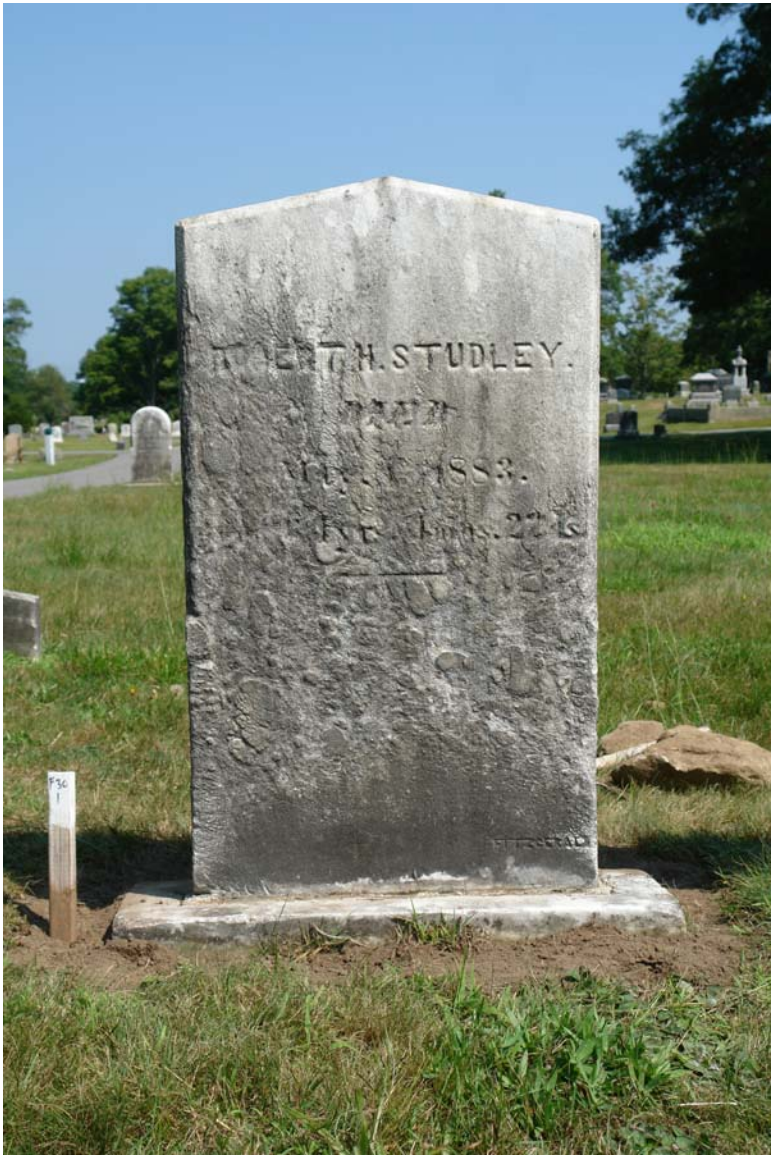
Hanover Center Cemetery, Hanover MA	
NAME ON MARKER	Robert Studley
Death Date: 5/1/1885	Marker Type: Headstone/base
Cond. of Inscription: Decipherable	Material: Marble
EXISTING CONDITIONS	CONSERVATION STRATEGY
Tilted base	Reset base with marker plumb
TREATMENT	
Treatment Dates 8/13-14/2015	
1. Marker and base found to be in sound condition with marker securely attached to base.	
2. Area excavated to an appropriate depth removing any roots or large stones.	
3. Base is aligned with adjacent markers and re-set level.	
4. Area around base was backfilled with tamped gravel and re-graded with existing topsoil

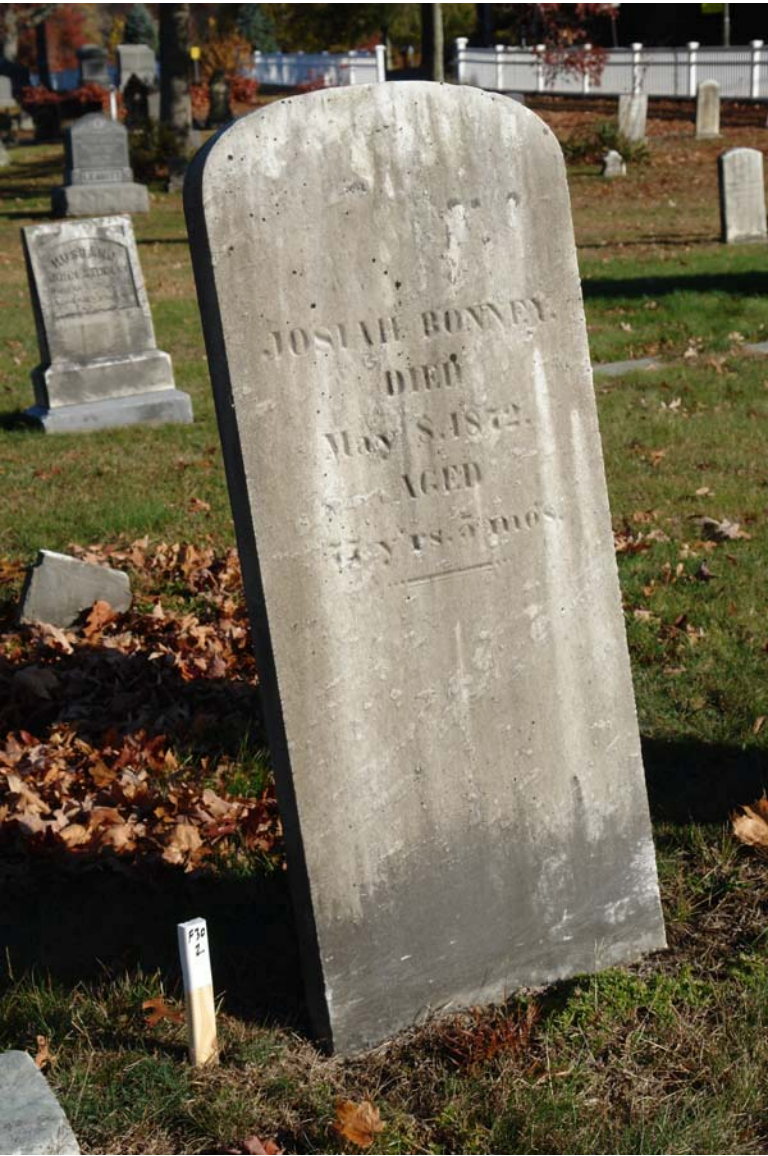
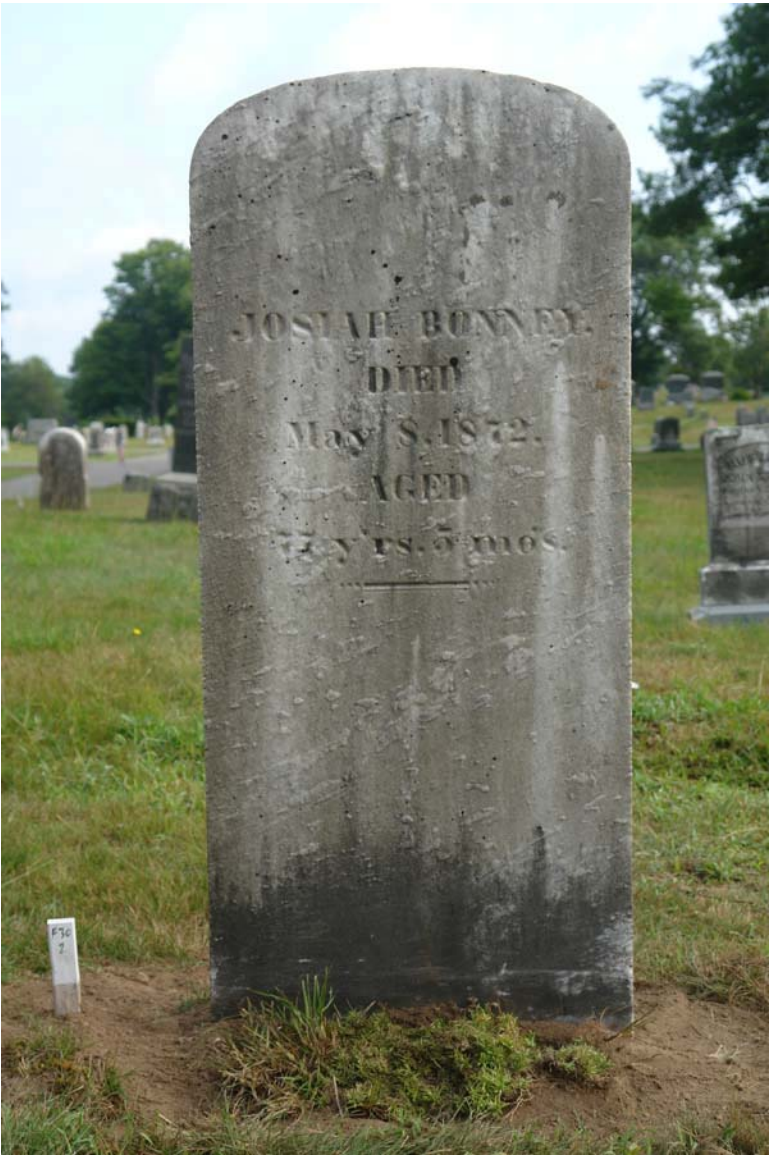
Hanover Center Cemetery, Hanover MA	
NAME ON MARKER Josiah Bonney	
Death Date: 5/8/1872	Marker Type: Headstone/base
Cond. of Inscription: Legible	Material: Marble
EXISTING CONDITIONS	CONSERVATION STRATEGY
Tilted	Evaluate resetting options Possible new below grade concrete base
TREATMENT	
Treatment Dates 8/27/2015	
<div>1. Existing base located below grade while excavating for resetting. Area excavated to an appropriate depth removing any roots or large stones.</div> <div>2. Base inspected and found to be sound and re-useable</div> <div>3. Base is aligned with adjacent markers and re-set level.</div> <div>4. Area around base was backfilled with tamped gravel and re-graded with existing topsoil</div> <div>5. Debris removed from setting slot. When required, power grinders were used to facilitate removal of stone fragments.</div> <div>6. When required, the lower setting edge was re-squared by power grinder with minimal loss.</div> <div>7. Marker reset plumb and level into setting slot with cement/lime grout (3/2/9) with 000 sand made fluid with a super plasticizer.</div> <div>8. Excess grout removed and joint area cleaned.</div> <div>9. Marker braced for a minimum 3 days</div>
