MONUMENT CONSERVATION COLLABORATIVE LLC, NORFOLK, CT

DOCUMENTATION OF STONE CONSERVATION TREATMENTS TO ASSINIPPI CEMETERY, HANOVER, MA June 2015

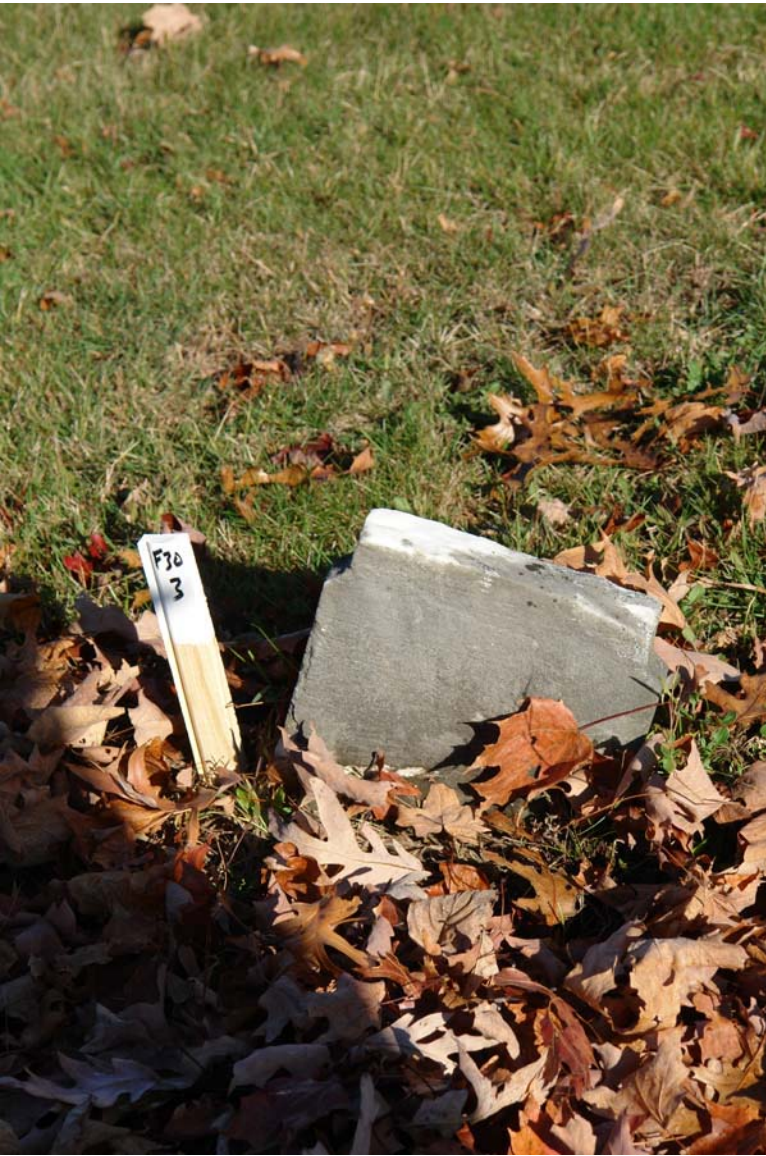
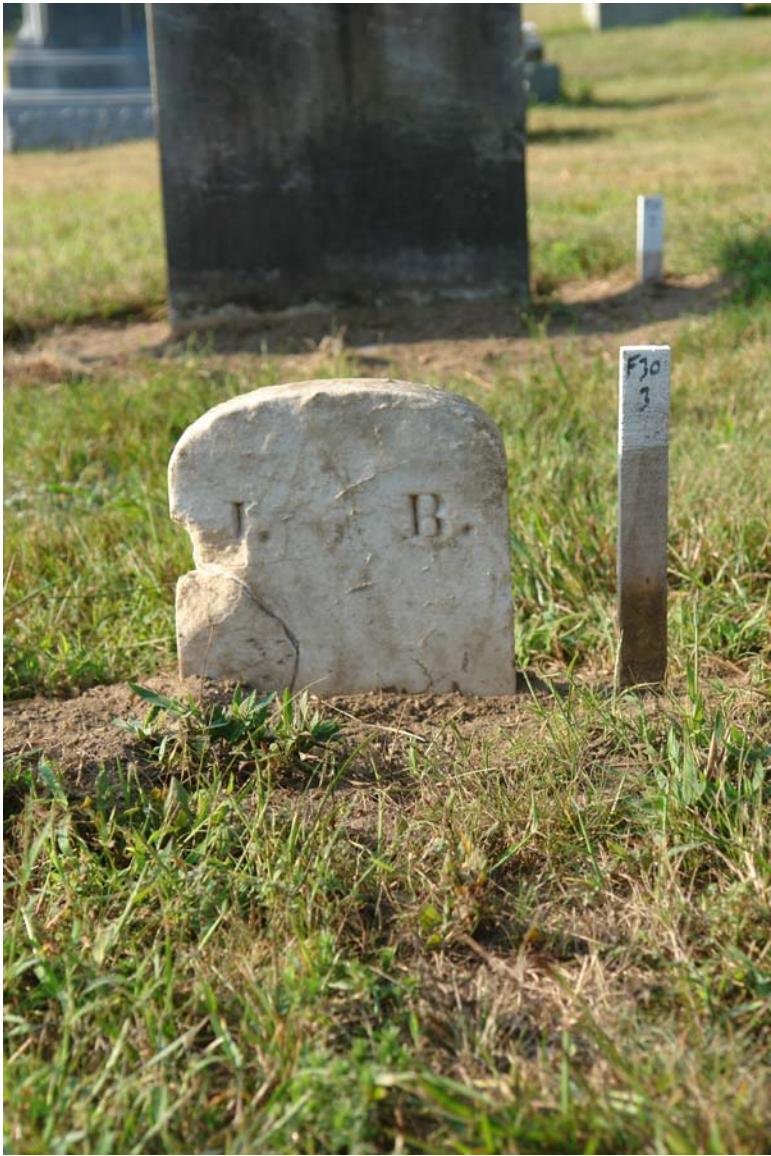
Hanover Center Cemetery, Hanover MA	
NAME ON MARKER	Josiah Bonney
Death Date:	Marker Type: Footstone
Cond. of Inscription: Legible	Material: Marble
EXISTING CONDITIONS	CONSERVATION STRATEGY
Tilted	Reset plumb

TREATMENT	Treatment Dates	8/26/2015
<p>1. Marker carefully excavated. The soil around tilted markers was removed to an appropriate depth. When required, the marker was removed from the ground. Marker appears to be sound.</p> <p>2. Soling removed by light brushing with nylon brushes and water.</p> <p>3. Setting area excavated to sufficient depth and stone re-set plumb at appropriate height and level onto gravel bed, aligned with adjacent markers</p> <p>4. Area backfilled around marker with tamped sand and gravel</p> <p>5. Disturbed areas re-graded with existing topsoil and sod.</p>

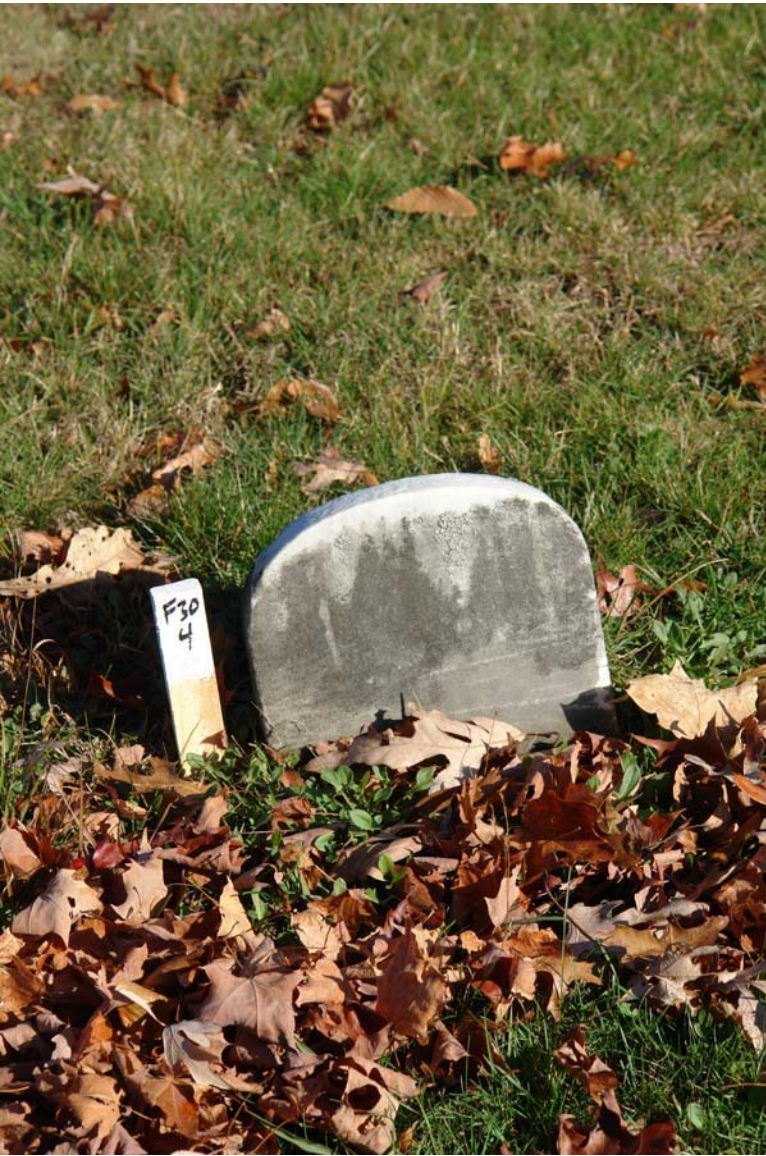
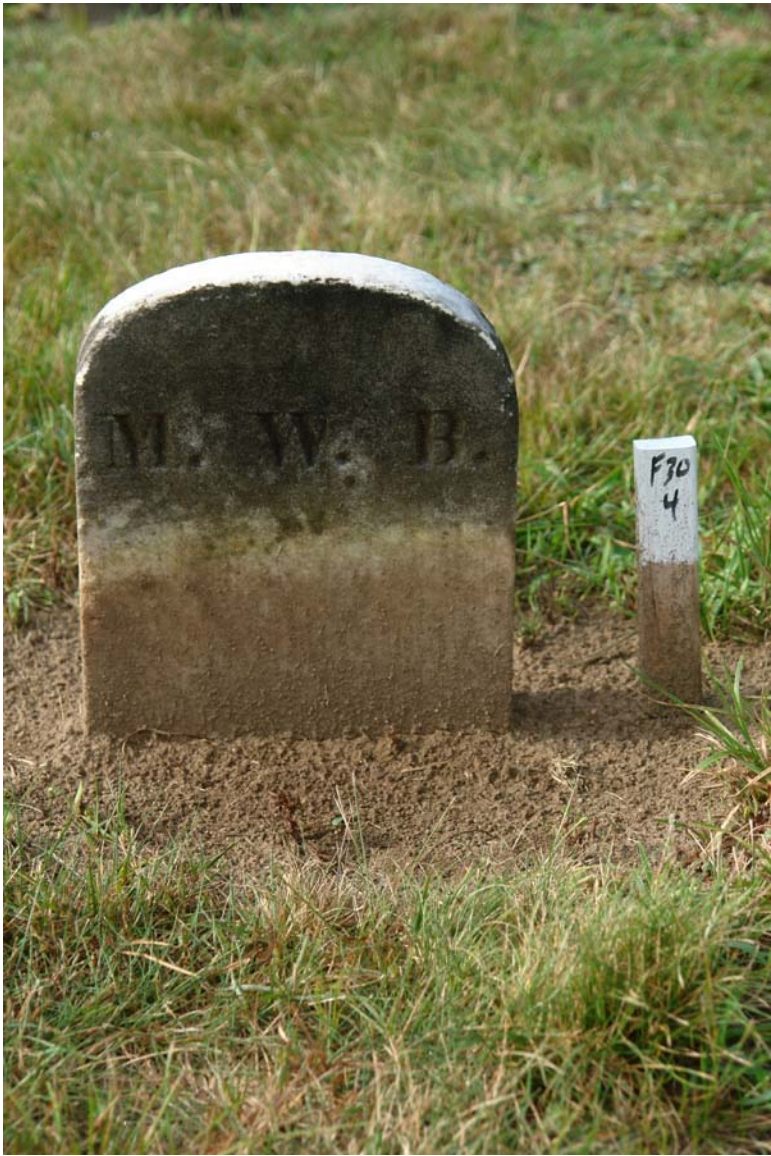
Hanover Center Cemetery, Hanover MA	
NAME ON MARKER	Marcy Bonney
Death Date:	Marker Type: Footstone
Cond. of Inscription: Legible	Material: Marble

EXISTING CONDITIONS	CONSERVATION STRATEGY
Loose	Evaluate resetting options Possible new below grade concrete base

TREATMENT	Treatment Dates
<div>1. Marker carefully excavated. The soil around tilted markers was removed to an appropriate depth. When required, the marker was removed from the ground. Marker appears to be sound.</div> <div>2. Soling removed by light brushing with nylon brushes and water.</div> <div>3. Setting area excavated to sufficient depth and stone re-set plumb at appropriate height and level onto gravel bed, aligned with adjacent markers</div> <div>4. Area backfilled around marker with tamped sand and gravel</div> <div>5. Disturbed areas re-graded with existing topsoil and sod.</div>

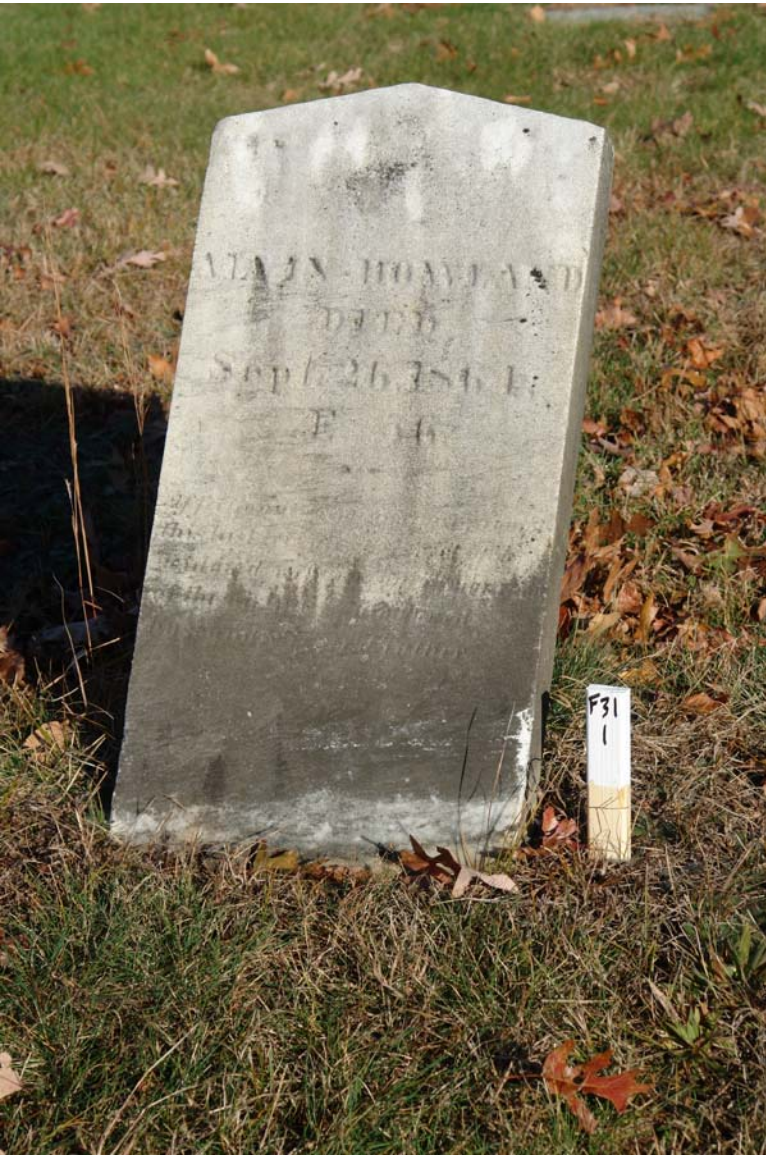
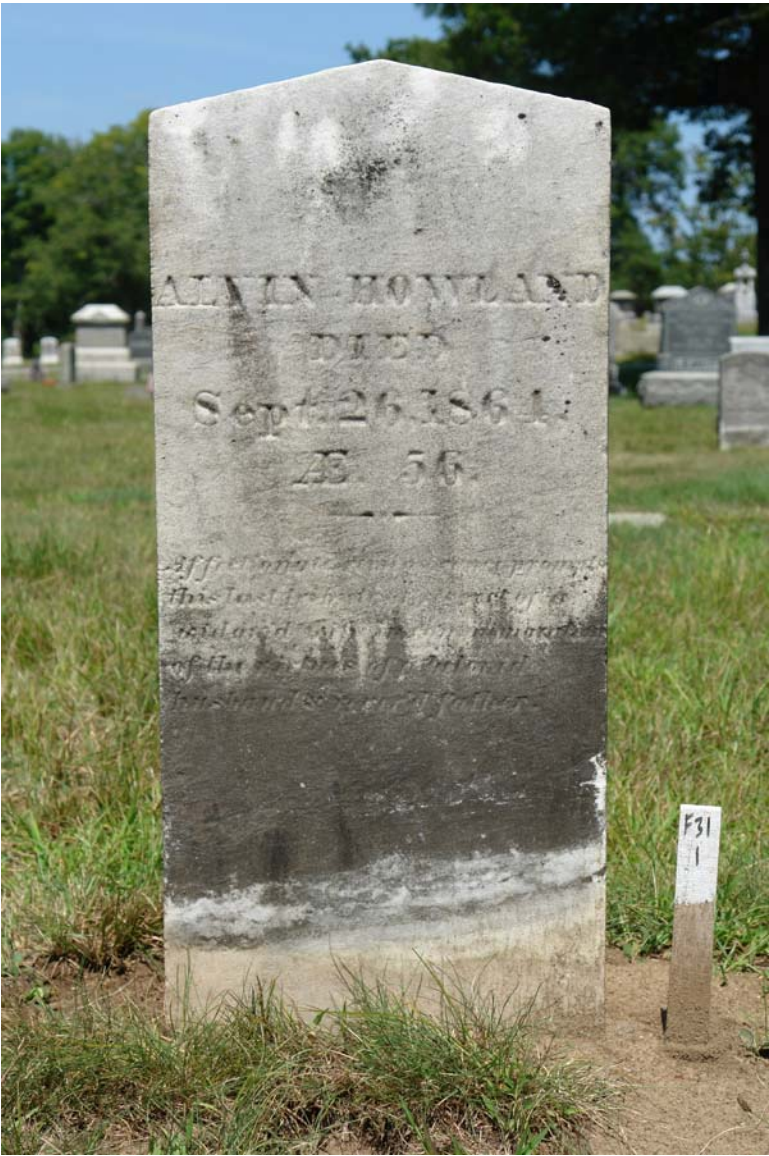
EXISTING CONDITIONS	CONSERVATION STRATEGY
Tilted	Evaluate resetting options Possible new below grade concrete base

2. Base inspected and found to be sound and re-useable

9. Marker braced for a minimum 3 days

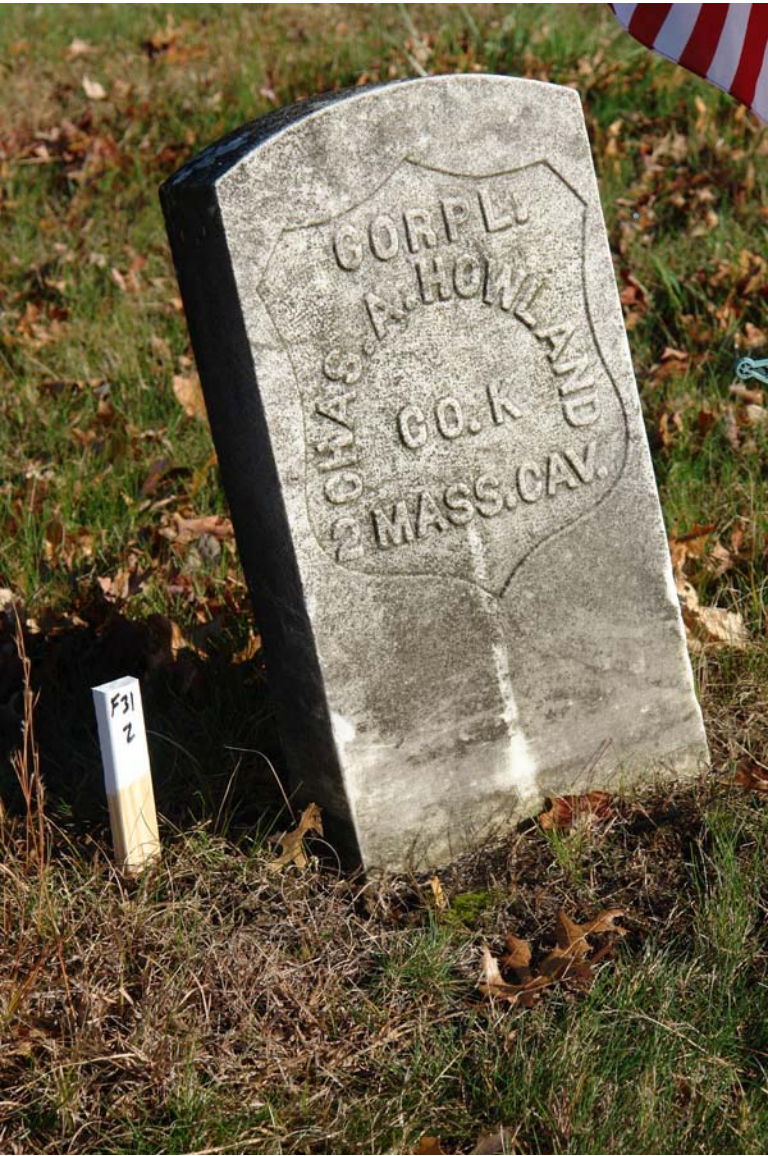
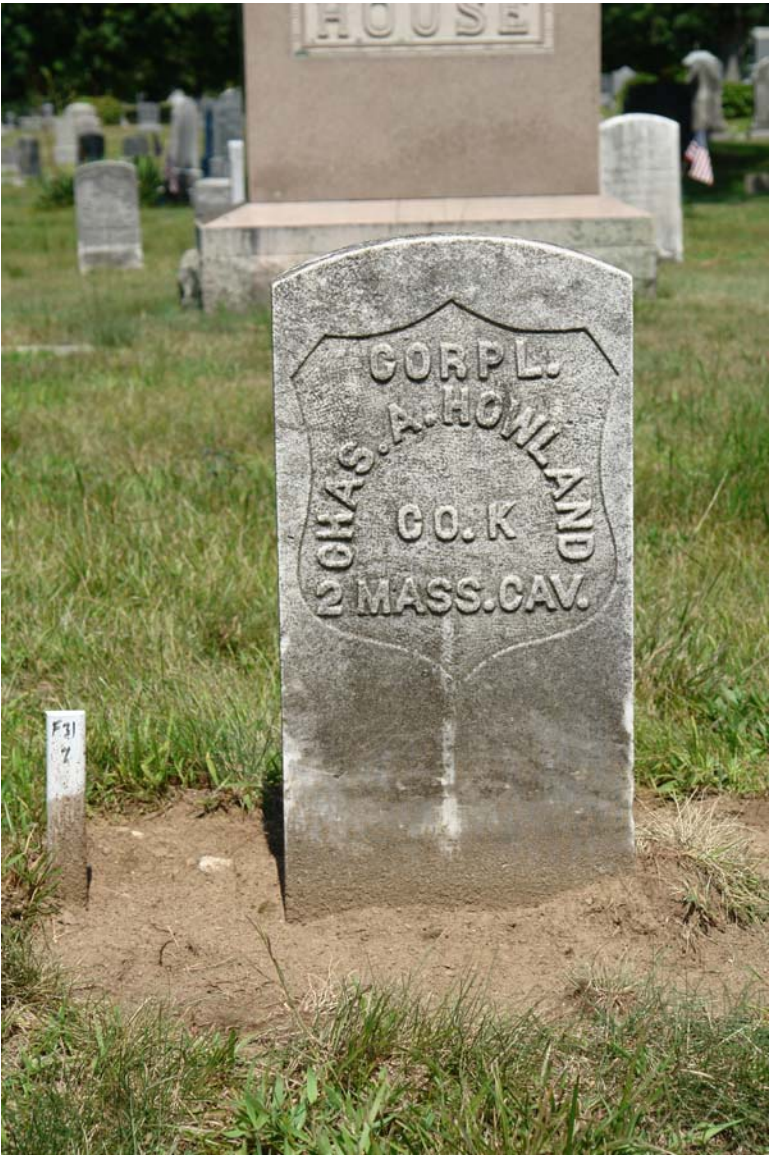
Hanover Center Cemetery, Hanover MA	
NAME ON MARKER	Corp. Charles Howland
Death Date:	Marker Type: Headstone
Cond. of Inscription: Legible	Material: Marble

EXISTING CONDITIONS	CONSERVATION STRATEGY
Tilted	Evaluate resetting options Possible new below grade concrete base

TREATMENT	Treatment Dates 8/14/2015
<p>1. Marker carefully excavated. The soil around tilted markers was removed to an appropriate depth. When required, the marker was removed from the ground. Marker appears to be sound.</p> <p>2. Soling removed by light brushing with nylon brushes and water.</p> <p>3. Setting area excavated to sufficient depth and stone re-set plumb at appropriate height and level onto gravel bed, aligned with adjacent markers</p> <p>4. Area backfilled around marker with tamped sand and gravel</p> <p>5. Disturbed areas re-graded with existing topsoil and sod.</p>

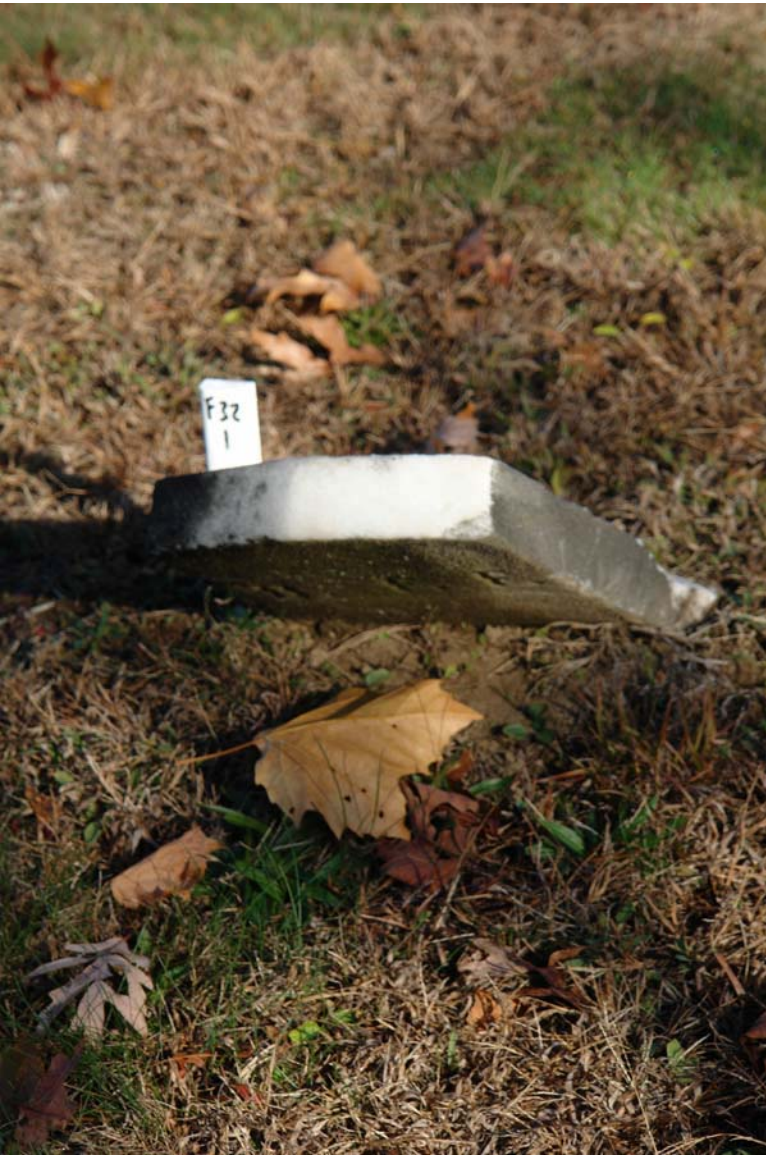
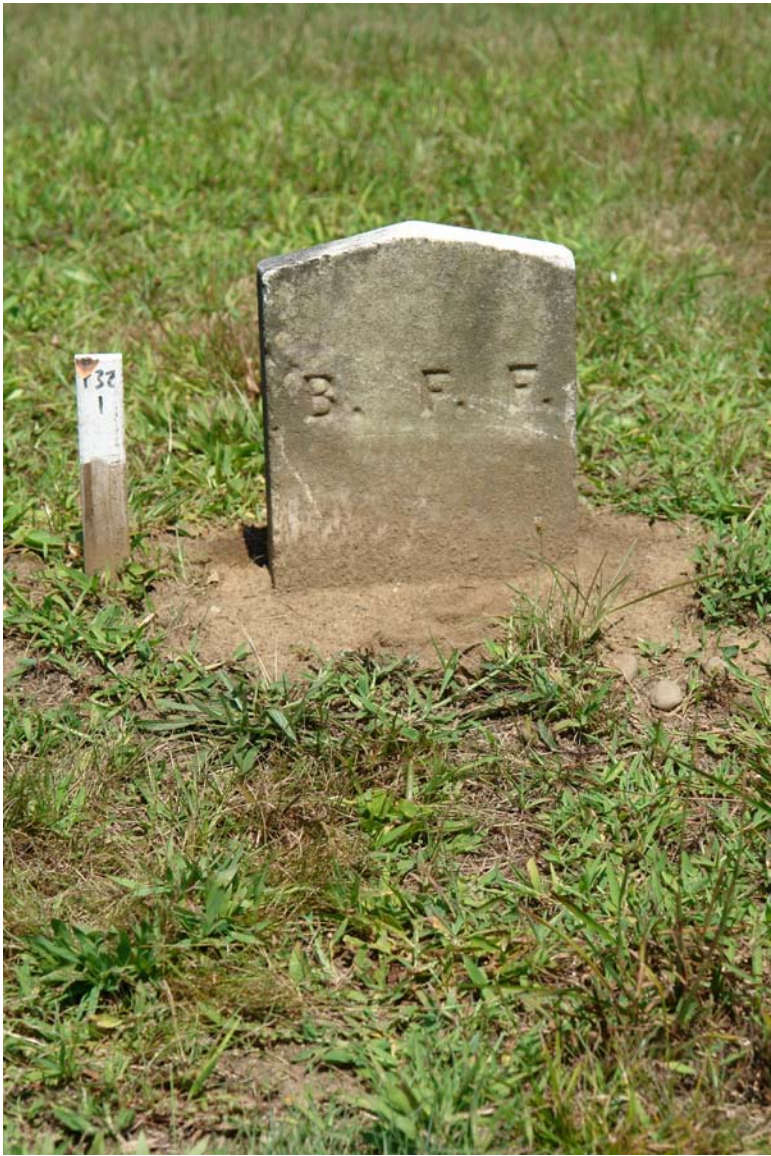
EXISTING CONDITIONS	CONSERVATION STRATEGY
Tilted	Reset plumb

Comments: **No headstone**

5. Disturbed areas re-graded with existing topsoil and sod.

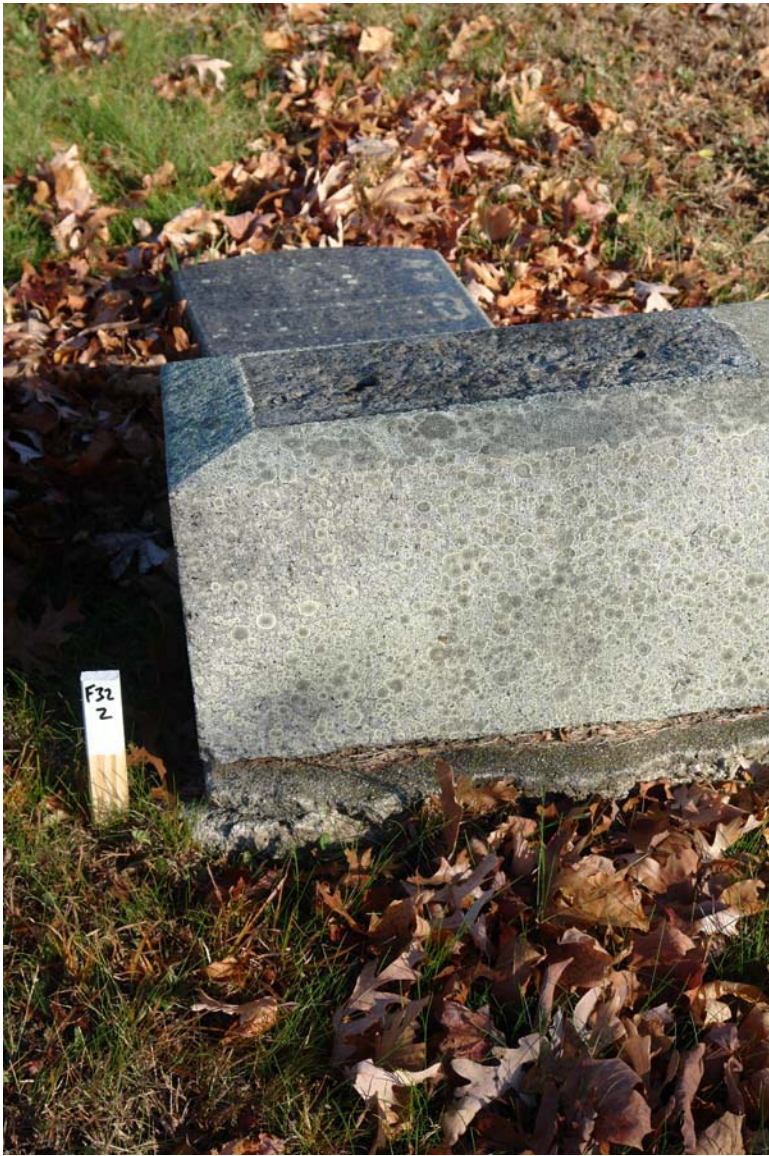
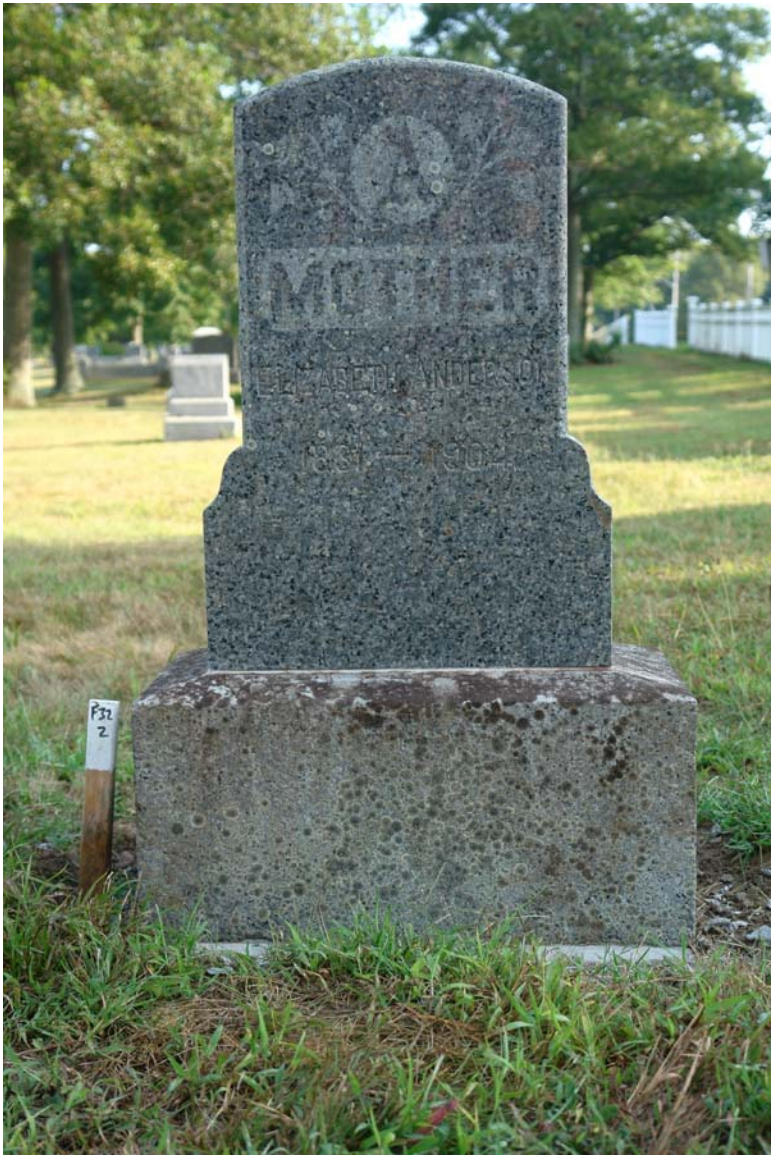
Hanover Center Cemetery, Hanover MA
NAME ON MARKER **Mother (Elisabeth Anderson)**
Death Date: 1904 Marker Type: Marker
Cond. of Inscription: Legible Material: Granite

EXISTING CONDITIONS	CONSERVATION STRATEGY
Tilted Loose on base	Reset base level Reset elements

TREATMENT	Treatment Dates
1. Elements removed from setting bases and inspected for soundness. 2. Area excavated to an appropriate depth removing any roots or large stones. 3. Base is aligned with adjacent markers and re-set level. 4. Area around base was backfilled with tamped gravel and re-graded with existing topsoil 5. Failed mortar removed from setting area and bottom of marker 6. When required, any existing pins were inspected, and if necessary, replaced with stainless steel threaded pins 7. Setting surfaces primed with Acryl 60 diluted 1:3 with water. 8. Marker reset plumb onto base with cement/lime mortar (3/2/9) with 000 sand. 9. Excess grout removed and joint area cleaned.	8/25-26/2015

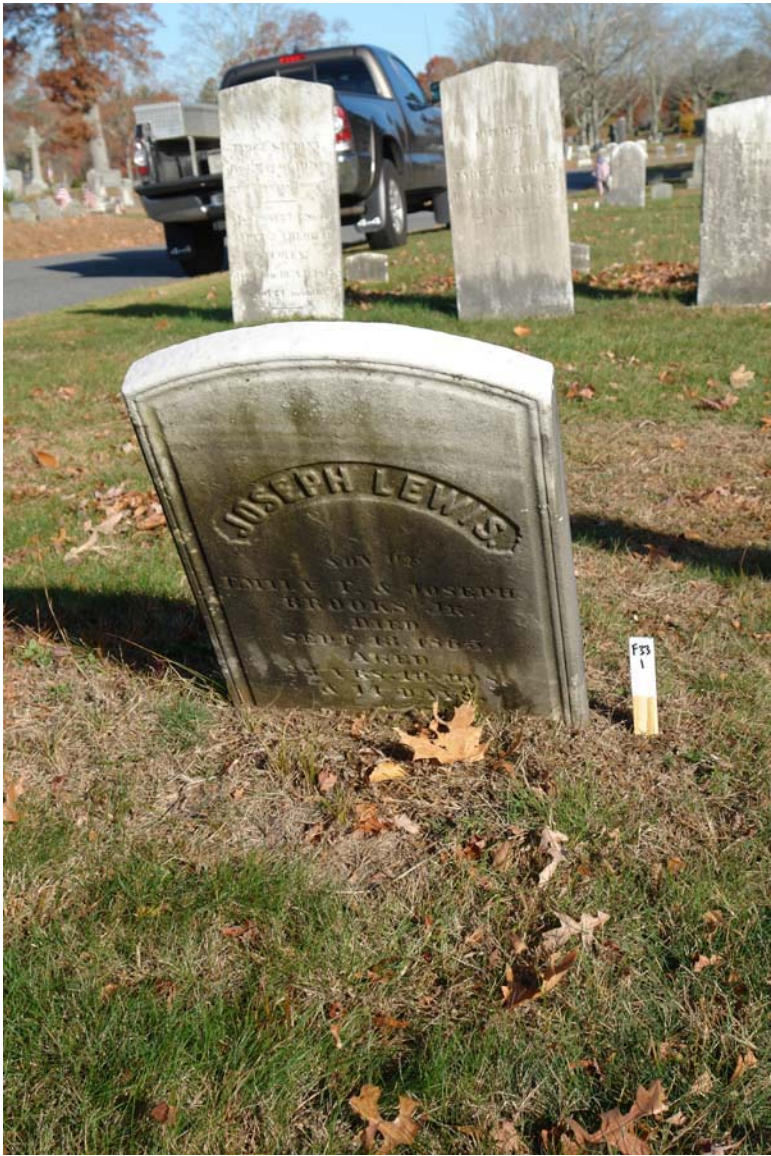
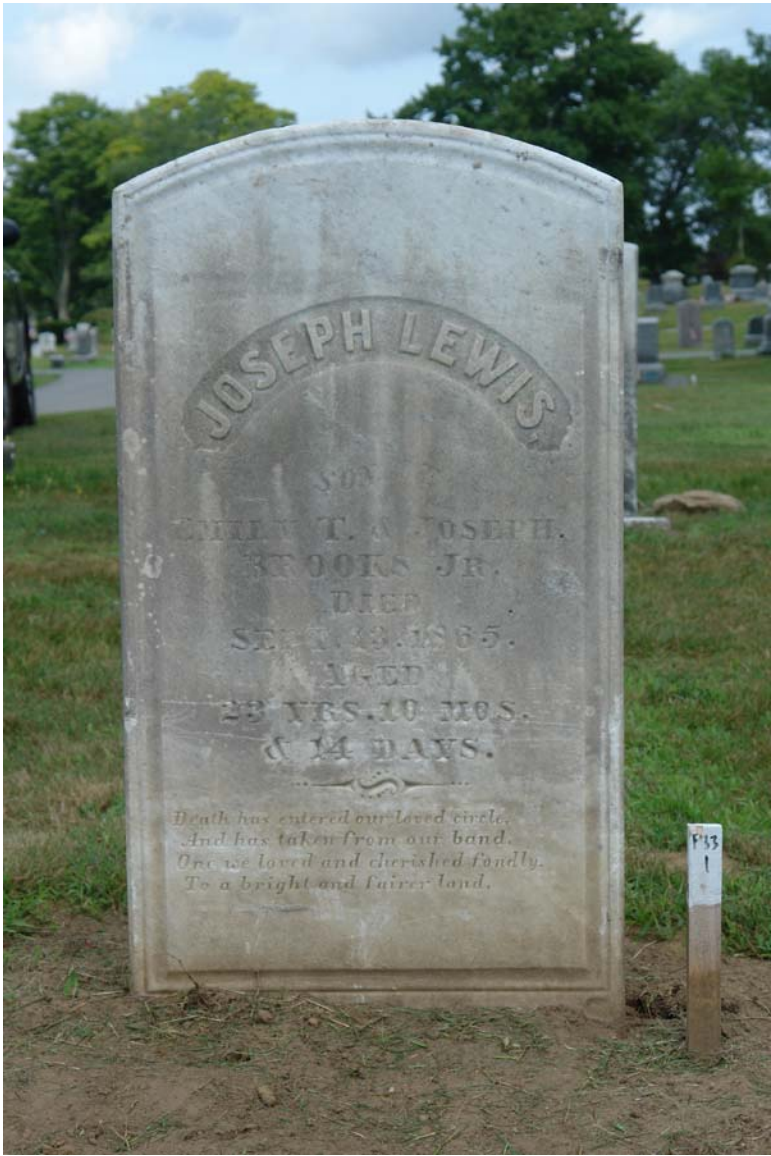
Hanover Center Cemetery, Hanover MA	
NAME ON MARKER	Joseph Brooks
Death Date: 9/13/1865	Marker Type: Headstone/base
Cond. of Inscription: Legible	Material: Marble
EXISTING CONDITIONS	CONSERVATION STRATEGY
Tilted	Reset plumb
TREATMENT	
Treatment Dates 8/17/2015	
<div>1. Existing base located below grade while excavating for resetting. Area excavated to an appropriate depth removing any roots or large stones.</div> <div>2. Base inspected and found to be sound and re-useable</div> <div>3. Base is aligned with adjacent markers and re-set level.</div> <div>4. Area around base was backfilled with tamped gravel and re-graded with existing topsoil</div> <div>5. Debris removed from setting slot. When required, power grinders were used to facilitate removal of stone fragments.</div> <div>6. When required, the lower setting edge was re-squared by power grinder with minimal loss.</div> <div>7. Marker reset plumb and level into setting slot with cement/lime grout (3/2/9) with 000 sand made fluid with a super plasticizer.</div> <div>8. Excess grout removed and joint area cleaned.</div> <div>9. Marker braced for a minimum 3 days</div>

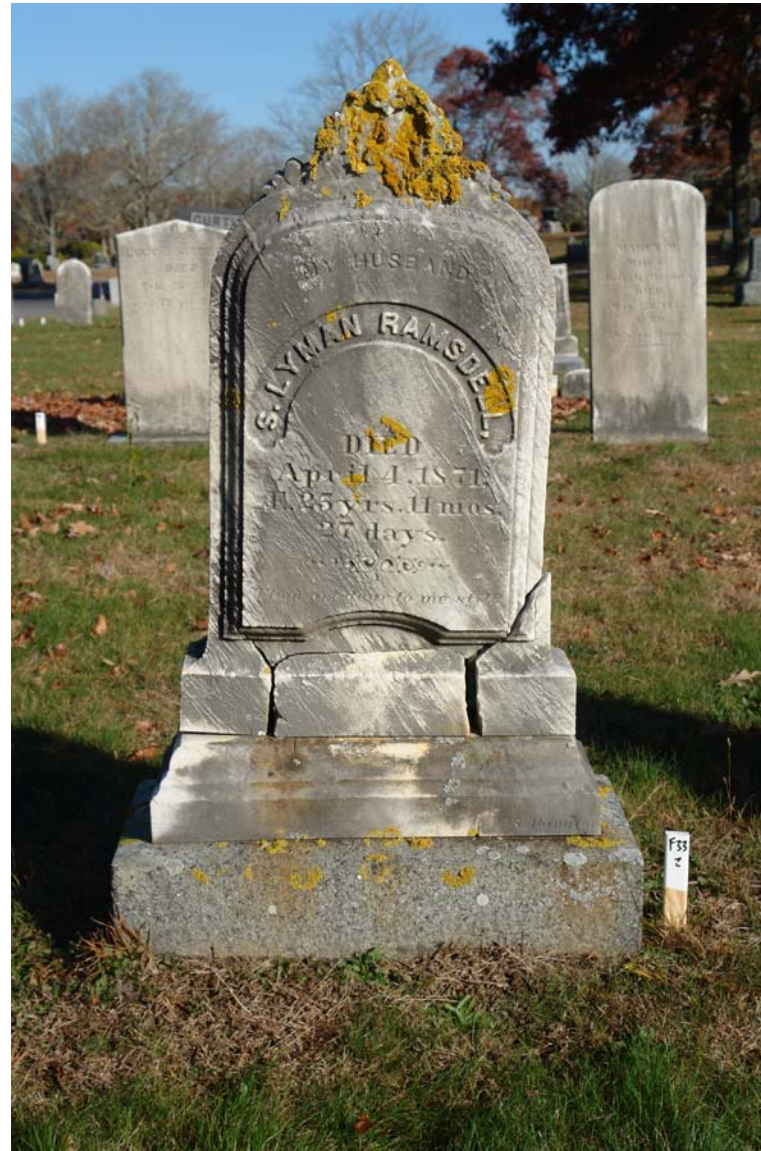
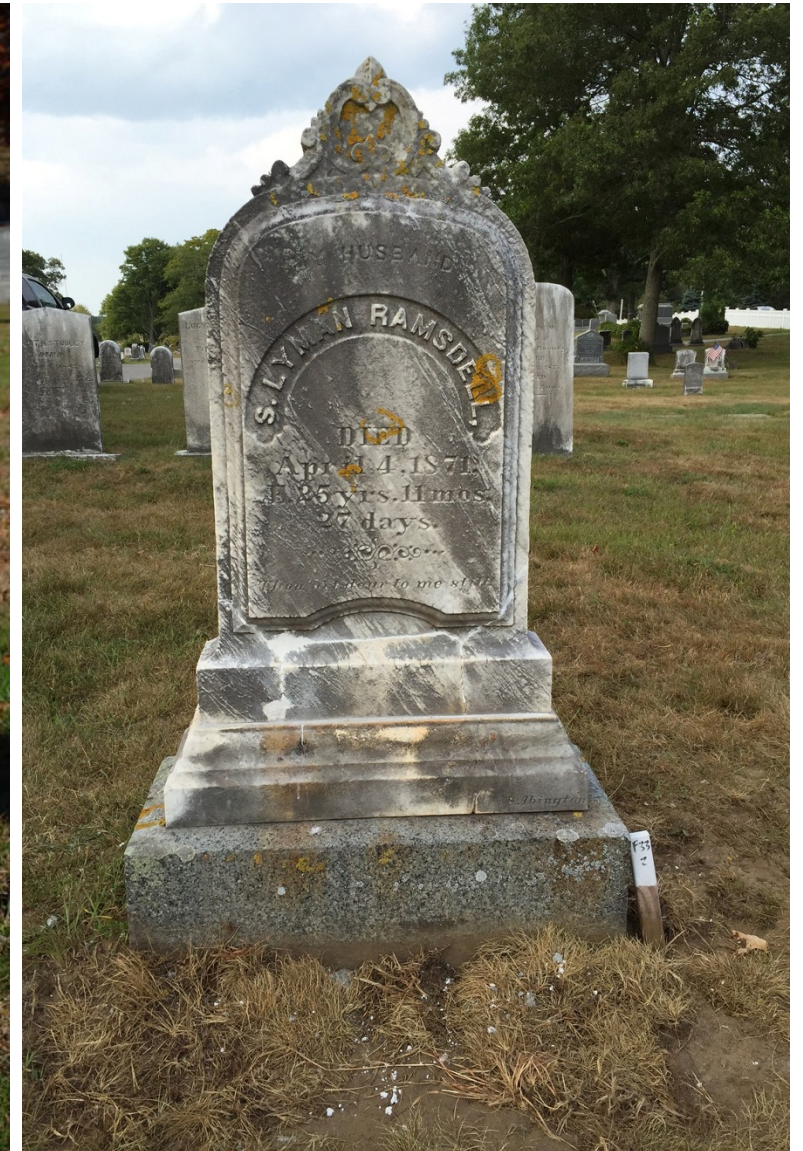
Fractures

Loose on base

1. Area excavated to an appropriate depth. Base is aligned with adj. markers and reset level at appropriate height.
2. All mating edges of fragments cleaned with water and any failed adhesives removed with hand tools
3. Fragments attached with structural adhesive (Abatron 55-22), clamped and braced until cured. Excess epoxy removed with hand chisels within 24 hours.
4. Setting surfaces cleaned of debris or failed mortar and base and market fragment reset plumb and level with a cement/lime grout (3/2/9) with 000 sand. Excess grout removed and joint area cleaned.
5. Marker braced for a minimum 3 days
6. Cracks and losses filled with RepliCal Marble or Jahn restoration mortar. products, filled areas misted with water and covered for 3 days minimum..

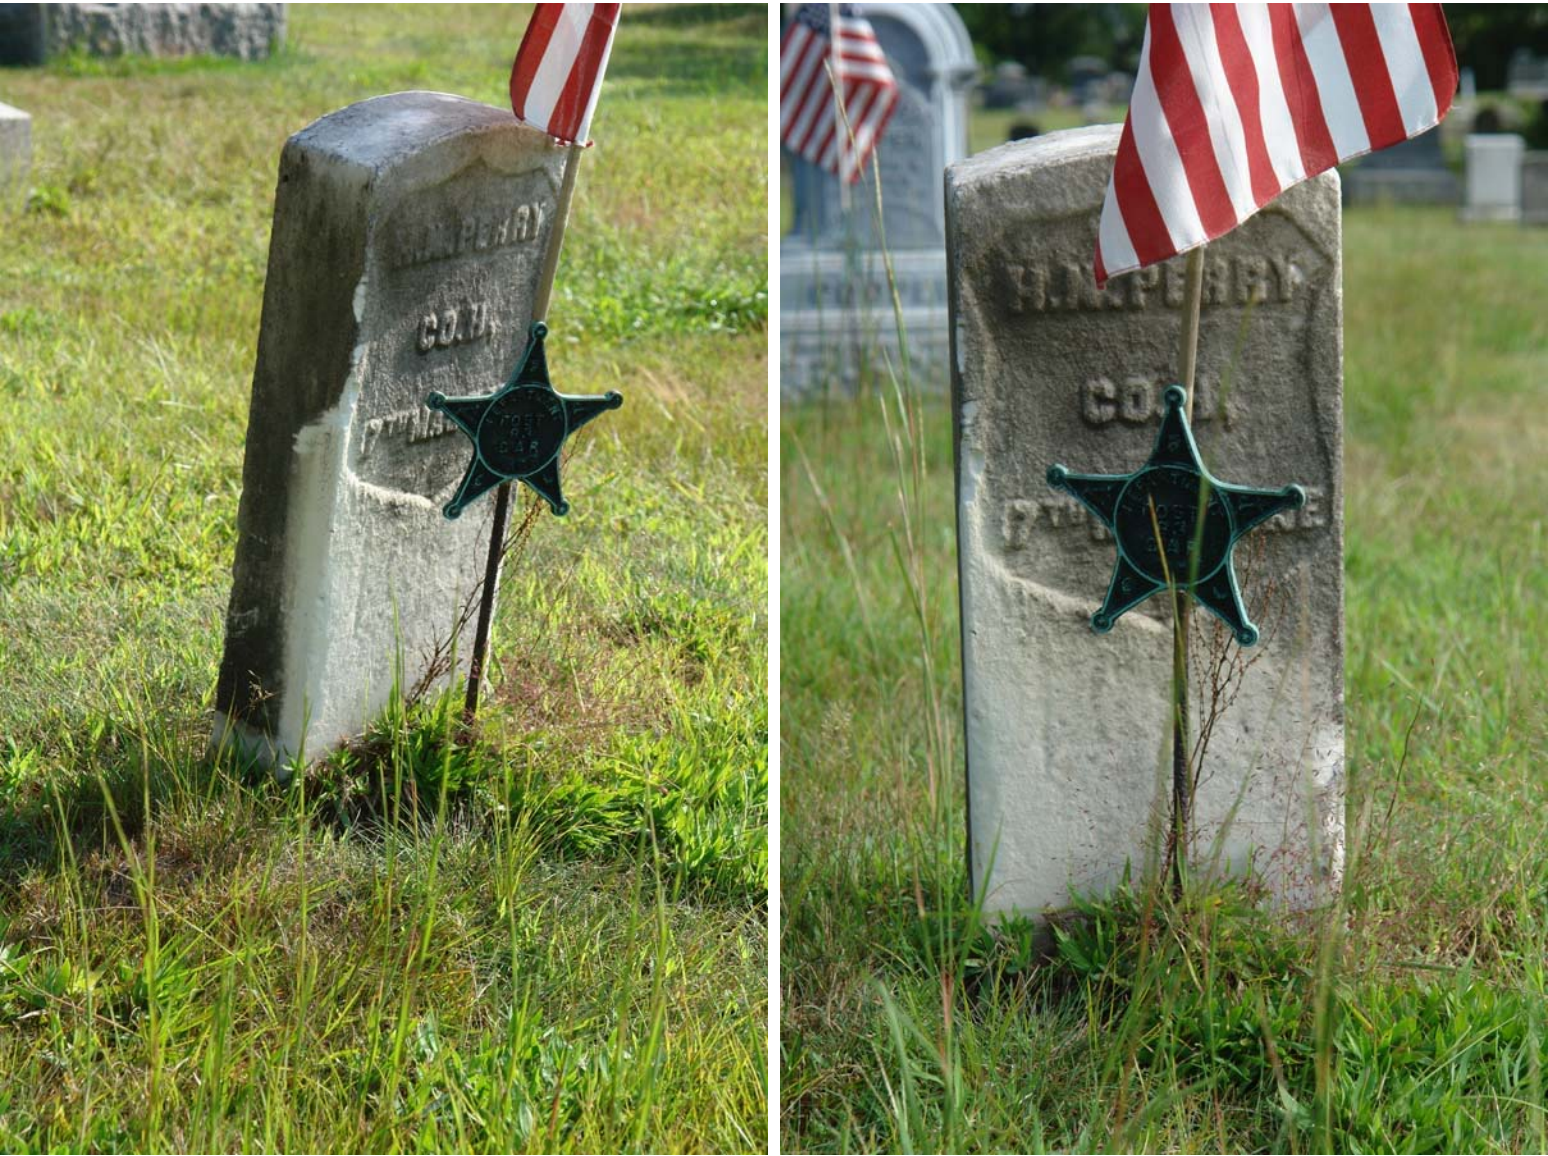
Height 40 Width 18 Thickness 4 Marker# **F.33.2**

EXISTING CONDITIONS	CONSERVATION STRATEGY
Tilted	Reset level

TREATMENT	Treatment Dates 9/1/2015
<p>1. Marker carefully excavated. The soil around tilted markers was removed to an appropriate depth. When required, the marker was removed from the ground. Marker appears to be sound.</p> <p>2. Soling removed by light brushing with nylon brushes and water.</p> <p>3. Setting area excavated to sufficient depth and stone re-set plumb at appropriate height and level onto gravel bed, aligned with adjacent markers</p> <p>4. Area backfilled around marker with tamped sand and gravel</p> <p>5. Disturbed areas re-graded with existing topsoil and sod.</p>

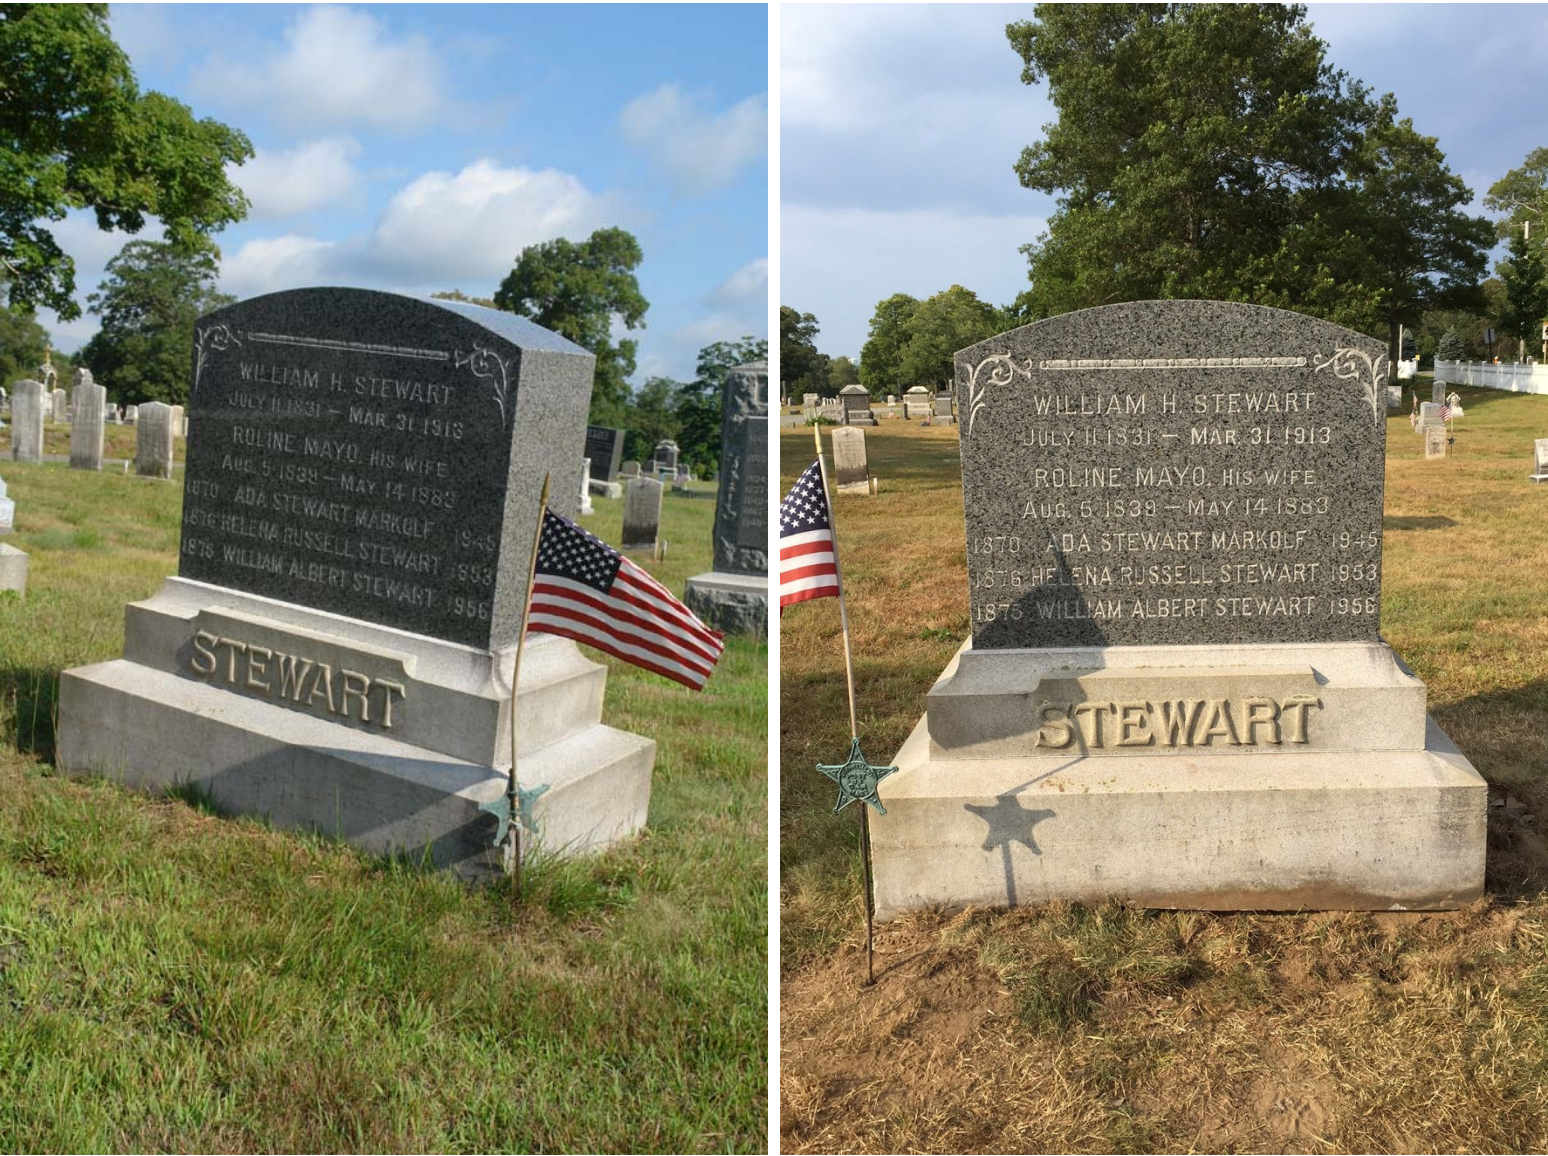
EXISTING CONDITIONS	CONSERVATION STRATEGY
Tilted	Reset level

3. Existing foundation stones exposed and built up to support base unit.

6. Disturbed areas re-graded with existing topsoil.

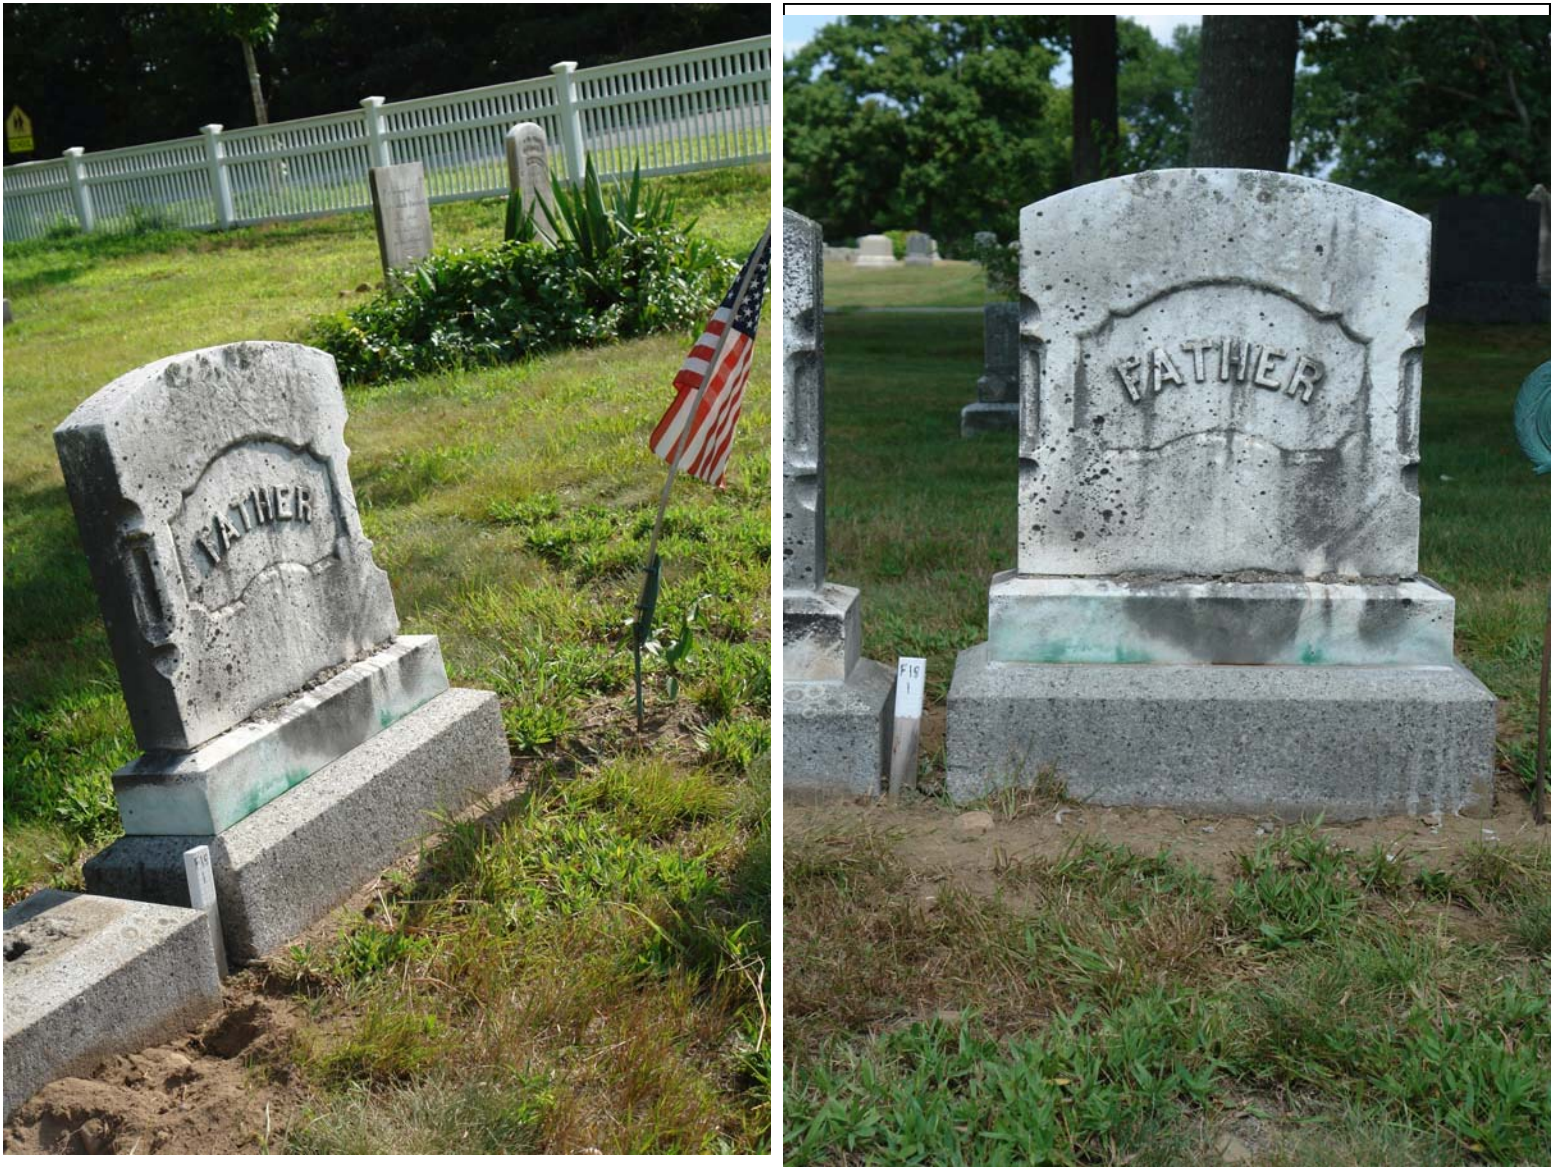
EXISTING CONDITIONS	CONSERVATION STRATEGY
Tilted	Reset level

1. Marker and base found to be in sound condition with marker securely attached to base.

4. Area around base was backfilled with tamped gravel and re-graded with existing topsoil
