MONUMENT CONSERVATION COLLABORATIVE LLC, NORFOLK, CT

DOCUMENTATION OF STONE CONSERVATION TREATMENTS TO ASSINIPPI CEMETERY, HANOVER, MA June 2015

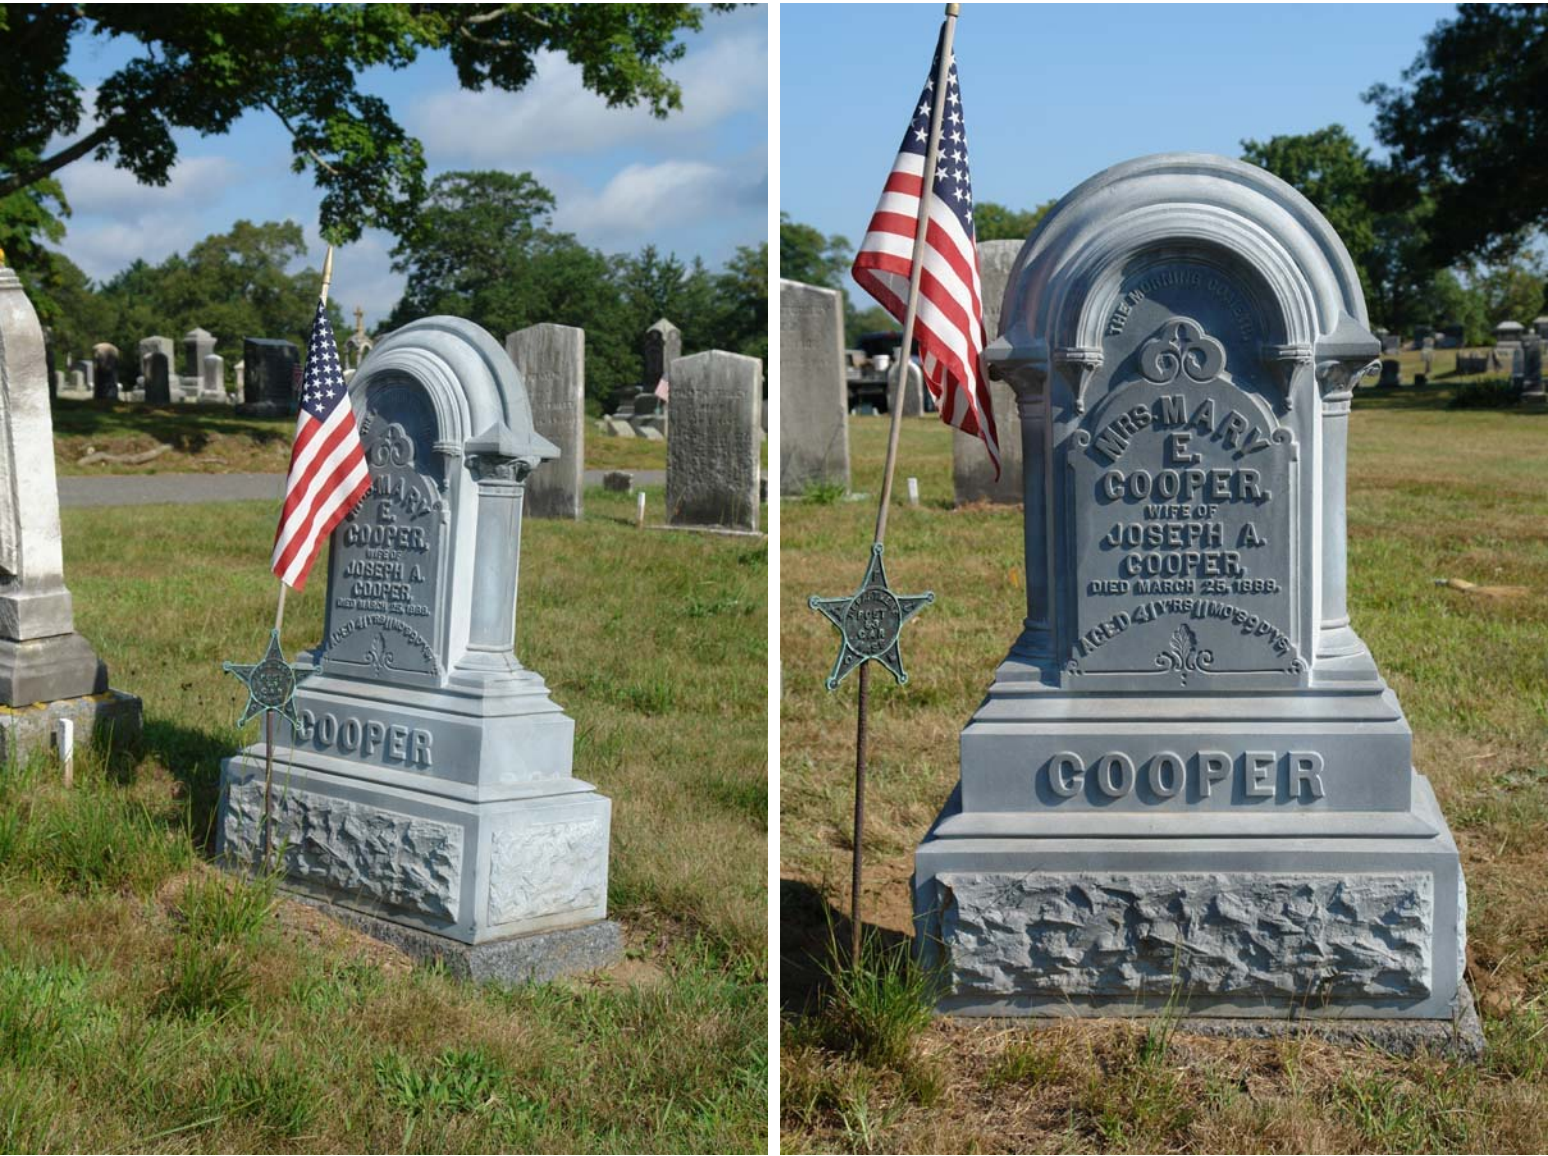
EXISTING CONDITIONS	CONSERVATION STRATEGY
Tilted	Reset level

1. Marker and base found to be in sound condition with marker securely attached to base.

4. Area around base was backfilled with tamped gravel and re-graded with existing topsoil

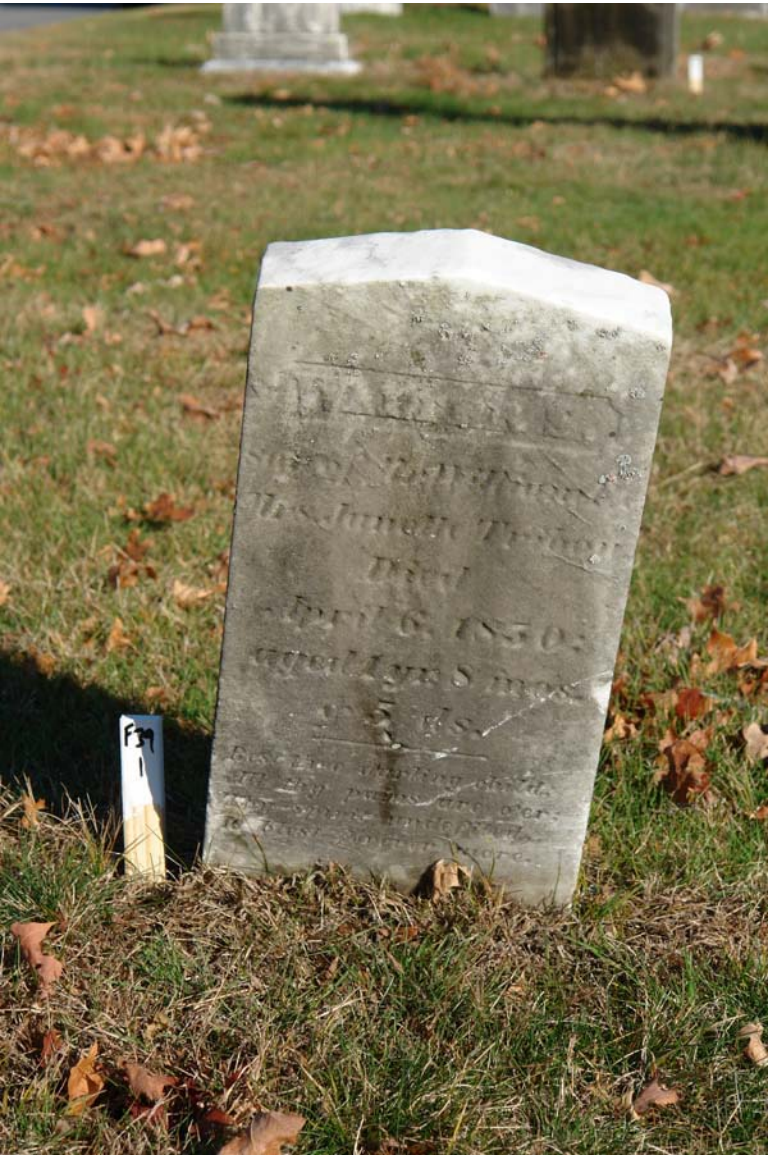
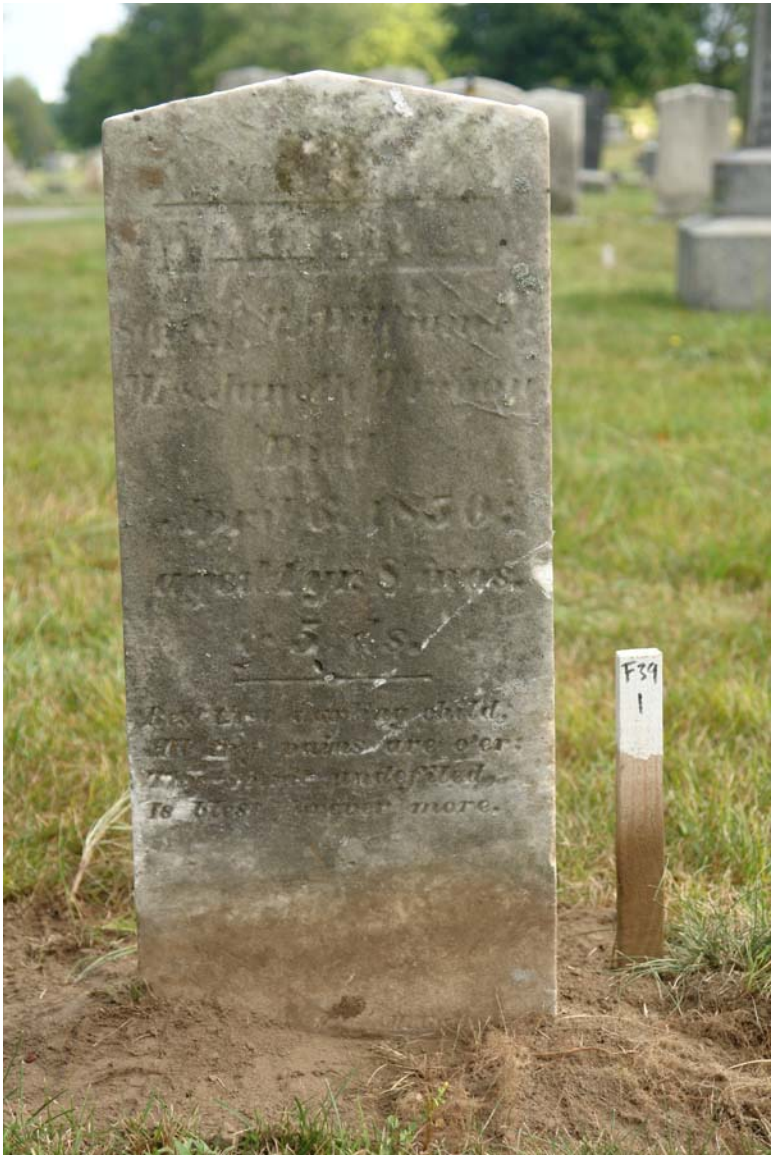
Hanover Center Cemetery, Hanover MA
NAME ON MARKER **Husband (Charles Perry)**
Death Date: Marker Type: Marker, slanted
Cond. of Inscription: Legible Material: Granite

EXISTING CONDITIONS	CONSERVATION STRATEGY
Tilted base	Reset base with marker plumb

TREATMENT	Treatment Dates
8/17/2015	
1. Marker carefully excavated. The soil around tilted markers was removed to an appropriate depth. When required, the marker was removed from the ground. Marker appears to be sound.	
2. Soling removed by light brushing with nylon brushes and water.	
3. Setting area excavated to sufficient depth and stone re-set plumb at appropriate height and level onto gravel bed, aligned with adjacent markers	
4. Area backfilled around marker with tamped sand and gravel	
5. Disturbed areas re-graded with existing topsoil and sod.

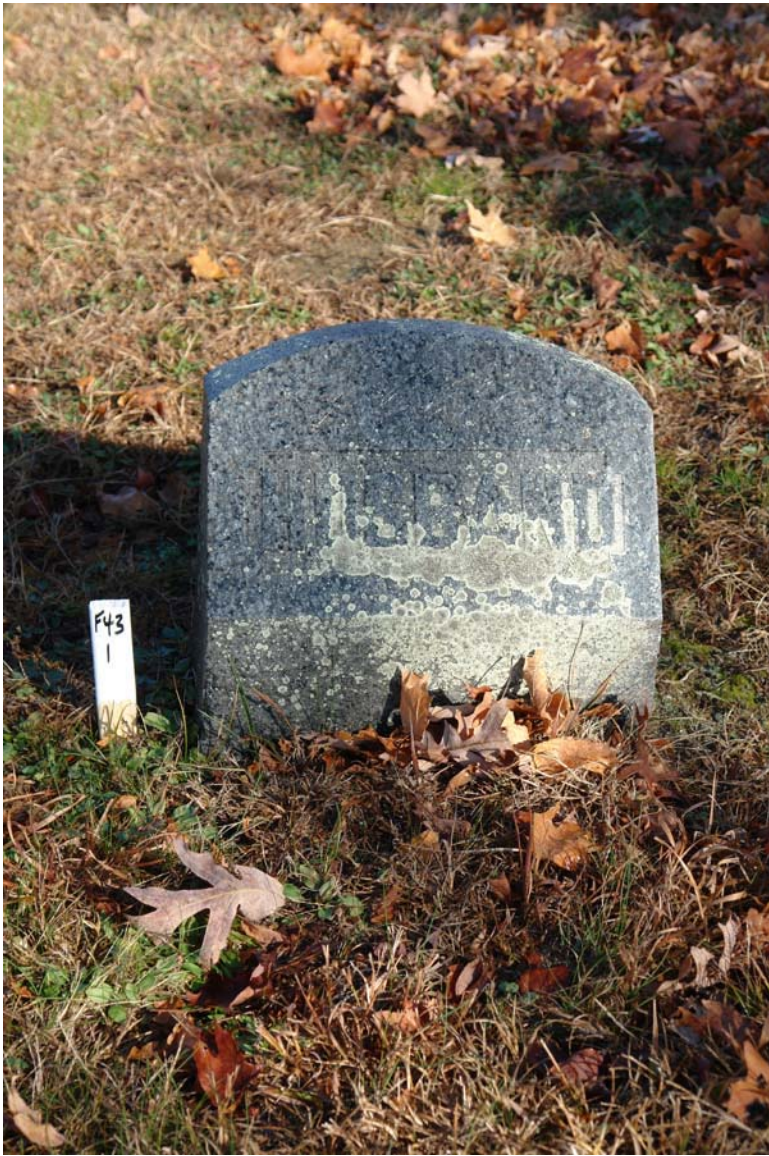
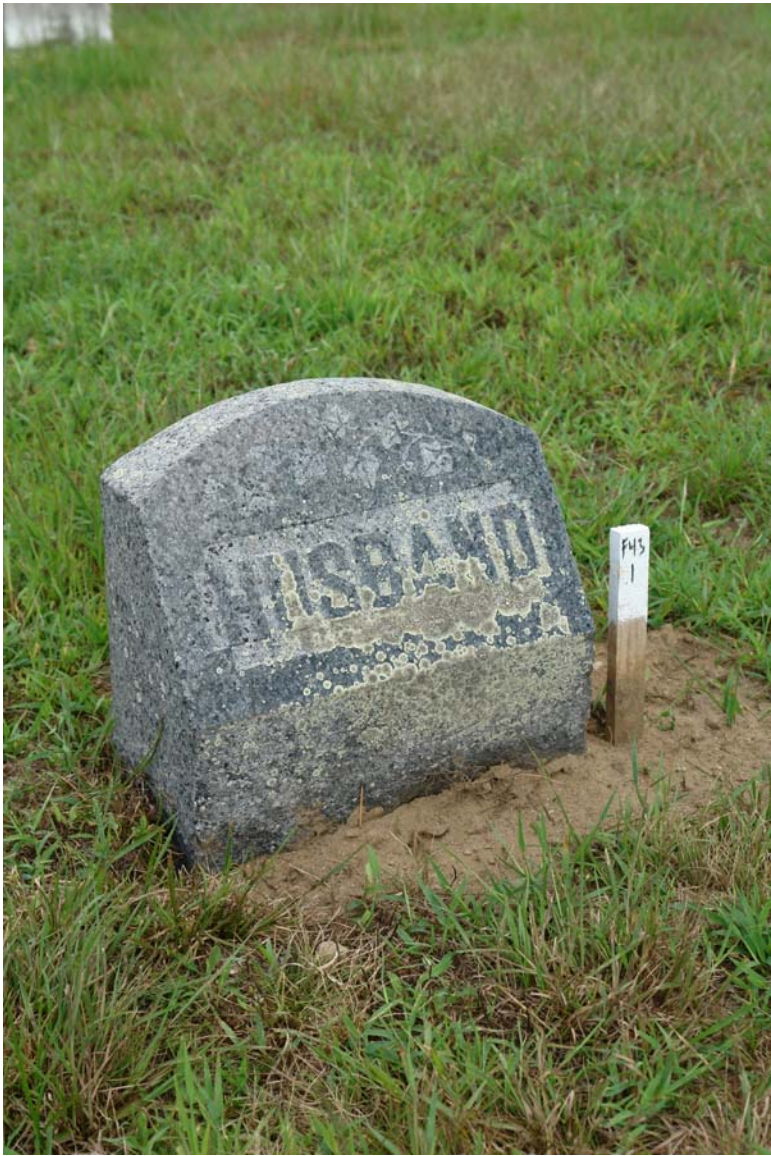
Hanover Center Cemetery, Hanover MA
NAME ON MARKER **O.W.H and J. W. H (House)**
Death Date: Marker Type: Headstone/pinned base
Cond. of Inscription: Legible Material: Marble

EXISTING CONDITIONS	CONSERVATION STRATEGY
Tilted Marker loose on base	Check base for level Reset marker plumb

TREATMENT	Treatment Dates
1. Elements removed from setting bases and inspected for soundness. 2. Area excavated to an appropriate depth removing any roots or large stones. 3. Base is aligned with adjacent markers and re-set level. 4. Area around base was backfilled with tamped gravel and re-graded with existing topsoil 5. Failed mortar removed from setting area and bottom of marker 6. When required, any existing pins were inspected, and if necessary, replaced with stainless steel threaded pins 7. Setting surfaces primed with Acryl 60 diluted 1:3 with water. 8. Marker reset plumb onto base with cement/lime mortar (3/2/9) with 000 sand. 9. Excess grout removed and joint area cleaned.	8/24-25/2015

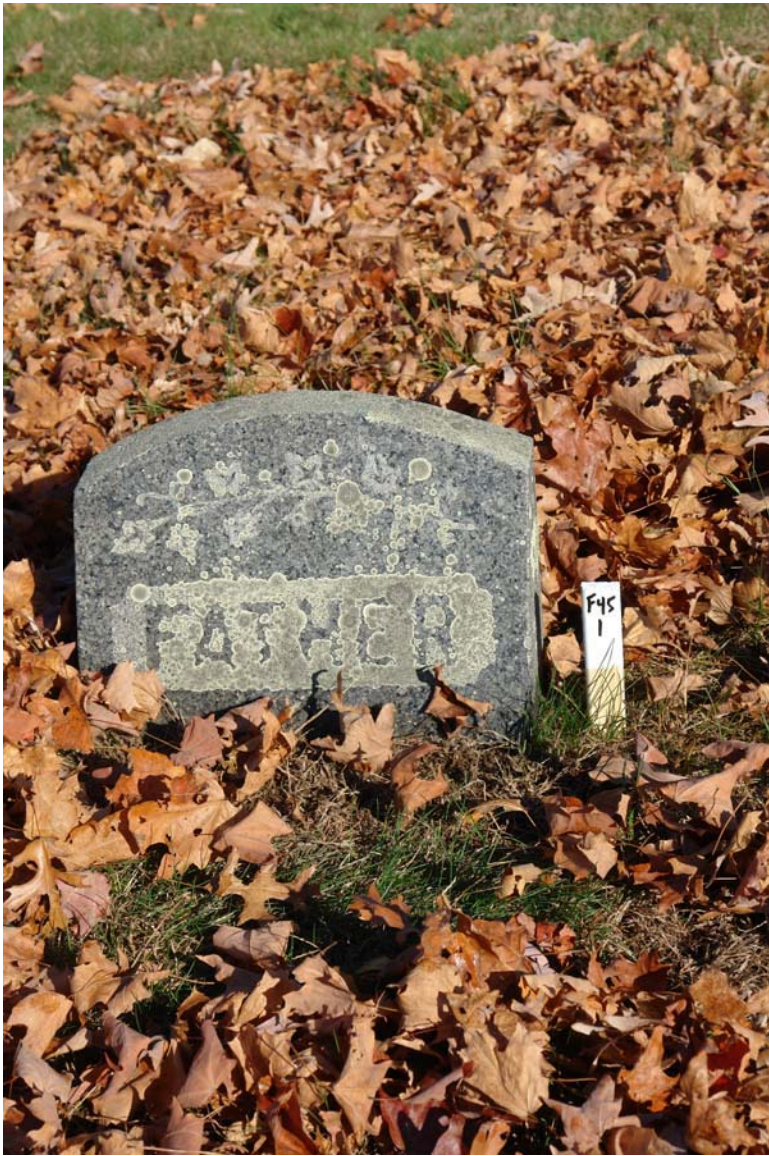
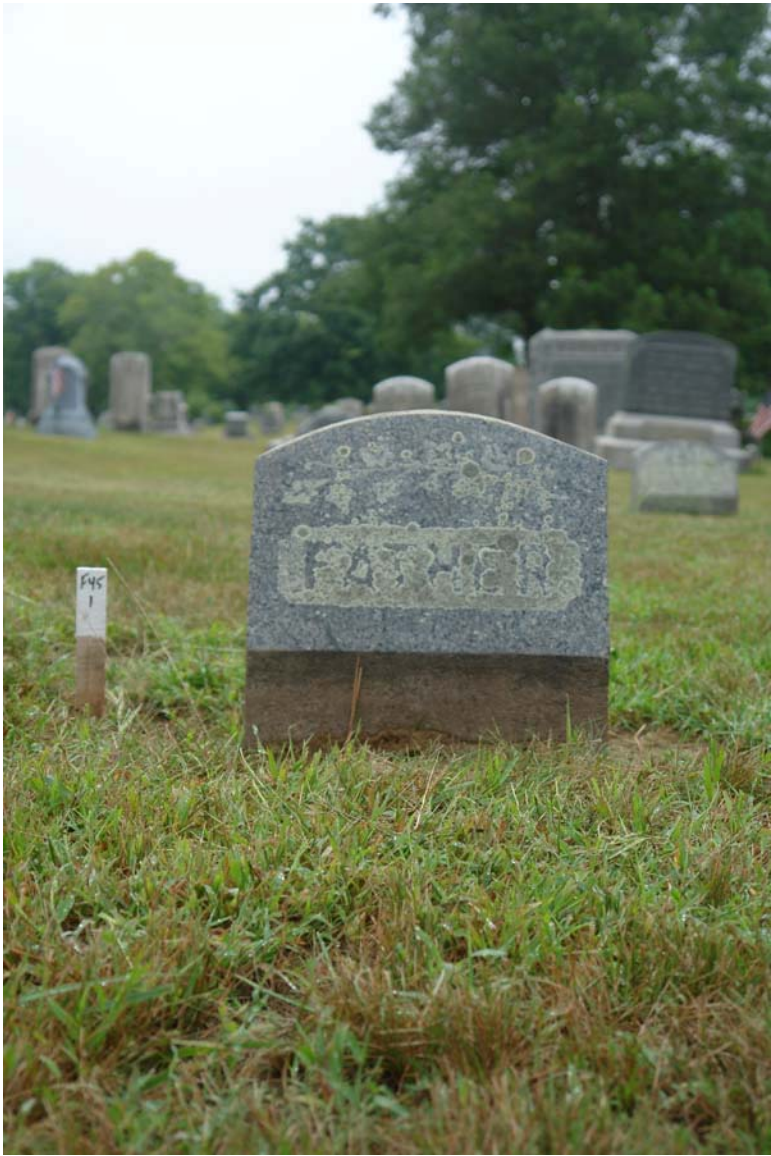
Hanover Center Cemetery, Hanover MA
NAME ON MARKER **Francis Ellis**
Death Date: 11/2/1843 Marker Type: Headstone/conc.base
Cond. of Inscription: Legible Material: Marble

EXISTING CONDITIONS	CONSERVATION STRATEGY
Tilted base	Reset base with marker plumb

TREATMENT	Treatment Dates
	8/24/2015
<div>1. Area excavated to an appropriate depth removing any roots or large stones.</div> <div>2. Base inspected and found to be sound and re-useable</div> <div>3. Base is aligned with adjacent markers and re-set level.</div> <div>4. Area around base was backfilled with tamped gravel and re-graded with existing topsoil</div> <div>5. Debris removed from setting slot. When required, power grinders were used to facilitate removal of stone fragments.</div> <div>6. When required, the lower setting edge was re-squared by power grinder with minimal loss.</div> <div>7. Marker reset plumb and level into setting slot with cement/lime grout (3/2/9) with 000 sand made fluid with a super plasticizer.</div> <div>8. Excess grout removed and joint area cleaned.</div> <div>9. Marker braced for a minimum 3 days</div>

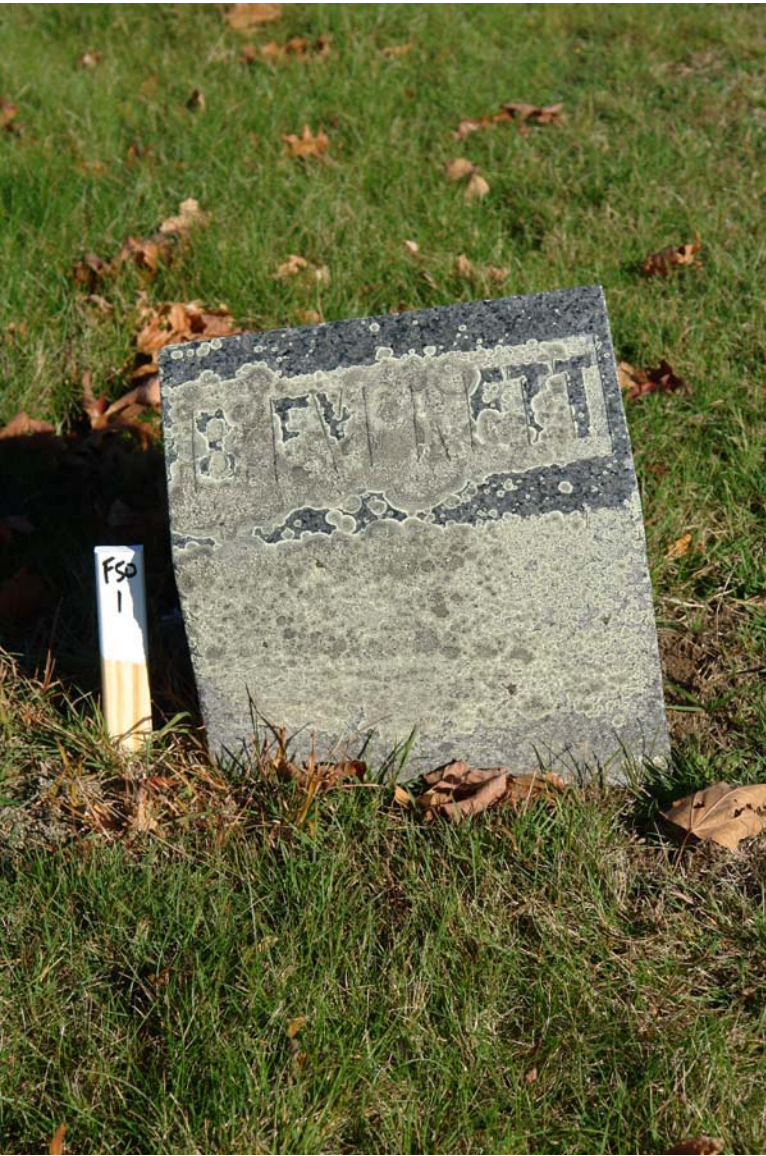
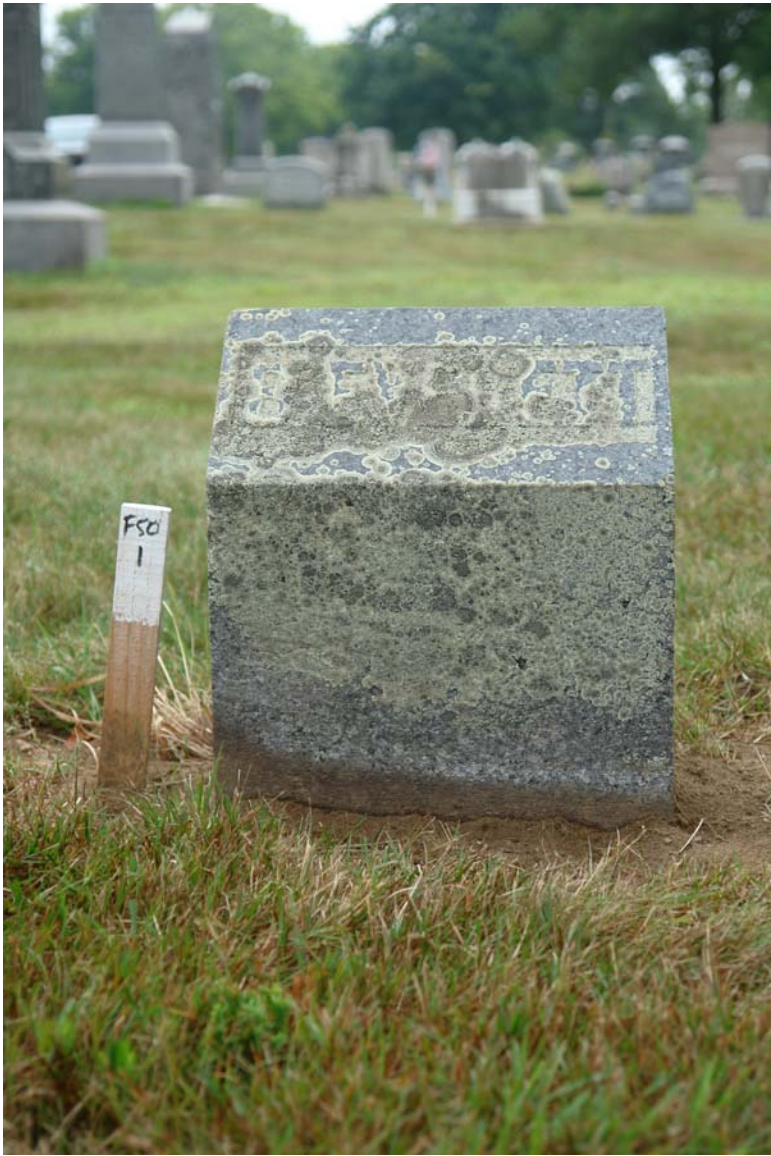
Hanover Center Cemetery, Hanover MA
NAME ON MARKER **Harrison Stetson**
Death Date: 6/4/1892 Marker Type: Headstone/pinned base
Cond. of Inscription: Legible Material: Granite

EXISTING CONDITIONS	CONSERVATION STRATEGY
Tilted base	Reset base with marker plumb

TREATMENT	Treatment Dates
8/25/2015	
1. Elements removed from setting bases and inspected for soundness. 2. Area excavated to an appropriate depth removing any roots or large stones. 3. Base is aligned with adjacent markers and re-set level. 4. Area around base was backfilled with tamped gravel and re-graded with existing topsoil 5. Failed mortar removed from setting area and bottom of marker 6. When required, any existing pins were inspected, and if necessary, replaced with stainless steel threaded pins 7. Setting surfaces primed with Acryl 60 diluted 1:3 with water. 8. Marker reset plumb onto base with cement/lime mortar (3/2/9) with 000 sand. 9. Excess grout removed and joint area cleaned.

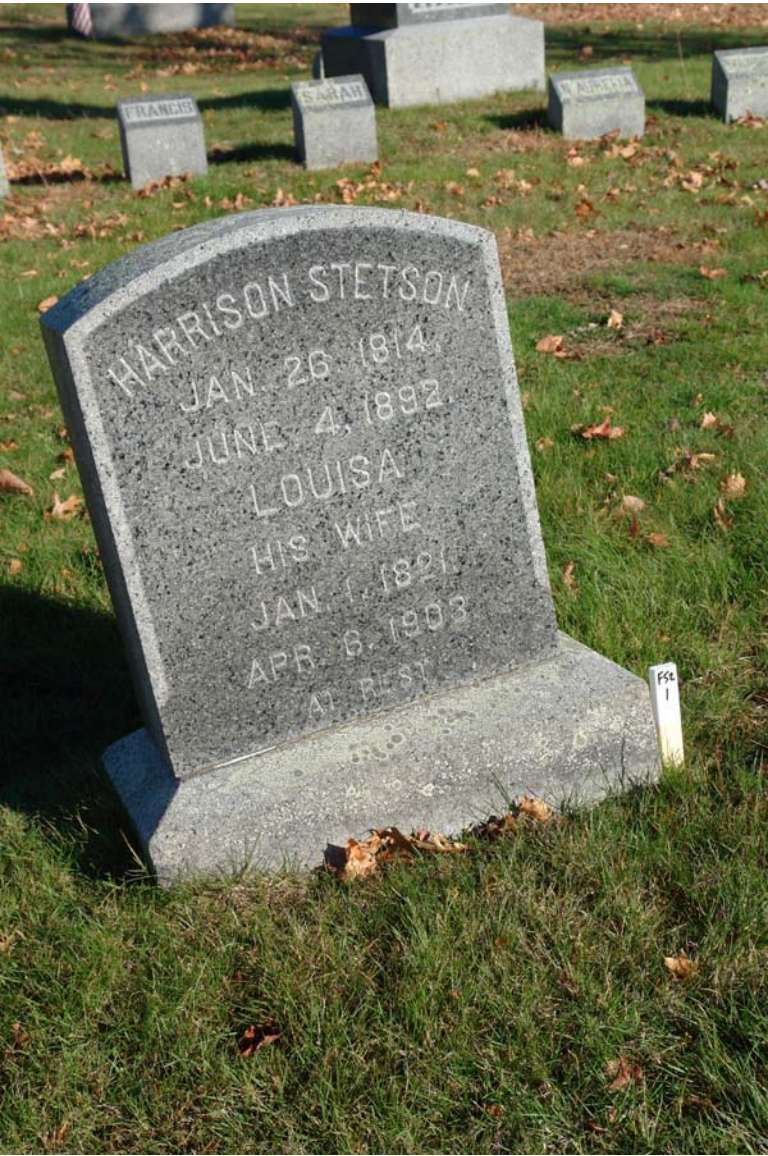
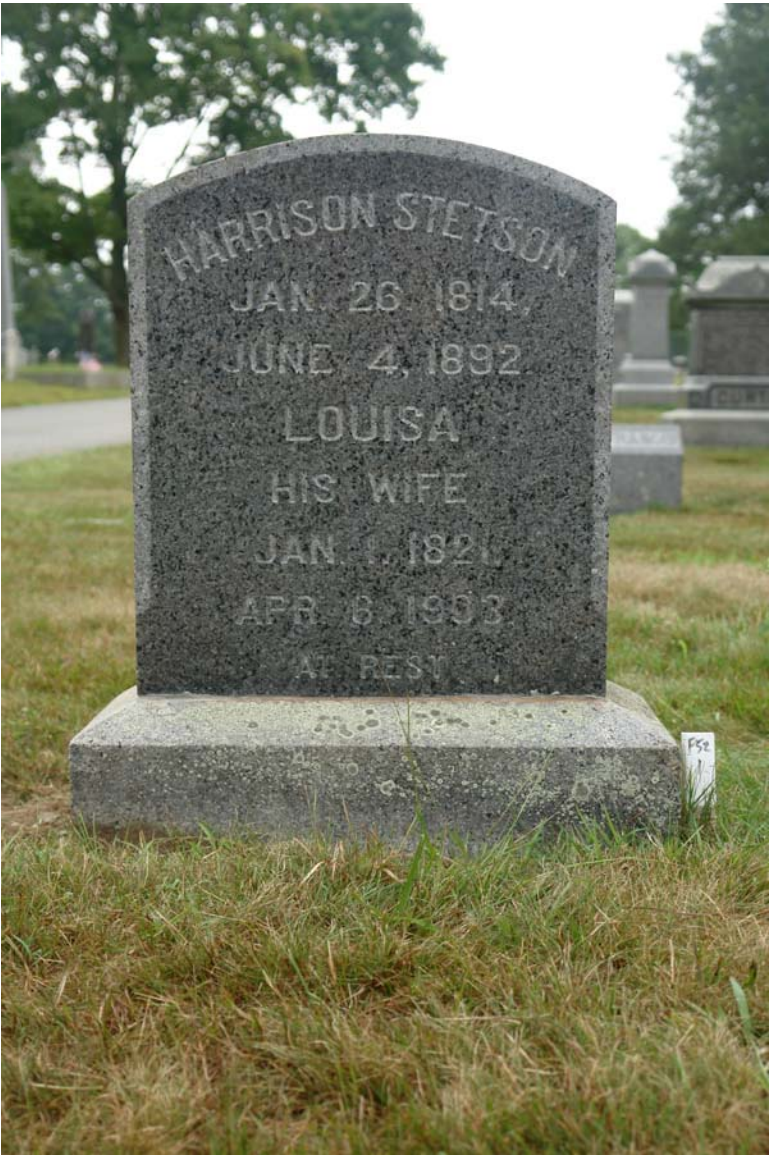
Hanover Center Cemetery, Hanover MA	
NAME ON MARKER Henry Bates	
Death Date: 8/30/1908	Marker Type: Headstone/base
Cond. of Inscription: Legible	Material: Granite

EXISTING CONDITIONS	CONSERVATION STRATEGY
Tilted Loose on base	Reset base level Reset elements

TREATMENT	Treatment Dates 8/17/2015
<div>1. Soil removed around base unit and base jacked up to level.</div> <div>2. Existing foundation stones exposed and built up to support base unit.</div> <div>3. Base re-set plumb at appropriate height and level, aligned with adjacent markers</div> <div>4. Area beneath and around base backfilled with tamped sand and gravel</div> <div>5. Disturbed areas re-graded with existing topsoil.</div> <div>6. Failed setting mortars removed from setting bed with hand chisels as necessary</div> <div>7. Setting pins examined, if sound they were re-used, if rusted or failed and required, replaced with stainless steel threaded studs.</div> <div>8. Setting bed area primed with Acryl 60 diluted 1:3 with water.</div> <div>9. Marker lifted with mechanical assistance and reset with cement/lime mortar (3/2/9) with 000 sand.</div>

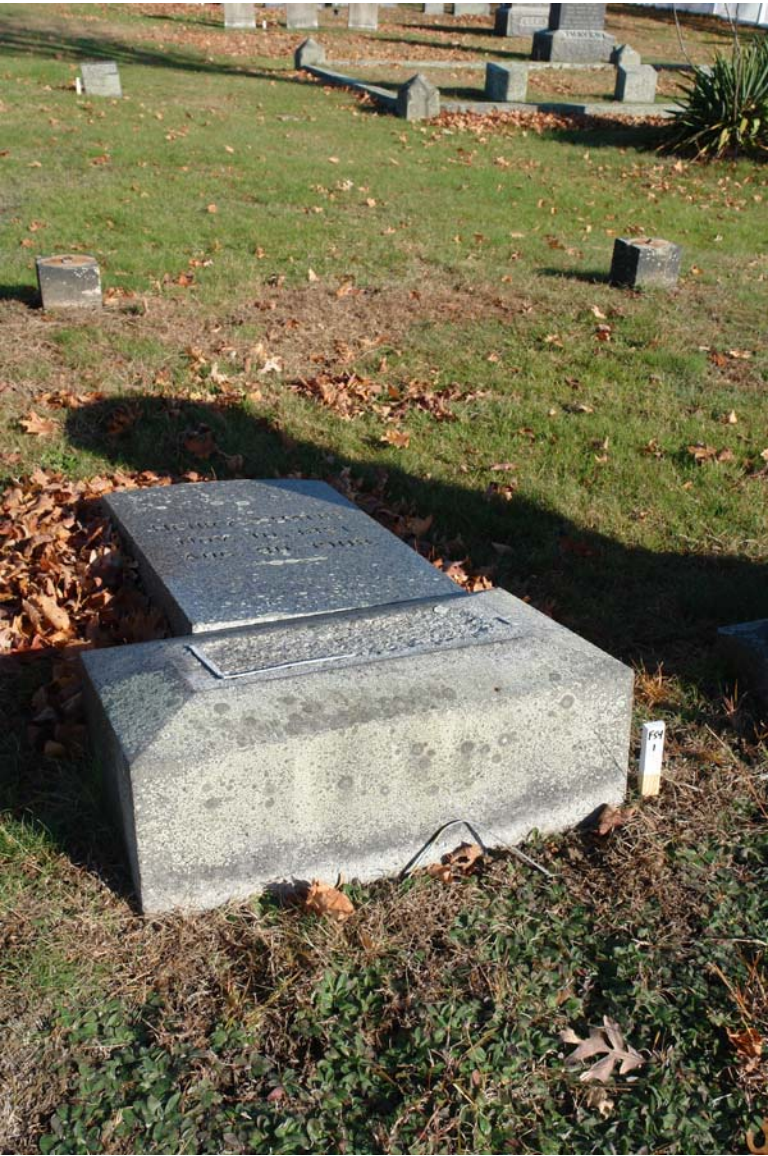
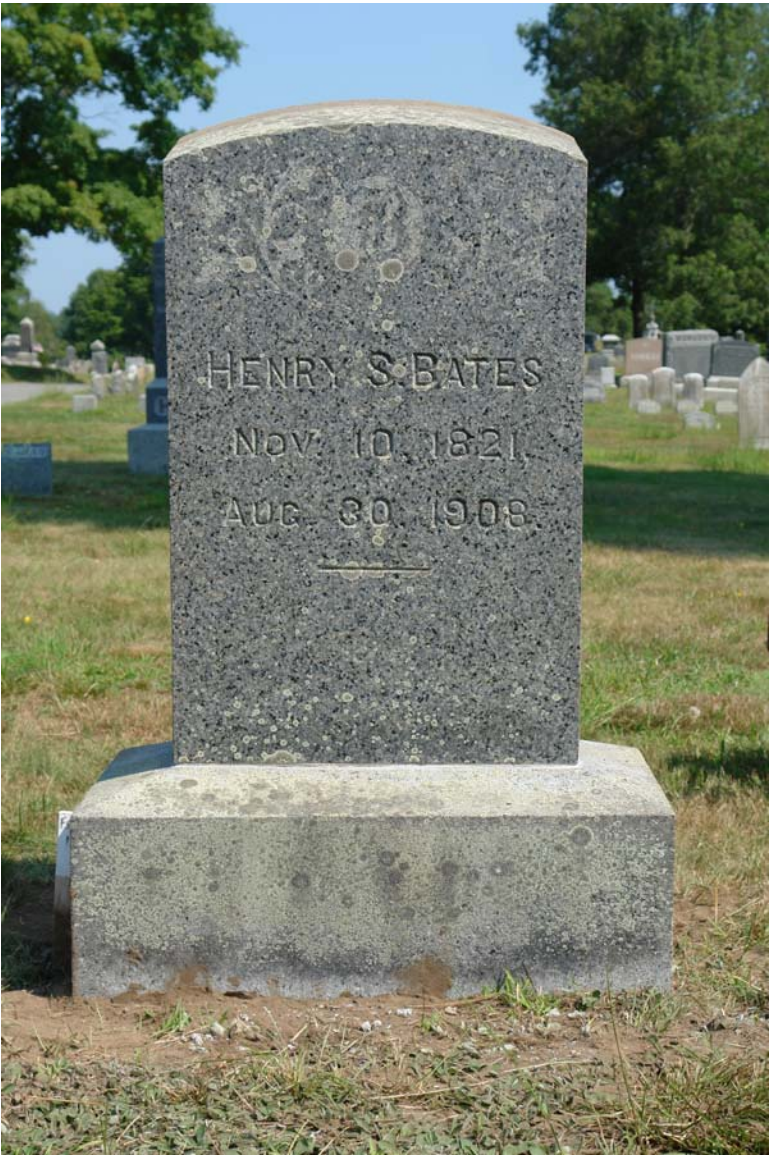
Hanover Center Cemetery, Hanover MA
NAME ON MARKER **Angie Bates**
Death Date: 3/10/1885 Marker Type: Headstone/pinned base
Cond. of Inscription: Legible Material: Marble

EXISTING CONDITIONS	CONSERVATION STRATEGY
Tilted Marker loose on base	Check base for level Reset marker plumb

TREATMENT	Treatment Dates 8/24-25/2015
<div>1. Elements removed from setting bases and inspected for soundness. 2. Area excavated to an appropriate depth removing any roots or large stones. 3. Base is aligned with adjacent markers and re-set level. 4. Area around base was backfilled with tamped gravel and re-graded with existing topsoil 5. Failed mortar removed from setting area and bottom of marker 6. When required, any existing pins were inspected, and if necessary, replaced with stainless steel threaded pins 7. Setting surfaces primed with Acryl 60 diluted 1:3 with water. 8. Marker reset plumb onto base with cement/lime mortar (3/2/9) with 000 sand. 9. Excess grout removed and joint area cleaned.</div>

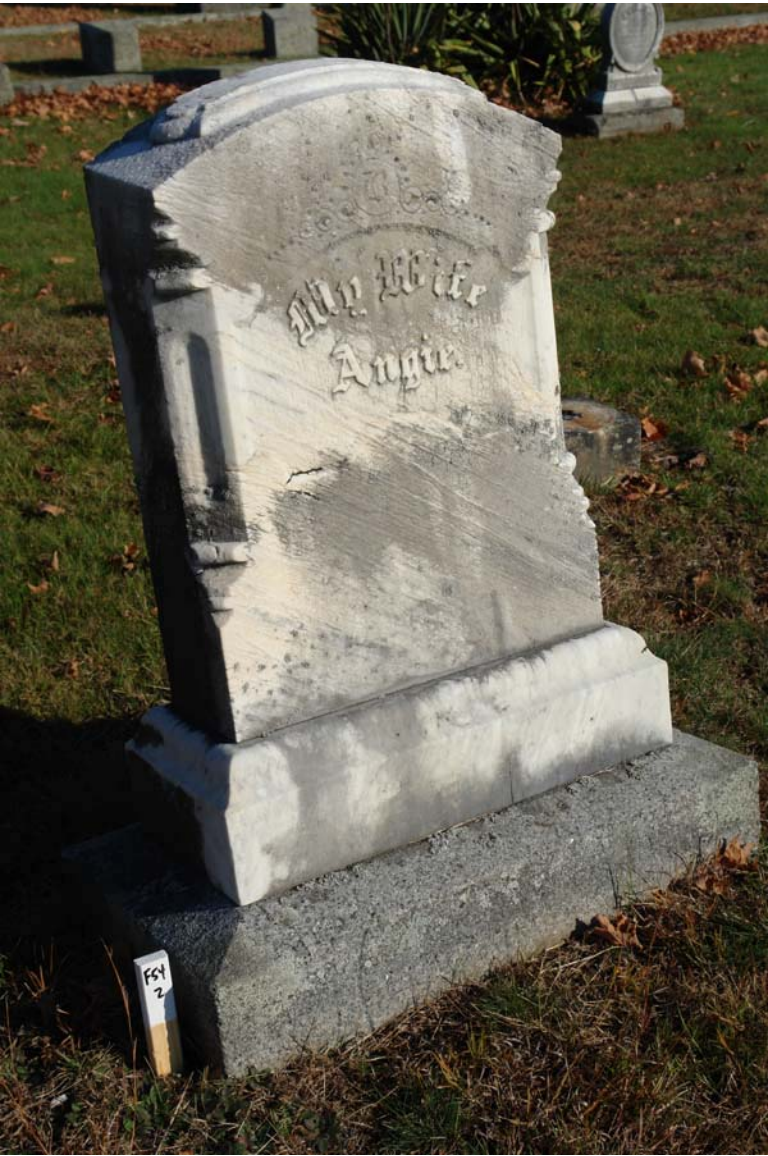
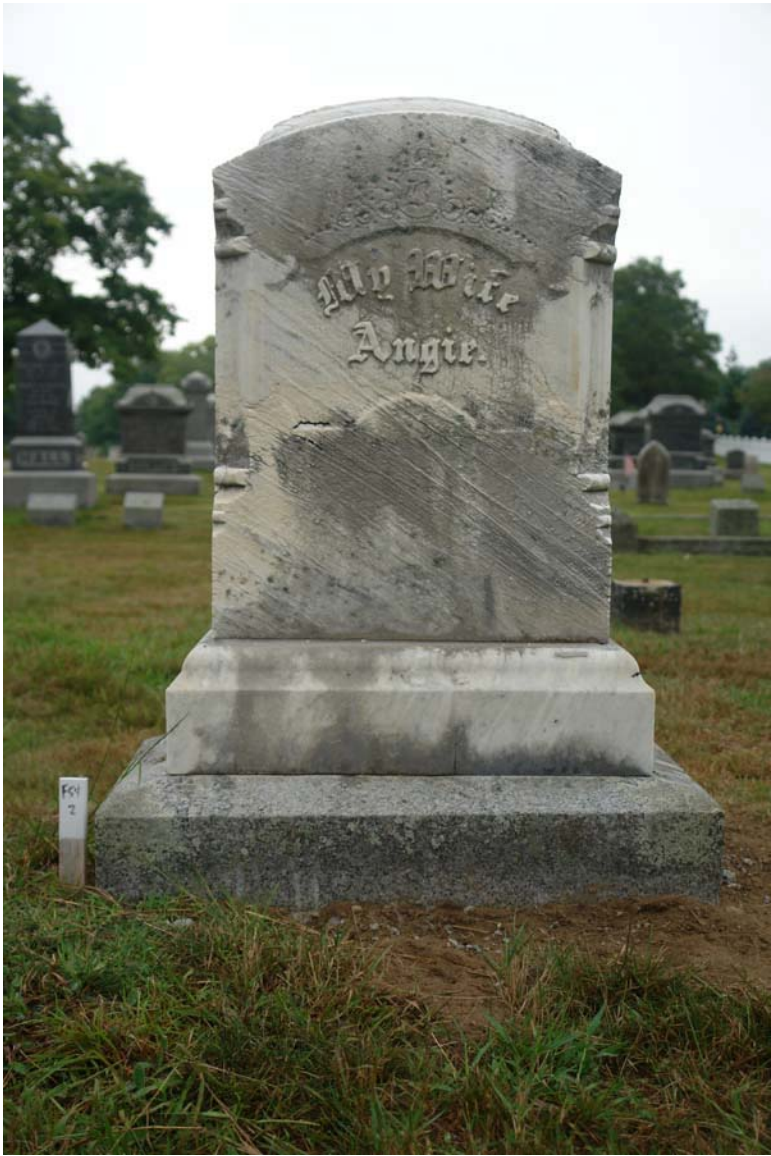
Hanover Center Cemetery, Hanover MA	
NAME ON MARKER	Andrew Gardner
Death Date: 1/10/1878	Marker Type: Headstone/base
Cond. of Inscription: Legible	Material: Marble
EXISTING CONDITIONS	CONSERVATION STRATEGY
Tilted base	Reset base with marker plumb
TREATMENT	
Treatment Dates 8/18/2015	
<div>1. Area excavated to an appropriate depth removing any roots or large stones.</div> <div>2. Base inspected and found to be sound and re-useable</div> <div>3. Base is aligned with adjacent markers and re-set level.</div> <div>4. Area around base was backfilled with tamped gravel and re-graded with existing topsoil</div> <div>5. Debris removed from setting slot. When required, power grinders were used to facilitate removal of stone fragments.</div> <div>6. When required, the lower setting edge was re-squared by power grinder with minimal loss.</div> <div>7. Marker reset plumb and level into setting slot with cement/lime grout (3/2/9) with 000 sand made fluid with a super plasticizer.</div> <div>8. Excess grout removed and joint area cleaned.</div> <div>9. Marker braced for a minimum 3 days</div>

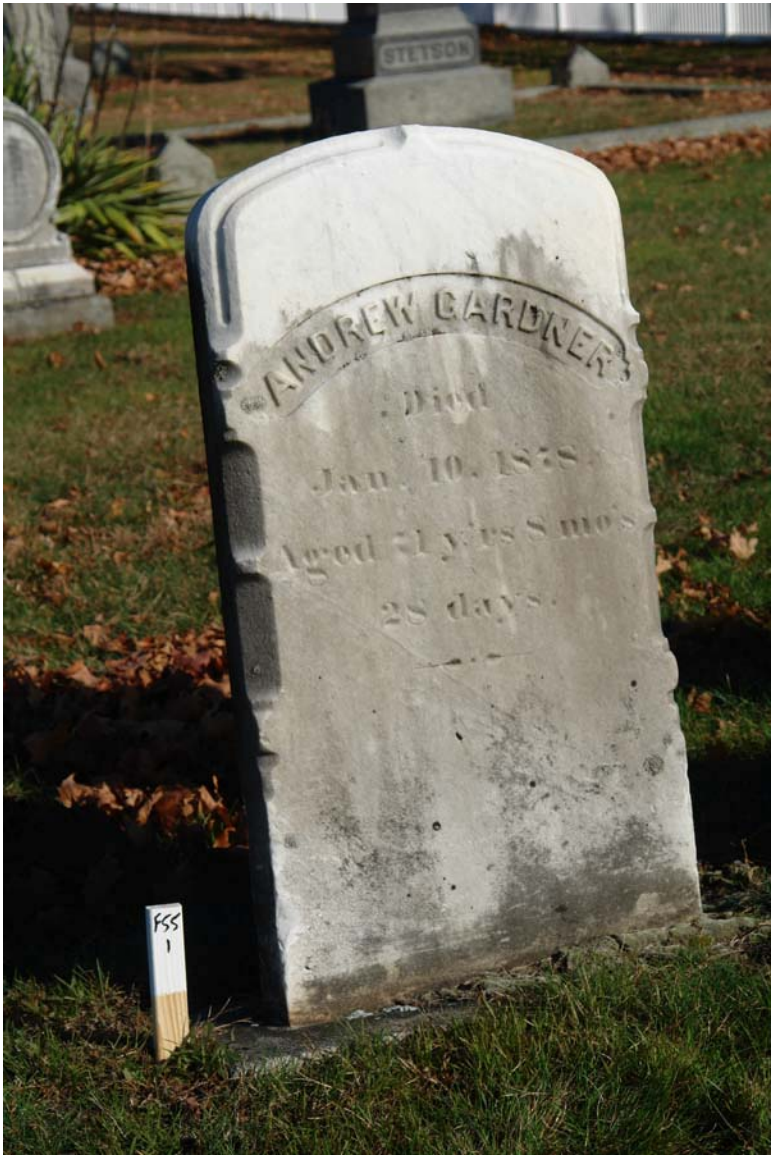
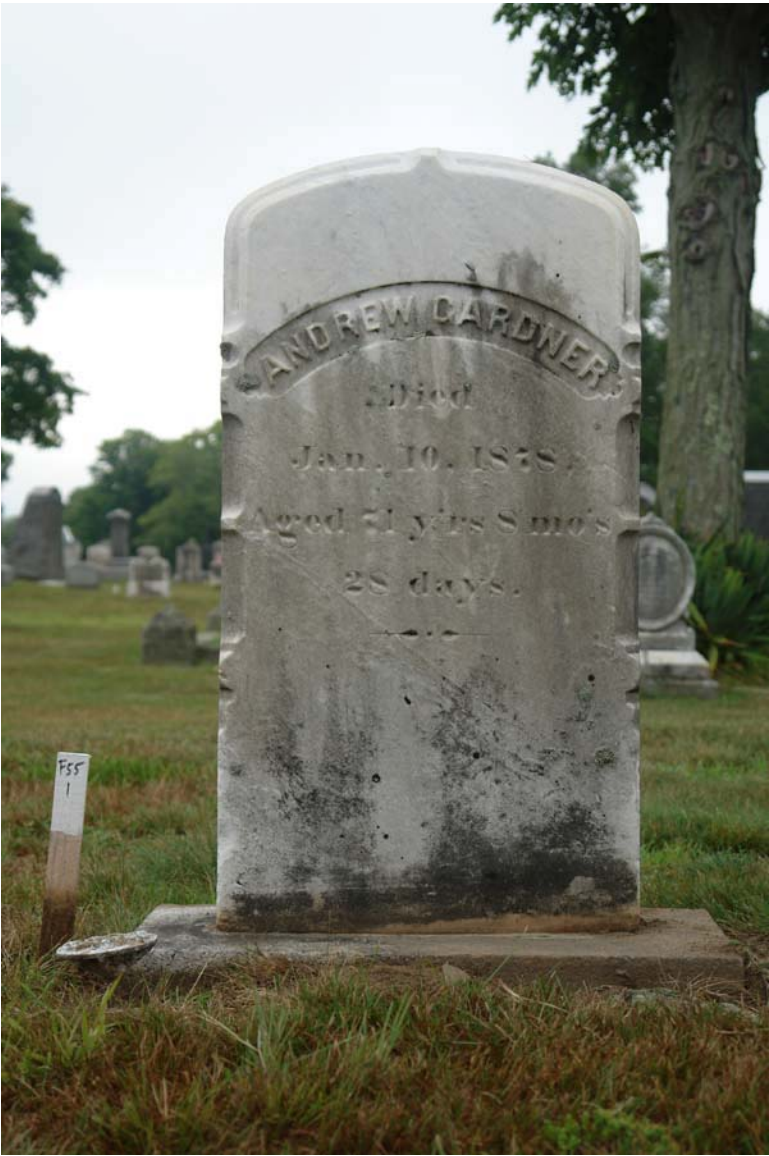
Hanover Center Cemetery, Hanover MA	
NAME ON MARKER Benjamin Pratt	
Death Date: 6/16/1875	Marker Type: Headstone/base
Cond. of Inscription: Legible	Material: Marble

EXISTING CONDITIONS	CONSERVATION STRATEGY
Tilted	Evaluate resetting options Possible new below grade concrete base

TREATMENT	Treatment Dates 8/24-9/1/2015
<div>1. Overgrowth removed by DPW</div> <div>2. Area excavated to an appropriate depth. Base is aligned with adj. markers and reset level at appropriate height.</div> <div>3. All mating edges of fragments cleaned with water and any failed adhesives removed with hand tools</div> <div>4. Fragments attached with structural adhesive (Abatron 55-22), clamped and braced until cured. Excess epoxy removed with hand chisels within 24 hours.</div> <div>5. Setting surfaces cleaned of debris or failed mortar and base and market fragment reset plumb and level with a cement/lime grout (3/2/9) with 000 sand. Excess grout removed and joint area cleaned.</div> <div>6. Marker braced for a minimum 3 days</div> <div>7. Cracks and losses filled with RepliCal Marble or Jahn restoration mortar. products, filled areas misted with water and covered for 3 days minimum..</div>

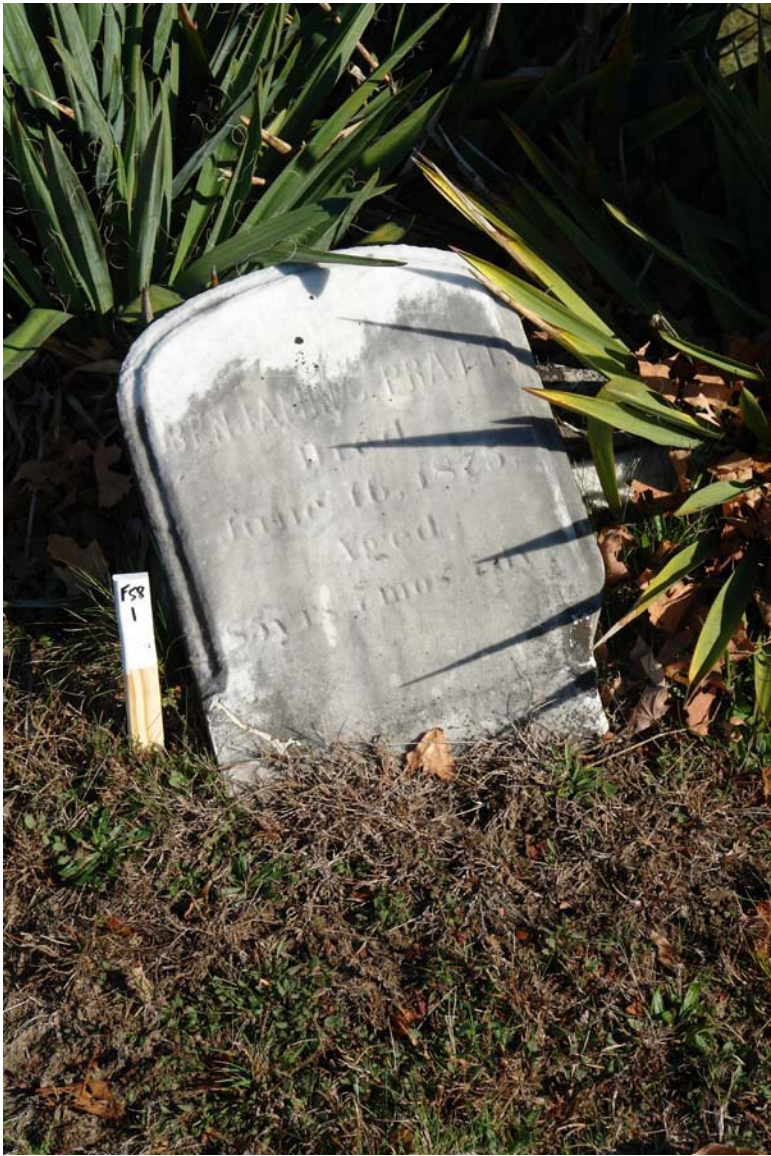
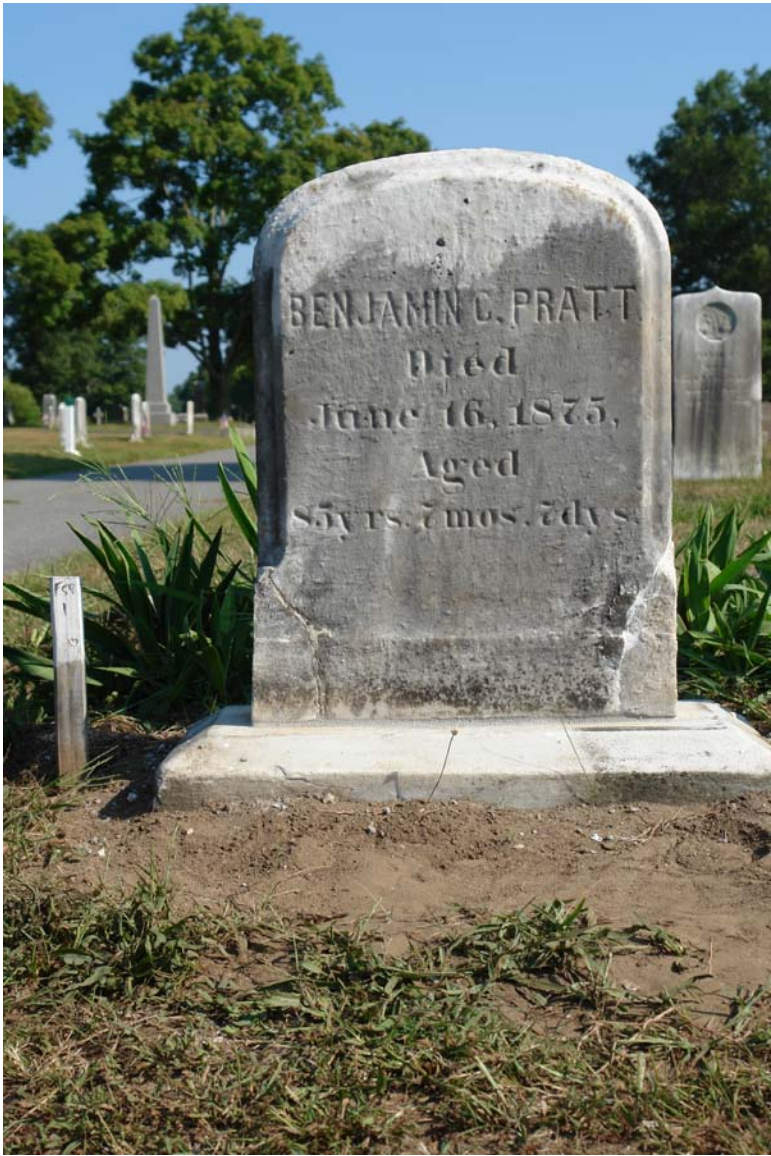
Hanover Center Cemetery, Hanover MA	
NAME ON MARKER	Rebecca Pratt
Death Date: 12/1/1844	Marker Type: Headstone/base
Cond. of Inscription: Decipherable	Material: Marble
EXISTING CONDITIONS	CONSERVATION STRATEGY
Tilted base	Reset base with marker plumb
TREATMENT	
Treatment Dates 8/24/2015	
1. Overgrowth removed by DPW	
2. Marker and base found to be in sound condition with marker securely attached to base.	
3. Area excavated to an appropriate depth removing any roots or large stones.	
4. Base is aligned with adjacent markers and re-set level.	
5. Area around base was backfilled with tamped gravel and re-graded with existing topsoil

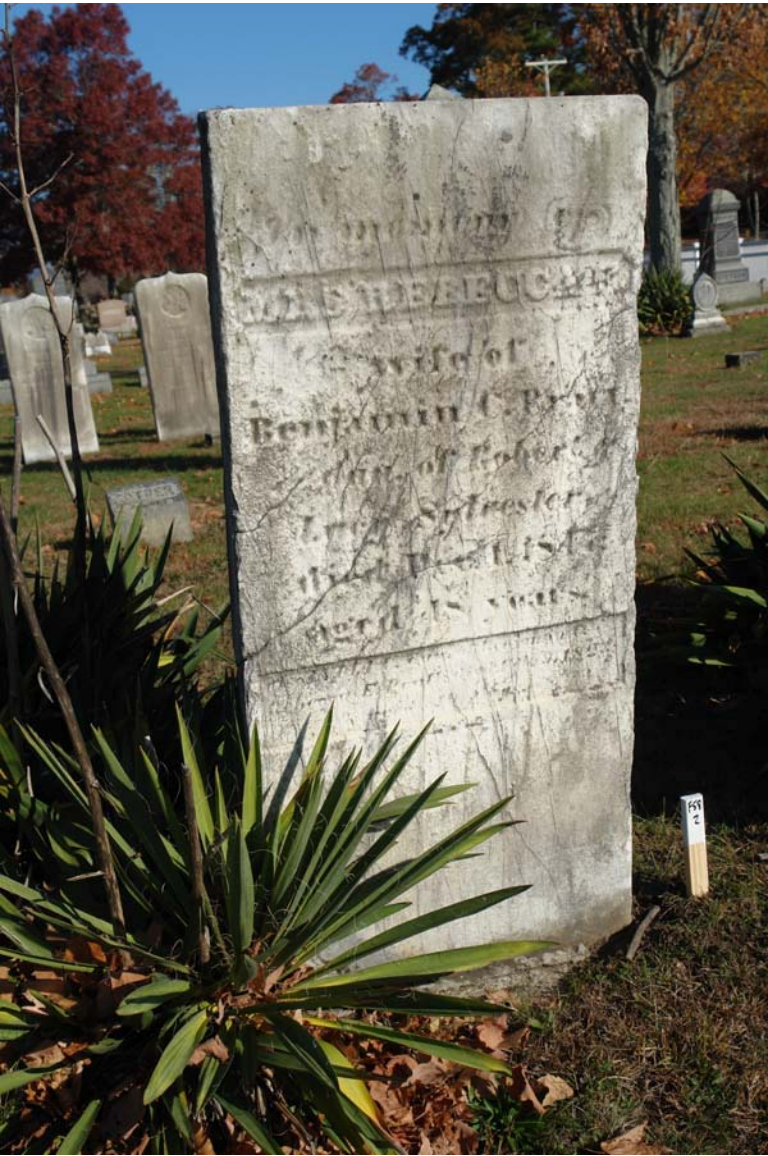
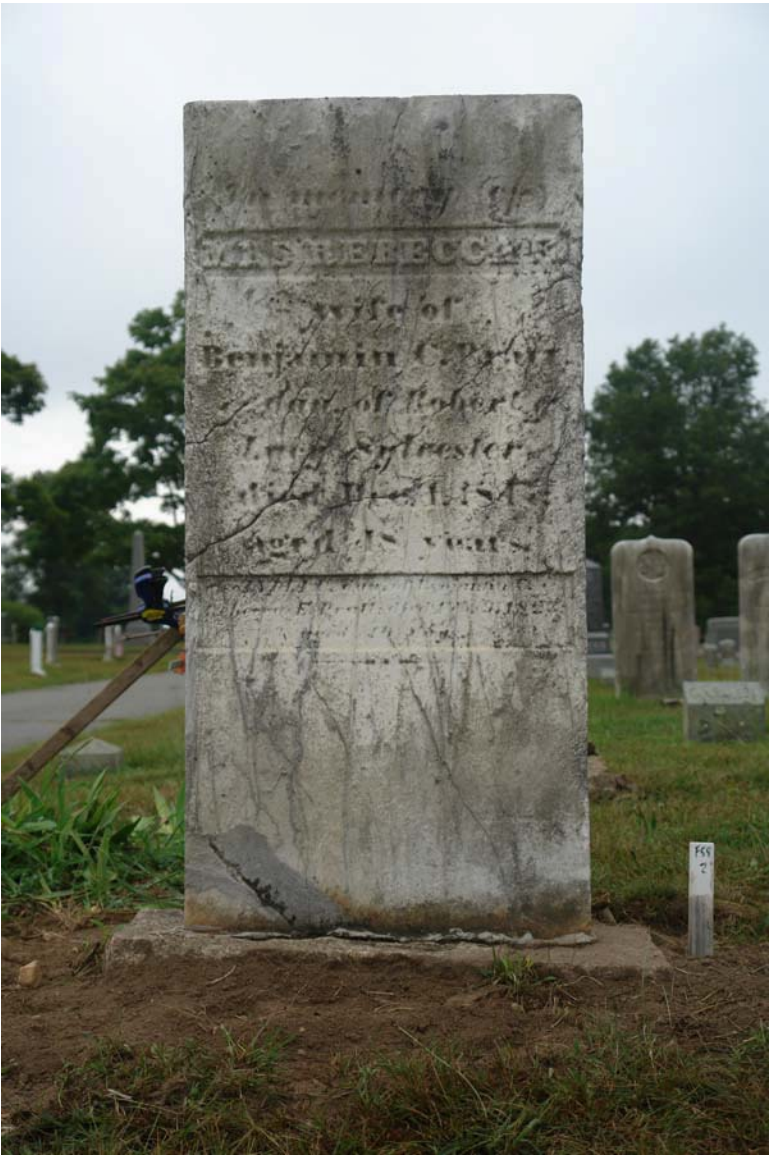
Hanover Center Cemetery, Hanover MA		
NAME ON MARKER		Lydia Pratt
Death Date:	7/6/1856	Marker Type: Headstone/base
Cond. of Inscription:	Legible	Material: Marble
EXISTING CONDITIONS		CONSERVATION STRATEGY
Tilted base		Reset base with marker plumb
TREATMENT		
Treatment Dates		8/24/2015
<div>1. Overgrowth removed by DPW</div> <div>2. Elements removed from setting bases and area excavated to an appropriate depth removing any roots or large stones.</div> <div>3. Base is aligned with adjacent markers and re-set level.</div> <div>4. Area around base was backfilled with tamped gravel and re-graded with existing topsoil</div> <div>5. Failed mortar removed from setting area and bottom of marker</div> <div>6. When required, any existing pins were inspected, and if necessary, replaced with stainless steel threaded pins</div> <div>7. Setting surfaces primed with Acryl 60 diluted 1:3 with water.</div> <div>8. Marker reset plumb onto base with cement/lime mortar (3/2/9) with 000 sand.</div> <div>9. Excess grout removed and joint area cleaned.</div>

Comments: Shrubs to be removed
