MONUMENT CONSERVATION COLLABORATIVE LLC, NORFOLK, CT

DOCUMENTATION OF STONE CONSERVATION TREATMENTS TO ASSINIPPI CEMETERY, HANOVER, MA June 2015

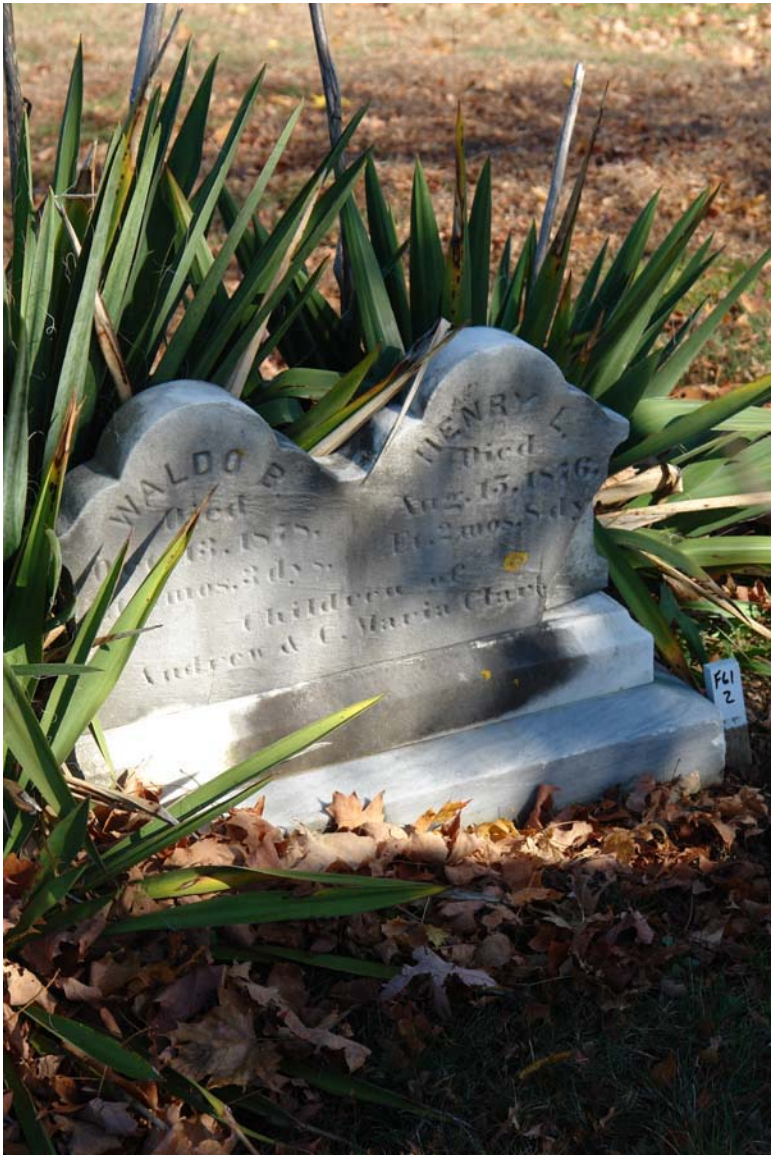
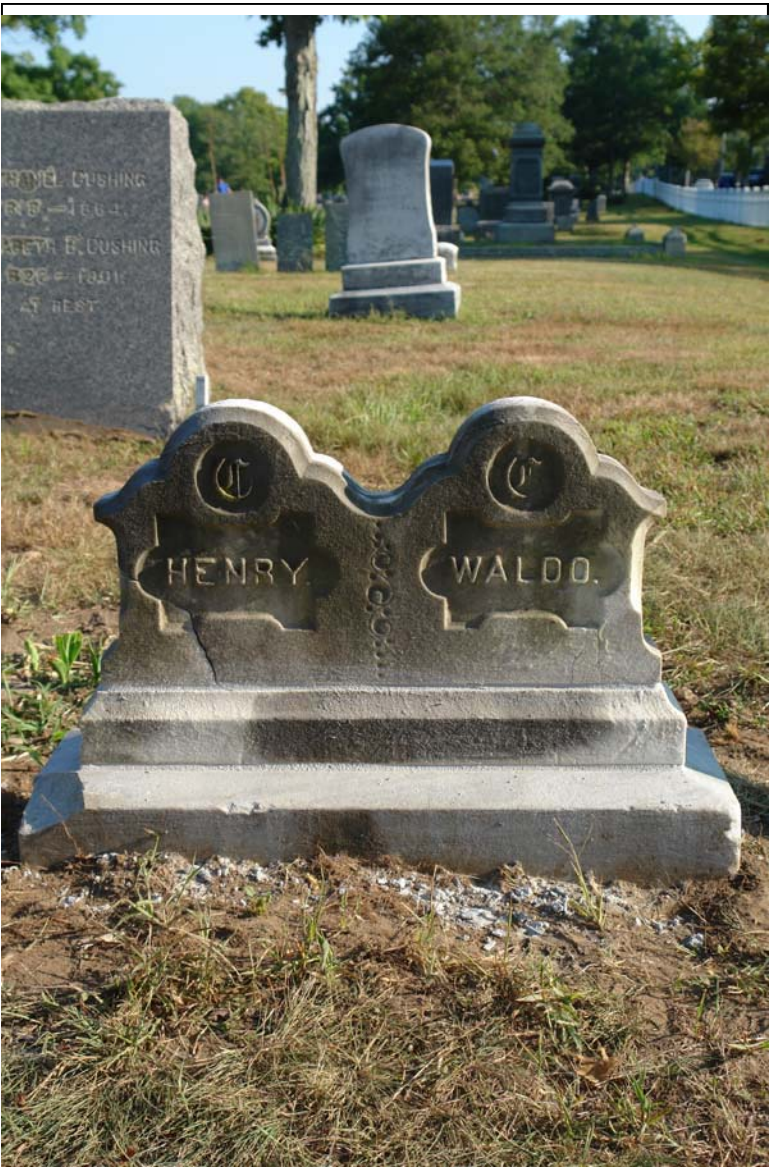
Hanover Center Cemetery, Hanover MA	
NAME ON MARKER Henry Clark	
Death Date: 1/7/1885	Marker Type: Headstone/base
Cond. of Inscription: Legible	Material: Marble

EXISTING CONDITIONS	CONSERVATION STRATEGY
Tilted base	Reset base with marker plumb

TREATMENT	Treatment Dates 8/26-31/2015
<div>1. Marker excavated and found to be sound. Light soiling removed by brushing with nylon brushes and water.</div> <div>2. Setting area excavated for new below grade cast concrete base sized minimum of 12 inches deep,</div> <div>3. Wooden forms stabilized and aligned with adjacent markers before concrete is poured</div> <div>4. Setting forms are removed after partial curing of the concrete and the base backfilled with tamped sand or gravel</div> <div>5. Setting surfaces primed with acryl 60 diluted 1:3 and marker reset with a cement/lime grout (3/2/9) with 000 sand..</div> <div>6. Marker set plumb and level, and braced for minimum of 3 days.</div> <div>7. Disturbed areas backfilled with existing topsoil.</div>

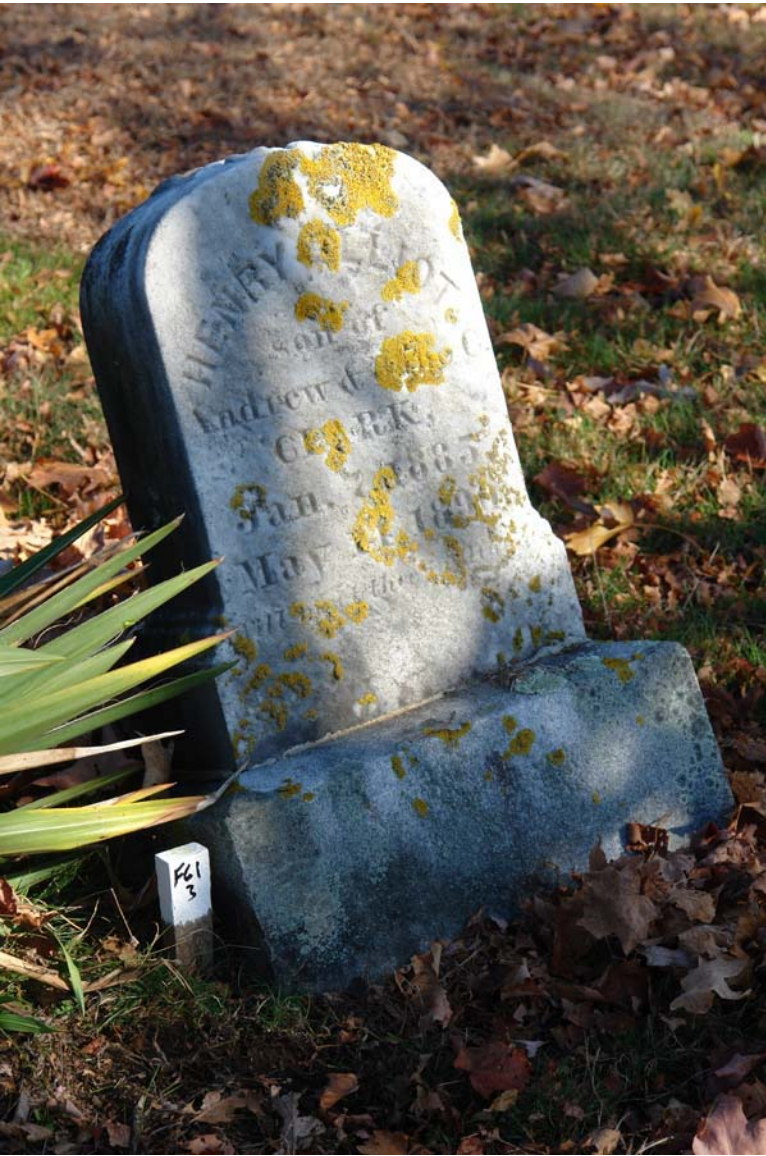
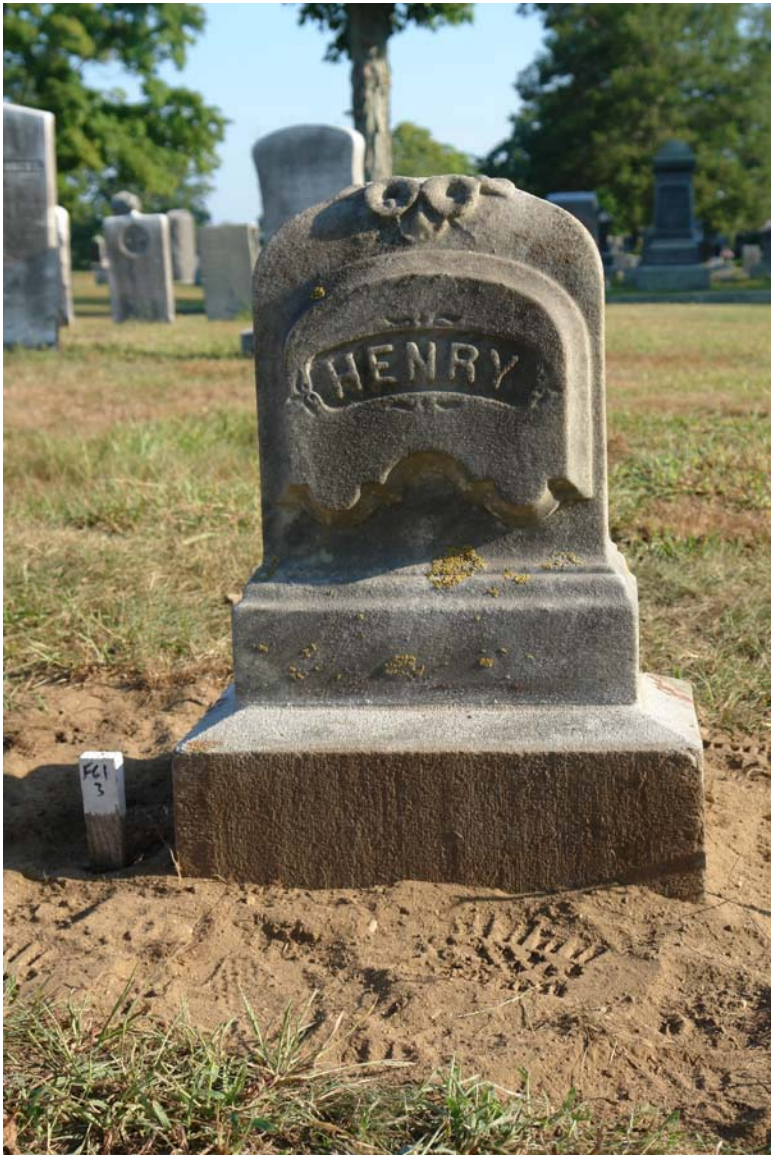
Hanover Center Cemetery, Hanover MA
NAME ON MARKER **John Eells**
Death Date: 11/25/1883 Marker Type: Headstone/pinned base
Cond. of Inscription: Legible Material: Marble

EXISTING CONDITIONS	CONSERVATION STRATEGY
Tilted Marker loose on base	Check base for level Reset marker plumb

TREATMENT	Treatment Dates
1. Elements removed from setting bases and inspected for soundness. 2. Area excavated to an appropriate depth removing any roots or large stones. 3. Base is aligned with adjacent markers and re-set level. 4. Area around base was backfilled with tamped gravel and re-graded with existing topsoil 5. Failed mortar removed from setting area and bottom of marker 6. When required, any existing pins were inspected, and if necessary, replaced with stainless steel threaded pins 7. Setting surfaces primed with Acryl 60 diluted 1:3 with water. 8. Marker reset plumb onto base with cement/lime mortar (3/2/9) with 000 sand. When required, lead shims were used to facilitate leveling. 9. Excess grout removed and joint area cleaned.	8/24/2015

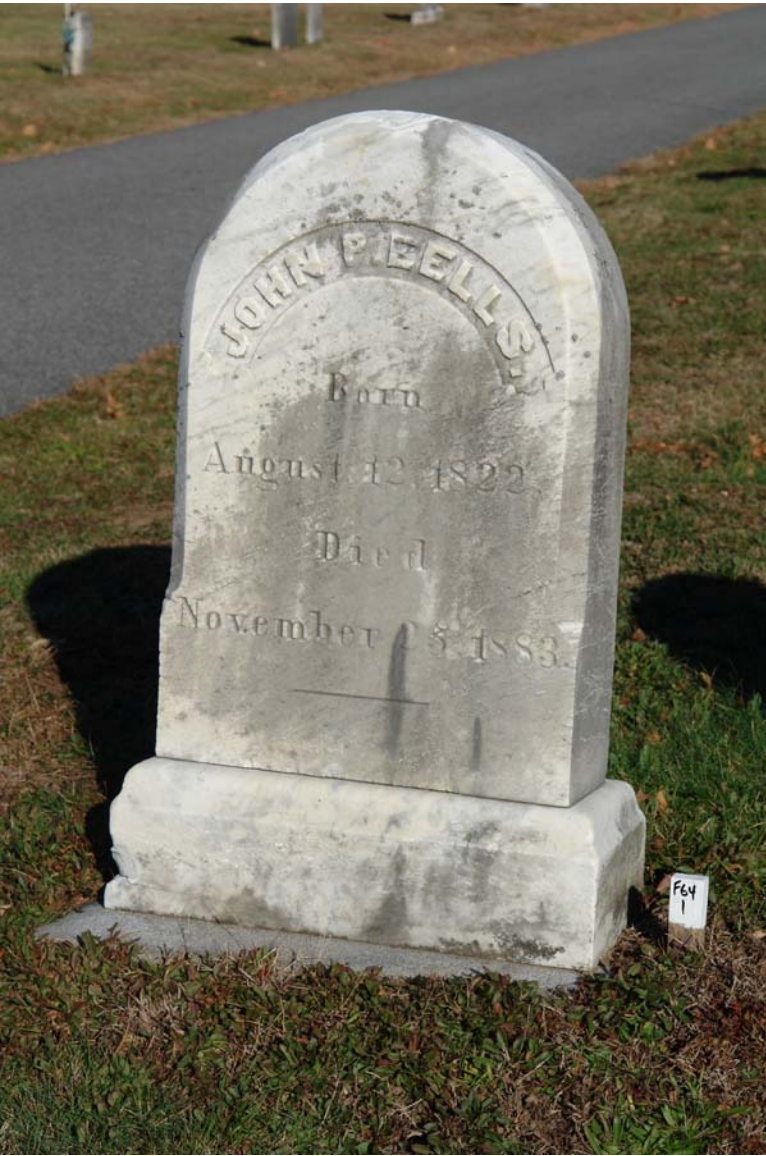
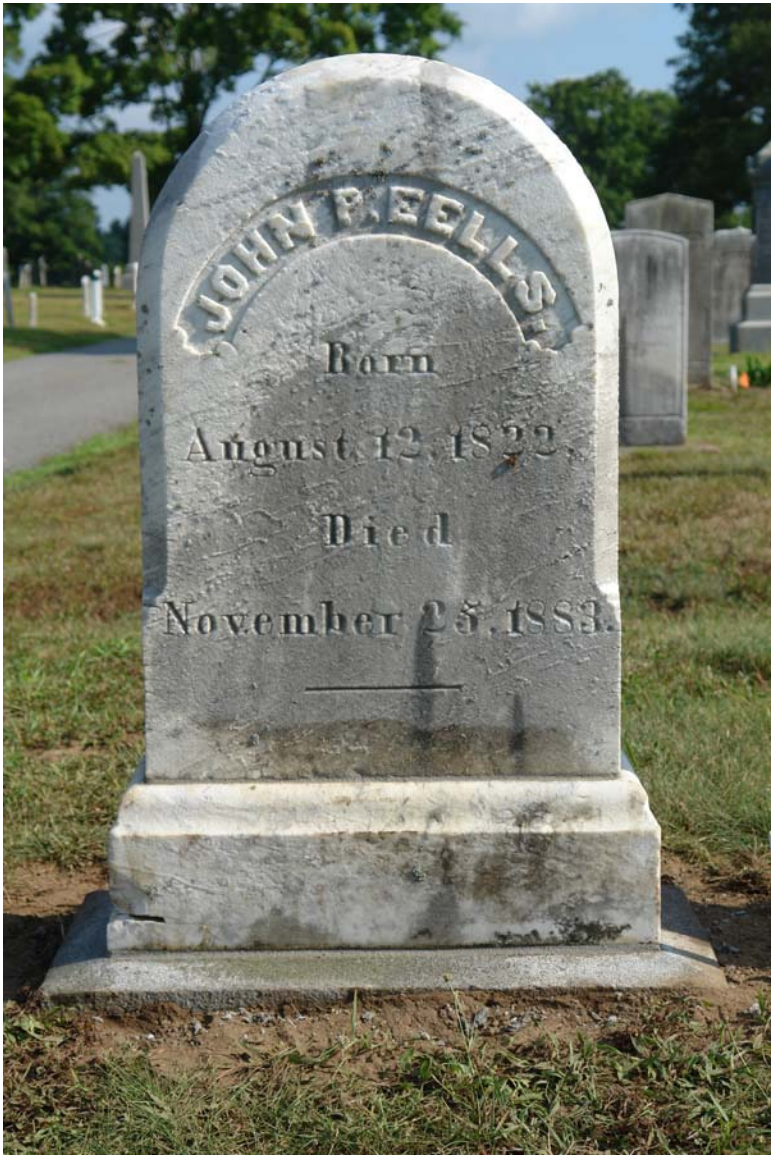
EXISTING CONDITIONS	CONSERVATION STRATEGY
Tilted base	Reset base with marker plumb

TREATMENT	Treatment Dates
1. Marker and base found to be in sound condition with marker securely attached to base. 2. Area excavated to an appropriate depth removing any roots or large stones. 3. Base is aligned with adjacent markers and re-set level. 4. Area around base was backfilled with tamped gravel and re-graded with existing topsoil	8/13/2015

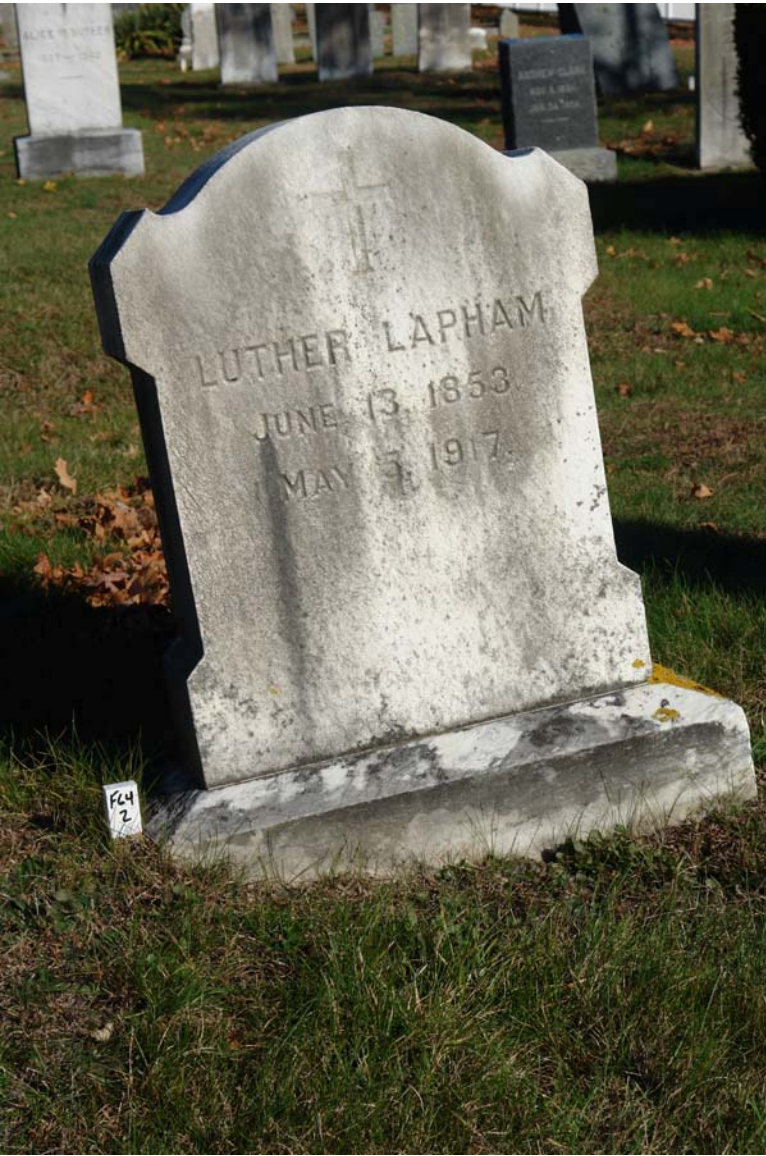
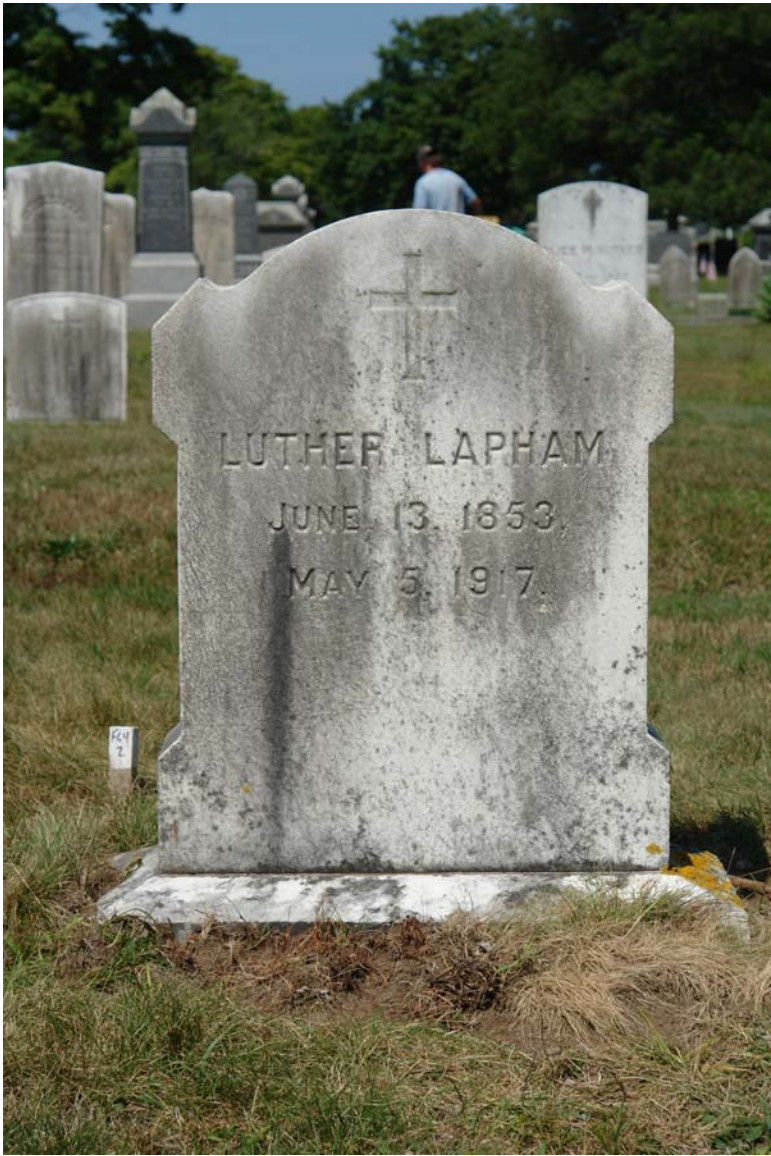
Height 29 Width 22 Thickness 6 Marker# **F.64.2**

Hanover Center Cemetery, Hanover MA	
NAME ON MARKER	Father Mother (Thayer)
Death Date:	Marker Type: Large die
Cond. of Inscription: Legible	Material: Granite
EXISTING CONDITIONS	CONSERVATION STRATEGY
Tilted base	Reset base with marker plumb

TREATMENT	Treatment Dates 8/31/2015
<div>1. Die is secure onto base</div> <div>2. Soil removed around base unit and base raised up with hydraulic jacks to level.</div> <div>3. Existing foundation stones exposed and built up to support base unit.</div> <div>4. Base re-set plumb at appropriate height and level</div> <div>5. Area beneath and around base backfilled with tamped sand and gravel</div> <div>6. Disturbed areas re-graded with existing topsoil.</div>

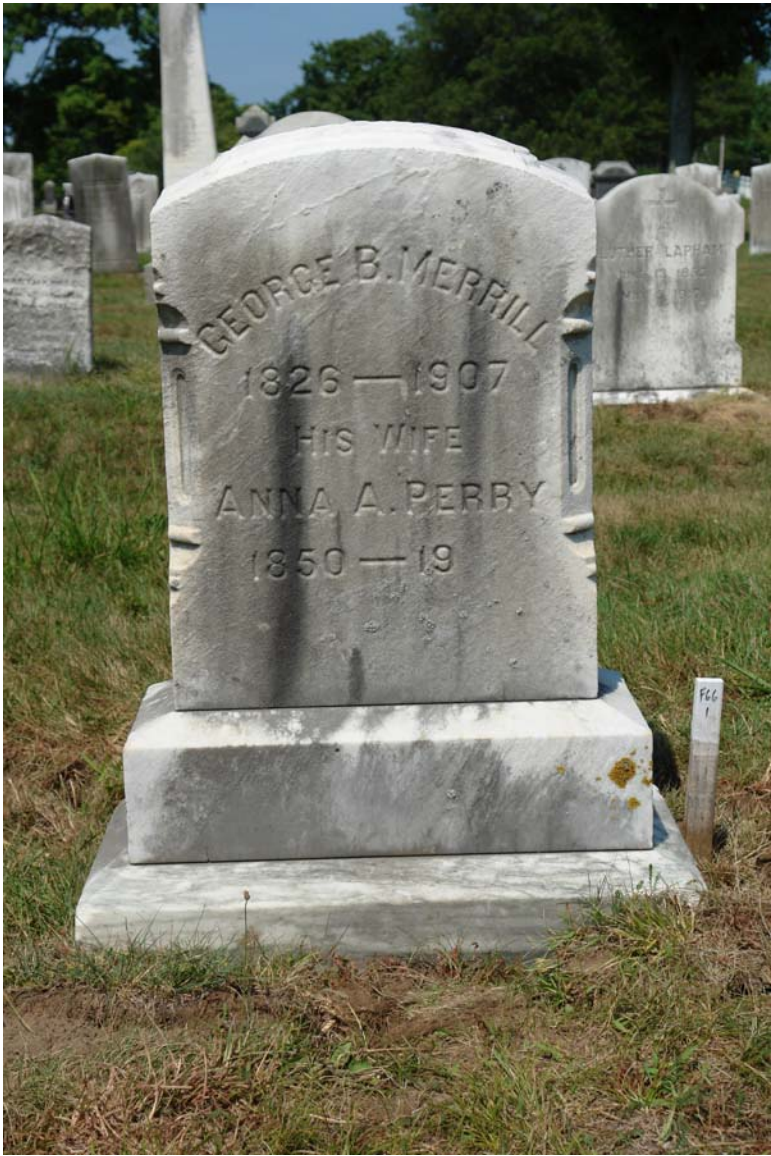
Hanover Center Cemetery, Hanover MA
NAME ON MARKER **George Merrill**
Death Date: 1907 Marker Type: Headstone/pinned base
Cond. of Inscription: Legible Material: Marble

EXISTING CONDITIONS	CONSERVATION STRATEGY
Tilted base	Reset base with marker plumb

TREATMENT	Treatment Dates
1. Marker and base found to be in sound condition with marker securely attached to base. 2. Area excavated to an appropriate depth removing any roots or large stones. 3. Base is aligned with adjacent markers and re-set level. 4. Area around base was backfilled with tamped gravel and re-graded with existing topsoil	8/14/2015

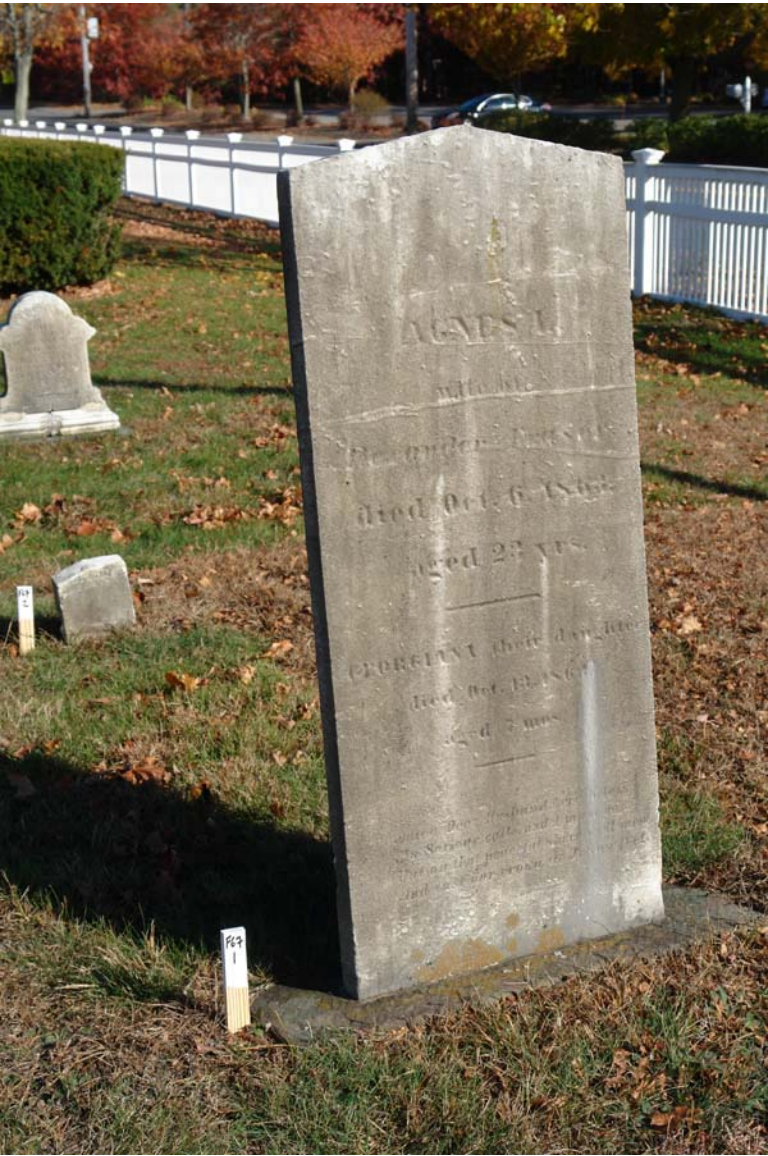
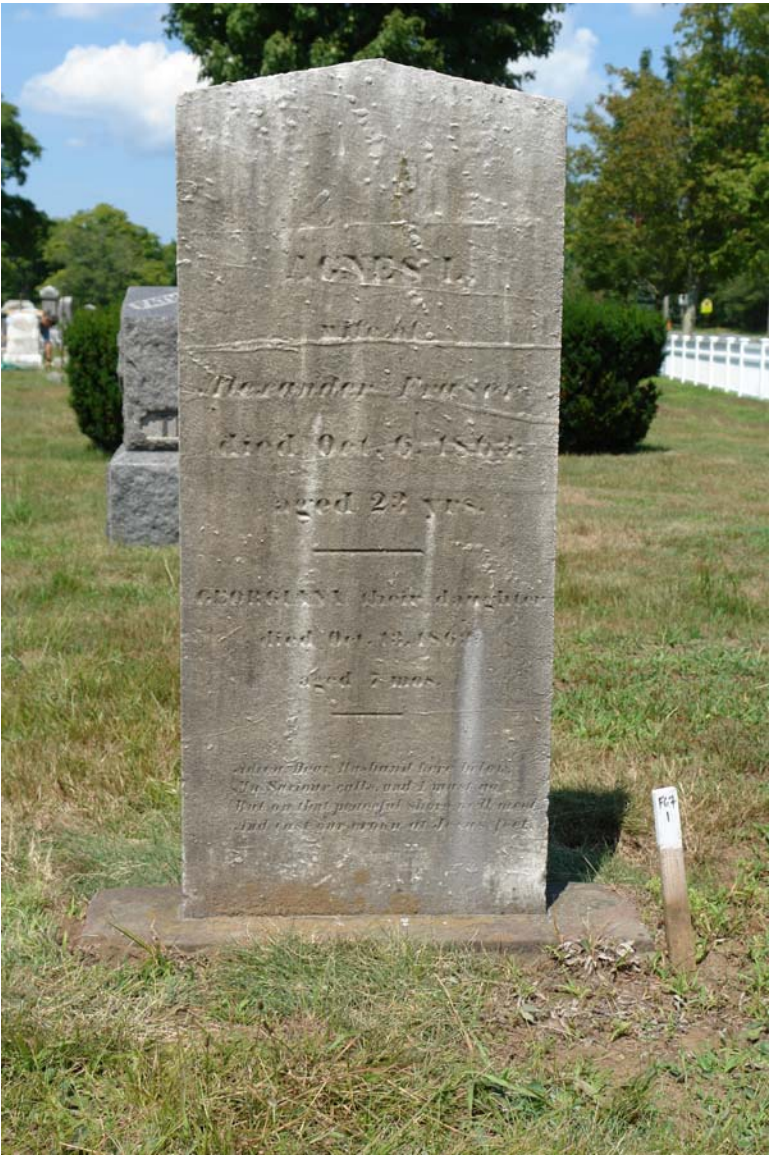
Hanover Center Cemetery, Hanover MA	
NAME ON MARKER	Agnes Fraser
Death Date: 10/6/1863	Marker Type: Headstone/base
Cond. of Inscription: Legible	Material: Marble
EXISTING CONDITIONS	CONSERVATION STRATEGY
Tilted base	Reset base with marker plumb
TREATMENT	
Treatment Dates 8/13/2015	
<div>1. Area excavated to an appropriate depth removing any roots or large stones.</div> <div>2. Base inspected and found to be sound and re-useable</div> <div>3. Base is aligned with adjacent markers and re-set level.</div> <div>4. Area around base was backfilled with tamped gravel and re-graded with existing topsoil</div> <div>5. Debris removed from setting slot. When required, power grinders were used to facilitate removal of stone fragments.</div> <div>6. When required, the lower setting edge was re-squared by power grinder with minimal loss.</div> <div>7. Marker reset plumb and level into setting slot with cement/lime grout (3/2/9) with 000 sand made fluid with a super plasticizer.</div> <div>8. Excess grout removed and joint area cleaned.</div> <div>9. Marker braced for a minimum 3 days</div>

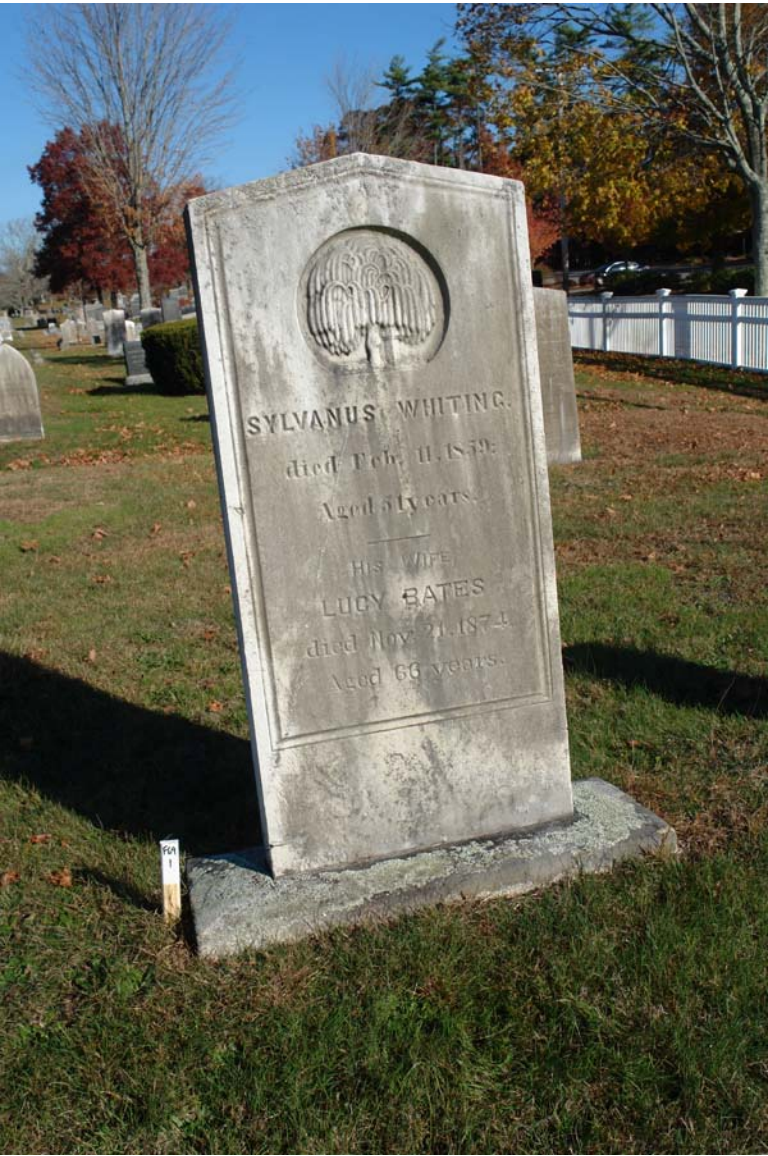
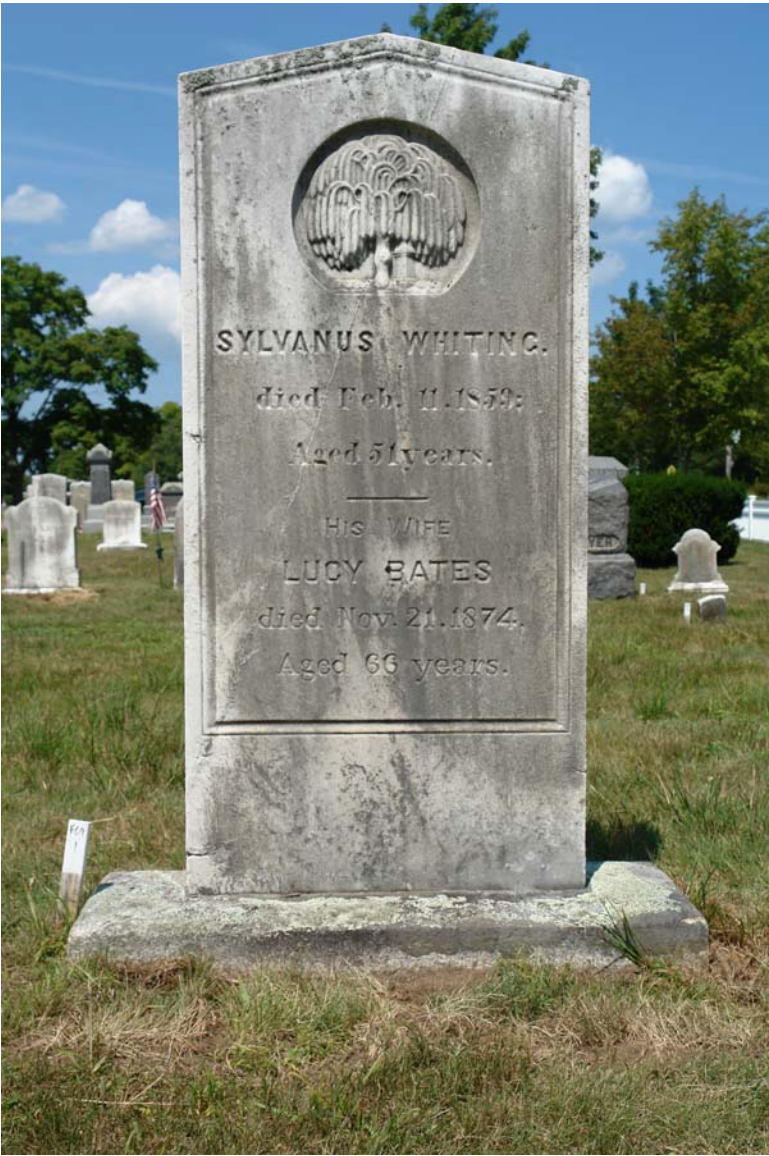
Hanover Center Cemetery, Hanover MA	
NAME ON MARKER	Sylvanus Whiting
Death Date: 2/11/1859	Marker Type: Headstone/base
Cond. of Inscription: Legible	Material: Marble
EXISTING CONDITIONS	CONSERVATION STRATEGY
Tilted base	Reset base with marker plumb
TREATMENT	
Treatment Dates 8/13/2015	
<div>1. Area excavated to an appropriate depth removing any roots or large stones.</div> <div>2. Base inspected and found to be sound and re-useable</div> <div>3. Base is aligned with adjacent markers and re-set level.</div> <div>4. Area around base was backfilled with tamped gravel and re-graded with existing topsoil</div> <div>5. Debris removed from setting slot. When required, power grinders were used to facilitate removal of stone fragments.</div> <div>6. When required, the lower setting edge was re-squared by power grinder with minimal loss.</div> <div>7. Marker reset plumb and level into setting slot with cement/lime grout (3/2/9) with 000 sand made fluid with a super plasticizer.</div> <div>8. Excess grout removed and joint area cleaned.</div> <div>9. Marker braced for a minimum 3 days</div>

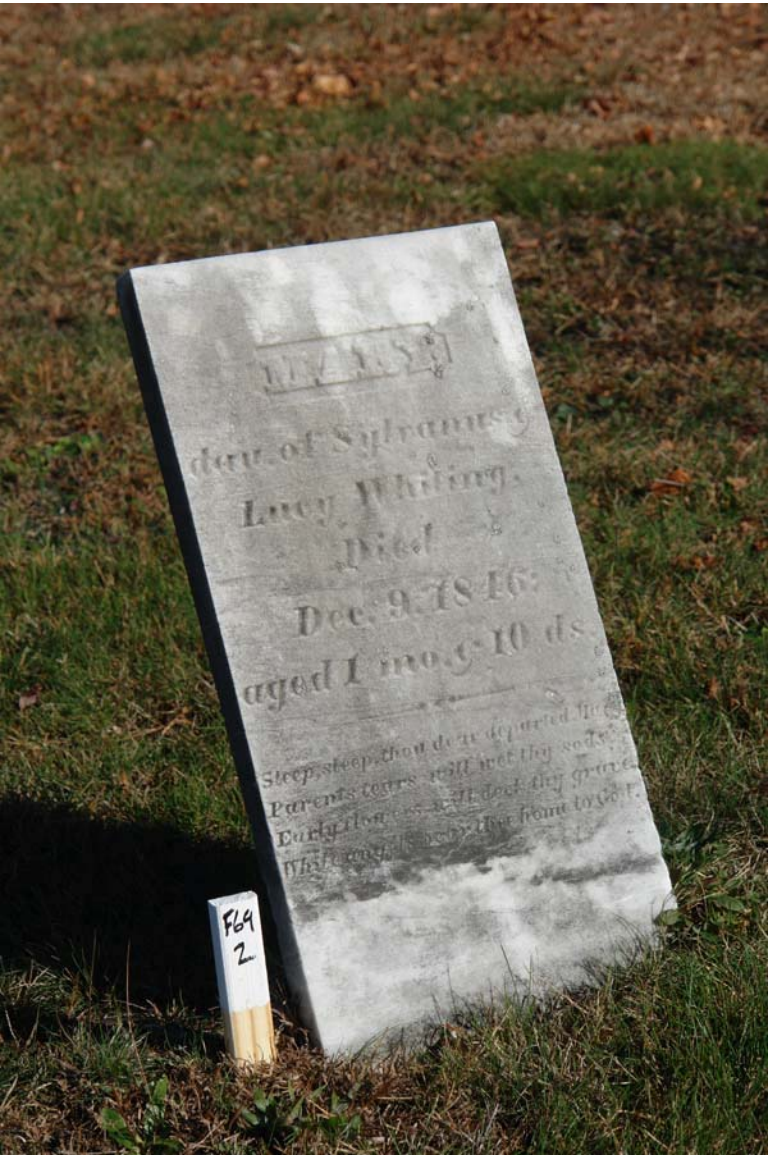
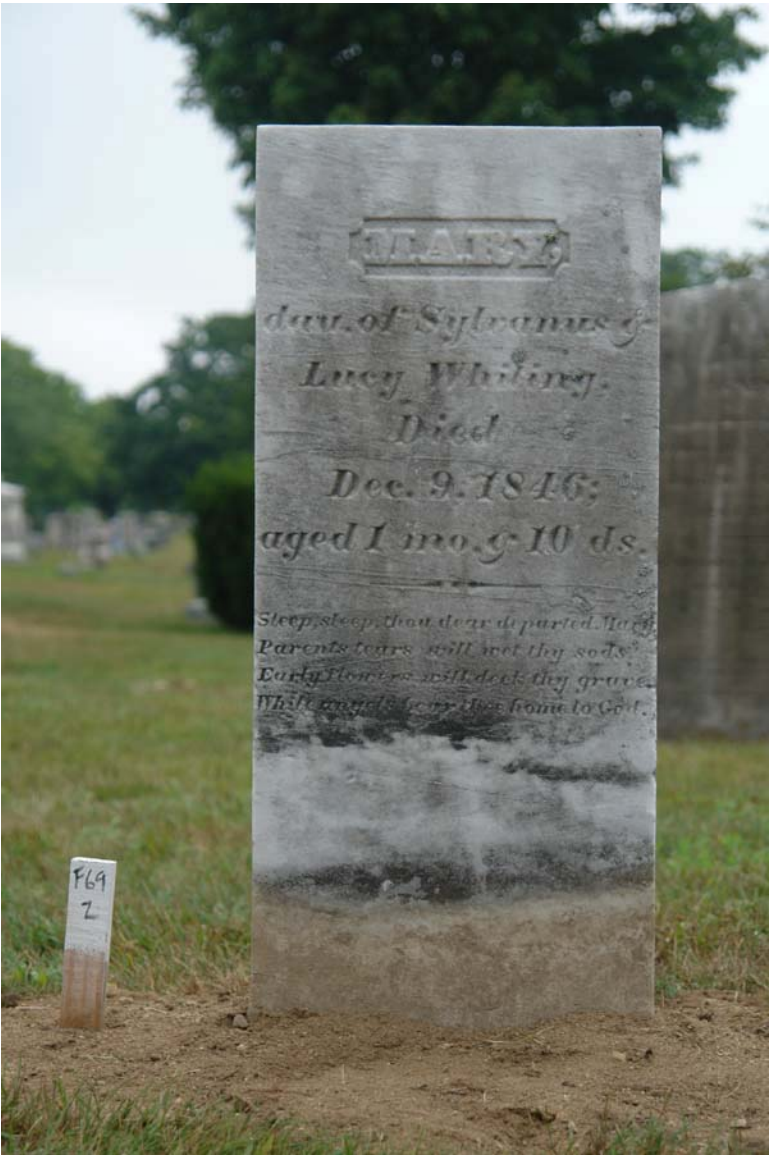
Hanover Center Cemetery, Hanover MA	
NAME ON MARKER	Mary Whiting
Death Date: 12/9/1846	Marker Type: Headstone
Cond. of Inscription: Decipherable	Material: Marble
EXISTING CONDITIONS	CONSERVATION STRATEGY
Tilted	Reset into new below grade concrete base
TREATMENT	
Treatment Dates 8/17-19/2015

1. Marker excavated and found to be sound. Light soiling removed by brushing with nylon brushes and water.	
2. Setting area excavated for new below grade cast concrete base sized minimum of 12 inches deep, 12 inches greater in thickness and 6 inches wider than the stone.

7. Marker set plumb and level, and braced for minimum of 5 days.	
8. Disturbed areas backfilled with existing topsoil.

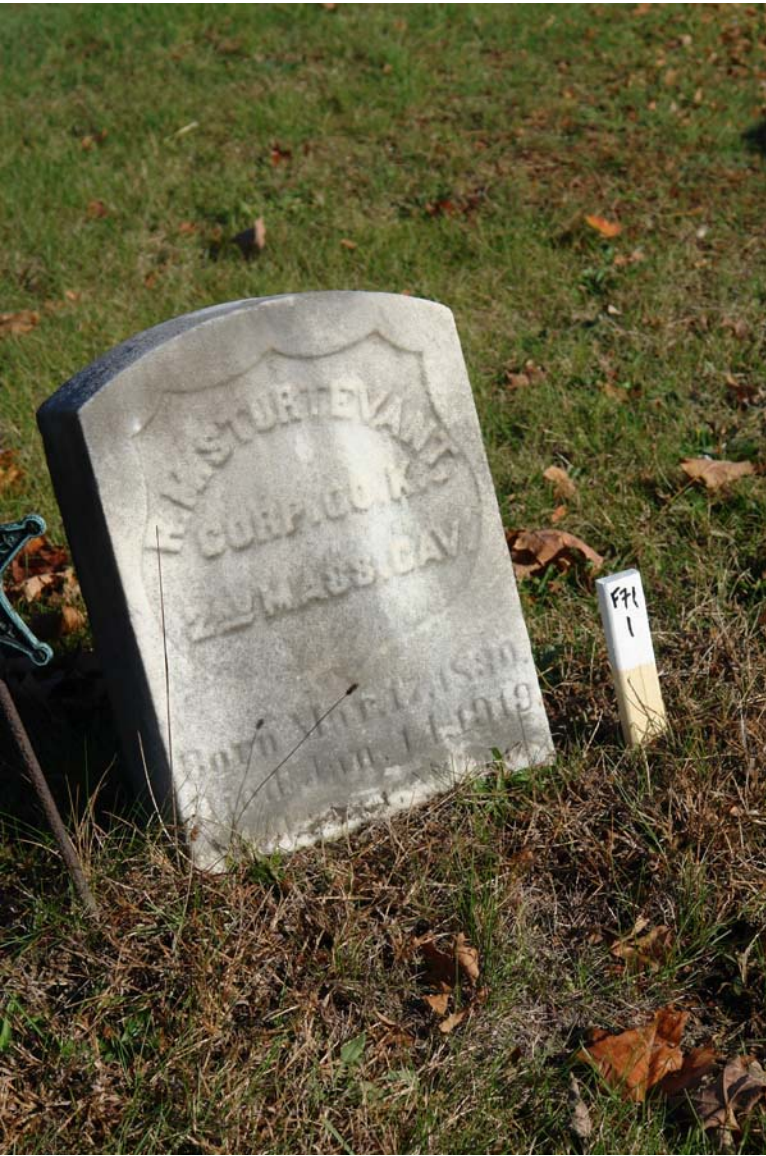
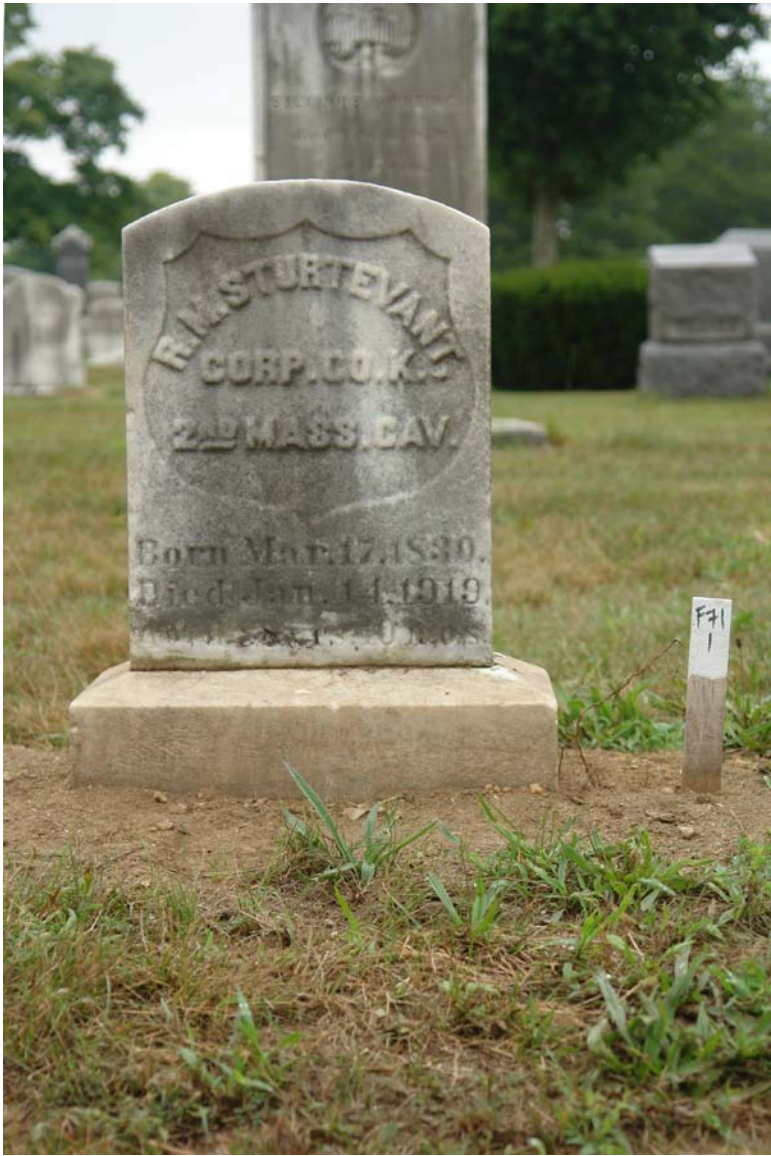
Hanover Center Cemetery, Hanover MA	
NAME ON MARKER	R.M. Sturtevant
Death Date: 1/14/1919	Marker Type: Headstone
Cond. of Inscription: Legible	Material: Marble
EXISTING CONDITIONS	CONSERVATION STRATEGY
Tilted	Reset plumb

TREATMENT	Treatment Dates 8/24/2015
<div>1. Elements removed from setting bases and inspected for soundness.</div> <div>2. Area excavated to an appropriate depth removing any roots or large stones.</div> <div>3. Base is aligned with adjacent markers and re-set level.</div> <div>4. Area around base was backfilled with tamped gravel and re-graded with existing topsoil</div> <div>5. Failed mortar removed from setting area and bottom of marker</div> <div>6. When required, any existing pins were inspected, and if necessary, replaced with stainless steel threaded pins</div> <div>7. Setting surfaces primed with Acryl 60 diluted 1:3 with water.</div> <div>8. Marker reset plumb onto base with cement/lime mortar (3/2/9) with 000 sand.</div> <div>9. Excess grout removed and joint area cleaned.</div>

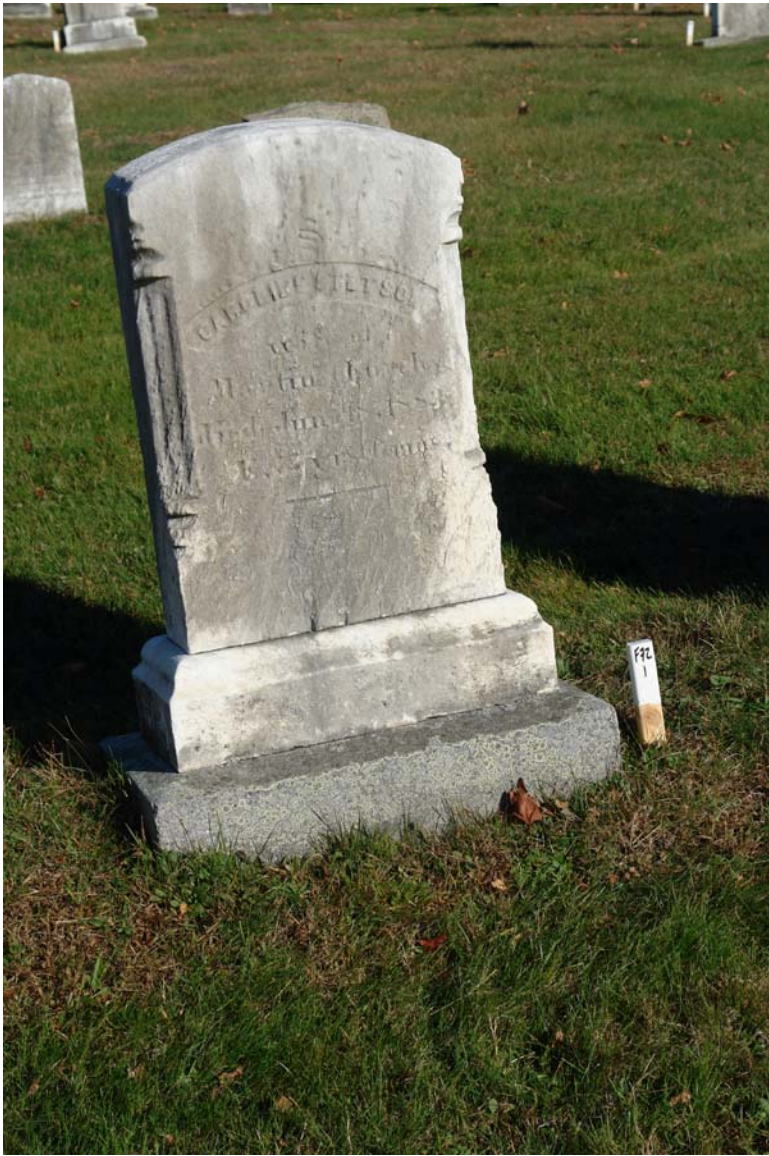
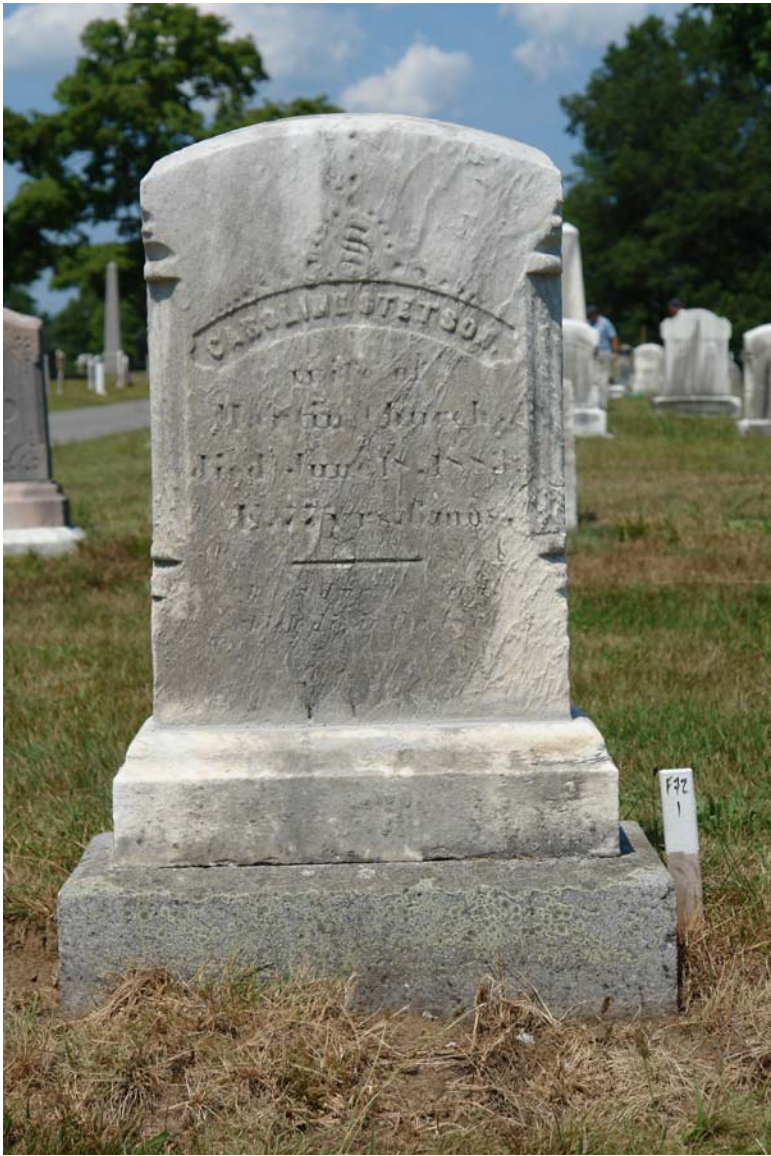
Hanover Center Cemetery, Hanover MA
NAME ON MARKER **Caroline Church**
Death Date: 6/18/1883 Marker Type: Headstone/pinned base
Cond. of Inscription: Legible Material: Marble

EXISTING CONDITIONS	CONSERVATION STRATEGY
Tilted Marker loose on base	Check base for level Reset marker plumb

TREATMENT	Treatment Dates 8/13-14/2015
<div>1. Elements removed from setting bases and inspected for sound- ness. 2. Area excavated to an appropriate depth removing any roots or large stones. 3. Base is aligned with adjacent markers and re-set level. 4. Area around base was backfilled with tamped gravel and re- graded with existing topsoil 5. Failed mortar removed from setting area and bottom of marker 6. When required, any existing pins were inspected, and if neces- sary, replaced with stainless steel threaded pins 7. Setting surfaces primed with Acryl 60 diluted 1:3 with water. 8. Marker reset plumb onto base with cement/lime mortar (3/2/9) with 000 sand. When required, lead shims were used to facilitate leveling. 9. Excess grout removed and joint area cleaned.</div>

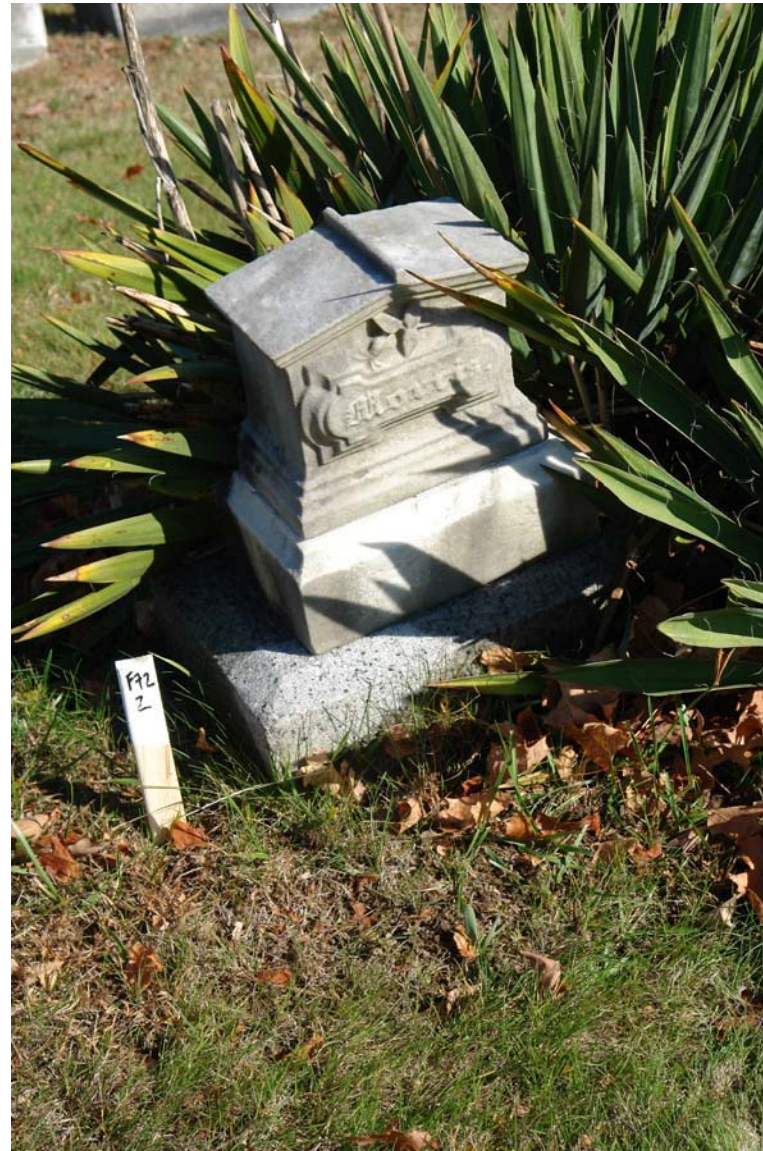
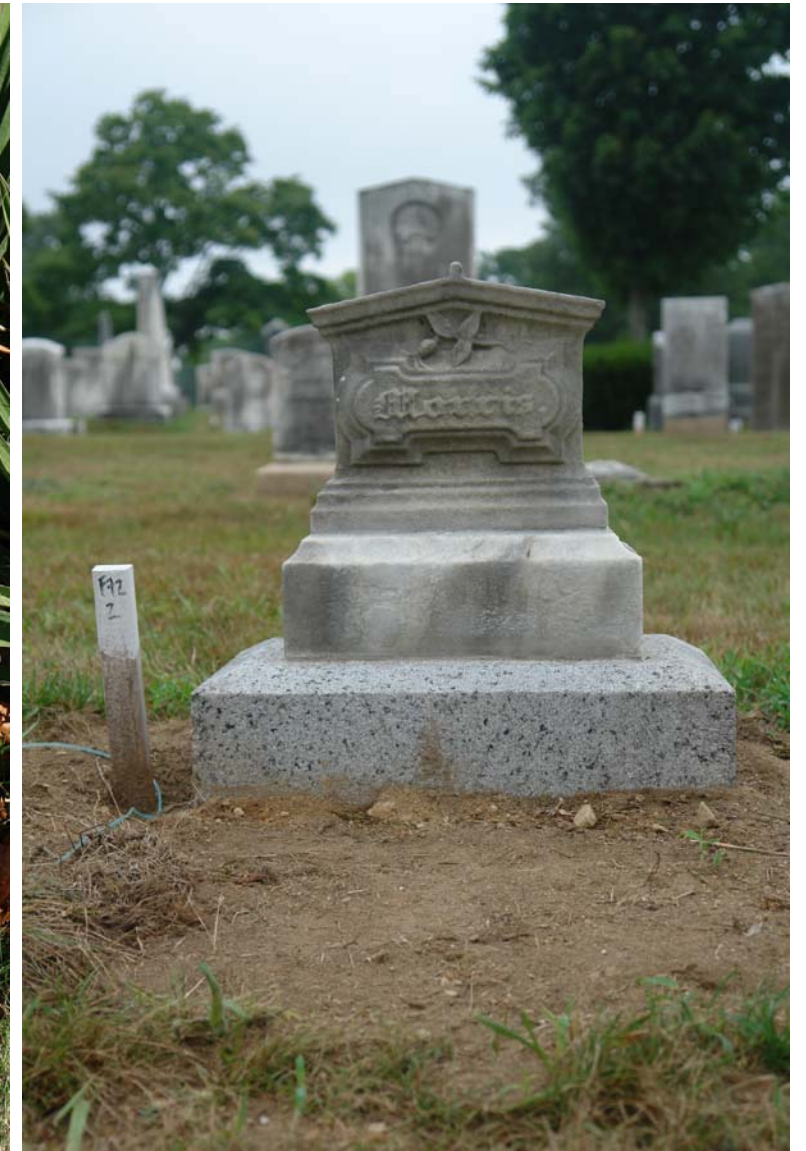
Tilted
Marker loose on base

Comments: **Shrubs to be removed**

1. Overgrowth removed by DPW
2. Elements removed from setting bases and area excavated to an appropriate depth removing any roots or large stones.
3. Base is aligned with adjacent markers and re-set level.
4. Area around base was backfilled with tamped gravel and re-graded with existing topsoil
5. Failed mortar removed from setting area and bottom of marker
6. When required, any existing pins were inspected, and if necessary, replaced with stainless steel threaded pins
7. Setting surfaces primed with Acryl 60 diluted 1:3 with water.
8. Marker reset plumb onto base with cement/lime mortar (3/2/9) with 000 sand.
9. Excess grout removed and joint area cleaned.
