MONUMENT CONSERVATION COLLABORATIVE LLC, NORFOLK, CT

DOCUMENTATION OF STONE CONSERVATION TREATMENTS TO ASSINIPPI CEMETERY, HANOVER, MA June 2015

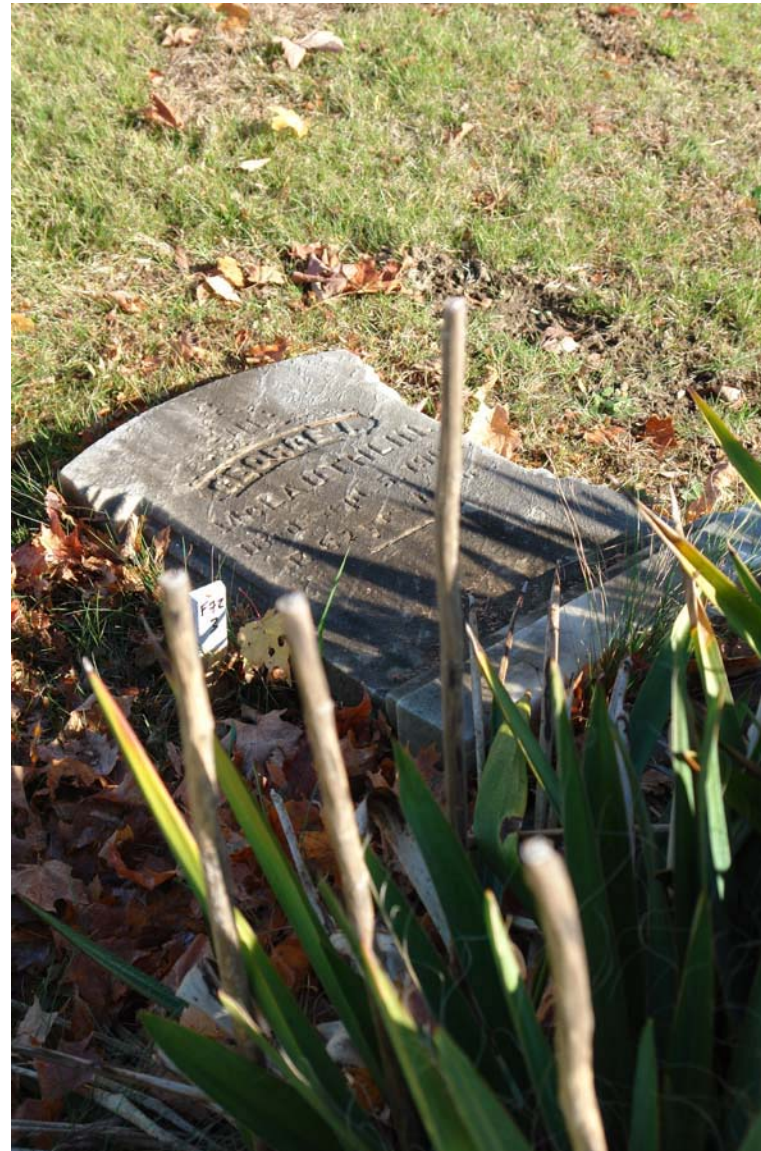
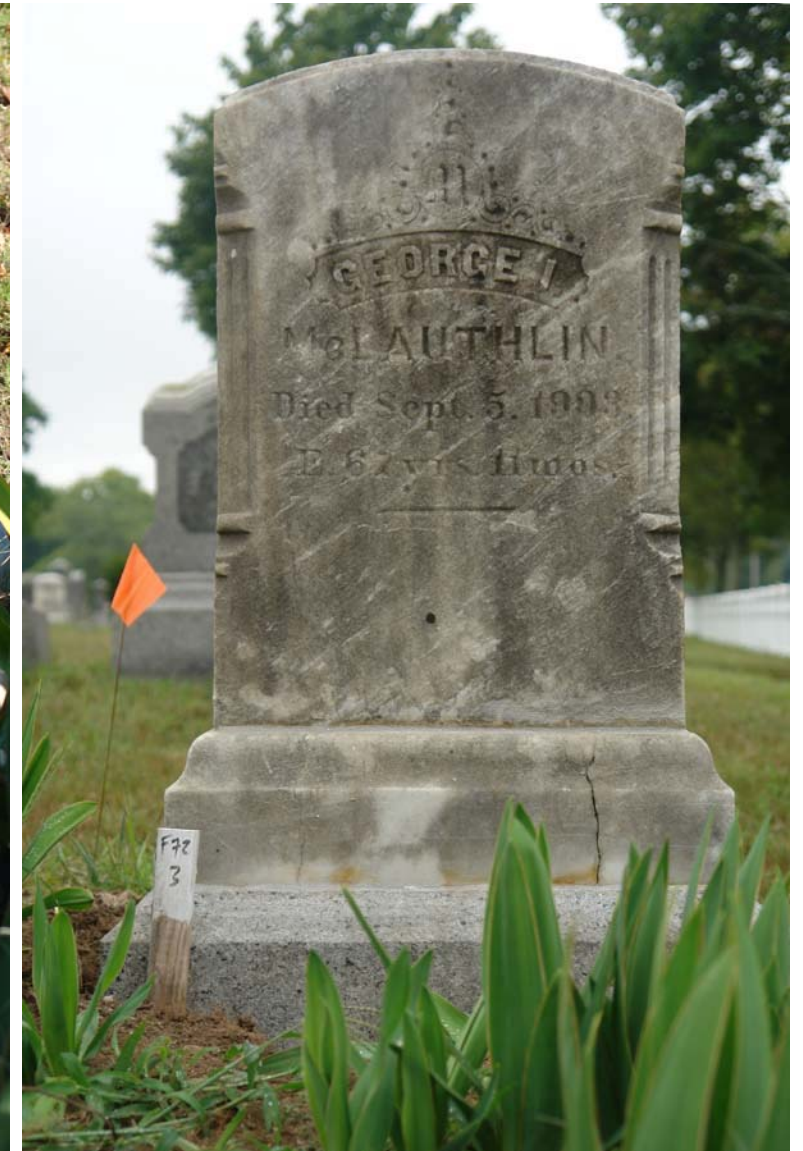
Tilted
Marker loose on base

Comments: **Shrubs to be removed**

1. Overgrowth removed by DPW
2. Elements removed from setting bases and area excavated to an appropriate depth removing any roots or large stones.
3. Base is aligned with adjacent markers and re-set level.
4. Area around base was backfilled with tamped gravel and re-graded with existing topsoil
5. Failed mortar removed from setting area and bottom of marker
6. When required, any existing pins were inspected, and if necessary, replaced with stainless steel threaded pins
7. Setting surfaces primed with Acryl 60 diluted 1:3 with water.
8. Marker reset plumb onto base with cement/lime mortar (3/2/9) with 000 sand.
9. Excess grout removed and joint area cleaned.

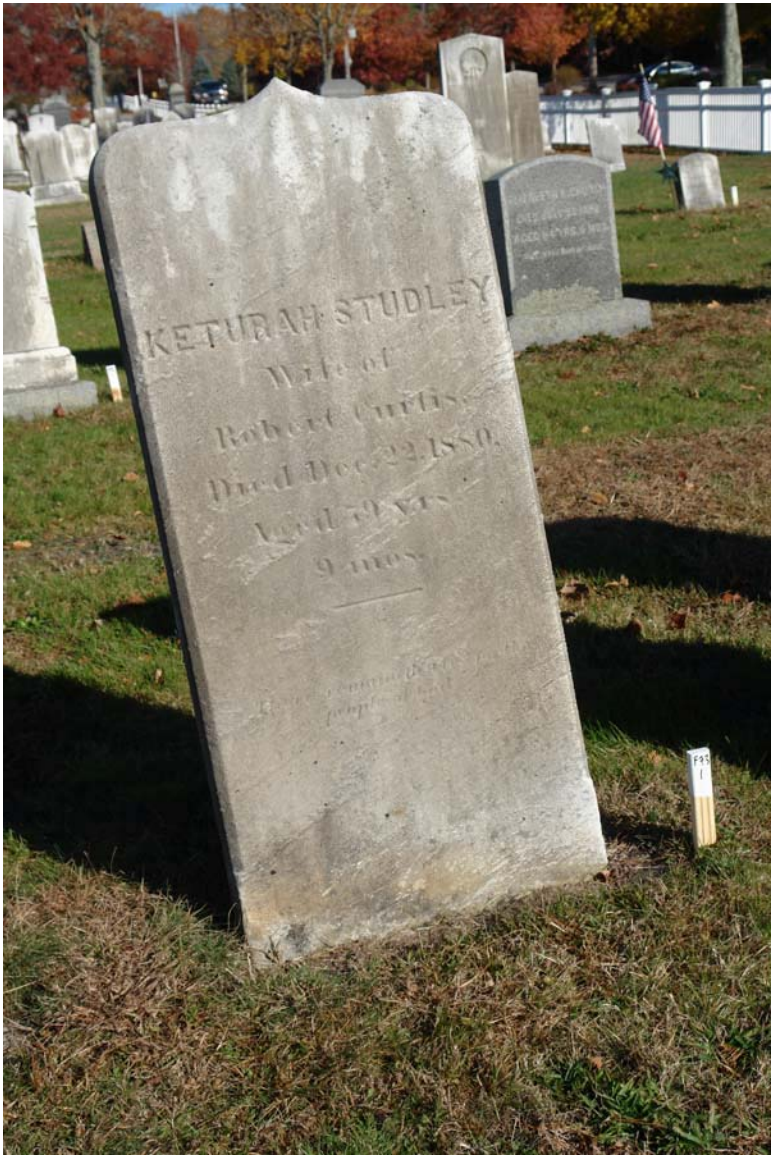
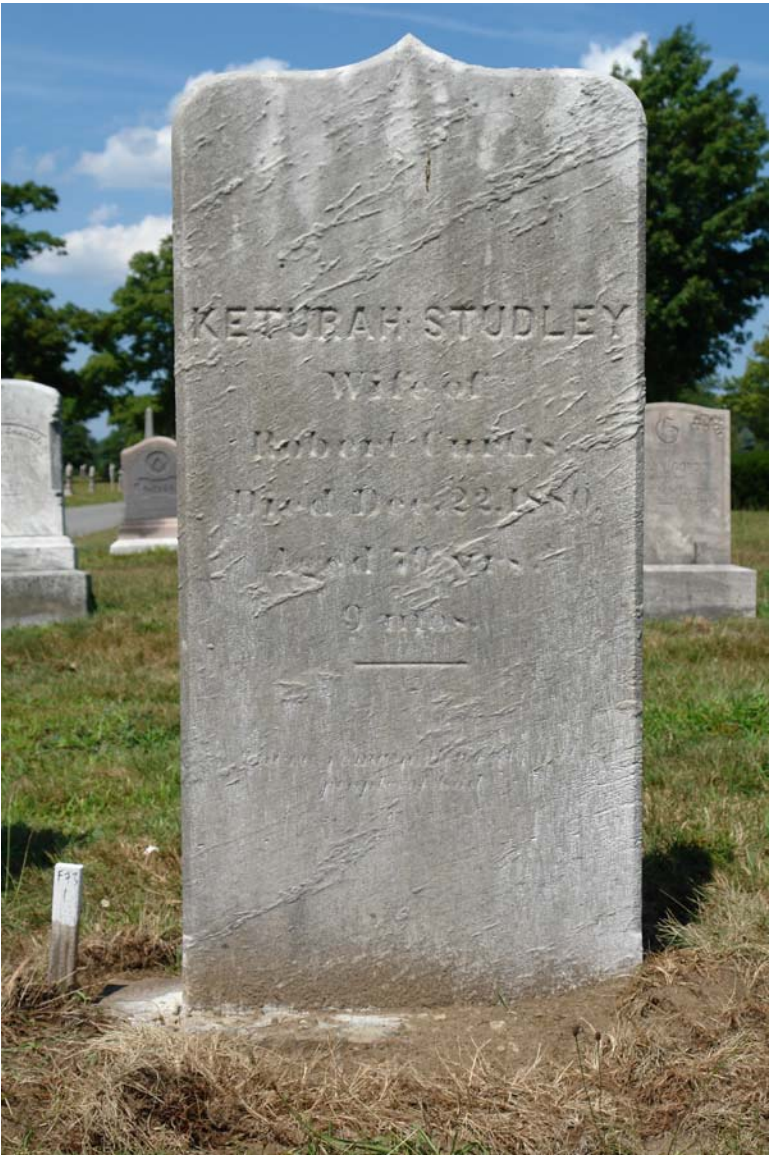
Hanover Center Cemetery, Hanover MA	
NAME ON MARKER	Keturah Studley
Death Date: 12/22/1880	Marker Type: Headstone/base
Cond. of Inscription: Legible	Material: Marble
EXISTING CONDITIONS	CONSERVATION STRATEGY
Tilted	Evaluate resetting options Possible new below grade concrete base
TREATMENT	
Treatment Dates 8/13-14/2015	
<div>1. Existing base located below grade while excavating for resetting. Area excavated to an appropriate depth removing any roots or large stones.</div> <div>2. Base inspected and found to be sound and re-useable</div> <div>3. Base is aligned with adjacent markers and re-set level.</div> <div>4. Area around base was backfilled with tamped gravel and re-graded with existing topsoil</div> <div>5. Debris removed from setting slot. When required, power grinders were used to facilitate removal of stone fragments.</div> <div>6. When required, the lower setting edge was re-squared by power grinder with minimal loss.</div> <div>7. Marker reset plumb and level into setting slot with cement/lime grout (3/2/9) with 000 sand made fluid with a super plasticizer.</div> <div>8. Excess grout removed and joint area cleaned.</div> <div>9. Marker braced for a minimum 3 days</div>

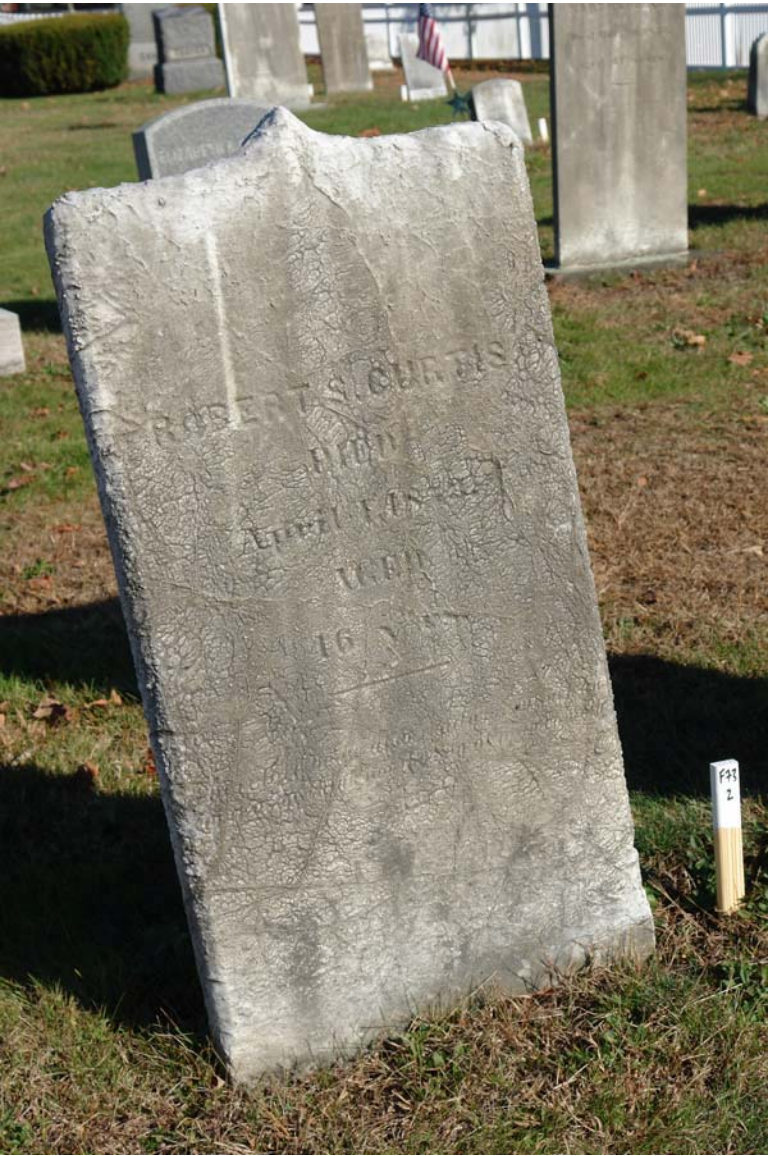
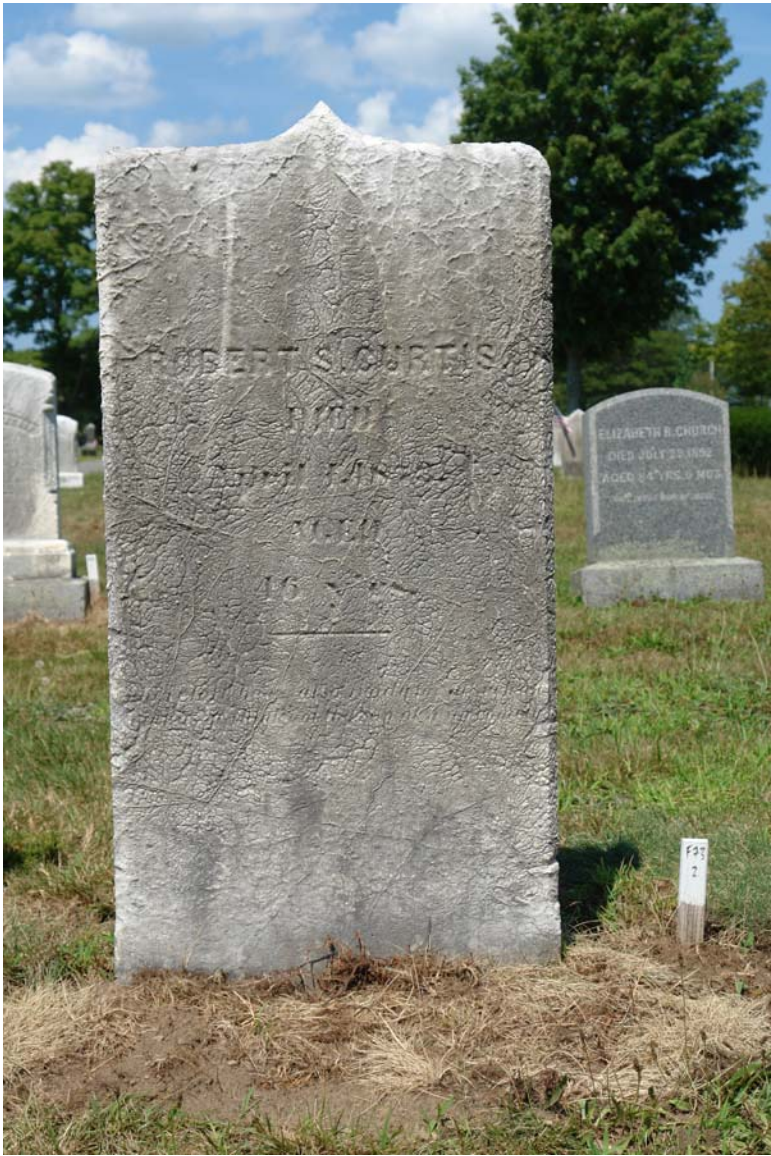
Hanover Center Cemetery, Hanover MA
NAME ON MARKER **Robert Curtis**
Death Date: 4/1/1873 Marker Type: Headstone/slotted base
Cond. of Inscription: Decipherable Material: Marble

EXISTING CONDITIONS	CONSERVATION STRATEGY
Tilted	Evaluate resetting options Possible new below grade concrete base

TREATMENT	Treatment Dates
8/14/2015	
<div>1. Existing base located below grade while excavating for resetting. Area excavated to an appropriate depth removing any roots or large stones.</div> <div>2. Base inspected and found to be sound and re-useable</div> <div>3. Base is aligned with adjacent markers and re-set level.</div> <div>4. Area around base was backfilled with tamped gravel and re-graded with existing topsoil</div> <div>5. Debris removed from setting slot. When required, power grinders were used to facilitate removal of stone fragments.</div> <div>6. When required, the lower setting edge was re-squared by power grinder with minimal loss.</div> <div>7. Marker reset plumb and level into setting slot with cement/lime grout (3/2/9) with 000 sand made fluid with a super plasticizer.</div> <div>8. Excess grout removed and joint area cleaned.</div> <div>9. Marker braced for a minimum 3 days</div>

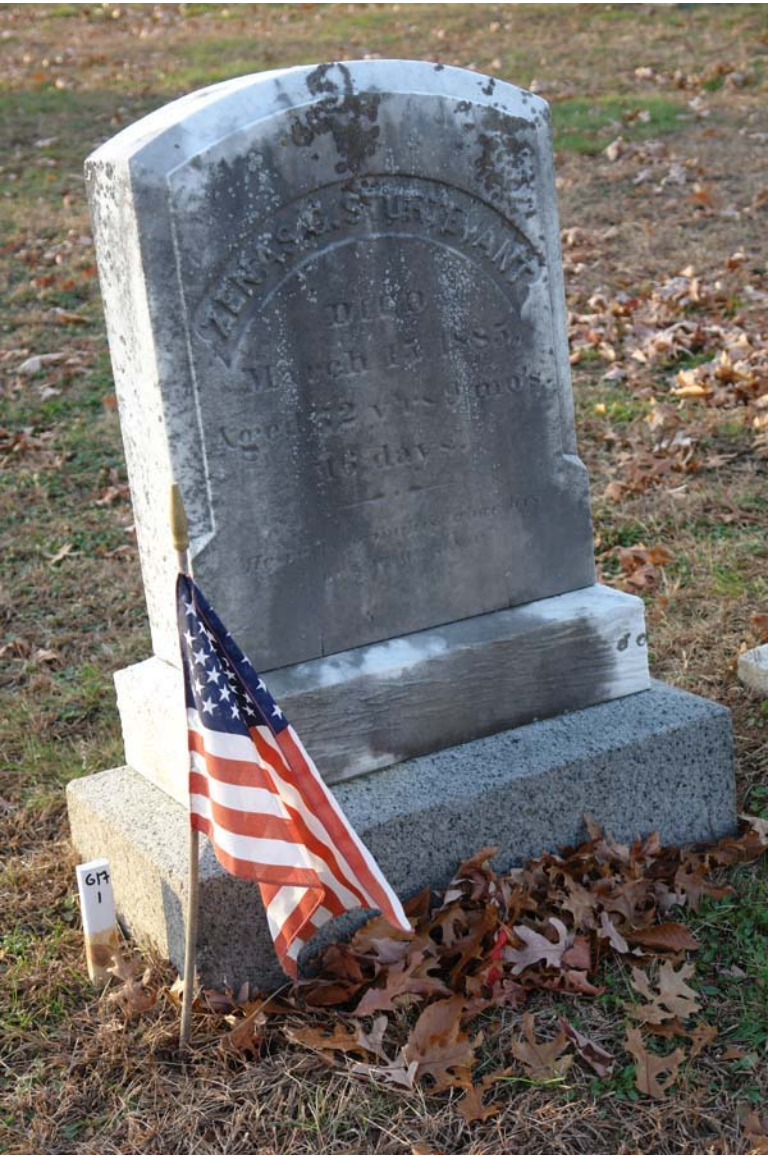
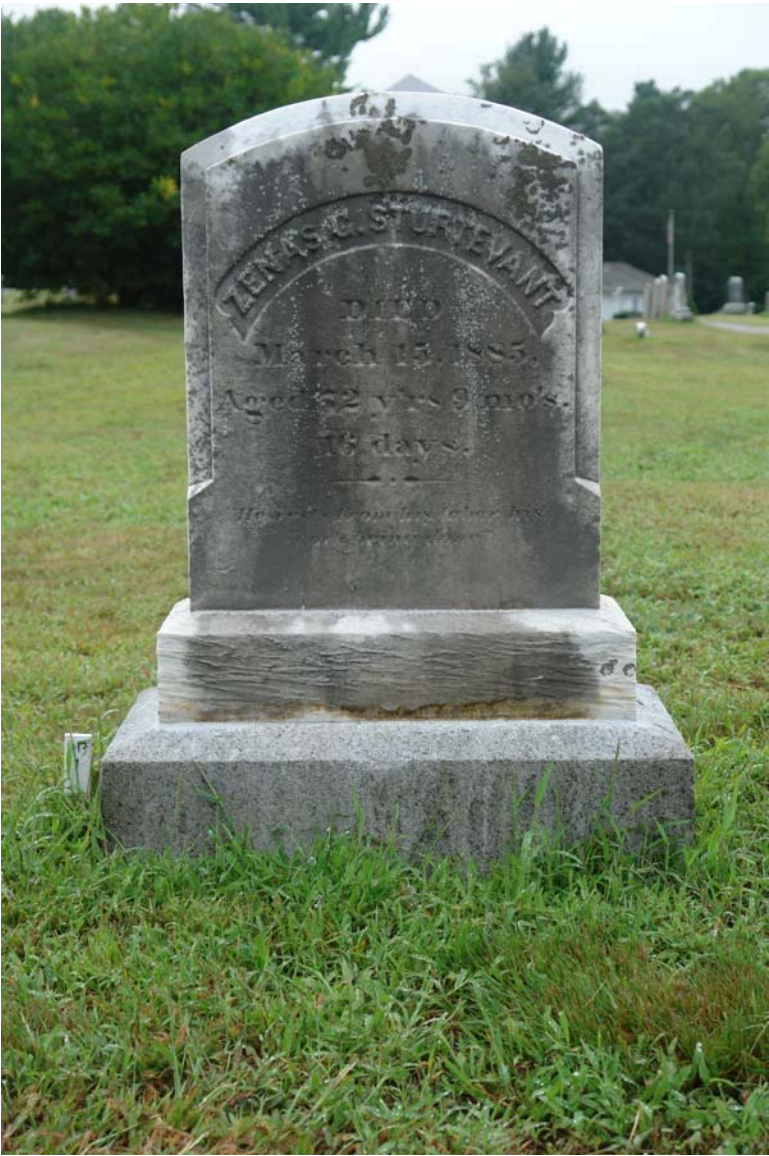
Hanover Center Cemetery, Hanover MA
NAME ON MARKER **Zenas Sturtevant**
Death Date: 3/15/1885 Marker Type: Headstone/pinned base
Cond. of Inscription: Legible Material: Marble

EXISTING CONDITIONS	CONSERVATION STRATEGY
Tilted base	Reset base with marker plumb

TREATMENT	Treatment Dates
1. Elements removed from setting bases and inspected for soundness. 2. Area excavated to an appropriate depth removing any roots or large stones. 3. Base is aligned with adjacent markers and re-set level. 4. Area around base was backfilled with tamped gravel and re-graded with existing topsoil 5. Failed mortar removed from setting area and bottom of marker 6. When required, any existing pins were inspected, and if necessary, replaced with stainless steel threaded pins 7. Setting surfaces primed with Acryl 60 diluted 1:3 with water. 8. Marker reset plumb onto base with cement/lime mortar (3/2/9) with 000 sand. 9. Excess grout removed and joint area cleaned.	8/24/2015

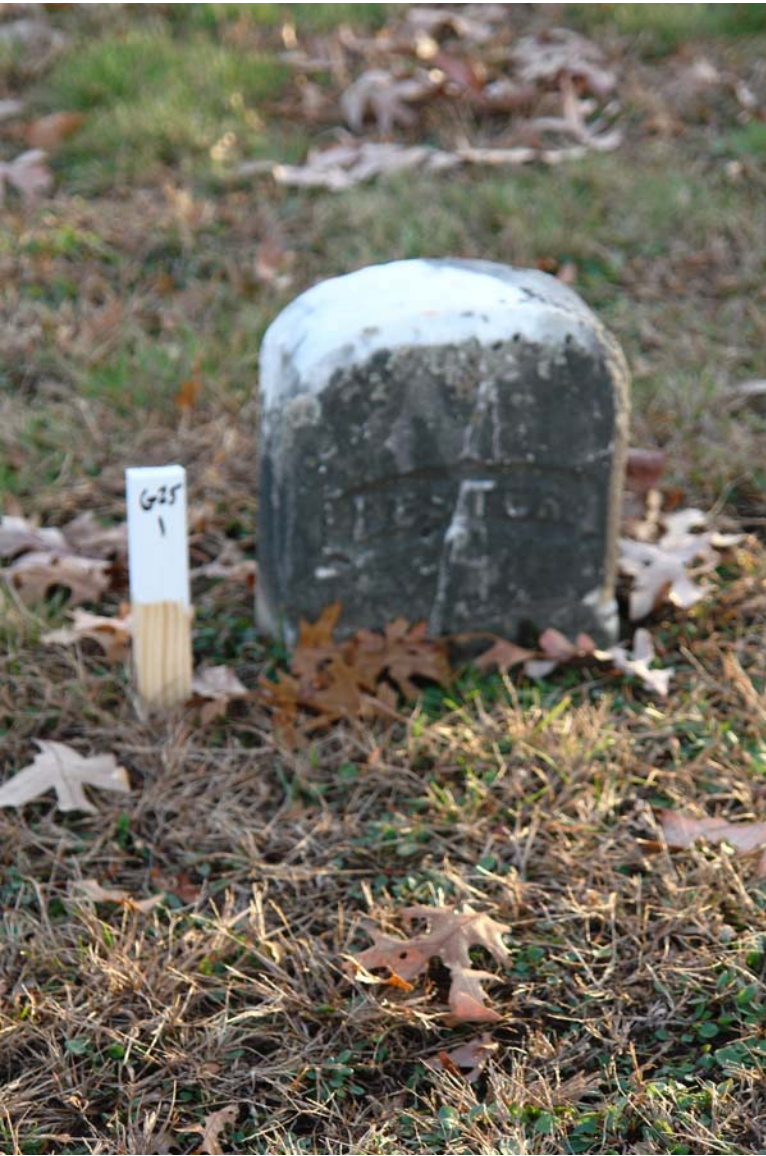
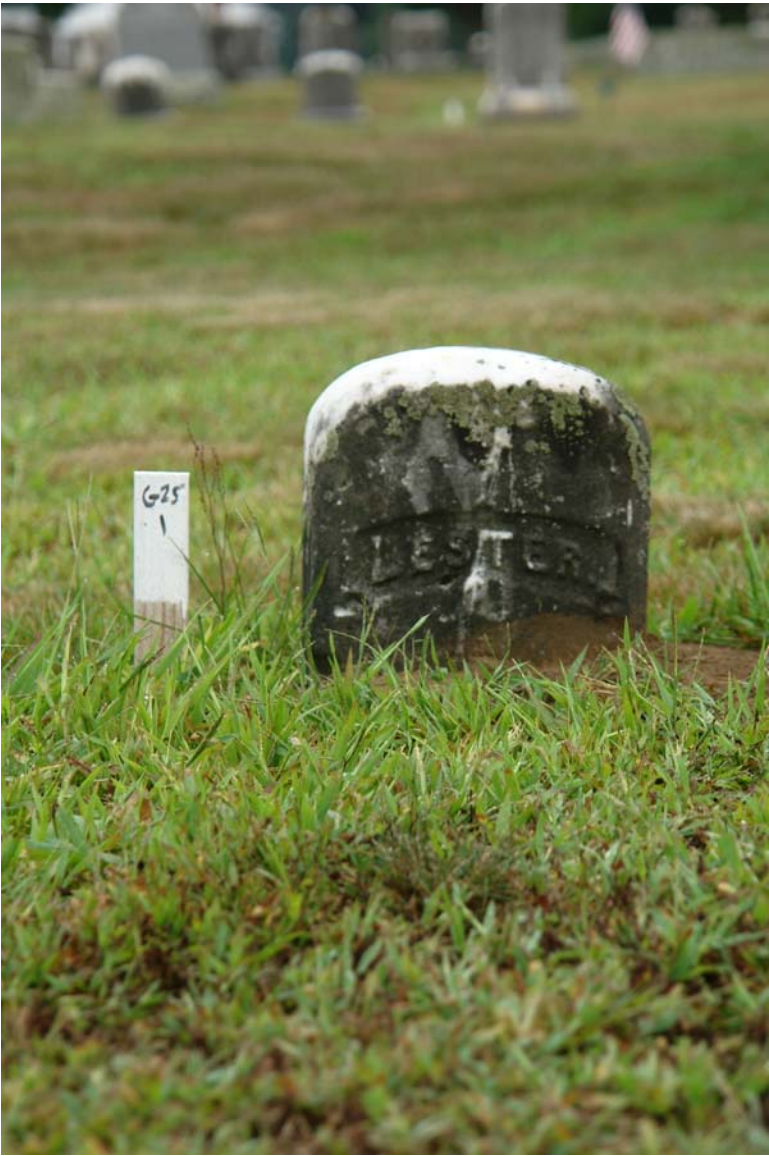
Hanover Center Cemetery, Hanover MA	
NAME ON MARKER	Lester (Larkum)
Death Date:	Marker Type: Small marker
Cond. of Inscription: Legible	Material: Marble

EXISTING CONDITIONS	CONSERVATION STRATEGY
Tilted Marker loose on base	Check base for level Reset marker plumb

1. Marker excavated and found to be sound. Light soiling removed by brushing with nylon brushes and water.

7. Disturbed areas backfilled with existing topsoil.

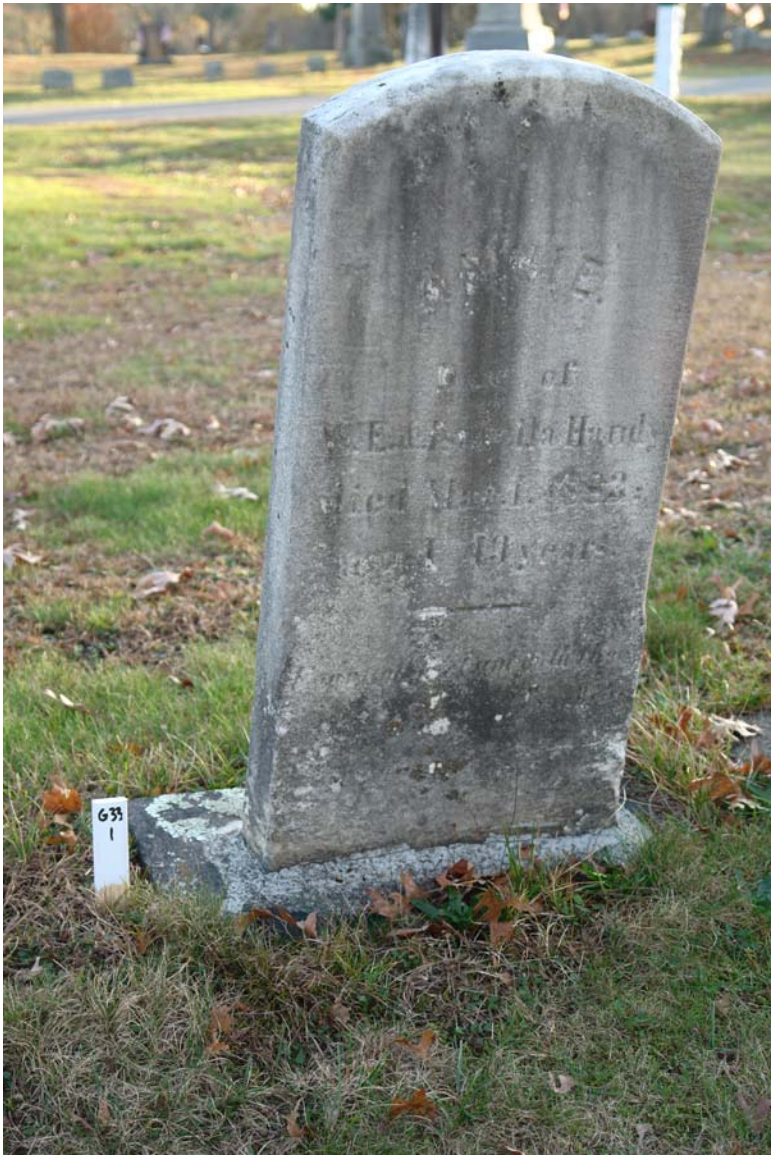
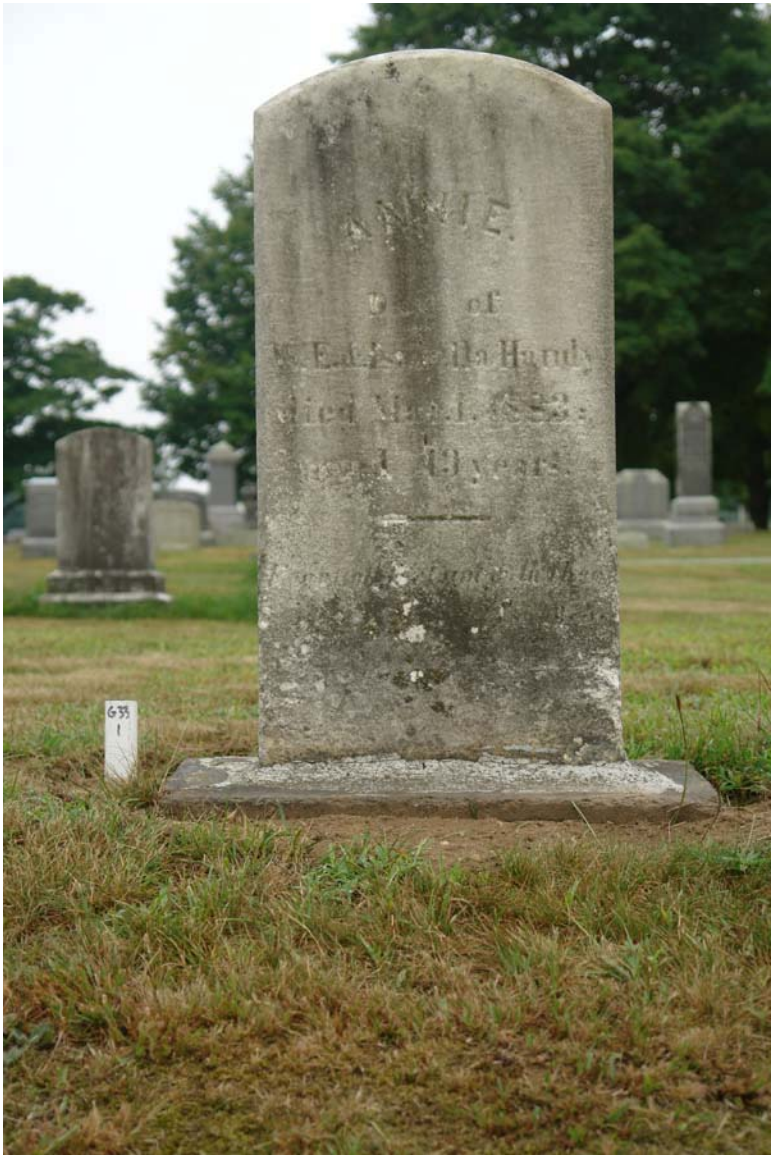
Hanover Center Cemetery, Hanover MA	
NAME ON MARKER	Annie Hardy
Death Date: 3/1/1883	Marker Type: Headstone/base
Cond. of Inscription: Decipherable	Material: Marble
EXISTING CONDITIONS	CONSERVATION STRATEGY
Tilted base	Reset base with marker plumb
TREATMENT	
Treatment Dates 8/24/2015	
<div>1. Area excavated to an appropriate depth removing any roots or large stones.</div> <div>2. Base inspected and found to be sound and re-useable</div> <div>3. Base is aligned with adjacent markers and re-set level.</div> <div>4. Area around base was backfilled with tamped gravel and re-graded with existing topsoil</div> <div>5. Debris removed from setting slot. When required, power grinders were used to facilitate removal of stone fragments.</div> <div>6. When required, the lower setting edge was re-squared by power grinder with minimal loss.</div> <div>7. Marker reset plumb and level into setting slot with cement/lime grout (3/2/9) with 000 sand made fluid with a super plasticizer.</div> <div>8. Excess grout removed and joint area cleaned.</div> <div>9. Marker braced for a minimum 3 days</div>

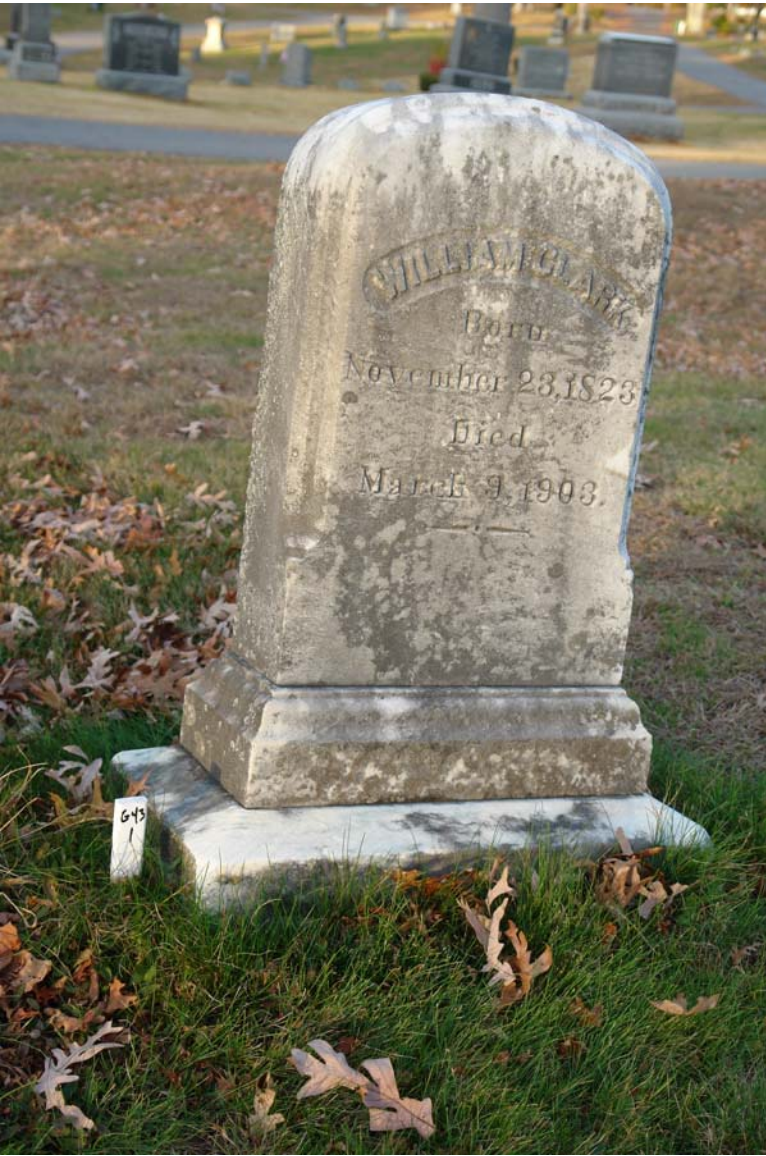
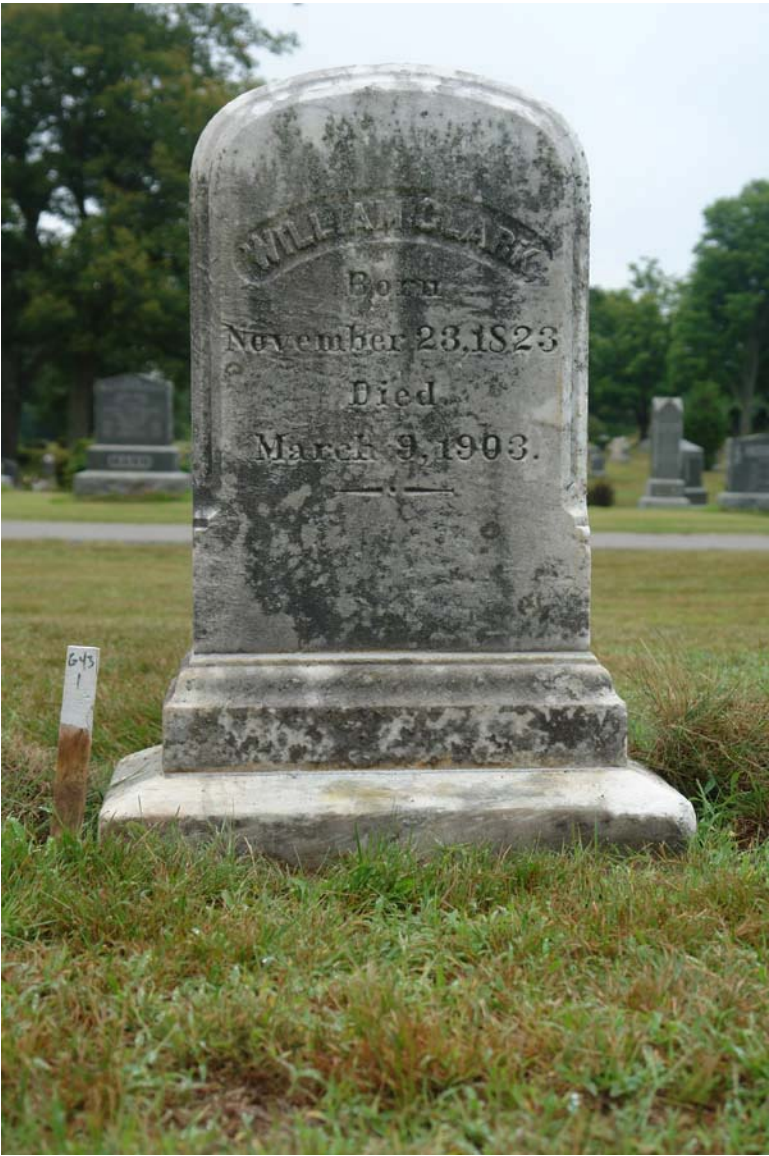
Hanover Center Cemetery, Hanover MA
NAME ON MARKER **William Clark**
Death Date: 3/9/1903 Marker Type: Headstone/pinned base
Cond. of Inscription: Legible Material: Marble

EXISTING CONDITIONS	CONSERVATION STRATEGY
Tilted base	Reset base with marker plumb

TREATMENT	Treatment Dates
1. Elements removed from setting bases and inspected for soundness. 2. Area excavated to an appropriate depth removing any roots or large stones. 3. Base is aligned with adjacent markers and re-set level. 4. Area around base was backfilled with tamped gravel and re-graded with existing topsoil 5. Failed mortar removed from setting area and bottom of marker 6. When required, any existing pins were inspected, and if necessary, replaced with stainless steel threaded pins 7. Setting surfaces primed with Acryl 60 diluted 1:3 with water. 8. Marker reset plumb onto base with cement/lime mortar (3/2/9) with 000 sand. 9. Excess grout removed and joint area cleaned.	8/24/2015

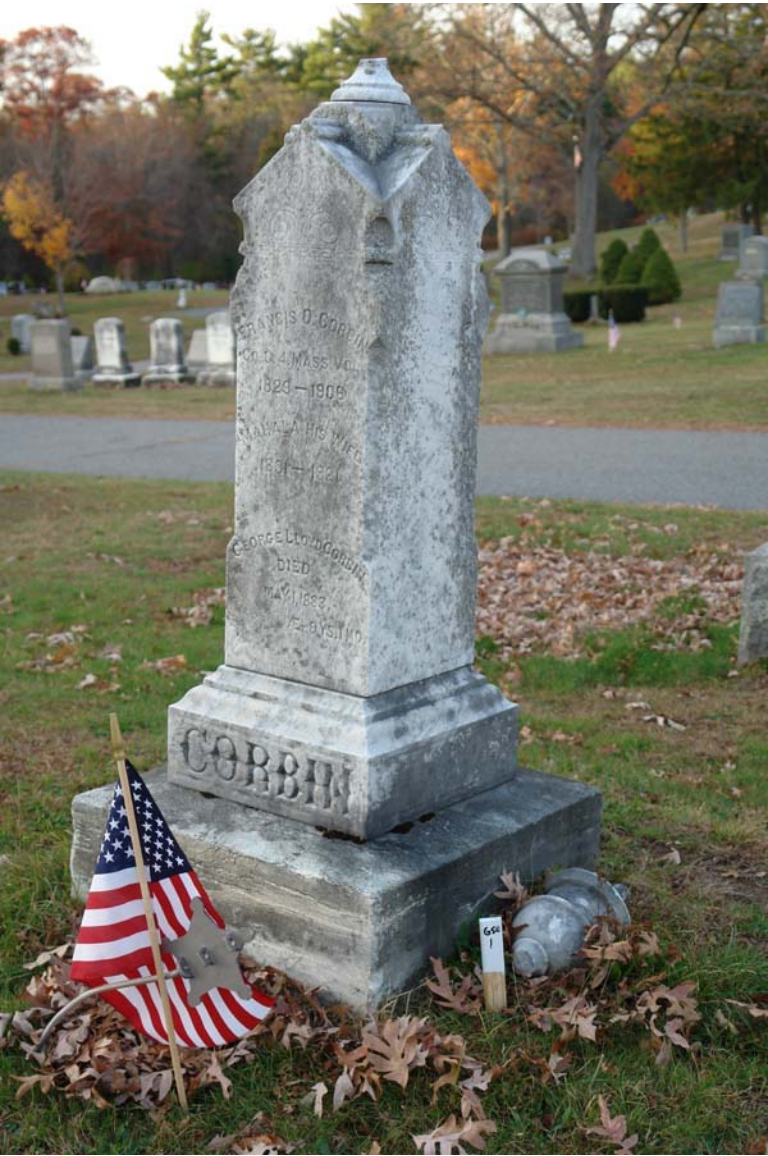
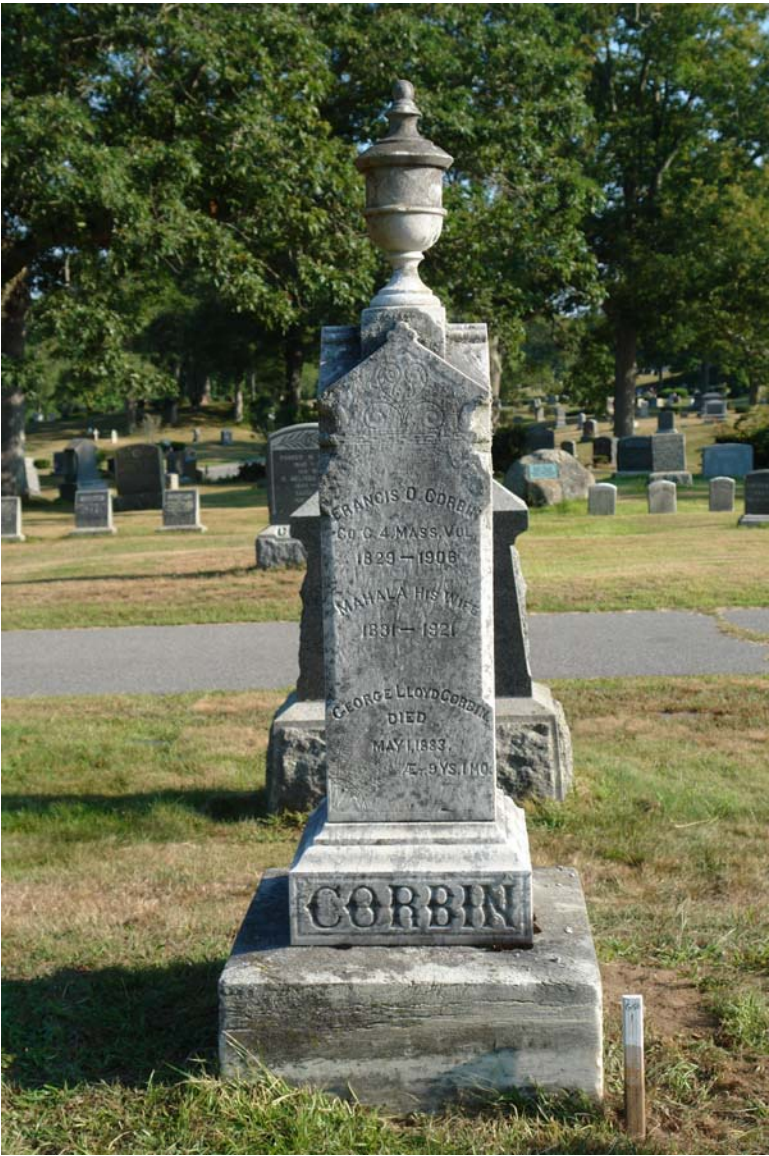
Hanover Center Cemetery, Hanover MA	
NAME ON MARKER	Francis Corbin
Death Date: 1906	Marker Type: Monument
Cond. of Inscription: Decipherable	Material: Marble
EXISTING CONDITIONS	CONSERVATION STRATEGY
Final fractured and fallen	Attach finial with structural adhesive
TREATMENT	
Treatment Dates 8/31-9/1/2015	
1. Soil removed around base unit and base raised up with hydraulic jacks to level.	
2. Existing foundation stones exposed and built up to support base unit.	
3. Base re-set plumb at appropriate height and level	
4. Area beneath and around base backfilled with tamped sand and gravel	
5. Disturbed areas re-graded with existing topsoil.	
6. Finial attached with structural adhesive

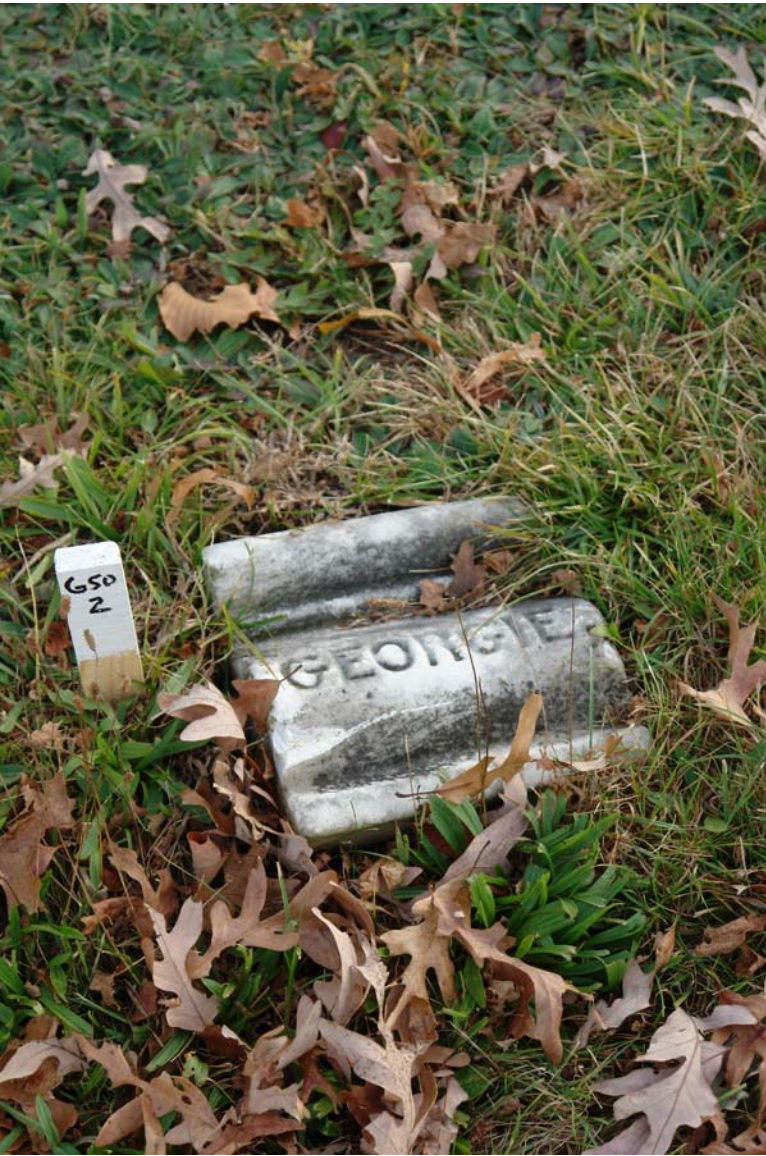
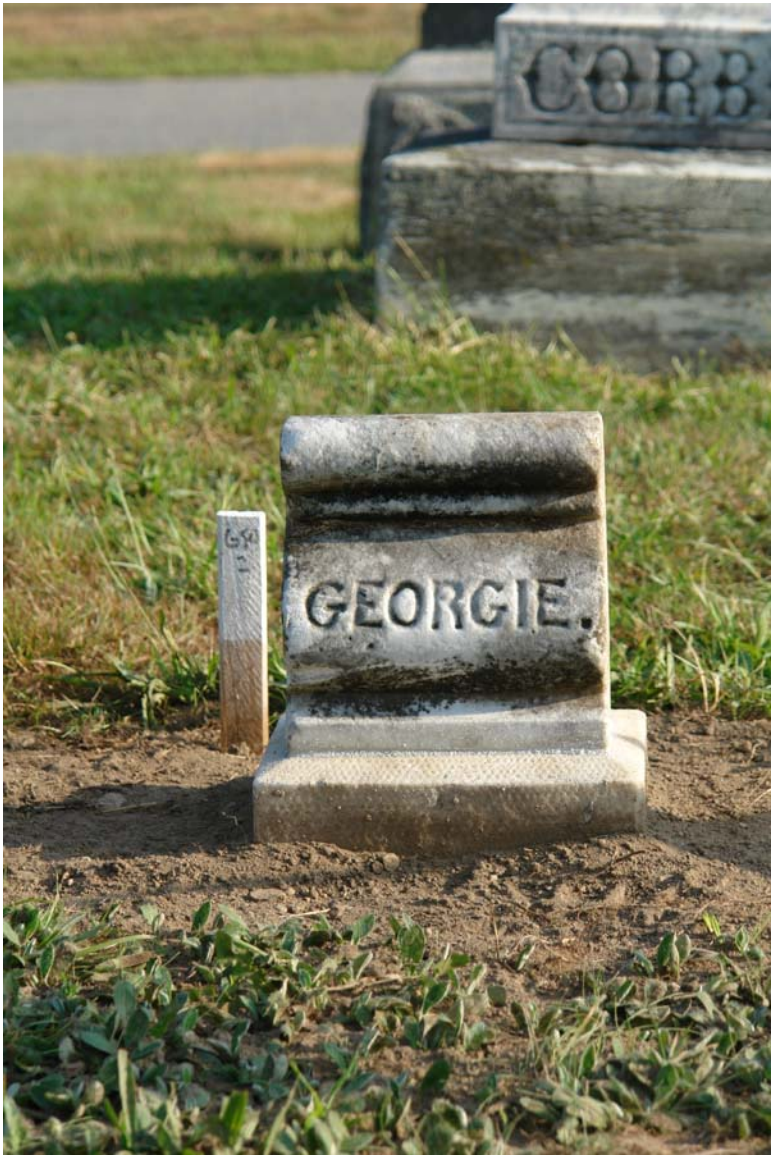
Loose on post

1. Marker excavated and found to be sound. Light soiling removed by brushing with nylon brushes and water.

7. Disturbed areas backfilled with existing topsoil.

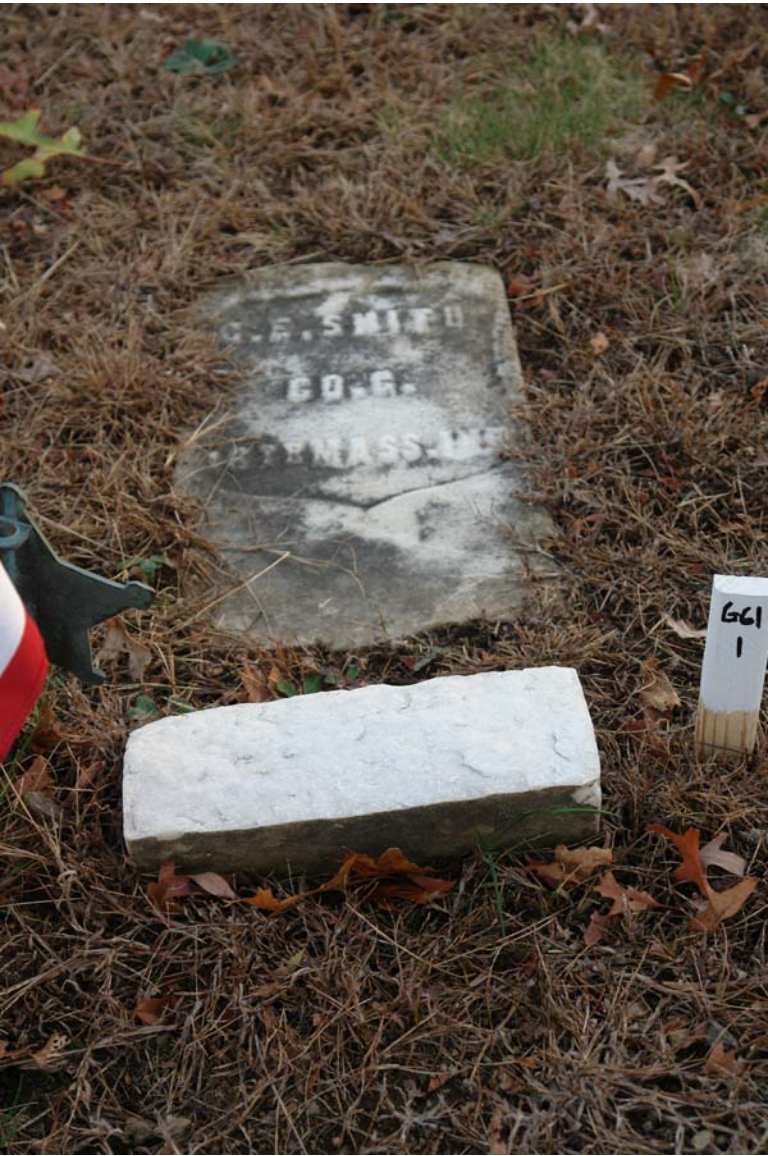
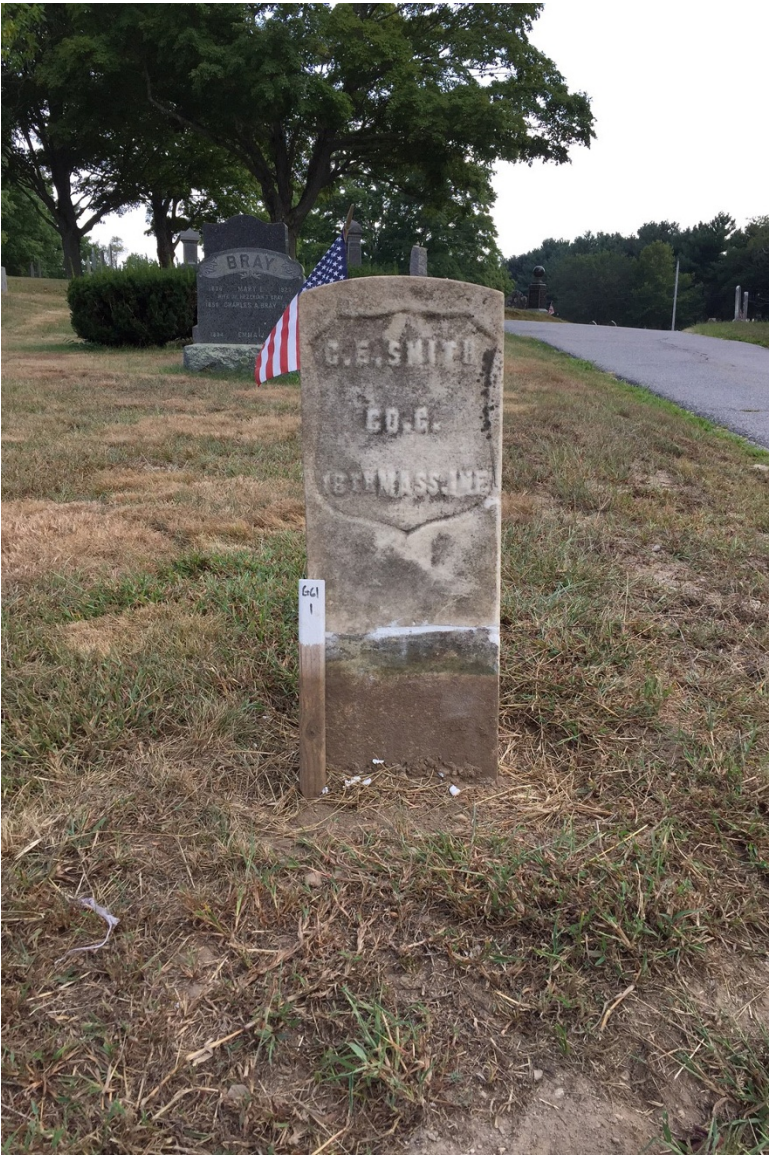
Hanover Center Cemetery, Hanover MA		
NAME ON MARKER		G.E. Smith
Death Date:	Marker Type: Headstone	
Cond. of Inscription: Legible	Material: Marble	
EXISTING CONDITIONS		CONSERVATION STRATEGY
Tilted Fractured		Reset in ground fragment plumb Attach fragments with structural adhesive
TREATMENT		
		Treatment Dates 8/26-9/1/2015
1. Area excavated to an appropriate depth removing any roots or large stones aligning base and lower fragment with adjacent markers and re-set level.		
2. Mating edges cleaned with water and dried.		
3. Fragments attached with structural adhesive, clamped and braced until cured. Epoxy removed with hand chisels within 24 hours.		
4. Cracks and losses filled with RepliCal Marble products or Jahn restoration mortar.		
5. Filled areas misted with water and covered for 3 days minimum		
6. Filled surface areas treated with light acid wash and rinsed thoroughly

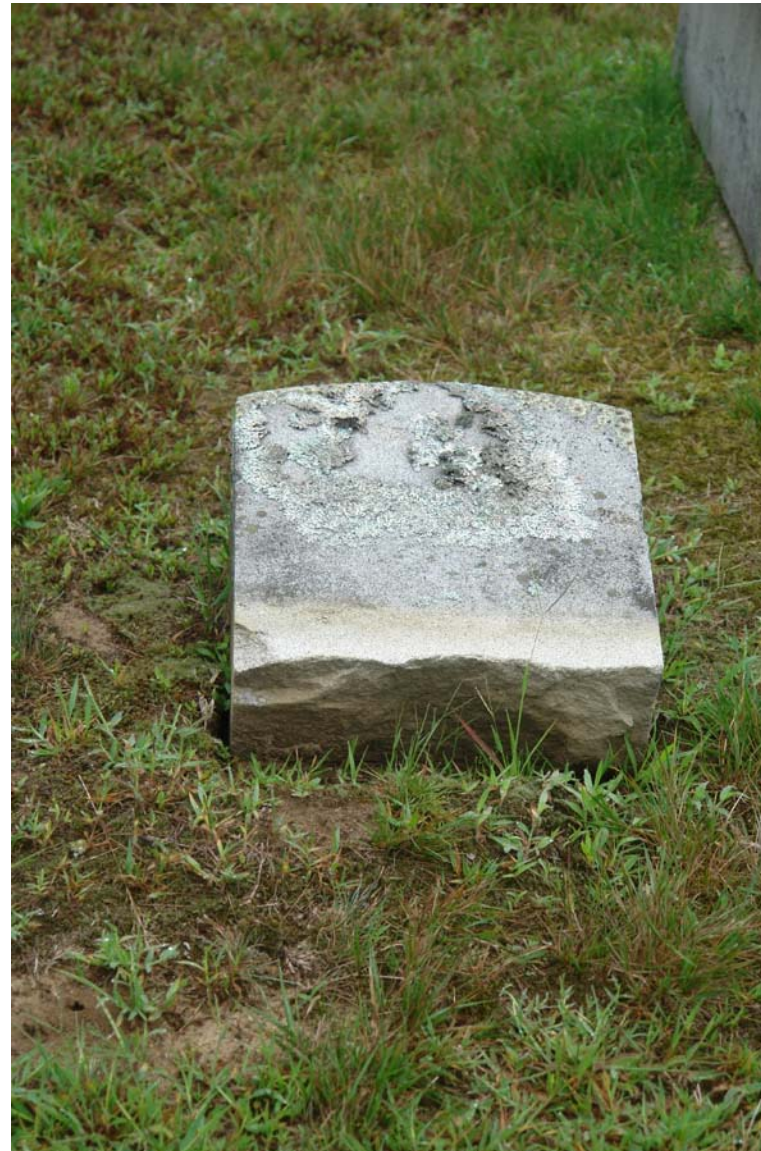
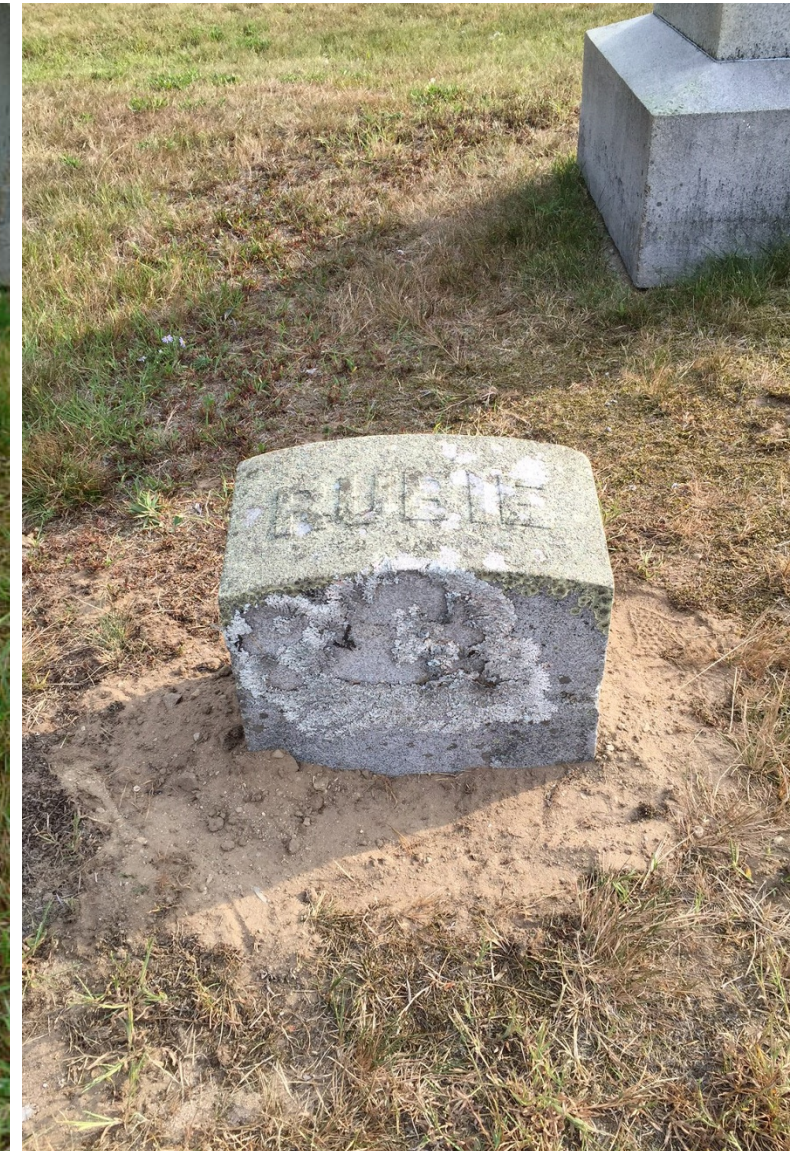
EXISTING CONDITIONS

1. Existing base located below grade while excavating for resetting. Area excavated to an appropriate depth removing any roots or large stones.
2. Base inspected and found to be sound and re-useable
3. Base is aligned with adjacent markers and re-set level.
4. Area around base was backfilled with tamped gravel and re-graded with existing topsoil
5. Failed mortar removed from setting area and bottom of marker
6. Setting surfaces primed with Acryl 60 diluted 1:3 with water.
7. Marker reset plumb onto base with cement/lime mortar (3/2/9)
8. Excess grout removed and joint area cleaned.

Comments: **Alongside roadway**
