MONUMENT CONSERVATION COLLABORATIVE LLC, NORFOLK, CT

DOCUMENTATION OF STONE CONSERVATION TREATMENTS TO ASSINIPPI CEMETERY, HANOVER, MA June 2015

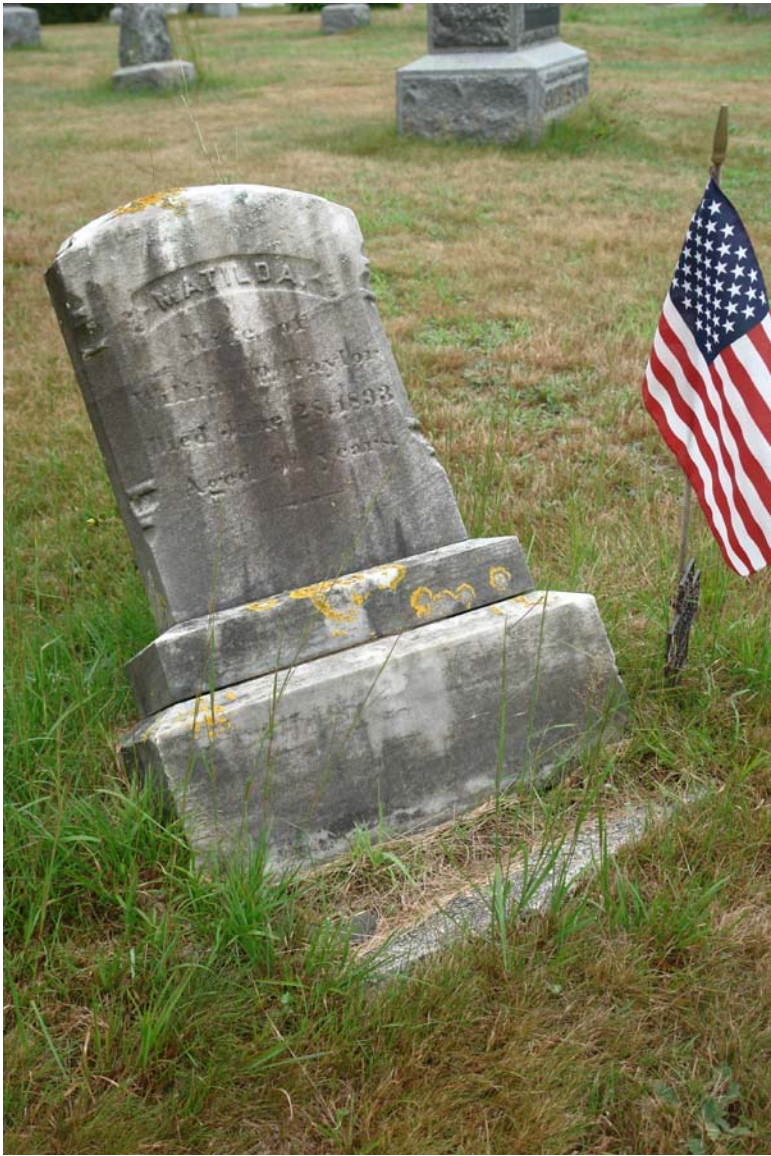
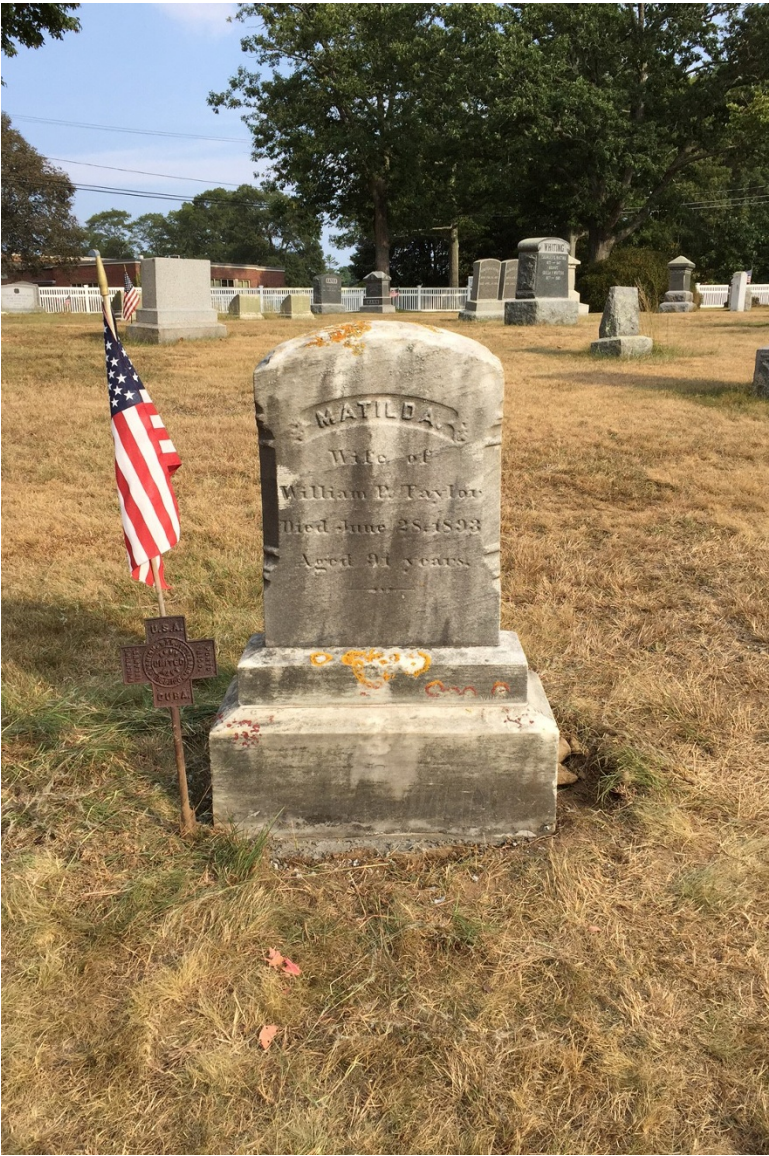
Hanover Center Cemetery, Hanover MA		
NAME ON MARKER		Matilda Taylor
Death Date:	6/28/1893	Marker Type: Headstone
Cond. of Inscription:	Legible	Material: Marble
EXISTING CONDITIONS		CONSERVATION STRATEGY
Tilted, unstable		Reset plumb
TREATMENT		
Treatment Dates		9/9/2015
<div>1. Elements removed from setting bases and inspected for soundness.</div> <div>2. Area excavated to an appropriate depth removing any roots or large stones.</div> <div>3. Base is aligned with adjacent markers and re-set level.</div> <div>4. Area around base was backfilled with tamped gravel and re-graded with existing topsoil</div> <div>5. Failed mortar removed from setting area and bottom of marker</div> <div>6. When required, any existing pins were inspected, and if necessary, replaced with stainless steel threaded pins</div> <div>7. Setting surfaces primed with Acryl 60 diluted 1:3 with water.</div> <div>8. Marker reset plumb onto base with cement/lime mortar (3/2/9) with 000 sand.</div> <div>9. Excess grout removed and joint area cleaned.</div>

Comments: **Located in area beyond section G**
